# Building and Timber Pest Inspection Report

Inspection Date: Tue, 30 Dec 2025

Property Address: 4/10 Siracusa Ave, Point Cook VIC 3030,  
Australia

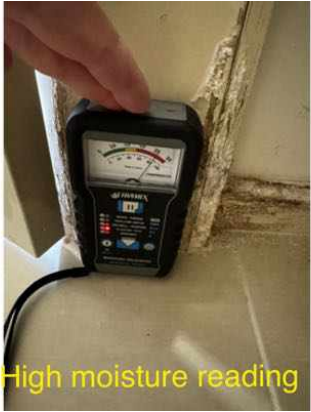
Building:	Main Building
Location:	Laundry > Ground Level
Finding:	Suspected moisture ingress to ground floor laundry and adjoining areas
Information:	<p>Very high moisture readings were detected to the ground floor laundry, particularly within the linen cupboard and beneath the laundry trough. Visible damage was observed to plaster walls, skirting boards, door jambs and tiled skirtings, with sections starting to separate from the wall at floor junctions. Moisture meter testing confirmed very high readings to the floor tiles and lower wall elements in these locations. The affected wall behind the laundry trough and linen cupboard is a boundary wall. A visual inspection of the adjoining property indicates suspected poor site drainage, with external paving sloping toward the boundary wall and no visible drainage provisions, which may be directing surface water toward the foundations and allowing moisture to migrate into the building envelope over time. An internal plumbing leak cannot be ruled out as a contributing factor. Additional moisture testing to surrounding wet areas, including the powder room, recorded medium moisture levels, suggesting suspected moisture migration beneath tiled surfaces. This condition is considered a major defect under AS 4349.1–2007 due to the extent of moisture damage and potential for ongoing deterioration if left unresolved.</p>

High moisture reading

A licensed plumber should be engaged to investigate and rule out any internal plumbing leaks. A qualified building consultant or waterproofing specialist should assess the boundary wall, footings (if accessible), and surrounding wet areas to determine the source and extent of moisture ingress. Rectification may require drainage improvements, damp-proofing or waterproofing works to the boundary wall, and replacement of moisture-damaged internal finishes. Coordination with the neighbouring property owner may be required if external drainage is contributing to the issue.

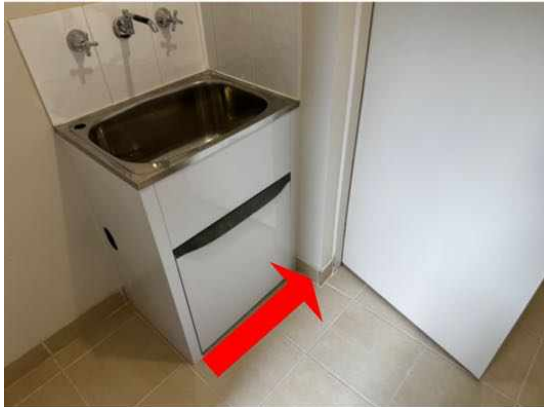
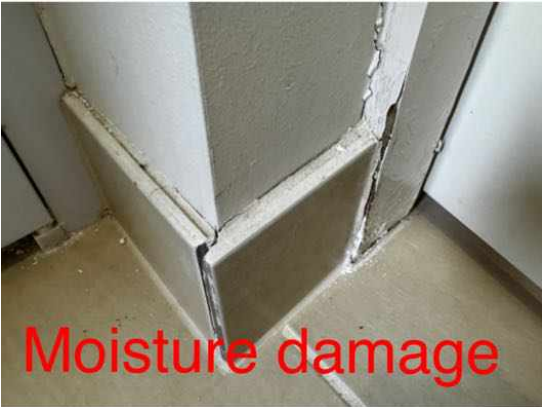
Moisture damage

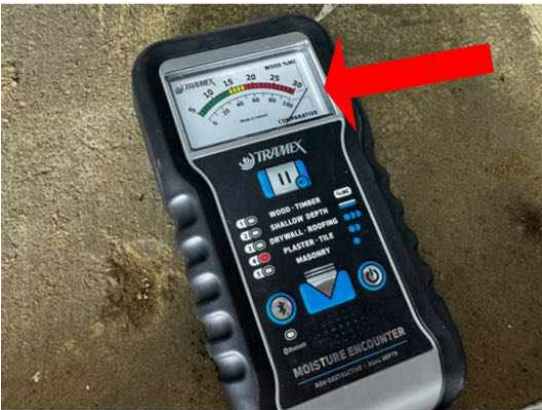
Boundary wall

Neighbours side

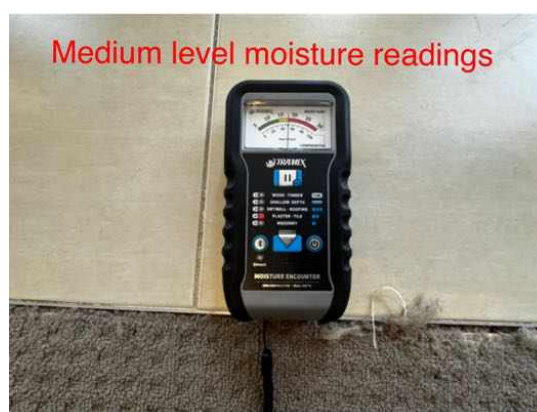
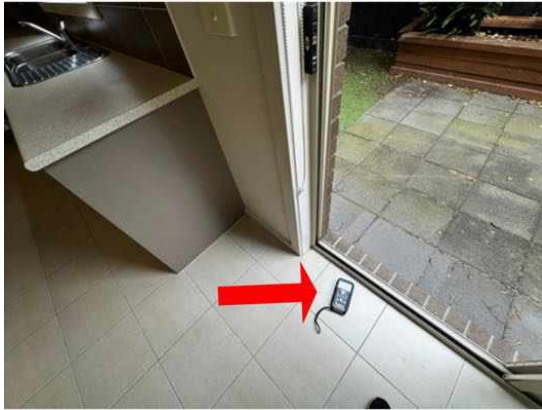
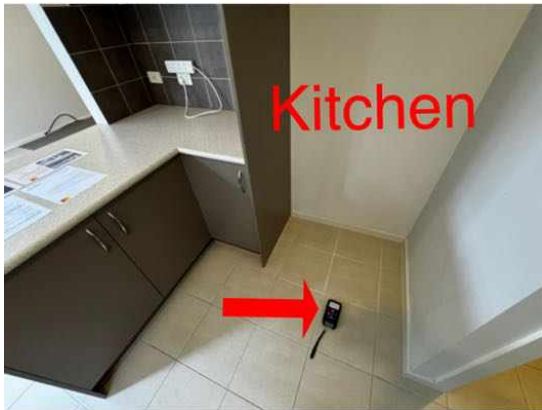
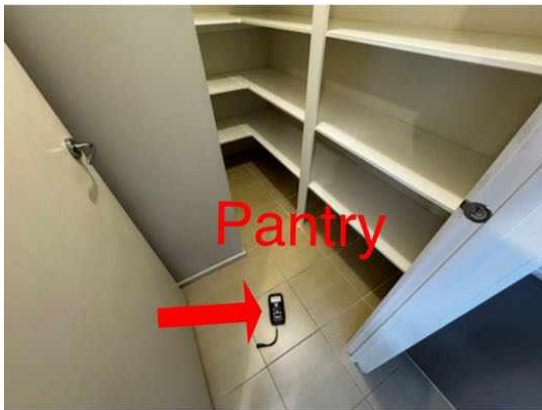
Building: Main Building  
Location: Dining, kitchen, pantry > Ground Level  
Finding: Suspected moisture ingress beneath tiled floors to kitchen, dining and pantry areas  
Information: Medium to high moisture readings were recorded to the tiled floor areas within the kitchen, dining and pantry during moisture meter testing. No visible signs of active plumbing leaks were observed at the time of inspection; however, the elevated readings indicate suspected moisture migration beneath the tiles. It is considered possible that moisture is travelling from the subgrade or footing level, potentially associated with suspected poor site drainage conditions, including surface water being directed toward the building from neighbouring land. Other potential moisture sources, such as concealed plumbing leaks or historic moisture ingress, cannot be ruled out without further investigation. This condition represents a suspected major defect under AS 4349.1–2007 due to the risk of ongoing deterioration to floor finishes, substrates and adjoining building elements if left unresolved.

Immediate. Further investigation is recommended without delay to identify the moisture source and prevent progressive damage to floor systems and internal finishes.

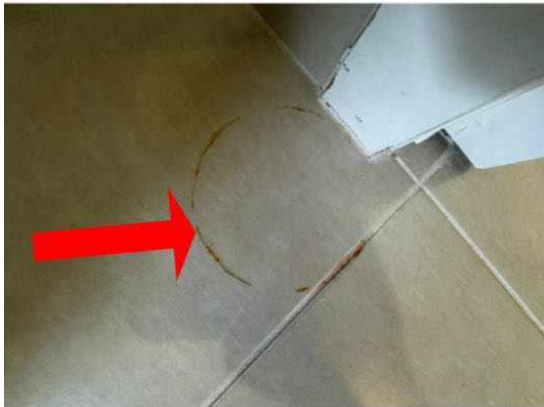
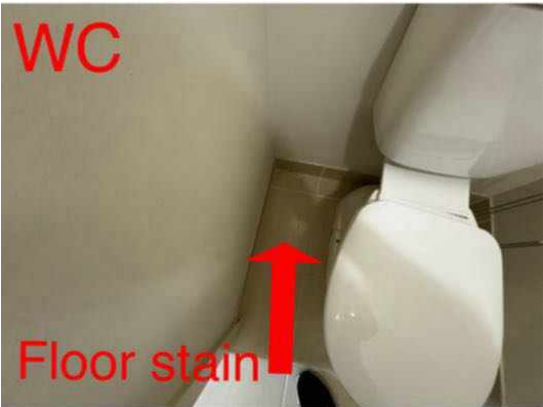
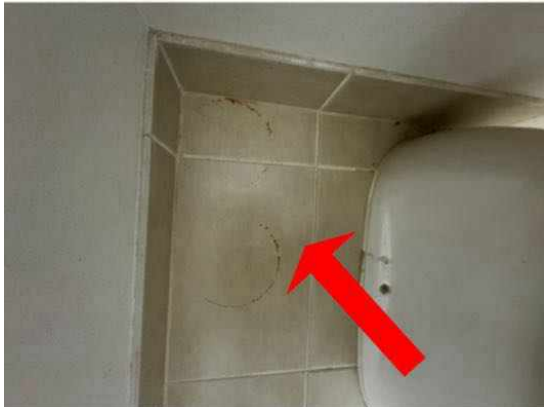
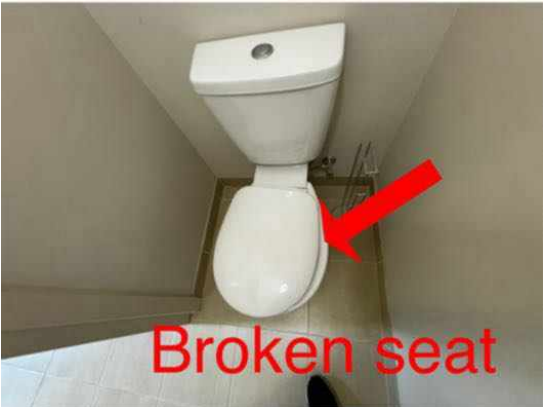
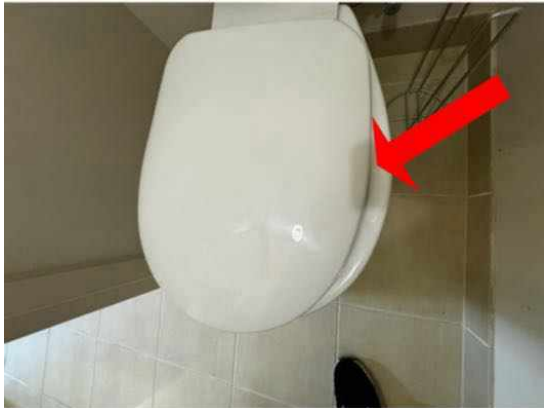
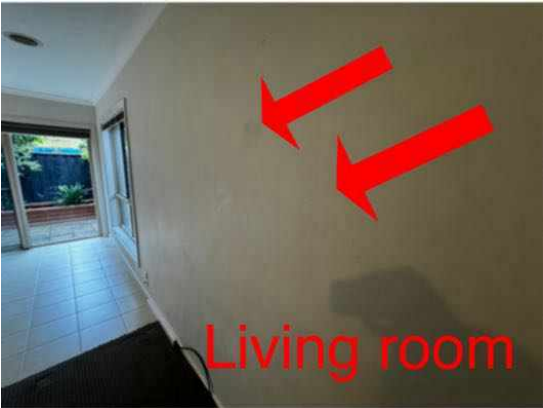
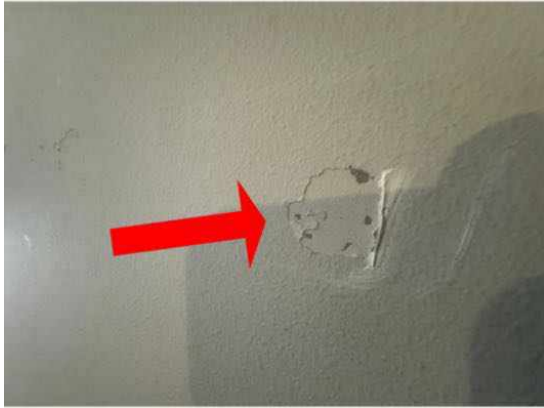
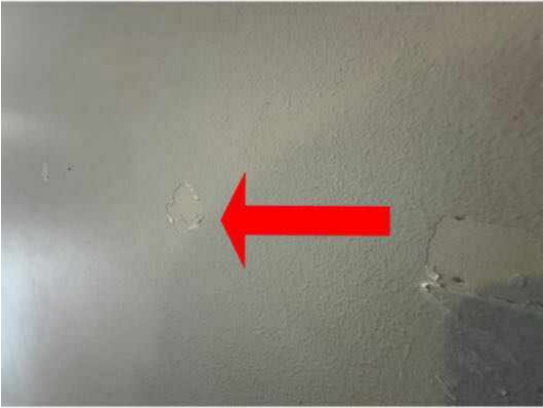
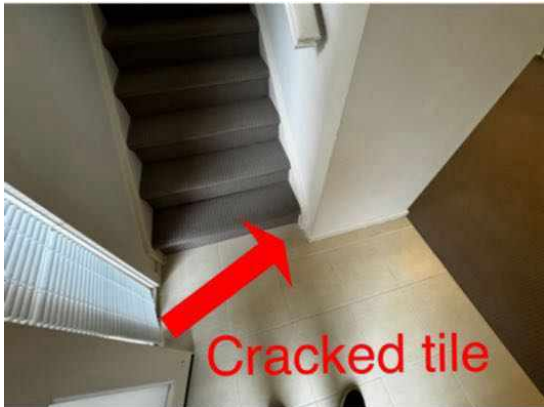
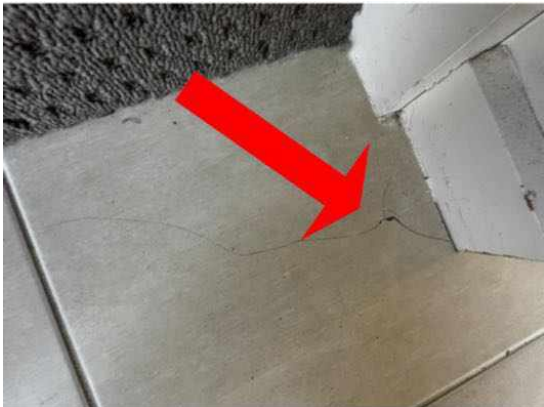
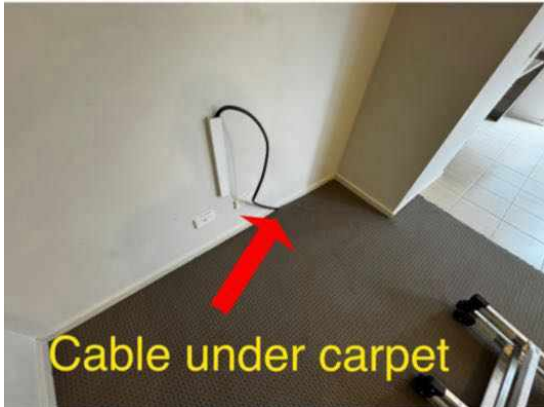
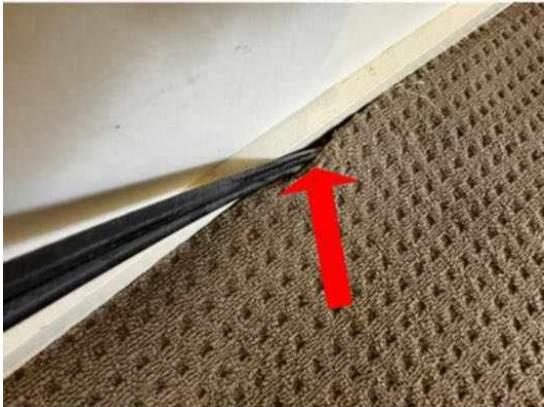
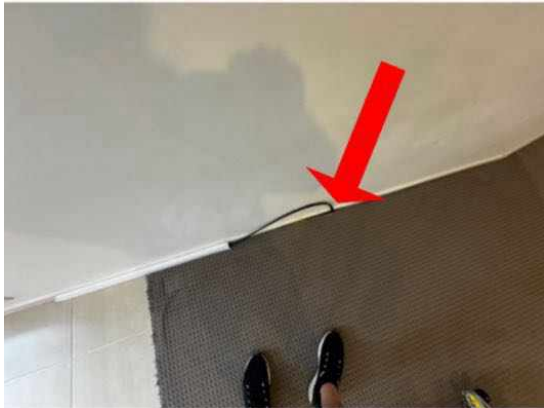
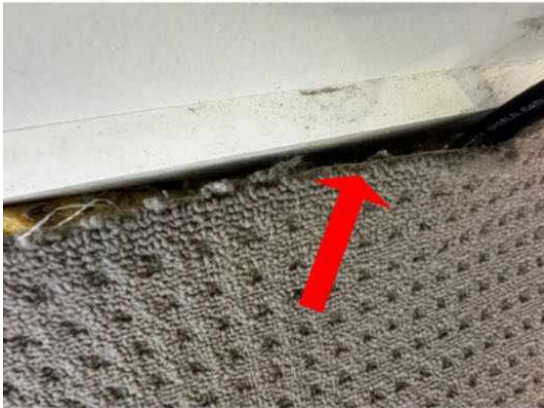
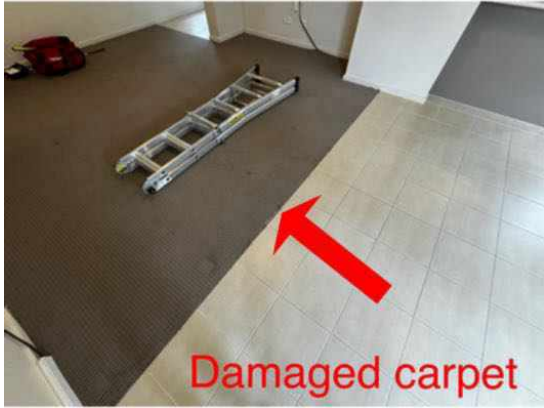
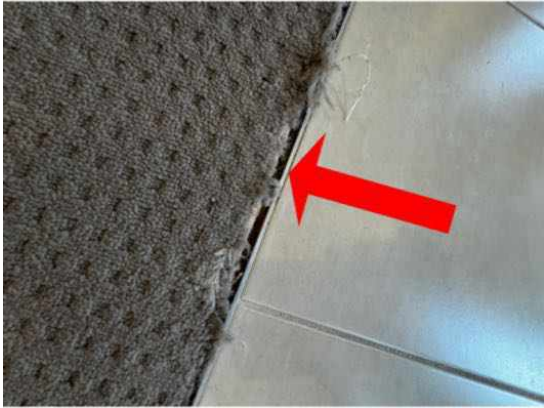
Building: Main Building  
 Location: All Areas > All Areas  
 Finding: Internal finishes defects and minor serviceability issues throughout dwelling  
 Information: Cracked and damaged plaster walls and ceilings were observed in multiple internal areas, along with carpet damage throughout the dwelling. A non-operational window winder and a damaged window blind were noted, affecting functionality and amenity. The main entry door does not latch correctly and the laundry door was observed to bind, indicating suspected installation or alignment issues. Staining was present to the powder room floor tiles, along with a broken toilet seat and a cracked floor tile. In addition, loose low-voltage cabling consistent with TV aerial or data cables was observed running beneath carpeted flooring. While these cables are not electrical, their location beneath floor coverings presents a suspected trip hazard and may lead to damage to the cabling over time. In accordance with AS 4349.1–2007, these matters are generally consistent with minor defects relating to poor finish, wear, or installation quality.

A licensed builder or handyman should repair damaged plaster surfaces, adjust or rehang doors so they latch and operate correctly, and replace damaged carpets, tiles, and sanitary fittings as required. A glazier or window installer should rectify the non-operational window winder and damaged blind. A qualified cabling technician or electrician should reroute or secure the TV aerial/data cabling within wall cavities or conduits to eliminate the trip hazard and protect the cables from damage.

Within the next 3 months, with the loose cabling beneath carpet addressed as a priority to reduce trip risk.

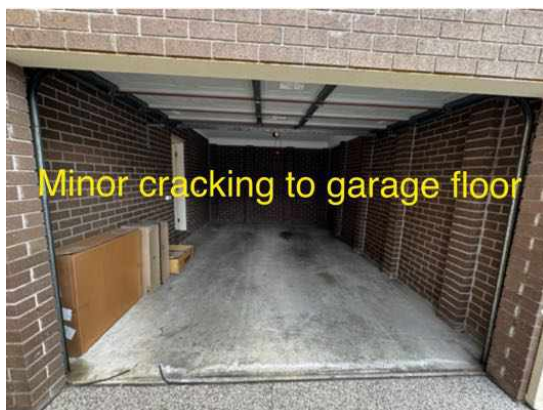
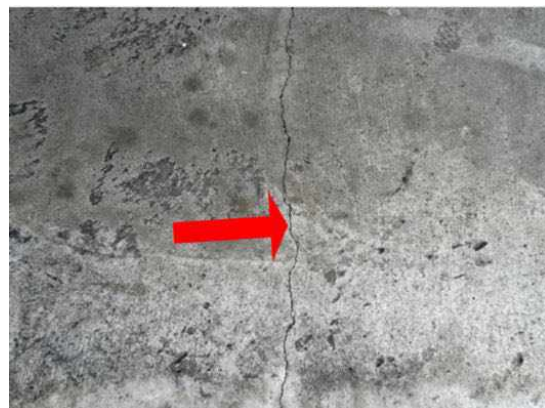
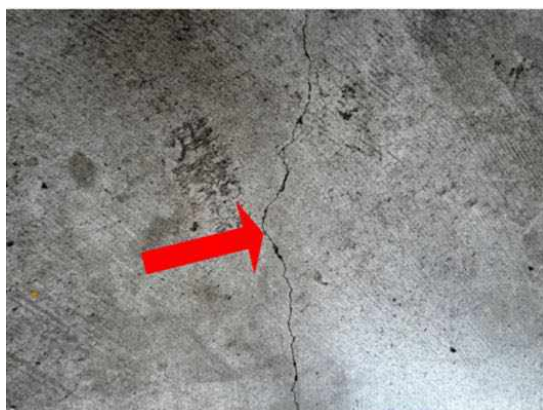
### Finding 3.04

Building:	Main Building
Location:	Garage > Front Right
Finding:	Garage floor cracking, oil staining, and incomplete finishes
Information:	Multiple cracks measuring less than 5 mm in width were observed to the concrete garage floor, which are consistent with minor shrinkage or age-related movement and are suspected to be within acceptable tolerances. A large oil stain was also present on the garage floor, which is cosmetic in nature but detracts from presentation. The garage door motor was observed to be missing its protective cover, leaving electronic components exposed; however, the garage door was tested at the time of inspection and was operational. In addition, incomplete paintwork was noted to the plaster

cornice above the garage door, where a section appears to have been replaced at some stage but not finished. The repair is suspected to relate to a previously cracked roof tile directly above this area, which appears to have been patched using a putty-type material. A moisture meter was used to test the affected ceiling area, and no abnormal moisture readings or active water leaks were detected at the time of inspection. In accordance with AS 4349.1-2007, these items are considered minor defects, as they do not currently affect structural performance but indicate incomplete maintenance and workmanship.

Monitor the garage floor cracks for any change in width or movement. Clean or treat the oil-stained area if improved presentation is desired. Reinstall or replace the missing garage door motor cover to protect electrical components. Complete painting to the repaired plaster cornice to achieve a consistent finish. The roof tile repair above this area should be reviewed by a licensed roof plumber to confirm it is weather-tight and durable.

Within the next 6–12 months as part of general maintenance, or sooner to prevent deterioration of finishes and exposed components.

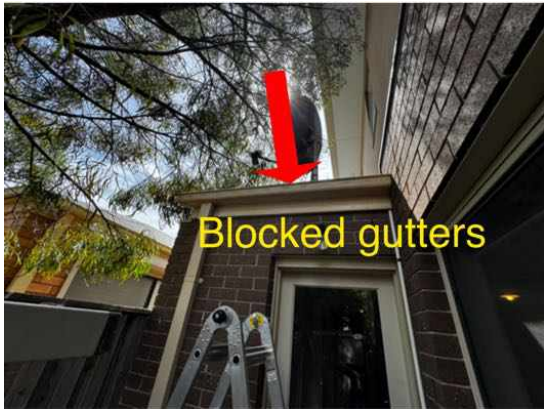
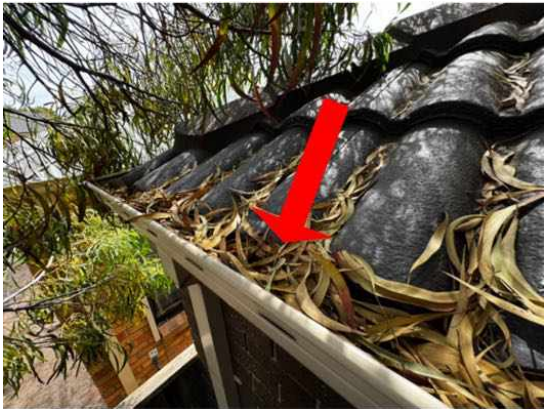
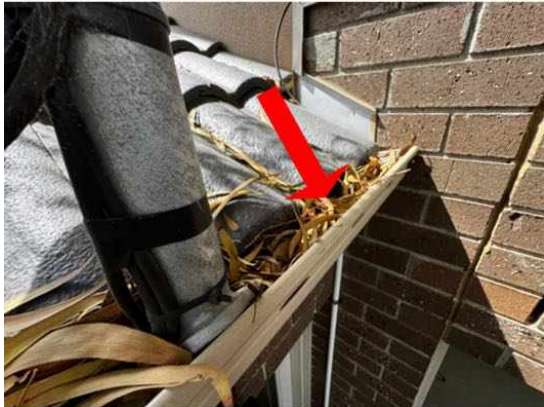
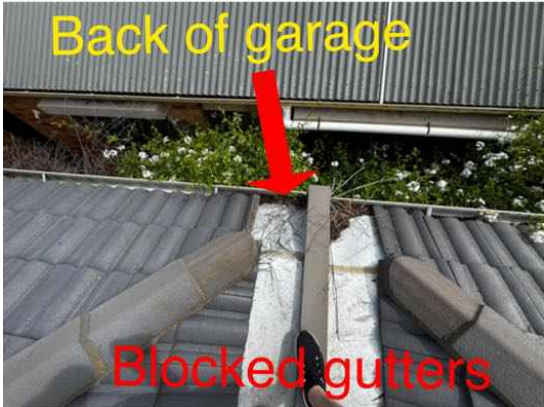
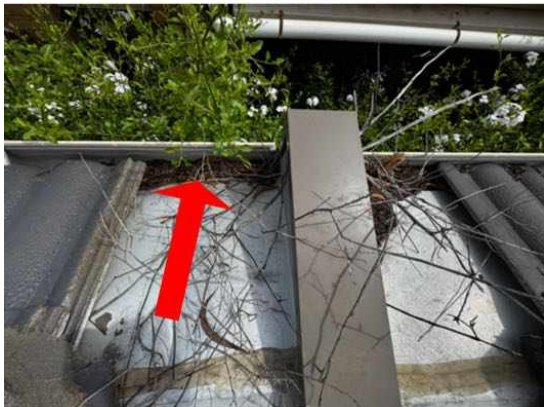
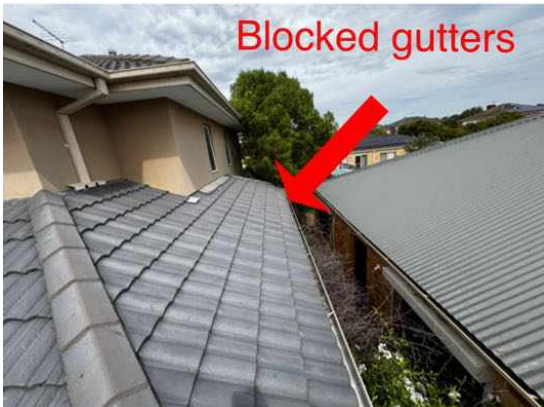
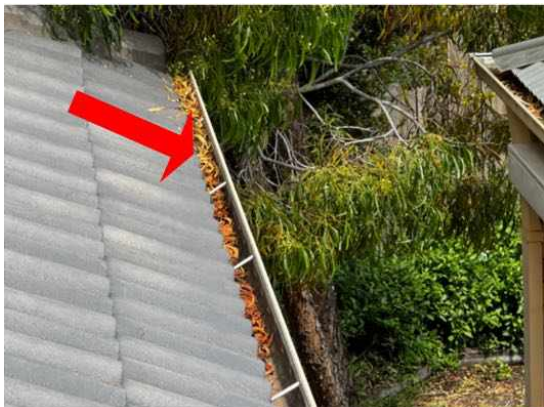
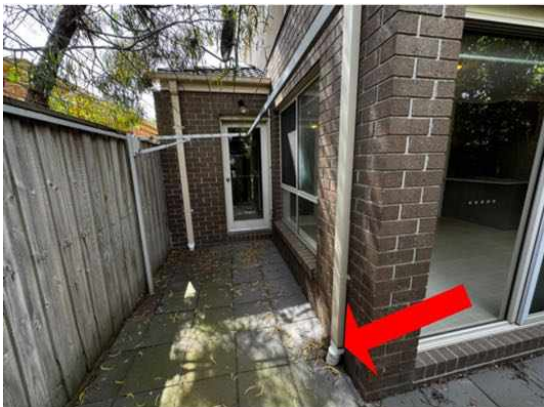
Building:	Main Building
Location:	Roof gutters, downpipe > All Areas
Finding:	Blocked gutters, compromised downpipe, and uncontrolled discharge from air-conditioning overflow
Information:	At the time of inspection, roof gutters located behind the garage and above and behind the boundary wall were observed to be blocked with accumulated organic matter. This condition is suspected to restrict effective roof drainage and may result in water overflow during rainfall events.

In addition, a downpipe located in the rear yard was observed to be slightly separated at its base, leaving a visible gap that may allow water to leak and discharge onto the ground during rainfall. This condition is suspected to contribute to ongoing moisture accumulation adjacent to the building.

It was also noted that the overflow pipe from the air-conditioning condenser unit was not connected to a suitable drainage system and was discharging directly onto the ground. This uncontrolled discharge further contributes to localised damp conditions around the building.

In accordance with AS 3660.2, poor roof drainage and uncontrolled discharge of water are recognised as conditions that increase termite risk, as persistent dampness around building elements and foundations can create environments conducive to termite activity and concealed foraging. Blocked gutters, leaking downpipes, and unconnected overflow pipes may therefore increase moisture exposure and undermine effective termite risk management.

As a result, these drainage-related defects are considered to increase the risk of moisture-related deterioration and termite activity. It is recommended that an appropriately qualified roof plumber and/or air-conditioning technician be engaged to clean and service the gutters, repair or reconnect the downpipe, and connect the air-conditioning overflow to an approved drainage point, ensuring that water is not discharged directly onto the ground, with further advice from a licensed termite management or pest control contractor where elevated termite risk is identified.

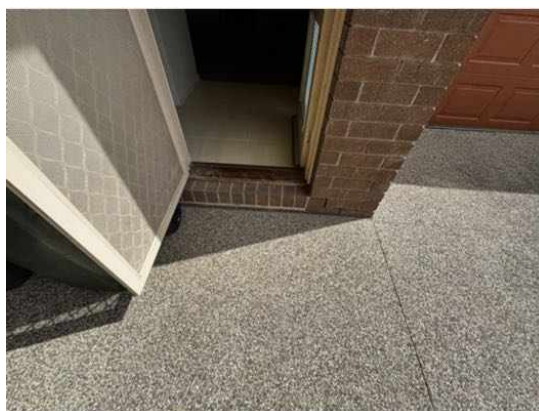
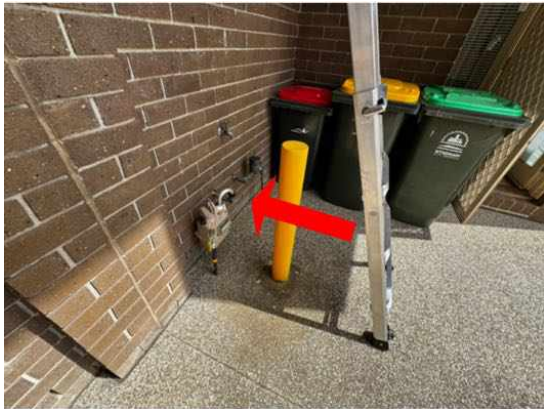
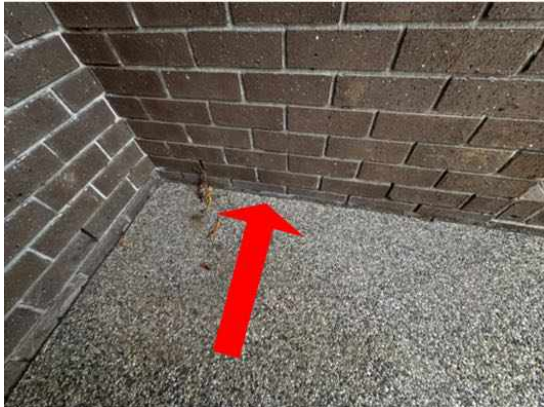
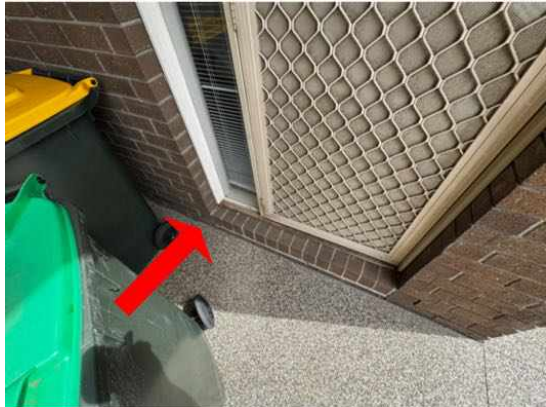
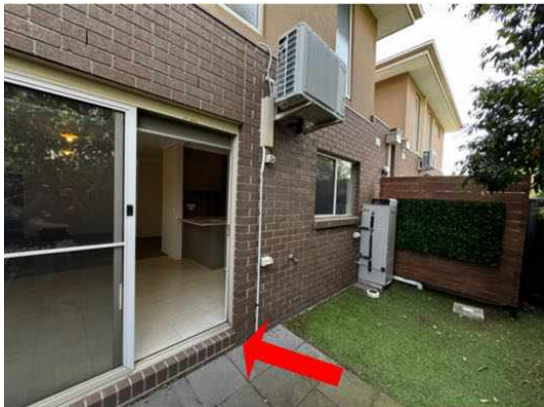
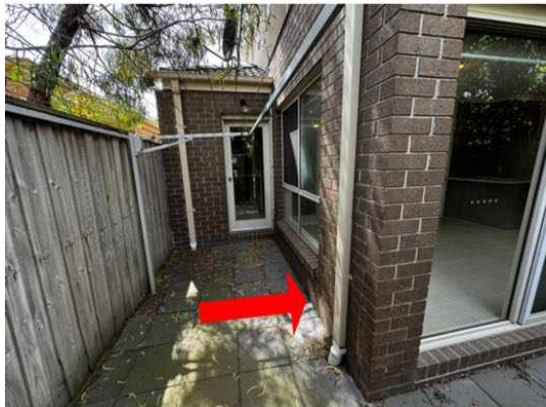
### Finding 6.02

Building: Main Building  
Location: Walls > All Areas  
Finding: Concrete paved porch are hard up against building (TP)  
Information: At the time of inspection, the concrete paved areas was observed to be constructed hard up against the building, concealing the slab edge. This condition restricts visual access to the slab perimeter and limits the ability to inspect critical areas intended for early detection of termite activity.

Effective termite risk management for existing buildings relies on maintaining accessible inspection zones around the structure. Where slab edges are concealed by paving or other hard surfaces, concealed termite entry paths may develop without early warning, increasing the likelihood of undetected termite activity.

As a result, the paved areas are considered to increase the risk of concealed termite entry. It is recommended that a licensed termite management or pest control contractor be engaged to assess this area and provide advice on suitable rectification options, which may include modifying the paving to reinstate inspection access or implementing supplementary termite management measures appropriate to the existing conditions.

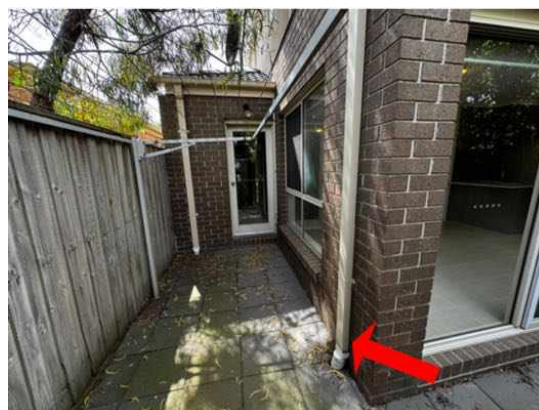
**Finding 6.03**

Building: Main Building  
 Location: Downpipes > Front Right,Rear Left  
 Finding: Downpipes hard against brickwork concealing inspection zones (TP)  
 Information: At the time of inspection, several downpipes were observed to be installed hard against the external brick walls. This configuration restricts visual access to the wall surface and slab edge behind the downpipes, making it difficult to identify early signs of termite activity.

may develop behind these elements without being readily visible, increasing the likelihood of undetected termite ingress.

As a result, the positioning of downpipes hard against the brickwork is considered to increase the risk of concealed termite entry. It is recommended that a licensed termite management or pest control contractor be engaged to assess these locations and provide advice on improving inspection access or implementing supplementary termite management measures to address the increased risk.

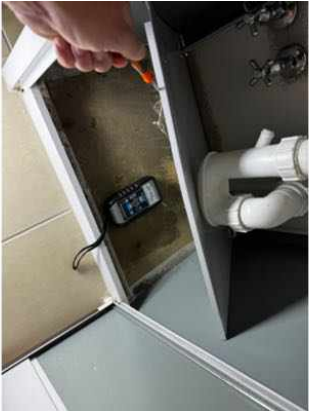
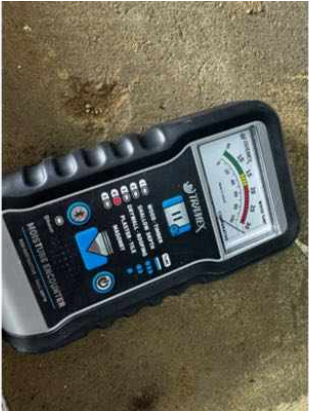
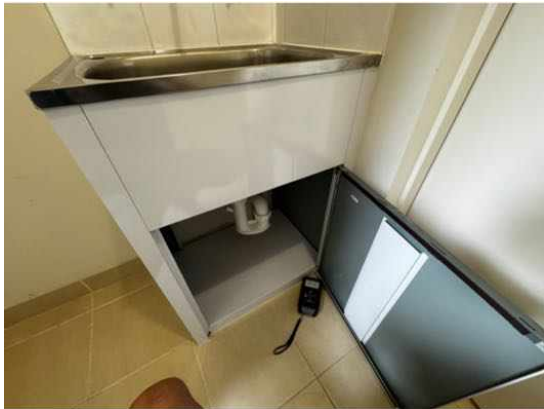
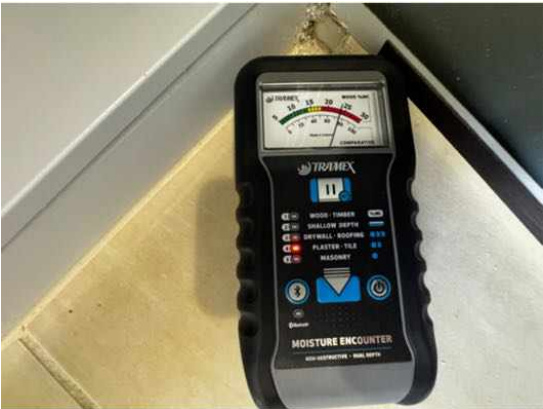
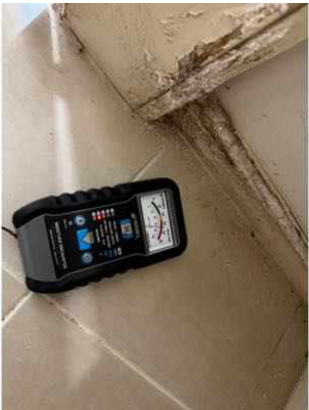
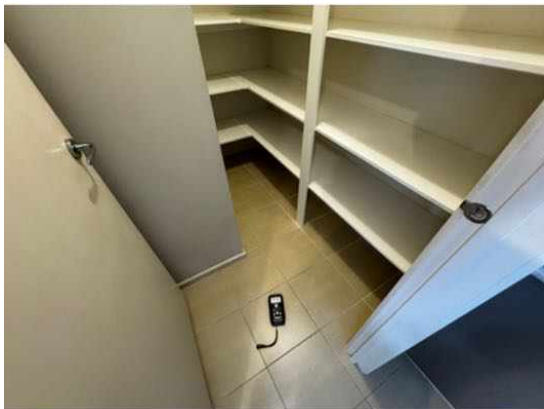
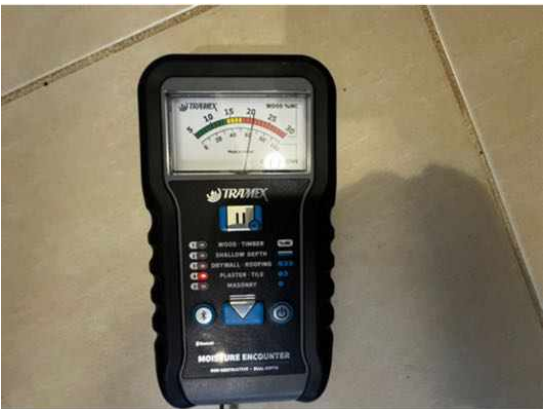
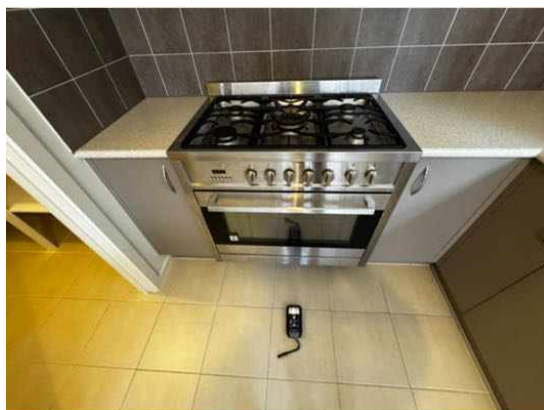
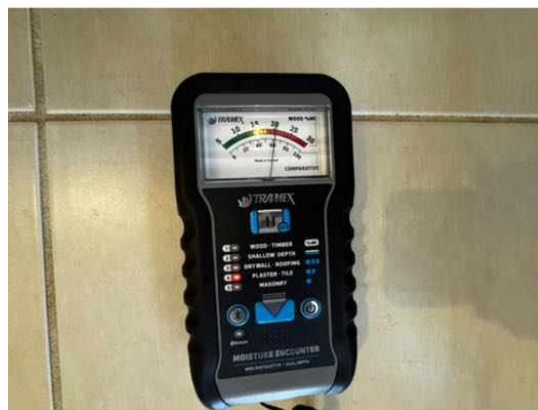
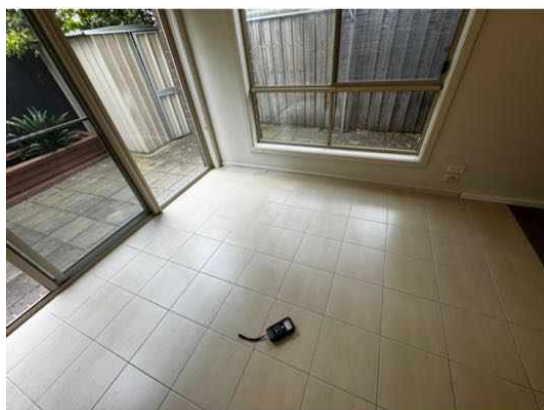
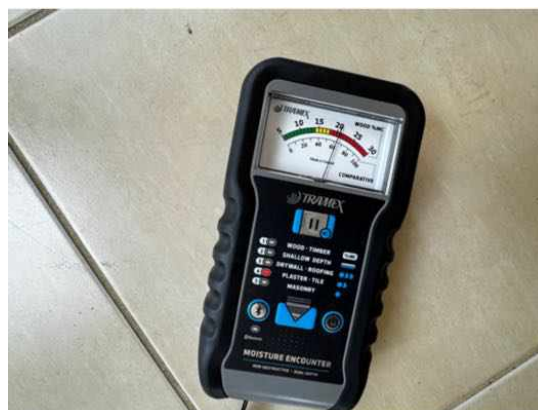
### Finding 6.04

Building:	Main Building
Location:	Tiled and wet areas > Ground Level
Finding:	Elevated moisture levels to ground floor wet and tiled areas (TP)
Information:	At the time of inspection, high moisture readings were detected using a moisture meter in the ground floor tiled and wet areas. In the laundry in particular, very high moisture readings were recorded to the floor tiles and surrounding building elements next to the laundry trough and inside the linen cupboard.

Additional elevated moisture readings were detected in the floor tiles in the dining, kitchen and pantry floors. This condition is suspected to indicate a possible internal plumbing leak within the wall or fitting or external drainage issues, and further investigation is required to confirm the source and extent of moisture ingress.

In accordance with AS 3660.2, wet areas and plumbing-related moisture issues are recognised as increasing termite risk, as persistent dampness within building elements can create conditions conducive to termite activity and concealed access. Ongoing moisture exposure may also lead to deterioration of surrounding materials, further elevating termite susceptibility.

As a result, the moisture issues identified are considered to increase the risk of termite activity and material deterioration. It is recommended that a licensed plumber be engaged to investigate and rectify the suspected leaks, with subsequent assessment by a licensed termite management or pest control contractor where elevated termite risk is identified.

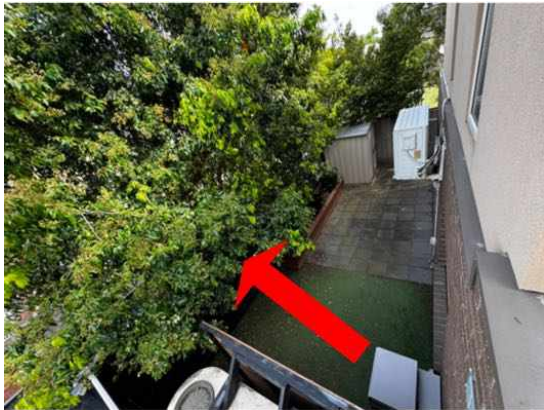
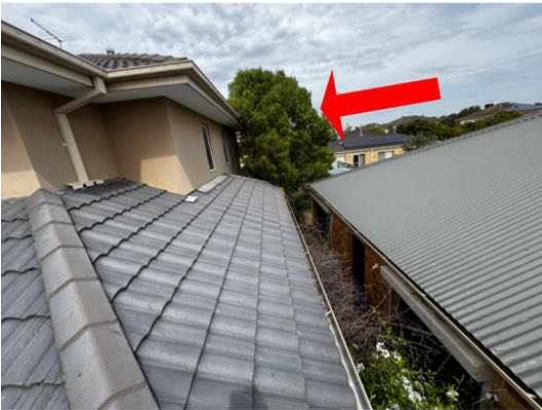
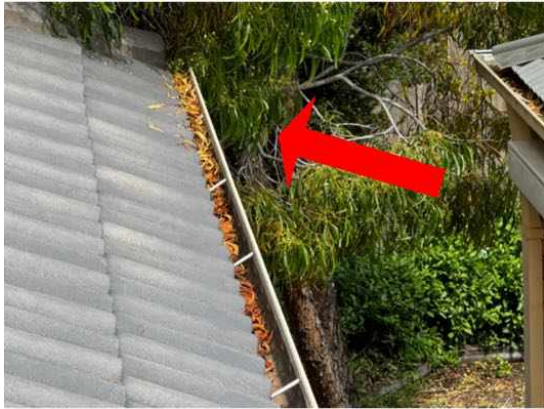
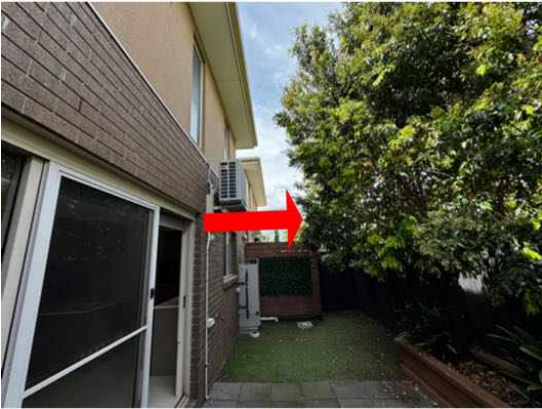
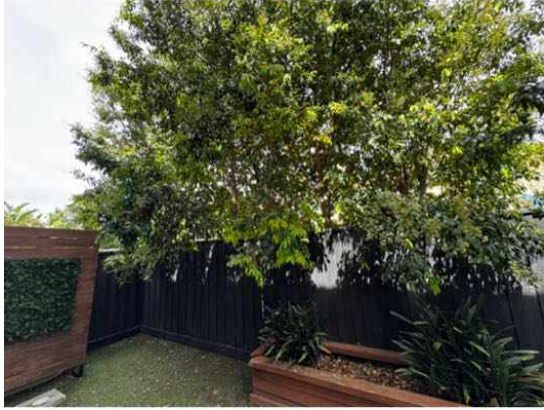
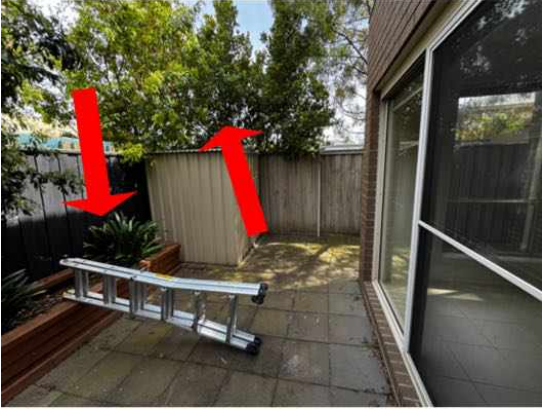
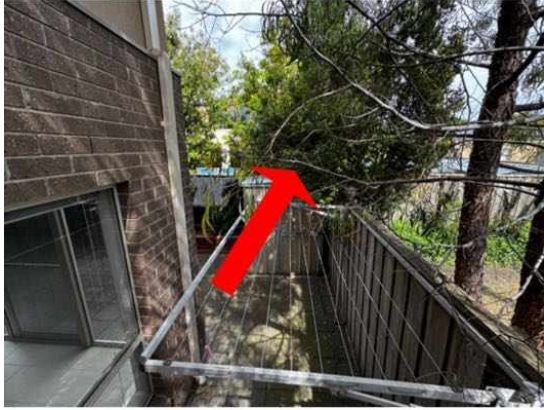
### Finding 6.05

Finding: Landscaping & vegetation - conducive conditions (TP)

Information: At the time of inspection, landscaping elements were observed to the rear yards, including mulched garden beds, trees, shrubs and neighbouring vegetation such as medium to large trees located in proximity to the building. These conditions create an environment that may be conducive to termite activity by retaining moisture and providing potential food sources and concealed access pathways.

In accordance with AS 3660.2, termite risk management for existing buildings includes consideration of environmental and site conditions surrounding the structure, as factors such as excessive moisture, mulch, garden beds, and vegetation close to the building can increase the likelihood of termite presence and concealed entry. Mulch and irrigated areas can maintain damp conditions against or near the building perimeter, while established trees and vegetation may harbour termite colonies or foraging activity that can extend toward the structure.

As a result, the existing landscaping configuration is considered to increase the overall risk of termite activity to the property. It is recommended that a licensed termite management or pest control contractor be engaged to assess the site conditions and provide advice on appropriate risk reduction measures, which may include modifying landscaping practices, managing moisture sources, and implementing or

supplementing termite management measures suitable for the existing building.

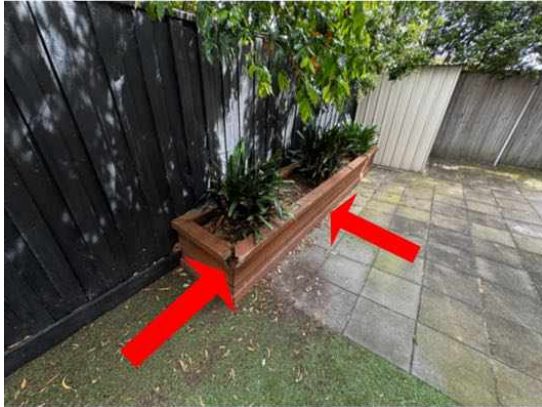
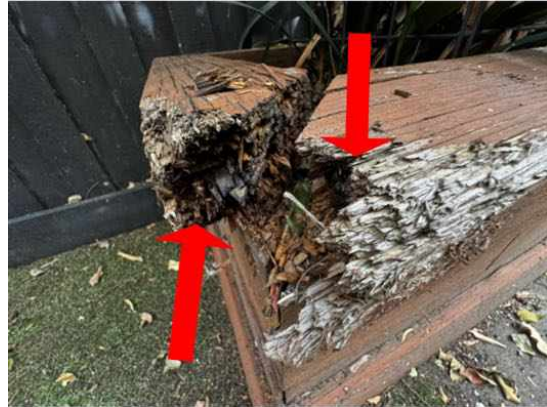
Building:	Main Building
Location:	Yard - Back > Ground Level
Finding:	Timber decay & rot - Conducive conditions (TP)
Information:	At the time of inspection, severe timber decay was observed to the rear garden bed timbers. This condition is suspected to have developed over time due to prolonged moisture exposure and a lack of appropriate timber maintenance, allowing moisture ingress and decay to progress within the timber elements.

In accordance with AS 3660.2, deteriorated and moisture-affected timber is recognised as increasing the risk of termite activity, as decayed timber can attract

termites and may provide concealed access or harbourage.

As a result, the condition of the timber garden bed is considered to present an elevated risk of ongoing deterioration and potential termite susceptibility. It is recommended that an appropriately qualified builder or carpenter be engaged to further assess the extent of timber decay, remove any concealed deteriorated material, and undertake suitable repairs or replacement, with consideration also given to advice from a licensed termite management or pest control contractor where termite risk is identified.

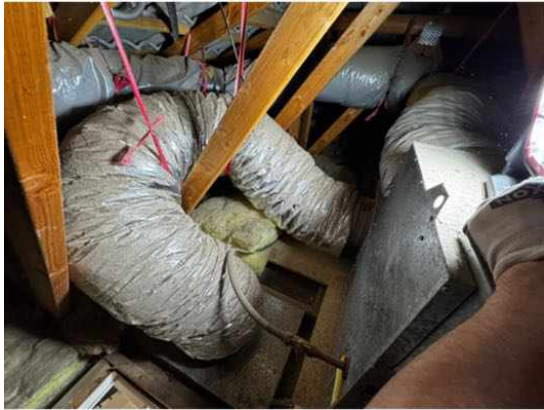
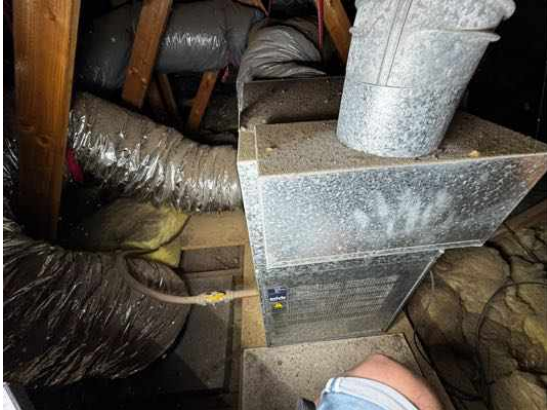
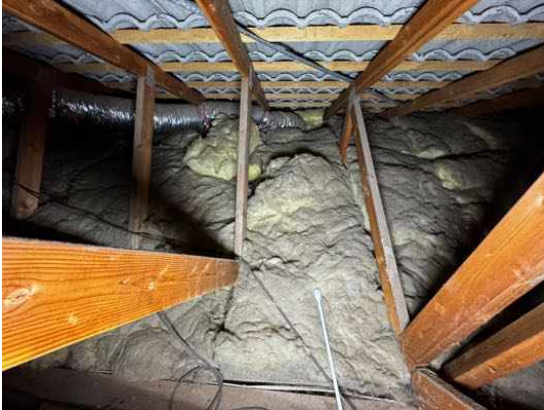
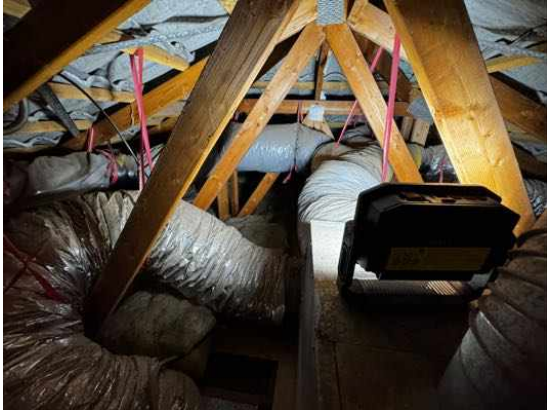
Building: Main Building  
Location: All Areas > All Areas  
Finding: Additional Photos - Obstructions and Limitations  
Information: These photographs are an indication of the obstructions and limitations which impeded full inspection of the property at the time of inspection. These obstructions can hide an array of defects and should be removed to allow full inspection to be carried out. A re-inspection is recommended once the areas are made accessible.
