# Building and Timber Pest Inspection Report

Inspection Date: Tue, 30 Dec 2025

Property Address: 4/10 Siracusa Ave, Point Cook VIC 3030,  
Australia

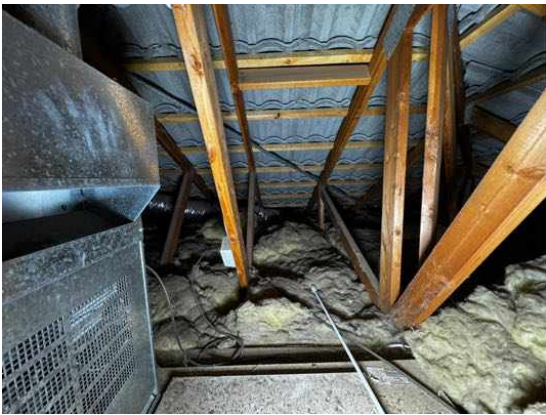
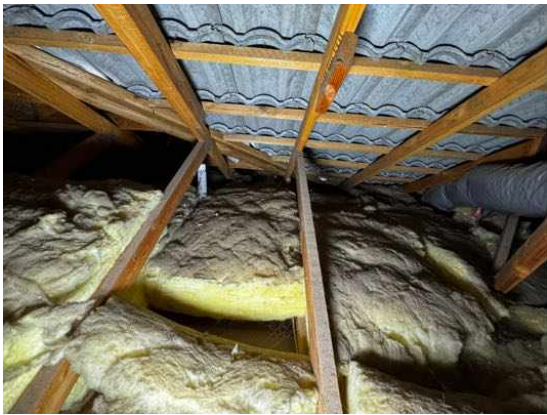
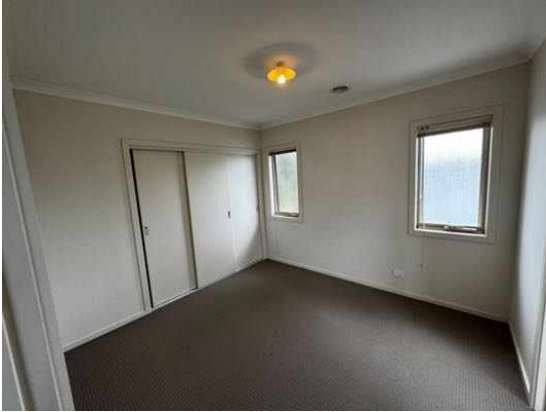
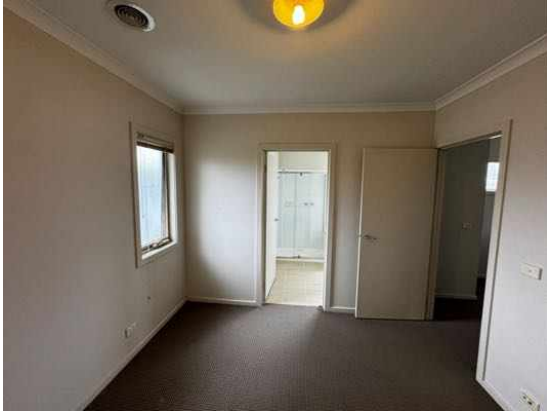
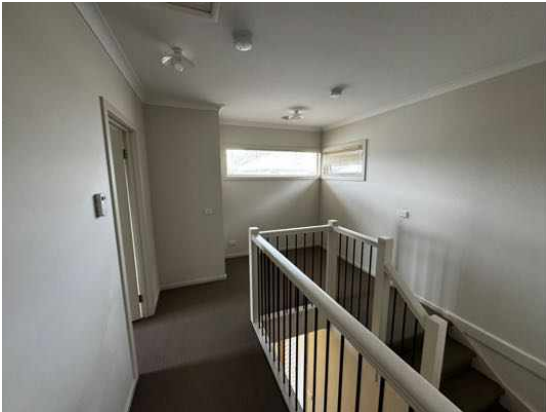
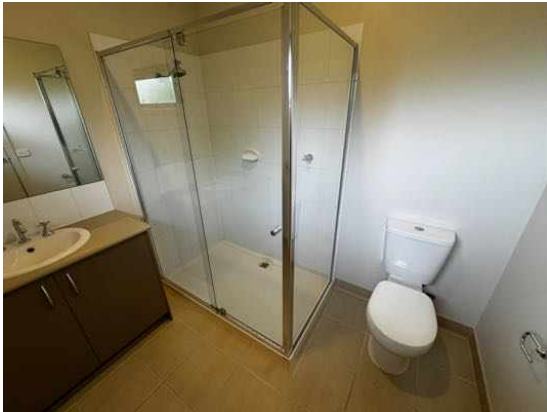
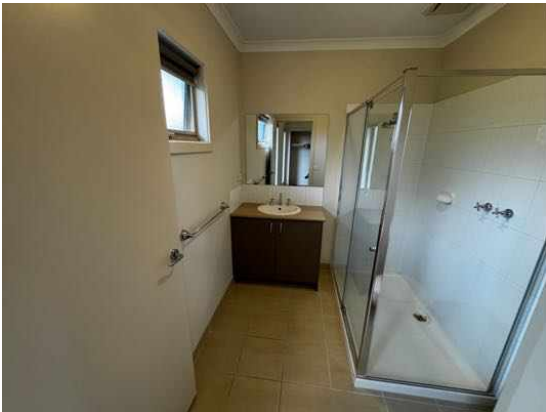
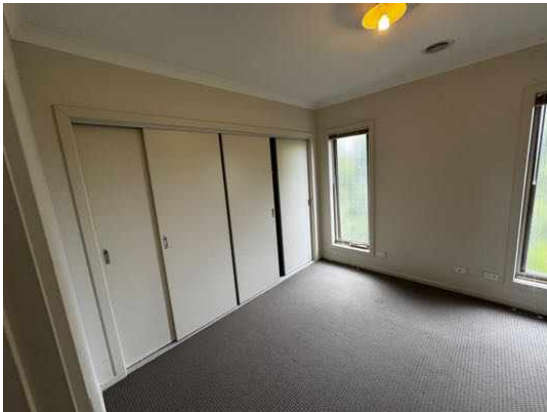
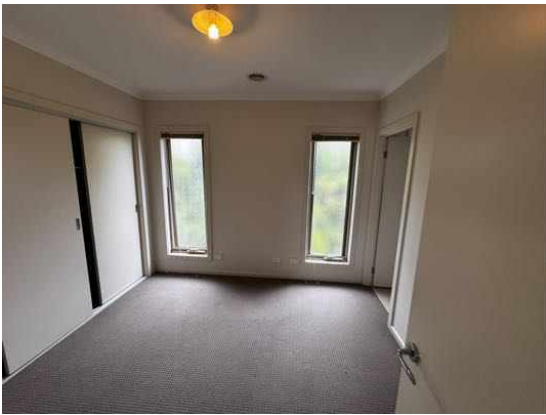
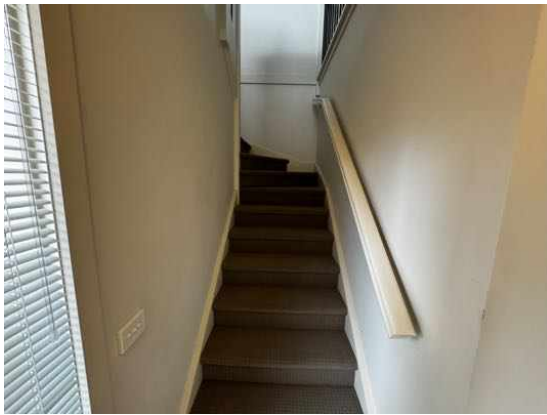
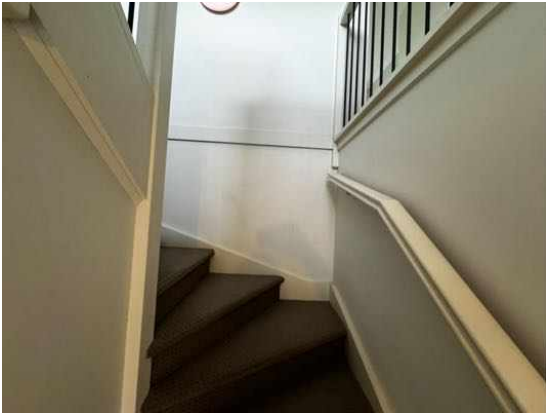
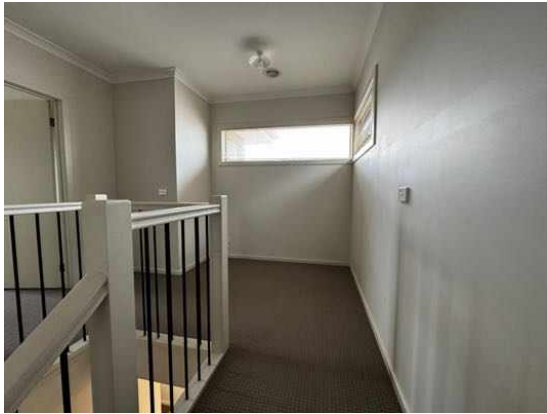
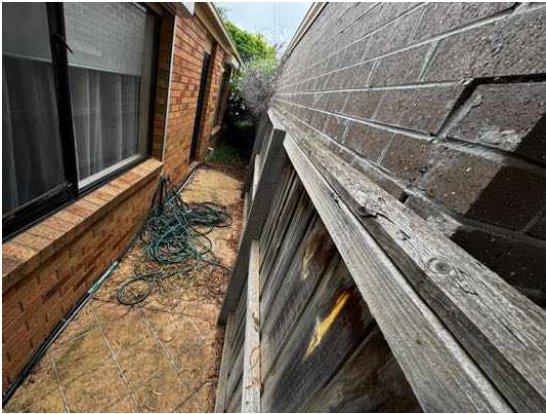
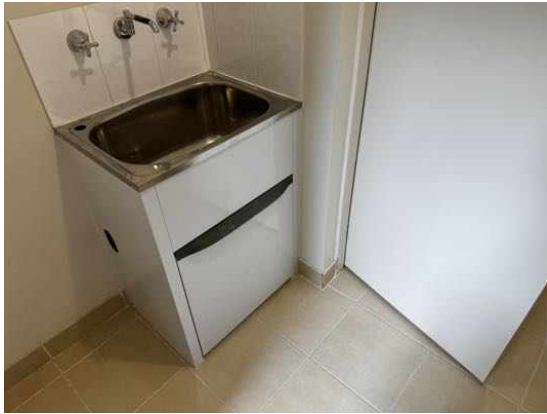
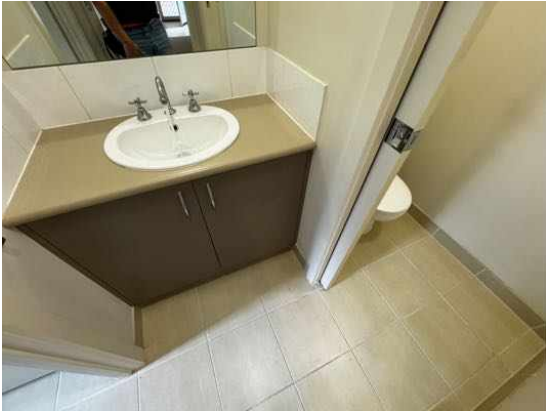
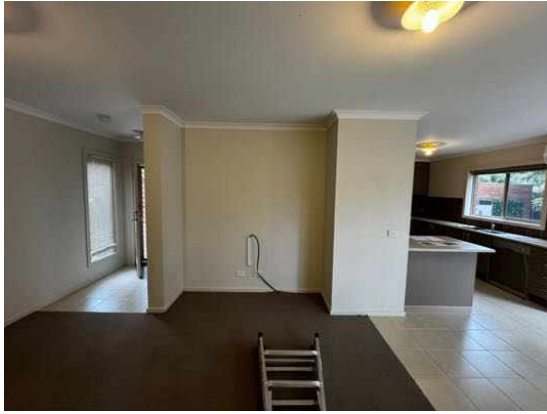
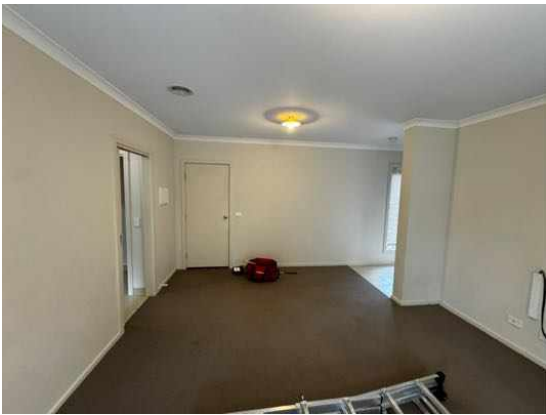
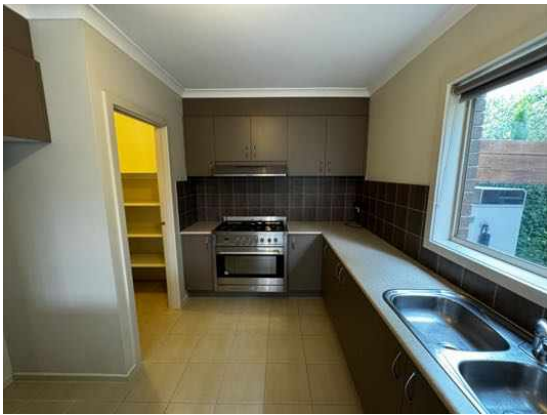
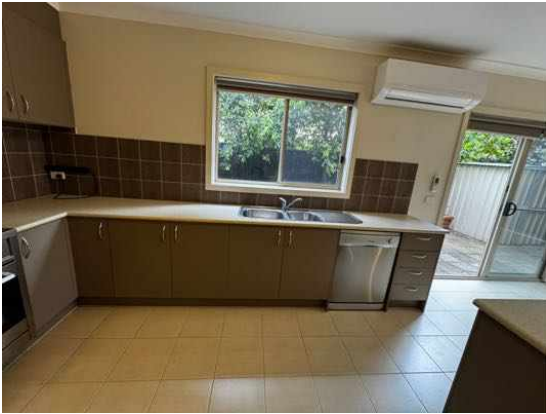
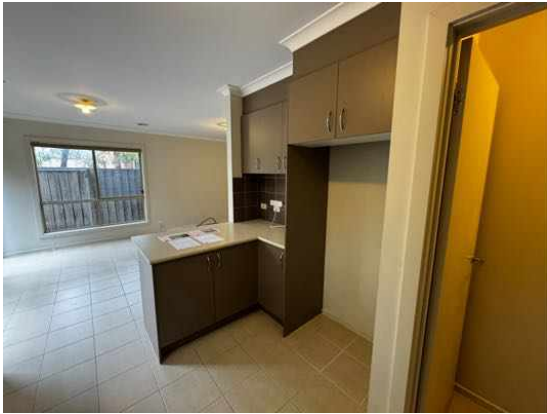
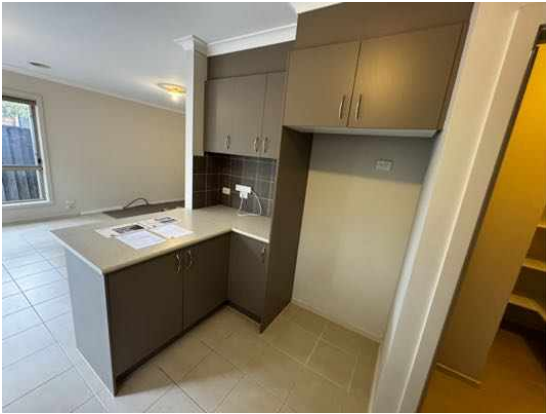
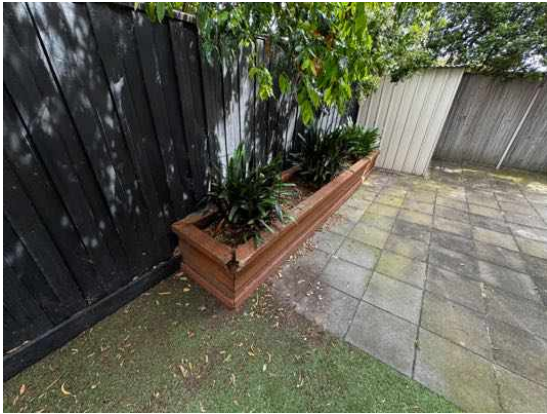
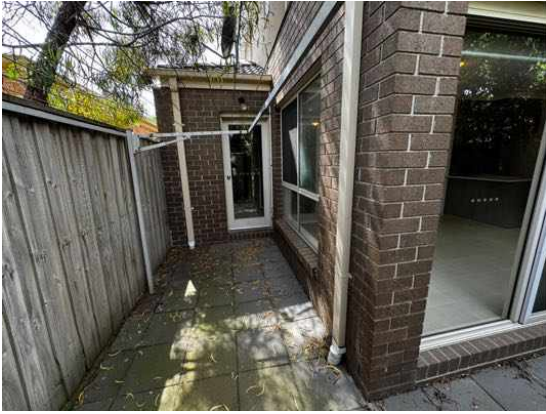
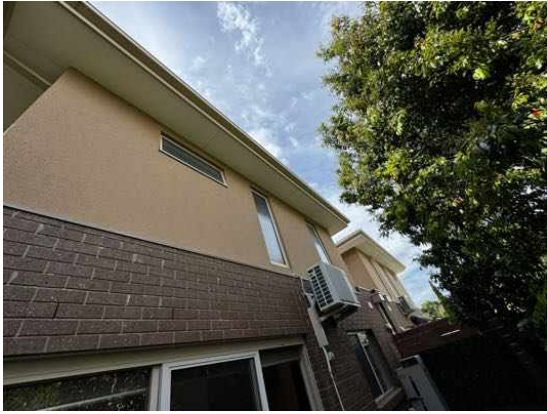
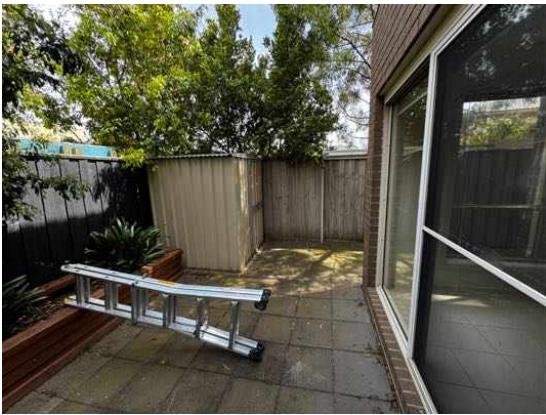
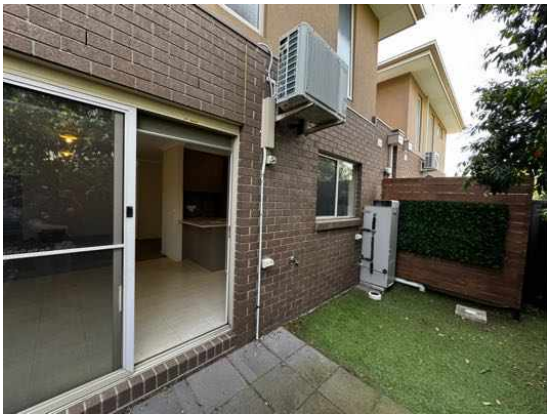
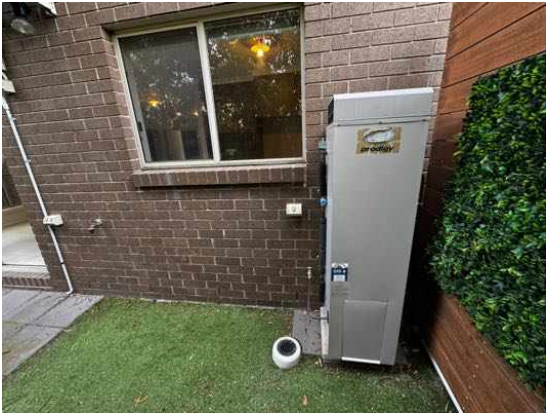
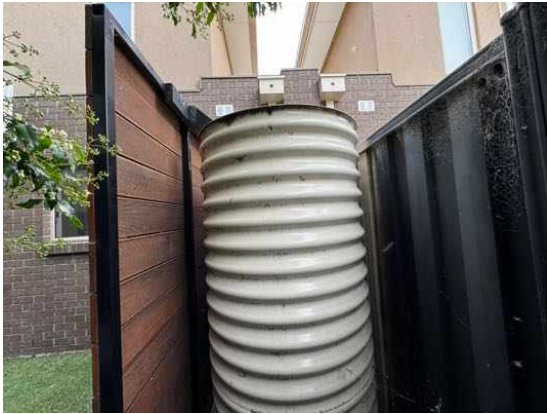
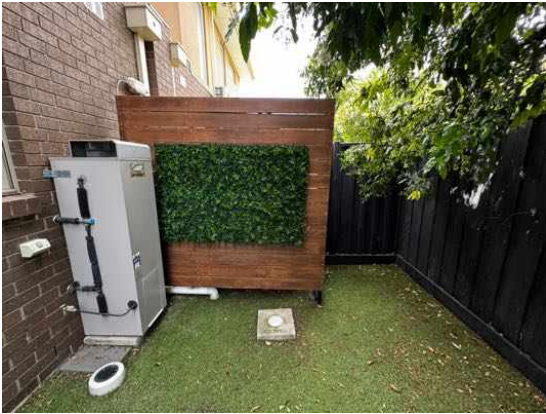
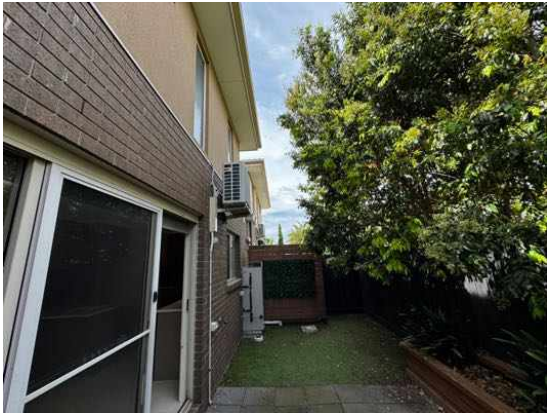
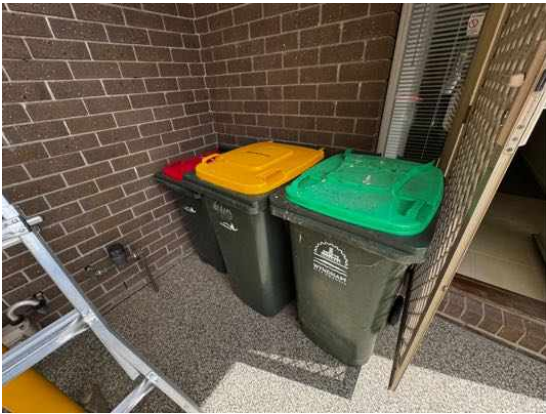
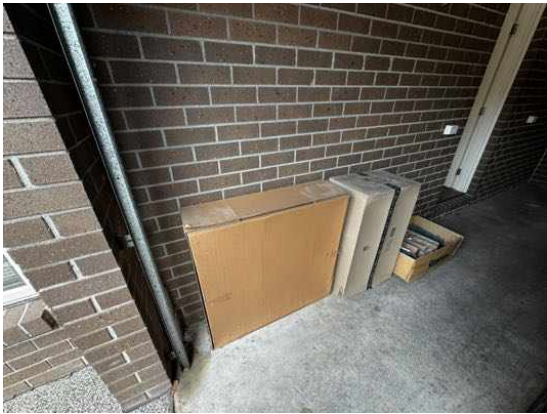
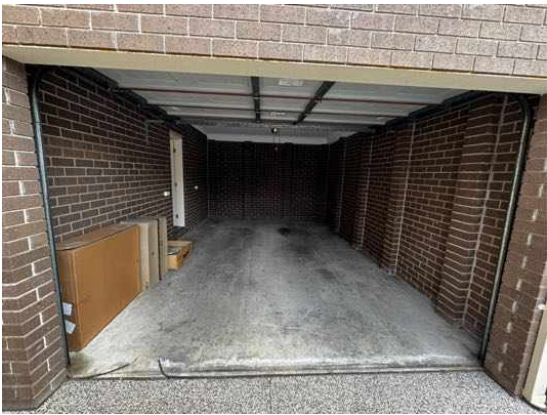
Building: Main Building  
Location: All Areas > All Areas  
Finding: Additional Photos - Obstructions and Limitations  
Information: These photographs are an indication of the obstructions and limitations which impeded full inspection of the property at the time of inspection. These obstructions can hide an array of defects and should be removed to allow full inspection to be carried out. A re-inspection is recommended once the areas are made accessible.

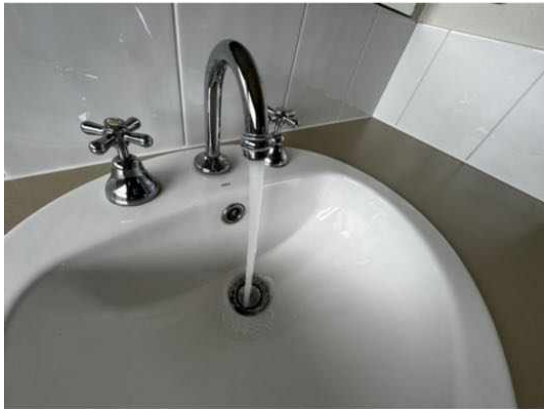
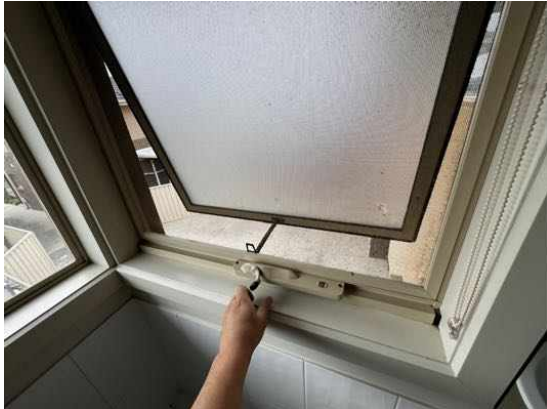
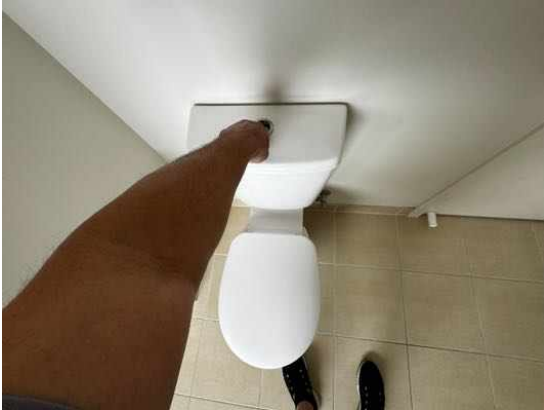
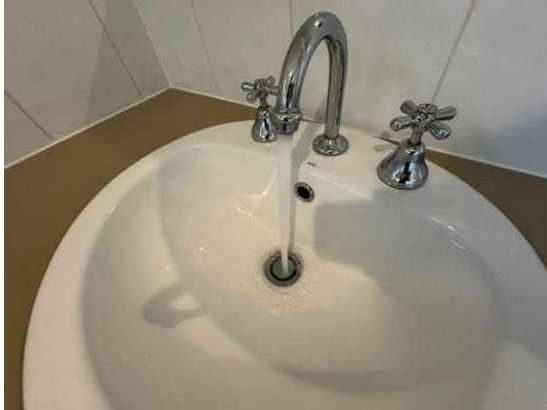
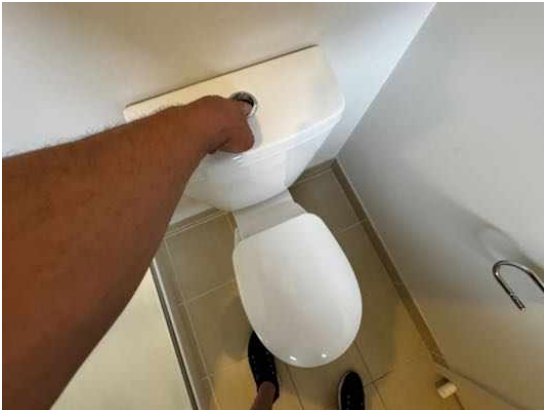
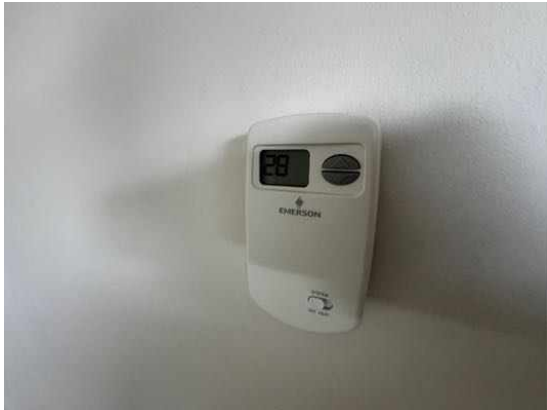
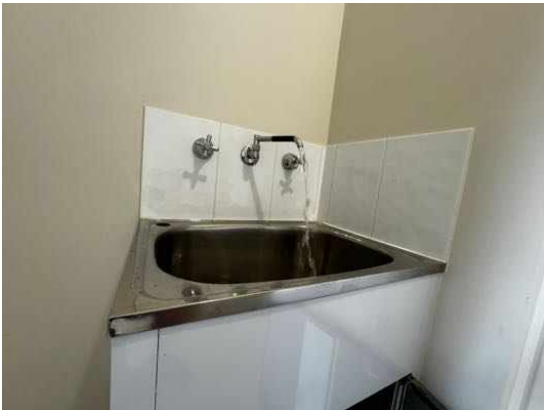
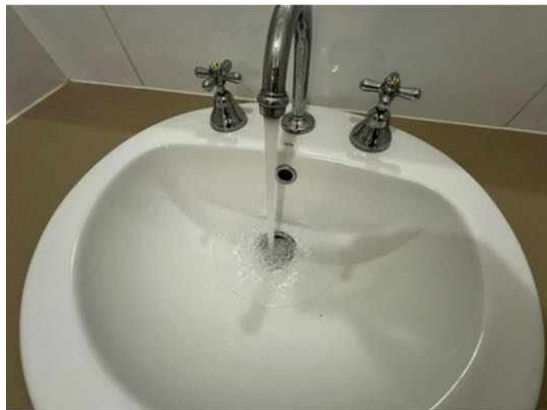
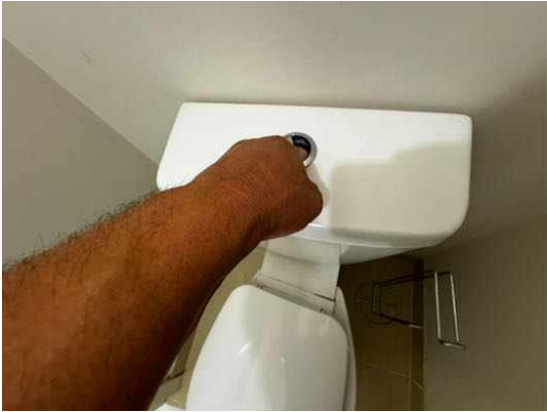
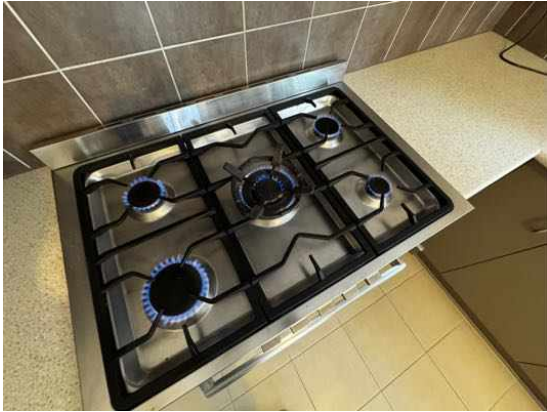
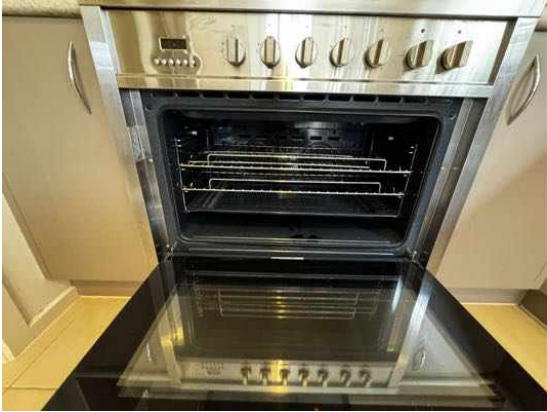
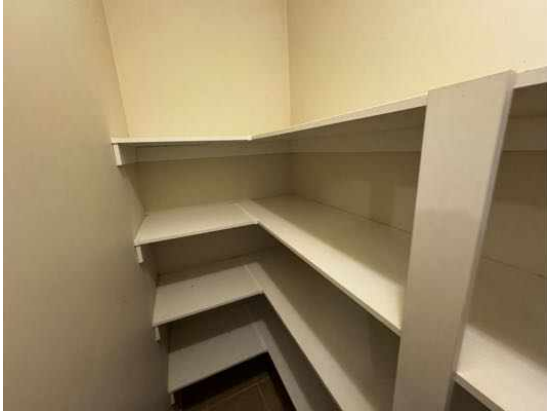
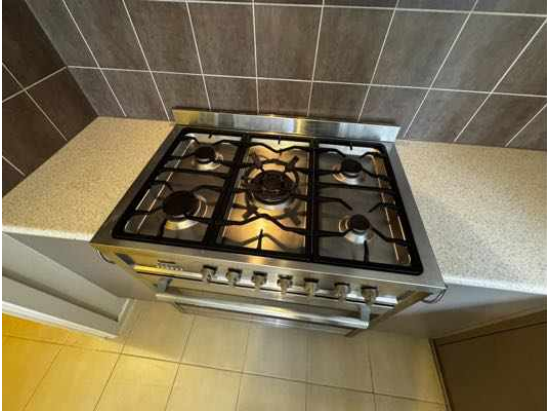
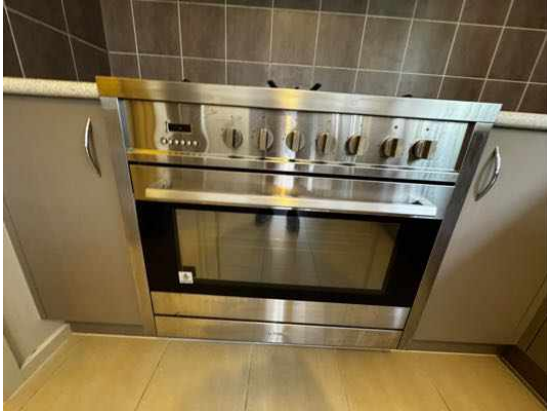
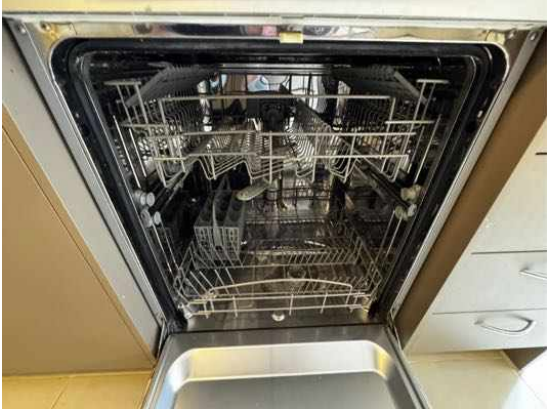
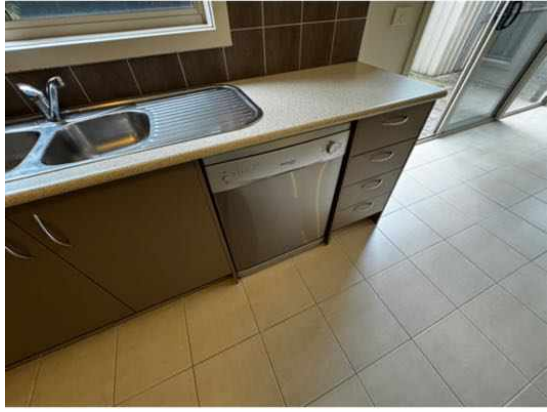
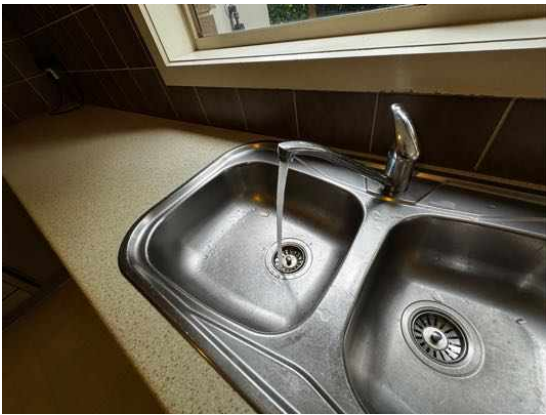
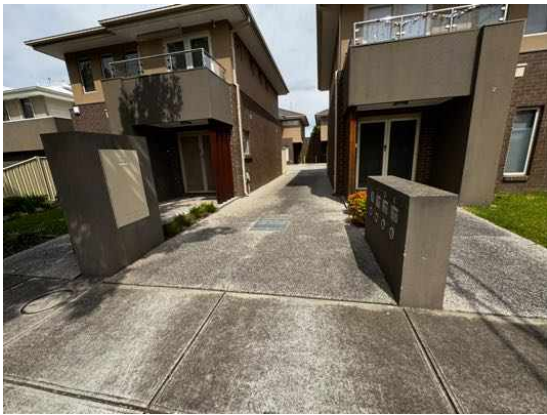
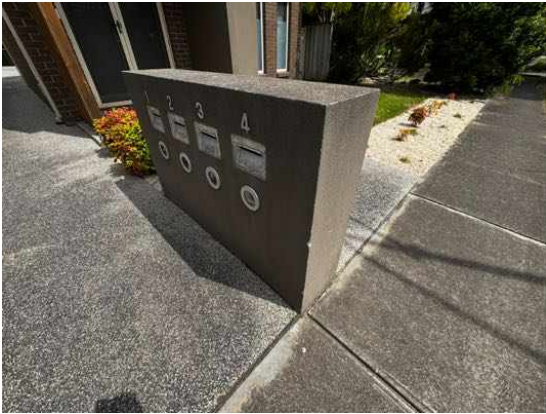
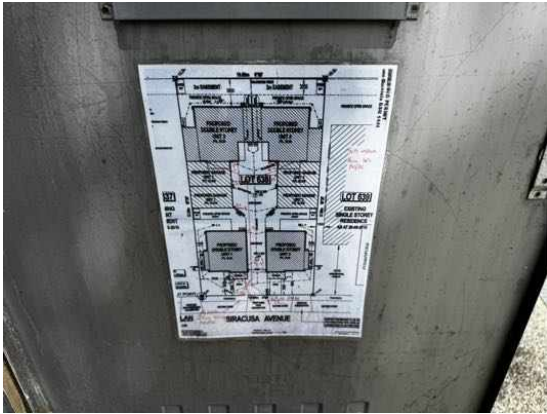
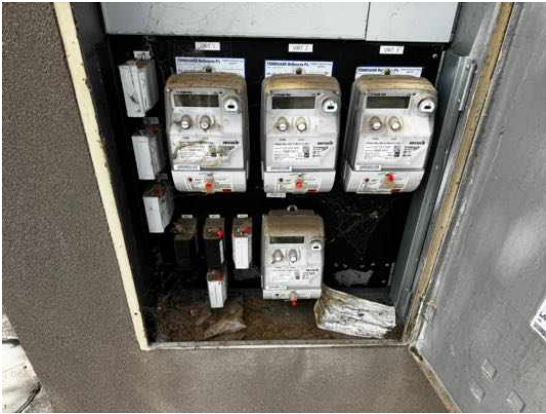
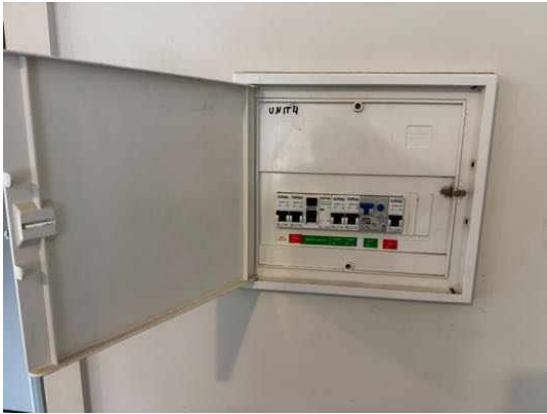
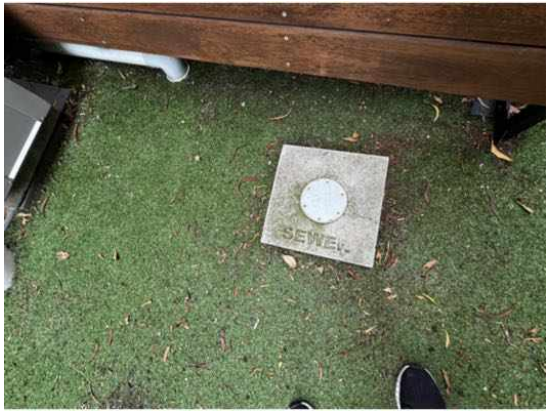
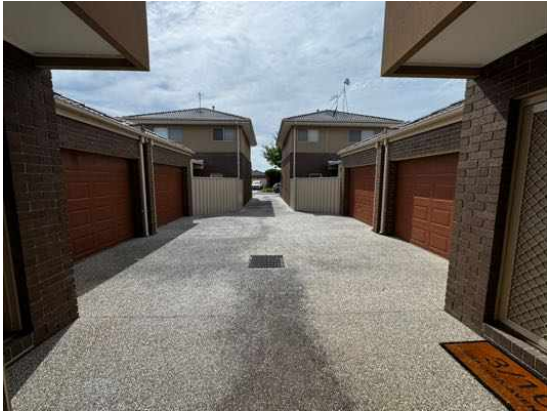
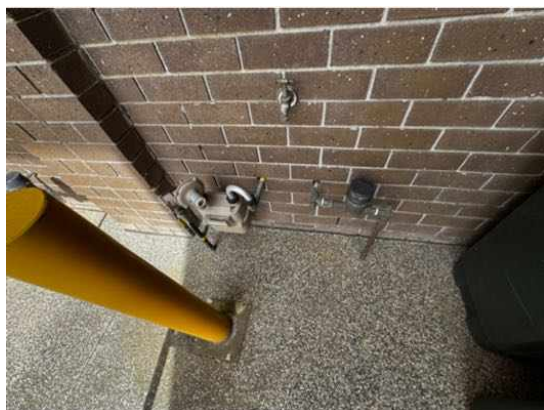
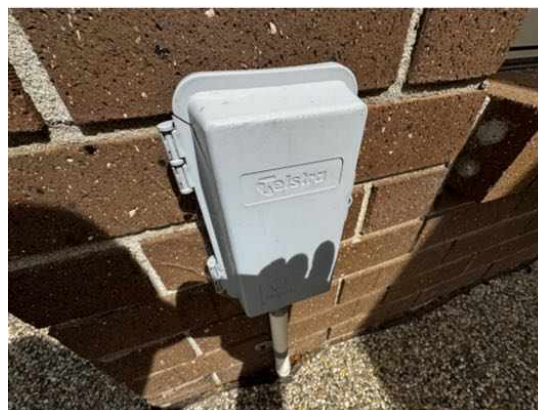
Building: Main Building  
Location: All Areas > All Areas  
Finding: Additional Photos  
Information: Additional photos are provided for your general reference

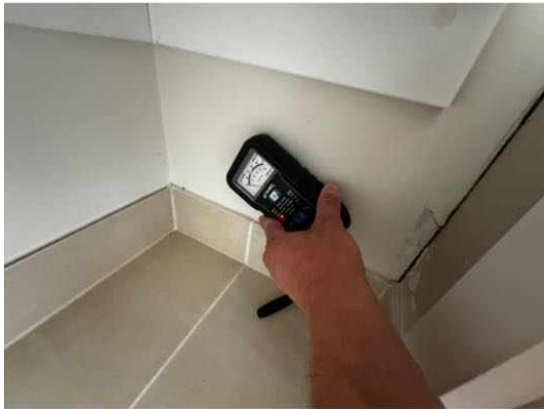
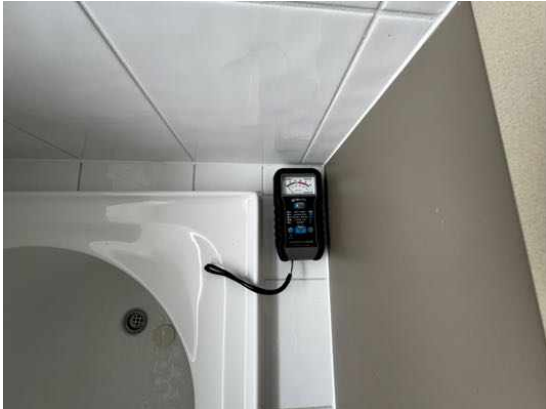
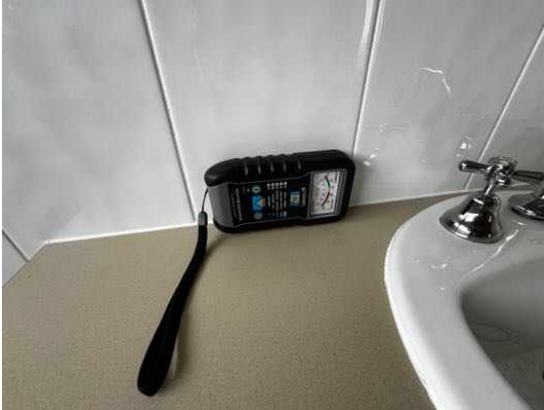
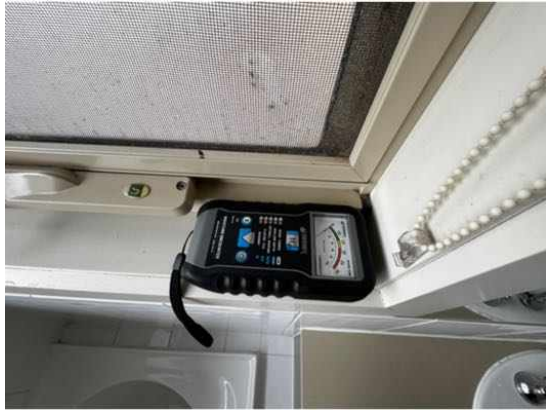
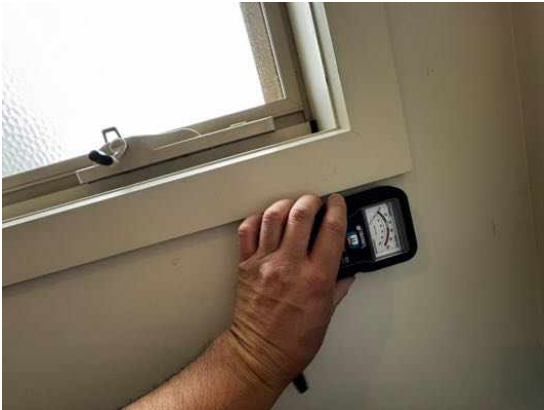
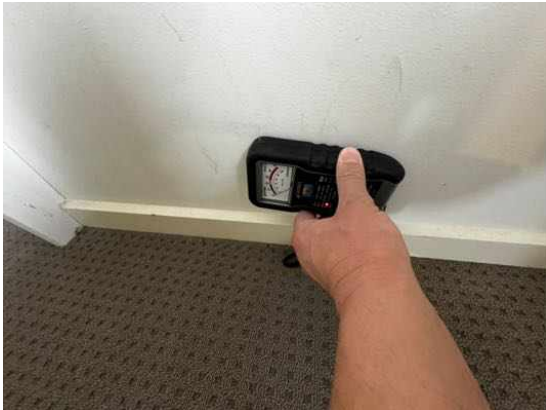
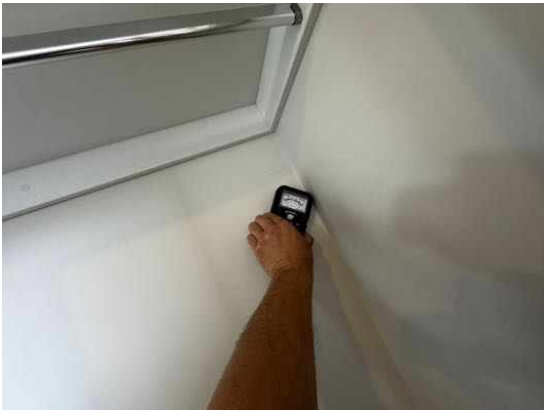
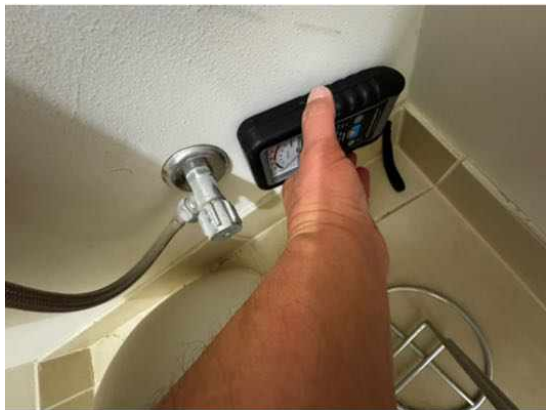
Building:	Main Building
Location:	All Areas > All Areas
Finding:	Termite investigation techniques (TP)
Information:	All accessible areas of the dwelling were inspected, with particular attention paid to wet areas, which were closely assessed for elevated moisture levels and temperature anomalies that may indicate conditions conducive to termite activity. No evidence of termite activity was identified within the interior of the dwelling at the time of inspection.

In an attempt to identify concealed or hidden timber pest activity, a range of inspection techniques were adopted. These included the use of a moisture meter to assess susceptible areas, sounding of timber elements using a handheld probing device, and visual assessment of materials for signs commonly associated with termite activity. These signs include moisture-related deterioration, deformation of timber, termite mud leads or bridging, and irregular or regular shaped holes within timber elements that may indicate pest-related damage.

It is noted that termite activity can generate increased moisture and localized temperature variations, and where such irregularities are detected, further investigation may be warranted. However, it is also acknowledged that certain obstructions, including floor coverings, wall linings, wall tiles, and fixed cabinetry such as bathroom fit-offs, can conceal termite activity and limit the effectiveness of visual inspection. As a result, the absence of visible evidence at the time of inspection does not eliminate the possibility of concealed termite activity within inaccessible or obstructed areas of the building.

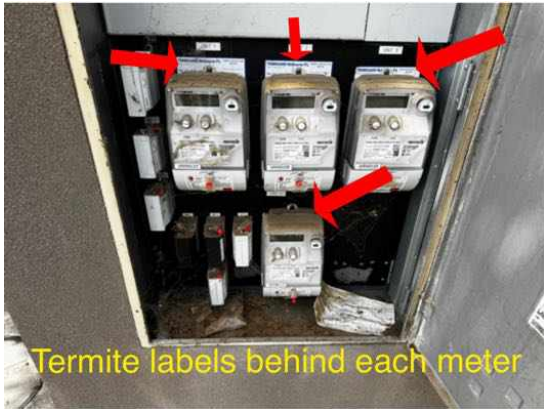
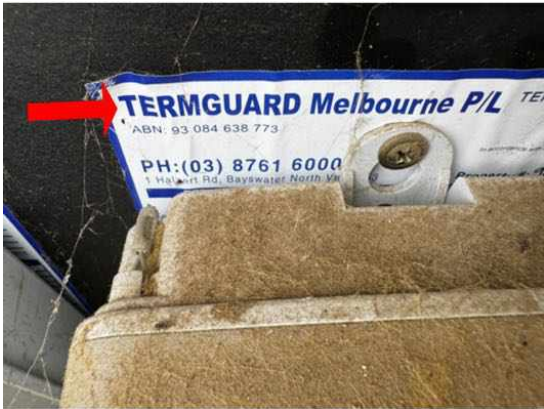
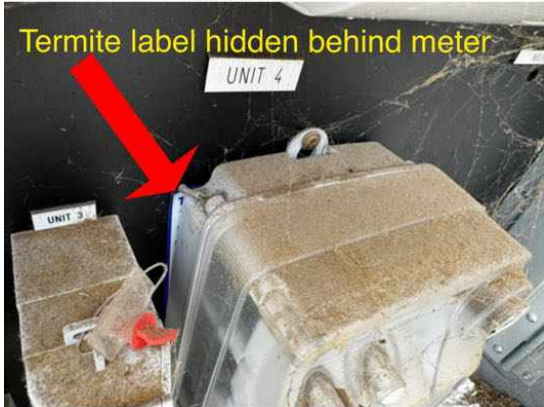
Building:	Main Building
Location:	Meter Box > Front
Finding:	Termite labels present but details obscured and unverifiable
Information:	At the time of inspection, termite labels were observed within the meter box, with a separate label located behind each electricity meter corresponding to each unit number. The labels were positioned mostly behind the meters and were largely obscured, preventing the treatment details from being read or verified.

In accordance with AS 3660.2, termite management systems to existing buildings require ongoing verification, inspection, and maintenance to ensure continued effectiveness. Where treatment details cannot be confirmed, the system must be considered suspected to be ineffective or inadequate.

It is recommended that contact be made with the identified termite management company as a matter of priority to obtain records confirming the nature, date, and maintenance history of any termite management measures previously applied to this property. Based on this information, a licensed termite management or pest control contractor should then advise whether the existing system can be validated or whether further inspection, servicing, or new treatment is required.
