# Building and Timber Pest Inspection Report

Inspection Date: Tue, 3 Feb 2026

Property Address: 4/223 Princes Hwy, Albion Park Rail NSW  
2527, Australia

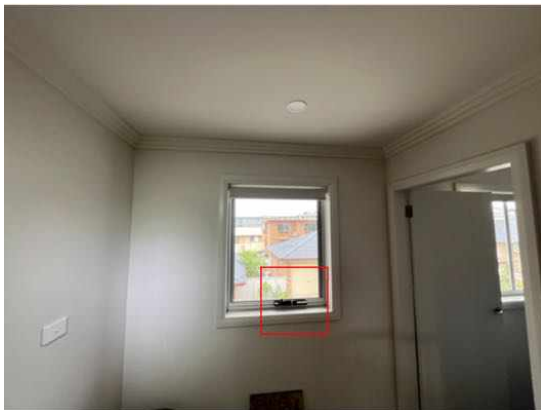
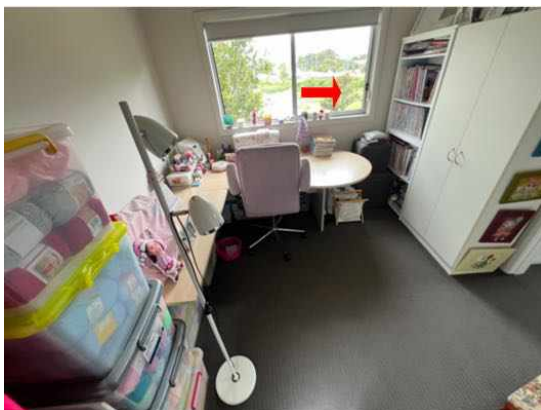
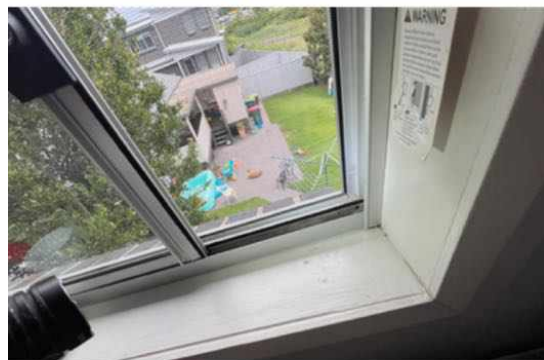
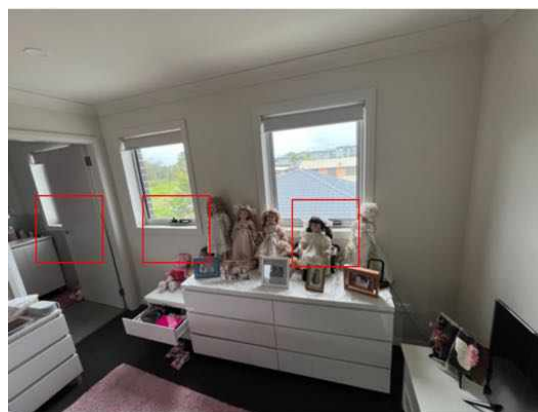
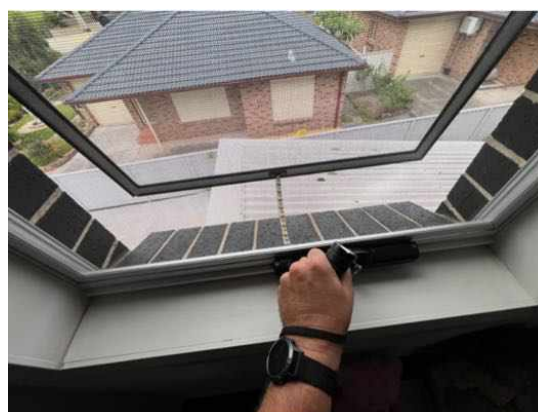
Building:	Main Building
Location:	Upstairs > Level 1
Finding:	Window restrictors recommended
Information:	It was noted that window restrictors were not installed on the upper level windows. This presents a safety hazard as per the Australian Standards AS5203 about fall protection, which requires that all upper-level windows must be fitted with window restrictors to prevent falls.

The lack of restrictors leaves the property vulnerable to potential accidents, particularly for children and other vulnerable individuals. It is recommended that window restrictors be installed on all upper-level windows as soon as possible to ensure the safety of the occupants and to comply with the relevant standards. The restrictors can be bought in a hardware stores or online and they can be installed by the home owner.

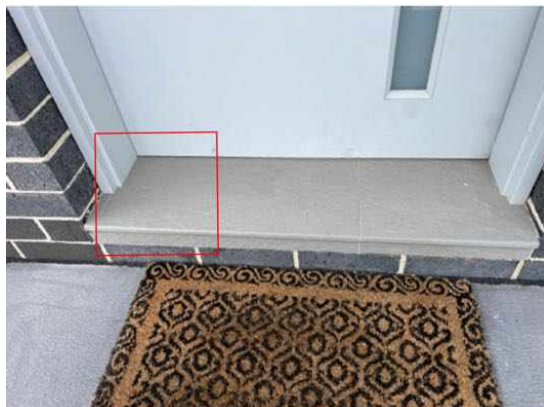
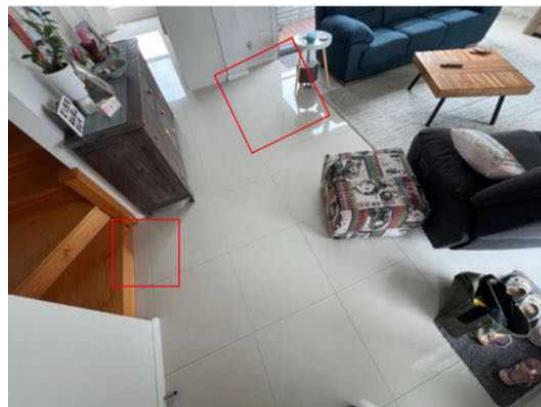
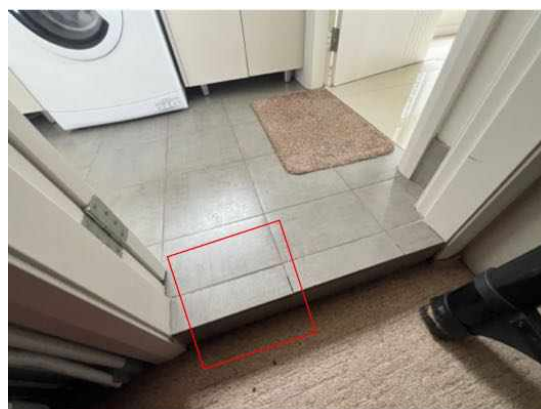
Building:	Main Building
Location:	Entry, Living Room, Garage
Finding:	Tiles - Drummy
Information:	Drummy tiled areas were identified at the time of inspection. The term 'drummy' refers to tiles that have become detached from their fixing, despite otherwise being in relatively good condition. Such defects are generally caused by physical or moisture damage to the area. Drummy tiled areas may also be a direct result of poor workmanship during the construction process.

Tiled areas may swell and shrink with changes in air humidity if the area has sustained moisture damage. Any exposure to moisture is capable of causing tiled areas to become drummy and/or cracked over a prolonged period of time. Drummy tiled areas generally require removal and replacement of affected tiles, with adequate sealant and grouting.

Specialist trades are available for these types of services. A registered builder may be required to undertake works if damage is extensive or if secondary building defects have resulted. Otherwise, it is advised that a tiling contractor be appointed to perform works as necessary. Immediate action is recommended to ensure that no further damage is sustained in the affected area.

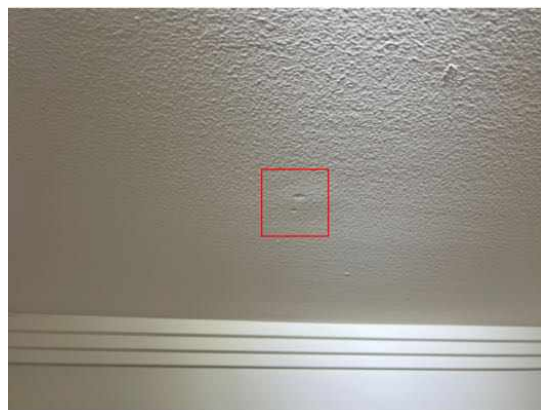
### Finding 3.02

Building:	Main Building
Location:	Living Room
Finding:	Ceiling nails - Popping
Information:	Numerous popped nails were identified in the internal ceiling at the time of inspection. Nails and screws hold simply by the friction between them and the surface they are applied to. Over time, the nails and screws can back out, which is often a result of general ageing and deterioration of the building structure.

If left unmanaged, the ceiling sheets may become loose and unstable, increasing the rate of deterioration of the internal ceiling and creating potential for the development of secondary defects.

Re-fastening of popped nails will help to maintain the stability of the internal ceiling and associated building elements. Such minor works will also help to improve the appearance of the affected area and secure the ceiling sheets, so as to prevent the

onset of ceiling sagging. These works should be performed by a qualified carpenter or plasterer at client discretion.

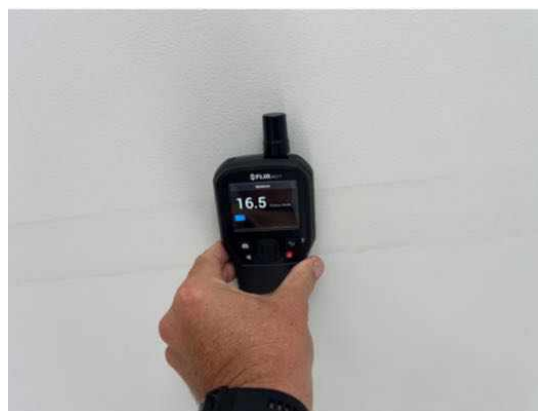
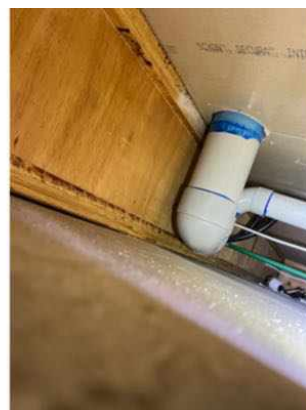
### Finding 3.03

Building:	Main Building
Location:	Living Room
Finding:	Ceiling Sheet Joint Shadowing - Suspected Air-Conditioner Condensation
Information:	A faint linear mark and localised colour variation were observed along a plasterboard ceiling sheet joint, running at right angles to the floor joists. The location and pattern were consistent with joint “shadowing” and suspected intermittent surface condensation, likely influenced by the nearby wall-mounted air-conditioning unit discharging directly across this area.

As part of the inspection process, the hot water was run for an extended period and the accessible underside of the floor structure, including the area adjacent to the shower waste plumbing, was observed. No active leakage was identified during these checks. Moisture meter testing to the ceiling lining did not detect elevated readings, with results consistent across the ceiling surface.

This condition is commonly associated with temperature differentials and humidity, where cooler ceiling zones around sheet joints can promote brief condensation and airborne dust adhesion, creating visible “ghosting” over time. While this appears to be

an aesthetic issue rather than evidence of current leakage, the area should be monitored. If staining worsens, or if the ceiling lining shows softening, bubbling, or deterioration, further investigation should be undertaken to confirm the cause and ensure the air-conditioning condensate management is performing as intended.

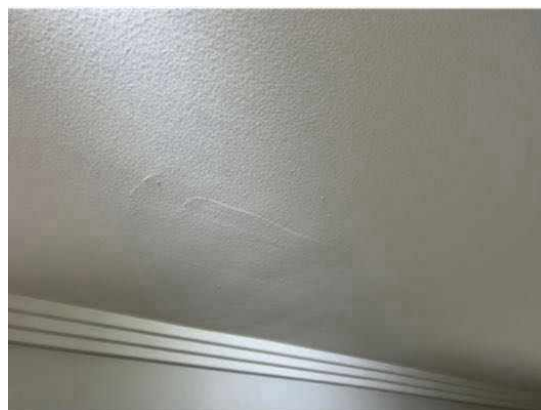
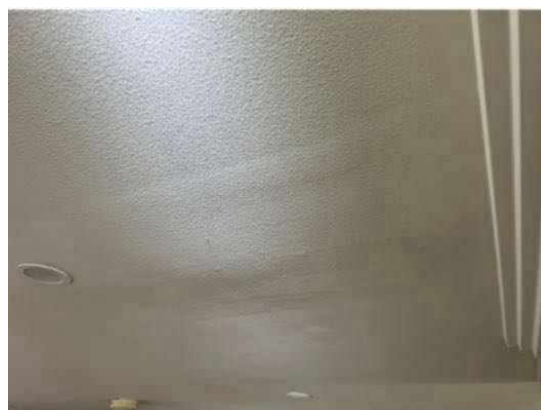
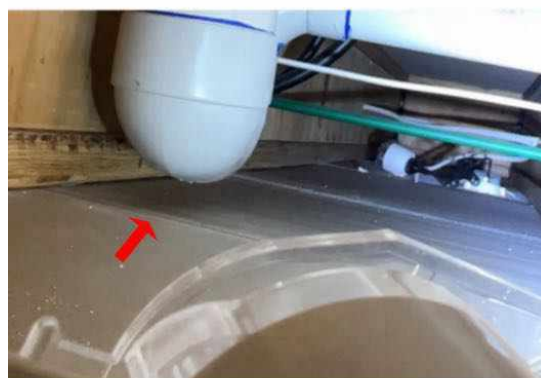
### Finding 3.04

Building:	Main Building
Location:	Living Room, Kitchen
Finding:	Ceiling Defects - Poor Finishing
Information:	Visual inspection revealed inconsistent flushing of joint lines. Minor sagging across some ceiling surfaces suggests that back-blocking may have been omitted or poorly executed during installation.

Poor joint treatment, while generally not structural, can lead to further deterioration of ceiling linings if left unmanaged. These issues detract from the ceiling's appearance and may compromise the long-term durability of the plasterboard fixing.

Rectification by a qualified plasterer is recommended. Works should include securing loose fixings, re-flushing affected joints, and applying back-blocking where necessary to stabilise the ceiling structure and improve the visual condition.

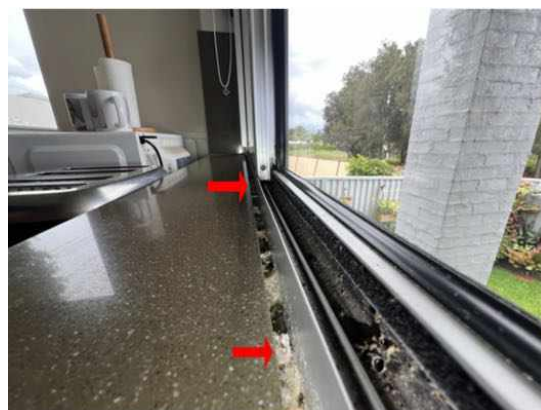
### Finding 3.05

Building:	Main Building
Location:	Living Room, Kitchen
Finding:	Sealant - missing
Information:	It was noted on inspection that sealant or grout is missing to this area.

Different materials move at different rates, generally causing cracking to grout or sealant at this point. A flexible sealant is required to allow for expected expansion and contraction, while keeping the joint water tight and protective of all associated building materials.

any subsequent water damage that is likely to occur. Regular maintenance and replacement of damaged or missing or damaged sealant and grout is highly recommended to the wet areas, as this is a regular wear and tear defect. Sealant and grouting in areas that come into regular contact with water should be maintained for the long term care of your property.

A sealant specialist or tiling contractor should be appointed to complete these works as soon as possible

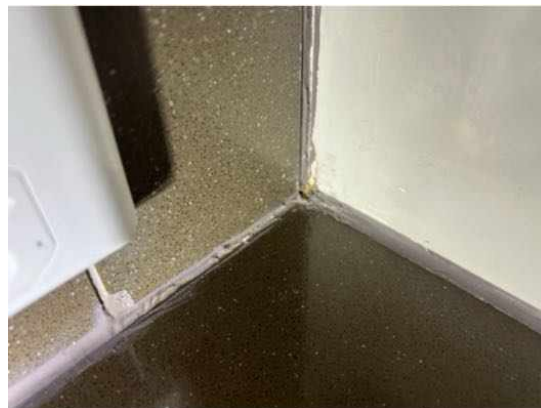
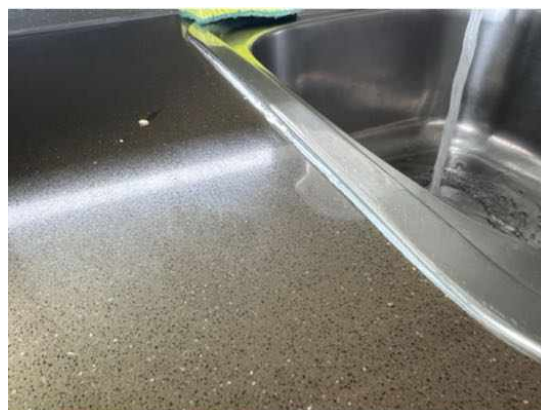
### Finding 3.06

Building:	Main Building
Location:	Kitchen
Finding:	Kitchen Sealant - degraded
Information:	It was noted on inspection that sealant or grout is degraded to the kitchen sink and splash back.

Different materials move at different rates, generally causing cracking to grout or sealant at this point. A flexible sealant is required to allow for expected expansion and contraction, while keeping the joint water tight and protective of all associated building materials.

Flexible and mould resistant materials should be applied to affected areas to prevent any subsequent water damage that is likely to occur. Regular maintenance and

replacement of damage or missing or damaged sealant and grout is highly recommended to the wet areas, as this is a regular wear and tear defect. Sealant and grouting in areas that come into regular contact with water should be maintained for the long term care of your property.

A sealant specialist or tiling contractor should be appointed to complete these works as soon as possible

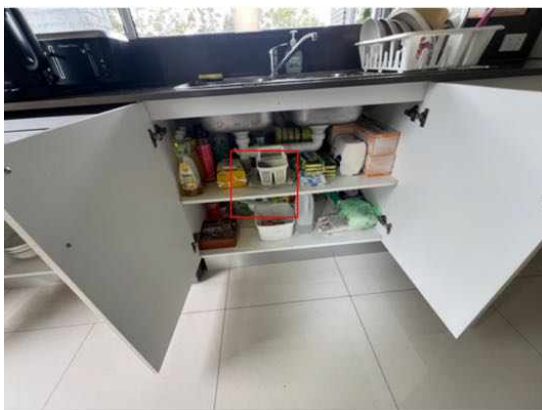
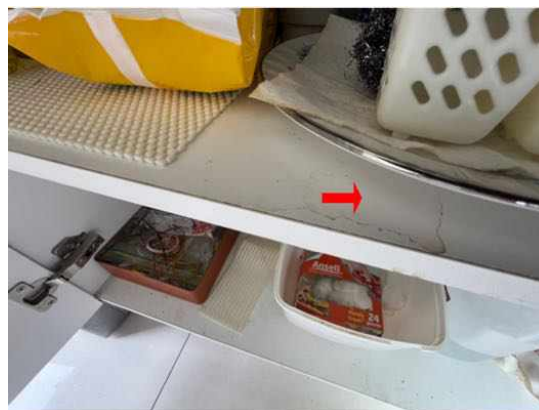
### Finding 3.07

Building:	Main Building
Location:	Kitchen
Finding:	Water staining - sink cabinetry
Information:	A water staining was observed to the cabinetry beneath the sink at the time of inspection. Water staining in this area is generally indicative of a previous or active leak from plumbing fixtures, waste connections, or sealant deterioration around the sink junction.

If left unmanaged, persistent moisture can lead to material deterioration, mould growth, and potential damage to adjacent cabinetry or flooring. It is advised that a licensed plumber be engaged to inspect the area, determine if an active leak is present, and undertake any necessary rectification works.

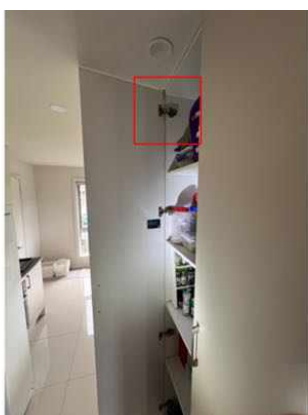
### Finding 3.08

Building:	Main Building
Location:	Kitchen
Finding:	Cabinetry - Loose hinges
Information:	Several cupboard doors are not level and detract from the operational state of the cabinetry. Upon further inspection, it was noted that the hinges to the cupboard doors have deteriorated over time and, as a result, have come loose from their original fixing. To improve operation of the affected cupboard doors, a general handyman may be appointed to replace the faulty hinges. Such works should be completed at discretion of the client.

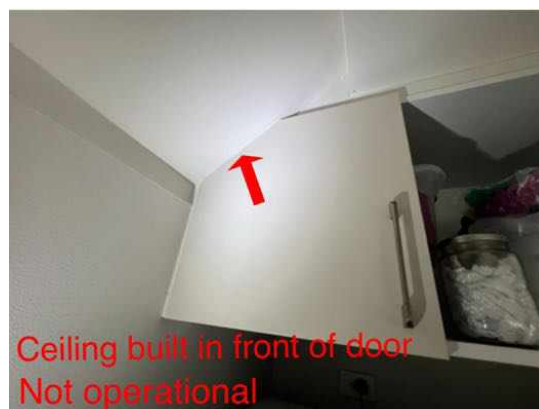
### Finding 3.09

Building:	Main Building
Location:	Kitchen
Finding:	Building element - Not operating
Information:	Non-operational items should be addressed to ensure that the full function of the building structure is available. Where some building elements are not operating as intended, it is possible that secondary building defects could arise due to their non-operation.

Repair and/or replacement of the faulty building element is recommended. It is highly

recommended that the relevant tradesperson be engaged to perform any necessary works.

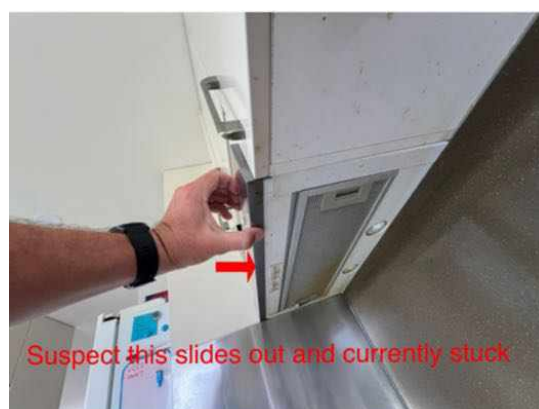
### Finding 3.10

Building:	Main Building
Location:	Kitchen
Finding:	Sliding Rangehood - Restricted Movement
Information:	The sliding rangehood was observed to be difficult to extend and did not slide out as intended. The unit operated when switched on; however, restricted movement indicates a functional issue with the sliding mechanism.

It is recommended that a suitably qualified appliance technician assess the range hood and carry out any necessary adjustment or servicing to restore proper sliding function.

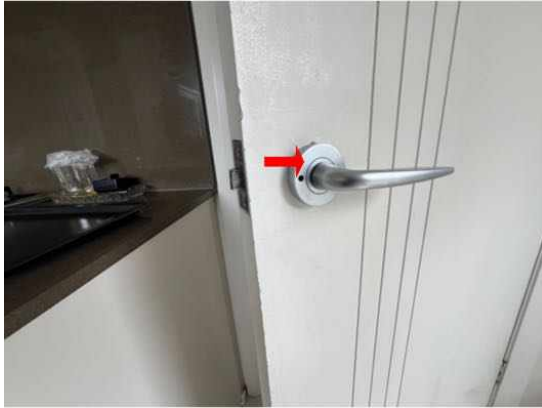
### Finding 3.11

Building:	Main Building
Location:	Kitchen
Finding:	Door Handle - Loose
Information:	The door handle in this area was identified as loose at the time of inspection. A loose door handle can impede the proper operation of the door and, if left unattended, may lead to further deterioration or damage to the associated door structure.

This defect is typically caused by wear and tear, insufficient fixing, or deterioration of the handle's components.

It is recommended that a qualified carpenter or general handyperson be appointed to secure or replace the handle to restore its functionality and ensure proper operation.

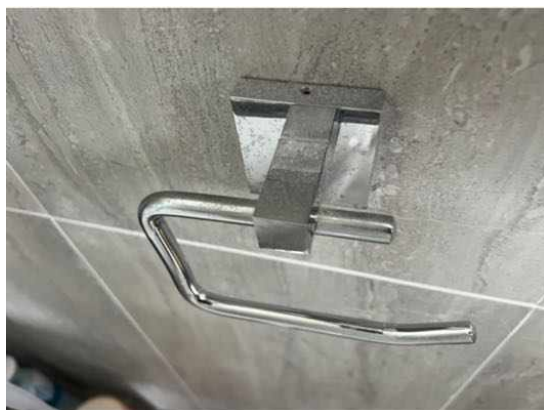
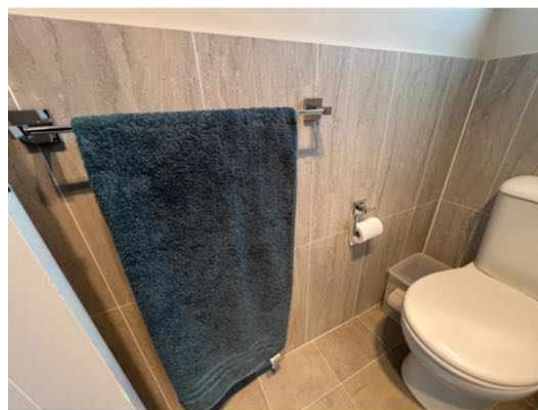
### Finding 3.12

Building:	Main Building
Location:	Toilet (WC), Ensuite, Bathroom
Finding:	Fitting or fixture - Loose
Information:	The fitting in this area is loose and requires adjustment to tighten.

If left unmanaged, the fitting may further deteriorate, causing potential for the development of other minor secondary defects.

A relevant tradesperson should be appointed to perform these rectification works at discretion of the client.

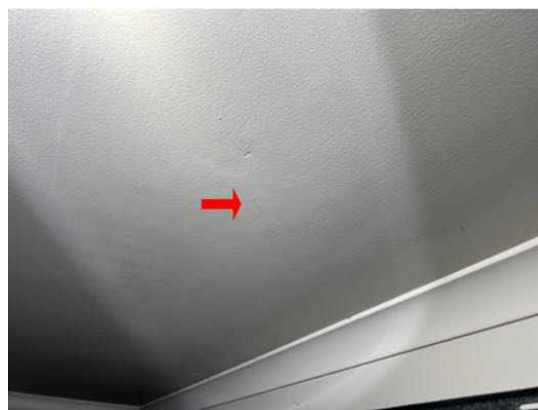
### Finding 3.13

Building:	Main Building
Location:	Garage
Finding:	Ceiling - Incomplete or substandard works
Information:	The ceiling patches to this area appear to be incomplete or have been completed to a substandard level.

Works that have not been completed to a satisfactory level create potential for the development of building defects and may impede on the safety and integrity of the overall structure.

It is highly recommended that a licensed plasterboard contractor should be appointed to repair the ceiling. To ensure the safety of the area and the longevity of all associated building elements.

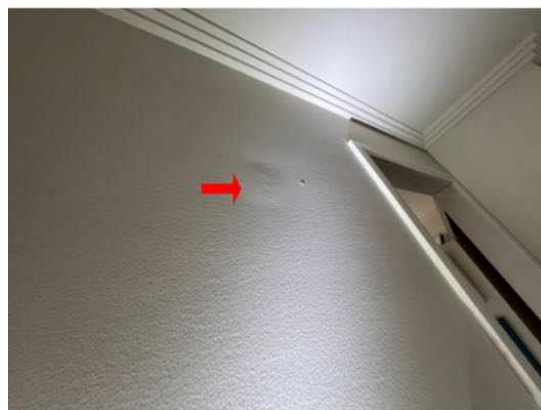
### Finding 3.14

Building:	Main Building
Location:	Stairs - Internal, Lounge Room
Finding:	Wall - Incomplete or substandard works
Information:	The plasterboard finishing to this area appear to be incomplete or have been completed to a substandard level.

Works that have not been completed to a satisfactory level create potential for the development of building defects and may impede on the safety and integrity of the overall structure.

It is highly recommended that a licensed plasterboard contractor or painter should be appointed to finish the wall to an acceptable standard.

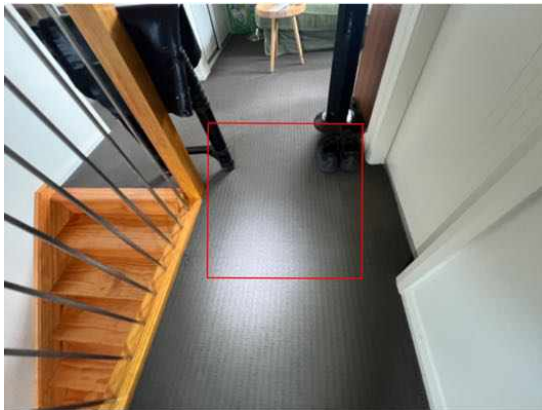
### Finding 3.15

Building:	Main Building
Location:	Stairs - Internal, Lounge Room
Finding:	Flooring (suspended timber) - Uneven
Information:	The internal flooring in this area is out of level and uneven. Uneven flooring of this nature is commonly associated with minor defects such as normal movement within suspended timber floor systems, including timber joists or I-beam floor structures, but may also indicate inadequate support or irregular installation of flooring sheets.

It is advised that the flooring be monitored to identify any progression of movement. Where the condition remains relatively unchanged over time, it is likely attributable to expected movement or construction tolerances within the suspended floor system.

However, where unevenness increases or becomes more pronounced, further investigation of the supporting floor structure, including joists, bearers, and sheet

fixings, may be required. In such cases, rectification works may be necessary and would typically be carried out by a registered builder.

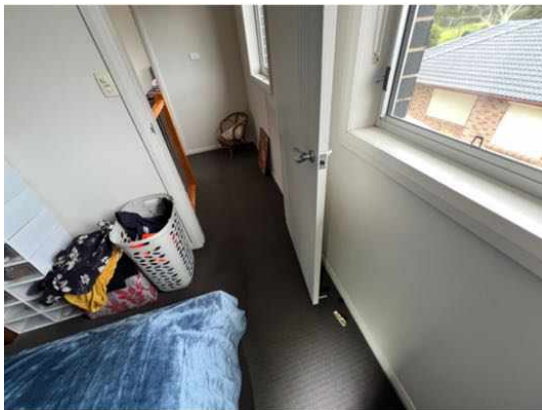
### Finding 3.16

Building:	Main Building
Location:	Bedroom 2
Finding:	Door - swings drifts open not stationary
Information:	The door was observed to swing or drift open and closed on its own, failing to remain stationary when positioned. A properly installed door should stay in place unless intentionally moved, and this condition is typically caused by a substandard door or jamb installation, or slight unevenness in the floor surface.

While not structural, this defect is inconvenient and detracts from normal use. A carpenter or general handyperson should be engaged to inspect the installation and make necessary adjustments to ensure the door remains stable when open or closed.

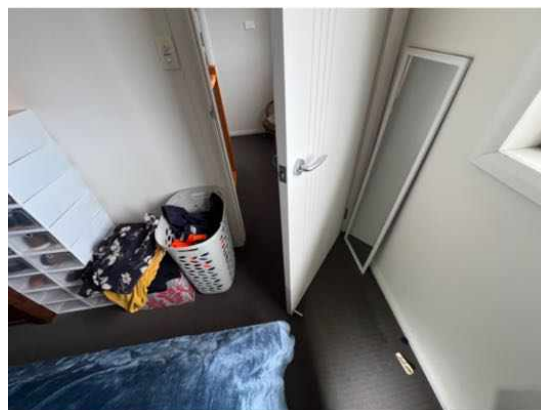
### Finding 3.17

Building: Main Building  
 Location: Bedroom 2  
 Finding: Door - damage handle  
 Information: The door handle in this area was found to be damaged at the time of inspection. Breakage occurs generally when the building materials have aged and decayed, but may be indicative of impact damage (accidental or deliberate).

Repair and/or replacement of the broken door handle is advised to improve the operational state of the associated door.

A qualified carpenter or general handyman should be appointed to repair/replace the door handle at the client's discretion.

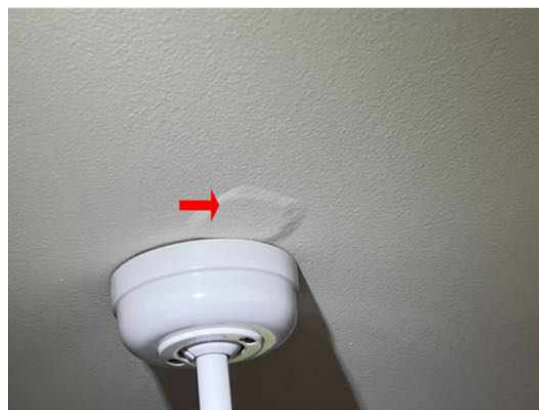
Building: Main Building  
 Location: Bedroom - Master  
 Finding: Ceiling - Damaged  
 Information: Breakage occurs generally when the building materials have either aged and decayed, or as a result of damage (accidental or deliberate).

Repair and/or replacement of broken elements is advised to ensure that additional

secondary defects do not arise as a consequence. Such works are necessary, as all building elements play a key role in the operation and function of the overall structure and its performance.

A plasterer, painter or handyman should be appointed to repair or replace the affected building element prior to any subsequent damage being caused.

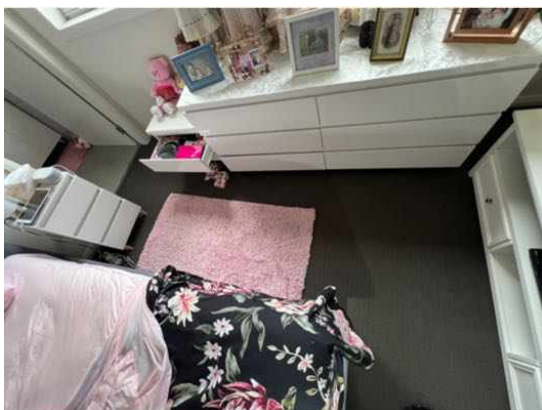
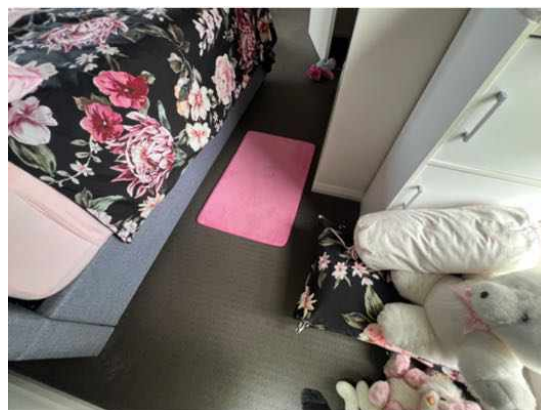
### Finding 3.19

Building:	Main Building
Location:	Bedroom - Master
Finding:	Floors (suspended timber) - bouncy
Information:	The internal flooring in this area was identified as being bouncy at the time of inspection. A bouncy floor surface generally presents as a discernible change in level as they are walked across, in noisy or creaking flooring, or in consequent movement of surrounding furniture and fixtures.

Bouncy floors are commonly associated with minor defects within suspended timber floor systems, such as loose or inadequately fixed flooring sheets to the supporting timber joists or I-beam members. This condition may also be caused by uneven support, insufficient stiffness of the floor framing, or gaps between the flooring and the underlying structural members.

The client is advised to seek quotations for required repairs from a registered builder. Depending on the cause, rectification may range from refixing flooring sheets through to strengthening or adjustment of the suspended timber floor structure.

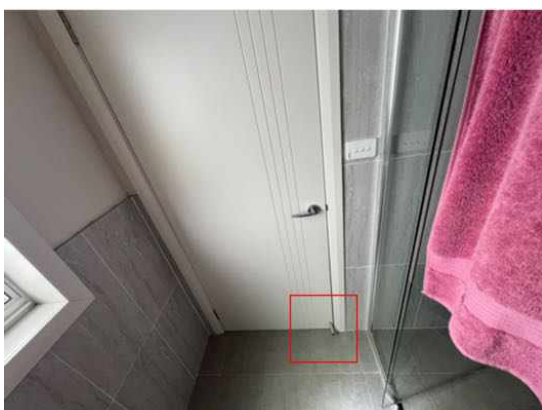
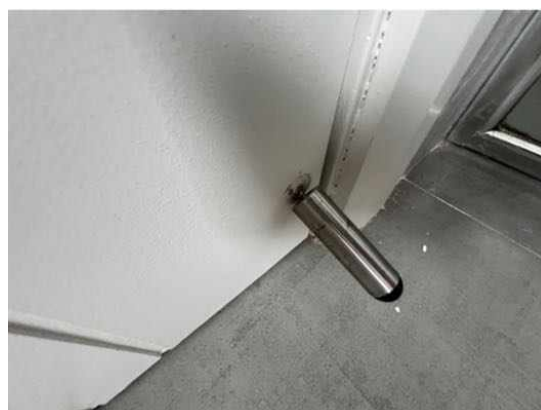
Building: Main Building  
 Location: Bedroom - Master  
 Finding: Door stop - Loose  
 Information: The door stop was observed to be loose at the time of inspection. This may be due to inadequate fixings, deterioration over time, or poor initial installation.

If left unmanaged, further movement may occur, potentially compromising the stability of the affected element and increasing the risk of secondary damage or detachment.

It is recommended that a general handy person or carpenter be engaged to assess and secure the loose element to ensure structural integrity and safety.

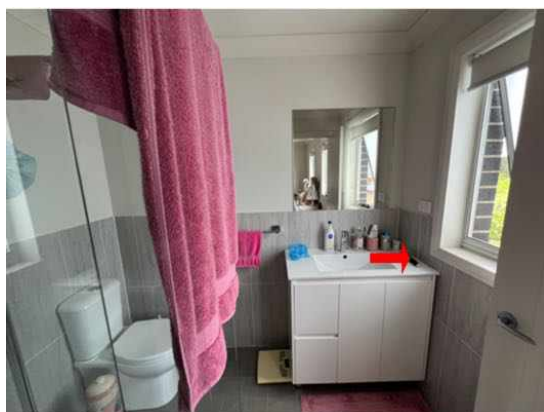
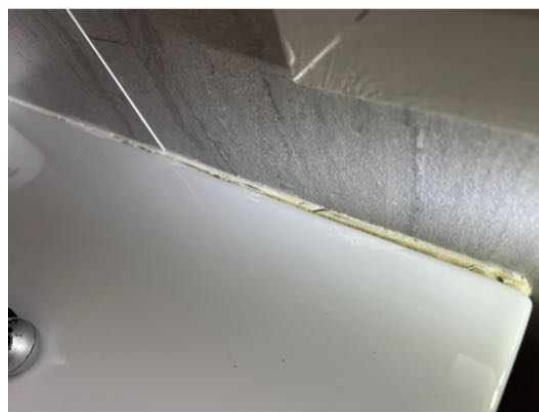
### Finding 3.21

Building: Main Building  
 Location: Ensuite  
 Finding: Sealant - degraded  
 Information: It was noted on inspection that sealant or grout is degraded to this area.

Different materials move at different rates, generally causing cracking to grout or sealant at this point. A flexible sealant is required to allow for expected expansion and contraction, while keeping the joint water tight and protective of all associated building

Flexible and mould resistant materials should be applied to affected areas to prevent any subsequent water damage that is likely to occur. Regular maintenance and replacement of damage or missing or damaged sealant and grout is highly recommended to the wet areas, as this is a regular wear and tear defect. Sealant and grouting in areas that come into regular contact with water should be maintained for the long term care of your property.

A sealant specialist or tiling contractor should be appointed to complete these works as soon as possible

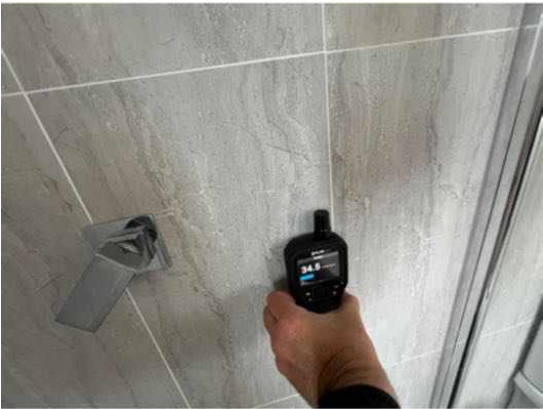
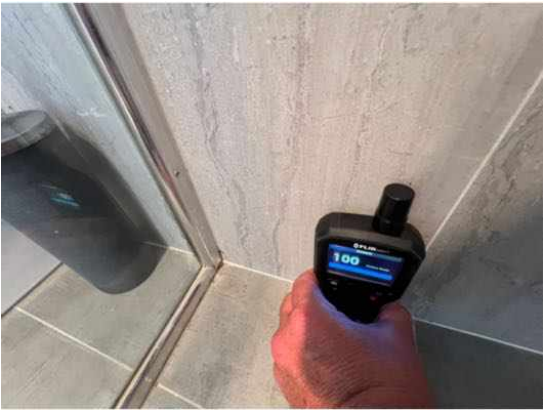
Building:	Main Building
Location:	Ensuite, Bathroom
Finding:	Moisture in Shower
Information:	Moisture is evident behind the tiles to the shower alcove. This defect is quite common, and is suspected to have been caused by moisture permeating through the grouting in this area. Leaking pipes within the adjoining wall is also a possible cause.

Damp (or structural damp) refers to the presence of unwanted moisture in the structure of a building, either as the result of intrusion from outside, or condensation from within the structure. In the shower area, internal water leaks or other sources of excessive moisture are generally the cause of damp. Always ensure that sealant and grout is in good condition to prevent any moisture issues occurring in the future.

Consultation with a qualified plumber or bathroom specialist is advised to identify the cause of damp and to perform remedial works as required.

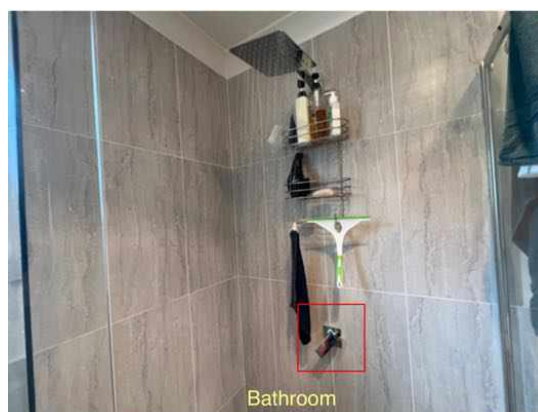
Finding 3.24

Building:	Main Building
Location:	Ensuite, Bathroom
Finding:	Tap - Water hammer
Information:	This tap shows evidence of water hammer being present. Water hammer, a pressure surge resulting when a fluid is forced to suddenly change direction, is a common defect in plumbing fittings, particularly those that are aged and not frequently maintained. Water hammer is generally caused by factors that create high water pressure in the affected plumbing fixture, usually evidenced by a faint banging noise during operation of the affected tap.

Although water hammer is generally considered to be a minor defect, subsequent damage such as erosion of tap hardware and/or water damage to associated building elements is likely to occur if left unmanaged.

A licensed plumber should be appointed as soon as possible to replace any affected tap hardware and perform any remedial works as necessary. Please be advised that the appointment of a cabinet maker or qualified carpenter may be necessary if water damage to associated building elements has occurred.

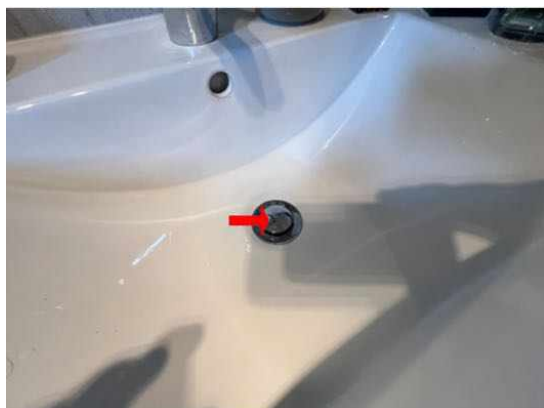
### Finding 3.25

Building:	Main Building
Location:	Bathroom
Finding:	Pop up waste - stiff /not operating
Information:	The plug waste is not functioning as intended, failing to pop up when engaged. This defect is common in pop-up waste mechanisms, which rely on a spring-loaded or lever mechanism to open and close the drain.

Inability to open or close the drain properly can lead to water retention in the sink, causing inconvenience in daily use. If left unrepaired, the mechanism may further deteriorate, potentially leading to a full malfunction or water drainage issues.

Engage a licensed plumber to inspect the plug waste mechanism and determine if the issue can be repaired or if the waste needs replacement. Ensure that the replacement

waste is properly installed and tested for smooth operation.

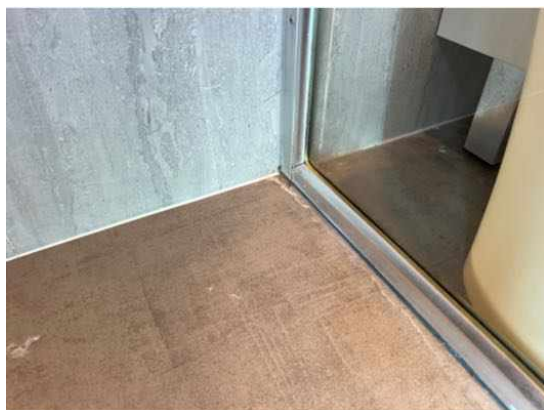
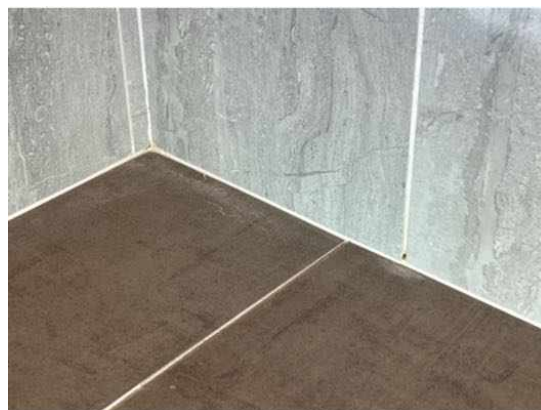
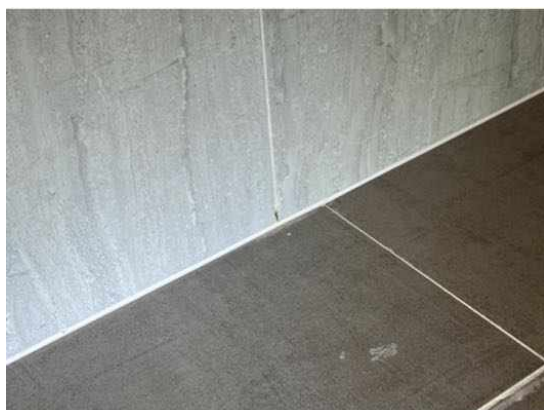
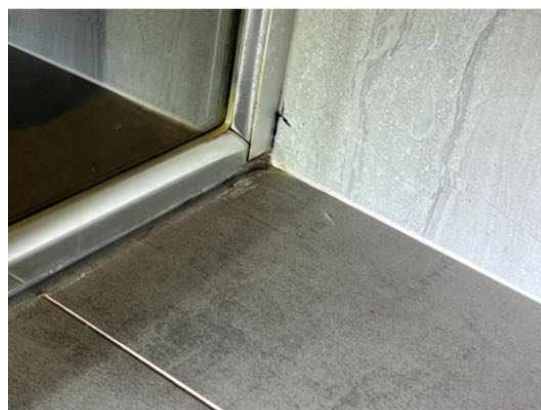
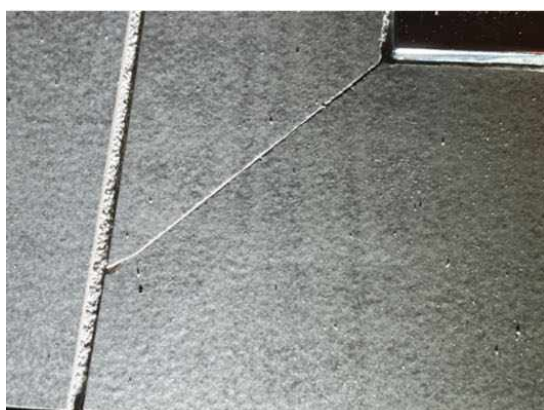
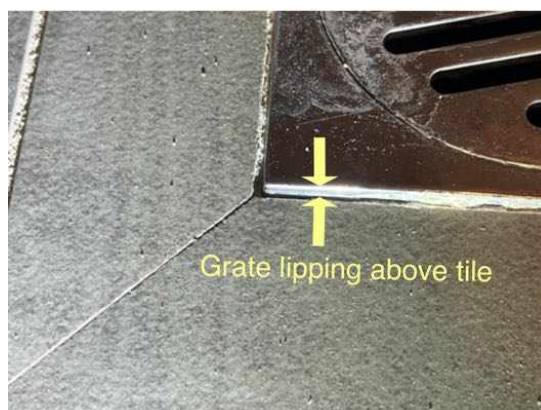
### Finding 3.26

Building:	Main Building
Location:	Bathroom
Finding:	Sealant and grouting - Missing or damaged
Information:	It was noted on inspection that sealant or grout is degraded to the tiled shower alcove and or other areas of the bathroom.

Different materials and floor areas move at different rates, generally causing cracking to grout or sealant at this point. A flexible sealant is required to allow for expected expansion and contraction, while keeping the joint water tight and protective of all associated building materials.

There appears to be excessive mould to the sealant and grout which will likely require scraping out and replacement.

Flexible and mould resistant materials should be applied to affected areas to prevent any subsequent water damage that is likely to occur. Regular maintenance and replacement of damage or missing or damaged sealant and grout is highly recommended to the wet areas, as this is a regular wear and tear defect. Sealant and grouting in areas that come into regular contact with water should be maintained for the long term care of your property.

A sealant specialist or tiling contractor should be appointed to complete these works as soon as possible

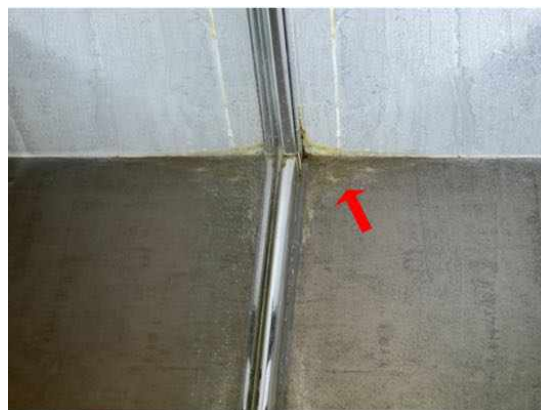
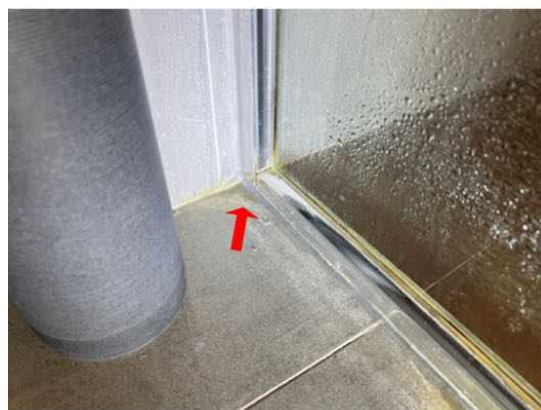
### Finding 3.27

Building:	Main Building
Location:	Bathroom
Finding:	Shower screen - active leak
Information:	A active leak was identified to the shower screen, likely due to deteriorated or inadequate sealant. If left unmanaged, water ingress may lead to damage to adjacent walls and flooring, as well as creating conditions conducive to mould growth.
	Resealing is recommended to restore a watertight seal and prevent further deterioration.

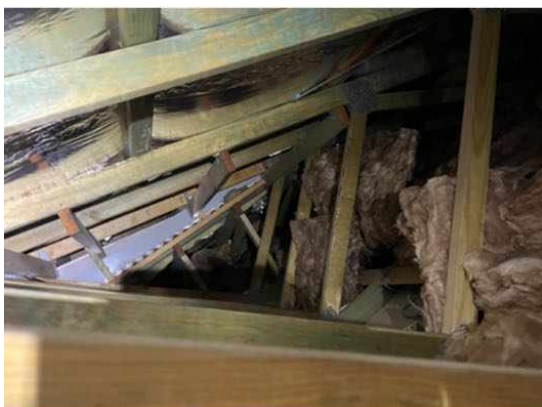
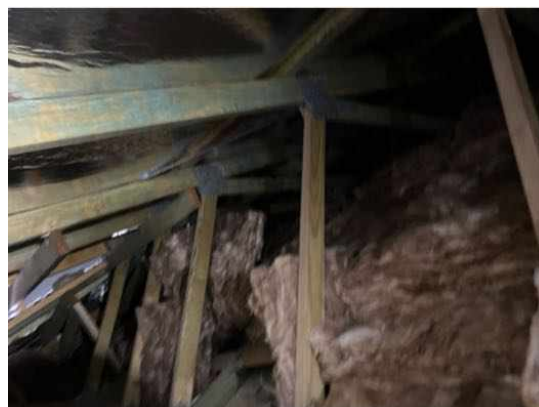
Building:	Main Building
Location:	Bathroom
Finding:	Insulation - Missing in areas
Information:	Upon inspection of the roof void it was noted that insulation is not present or displaced in some areas

Insufficient insulation will result in a comparatively higher cost to heat and cool a property as there is a lack of Insulation (or uneven coverage of insulation) which works as a barrier to heat transfer. This helps to keep out unwanted heat in summer and preserves warmth inside your home in winter. It can also help soundproof your home from unwanted airborne noise transfer.

Where insulation is absent, the area does not meet current Australian Standards. Installation of adequate insulation is required and should be conducted as soon as possible.

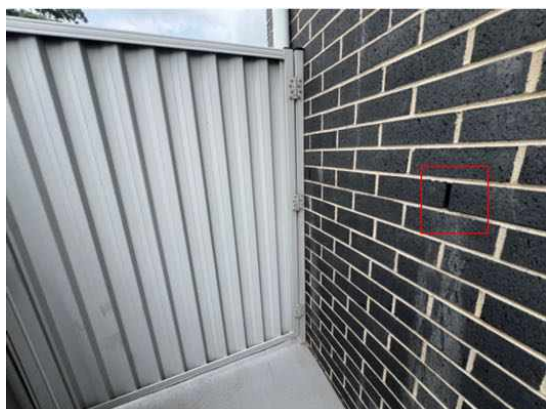
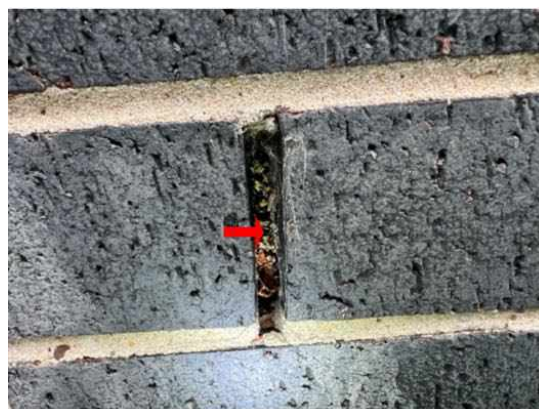
### Finding 3.30

Building:	Main Building
Location:	All External Areas
Finding:	Weep holes blocked

Information: The weep holes to the brickwork are blocked. Weep holes are designed to allow water to escape the cavity from leaks or seepages in brickwork before the water enters in or damages the wall cavity and in particular to windows and doorways. Weep holes should be kept clean and free of debris or blockages

Depending on the nature of the blockage the homeowner may be able to undertake remedial works. Where weepholes are extensively blocked the registered builder on site should perform such works.

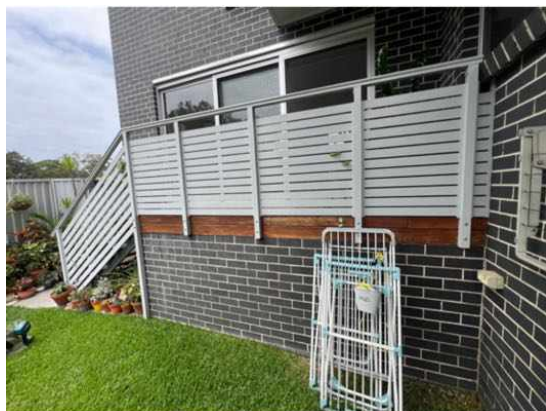
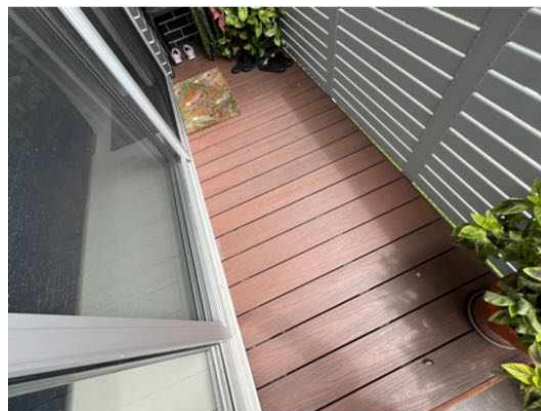
## Finding 6.04

Building:	Main Building
Location:	All External Areas
Finding:	Bridging (decking)- Attachments to Buildings.
Information:	Decking to rear landing about dwelling causing bridging and concealment. Bridging occurs when items against a building provide a concealed entry point for termites into the building or by passing around a termite management system.

a clear gap of not less than 25mm from the building, bridging occurs. Attachments to buildings such as hot water services, downpipes, verandahs, decks, steps, fences, service conduits and the like provide the opportunity for concealed entry.

Building attachments of this nature need to be frequently inspected for termite activity by a qualified inspector.

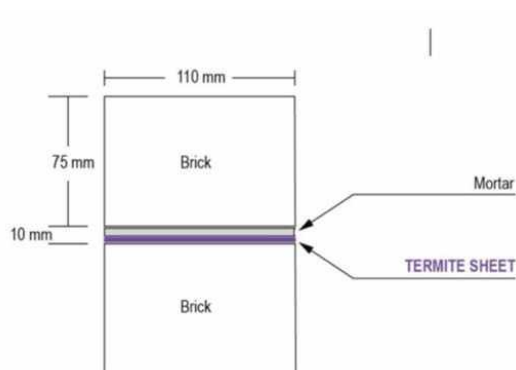
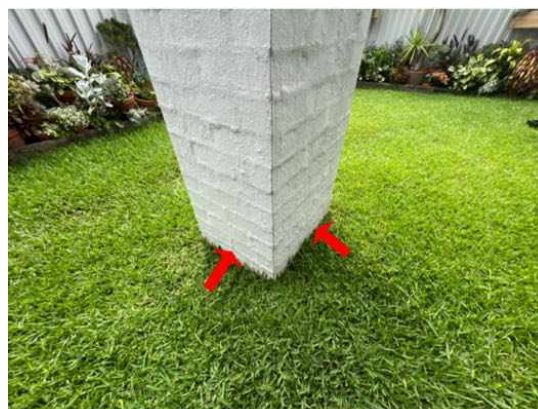
### Finding 6.05

Building:	Main Building
Location:	Porch, Alfresco
Finding:	Bridging of physical termite barriers - Concrete Patio
Information:	The tiled concrete pad to the patio and alfresco including other areas directly abuts dwelling causing bridging. Bridging is the span of a physical termite barrier or inspection zone so that subterranean termites have an entry point over or around that barrier.

The client should consider obtaining further advice from a timber pest technician regarding treatments required in this area. It is recommended that obtaining such advice be a short-term priority.

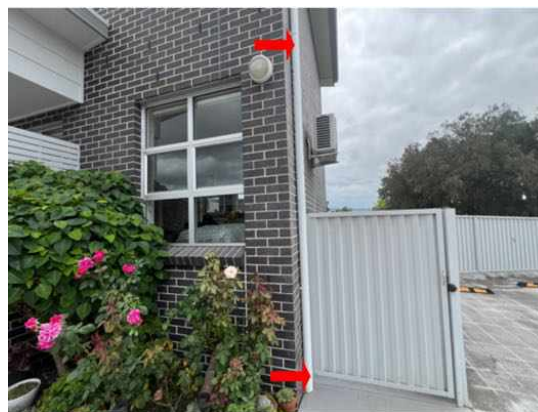
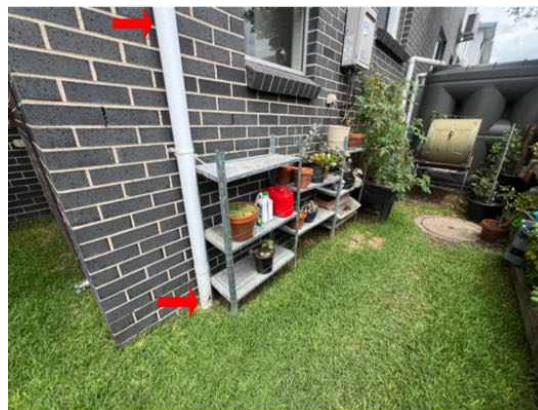
## Finding 6.07

Building:	Main Building
Location:	All External Areas
Finding:	Bridging - Attachments to Buildings.
Information:	Bridging occurs when items against a building provide a concealed entry point for termites into the building or by passing around a termite management system.

Where any part of an attachment to a building is not isolated and is not provided with a clear gap of not less than 25mm from the building, bridging occurs. Attachments to buildings such as hot water services, downpipes, verandahs, decks, steps, fences, service conduits and the like provide the opportunity for concealed entry.

Building attachments of this nature need to be frequently inspected for termite activity by a qualified inspector

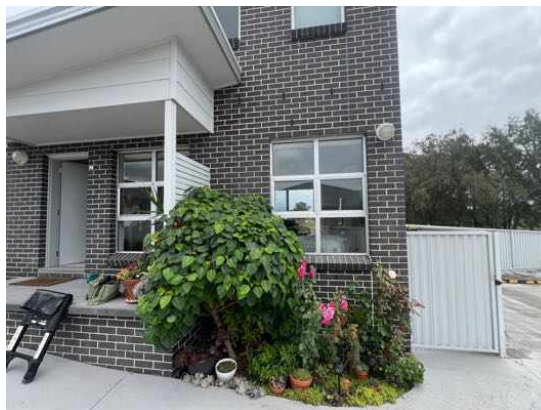
### Finding 6.08

Building:	Main Building
Location:	All External Areas
Finding:	Garden Beds - Conditions Conducive to Termites
Information:	Garden beds were observed around the perimeter of the building, obstructing visual inspection of lower wall areas and providing potential concealed termite entry points.

Raised soil levels and retained moisture from watering can allow termites to access wall cavities or weep holes undetected, while timber edging materials may further encourage activity.

It is recommended that garden beds be reduced or cleared from the building perimeter, or that regular timber pest inspections be carried out in accordance with AS 4349.3 or AS 3660.2 to monitor risk.

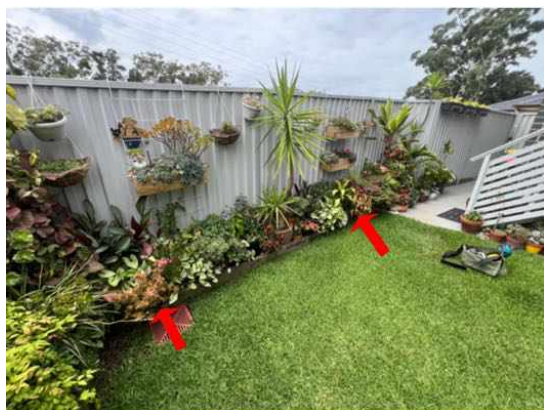
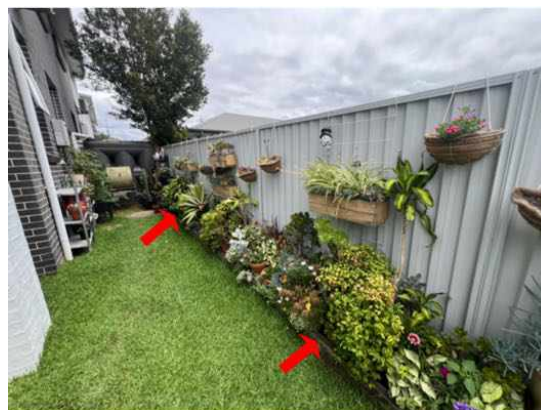
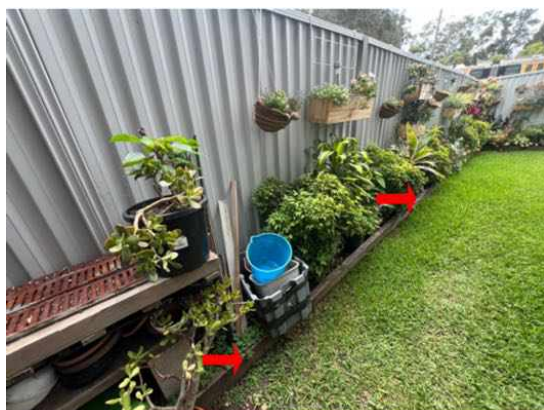
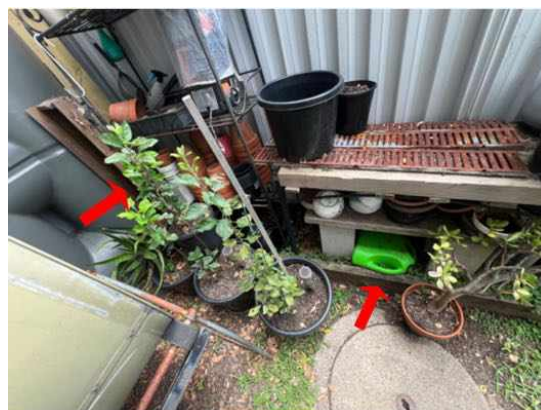
### Finding 6.09

Building:	Yard
Location:	All External Areas
Finding:	In ground contact
Information:	Any timbers in direct ground contact provide opportunity for concealed termite entry and are likely to be subject to premature rot and decay as the soil retains moisture or damp conditions against the timbers.

Remove untreated timber that is in direct contact with external grounds. Consider replacement with more durable materials i.e. treated timber or non timber elements. Frequent pest inspections are advised to readily identify any termite activity in these areas.

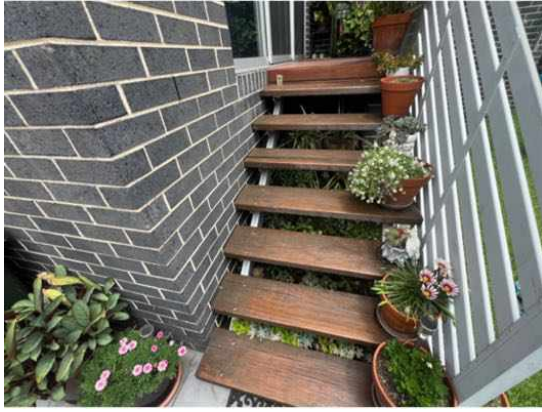
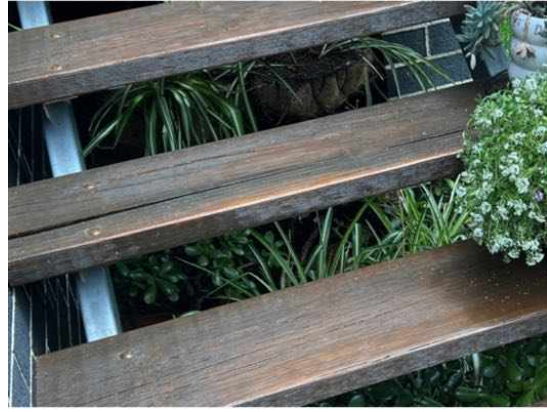
### Finding 7.01

Building:	Main Building
Location:	Decking - Landing
Finding:	Fungal decay - present (localised)
Information:	Fungal decay also known as wood decay or wood rot generally refers to the deterioration of timber elements when in contact with excessive levels of moisture for a prolonged period of time.

The development of fungal decay is accelerated by temperatures in the range of 5degreeC to 40degreeC as well as the presence of oxygen. Generally fungal decay develops on timber elements that are in use in an external environment which are exposed to rain penetration.

In this case although the affected timber element is in a decaying state the extent of any visible damage appears to be localised to a specific area and is yet to spread to other parts of the building element or affect adjoining structures. The fungal decay is therefore likely to be of a relatively superficial nature with minimal impact on the structural integrity or tensile strength of the timber element.
