# Building and Timber Pest Inspection Report

Inspection Date: Tue, 3 Feb 2026

Property Address: 4/223 Princes Hwy, Albion Park Rail NSW  
2527, Australia

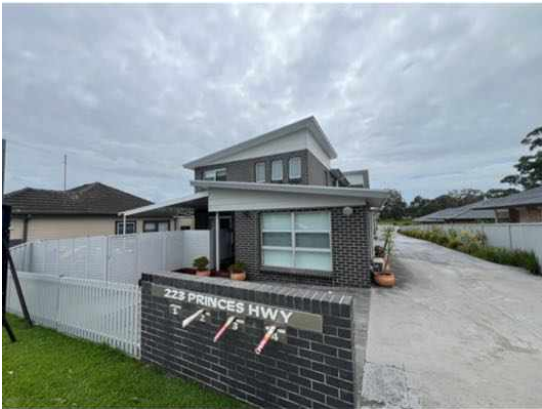
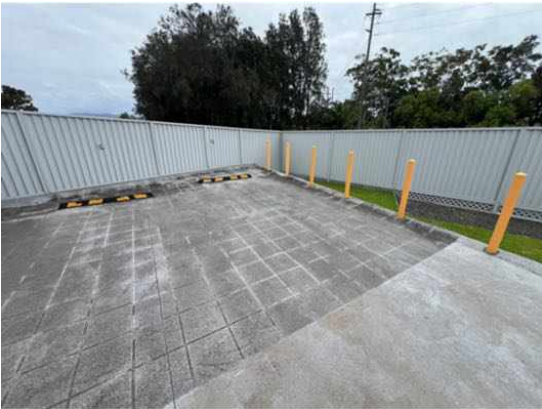
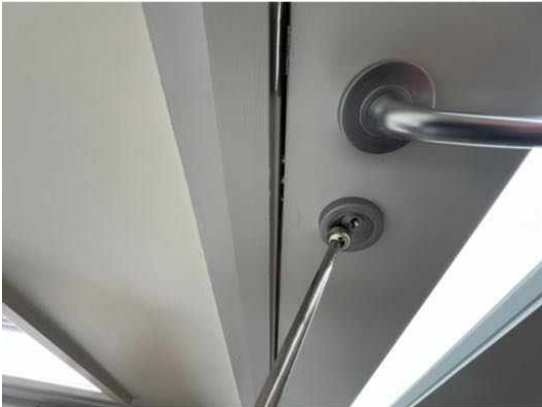
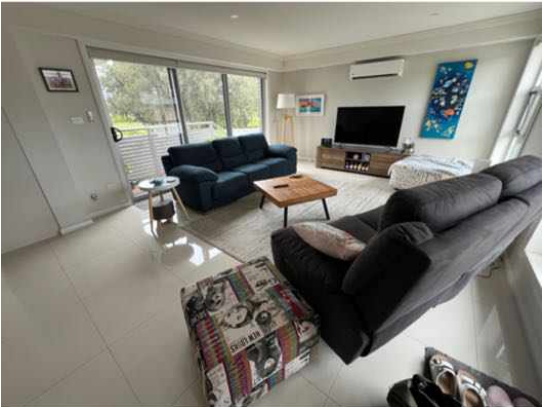
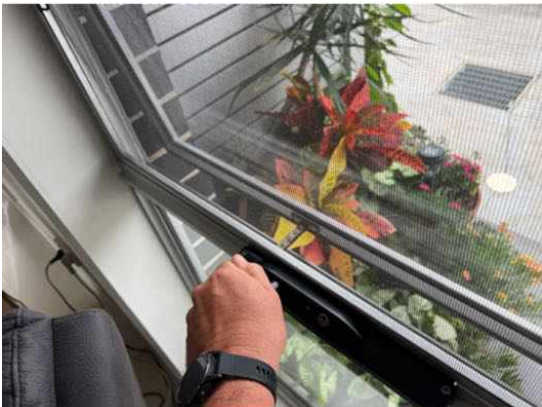
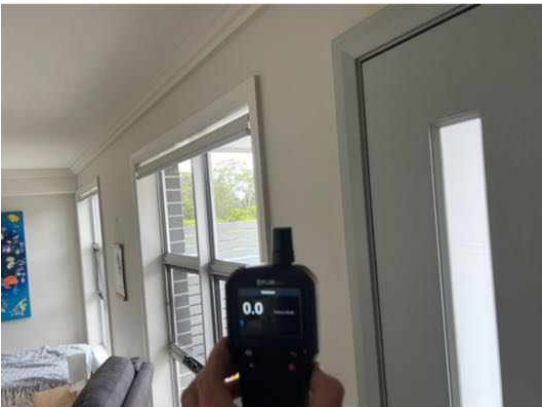
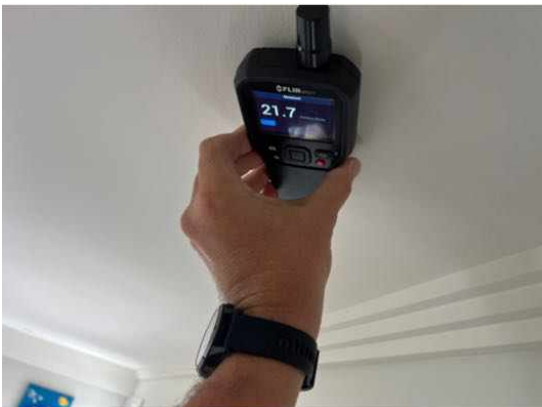
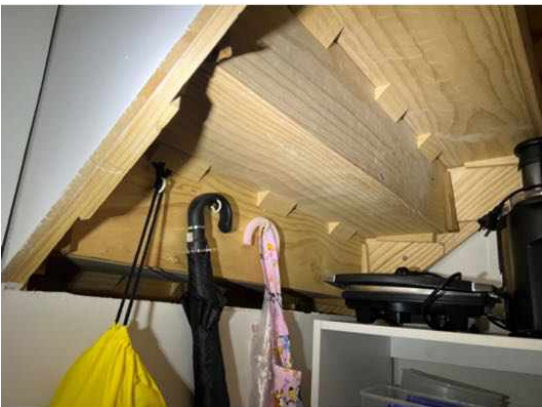
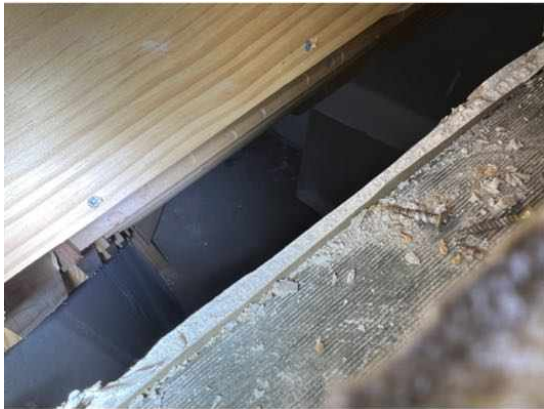
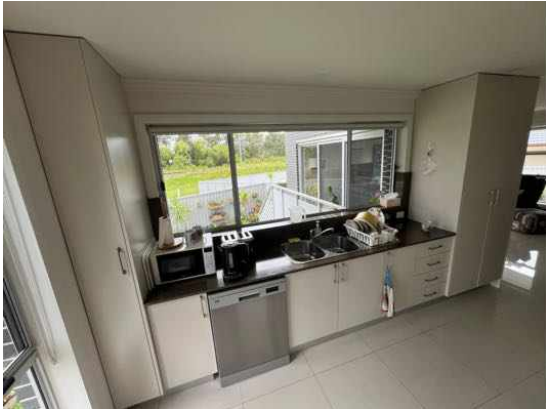
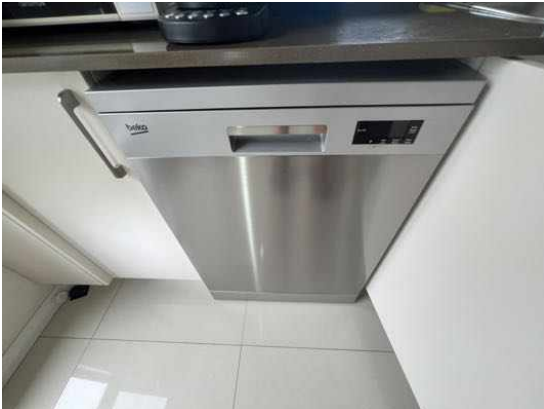
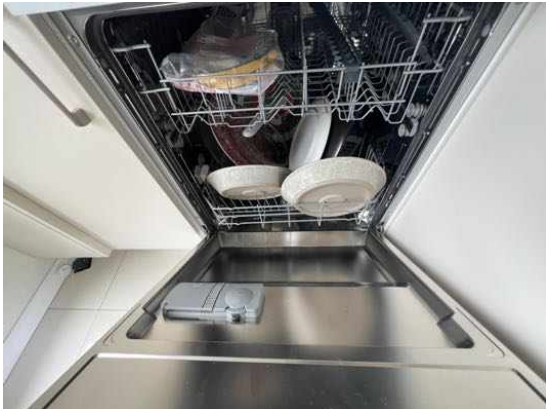
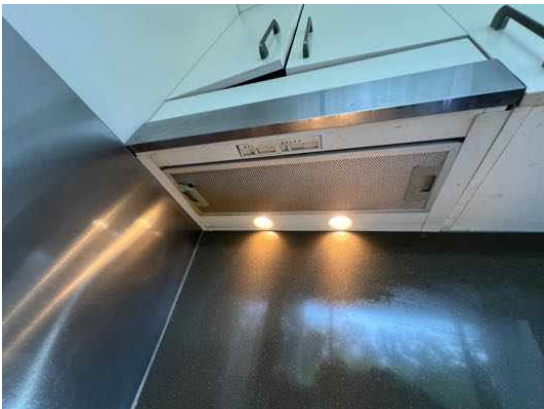
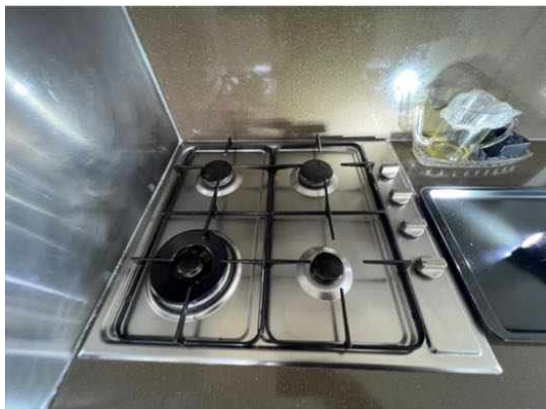
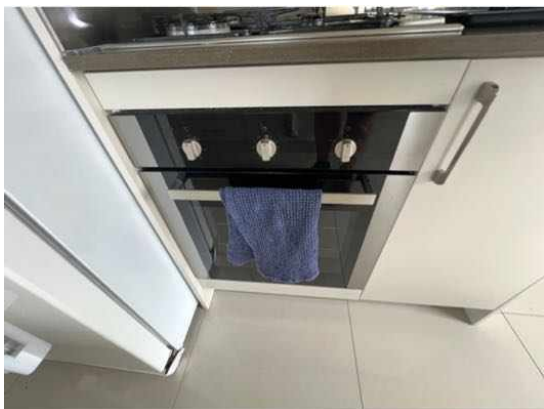
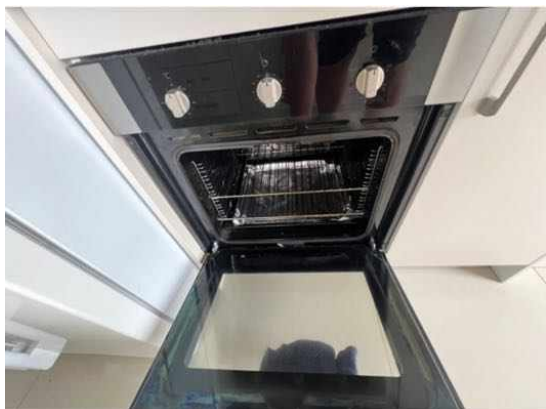
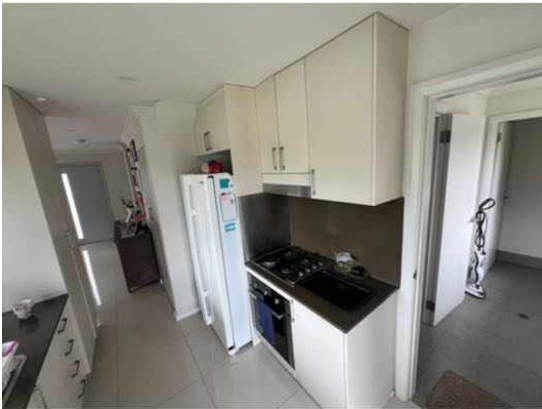
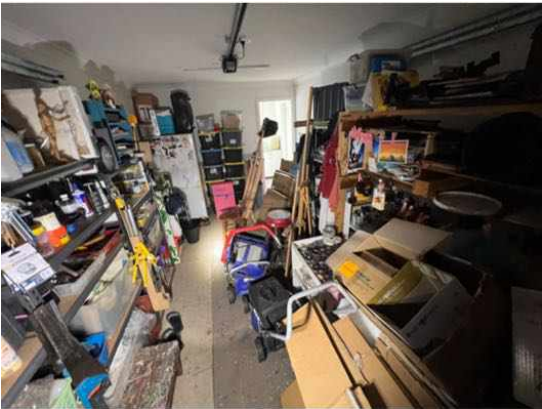
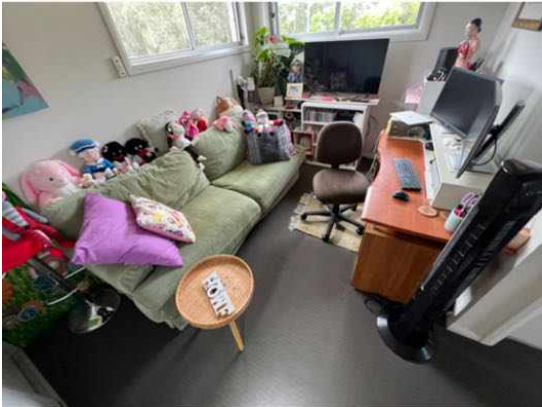
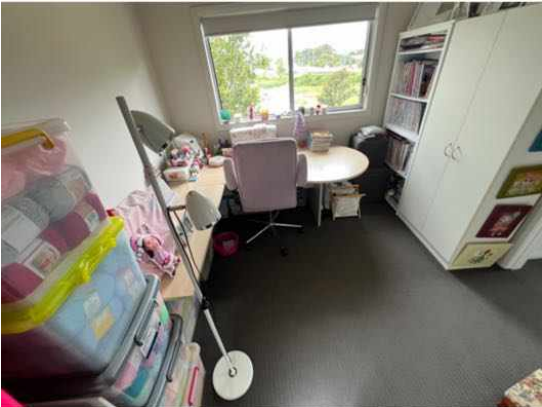
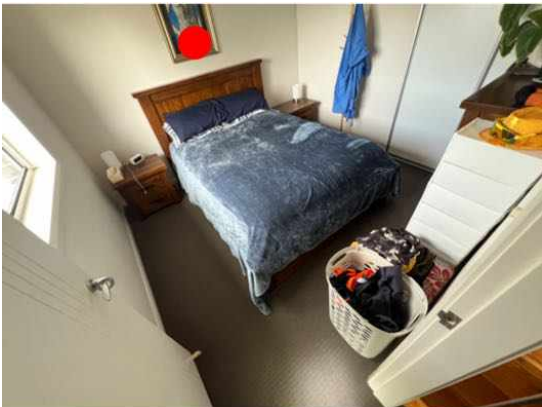
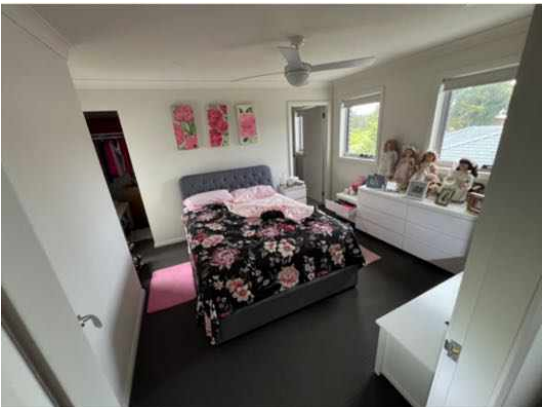
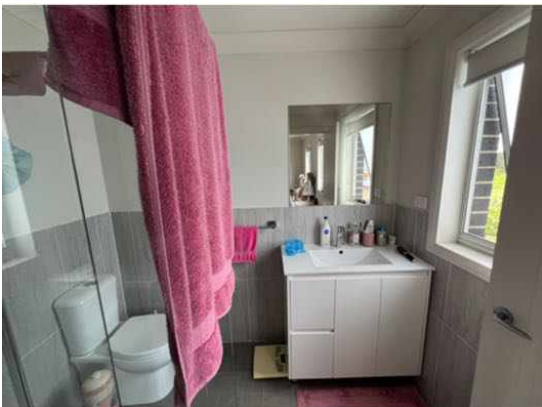
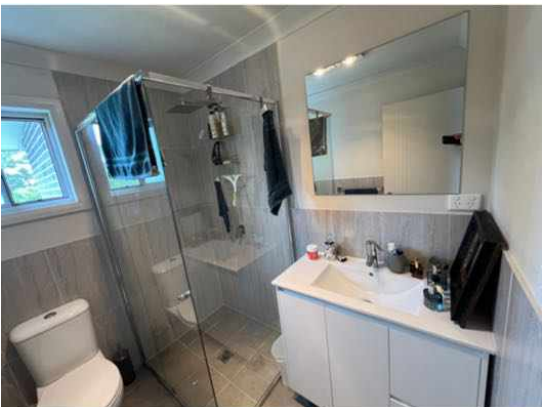
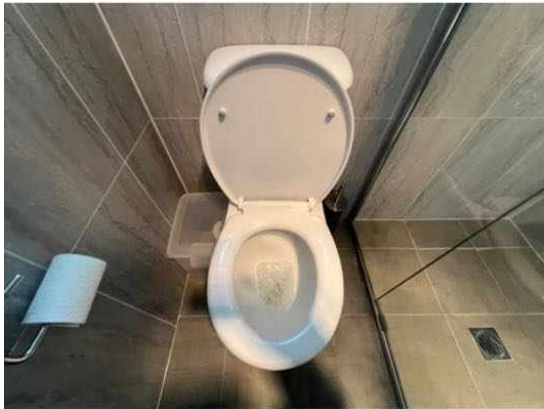
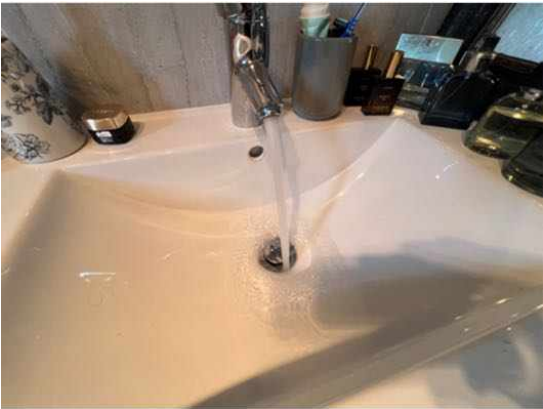
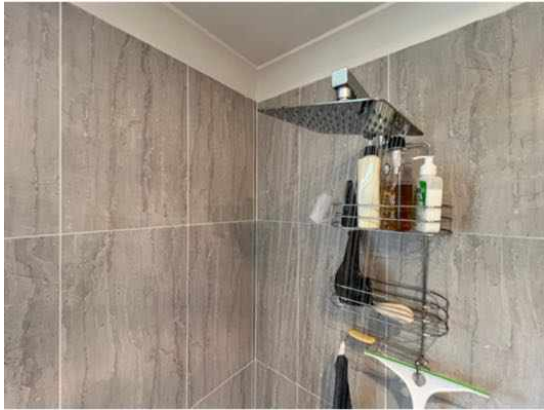
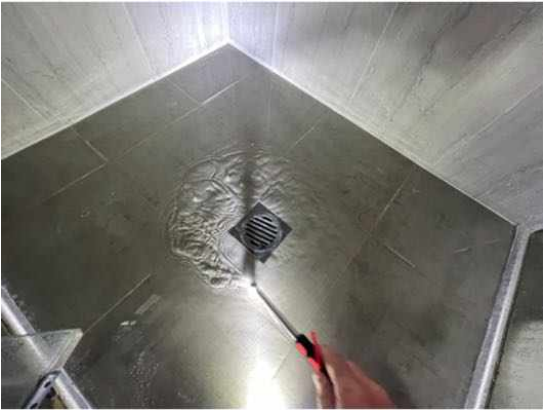
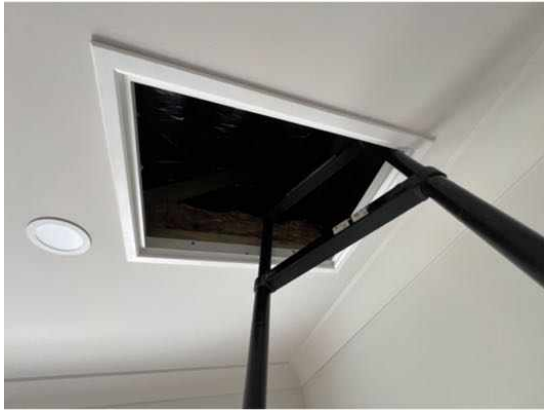
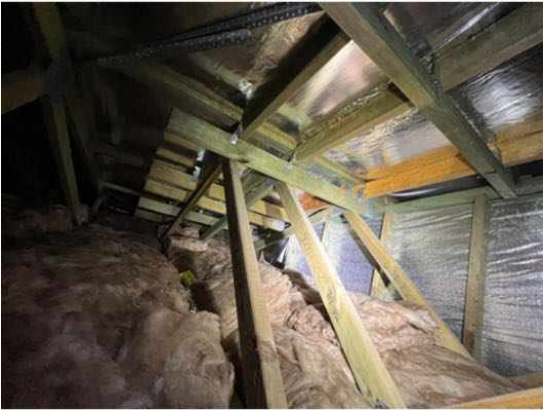
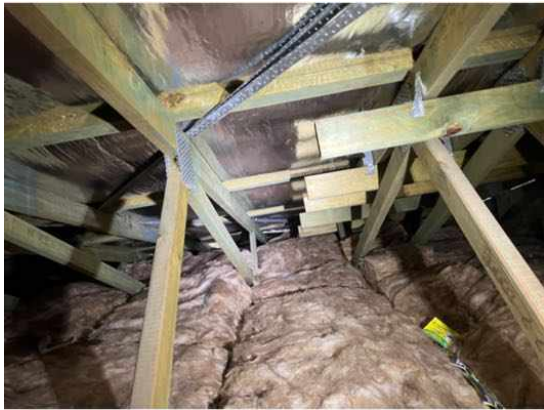
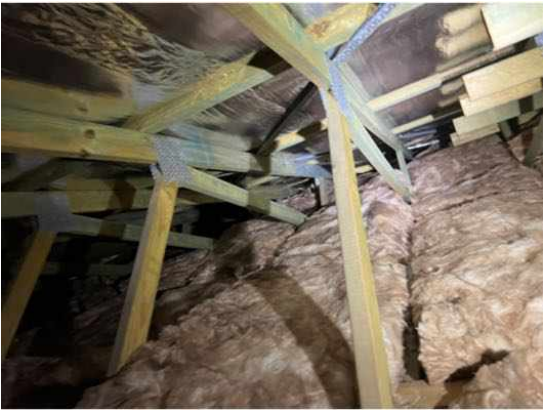
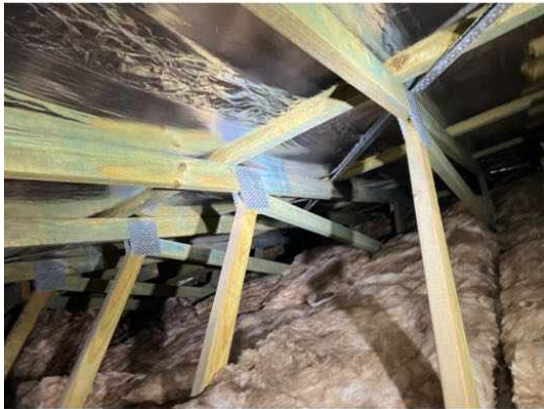
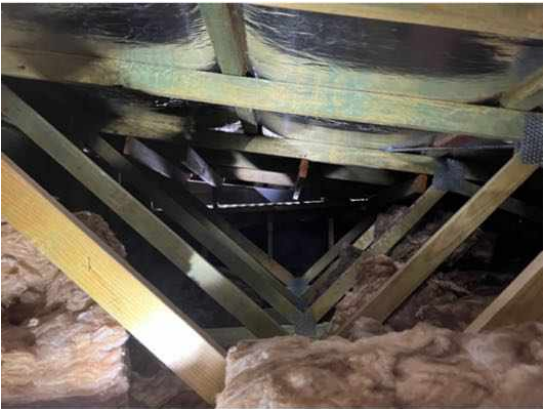
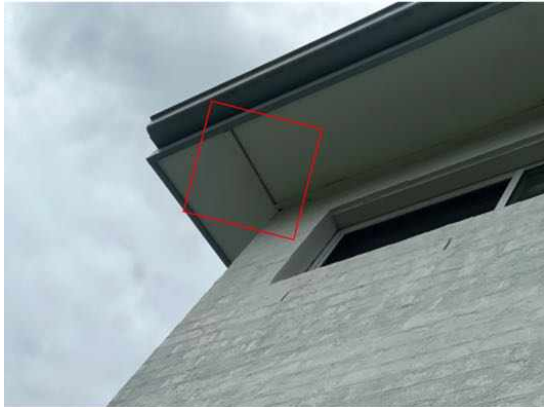
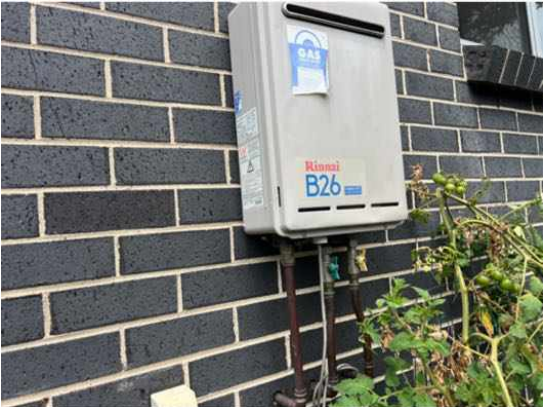
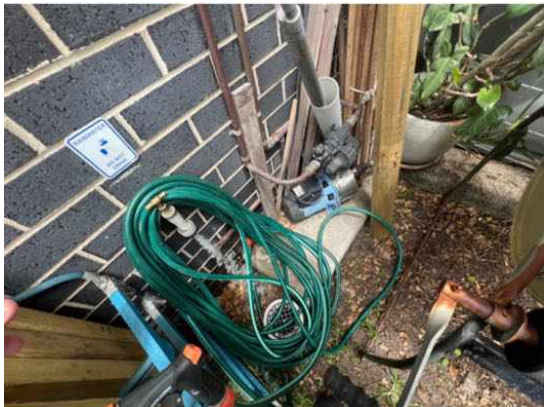
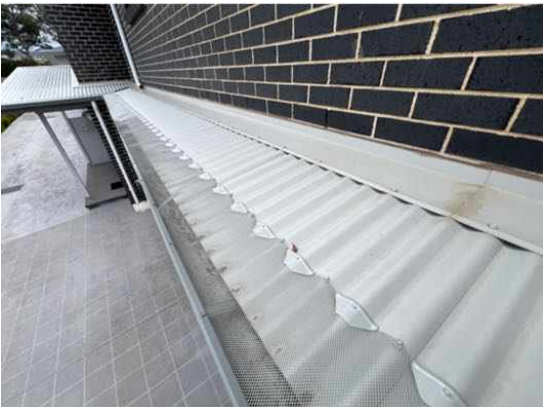
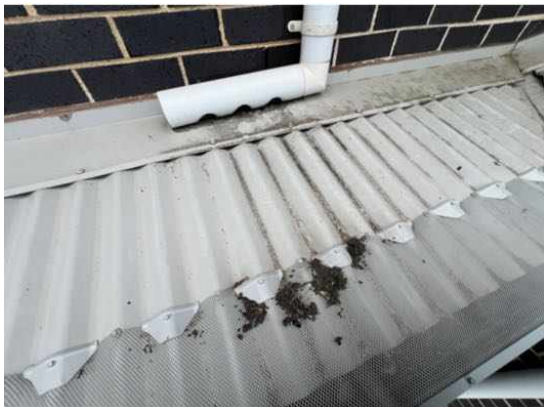
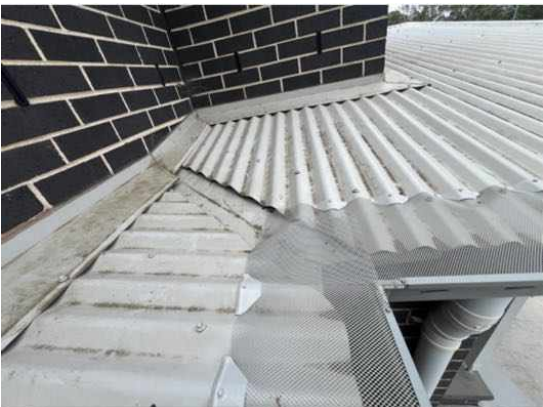
Finding: FYI - Additional Photos

Information: Additional photos are provided for your general reference and may include obstructions, testing of water & windows, moisture readings or minor maintenance items.
