# Building and Timber Pest Inspection Report

Inspection Date: Thu, 19 Mar 2026

Property Address: 17 Burra Close, Glenmore Park NSW 2745

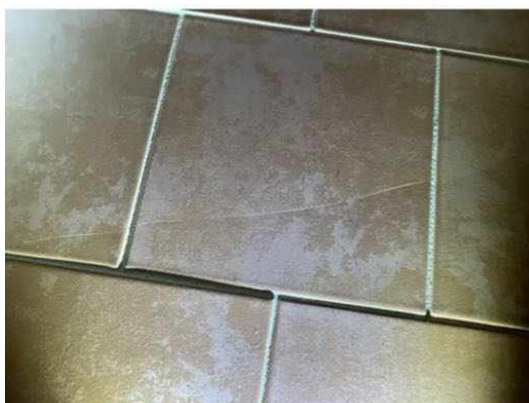
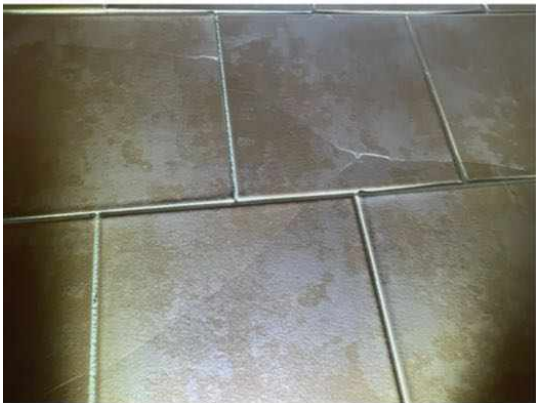
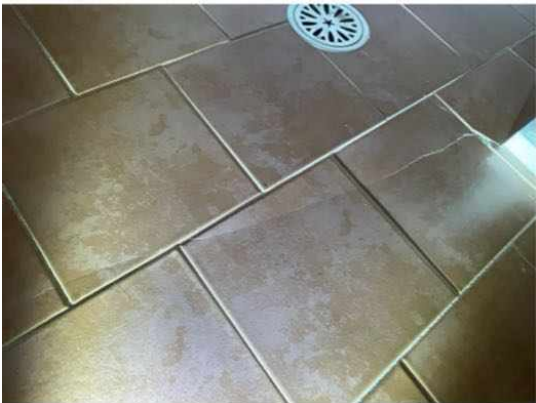
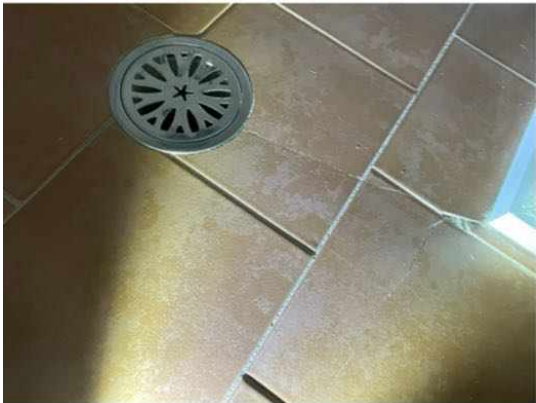
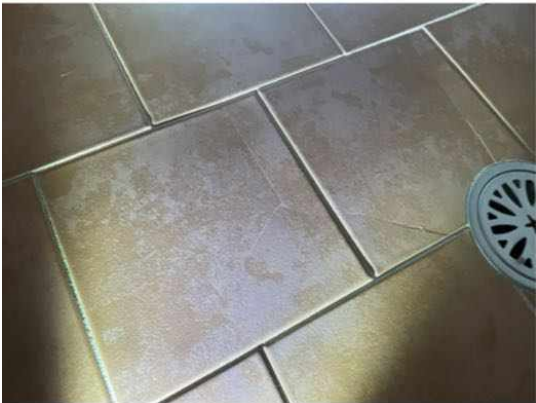
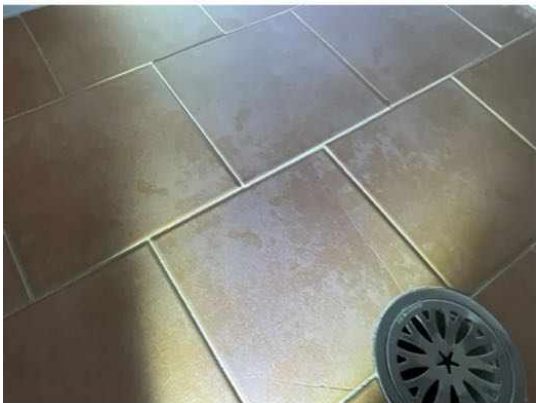
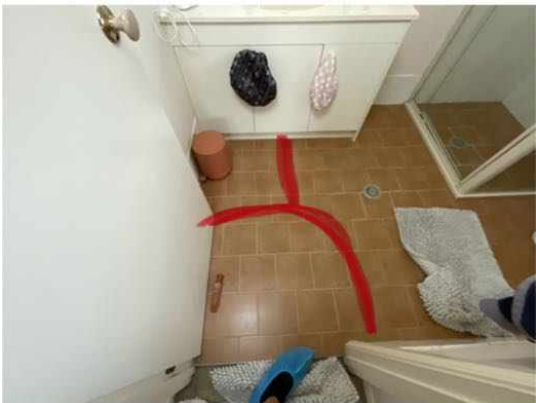
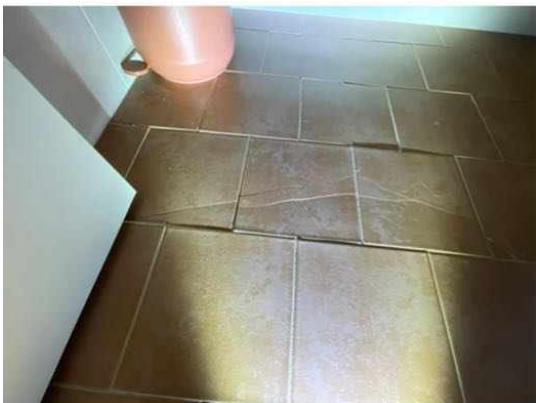
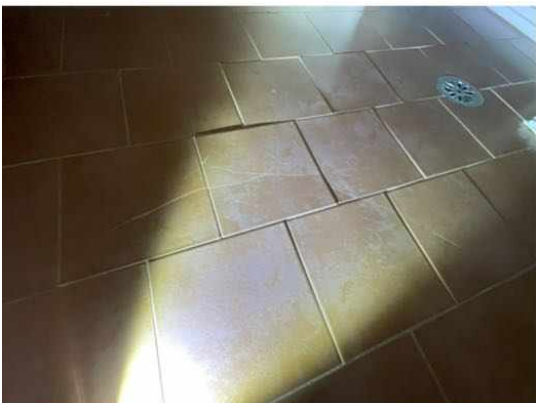
Building:	Main Building
Location:	Bathroom & Ensuite
Finding:	Major Defect – Cracked Floor Tiles to Bathroom and Ensuite
Information:	Observation

At the time of inspection, cracking to multiple floor tiles was observed in the main traffic areas outside the shower zones within both the Bathroom and Ensuite, located on the upper level of the dwelling. These areas are constructed over a suspended timber floor system. The cracking appeared to affect several tiles and was not isolated to a single point, indicating a broader issue rather than incidental damage.

The pattern and location of the cracking suggest the likelihood of substrate movement and/or inadequate rigidity of the underlying floor structure or tile underlay. In suspended timber floor systems, excessive deflection, insufficient sheet flooring thickness, poor installation of tile underlay, or deterioration of supporting structural members can result in tile failure.

This condition is considered a major defect as it may indicate ongoing movement within the floor system. Continued movement can lead to further tile cracking, loosening of tiles, and potential failure of waterproofing membranes. Once compromised, waterproofing may allow moisture ingress into the subfloor structure, which can contribute to timber decay, mould growth, and deterioration of associated building elements.

It is recommended that a suitably qualified and licensed builder be engaged to undertake a comprehensive assessment of the floor structure, including the adequacy of the substrate, framing, and tile underlay system. Further investigation may require removal of sections of the tiled surface to determine the extent of movement and condition of the supporting elements.

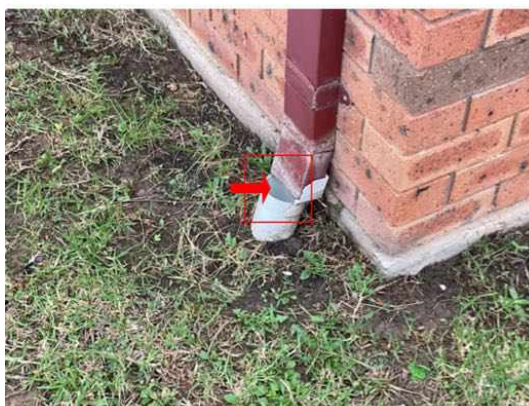
The current roof plumbing setup poses both compliance and moisture-management concerns, with the potential to contribute to structural or pest-related issues. Prompt rectification by a qualified professional is advised to ensure proper water management and protect the integrity of the building.

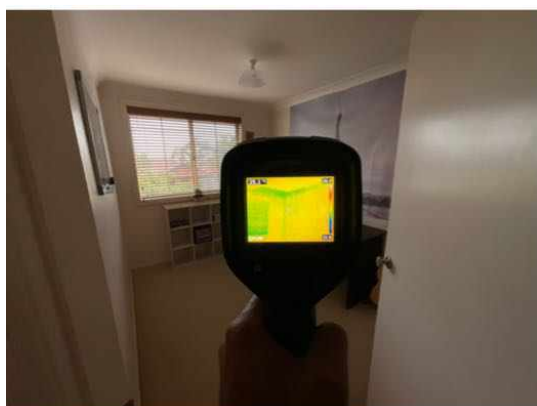
At the time of the inspection, no abnormalities indicating live termite activity were observed. However, it's important to note that various factors—such as obstructions, ambient temperature, and wall material/thickness—can impact the accuracy of thermal readings. In cases where surfaces are visually restricted or obstructed, a comprehensive thermal scan may not always be feasible.

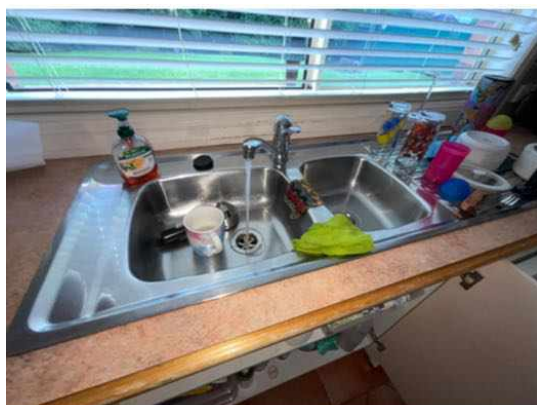
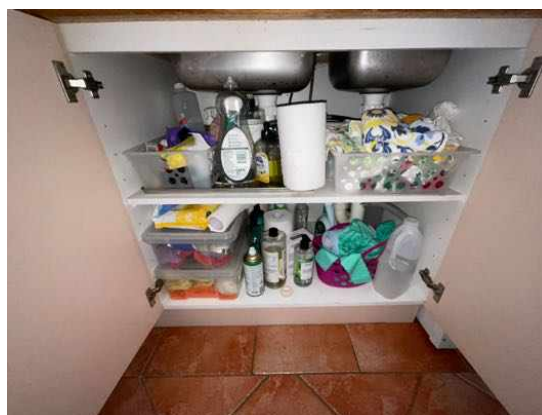
Building: Main Building  
 Location: Kitchen  
 Finding: Kitchen Sink – Overall Condition & Recommendations.  
 Information: Observations:

- Further monitoring and testing are recommended once the tap(s) are in constant use, to identify any drainage issues or signs of slow leaks not evident during the limited inspection.
- Flexible, mould-resistant sealant should be applied at wall junctions and other wet-area interfaces to prevent water ingress and potential damage. This is considered routine maintenance, and damaged or missing sealant should be replaced as needed.
- For long-term property care, it is advised that sealant and grouting in water-exposed areas be regularly inspected and maintained. A sealant specialist or tiling contractor may be engaged to carry out these works where necessary.
- It is recommended that the stored items beneath the sink be removed to allow for a full re-inspection of the plumbing and cabinetry, ensuring no concealed defects are present.

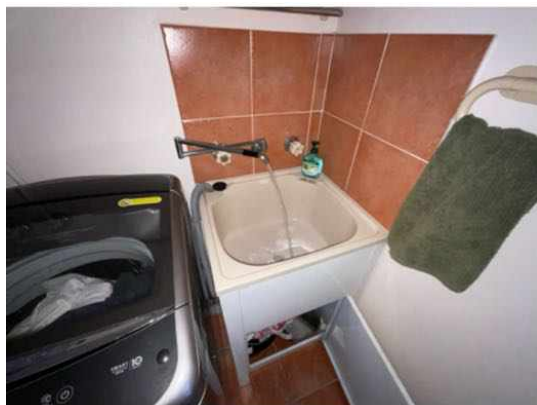
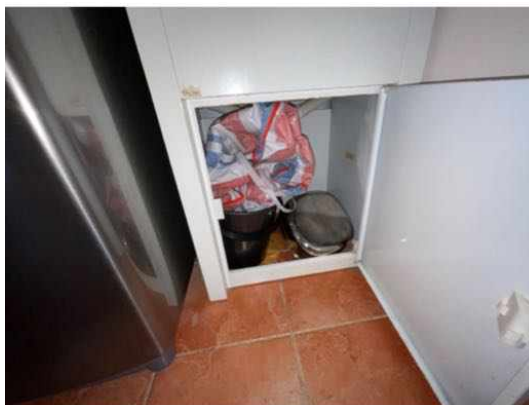
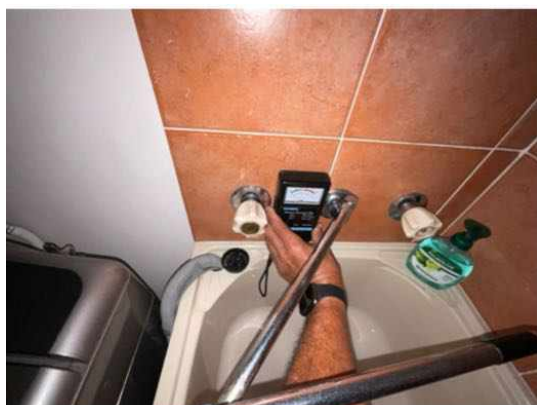
Building: Main Building  
 Location: Laundry  
 Finding: Laundry - Taps/Plumbing/Drainage.  
 Information: Observation: Laundry Tub – Taps, Plumbing, and Cabinetry

- Further monitoring or testing is recommended once the taps are placed into regular use, to ensure no leaks develop over time and that the drainage system continues to perform adequately.
- Sealant and grouting in wet areas should be maintained as part of the long-term care and upkeep of the property.

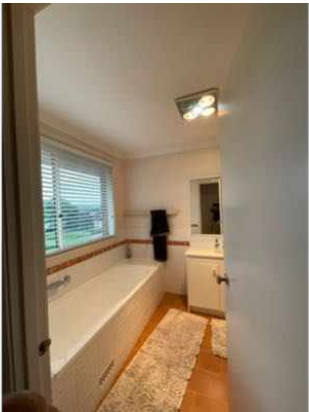
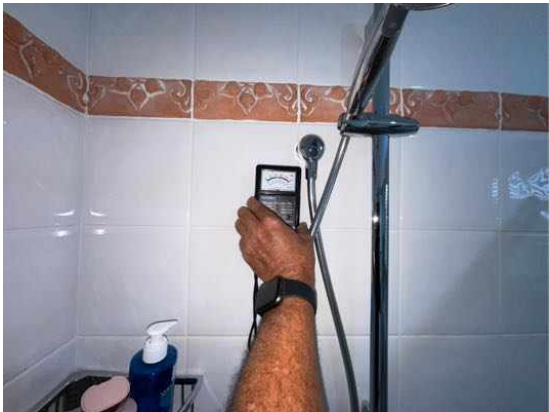
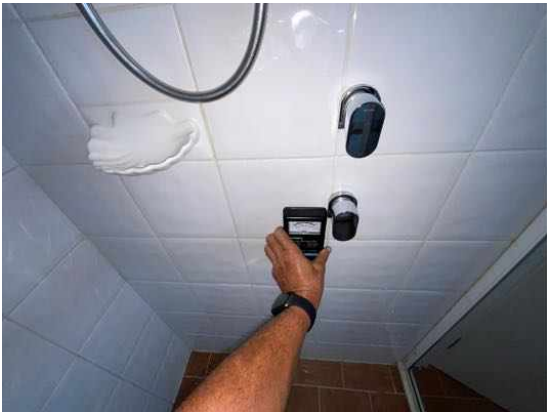
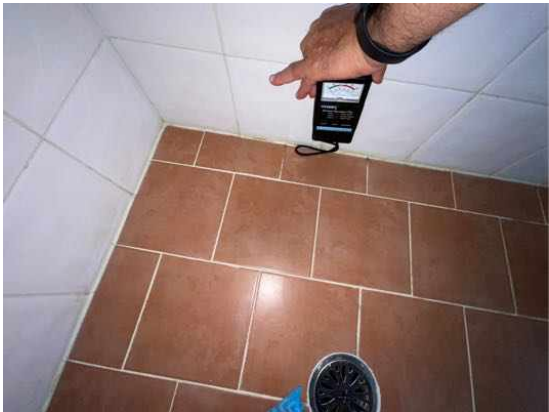
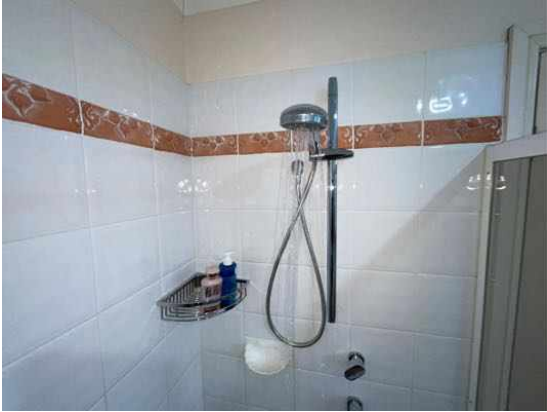
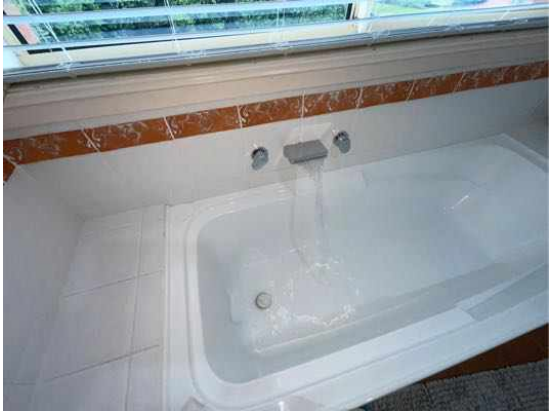
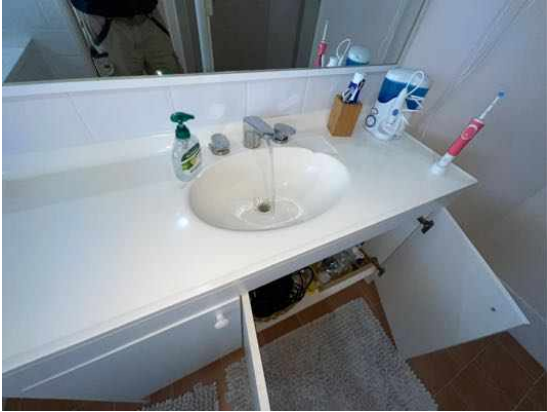
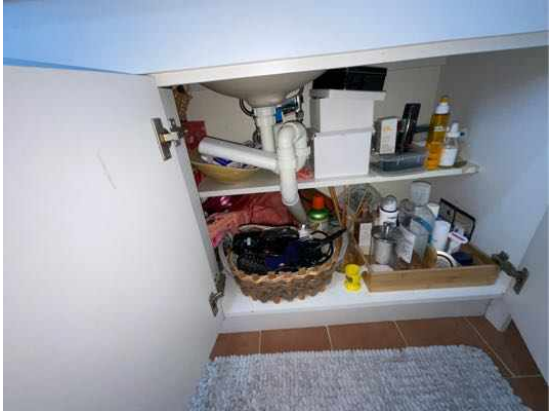
Building: Main Building  
Location: Ensuite  
Finding: Wet Areas - Bathroom(s) - Overall Condition & Recommendations.  
Information: Overall Condition & Recommendations

- Floor waste was found to be clear and free of blockages at the time of inspection. Further monitoring is advised after consistent use to identify any drainage issues or buildup requiring cleaning.

- No elevated moisture readings were detected around the tap fittings or behind the shower walls (as viewed from adjacent rooms), suggesting no active plumbing leaks at the time of inspection.

- Elevated moisture readings were found in the lower shower walls, which is a common occurrence with certain tile types that naturally absorb more moisture. This should be monitored over time.

- Sealing of grout and tiles is recommended to prevent moisture buildup and mould growth in damp areas such as showers.
- The condition of grout appeared to be serviceable, with some areas potentially requiring cleaning or replacement.

- Grout in wall and/or floor junctions may crack and deteriorate over time. It is recommended to remove any rigid grout from junctions and replace with flexible, mould-resistant sealant in accordance with best building practices.

- The exhaust fan appeared to be operational, which supports moisture control in the bathroom.

- No leaks were observed during flushing. The toilet operated normally, and the toilet pan appeared to be securely fixed to the floor.

- Basin(s) were water tested and inspected, with no leaks or blockages identified in the plumbing or drainage system at the time of inspection.
- Further monitoring is recommended after the basin(s) are placed under regular use to confirm ongoing performance and cleanliness.
- No visible water damage was observed to the vanity cabinetry at the time of inspection.
- Stored items inside the vanity obstructed full visibility during the inspection. It is advised that the area be re-inspected once all obstructions are removed.

- Flood testing of the shower recess is recommended. This may reveal inadequacies in the waterproofing or shower screens, which could lead to water damage in surrounding areas.

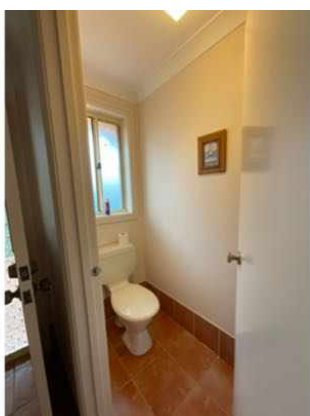
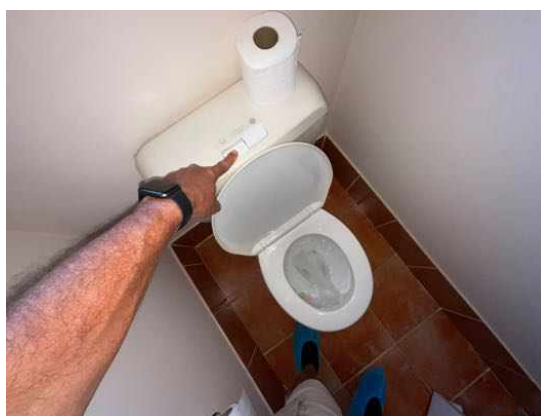
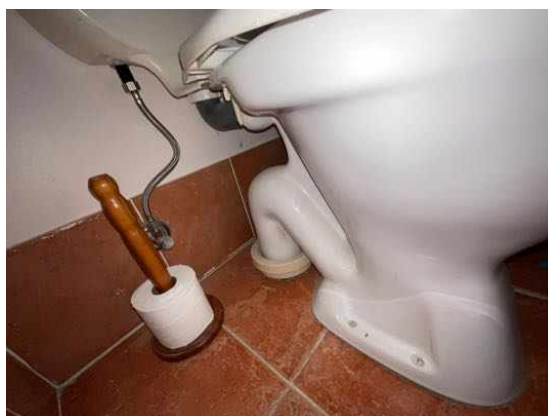
Building: Main Building  
 Location: All Areas  
 Finding: Water Pressure – Observation Only.  
 Information: During the inspection, water pressure appeared to be within a normal operating range based on a basic functional check. However, this observation was made without the use of pressure testing equipment and does not constitute an assessment by a licensed plumber.

It is strongly recommended that a Licensed Plumber be engaged to conduct a comprehensive assessment of the plumbing system to verify its functionality, check for any underlying issues, and confirm compliance with current regulations and standards.

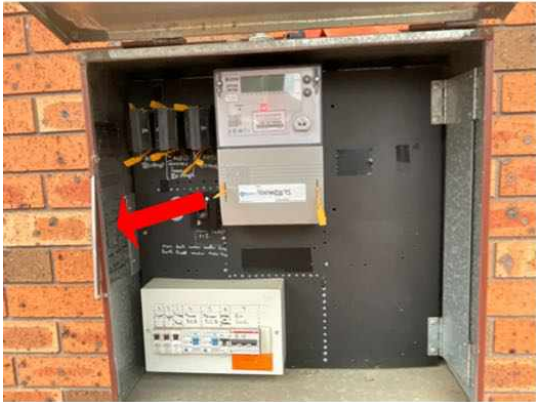
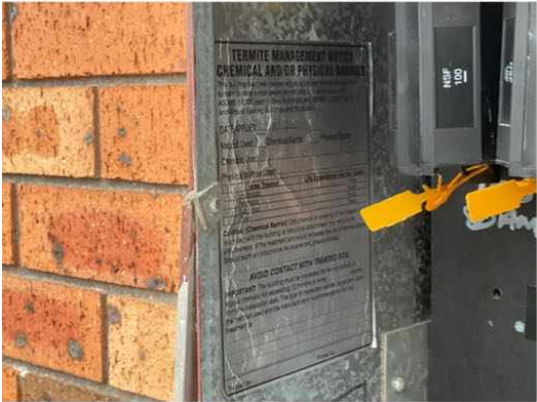
**The following items were noted as - Evidence of a previous termite**

- Regular inspections and monitoring

These measures work together to reduce the likelihood of undetected termite access and long-term structural damage to the building.
