Building and Timber Pest Inspection Report

Inspection Date: Fri, 6 Feb 2026

Property Address: 79 Pandorea Street, Claremont Meadows
NSW 2747

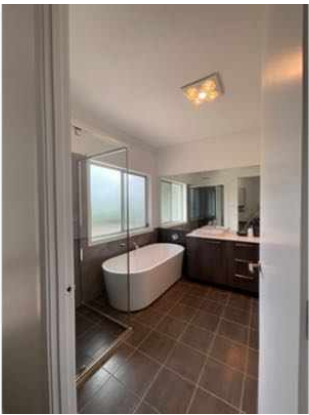
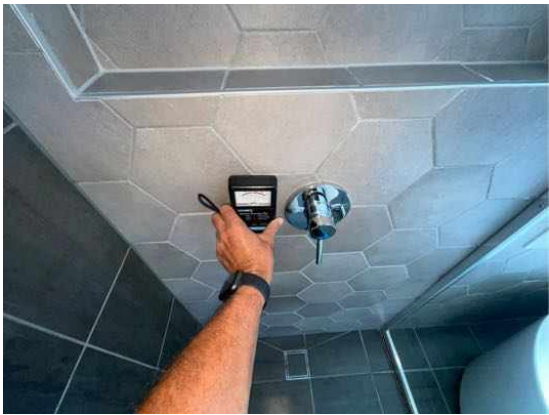
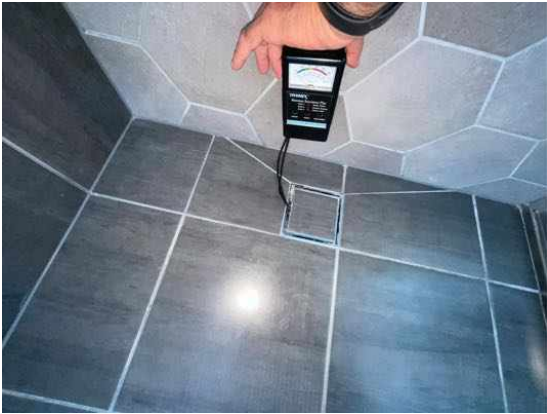
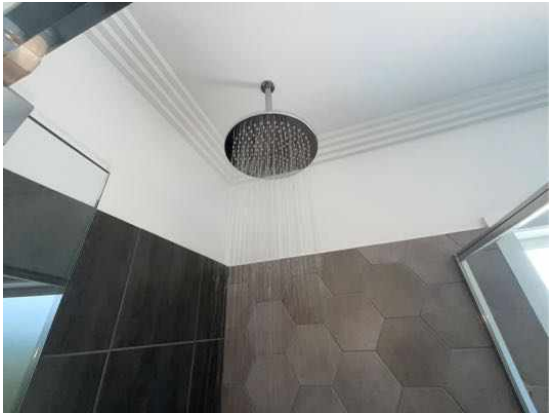
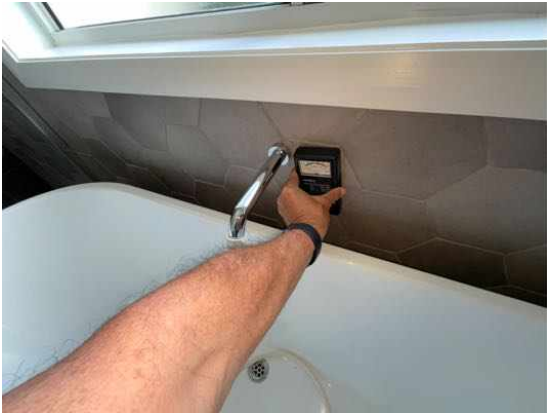
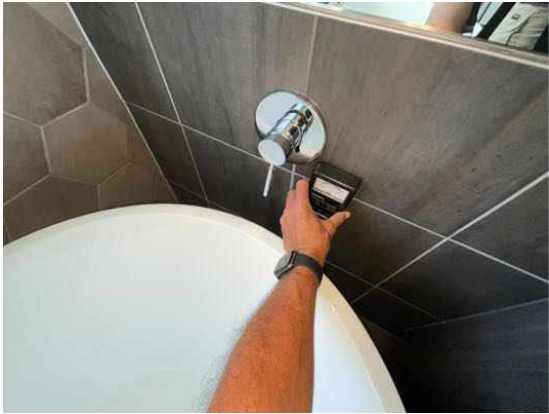
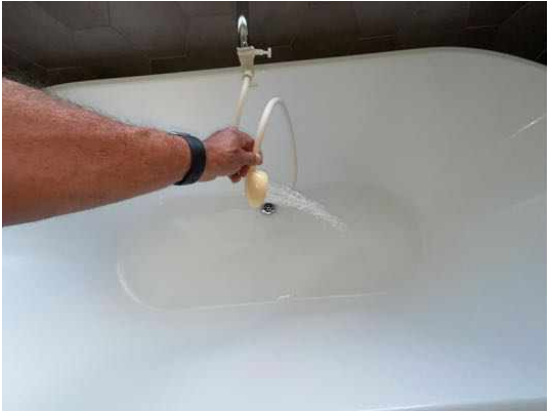
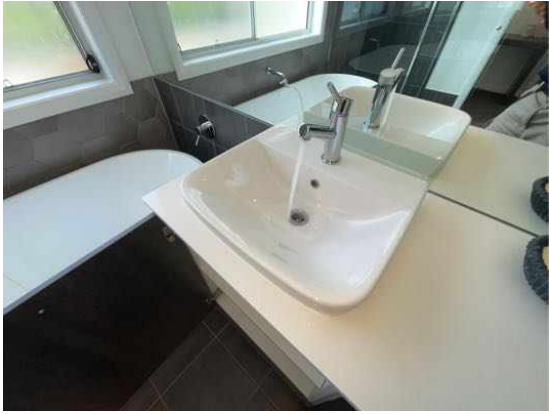
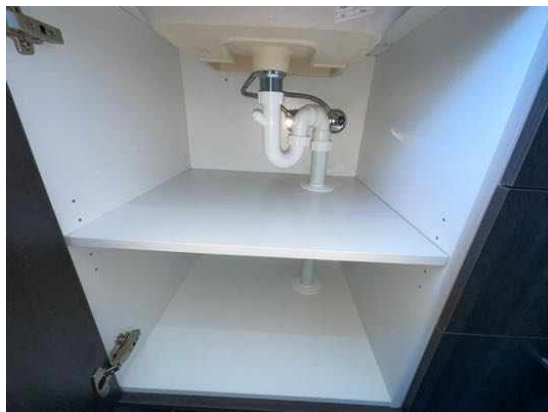
Building: Main Building
 Location: Ensuite
 Finding: Wet Areas - Bathroom(s) - Overall Condition & Recommendations.
 Information: Overall Condition & Recommendations

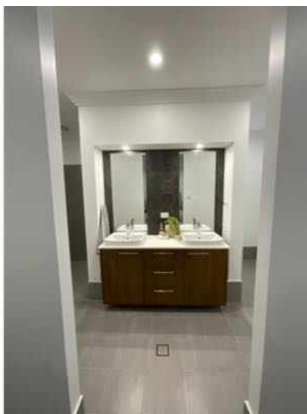
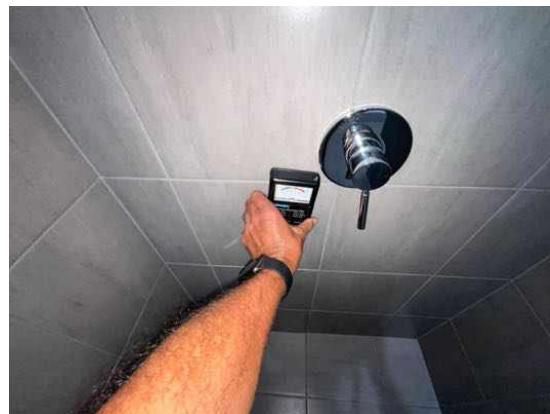
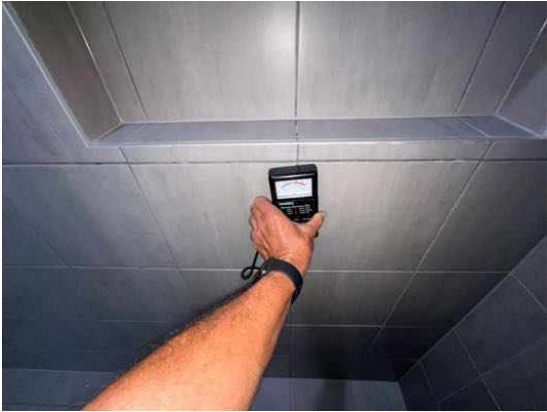
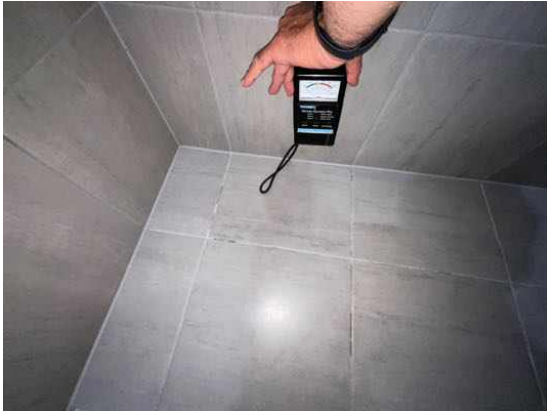
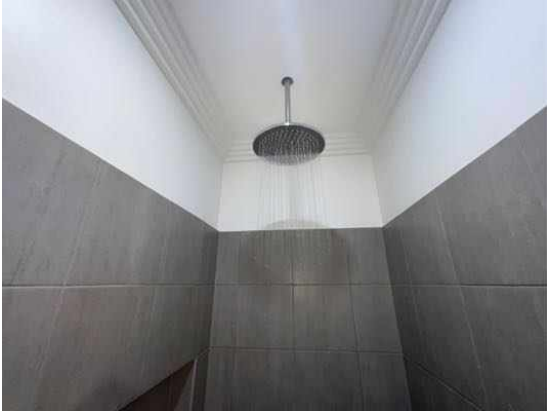
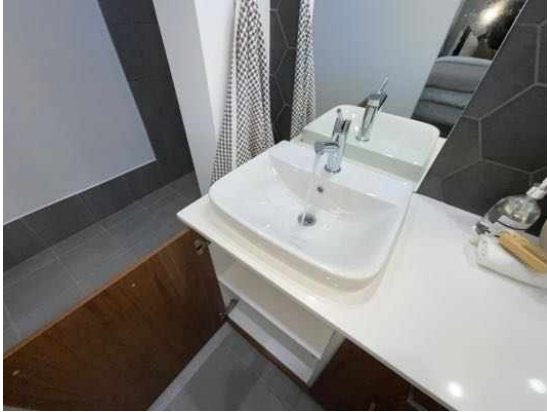
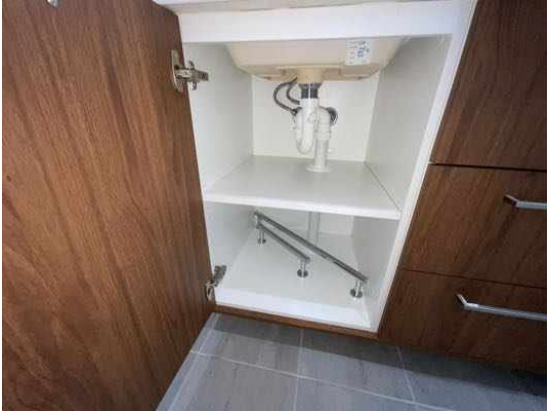
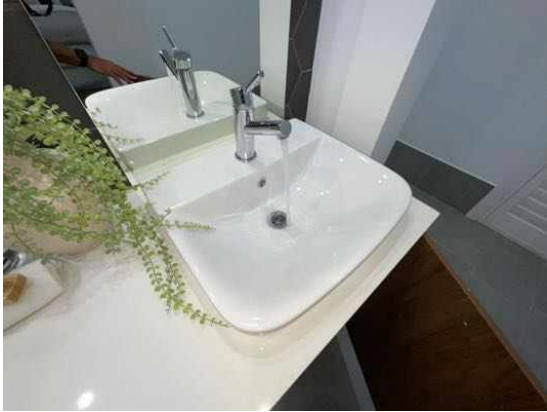
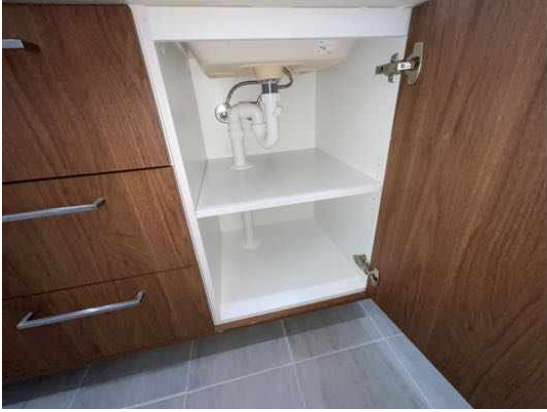
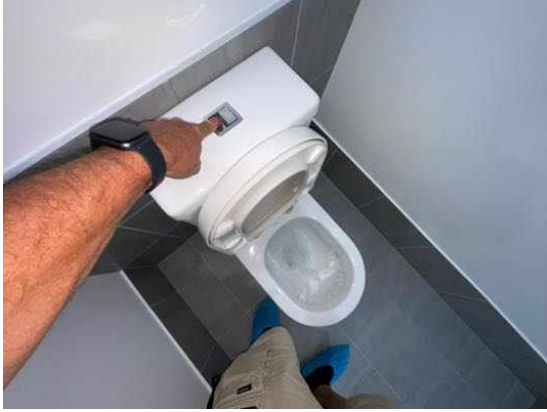
Building: Main Building
Location: Toilet (WC)
Finding: Overall Condition: Toilet & Basin.
Information: TOILET & BASIN ASSESSMENT

- The vanity unit showed no visible signs of water damage, rust, or swelling at the time of inspection.
- Cabinetry doors and panels were secure and functional, with no evidence of structural deterioration.
- Regular maintenance of sealant and grouting in wet areas is essential to prolong the life of surrounding materials and reduce the risk of water damage.

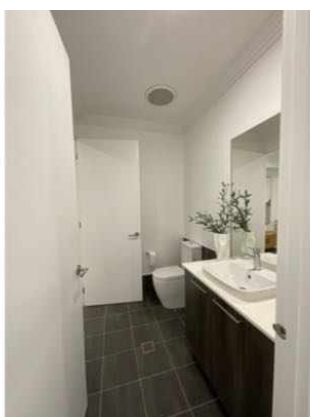
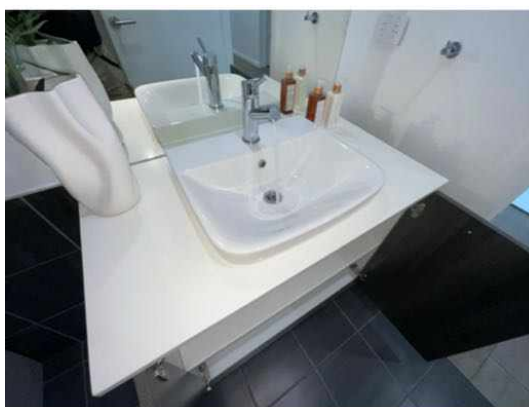
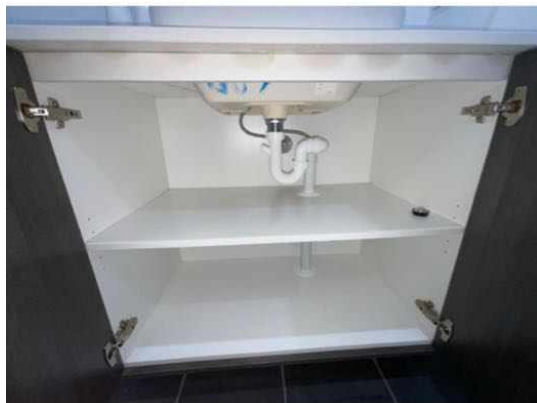
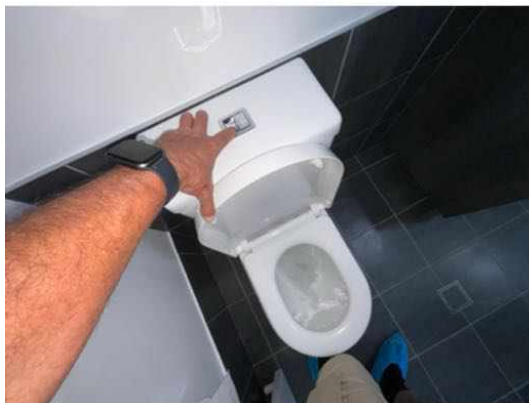
Building: Main Building
 Location: All Areas
 Finding: Water Pressure – Observation Only.
 Information: During the inspection, water pressure appeared to be within a normal operating range based on a basic functional check. However, this observation was made without the use of pressure testing equipment and does not constitute an assessment by a licensed plumber.

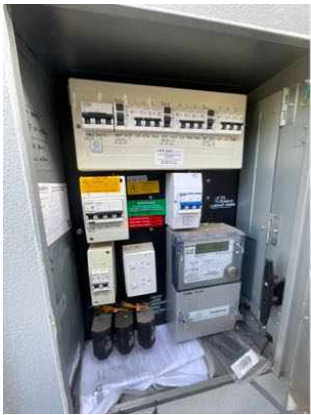
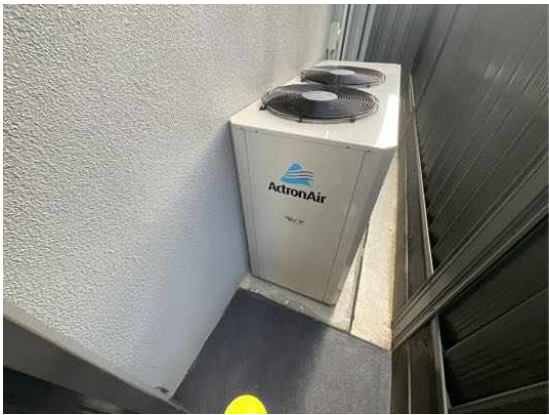
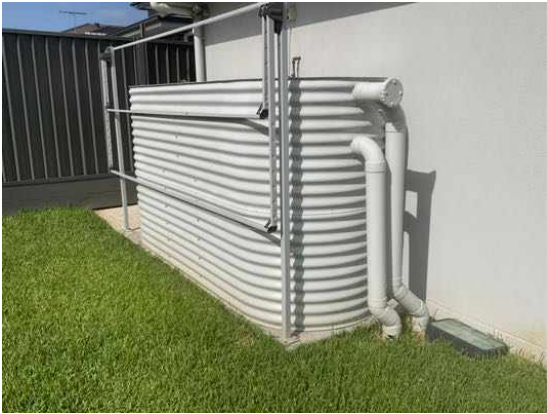
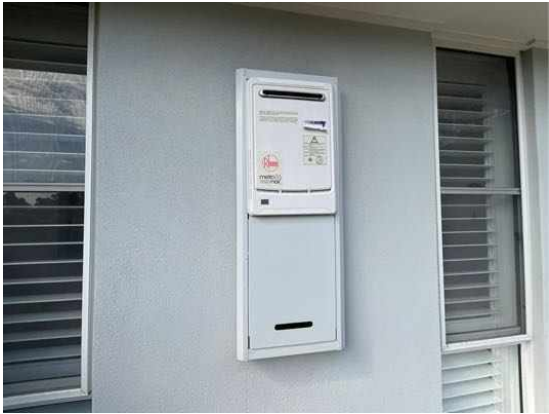
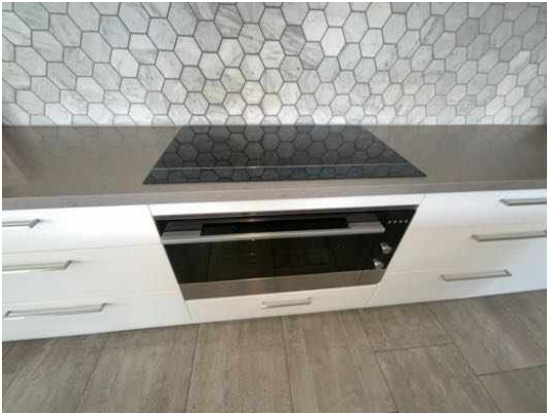
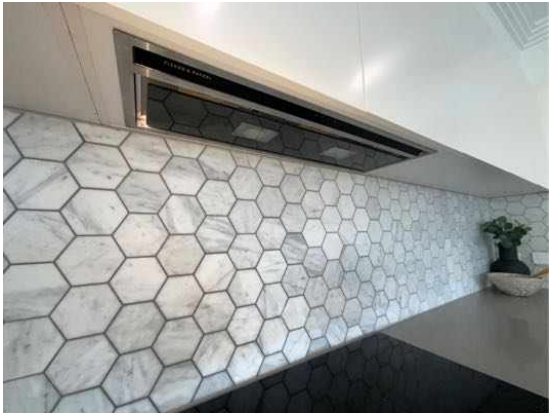
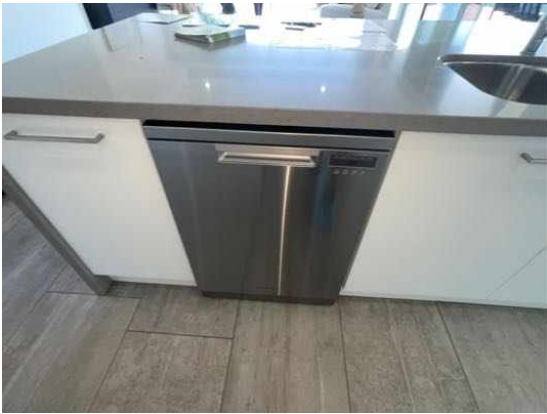
Building: Main Building
 Location: All Areas
 Finding: Plumbing, Electrical & Gas Installations – Scope and Recommendations.
 Information: Plumbing and electrical inspections fall outside the scope of this building inspection and must be carried out by appropriately licensed and registered tradespersons.

While this inspection includes observations of visually apparent defects relating to plumbing and electrical elements, it does not assess compliance with current regulations. Legislation requires that any such assessment be undertaken and documented by licensed electricians and plumbers.

Additional photos have been supplied with this report for your general reference.

- Any gas appliances (if applicable) must be inspected by a licensed gas plumber to confirm they are operating safely and efficiently.
- We also recommend that all other plumbing and electrical installations be thoroughly checked by qualified professionals to ensure they are functioning correctly and meet current safety and compliance standards.

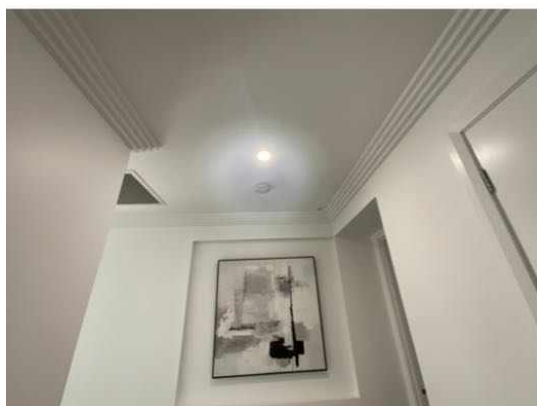
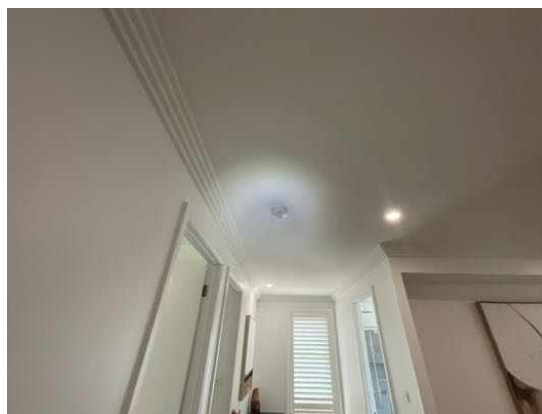
Building:	Main Building
Location:	All Areas
Finding:	Smoke Detectors / Alarms.
Information:	Reporting on the presence, type, location, or compliance of smoke detectors or alarms, including hard-wired smoke detection systems and their legislative requirements, is outside the scope of this inspection report.

Failure to comply with these requirements may pose a serious risk to occupant safety.

To ensure compliance and safety, further inspection and/or advisory services from a qualified specialist are recommended. These services can confirm the sufficiency, type, location, and functionality of all smoke detection devices within the property.

- All smoke detectors be tested monthly by the homeowner.
- All systems comply with the requirements of AS 3786 and any applicable state-based legislation.

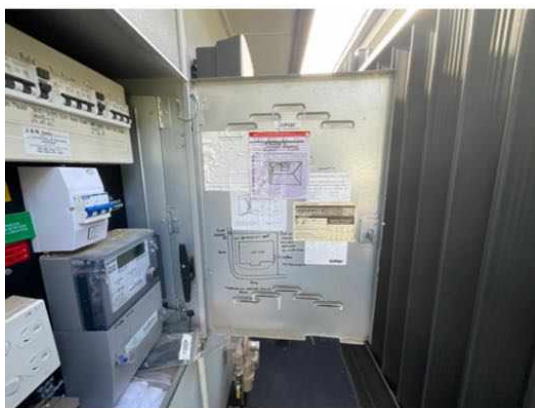
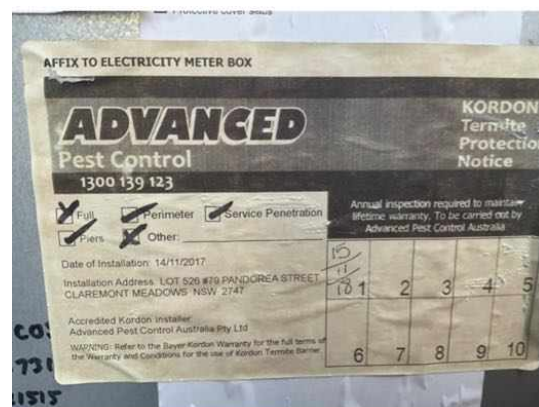
Building:	Main Building
Location:	All Areas
Finding:	Termite Management System – Previous Barrier Noted..
Information:	Observation:

At the time of inspection, evidence of a previous termite management system was noted, indicated by the presence of a durable notice affixed to the electrical switchboard.

- The installation of a termite management system is strongly recommended for all properties, particularly those with timber building elements. These systems provide a proactive defence against termite attack and are effective in minimising the risk of concealed termite entry and structural damage.

- The client is advised to contact the pest control provider listed on the durable notice (if identifiable) to obtain further information regarding:
 - The type of system installed (e.g., chemical barrier, baiting system, or physical barrier)
 - The installation date
 - Any warranty conditions, service history, or ongoing maintenance requirements
- If no reliable information can be obtained, or if the existing system is found to be outdated or non-functional, it is recommended that a new termite management system be installed by a licensed pest control professional.
