# Building and Timber Pest Inspection Report

Inspection Date: Tue, 17 Feb 2026

Property Address: 55 Harris St, Windsor NSW 2756, Australia

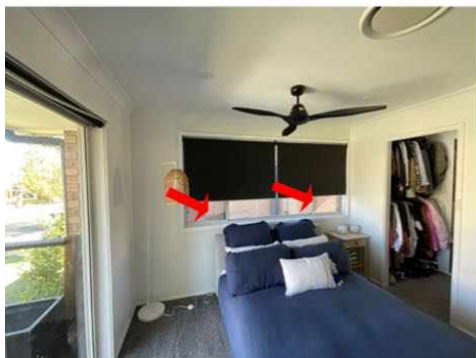
Building:	Building 1
Location:	Bedroom - Master
Finding:	Window opening restrictors missing.
Information:	The Building Code of Australia rules require all openable windows (where the internal floor is more than 2m above the ground outside) in residential rooms to be fitted with a suitable screen or restrictor. Windows located 1.7m above the floor level do not require protection.

Window restrictors are required where people who are vulnerable to the risk of falling have access to windows. This means all windows above ground level which do not have another fall prevention safety measure in place, such as a balcony or balustrade should have a restrictor.

These need to be added urgently for the safety of all persons.

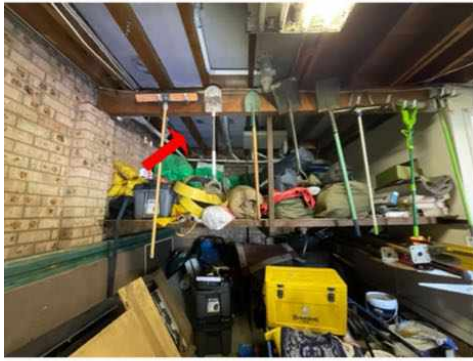
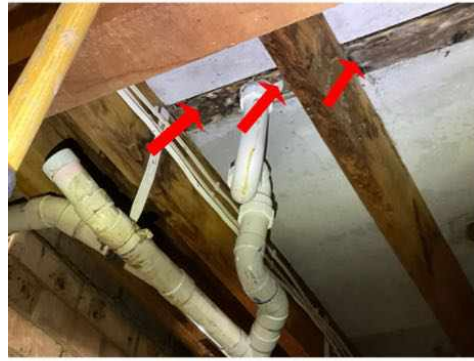
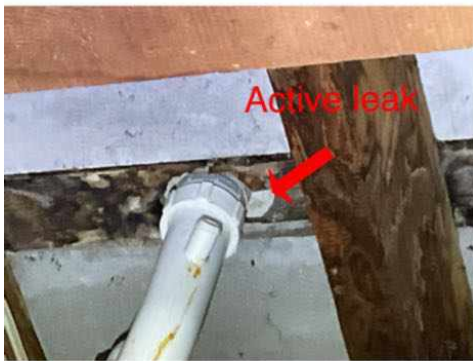
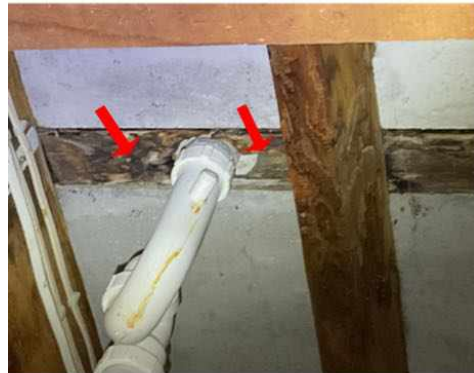
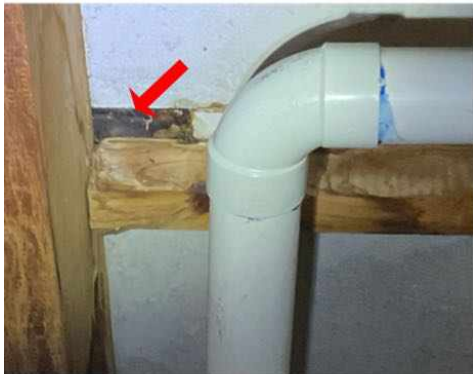
### Finding 2.01

Building:	Building 1
Location:	Garage under bathroom
Finding:	Waterproofing failed and wood rot found in bathroom floor
Information:	An active water leak was found under the bathroom after running the shower for 6 minutes. This area shows structural wood rot indicating this has been occurring for many months/ years.

F1.7 requires that certain areas designated as "wet areas" be made impervious to water. This applies to showers, floors and walls adjacent to baths, tubs or laundry troughs, basins, sinks etc. The aim is to protect adjacent areas from damage by water splashed from these fixtures.

This area is close to the external rear left wall where 1 metre of timber debris has been stored making this area highly susceptible to termite damage.

The flooring in this area needs to be removed to replace the wood rotted timbers then the bathroom waterproofed to stop further damage.

Substantial costs should be budgeted for.

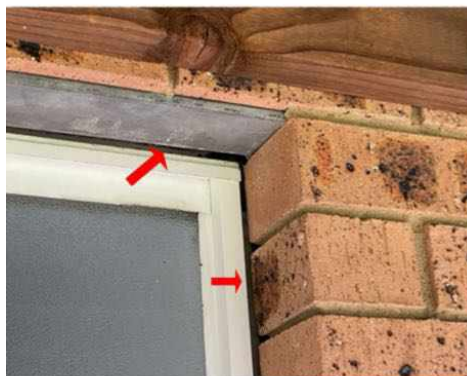
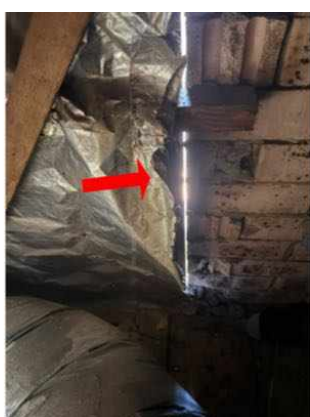
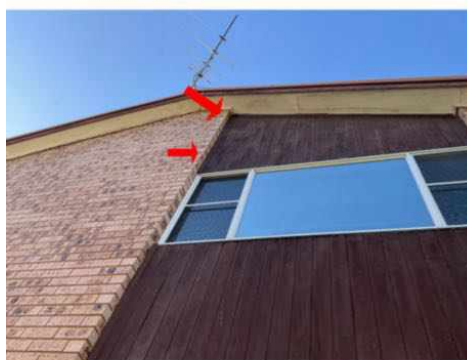
## Finding 2.02

Building: Building 1  
 Location: Pictured Areas  
 Finding: Sealant (external) - Missing.  
 Information: It was noted on inspection that areas of external sealant was missing to areas of the external walls.

Flexible sealants should be applied to these affected areas to prevent any subsequent water damage that is likely to occur.

A sealant specialist or skilled handy person should be appointed to complete these works as soon as possible

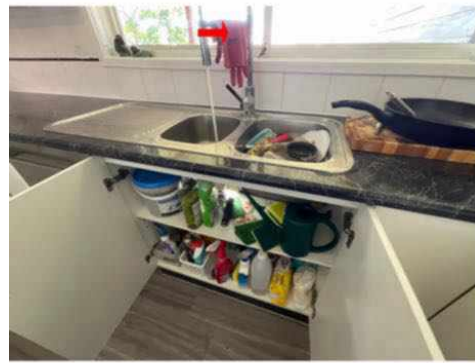
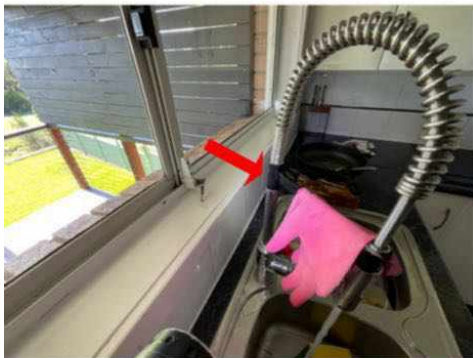
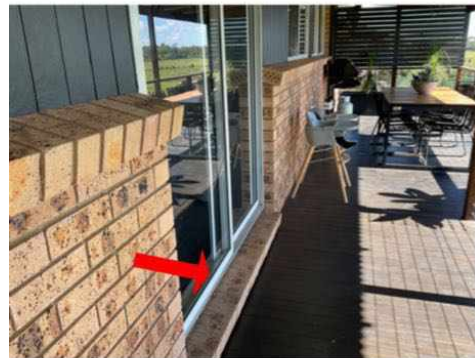
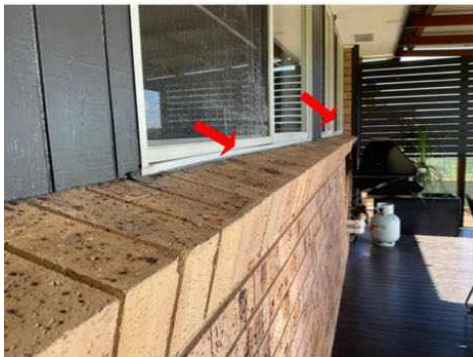
### Finding 3.01

Building: Building 1  
 Location: Pictured external areas  
 Finding: Building elements - Damaged  
 Information: Evidence of minor missing or damaged areas was identified at the time of the inspection. These include -

1. Some brickwork is damaged not requiring immediate repair.
2. The kitchen sink tap is leaking at the top.
3. The rear kitchen door appears to need new rollers.
4. All rear left window sills show minor bowing (see windows hard to slide defect).

A carpenter would be the trade responsible for rectification of these areas when convenient.

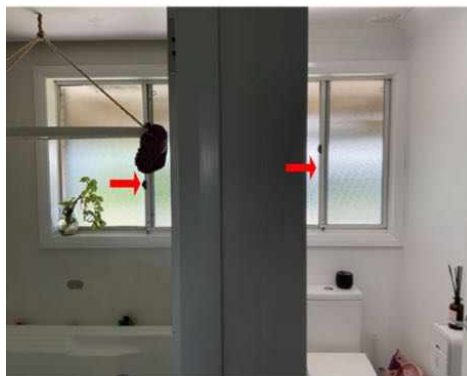
### Finding 3.02

Building:	Building 1
Location:	Bathroom & toilet
Finding:	Windows - Stiff to slide
Information:	The windows in these areas was jammed and difficult to operate at the time of the inspection. Windows provide ventilation to the adjoining area and should be at a fully operational level to ensure user comfort. Restricted function of the window may also pose as a potential safety hazard if required for emergency egress from the building.

maintenance are the usual causes for this type of defect.

Replacement of window hardware or frame may be required, as well as minor repairs and cleaning. A registered builder or general handy person will be required to repair the window.

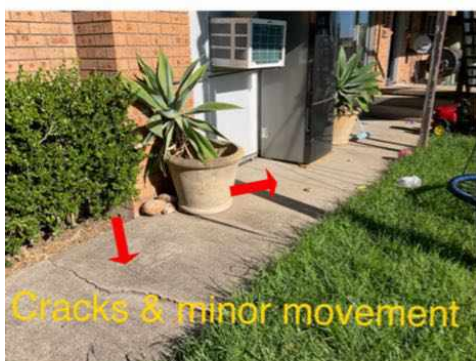
Building:	Building 1
Location:	Yard - front & back
Finding:	Crack in concrete slabs - Category 1
Information:	Cracks coded as Category 1 was identified in these pictured slabs. A Category 1 crack is described as a fine but noticeable crack, with the slab at an otherwise reasonable level. To be considered Category 1, the approximate width of the crack is less than 1.0mm, or a less than 10mm change in offset when a 3m straight edge is placed over the defect.

Category 1 cracks should be monitored for a period of 12 months. At the end of the monitoring period, identified cracks that are rated greater than Category 2 are considered defects, and require rectification.

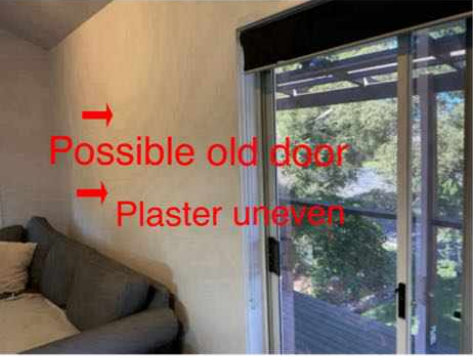
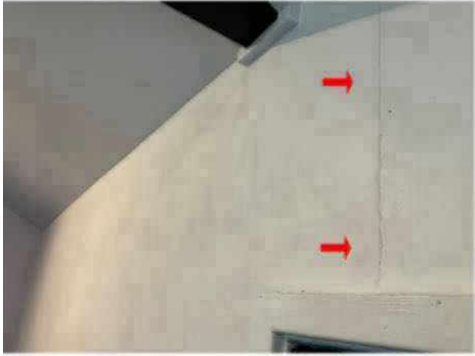
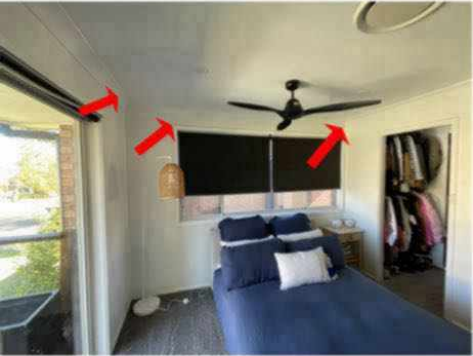
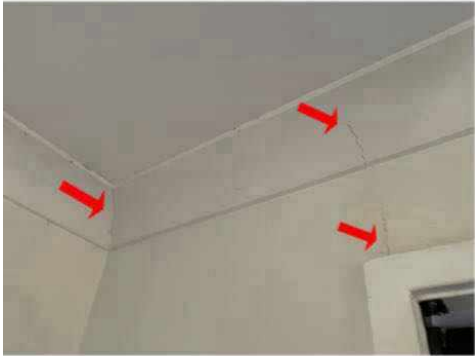
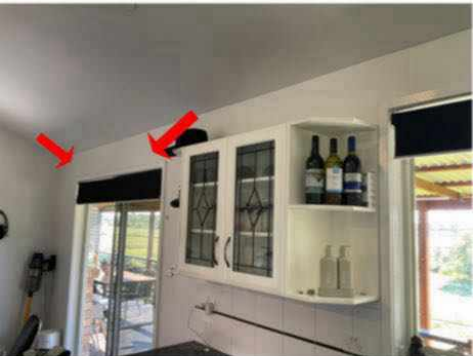
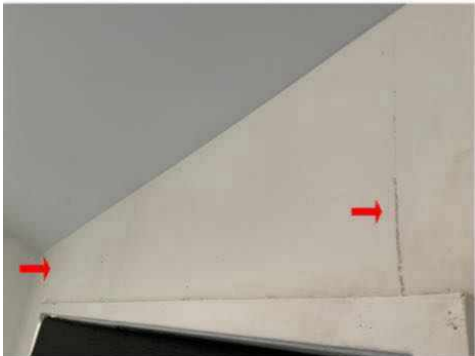
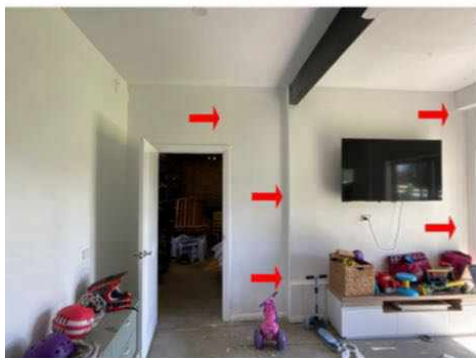
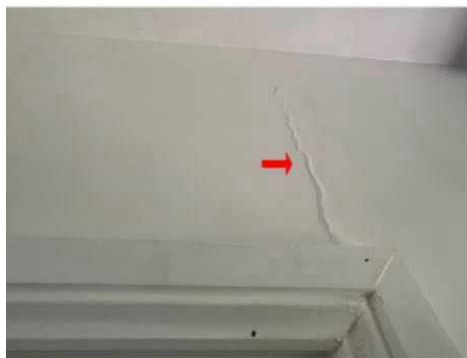
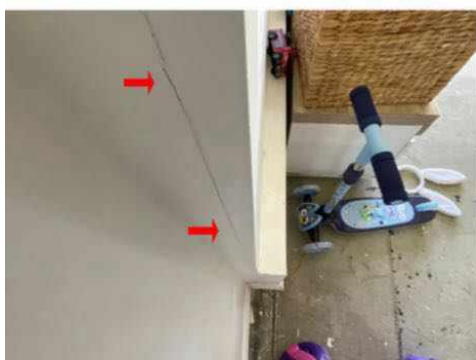
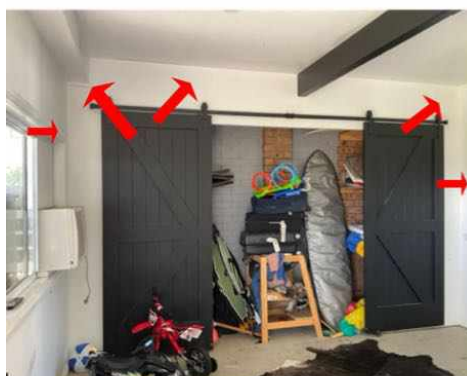
### Finding 3.05

Building:	Building 1
Location:	Many areas
Finding:	Cracking - Damage Category 1 - Fine (up to 1mm)
Information:	Although fine cracks are quite noticeable, they are often only considered to be an appearance defect, and usually do not indicate any structural damage. Generally, the cause of a fine crack is indicative of a separation between building materials and finishes (e.g. paint, plaster, etc.) along joins.

Cracking of this nature can generally be repaired with minor sanding, filling and/or repainting. Such works should be performed by a qualified painter or a general handyman.

Monitoring of all cracking should be conducted frequently. Always contact a building inspector should cracks widen, lengthen, or become more numerous.

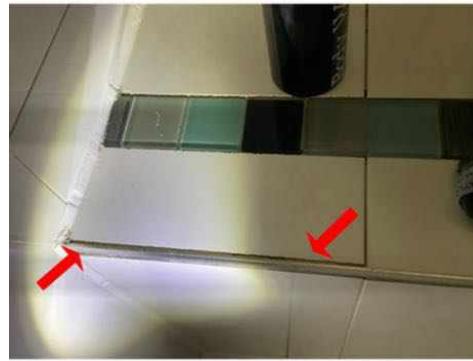
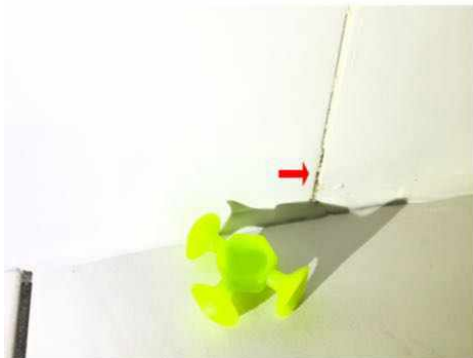
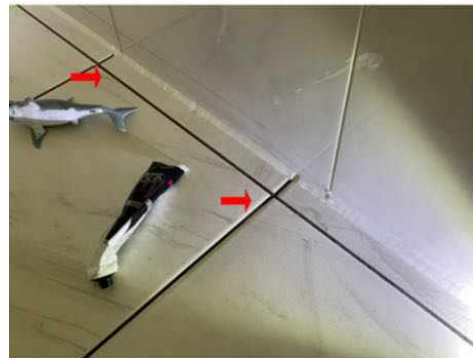
### Finding 3.06

Building:	Building 1
Location:	Kitchen and bathroom
Finding:	Sealant and grouting - Missing or damaged
Information:	It was noted on inspection that sealant or grout is degraded to these pictured wet areas. Water is also pooling on the shower ledge accelerating the degradation of the sealant/grout.

Different materials and floor areas move at different rates, generally causing cracking to grout or sealant at this point. A flexible sealant is required to allow for expected expansion and contraction, while keeping the joint water tight and protective of all associated building materials.

Flexible and mould resistant materials should be applied to affected areas to prevent any subsequent water damage that is likely to occur. Regular maintenance and replacement of damage or missing or damaged sealant and grout is highly recommended to the wet areas, as this is a regular wear and tear defect. Sealant and grouting in areas that come into regular contact with water should be maintained for the long term care of your property.

A sealant specialist or tiling contractor should be appointed to complete these works as soon as possible

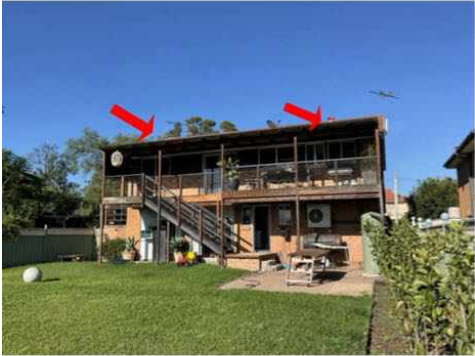
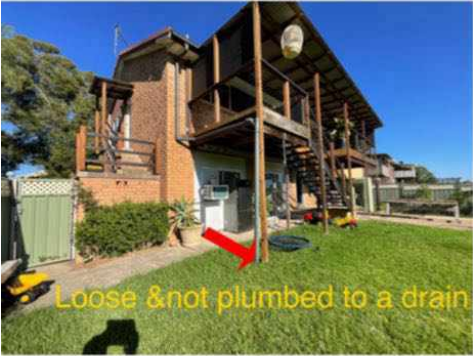
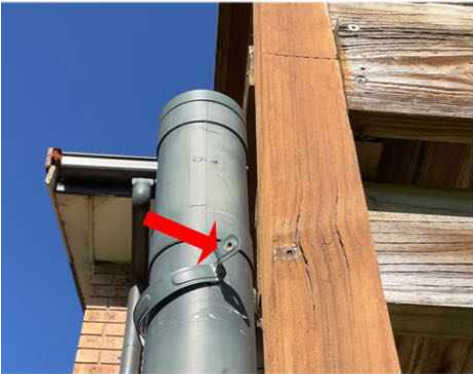
### Finding 3.07

Building:	Building 1
Location:	Walls
Finding:	Site drainage - Inadequate
Information:	The site drainage in this area was found to be inadequate at the time of inspection, creating potential for subsequent water damage to associated building elements.

The pergola rooves have no gutters. The rear downpipe is loose and runs onto the grass. The rear right concrete slopes toward the stairs with no drainage evident.

disgorge stormwater onto lower walls or plinths. Stormwater should be carried away by large, regularly cleaned drains. Ground levels may need to be lowered to expose a buried DPC.

Where site drainage is inadequate, installation of an Agricultural (Aggie) Drain may be required. A qualified plumber should be appointed to further inspect the property and perform any remedial works as necessary. Secondary defects are likely to occur if left unmanaged.

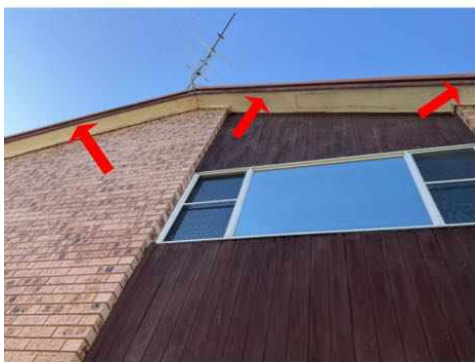
Building: Building 1  
 Location: Pictured areas  
 Finding: Painting deteriorated or unfinished  
 Information: Much of the external paintwork has been neglected and require attention to prepare and re-paint.

Whilst incomplete or missing paint finish is generally an appearance defect, it can also lead to the development of secondary building defects over time. Incomplete areas of paint finish expose the area to moisture, potentially accelerating the deterioration of underlying building materials.

Degraded paint finishes should be sanded back, filled, leveled and painted, as applicable. Where inadequate or missing paint protection has led to the deterioration of the associated building element, repair and/or replacement of this building element may be required.

A painting contractor should be appointed as soon as possible to perform necessary works to aid the appearance of the affected area and to ensure the area is protected against further deterioration. Alternatively, the homeowner following manufacturer

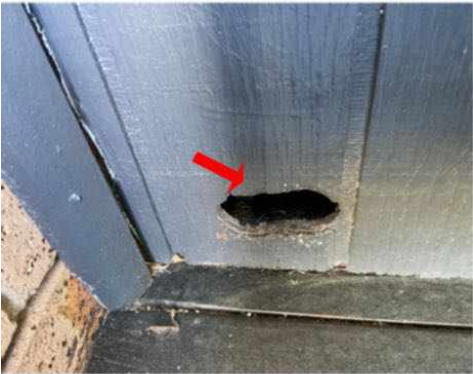
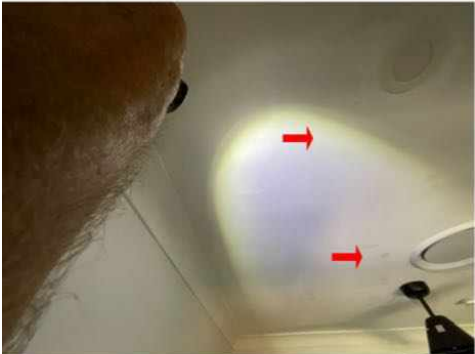
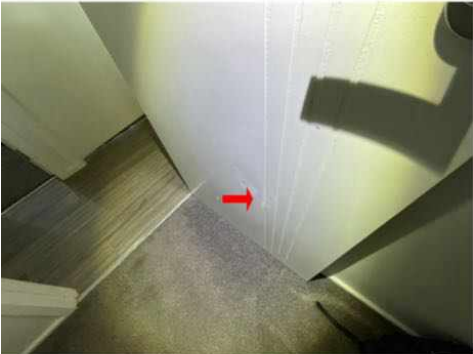
### Finding 3.10

Building:	Building 1
Location:	Front Deck, paint on some walls and ceilings
Finding:	Unfinished construction
Information:	The construction of this structure appears to be incomplete. The safety of the structure can therefore not be ensured and the creation of secondary defects to surrounding building elements may be likely.

A Registered Builder should be appointed immediately to complete this construction

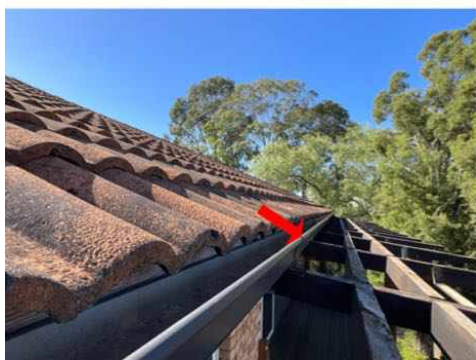
### Finding 3.11

Building:	Building 1
Location:	Front Deck
Finding:	Gutter - Insufficient fall
Information:	It was identified that there is insufficient fall or angle in the guttering at the front which is leading to pooling of water in the gutter and an array of secondary related building defects such as rust and fascia damage. Such defects are likely to include material deterioration, leaks and/or corrosion of associated building materials.

Over time, if this defect is not addressed, further building defects will develop.

Consultation with a roofing plumber or roofing restoration contractor is required for quotations regarding these works.

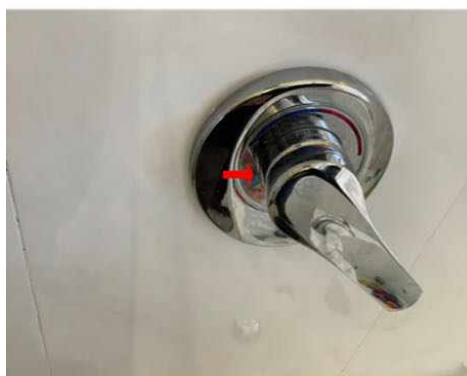
### Finding 3.12

Building:	Building 1
Location:	Bathroom
Finding:	Tap - Water hammer
Information:	This tap shows evidence of water hammer being present. Water hammer, a pressure surge resulting when a fluid is forced to suddenly change direction, is a common defect in plumbing fittings, particularly those that are aged and not frequently maintained. Water hammer is generally caused by factors that create high water pressure in the affected plumbing fixture, usually evidenced by a faint banging noise during operation of the affected tap.

Although water hammer is generally considered to be a minor defect, subsequent damage such as erosion of tap hardware and/or water damage to associated building elements is likely to occur if left unmanaged.

A licensed plumber should be appointed as soon as possible to replace any affected tap hardware and perform any remedial works as necessary. Please be advised that the appointment of a cabinet maker or qualified carpenter may be necessary if water

damage to associated building elements has occurred.

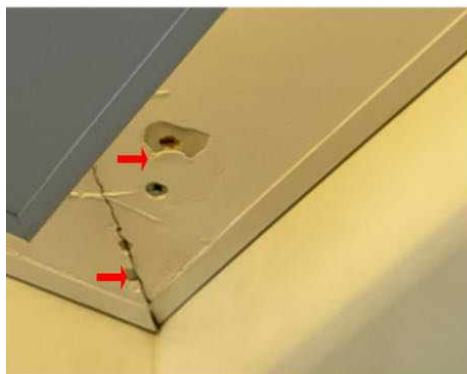
### Finding 3.13

Information: Sections of the ceiling were found to be sagging at the time of inspection. Sagging to the fixed ceiling structure generally indicates that the building materials have swollen, due to contact with water, or that fixings (e.g. nails or glue) have become loose and require reattachment.

In some cases, sagging ceiling linings may also indicate that there are structural issues, causing surfaces to warp, twist or sag. Where sagging appears to be major, appointment of a structural engineer is advised to further inspect the property and identify the source and rectification works required.

Where minor sagging is evident, comparatively minor works, such as re-gluing of ceiling sheets, may be required. Such works may be performed by relevant tradespeople, such as plasterers and painters. Where excessive moisture has caused the roofing structure to swell and sag, the source of the water leak should primarily be identified prior to any remedial works being performed.

The appropriate action should be taken by the client as soon as possible to ensure that any potential further damage is limited.

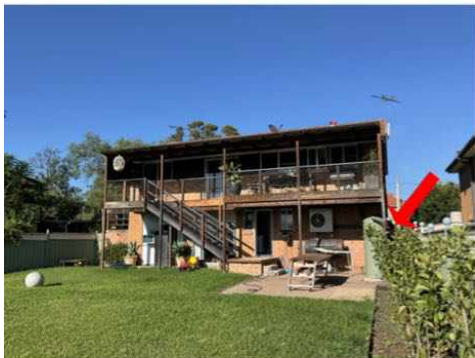
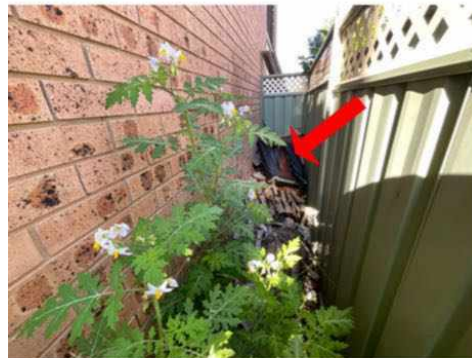
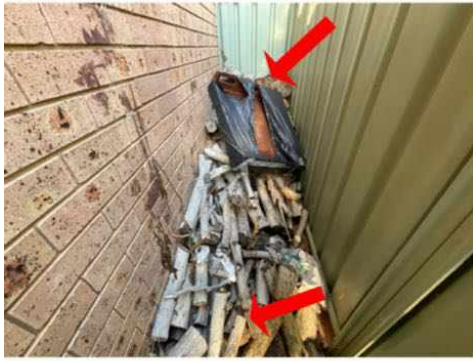
Information: Any timbers in direct ground contact provide opportunity for concealed termite entry and are likely to be subject to premature rot and decay as the soil retains moisture or damp conditions against the timbers.

Removal of all waste timber that is in direct contact with ground is highly advised. This timber is promoting mould and wood rot and is very attractive to termites.

Frequent pest inspections are advised to readily identify any termite activity in these areas.

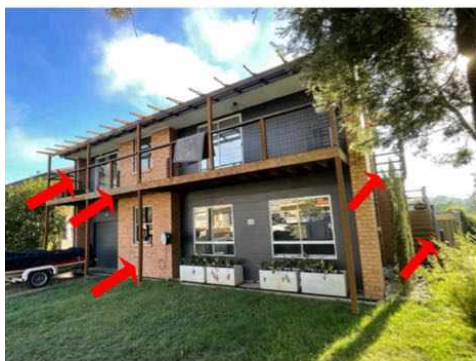
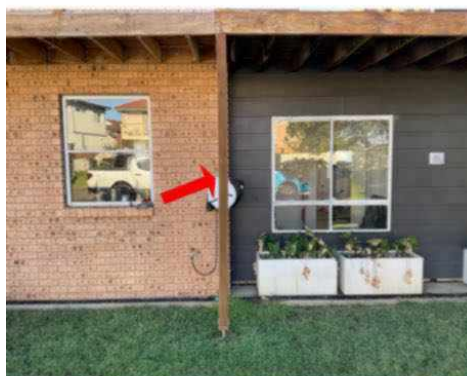
The front deck on the right side is missing joist hangars and has one slightly bowing middle post.

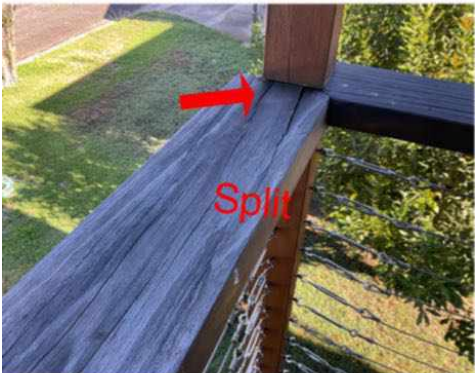
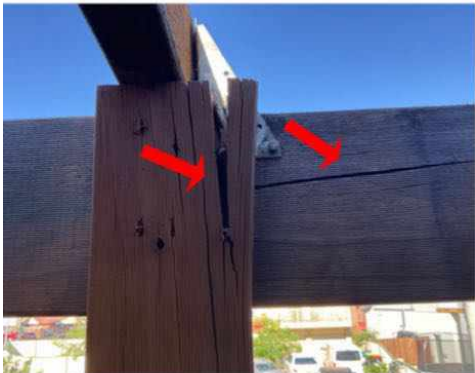
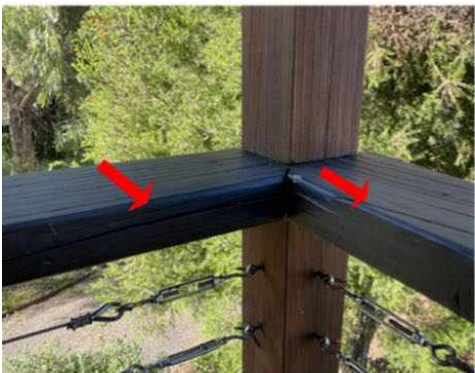
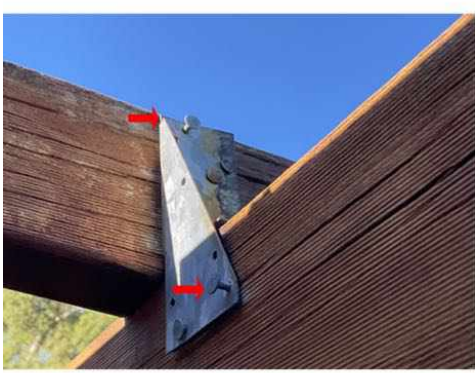
**Noted Item**

Building: Building 1  
 Location: Pictured areas  
 Finding: Safety Hazards and Major defects require immediate rectification  
 Information: All safety hazards should be rectified immediately as a matter of urgency as leaving these unattended may result in severe injury.

All major defects should be rectified immediately as a matter of urgency. Leaving these major defects unmanaged will lead to further deterioration of structural elements which may become safety hazards.

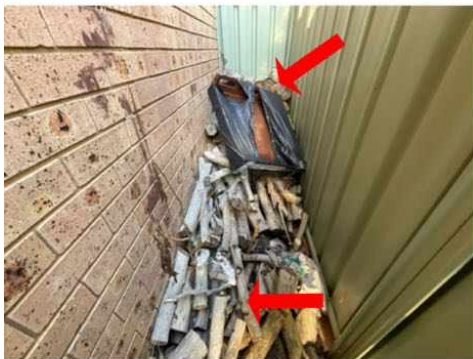
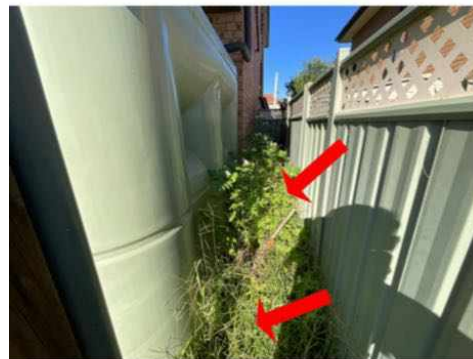
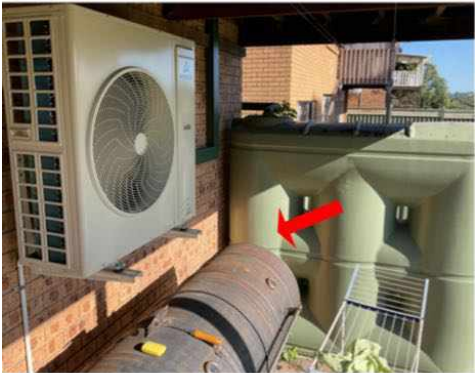
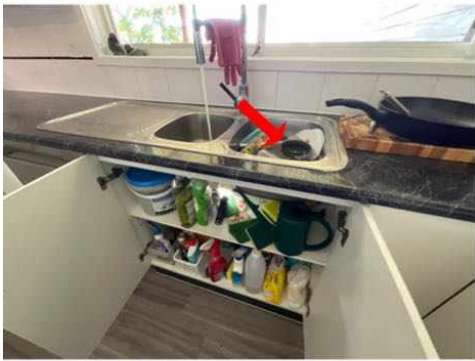
## Noted Item

Building:	Building 1
Location:	All External Areas
Finding:	Additional Photos - Obstructions and Limitations of EXTERNAL AREAS
Information:	These photographs are an indication of the obstructions and limitations which impeded full inspection of external areas at the time of inspection. These obstructions can hide an array of defects and should be removed to allow full inspection to be carried out. A re-inspection is recommended once the areas are made accessible.

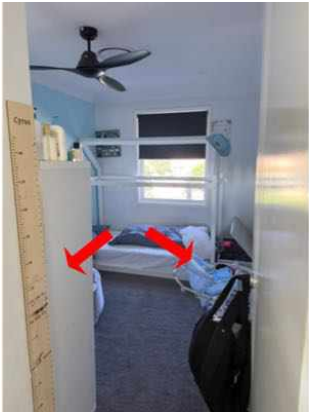
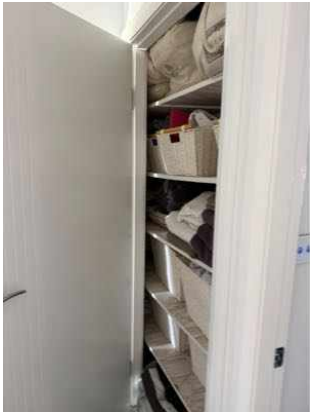
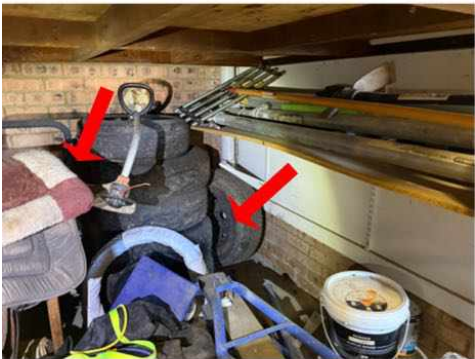
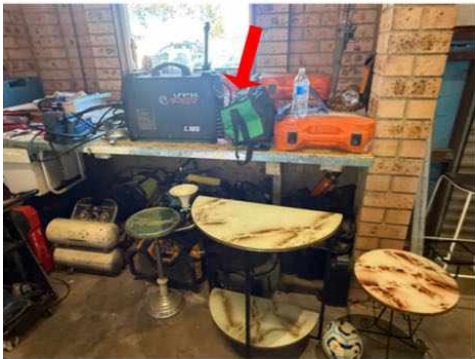
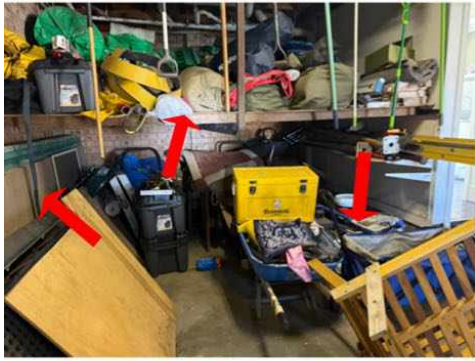
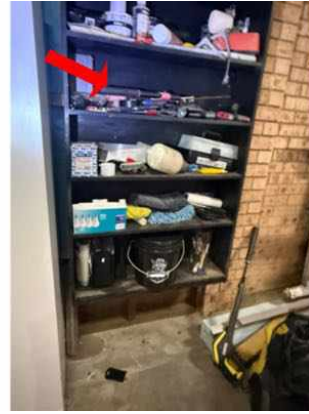
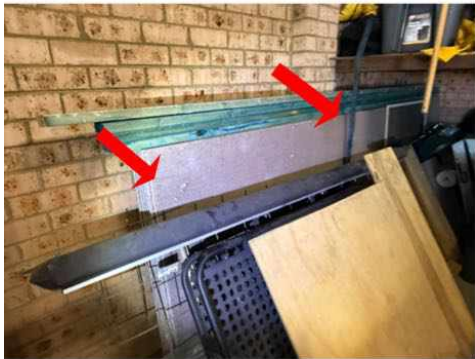
**Noted Item**

Building: Building 1  
Location: All Internal Areas  
Finding: Additional Photos - Obstructions and Limitations of INTERNAL AREAS  
Information: These photographs are an indication of the obstructions and limitations which impeded full inspection of Internal areas at the time of inspection. These obstructions can hide an array of defects and should be removed to allow full inspection to be carried out. A re-inspection is recommended once the areas are made accessible.

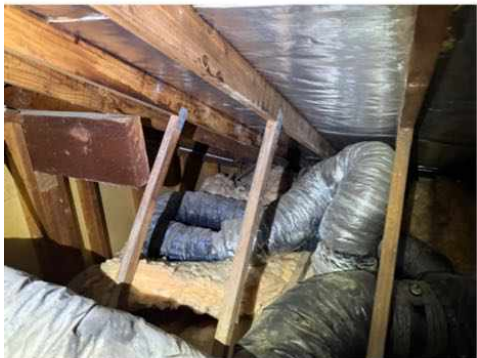
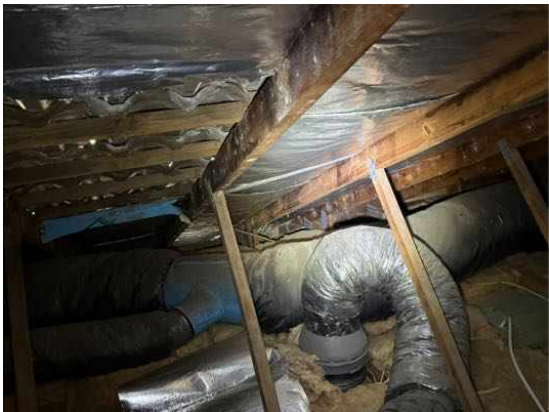
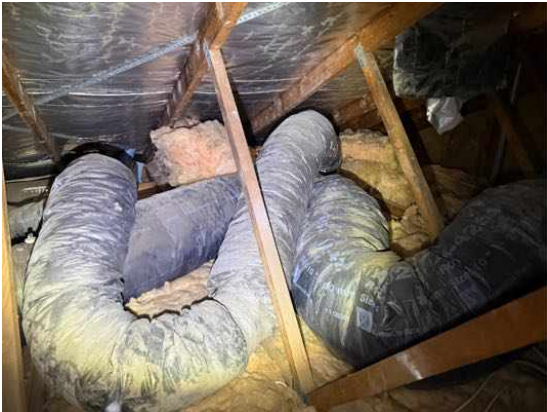
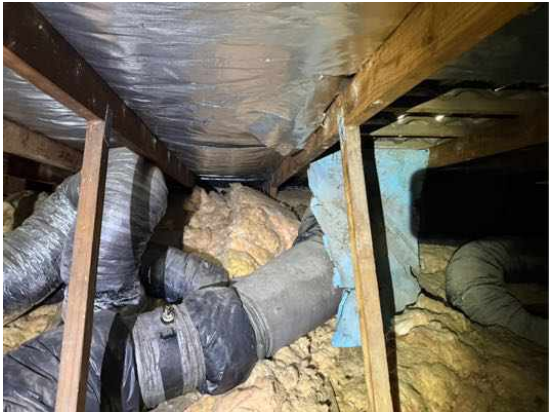
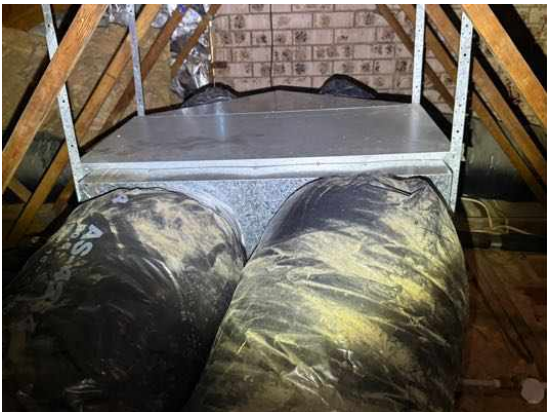
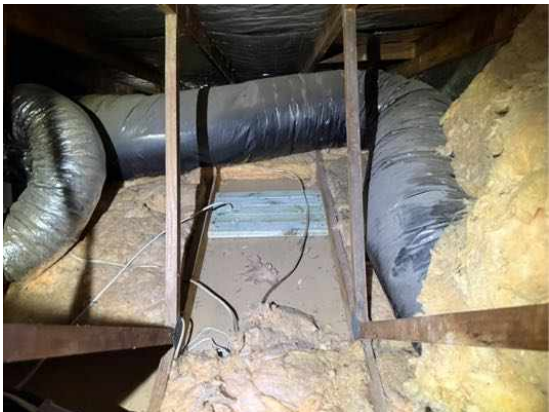
### Noted Item

Building: Building 1  
 Location: All Roof cavity areas  
 Finding: Additional Photos - Obstructions and Limitations of the ROOF CAVITY  
 Information: These photographs are an indication of the obstructions and limitations which impeded full inspection of roof cavity areas at the time of inspection. These obstructions can hide an array of defects and should be removed to allow full inspection to be carried out if applicable. A re-inspection is recommended once the areas are made accessible.

The inspection was also limited to areas with an allowable crawl space of 600mm x 600mm, in particular towards the external walls where the roof line diminishes, these areas were not accessible.

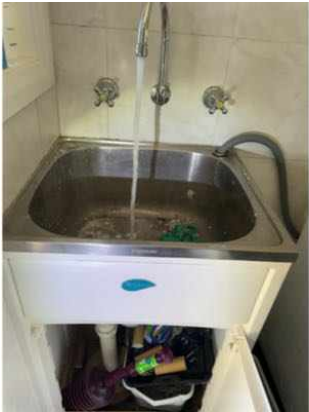
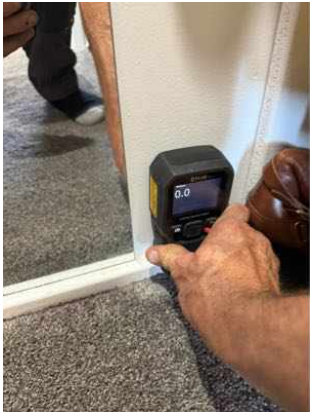
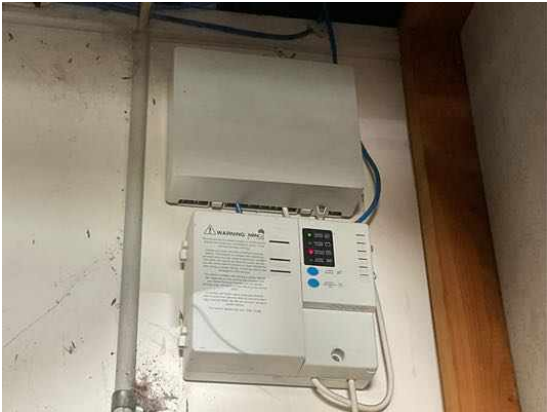
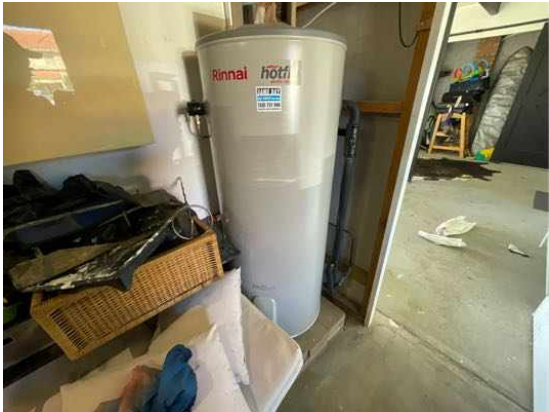
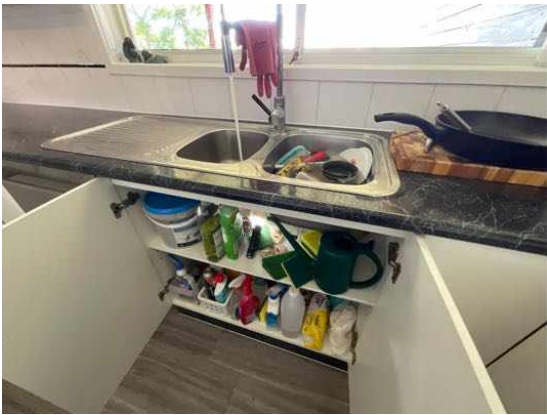
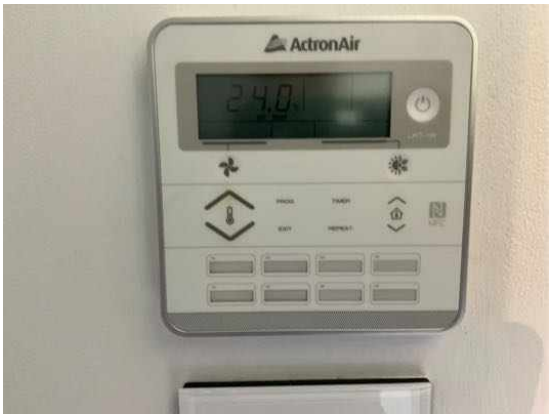
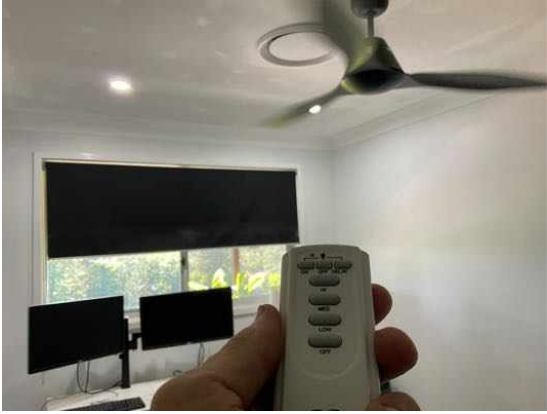
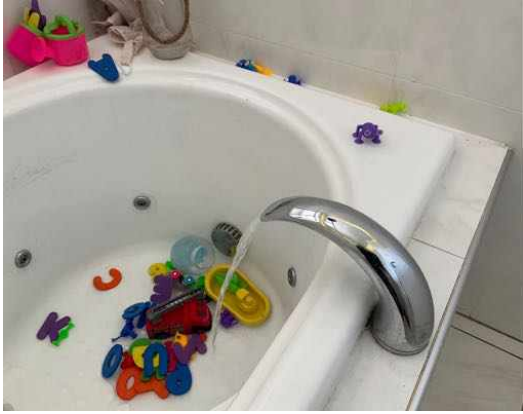
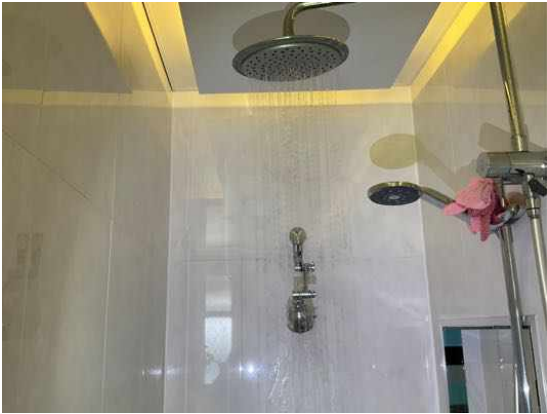
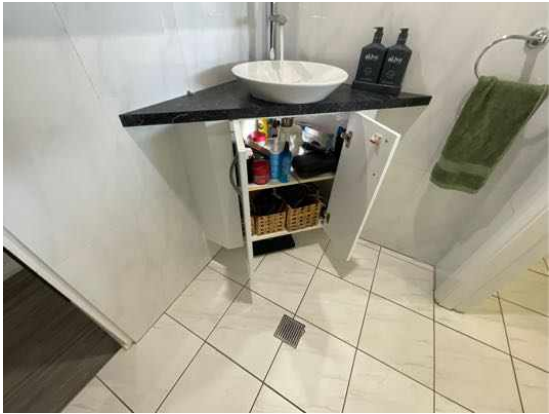
Building: Building 1  
Location: All Internal Areas  
Finding: Additional Photos  
Information: Additional photos are provided for your general reference
