Building and Timber Pest Inspection Report

Inspection Date: Fri, 20 Feb 2026

Property Address: 22/1271 Botany Rd, Mascot NSW 2020,
Australia

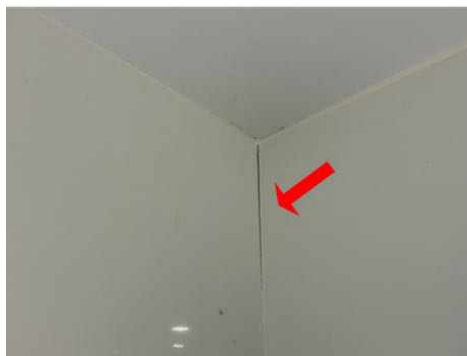
Building:	Main Building
Location:	Bathroom
Finding:	Sealant and grouting - Missing or damaged
Information:	It was noted on inspection that sealant or grout is degraded to the tiled shower alcove and or other areas of the bathroom.

Different materials and floor areas move at different rates, generally causing cracking to grout or sealant at this point. A flexible sealant is required to allow for expected expansion and contraction, while keeping the joint water tight and protective of all associated building materials.

There appears to be excessive mould to the sealant and grout which will likely require scraping out and replacement.

Flexible and mould resistant materials should be applied to affected areas to prevent any subsequent water damage that is likely to occur. Regular maintenance and replacement of damage or missing or damaged sealant and grout is highly recommended to the wet areas, as this is a regular wear and tear defect. Sealant and grouting in areas that come into regular contact with water should be maintained for the long term care of your property.

A sealant specialist or tiling contractor should be appointed to complete these works as soon as possible

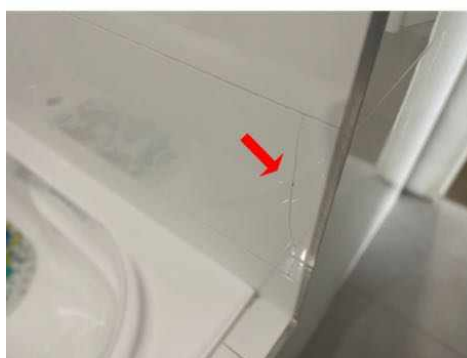
Finding 3.02

Building:	Main Building
Location:	Bathroom
Finding:	Tiles cracked or damaged- (wet areas)
Information:	Cracking was evident to the tiling in this area at the time of inspection. While the cracking appears to be minor, this area is frequently exposed to water, allowing potential for water penetration into adjoining sections of walls or flooring.

If left unmanaged, water penetration to these areas may lead to subsequent water damage, which is likely necessitate repair work to affected building elements.

A tiling contractor should be appointed to ensure that no further water damage occurs. The re-application of silicone and grouting throughout remaining tile work is also advised, to further protect the area against water penetration.

Where water penetration has led to water damage, appointment of a relevant tradesperson may be required to repair damaged building elements.

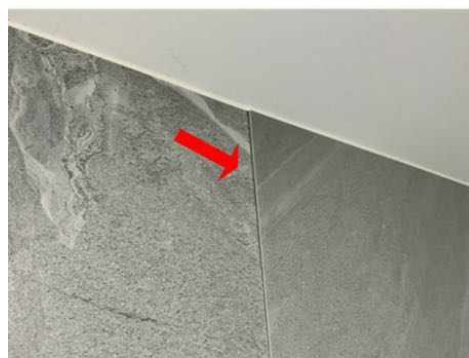
Finding 3.03

Building:	Main Building
Location:	Bathroom
Finding:	Tiles - Drummy

Information: Drummy tiled areas were identified at the time of inspection. The term 'drummy' refers to tiles that have become detached from their fixing, despite otherwise being in relatively good condition. Such defects are generally caused by physical or moisture damage to the area. Drummy tiled areas may also be a direct result of poor workmanship during the construction process.

Tiled areas may swell and shrink with changes in air humidity if the area has sustained moisture damage. Any exposure to moisture is capable of causing tiled areas to become drummy and/or cracked over a prolonged period of time. Drummy tiled areas generally require removal and replacement of affected tiles, with adequate sealant and grouting.

Specialist trades are available for these types of services. A registered builder may be required to undertake works if damage is extensive or if secondary building defects have resulted. Otherwise, it is advised that a tiling contractor be appointed to perform works as necessary. Immediate action is recommended to ensure that no further damage is sustained in the affected area.

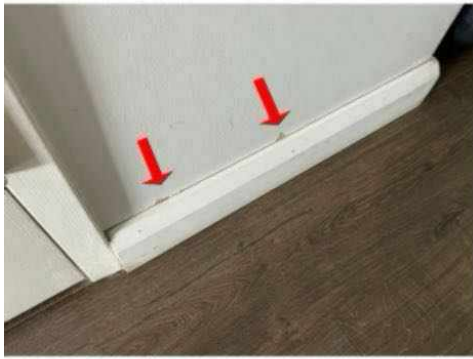
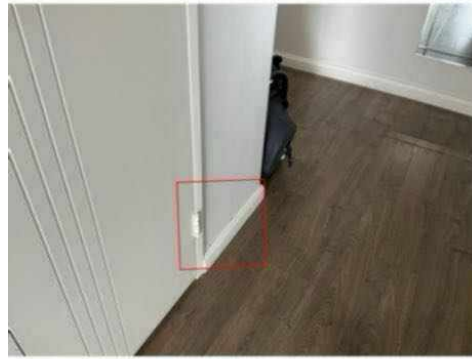
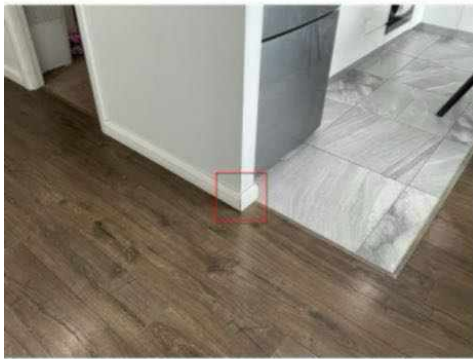
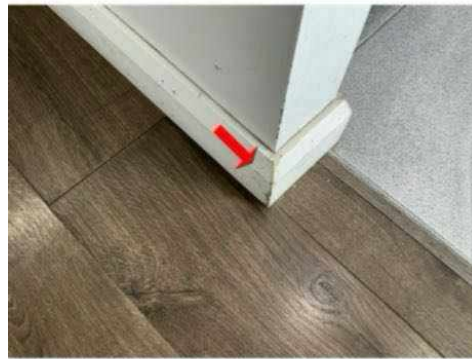
Finding 3.04

Building: Main Building
Location: Bedroom, entrance, hallway
Finding: Paint finish - Substandard
Information: The paint finish in this area was found to have been completed to a substandard level. Substandard painting is generally classified as an appearance defect. However, the substandard appearance may also be indicative of poor surface preparation and substandard workmanship.

If this applies, further areas of poor and incomplete finishes could develop over time. Furthermore, substandard paint finishes in areas exposed to moisture, e.g. external areas or wet areas, could lead to deterioration of underlying building materials.

Substandard paint finishes should be sanded back, filled, leveled and repainted, as applicable. Where inadequate paint protection has led to the deterioration of the associated building element, repair and/or replacement of this building element may

A painting contractor should be appointed as soon as possible to perform necessary works to aid the appearance of the affected area and to ensure that the area is protected against further deterioration. Alternatively, the homeowner following manufacturer instructions may be able to provide this service.

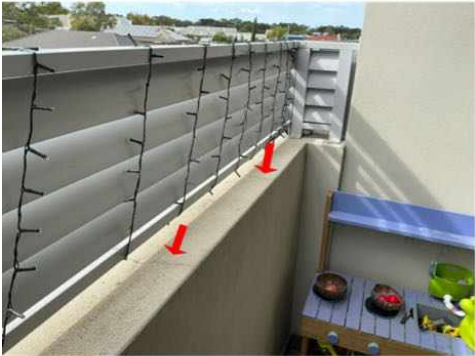
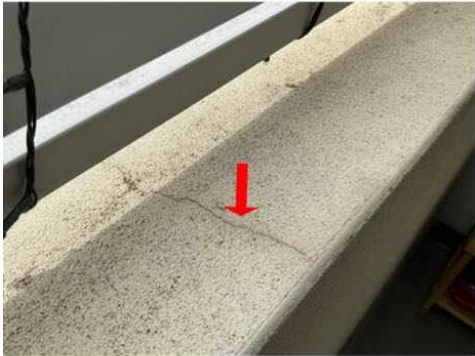
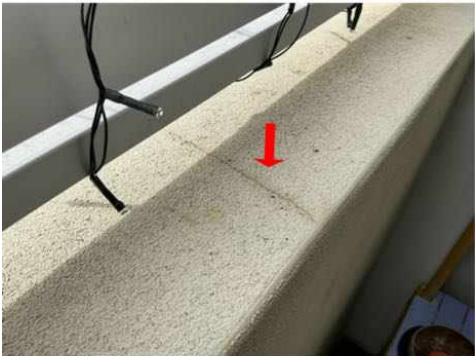
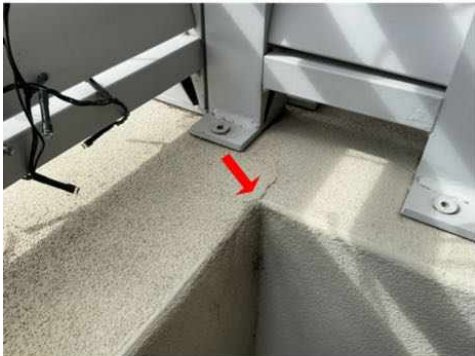
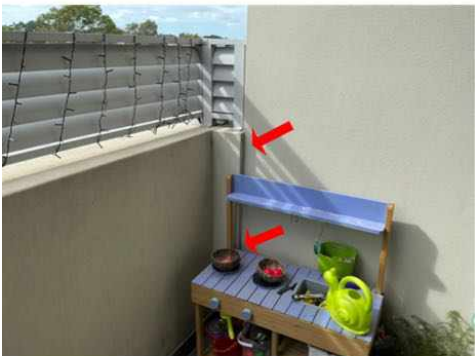
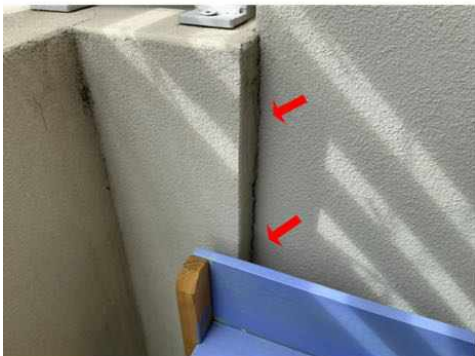
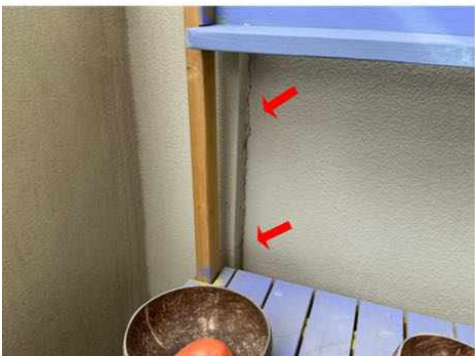
Finding 3.05

Building:	Main Building
Location:	Front entrance
Finding:	Cracks to internal render - Category 1
Information:	It has been observed that cracking to internal rendered surfaces has occurred. The degree of damage falls within Category 1, described as fine cracks that do not need repair and which are less than 1.0mm in width limit.

Damage of this category is not considered a defect for rectification. Always contact your building inspector should cracks widen, lengthen, or become more numerous.

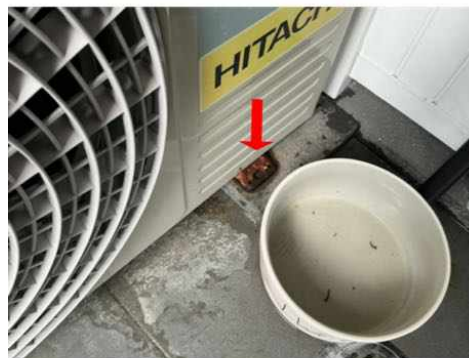
Finding 3.07

Building:	Main Building
Location:	Balcony
Finding:	Overflow - Not plumbed for drainage
Information:	The overflow is not plumbed or connected to suitable drainage, which has resulted in the surrounding area becoming excessively damp. These damp conditions can lead to secondary defects such as rot, rust or corrosion of associated building elements, the formation of fungal decay, or even the creation of potential slip hazards. When coupled with poor site drainage, pooling of water may also attract termite activity to this area. It is highly recommended that a qualified plumber be appointed to install adequate drainage to the overflow. These works will ensure that the area remains dry and free of any secondary defects.

Where possible, the use of galvanized (treated) metals or aluminium coated metals aid in rust prevention, as does regular general maintenance. Rust formation can be controlled with coatings, such as paint, that isolate the iron from the environment.

Rusting and corrosion should be managed by ideally removing or limiting the affected surface from exposure to moisture. A registered builder may be appointed to replace any building elements that have been severely affected by rust or water damage.

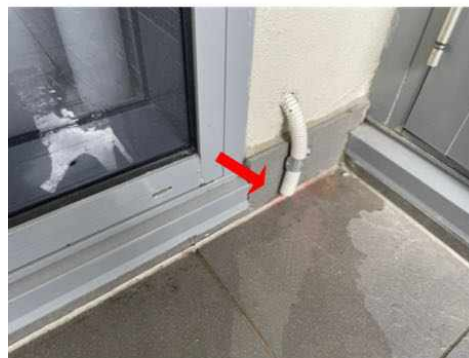
Information: The overflow is not plumbed or connected to suitable drainage, which has resulted in the surrounding area becoming excessively damp. These damp conditions can lead to secondary defects such as rot, rust or corrosion of associated building elements, the formation of fungal decay, or even the creation of potential slip hazards.

When coupled with poor site drainage, pooling of water may also attract termite activity to this area. It is highly recommended that a qualified plumber be appointed to install adequate drainage to the overflow. These works will ensure that the area remains dry and free of any secondary defects.

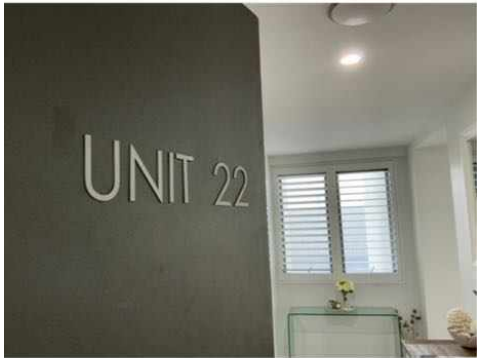
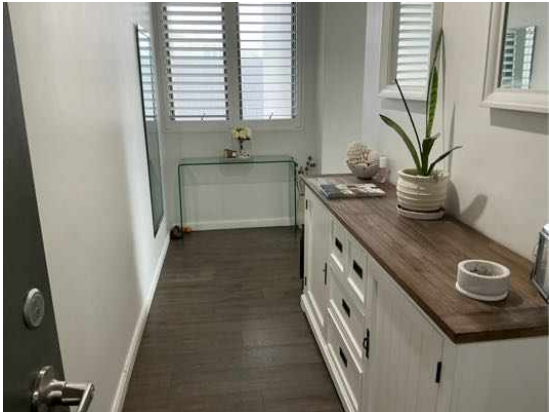
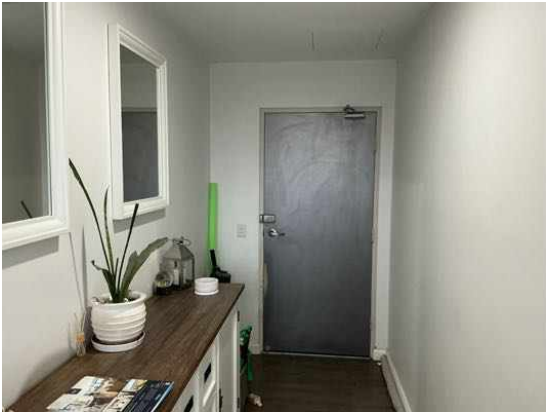
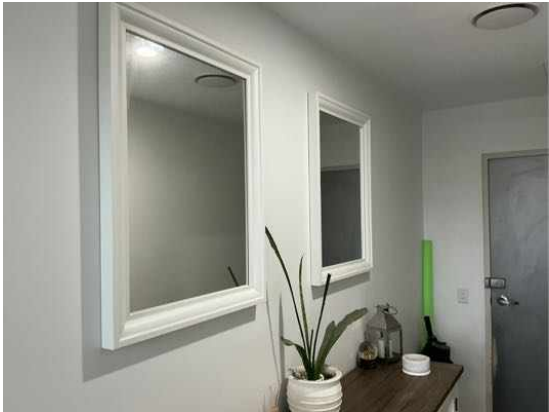
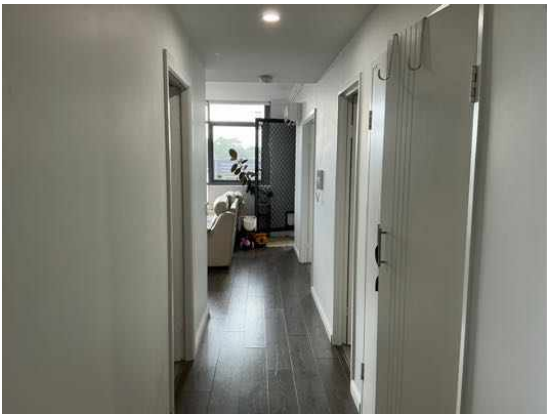
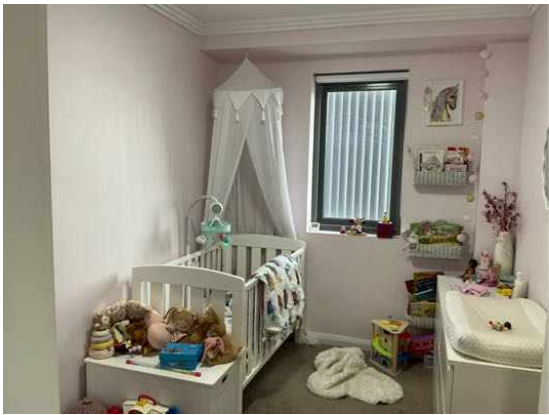
Noted Item

Building: Main Building
Location: All Areas- internal
Finding: Additional Photos - Obstructions and Limitations
Information: These photographs are an indication of the obstructions and limitations which impeded full inspection of the property at the time of inspection. These obstructions can hide an array of defects and should be removed to allow full inspection to be carried out. A re-inspection is recommended once the areas are made accessible.

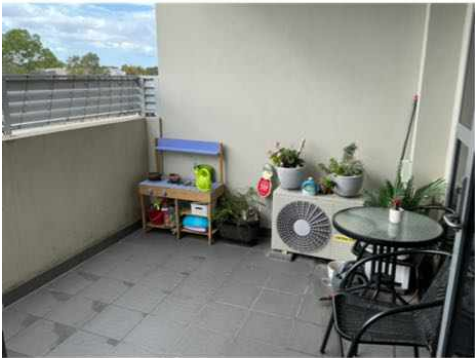
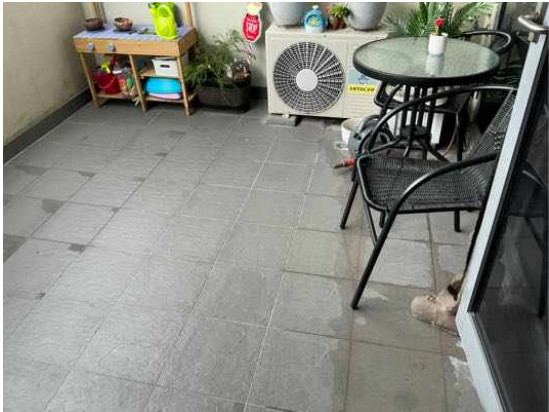
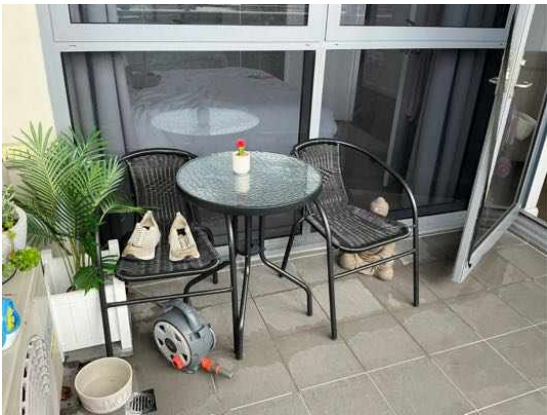
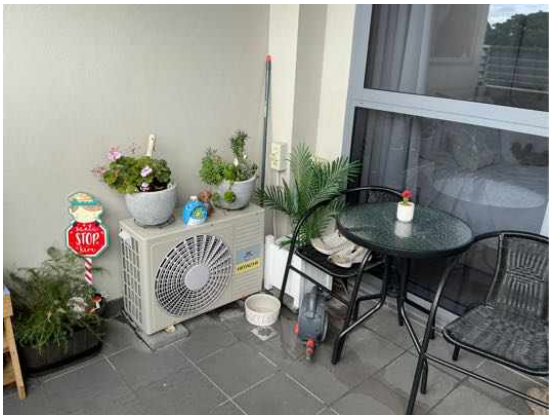
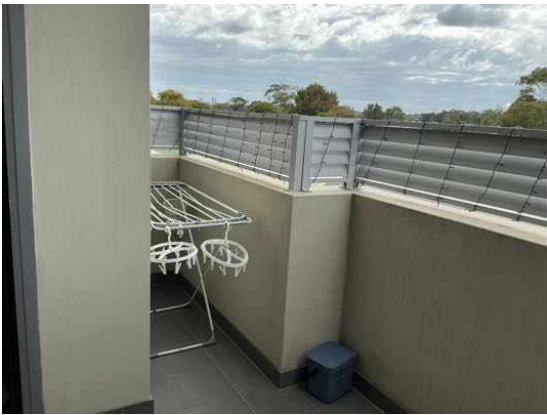
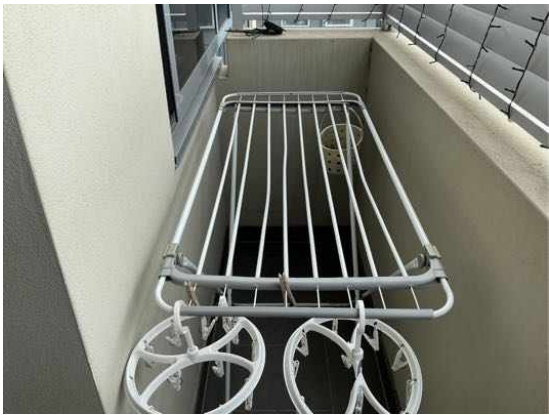
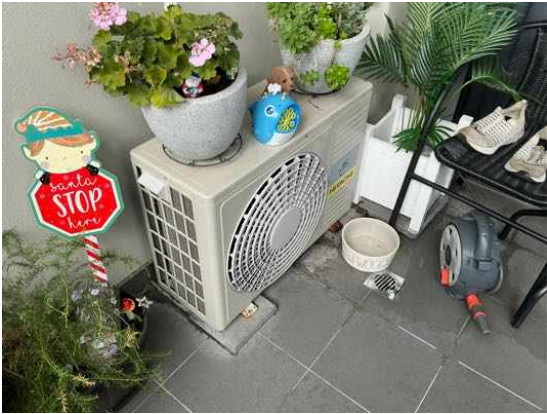
Building: Main Building
Location: All Areas- external
Finding: Additional Photos - Obstructions and Limitations
Information: These photographs are an indication of the obstructions and limitations which impeded full inspection of the property at the time of inspection. These obstructions can hide an array of defects and should be removed to allow full inspection to be carried out. A re-inspection is recommended once the areas are made accessible.
