Building and Timber Pest Inspection Report

Inspection Date: Fri, 16 Jan 2026

Property Address: 7 Granville St, Semaphore Park SA 5019,
Australia

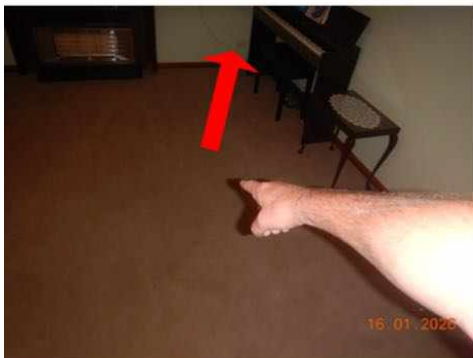
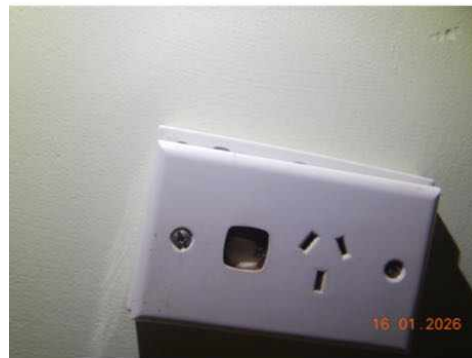
Building:	Building 1
Location:	Lounge Room
Finding:	Electrical fittings - Broken
Information:	The power outlet in the lounge was damaged at the time of inspection.

Breakage occurs generally when the building materials have aged and decayed, but may also be indicative of impact damage to the building element (accidental or deliberate).

Left unmanaged, the fitting is unlikely to cause further damage to surrounding building elements. However, the broken fitting may expose electrical works, and may create a safety hazard if there is potential contact with persons in the area.

Repair and/or replacement of the broken fitting is advised. A Licensed electrician should be appointed to repair/replace the fittings immediately.

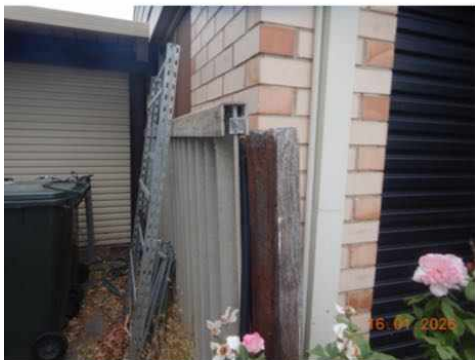
Finding 2.01

Building:	Building 1
Location:	All External Areas
Finding:	Fencing - Deteriorated
Information:	It was noted at the time of inspection that sections of the fencing throughout the property have deteriorated not to mention are likely asbestos containing material.

Typically fencing deteriorates due to age and or wear, rot and or rust which is

generally expected for a structure of this age, due to prolonged exposure to weather conditions. Sometimes inadequate installation or maintenance can be to blame.

If left unattended, it is likely that further damage will occur. It is suspected that repair of several elements of the fencing may be required however replacement may be a consideration of the client also.

A licensed fencing contractor should be appointed to provide further advice and perform rectification works as necessary. A licensed asbestos removal company should be appointed to remove the fence when required and then asbestos inspection could be a consideration also to confirm the presence of asbestos containing materials.

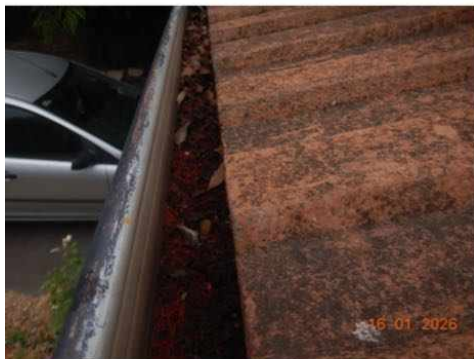
Finding 2.02

Building:	Building 1
Location:	Roof Exterior
Finding:	Gutters - Blocked
Information:	Roof plumbing structures, such as guttering and downpipes, should be free of all debris to prevent blockages. Blockages of the guttering and downpipes will lead to pooling and accumulated water overflows, which is likely to subsequently flood eaves and exterior walls.

Blocked gutters are likely to lead to high levels of moisture in the affected areas. Such moisture will not only cause rust and decay of the associated building materials, but can also provide conditions that are conducive to termite and timber pest activity. Blockages in gutters should therefore be removed immediately to ensure dry conditions are maintained.

Consult a Licensed Plumber for further specific advice on remedial works that may be required. In the interim, it is highly advised that blocked gutters be removed by the homeowner or a general handyperson as a matter of urgency.

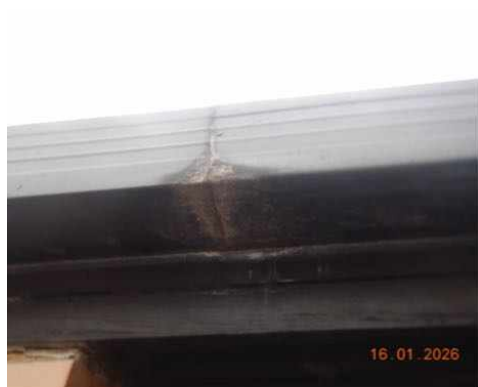
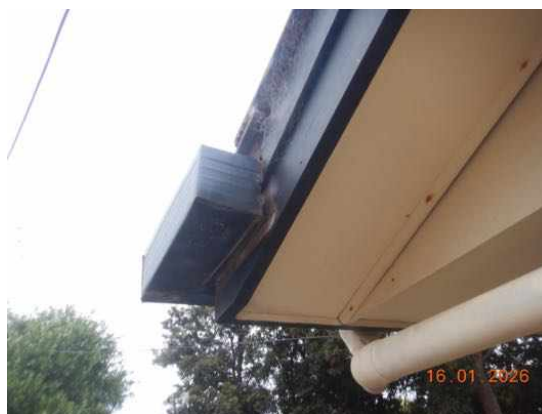
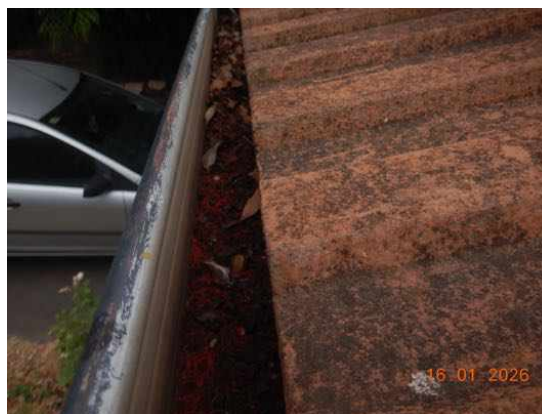
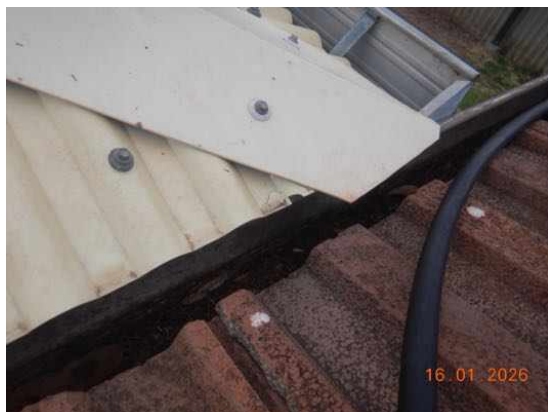
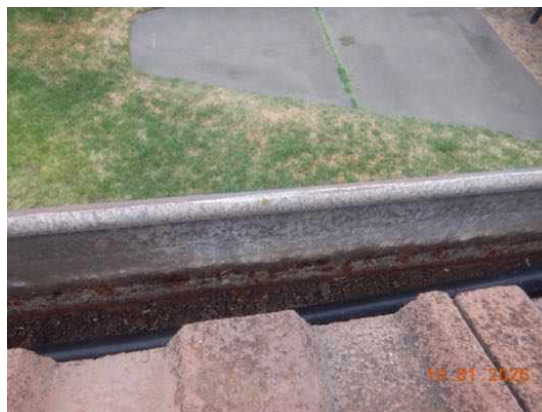
Finding 2.03

Building:	Building 1
Location:	Roof Exterior
Finding:	Roof plumbing - Rusted or corroded
Information:	The roof plumbing has areas of rust and corrosion. It is suspected that this has been caused by blockages, resulting in pooling or standing water, that have prematurely rusted elements of the roof plumbing.

Rusted roof plumbing will generally develop holes and leaks that can affect other building elements with poor drainage of storm water.

Poorly drained roof areas will also lead to damp conditions surrounding the base perimeter of the building which, if left unmanaged, can lead to a range of secondary building defects.

Repair and/or replacement of rusted roof plumbing is highly required in order to reinstate the roof drainage system to a fully operational level.

To further maintain these areas, gutters should be cleaned frequently, allowing the avoidance of any partial blockages.

A licensed plumber or specialist roof restoration company should be appointed to undertake these works. It is advised that such works be completed as soon as possible to prevent any further damage and deterioration.

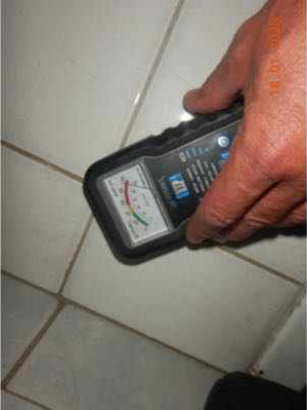
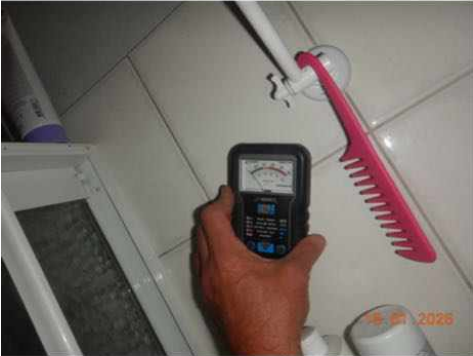
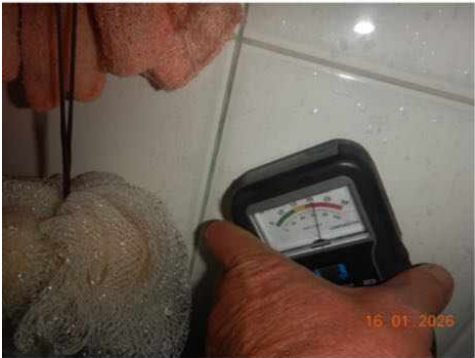
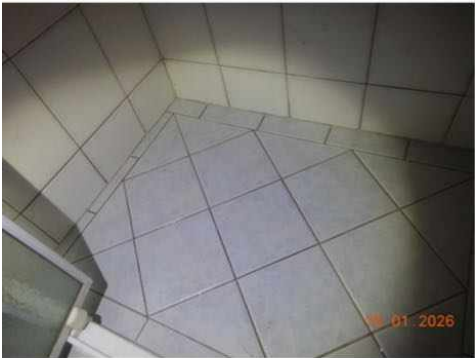
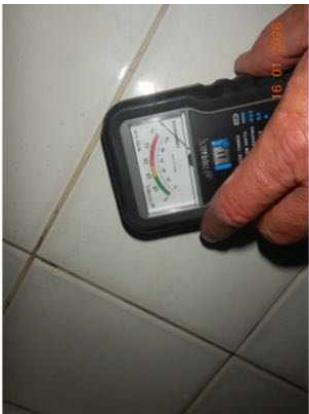
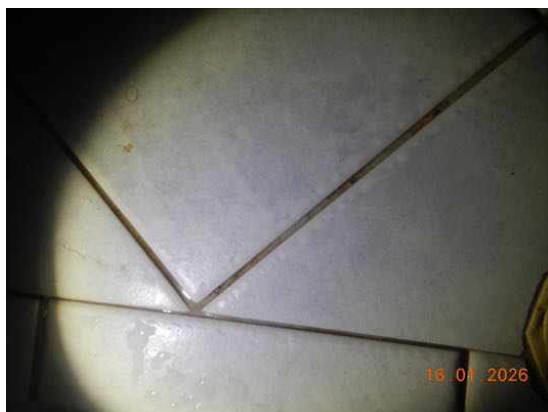
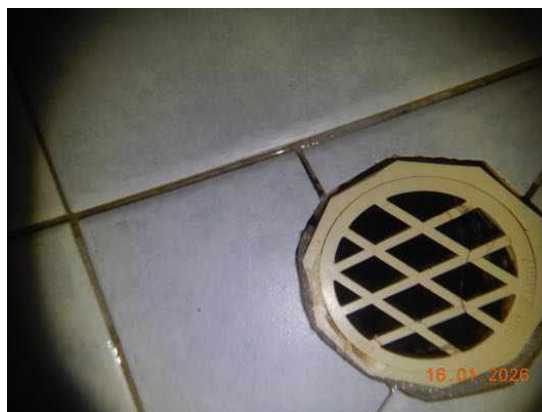
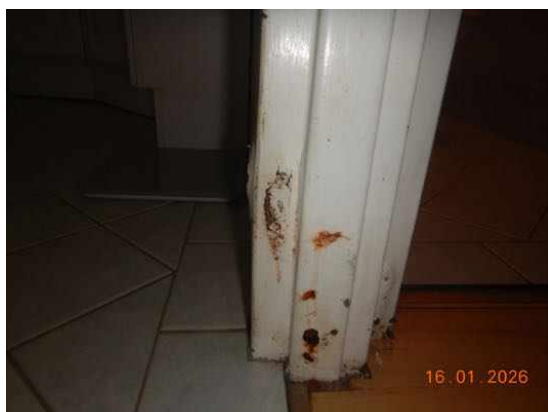
Finding 2.04

Building:	Building 1
Location:	Bathroom
Finding:	Shower damp - Sealant and grout
Information:	Damp is evident to sections of the lower wall to the bathroom and shower alcove. There is also some rust to door frames.

This defect is quite common, and is suspected to have been caused by moisture permeating or leaching through the tiling, grouting and sealant in this area, which shows evidence of deterioration.

There were no high moisture readings around the taps.

Unmanaged damp in the shower recess is likely to facilitate the formation and development of mould and fungi growth, decaying associated building materials and compromising their structural integrity of associated elements.

Consultation with a bathroom sealant specialist is advised immediately to make repairs to the shower alcove.

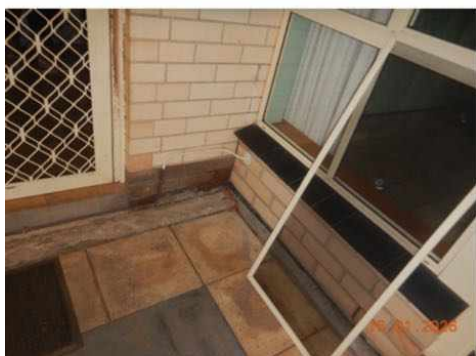
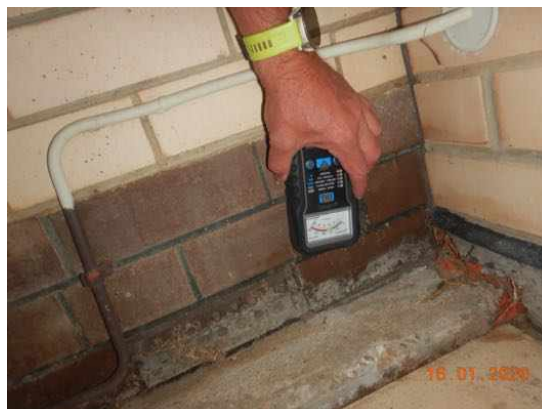
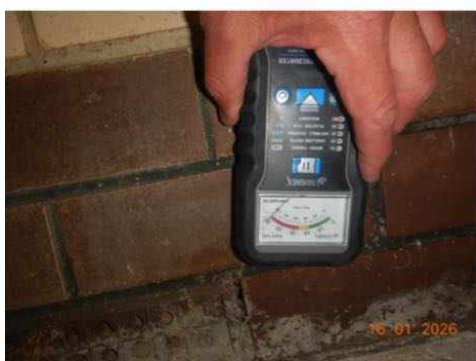
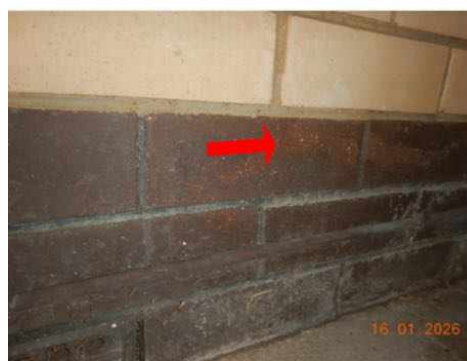
Finding 3.01

Building:	Building 1
Location:	Exterior walls - rear
Finding:	Brickwork - Deterioration
Information:	The onset of brickwork deterioration was evident to the rear of the dwelling at the time of inspection. Commonly referred to as brick corrosion or erosion, the bricks are aged and likely to have been affected by a variety of factors, including weather exposure, damage, salt-based deterioration, and more.

Overtime, these factors can affect the bricks, causing them to become brittle and appear corroded or eroded. The mortar in the brickwork may also become powdery, further detracting from the structural integrity of the brickwork. If left unmanaged, potential implications include further deterioration of the building materials, the development of secondary defects, and potential development of structural instability of the wall.

Moisture was found in the lower section of the rear brickwork however it does not appear to be rising into the brickwork above. Many older buildings had no damp proof membrane installed and simply relied on additives in the mortar to reduce rising damp. It is therefore common to have moisture in the lower courses of these type of

Eventually repairs may be required however no works are recommended at present.

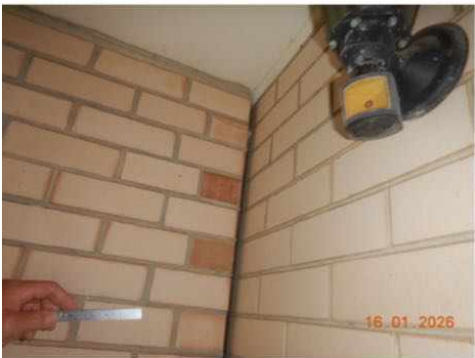
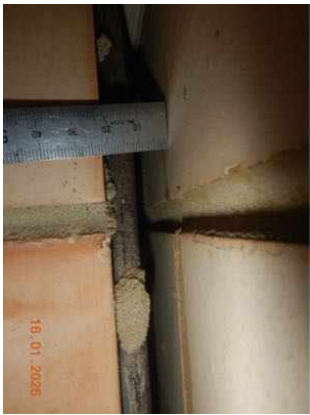
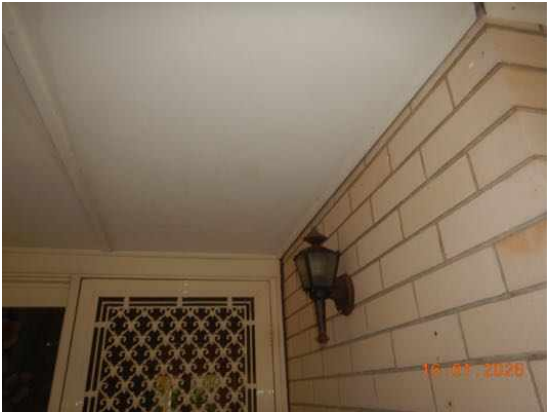
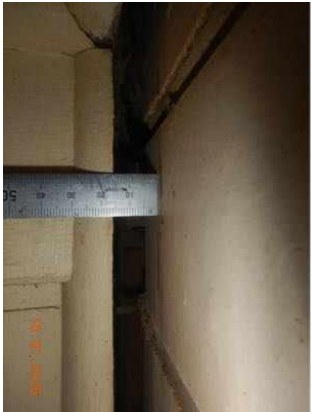
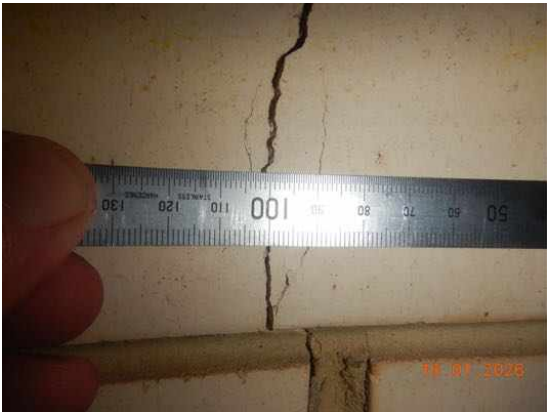
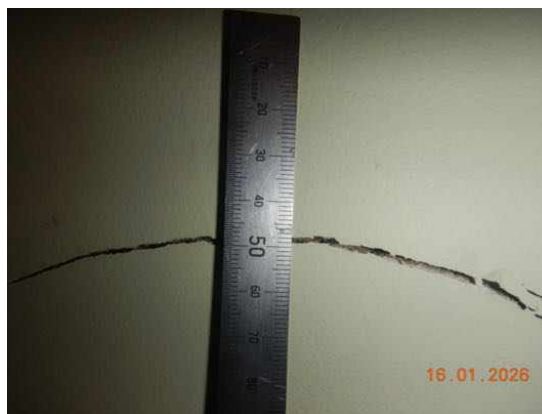
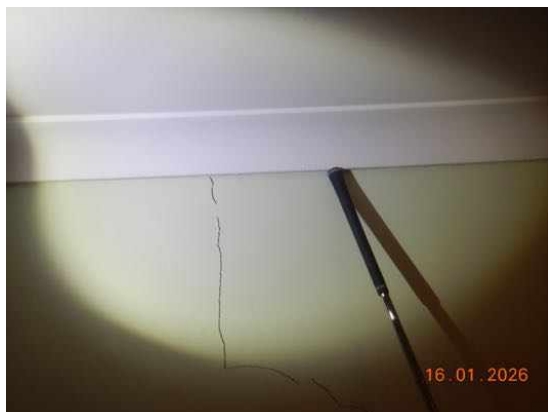
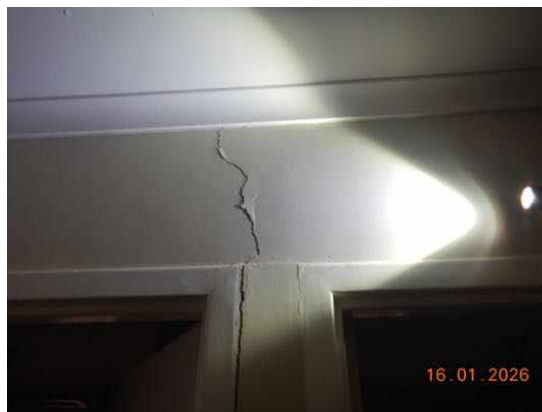
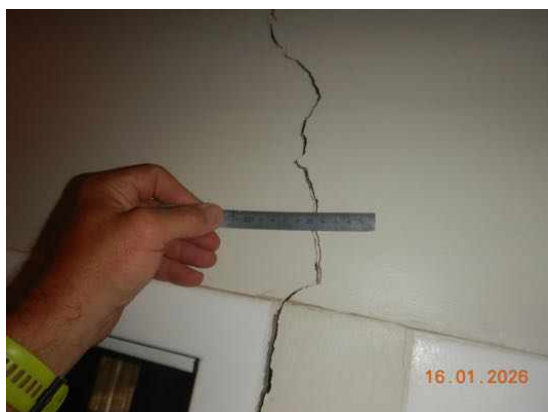
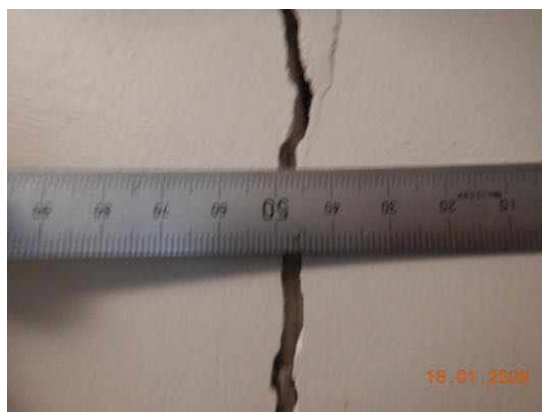
Finding 3.02

Building:	Building 1
Location:	All Areas
Finding:	Brickwork - Cracking noticeable
Information:	There were several cracks and or gaps around windows/ articulation joins evident to external and internal brickwork at the time of inspection.

Noticeable cracks are a common occurrence in external brickwork and are a likely result of age expected building movement, general expansion, and/or contraction of building materials in different weather conditions.

It is advised to closely monitor any movement and contact a Jim's Building Inspections should cracks widen, lengthen, or become more numerous.

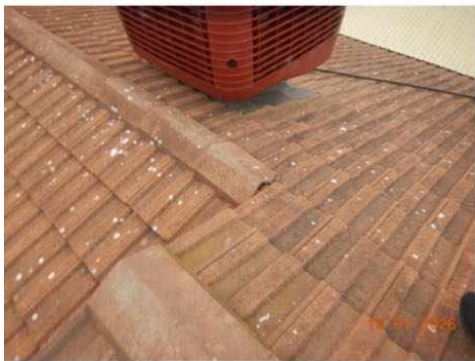
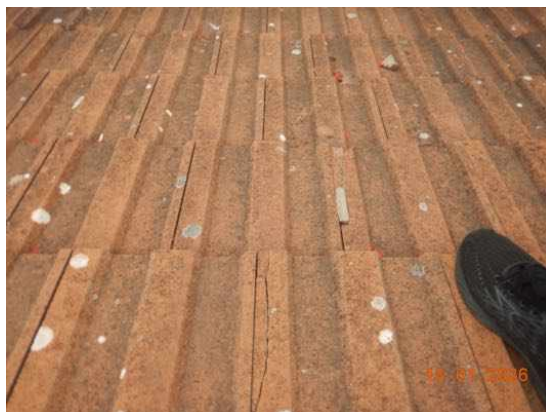
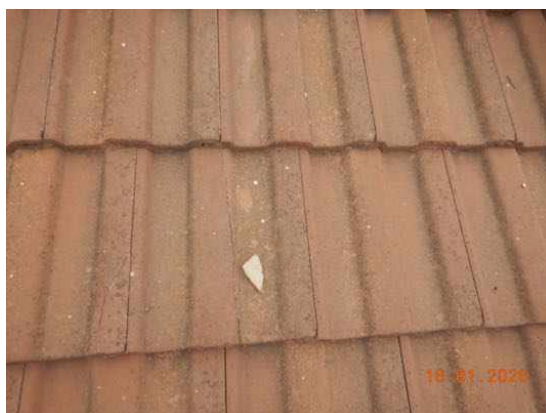
Finding 3.03

Building:	Building 1
Location:	Roof Exterior
Finding:	Mortar - Deterioration, cracked roof tile
Information:	Mortar, or 'bedding', is the material which fills joints and intersections between tiles and other building elements on the exterior roof covering, such as gable ends, hip capping and valleys.

Mortar generally deteriorates as a result of frequent exposure to weather conditions

Deteriorated mortar also detracts from the functionality of roof tiles and other roofing elements, potentially decreasing weather tightness and roof drainage.

Mortar deterioration and cracked tiles can be attended to by a handy person where areas of deterioration are localised and easily accessible. Otherwise, consultation with a roofing contractor is advised where greater works are required.

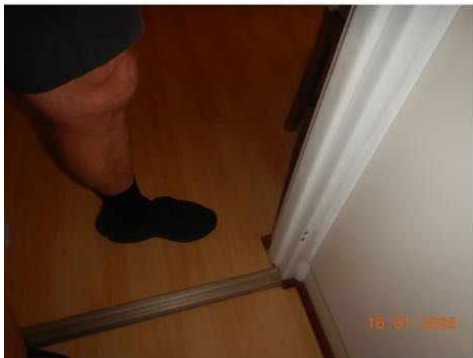
Finding 3.04

Building: Building 1
Location: All Internal Areas
Finding: Flooring - Uneven
Information: The internal flooring throughout the dwelling are out of level and uneven in several areas.

It is advised that the remaining flooring be closely monitored to identify any further movement. Where flooring remains relatively unchanged for an extended period of time (i.e. several months), it is likely that this defect has been caused by expected movement of the foundations of the property.

However, where flooring is uneven further, potentially invasive inspection of the subfloor structures may be required.

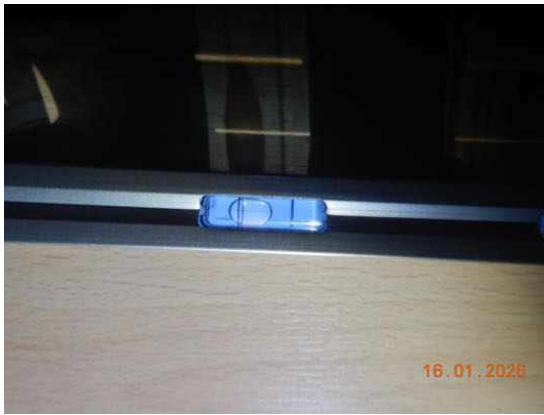
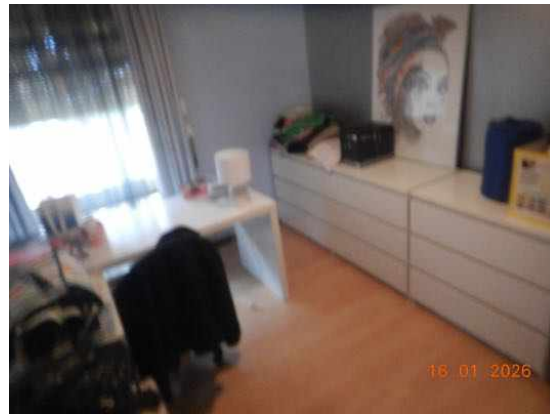
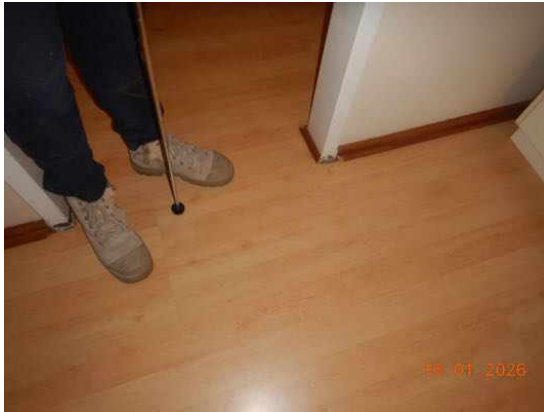
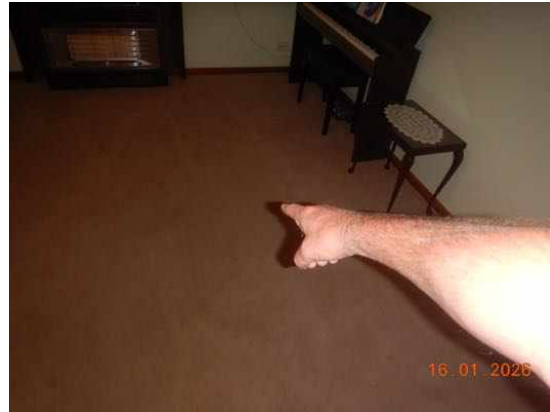
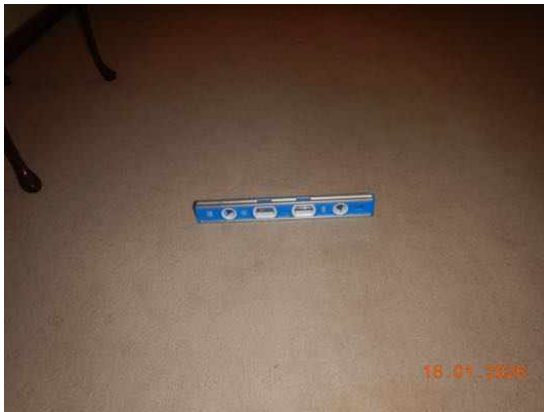
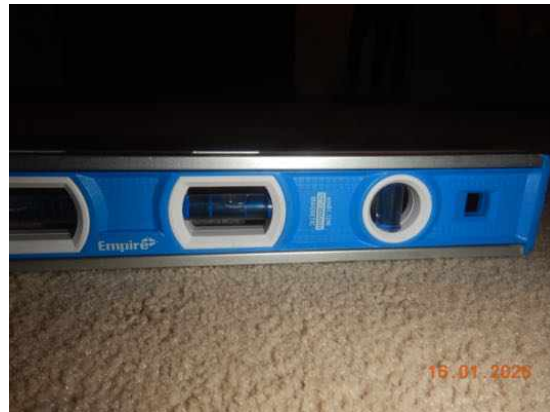
Uneven flooring is likely to indicate minor defects such as expected movement of the foundations of the property, but may also indicate subsidence of the associated subfloor and or general movement or minor discrepancies when the extension was installed.

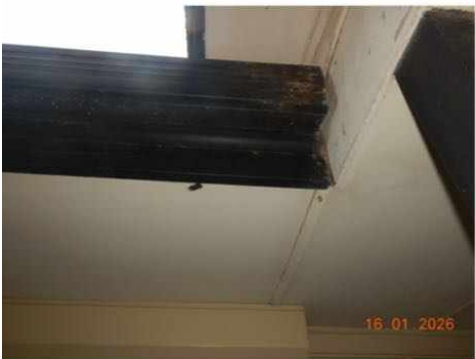
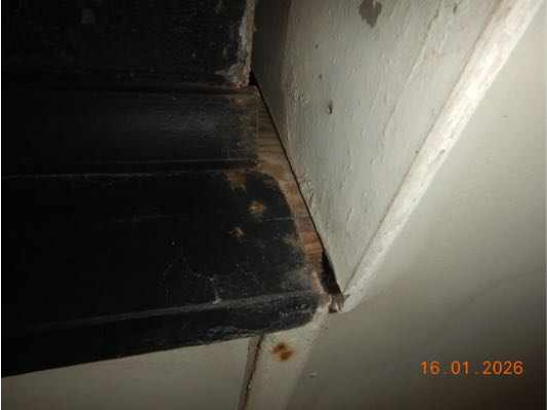
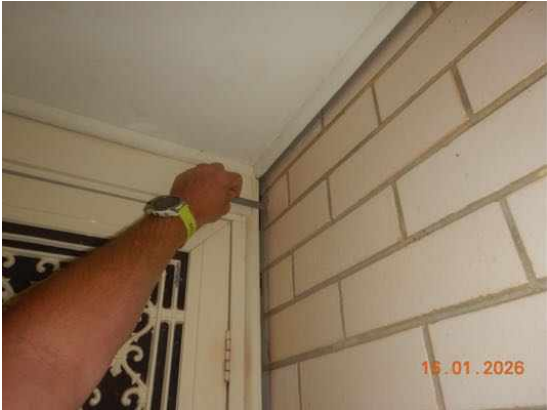
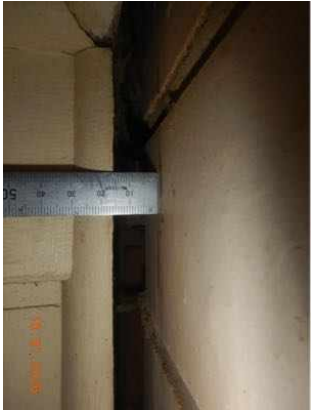
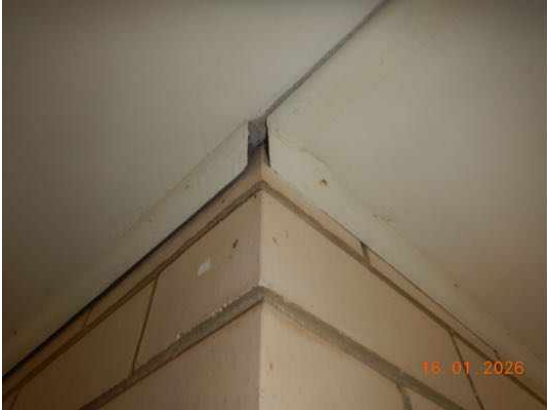
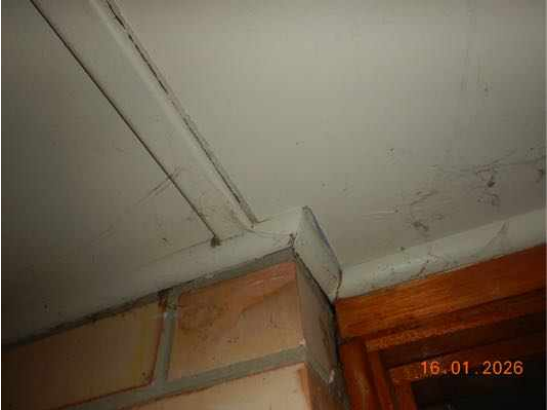
Finding 3.05

Building: Building 1
 Location: All Areas
 Finding: Ceilings and eaves Gaps Timber Frame
 Information: Several gaps and movement was identified to the ceilings throughout the dwelling at the time of inspection.

The damage may have been sustained as a result of a number of possible causes, including minor settlement of the property or general expansion and contraction of building materials over some 60 years.

Movement has been documented in photographs and monitoring the areas is

recommended. A licensed carpenter or a general handy-person could be appointed to make repairs at the discretion of the client which would likely include localised replacement or repairs of cornices and timber beading.

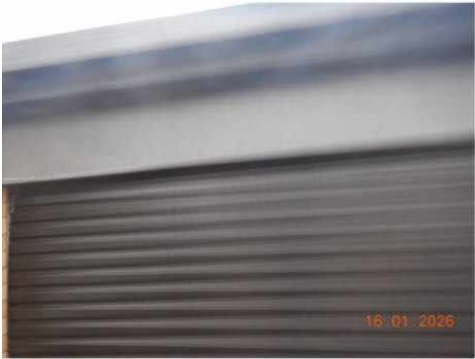
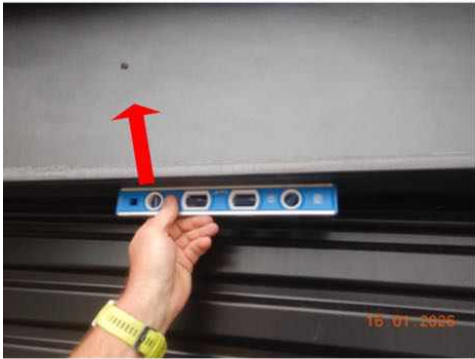
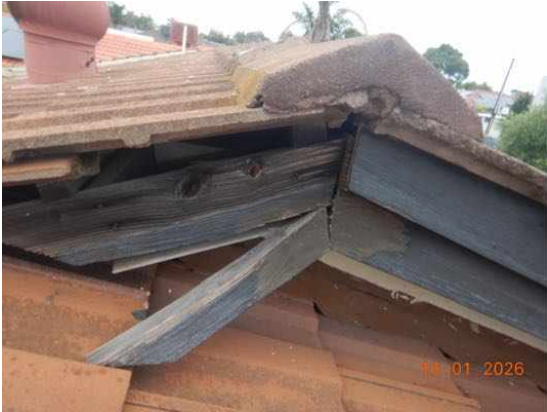
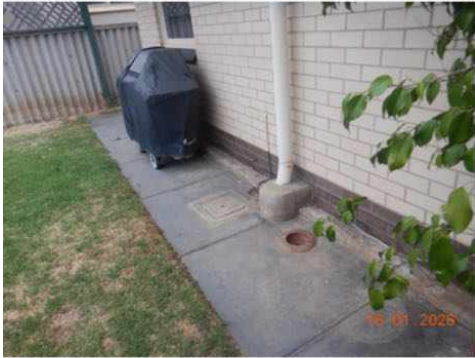
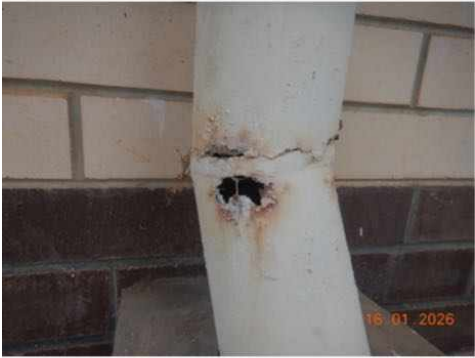
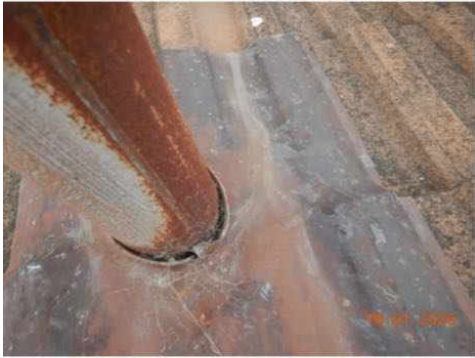
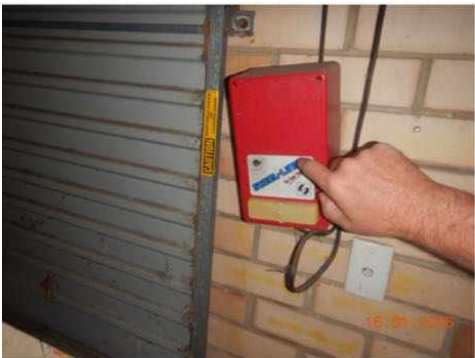
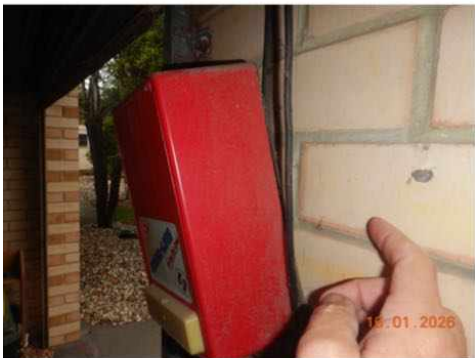
Finding 3.07

Building:	Building 1
Location:	All Areas
Finding:	Minor defects present
Information:	There were several age and maintenance related defects evident to the dwelling at the time of inspection. These defects include but are not limited to <ul style="list-style-type: none"> - Garage cladding facade deteriorated - Front porch tiles drummy/ damaged

- Minor damage to timber barges
- Plumbing vent requires replacement.
- Roller door operator loose

Appropriate licensed trades people could be appointed to make repairs at the discretion of the client.

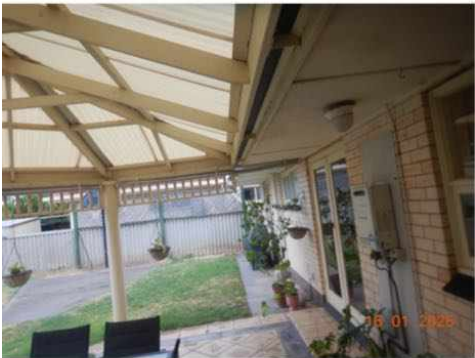
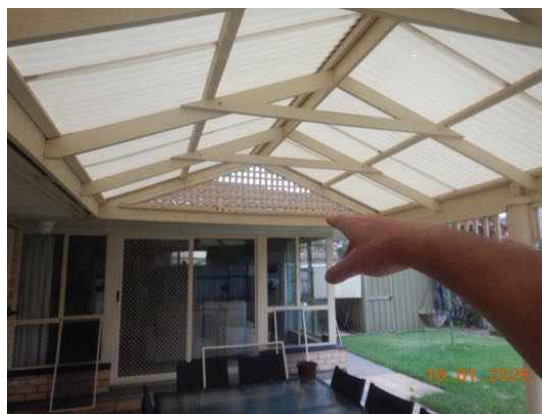
Finding 3.08

Building: Building 1
Location: Pergola
Finding: Pergola inadequate connection to house.
Information: This rear pergola structure appeared to have inadequate connection to the roof structure which intern has led to sagging of the eaves.

Sagging is evident to the fascia and pergola and as such the structural integrity of the roof cannot be guaranteed. If not address the pergola may deteriorate further creating additional stress to the house what potentially living gutters with water pooling due to inadequate fall.

Movement appears to be reasonably minimal at present therefore repair is left to the discretion of the client and would be carried out by a licensed builder potentially under advice from a structural engineer

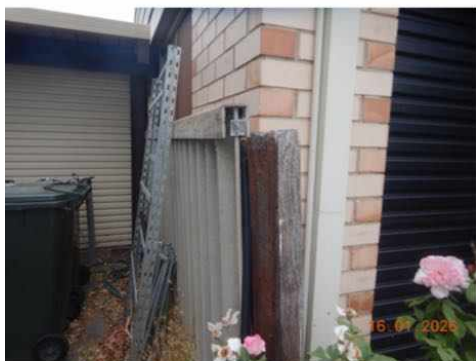
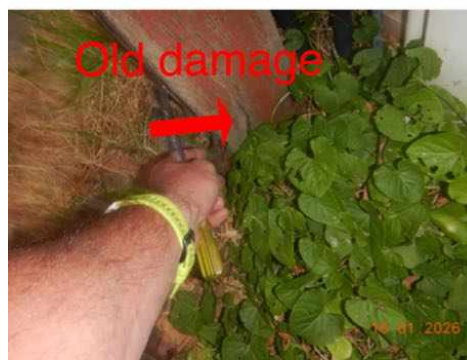
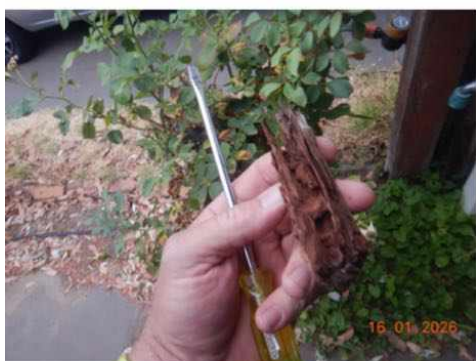
Building:	Building 1
Location:	Yard - Back
Finding:	Evidence of termite damage - minor
Information:	Despite no live termite or timber pest activity being indicated, previous termite damage was found to have affected this area. This damage is considered to be inactive and is minor in nature.

It is advised that the area be visually inspected frequently to ensure that the condition of affected building materials does not worsen. At the time of inspection, damage is not structural and is only considered to be superficial.

It is likely that further invasive investigation would uncover currently concealed defects.

A building contractor may be appointed to provide a further invasive inspection if further damage is evident.

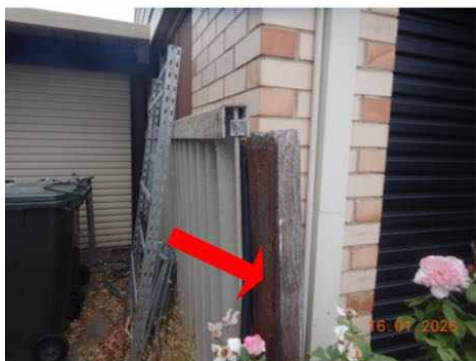
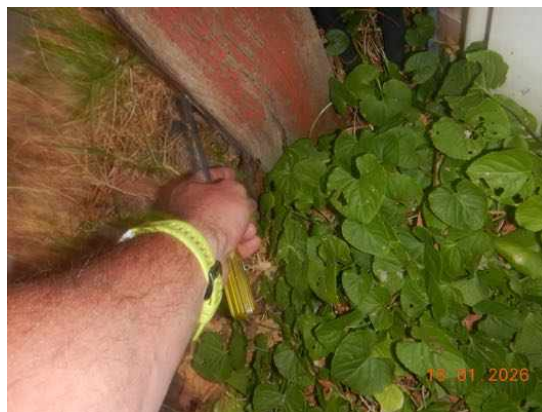
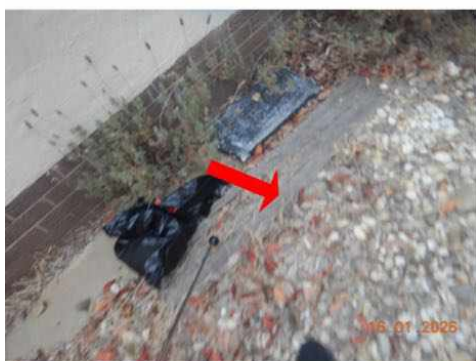
Finding 6.01

Building:	Building 1
Location:	All External Areas
Finding:	Untreated or non-durable timbers in a hazardous environment
Information:	To reduce the risk of timber pest attack it is essential that timber used in a hazardous environment (e.g. in direct contact with the ground or frequently exposed to damp conditions) is of sufficient durability and/or is adequately preservative treated. Additionally any timber lying around or timber stumps should be removed.

Untreated timbers in direct contact with the ground are likely to develop severe wood rot and/or fungal decay if left unattended creating attraction for subterranean termites to infest the timbers from surrounding areas.

If untreated or non-durable timbers are found to be in a hazardous environment it is highly advised that replacement of these building elements be performed as soon as possible to aid the protection of the property against termite / timber pest attack. Failing this close monitoring is recommended in an attempt to identify termite infestation at an early stage.

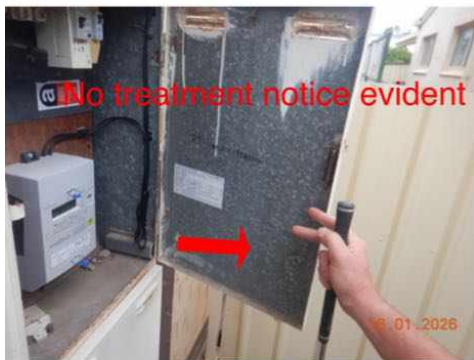
Finding 6.02

Building:	Building 1
Location:	All Areas
Finding:	Termite Management System - no evidence of a chemical installation
Information:	The application of a post-construction chemical termite barrier is highly recommended for all properties, particularly if live termite activity has been found on the site previously. Such barriers are highly effective in preventing termite attack on any timber building elements throughout the property.

At the time of inspection, it appeared as though no termite management system has been installed, with no evidence to suggest preventative works taking place.

The client may consider gaining further advice from a pest controller as to the costs and procedures involved with this application. It is recommended that obtaining such advice be a short-term priority.

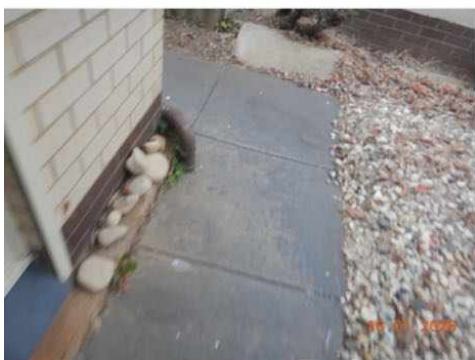
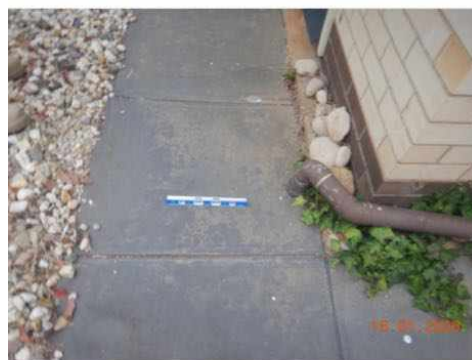
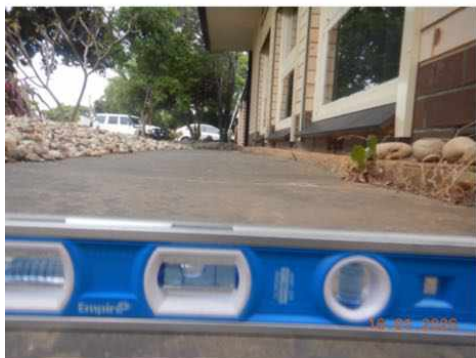
Building:	Building 1
Location:	Front Elevation
Finding:	Perimeter Paving - Insufficient Fall
Information:	The perimeter paving at the front right corner of the dwelling were found to have an inadequate slope away from the adjoining building structure, creating potential for water pooling in this area.

This standard ensures that excessive moisture does not pool around the base of building structures, which creates potential for water and structural damage, as well as making the area susceptible to termite and timber pest activity.

Where paving or ground levels do not have adequate fall, a licensed paving contractor should be appointed to install or remove and re-level pavement.

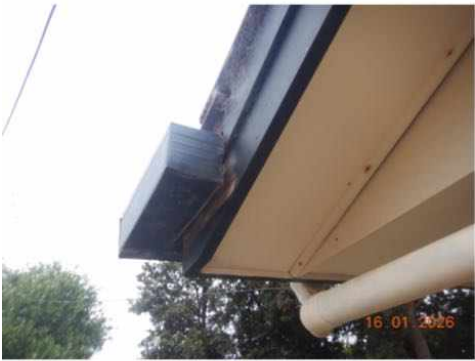
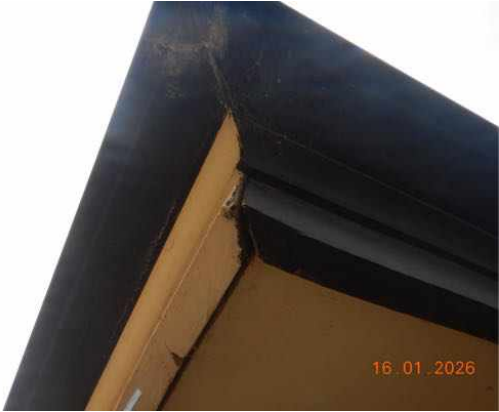
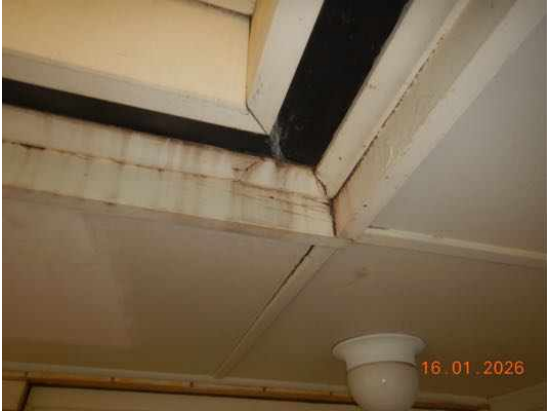
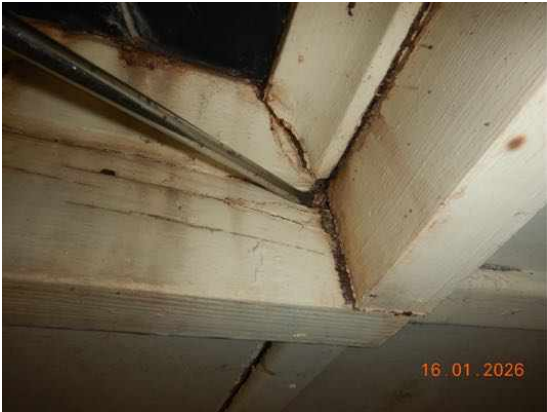
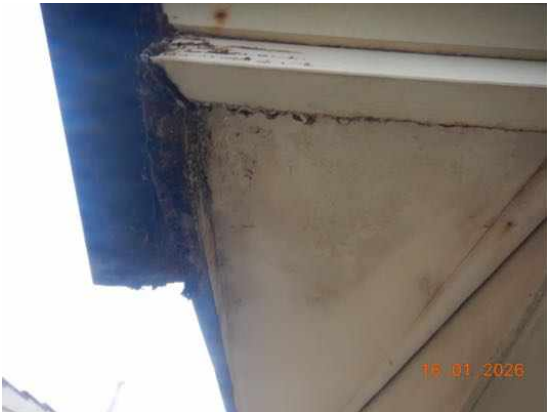
Finding 7.01

Building:	Building 1
Location:	All External Areas
Finding:	Fascias - Wood rot
Information:	Wood rot was found to be affecting fascias and barges throughout the roof, evidenced by the presence of deterioration on the surface in some areas. Wood rot, also known as Fungal Decay, occurs when timbers and other cellulose building materials are exposed to damp conditions on an ongoing basis.

It is likely that this wood rot has developed as a result of faults in the roof plumbing, creating excessive moisture in this areas.

Frequent exposure to rain and other weather conditions also make fascias and barges susceptible to accelerated deterioration.

Early intervention and regular maintenance will prolong the useful life of these building elements. Prior to any works being performed, the cause of the moisture that has created the visible wood rot should be identified and addressed in a suitable manner.

It is advised that a roof plumber be appointed to inspect all roof plumbing and subsequently identify the cause of the wood rot. Replacement of affected fascias and barges may then be a necessary step in protecting surrounding building elements from such deterioration.

A qualified plumber may be appointed to assess the cause of excessive moisture and to provide advice on any remedial works as required. A qualified carpenter or may also be required to replace affected building materials.

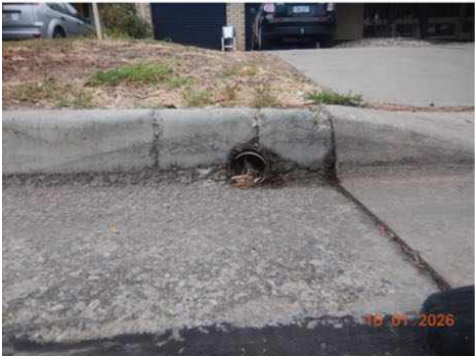
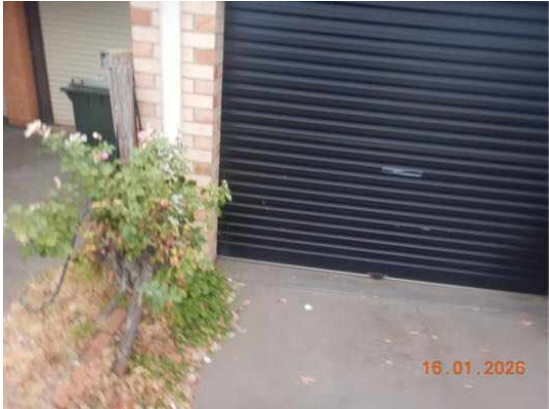
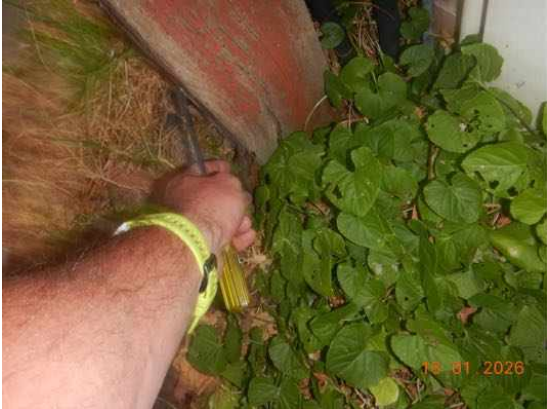
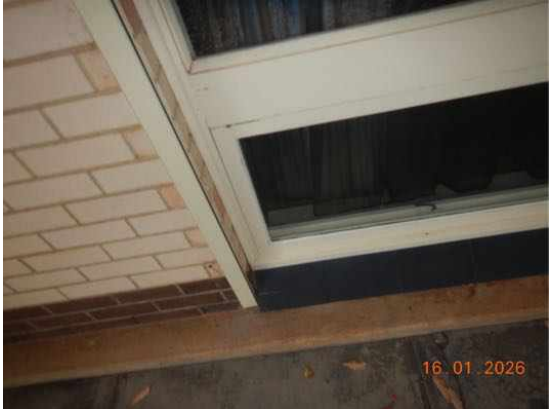
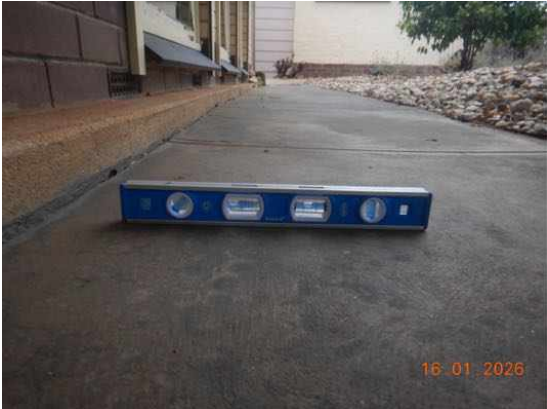
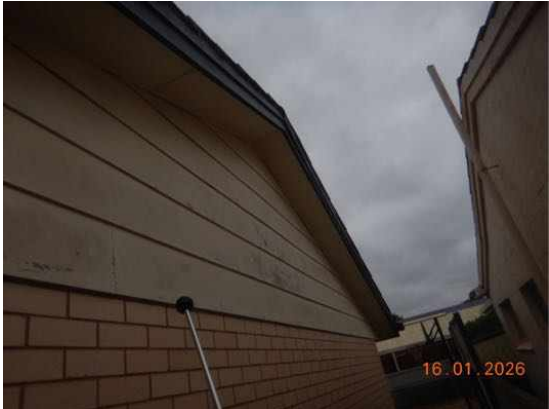
Building: Building 1
Location: All Areas
Finding: Additional Photos - Obstructions and Limitations
Information: These photographs are an indication of the obstructions and limitations which impeded full inspection of the property at the time of inspection.

These obstructions can hide an array of defects and should be removed to allow full inspection to be carried out.

A re-inspection is recommended once the areas are made accessible.

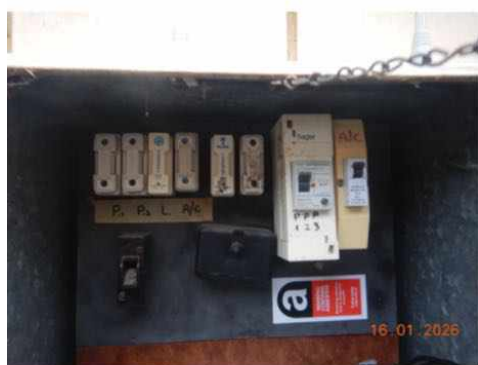
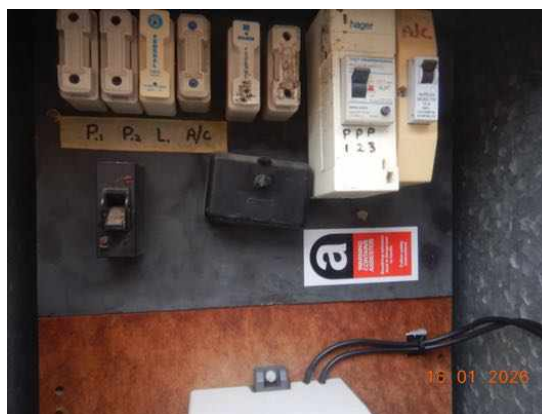
Noted Item

Building: Building 1
Location: All External Areas
Finding: Electrical switchboard - Old ceramic fuses
Information: The electrical switchboard has old ceramic fuses in place and also no safety switches in some switchboards.

While having ceramic fuses on its own on is not considered a defect it is noted for the clients consideration that a switchboard upgrade may be required in the short to mid term to improve the functionality of the electrical system.

A licensed electrician could be appointed to provide quotation for the works at the client's discretion which may in turn expose other required works to bring the system up to a compliant state.
