Building Inspection Report

Inspection Date: Tue, 27 Jan 2026

Property Address: 318/1 Josue Cres, Schofields NSW 2762,
Australia

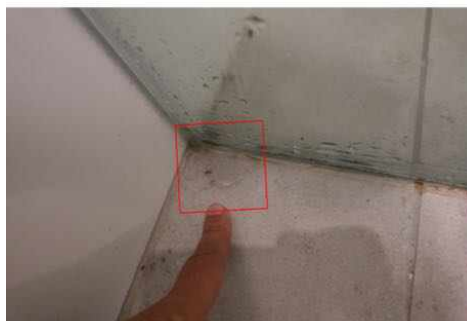
Defects 3.02

Building:	Main Building
Location:	several wet areas
Finding:	Sealant and grouting - Inadequate
Information:	It was noted on inspection that sealant or grout is degraded to several wet areas. Different materials and floor areas move at different rates, generally causing cracking to grout or sealant at this point.

Flexible and mould resistant materials should be applied to affected areas to prevent any subsequent water damage that is likely to occur. Regular maintenance and replacement of damage or missing or damaged sealant and grout is highly recommended to the wet areas, as this is a regular wear and tear defect

A licensed sealant specialist /licensed tiling contractor should be appointed to complete these works as soon as possible.

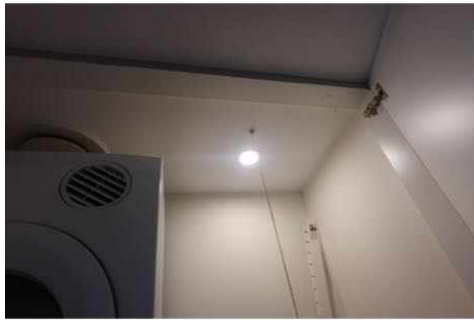
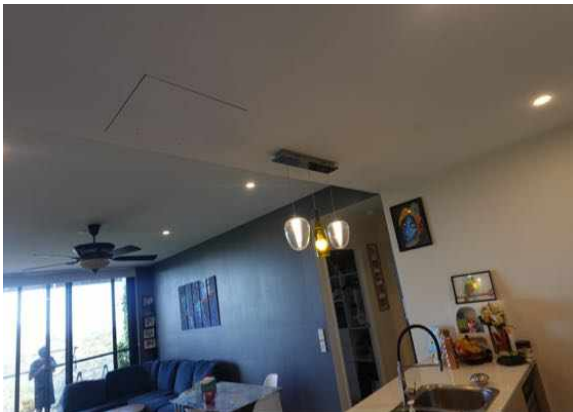
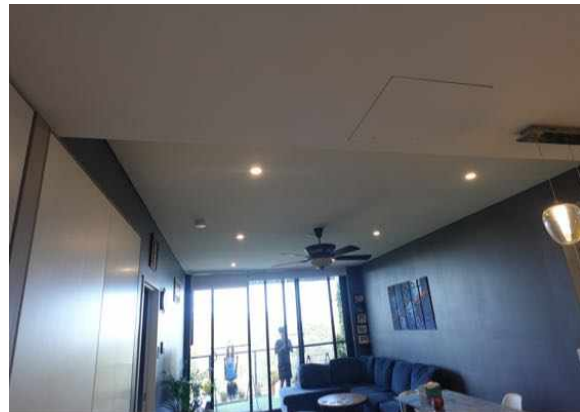
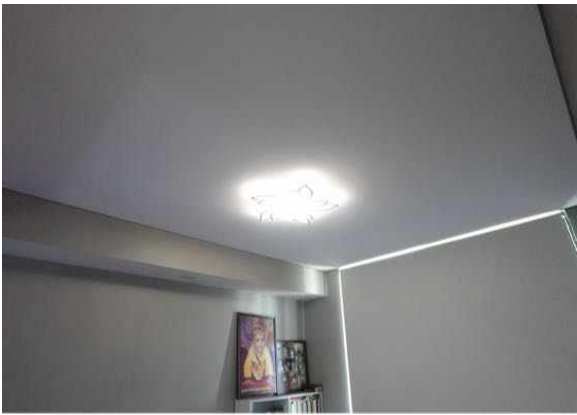
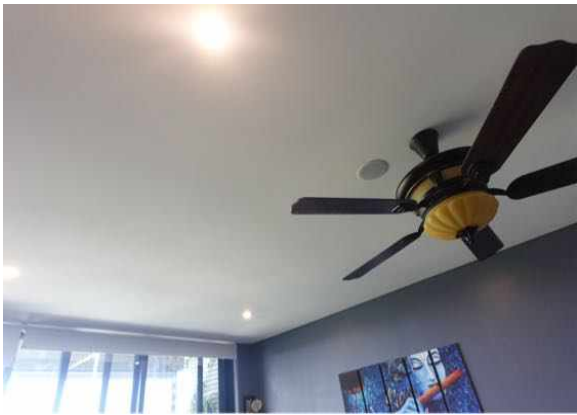
Noted Item

Whilst we note and comment of visually apparent defects that present during the building inspection, legislation requires the checking and documenting of compliance for plumbing and electrical requirements be done by licensed electrician to ensure they are functioning correctly.

It is highly recommended that the client makes arrangements to have the electrical checked by a licensed tradesperson to ensure that they are working safely and efficiently.

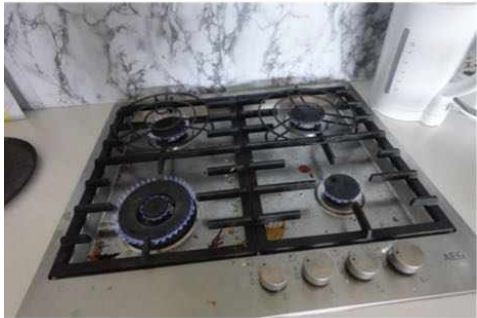
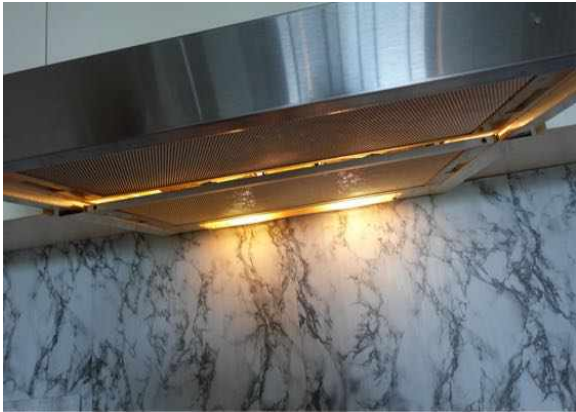
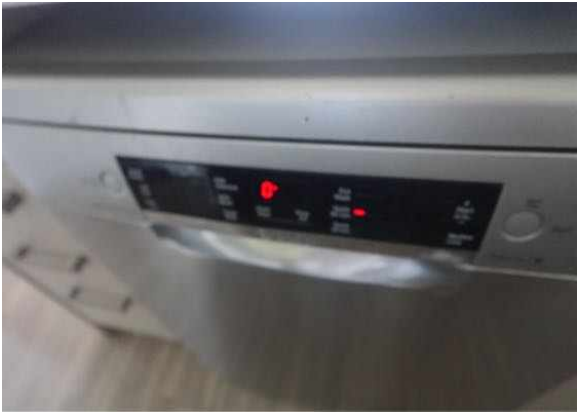
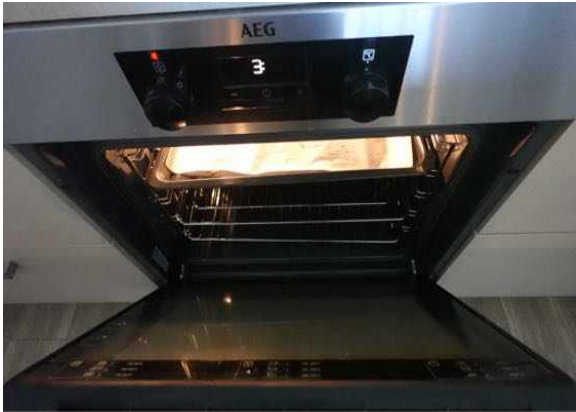
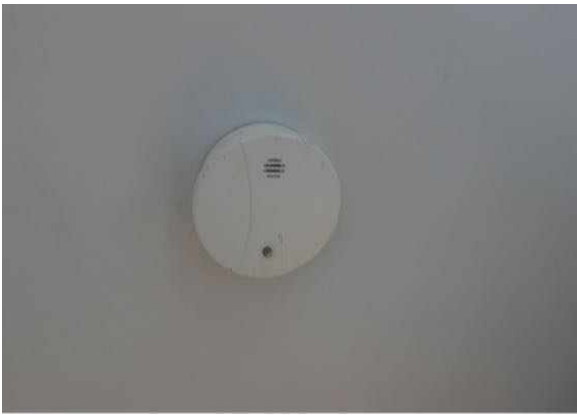
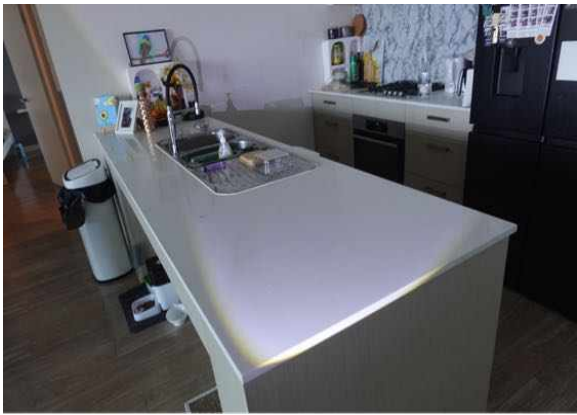
Noted Item

Building: Main Building
Location: All Areas
Finding: Additional Photos
Information: Additional photos are provided for your general reference only.

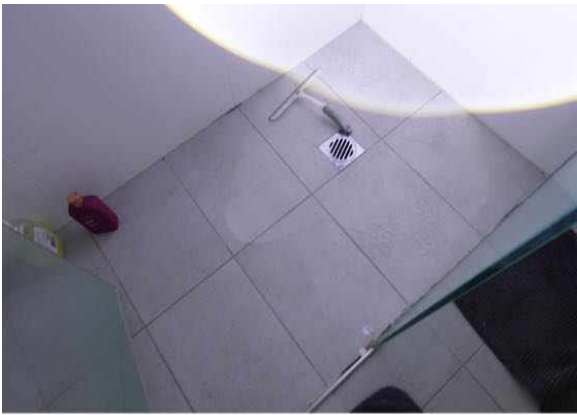
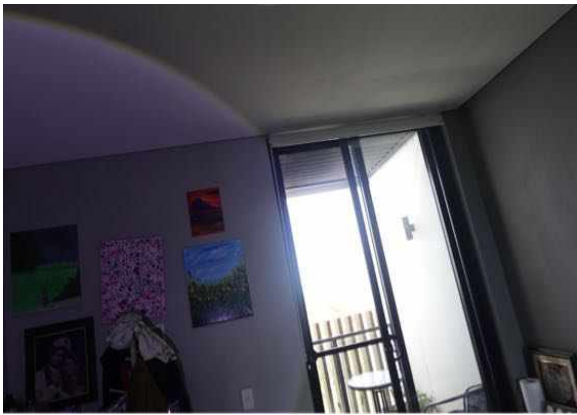
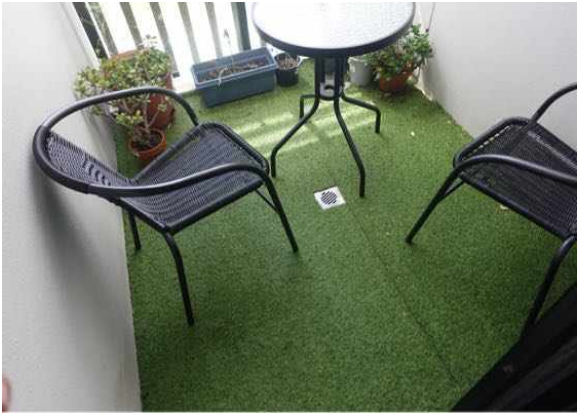
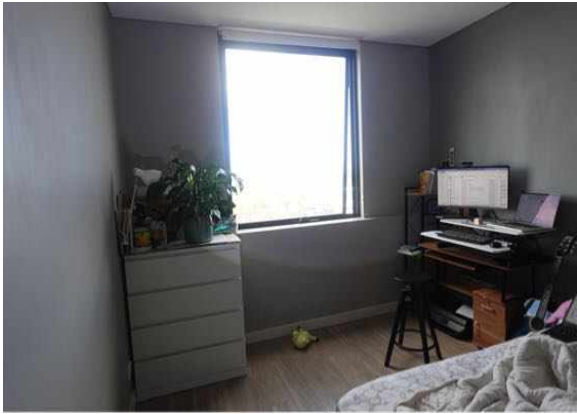
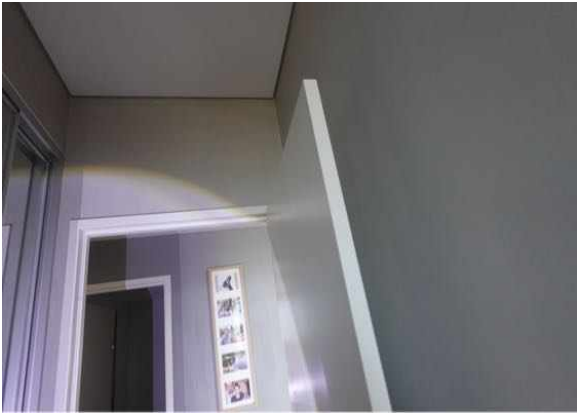
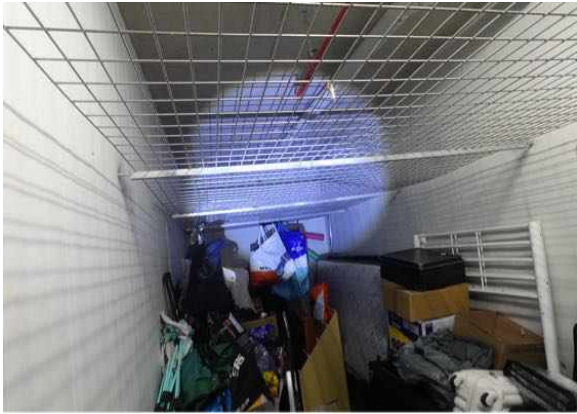
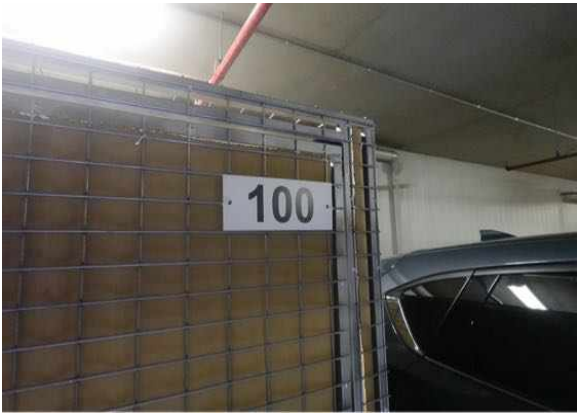
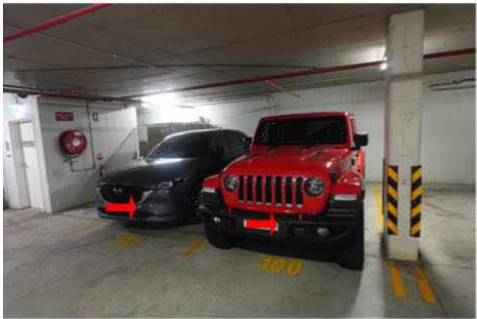
Noted Item

Building: Main Building
Location: All Areas
Finding: Additional Photos - Obstructions and Limitations
Information: These photographs are an indication of the obstructions and limitations which impeded full inspection of the property at the time of inspection.

These obstructions can hide an array of defects and should be to allow full inspection to be carried out.
