# Building and Timber Pest Inspection Report

Inspection Date: Wed, 11 Feb 2026

Property Address: 43 Jaspers Brush Rd, Jaspers Brush NSW  
2535, Australia

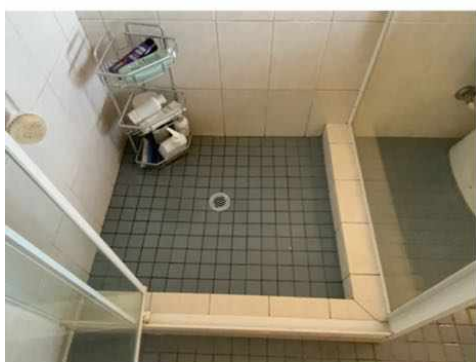
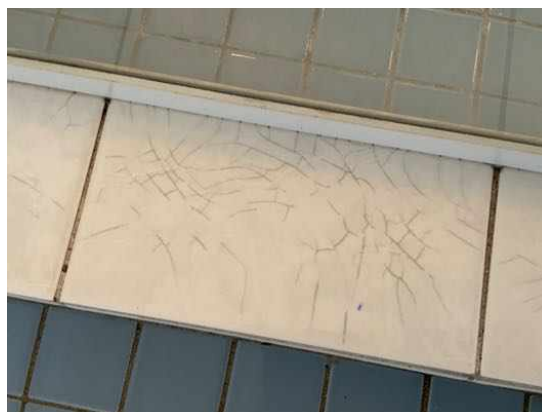
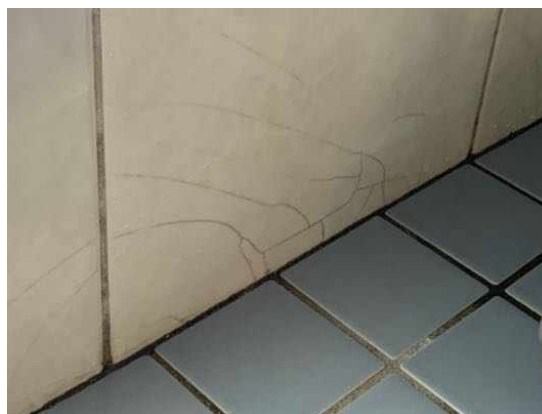
Building: Main Building  
Location: Bathroom  
Finding: Tiles - Cracked or damaged  
Information: Cracking was evident to the tiling in this area at the time of inspection. While the cracking appears to be minor, this area is frequently exposed to water, allowing potential for water penetration into adjoining sections of walls or flooring.

If left unmanaged, water penetration to these areas may lead to subsequent water damage, which is likely necessitate repair work to affected building elements.

A tiling contractor should be appointed to ensure that no further water damage occurs. The re-application of silicone and grouting throughout remaining tile work is also advised, to further protect the area against water penetration.

Where water penetration has led to water damage, appointment of a relevant tradesperson may be required to repair damaged building elements.

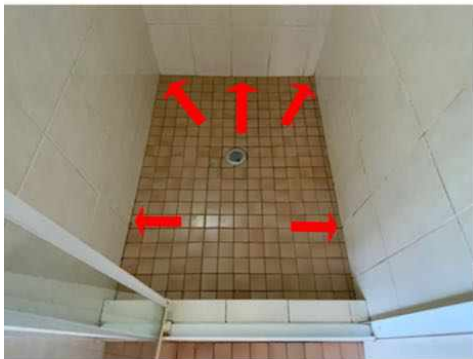
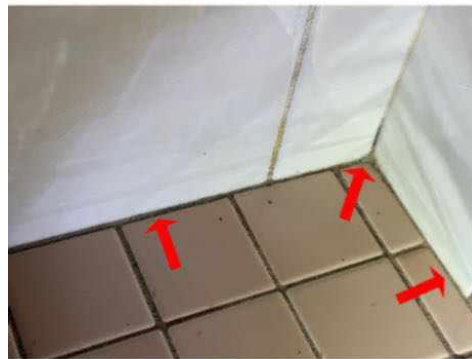
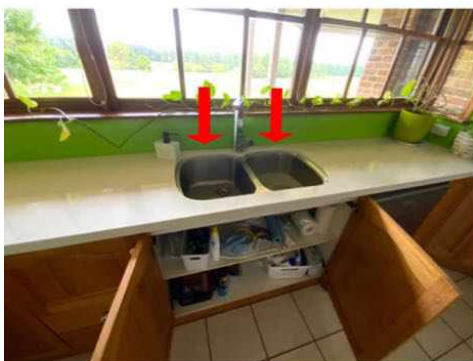
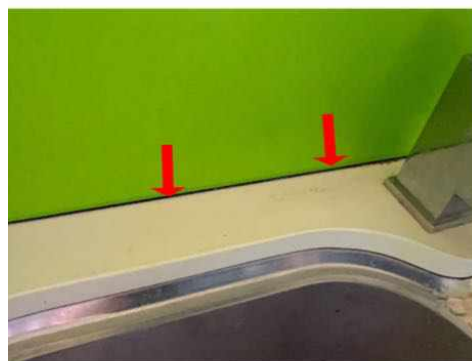
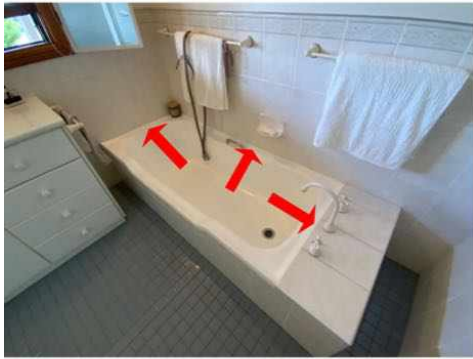
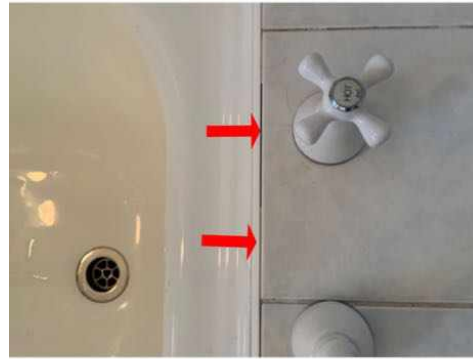
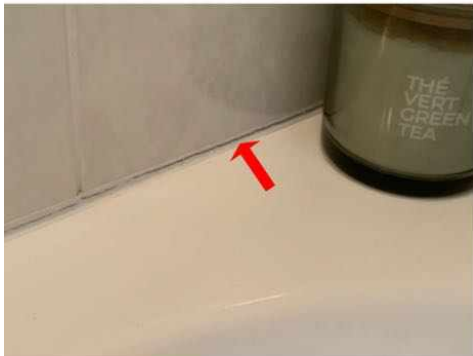
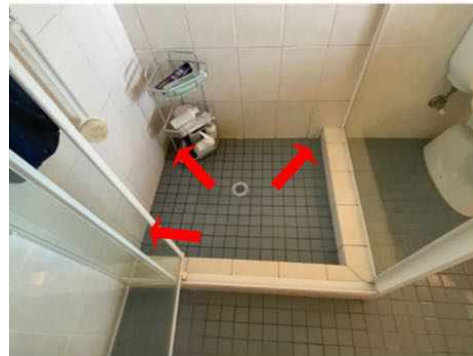
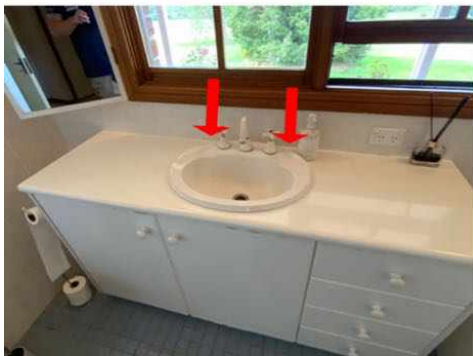
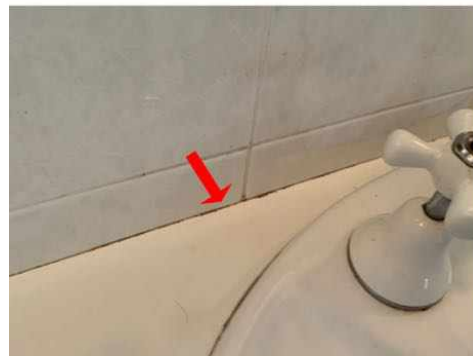
### Finding 3.02

Building:	Main Building
Location:	All Wet Areas
Finding:	Sealant or Grout - Deteriorated, Missing or substandard installation
Information:	Sealant appears to be inadequate to these tiled areas. The different materials and floor areas move at different rates therefore cracking the grout at this point. A flexible sealant is required to allow for this expansion & contraction while keeping the joint water tight and without holes for long term care of all building materials.

Apply a flexible sealant to match the grout that is best suited to the purpose as per product specifications. Regular maintenance &/or replacement of damage or missing sealant is highly recommended to the kitchen benches/splashbacks, vanity top to wall/splashback, laundry tub edge/splashback, wet areas floor edges and the shower floor & wall corners for the long term care of your property.

Regular maintenance &/or replacement of damage or missing sealant is highly recommended for the long term care of your property.

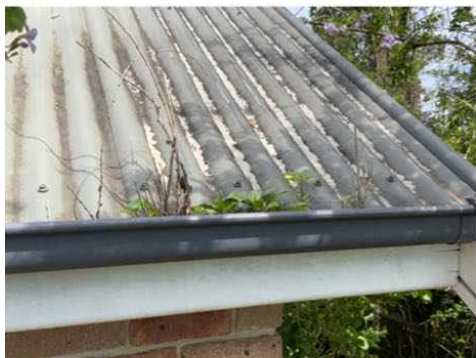
### Finding 3.03

Blocked gutters are likely to lead to high levels of moisture in the affected areas. Such moisture will not only cause rust and decay of the associated building materials, but can also provide conditions that are conducive to termite and timber pest activity. Blockages in gutters should therefore be removed immediately to ensure dry conditions are maintained.

Consult a Licensed Plumber for further specific advice on remedial works that may be required. In the interim, it is highly advised that blocked gutters be removed by the homeowner or a general handyperson as a matter of urgency.

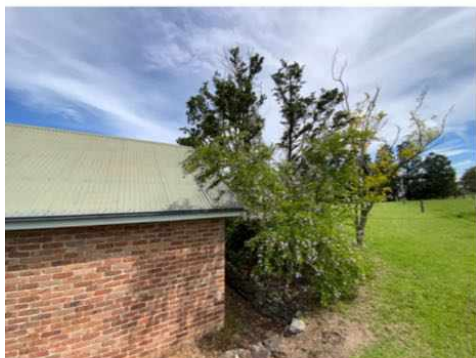
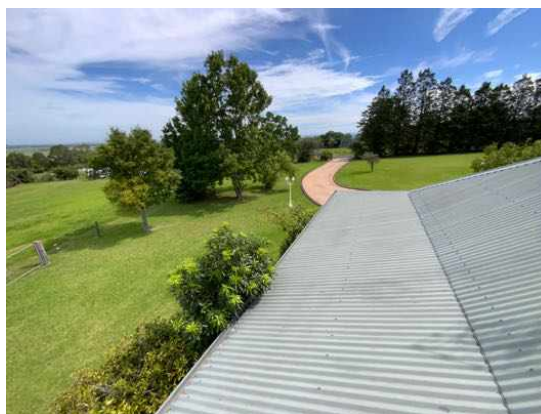
### Finding 3.04

Building:	Main Building
Location:	Roof Exterior
Finding:	Trees - Overhanging and filling gutters
Information:	Overhanging trees often result in excessive amounts of leaf debris accumulating in gutters.

It is highly advised that all overhanging tree branches be removed as soon as possible to prevent any further damage. Repair and/or replacement of sections of damaged guttering may also be required where the extent of the damage necessitates.

Such works should be performed by the homeowner; however, appointment of a landscape contractor or an arborist may be required. Consultation with a licensed roof plumber is required where guttering has been damaged.

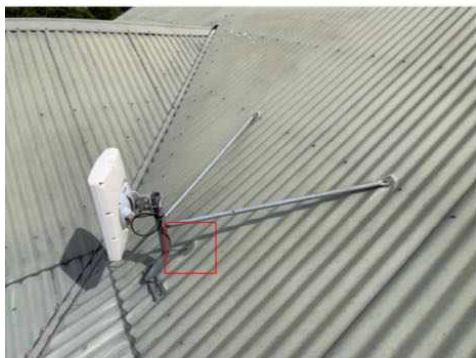
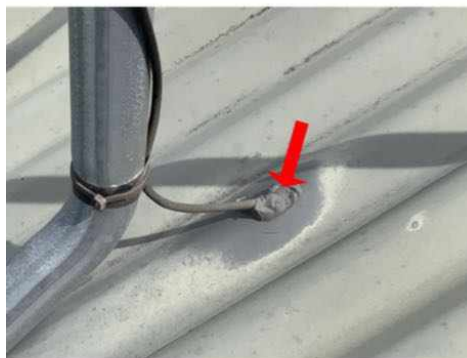
### Finding 3.05

Building:	Main Building
Location:	Roof Exterior
Finding:	Roof plumbing - Flashing Missing (relying on sealant only)
Information:	Some sections of the roof are missing or have inadequate roof flashings. Flashings are metal and other materials which are applied to seals and intersections between roof coverings and building elements. They are designed to aid in weatherproofing of roof joins.

Premature ageing and secondary building defects are imminent where roof plumbing is missing or inadequately installed. Additionally, water pooling also creates an environment that is susceptible to termite and pest infestation.

A roofing plumber should be appointed as soon as possible to install relevant roof plumbing materials, ensuring that no further damage is sustained.

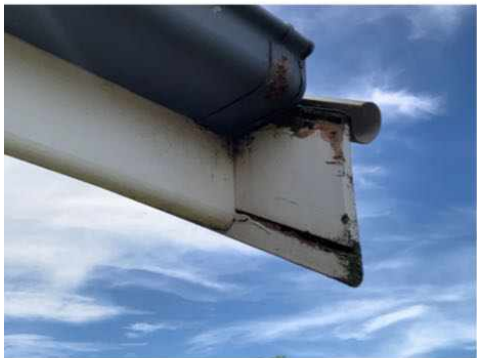
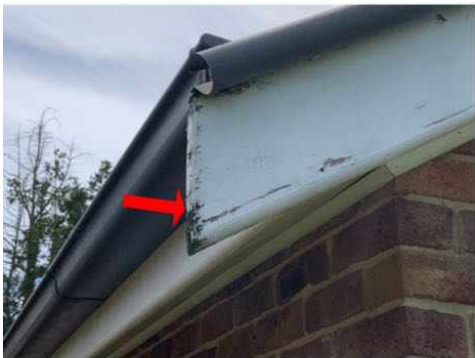
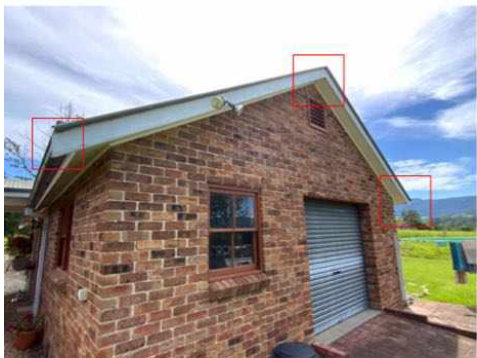
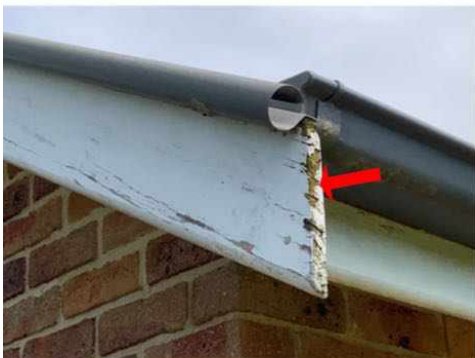
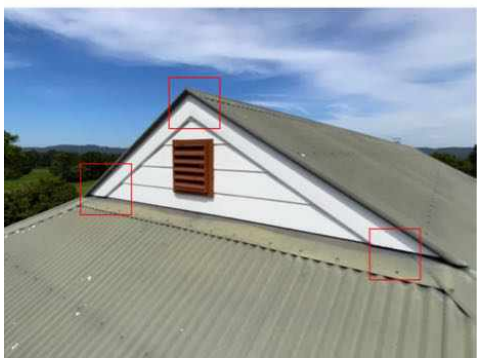
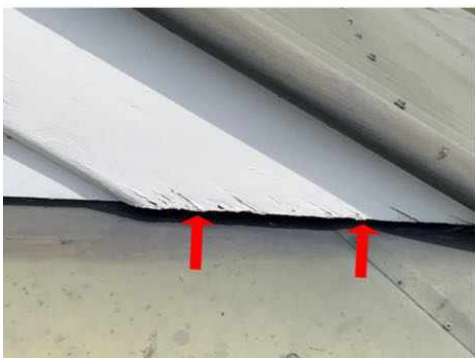
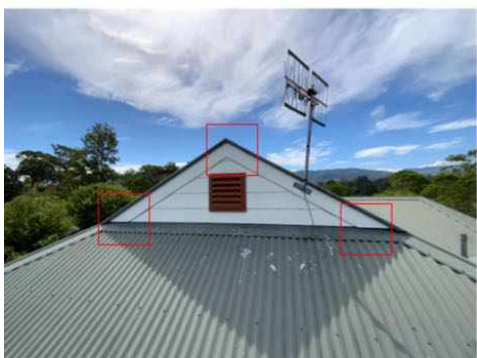
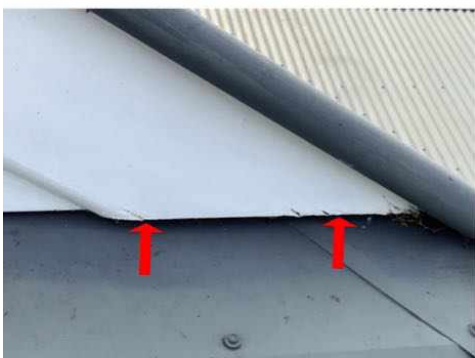
### Finding 3.06

Building:	Main Building
Location:	Roof Exterior
Finding:	Fascias - Wood rot
Information:	Wood rot was found to be affecting fascias and barges in this area, evidenced by the presence of mould on the surface in some areas. Wood rot, also known as Fungal Decay, occurs when timbers and other cellulose building materials are exposed to damp conditions on an ongoing basis.

It is advised that a roof plumber be appointed to inspect all roof plumbing and subsequently identify the cause of the wood rot. Replacement of affected fascias and barges may then be a necessary step in protecting surrounding building elements from such deterioration.

A qualified plumber may be appointed to assess the cause of excessive moisture and to provide advice on any remedial works as required. A qualified carpenter or registered builder may also be required to replace affected building materials.

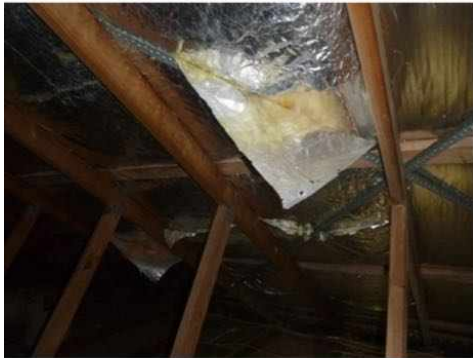
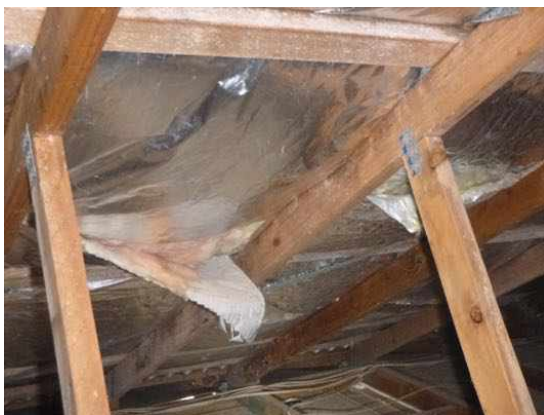
Finding 3.07

Building: Main Building  
Location: Roof Void  
Finding: Sarking - Damaged or Loose  
Information: Sarking to under the roofing material is damaged, loose or has holes and gaps. Sarking acts as an insulator, helps with noise reduction & is a second barrier against water penetration from broken or slipped tile leaks & condensation.

A Builder, Carpenter or handyman will be able to repair the holes with pieces of sarking and AS4254 tape specific foil tape for this product.

Consult a builder or insulation specialist for further advice.

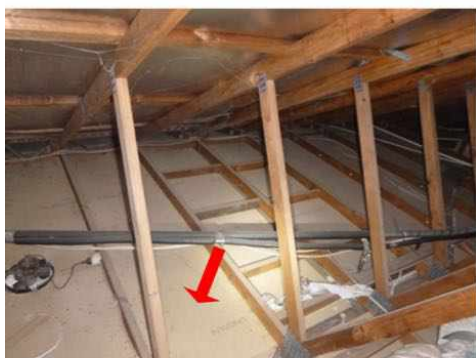
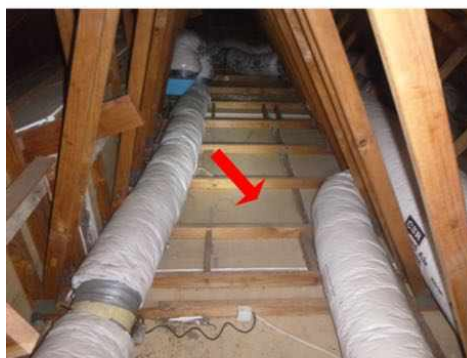
### Finding 3.08

Insufficient insulation will result in a comparatively higher cost to heat and cool a property as there is a lack of Insulation (or uneven coverage of insulation) which works as a barrier to heat transfer. This helps to keep out unwanted heat in summer and preserves warmth inside your home in winter. It can also help soundproof your home from unwanted airborne noise transfer.

Where insulation is absent, the area does not meet current Australian Standards. Installation of adequate insulation is required and should be conducted as soon as possible.

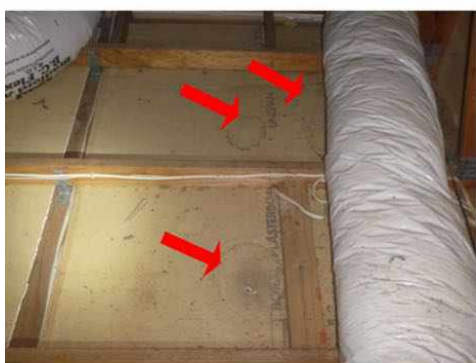
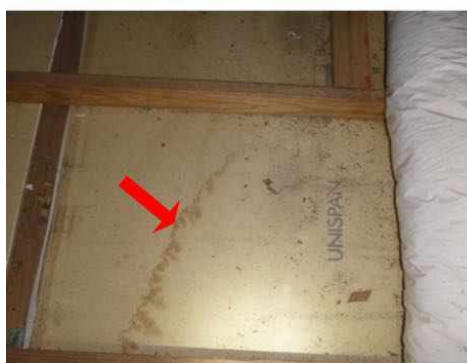
### Finding 3.09

Building:	Main Building
Location:	Roof Void
Finding:	Ceiling - Water stained - monitoring of the area is recommended
Information:	Water staining to ceiling linings in this area was evident at the time of inspection. Water

Where water staining is active, a licensed plumber must be consulted to identify the cause of the staining and to provide advice on any reparation works that may be required. Replacement of any damaged structures is advised.

Conversely, where water staining is old and inactive, affected building materials may be repaired or replaced at client discretion.

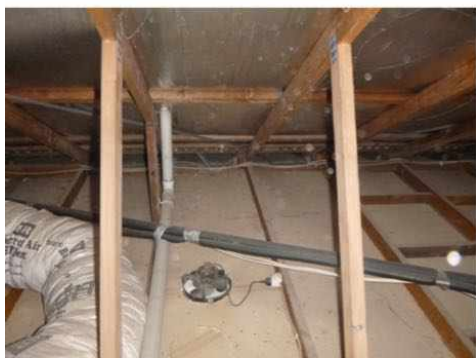
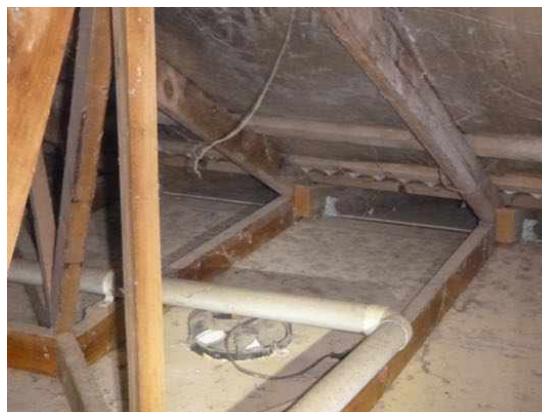
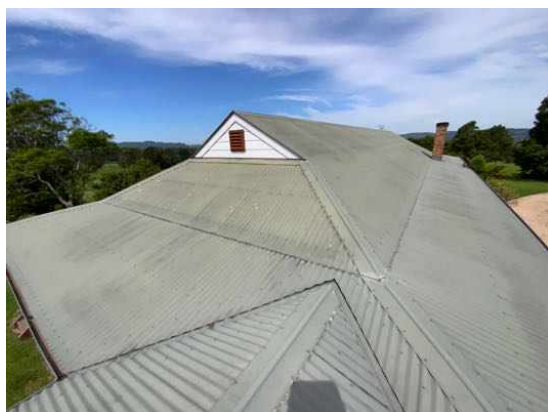
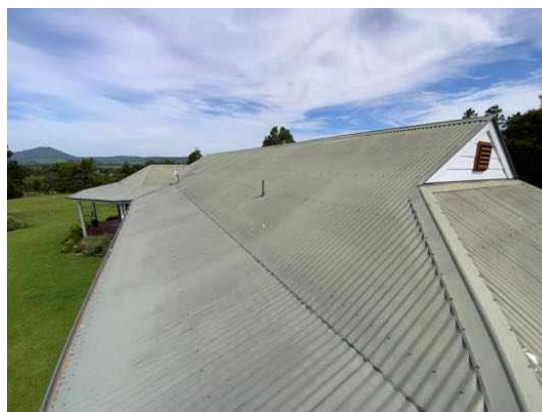
### Finding 3.10

Building:	Main Building
Location:	Roof Void
Finding:	Exhaust fans - Sarking on roof (Ducting, Roof Vent or Eave Vents are recommended)
Information:	On inspection of the roof void, it was observed that the exhaust fans to the bathroom and ensuite do not exhaust directly to the outside of the building, which is recommended if sarking has been fitted, as it has in this home.

High levels of moisture in the affected areas can provide conditions that are conducive to termite and timber pest activity. Consult a Licensed Builder or Plumber for further specific advice on remedial works that may be required.

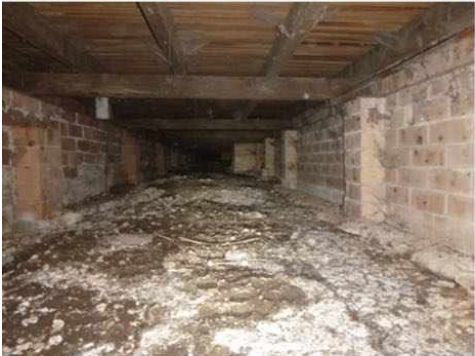
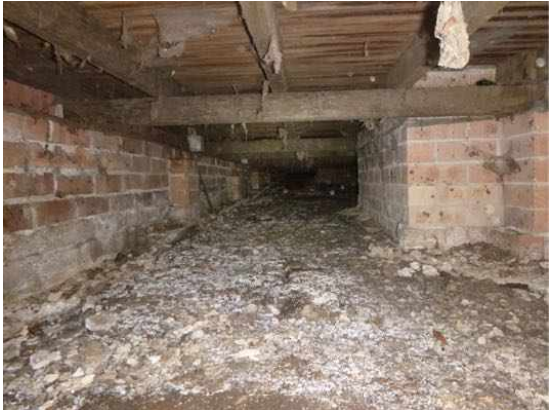
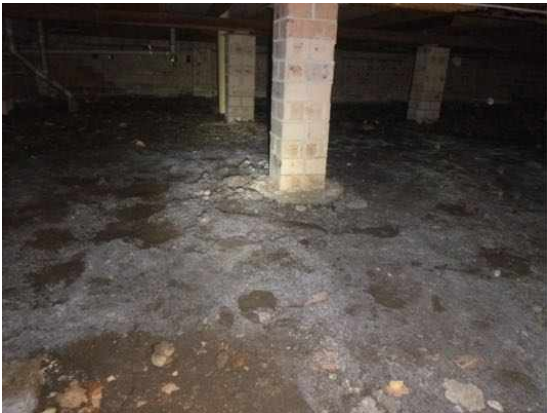
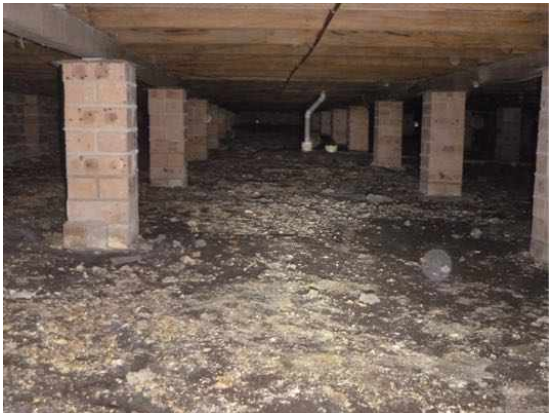
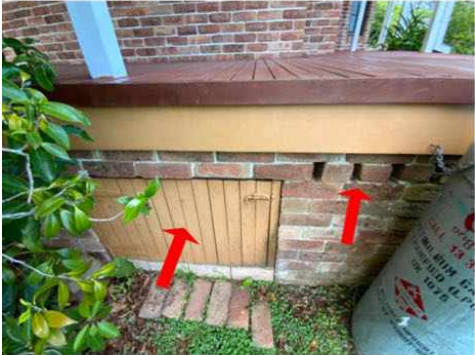
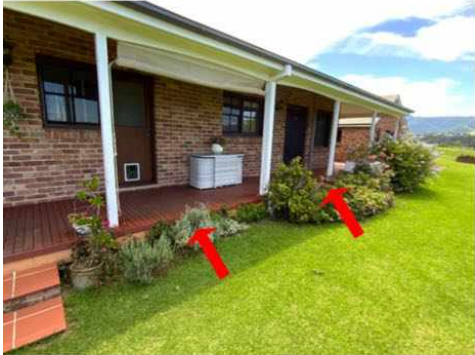
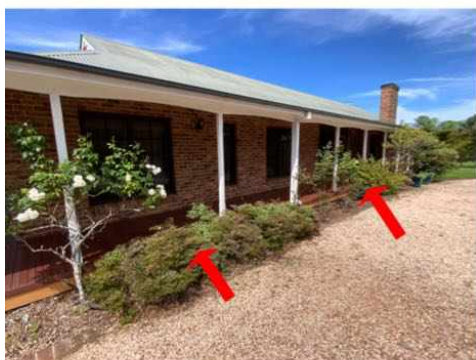
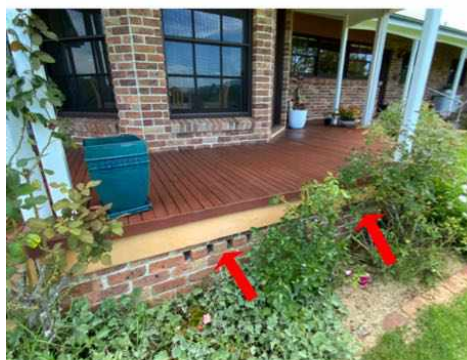
Building:	Main Building
Location:	Subfloor
Finding:	Subfloor Ventilation - Inadequate (mouldy subfloor soil to some areas)
Information:	Adequate subfloor ventilation and drainage aids in preventing excessive moisture, mouldy subsoil, wood rot and termite activity by ensuring a dry subfloor environment.

Where ventilation is substandard it is usually caused by factors such as failure to install adequate vents during construction, subsequent building works or earth and vegetation covering over vents, low subfloor clearance and items or debris in the subfloor restricting airflow.

Subfloor ventilation can be improved in most cases by addressing the causes such as exposing subfloor vents, replacing access doors with a gauze or slat door, installing additional new vents (large gauze type is best- 2 bricks high x 2 bricks wide), installing mechanical (forced airflow) ventilation and removing debris & obstructions to air flow from the subfloor.

A registered builder or sub floor ventilation specialist should be appointed as soon as

possible to look at improving ventilation & drainage to the perimeter of the building and to perform these works as necessary.

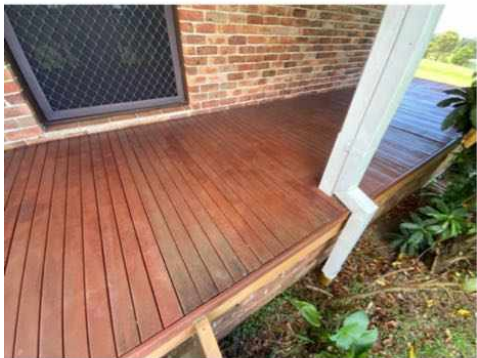
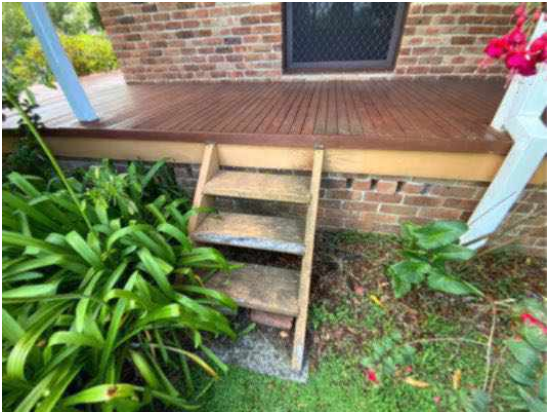
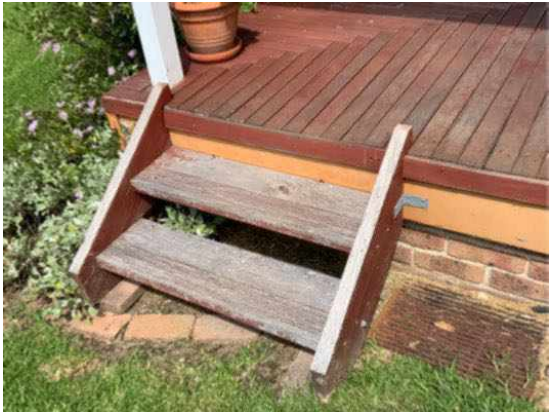
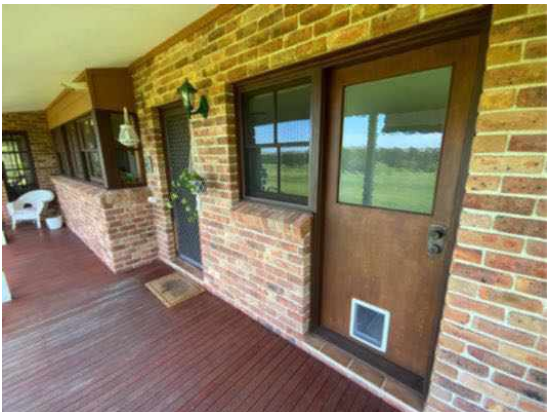
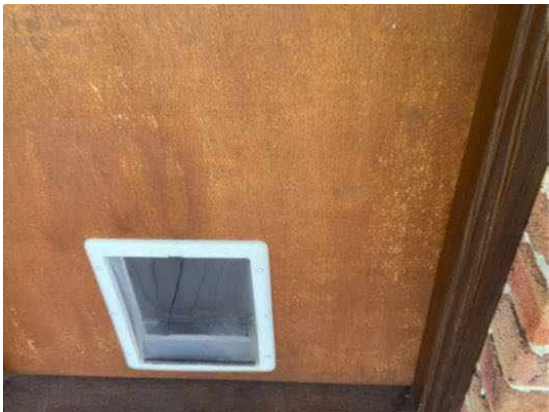
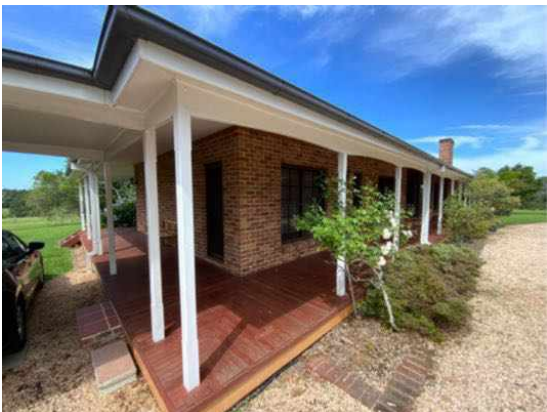
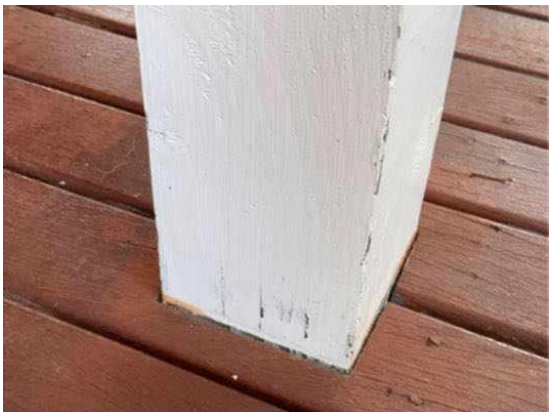
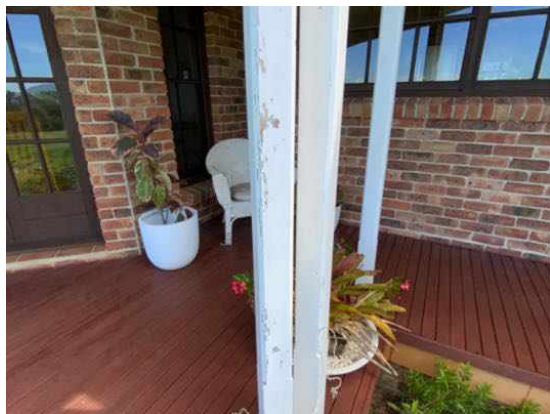
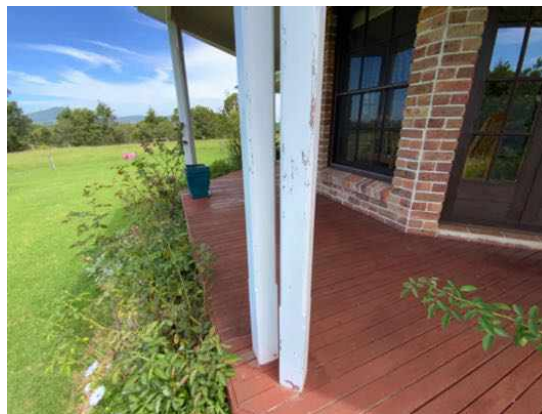
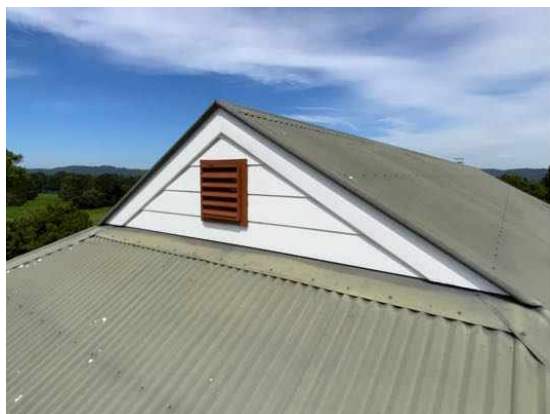
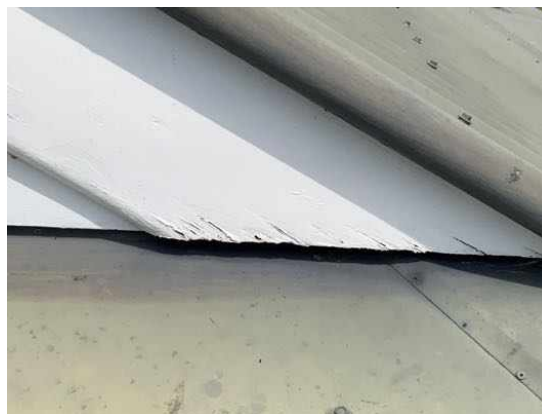
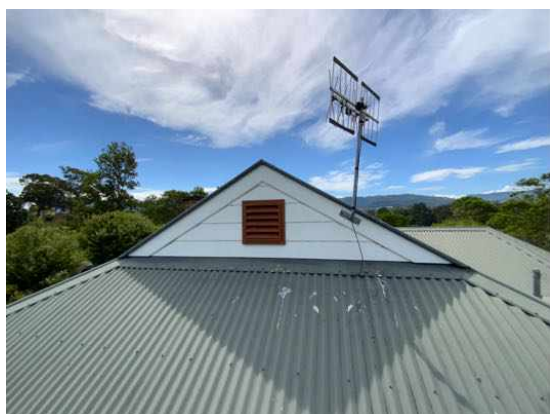
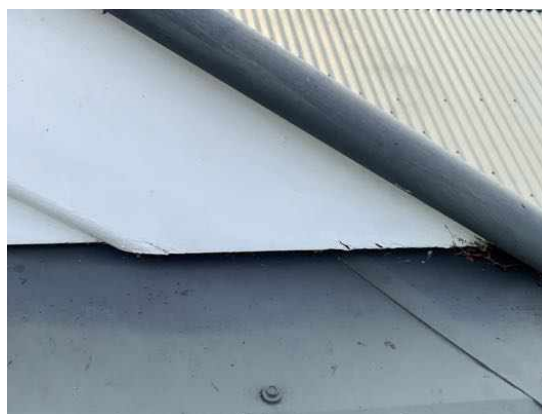
### Finding 3.12

Building:	Main Building
Location:	All Areas
Finding:	External paint to timbers - deteriorated
Information:	Much of the external paintwork including but not limited to external timbers and trims have been neglected and require attention to prepare and re-paint.

Whilst incomplete or missing paint finish is generally an appearance defect, it can also lead to the development of secondary building defects over time. Incomplete areas of paint finish expose the area to moisture, potentially accelerating the deterioration of underlying building materials.

Degraded paint finishes should be sanded back, filled, leveled and painted, as applicable. Where inadequate or missing paint protection has led to the deterioration of the associated building element, repair and/or replacement of this building element may be required.

A painting contractor should be appointed as soon as possible to perform necessary works to aid the appearance of the affected area and to ensure the area is protected against further deterioration. Alternatively, the homeowner following manufacturer instructions may perform these works.

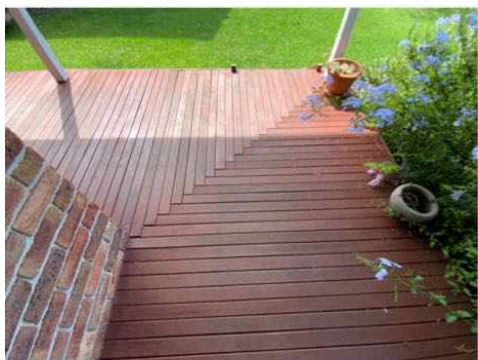
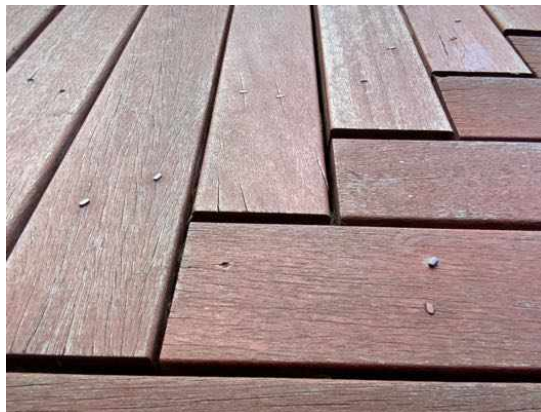
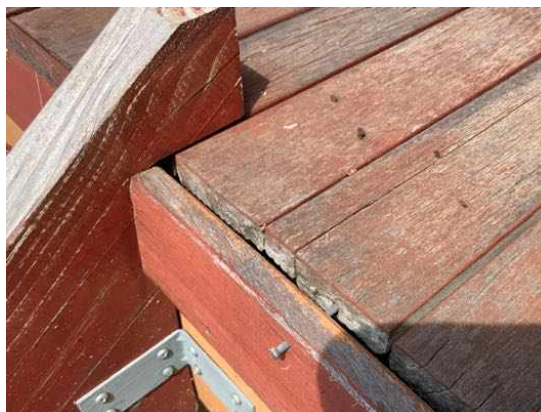
### Finding 3.13

Building:	Main Building
Location:	Deck
Finding:	Nails - Popping to decking (SAFETY HAZARD)
Information:	Numerous popped nails were identified at the time of inspection. Nails and screws are held by the friction between them and the surface that they are applied to. Over time, the nails and screws can back out, which is often a result of general ageing and deterioration of the building structure.

If left unmanaged, internal wall and ceiling sheeting may become loose and unstable, increasing the rate of deterioration of these building elements and creating potential for the development of secondary defects.

Re-fastening of popped nails will help to maintain the stability of these, and associated, building elements. Such minor works will also help to improve the appearance of the affected area and secure the linings. These works should be performed by a qualified carpenter or plasterer at client discretion.

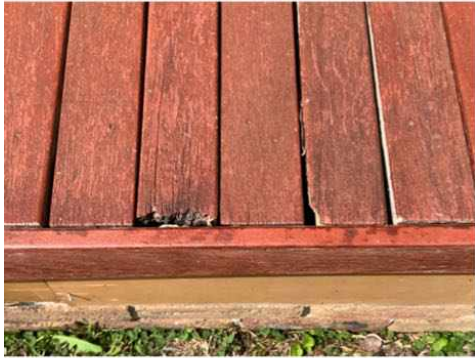
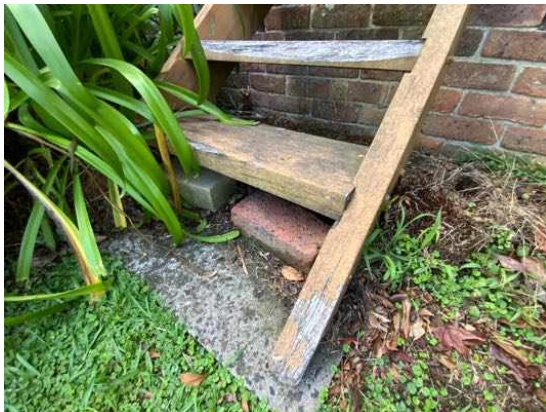
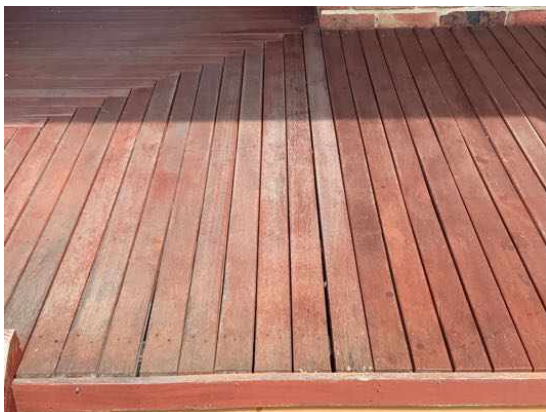
### Finding 3.14

Building:	Main Building
Location:	Deck
Finding:	Wood rot to decking and steps to some areas
Information:	This building element shows evidence of wood rot. Wood rot, also known as Fungal Decay, occurs when timbers and other cellulose building materials are exposed to damp conditions on an ongoing basis. This could be the result of exposure to weathering over a prolonged period of time, or the attraction of excessive moisture from other abutting building materials. Contributing factors also include poor air ventilation in the area.

Wood rot is often associated with general damp problems and is evidenced by a 'musty' smell or mould and mildew occurring on surfaces. If left unmanaged, damp conditions can lead to further health problems and the decay of timbers will continue.

the useful life of these building elements. Prior to any works being performed, the cause of the moisture that has created the visible wood rot should be identified and addressed in a suitable manner. Replacement of affected timbers may then be a necessary step in protecting surrounding building elements from such deterioration.

A qualified plumber may be appointed to assess the cause of excessive moisture and to provide advice on any remedial works as required. A qualified carpenter or registered builder may also be required to replace affected building materials.

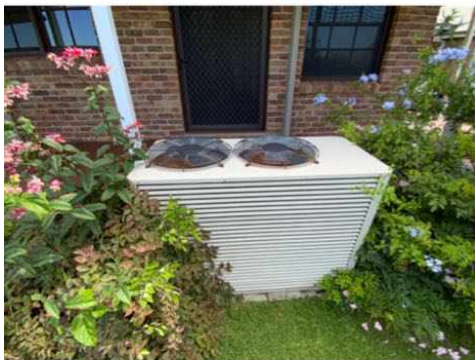
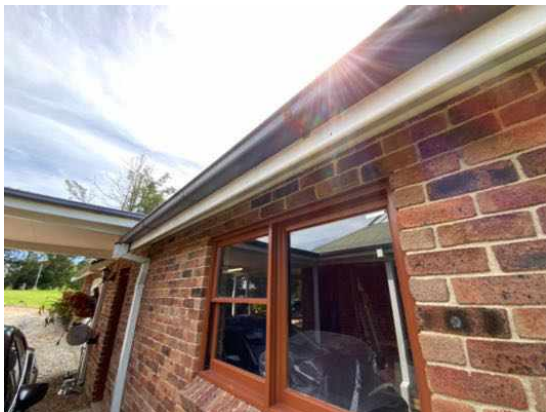
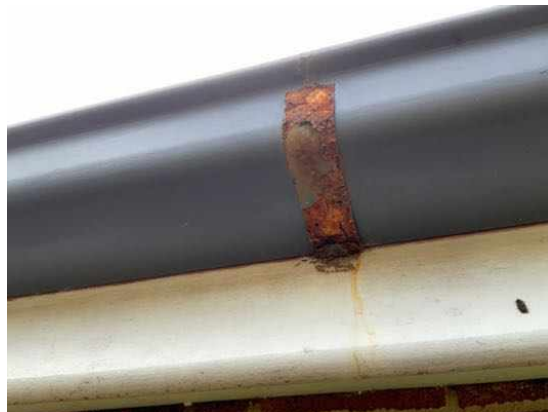
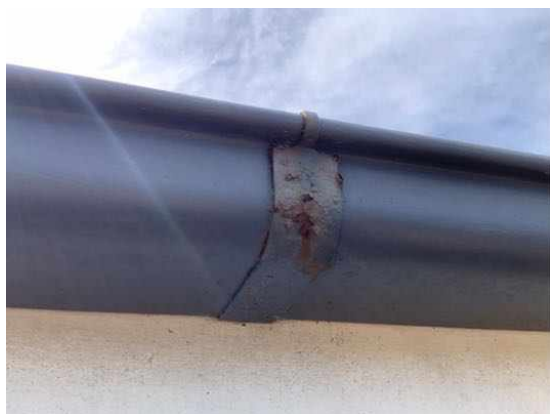
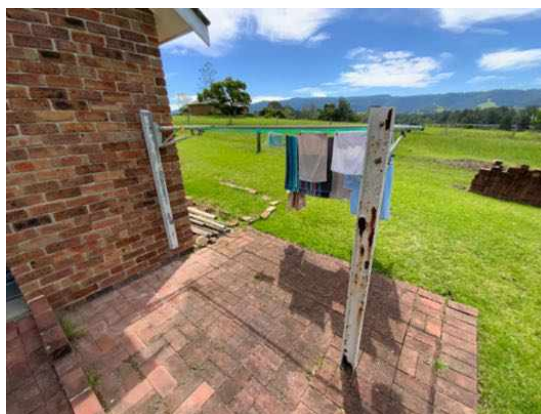
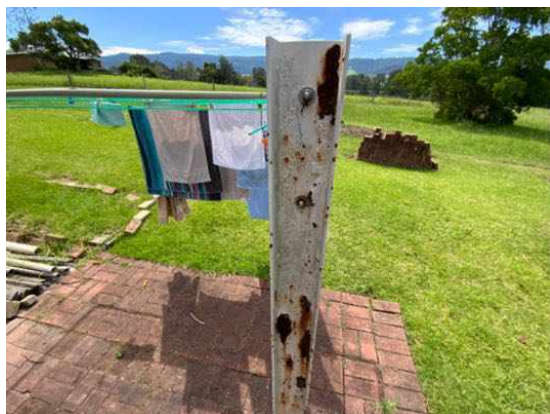
### Finding 3.15

Location: Yard - Back  
Finding: Building elements - Rusted or corroded (Gutter brackets, A/C unit, Clothesline Post)  
Information: This building element shows evidence of rusting and corrosion, which is likely to have developed as a result of excessive exposure to moisture and or inadequate coatings.

As surface rust provides no protection to the underlying iron, the deteriorating condition is likely to worsen if not addressed in the short-term future.

Where possible, the use of galvanized (treated) metals or aluminium coated metals aid in rust prevention, as does regular general maintenance. Rust formation can be controlled with coatings, such as paint, that isolate the iron from the environment.

Rusting and corrosion should be managed by ideally removing or limiting the affected surface from exposure to moisture. A registered builder may be appointed to replace any building elements that have been severely affected by rust or water damage.

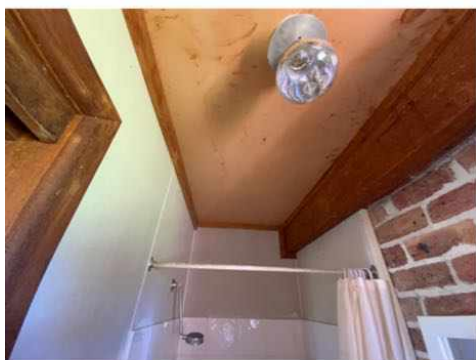
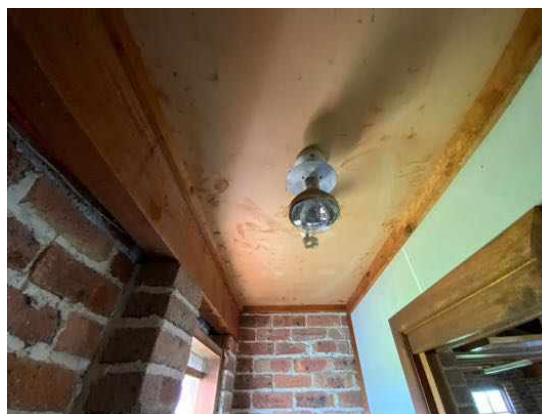
### Finding 3.16

Building:	Garage
Location:	Bathroom
Finding:	Paint finish - Incomplete
Information:	The paint finish in this area was identified as being incomplete at the time of inspection.

Whilst incomplete or missing paint finish is generally an appearance defect, it can also lead to the development of secondary building defects over time. Incomplete areas of paint finish expose the area to moisture, potentially accelerating the deterioration of underlying building materials.

Incomplete paint finishes should be sanded back, filled, leveled and painted, as applicable. Where inadequate or missing paint protection has led to the deterioration of the associated building element, repair and/or replacement of this building element may be required.

A painting contractor should be appointed as soon as possible to perform necessary works to aid the appearance of the affected area and to ensure the area is protected against further deterioration. Alternatively, the homeowner following manufacturer instructions may perform these works.

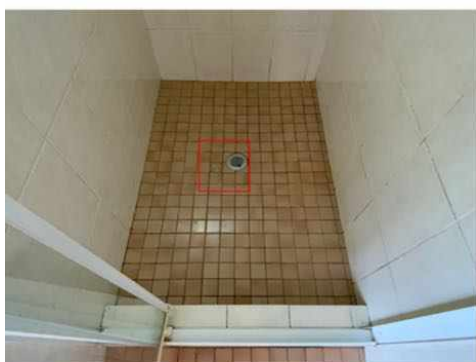
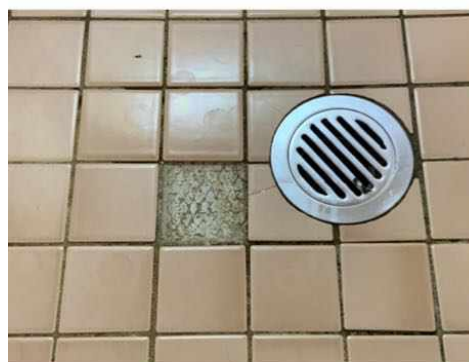
### Finding 3.17

Building:	Main Building
Location:	Ensuite - Master
Finding:	Tiles - Missing and cracked
Information:	Tiles were found to be missing in this tiled area. It appears as though broken tiles have been removed and not replaced, or have come loose from their original fixing through general deterioration.

Where tiles are missing, water penetration is likely to occur to exposed walls and flooring, creating potential for subsequent water damage.

Any tiles that are missing should be replaced immediately by a tiling contractor or general handyman. If left unmanaged over a prolonged period of time, water damage is likely to necessitate repair works to surrounding building elements.

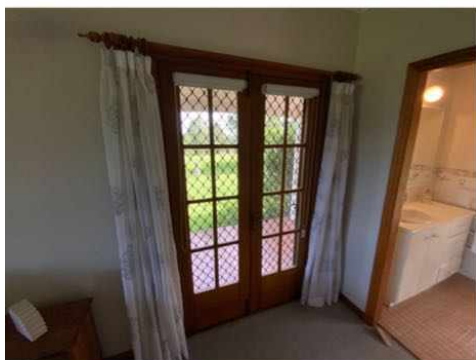
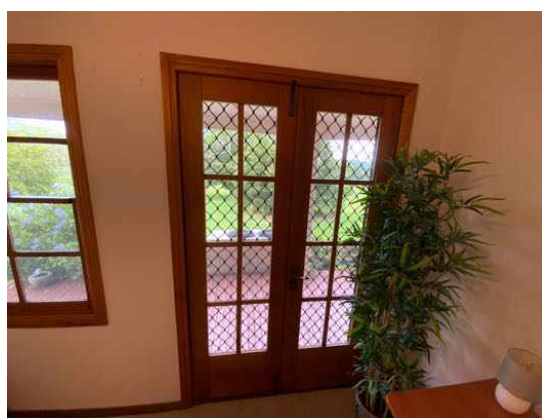
Building:	Main Building
Location:	All Areas
Finding:	Doors - Binding/Jamming to some areas
Information:	Binding and/or jamming of several doors throughout the property were evident during standard operation. This defect inhibits the functionality of affected doors as well as

creating potential for secondary defects to associated building elements, such as damage to the floor covering.

A door that binds to flooring or to the associated door frame may have several causes, ranging from minor defects, such as poor installation of the door or deteriorated hinges, through to major structural issues, such as damage to subfloor structures.

Where door binding/jamming appears to indicate major structural issues, a registered builder specialising in re-stumping should be appointed to provide an estimate on the cost of rectification.

For minor causes, a qualified carpenter or general handyperson should be appointed to perform minor rectification works at client discretion.

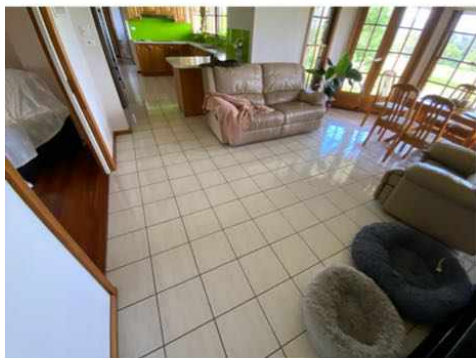
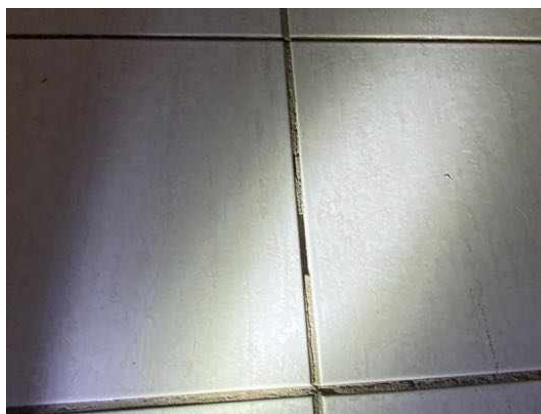
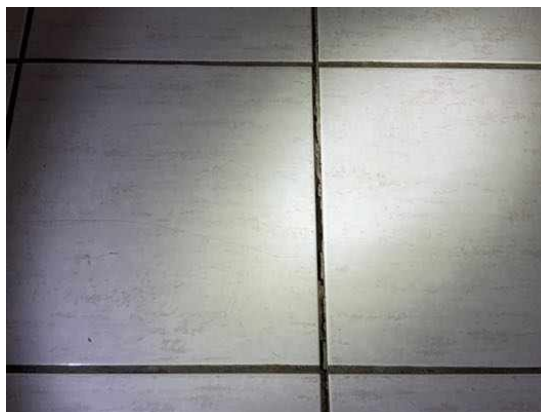
### Finding 3.19

Building:	Main Building
Location:	All Areas
Finding:	Grout - Missing and cracked to some areas
Information:	Grout is missing in this area. Grout is used to protect gaps and crevices in building materials to ensure that they are water-tight and prevent water penetration to the associated structures.

Where grout is missing, a tiling contractor should be appointed immediately to apply grout and re-apply any silicone where necessary. Failure to do so is likely to lead to water damage to the surrounding area.

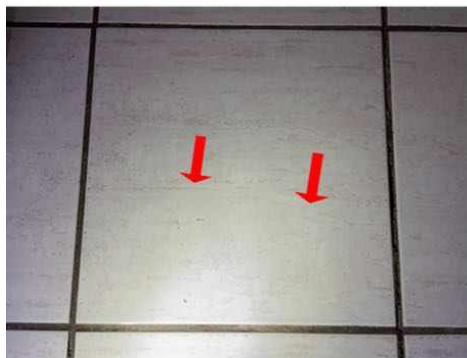
### Finding 3.20

Building:	Main Building
Location:	All Areas
Finding:	Floor tiles - Cracked to some areas
Information:	Cracking in the floor tiles was evident in this area at the time of inspection. It is suspected that this cracking has occurred as a result of the floor being uneven and lacking a solid or suitable foundation for the tiles to be laid on. Settlement in the floor foundations may also have caused movement and resulted in the cracking of tiles in this area.

Cracked tiles throughout the household detract from the overall appearance of the affected areas, as well as creating potential for water penetration to adjoining building elements. If left unmanaged, water damage may occur as a result of constant water penetration over a prolonged period of time.

While not considered a matter of urgency, replacement of cracked floor tiles is advised as a solution. A tiling contractor or general handyperson may be appointed to perform these works at client discretion. Where cracks become more numerous, consultation with a registered builder specialising in re-stumping may be required.

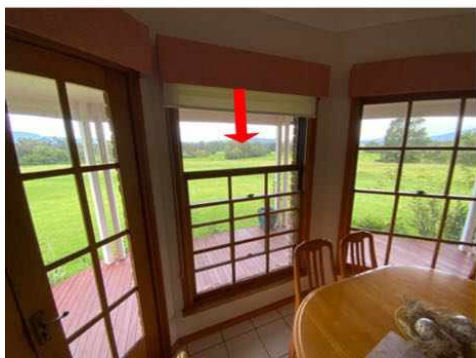
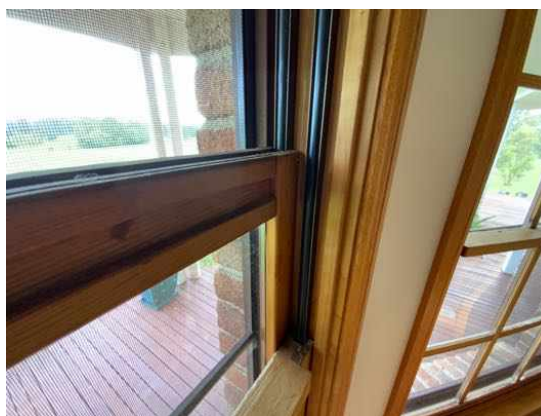
### Finding 3.21

Building:	Main Building
Location:	All Areas
Finding:	Windows - Sash balances broken or inadequate to some windows
Information:	Sashes are the moveable panes of windows that primarily slide vertically over each other to expose one half of the window area. Each sash is provided with springs balances and/or compression weather-stripping, which act to hold the window in place in one position.

The sash balance mechanism will need replacement to allow the window to function as intended. Such works may be completed by a qualified carpenter or registered builder.

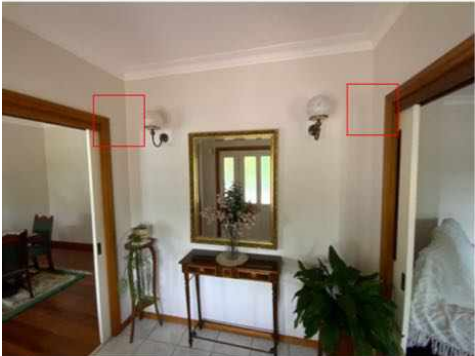
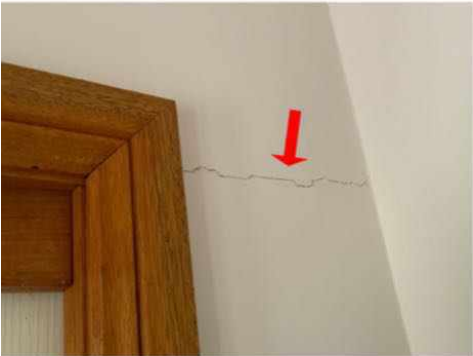
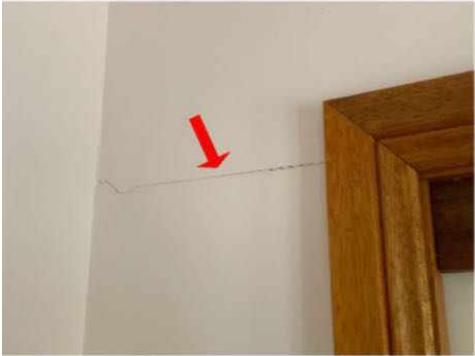
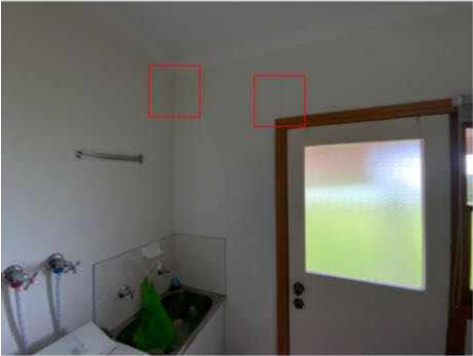
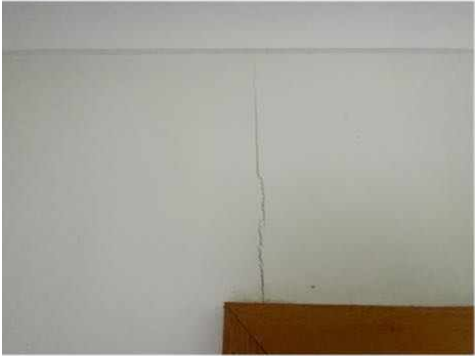
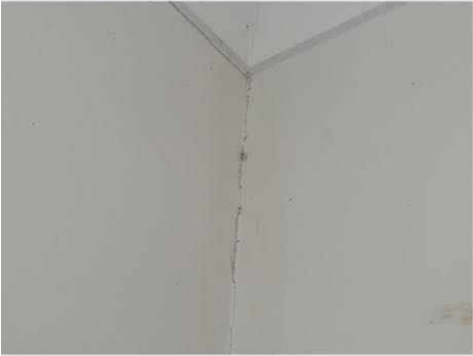
### Finding 3.22

Building:	Main Building
Location:	All Areas
Finding:	Cracking - Damage Category 2 - Noticeable (up to 5mm)
Information:	Noticeable cracks are a common occurrence as a result of many primary defects. Such causes may include age, general wear and tear, expected building movement, general expansion/contraction of building materials in different weather conditions, and/or minor failings in the installation or application of building materials.

Noticeable cracks may result in minor sticking or jamming of associated doors and windows, which require easement. However, noticeable cracks are easily filled and repaired. A plasterer can be consulted to install an expansion joint at this point to allow for this movement during different weather conditions.

Monitoring of all cracking should be conducted frequently. Always contact a building inspector should cracks widen, lengthen, or become more numerous. Additionally, your building inspector should also be contacted if associated building elements such as doors and windows become more difficult to operate over time.

Relevant tradespeople, such as carpenters, painters and plasterers, should be appointed to perform remedial works, as deemed necessary.
