# Building and Timber Pest Inspection Report

Inspection Date: Wed, 11 Feb 2026

Property Address: 43 Jaspers Brush Rd, Jaspers Brush NSW  
2535, Australia

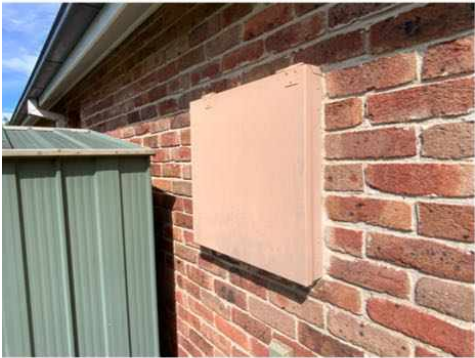
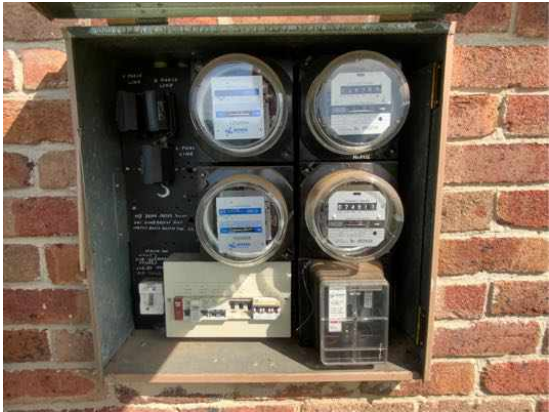
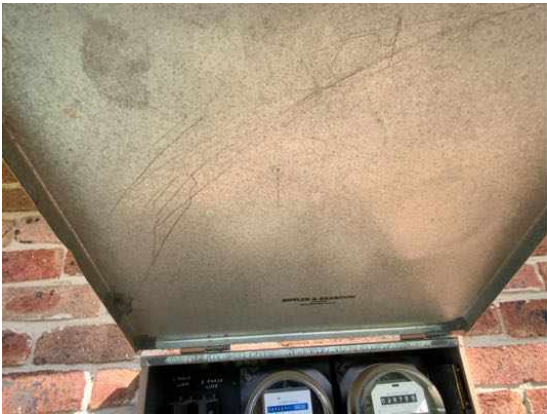
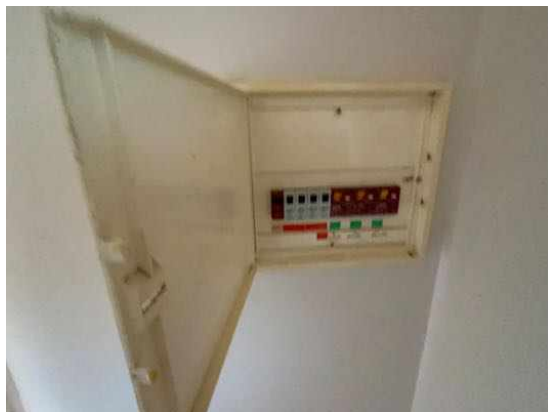
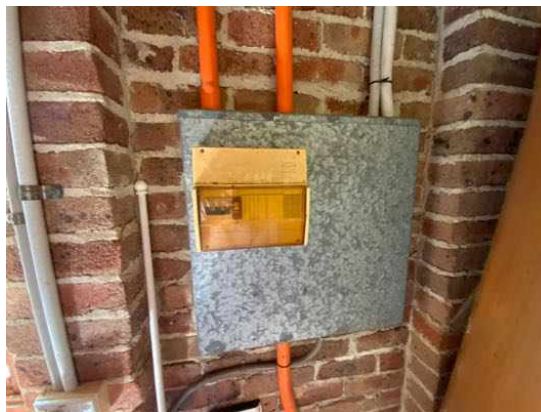
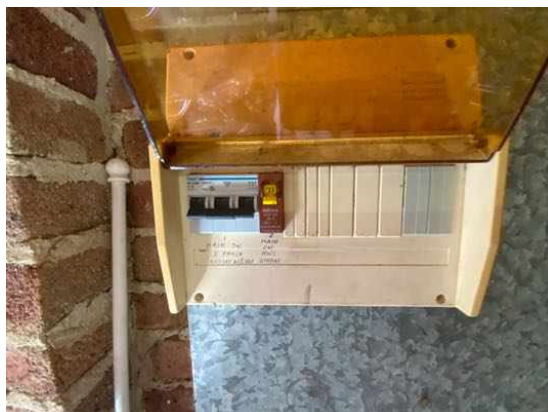
Building: Main Building  
Location: All Areas  
Finding: Termite Management System - no evidence of a chemical installation  
Information: The application of a post-construction chemical termite barrier is highly recommended for all properties, particularly if live termite activity has been found on the site previously. Such barriers are highly effective in preventing termite attack on any timber building elements throughout the property.

A durable notice should be placed in the switchboard unit to indicate current termite barriers. At the time of inspection, it appeared as though no termite management system has been installed, with no evidence to suggest preventative works taking place.

The client may consider gaining further advice from a pest controller as to the costs and procedures involved with this application. It is recommended that obtaining such advice be a short-term priority.

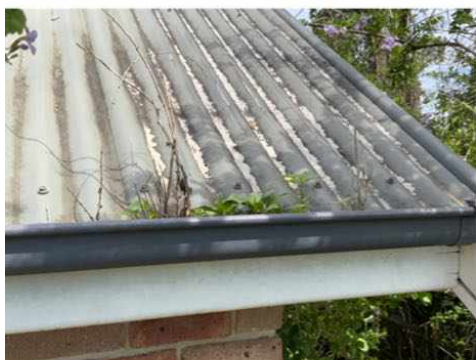
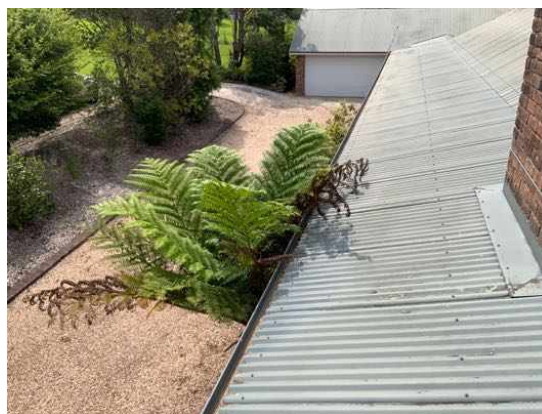
### Finding 6.02

Building:	Main Building
Location:	Roof Exterior
Finding:	Gutters - Blocked
Information:	Roof plumbing structures, such as guttering and downpipes, should be free of all debris to prevent blockages. Blockages of the guttering and downpipes will lead to pooling and accumulated water overflows, which is likely to subsequently flood eaves and exterior walls.

Blocked gutters are likely to lead to high levels of moisture in the affected areas. Such moisture will not only cause rust and decay of the associated building materials, but can also provide conditions that are conducive to termite and timber pest activity. Blockages in gutters should therefore be removed immediately to ensure dry conditions are maintained.

Consult a Licensed Plumber for further specific advice on remedial works that may be required. In the interim, it is highly advised that blocked gutters be removed by the homeowner or a general handyperson as a matter of urgency.

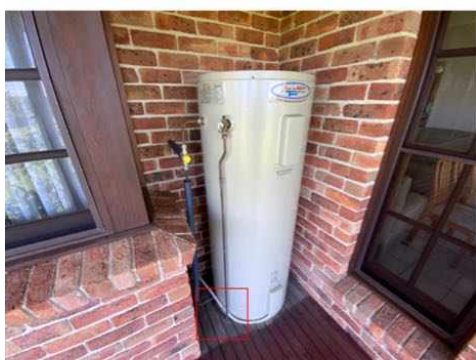
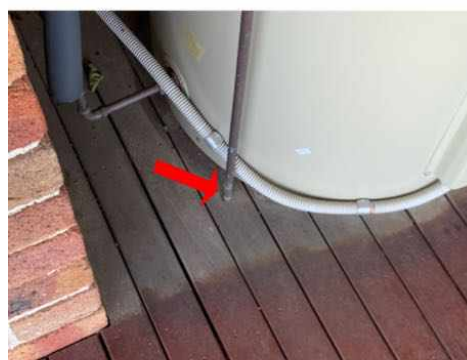
### Finding 6.03

Building:	Main Building
Location:	All Areas
Finding:	HWS Overflow - Not Connected
Information:	The Hot Water System (HWS) overflow was found to be disconnected from storm water drainage and is creating excessive moisture in the surrounding area.

These damp conditions can lead to secondary defects such as rot, rust or corrosion of associated building elements, the formation of fungal decay, or even the creation of potential slip hazards. When coupled with poor site drainage, pooling of water may also attract termite activity to this area.

It is highly recommended that a licensed plumber be appointed to connect the HWS overflow in order to prevent such an environment from being created. These minor works should be carried out as soon as possible.

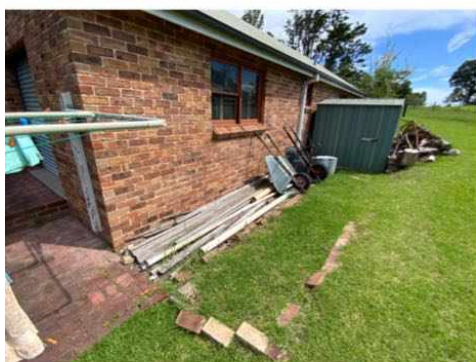
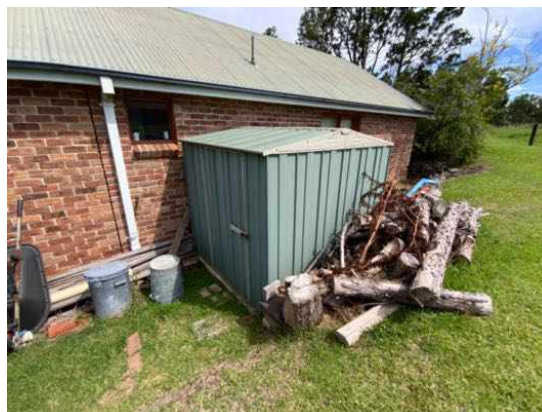
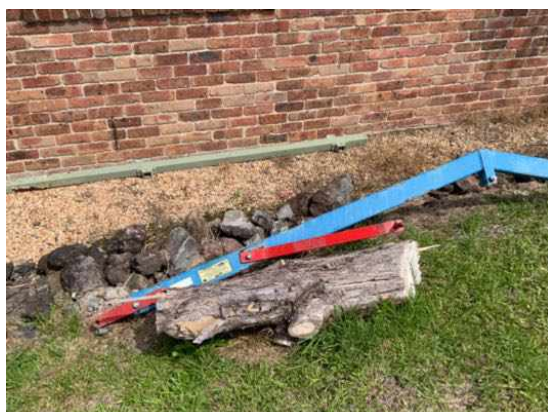
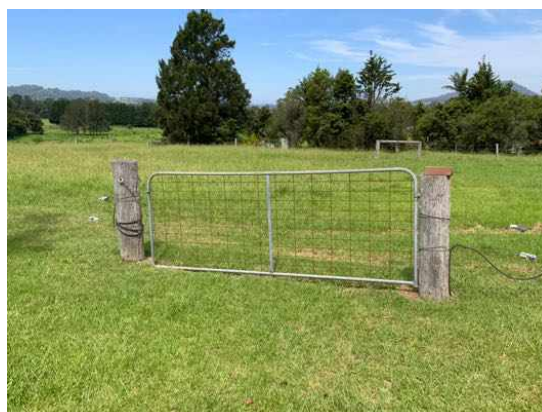
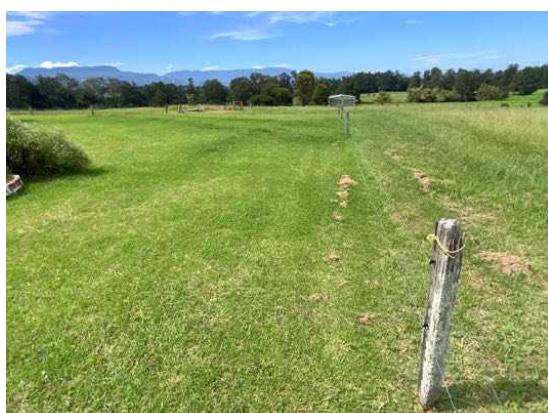
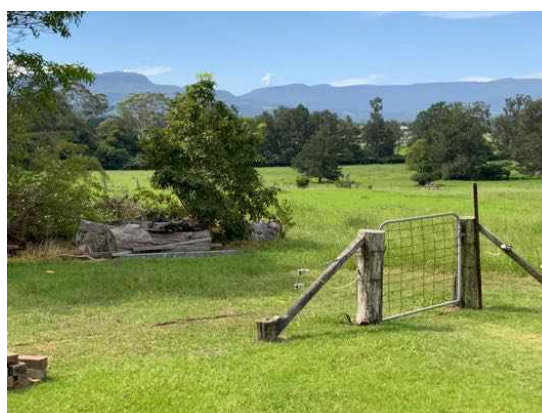
### Finding 6.04

Building:	Main Building
Location:	All Areas
Finding:	Timber in ground contact
Information:	To reduce the risk of timber pest attack it is essential that timber used in a hazardous

environment (e.g. in direct contact with the ground or frequently exposed to damp conditions) is of sufficient durability and/or is adequately preservative treated.

Untreated timbers in direct contact with the ground are likely to develop severe wood rot and/or fungal decay if left unattended creating attraction for subterranean termites to infest the timbers from surrounding areas.

If untreated or non-durable timbers are found to be in a hazardous environment it is highly advised that replacement of these building elements be performed as soon as possible to aid the protection of the property against termite / timber pest attack.

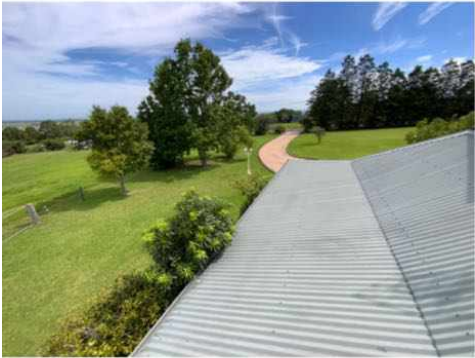
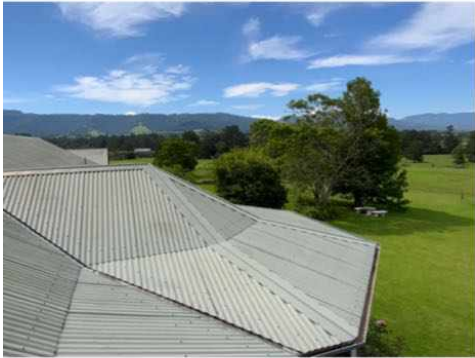
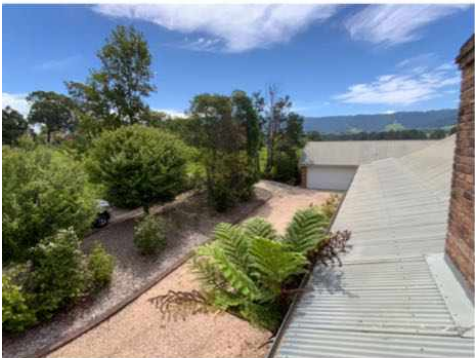
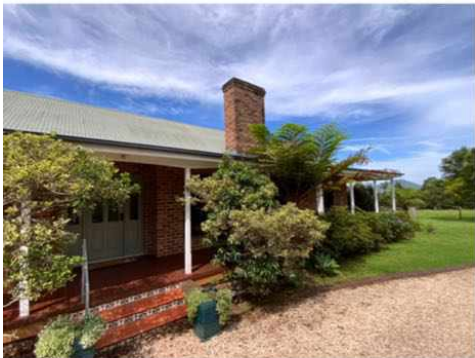
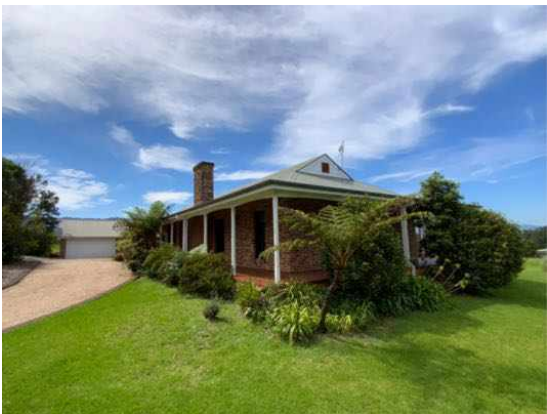
### Finding 6.05

Building: Main Building  
Location: All Areas  
Finding: Trees within 50m of the property  
Information: Trees within 50m of the property can be conducive to termite activity. It is recommended an invasive inspection of all trees with 50m to the property be carried out by a qualified pest control expert.

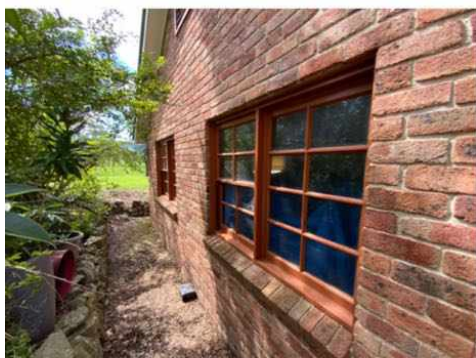
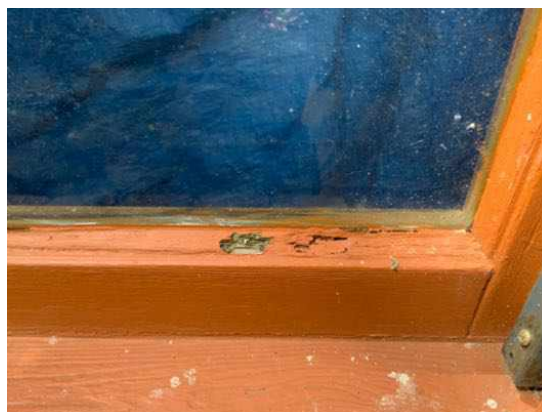
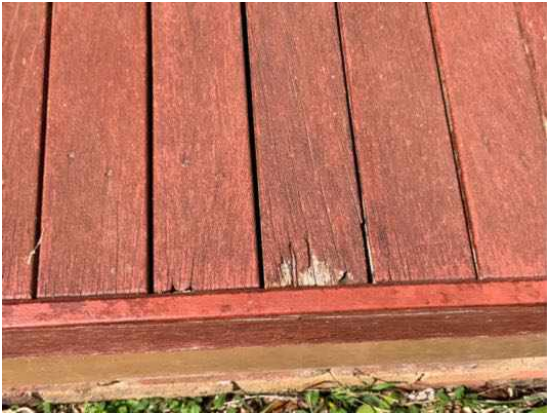
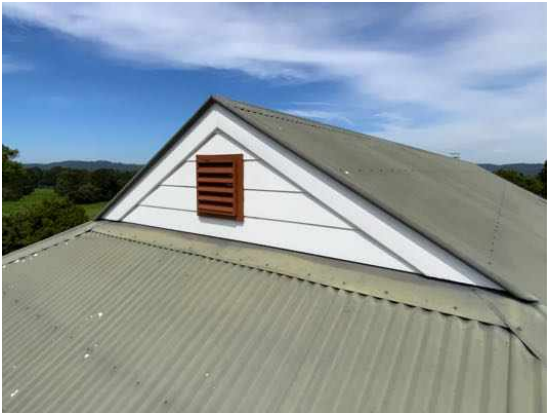
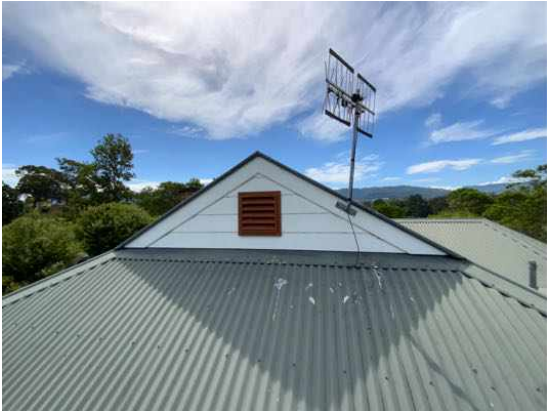
### Finding 7.01

Building:	Main Building
Location:	All Areas
Finding:	Fungal decay - present (to several areas of external timbers)
Information:	Fungal decay also known as wood decay or wood rot generally refers to the deterioration of timber elements when in contact with excessive levels of moisture for a prolonged period of time.

In this case although the affected timber element is in a decaying state the extent of any visible damage appears to be localised to a specific area and is yet to spread to other parts of the building element or affect adjoining structures. The fungal decay is therefore likely to be of a relatively superficial nature with minimal impact on the structural integrity or tensile strength of the timber element.

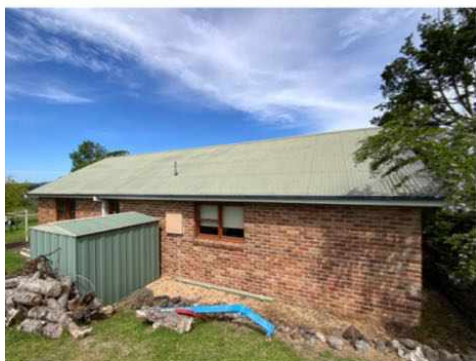
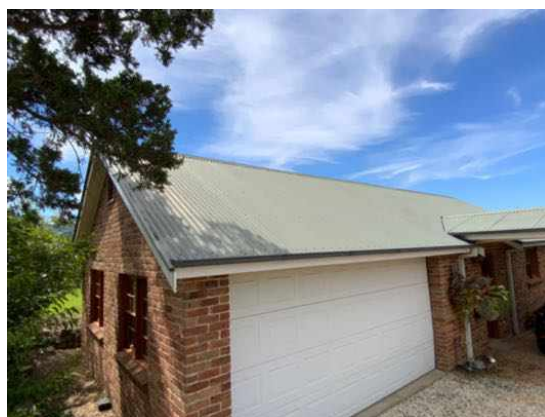
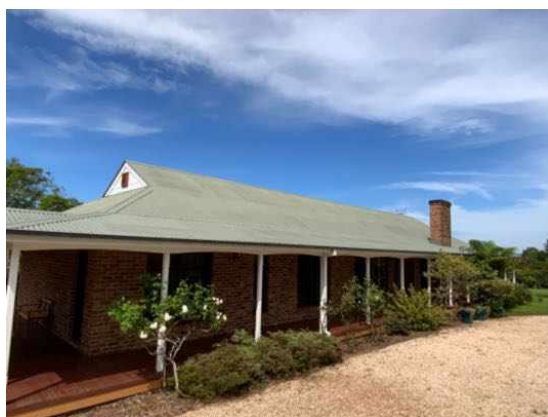
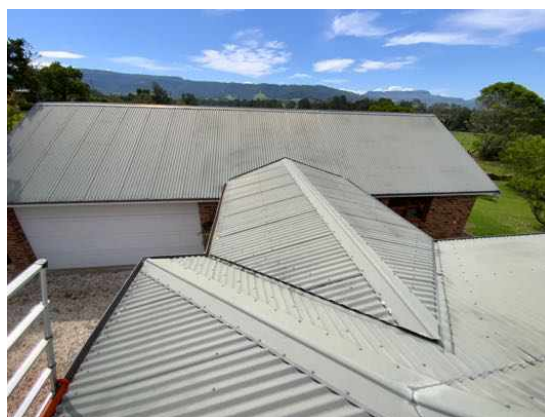
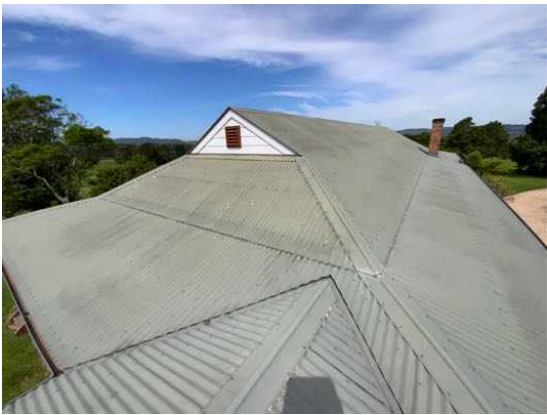
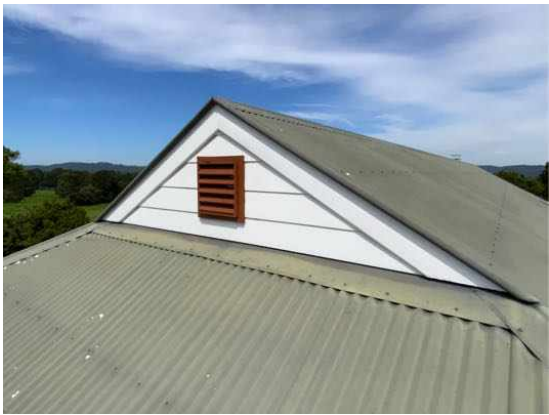
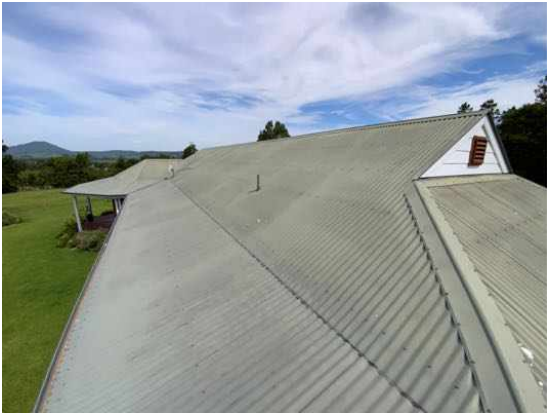
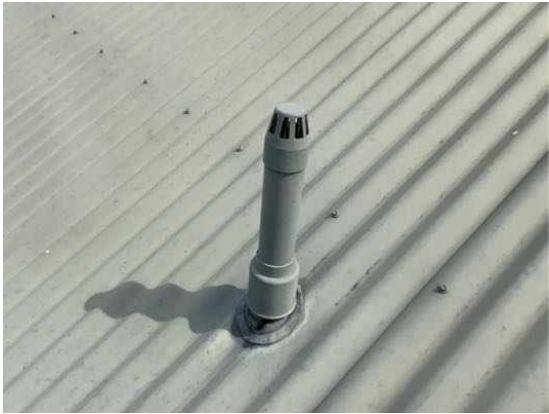
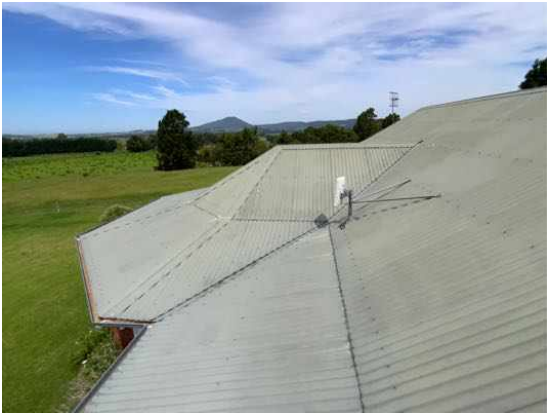
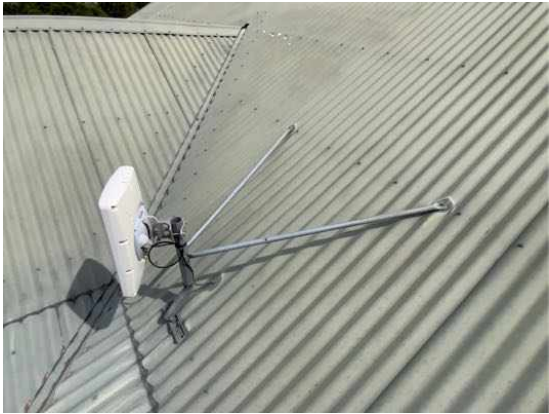
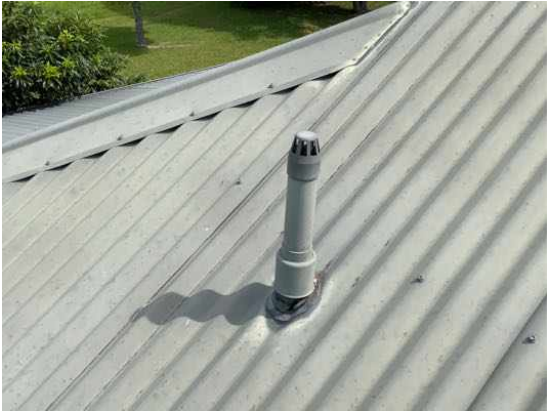
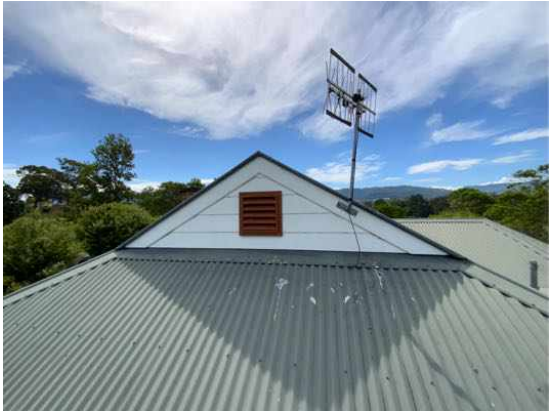
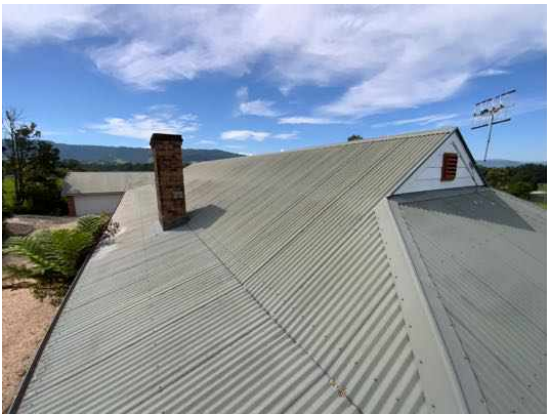
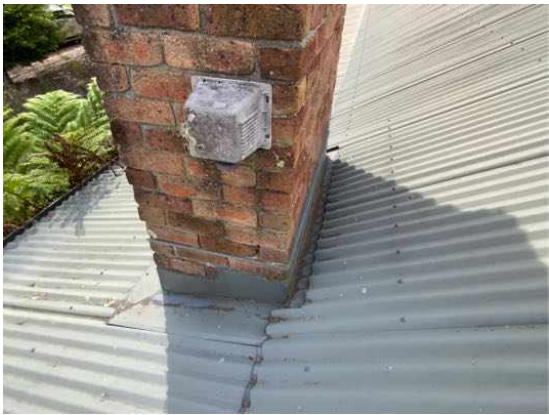
Building: Main Building  
Location: Roof Exterior  
Finding: Additional Photos - Obstructions and Limitations  
Information: These photographs are an indication of the obstructions and limitations which impeded full inspection of the property at the time of inspection. These obstructions can hide an array of defects and should be removed to allow full inspection to be carried out. A re-inspection is recommended once the areas are made accessible.

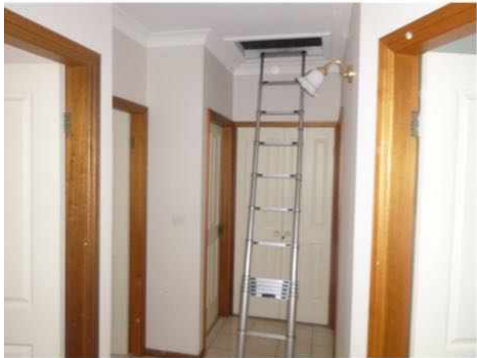
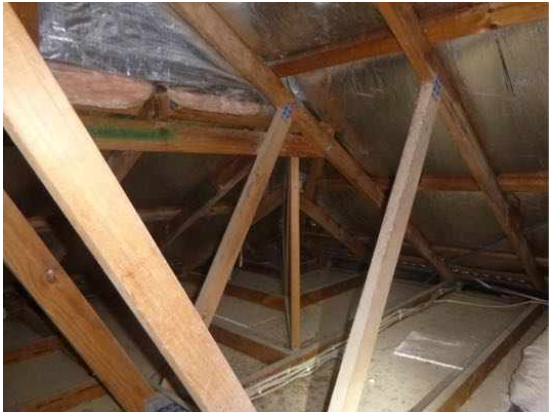
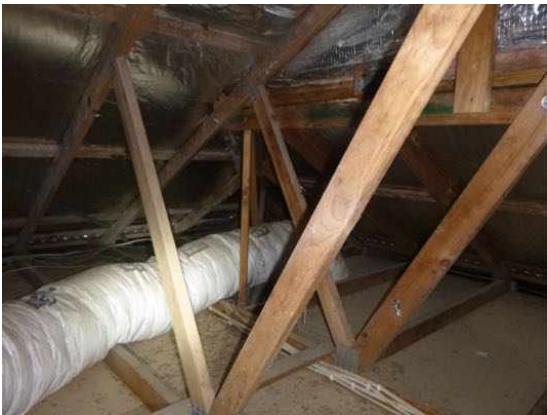
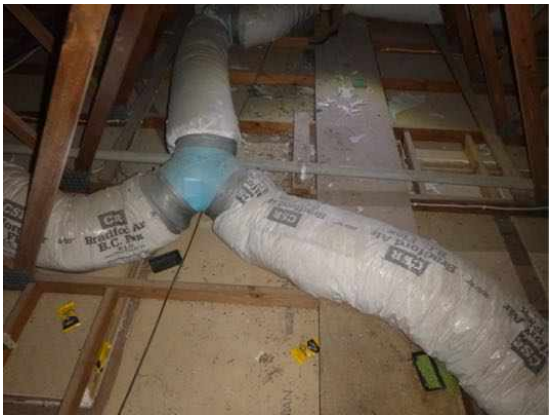
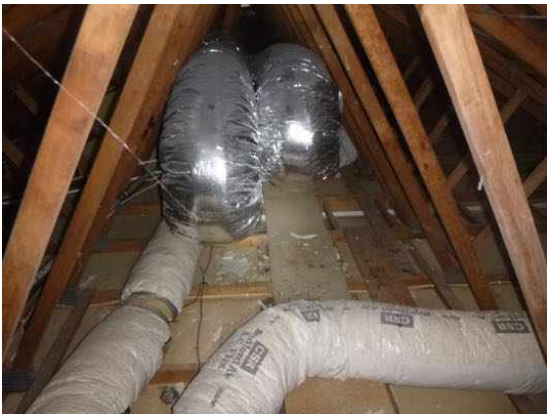
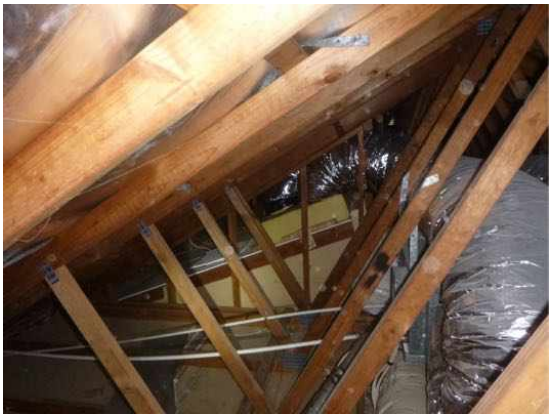
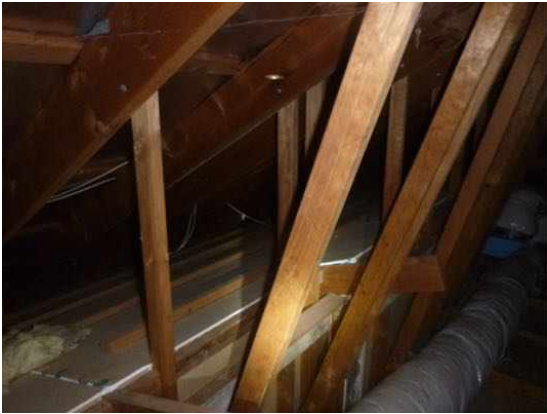
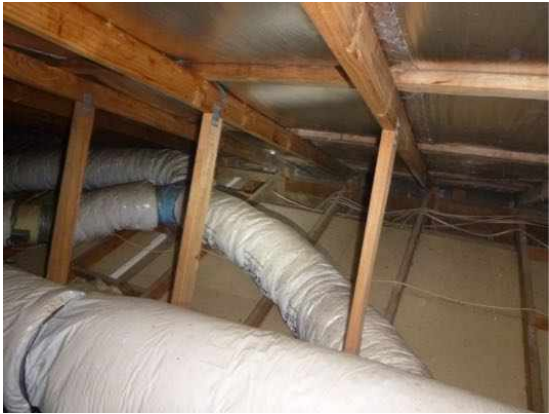
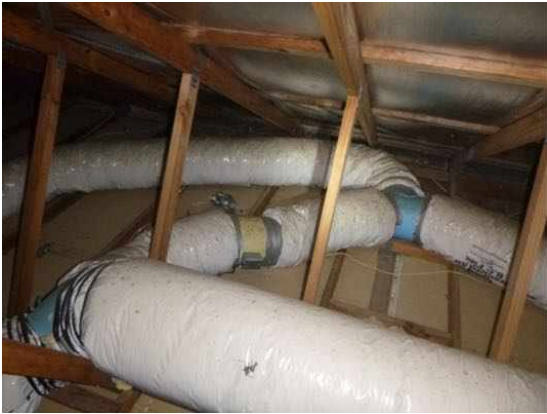
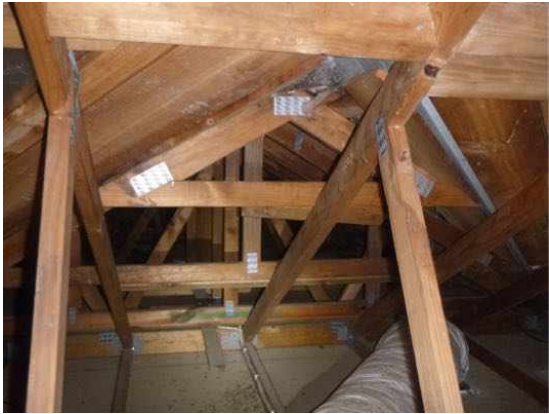
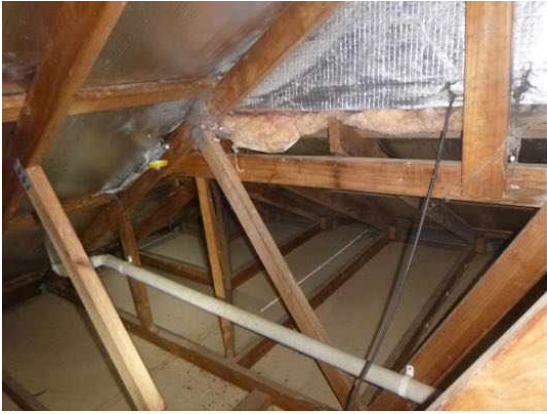
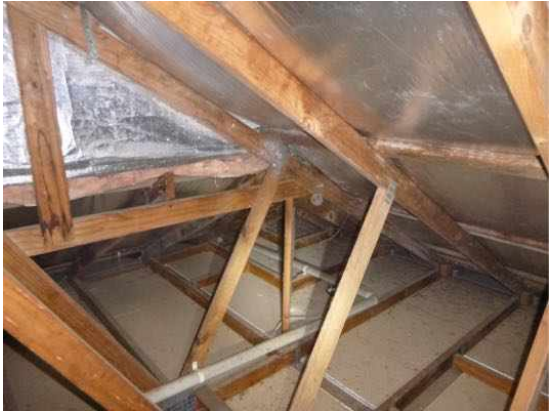
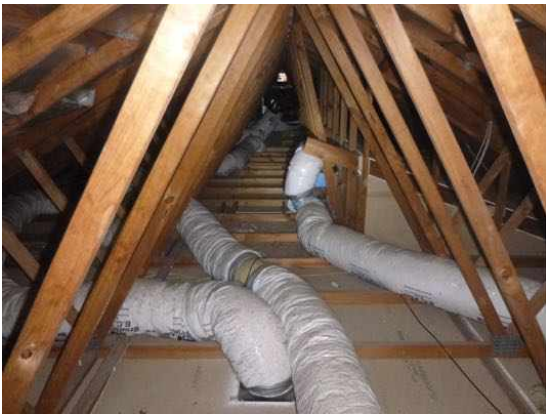
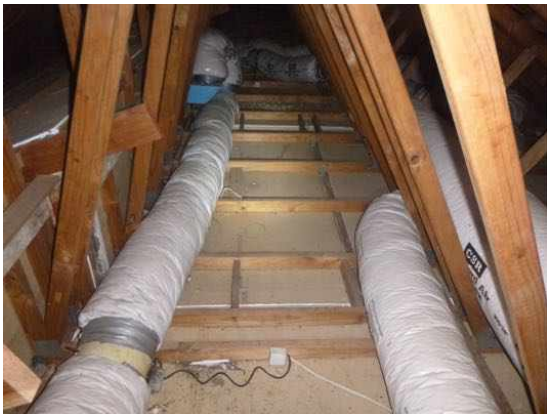
Building: Main Building  
Location: Roof Void  
Finding: Additional Photos - Obstructions and Limitations  
Information: These photographs are an indication of the obstructions and limitations which impeded full inspection of the property at the time of inspection. These obstructions can hide an array of defects and should be removed to allow full inspection to be carried out. A re-inspection is recommended once the areas are made accessible.

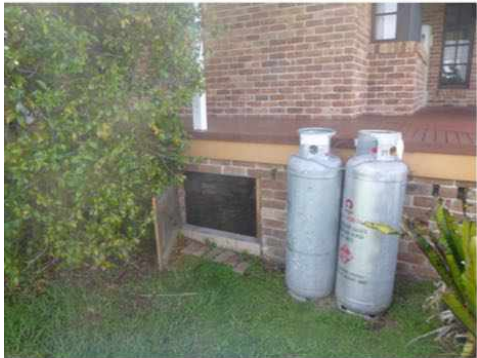
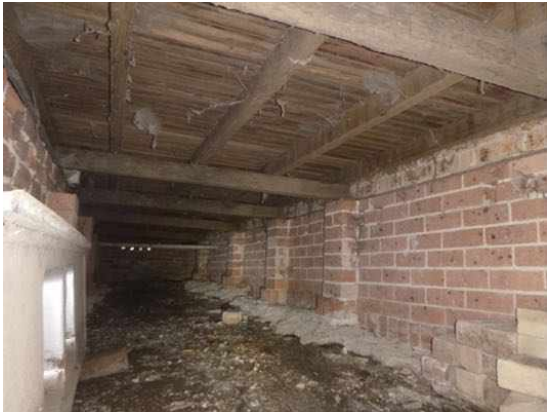
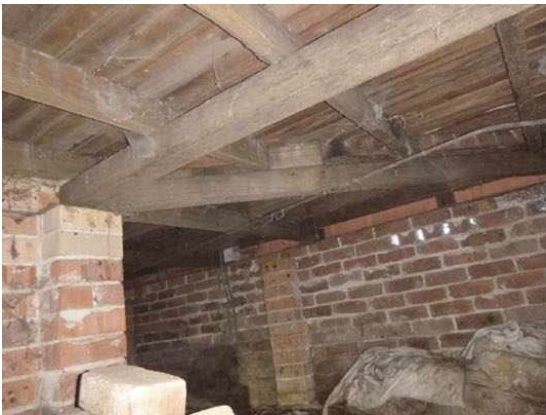
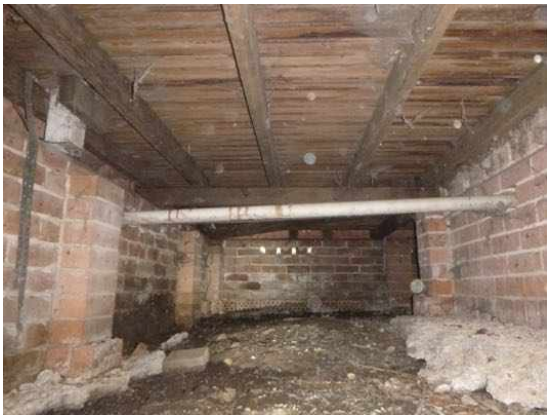
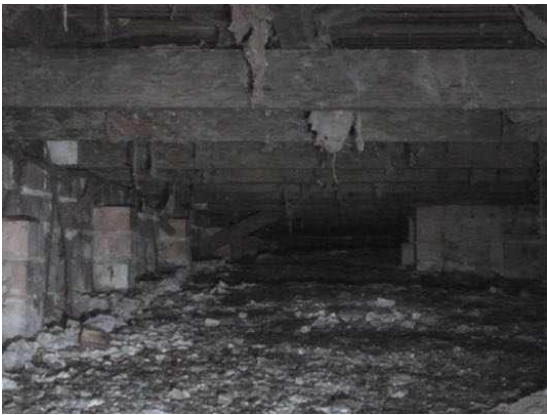
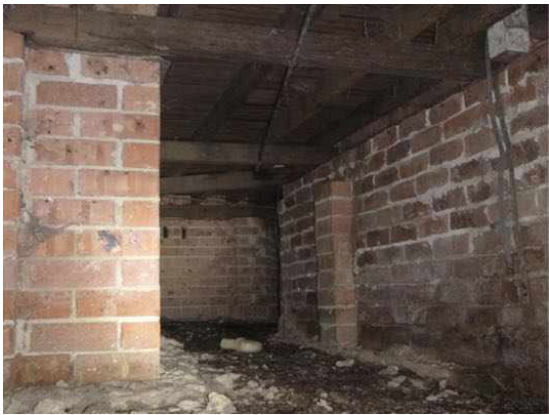
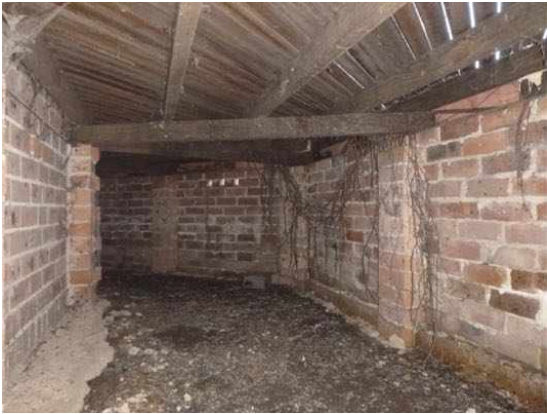
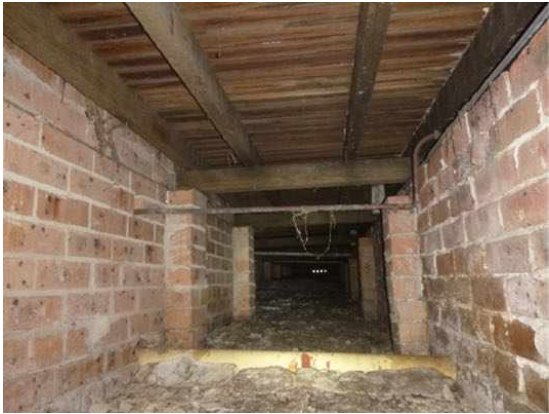
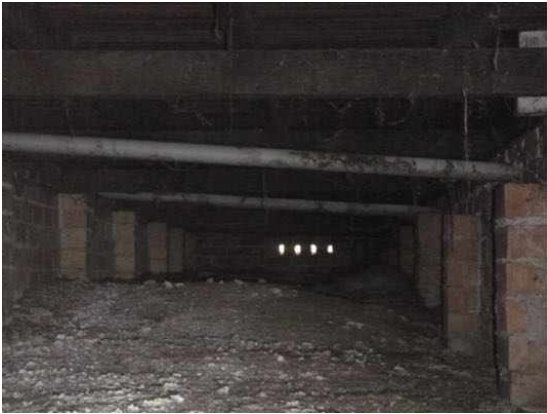
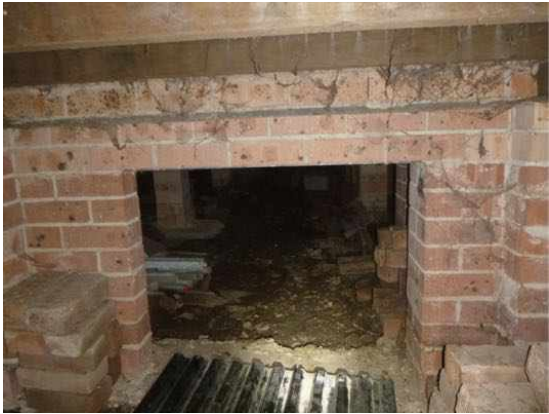
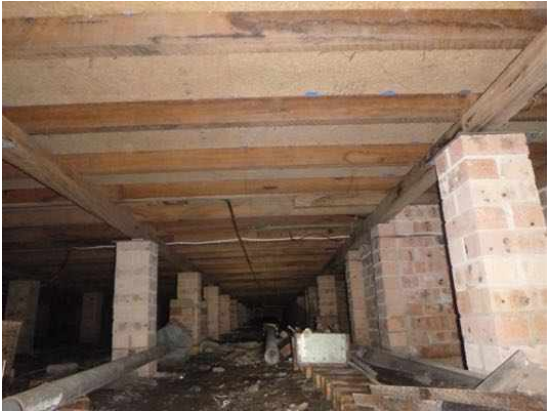
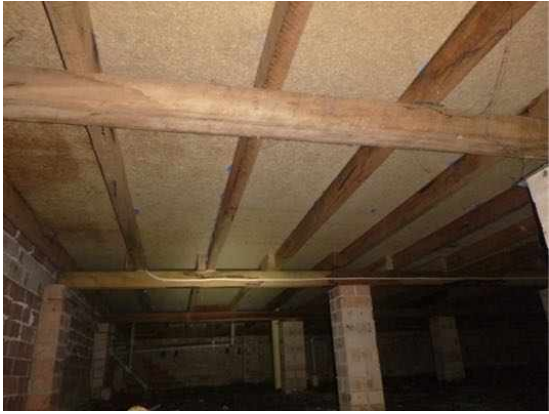
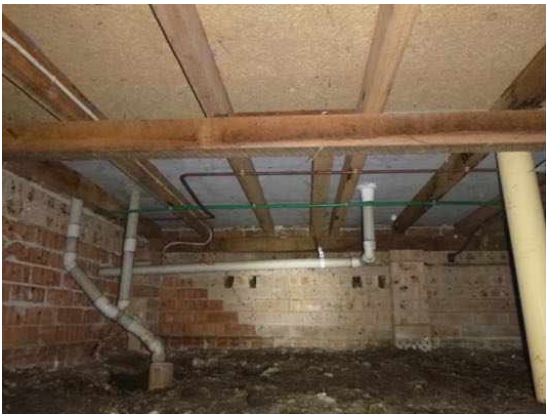
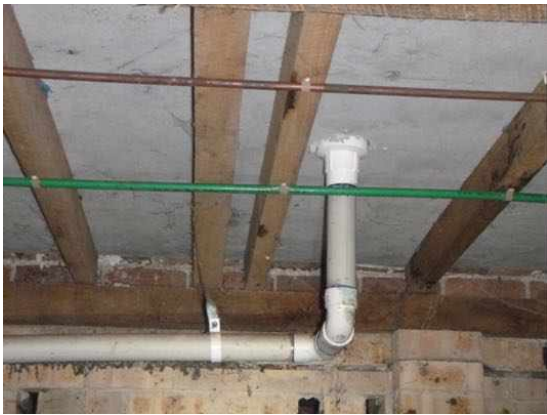
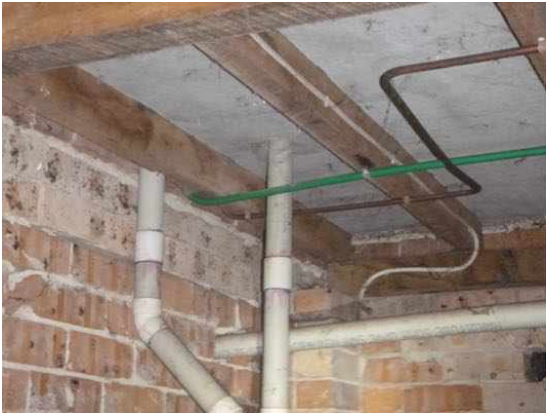
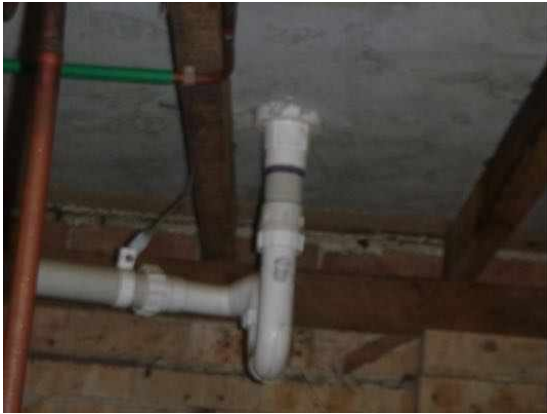
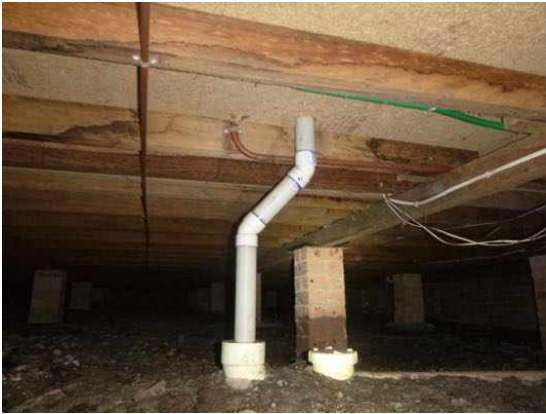
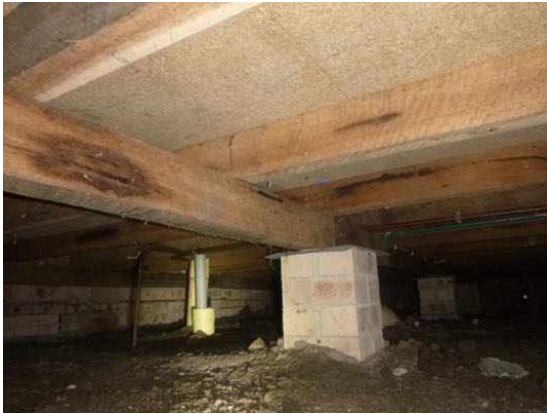
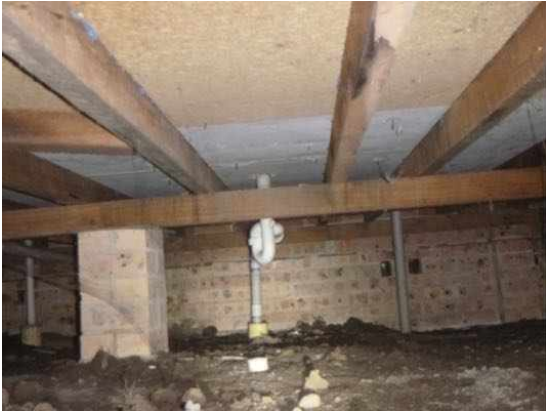
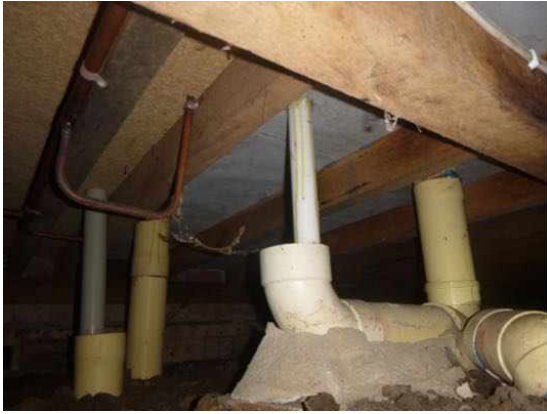
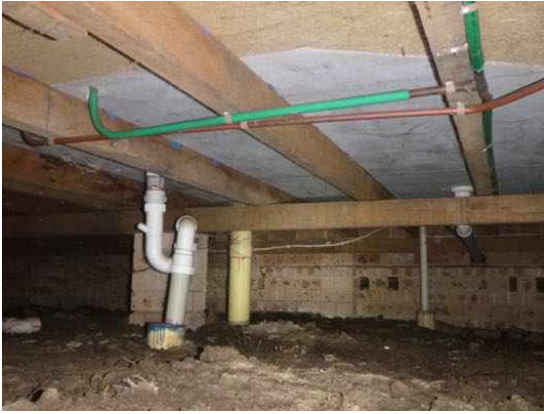
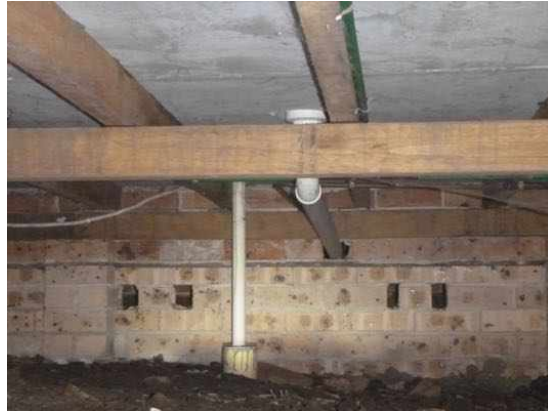
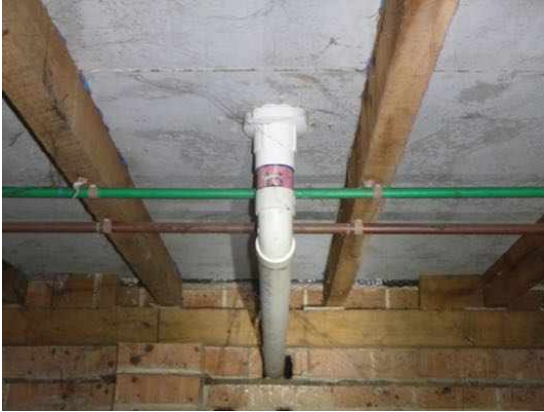
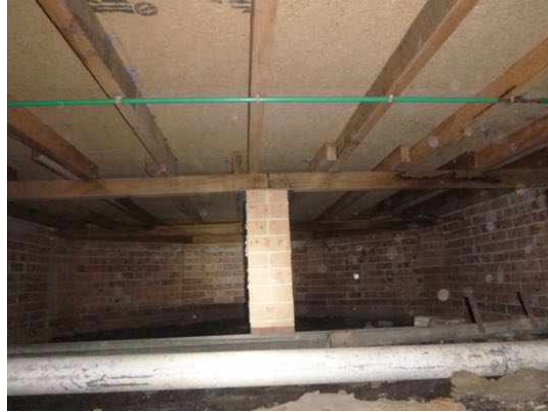
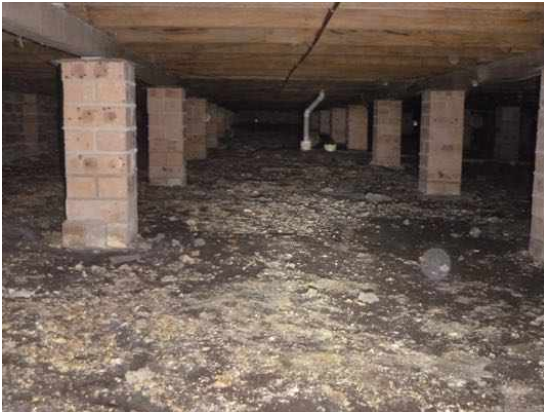
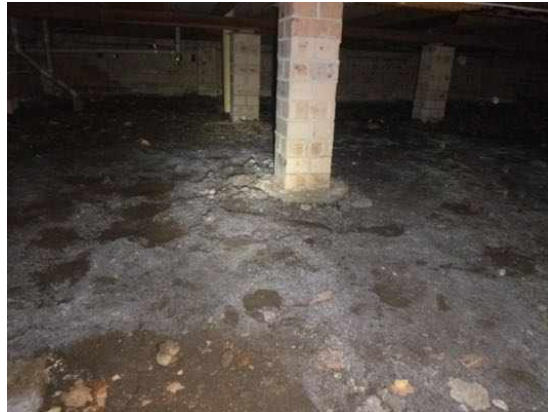
Building: Main Building  
Location: Subfloor  
Finding: Additional Photos - Obstructions and Limitations  
Information: These photographs are an indication of the obstructions and limitations which impeded full inspection of the property at the time of inspection. These obstructions can hide an array of defects and should be removed to allow full inspection to be carried out. A re-inspection is recommended once the areas are made accessible.

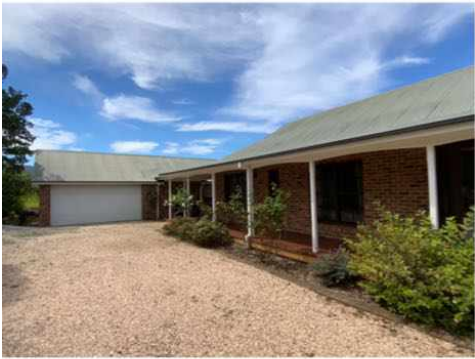
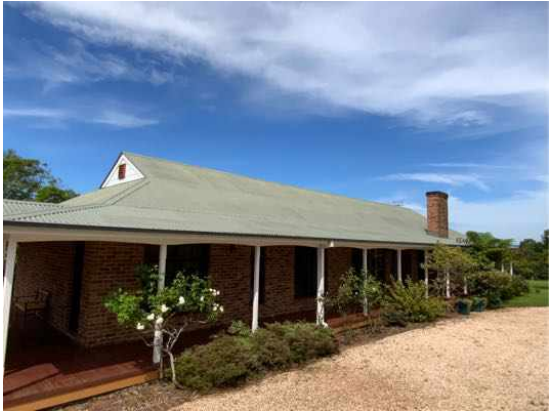
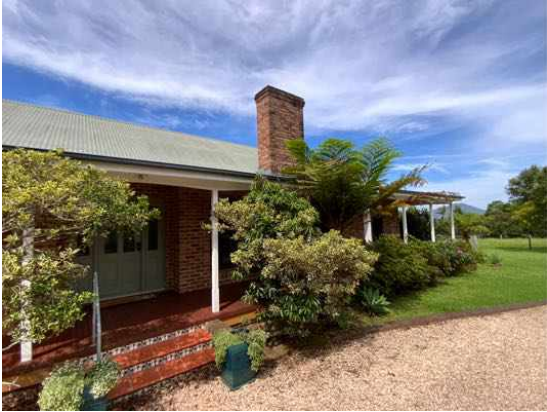
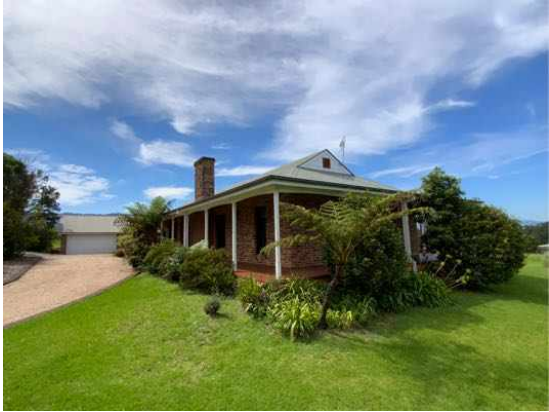
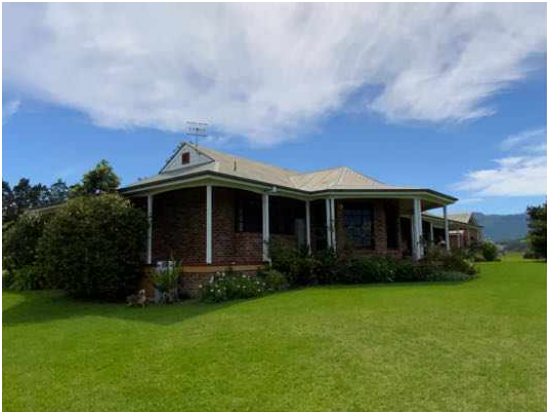
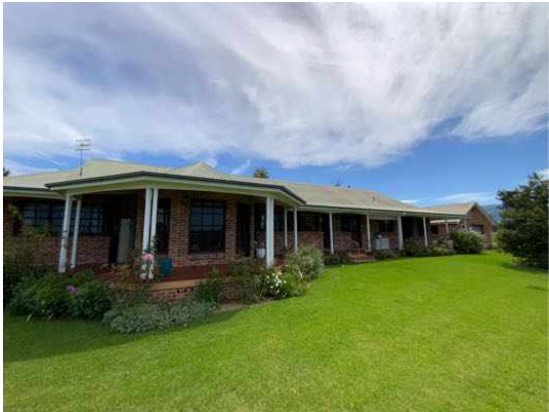
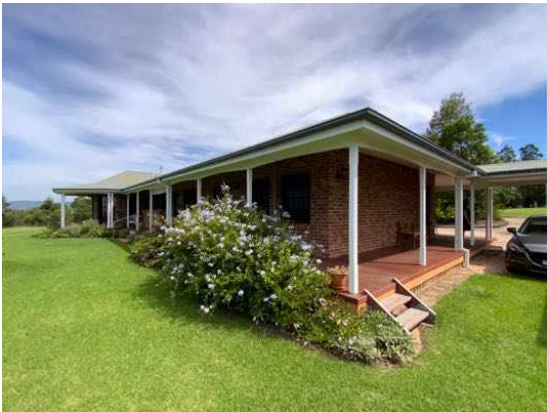
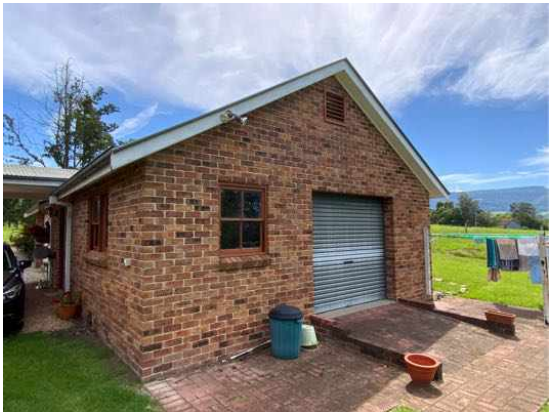
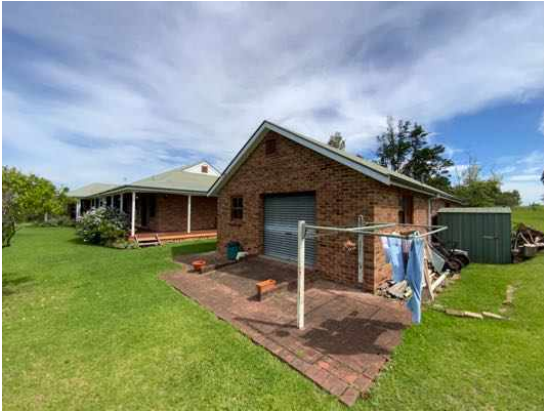
Building:	Main Building
Location:	All Areas
Finding:	Additional Photos - Obstructions and Limitations
Information:	These photographs are an indication of the obstructions and limitations which impeded full inspection of the property at the time of inspection. These obstructions can hide an array of defects and should be removed to allow full inspection to be carried out. A re-inspection is recommended once the areas are made accessible.

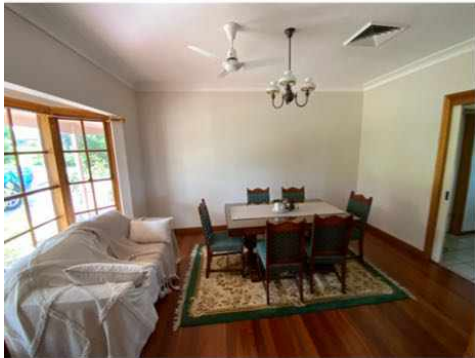
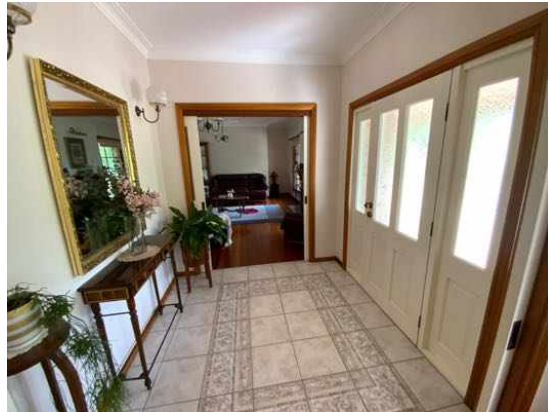
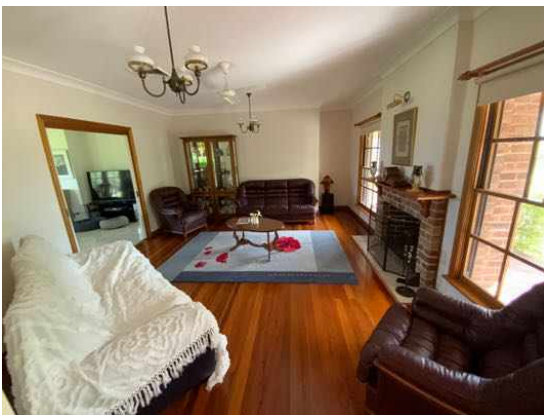
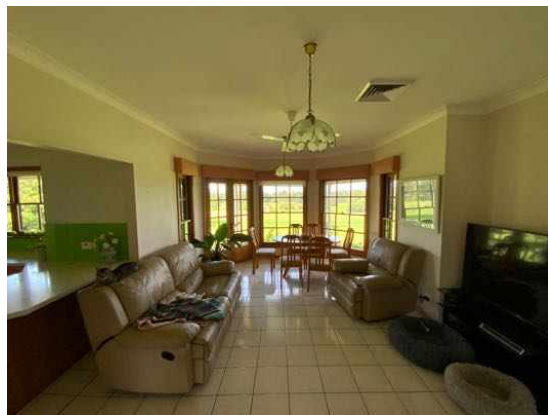
Building: Main Building  
 Location: All Areas  
 Finding: Additional Photos - Obstructions and Limitations  
 Information: These photographs are an indication of the obstructions and limitations which impeded full inspection of the property at the time of inspection. These obstructions can hide an array of defects and should be removed to allow full inspection to be carried out. A re-inspection is recommended once the areas are made accessible.
