# Building and Timber Pest Inspection Report

Inspection Date: Wed, 11 Feb 2026

Property Address: 43 Jaspers Brush Rd, Jaspers Brush NSW  
2535, Australia

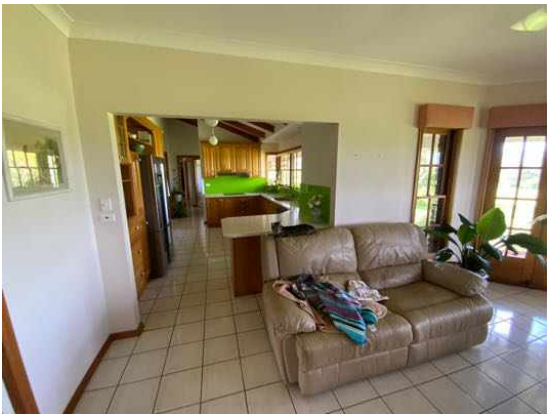
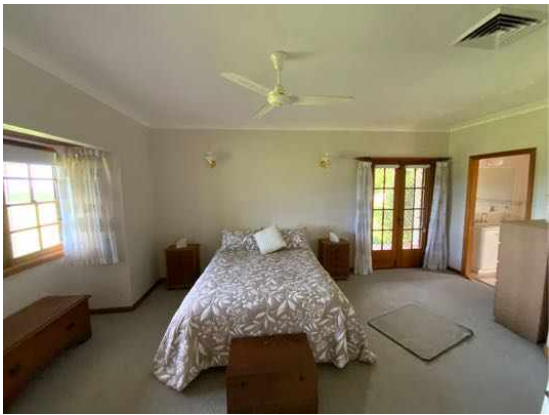
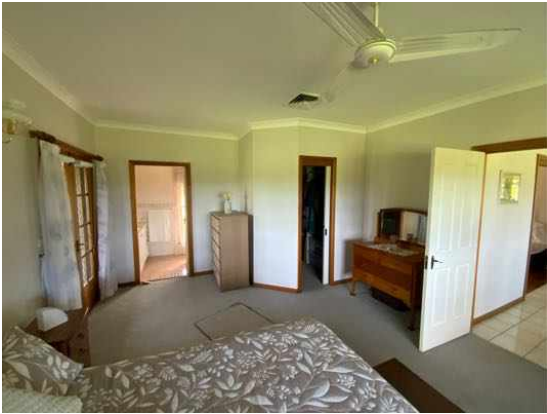
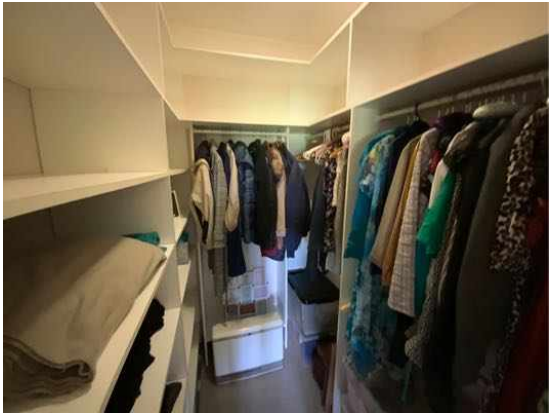
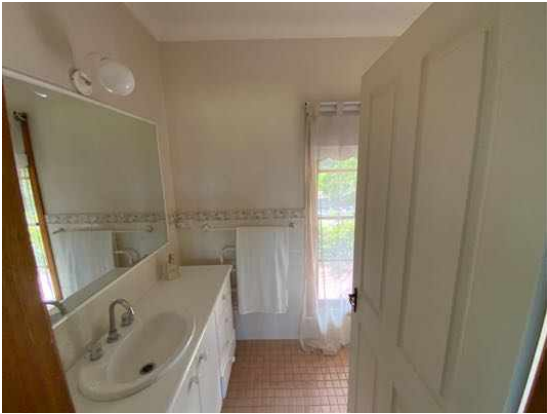
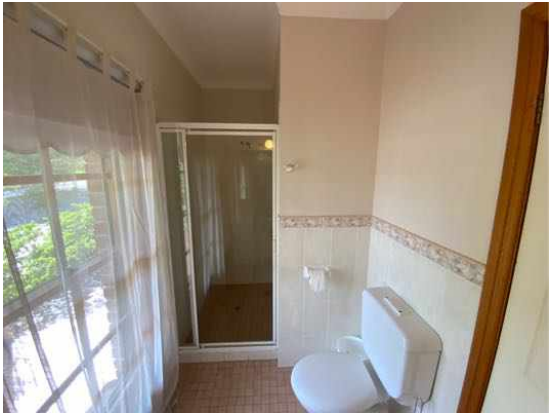
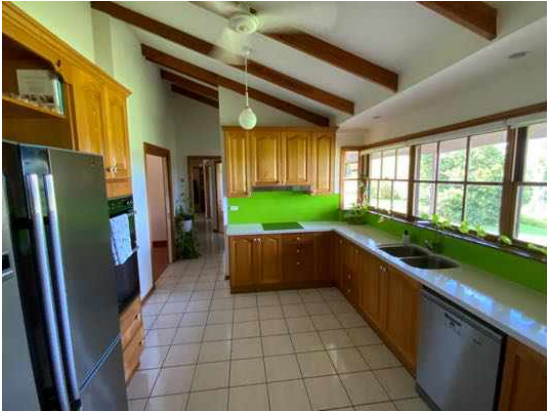
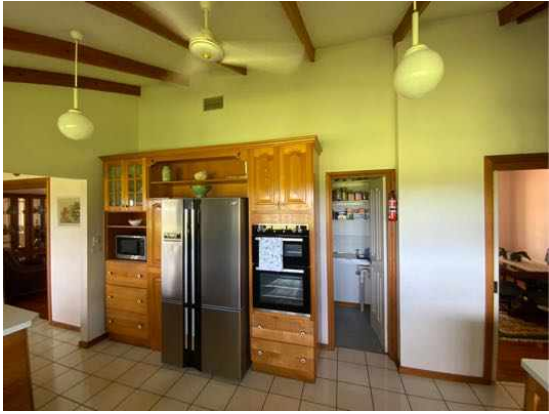
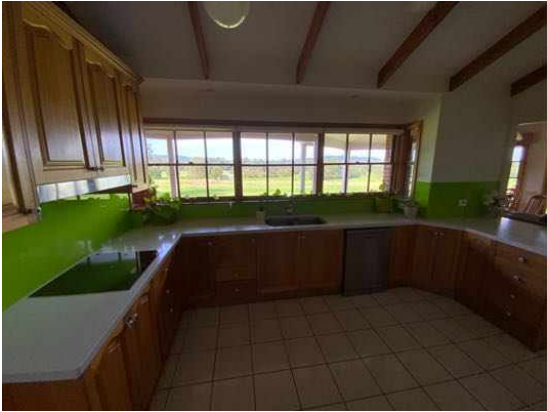
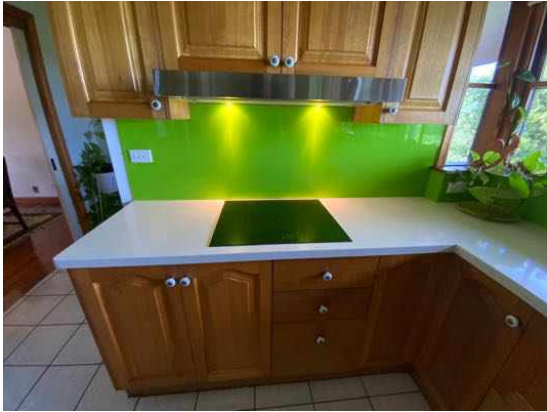
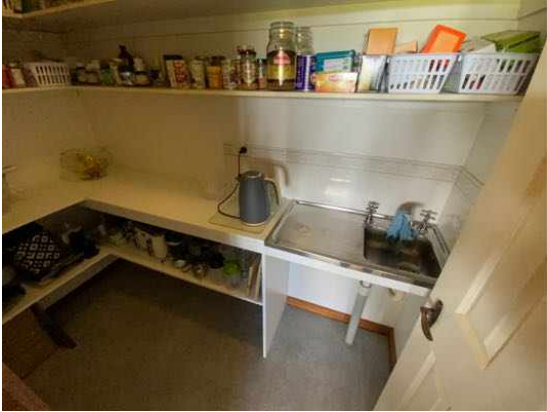
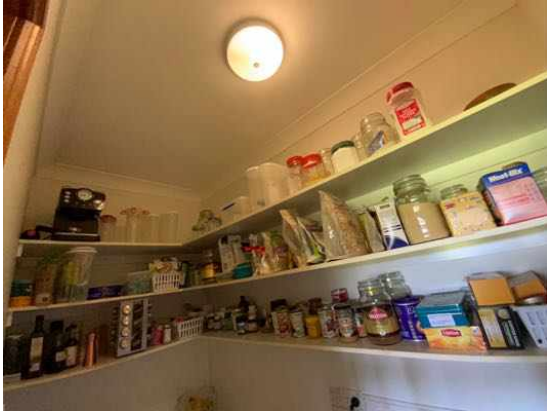
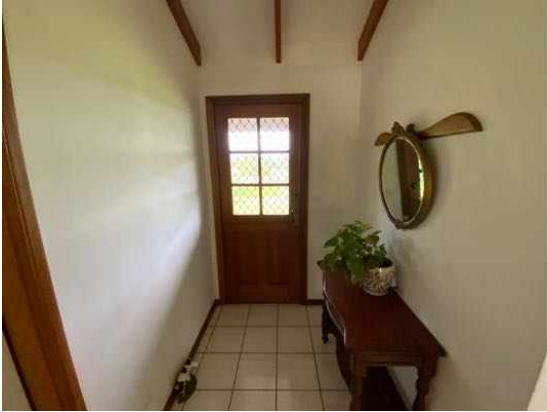
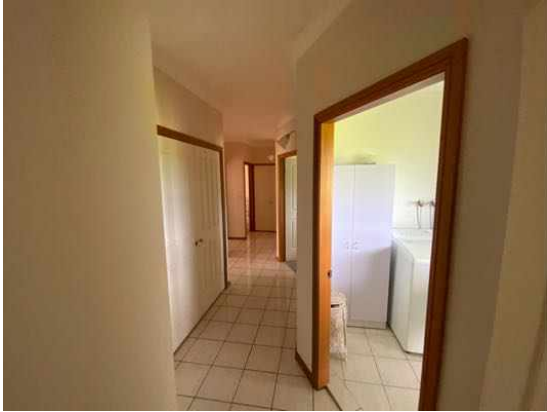
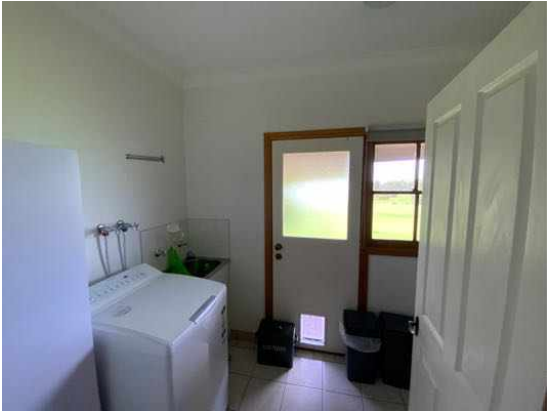
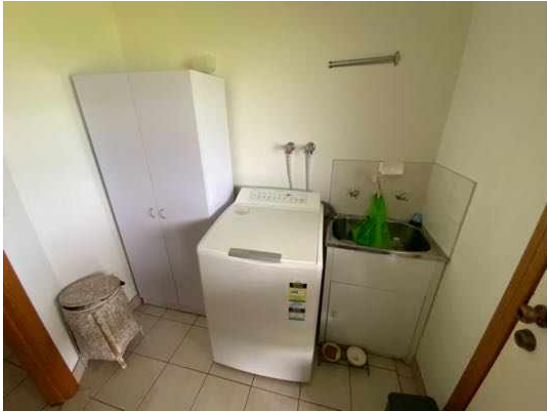
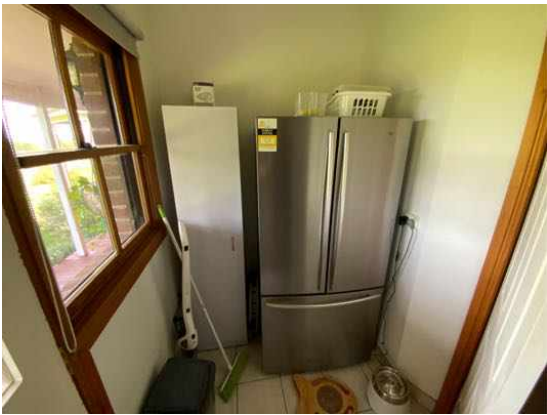
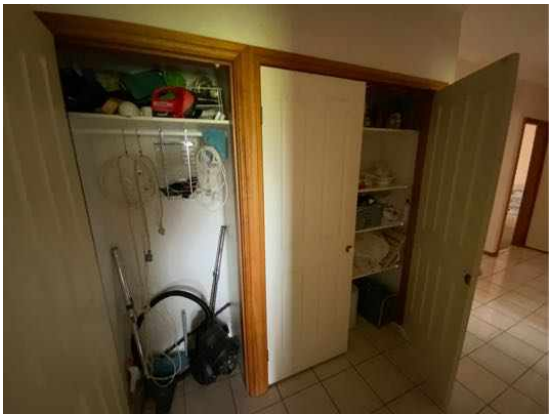
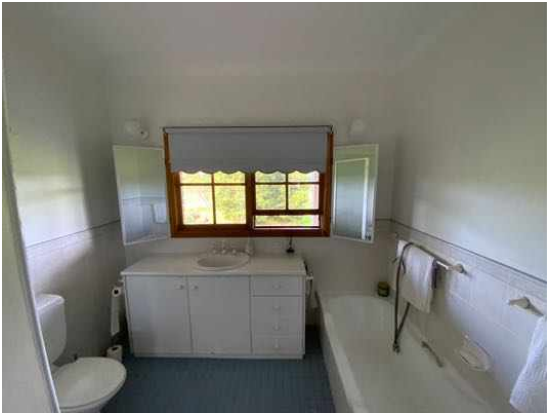
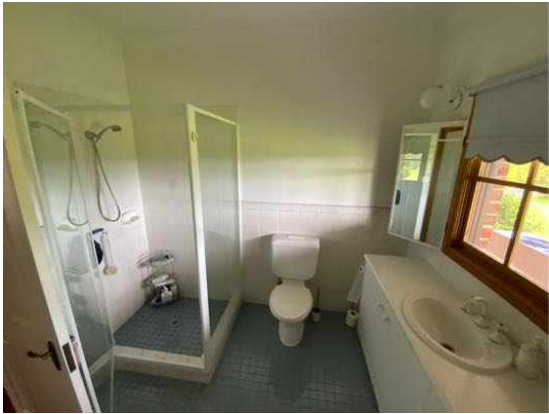
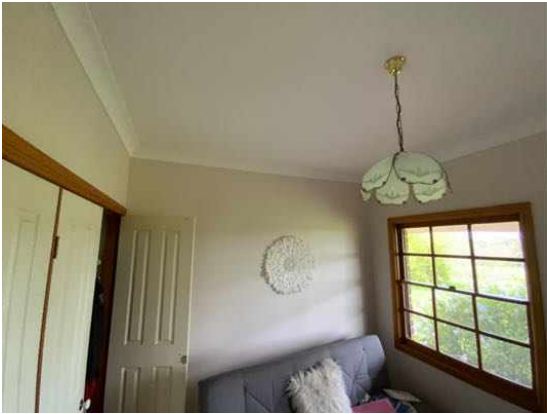
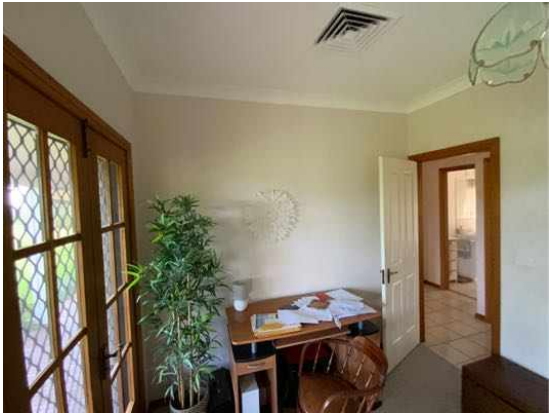
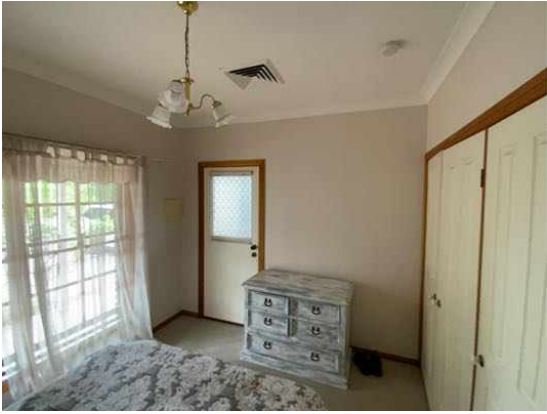
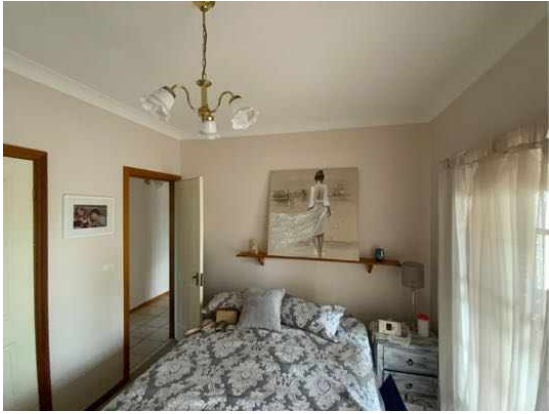
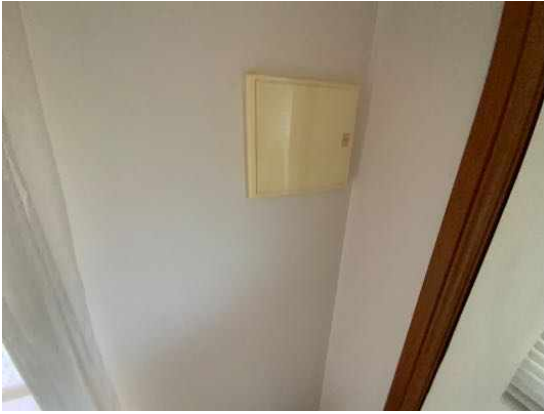
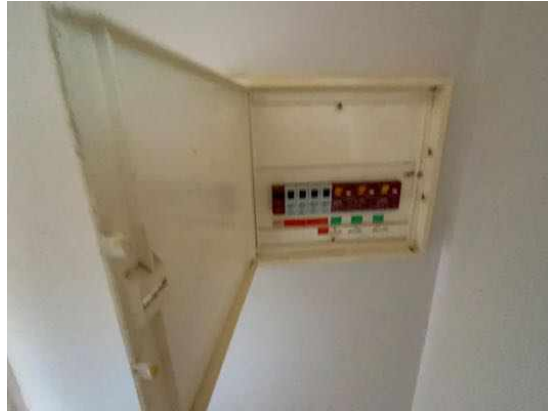
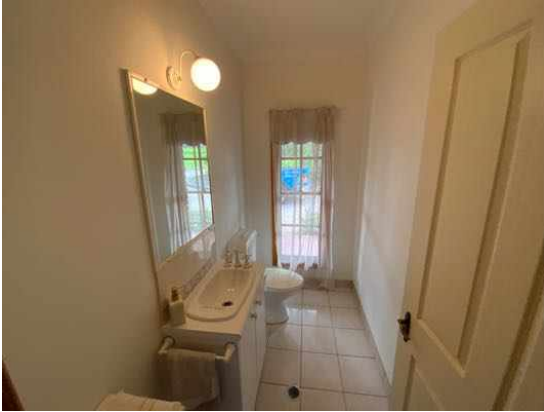
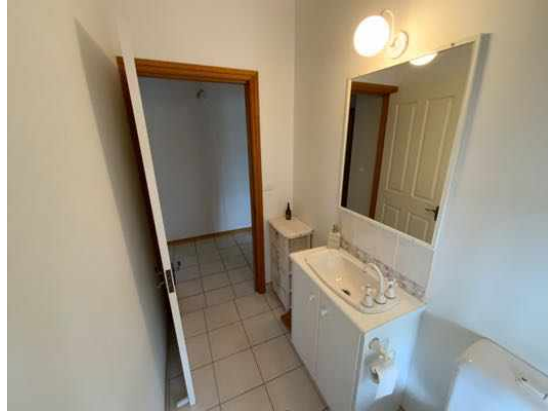
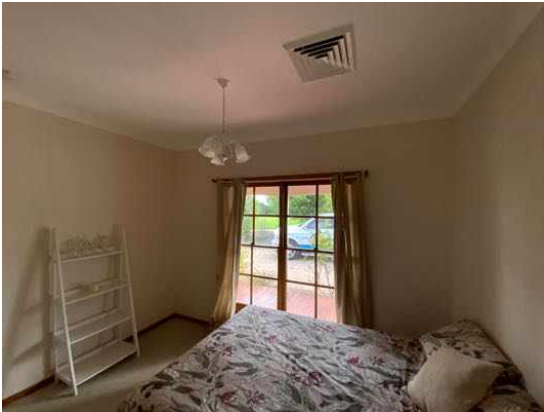
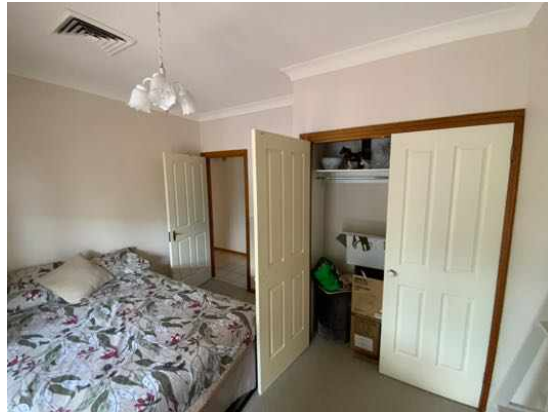
Building: Main Building  
 Location: All Areas  
 Finding: Additional Photos - Obstructions and Limitations  
 Information: These photographs are an indication of the obstructions and limitations which impeded full inspection of the property at the time of inspection. These obstructions can hide an array of defects and should be removed to allow full inspection to be carried out. A re-inspection is recommended once the areas are made accessible.

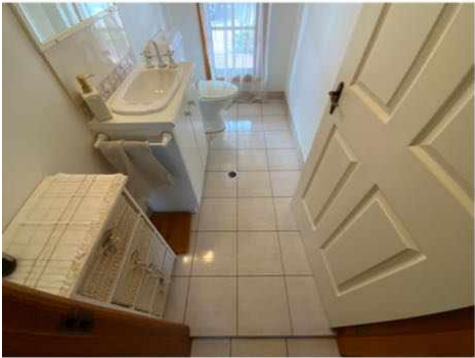
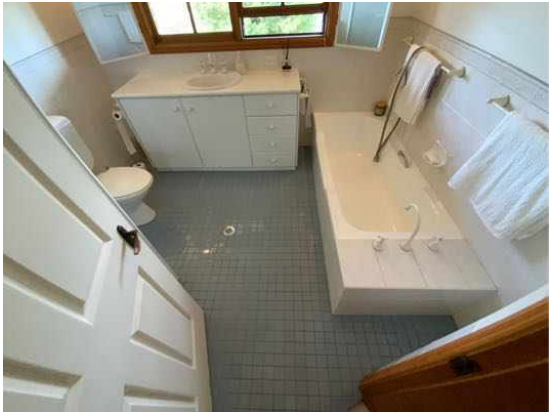
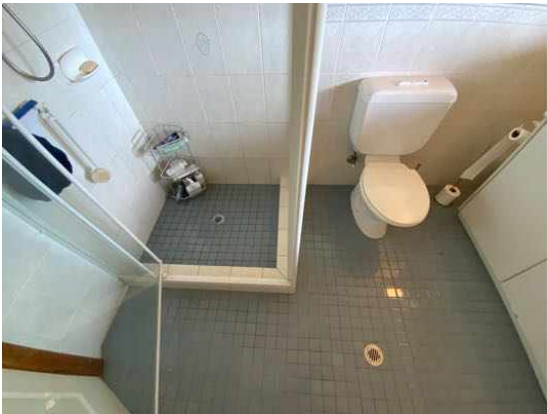
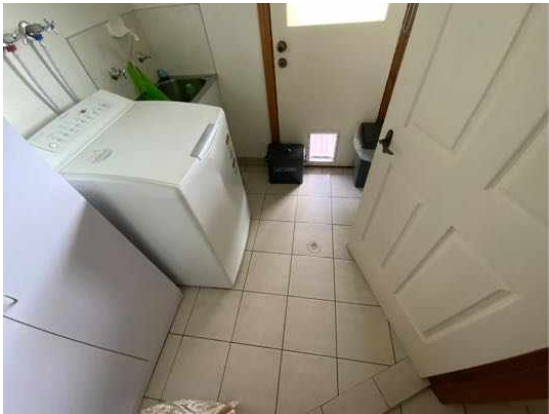
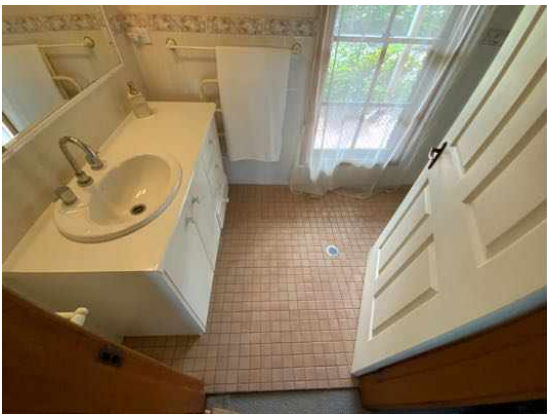
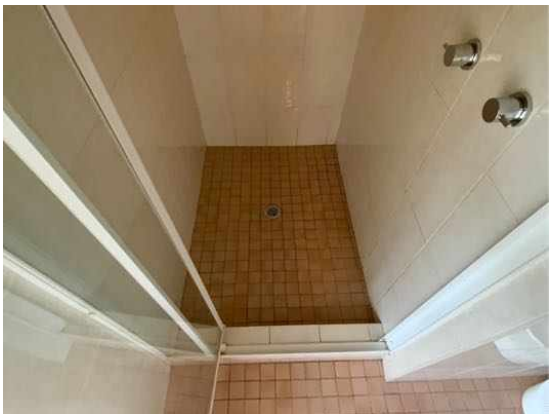
Building: Main Building  
 Location: All Wet Areas  
 Finding: Water Proofing Membranes - Information Only  
 Information: Internal Water Proofing Membranes, are crucial in preventing water ingress into the property is important to know that the Membrane System used is to Australian Standards and has been installed correctly.

With older property's where this information is unavailable all wet areas should be monitored. Generally waterproofing certificates are only valid for approximately 7-8yrs. If any leaks, water staining, peeling or bubbling of the paint become evident to any adjacent walls or ceilings below a licensed builder or waterproofing specialist is recommended to investigate further.

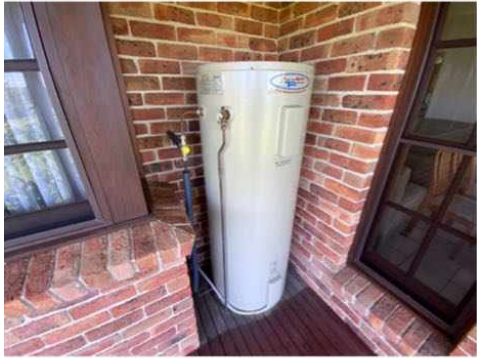
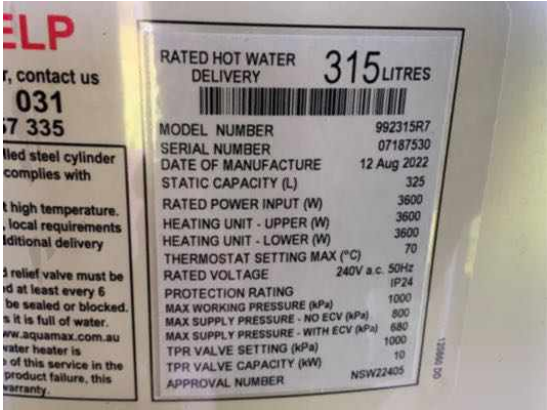
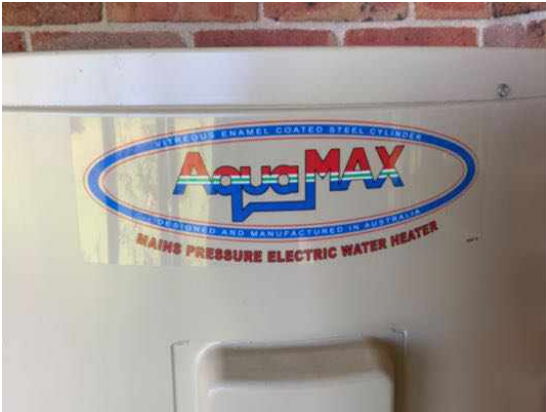
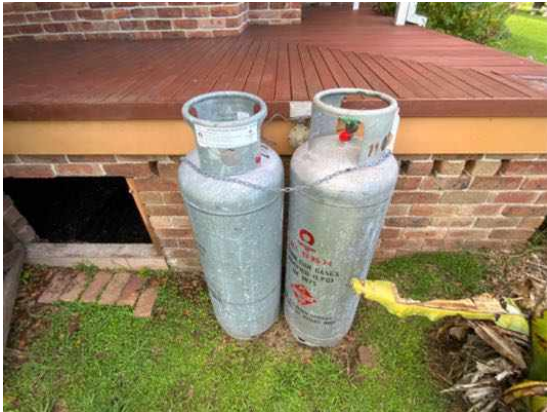
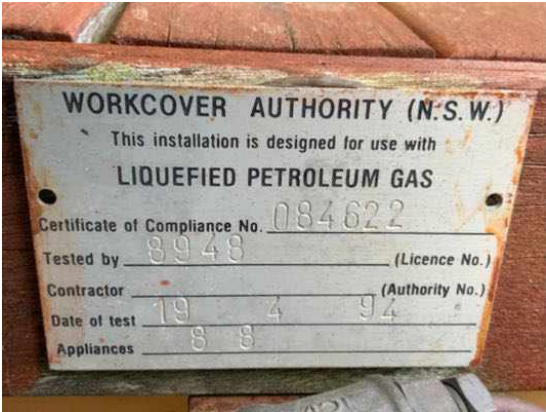
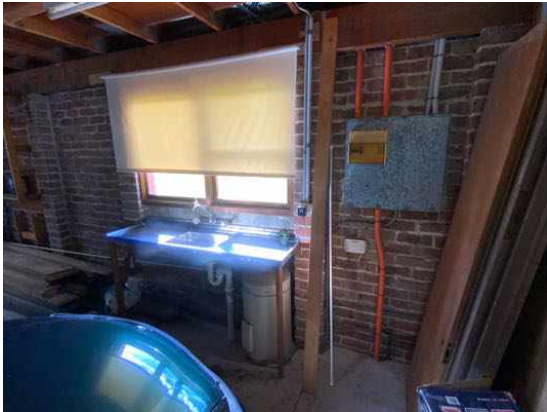
Finding: Additional Photos

Information: Additional photos are provided for your general reference. Arrows have been included to highlight areas of importance. Please discuss these photos with your building consultant for clarification.

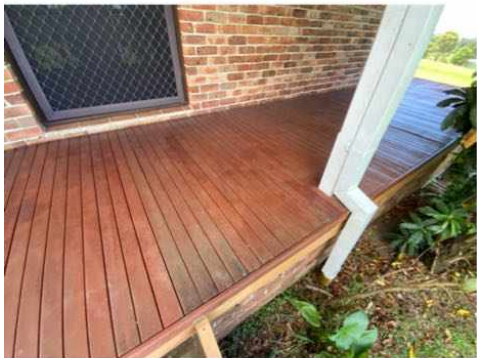
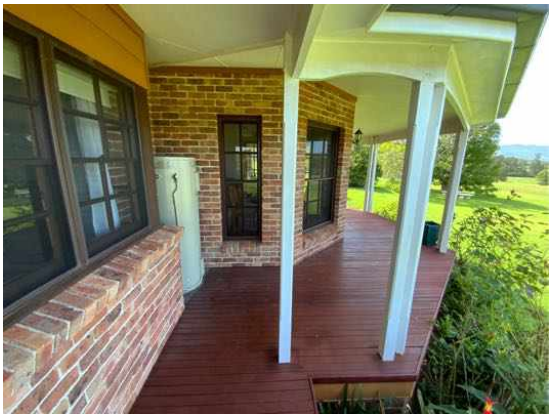
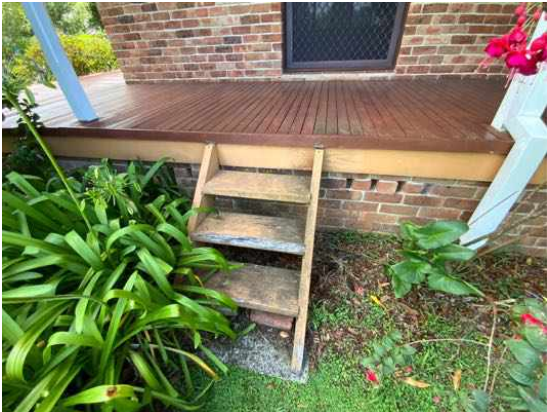
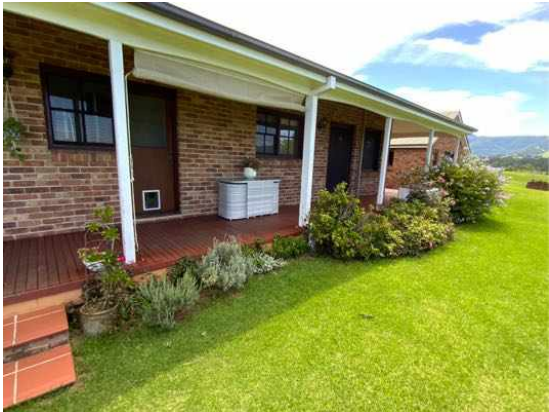
Building: Main Building  
 Location: Balcony, Deck, Verandah or Similar  
 Finding: Elevated structure inspections (Elevated Structure)  
 Information: Where any elevated Structure (deck, balcony, verandah etc) is present, and this elevated structure is designed to accommodate people, you MUST have this structure checked by an engineer or other suitably qualified person.

You should also arrange annual inspections of the structure by an engineer or other suitably qualified person to ensure any maintenance, that may become necessary, is identified. Care must be taken not to overload the structure.
