Building and Timber Pest Inspection Report

Inspection Date: Tue, 24 Mar 2026

Property Address: 30 John St, South Tamworth NSW 2340,
Australia

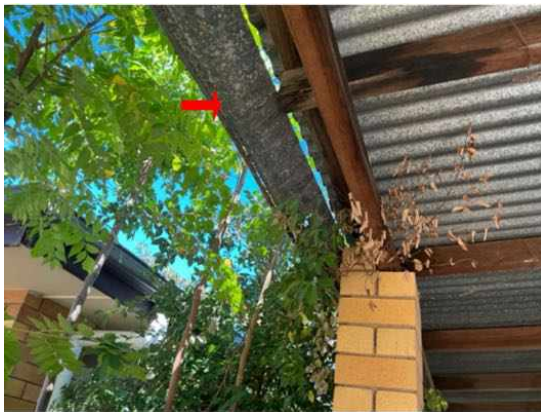
Building: Main Building
Location: Carport
Finding: Gutters Damaged/Deteriorated
Information: Breakage and deterioration occurs generally when the building materials have either aged and decayed with excessive moisture, or as a result of damage (accidental or deliberate).

Repair and/or replacement of these materials is advised to ensure that additional secondary defects do not arise as a consequence. Such works are necessary, as all building elements play a key role in the operation and function of the overall structure and its performance.

A licensed roof plumber should be appointed to repair or replace the affected building element prior to any subsequent damage being caused.

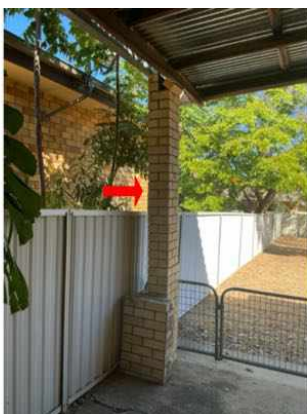
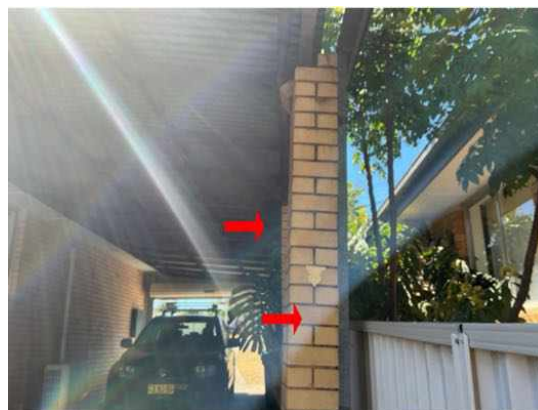
Finding 2.02

Building:	Main Building
Location:	Carport
Finding:	Brick Pier - Impact Damaged
Information:	A brick pier supporting the carport structure was observed to be out of plumb, with visible displacement and dislodged brickwork.

The condition appears consistent with possible impact damage, resulting in movement of the pier. This is of concern as the pier forms part of the structural support to the carport roof. While other adjacent piers appear to be in satisfactory condition, the affected pier shows clear signs of structural disturbance.

It is recommended that the client arrange for assessment by a suitably qualified structural engineer or builder. Remedial works may include realignment, rebuilding, or replacement of the affected pier to restore structural integrity and ensure the ongoing support of the carport.

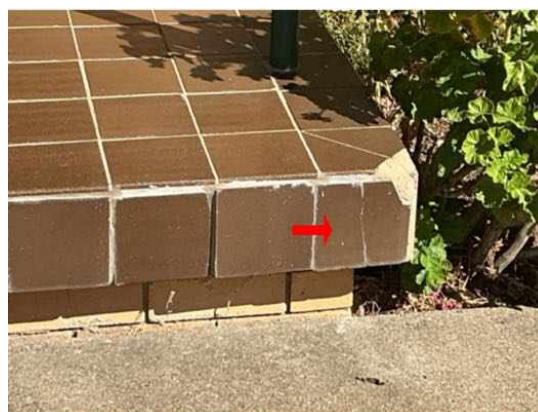
Finding 3.01

Building:	Main Building
Location:	Entry
Finding:	Tiles - Cracked or damaged
Information:	Cracking was evident to the tiling in this area at the time of inspection. While the cracking appears to be minor, this area is frequently exposed to water, allowing potential for water penetration into adjoining sections of of the home.

If left unmanaged, water penetration to these areas may lead to subsequent water damage, which is likely necessitate repair work to affected building elements. This can be seen in the photos.

A tiling contractor should be appointed to ensure that no further water damage occurs. The re-application of silicone and grouting throughout remaining tile work is also advised, to further protect the area against water penetration.

Where water penetration has led to water damage, appointment of a relevant tradesperson may be required to repair damaged building elements.

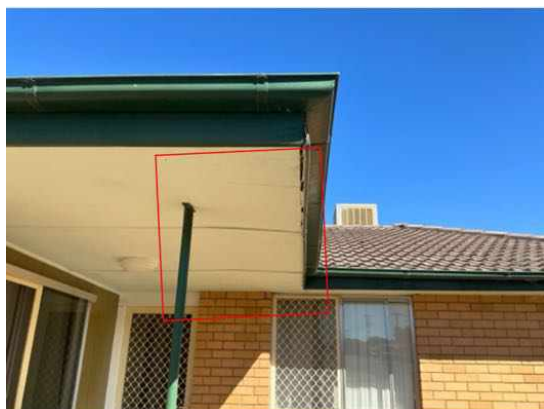
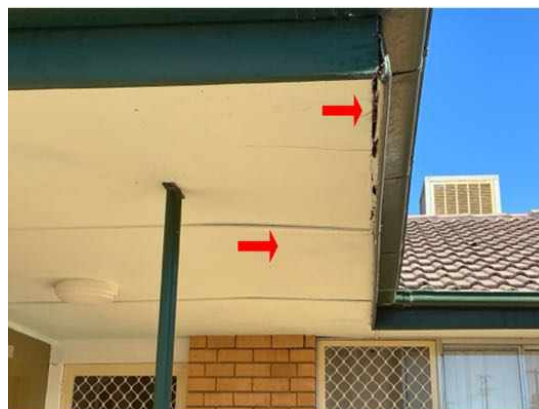
Finding 3.02

Building: Main Building
 Location: Entry
 Finding: Eaves - Sagging General
 Information: Sagging to the eaves was evident at the time of inspection. This type of defect is generally consistent with older properties, where the eave sheeting has worn over time.

Sagging eaves are susceptible to the attraction of excessive moisture, and are therefore considered non-functional. This defect also detracts from the overall appearance and condition of the roofing structure and any associated structures.

A roofing plumbing or general handyman is recommended to perform rectification works as soon as possible. Subsequent water damage is likely to result over time if left unattended.

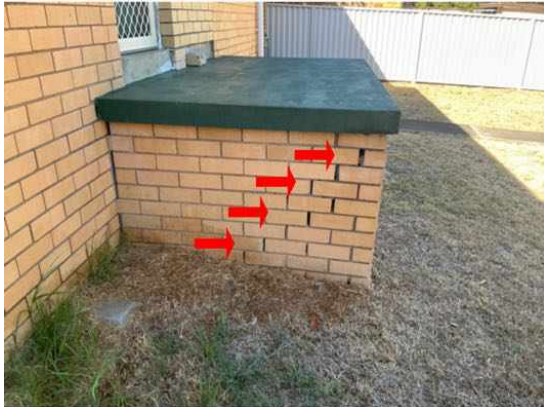
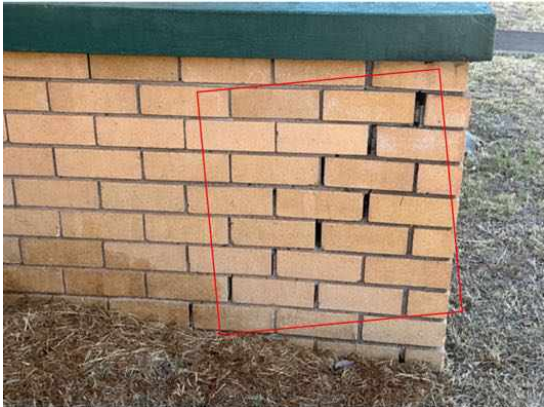
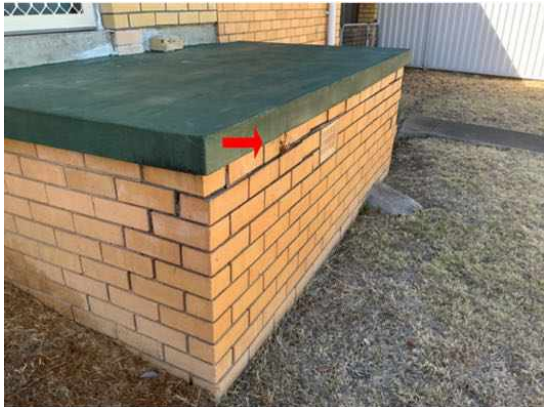
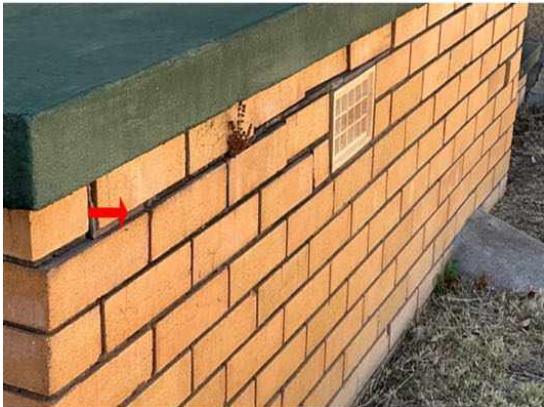
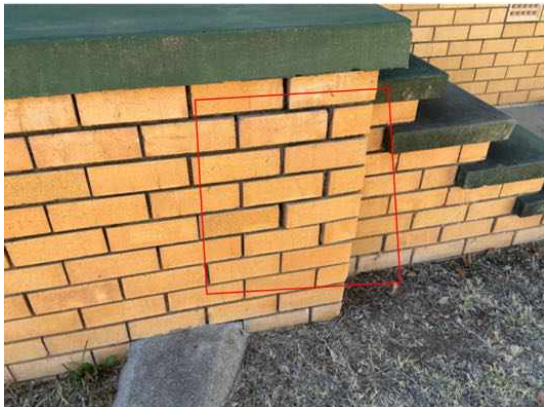
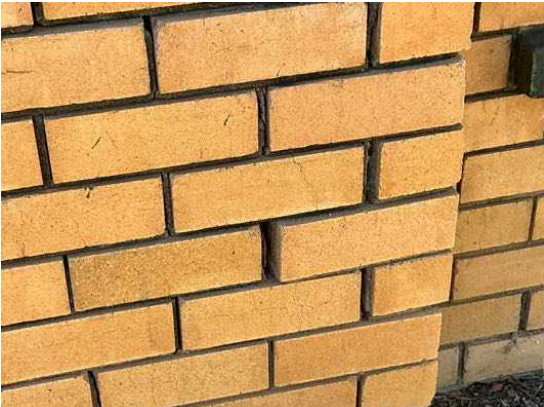
Finding 3.03

Building: Main Building
 Location: Porch
 Finding: Brickwork - Step cracking
 Information: Step cracking was identified to the brickwork in various areas at the time of inspection. Step cracking, which is similar to other forms of cracking, has a variety of possible causes. However, the most common is the subsidence of adjacent footings.

Step cracking is a relatively common defect, and is most likely to occur adjacent to windows, doors and other openings. Mortar failure in the gaps between affected bricks indicates the stresses and tensions affecting the wall.

Where step cracking is extensive or severe, the client is advised to consult a structural

engineer. Minor step cracking can be used as a warning sign to address factors causing stress to the wall, which can include the effect of surrounding trees, water leaks, soil erosion, or even the presence of reactive soils in the surrounding area.

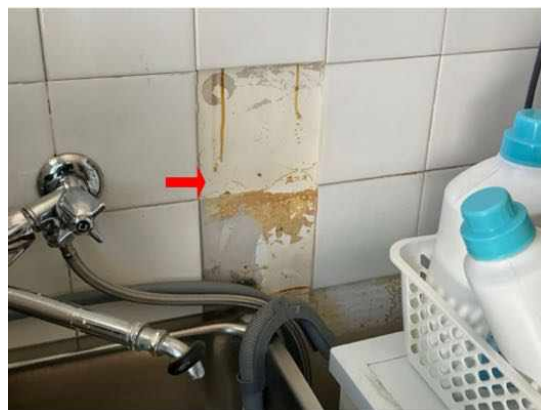
Building:	Main Building
Location:	Laundry
Finding:	Damaged/Deteriorated
Information:	Breakage occurs generally when the building materials have either aged and decayed, or as a result of damage (accidental or deliberate).

Repair and/or replacement of these materials is advised to ensure that additional

secondary defects do not arise as a consequence. Such works are necessary, as all building elements play a key role in the operation and function of the overall structure and its performance.

A relevant tradesperson should be appointed to repair or replace the affected building element prior to any subsequent damage being caused.

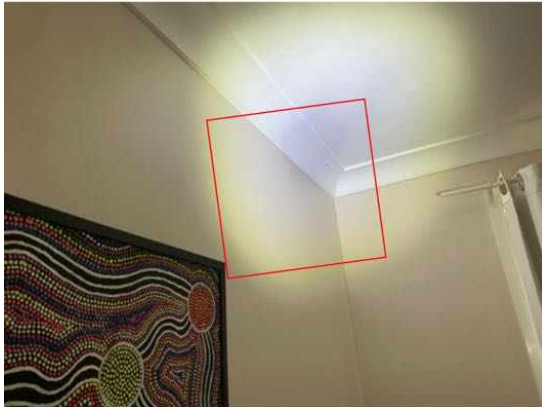
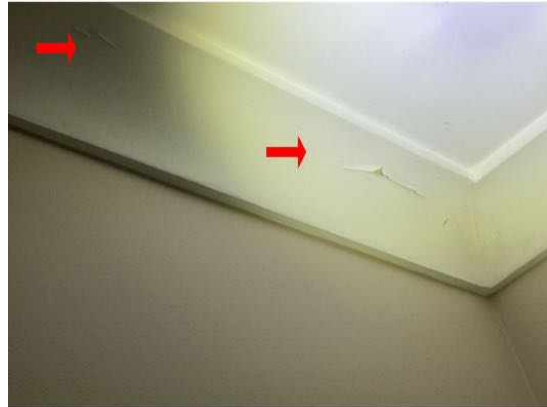
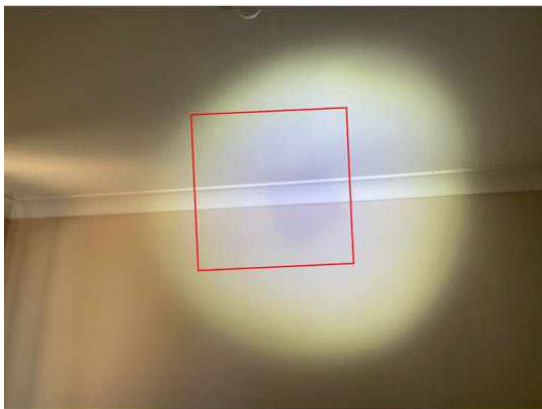
Finding 3.07

Finding: Paint - Interior Deteriorated

Information: The internal paintwork as shown throughout the home, including but not limited to walls, ceilings, architraves, and skirtings, shows signs of wear, damage, or incomplete finishing and requires attention to restore a consistent and protective surface. While issues with internal paintwork are often considered cosmetic in nature, deteriorated or missing paint can also contribute to secondary defects such as staining, moisture absorption, or surface degradation over time.

Areas with flaking, scuffed, or patchy paint should be properly prepared by sanding, filling, and levelling before repainting. In locations where the lack of adequate paint protection has resulted in damage to the underlying surface, further repair or replacement of the affected materials may be necessary prior to painting.

It is recommended that a qualified painting contractor be engaged to carry out the required works to improve the visual presentation of the interior and provide adequate protection for internal surfaces. Alternatively, the homeowner may undertake these works in accordance with manufacturer guidelines and industry best practices.

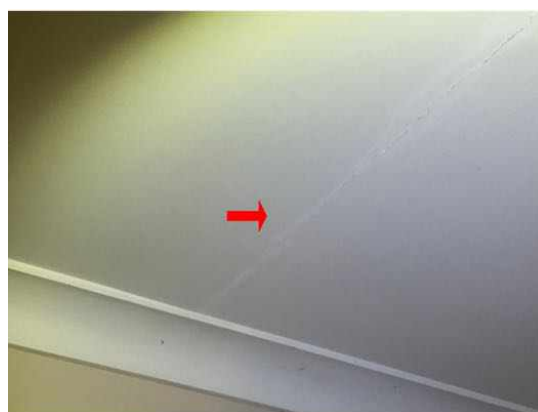
Building:	Main Building
Location:	Hall
Finding:	Cracking - Plasterboard
Information:	Fine cracks in plasterboard, while occasionally noticeable, are typically regarded as cosmetic defects and do not usually signify structural damage. These cracks often result from separation between building materials and finishes (e.g., paint, plaster) along joints. In most cases, such cracks can be addressed through minor repairs such as sanding, filling, or repainting, which should be carried out by a qualified painter or general handyman.

However, regular monitoring of these cracks is essential. If any cracks show signs of widening, lengthening, or increasing in number, it is advisable to contact a building inspector for further assessment.

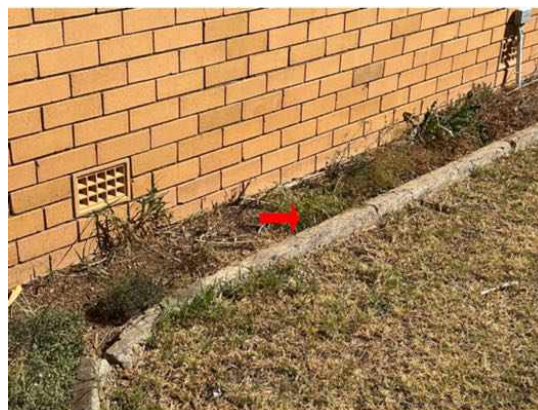
Building: Main Building
 Location: All External Areas
 Finding: Garden Beds - Conditions Conducive to Termites
 Information: Garden beds were observed in direct contact with the building's perimeter across various areas of the property. In some areas, untreated timber and mulch were used. This configuration, combined with regular watering or hosing, creates conditions conducive to termite activity and increases the risk of termite ingress into the structure.

Garden beds placed against external walls, particularly those incorporating untreated timber or excessive mulch, can retain moisture and create hidden entry points for termites. This undermines the effectiveness of termite barriers, compromises weep hole visibility, and elevates the risk of concealed termite activity that may lead to structural damage.

The current placement and construction of garden beds present a termite risk and deviate from best practice recommendations for termite management. Rectification and professional input from both a landscaper and pest management specialist are

advised to ensure the building remains protected while achieving the desired landscape design.

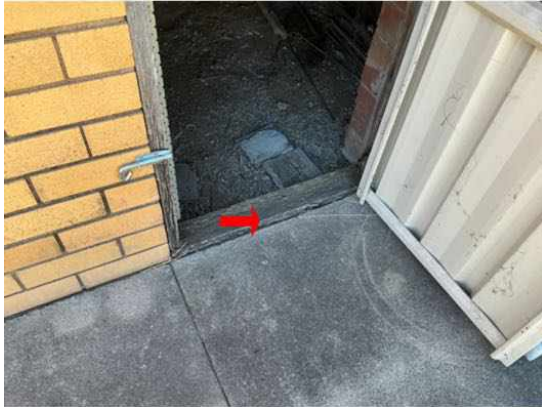
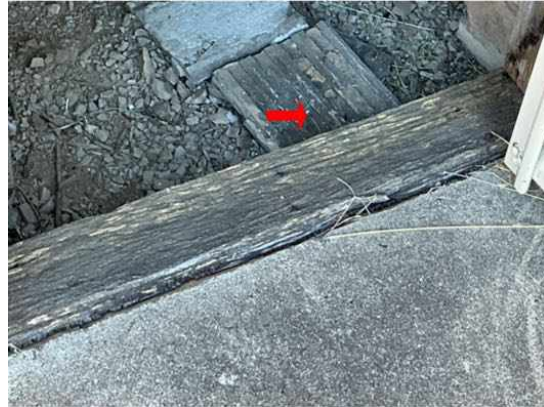
Finding 6.02

Building:	Main Building
Location:	All External Areas
Finding:	Timber Materials In Direct Ground Contact- Conducive to Termites
Information:	Timber elements that are in direct contact with the ground and exposed to moisture or damp conditions are highly conducive to termite activity. This susceptible arises because of timber, when in contact with soil and dampness, create an environment that is particularly attractive to termites, encouraging infestation and potential structural compromise. Whether the timber is used as part of the building construction or incorporated into fencing, the presence near or on the ground can become a pathway for termites to access And damage the property.

When exposed to excessive moisture, timber begins to deteriorate developing condition such as wood decay or rot. These compromised areas of timber are even more appealing to termites as they are easier to infest and consume. This is especially true for untreated or non-durable timber, which lacks the protective treatments that can deter or withstand termite attacks. Termites can use these weakened moisture laden elements as a bridge into other parts of the structure, creating an entry point for potential infestations that can spread and cause extensive damage if left unchecked.

For any timber in direct contact with the external ground special attention is required the combination of moisture untreated wood and direct ground contact not only accelerate the decay process but also provide subterranean termites with a straightforward means of ingress into the structure this can lead to termites moving undetected into other vulnerable areas resulting in potentially significant structural issues and costly repairs.

the client is advised to schedule regular termite treatments to maintain an effective barrier against infestations and ensure ongoing protection.

Regular inspections, proactive maintenance and consistent termite treatment are essential steps in minimising the risk of termite attack and protecting the structural integrity of the property. Taking these preventative measures is crucial for maintaining a termite free environment and avoiding potentially costly damage and future repairs.

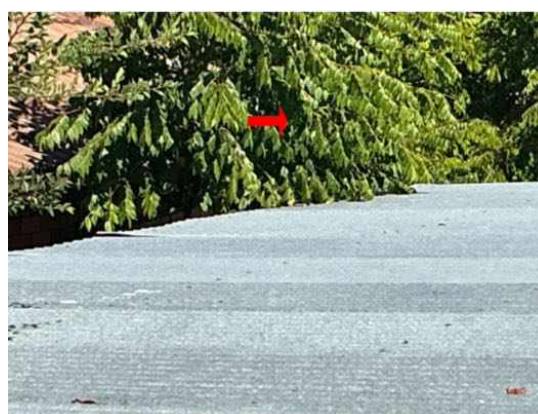
Finding 6.03

Building: Main Building
 Location: All External Areas >
 Finding: Bridging Of Physical Barriers - Patios/Porches
 Information: Breaching is the spanning of a physical termite barrier or inspection zone so that subterranean termites are provided with an entry point over or around that barrier.

The client should consider gaining further advice from a timber pest technician as to treatments required in this area. It is recommended that obtaining such advice be a short-term priority.

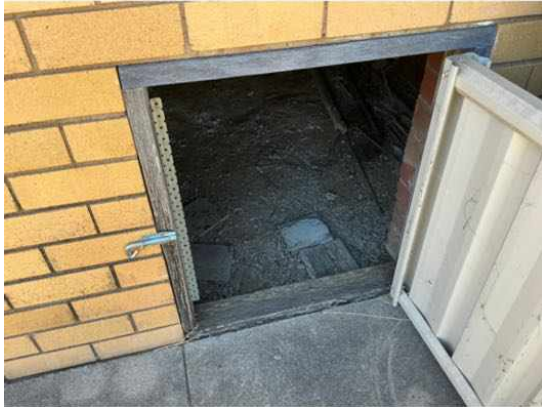
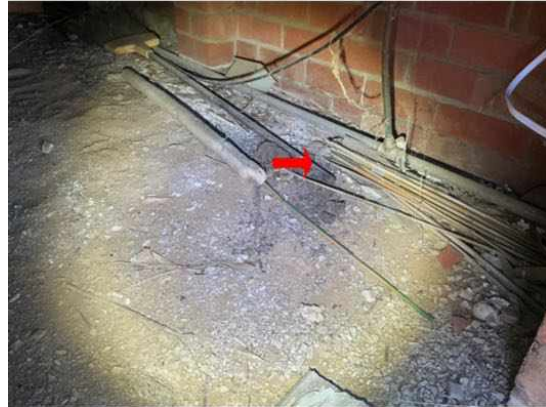
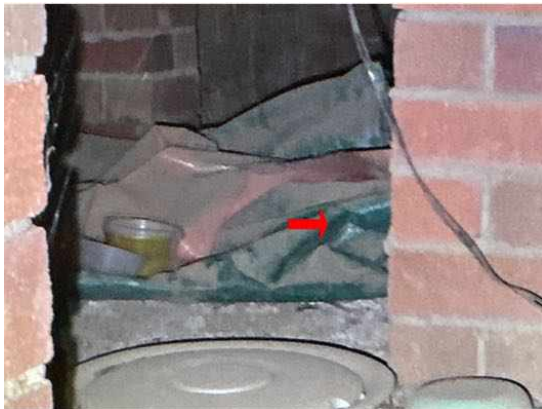
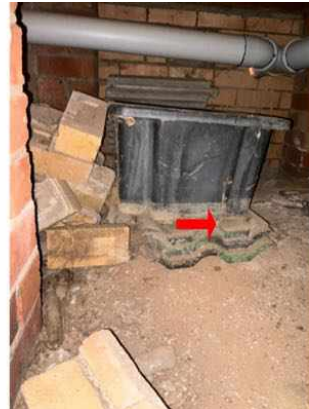
Finding 6.06

Building:	Main Building
Location:	Subfloor
Finding:	Stored Items - Subfloor
Information:	At the time of inspection, various stored items and leftover building materials were observed within the subfloor area of the dwelling. Subfloor areas are required to remain clear and unobstructed to allow for adequate ventilation, routine inspection access, and to prevent the accumulation of moisture and pests.

The storage of materials and general items in this space can obstruct air flow, potentially contributing to poor ventilation and the buildup of damp conditions, which may lead to timber decay, mould growth, or termite activity. Additionally, stored items can conceal defects or damage within the subfloor, delaying their detection and rectification.

It is recommended that all stored items and debris be removed from the subfloor area to maintain compliance with good building practice and to preserve the structural and environmental integrity of the subfloor space.

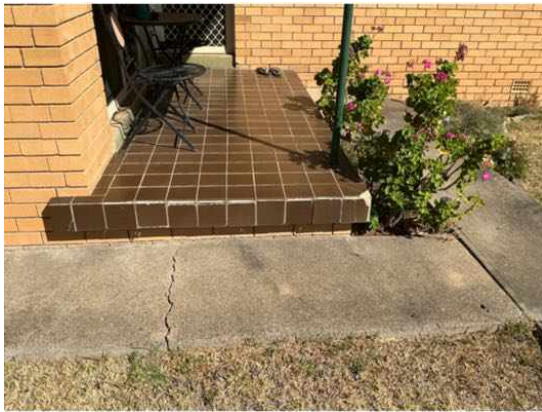
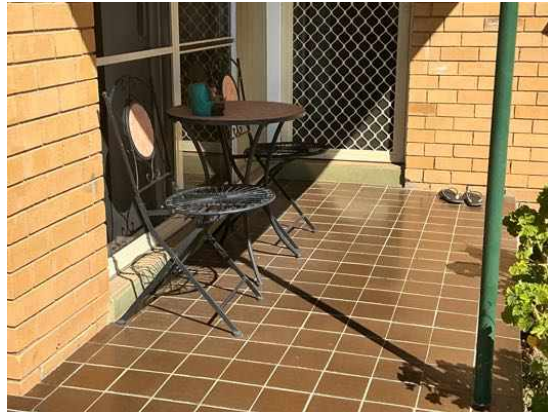
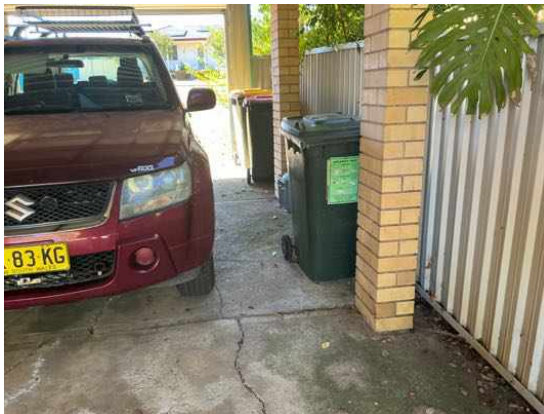
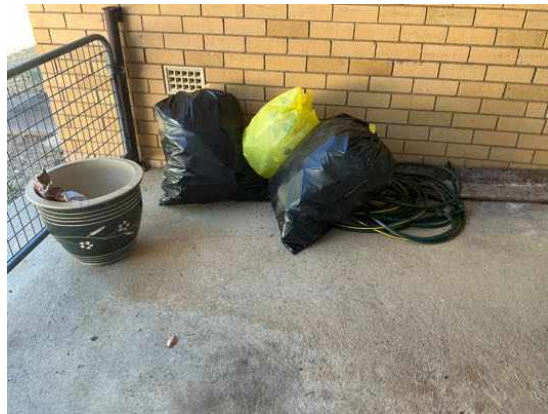
Building: Main Building
Location: All Areas
Finding: Additional Photos - Obstructions and Limitations
Information: These photographs are an indication of the obstructions and limitations which impeded full inspection of the property at the time of inspection. These obstructions can hide an array of defects and should be removed to allow full inspection to be carried out. A re-inspection is recommended once the areas are made accessible.

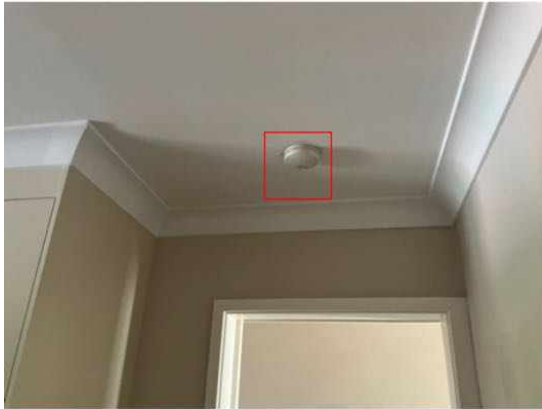
Building: Main Building
Location: All Internal Areas
Finding: Smoke Detectors and Alarms
Information: Reporting on Smoke Detectors or Alarms, including hard wired smoke detection systems and their legislative requirements, is outside the Scope of this Report.

Always ensure sufficient working and suitable smoke detectors are installed prior to occupying any building. Additionally, it is advised that all smoke detectors be tested by the homeowner on a monthly basis.

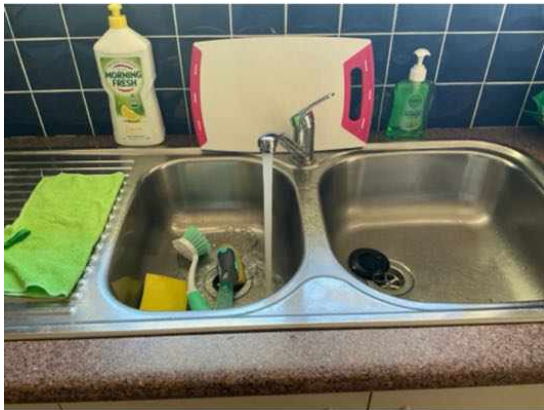
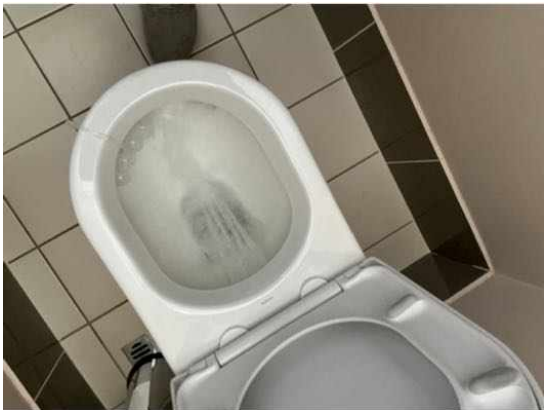
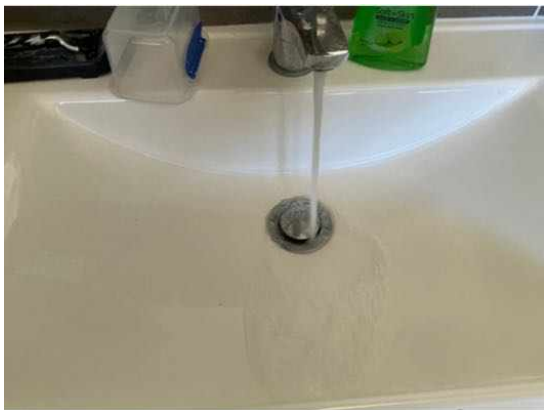
Building: Main Building
 Location: All Wet Areas
 Finding: Taps, Drainage and Toilets Tested
 Information: During the inspection, taps, draining systems and toilets were checked for both water flow and drainage efficiency, as well as inspected for any visible signs of leakage at the time of the inspection. No issues were noted in these areas ,unless highlighted in a separate ,no immediate remedial work appears to be necessary for these items. Any relevant photo's Documenting these inspections may be found in the additional photo section for reference.

However, it is important to note that while a thorough inspection of cupboards and cabinetry was conducted the presence of instructions such as stored items or fixtures may have limited full visibility of potential water damage or hidden defects. These obstructions can conceal underlying issues that may not be immediately visible during the initial inspection. Furthermore, conditions can change after the inspection has been carried out and defects or damage could be revealed once obstructions are removed or as time progresses.

Given this, it is strongly recommended that a reinspection be conducted after all obstructions have been removed from the cupboards to allow for a full thorough assessment of these areas. This will ensure that any concealed damage or defects are identified and addressed in a timely manner. Regular maintenance and monitoring of plumbing and drainage systems are also advised to insure long-term functionality and to prevent future problems from arising.

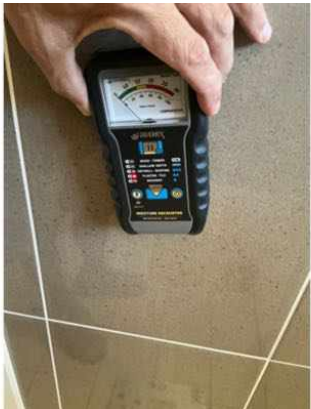
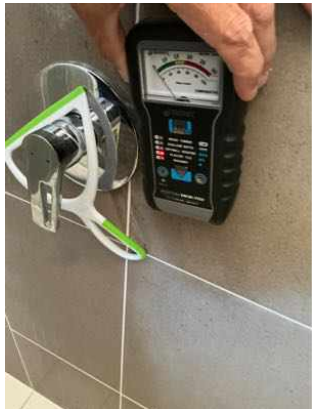
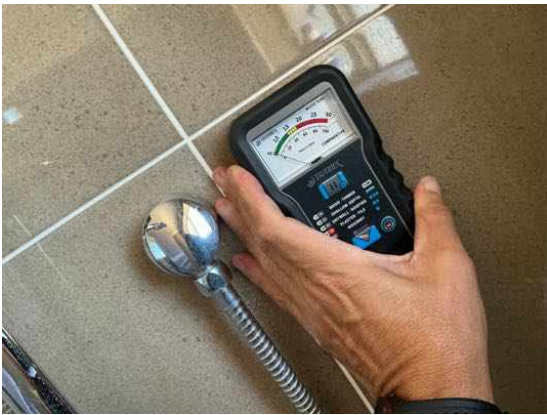
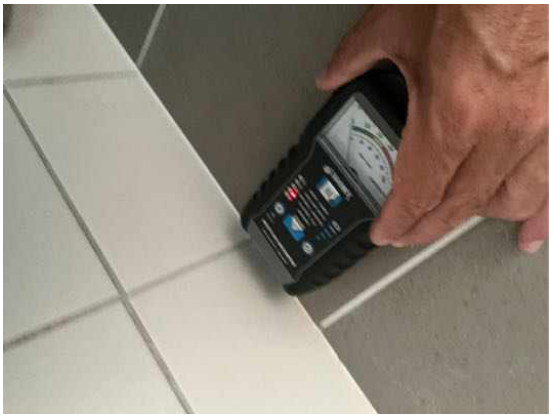
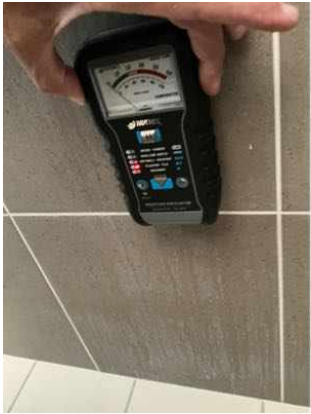
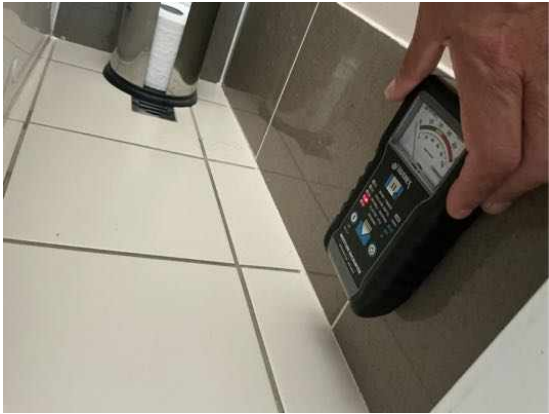
Building: Main Building
Location: All Internal Areas
Finding: Photos added Moisture Readings - Wet Areas
Information: Additional photos are provided for your general reference.

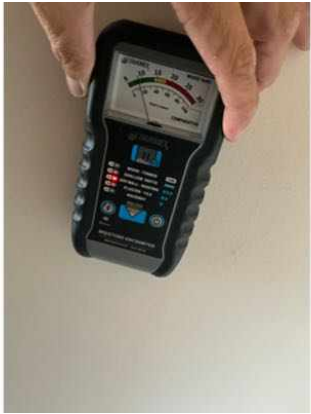
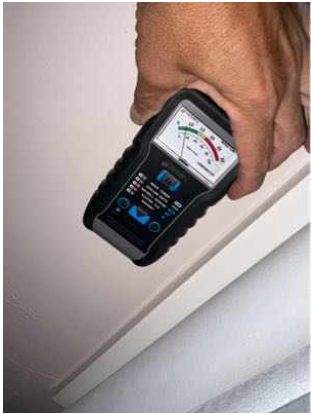
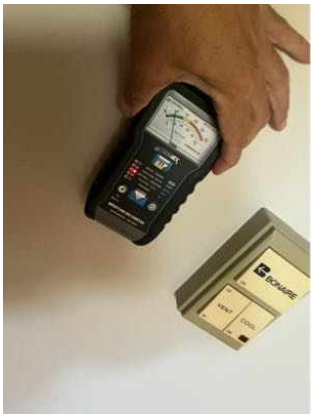
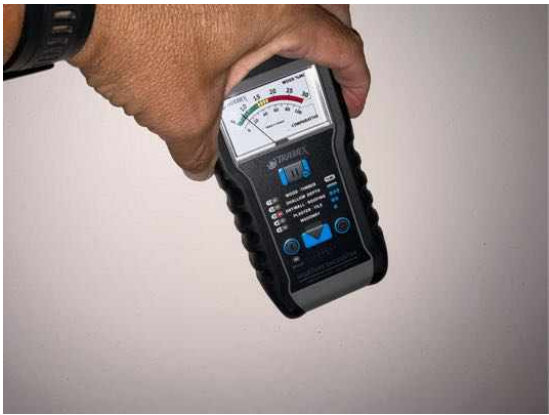
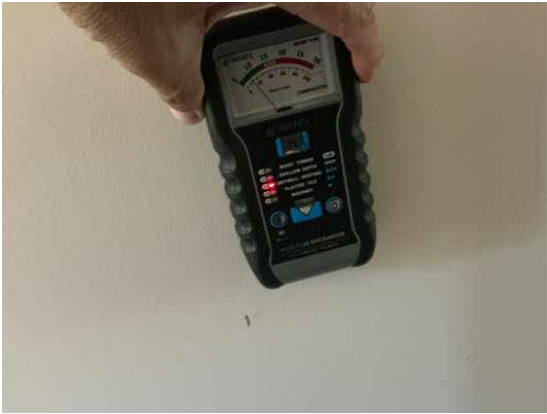
Building: Main Building
Location: All Internal Areas
Finding: Photos added Moisture Readings - Other Areas
Information: Additional photos are provided for your general reference.

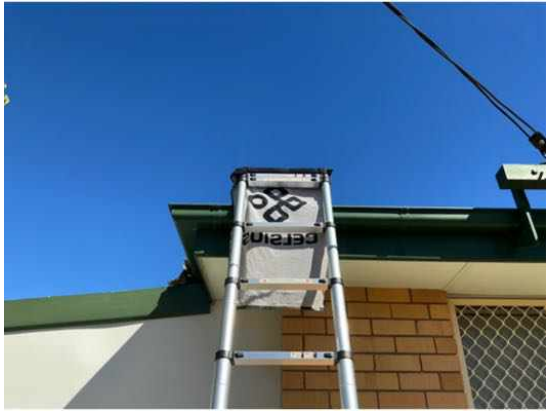
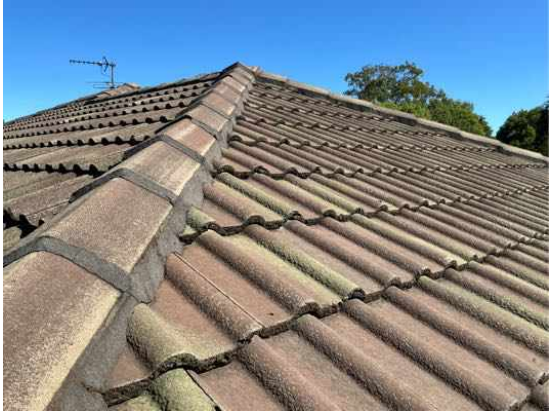
Building: Main Building
Location: Roof Exterior
Finding: Additional Photos Roof
Information: Additional photos are provided of the general roof area for your general reference at the time of inspection.

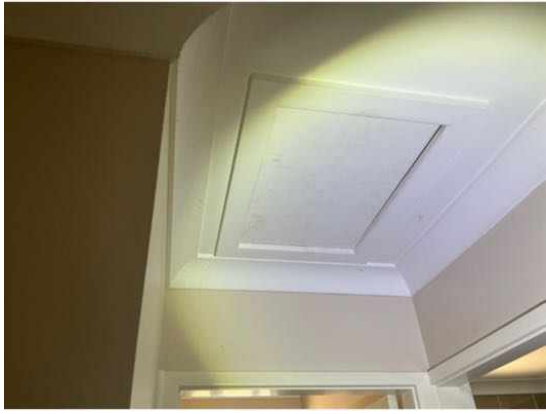
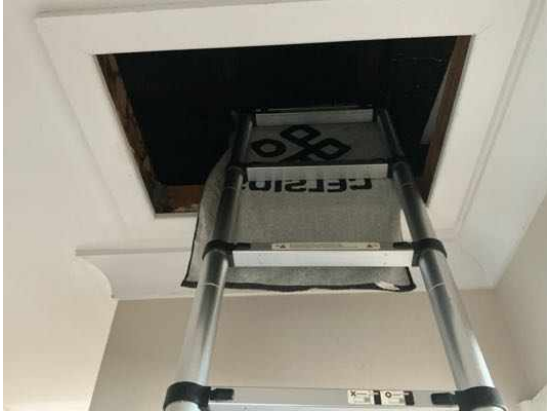
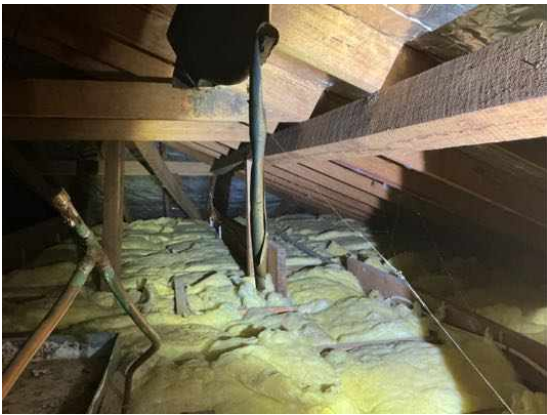
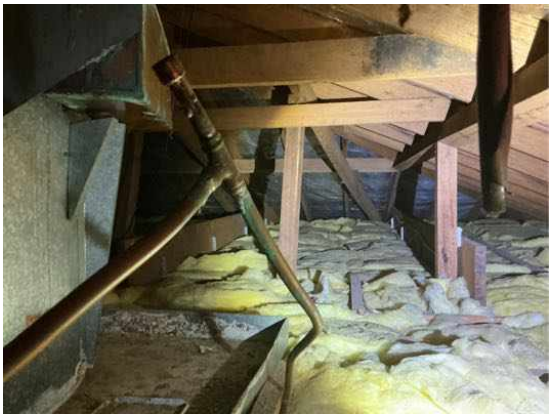
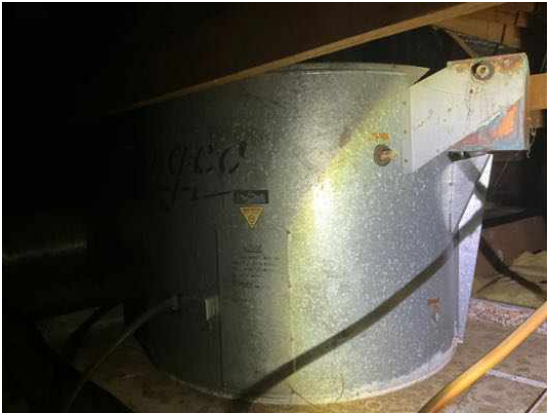
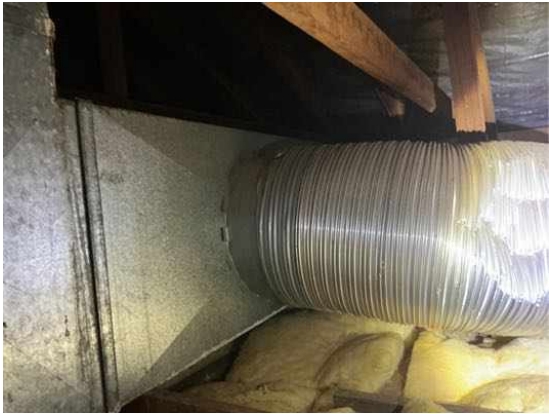
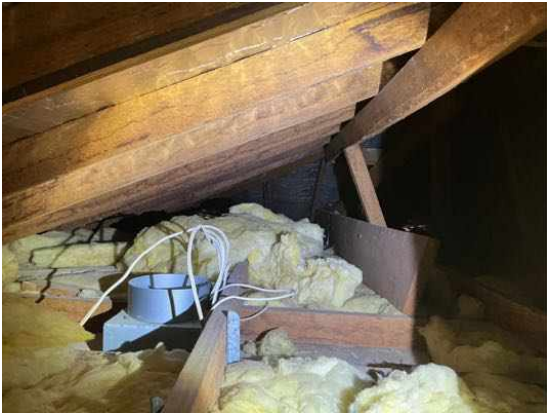
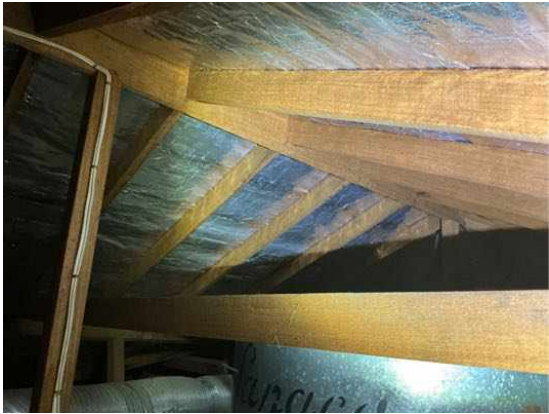
Building: Main Building
Location: Roof Void
Finding: Additional Photos Roof Void
Information: Additional photos are provided of the general roof void for your general reference at the time of inspection.

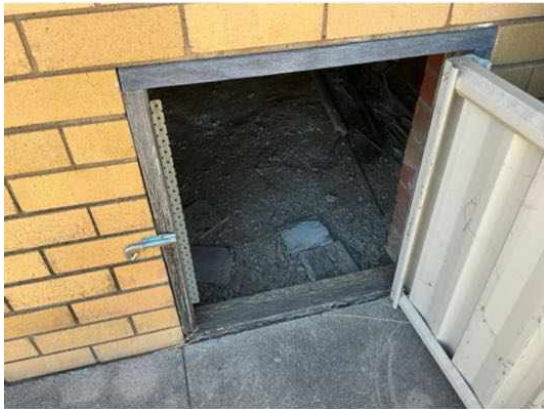
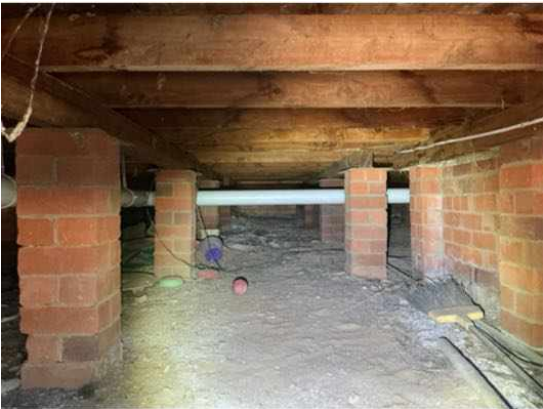
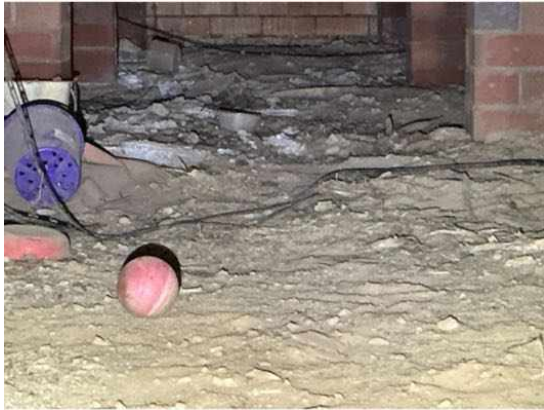
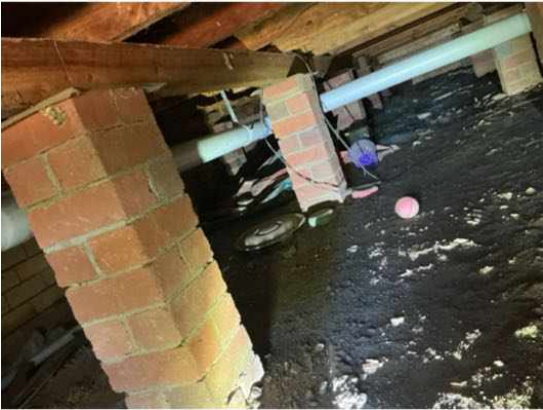
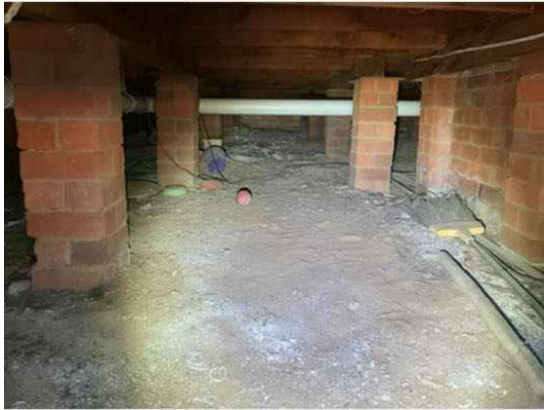
Building: Main Building
Location: Subfloor
Finding: Additional Photos - Subfloor
Information: Additional photos are provided for your general reference
