Building and Timber Pest Inspection Report

Inspection Date: Tue, 3 Feb 2026

Property Address: 108A Bland St, Kiama NSW 2533, Australia

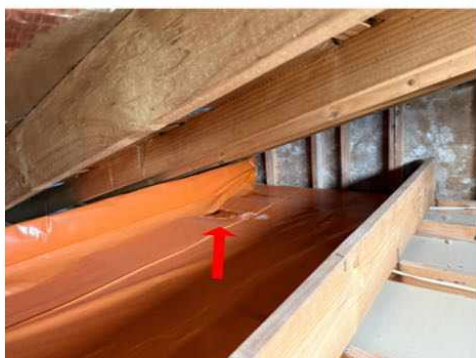
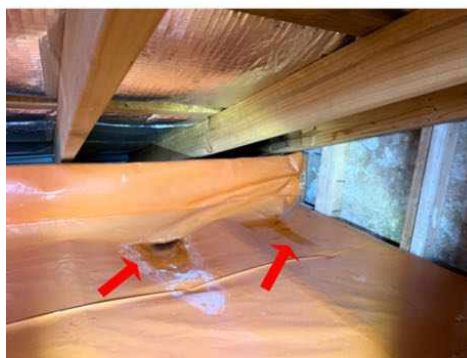
Building:	Building 1
Location:	North corner areas
Finding:	Exterior roof - Leaking
Information:	Active roof leaks were evident at the time of inspection. Roof leaks can have a number of causes, including damage to roof coverings, deterioration of roof fixtures and fittings, or loosely associated materials (fascias etc.).

Where water leaks are active, rain penetration is likely to cause water damage to associated structures and building elements in this area, which can have a range of implications. If left unmanaged, the development of major structural damage to the roofing and associated structures may occur. Due to the combined insulation/sarking material, the source of the leak was not evident.

A roof plumber or roofing contractor should be appointed as soon as possible to primarily identify the cause of the leak, likely to be a loose seal or screw, and to provide subsequent repair works as necessary. Depending on the extent of the damage, replacement of sections of the roof covering and/or roofing structures may be required, and may be performed by a registered builder or qualified carpenter.

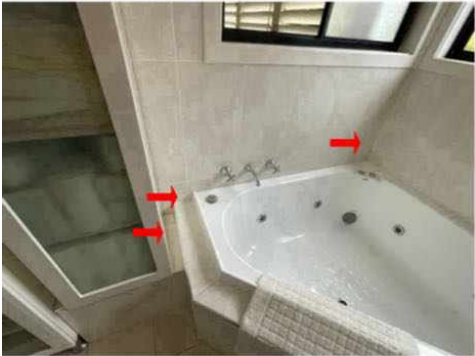
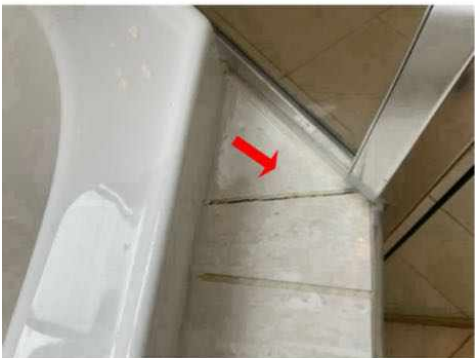
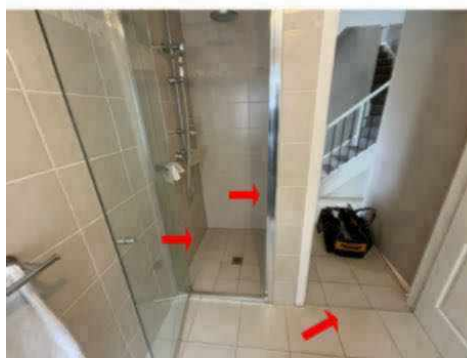
Finding 3.07

Building:	Building 1
Location:	Many areas
Finding:	Sealant and grouting - Missing or damaged
Information:	It was noted on inspection that sealant or grout is degraded to these pictured areas.

Different materials and floor areas move at different rates, generally causing cracking to grout or sealant at this point. A flexible sealant is required to allow for expected expansion and contraction, while keeping the joint water tight and protective of all associated building materials.

any subsequent water damage that is likely to occur. Regular maintenance and replacement of damaged or missing or damaged sealant and grout is highly recommended to the wet areas, as this is a regular wear and tear defect. Sealant and grouting in areas that come into regular contact with water should be maintained for the long term care of your property.

A sealant specialist or tiling contractor should be appointed to complete these works as soon as possible

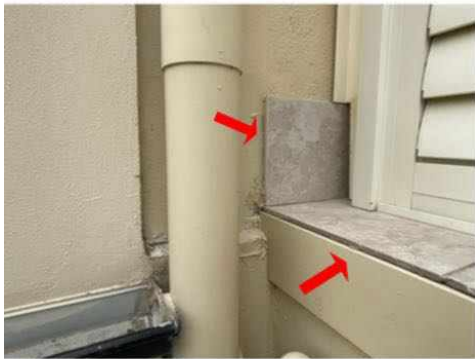
Finding 3.08

Building:	Building 1
Location:	Exterior rear right walls
Finding:	Sealant (external) - missing
Information:	It was noted on inspection that areas of external sealant was missing to small areas of the external walls.

Flexible sealants should be applied to these affected areas to prevent any subsequent water damage that is likely to occur.

A sealant specialist or skilled handy person should be appointed to complete these works as soon as possible

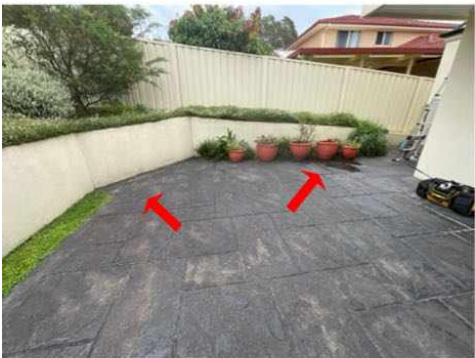
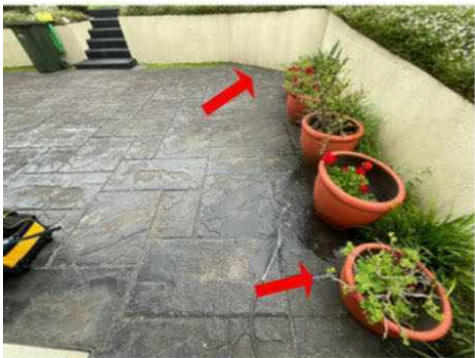
Finding 3.09

Building:	Building 1
Location:	Rear areas
Finding:	Site drainage - Inadequate
Information:	The site drainage in this rear area was found to be slightly inadequate at the time of inspection, creating potential for subsequent water damage to associated building elements. Small areas of water pooled against the right rear retaining walls. It is thought, in heavy rain most water would reach one of the 3 nearby drains.

Where site drainage is inadequate and if large amounts of rainwater does pool in high rain events, the installation of an Agricultural (Aggie) Drain may be required. In this case a qualified plumber should be appointed to further inspect the property and perform any remedial works as necessary. Water damage and secondary defects are likely to occur if left unmanaged.

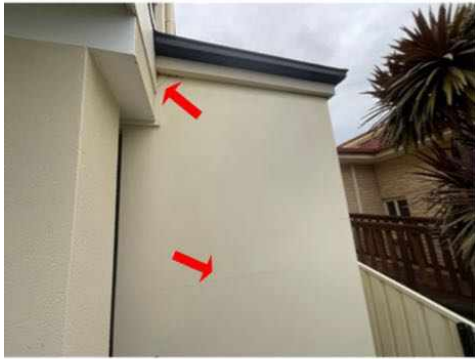
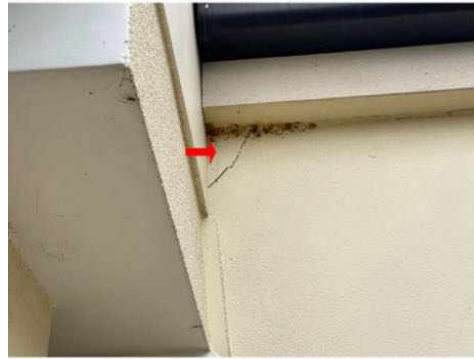
Finding 3.10

Building: Building 1
Location: Small external wall areas
Finding: Render (external) cracking.
Information: It has been observed that cracking to some external rendered surfaces. The degree of damage is described as “slight” noticeable cracks which are easily filled. Cracking of this size are generally less than 5mm in width.

Always contact your building inspector should cracks widen, lengthen, or become more numerous.

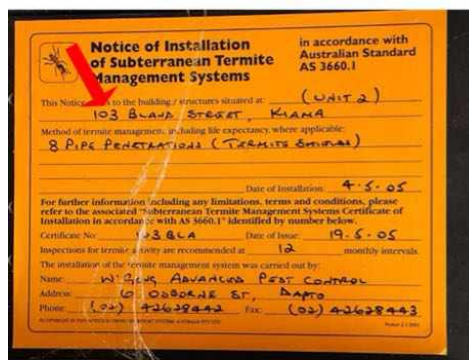
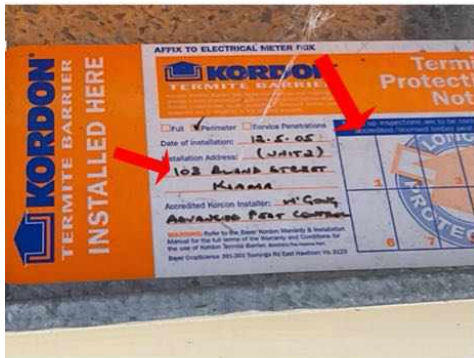
Building: Building 1
 Location: Meter Box
 Finding: Termite Management System - no evidence of a chemical installation
 Information: The application of a post-construction chemical termite barrier is highly recommended for all properties. Such barriers are highly effective in preventing termite attack on any timber building elements throughout the property.

A durable notice should be placed in the switchboard unit to indicate current termite barriers. At the time of inspection, the durable notice was evident with the wrong address and it appeared as though no chemical termite management system has been installed, with no evidence to suggest preventative works taking place since the property was built.

The client may consider gaining further advice from a pest controller as to the costs and procedures involved with a 'chemical' application. It is recommended that obtaining such advice be a short-term priority.

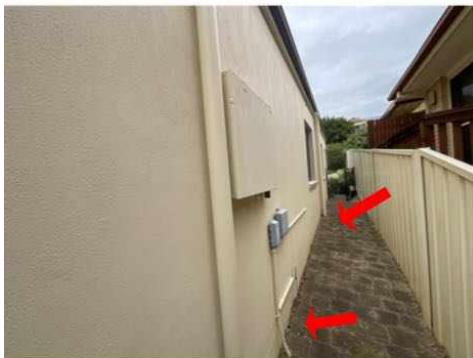
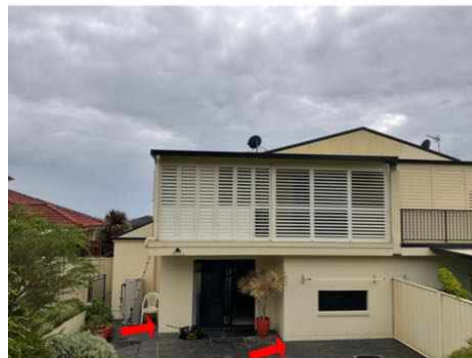
Finding 6.02

Building:	Building 1
Location:	Exterior walls
Finding:	Slab Edge - Exposure
Information:	An inspection zone of at least 75mm in relation to the exposed slab edge, between the bottom brick and the perimeter pavement, is required. This inspection zone should be maintained in order to force termites into the open where they can be detected more readily during regular inspections. The slab edge should not be concealed by anything that may prevent inspection of the area, including render, landscaping, soil, turf, paving, concrete cladding or other structures.

If the slab edge is not properly exposed there is a high risk of termite attack. Sometimes, in order to determine the type of slab, a suitably qualified person such as an architect or builder may be required to consult the construction plans.

Where the slab edge cannot be properly inspected, it is highly recommended that termite or timber pest inspections be carried out every 6-12 months to aid protection of the property against infestation.

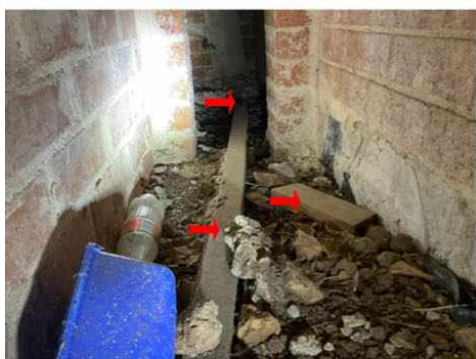
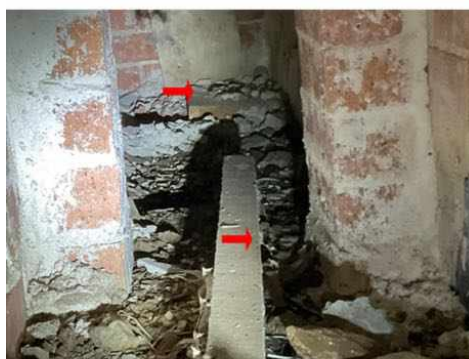
Finding 6.03

Building:	Building 1
Location:	Verandah subfloor

Finding: Timber in contact with the ground
Information: Any timbers in direct ground contact provide opportunity for concealed termite entry and are likely to be subject to premature rot and decay as the soil retains moisture or damp conditions against the timbers.

Removal of all waste timber that is in direct contact with ground is highly advised. This timber is promoting mould and wood rot and is very attractive to termites.

Frequent pest inspections are advised to readily identify any termite activity in these areas.

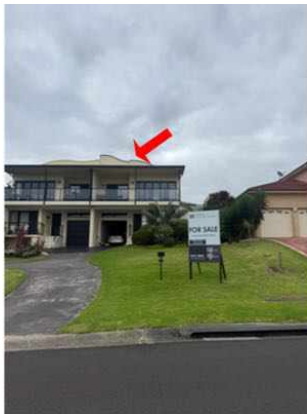
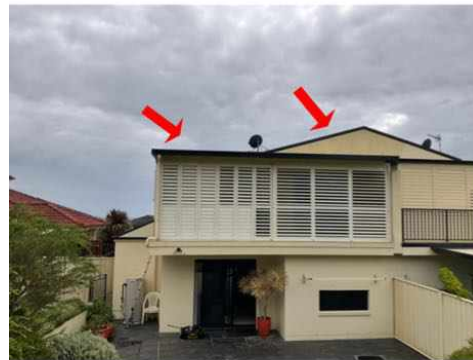
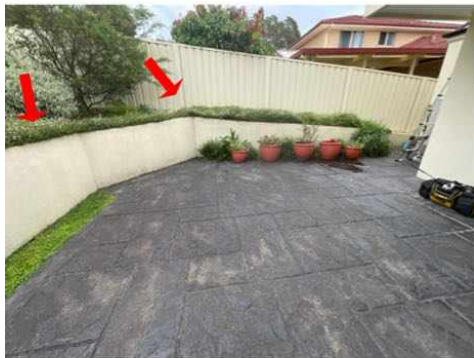
Building: Building 1
 Location: All External Areas
 Finding: Additional Photos - Obstructions and Limitations of EXTERNAL AREAS
 Information: These photographs are an indication of the obstructions and limitations which impeded full inspection of external areas at the time of inspection. These obstructions can hide an array of defects and should be removed to allow full inspection to be carried out. A re-inspection is recommended once the areas are made accessible.

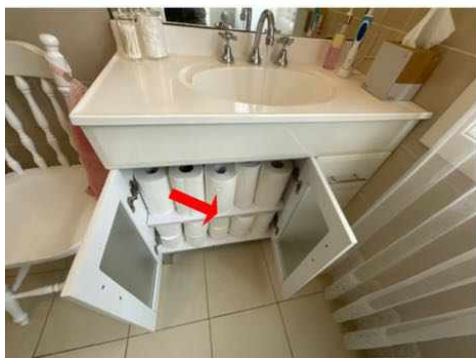
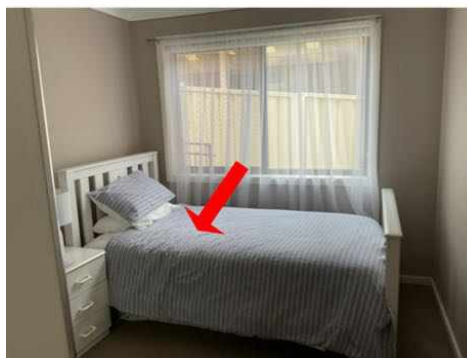
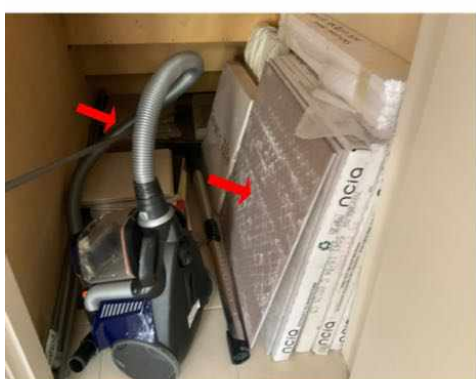
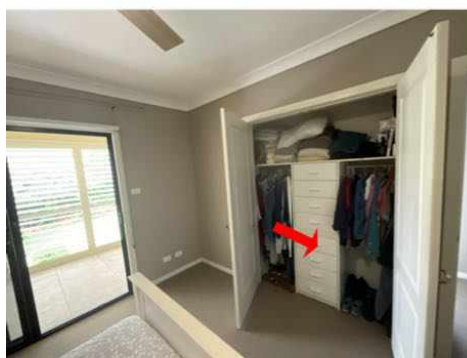
Building: Building 1
 Location: All Internal Areas
 Finding: Additional Photos - Obstructions and Limitations of INTERNAL AREAS
 Information: These photographs are an indication of the obstructions and limitations which impeded full inspection of Internal areas at the time of inspection. These obstructions can hide an array of defects and should be removed to allow full inspection to be

carried out. A re-inspection is recommended once the areas are made accessible.

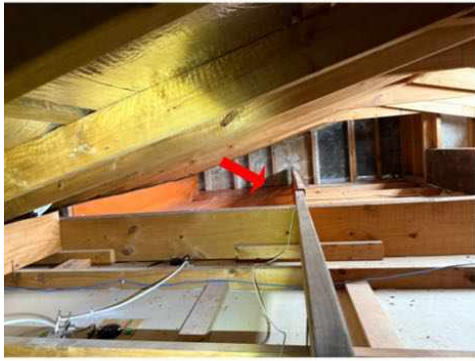
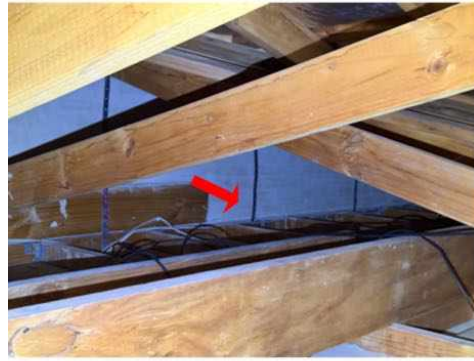
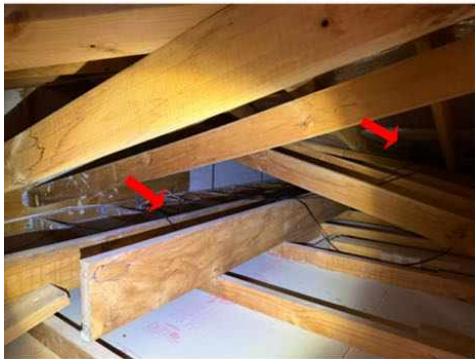
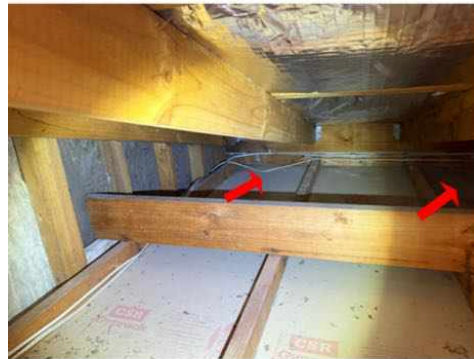
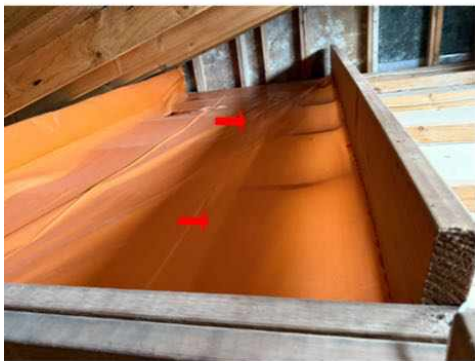
Building: Building 1
 Location: All Roof cavity areas
 Finding: Additional Photos - Obstructions and Limitations of the ROOF CAVITY
 Information: These photographs are an indication of the obstructions and limitations which impeded full inspection of roof cavity areas at the time of inspection. These obstructions can hide an array of defects and should be removed to allow full inspection to be carried out if applicable. A re-inspection is recommended once the areas are made accessible.

The inspection was also limited to areas with an allowable crawl space of 600mm x 600mm, in particular towards the external walls where the roof line diminishes, these areas were not accessible.

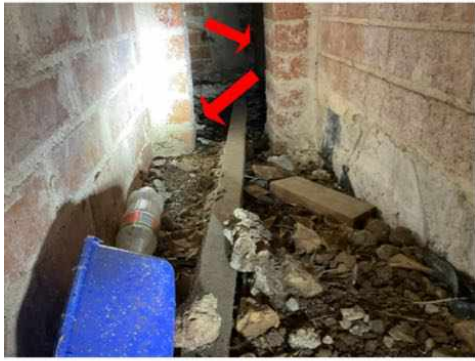
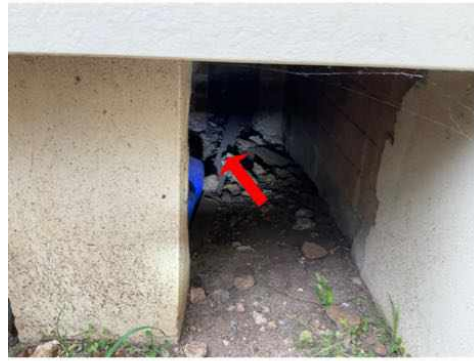
Building:	Building 1
Location:	All Subfloor Areas
Finding:	Additional Photos - Obstructions and Limitations of SUBFLOOR AREAS
Information:	These photographs are an indication of the obstructions and limitations which impeded full inspection of subfloor areas at the time of inspection. These obstructions can hide an array of defects and should be removed to allow full inspection to be carried out. A re-inspection is recommended once the areas are made accessible.

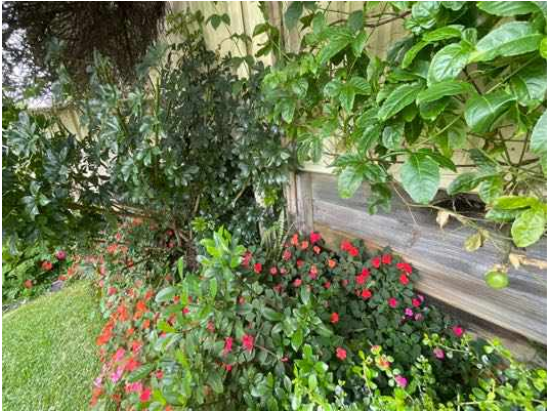
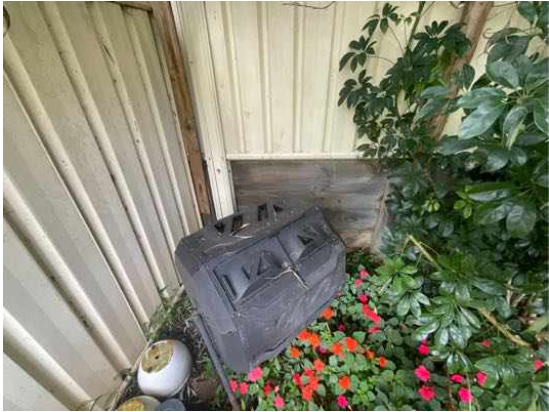
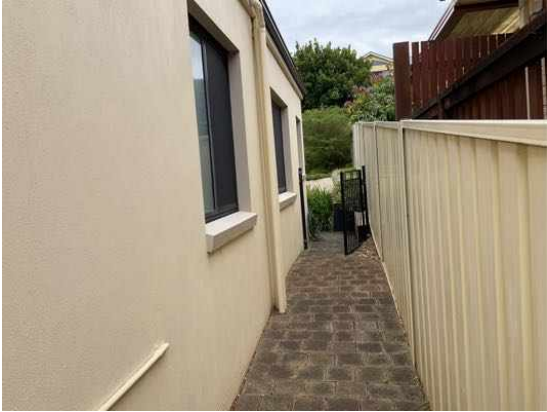
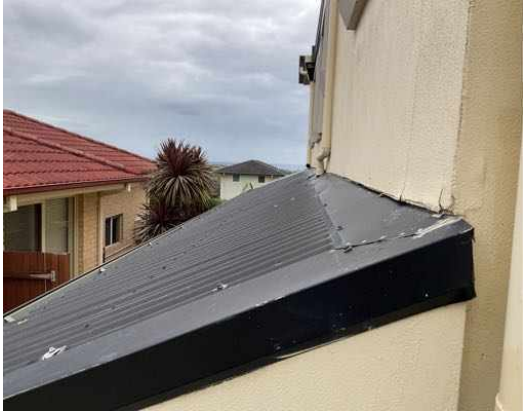
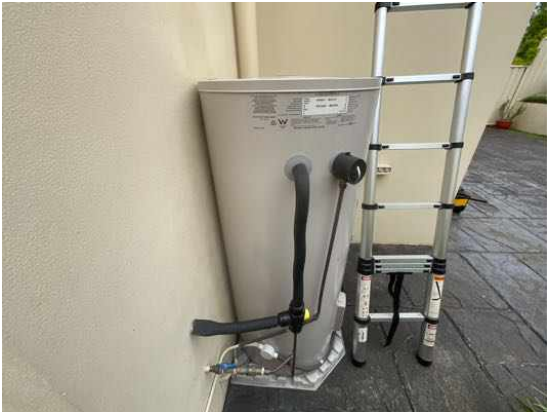
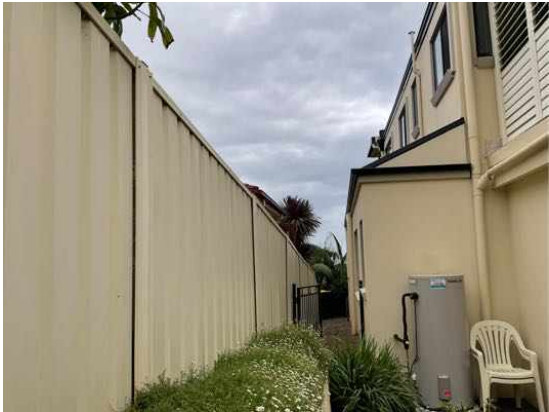
Building: Building 1
Location: All External Areas
Finding: Additional Photos
Information: Additional photos are provided for your general reference

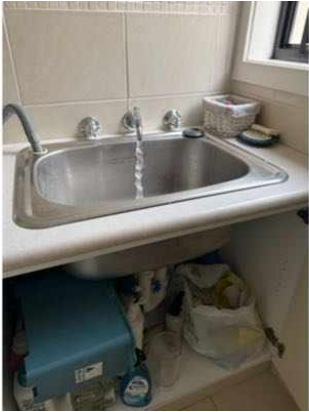
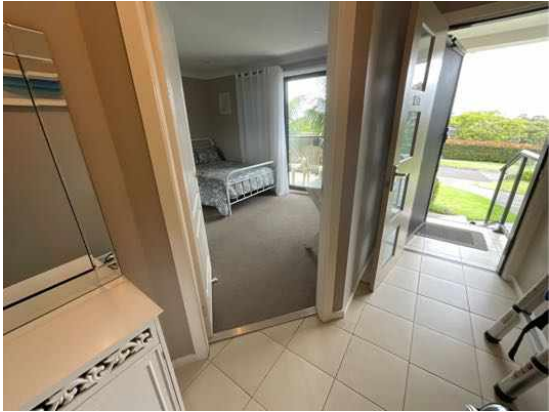
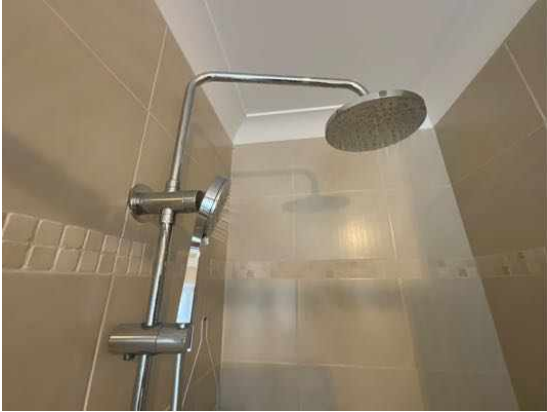
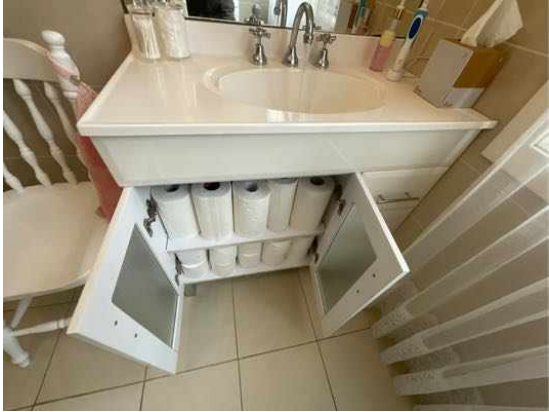
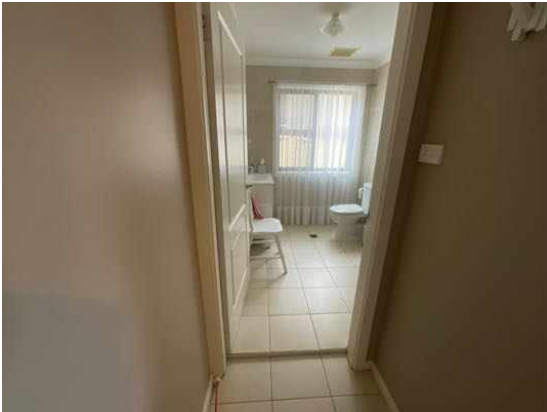
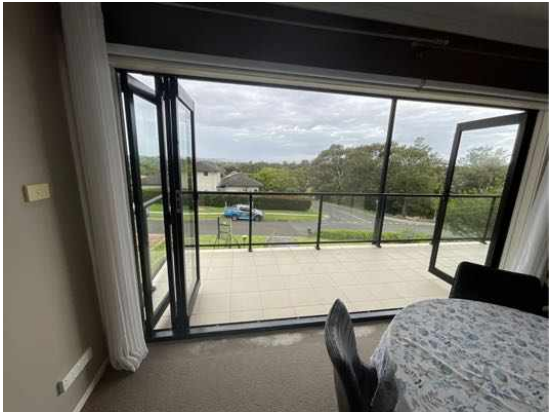
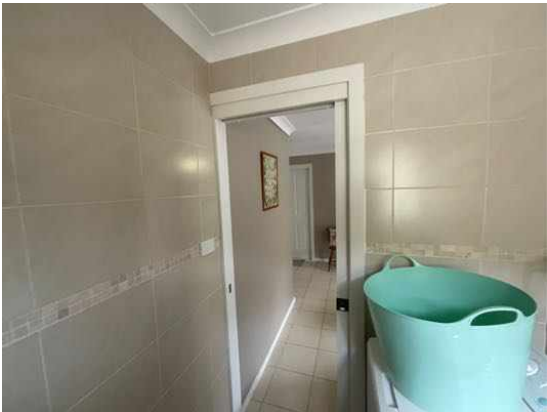
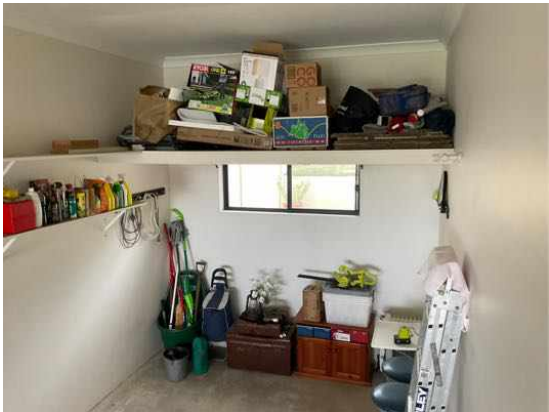
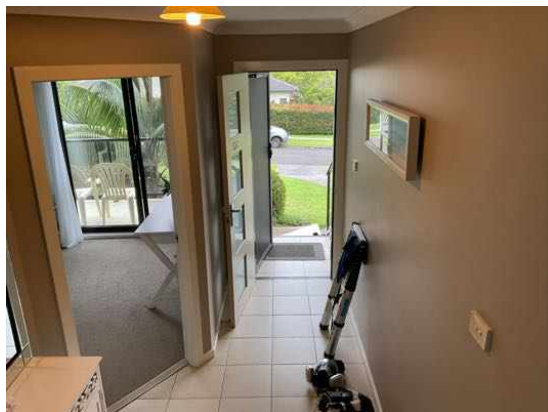
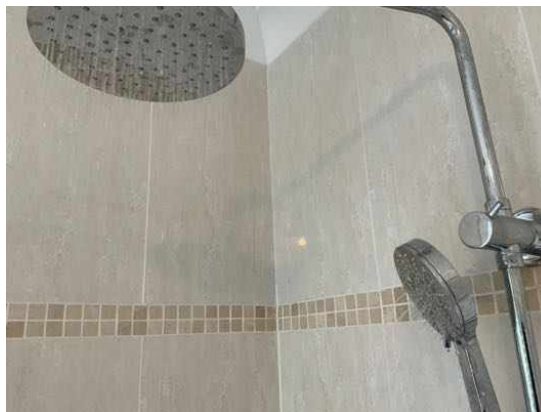
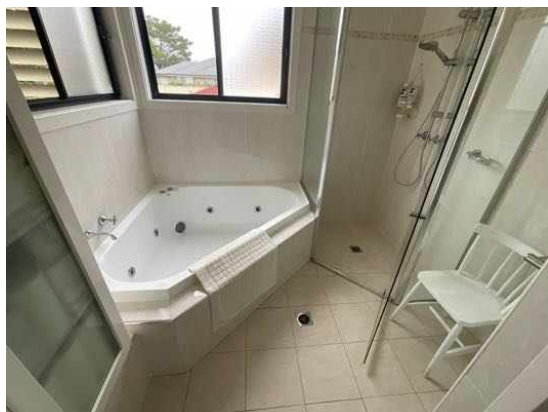
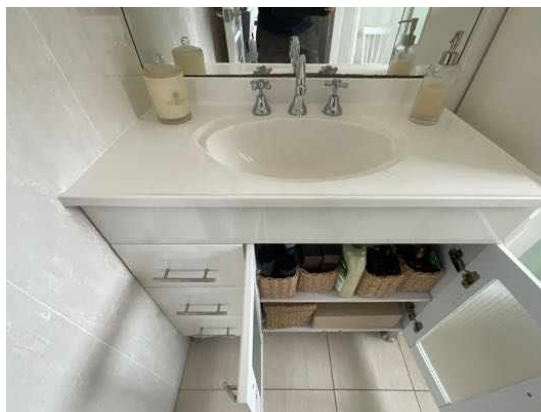
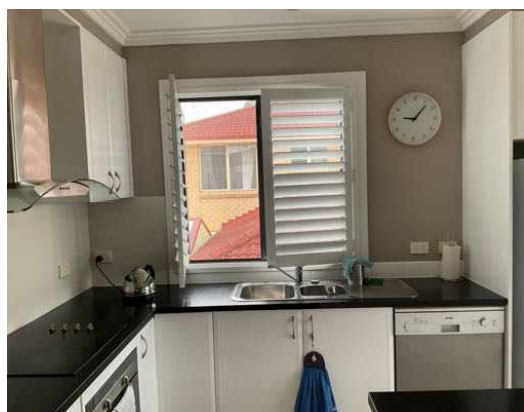
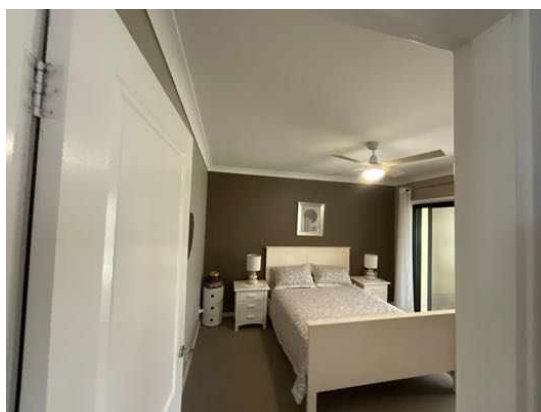
Building: Building 1
Location: All Internal Areas
Finding: Additional Photos
Information: Additional photos are provided for your general reference

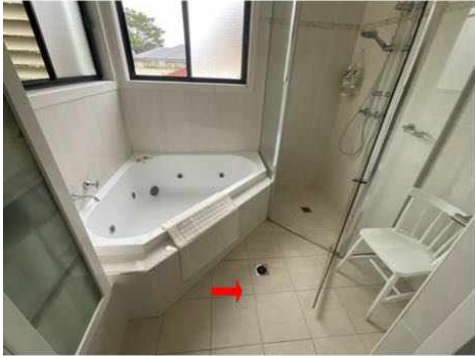
Building: Building 1
 Location: Bathrooms and laundry
 Finding: Waterproofing membranes - Information Only
 Information: Internal Water Proofing Membranes, are crucial in preventing water ingress into the property is important to know that the Membrane System used is to Australian Standards and has been installed correctly.

With older property's where this information is unavailable all wet areas should be monitored. If any leaks, water staining, peeling or bubbling of the paint become evident to any adjacent walls or ceilings below a licensed builder or waterproofing specialist is recommended to investigate further.

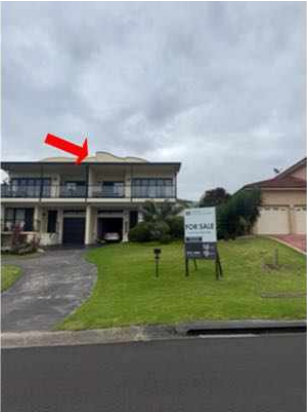
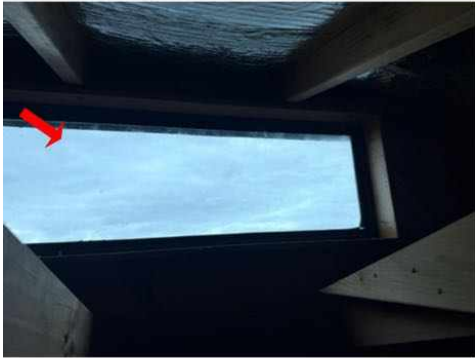
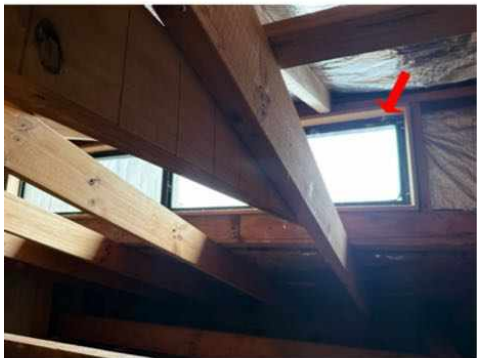
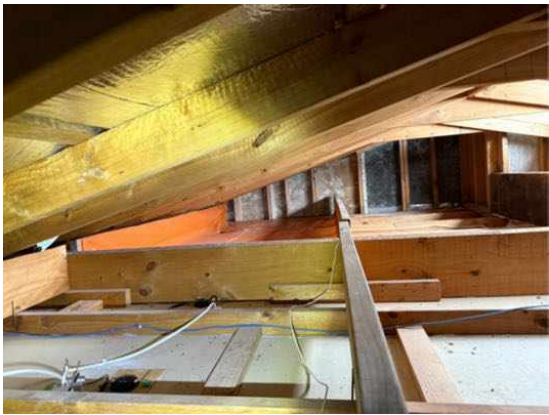
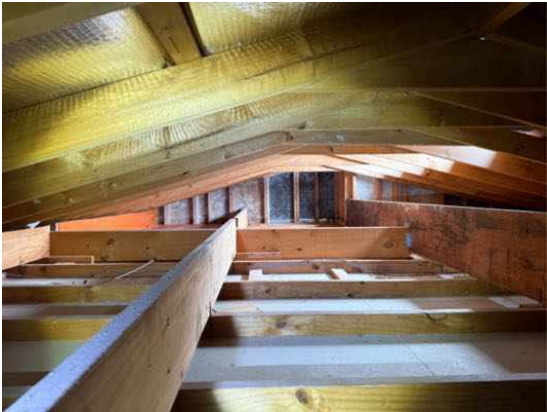
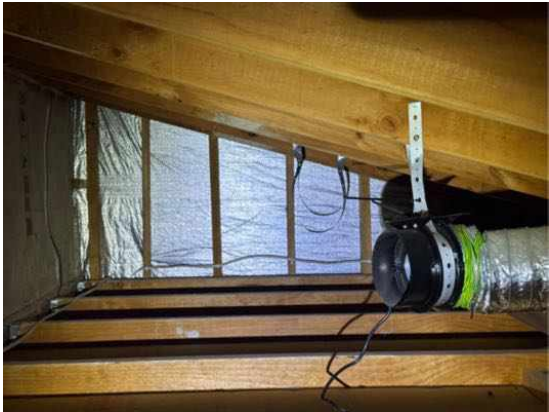
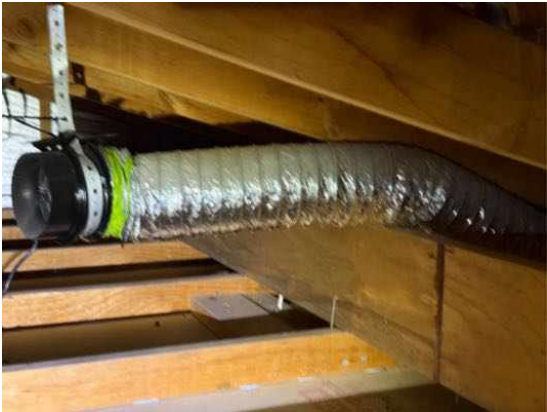
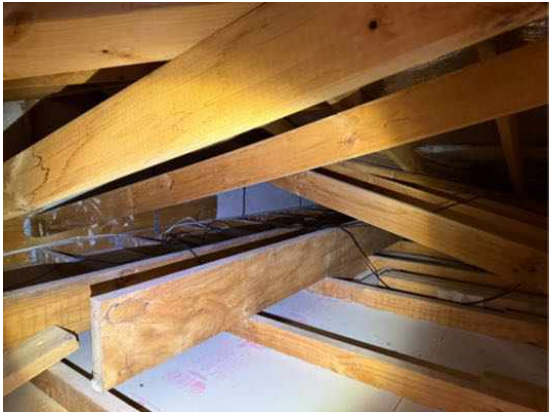
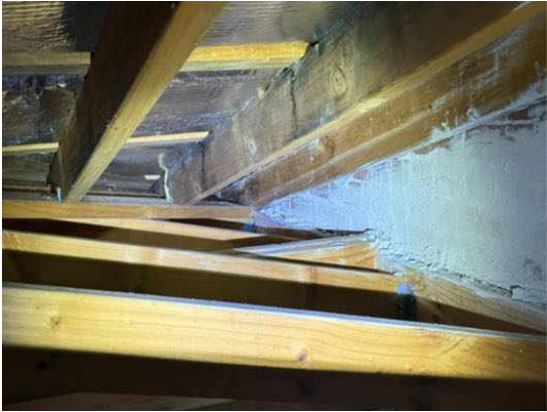
Building: Building 1
Location: All Roof cavity areas
Finding: Additional Photos
Information: Additional photos are provided for your general reference
