Building and Timber Pest Inspection Report

Inspection Date: Thu, 26 Feb 2026

Property Address: 103 Eighteenth Ave, Austral NSW 2179,
Australia

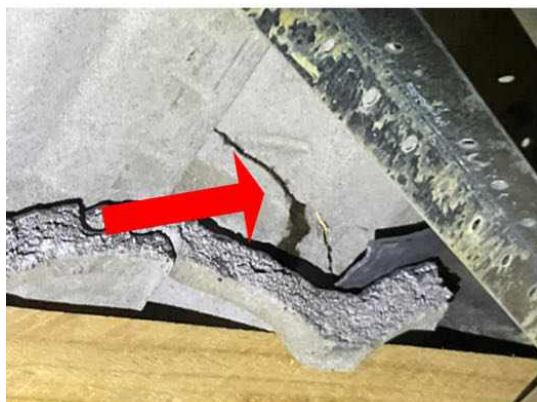
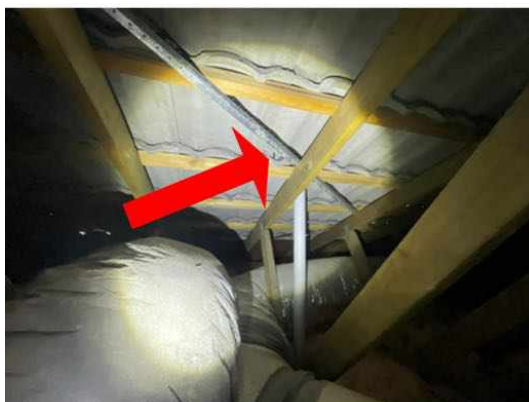
Building: Main Building
 Location: Roof Void
 Finding: Roof tiles - Broken
 Information: Upon inspection of the exterior roof covering, broken roofing tiles were identified. Broken and friable roof tiles are generally the result of ageing and weathering of what is essentially a porous material.

If left to further deteriorate, broken and brittle roof tiles are likely to lead to water penetration via the roof into the ceiling space, causing secondary damage to ceiling linings, insulation and roof structures. Broken roof tiles are also likely to detract from the effectiveness of the roof drainage system, creating potential for secondary damage to the exterior roof covering and roof plumbing.

Replacement of broken tiles is required and should be performed by a roofing contractor as soon as possible.

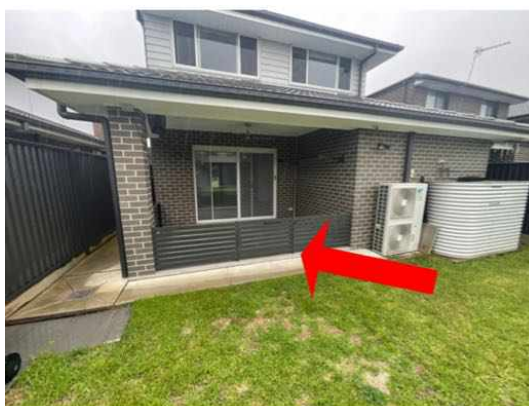
Finding 3.01

Building: Main Building
 Location: All External Areas
 Finding: Tiles - Cracked or damaged

Information: Cracking was evident to the tiling in this area at the time of inspection. While the cracking appears to be minor, this area is frequently exposed to water, allowing potential for water penetration into adjoining sections of walls or flooring.

If left unmanaged, water penetration to these areas may lead to subsequent water damage, which is likely necessitate repair work to affected building elements.

A tiling contractor should be appointed to ensure that no further water damage occurs. The re-application of silicone and grouting throughout remaining tile work is also advised, to further protect the area against water penetration.

Where water penetration has led to water damage, appointment of a relevant tradesperson may be required to repair damaged building elements.

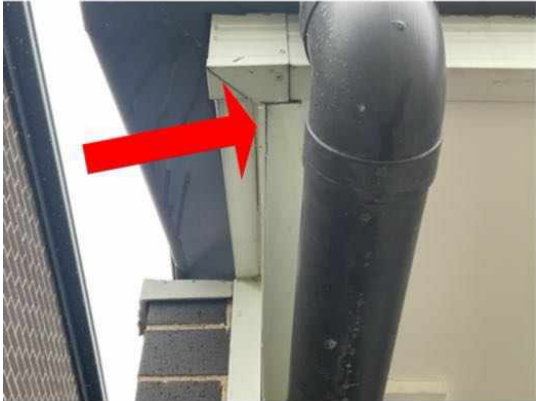
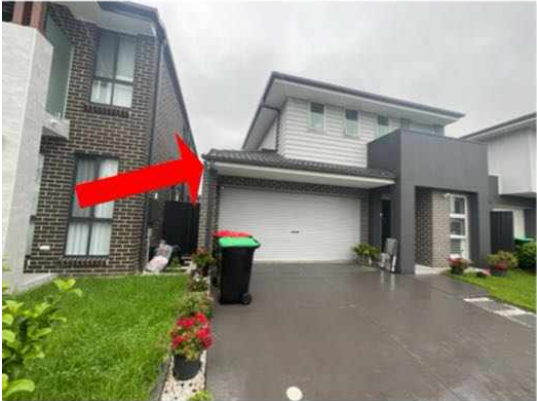
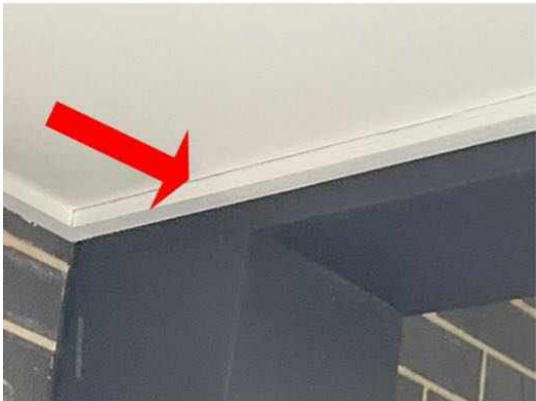
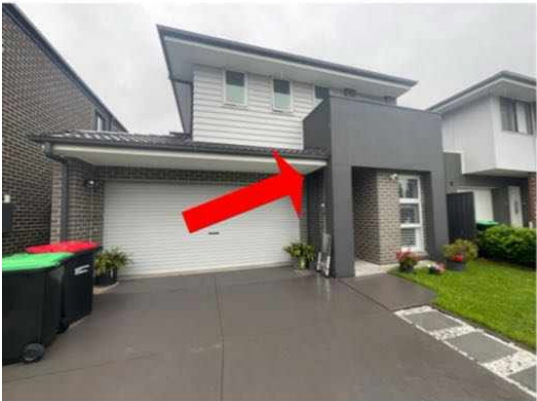
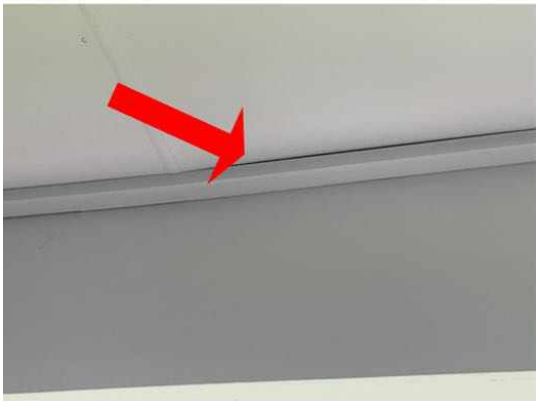
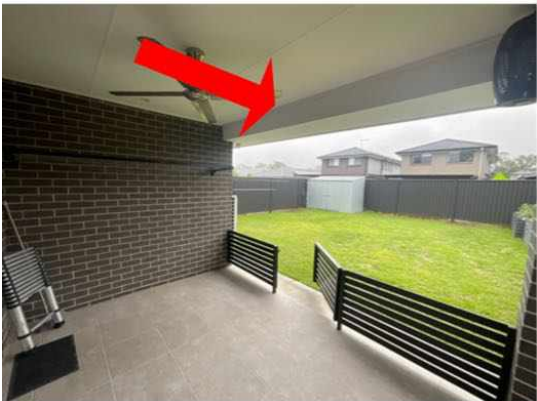
Finding 3.02

Building: Main Building
 Location: All External Areas
 Finding: Beads - Damaged
 Information: Beading acts (like cornice or skirtings) to cover the intersection or joins of building materials. It was noted at the time of inspection that beading in this area has deteriorated. This deterioration is suspected to have been caused by general ageing and frequent exposure to weather, which is expected in a building of this age and condition.

Beading is important in weatherproofing the surrounding building elements and preventing termite or pest ingress. Furthermore, beading works to protect the joins of building materials, which are more susceptible to deterioration and decay.

Repair or replacement of the beading is advised to ensure the protection and longevity of any associated building elements. Such works may be performed by a general handyperson or qualified carpenter.

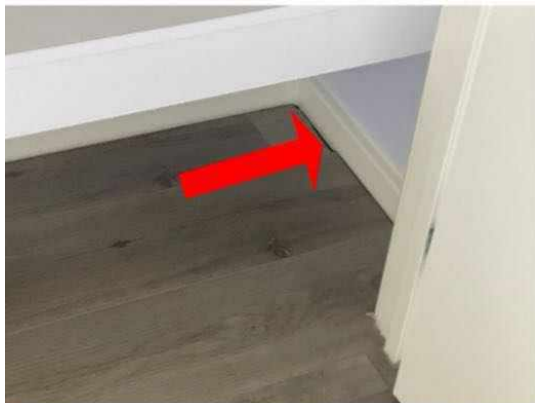
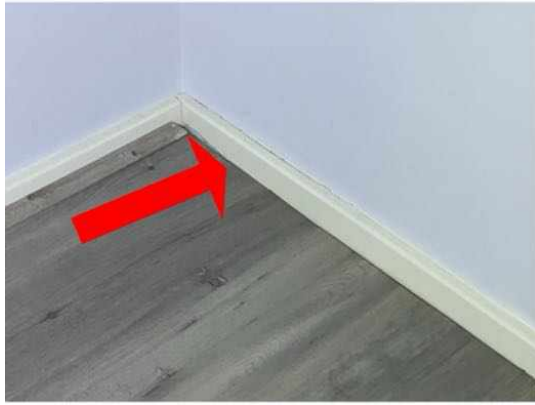
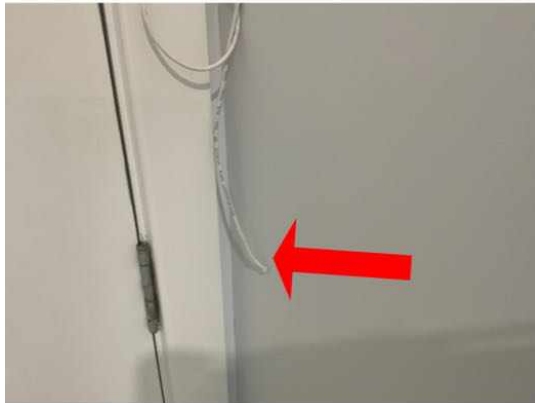
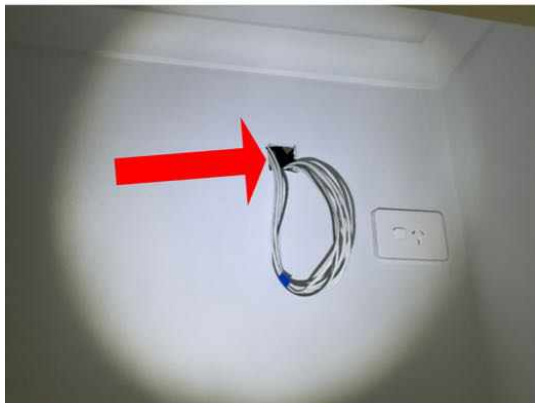
Finding 3.03

Building: Main Building
Location: All Internal Areas
Finding: Installation - substandard or incomplete
Information: The installation of this building element appears to have been completed to a substandard level of workmanship or is incomplete. Generally substandard repairs or installation are related to poor workmanship, the use of inappropriate materials, or a failure to complete installation to a suitable standard.

Where installation is substandard and/or incomplete, the client should contact the responsible trade to undertake rectification. Unfinished and substandard building works are likely to degrade more quickly and may create potential for secondary defects to associated building elements.

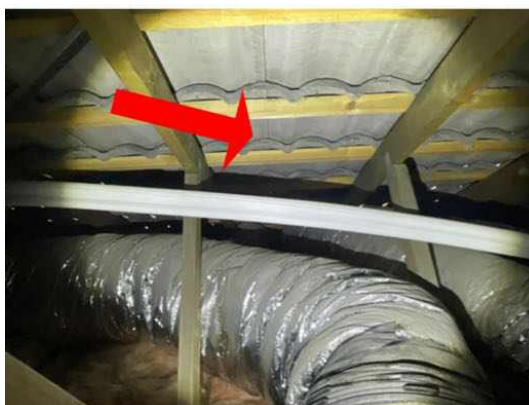
Finding 3.04

Finding: Sarking - Missing

Information: Sarking is missing under the roof sheeting. Sarking acts as an insulator that helps with noise reduction and protects against water penetration. Sarking plays a key role in the operation and function of the overall roofing structure and its performance.

Although not a requirement at the time of construction, replacement of any missing building element is advisable (although this can be quite expensive to do after the time of construction). Where sarking is missing, regular inspections of the roof tiles for cracking and potential moisture penetration is required.

Sarking may be retrospectively fitted by a registered builder at the discretion of the client.

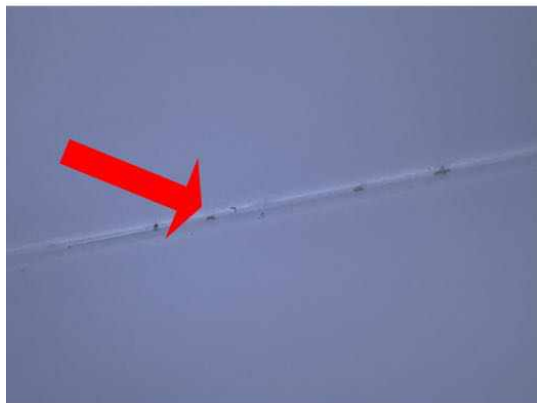
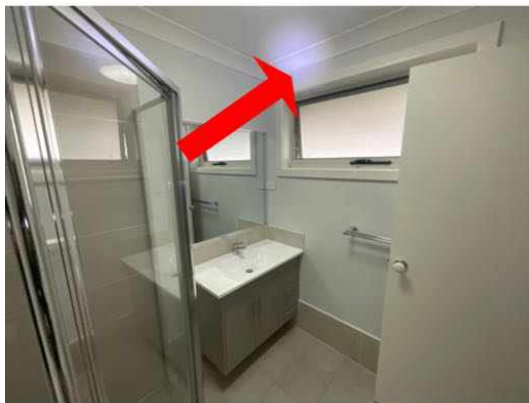
Finding 3.05

Building:	Main Building
Location:	Ensuite
Finding:	Bathroom Ceiling - Mould Growth
Information:	Minor mould growth was observed to the bathroom ceiling along the joint line. This is likely due to condensation and elevated moisture levels within the bathroom environment.

While the mould appears localised and minor at the time of inspection, prolonged moisture exposure may lead to further deterioration of paint finishes and potential substrate damage.

- Clean and treat affected areas with an appropriate mould removal solution.
- Repaint with mould-resistant paint if required.
- Improve ventilation (ensure exhaust fan is operational and ducted externally).
- Monitor for recurrence.

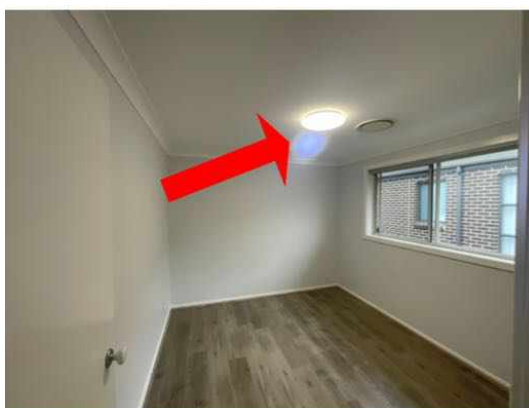
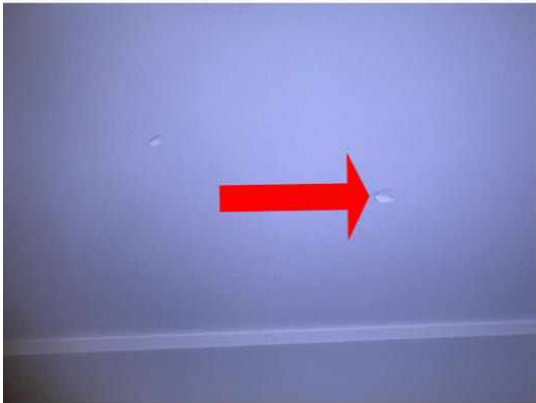
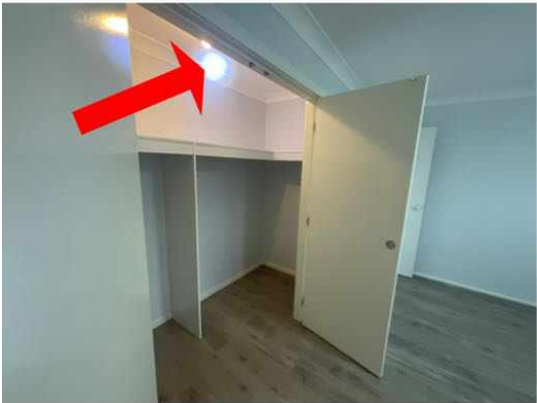
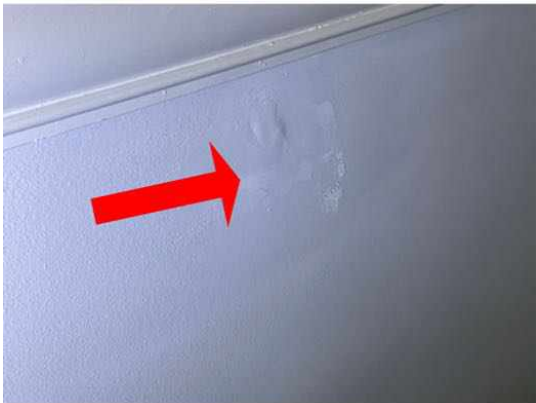
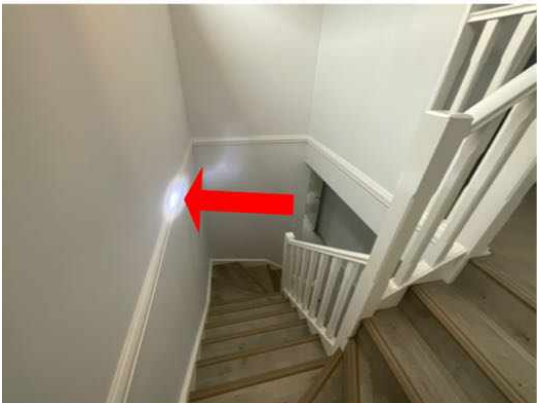
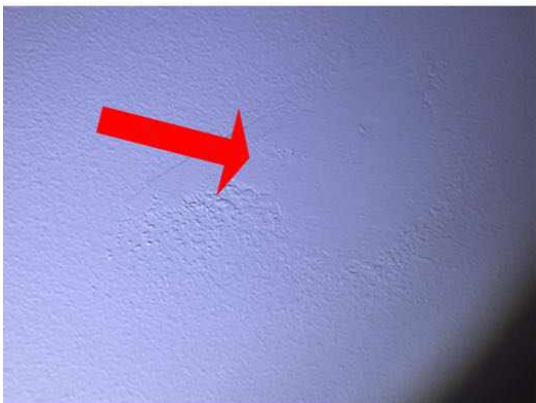
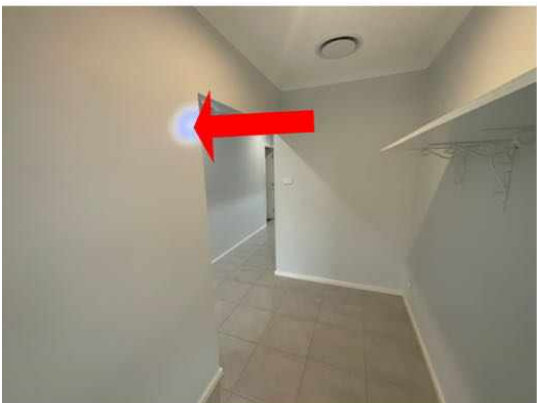
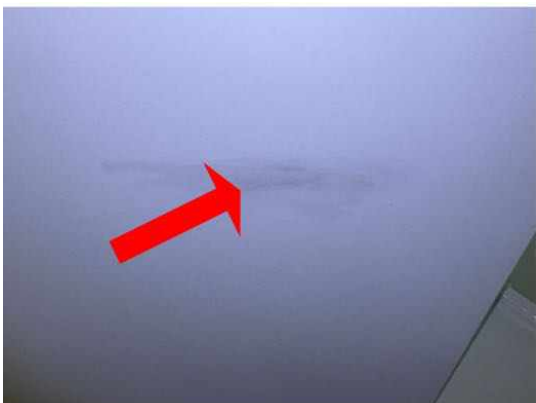
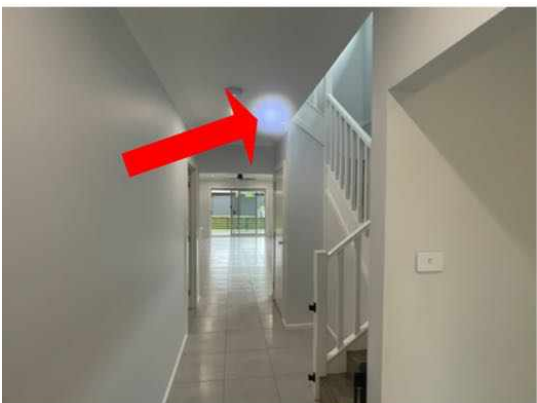
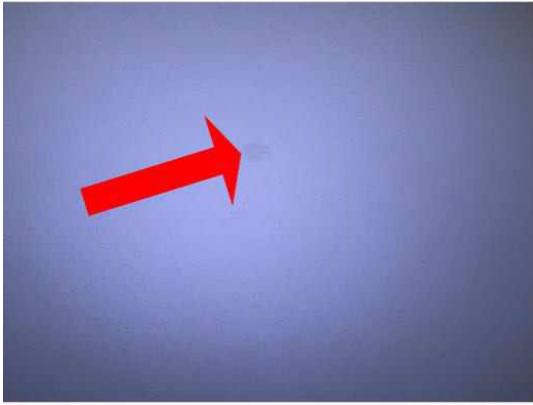
Finding 3.06

Building:	Main Building
Location:	All Internal Areas
Finding:	Paint finish - Substandard
Information:	The paint finish in this area was found to have been completed to a substandard level. Substandard painting is generally classified as an appearance defect. However, the substandard appearance may also be indicative of poor surface preparation and substandard workmanship.

If this applies, further areas of poor and incomplete finishes could develop over time. Furthermore, substandard paint finishes in areas exposed to moisture, e.g. external areas or wet areas, could lead to deterioration of underlying building materials.

Substandard paint finishes should be sanded back, filled, leveled and repainted, as applicable. Where inadequate paint protection has led to the deterioration of the associated building element, repair and/or replacement of this building element may be required.

A painting contractor should be appointed as soon as possible to perform necessary works to aid the appearance of the affected area and to ensure that the area is protected against further deterioration. Alternatively, the homeowner following manufacturer instructions may be able to provide this service.

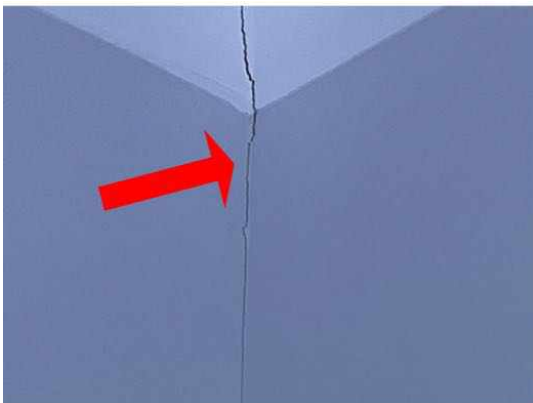
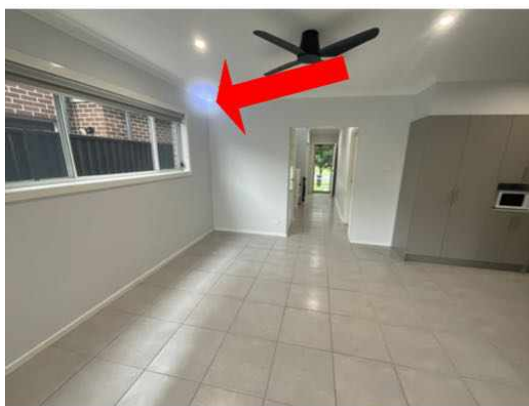
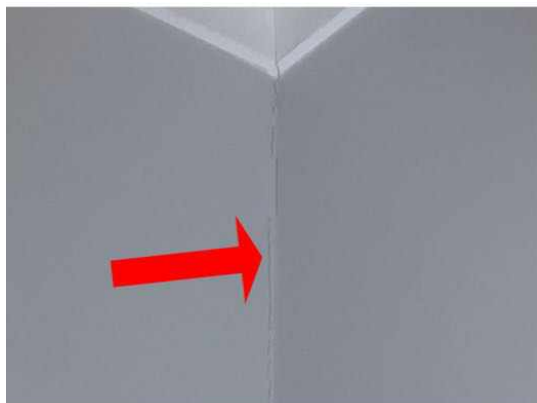
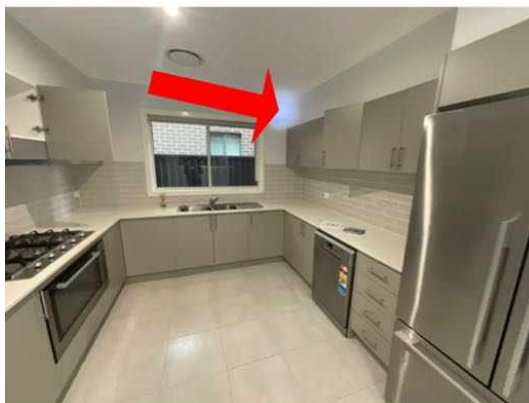
Finding 3.07

Building:	Main Building
Location:	All Internal Areas
Finding:	Cracking - Damage Category 1 - Fine (up to 1mm)
Information:	Although fine cracks are quite noticeable, they are often only considered to be an appearance defect, and usually do not indicate any structural damage. Generally, the cause of a fine crack is indicative of a separation between building materials and finishes (e.g. paint, plaster, etc.) along joints.

Cracking of this nature can generally be repaired with minor sanding, filling and/or repainting. Such works should be performed by a qualified painter or a general handyman.

Monitoring of all cracking should be conducted frequently. Always contact a building inspector should cracks widen, lengthen, or become more numerous.

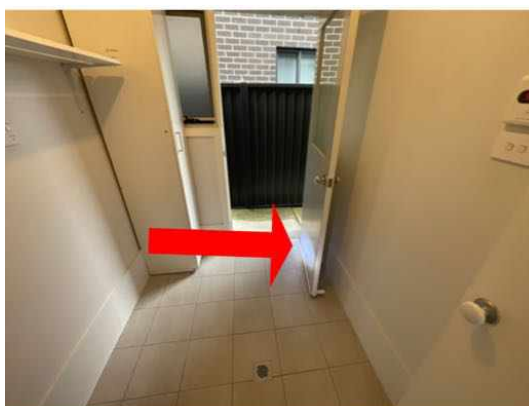
Finding 3.08

Building:	Main Building
Location:	Laundry
Finding:	Bottom seal of entry door - inadequate
Information:	The bottom seal of the door is inadequate at the time of inspection, allowing water to enter the interior of the building. This defect compromises the weatherproofing of the door, potentially leading to water damage, moisture-related issues, and reduced energy efficiency.

Mandates that external doors must be designed and installed to prevent water penetration under wind and rain conditions. A properly fitted bottom seal is critical to

- Install or replace the bottom seal of the door with a compliant weatherproof seal that prevents water from entering the interior during rain or wind conditions.
- Ensure that the seal is durable and appropriately fitted without affecting the door's functionality or accessibility.
- Test the door seal after installation under simulated wet conditions to confirm effectiveness.

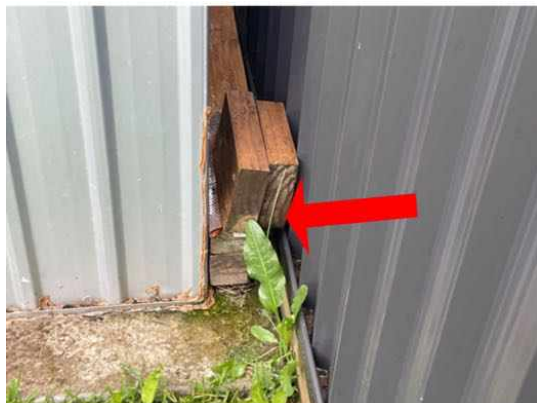
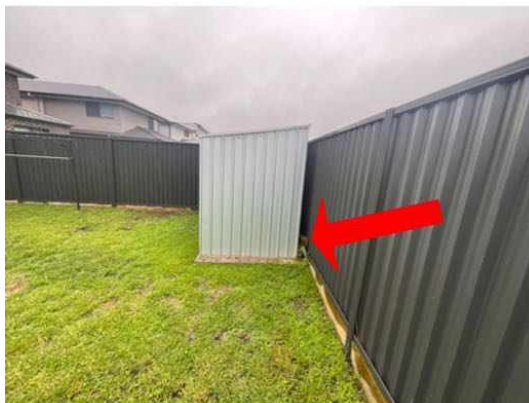
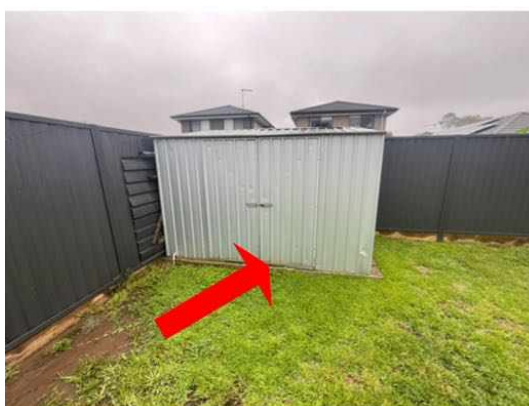
Building:	Main Building
Location:	All Areas
Finding:	Garden Beds - Conditions Conducive to Termites
Information:	Garden beds were found to be evident in the garden area. These garden beds can

include untreated timber, and with a combination of moisture from watering hosing can make conditions conducive to termite activity and termite ingress.

Building:	Main Building
Location:	All Areas
Finding:	In ground contact
Information:	Any timbers in direct ground contact provide opportunity for concealed termite entry and are likely to be subject to premature rot and decay as the soil retains moisture or damp conditions against the timbers.

Remove untreated timber that is in direct contact with external grounds. Consider replacement with more durable materials i.e. treated timber or non timber elements. Frequent pest inspections are advised to readily identify any termite activity in these areas.

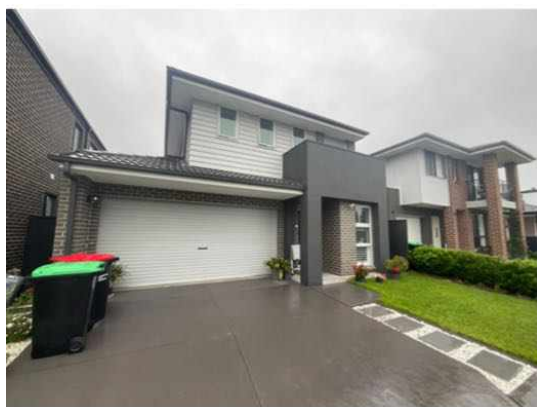
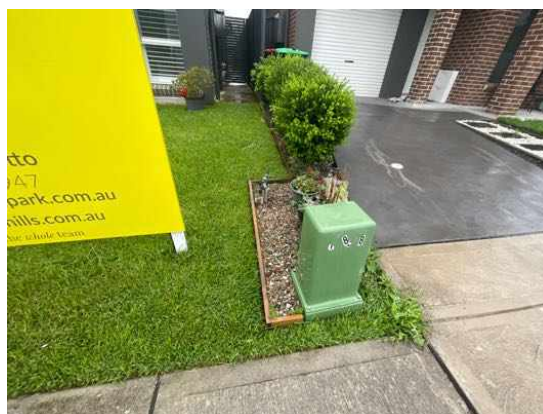
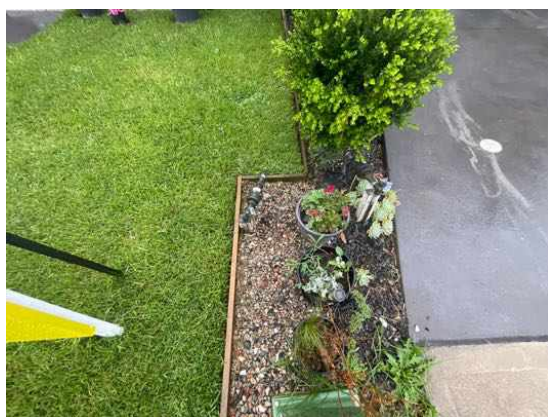
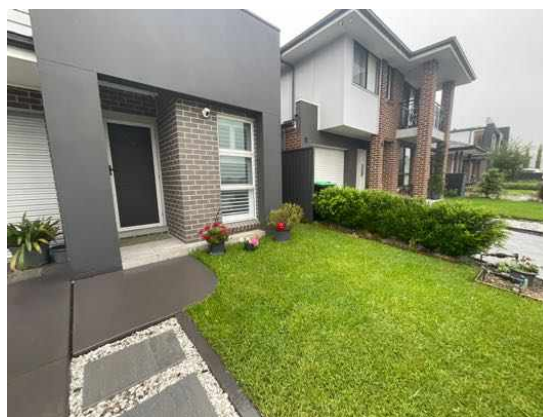
Building: Main Building
Location: All Areas
Finding: Additional Photos - Obstructions and Limitations
Information: These photographs are an indication of the obstructions and limitations which impeded full inspection of the property at the time of inspection. These obstructions can hide an array of defects and should be removed to allow full inspection to be carried out. A re-inspection is recommended once the areas are made accessible.

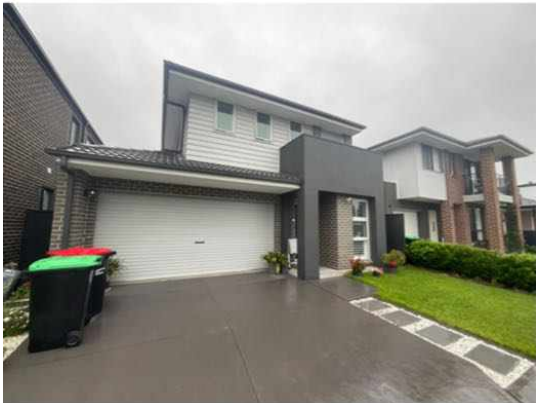
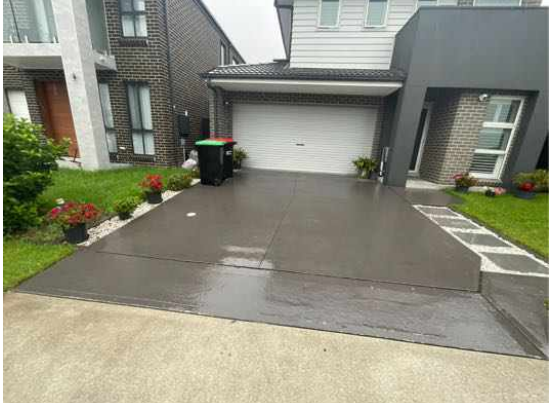
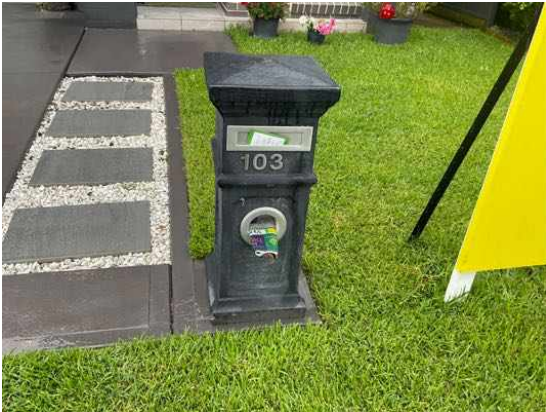
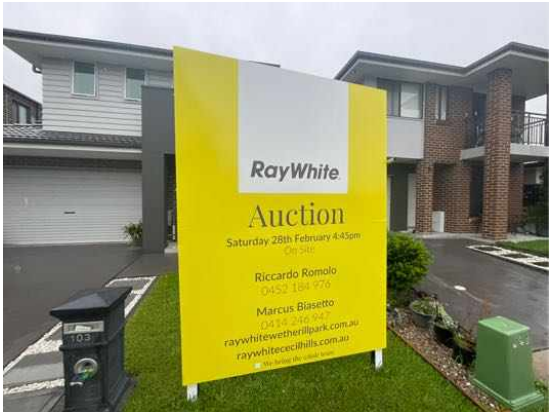
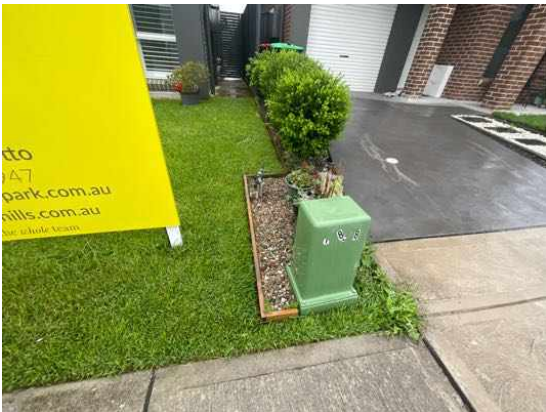
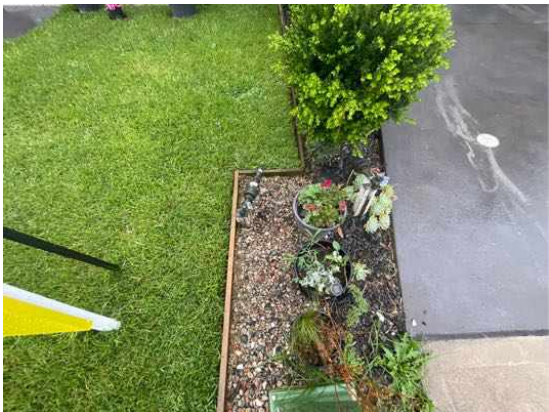
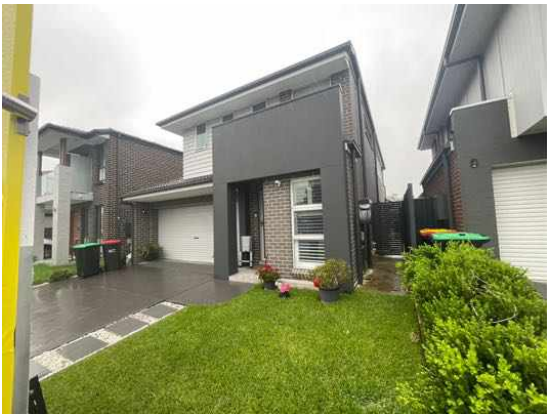
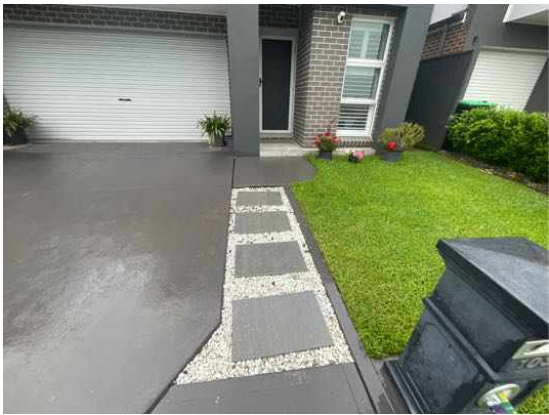
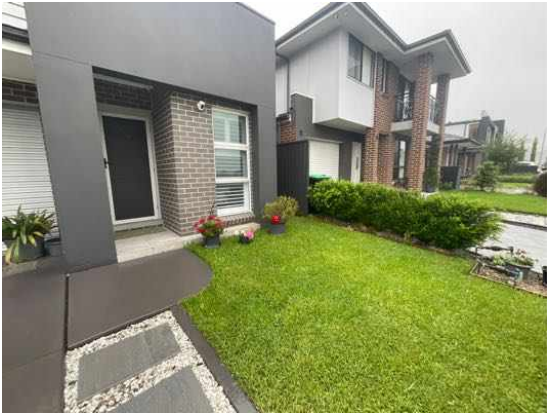
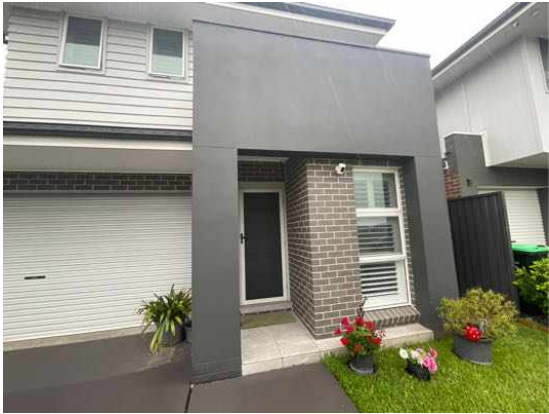
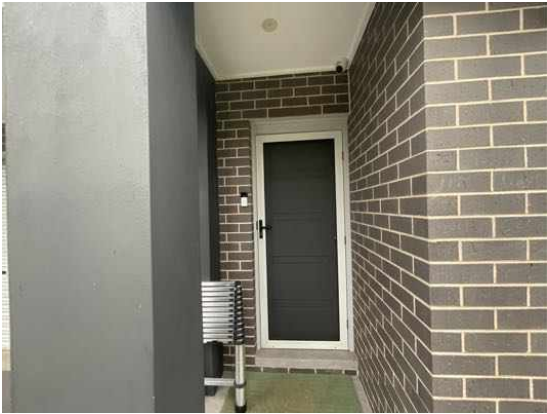
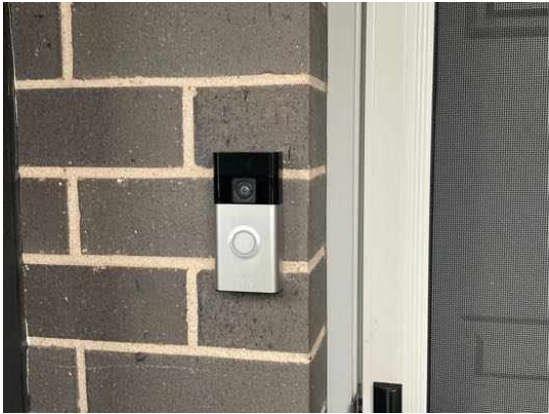
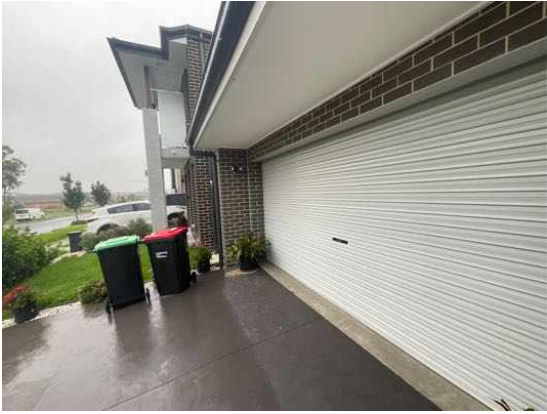
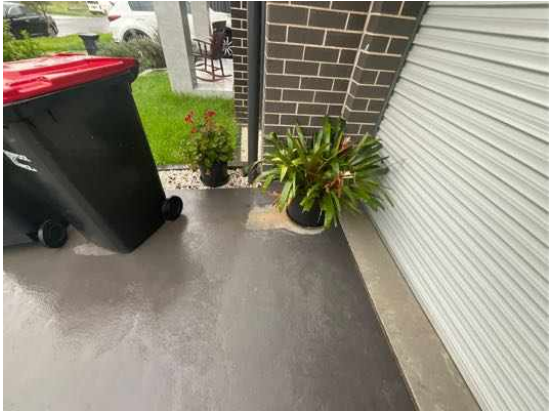
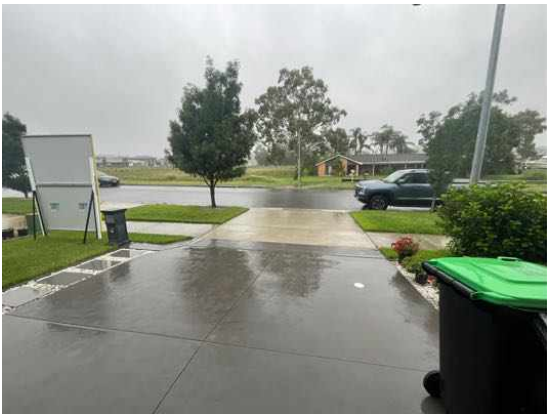
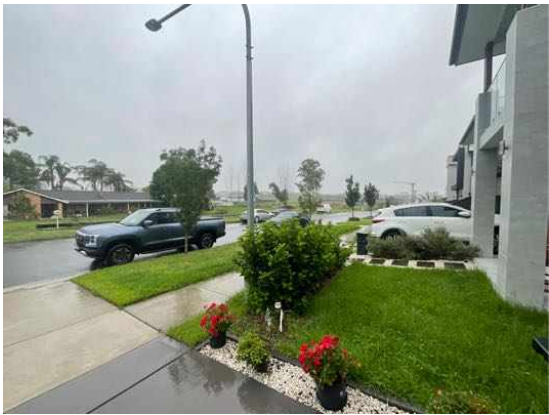
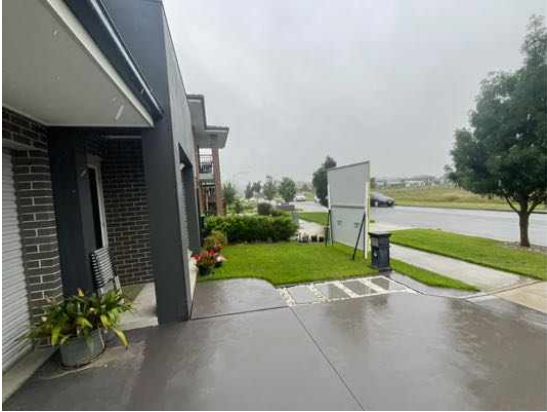
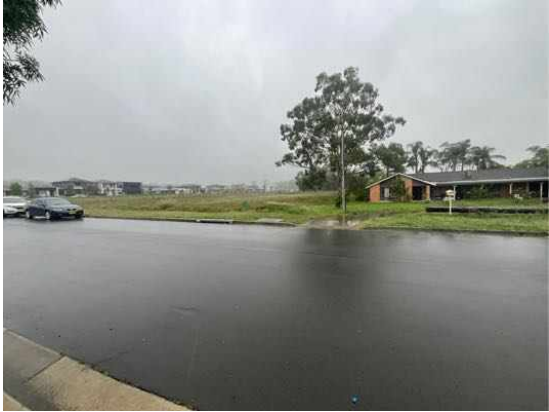
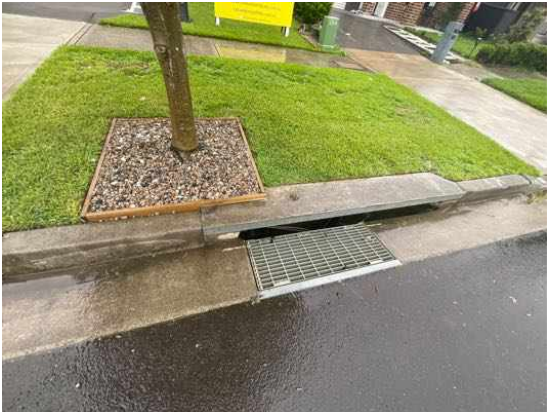
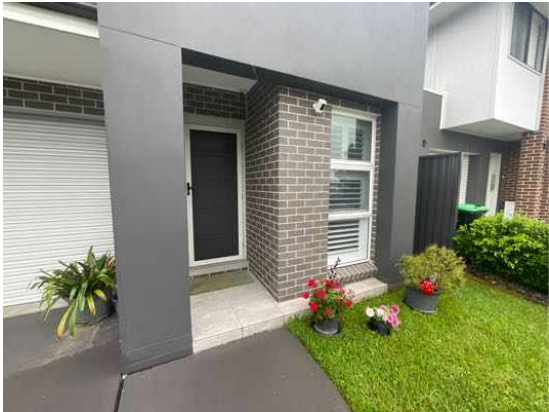
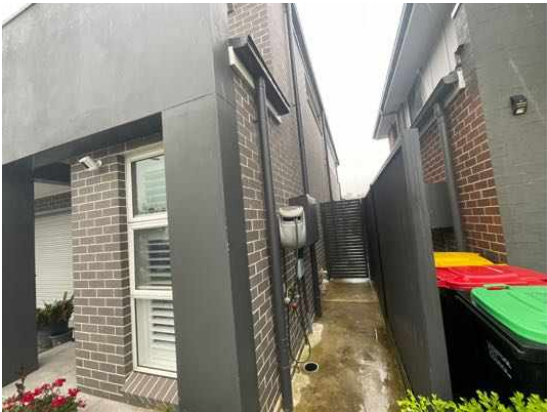
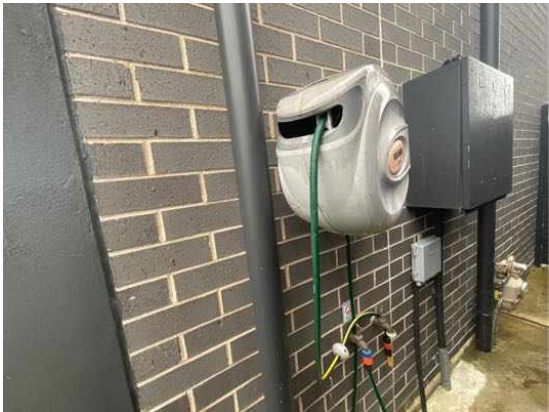
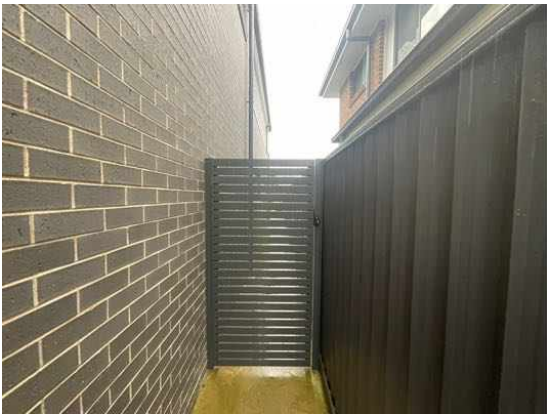
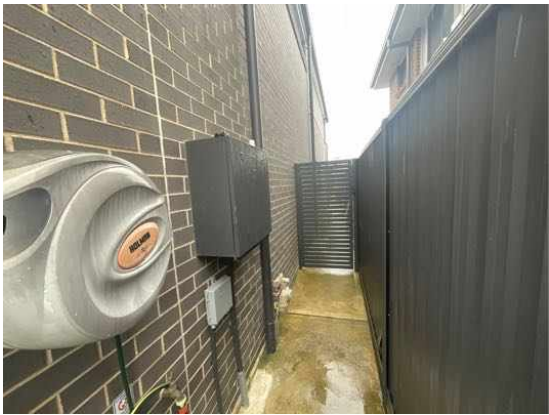
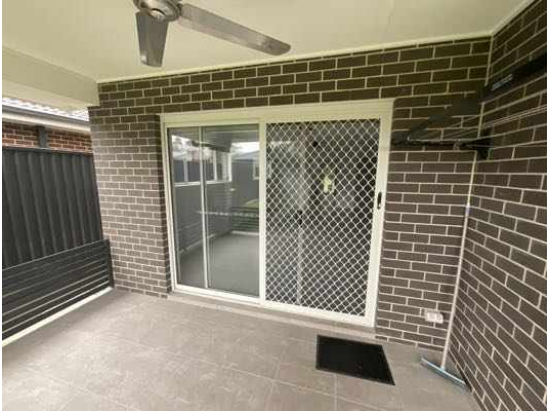
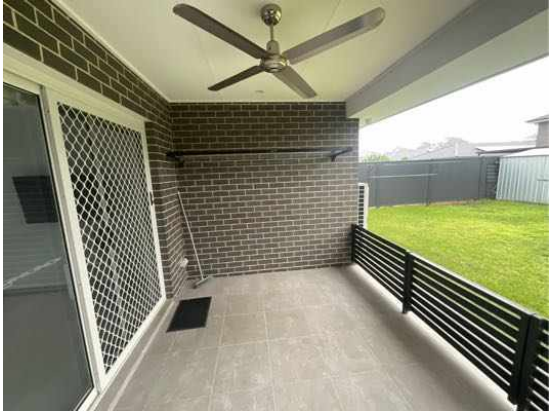
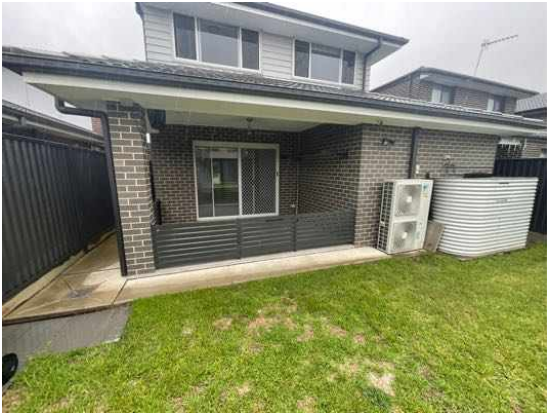
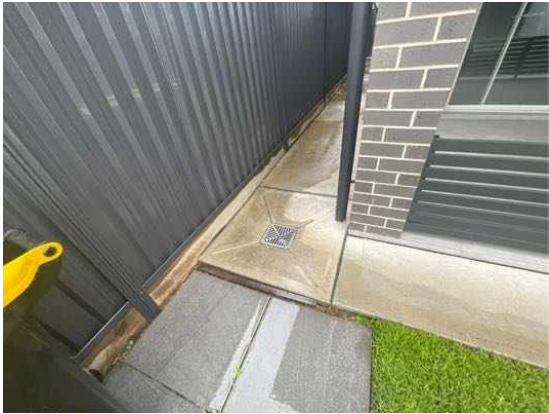
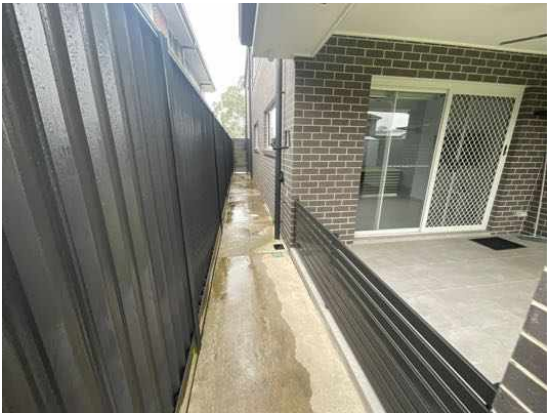
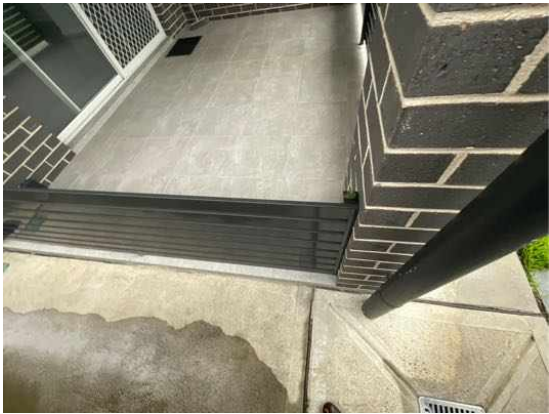
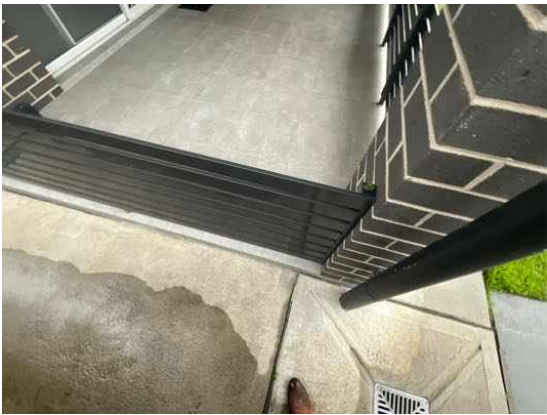
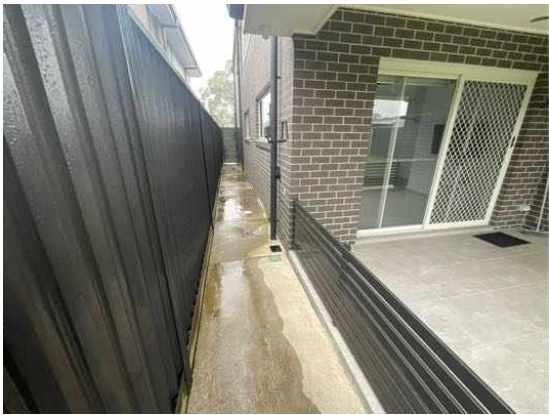
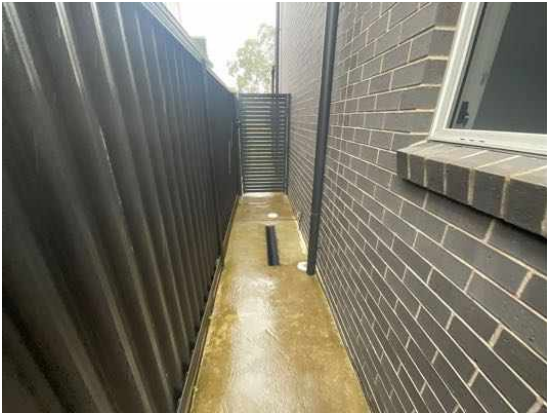
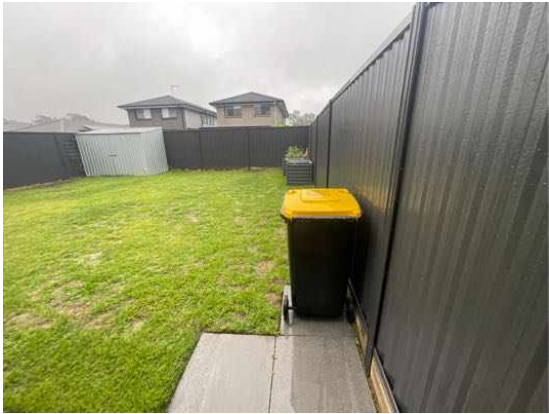
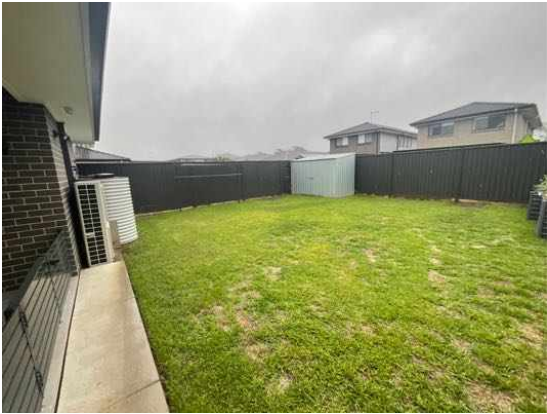
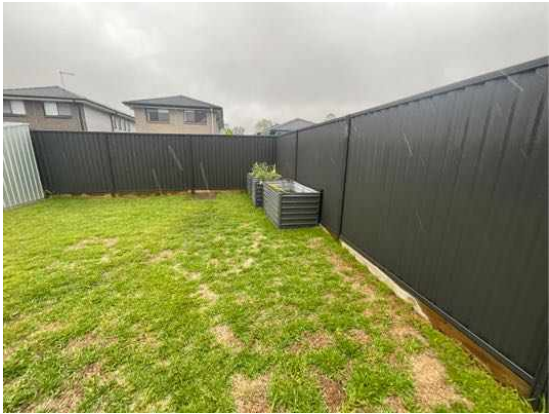
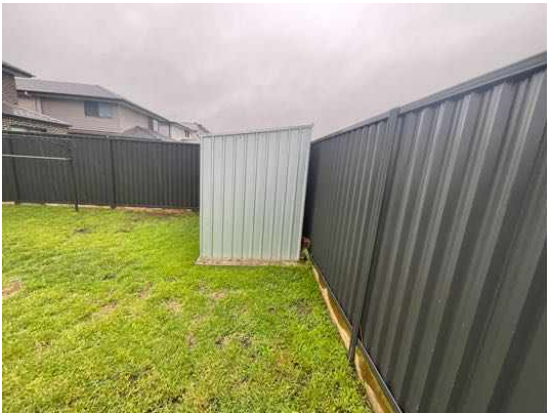
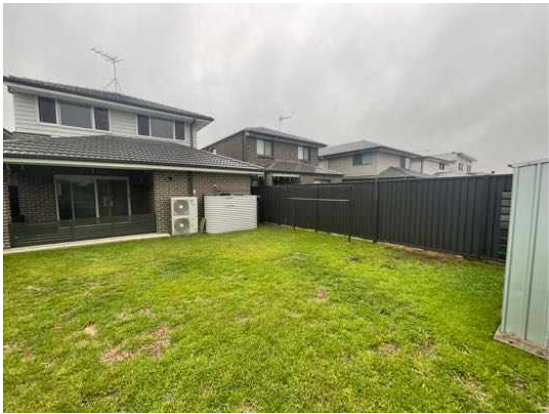
Building: Main Building
Location: All Areas
Finding: Additional Photos
Information: Additional photos are provided for your general reference
