Building and Timber Pest Inspection Report

Inspection Date: Thu, 26 Feb 2026

Property Address: 103 Eighteenth Ave, Austral NSW 2179,
Australia

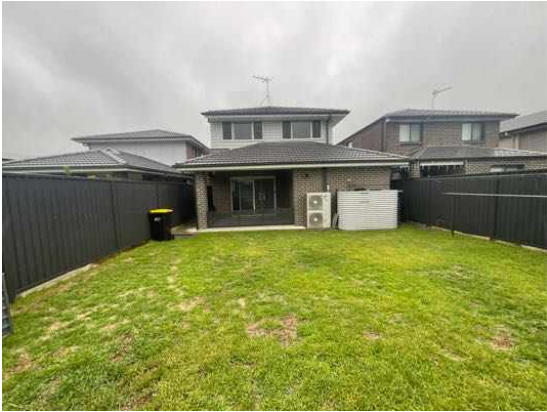
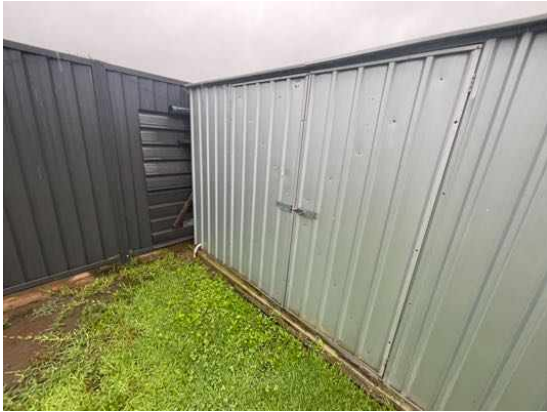
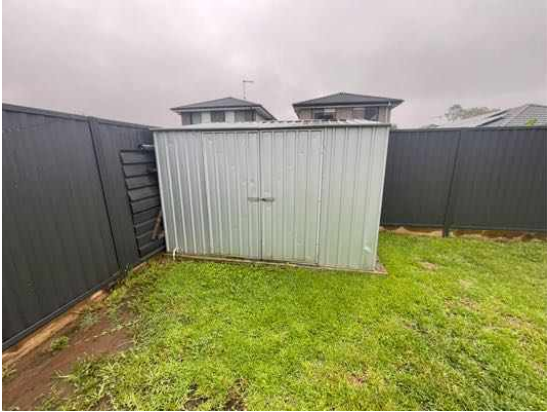
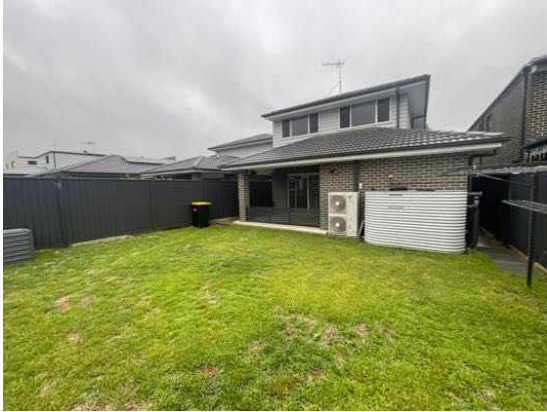
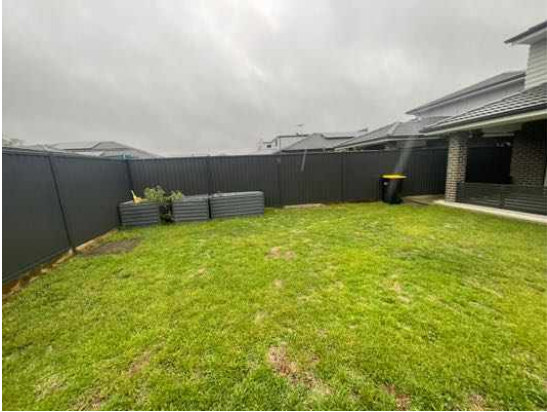
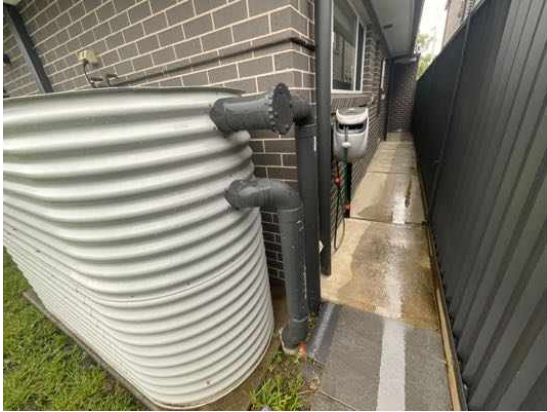
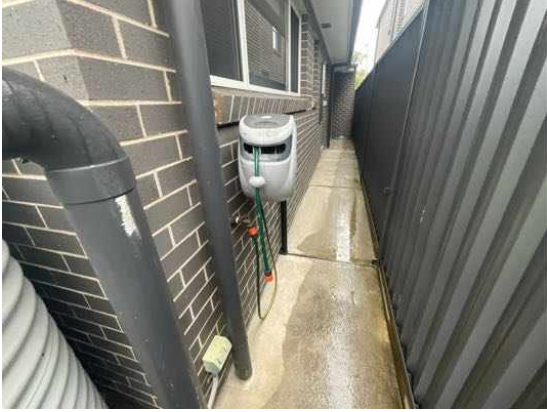
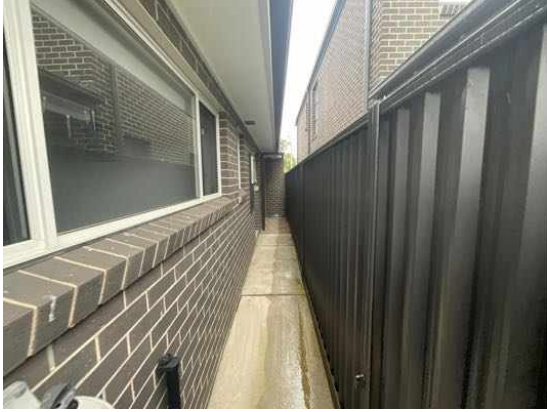
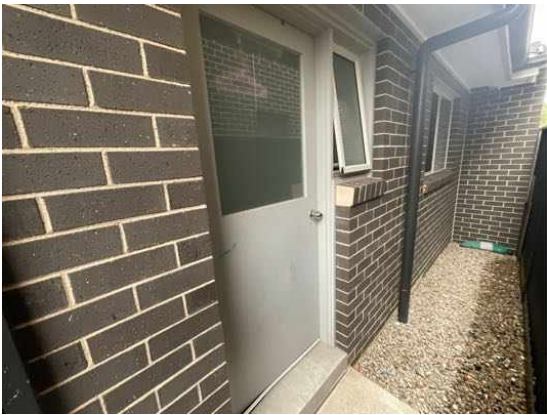
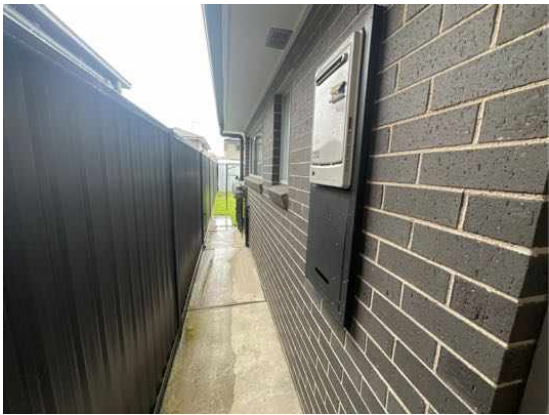
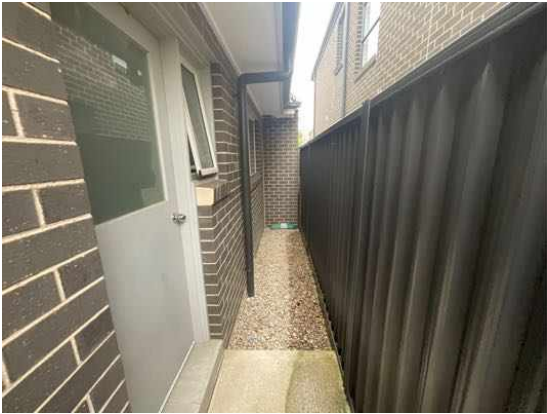
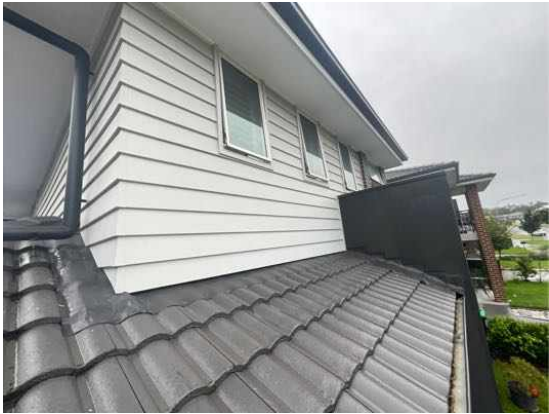
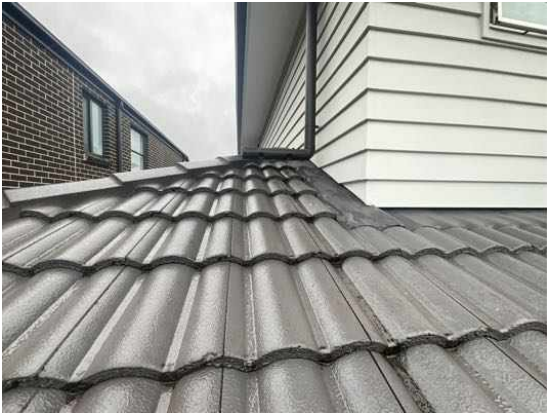
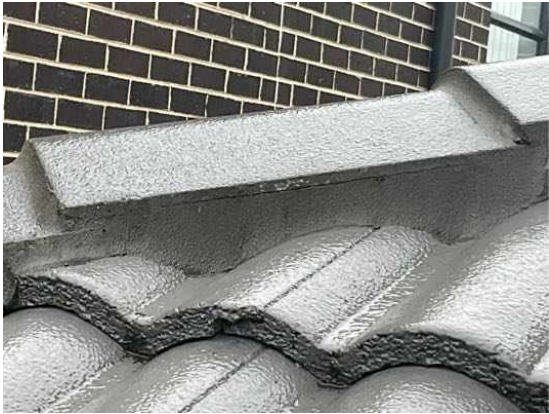
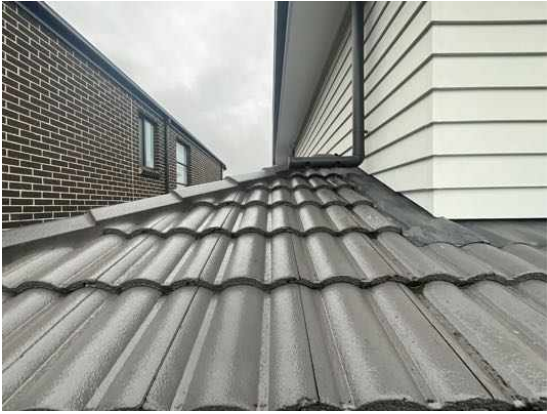
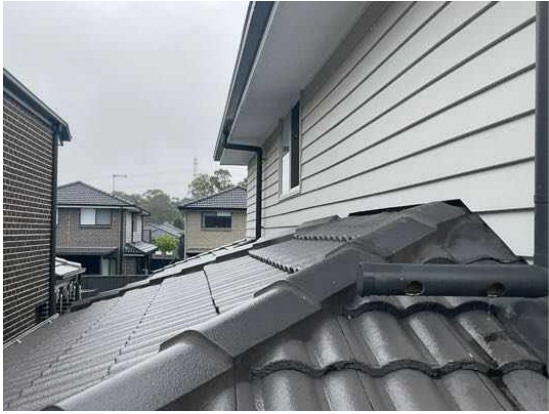
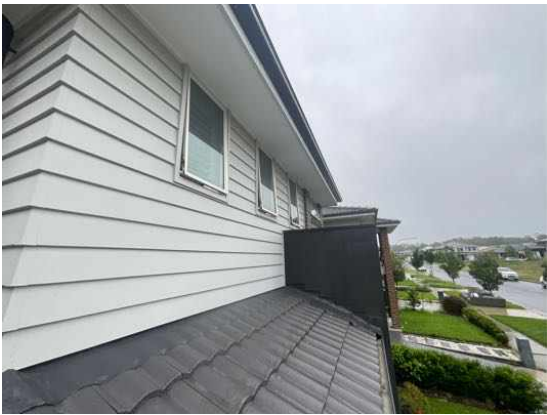
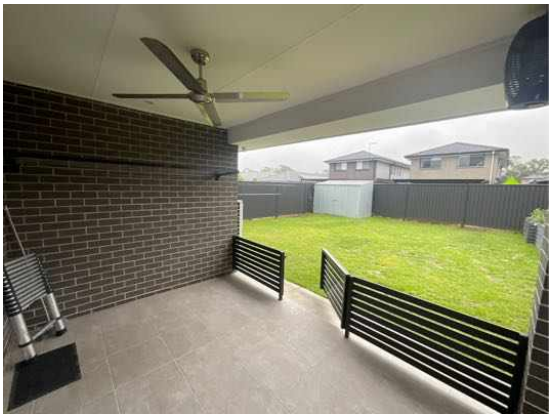
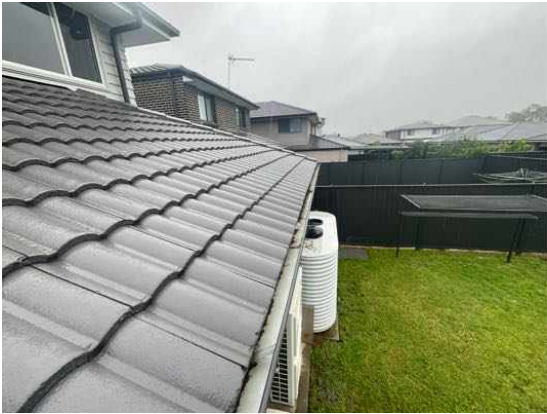
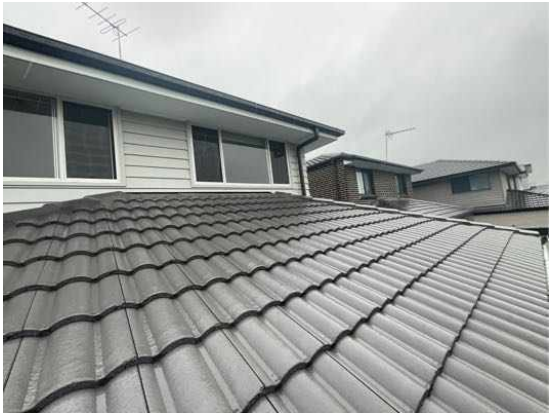
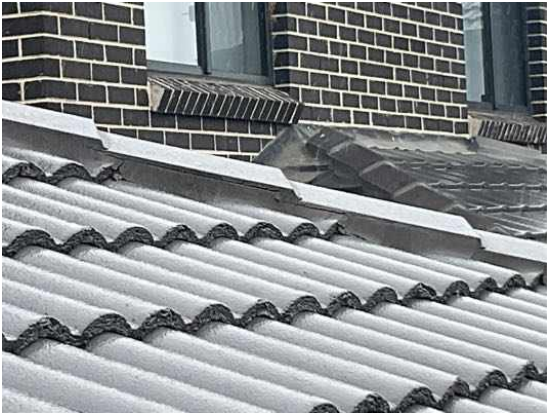
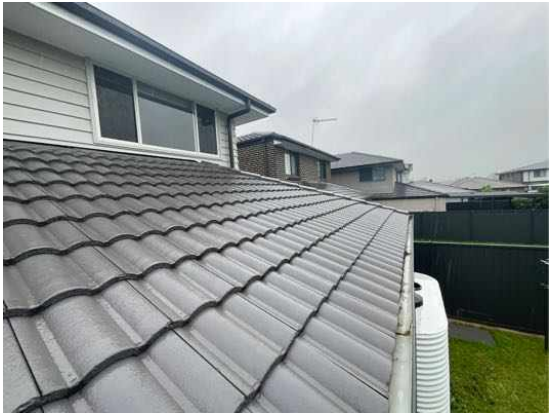
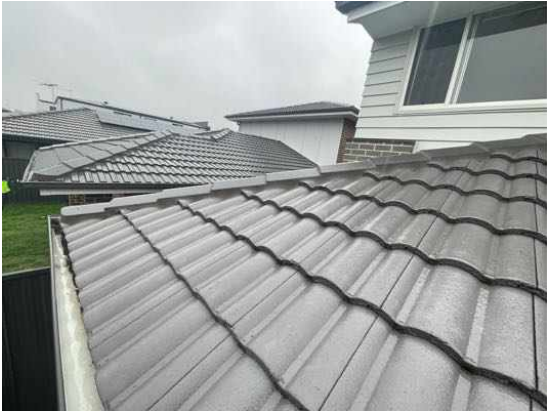
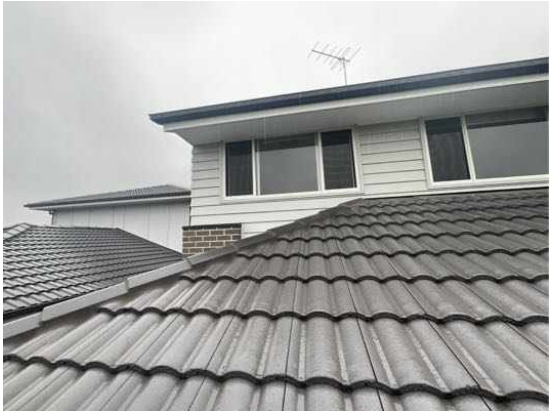
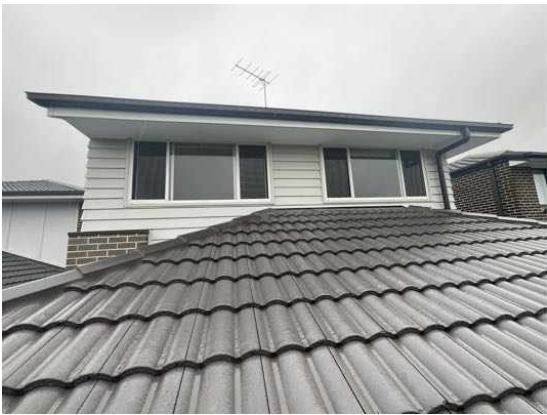
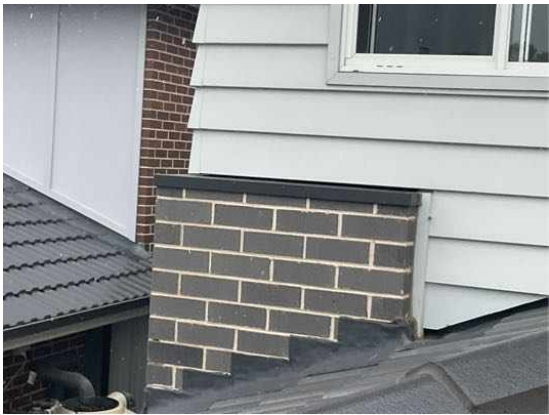
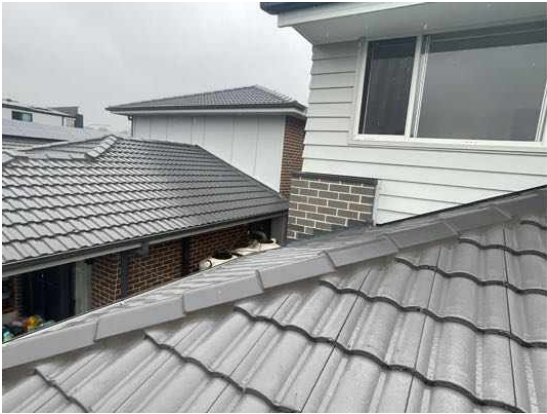
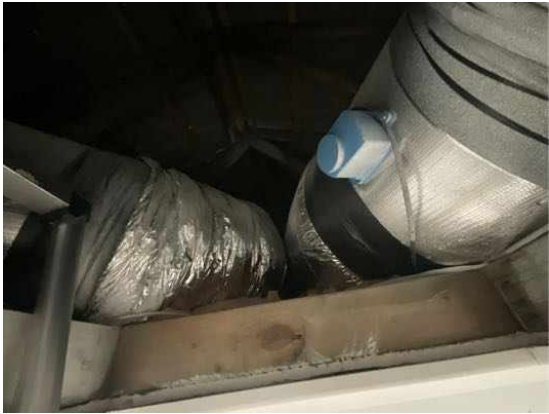
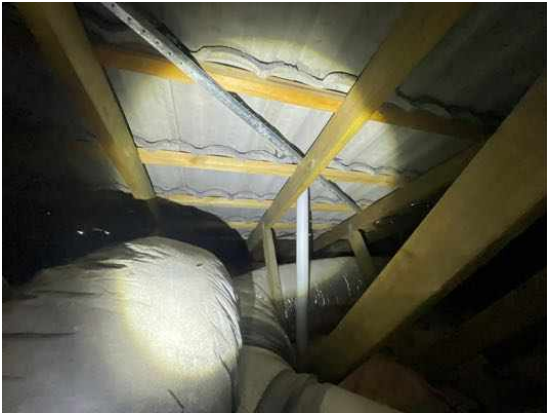
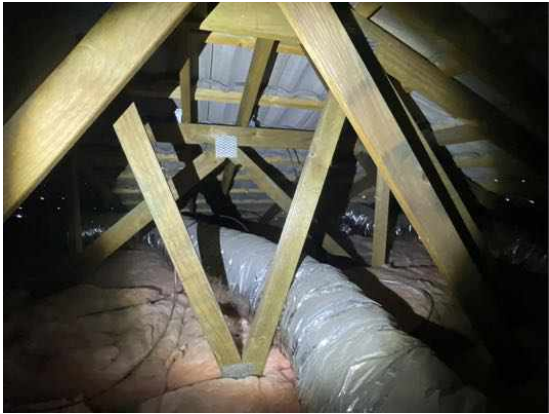
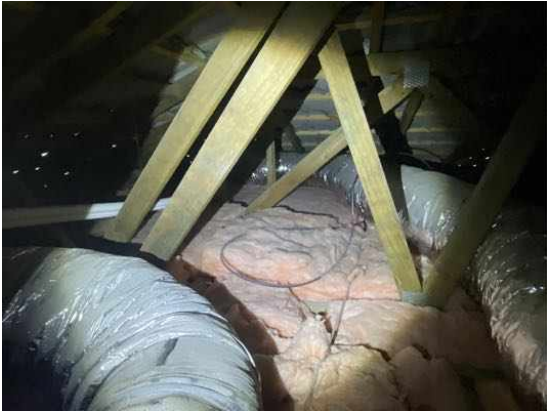
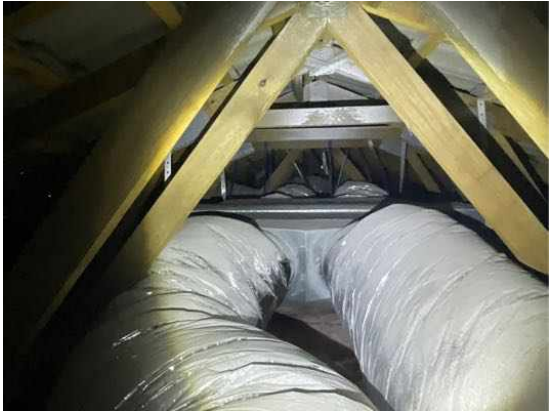
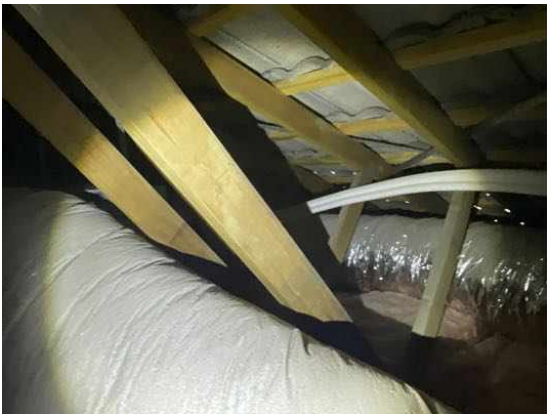
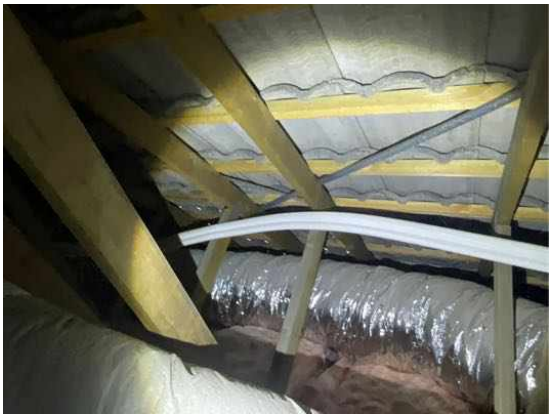
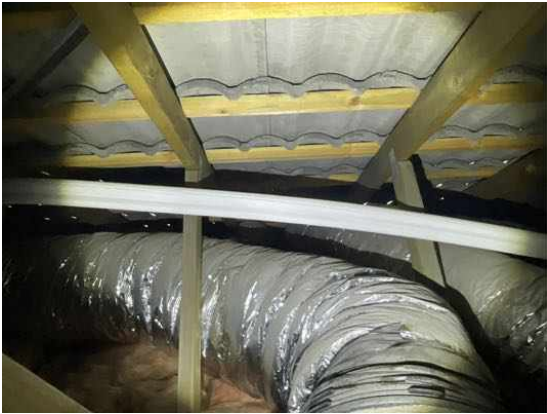
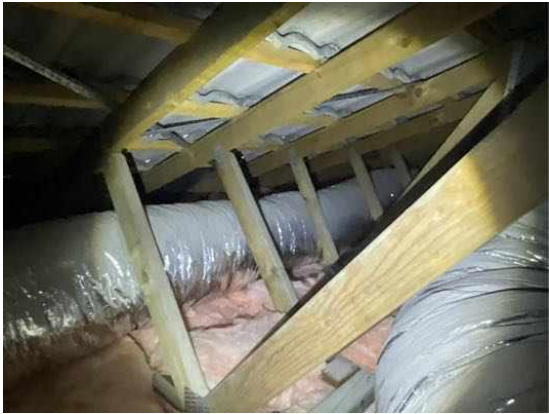
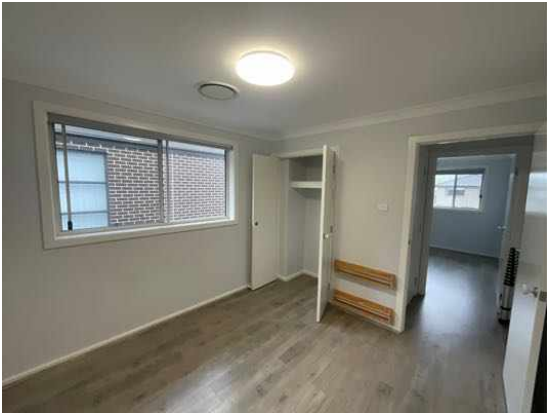
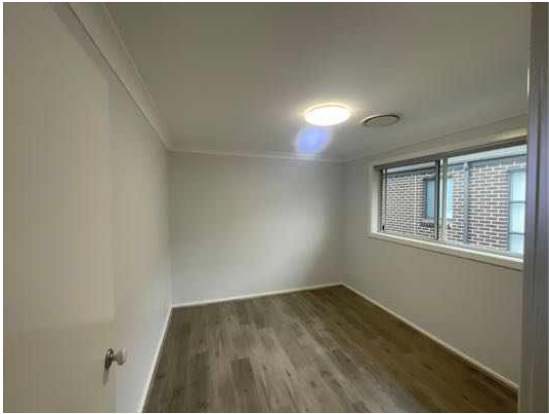
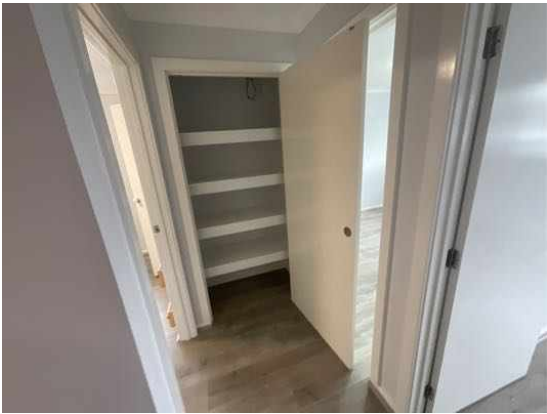
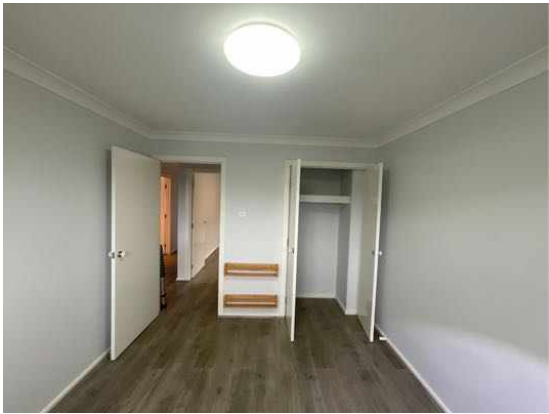
Building: Main Building
Location: All Areas
Finding: Additional Photos - Obstructions and Limitations
Information: These photographs are an indication of the obstructions and limitations which impeded full inspection of the property at the time of inspection. These obstructions can hide an array of defects and should be removed to allow full inspection to be carried out. A re-inspection is recommended once the areas are made accessible.

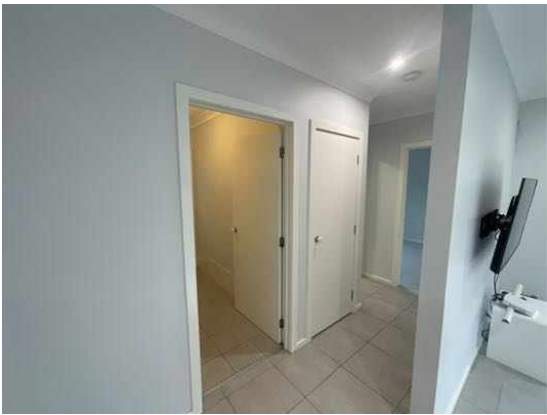
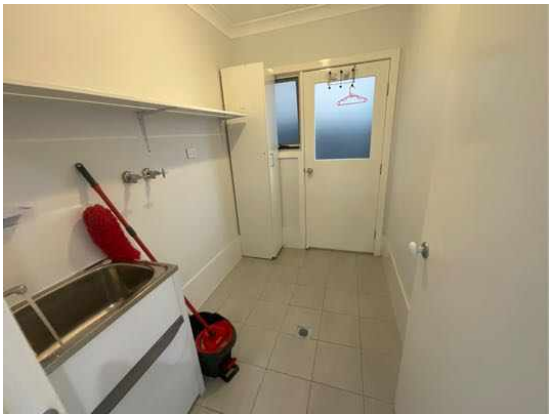
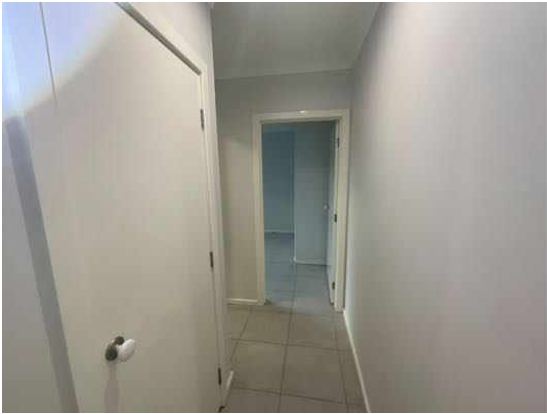
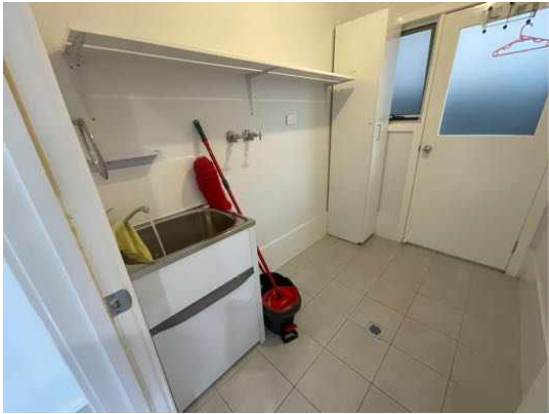
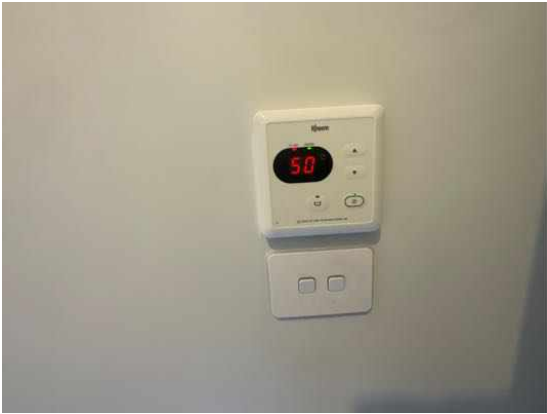
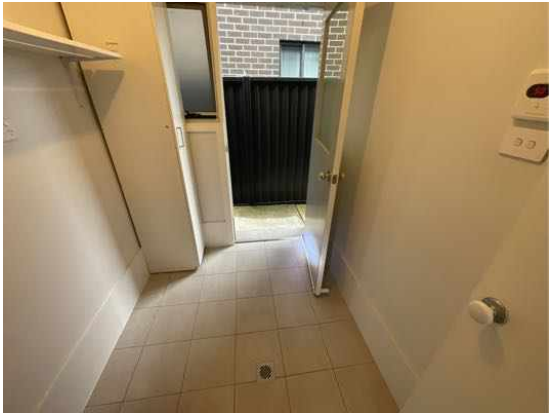
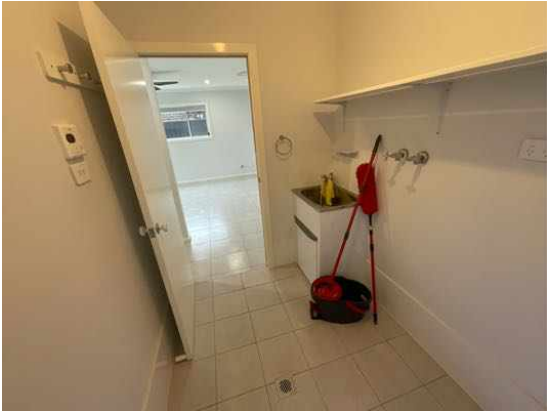
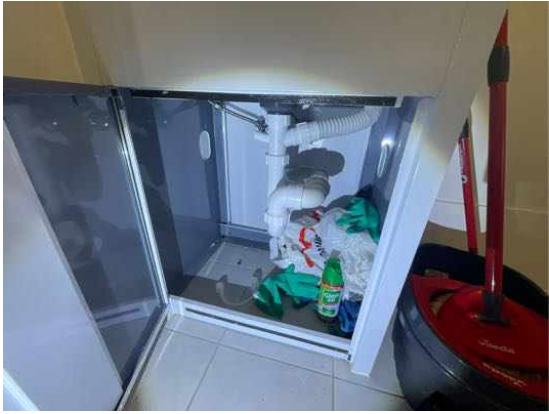
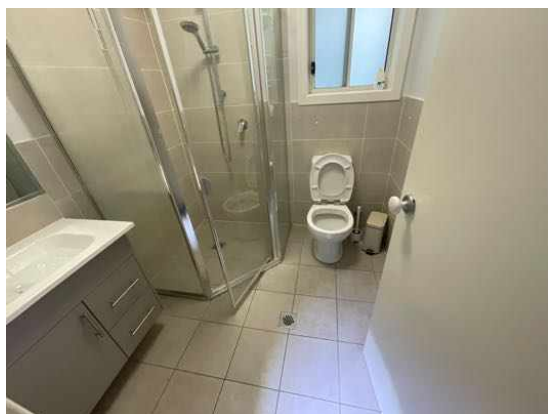
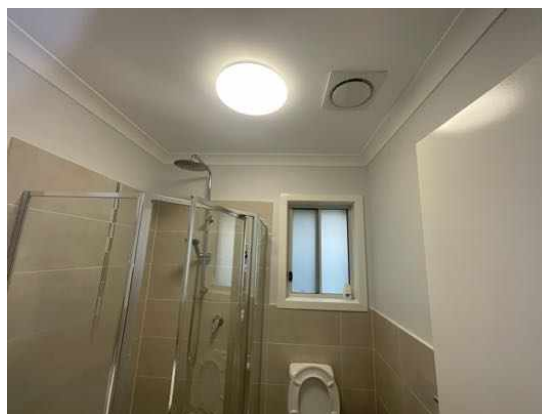
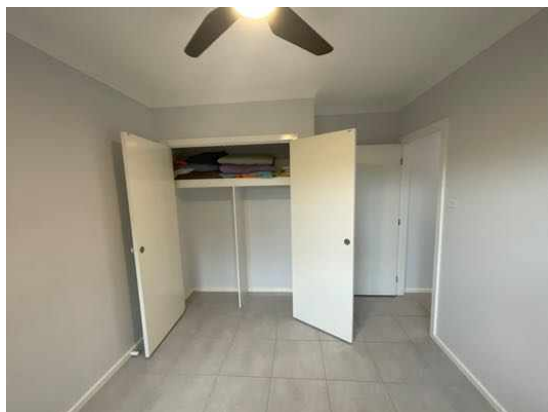
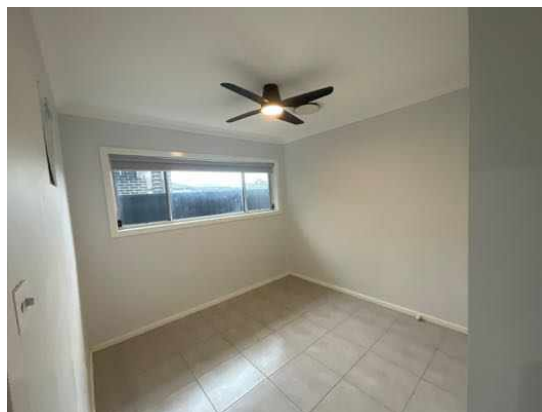
Noted Item

Building:	Main Building
Location:	All Areas
Finding:	Water Proofing Membranes - Information Only
Information:	Internal Water Proofing Membranes, are crucial in preventing water ingress into the property is important to know that the Membrane System used is to Australian Standards and has been installed correctly. Please refer to the original Building Documents or Maintenance Schedule for the relevant information including; - Membrane used and Manufacturers Specifications. - The Installer and Installation Certification. Especially with older property's where this information is unavailable, all wet areas should be monitored. Generally new waterproofing with a certificate may only have a guarantee of 8yrs. If any leaks, water staining, peeling or bubbling of the paint become evident to any adjacent walls or ceilings below a licensed builder or waterproofing specialist is recommended to investigate further.

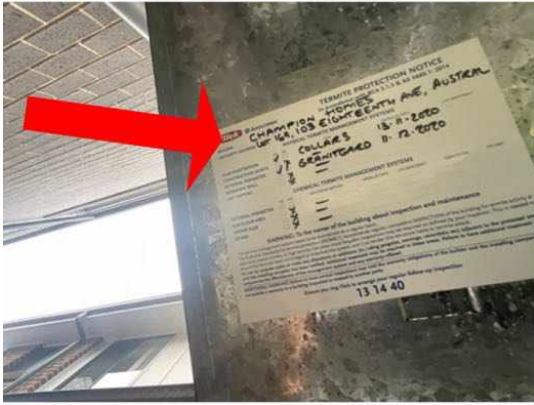
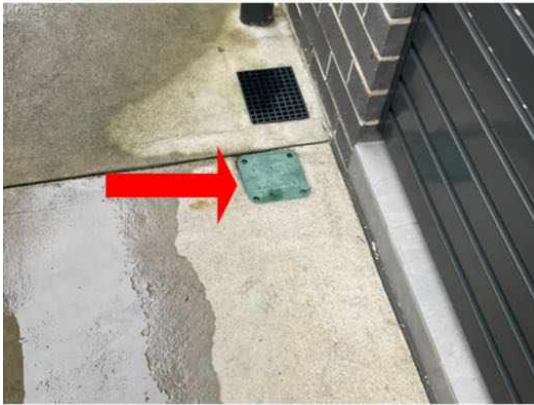
Noted Item

Building:	Main Building
Location:	All Areas
Finding:	Evidence of a chemical treated zone barrier was identified
Information:	During inspection of the property, it was noted that works to install a chemical treated zone barrier had previously been completed. A chemical treated zone barrier is likely to ensure effective protection against termites.

However, we strongly recommend annual inspections of the barrier and surrounding areas as there are several factors that can lead to deterioration of the barrier and decrease its effectiveness.

Where a Termite Management System has been identified, the client should identify to the type of barrier, date of installation, warranty conditions and any documentation provided by a builder or past owner. Consult the company who installed the barrier to confirm whether the system is still under warranty.
