# Building and Timber Pest Inspection Report

Inspection Date: Mon, 30 Mar 2026

Property Address: 2/30 Doomben Ave, Eastwood NSW 2122,  
Australia

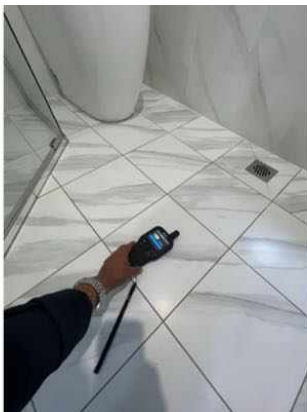
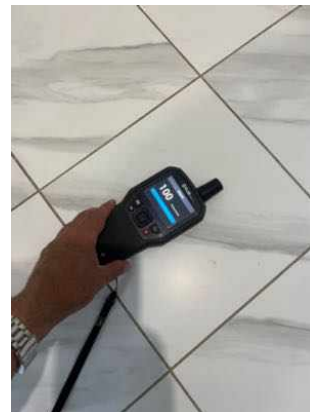
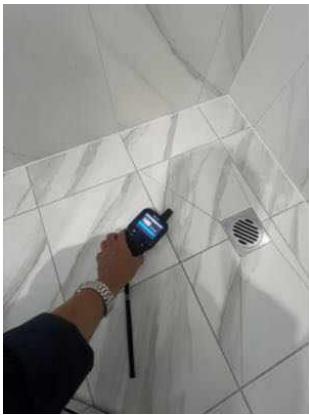
#### Finding 3.01

Building: Main Building  
Location: Bathroom  
Finding: Elevated Moisture Bathroom & Back of shower  
Information: Elevated moisture levels were detected to tiled surfaces in bathroom/shower areas. This may be due to porous or missing grout, cracked tiles or recent use, however the possibility of waterproofing membrane failure or plumbing leaks cannot be excluded. Persistent moisture ingress can lead to concealed damage, including timber rot and mould growth. Further investigation by a licensed plumber and/or waterproofing contractor is recommended as soon as possible. The back of shower area also showed elevated moisture but no visible deterioration was evident at the time of inspection.

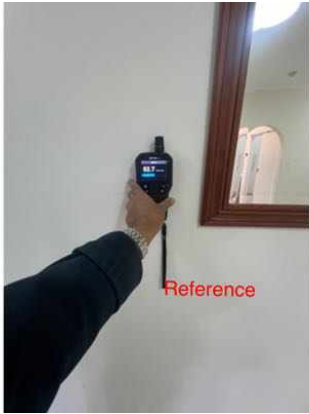
**Finding 3.02**

Building: Main Building  
Location: All Internal Areas - Lounge , bedroom  
Finding: Elevated Moisture – Further Investigation Recommended  
Information: Elevated moisture readings were detected in several locations at the lower walls with some areas also showing signs of minor deterioration or repairs. although no significant structural damage was evident at the time of inspection, dampness can contribute to deterioration if left unaddressed. A further investigation by a licensed plumber or waterproofing specialist is recommended to confirm the source and ensure no concealed issues are developing.

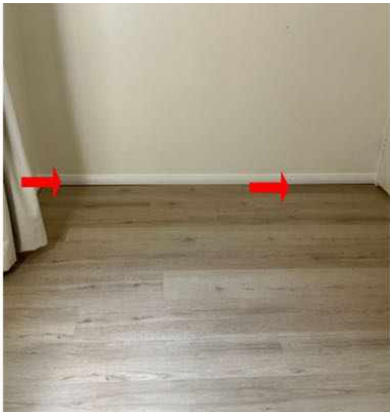
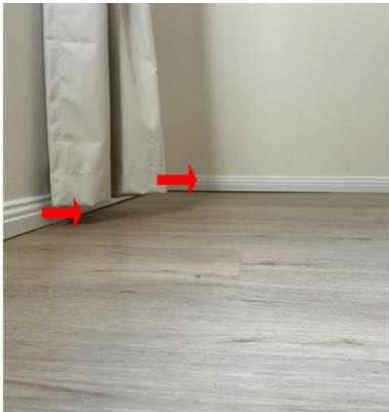
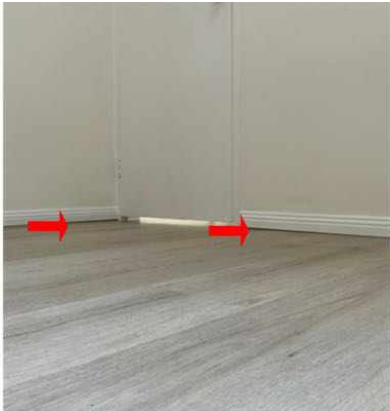
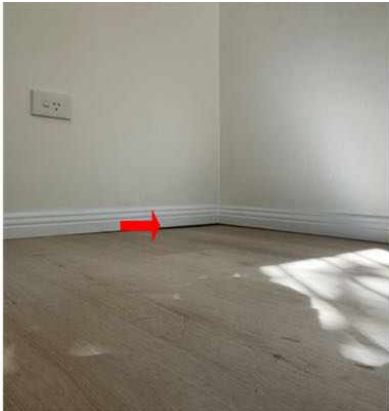
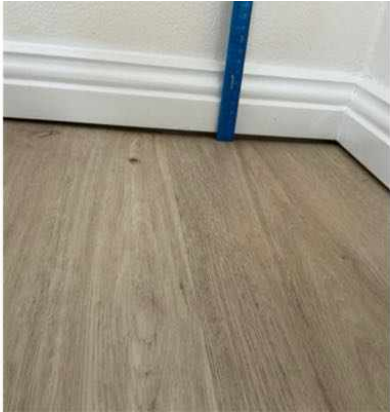
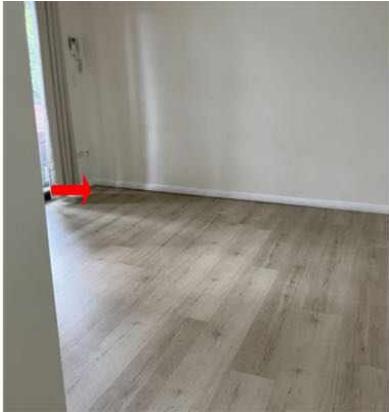
Finding 3.03

Building: Main Building  
Location: All Internal Areas  
Finding: Gap in skirting and flooring  
Information: A consistent gap is visible between the skirting and timber floorboards, with shrinkage and spacing evident across the floor surface. This condition is typically associated with natural timber movement or minor settlement. This may cause potential accumulation of dust and potential pest. Monitoring is recommended and contact a licensed builder if gap widens.

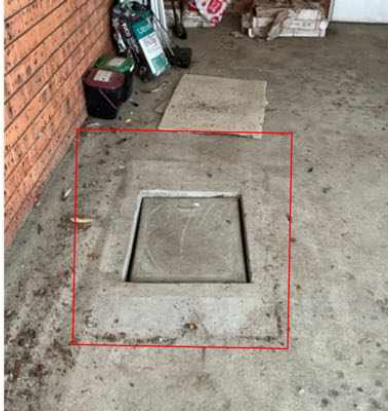
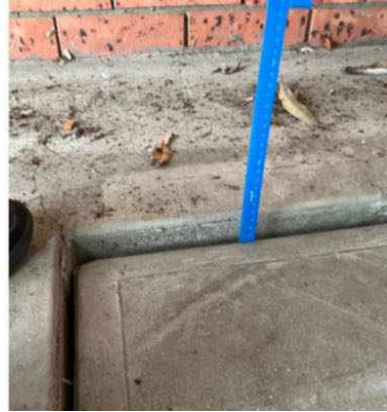
**Finding 3.05**

Building: Main Building  
 Location: Garage  
 Finding: Pit Lid Observation  
 Information: Recessed service pit lid noted within the slab; it is unclear whether the current set-down is by design or due to minor settlement. Confirmation with strata is recommended. No significant structural concerns evident at the time of inspection; however, a potential trip hazard may exist.

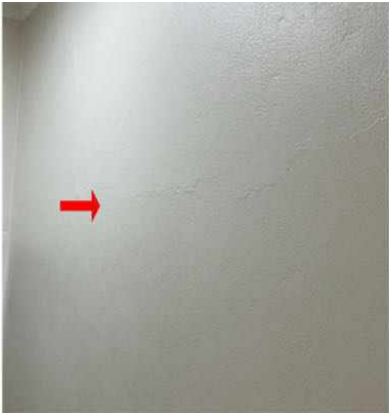
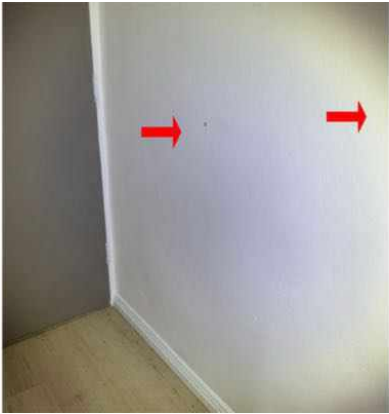
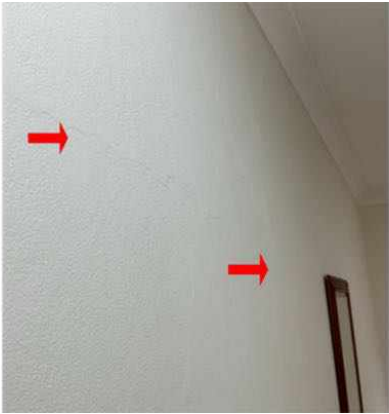
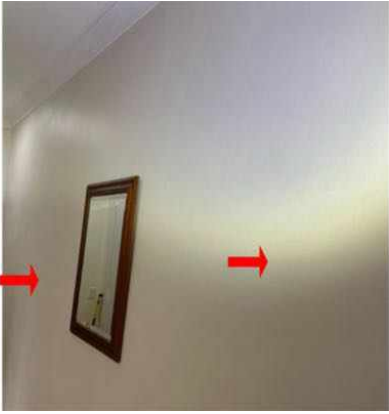
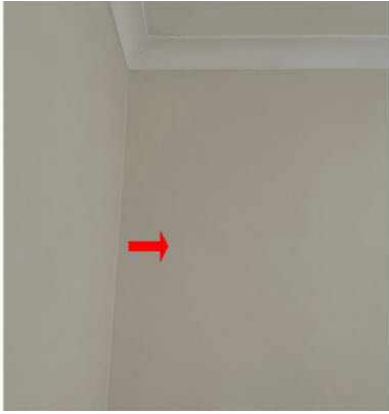
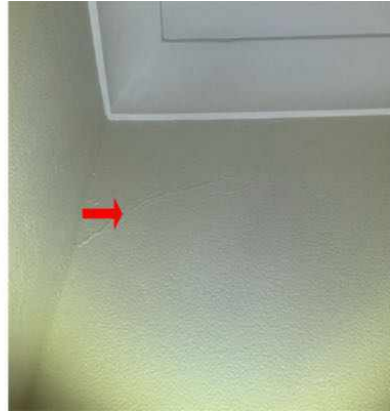
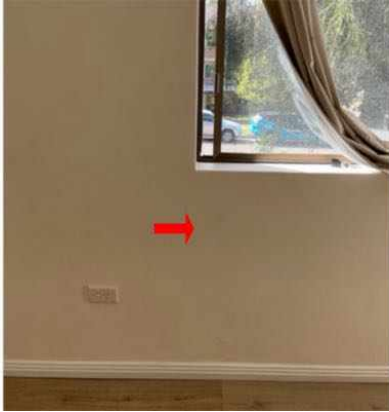
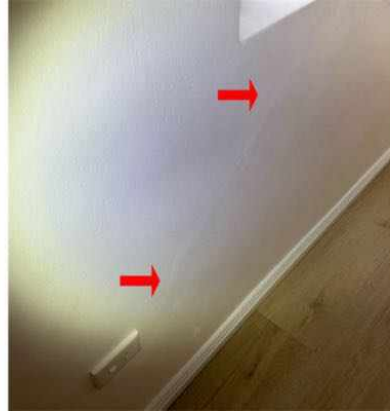
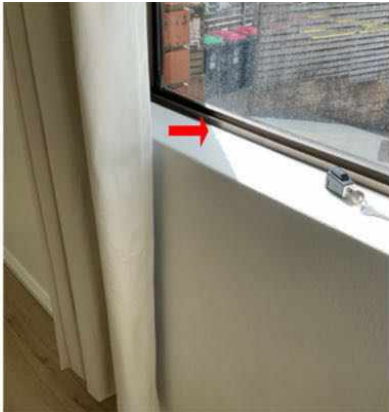
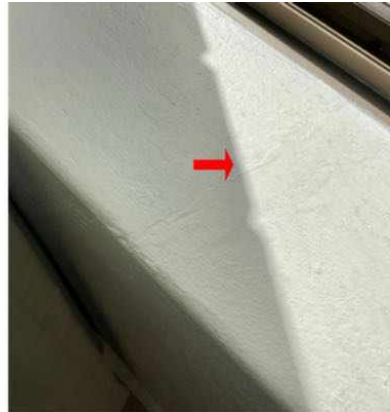
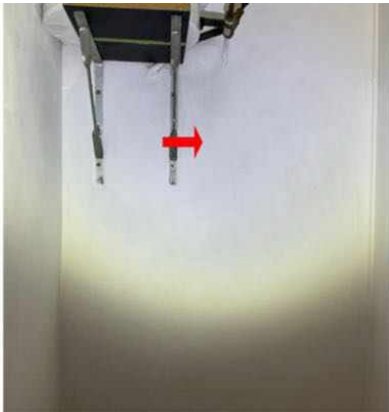
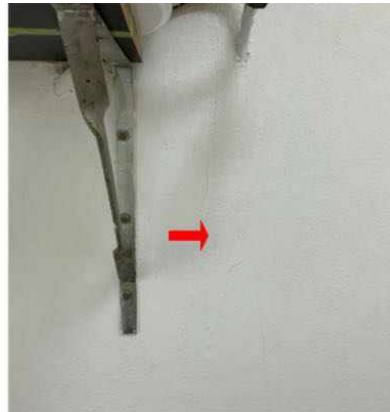
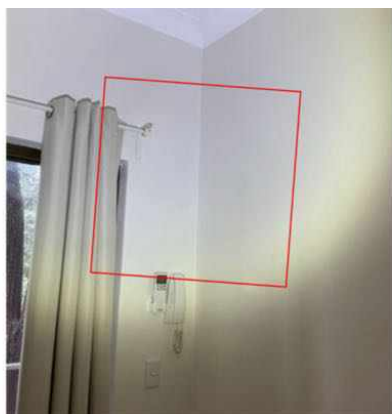
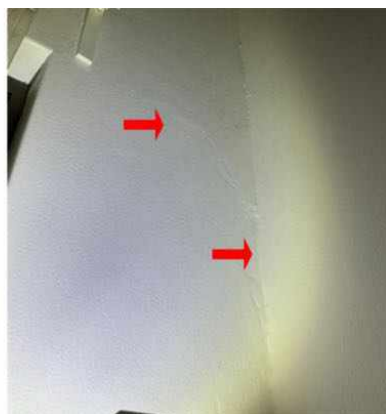
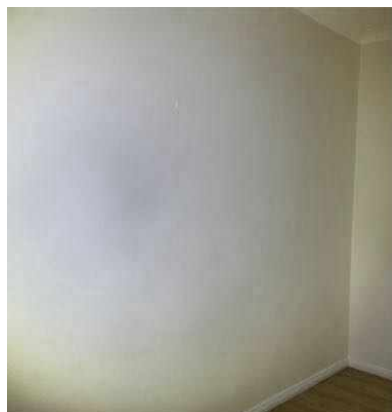
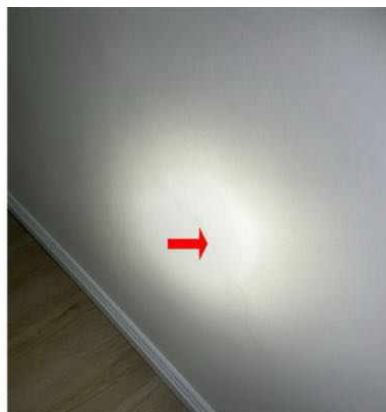
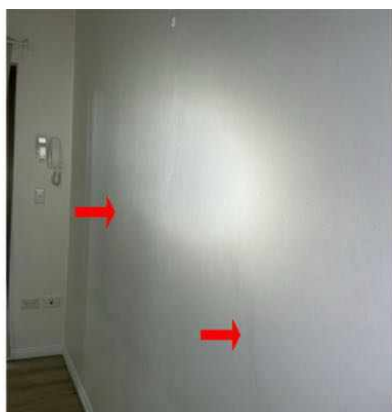
Building: Main Building  
Location: All Internal Areas  
Finding: Cracks to internal render - Category 1 and past repairs  
Information: It has been observed that cracking to internal rendered surfaces has occurred. The degree of damage falls within Category 1, described as fine cracks that do not need repair and which are less than 1.0mm in width limit.

Evidence of previous repairs was also identified extent of which cannot be determined in visual non-invasive inspection

. Always contact your building inspector should cracks widen, lengthen, or become more numerous.

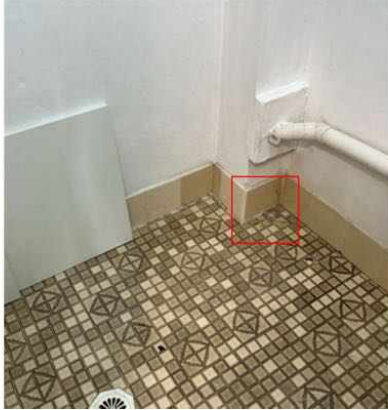
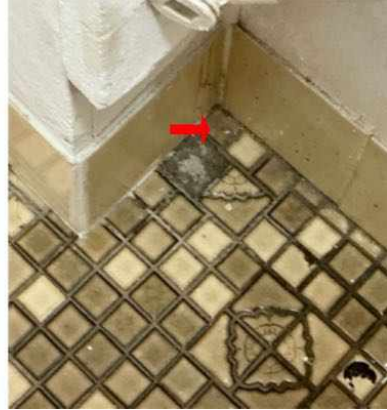
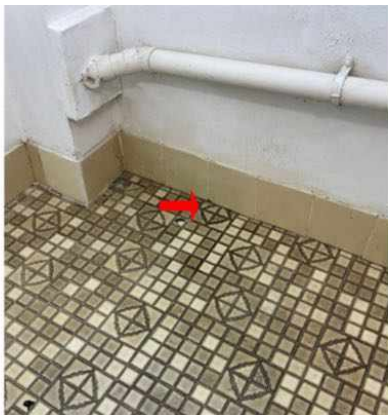
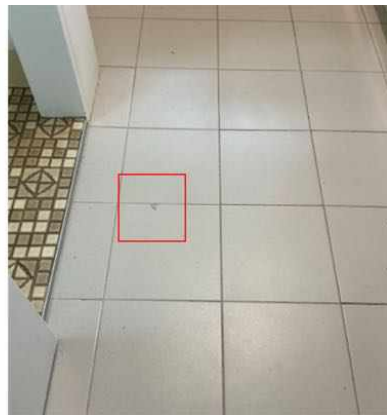
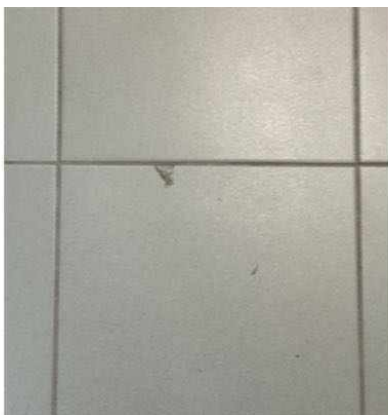
### Finding 3.08

Finding: Tiles - Cracked or damaged

Information: Cracking was evident to the tiling in this area at the time of inspection. While the cracking appears to be minor, this area is frequently exposed to water, allowing potential for water penetration into adjoining sections of walls or flooring.

If left unmanaged, water penetration to these areas may lead to subsequent water damage, which is likely necessitate repair work to affected building elements.

A tiling contractor should be appointed to ensure that no further water damage

occurs. The re-application of silicone and grouting throughout remaining tile work is also advised, to further protect the area against water penetration.

Where water penetration has led to water damage, appointment of a relevant tradesperson may be required to repair damaged building elements.

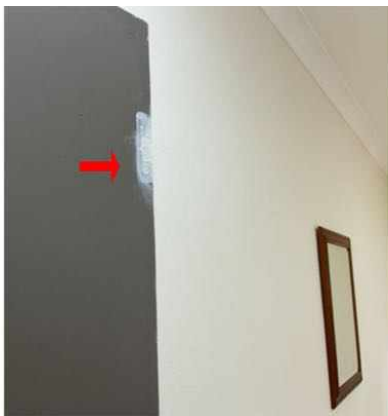
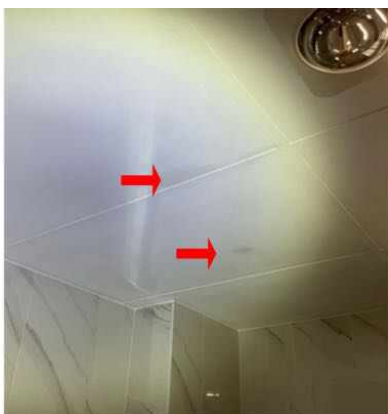
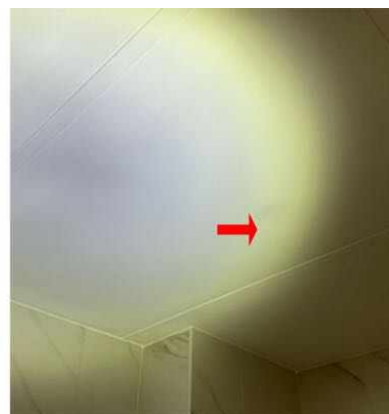
### Finding 3.09

Building:	Main Building
Location:	All Internal Areas
Finding:	Paint finish and hairline cracking to some areas
Information:	The paint finish in this area was identified as being incomplete at the time of inspection

including some hairline minor cracking.

Whilst incomplete or missing paint and minor cracking and imperfections in finish is generally an appearance defect, it can also lead to the development of secondary building defects over time. Incomplete areas of paint finish expose the area to moisture, potentially accelerating the deterioration of underlying building materials.

Incomplete paint finishes should be sanded back, filled, leveled and painted, as applicable. Where inadequate or missing paint protection has led to the deterioration of the associated building element, repair and/or replacement of this building element may be required.

A painting contractor should be appointed as soon as possible to perform necessary works to aid the appearance of the affected area and to ensure the area is protected against further deterioration. Alternatively, the homeowner following manufacturer instructions may perform these works.

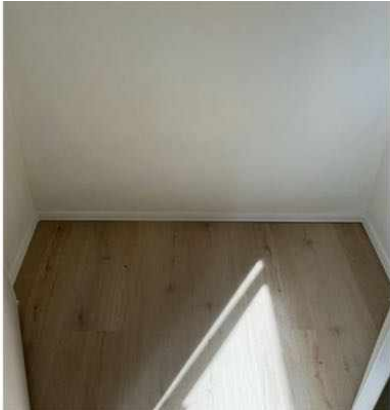
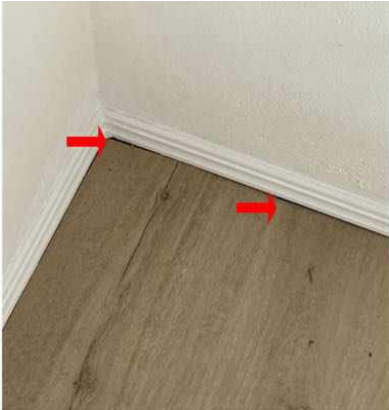
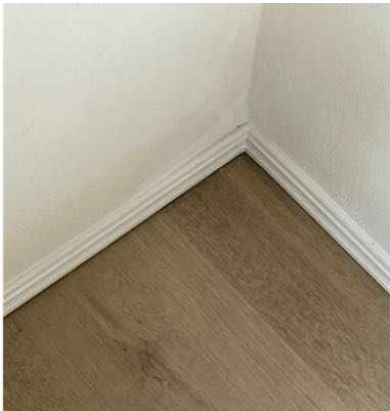
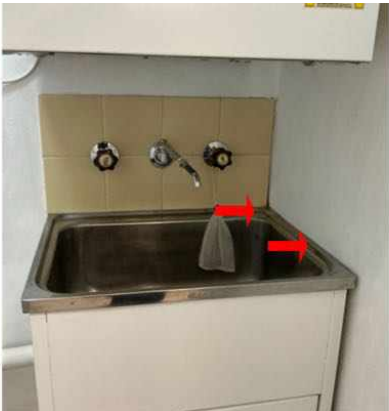
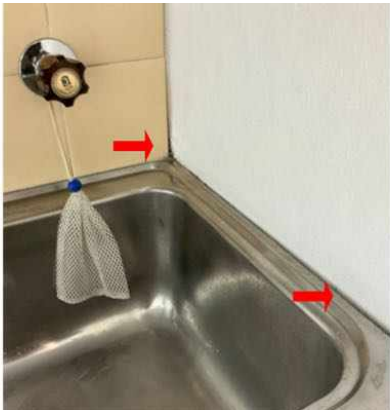
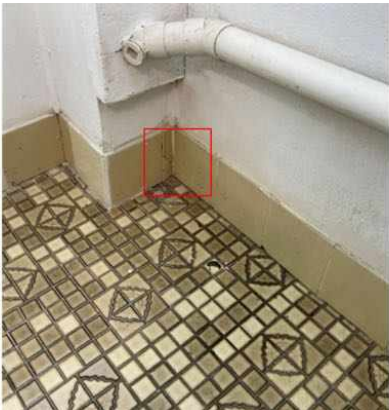
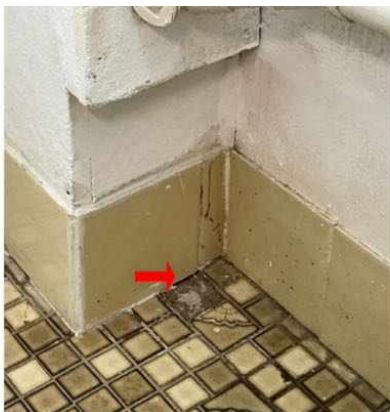
### Finding 3.10

Building:	Main Building
Location:	All Internal Areas
Finding:	Sealant and grouting - Missing or degraded to some areas
Information:	It was noted on inspection that sealant or grout is degraded. There is also evidence of poor workmanship and excessive use of sealant. Silicone should never be used as a first line of defence against waterproofing. Further inspection by a licensed waterproofing contractor is highly recommend

Different materials and floor areas move at different rates, generally causing cracking to grout or sealant at this point. A flexible sealant is required to allow for expected expansion and contraction, while keeping the joint water tight and protective of all associated building materials.

There appears to be excessive mould to the sealant and grout which will likely require scraping out and replacement.

Flexible and mould resistant materials should be applied to affected areas to prevent any subsequent water damage that is likely to occur. Regular maintenance and replacement of damage or missing or damaged sealant and grout is highly recommended to the wet areas, as this is a regular wear and tear defect. Sealant and grouting in areas that come into regular contact with water should be maintained for the long term care of your property.

A sealant specialist or tiling contractor should be appointed to complete these works as soon as possible

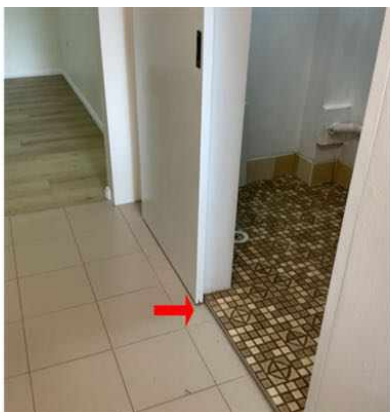
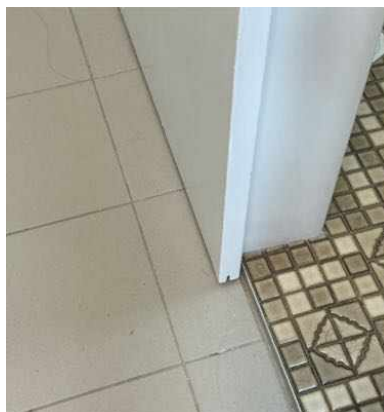
### Finding 3.11

Building:	Main Building
Location:	Kitchen
Finding:	Building element - Missing - No track in sliding door kitchen
Information:	Although some building elements may seem irrelevant or unnecessary, all building elements play a key role in the operation and function of the overall structure and its performance.

Replacement of any missing building element should be conducted as soon as possible to ensure that no damage or functional issues occur to associated building materials.

The appropriate tradesperson should be appointed as soon as possible to replace the missing building element.

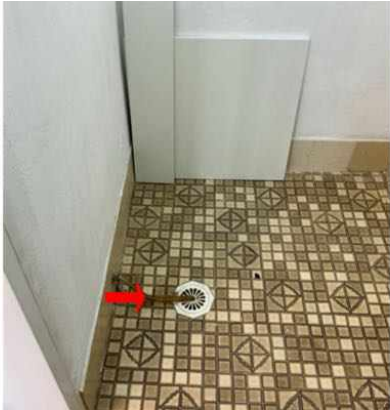
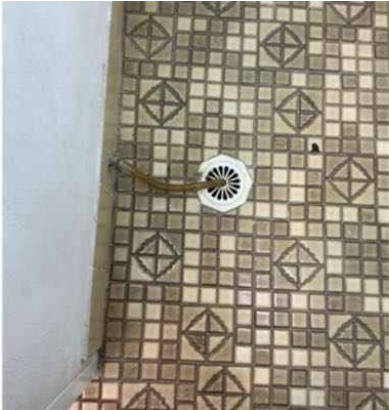
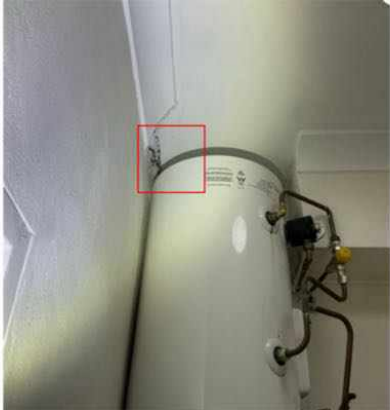
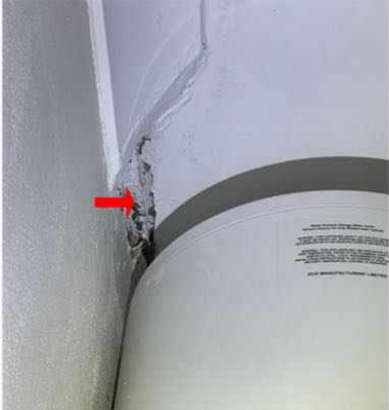
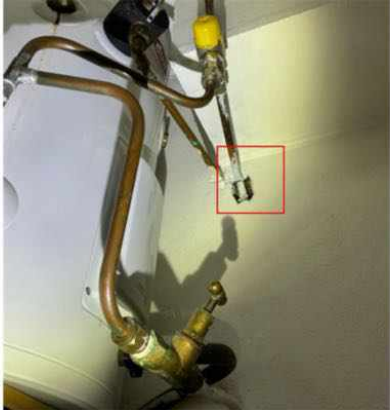
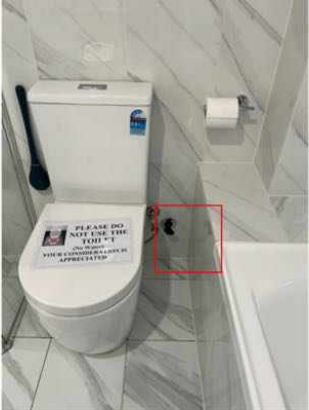
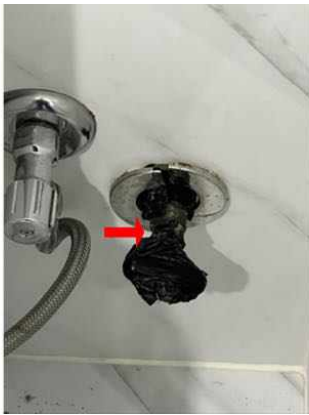
### Finding 3.12

Building:	Main Building
Location:	Laundry
Finding:	Installation - substandard or incomplete - poor workmanship , hole not sealed , incomplete finishes , plumbing fixing possible damage or incomplete works
Information:	The installation of this building element appears to have been completed to a

substandard level of workmanship or is incomplete. Generally substandard repairs or installation are related to poor workmanship, the use of inappropriate materials, or a failure to complete installation to a suitable standard.

Where installation is substandard and/or incomplete, the client should contact the responsible trade to undertake rectification. Unfinished and substandard building works are likely to degrade more quickly and may create potential for secondary defects to associated building elements.

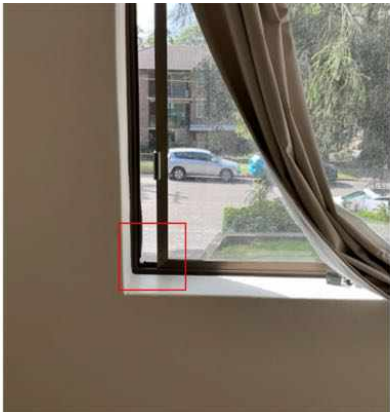
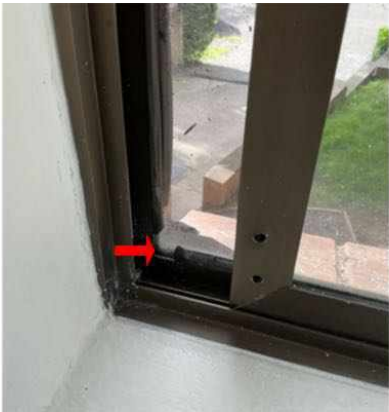
**Finding 3.13**

Building: Main Building  
Location: Bedrooms, Kitchen  
Finding: Building element - Damaged - window seal damaged  
Information: Breakage occurs generally when the building materials have either aged and decayed, or as a result of damage (accidental or deliberate).

Repair and/or replacement of broken elements is advised to ensure that additional secondary defects do not arise as a consequence. Such works are necessary, as all building elements play a key role in the operation and function of the overall structure and its performance.

A relevant tradesperson should be appointed to repair or replace the affected building element prior to any subsequent damage being caused.

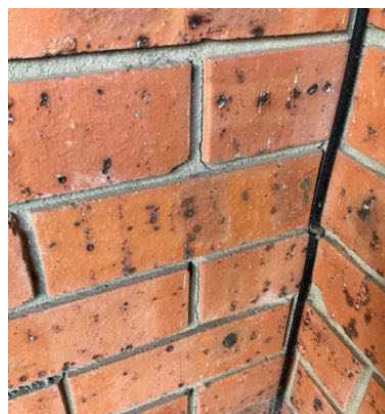
### Finding 3.15

Building:	Main Building
Location:	All External Areas
Finding:	Installation - substandard or incomplete - Excessive silicone use and workmanship
Information:	The installation of this building element appears to have been completed to a substandard level of workmanship or is incomplete. Generally substandard repairs or installation are related to poor workmanship, the use of inappropriate materials, or a failure to complete installation to a suitable standard.

Where installation is substandard and/or incomplete, the client should contact the responsible trade to undertake rectification. Unfinished and substandard building works are likely to degrade more quickly and may create potential for secondary defects to associated building elements.

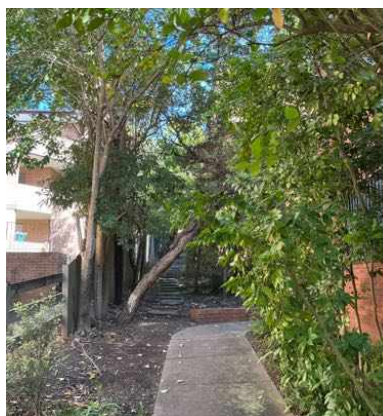
### Finding 6.01

Building:	Main Building
Location:	All External Areas
Finding:	Trees within 50m
Information:	Trees within 50m of the property can be conducive to termite activity. It is recommended an invasive inspection of all trees with 50m to the property be carried out by a qualified pest control expert.

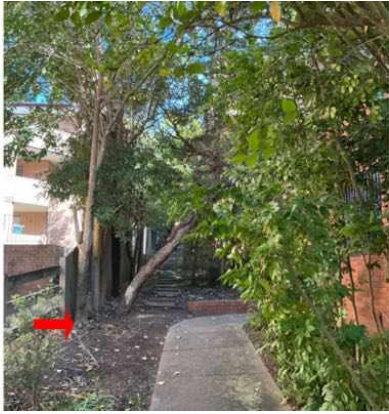
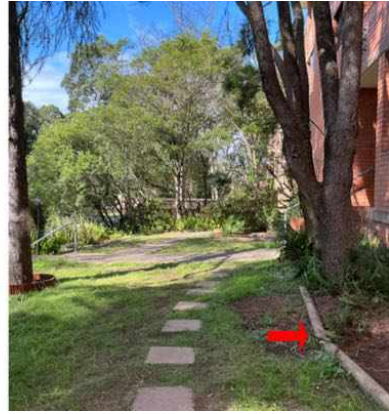
### Finding 6.02

Building:	Main Building
Location:	All External Areas
Finding:	In ground contact - Timber
Information:	Any timbers in direct ground contact provide opportunity for concealed termite entry and are likely to be subject to premature rot and decay as the soil retains moisture or damp conditions against the timbers.

Remove untreated timber that is in direct contact with external grounds. Consider replacement with more durable materials i.e. treated timber or non timber elements. Frequent pest inspections are advised to readily identify any termite activity in these areas.

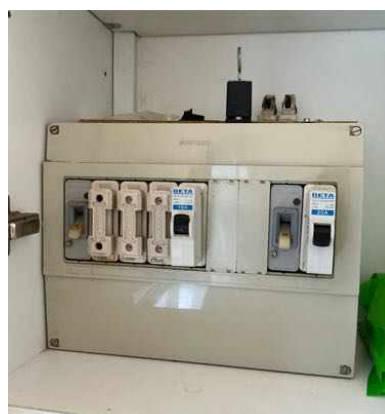
Building: Main Building  
 Location: Kitchen  
 Finding: Electrical switchboard - Old ceramic fuses  
 Information: The electrical switchboard while appearing to have adequate safety switches installed has old ceramic fuses in place.

While this on its own on is not considered a defect it is noted for the clients consideration that a switchboard upgrade may be required in the short to mid term to improve the functionality of the electrical system. A licensed electrician could be appointed to provide quotation for the works at the client's discretion which may in turn expose other required works to bring the system up to a compliant state.

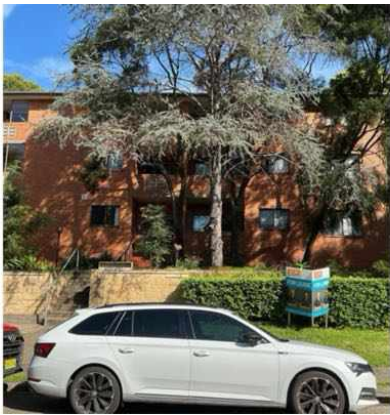
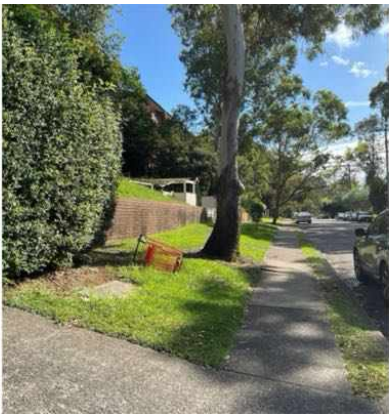
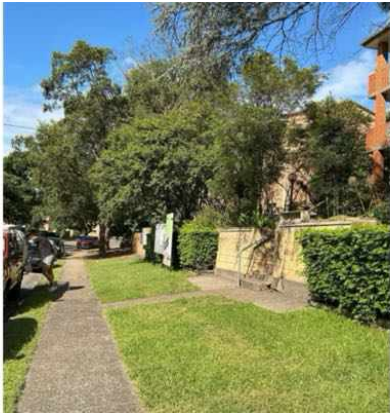
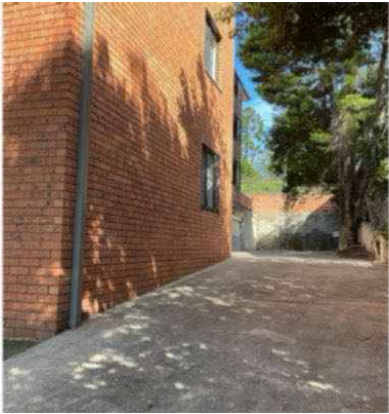
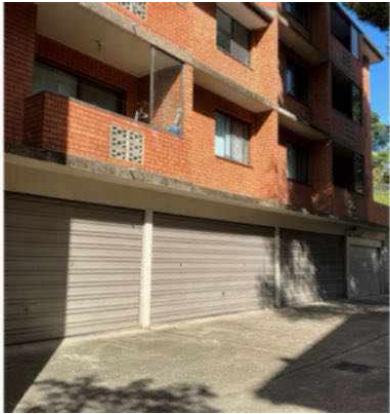
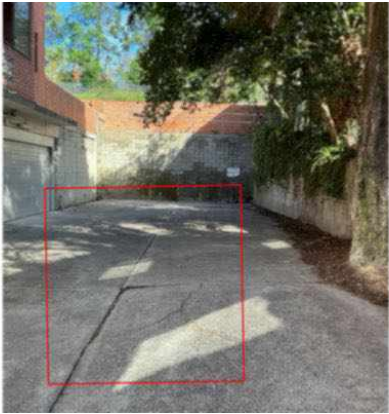
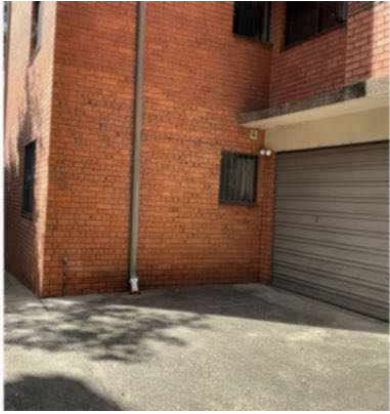
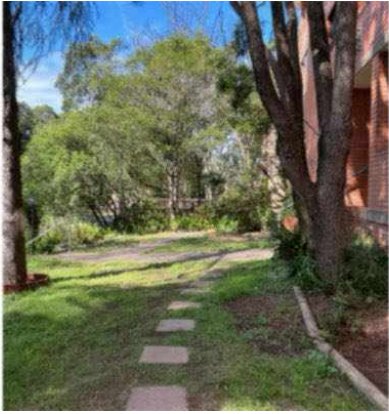
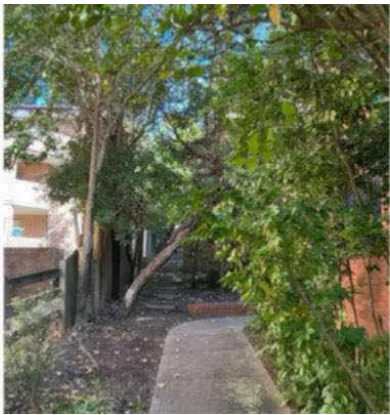
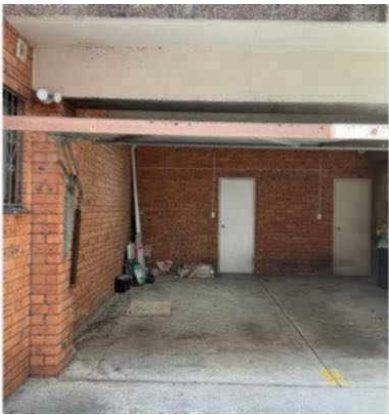
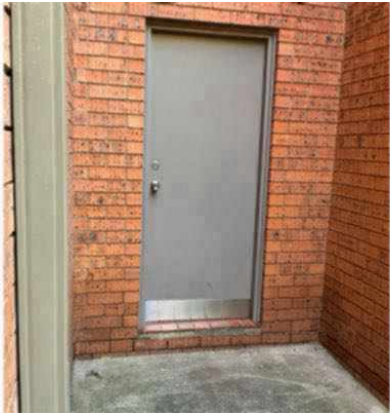
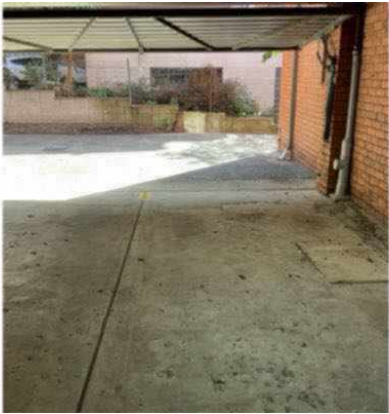
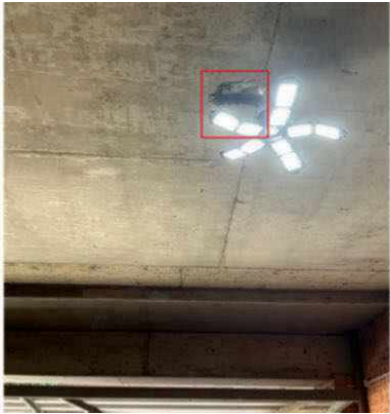
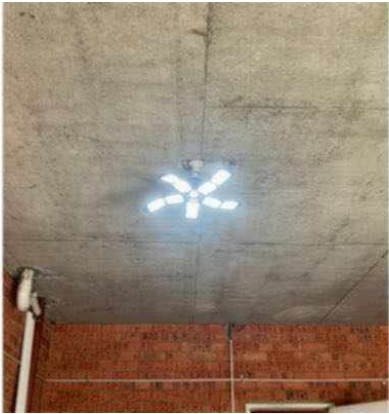
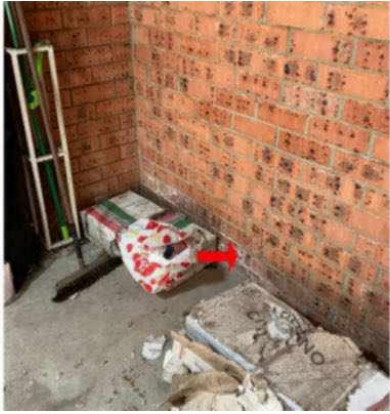
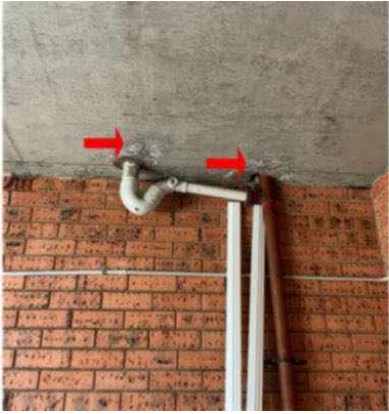
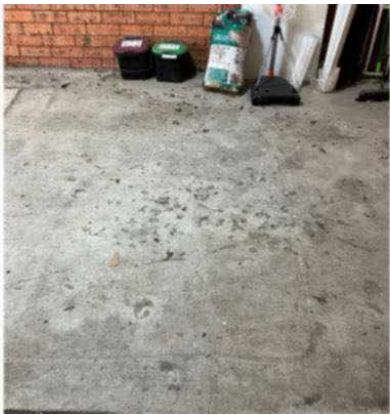
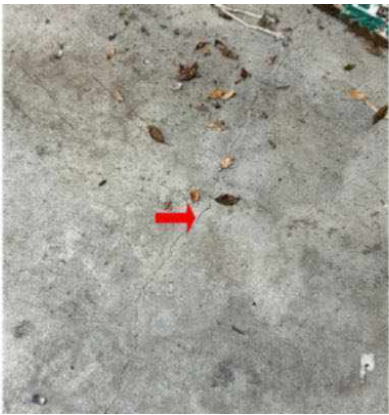
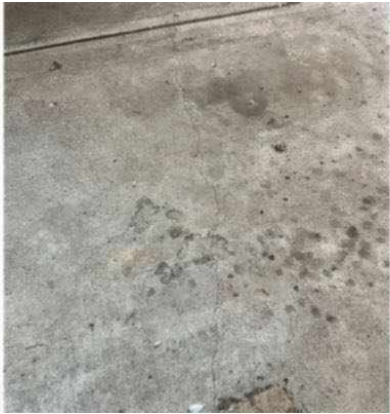
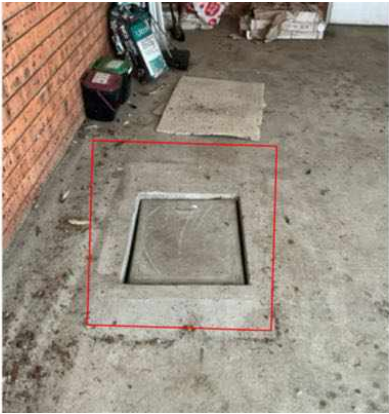
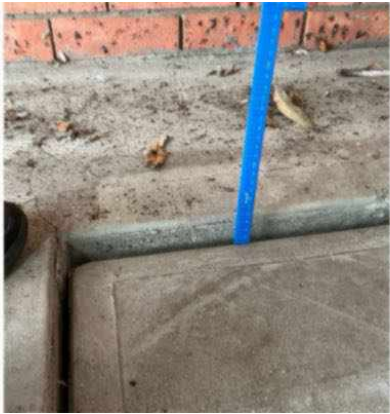
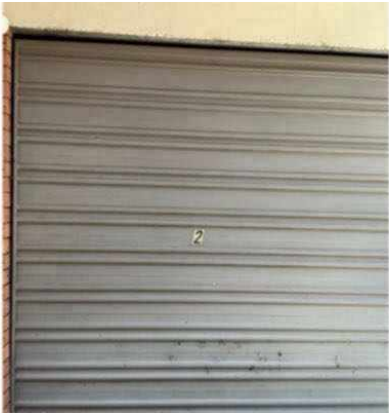
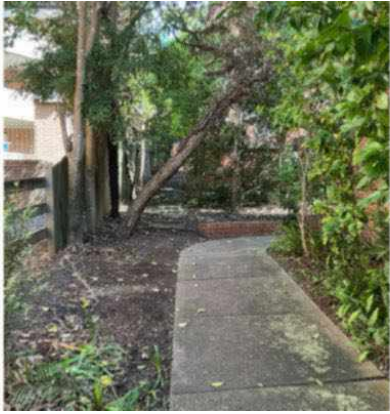
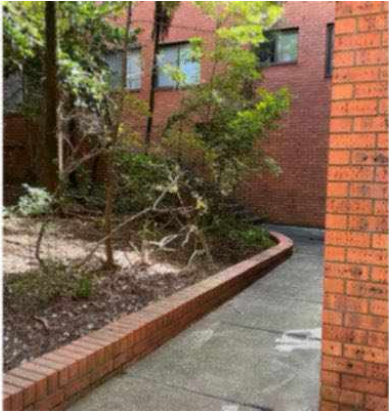
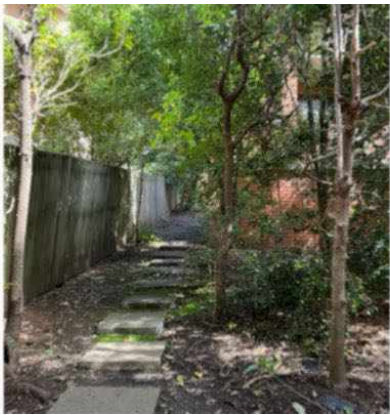
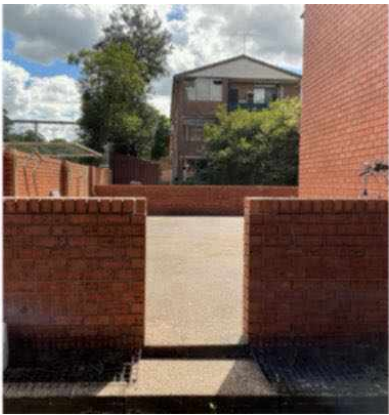
Building: Main Building  
 Location: All External Areas  
 Finding: Additional Photos - Obstructions and Limitations  
 Information: These photographs are an indication of the obstructions and limitations which impeded full inspection of the property at the time of inspection. These obstructions can hide an array of defects and should be removed to allow full inspection to be carried out. A re-inspection is recommended once the areas are made accessible.

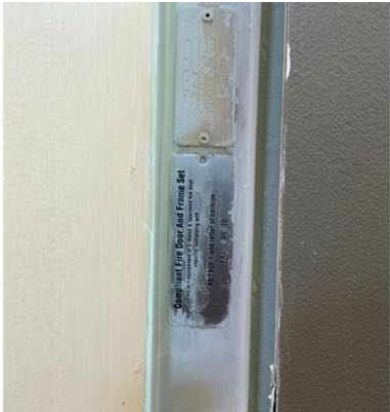
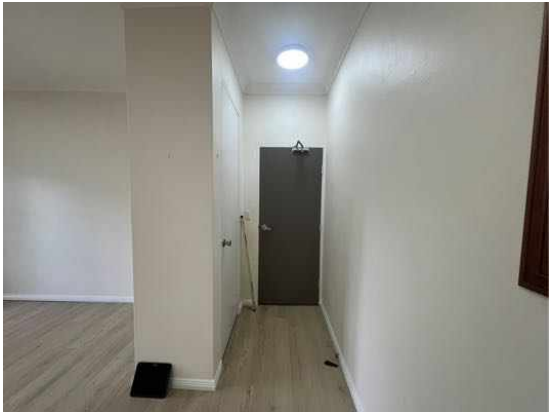
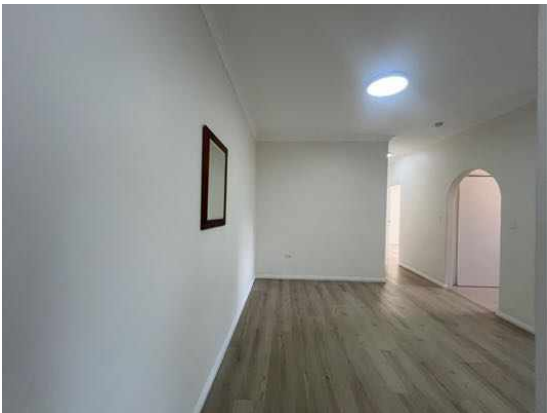
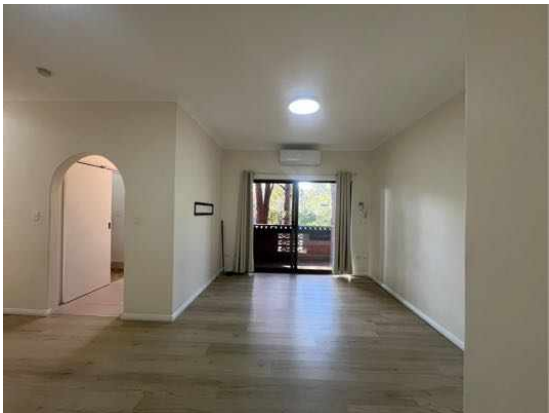
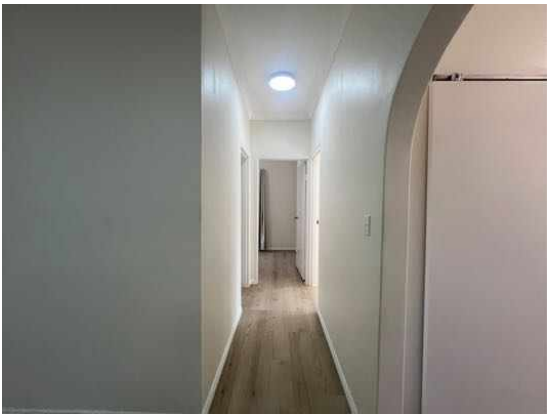
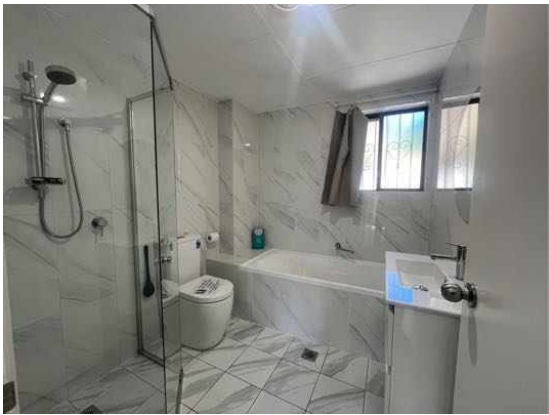
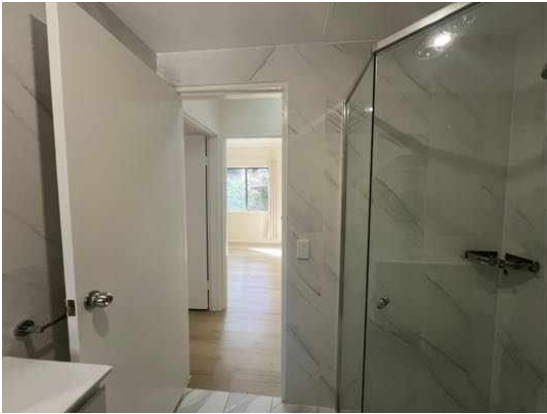
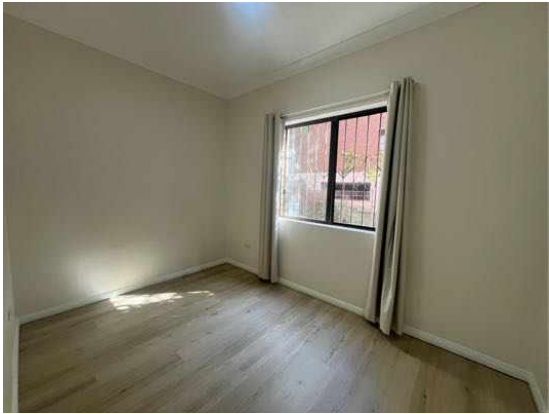
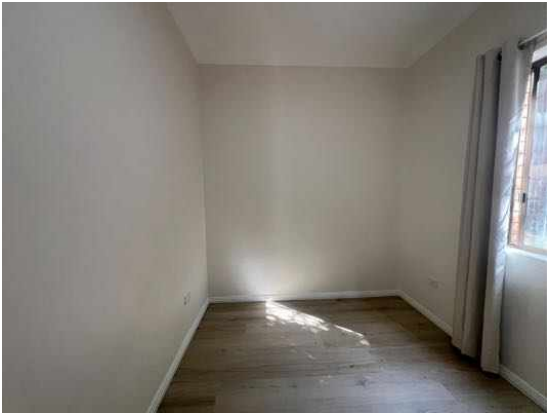
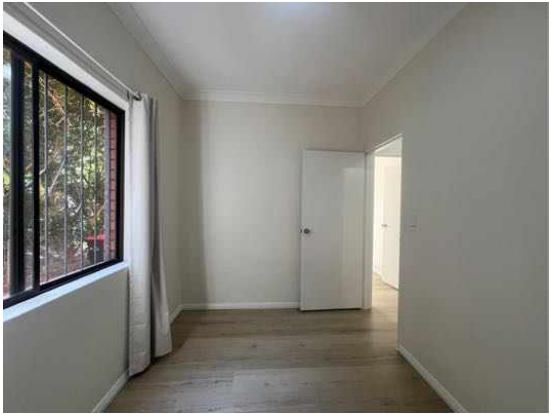
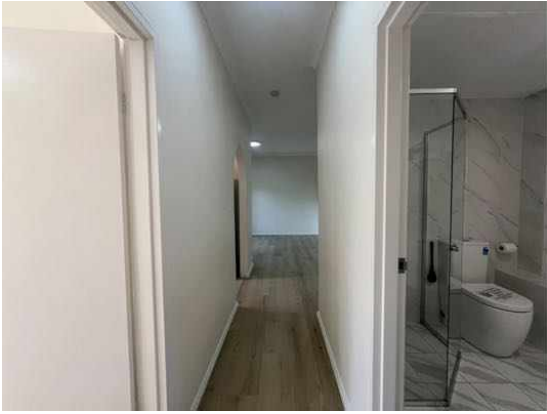
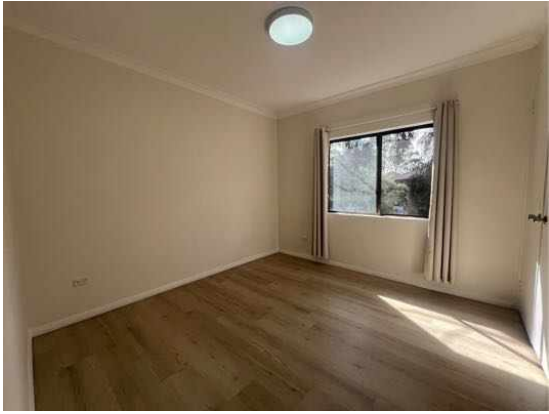
Building: Main Building  
Location: All Internal Areas  
Finding: Additional Photos - Obstructions and Limitations  
Information: These photographs are an indication of the obstructions and limitations which impeded full inspection of the property at the time of inspection. These obstructions can hide an array of defects and should be removed to allow full inspection to be carried out. A re-inspection is recommended once the areas are made accessible.

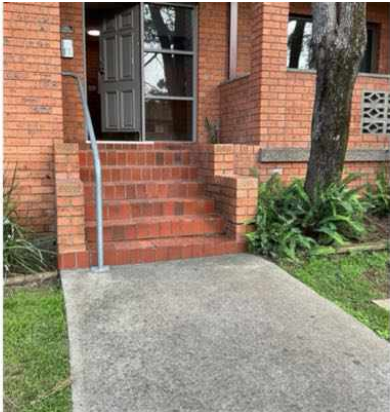
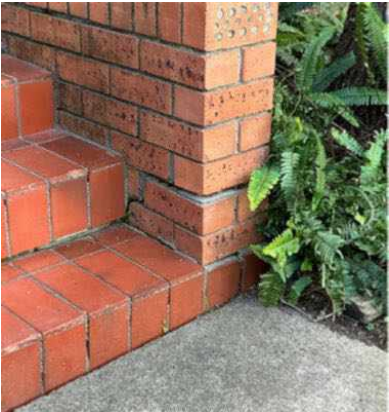
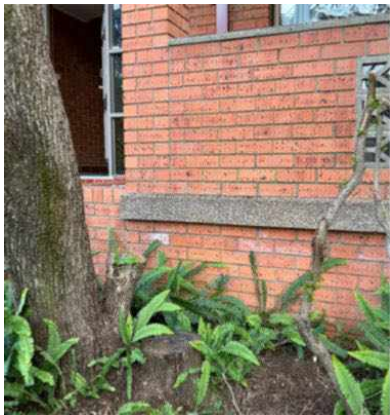
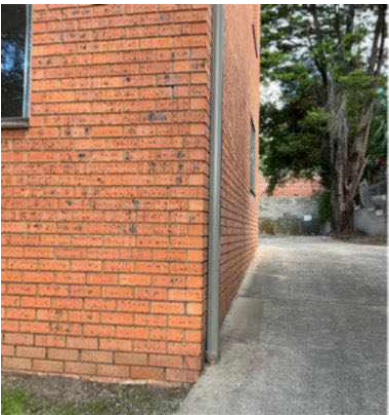
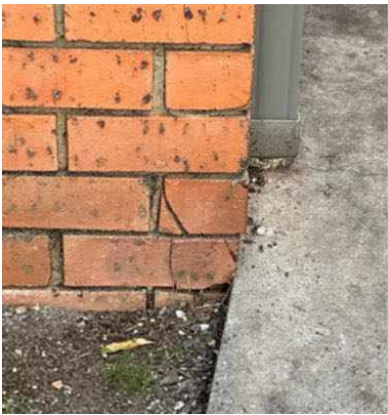
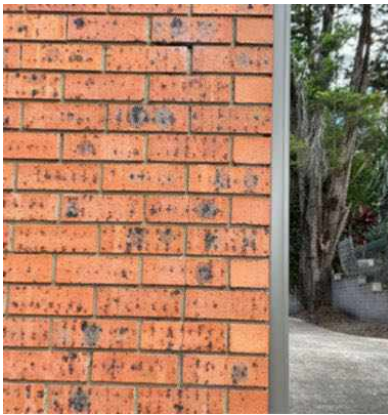
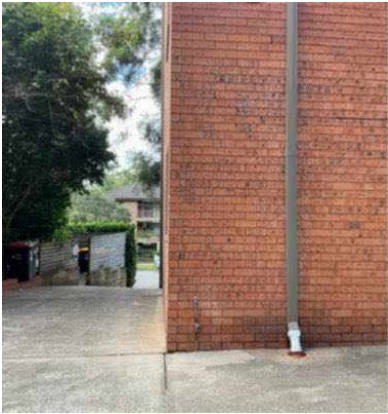
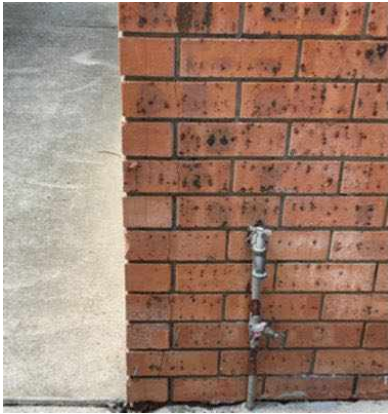
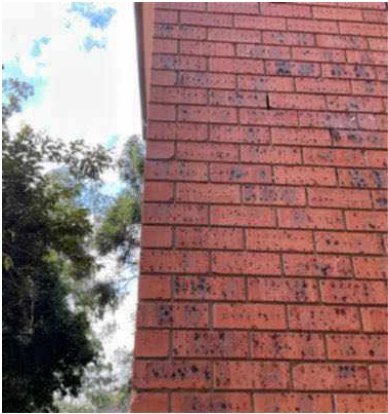
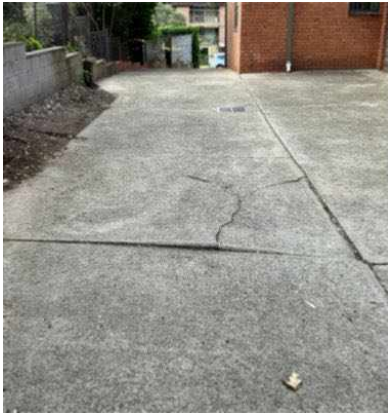
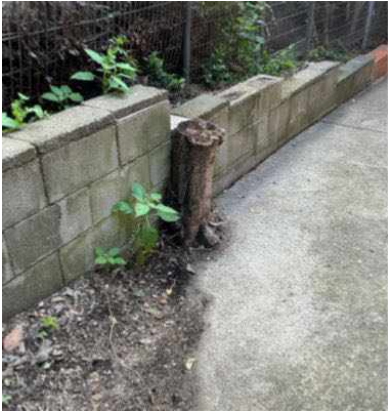
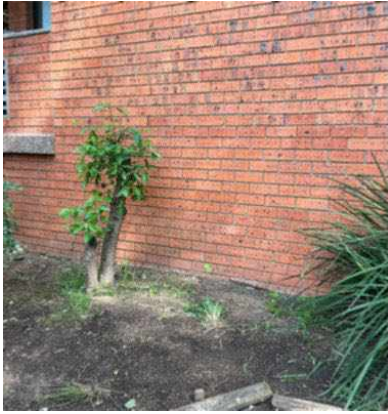
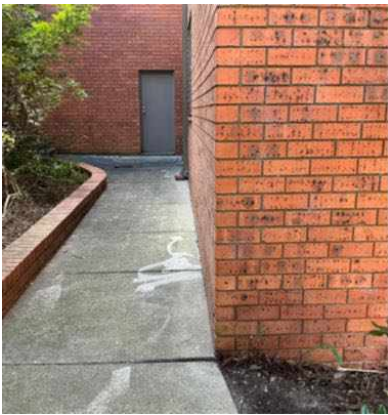
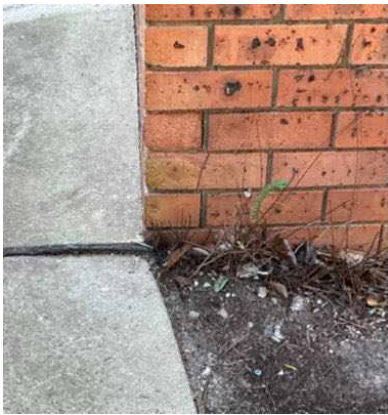
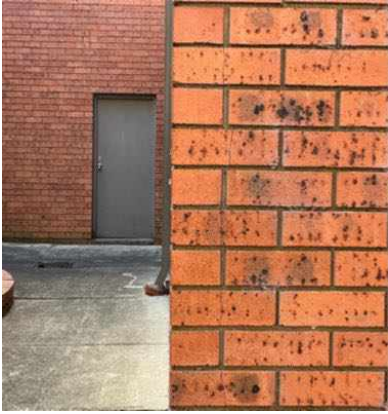
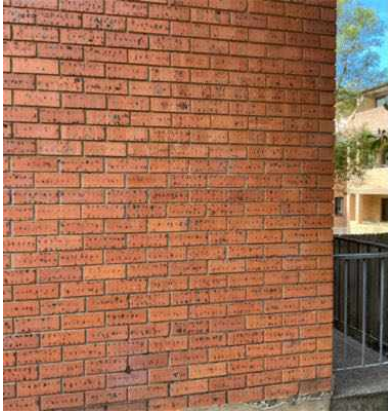
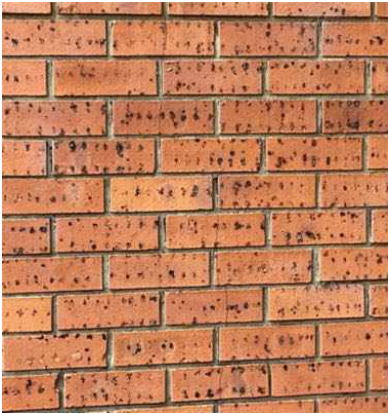
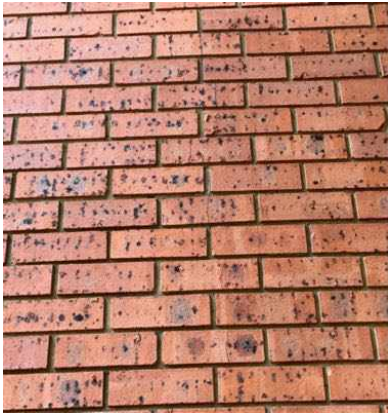
Building: Main Building  
Location: All External Areas  
Finding: Additional Photos - Obstructions and Limitations  
Information: These photographs are an indication of the obstructions and limitations which impeded full inspection of the property at the time of inspection. These obstructions can hide an array of defects and should be removed to allow full inspection to be carried out. A re-inspection is recommended once the areas are made accessible.
