Building and Timber Pest Inspection Report

Inspection Date: Tue, 3 Mar 2026

Property Address: 2A Bellevue St, Coburg VIC 3058, Australia

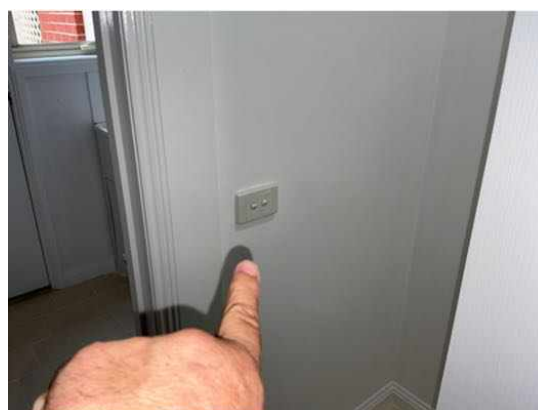
| Finding: | Electrical fitting - Broken |
| Information: | The electrical fitting in the WC was found to be broken at the time of inspection. Breakage occurs generally when the building materials have aged and decayed, but may also be indicative of impact damage to the building element (accidental or deliberate). |

Left unmanaged, the fitting is unlikely to cause further damage to surrounding building elements. However, the broken fitting does expose electrical works, and may create a safety hazard if there is potential contact with persons in the area.

Repair and/or replacement of the broken fitting is advised. A Licensed electrician should be appointed to repair/replace the fitting immediately.

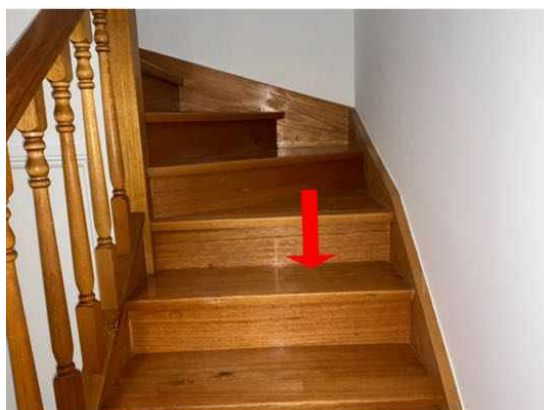
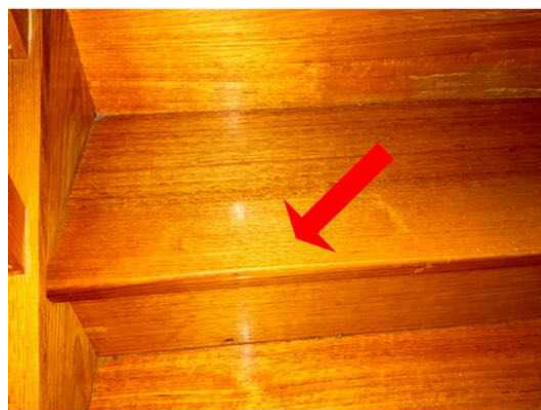
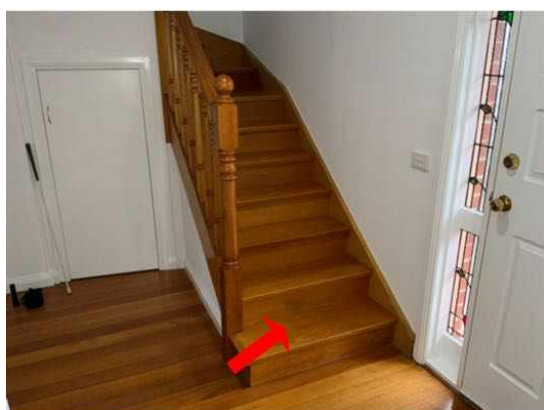
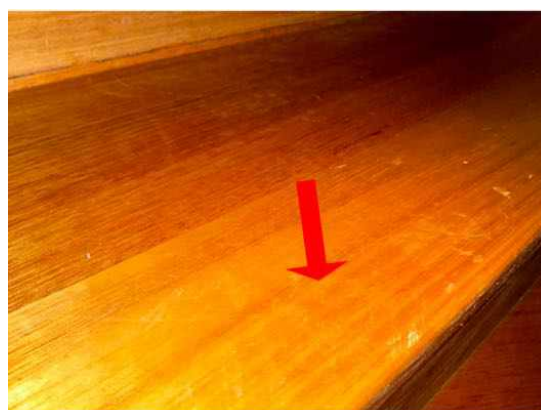
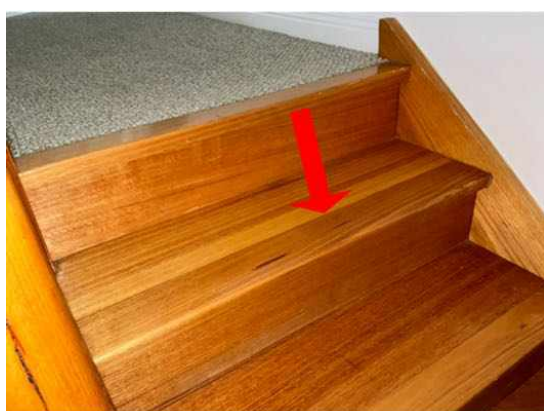
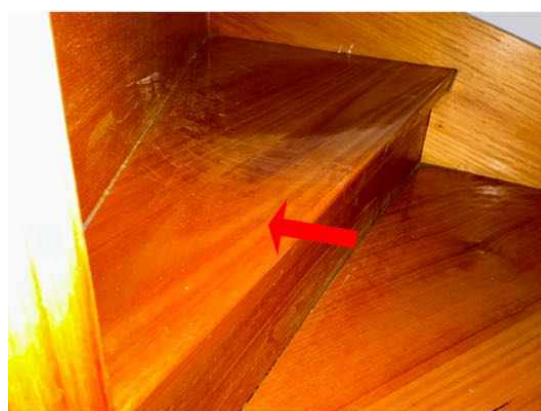
Finding 1.02

| Information: | It was observed that the polished timber stairs were finished in a coating that has no slip index rating and appears to be quite smooth |

Polished timber stairs should be finished in an appropriate non-nonslip coating with a rough surface finish. Alternatively the stairs should be fitted with nonslip nosing to the treads or a non-slip tape to the stair treads

A general handyman or painting contractor should review as soon as possible.

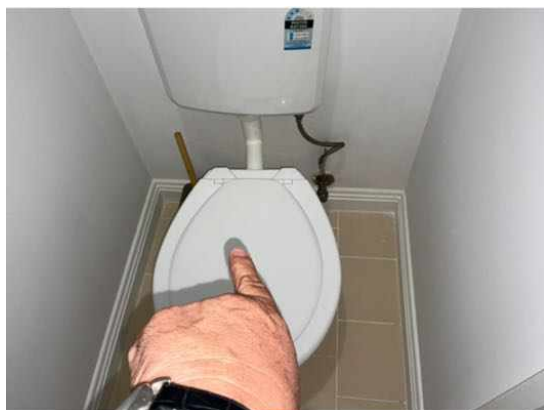
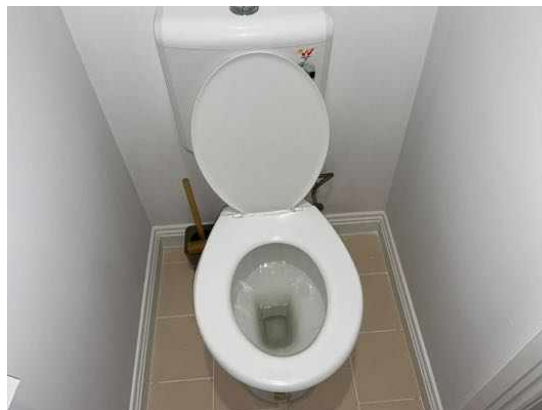
Finding 1.03

Finding: Toilet seat loose

Information: It was observed that the toilet seat was loose and unstable.

Loose seats can cause fall injury to persons while in use and lead to serious injury

A licensed sanitary plumber should be engaged to review prior to use

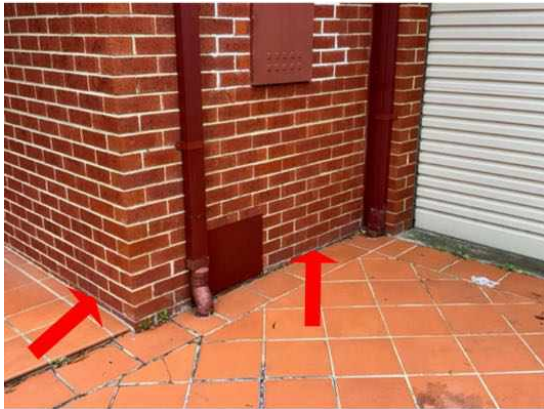
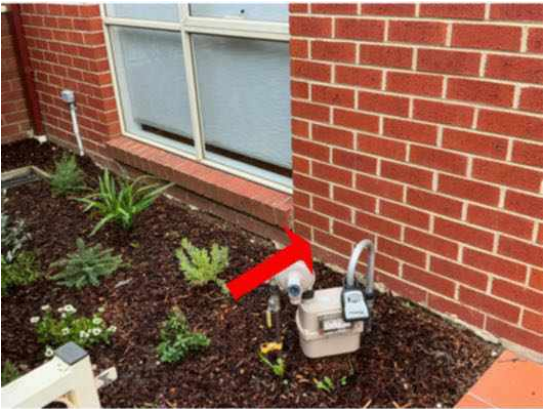
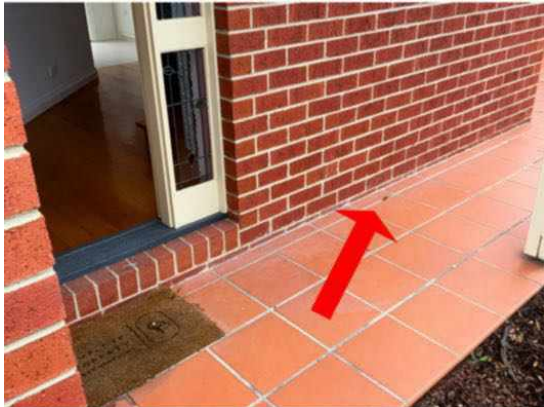
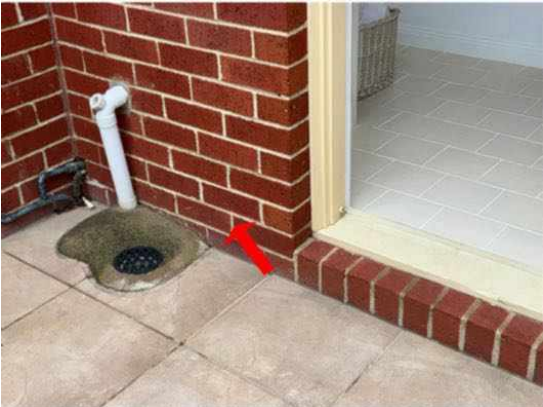
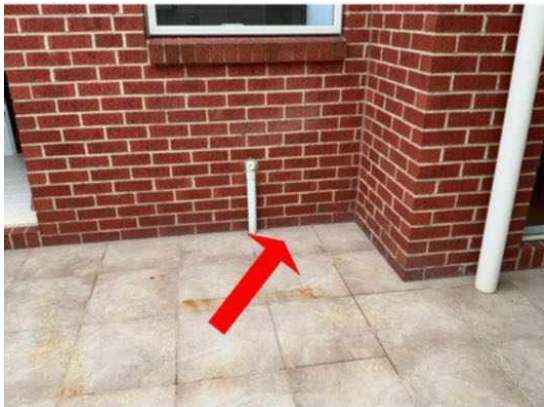
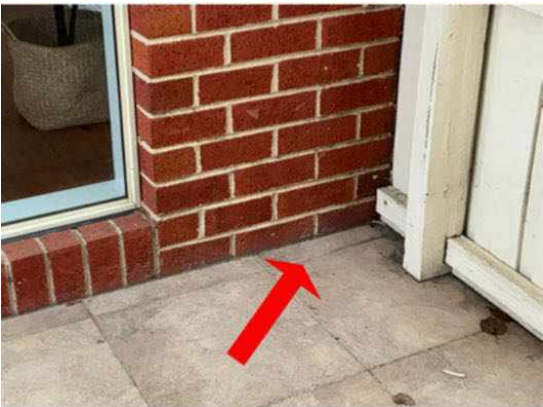
| Finding: | Air vents / weep holes- Blocked or inadequate |
| Information: | It was noted at the time of inspection that the subfloor area lacks adequate ventilation. The cause of this inadequate ventilation is the state of the air vents to the subfloor area. Where air vents are insufficient in number or are blocked, either fully or partially, subfloor ventilation is decreased. |

A well ventilated subfloor aids in maintaining dry conditions, preventing secondary damage such as wood rot and pest activity, as well as preventing the development of mould/fungi and mildew (which can lead to major respiratory issues or safety hazards for occupants, particularly the elderly, the very young and those with existing illnesses).

All air vents should be cleared of blockages to promote adequate air flow to the area. Where ventilation is still insufficient, retrospective installation of air vents may be required. Appointment of a registered builder may be required to perform these works as necessary.

It is noted that access to the subfloor area was not possible and a further invasive inspection is highly recommended

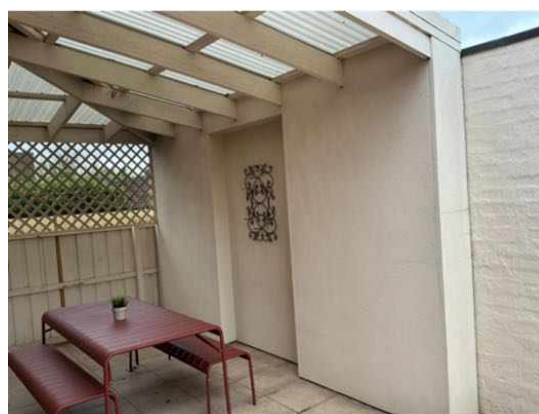
Finding 2.03

Building: Main Building
 Location: Yard - Back
 Finding: Additional structure built without a permit (Suspected)
 Information: The pergola structure at the rear of the house is suspected to have been constructed without a building permit. A building permit would be required for the structure.

It is highly advised to request that the current owner provide a Defect report (Owner Builder/Section 137b) for this structure. This would involve a structural engineer or a licenced building surveyor conducting an inspection of the structure and advising of any defects and/or areas of non-compliance in accordance with the current building codes. The current owner should then attend to any issues on this report prior to settlement.

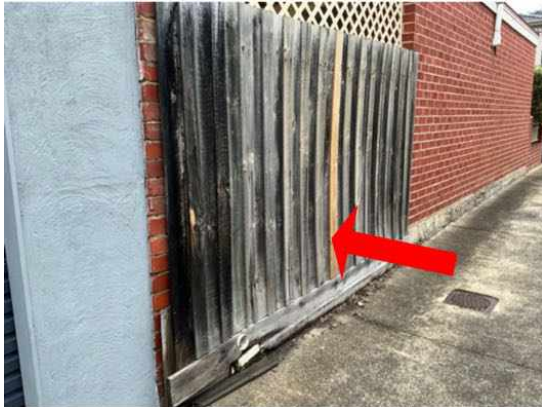
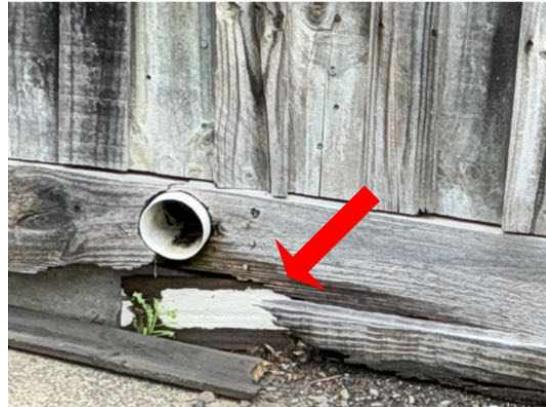
Finding 3.01

Building: Main Building
 Location: All External Areas
 Finding: Fencing - Deteriorated
 Information: It was noted at the time of inspection that sections of the fencing throughout the property have deteriorated. Typically fencing deteriorates due to age and or wear, rot and or rust which is generally expected for a structure of this age, due to prolonged exposure to weather conditions. Sometimes inadequate installation or maintenance can be to blame.

If left unattended, it is likely that further damage will occur. It is suspected that repair of several elements of the fencing may be required however replacement may be a consideration of the client also.

A licensed fencing contractor should be appointed to provide further advice and perform rectification works as necessary.

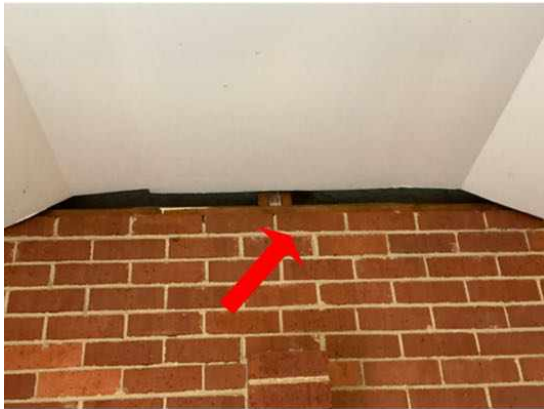
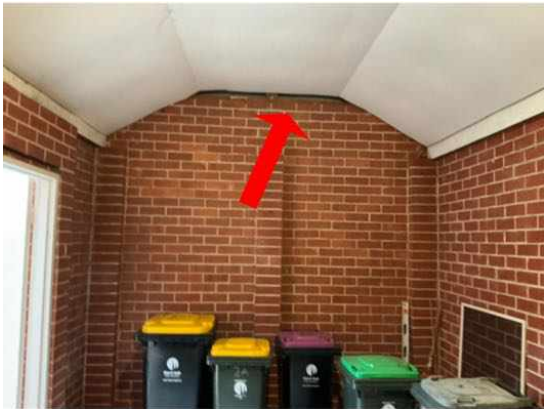
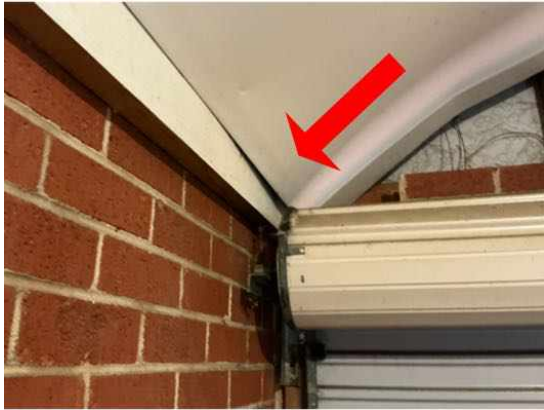
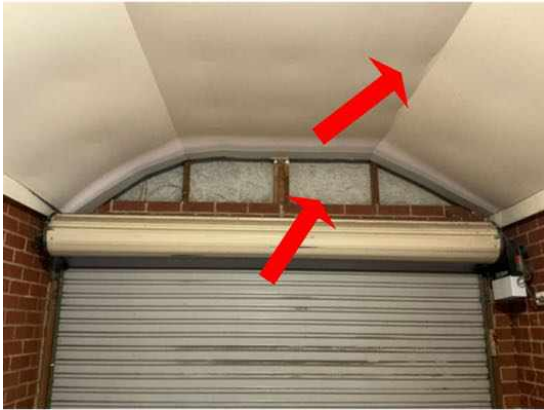
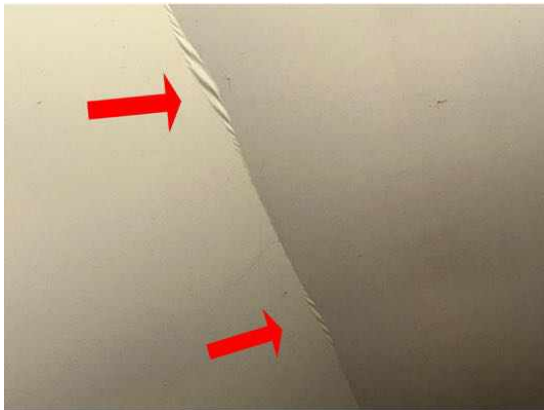
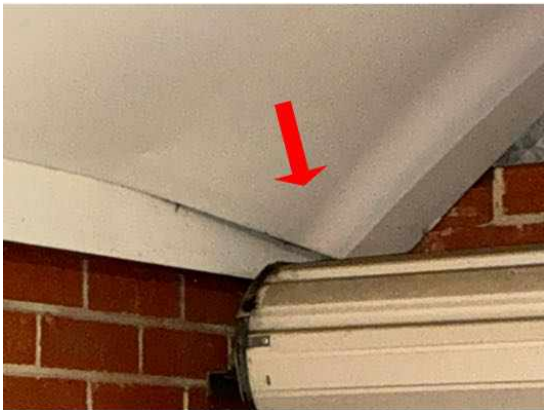
Finding 3.02

Works that have not been completed to a satisfactory level create potential for the development of building defects and may impede on the safety and integrity of the overall structure.

It is highly recommended that relevant trades be appointed to complete these works and ensure the safety of the area and the longevity of all associated building elements.

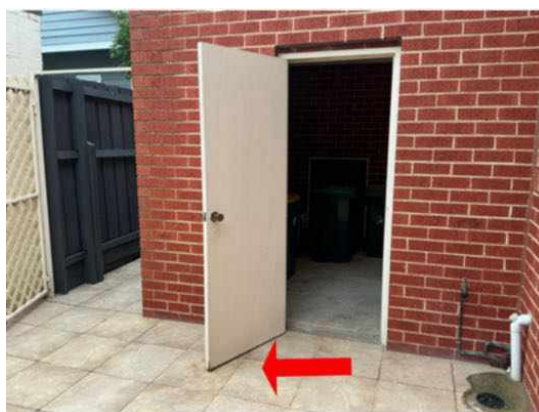
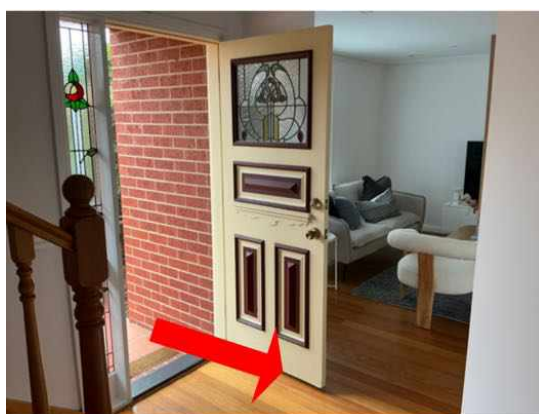
Finding 3.03

Building: Main Building
 Location: Garage
 Finding: External door/weather deteriorated
 Information: It was noted that the external door to the garage and front entry have sustained some moisture damage and has prematurely deteriorated the door.

Unattended to the door could further deteriorate and reduce the security and operation of the door.

A qualified carpenter and painter should be engaged to review at the clients discretion

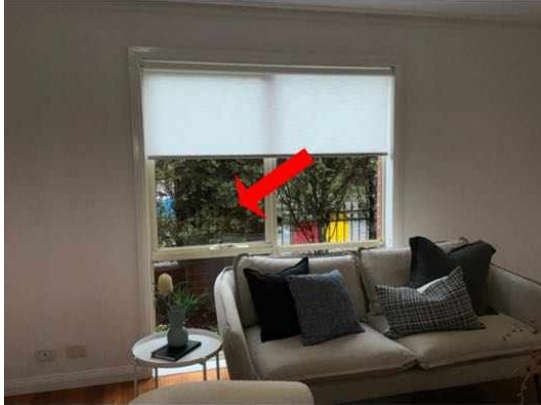
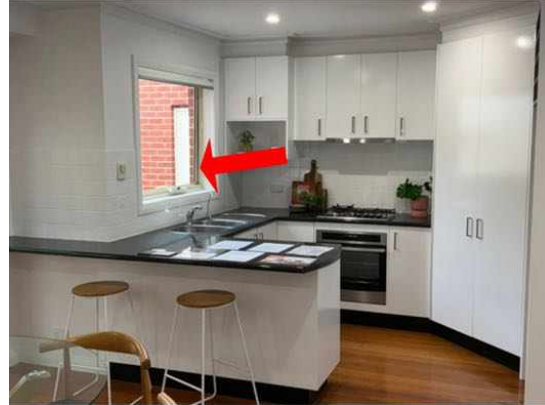
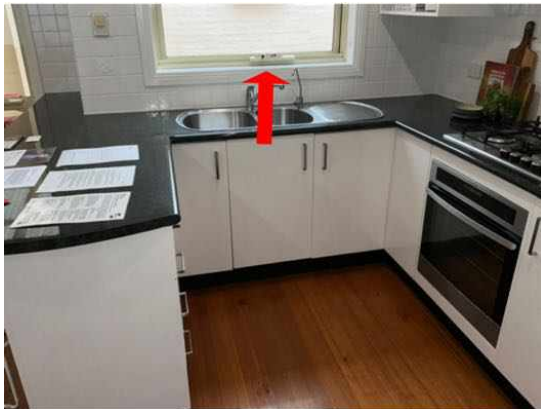
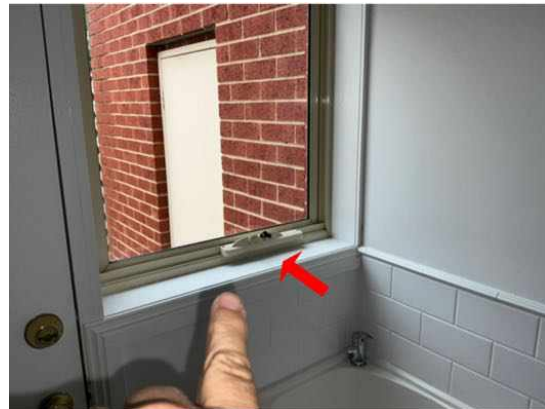
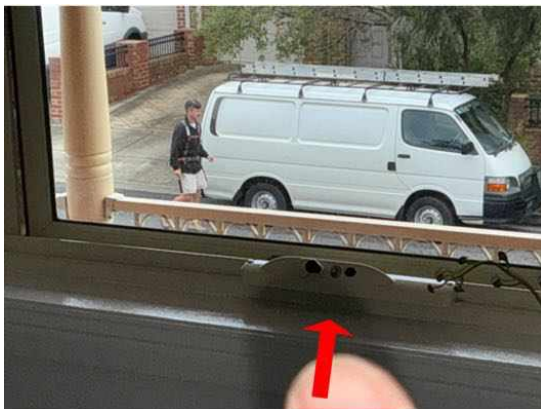
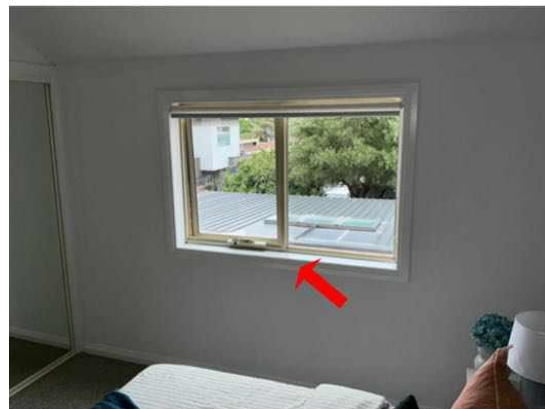
Finding 3.04

Building: Main Building
 Location: All Areas
 Finding: Windows - Stiff to slide- locked
 Information: Several windows throughout the property were jammed , locked and difficult to operate at the time of the inspection. Windows provide ventilation to the adjoining area and should be at a fully operational level to ensure user comfort. Restricted function of the window may also pose as a potential safety hazard if required for emergency egress from the building.

maintenance are the usual causes for this type of defect.

Replacement of window hardware or frame may be required, as well as minor repairs and cleaning. A registered builder or general handy person will be required to repair the affected windows.

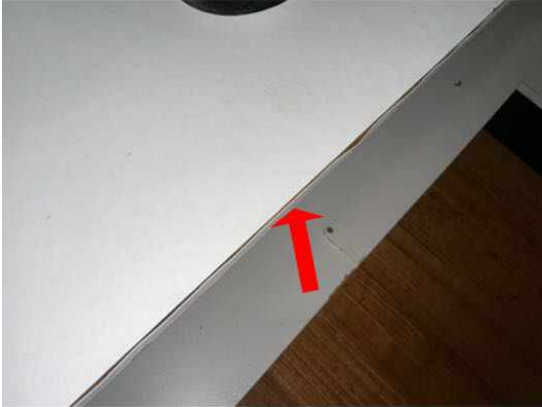
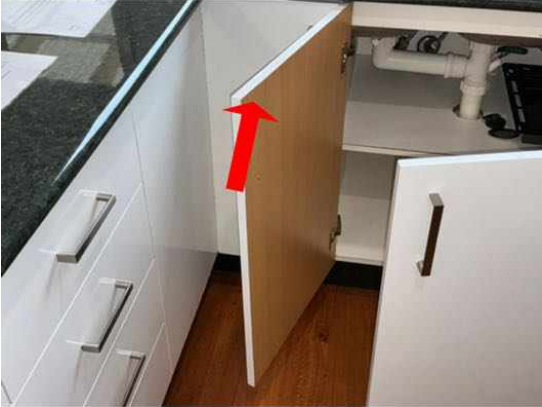
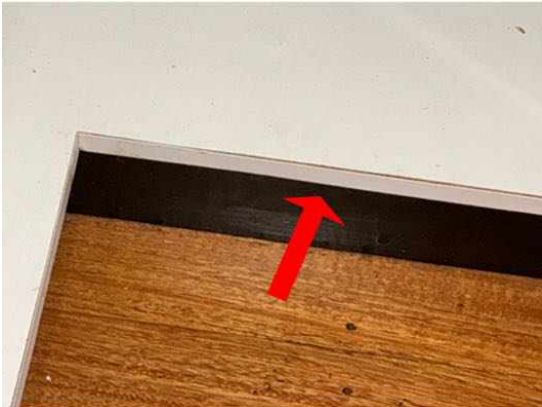
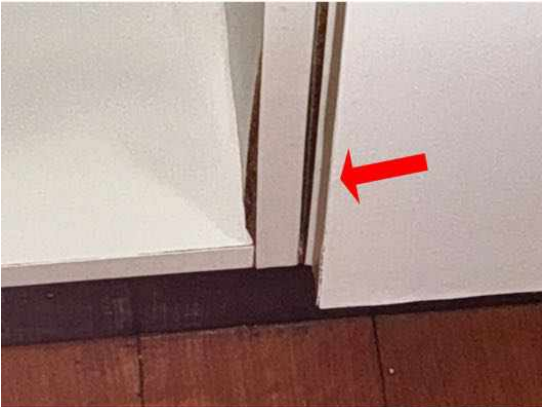
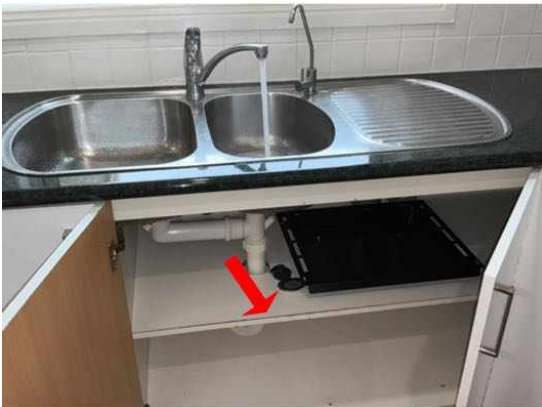
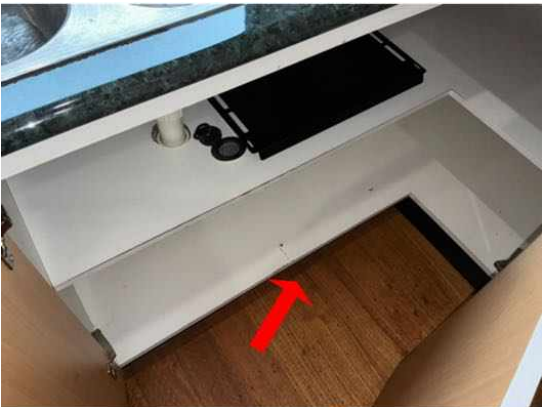
| Finding: | Malaine deteriorated- water damaged |
| Information: | It was observed that the white malamine surface to the kitchen sink cabinet shelf was |

deteriorated and water damaged

The white melamine coating is required to prevent the ingress of moisture into the kitchen cabinets substrate. damaged Malaine on cabinets is also an aesthetic defect and from the overall appeal of the building.

A qualified cabinet maker should be engaged to review at their owners discretion

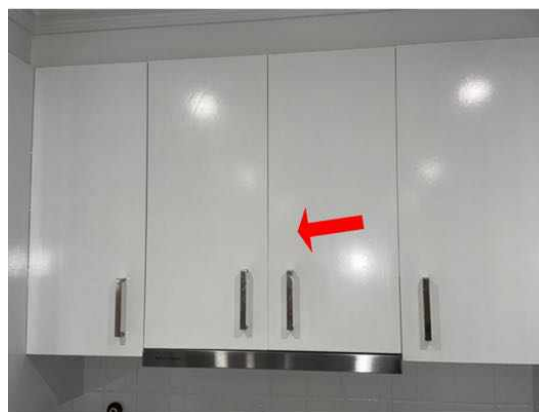
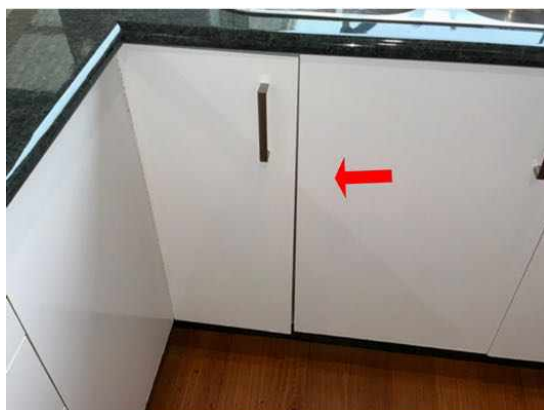
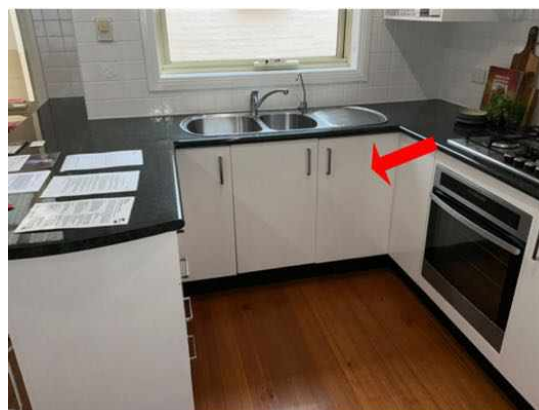
Finding 3.06

Building: Main Building
Location: Kitchen

Information: It was observed that many cabinet doors to the kitchen require adjustment as they appear to be binding

Unattended to the doors will continue to jam and operate ineffectively, which in time could cause further damage to the doors

A qualified carpenter should be engaged to review at the owners discretion

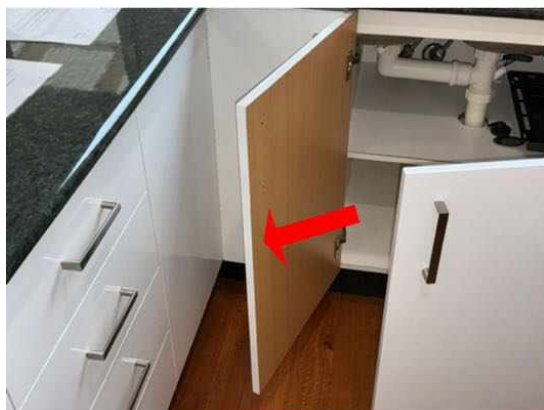
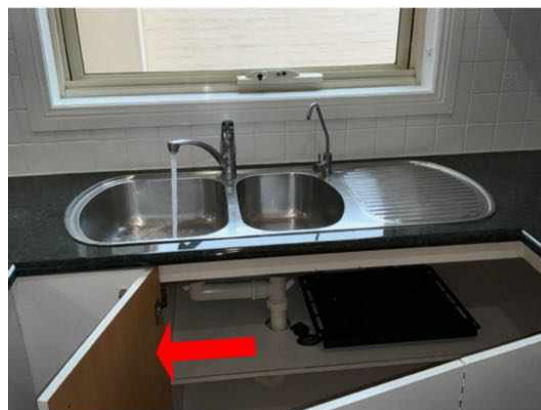
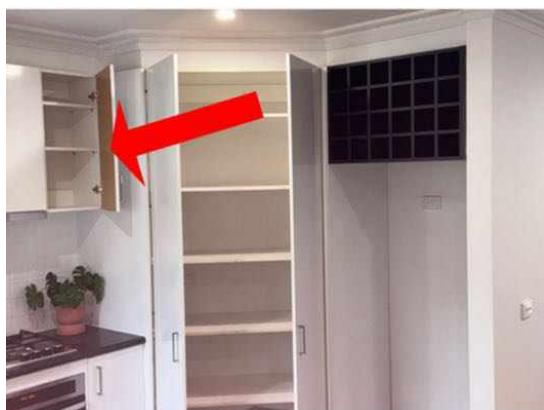
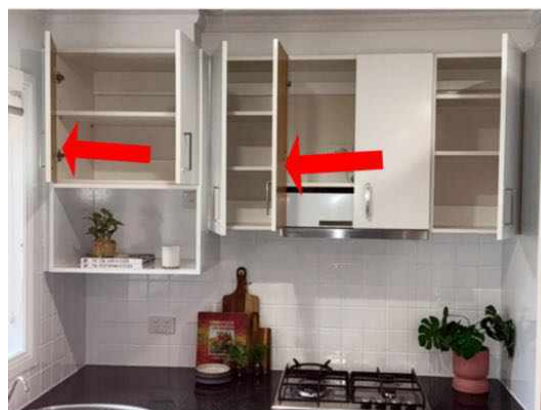
Finding 3.07

Building: Main Building

Information: It was observed at the time of the inspection that the melamine coated doors to the kitchen cabinet have been painted. The original colour was a wood grain finish and the paint finish is white in colour.

It could be possible that the paint could peel or prematurely deteriorate as the paint finish is applied onto a smooth melamine surface.

A qualified cabinet maker should be engaged to review at their owners discretion

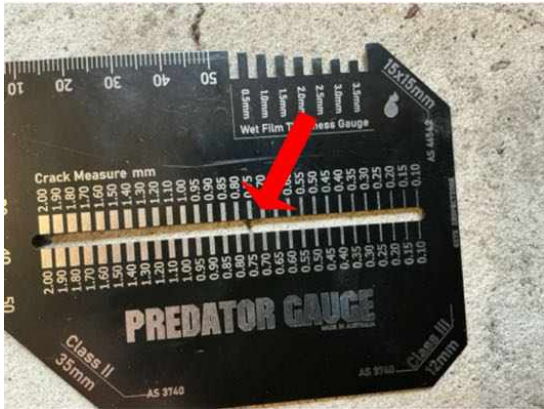
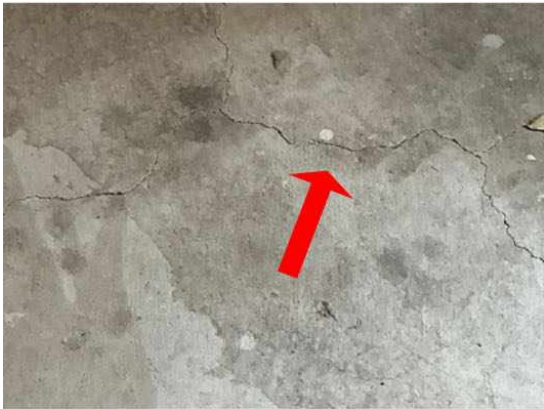
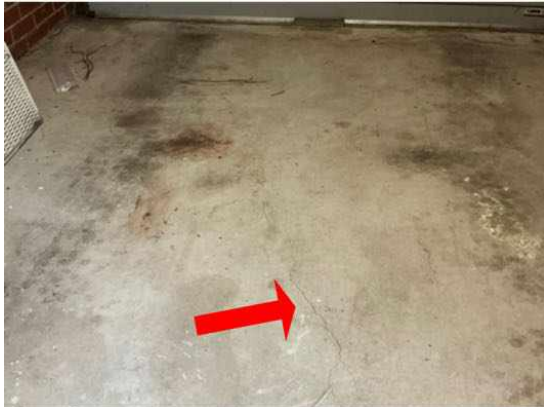
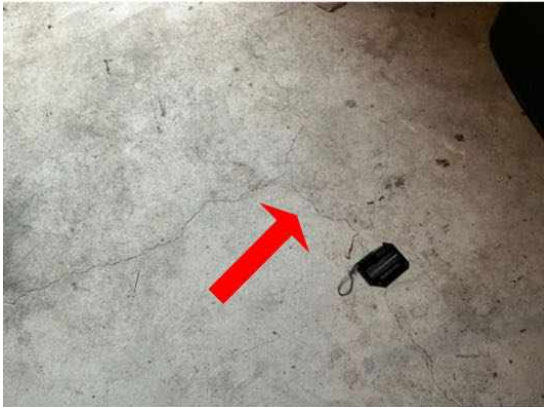
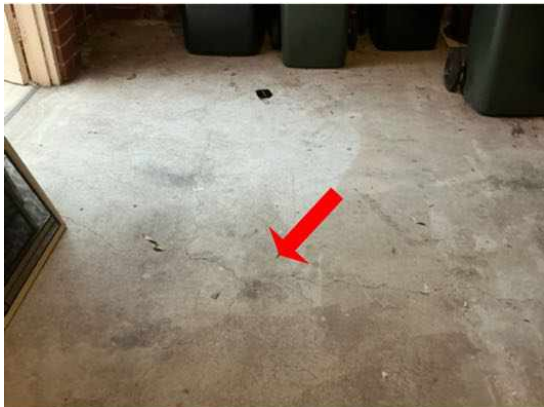
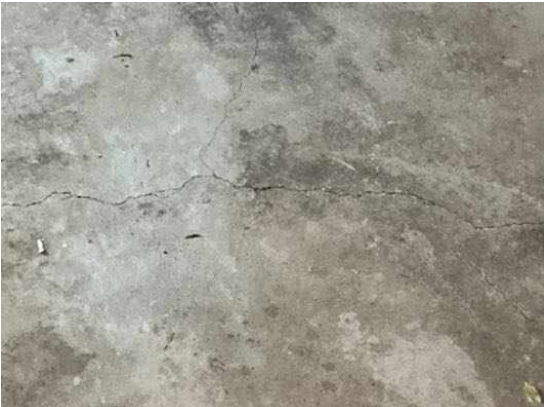
Finding 3.08

Building: Main Building
 Location: Garage
 Finding: Crack in concrete slab - Category 1
 Information: A crack coded as Category 1 was identified in the slab. A Category 1 crack is described as a fine but noticeable crack, with the slab at an otherwise reasonable level.

To be considered Category 1, the approximate width of the crack is less than 1.0mm, or a less than 10mm change in offset when a 3m straight edge is placed over the defect.

Category 1 cracks should be monitored for a period of 12 months. At the end of the monitoring period, identified cracks that are rated greater than Category 2 are considered defects, and require rectification.

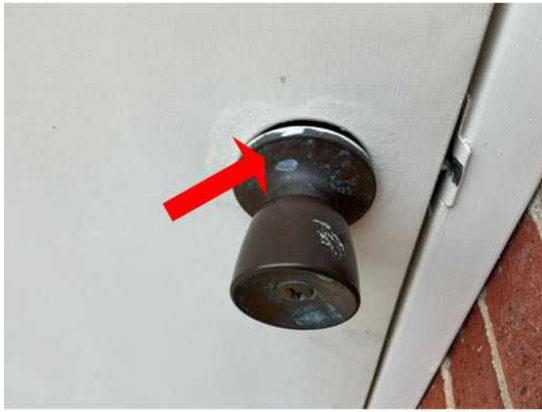
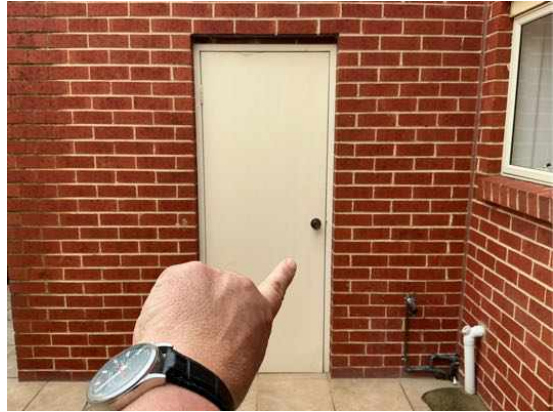
Finding 3.09

Building: Main Building
 Location: Garage
 Finding: Door handle loose
 Information: The door handle was found to be loose.

Unattended to the handle could fall off and make the door inoperative.

A carpenter/handy man should be appointed immediately to review and adjust at the owners discretion.

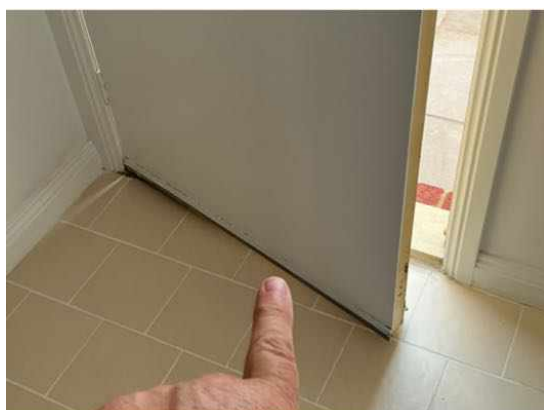
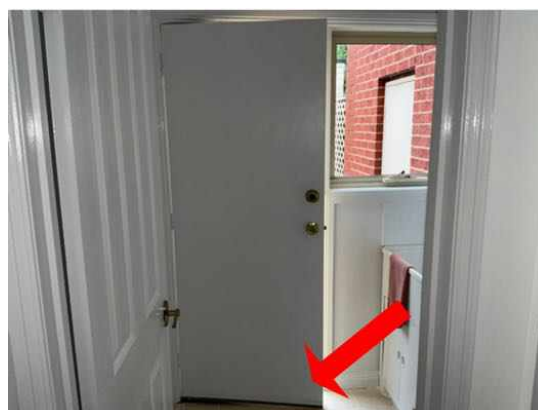
Building: Main Building
 Location: Laundry
 Finding: Door - Binding/jamming
 Information: Binding and/or jamming of the laundry door is evident during standard operation. This defect inhibits the functionality of the affected door as well as creating potential for secondary defects to associated building elements, such as damage to the floor covering.

A door that binds to flooring or to the associated door frame may have several causes, ranging from minor defects, such as poor installation of the door or deteriorated hinges, through to major structural issues, such as damage to subfloor structures.

Where door binding/jamming appears to indicate major structural issues, a registered builder specialising in re-stumping should be appointed to provide an estimate on the cost of rectification.

For minor causes, a qualified carpenter or general handyman should be appointed to perform minor rectification works at client discretion.

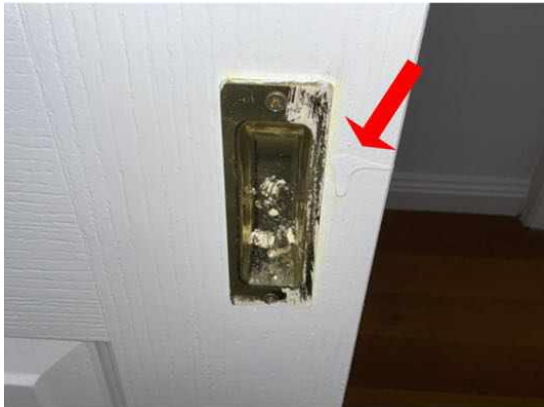
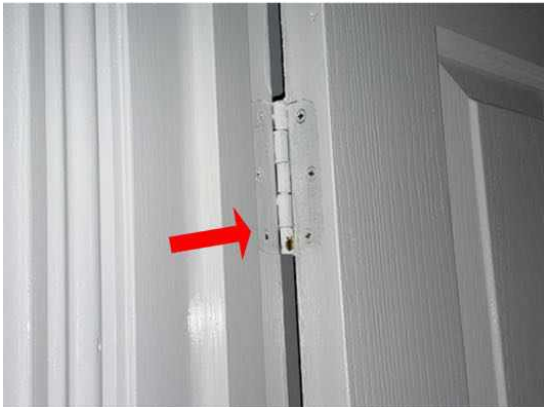
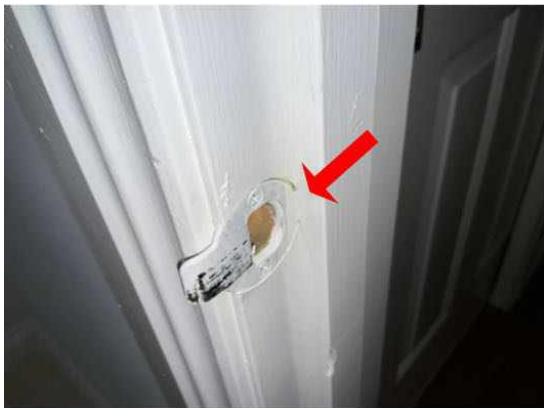
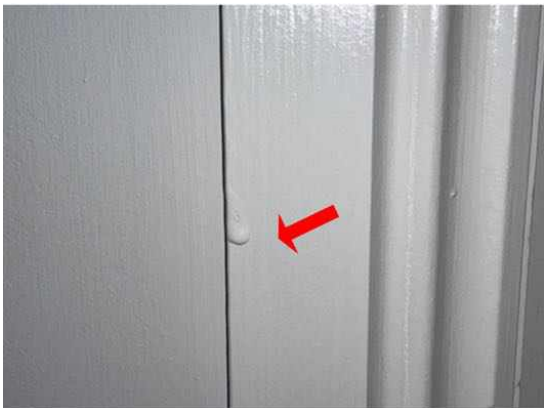
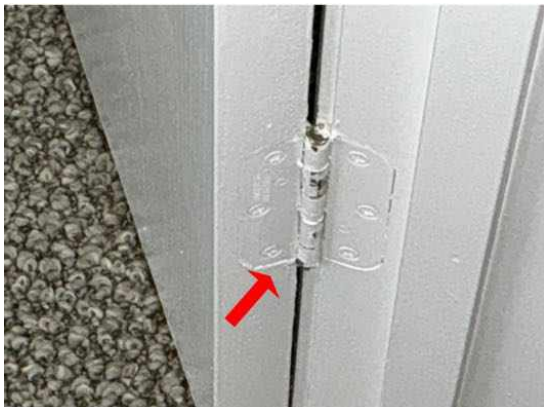
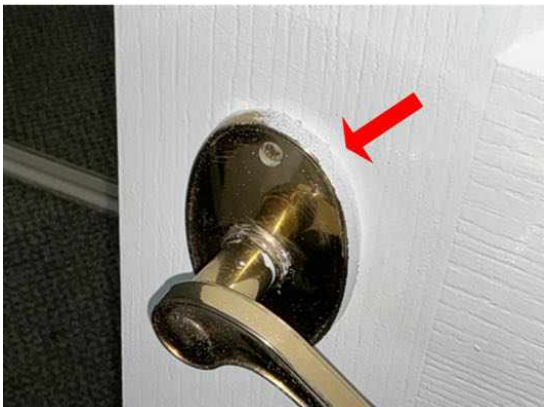
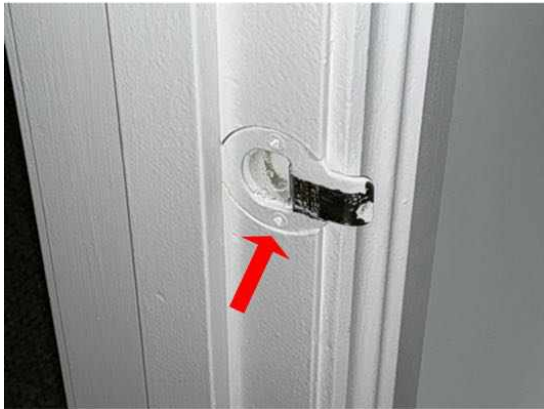
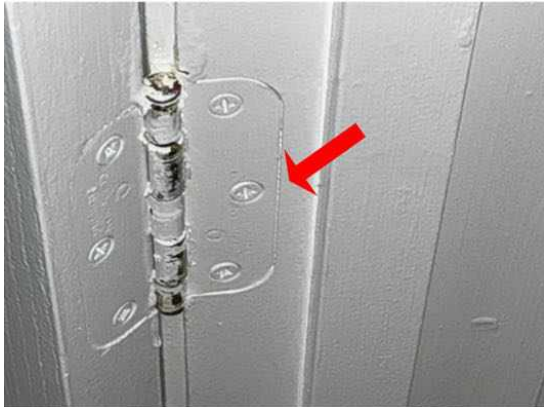
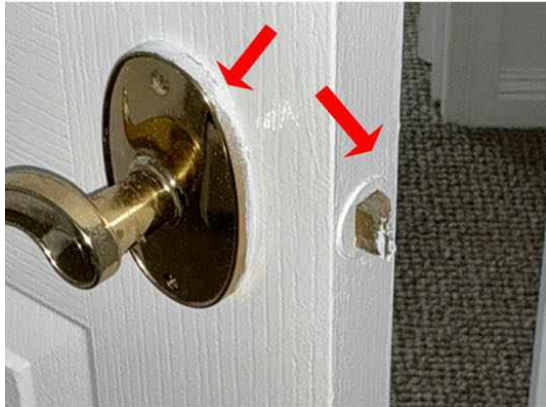
Finding 3.12

Building: Main Building
 Location: All Internal Areas
 Finding: Poor quality painting work
 Information: It was observed at the time of the inspection that the building has recently been repainted. The overall paintwork is demonstrating poor workmanship and appears to be incomplete.

Although anaesthetic defect it detracts from the overall appearance of the building and demonstrates poor quality workmanship

The owners should engage a professional painting contractor to review at their discretion

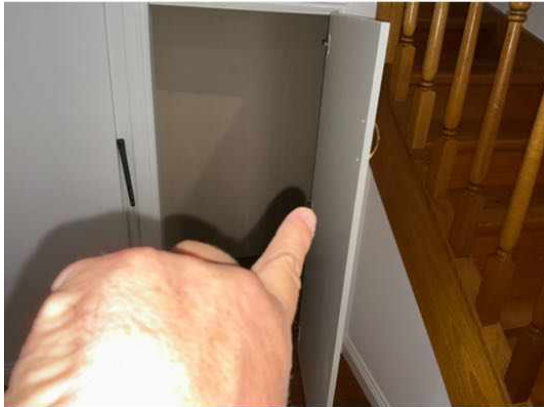
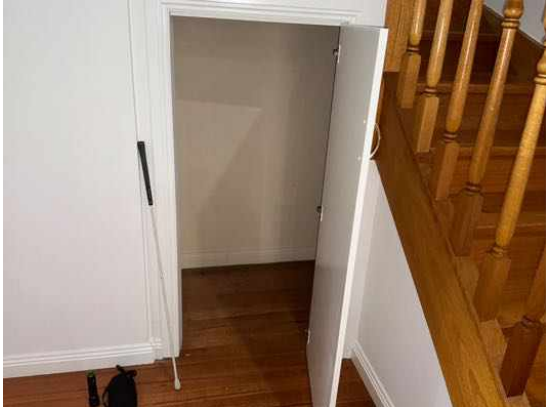
Finding 3.13

Building: Main Building
 Location: Storage Cupboard
 Finding: Door catch missing
 Information: Was observed at the time of the inspection that the door catch to the store cupboard door under the stairs was missing.

Missing door catches can cause the door to rattle, open unexpectedly and be non-securable

A general handyman should be engaged to provide a door catch to the door

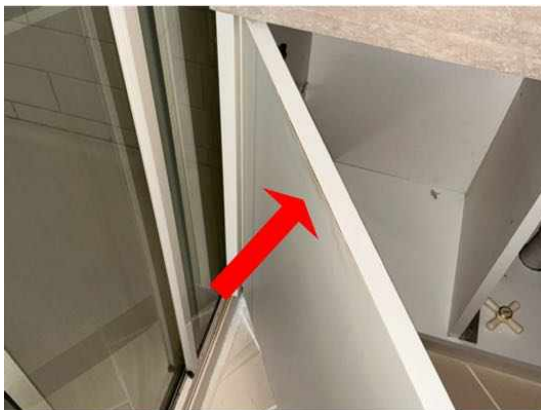
Building: Main Building
 Location: Bathroom
 Finding: Cabinet edge tape
 Information: It was observed that the tape to the bathroom cabinet has sustained some previous water damage

Edge tape is required to prevent the ingress of moisture to the substrate of the cabinet carcass preventing swelling and premature deterioration of the cabinet structure

A qualified cabinet maker should be engaged to review at the clients discretion

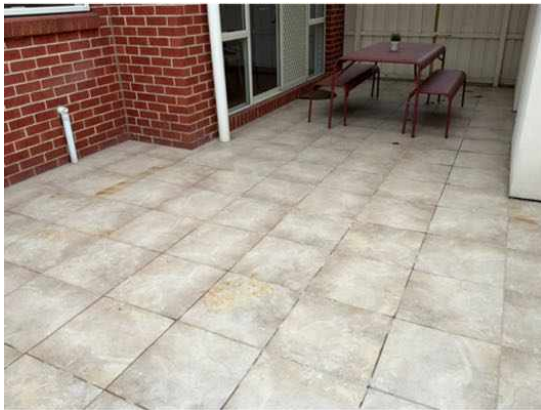
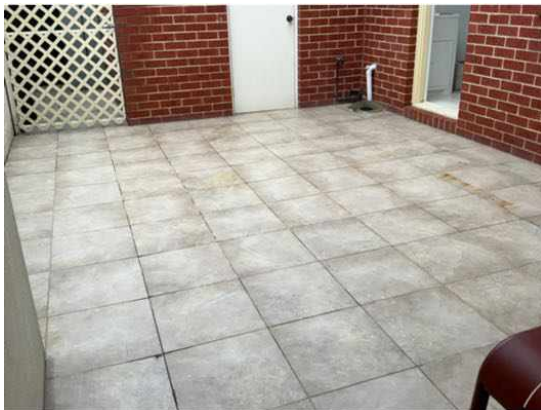
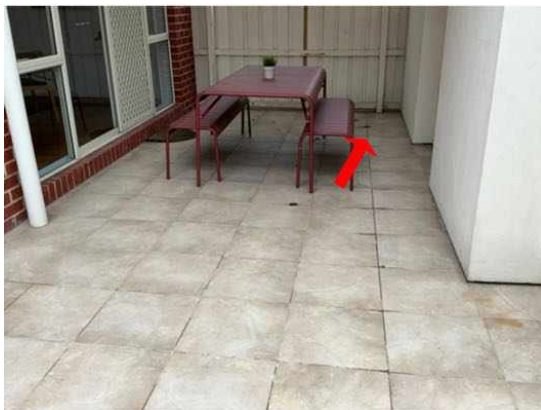
Finding 3.17

Building: Main Building
 Location: Yard - Back
 Finding: Site drainage - Inadequate
 Information: The site drainage in patio area was found to be inadequate at the time of inspection, creating potential for subsequent water damage to associated building elements.

It is important that water does not lie against the base of walls; surrounding paths and ground levels should be sloped to drain water away from walls. Downpipes should not discharge stormwater onto lower walls or plinths. Stormwater should be carried away by large, regularly cleaned drains. Ground levels may need to be lowered to expose a buried DPC.

Where site drainage is inadequate, installation of an Agricultural (Aggie) Drain may be required. A qualified plumber should be appointed to further inspect the property and perform any remedial works as necessary. Water damage and secondary defects are likely to occur if left unmanaged.

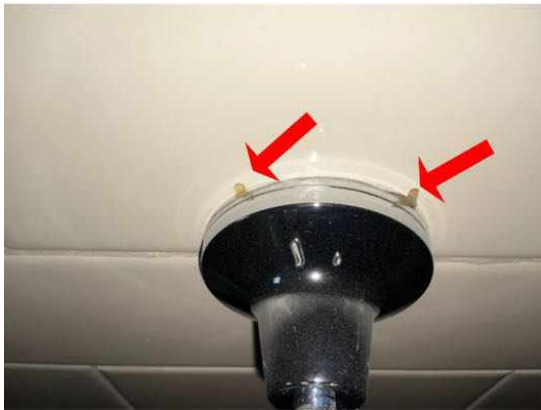
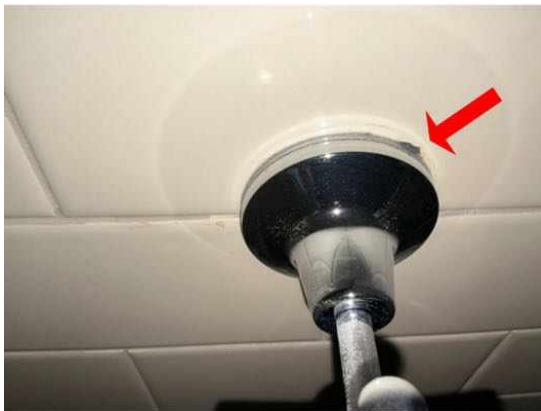
Finding 3.18

Building: Main Building
 Location: Bathroom
 Finding: Tiles cut short of tap flange
 Information: It was noted at the time of the inspection that the tiles in the bathroom shower closet were cut short and were exposed at the tap flanges. It appeared that the overcuts had been sealed at the time of the inspection and leaking from these exposed tile cuts is not suspected

This is an aesthetic defect and a demonstration of poor workmanship.

A Qualified ceramic tiler should be engaged to review at the owners discretion.

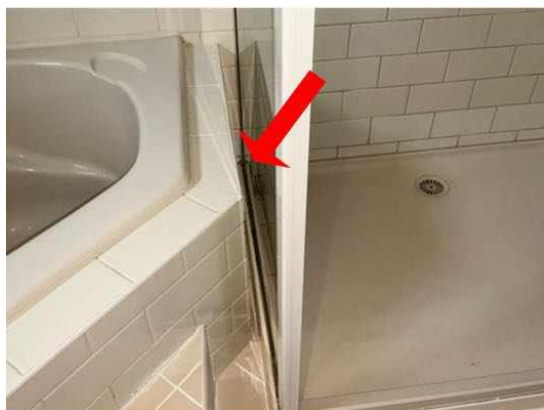
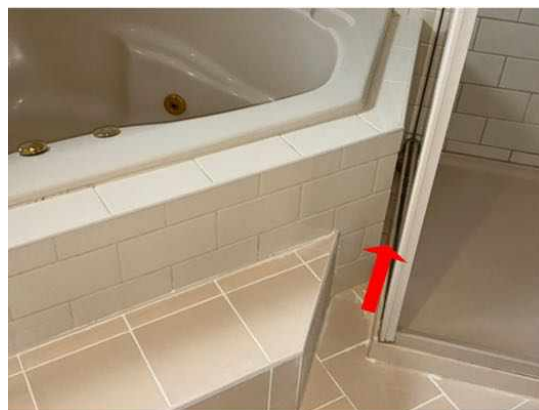
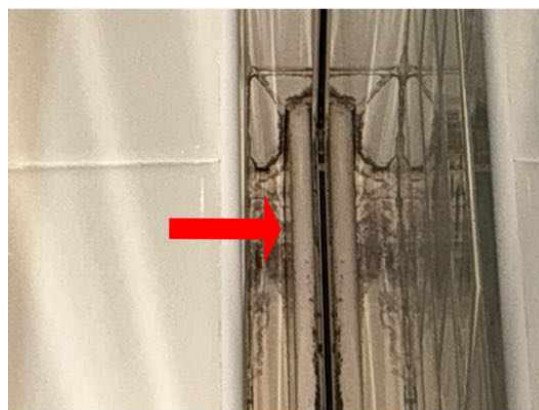
Finding 3.19

Building: Main Building
 Location: Bathroom
 Finding: Minor mould
 Information: It was observed that a small amount of mould was present in the sealant at the bottom of the spa bath. This is minor in nature and requires a through clean prior to use of the shower. It is noted that this area would be very difficult to clean due to accessibility between the shower screen and the spa bath.

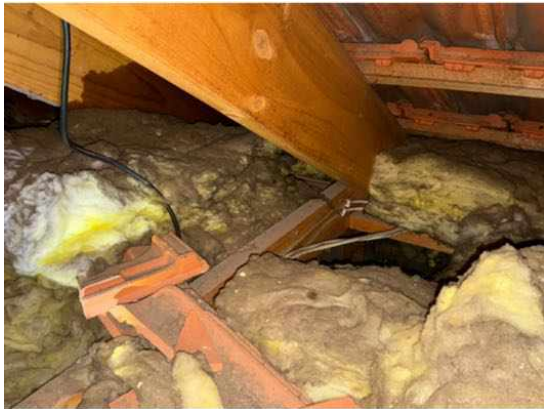
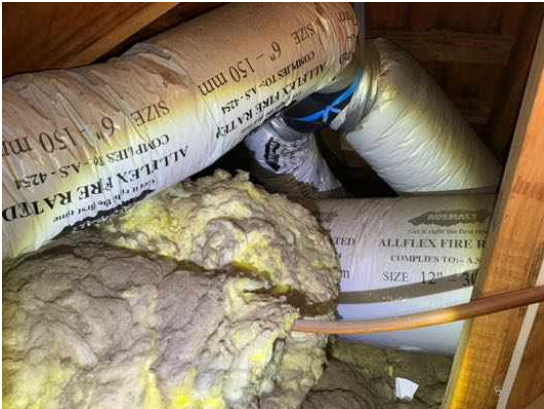
Finding 3.20

| Finding: | Insulation - Missing-disturbed |
| Information: | Upon inspection of the roof void it was noted that insulation is not present or disturbed. |

Insufficient insulation will result in a comparatively higher cost to heat and cool a property as there is a lack of Insulation (or uneven coverage of insulation) which works as a barrier to heat transfer. This helps to keep out unwanted heat in summer and preserves warmth inside your home in winter. It can also help soundproof your home from unwanted airborne noise transfer.

Where insulation is absent, the area does not meet current Australian Standards. Installation of adequate insulation is required and should be conducted as soon as possible.

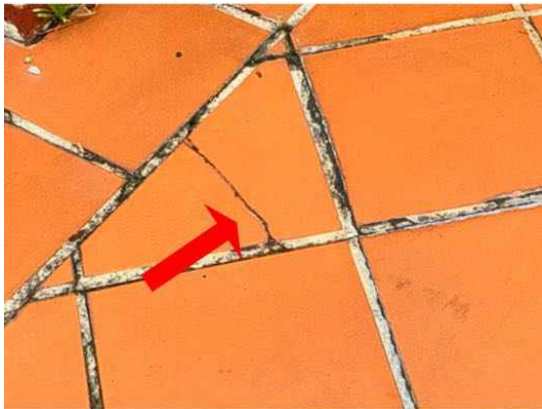
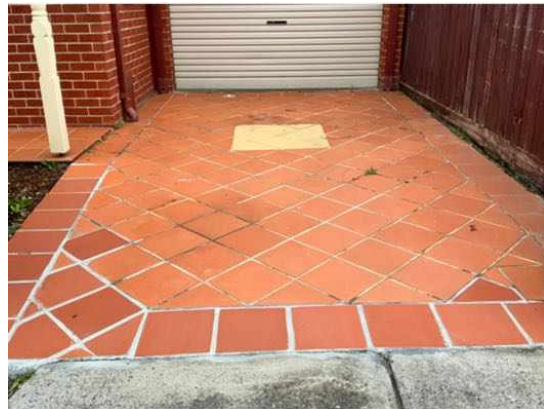
Building: Main Building
 Location: Driveway
 Finding: Cracked floor tiles- driveway
 Information: Cracking in the floor tiles was evident in the driveway at the time of inspection. It is suspected that this cracking has occurred as a result of minor settlement or shrinkage of the slab.

Cracked tiles throughout detract from the overall appearance of the affected areas however it is unlikely to create or lead to any secondary defects.

While not considered a matter of urgency, replacement of cracked floor tiles is recommended at the clients discretion. A tiling contractor may be appointed to perform these works. Where cracks become more numerous, contact a licensed building inspector for further investigation.

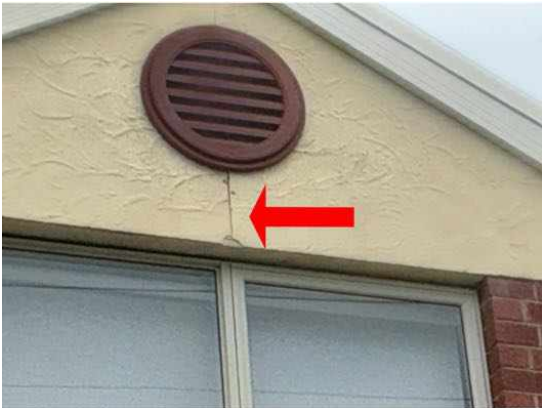
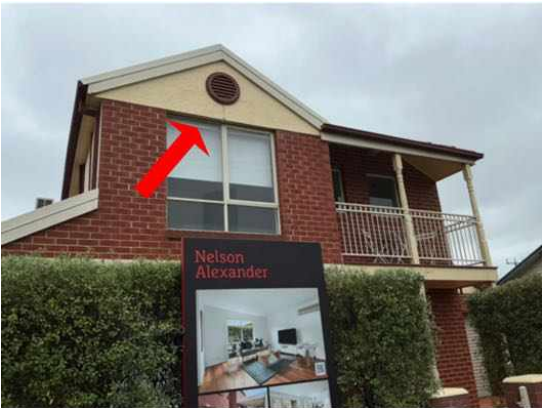
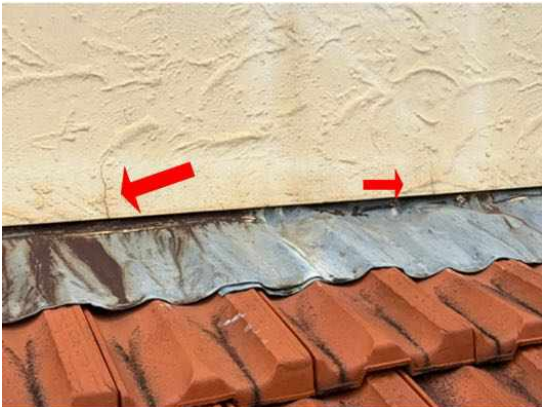
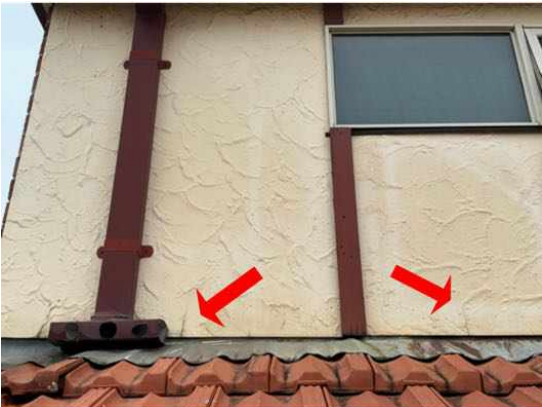
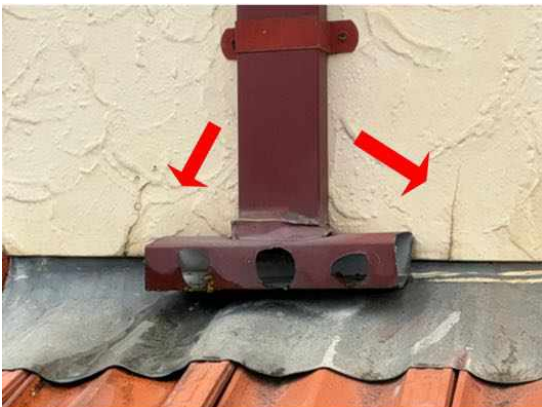
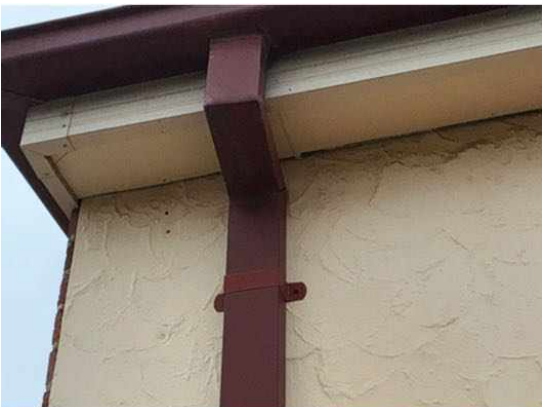
Finding 3.23

Building: Main Building
 Location: Exterior walls - left side- front
 Finding: Deteriorated paint finish and damage
 Information: It was observed at the time of the inspection that the decorative cement sheet cladding was showing signs of minor deterioration and damage.

The paintwork has deteriorated and unattended to could cause further premature deterioration of the cladding.

A qualified painting contractor should be engaged to review at their owners discretion
