Building and Timber Pest Inspection Report

Inspection Date: Tue, 3 Mar 2026

Property Address: 2A Bellevue St, Coburg VIC 3058, Australia

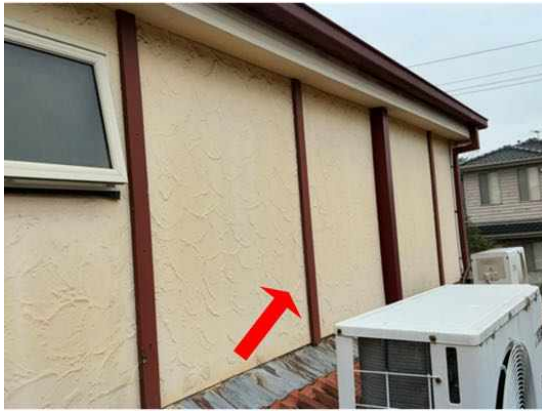
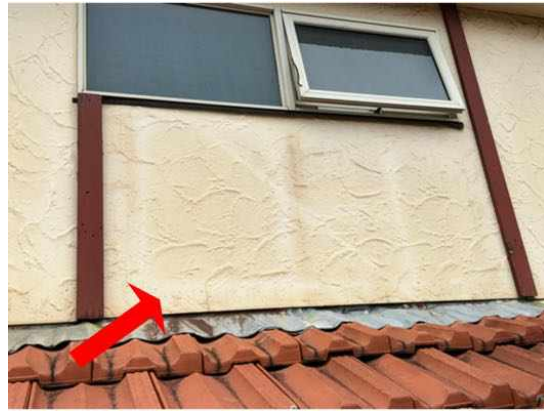
Building: Main Building
 Location: Exterior walls - left side- front
 Finding: Deteriorated paint finish and damage
 Information: It was observed at the time of the inspection that the decorative cement sheet cladding was showing signs of minor deterioration and damage.

The paintwork has deteriorated and unattended to could cause further premature deterioration of the cladding.

A qualified painting contractor should be engaged to review at their owners discretion

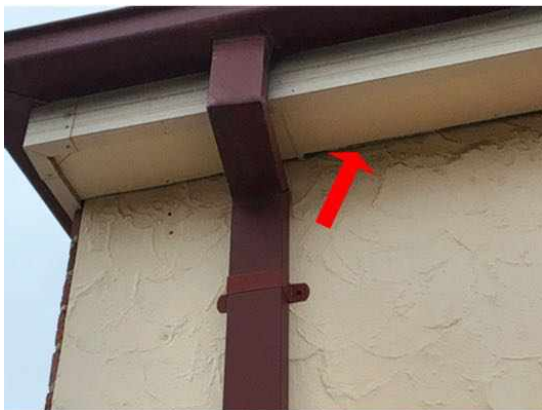
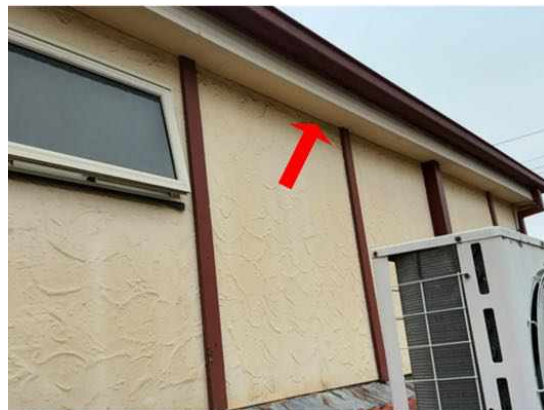
Finding 3.24

| Finding: | Eaves quad missing |
| Information: | It was noted at the time of the inspection that the quad moulding which covers a joint between the wall cladding and horizontal eave sheets was missing and appears to have never been installed since construction. Quad moulding provides an appealing finish to the joint and prevents the ingress of unwanted pest activity. |

A qualified carpenter or handyman should be engaged to install the quad moulding and paint at the owners discretion

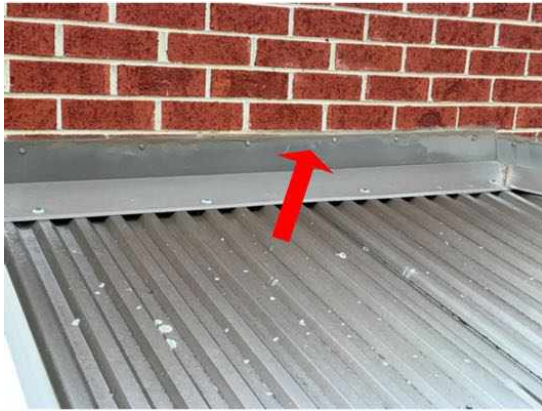
Finding 3.25

| Information: | It was noted at the time of the inspection that the roof flashings to the pergola where it about the house were inadequate and appeared to be poor handyman quality workmanship. The owners should confirm the presence of a building permit for this pergola structure. |

The over flashing or pressure flashing was missing and the fixings were suspected to be non-compliant

A registered roof plumber should be engaged to review at the owners discretion

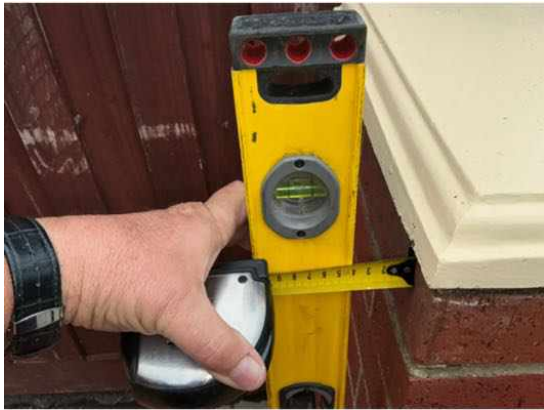
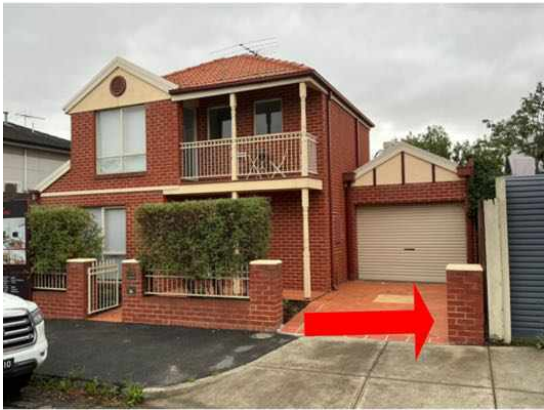
Finding 3.26

Information: It appears that the brick front fence pillar has been affected by movement of the foundations, often referred to as sinking or subsidence. Whilst a degree of movement is expected in brick pillars over time, especially as environmental conditions change and buildings 'settle' after construction, this degree of movement requires attention.

General subsidence is usually initiated by changes in soil moisture content. The most critical factor is identifying the specific causes, and identifying if this is a recurring or ongoing problem, or one that has been resolved by previous works in the past.

Subsidence can have complex and varying causes, which will influence the required remedial works.

A Registered Builder should be engaged to review as soon as possible

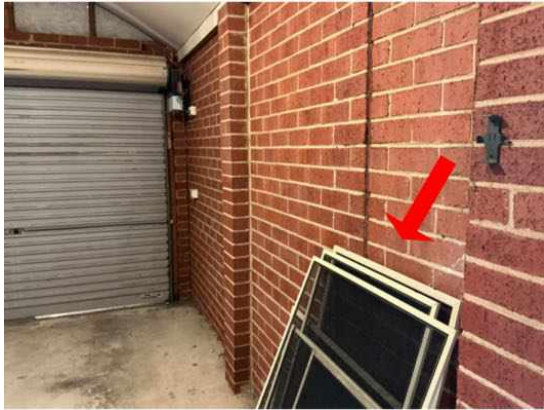
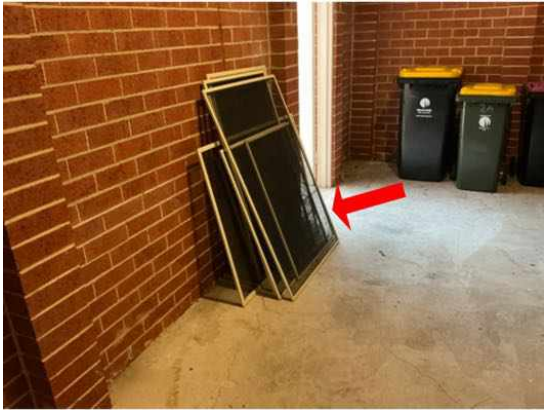
Finding 3.27

Building: Main Building
Location: All Areas
Finding: Fly wire screens not fitted
Information: It was noted at the time of the inspection that the fly wire screens were stored in the garage. The fly wire screen should be fitted to all windows to prevent the ingress of unwanted airborne pests.

A general handyman should be engaged to refit the screens at the owners discretion

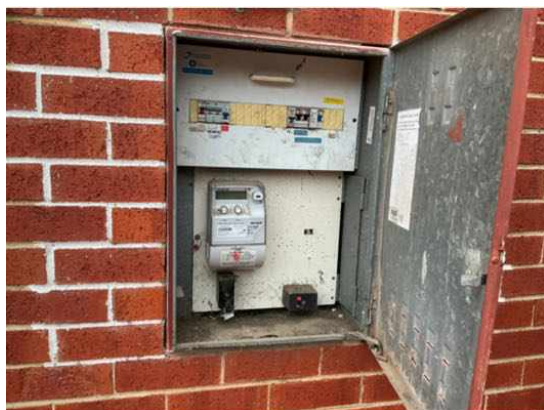
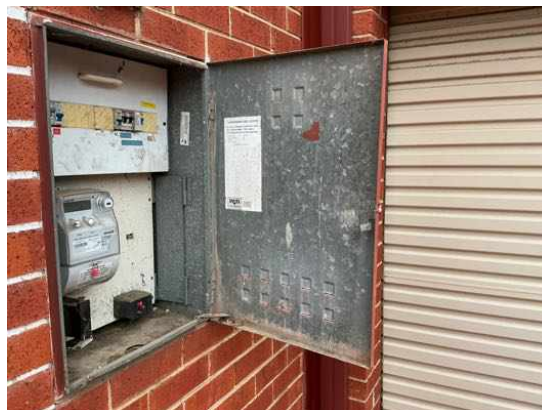
| Information: | The application of a post-construction chemical termite barrier is highly recommended for all properties, particularly if live termite activity has been found on the site previously. Such barriers are highly effective in preventing termite attack on any timber building elements throughout the property. |

A durable notice should be placed in the switchboard unit to indicate current termite barriers. At the time of inspection, it appeared as though no termite management system has been installed, with no evidence to suggest preventative works taking place.

The client may consider gaining further advice from a pest controller as to the costs and procedures involved with this application. It is recommended that obtaining such advice be a short-term priority.

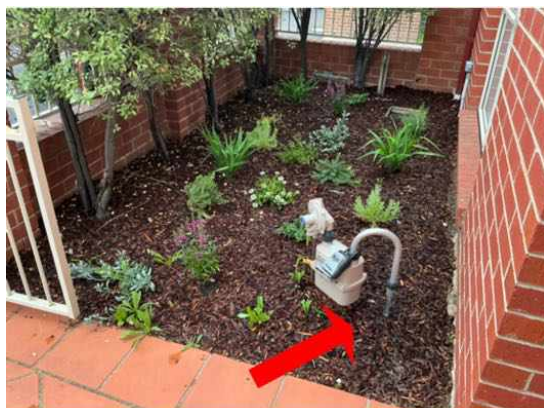
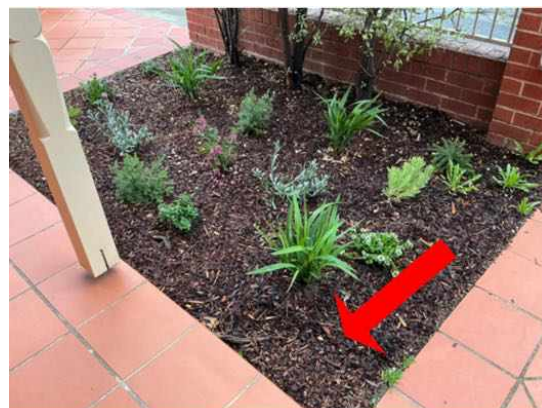
Finding 6.02

| Finding: | Garden Beds - Conditions Conducive to Termites |
| Information: | Garden beds were found to be evident in the garden area. These garden beds can include untreated timber, and with a combination of moisture from watering hosing can make conditions conducive to termite activity and termite ingress. |

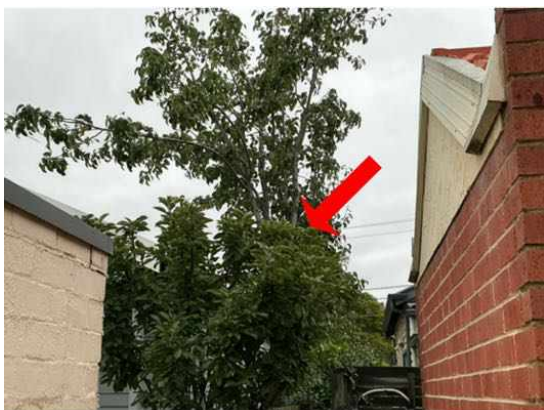
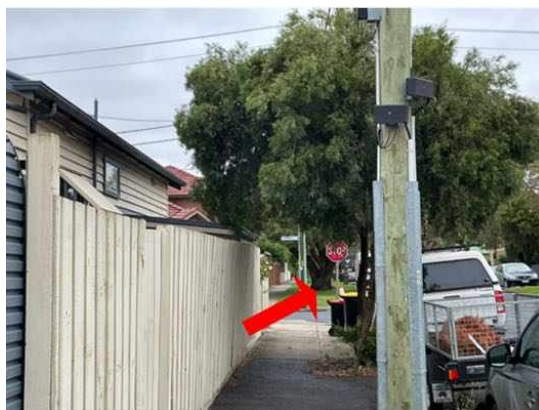
Finding 6.03

| Information: | It was observed that there were several large trees next to or nearby the building. |

The trees have the potential to provide conducive conditions for termite infestation

It is recommended that periodic 12 monthly inspections by a registered pest control contractor be undertaken and further reinstatement of outdated termite barriers as soon as possible.

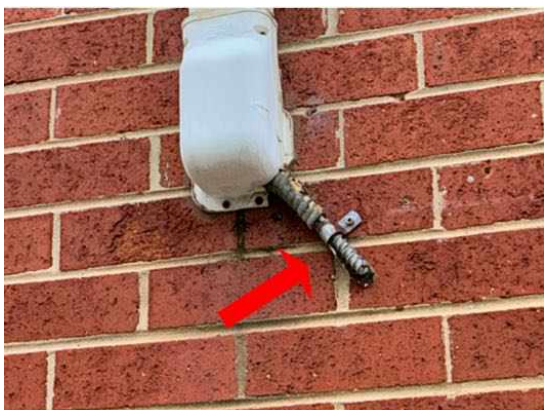
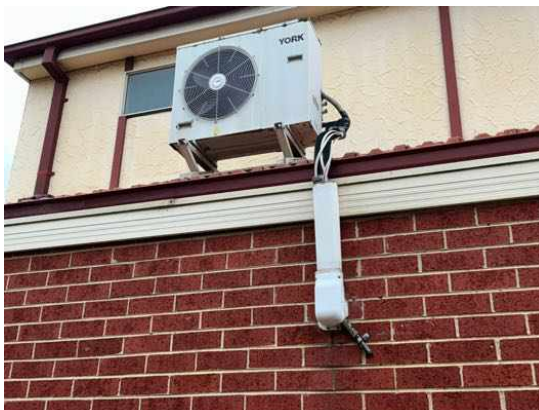
Finding 6.04

Building: Main Building
 Location: Exterior walls - left side
 Finding: Air conditioner condenser pipe not connected
 Information: The A/C Condenser overflows were found to be disconnected from the stormwater system and is creating excessive moisture to the surrounding area.

Such leaking creates an environment which is conducive to an array of defects including water damage to associated building materials and the attraction of termites or timber pest infestation.

A Licensed plumber should be engaged to review as soon as possible

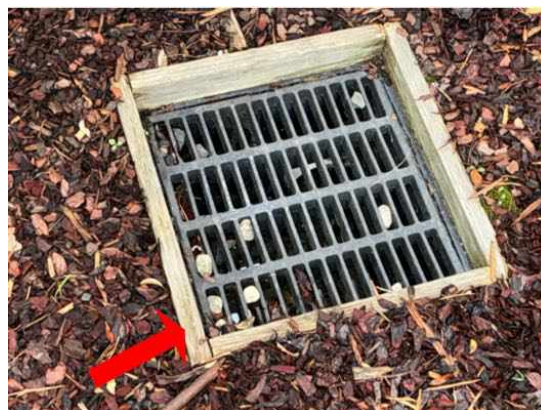
Finding 6.05

Building: Main Building
 Location: Yard - Front
 Finding: Untreated or non-durable timbers in a hazardous environment
 Information: To reduce the risk of timber pest attack it is essential that timber used in a hazardous environment (e.g. in direct contact with the ground or frequently exposed to damp conditions) is of sufficient durability and/or is adequately preservative treated.

rot and/or fungal decay if left unattended creating attraction for subterranean termites to infest the timbers from surrounding areas.

If untreated or non-durable timbers are found to be in a hazardous environment it is highly advised that replacement of these building elements be performed as soon as possible to aid the protection of the property against termite / timber pest attack.

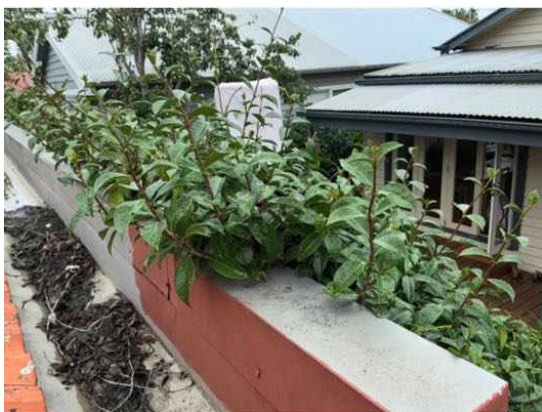
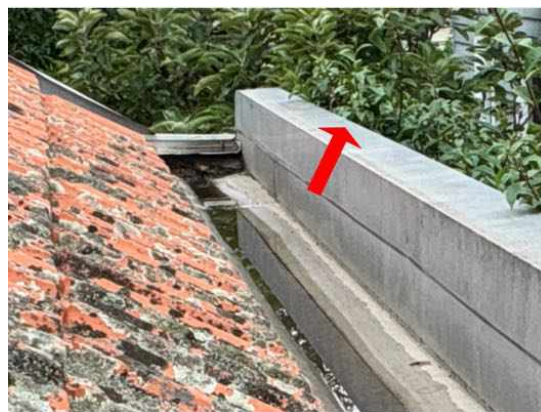
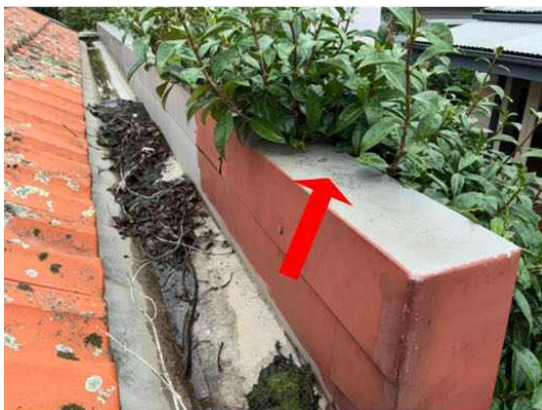
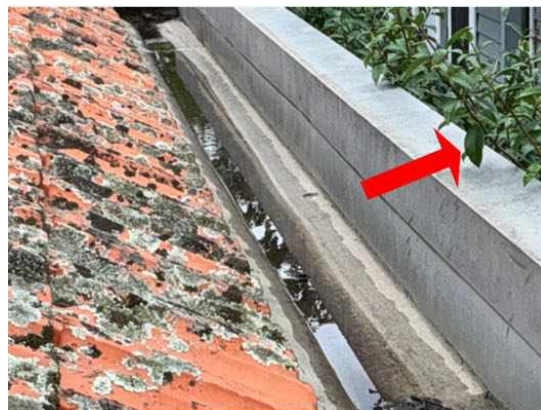
Finding 6.06

| Information: | Where vegetation obstructs inspection of building elements, also known as bridging as it provides a bridging point for the access of termites, full inspection can not be achieved. Consequently moisture or dampness may be present and the areas becomes conducive to termite activity. Plants against or very close to buildings provide cover, shade and can provide an environment that is attractive to termite infestation. |

The removal and replanting of species that do not provide "cover" or cutting back of existing vegetation will assist greatly in preventing Bridging from occurring.

The removal of any such materials that may be conducive to termite activity should be carried out as soon as possible and arrange re inspection to minimize the risk of termite attack.

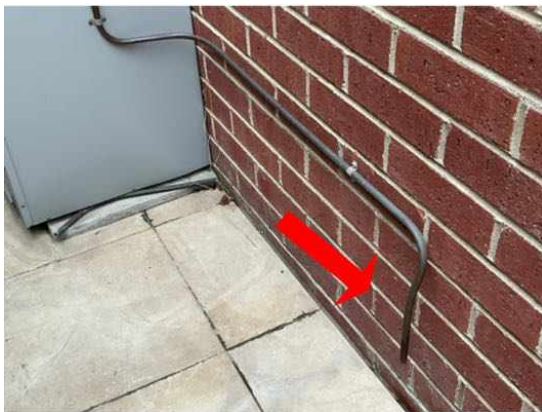
Information: The water heater drain overflow where found to be disconnected from the stormwater system and is creating excessive moisture to the surrounding area.

Such leaking creates an environment which is conducive to an array of defects including water damage to associated building materials and the attraction of termites or timber pest infestation.

A Licensed plumber should be engaged to review as soon as possible

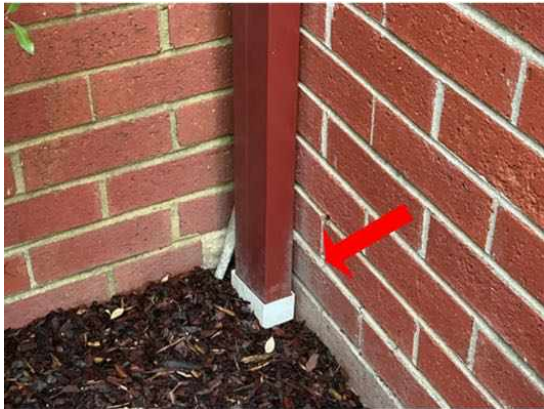
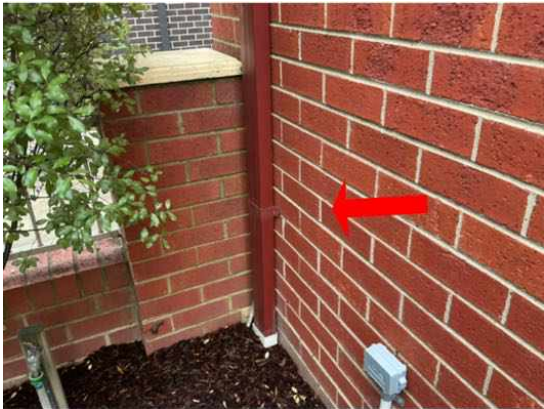
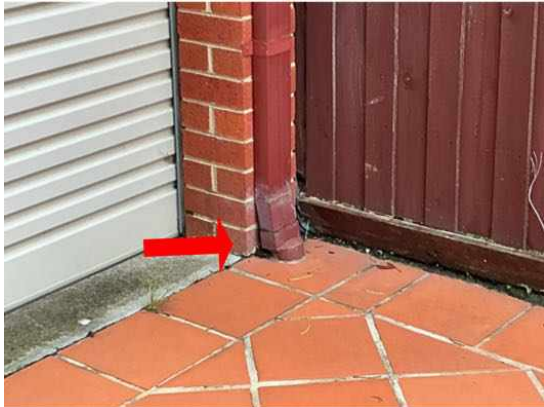
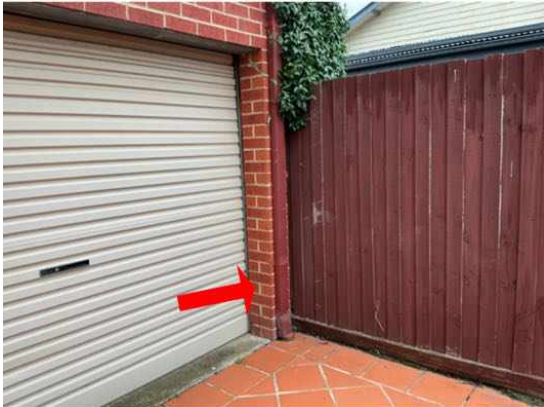
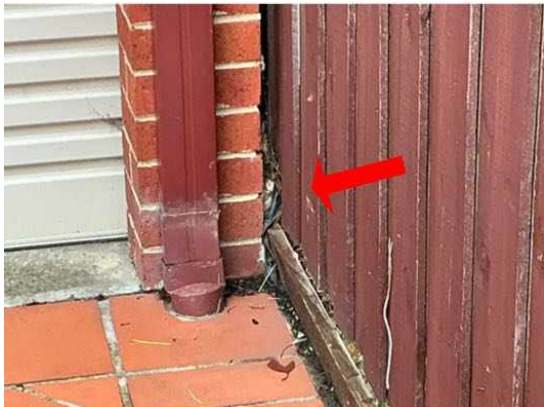
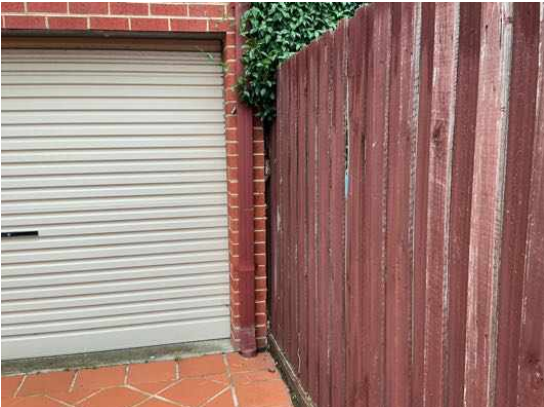
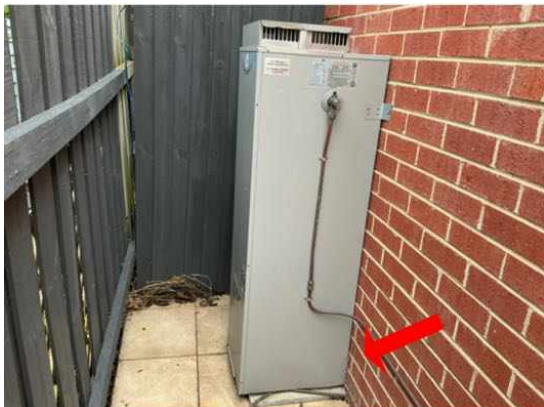
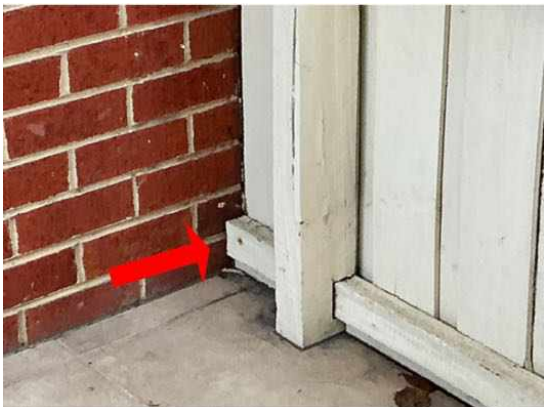
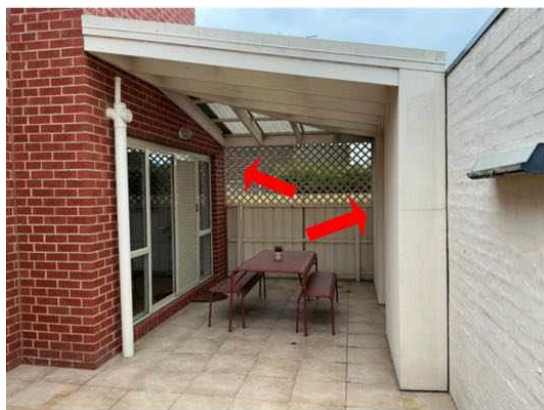
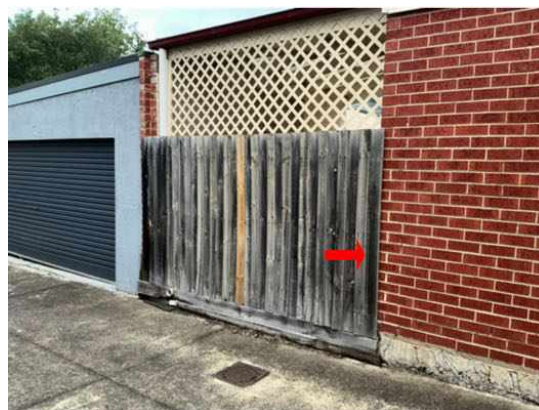
It is important for internal flooring to be raised above adjacent external ground levels. Where external ground levels are above internal flooring water pooling and subsequent internal flooding is likely to occur which may attract termite activity to the internal area.

It is highly advised that a landscaper or paver be appointed to lower external grounds that are raised above adjacent internal flooring. Alternatively if external grounds and internal flooring is level installation of a raised door sill may be appropriate in preventing any water pooling in the area.

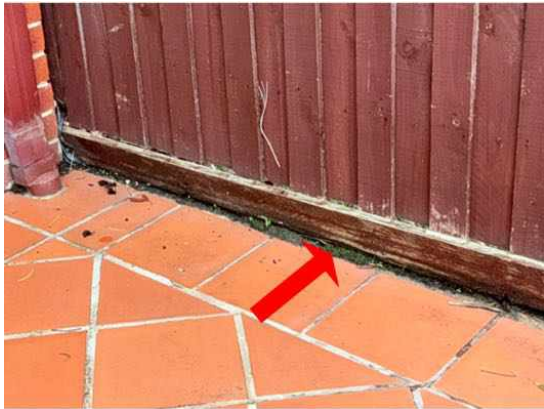
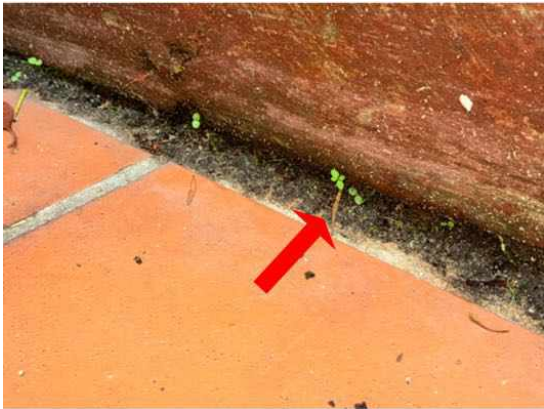
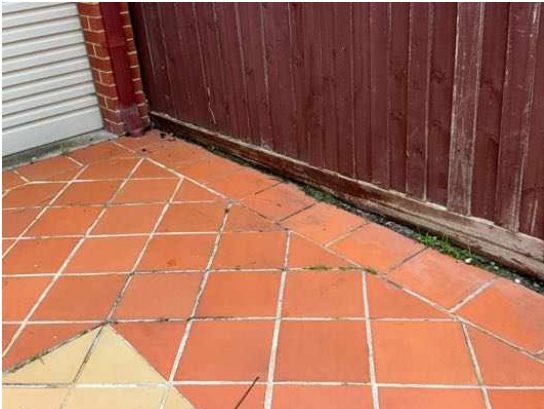
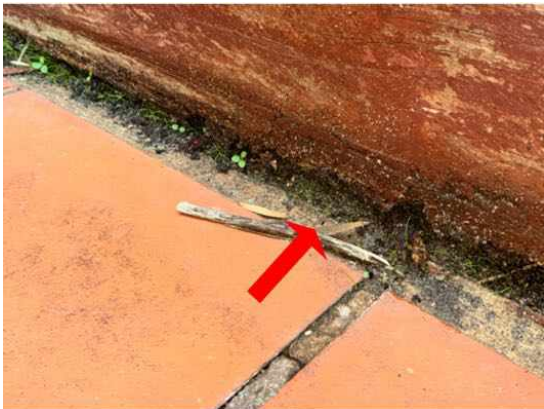
Finding 7.01

Finding: Wood rot

Information: This building element shows evidence of wood rot. Wood rot, also known as Fungal Decay, occurs when timbers and other cellulose building materials are exposed to damp conditions on an ongoing basis. This could be the result of exposure to weathering over a prolonged period of time, or the attraction of excessive moisture from other abutting building materials. Contributing factors also include poor air ventilation in the area.

Wood rot is often associated with general damp problems and is evidenced by a 'musty' smell or mould and mildew occurring on surfaces. If left unmanaged, damp conditions can lead to further health problems and the decay of timbers will continue.

Fungal decay was evident to the timber fence plinth at the time of inspection.

Early intervention and regular maintenance, particularly of exterior timbers, will prolong the useful life of these building elements. Prior to any works being performed, the cause of the moisture that has created the visible wood rot should be identified and addressed in a suitable manner. Replacement of affected timbers may then be a necessary step in protecting surrounding building elements from such deterioration.

A qualified plumber may be appointed to assess the cause of excessive moisture and to provide advice on any remedial works as required. A qualified carpenter or registered builder may also be required to replace affected building materials.

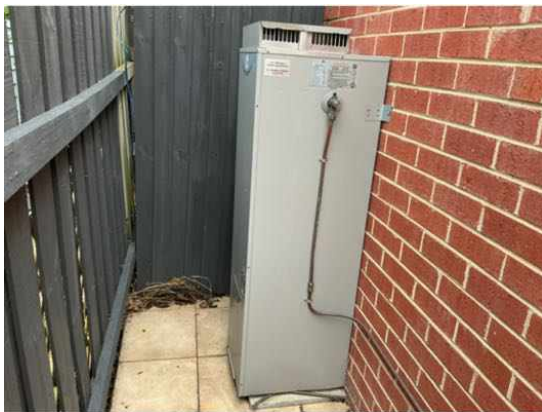
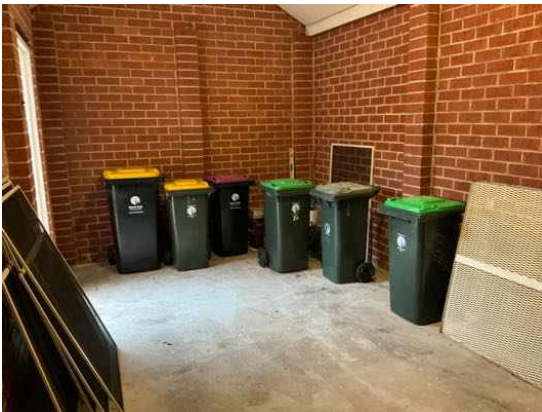
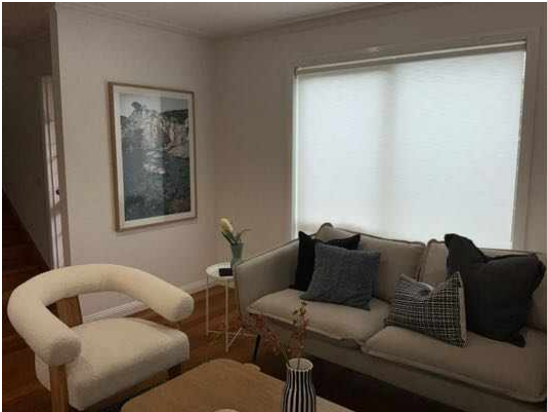
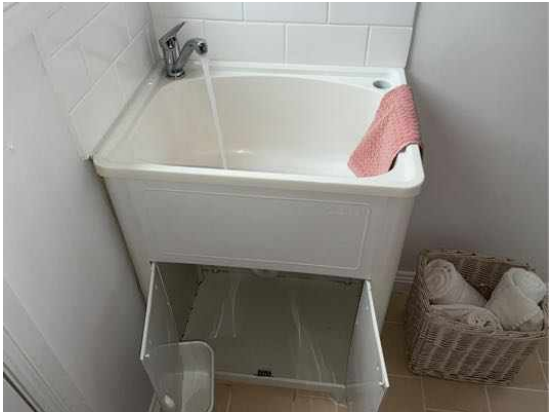
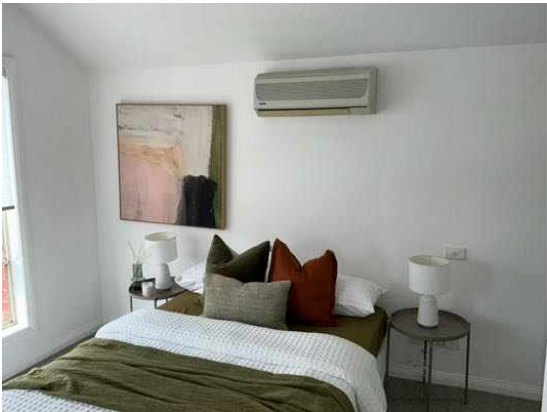
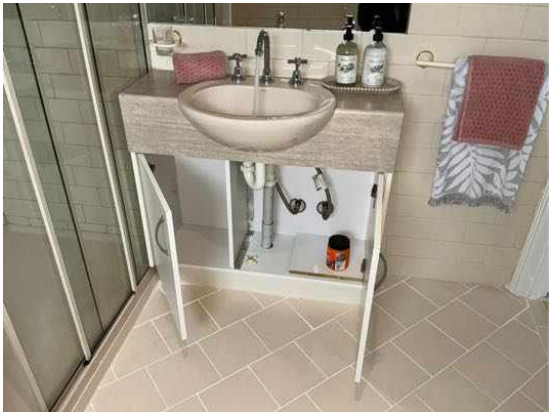
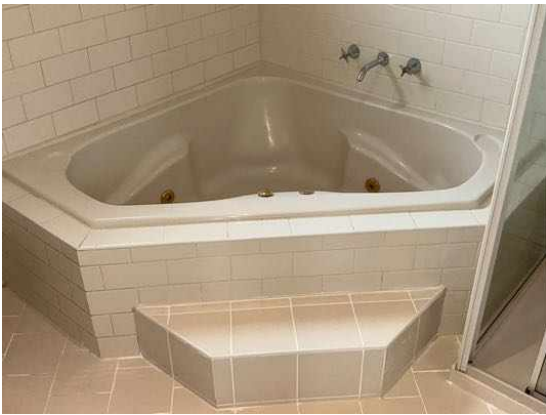
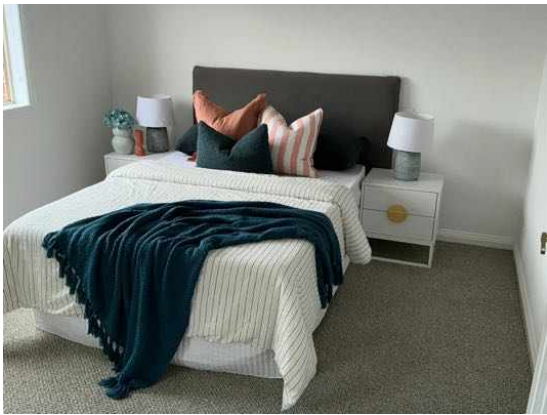
Noted Item

Building: Main Building
Location: All Areas
Finding: Additional Photos - Obstructions and Limitations
Information: These photographs are an indication of the obstructions and limitations which impeded full inspection of the property at the time of inspection. These obstructions can hide an array of defects and should be removed to allow full inspection to be carried out. A re-inspection is recommended once the areas are made accessible.
