# Building and Timber Pest Inspection Report

Inspection Date: Thu, 12 Mar 2026

Property Address: 25 Stanley St, Blacktown NSW 2148,  
Australia

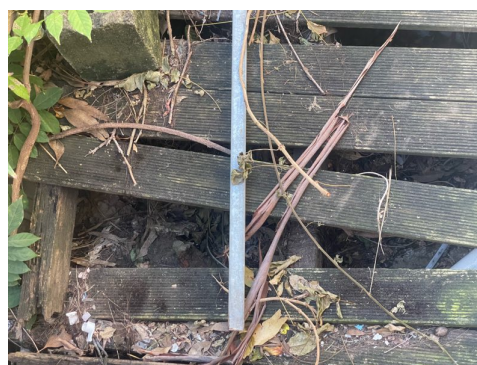
Finding: Timber Deck – Damaged / Safety Hazard

Information: The external deck was observed to be broken in parts at the time of inspection. The affected area showed visible damage and deterioration to the decking, which was apparent during the visual assessment.

This condition is significant because broken deck elements may no longer perform as intended under normal use.

Depending on the extent of the damage, the defect may create uneven surfaces, sharp edges, unstable footing, or localised structural weakness.

As a result, the damaged deck presents a safety hazard to occupants and visitors using the area. The defect should be treated as a priority safety concern due to the risk of injury.

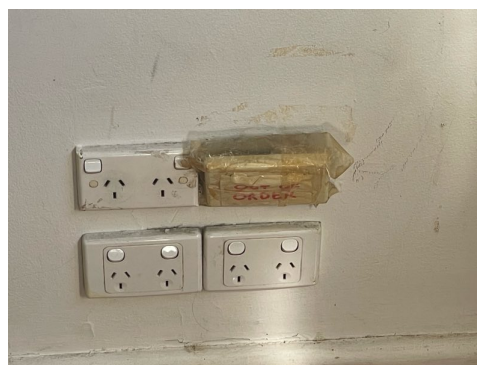
#### Finding 1.02

Finding: Electrical Socket – Broken and Unsafe Condition

Information: An electrical socket was observed to be broken at the time of inspection. The cover plate and protective components were damaged, leaving the socket in a compromised condition.

Broken electrical fittings can expose live wiring or conductive parts, presenting a potential electric shock hazard to occupants. This is considered a serious safety issue that requires urgent attention.

It is strongly recommended that a licensed electrician be engaged as soon as possible to repair or replace the damaged socket to restore safe and compliant operation.

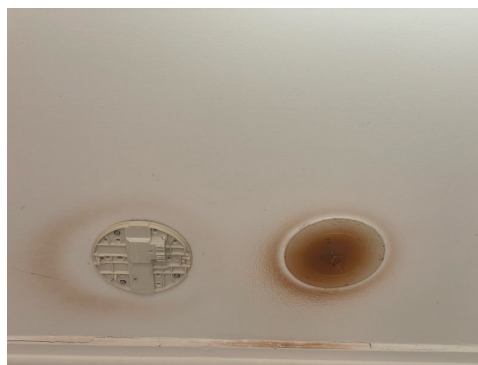
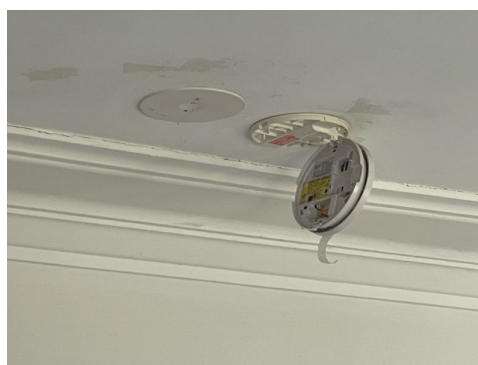
### Finding 1.03

Information: At the time of inspection, a fire alarm system was not installed and/or was not operational within the dwelling. The absence or non-functioning of a fire alarm system presents a significant safety hazard, as it may delay the early detection of fire and reduce the available warning time for occupants to safely evacuate the premises.

Fire alarm systems are a critical life-safety measure intended to provide early warning in the event of fire, particularly during sleeping hours. Without a functional system, occupants may be exposed to an increased risk of injury or loss of life due to smoke inhalation or fire spread.

This matter is considered a safety issue and requires prompt attention. It is recommended that the installation and/or rectification of the fire alarm system be carried out by a suitably qualified and licensed contractor to ensure the system is provided and operating in accordance with the applicable regulatory requirements at the time of installation.

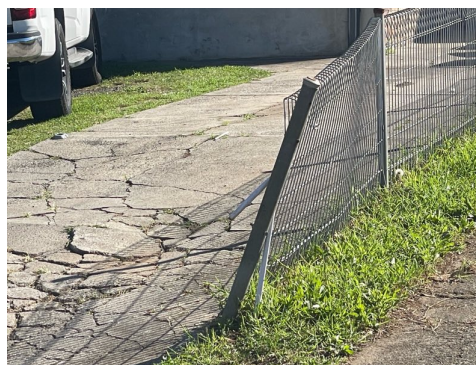
Finding: Perimeter Fence – Impact Damage

Information: During inspection, the perimeter fence, constructed from a steel frame with corrugated steel infill panels, was noted to have sustained damage due to an impact load. The affected section shows distortion and misalignment, with visible bending that reduces both its presentation and structural integrity.

The damaged area appears consistent with force applied directly to the panels and frame.

This has resulted in an uneven surface and compromised finish, detracting from the overall appearance of the boundary structure.

This defect was identified along the perimeter fence during the inspection. It is recommended that a competent contractor be engaged to assess the extent of the damage and carry out necessary repairs or replacement to restore the fence to a serviceable and presentable condition.

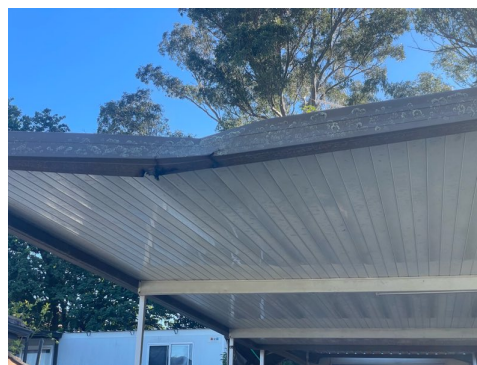
### Finding 2.03

Finding: Roof gutter – Damage observed

Information: At the time of inspection sections of the roof guttering were found to be damaged. The gutter is dented and misshaped in areas and may be pulling away from the fascia in places. This type of damage can change the way water flows and prevents the gutter from working as designed during rainfall.

Damaged gutters can cause water to overflow and discharge down external walls or over the edges of the roof.

Over time this can lead to staining and decay of fascia and eaves linings and may contribute to moisture issues around the base of the building including possible dampness in walls or slab movement. Overflowing water can also create slip hazards on paths and entry areas.

Further assessment and repair of the affected guttering by a licensed roof plumber or roofing contractor is recommended.

Works may include straightening, re-fixing or replacing damaged sections so that water is collected and discharged correctly to the downpipes and stormwater system. Repairs should be carried out as a priority before periods of heavy rain.

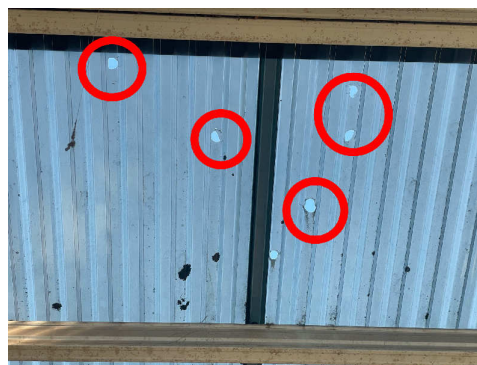
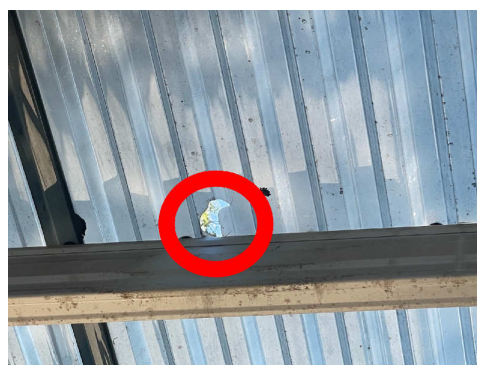
### Finding 2.04

Finding: Corrugated Roof Sheeting – Damaged Clear Sheeting

Information: During inspection of the exterior roof covering, sections of the clear corrugated roof sheeting were found to be cracked and damaged. This material is typically used for skylight or patio roofing and is often made of polycarbonate or fibreglass, both of which can become brittle over time due to UV exposure and temperature changes.

The damage allows potential water ingress and reduces the weatherproofing performance of the roof.

In addition, cracks and surface deterioration may compromise the sheet's strength, posing a risk of breakage under load or during maintenance.

It is recommended that the damaged clear sheets be replaced by a qualified roofing or patio contractor. When replacing, a UV-stabilised polycarbonate or similar high-durability product should be used to ensure long-term resistance to weathering and maintain light transmission.

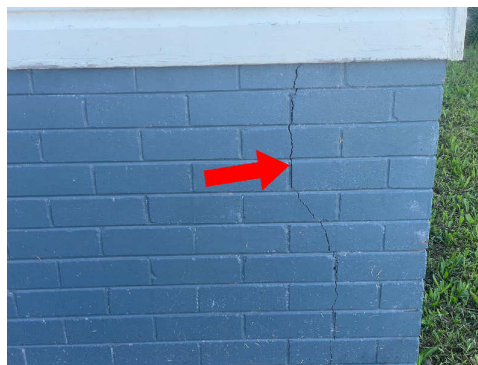
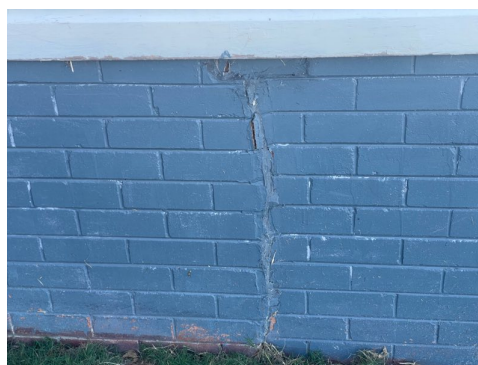
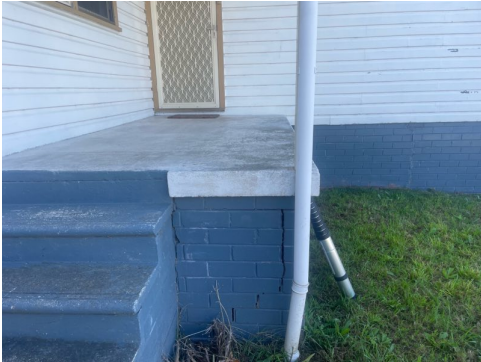
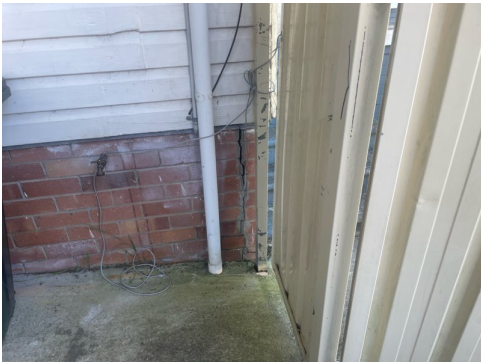
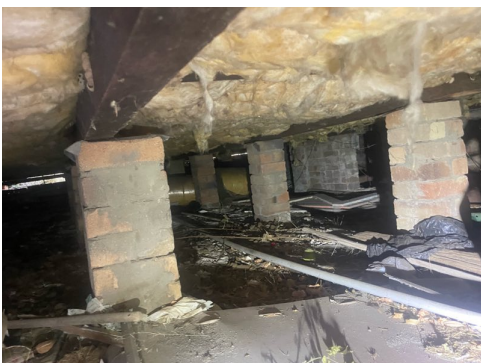
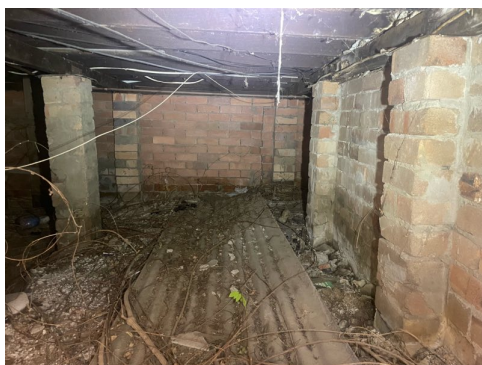
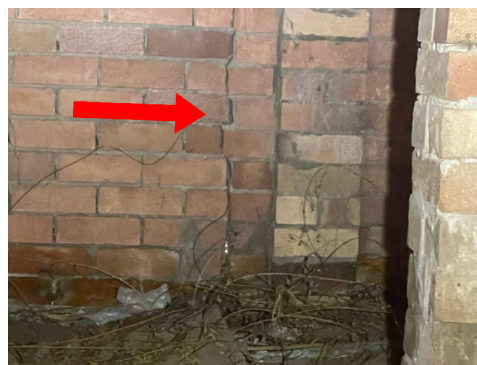
### Finding 2.05

Finding: Brick Pier / External Wall – Leaning Pier and Cracking

The associated wall cracking is consistent with structural movement, settlement, displacement, or deterioration affecting the supporting elements of the building.

As a result, the defect is considered a major structural concern and may also present a safety risk if movement is ongoing or the support capacity has been reduced. Further movement may lead to additional cracking, distortion, and instability to the affected part of the structure.

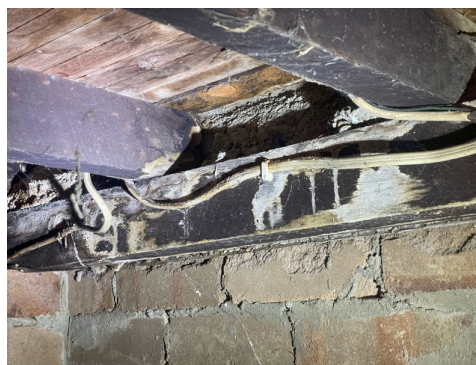
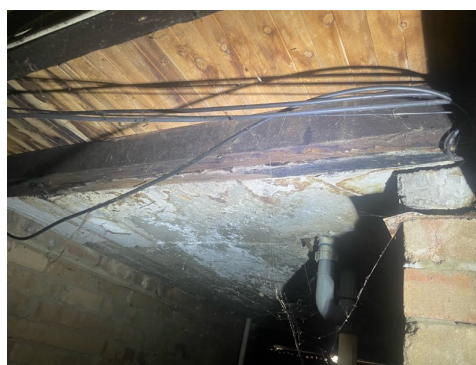
### Finding 2.06

Finding: Subfloor Area Under Bathrooms – Timber Deterioration and Wood Rot

The presence of wood rot in this location is also conducive to termite infestation. As timber stumps and bearers may be in direct contact with damp soil, concealed termite entry is possible.

Once timbers become weakened by rot, their natural resistance is reduced, making them far more vulnerable to attack. Rectification or replacement of affected elements is required, and where deterioration is widespread, sections of the subfloor structure may need full replacement. Consultation with a structural engineer or a registered builder specialising in re-stumping and subfloor repairs is strongly recommended without delay.

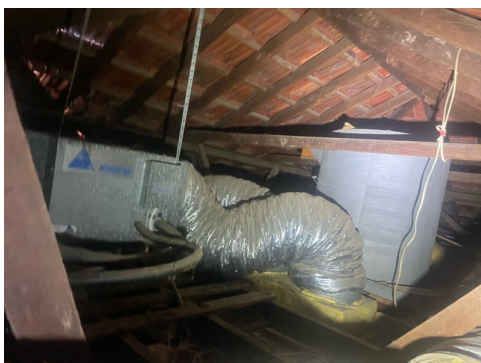
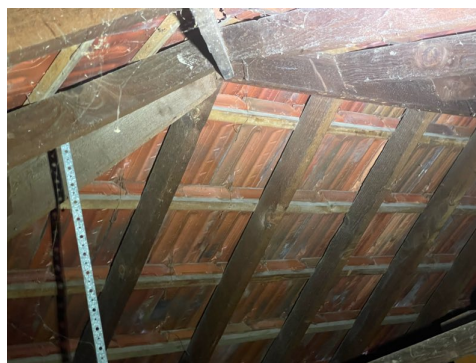
### Finding 2.10

Where sarking is missing, regular inspections of the roof tiles for cracking and potential moisture penetration is required.

Sarking may be retrospectively fitted by a registered builder at the discretion of the client.

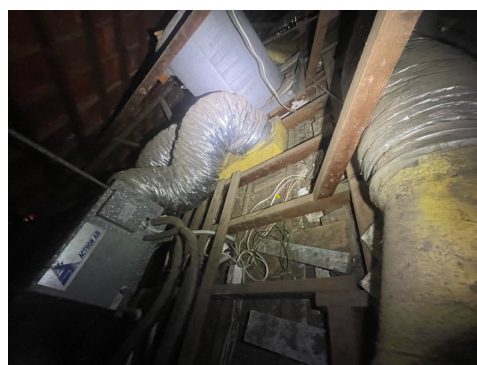
## Finding 2.11

In addition, insulation that is not properly placed can reduce soundproofing performance.

To achieve consistent coverage and optimum performance, the insulation should be re-fitted correctly throughout the roof void. A licensed contractor can adjust or top up the insulation as required to ensure full coverage and improved energy efficiency.

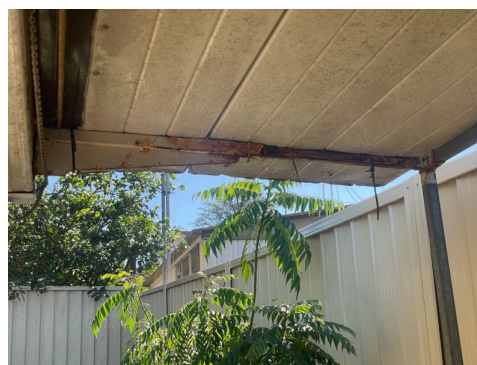
### Finding 3.01

Where possible, the use of galvanized (treated) metals or aluminium coated metals aid in rust prevention, as does regular general maintenance. Rust formation can be controlled with coatings, such as paint, that isolate the iron from the environment.

Rusting and corrosion should be managed by ideally removing or limiting the affected surface from exposure to moisture. A registered builder may be appointed to replace any building elements that have been severely affected by rust or water damage.

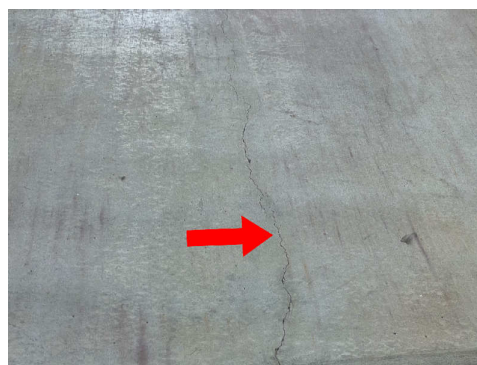
### Finding 3.02

| Finding: | Cracking - Damage Category 2 - Noticeable (up to 5mm) |
| Information: | <p>Noticeable cracks are a common occurrence as a result of many primary defects. Such causes may include age, general wear and tear, expected building movement, general expansion/contraction of building materials in different weather conditions, and/or minor failings in the installation or application of building materials.</p> <p>Noticeable cracks may result in minor sticking or jamming of associated doors and windows, which require easement. However, noticeable cracks are easily filled and repaired. A plasterer can be consulted to install an expansion joint at this point to allow for this movement during different weather conditions.</p> <p>Monitoring of all cracking should be conducted frequently. Always contact a building inspector should cracks widen, lengthen, or become more numerous. Additionally, your building inspector should also be contacted if associated building elements such as doors and windows become more difficult to operate over time.</p> <p>Relevant tradespeople, such as carpenters, painters and plasterers, should be appointed to perform remedial works, as deemed necessary.</p> |

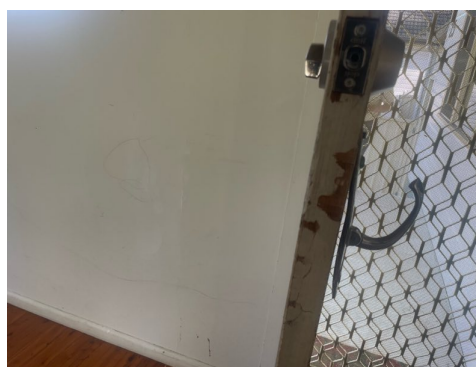
### Finding 3.03

This type of defect often happens due to normal wear and tear poor installation or loose or missing screws over time. A loose or missing handle can affect the correct operation of the door and may reduce security and privacy and in some cases create a minor safety risk if the door cannot be opened or closed easily.

Repair or replacement of the affected door handle by a suitably qualified tradesperson is recommended. Works may include tightening and refixing the existing hardware or installing a new handle set so that the door operates smoothly and the opening can be used and secured as intended.

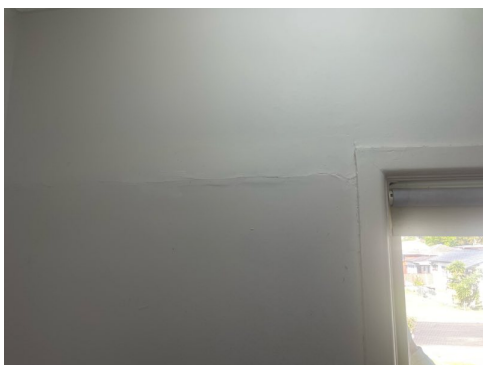
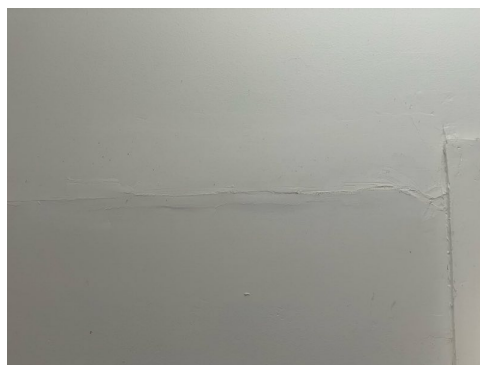
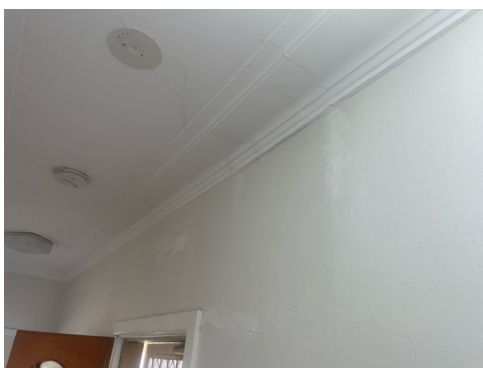
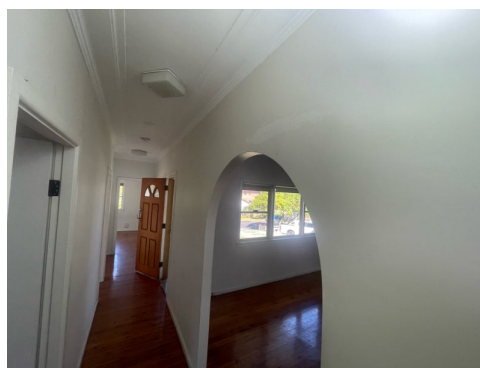
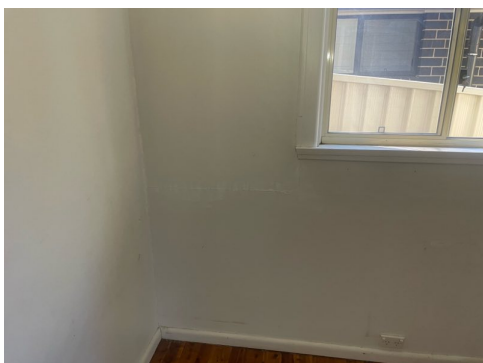
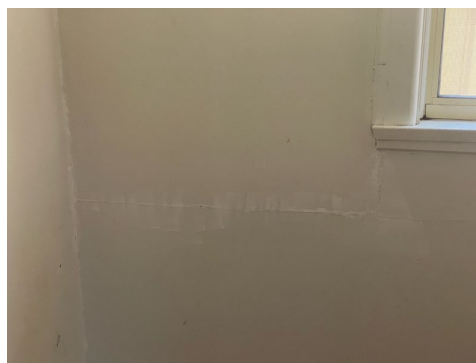
### Finding 3.04

Additionally, your building inspector should also be contacted if associated building elements such as doors and windows become more difficult to operate over time.

Relevant tradespeople, such as carpenters, painters and plasterers, should be appointed to perform remedial works, as deemed necessary.

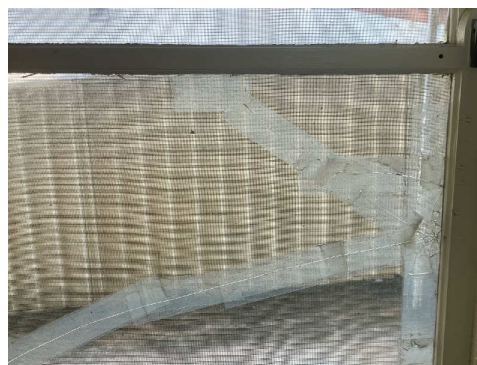
### Finding 3.05

If laminated, the interlayer may continue to hold the glass together even if further cracking occurs, but this does not eliminate the need for rectification.

It is recommended that a qualified glazing professional be engaged to further assess the extent of the damage and advise whether repair (if feasible) or replacement is required to maintain safety and performance standards.

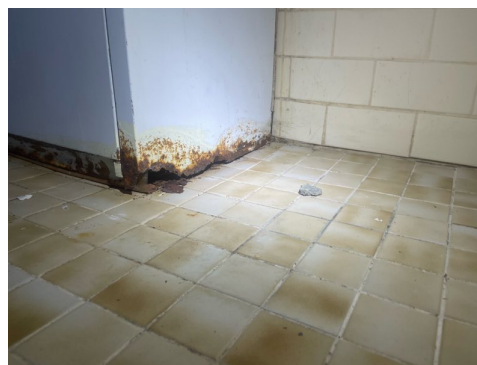
### Finding 3.09

Finding: Tiles - Cracked or damaged

Information: Cracking was evident to the tiling in this area at the time of inspection. While the cracking appears to be minor, this area is frequently exposed to water, allowing potential for water penetration into adjoining sections of walls or flooring.

If left unmanaged, water penetration to these areas may lead to subsequent water damage, which is likely necessitate repair work to affected building elements.

A tiling contractor should be appointed to ensure that no further water damage occurs.

The re-application of silicone and grouting throughout remaining tile work is also advised, to further protect the area against water penetration.

Where water penetration has led to water damage, appointment of a relevant tradesperson may be required to repair damaged building elements.

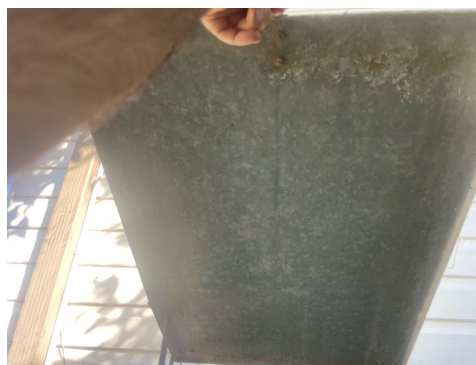
### Finding 6.02

**Information:** The application of a post-construction chemical termite barrier is highly recommended for all properties, particularly if live termite activity has been found on the site previously. Such barriers are highly effective in preventing termite attack on any timber building elements throughout the property.

The client may consider gaining further advice from a pest controller as to the costs and procedures involved with this application. It is recommended that obtaining such advice be a short-term priority.

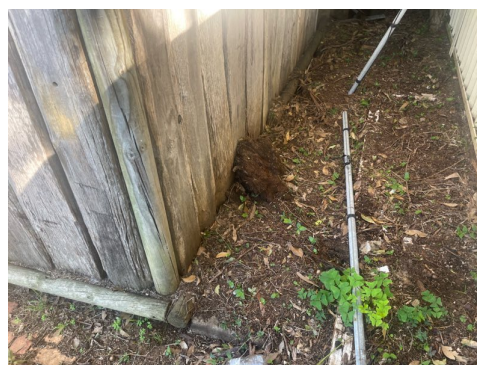
### Finding 6.04

Information: The storing of timbers in the subfloor space or around the external property increases the risk of termite activity being present. As they are likely to come into contact with weather conditions or excessive moisture wood rot is likely to develop on timbers that are not treated.

It is highly recommended that any stored timbers be immediately removed from areas in which they may attract any termite / timber pest attack. Minimisation of risk / prevention of termite attack is far more adequate than dealing with the presence of termite activity.

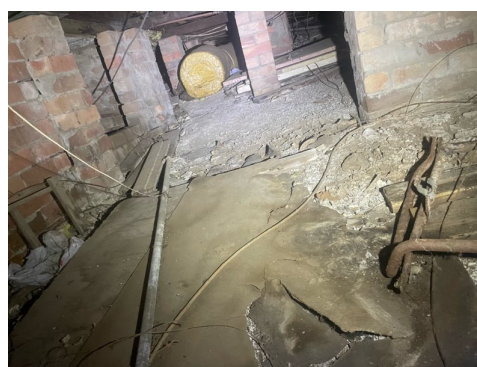
### Finding 6.05

These damp conditions can lead to secondary defects such as rot, rust or corrosion of associated building elements, the formation of fungal decay, or even the creation of potential slip hazards. When coupled with poor site drainage, pooling of water may also attract termite activity to this area.

It is highly recommended that a qualified plumber be appointed to install adequate drainage to the overflow. These works will ensure that the area remains dry and free of any secondary defects.

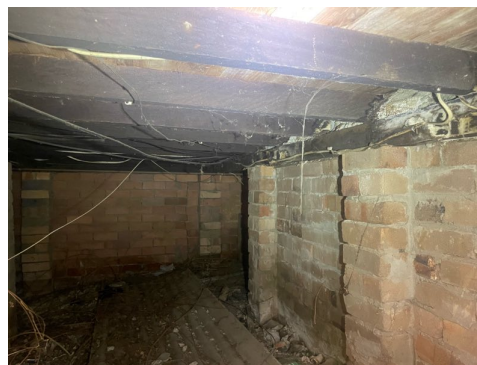
### Finding 6.09

Finding: Subfloor Site Drainage - Inadequate

Information: The property exhibits poor drainage under the subfloor, leading to several critical issues. Water can accumulate and does not properly drain away from the subfloor area, creating a hazardous condition.

1. Frequent water pooling and stagnation under the subfloor.
2. Risk of subfloor structural damage due to prolonged moisture exposure and attracting termites.
3. Potential for mould and mildew growth, compromising indoor air quality.
4. Safety hazard for occupants due to slippery surfaces and potential electrical hazards.
5. Creating conducive conditions to termites.

The poor site drainage under the subfloor poses a significant safety risk to the occupants, as it can lead to structural damage and health hazards.

This issue requires immediate attention and rectification.

A licensed and experienced plumber or licensed builder specialising in drainage and foundation work should be engaged to assess the problem and implement necessary drainage solutions, such as improved grading, installation of drainage systems, and moisture barrier enhancements. Regular maintenance and inspections should also be scheduled to prevent future occurrences. Water damage and secondary defects are likely to occur if left unmanaged.
