Building and Timber Pest Inspection Report VR

Inspection Date: Wed, 11 Feb 2026

Property Address: 2/22 Oatlands St, Wentworthville NSW
2145, Australia

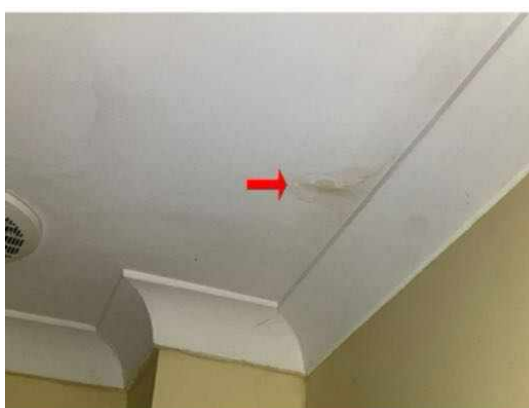
Finding: Water staining

Information: Water staining was evident in this area at the time of inspection. Water staining indicates that surfaces have been exposed to excessive moisture over time. The minerals and other elements in the water lead to staining, which may graduate to corrosion and deterioration if left unmanaged.

While mostly an appearance defect, water staining can be indicative of more serious defects, which may be currently concealed by other building elements.

A licensed plumber must be consulted to identify the cause of the staining and to provide advice on any reparation works that may be required. Replacement of any broken or damaged structures is advised.

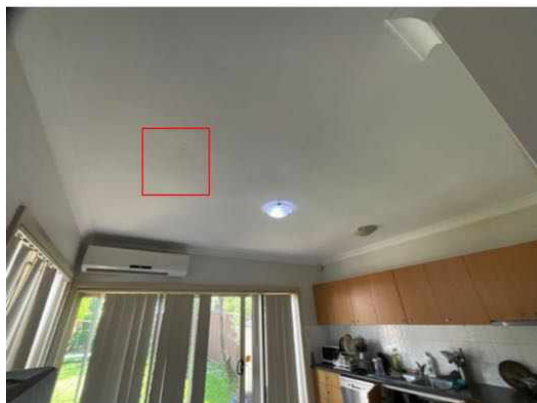
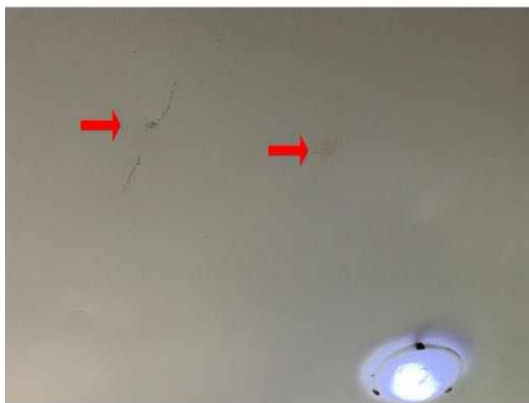
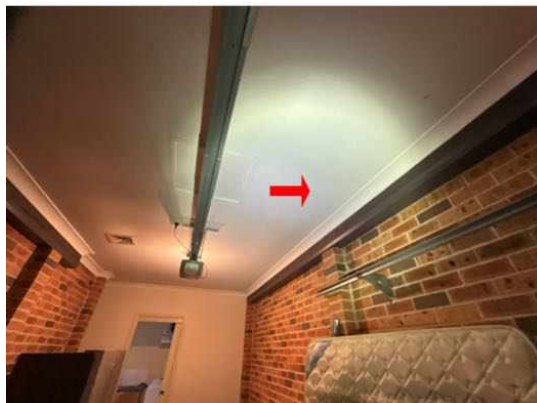
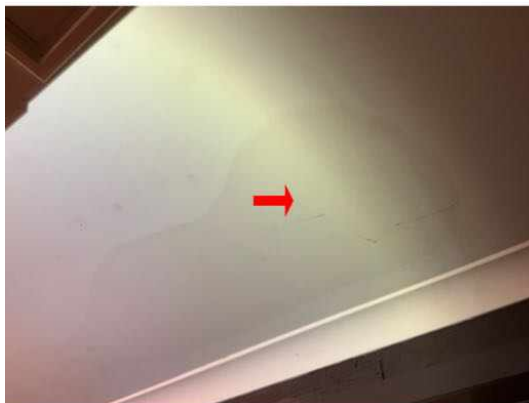
Building:	Main Building
Location:	Kitchen, garage
Finding:	Ceiling - Water stained
Information:	Water staining to ceiling linings in this area was evident at the time of inspection. Water staining indicates that surfaces have been exposed to excessive moisture over time. The minerals and other elements in the water lead to staining, which may graduate to corrosion and deterioration if left unmanaged.

While mostly an appearance defect, water staining can be indicative of more serious defects, which may be currently concealed by interior ceilings.

Where water staining is active, a licensed roof plumber or a roof contractor must be consulted to identify the cause of the staining and to provide advice on any reparation works that may be required. Replacement of any damaged structures is advised.

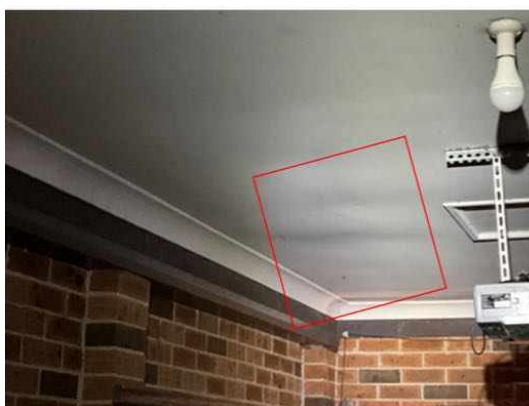
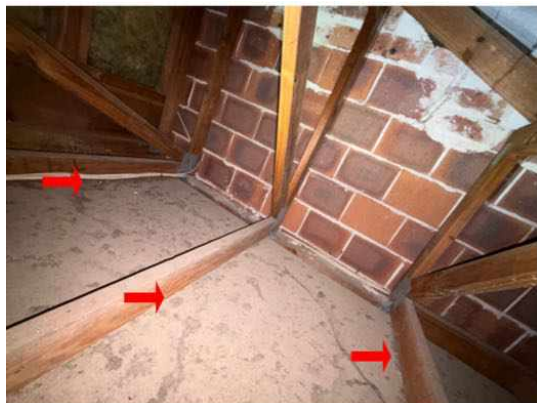
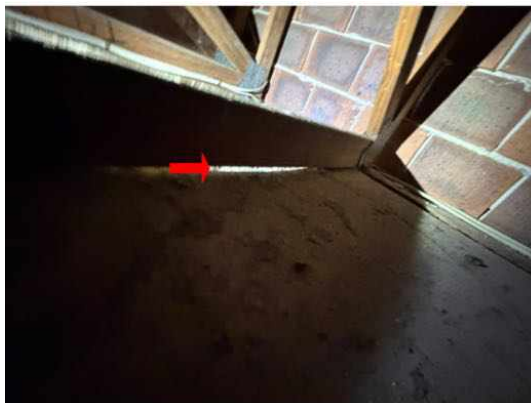
Finding 3.04

Information: Sections of the ceiling were found to be sagging at the time of inspection. Sagging to the fixed ceiling structure generally indicates that the building materials have swollen, due to contact with water, or that fixings (e.g. nails or glue) have become loose and require reattachment.

Where minor sagging is evident, comparatively minor works, such as re-gluing of ceiling sheets, may be required. Such works may be performed by relevant tradespeople, such as plasterers and painters. Where excessive moisture has caused the roofing structure to swell and sag, the source of the water leak should primarily be identified prior to any remedial works being performed.

The appropriate action should be taken by the client as soon as possible to ensure that any potential further damage is limited.

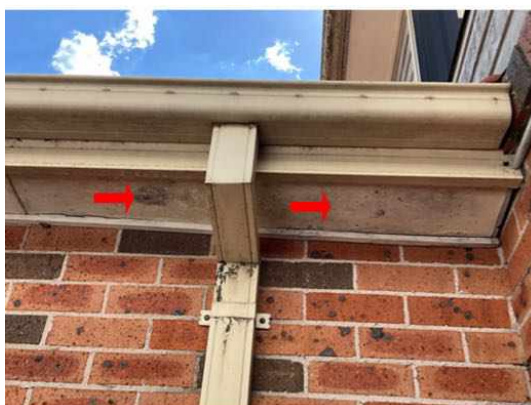
Finding 3.05

Building:	Main Building
Location:	Rear right corner
Finding:	Eaves/Roof plumbing -- water damages
Information:	Water damage is generally an indication of excessive moisture being present, usually via a leak. It is suspected that gutter blockages causing stormwater to backflow into the eaves causing water damages. This is additionally conducive to termite activity due to the damp conditions.

Where water damage is evident, the primary requirement is to identify and rectify the source of the leak. Gutters must be kept clear of any blockages moving forward. A roofing plumber should be appointed for further assessment if the problem persists.

Once the leak is repaired, consultation with relevant tradespeople, including carpenters, plasterers and painters, is advised.

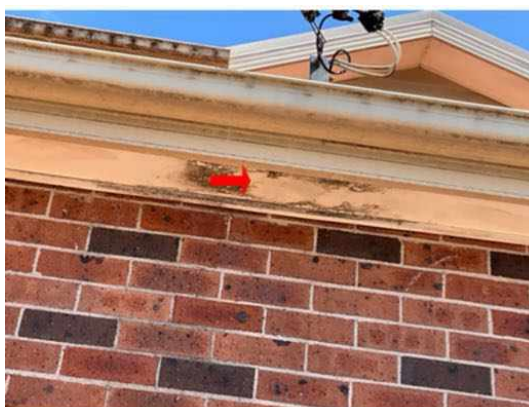
Finding 3.06

Building:	Main Building
Location:	Garage
Finding:	Water leak - Inactive
Information:	Water leaks generally occur when a particular area of the property is not weather- or

water-tight. While the damage in this area appears to be from an old inactive water leak, the area should be monitored frequently for the recurrence of any dampness.

Repair and / or replacement of previously affected building elements is at client discretion. Consider a further invasive inspection: removal of obstructions around the damaged area may reveal further damage which has been concealed. A more significant or major defect may be identified at this time.

Where recurrence of an active water leak is identified, a licensed roofing plumber should be appointed immediately to rectify the leak and advise on any further preventative works as necessary.

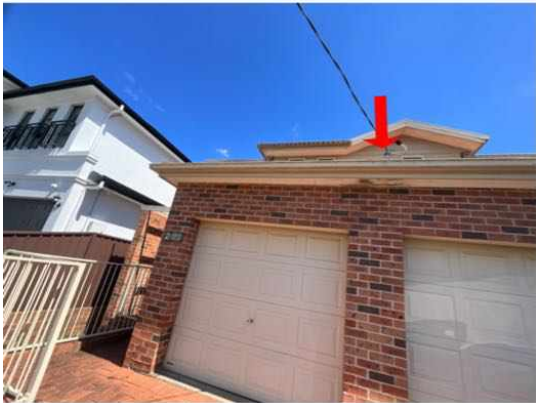
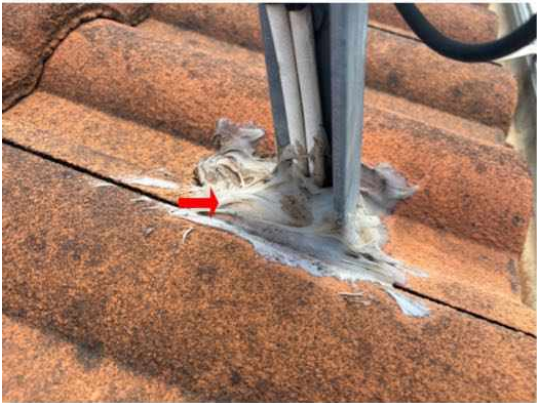
Finding 3.07

Building: Main Building
 Location: Garage
 Finding: Roof flashing (acceptable) - Non-standard
 Information:

The roof flashing that has been installed does not appear to comply with current building practice. However the flashing appears to be in an acceptable condition and is fulfilling its purpose in ensuring the roof covering is weather-tight.

Whilst retrospective fixing is not required if flashing begins to come loose from its fixing or deteriorates as evidenced by roof leaks a licensed roofing plumber should be

appointed immediately to replace the building element.

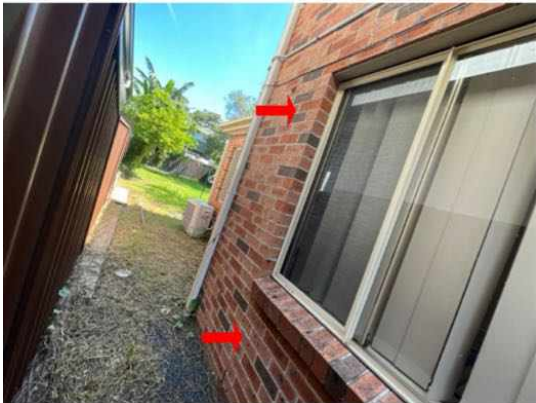
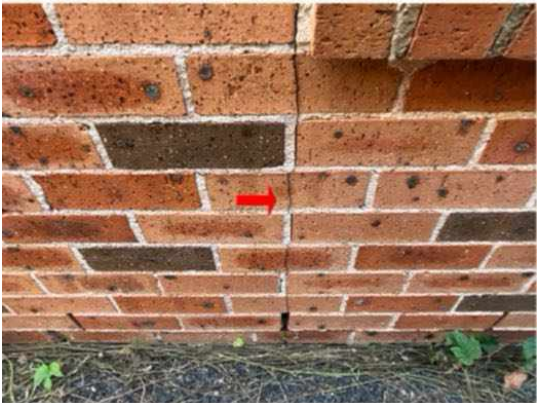
Finding 3.08

Building: Main Building
Location: Rear right corner
Finding: Damage to Masonry Walls (Cracks)- Category 2
Information: It has been observed that damage to masonry walls caused by movement of slabs, footings, or other causes, has occurred. The degree of damage falls within Category 2, described as noticeable cracks which are easily filled. Such cracking may cause doors and/or windows to stick slightly, and are generally less than 5mm in width.

Damage of this category is required to be monitored for a period of 12 months, after which time a crack rated at Category 2 or above is considered a defect requiring rectification, such as minor repairs and repointing. Always contact your building inspector should cracks widen, lengthen, or grow more numerous.

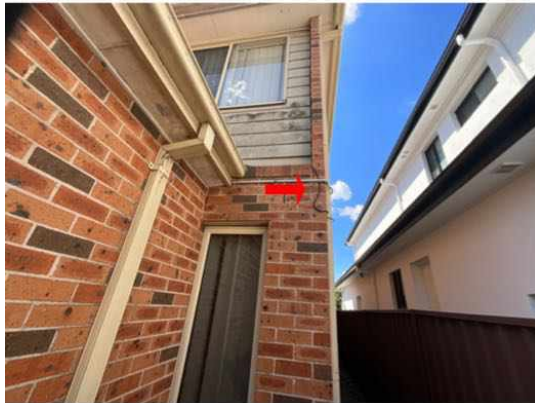
Finding 3.09

Building:	Main Building
Location:	Multiple areas of roof plumbing
Finding:	Water leak - External
Information:	Water leaks were found to be present to exterior plumbing work. Leaks are generally caused by deterioration of the plumbing elements over time, due to exposure to weather conditions, but may have also been caused by minor impact damage.

Such leaking creates damp conditions in the affected area, causing potential for water pooling and subsequent water damage if left unattended. These conditions may also attract termite attack, particularly if the area is subject to minimal levels of sun throughout daylight hours.

It is highly advised that a licensed plumber be appointed to rectify any water leaks that may be present. Areas of repair and replacement of plumbing fittings and fixtures may be required and, as such, a quotation should be sought.

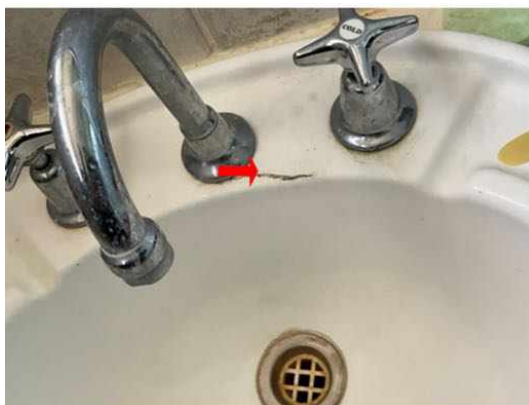
Building: Main Building
 Location: Ensuite
 Finding: Basin - Cracked
 Information: Cracking was evident to the basin at the time of inspection, which is suspected to

have been by minor impact damage. While the cracking appears to be minor, any further impact damage sustained by the basin may lead to additional cracking.

As the cracking provides potential ingress for water, secondary water damage may occur to associated cabinetry, walls or flooring, if the cracking is left unmanaged.

Consultation with a plumber regarding basin repair or replacement is required. Remedial works may be required to protect against any further damage.

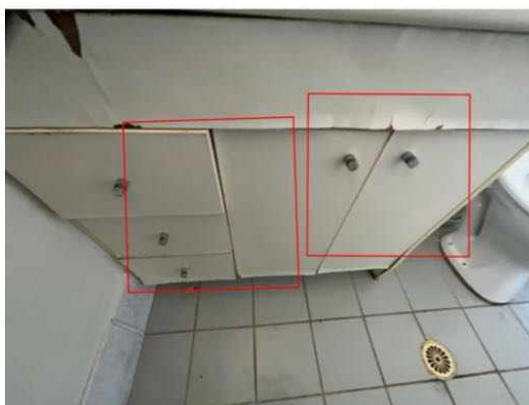
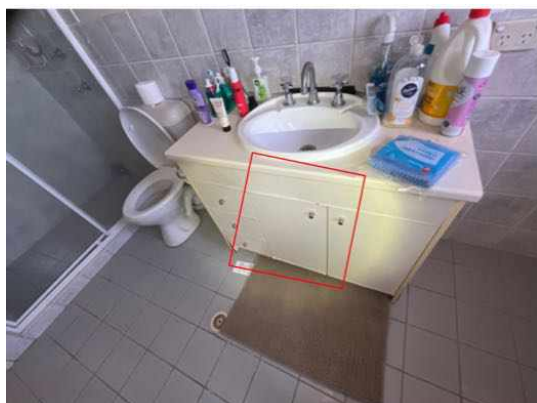
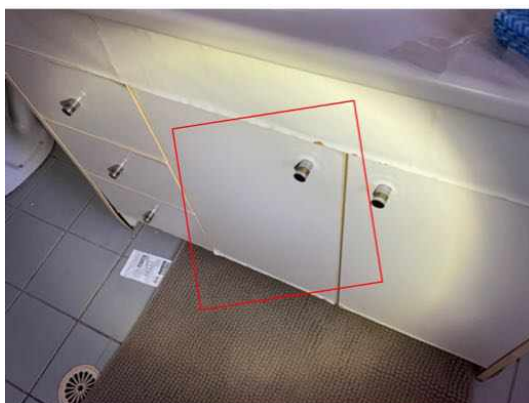
Finding 3.20

Building:	Main Building
Location:	Ensuite, bathroom
Finding:	Cupboard/vanity - Swollen/Water Damaged
Information:	Water damage was identified inside the vanity/cupboards in this area and it was also found to be swollen. Water damaged/swollen building elements generally indicate that the building materials have been affected by excessive moisture over a prolonged period of time, and have swollen as a result. A licensed plumber should be engaged to assess where the moisture is coming from and carry out any rectification as soon as possible. Replacement of the vanity/cupboards is also advised by a licensed cabinetmaker.

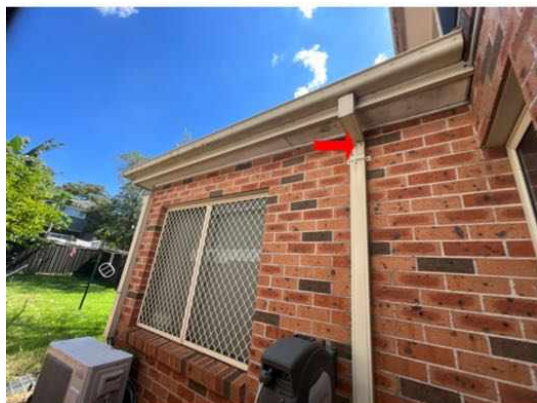
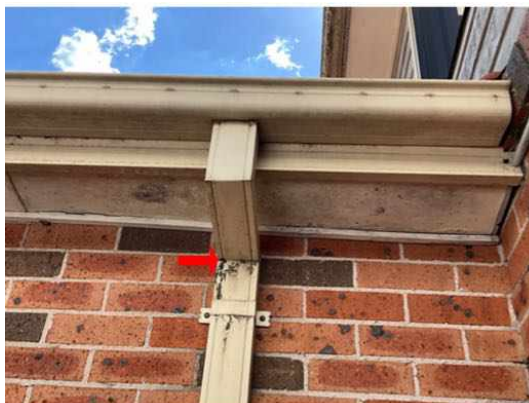
Building:	Main Building
Location:	Multiple areas of roof plumbing
Finding:	Water leak - External
Information:	Water leaks were found to be present to exterior plumbing work. Leaks are generally caused by deterioration of the plumbing elements over time, due to exposure to weather conditions, but may have also been caused by minor impact damage.

Such leaking creates damp conditions in the affected area, causing potential for water pooling and subsequent water damage if left unattended. These conditions may also attract termite attack, particularly if the area is subject to minimal levels of sun throughout daylight hours.

It is highly advised that a licensed plumber be appointed to rectify any water leaks that may be present. Areas of repair and replacement of plumbing fittings and fixtures may be required and, as such, a quotation should be sought.

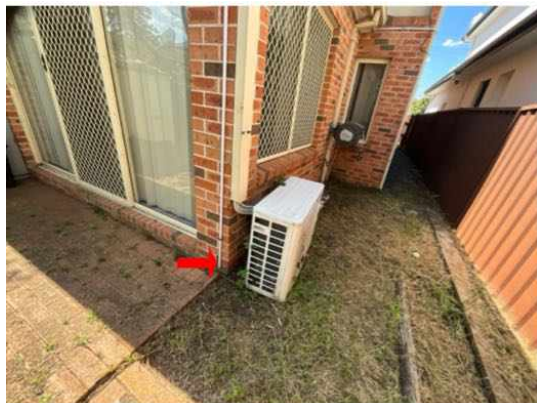
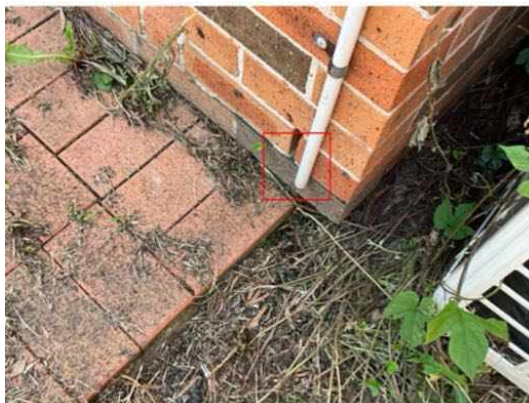
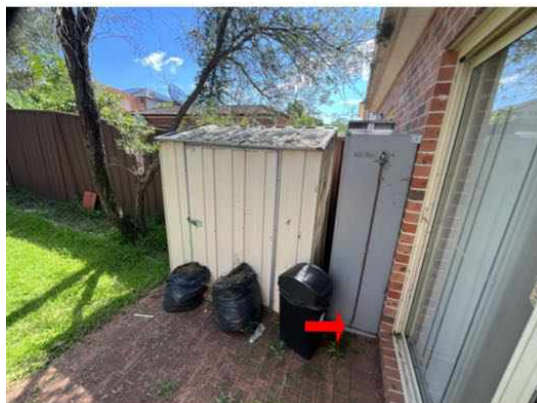
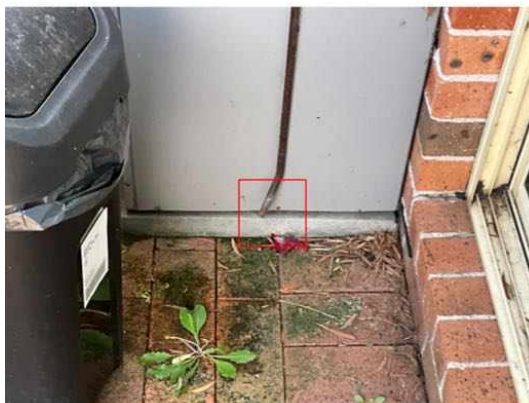
These damp conditions can lead to secondary defects such as rot, rust or corrosion of associated building elements, the formation of fungal decay, or even the creation of potential slip hazards. When coupled with poor site drainage, pooling of water may also attract termite activity to this area.

It is highly recommended that a licensed plumber be appointed to install adequate drainage to the overflow. These works will ensure that the area remains dry and free of any secondary defects.

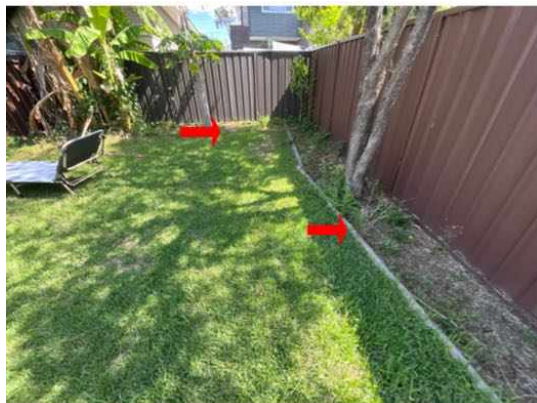
Finding 6.06

Building:	Main Building
Location:	Fencing & Landscaping
Finding:	Building materials in direct ground contact - conducive to termites
Information:	Where timber elements are in direct contact with the ground and consequently moisture or dampness they become conducive to termite activity. Whether timber is used as a building element part of a fencing structure or stored as an unused item they can provide an environment that is attractive to termite infestation.

When met with excessive moisture timber begins to decay and develop wood rot. Any timbers that are in direct contact with external grounds especially if left untreated or non-durable also provide ingress for subterranean termites into that particular element.

The removal of any such materials that may be conducive to termite activity should be removed as soon as possible to minimise the risk of termite attack.

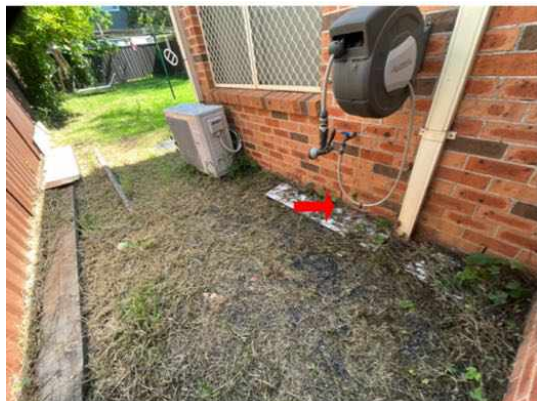
Building:	Main Building
Location:	External tap
Finding:	Tap - No drain
Information:	The external tap in this area was noted to have no drain at the time of inspection.

conducive to termite activity.

A licensed plumber must be appointed to ensure an appropriate drain is installed.

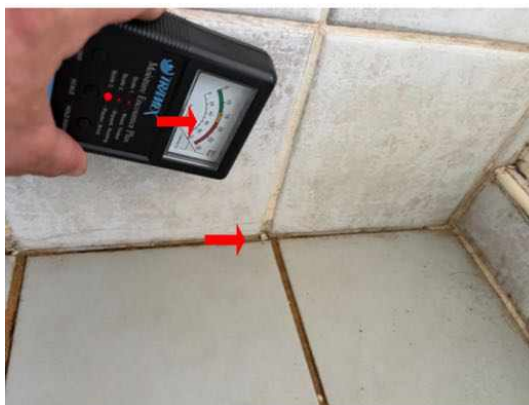
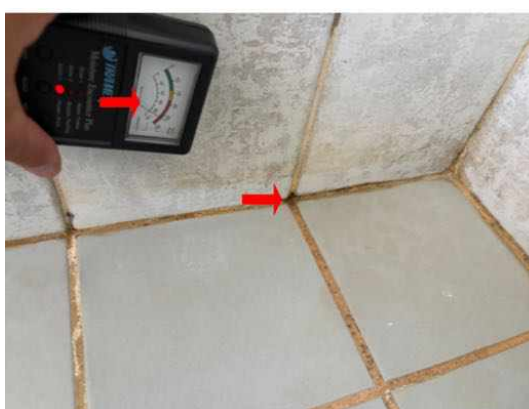
Finding 6.09

Building:	Main Building
Location:	Bathroom, ensuite
Finding:	Shower damp - Sealant and grout
Information:	Damp is evident to the lower 400mm of wall to the shower alcove. This defect is quite common, and is suspected to have been caused by moisture permeating or leaching through the grouting and sealant in this area, which shows evidence of deterioration. Leaking pipes within the wall is also a possible cause however this seems unlikely in this instance as there is no moisture build up around the taps or transferring to the other side of the wall. There appears to be no sealant around the tap spindles which may be a small contributing factor.

Damp (or structural damp) refers to the presence of unwanted moisture in the structure of a building, either as the result of intrusion from outside, or condensation from within the structure. In the shower area, internal water leaks, degraded materials or other sources of excessive moisture are generally the cause of damp.

Unmanaged damp in the shower recess is likely to facilitate the formation and development of mould and fungi growth, decaying associated building materials and compromising their structural integrity of associated elements. It is important to address damp conditions, as the World Health Organisation notes that excess moisture leads - on almost all indoor materials - to growth of microbes such as moulds, fungi and bacteria, which subsequently emit spores and other matter into the indoor air. Exposure to these contaminants is associated with a wide range of respiratory and other health-related problems. Damp conditions also create a conducive environment for termite infestation.

Consultation with a bathroom sealant specialist is advised immediately to identify the cause of damp and to perform remedial works as required.

Always ensure that sealant and grout is in good condition to prevent any moisture issues occurring in the future.

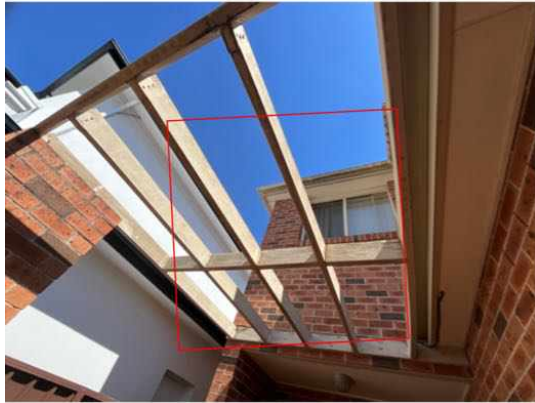
Finding 7.01

Building:	Main Building
Location:	Porch
Finding:	Wood rot/decay
Information:	This building element shows evidence of wood rot. Wood rot, also known as Fungal Decay, occurs when timbers and other cellulose building materials are exposed to damp conditions on an ongoing basis. This could be the result of exposure to weathering over a prolonged period of time, or the attraction of excessive moisture from other abutting building materials. Contributing factors also include poor air ventilation in the area.

Wood rot is often associated with general damp problems and is evidenced by a `musty` smell or mould and mildew occurring on surfaces. If left unmanaged, damp conditions can lead to further health problems and the decay of timbers will continue.

the useful life of these building elements. Prior to any works being performed, the cause of the moisture that has created the visible wood rot should be identified and addressed in a suitable manner. Replacement of affected timbers may then be a necessary step in protecting surrounding building elements from such deterioration.

A licensed plumber may be appointed to assess the cause of excessive moisture and to provide advice on any remedial works as required. A licensed carpenter may also be required to replace affected building materials.

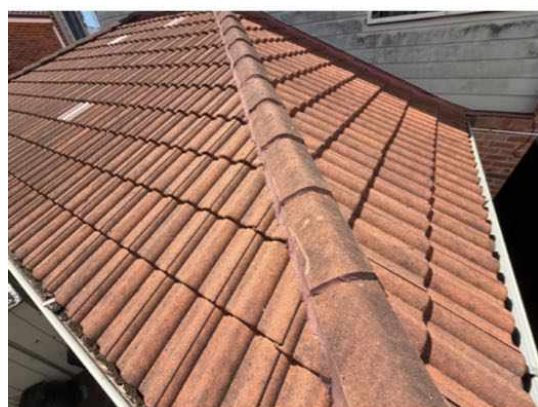
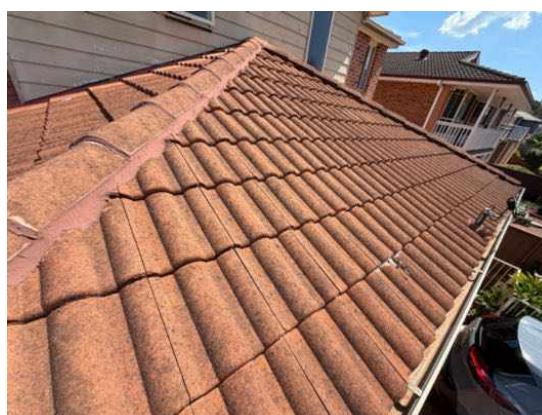
Building: Main Building
 Location: Roof Exterior
 Finding: Additional Photos
 Information:

Additional photos are provided for your general reference.

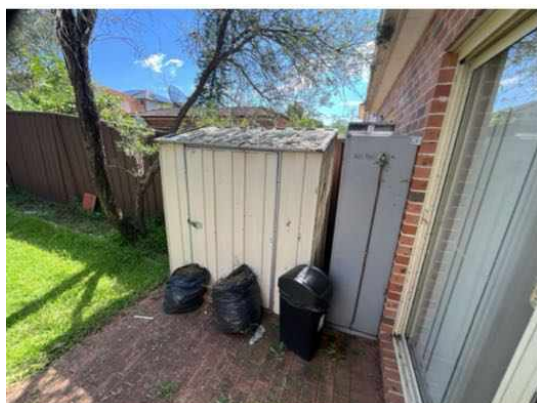
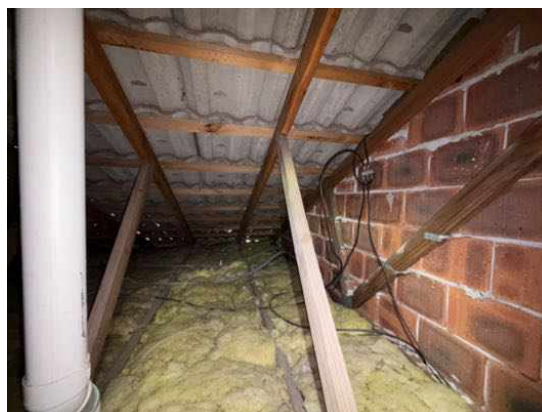
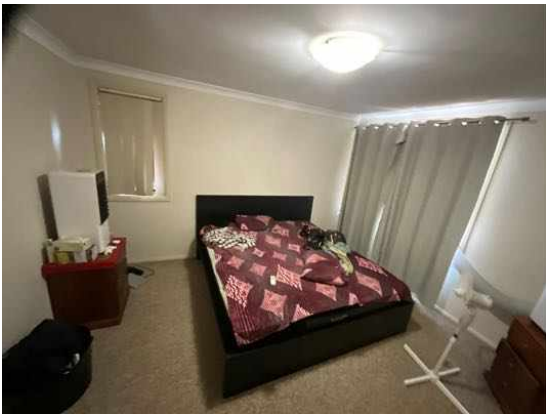
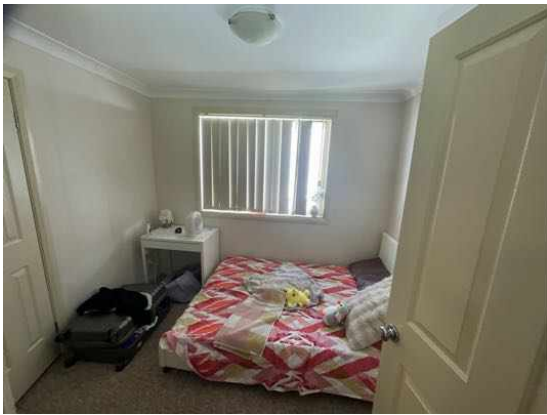
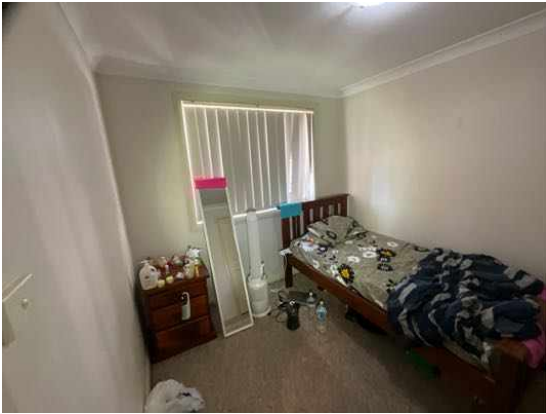
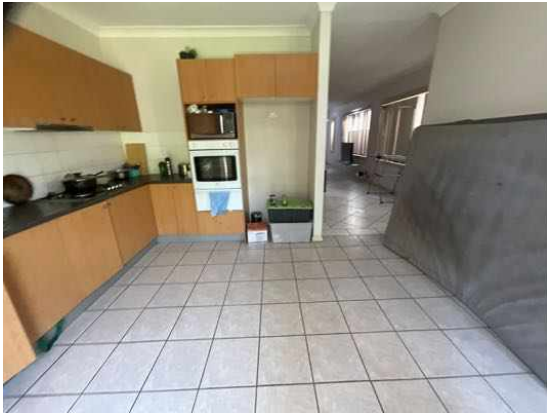
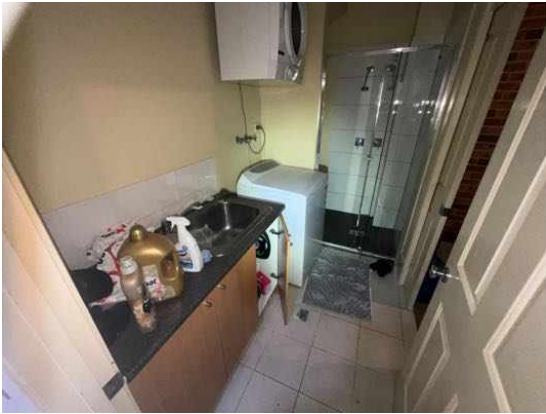
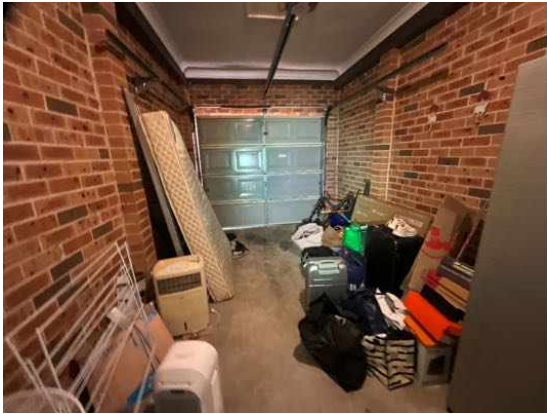
Building:	Main Building
Location:	All Areas
Finding:	Additional Photos - Obstructions and Limitations
Information:	These photographs are an indication of the obstructions and limitations which impeded full inspection of the property at the time of inspection. These obstructions can hide an array of defects and should be removed to allow full inspection to be carried out. A re-inspection is recommended once the areas are made accessible.
