# Building and Timber Pest Inspection Report

Inspection Date: Thu, 12 Feb 2026

Property Address: 23 Lewis St, Euroa VIC 3666, Australia

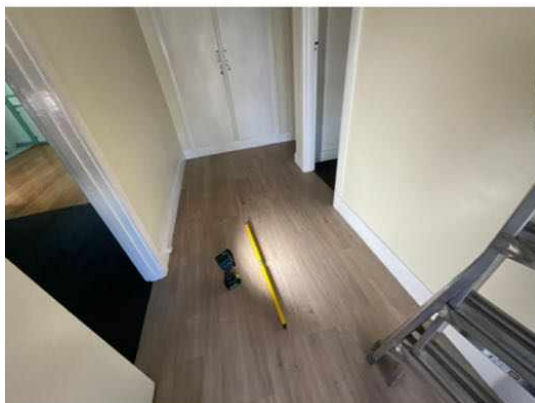
Building: Building 1  
Location: All Internal Areas  
Finding: Flooring - Uneven  
Information: The internal flooring in this area is out of level and uneven. Uneven flooring is likely to indicate minor defects such as expected movement of the foundations of the property, but may also indicate subsidence of the associated subfloor stumps.

It is advised that the flooring be closely monitored to identify any further movement. Where flooring remains relatively unchanged for an extended period of time (i.e. several months), it is likely that this defect has been caused by expected movement of the foundations of the property.

However, where flooring is uneven further, potentially invasive inspection of the subfloor structures and stumps in this area is required. In this case, works to repair are likely to be required, and would be carried out by a registered builder specialising in re-stumping.

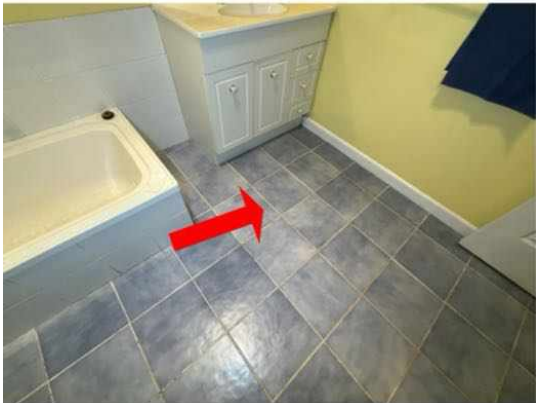
Building: Building 1  
 Location: Bathroom, kitchen  
 Finding: Inadequate sealant or Grout  
 Information: This area has a lack of effective Sealant or Grout. This is allowing the ingress of water to the structure inside the wall.

The presence of water encourages Termite attack, Mould and Fungal Decay.

A Tiler or General Handy person must be contacted as soon as possible to effect repairs and prevent further deterioration.

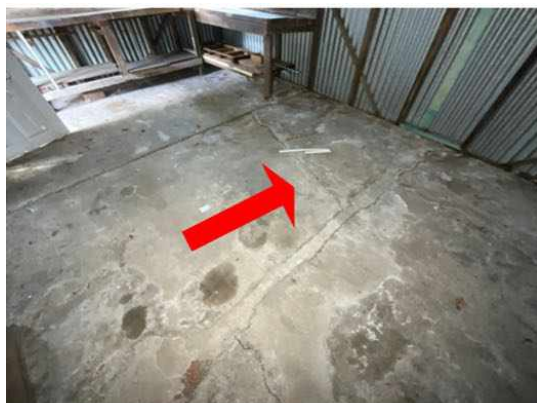
Building:	Building 1
Location:	Yard - Back, garage
Finding:	Cracking - External Concrete Paving Damage Category 4 - Gaps in Slab (4mm - 10mm +)
Information:	Gaps in the slab were identified in external concrete paving. Gaps in the slab are significant and are likely to lead to the development of safety hazards and secondary defects if left unmanaged, such as the creation of a trip hazard.

Cracking to this degree may also be due to poor original installation of the concrete. Factors such as poor compaction of the sub surface and/or inadequate reinforcing of the slab may create cracking and other secondary defects. Gaps in the concrete paving may also have a more significant structural cause, such as subsidence of soils.

Where gaps in the concrete paving are adjacent to structural elements of the building, the advice of a Structural Engineer is advisable before undertaking repairs. Significant repair and likely replacement of the concrete paving is probable.

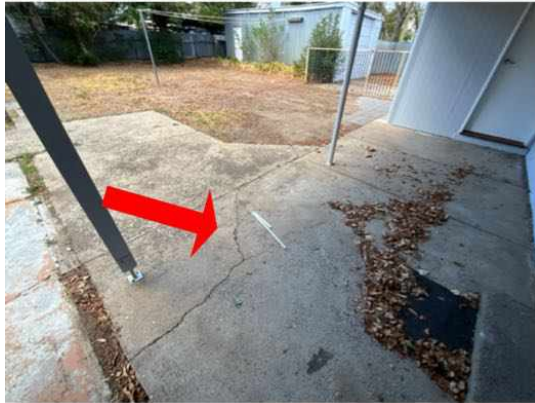
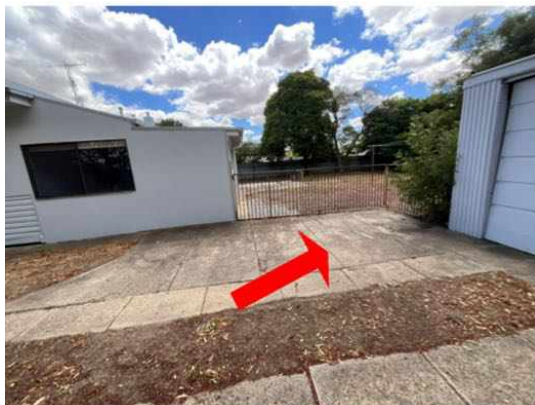
### Finding 3.09

Building:	Building 1
Location:	Verandah, driveway
Finding:	Cracking - External Concrete Paving Damage Category 1 - Fine (less than 2mm)
Information:	Fine cracks were identified in external concrete paving. Although fine cracks are quite noticeable, they are often only considered to be an appearance defect, and usually do not indicate any structural damage. To be considered a Category 1 or fine crack, the crack is found to be less than 2mm in width.

Fine cracks may also be due to poor original installation of the concrete. Factors such as poor compaction of the sub surface and/or inadequate reinforcing of the slab may create cracking and other secondary defects.

Monitoring of all cracking should be conducted frequently. Always contact a building inspector should cracks widen, lengthen, or become more numerous.

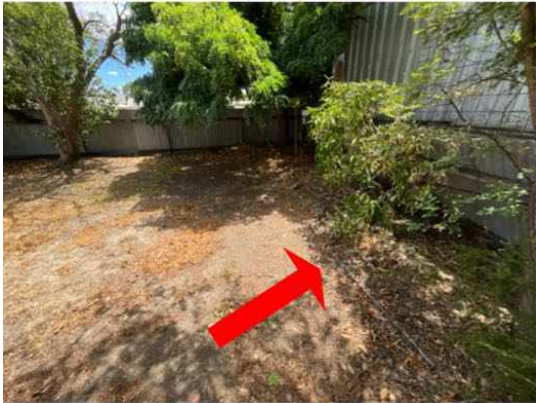
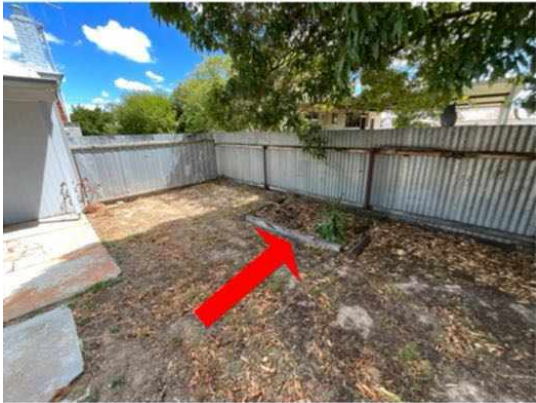
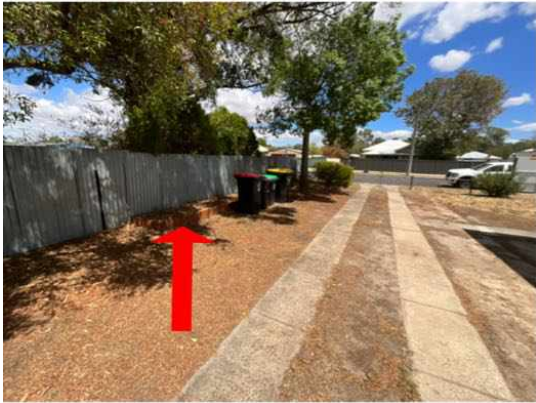
Untreated timbers in direct contact with the ground are likely to develop severe wood rot and/or fungal decay if left unattended creating attraction for subterranean termites to infest the timbers from surrounding areas.

If untreated or non-durable timbers are found to be in a hazardous environment it is highly advised that replacement of these building elements be performed as soon as possible to aid the protection of the property against termite / timber pest attack.

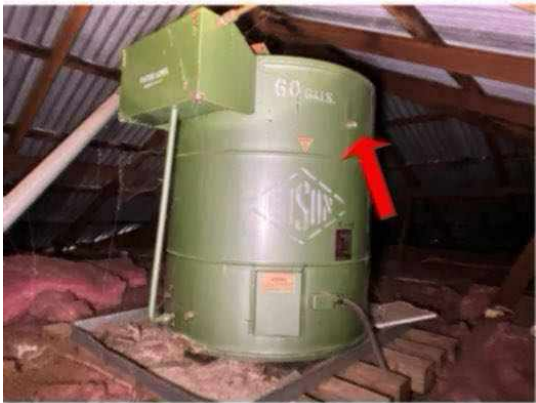
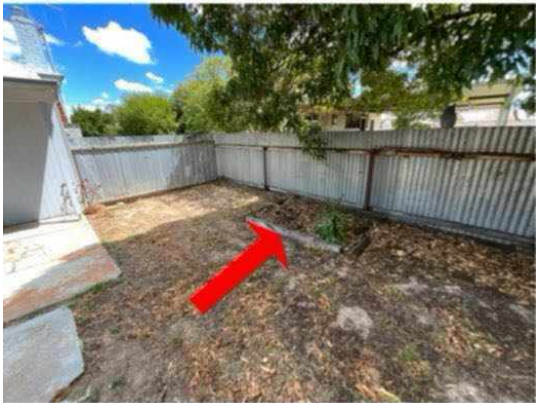
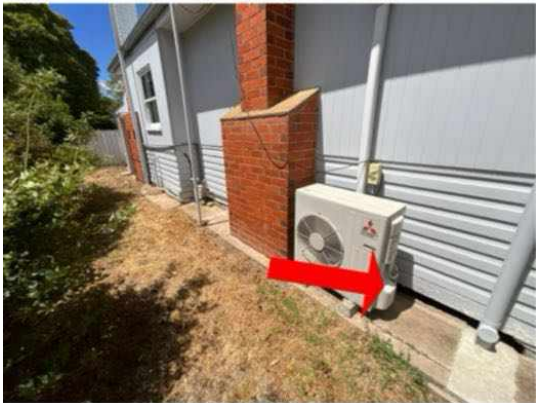
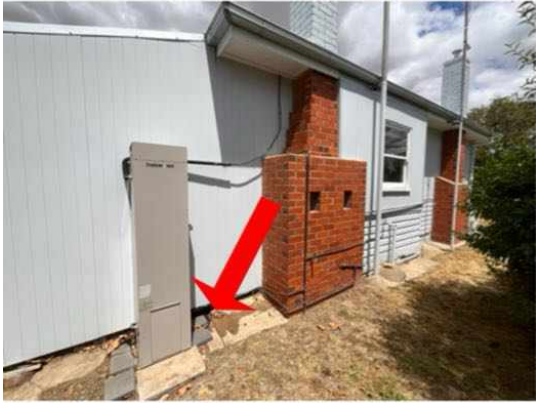
A durable notice should be placed in the switchboard unit to indicate current termite barriers. At the time of inspection, it appeared as though no termite management system has been installed, with no evidence to suggest preventative works taking place.

The client may consider gaining further advice from a pest controller as to the costs and procedures involved with this application. It is recommended that obtaining such advice be a short-term priority.
