Building and Timber Pest Inspection Report

Inspection Date: Tue, 10 Feb 2026

Property Address: 84 Hamblynn Rd, Elizabeth Downs SA 5113,
Australia

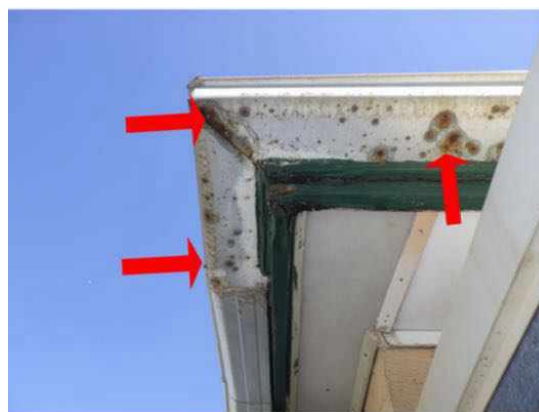
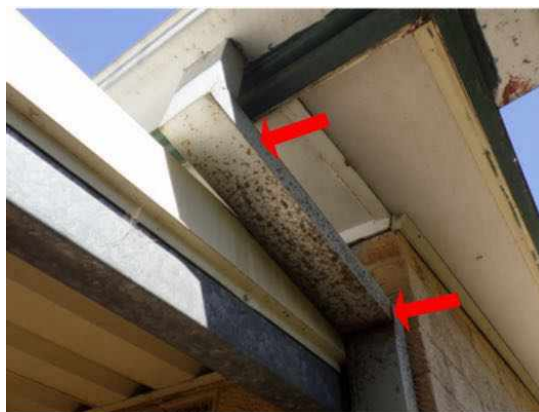
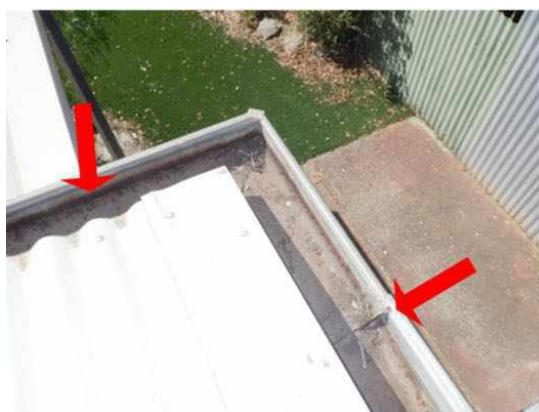
Building: Building 1
Location: Roof Exterior
Finding: Roof plumbing - Rusted or corroded
Information: The roof plumbing has areas of rust and corrosion throughout large sections of the guttering and down-piping. It is suspected that this has been caused by blockages, resulting in pooling or standing water, that have prematurely rusted elements of the roof plumbing.

Rusted roof plumbing will generally develop holes and leaks that can affect other building elements with poor drainage of storm water.

Poorly drained roof areas will also lead to damp conditions surrounding the base perimeter of the building which, if left unmanaged, can lead to a range of secondary building defects.

Repair and/or replacement of rusted roof plumbing is highly required in order to reinstate the roof drainage system to a fully operational level.

To further maintain these areas, gutters should be cleaned frequently, allowing the avoidance of any partial blockages.

A licensed plumber or specialist roof restoration company should be appointed to undertake these works. It is advised that such works be completed as soon as possible to prevent any further damage and deterioration.

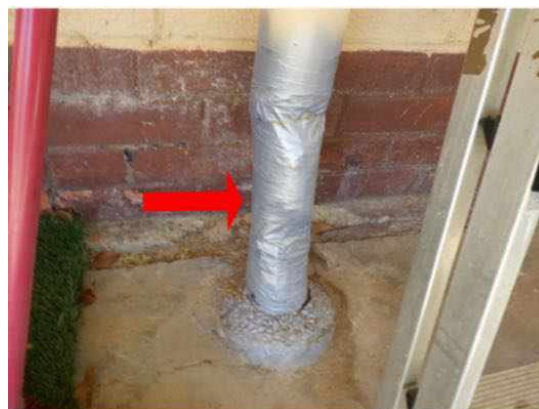
Finding 3.01

become excessively damp, potentially creating an environment that is susceptible to rust and corrosion of surrounding building elements, as well as attracting termites and other pests.

It is highly recommended that a plumber be appointed to further inspect the area and to install adequate drainage equipment where necessary.

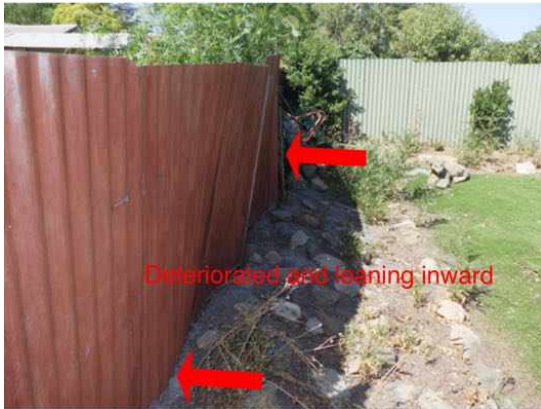
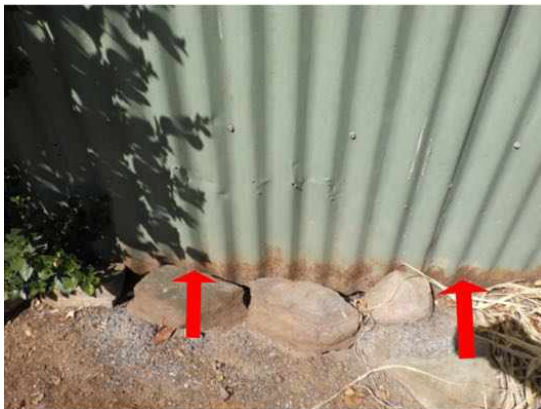
Finding 3.02

Building:	Building 1
Location:	All External Areas
Finding:	Fencing - Deteriorated
Information:	It was noted at the time of inspection that sections of the fencing throughout the property have deteriorated. Typically fencing deteriorates due to age and or wear, rot and or rust which is generally expected for a structure of this age, due to prolonged exposure to weather conditions. Sometimes inadequate installation or maintenance can be to blame.

If left unattended, it is likely that further damage will occur. It is suspected that repair of several elements of the fencing may be required however replacement may be a consideration of the client also.

A licensed fencing contractor should be appointed to provide further advice and

perform rectification works as necessary.

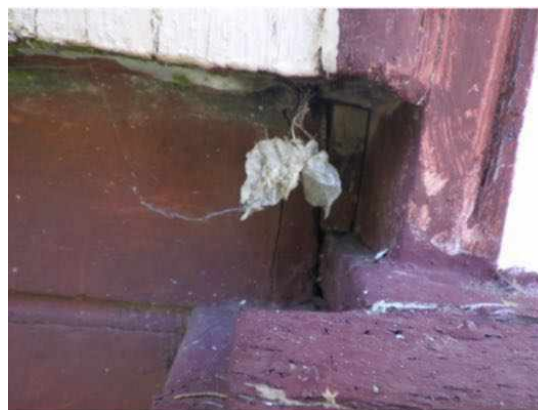
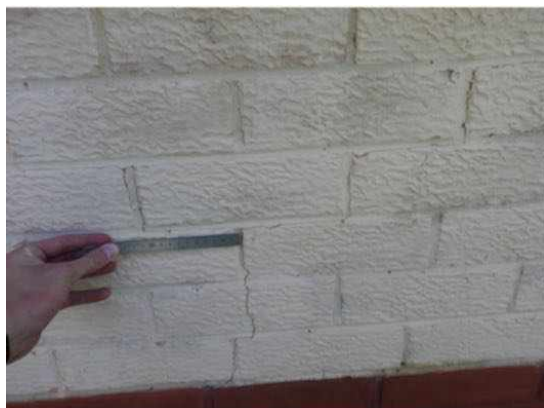
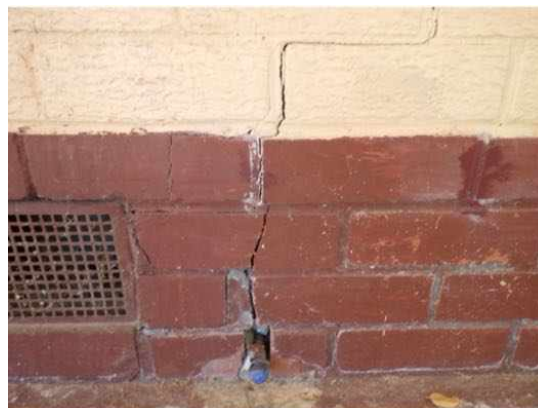
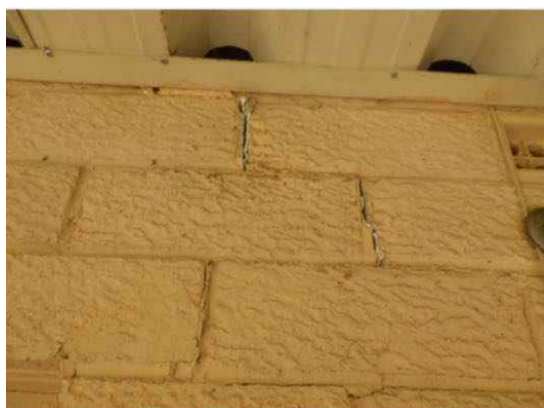
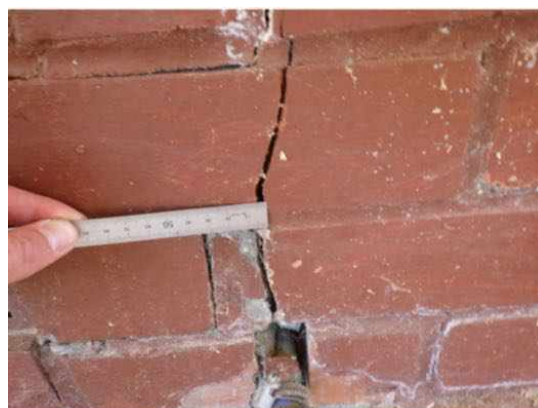
Finding 3.03

Building:	Building 1
Location:	Exterior walls
Finding:	Brickwork - Cracking [Fine]
Information:	There were fine cracks evident to the external brickwork at the time of inspection.

Although fine cracks are quite noticeable, they are often only considered to be an appearance defect and usually do not indicate any structural damage. Generally, the cause of a fine crack is indicative of a separation between brickwork and mortar throughout the structure, but single bricks may also show cracks of this nature.

Cracking of this nature can generally be repaired with minor filling and should be conducted by a qualified bricklayer.

Always contact a building inspector should cracks widen lengthen or become more numerous.

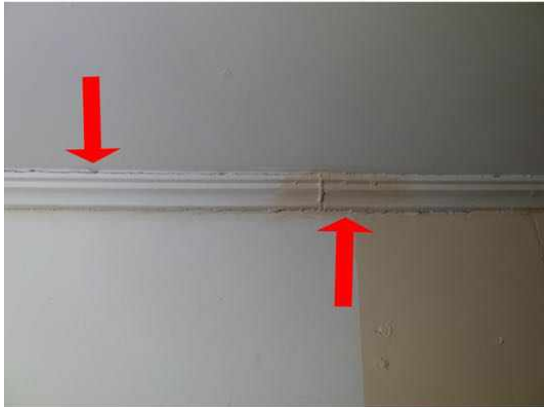
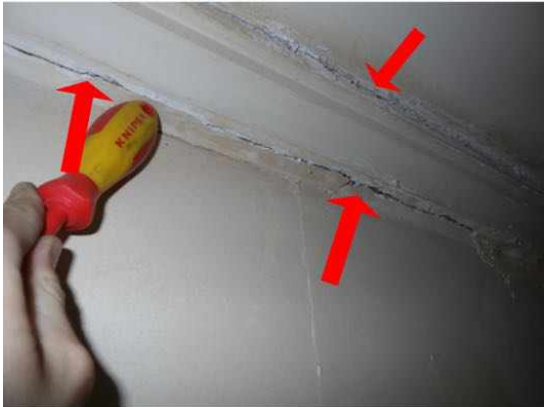
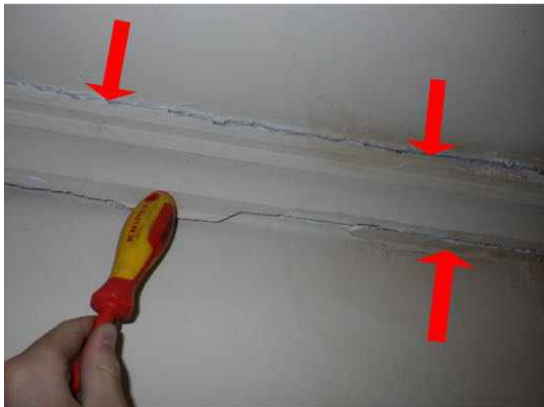
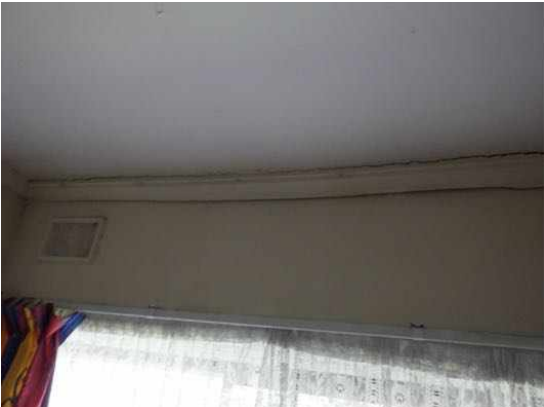
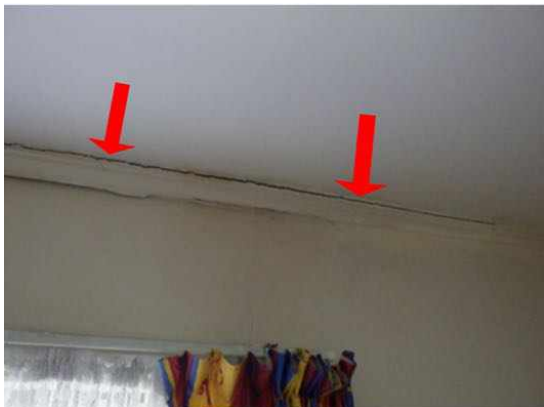
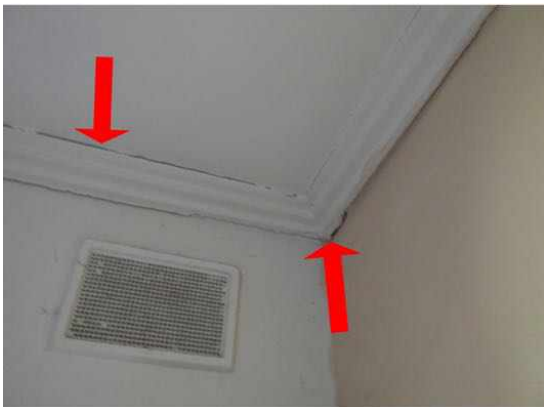
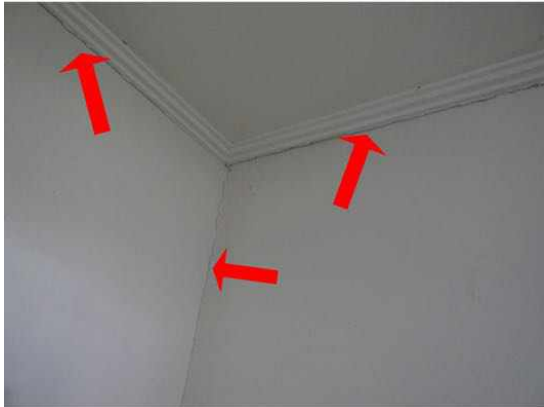
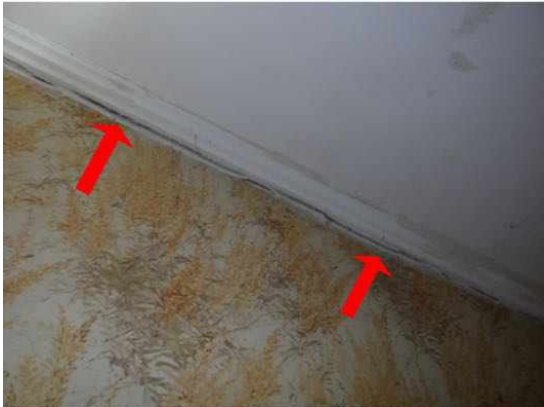
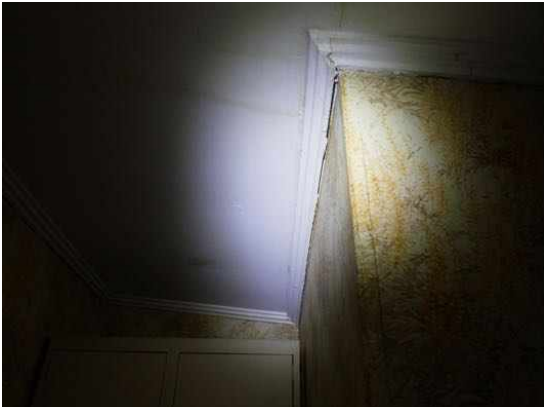
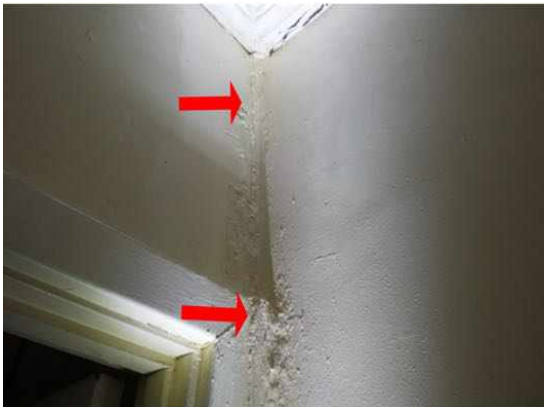
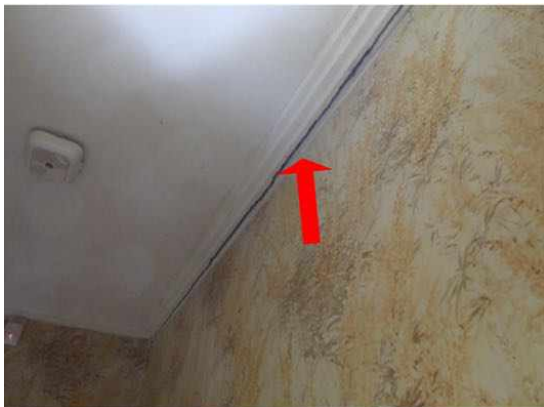
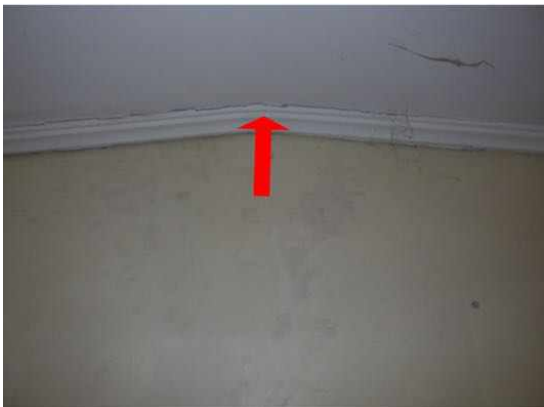
Building:	Building 1
Location:	All Internal Areas
Finding:	Cracking and repairs, Walls and ceilings
Information:	Several cracks and or crack repairs were evident throughout the internal walls and ceilings of the property.

Although fine cracks are quite noticeable, they are often only considered to be an appearance defect and usually do not indicate any structural damage. Generally, the cause of a fine crack is indicative of minor expected movement of a structure of this age however as repairs have been carried out, it is impossible to know the extent of any cracking.

Cracking of this nature can generally be repaired with minor filling and should be conducted by a qualified painting contractor

Always contact a building inspector should cracks widen lengthen or become more numerous.

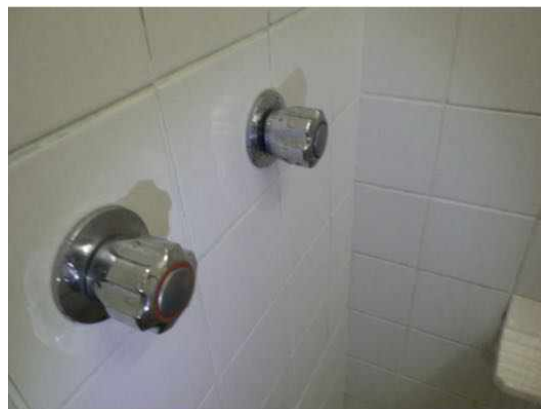
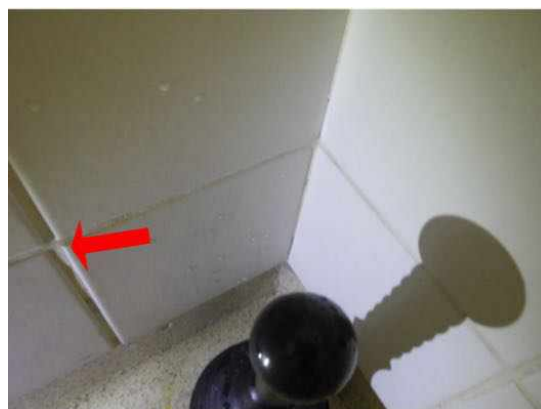
Finding 3.06

Building:	Building 1
Location:	Bathroom
Finding:	Sealant and grouting - Regular maintenance
Information:	It was noted on inspection that sealant and grout has small areas of deterioration evident to the shower alcove at the time of inspection.

Silicone and grout generally need repair at least every 5 years and as such close monitoring should be carried out in the future after repairs are carried out.

Different materials and floor areas move at different rates, generally causing cracking to grout or sealant at this point. A flexible sealant is required to allow for expected expansion and contraction, while keeping the joint water tight and protective of all associated building materials.

Flexible and mould resistant materials should be applied to affected areas to prevent any subsequent water damage that is likely to occur. Regular maintenance and replacement of damage or missing or damaged sealant and grout is highly recommended to the wet areas, as this is a regular wear and tear defect. Sealant and grouting in areas that come into regular contact with water should be maintained for the long term care of your property.

A sealant specialist or tiling contractor should be appointed to complete these works

as soon as possible

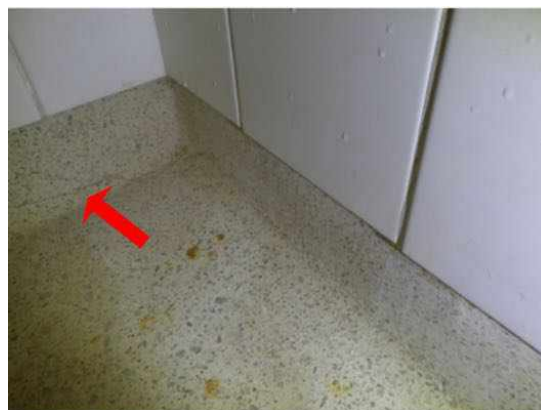
Finding 3.07

Building:	Building 1
Location:	Bathroom
Finding:	Terrazzo - Cracked
Information:	Cracking in the floor was evident in the shower area at the time of inspection. It is suspected that this cracking has occurred as a result of general old age and old construction methods.

Cracked tiles throughout the household detract from the overall appearance of the affected areas, as well as creating potential for water penetration to adjoining building elements. If left unmanaged, water damage may occur as a result of constant water penetration over a prolonged period of time.

While not considered a matter of urgency, repairs are recommended by a terrazzo repair specialist.

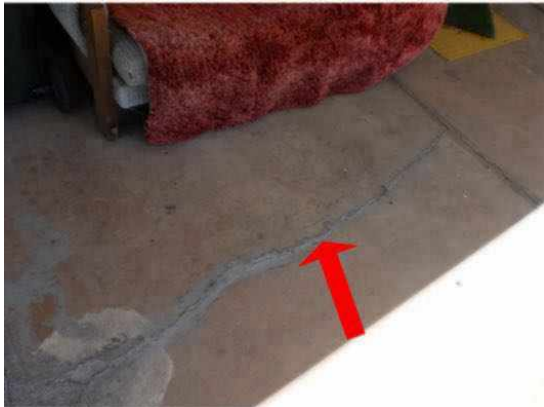
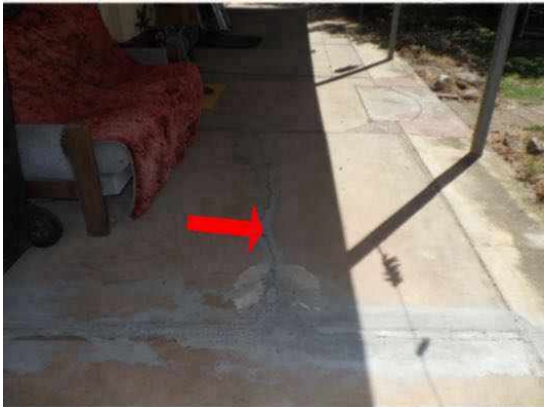
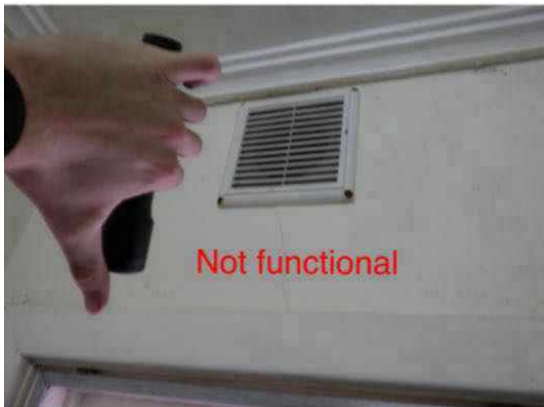
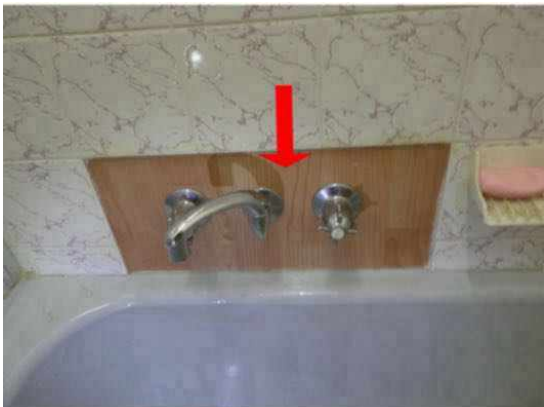
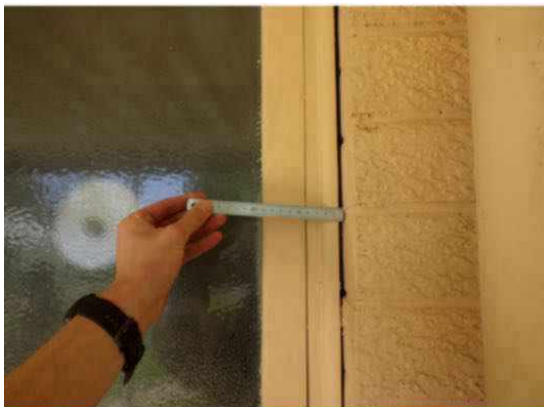
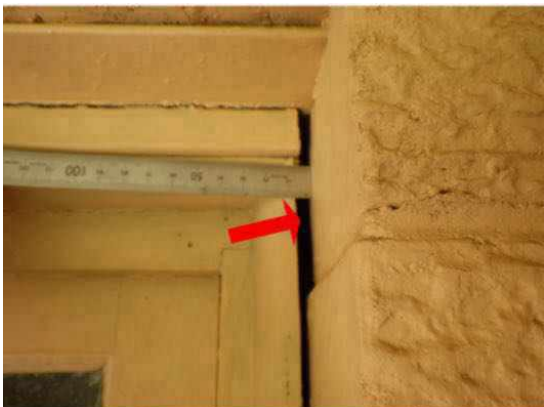
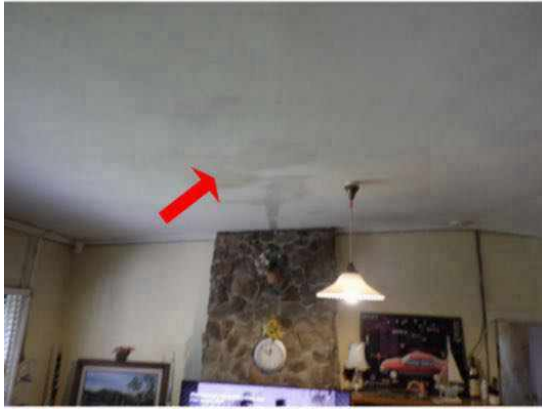
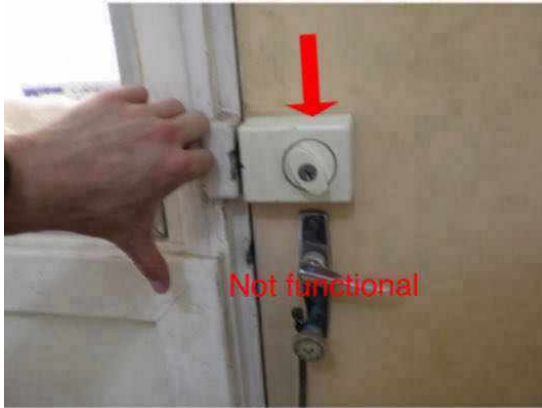
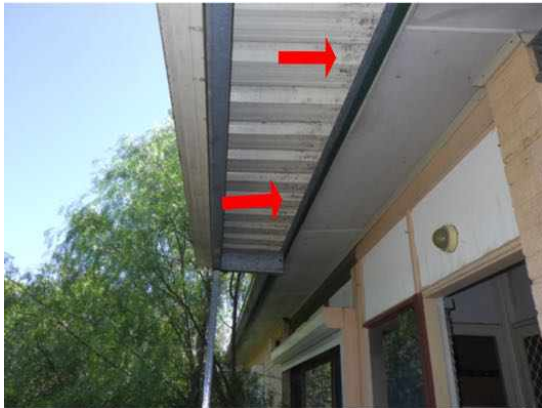
Finding 3.08

Building: Building 1
 Location: All Areas
 Finding: Minor defects present
 Information: There were several age and maintenance related defects evident to the dwelling at the time of inspection. These defects include but are not limited to

- Back porch concrete cracking
- Missing external cornice preventing weathertight seal.
- Fan not functional in bathroom
- Missing tiles beside bath mixer and taps.
- Gaps beside windows.
- Water staining from old water leak.
- Lock not functional.
- Letter box leaning
- Slightly corroded roof sheets.

Appropriate licensed trades people could be appointed to make repairs at the discretion of the client.

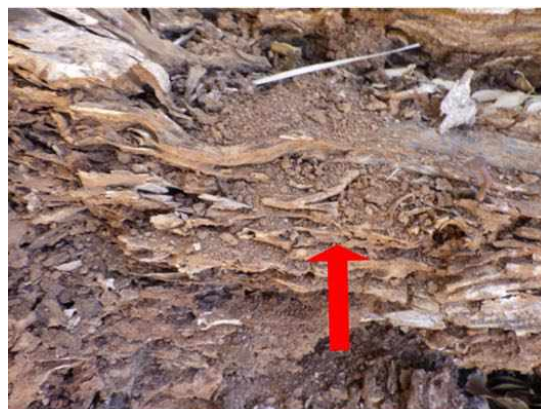
Building:	Building 1
Location:	Yard - Back
Finding:	Evidence of termite damage - minor
Information:	Despite no live termite or timber pest activity being indicated, previous termite damage was found to have affected this area. This damage is considered to be inactive and is minor in nature.

It is advised that the area be visually inspected frequently to ensure that the condition of affected building materials does not worsen. At the time of inspection, damage is not structural and is only considered to be superficial.

A building contractor may be appointed to provide a further invasive inspection if further damage is evident.

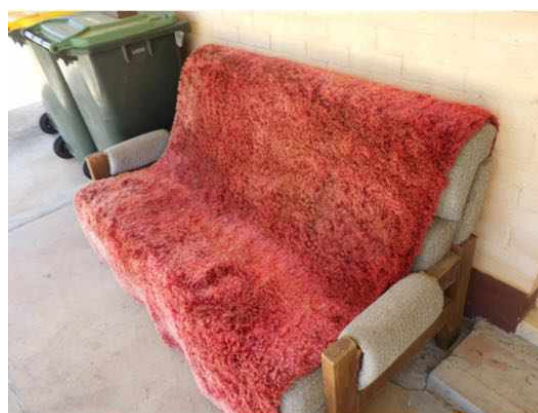
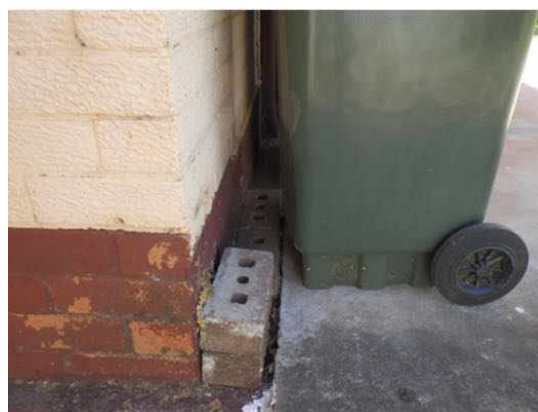
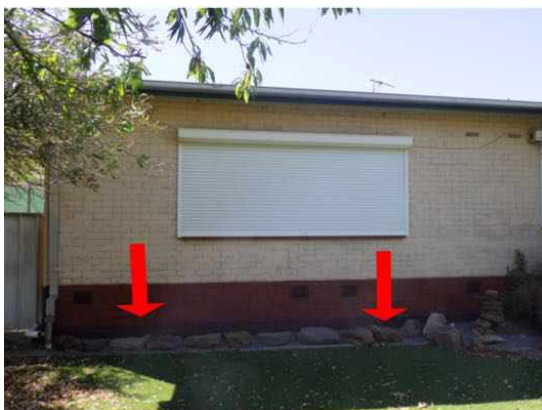
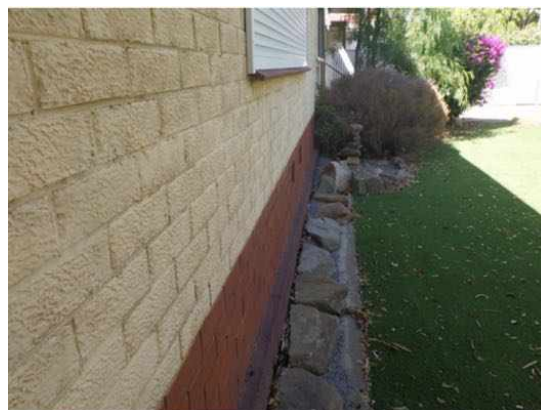
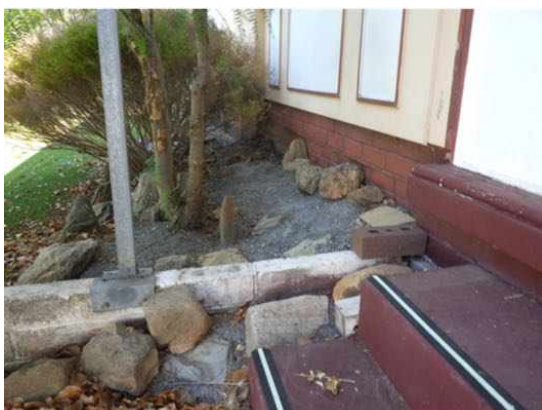
Finding 6.02

Building:	Building 1
Location:	All External Areas
Finding:	Untreated or non-durable timbers in a hazardous environment
Information:	To reduce the risk of timber pest attack it is essential that timber used in a hazardous environment (e.g. in direct contact with the ground or frequently exposed to damp conditions) is of sufficient durability and/or is adequately preservative treated. Additionally any timber lying around or timber stumps should be removed.

Untreated timbers in direct contact with the ground are likely to develop severe wood rot and/or fungal decay if left unattended creating attraction for subterranean termites to infest the timbers from surrounding areas.

If untreated or non-durable timbers are found to be in a hazardous environment it is highly advised that replacement of these building elements be performed as soon as possible to aid the protection of the property against termite / timber pest attack. Failing this close monitoring is recommended in an attempt to identify termite infestation at an early stage.

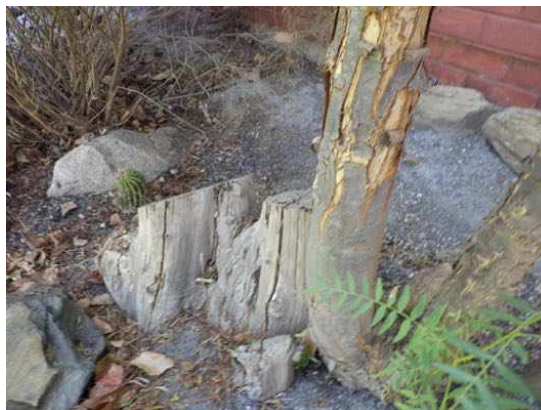
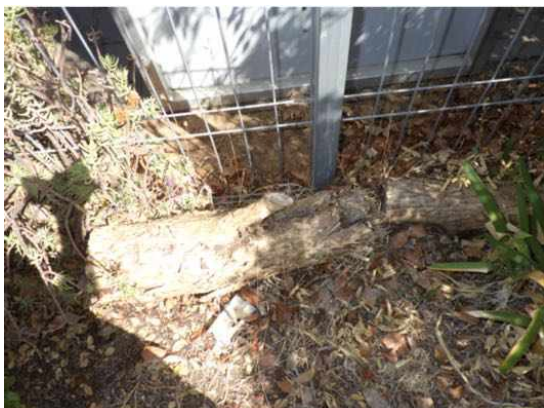
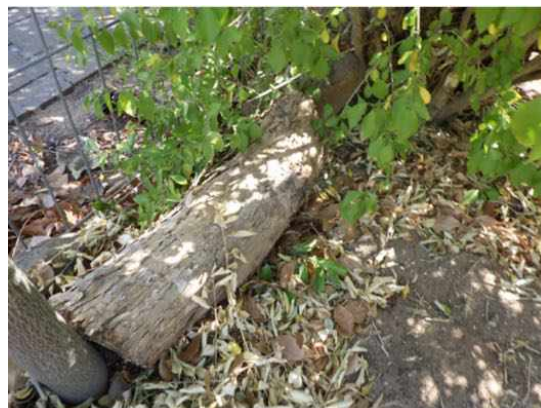
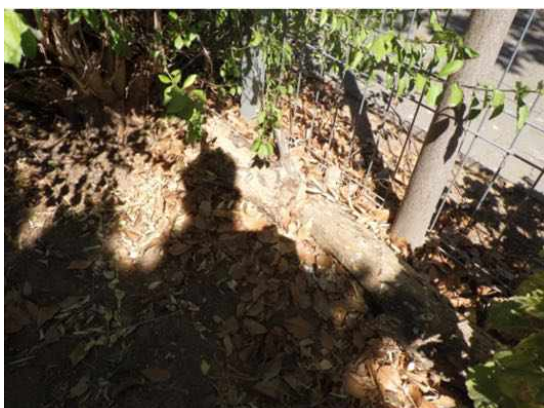
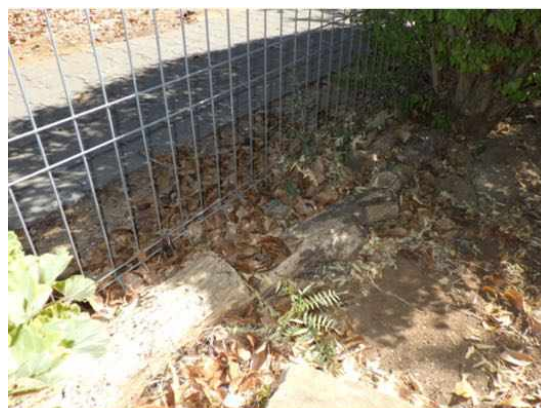
Finding 6.03

Building:	Building 1
Location:	All Areas
Finding:	Termite Management System - no evidence of a chemical installation
Information:	The application of a post-construction chemical termite barrier is highly recommended for all properties, particularly if live termite activity has been found on the site previously. Such barriers are highly effective in preventing termite attack on any timber building elements throughout the property.
	A durable notice should be placed in the switchboard unit to indicate current termite barriers.

At the time of inspection, it appeared as though no termite management system has been installed, with no evidence to suggest preventative works taking place.

The client may consider gaining further advice from a pest controller as to the costs and procedures involved with this application. It is recommended that obtaining such advice be a short-term priority.

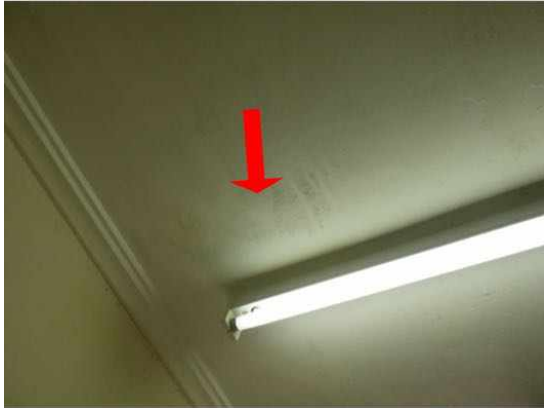
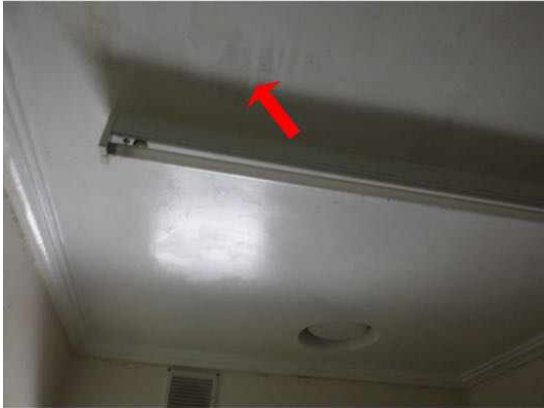
Finding 7.02

Building: Building 1
Location: Bathroom
Finding: Mould - Present
Information: There was mould evident to the bathroom ceiling at the time of the inspection.

Generally, the client is advised to ensure that the general environment is free of moisture and humidity to aid in the prevention of mould formation and development. Any mould found during the inspection should be cleaned immediately by a cleaning contractor or general handy person to ensure that mould is neutralised.

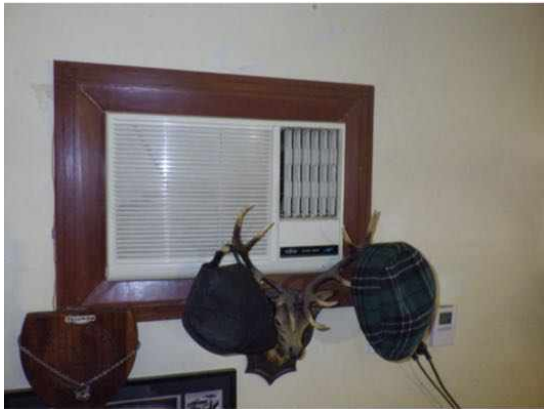
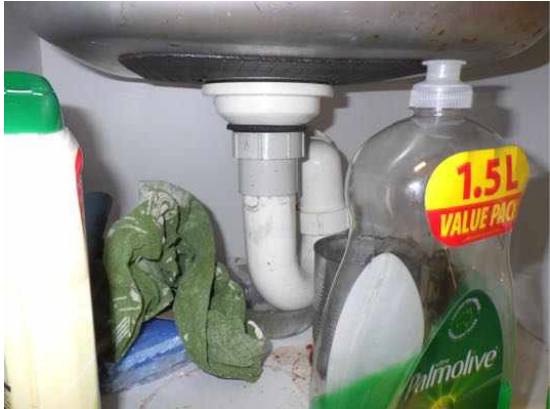
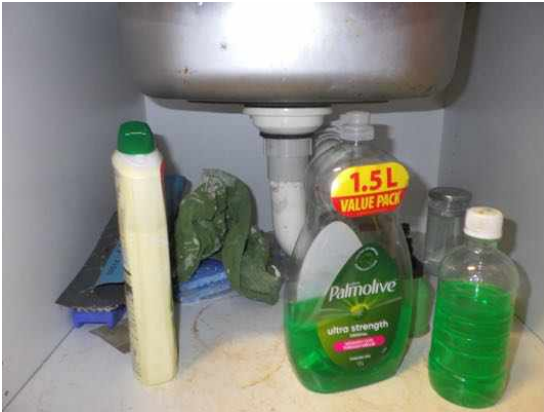
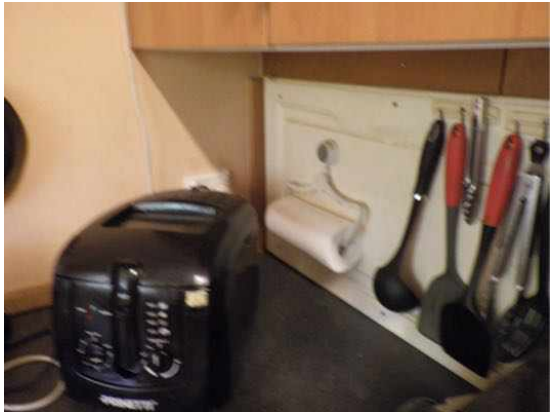
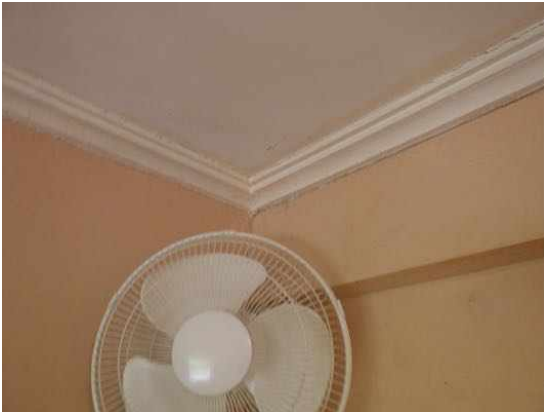
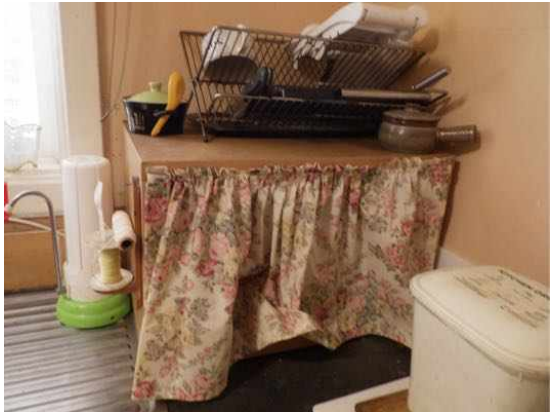
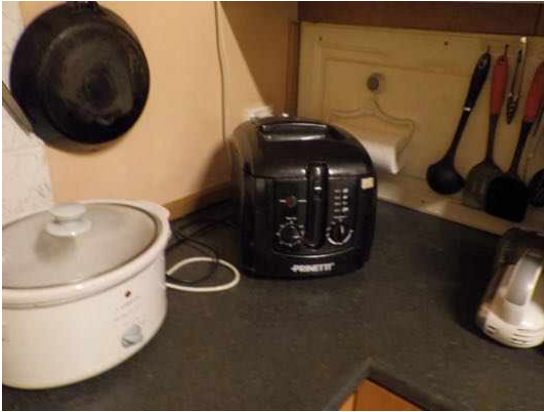
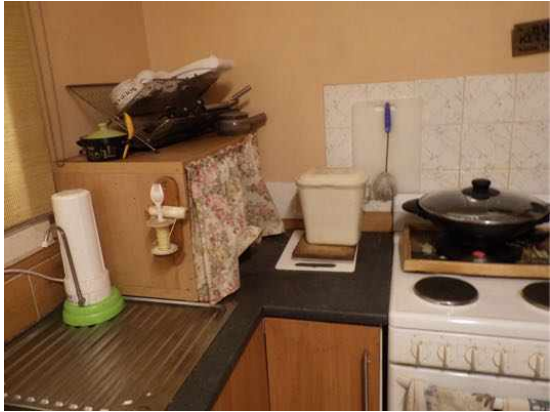
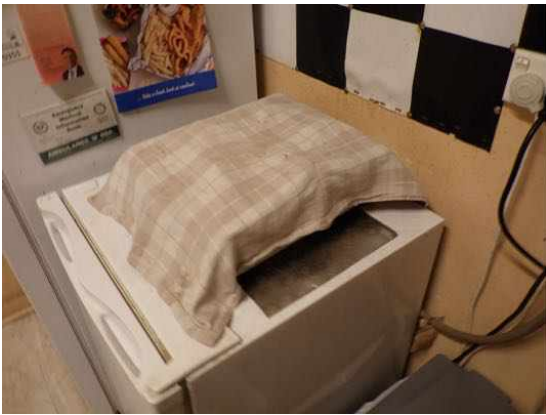
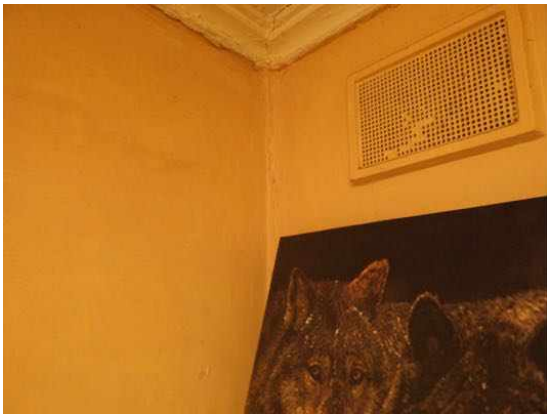
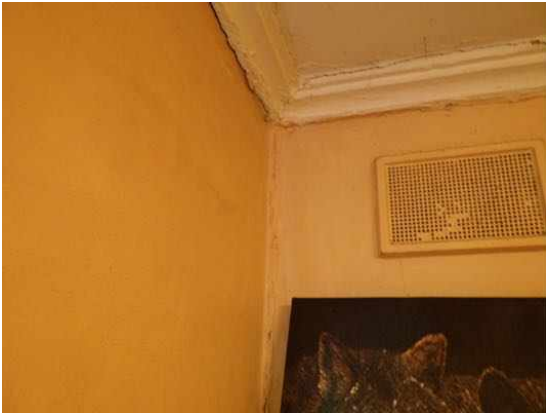
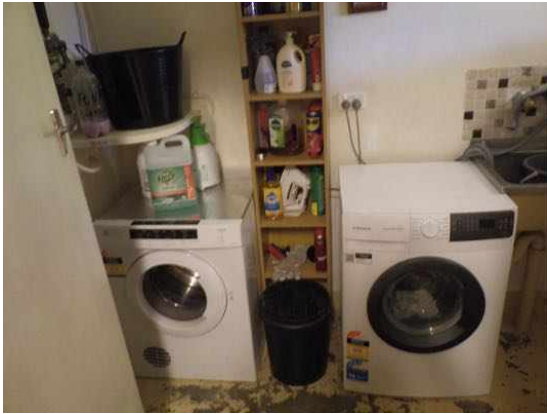
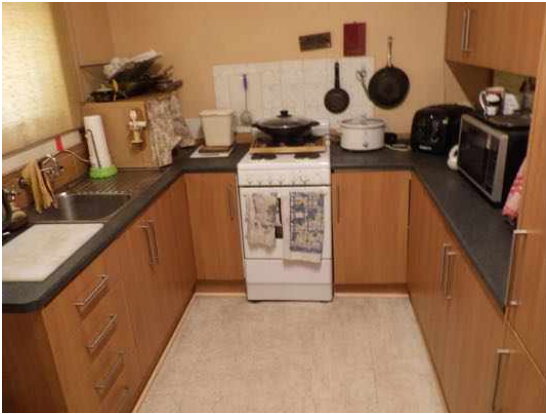
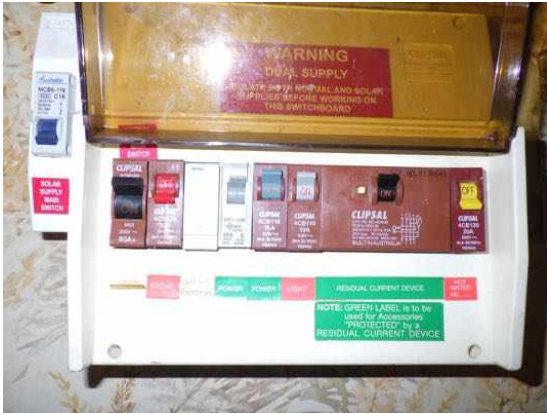
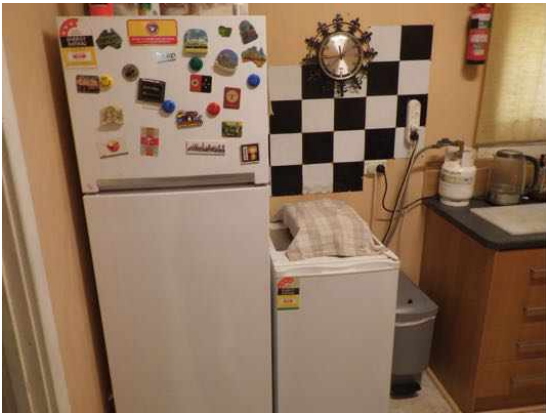
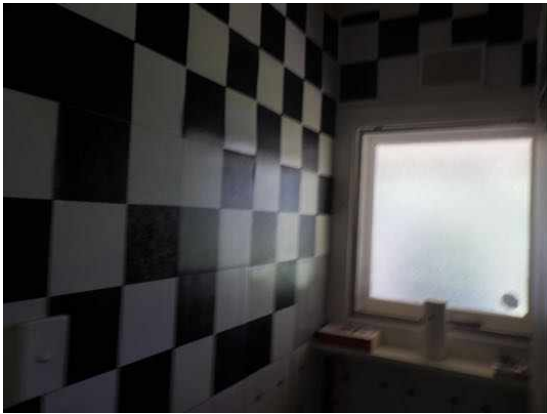
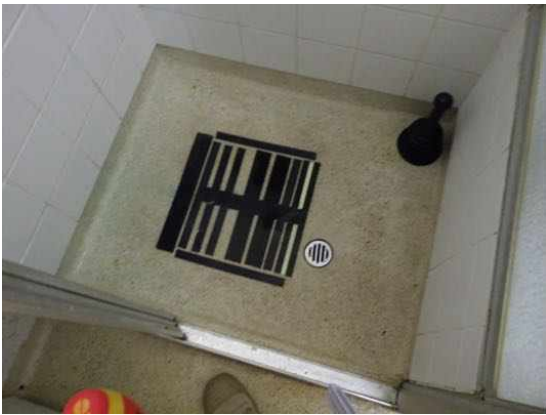
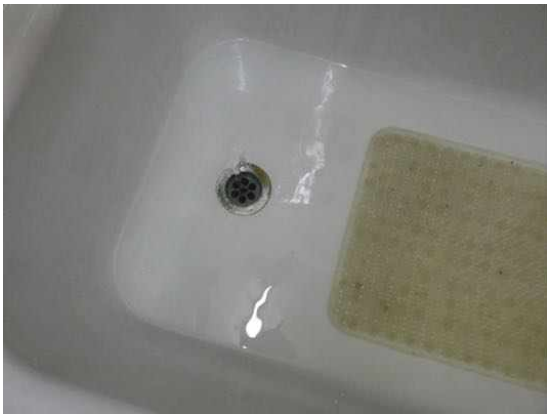
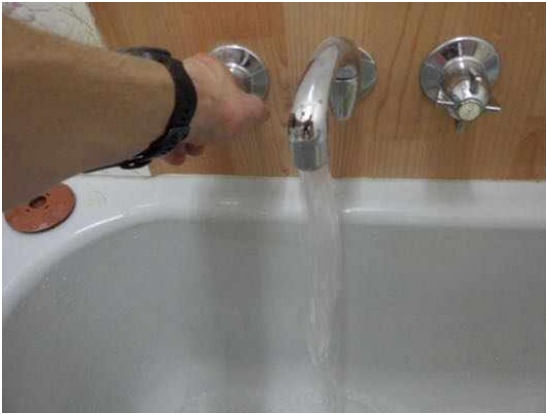
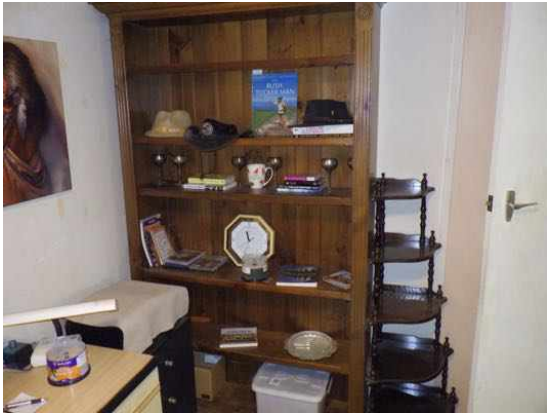
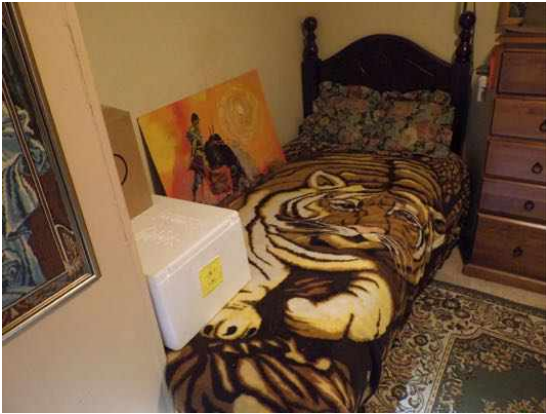
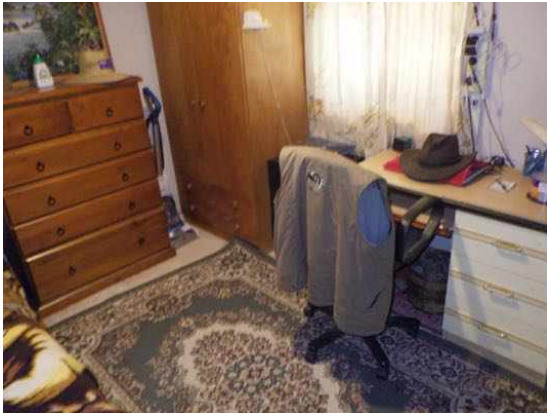
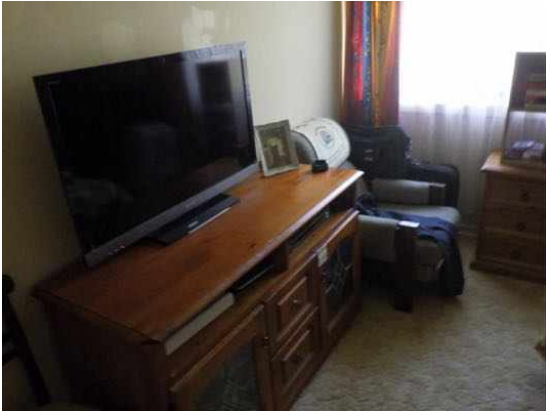
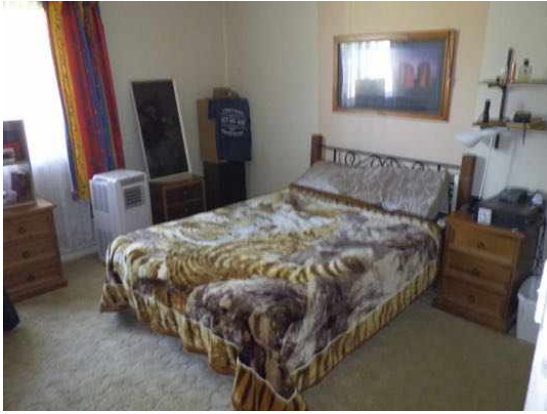
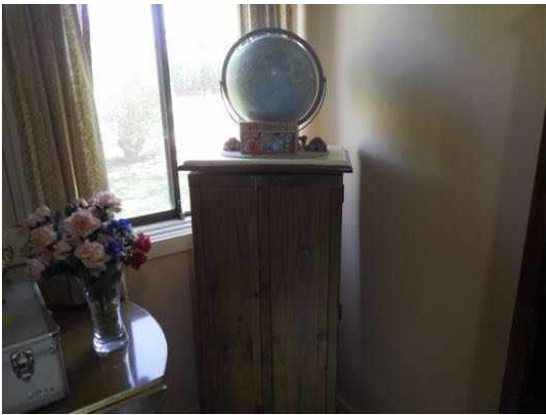
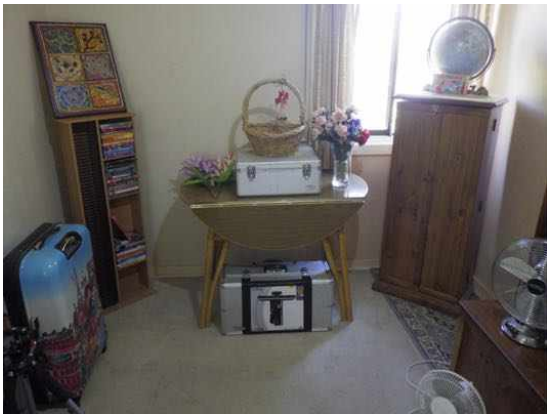
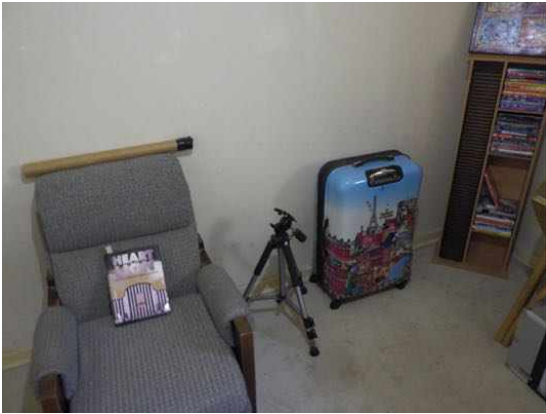
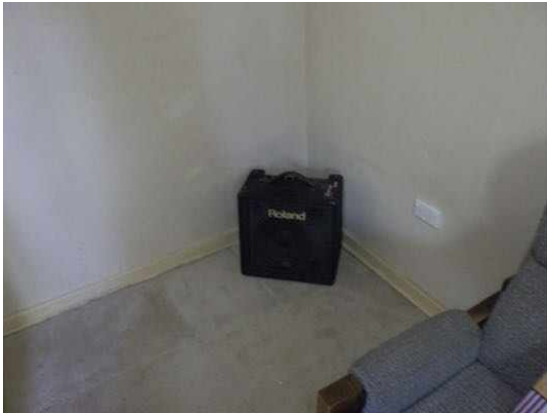
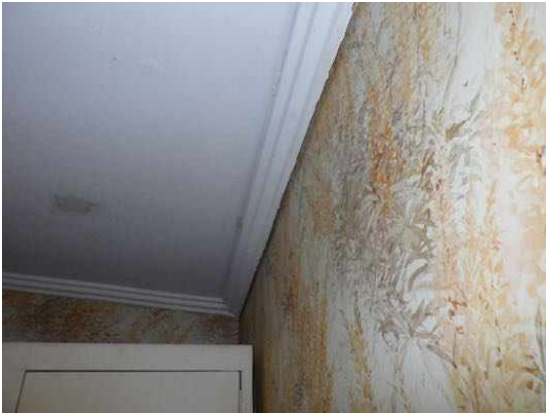
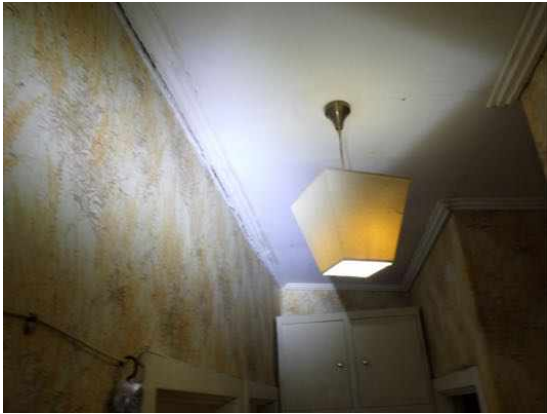
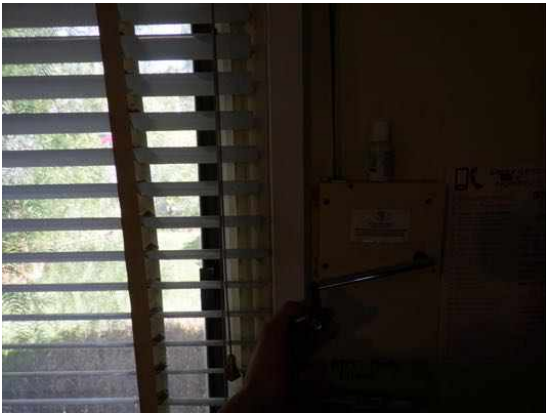
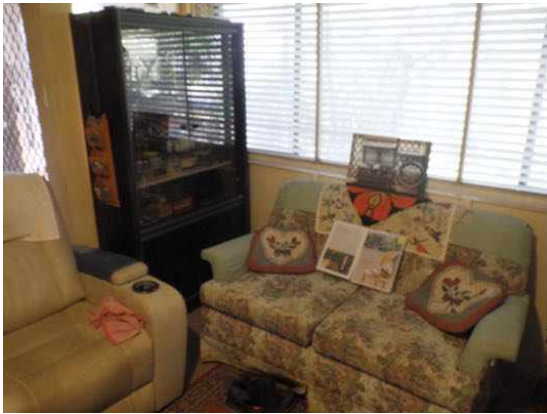
Building: Building 1
 Location: All Areas
 Finding: Additional Photos - Obstructions and Limitations
 Information:

These photographs are an indication of the obstructions and limitations which impeded full inspection of the property at the time of inspection. These obstructions can hide an array of defects and should be removed to allow full inspection to be carried out.
