# Building and Timber Pest Inspection Report

Inspection Date: Wed, 18 Mar 2026

Property Address: 20 Greendale Ave, Pymble NSW 2073,  
Australia

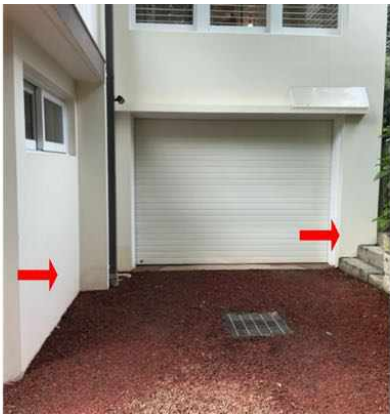
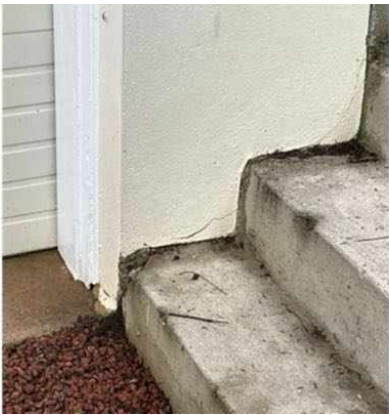
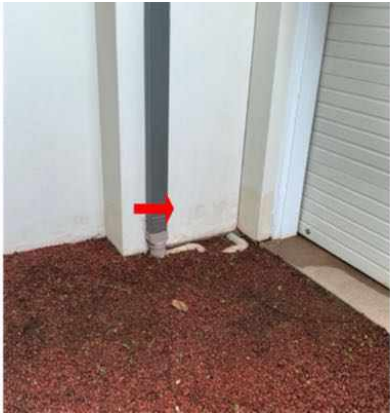
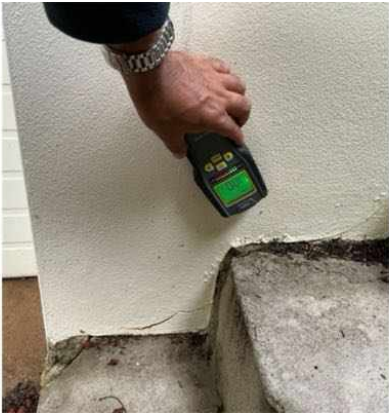
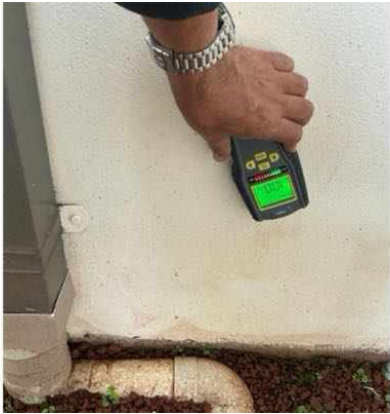
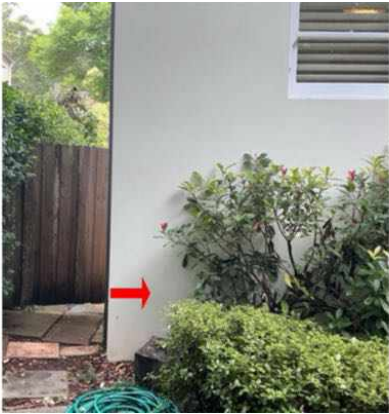
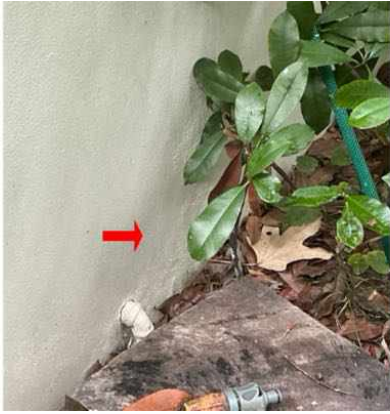
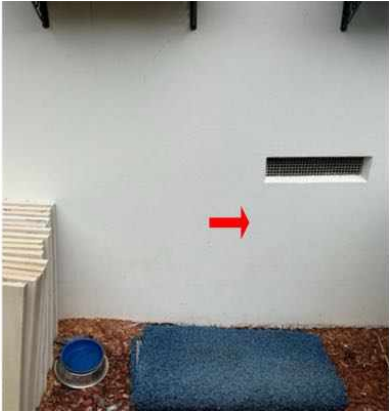
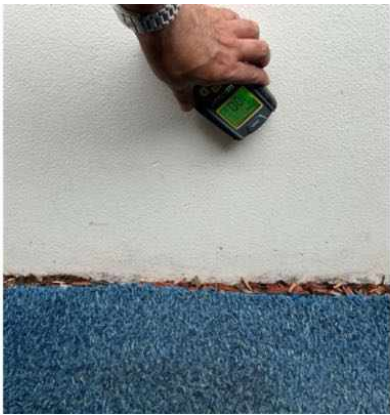
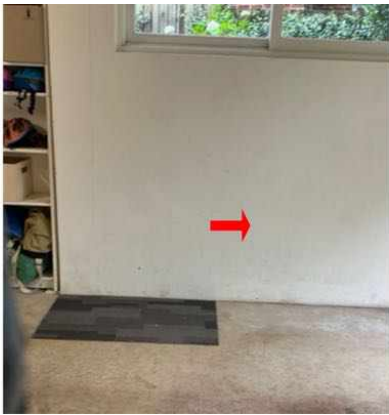
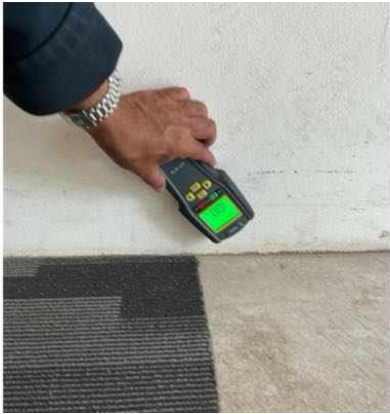
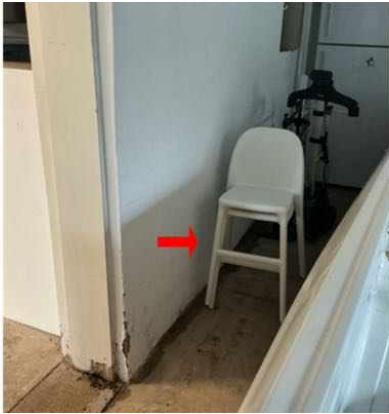
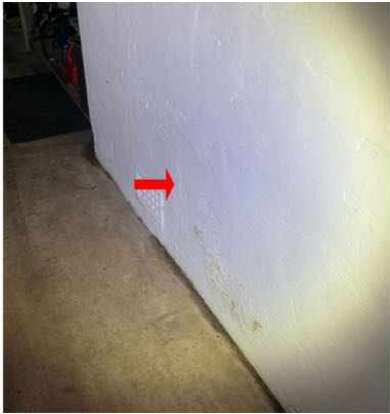
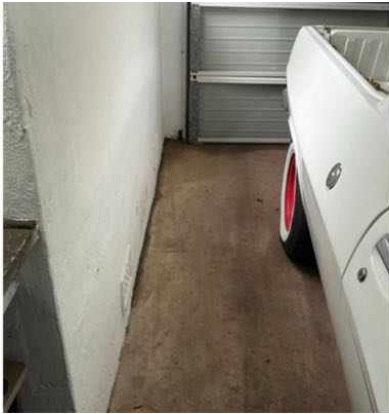
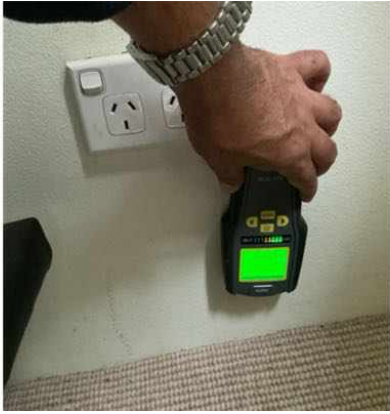
The first step in addressing damp is to diagnose the cause. The identified cause should be addressed first prior to repairing the appearance and other defects which have resulted from the rising damp. If the original cause is not resolved, further cases of damp are likely to ensue, resulting in secondary defects.

Consultation with a qualified plumber is advised immediately to identify the cause of damp and perform remedial works as required. Where excessive mould growth is present, further inspection by a specialist environmental health inspector should also be considered.

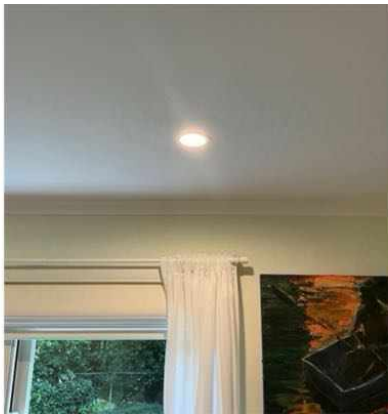
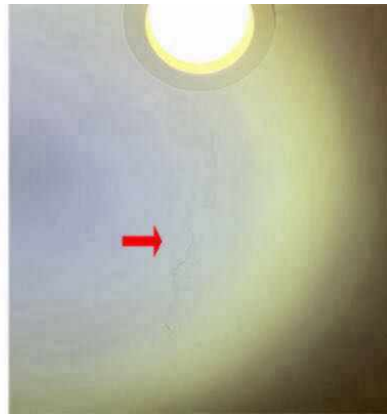
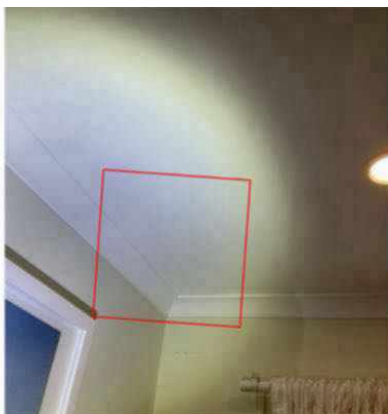
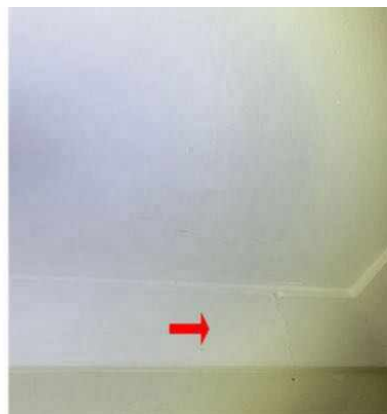
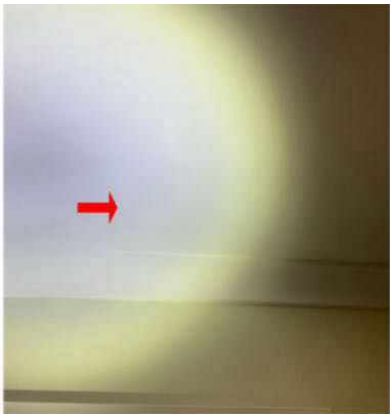
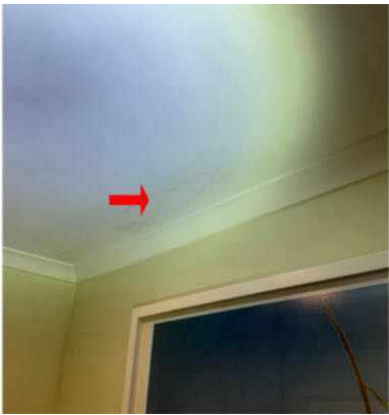
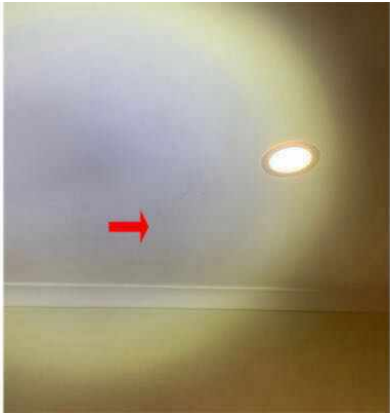
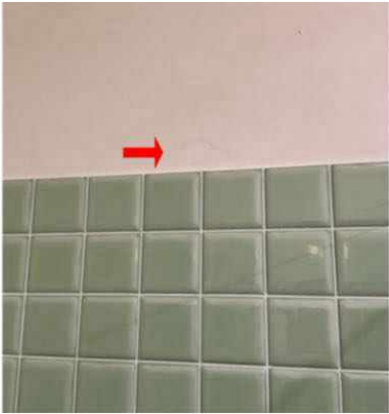
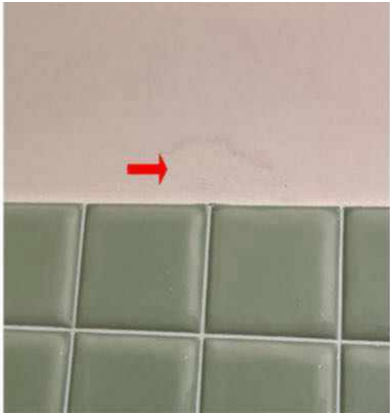
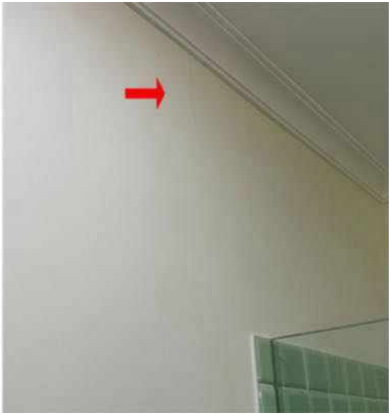
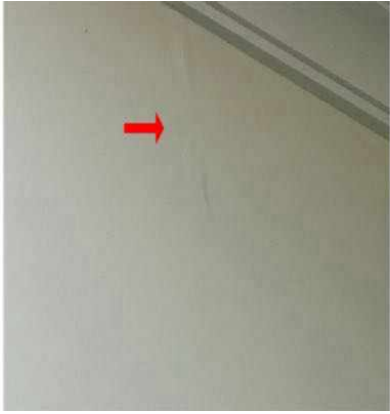
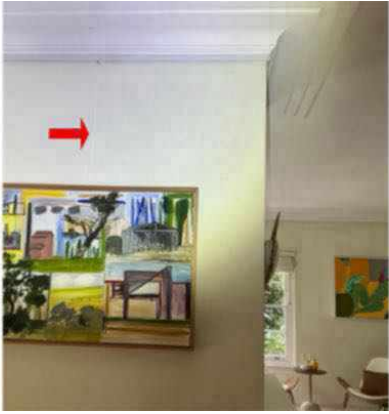
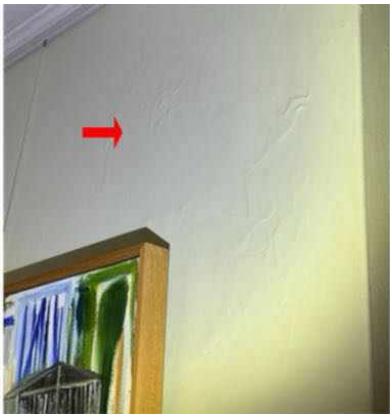
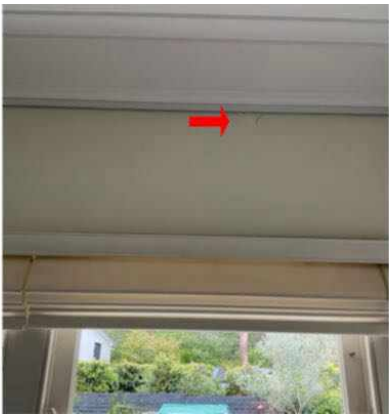
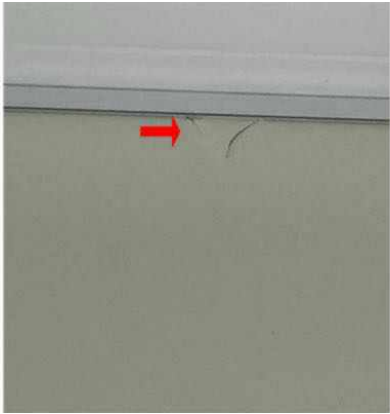
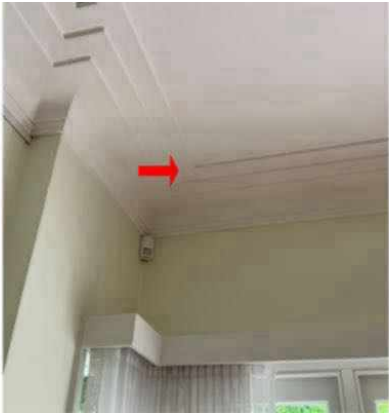
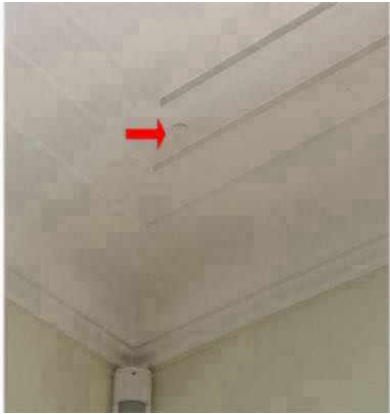
Finding 2.02

Building: Main Building  
Location: All Internal Areas - Lower area, bathroom, dining , chimney wall, bathroom 2  
Finding: Painted surface - Bubbling and water staining - Multiple Areas  
Information: Sections of paint in this area was found to have bubbled and deteriorated. Paint bubbling is generally an indication of excessive moisture in the area, that is currently hidden by the painted surface.

The presence of excessive moisture can have major implications on associated building elements if left unattended. While only seemingly minor at this stage, the damage cannot be determined due to the paint obstructing any further inspection of the damage.

It is highly advised that the affected paint be cleaned to allow a further, more invasive inspection by a licensed plumber. Failure to act on this defect may necessitate major works in the future.

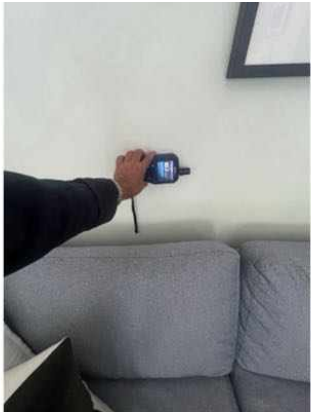
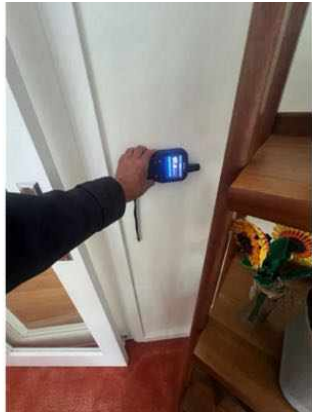
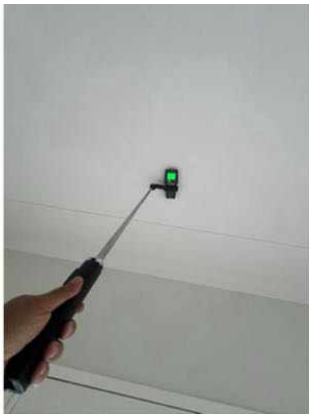
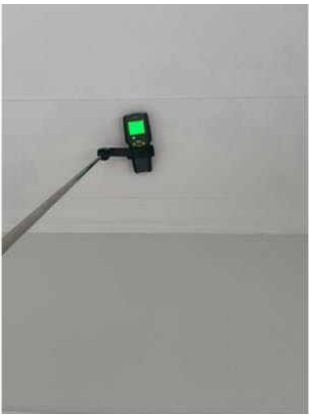
Building:	Main Building
Location:	All Internal Areas - Bedrooms front , kids bedroom , hallway , formal dining , ceiling front bedrooms
Finding:	Elevated Moisture – Further Investigation Recommended
Information:	Elevated moisture readings were detected in several locations, with some areas also showing minor deterioration while others did not present visible surface issues, although no significant structural damage was evident at the time of inspection, dampness can contribute to deterioration if left unaddressed. Inspector was not able to inspect the external wall due to space constraints. A further investigation by a licensed plumber or waterproofing specialist is recommended to confirm the source and ensure no concealed issues are developing.

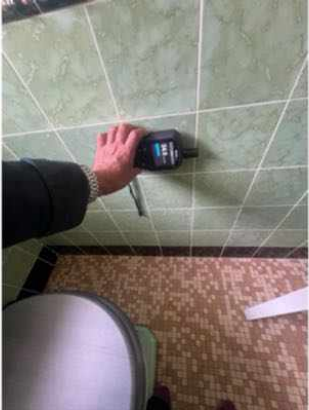
**Finding 3.02**

Building: Main Building  
Location: Bathrooms  
Finding: Elevated Moisture Bathroom & Back of shower - Further investigation required (Possible waterproofing)  
Information: Elevated moisture levels were detected to tiled surfaces in bathroom/shower areas. This may be due to porous or missing grout, cracked tiles or recent use, however the possibility of waterproofing membrane failure or plumbing leaks cannot be excluded. Persistent moisture ingress can lead to concealed damage, including timber rot and mould growth. Further investigation by a licensed plumber and/or waterproofing contractor is recommended as soon as possible. The back of shower area also showed elevated moisture but no visible deterioration was evident at the time of inspection.

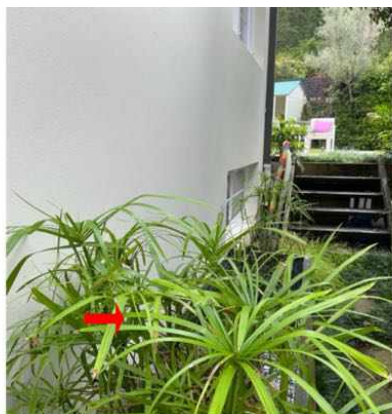
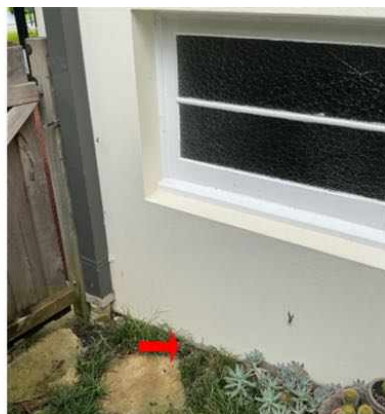
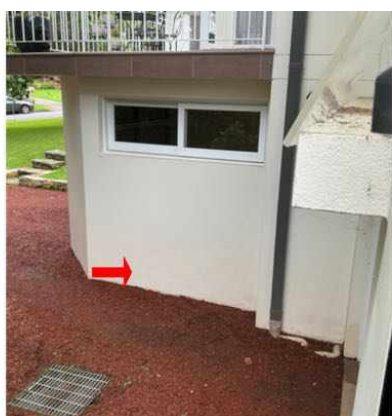
Finding 3.03

Building:	Main Building
Location:	All External Areas
Finding:	Render Finish Covering Damp Membrane
Information:	During the inspection, it was noted that the applied render finish is covering the damp-proof membrane. This is affecting the membrane's ability to prevent moisture movement above it, leading to moisture-related issues over time. It is recommended to consult a qualified builder to ensure the damp-proof membrane is properly exposed, maintaining its effectiveness in preventing moisture ingress.

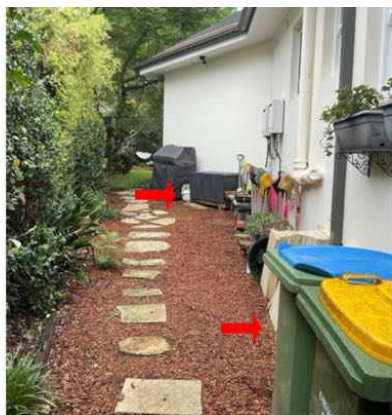
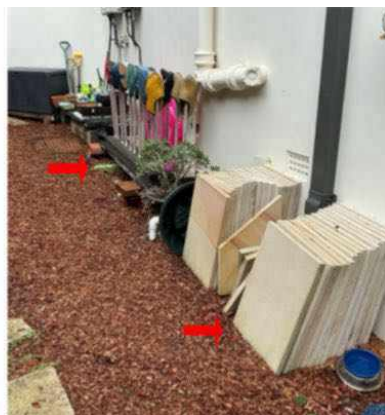
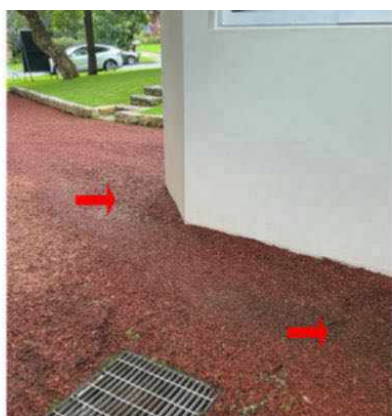
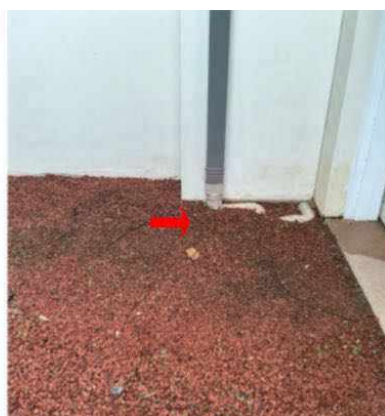
### Finding 3.04

Building:	Main Building
Location:	All External Areas
Finding:	Site drainage - Inadequate
Information:	The site drainage in this area was found to be inadequate at the time of inspection, creating potential for subsequent water damage to associated building elements.

It is important that water does not lie against the base of walls; surrounding paths and ground levels should be sloped to drain water away from walls. Downpipes should not discharge stormwater onto lower walls or plinths. Stormwater should be carried away by large, regularly cleaned drains. Ground levels may need to be lowered to expose a buried DPC.

Where site drainage is inadequate, installation of an Agricultural (Aggie) Drain may be required. A qualified plumber should be appointed to further inspect the property and perform any remedial works as necessary. Water damage and secondary defects are likely to occur if left unmanaged.

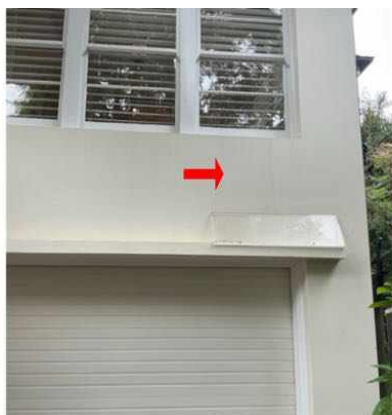
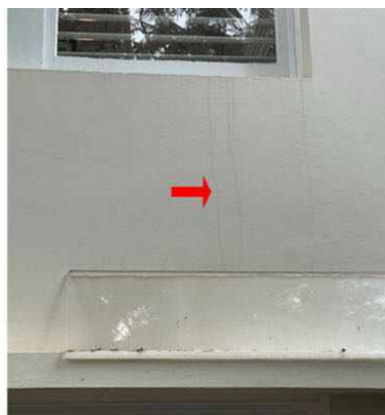
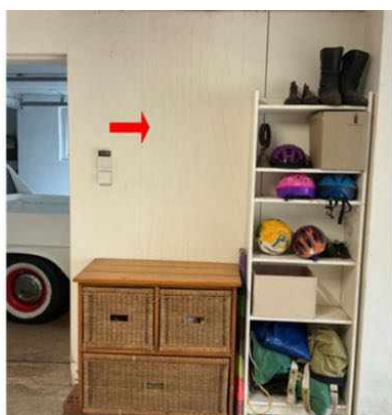
### Finding 3.05

Building:	Main Building
Location:	All External Areas - Garage and lower ground wall internal
Finding:	Walls - Water stained
Information:	Water staining to sections of the walls in this area was evident at the time of inspection. Water staining indicates that surfaces have been exposed to excessive moisture over time. The minerals and other elements in the water lead to staining, which may graduate to corrosion and deterioration if left unmanaged.

While mostly an appearance defect, water staining can be indicative of more serious defects, which may be currently concealed by wall linings.

Where water staining is active, a licensed plumber must be consulted to identify the cause of the staining and to provide advice on any reparation works that may be required. Replacement of any broken or damaged structures is advised.

Conversely, where water staining is old and inactive, affected building materials may

be repaired or replaced at client discretion.

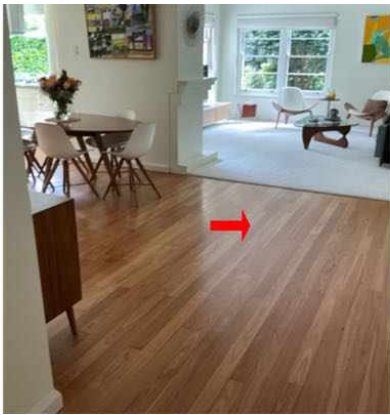
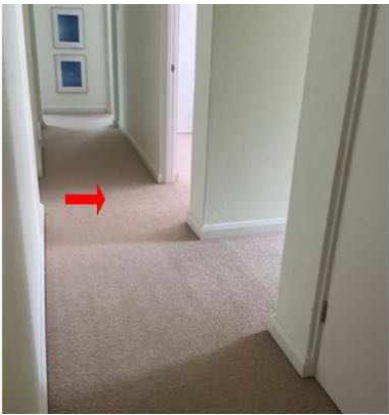
### Finding 3.06

Bouncy floors generally indicate that the floorboards or the subfloor structures are coming loose from the joists that they are installed on. Bouncy flooring may also be the result of gaps between flooring and stumps or joist structures, which require packing.

The client is advised to seek quotations for required repairs from a Registered Builder specialising in re-stumping. The potential resolution may range from packing gaps in subfloor structures through to replacement of subfloors stumps and refixing of flooring.

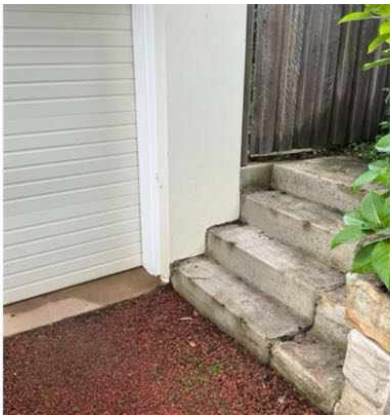
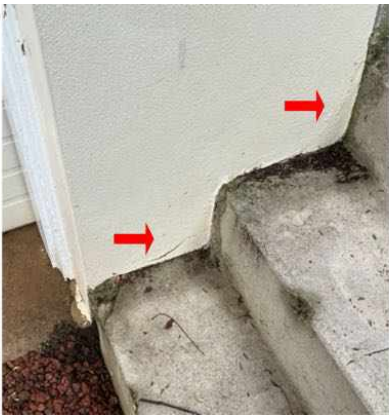
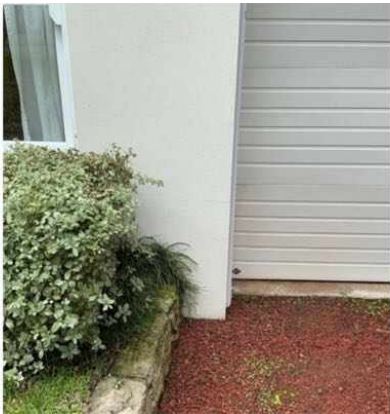
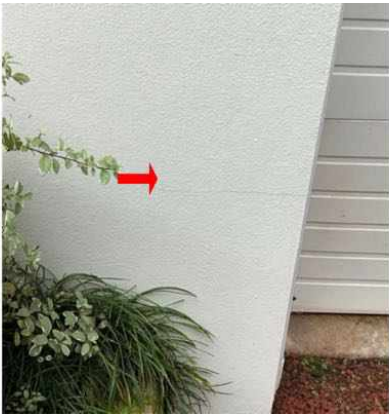
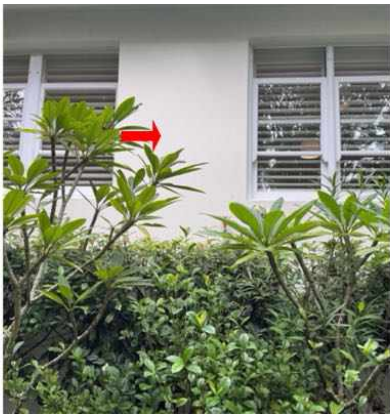
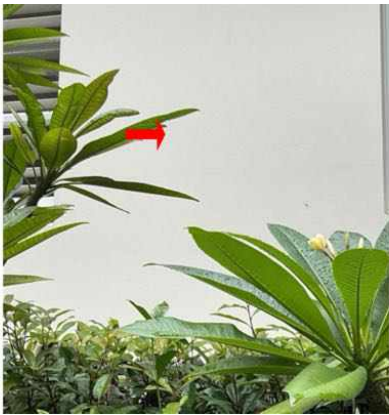
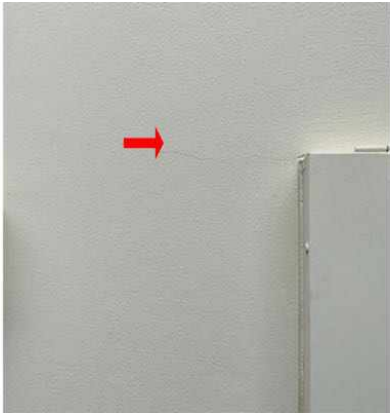
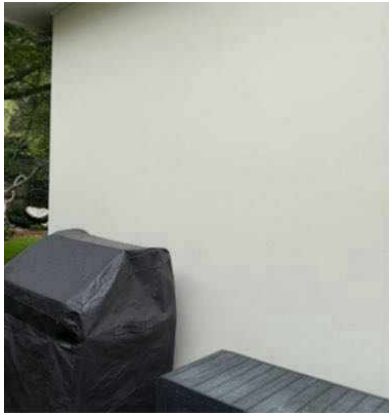
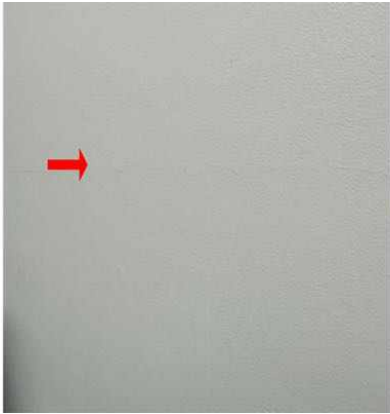
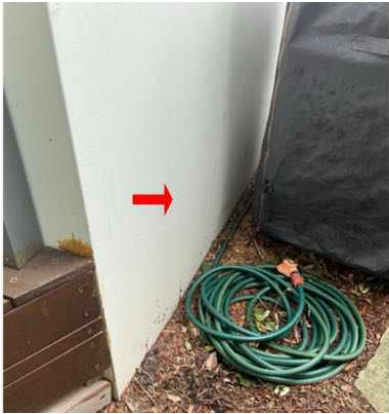
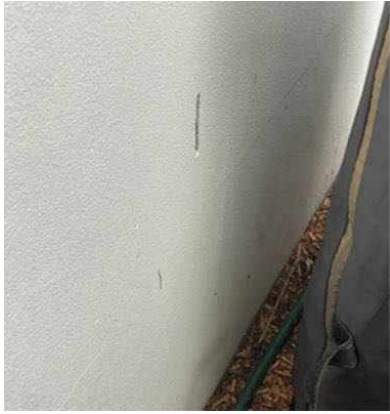
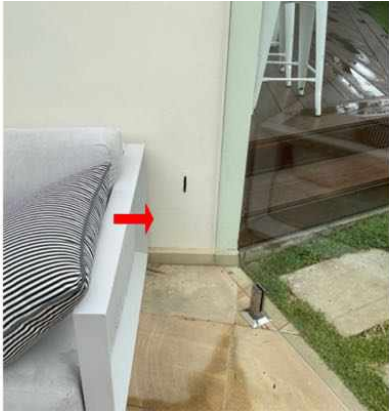
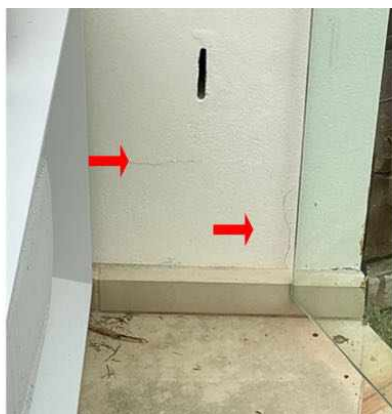
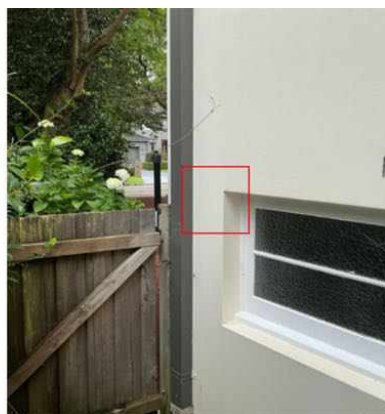
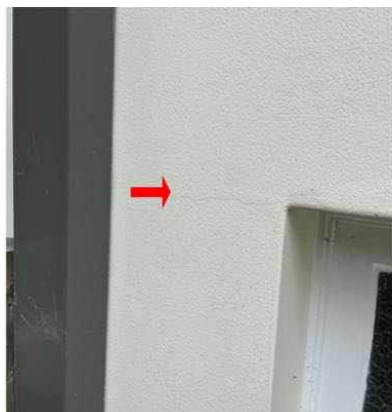
**Finding 3.07**

Building: Main Building  
Location: All External Areas  
Finding: Cracks to render - Category 1 to some areas  
Information: It has been observed that cracking to rendered surfaces has occurred. The degree of damage falls within Category 1, described as fine cracks that do not need repair and which are less than 1.0mm in width limit.

Damage of this category is not considered a defect for rectification. Always contact your building inspector should cracks widen, lengthen, or become more numerous.

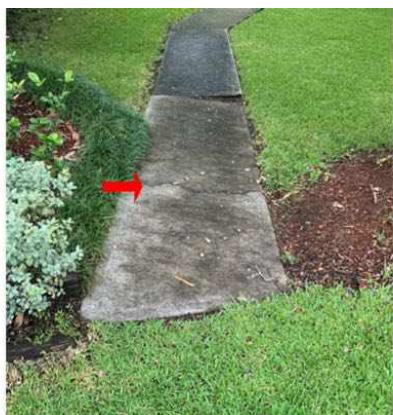
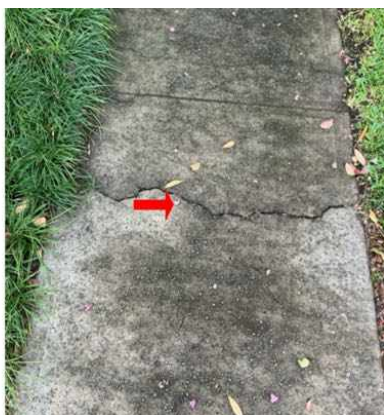
### Finding 3.08

Building:	Main Building
Location:	All External Areas
Finding:	Cracking - External Concrete Paving Damage Category 4 - Gaps in Slab (4mm - 10mm +)
Information:	Gaps in the slab were identified in external concrete paving. Gaps in the slab are significant and are likely to lead to the development of safety hazards and secondary defects if left unmanaged, such as the creation of a trip hazard.

General age and expected deterioration of the paved areas is a common cause of this type of cracking. However, expansion and contraction of the slab may also have occurred due to environmental factors. Such factors include variable moisture and weather conditions, the presence of trees and their roots having a settling or lifting affect on the soil, or the effect of load bearing, e.g. heavy vehicles over a sustained period of time.

Cracking to this degree may also be due to poor original installation of the concrete. Factors such as poor compaction of the sub surface and/or inadequate reinforcing of the slab may create cracking and other secondary defects. Gaps in the concrete paving may also have a more significant structural cause, such as subsidence of soils.

Where gaps in the concrete paving are adjacent to structural elements of the building, the advice of a Structural Engineer is advisable before undertaking repairs. Significant

repair and likely replacement of the concrete paving is probable.

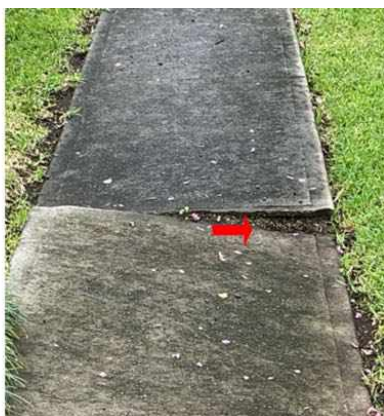
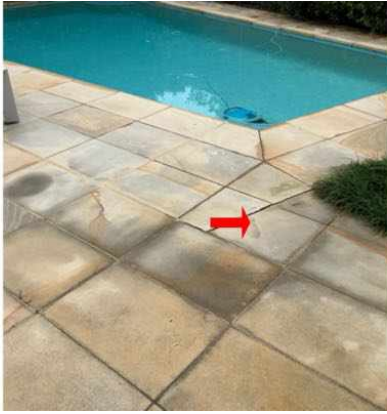
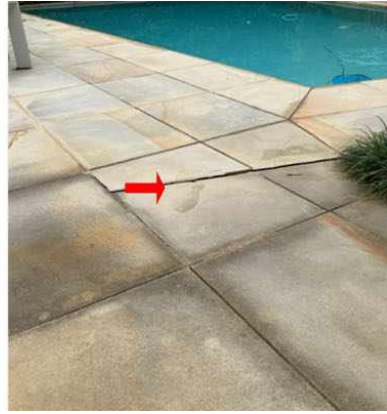
### Finding 3.09

Information: Sections of the external paved area are uneven, creating a potential trip hazard. It appears as though the area has been subject to rough installation, or that paving sections have lifted due to movements in the foundation of the property.

Where paving creates a trip hazard, personal injury may ensue if due caution is not taken by all persons within this area.

Re-paving of the area is required as soon as possible to remedy this situation. Further consultation with a specialist concreter is advised.

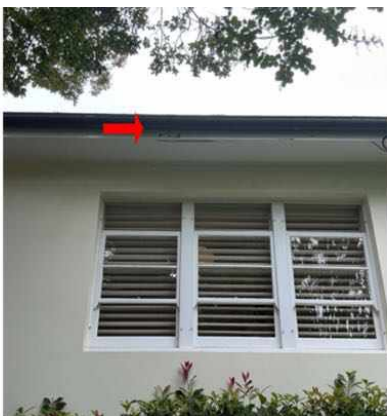
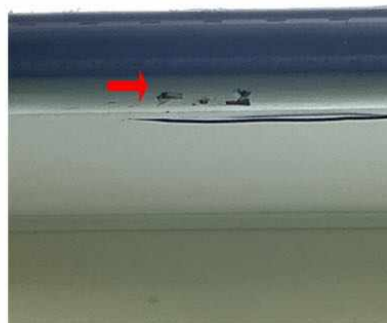
### Finding 3.10

Building:	Main Building
Location:	All External Areas
Finding:	External painting deteriorated
Information:	paint.

Whilst incomplete or missing paint finish is generally an appearance defect, it can also lead to the development of secondary building defects over time. Incomplete areas of paint finish expose the area to moisture, potentially accelerating the deterioration of underlying building materials.

Degraded paint finishes should be sanded back, filled, leveled and painted, as applicable. Where inadequate or missing paint protection has led to the deterioration of the associated building element, repair and/or replacement of this building element may be required.

A painting contractor should be appointed as soon as possible to perform necessary works to aid the appearance of the affected area and to ensure the area is protected against further deterioration. Alternatively, the homeowner following manufacturer instructions may perform these works.

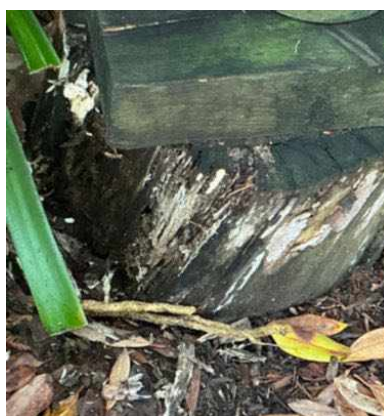
### Finding 3.11

Building:	Main Building
Location:	All External Areas
Finding:	Wood rot to some areas
Information:	This building element shows evidence of wood rot. Wood rot, also known as Fungal Decay, occurs when timbers and other cellulose building materials are exposed to damp conditions on an ongoing basis. This could be the result of exposure to weathering over a prolonged period of time, or the attraction of excessive moisture from other abutting building materials. Contributing factors also include poor air ventilation in the area.

Wood rot is often associated with general damp problems and is evidenced by a 'musty' smell or mould and mildew occurring on surfaces. If left unmanaged, damp conditions can lead to further health problems and the decay of timbers will continue.

Early intervention and regular maintenance, particularly of exterior timbers, will prolong the useful life of these building elements. Prior to any works being performed, the cause of the moisture that has created the visible wood rot should be identified and addressed in a suitable manner. Replacement of affected timbers may then be a necessary step in protecting surrounding building elements from such deterioration.

A qualified plumber may be appointed to assess the cause of excessive moisture and to provide advice on any remedial works as required. A qualified carpenter or registered builder may also be required to replace affected building materials.

Even though Liverpool termite activity was not visible. A further invasive inspection by a licensed termite technician its also highly recommended to eliminate possibility of potential termite activity.

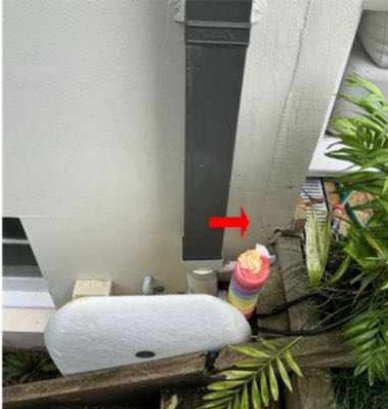
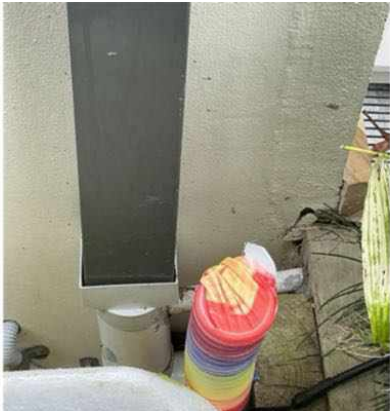
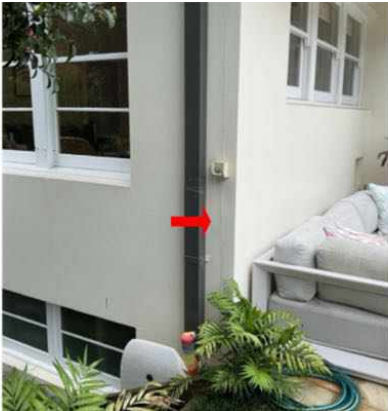
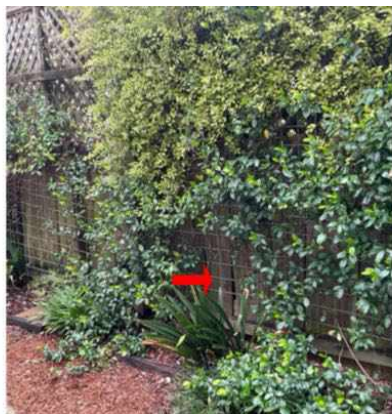
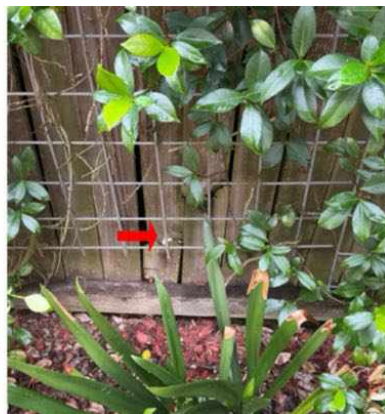
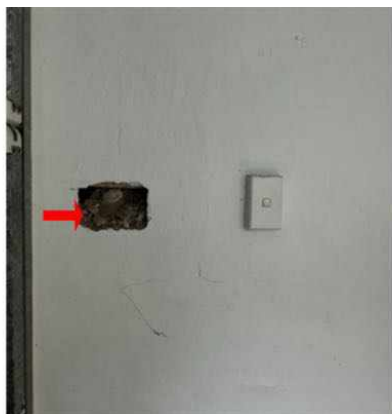
Building: Main Building  
Location: All External Areas  
Finding: Building element - Damaged - Garage door dented , chipped render right side , fence slight lean and damage , hole not sealed garage , side gate binding  
Information: Breakage occurs generally when the building materials have either aged and decayed, or as a result of damage (accidental or deliberate).

Repair and/or replacement of broken elements is advised to ensure that additional secondary defects do not arise as a consequence. Such works are necessary, as all building elements play a key role in the operation and function of the overall structure and its performance.

A relevant tradesperson should be appointed to repair or replace the affected building element prior to any subsequent damage being caused.

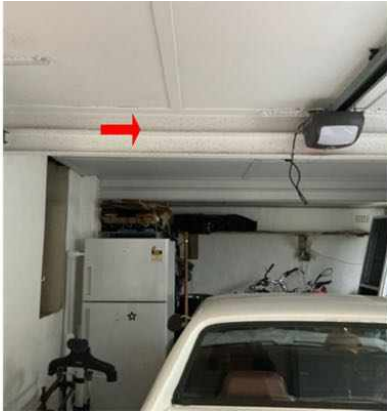
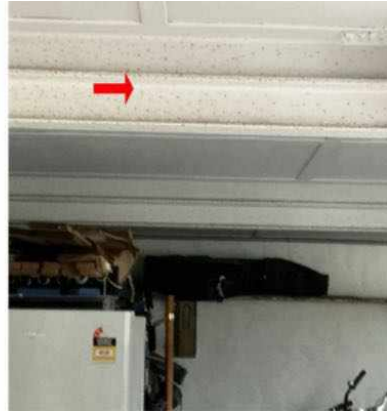
### Finding 3.14

Building:	Main Building
Location:	Garage
Finding:	Building element - Rusted or corroded
Information:	This building element shows evidence of rusting and corrosion, which is likely to have developed as a result of excessive exposure to moisture and or inadequate coatings.

As surface rust provides no protection to the underlying iron, the deteriorating condition is likely to worsen if not addressed in the short-term future.

Where possible, the use of galvanized (treated) metals or aluminium coated metals aid in rust prevention, as does regular general maintenance. Rust formation can be controlled with coatings, such as paint, that isolate the iron from the environment.

Rusting and corrosion should be managed by ideally removing or limiting the affected surface from exposure to moisture. A registered builder may be appointed to replace any building elements that have been severely affected by rust or water damage.

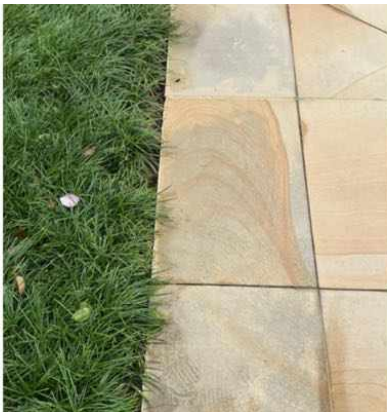
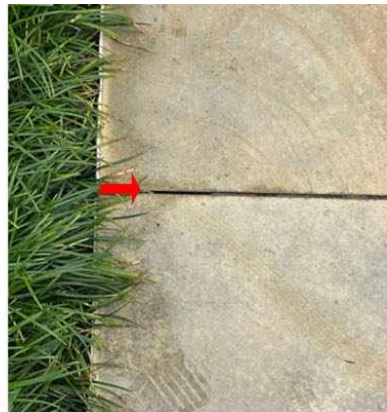
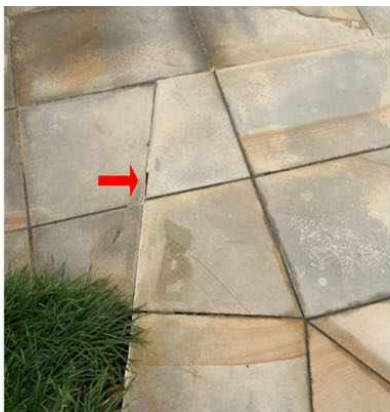
### Finding 3.15

Building:	Main Building
Location:	Pool Area
Finding:	Sealant and grouting - Missing or damaged
Information:	Different materials and floor areas move at different rates, generally causing cracking to grout or sealant at this point. A flexible sealant is required to allow for expected expansion and contraction, while keeping the joint water tight and protective of all associated building materials.

There appears to be excessive mould to the sealant and grout which will likely require scraping out and replacement.

Flexible and mould resistant materials should be applied to affected areas to prevent any subsequent water damage that is likely to occur. Regular maintenance and replacement of damage or missing or damaged sealant and grout is highly recommended to the wet areas, as this is a regular wear and tear defect. Sealant and grouting in areas that come into regular contact with water should be maintained for the long term care of your property.

A sealant specialist or tiling contractor should be appointed to complete these works as soon as possible

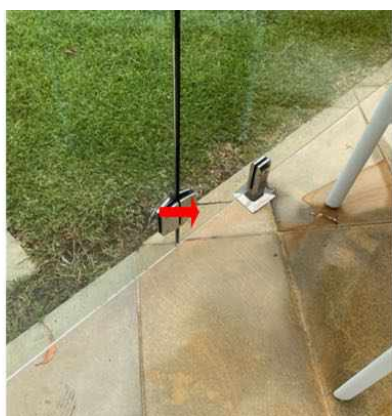
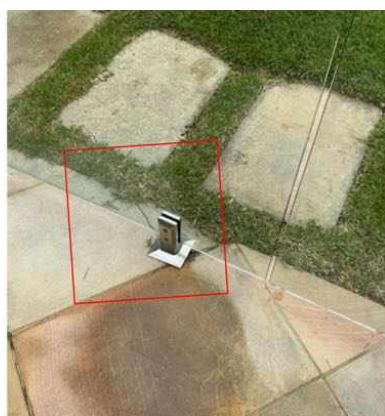
### Finding 3.16

Building:	Main Building
Location:	All External Areas
Finding:	Cracked floor tiles - Pavers
Information:	Cracking in the floor tiles was evident in this area at the time of inspection. It is suspected that this cracking has occurred as a result of minor settlement or shrinkage of the slab.

Cracked tiles throughout the household detract from the overall appearance of the affected areas however it is unlikely to create or lead to any secondary defects.

While not considered a matter of urgency, replacement of cracked floor tiles is recommended at the clients discretion. A tiling contractor may be appointed to perform these works. Where cracks become more numerous, contact a licensed building inspector for further investigation.

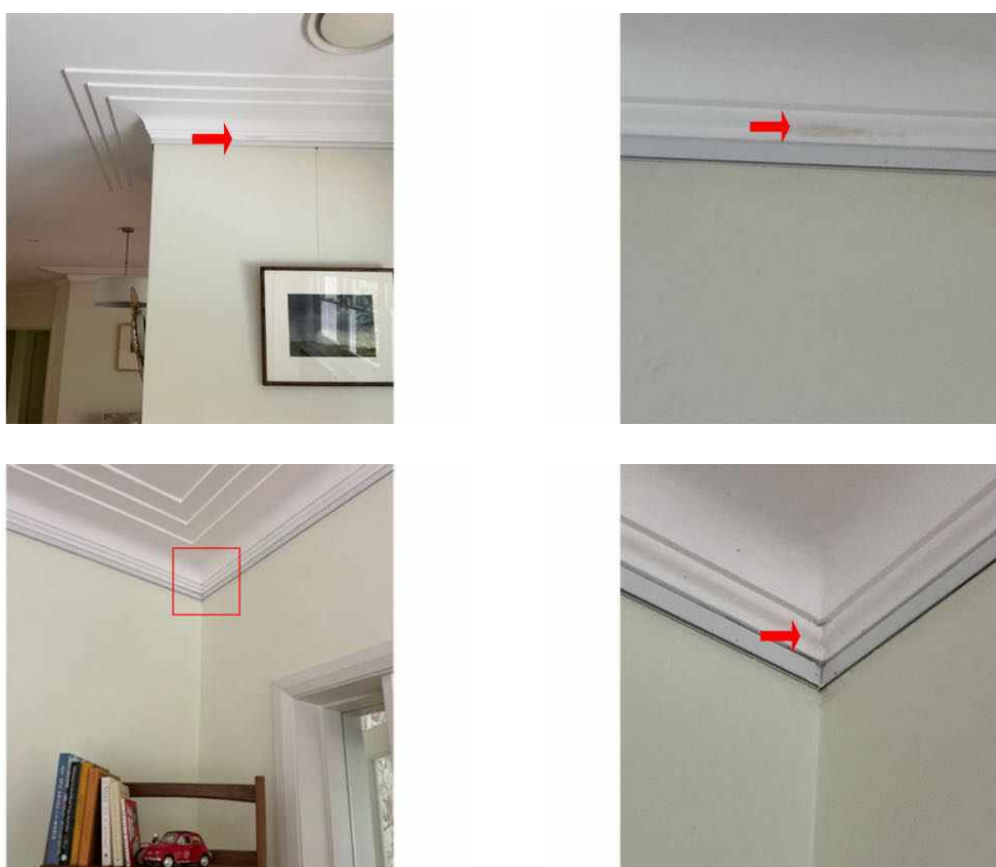
### Finding 3.17

Building:	Main Building
Location:	All Internal Areas - Lounge , formal sitting
Finding:	Water staining
Information:	Water staining was evident in this area at the time of inspection. Water staining

indicates that surfaces have been exposed to excessive moisture over time. The minerals and other elements in the water lead to staining, which may graduate to corrosion and deterioration if left unmanaged.

While mostly an appearance defect, water staining can be indicative of more serious defects, which may be currently concealed by other building elements.

Where water staining is active, a licensed plumber must be consulted to identify the cause of the staining and to provide advice on any reparation works that may be required. Replacement of any broken or damaged structures is advised.

Conversely, where water staining is old and inactive, affected building materials may be repaired or replaced at client discretion. A qualified carpenter or registered builder may be appointed to perform these works.

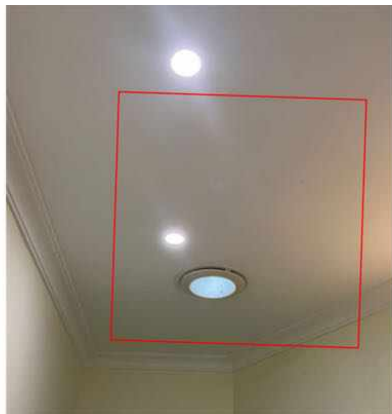
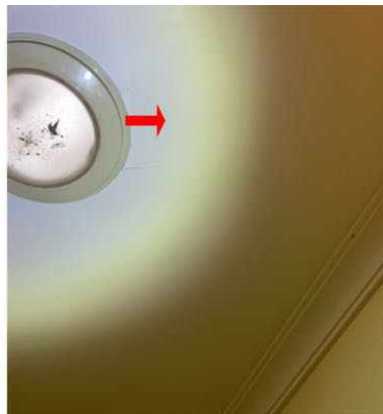
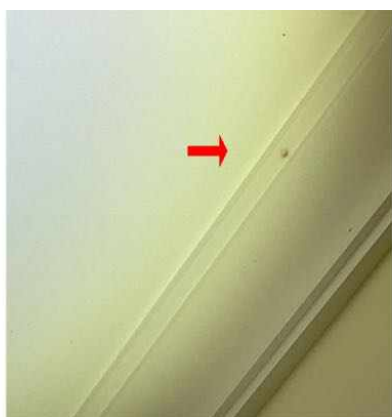
### Finding 3.18

Building:	Main Building
Location:	Bathroom
Finding:	Water Staining - Humidity or Ventilation
Information:	The ceiling surface shows faint darkened spotting or shadowing, commonly consistent with surface mould or humidity-related staining, often found in bathroom or wet area ceilings with insufficient ventilation. While there is no visible sagging or major water damage, the pattern suggests prolonged moisture exposure, possibly due to steam

accumulation or minor condensation issues. According to AS 4349.1–2007 (Appendix C), this would be classified as a minor defect unless further deterioration or active leaks are found. Recommend improving mechanical or natural ventilation, cleaning the surface with mould treatment, and monitoring for recurrence.

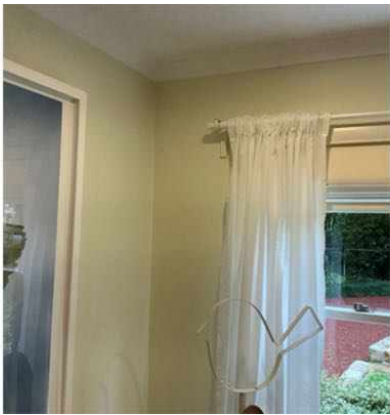
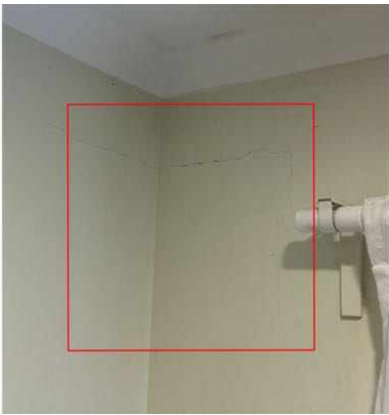
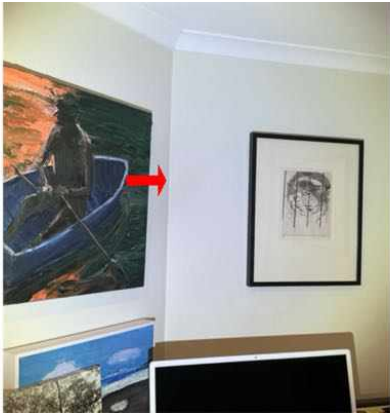
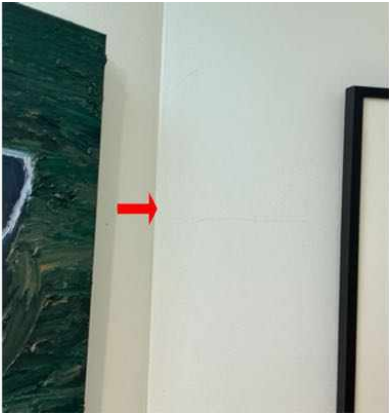
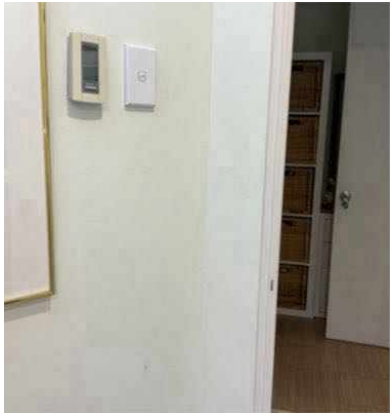
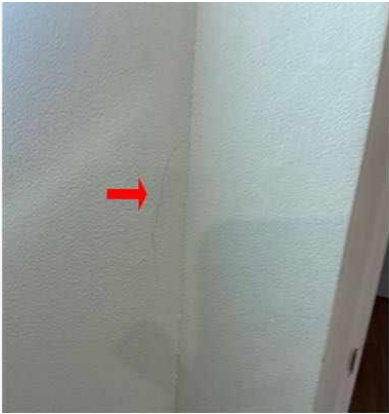
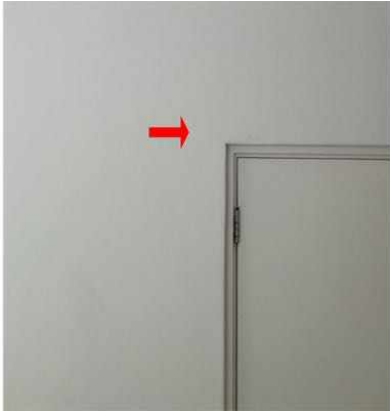
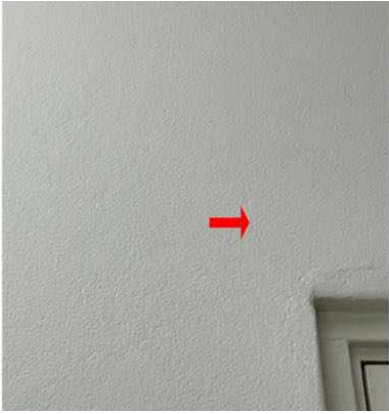
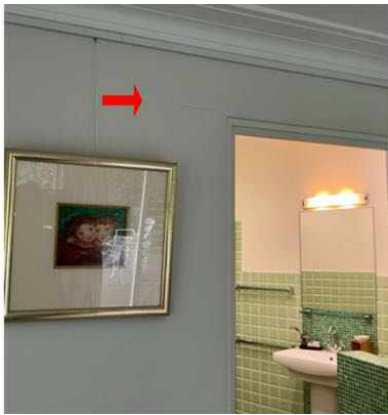
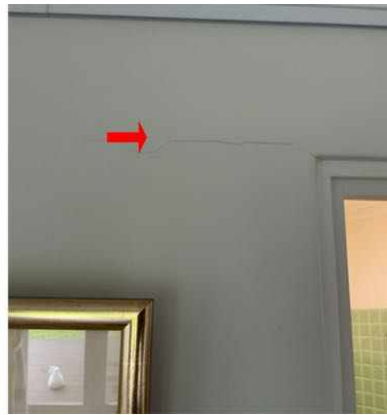
### Finding 3.19

Building:	Main Building
Location:	All Internal Areas
Finding:	Cracks to internal render - Category 1 to some areas
Information:	It has been observed that cracking to internal rendered surfaces has occurred. The degree of damage falls within Category 1, described as fine cracks that do not need repair and which are less than 1.0mm in width limit.

Damage of this category is not considered a defect for rectification. Always contact your building inspector should cracks widen, lengthen, or become more numerous.

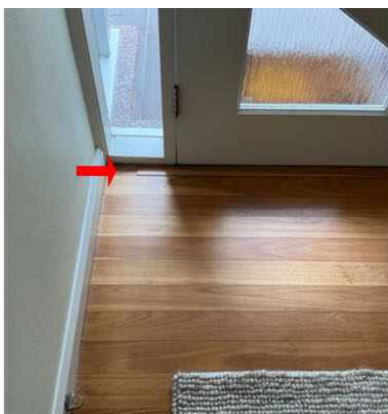
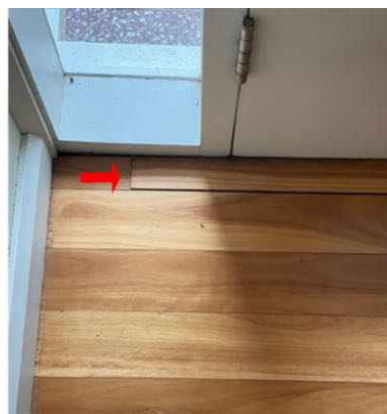
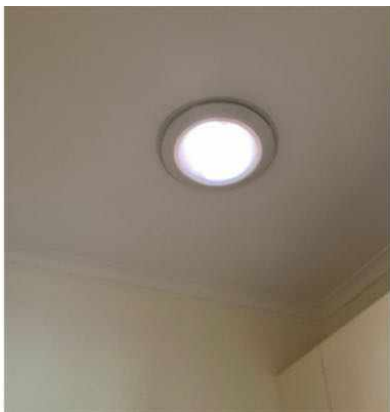
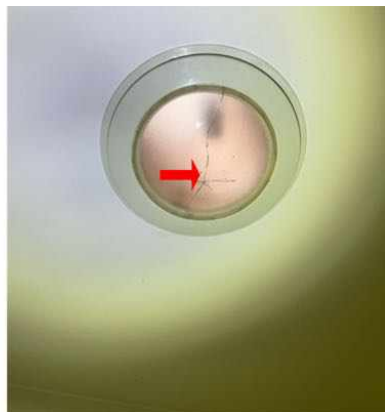
### Finding 3.20

Building:	Main Building
Location:	All Internal Areas
Finding:	Building element - Damaged - Floor possible moisture damage (Lifting) front , Cracked light fixing
Information:	Breakage occurs generally when the building materials have either aged and decayed, or as a result of damage (accidental or deliberate).

Repair and/or replacement of broken elements is advised to ensure that additional secondary defects do not arise as a consequence. Such works are necessary, as all building elements play a key role in the operation and function of the overall structure and its performance.

A relevant tradesperson should be appointed to repair or replace the affected building element prior to any subsequent damage being caused.
