# Building and Timber Pest Inspection Report

Inspection Date: Wed, 18 Mar 2026

Property Address: 20 Greendale Ave, Pymble NSW 2073,  
Australia

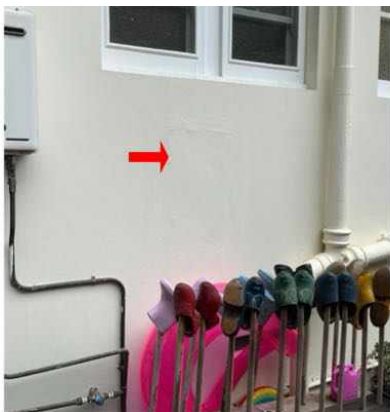
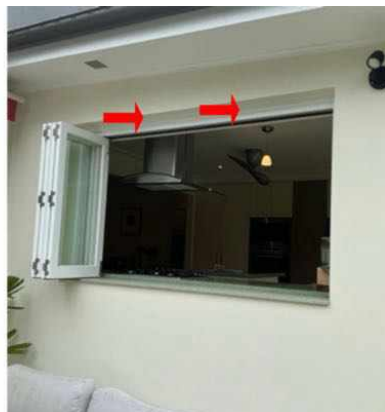
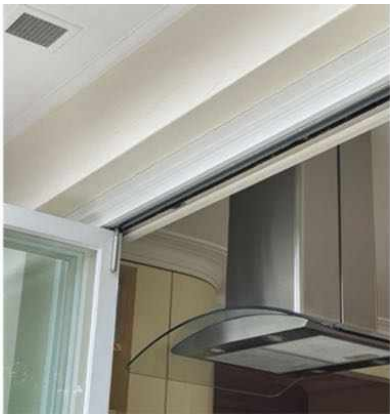
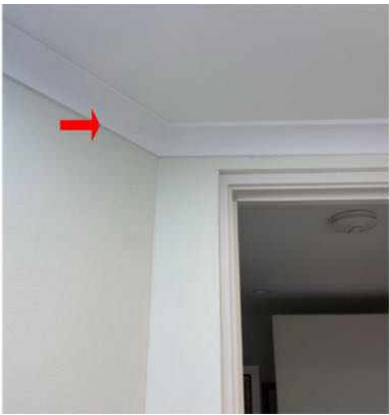
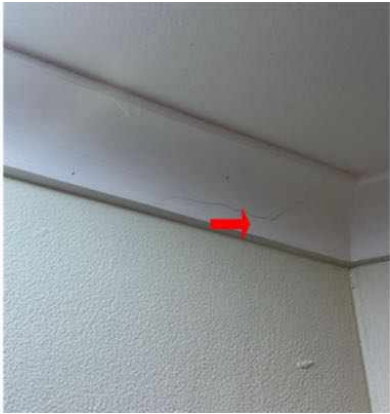
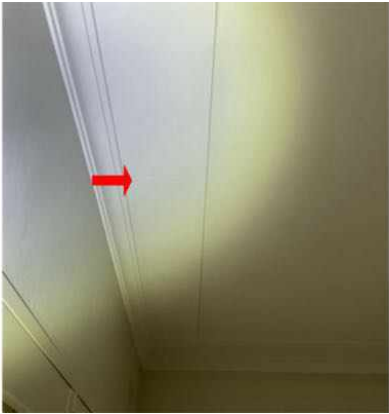
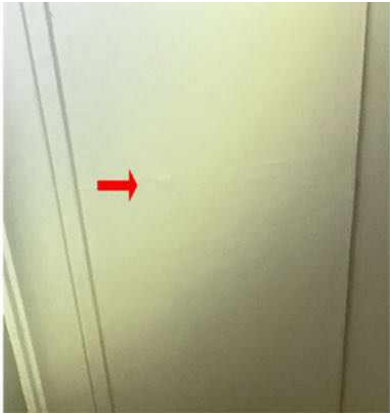
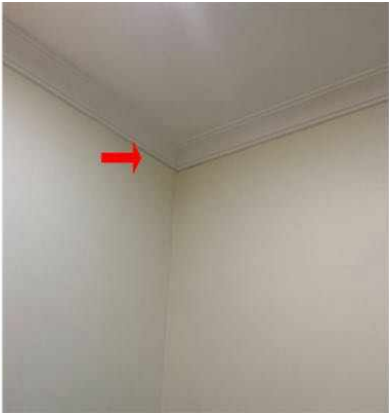
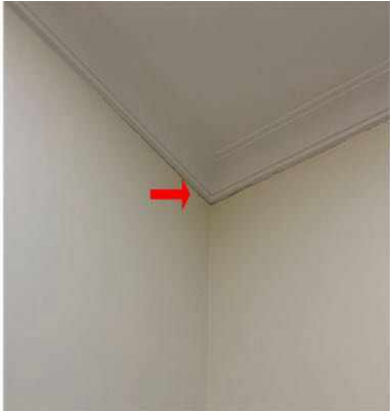
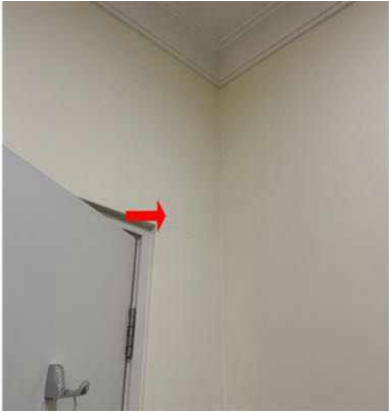
Building:	Main Building
Location:	All Internal Areas
Finding:	Paint Finish & Hairline Cracking - To some areas
Information:	The paint finish in this area was identified as being incomplete at the time of inspection including some hairline minor cracking.

Whilst incomplete or missing paint and minor cracking and imperfections in finish is generally an appearance defect, it can also lead to the development of secondary building defects over time. Incomplete areas of paint finish expose the area to moisture, potentially accelerating the deterioration of underlying building materials.

Incomplete paint finishes should be sanded back, filled, leveled and painted, as applicable. Where inadequate or missing paint protection has led to the deterioration of the associated building element, repair and/or replacement of this building element may be required.

A painting contractor should be appointed as soon as possible to perform necessary works to aid the appearance of the affected area and to ensure the area is protected against further deterioration. Alternatively, the homeowner following manufacturer instructions may perform these works.

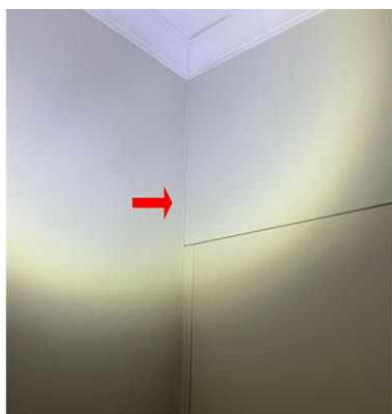
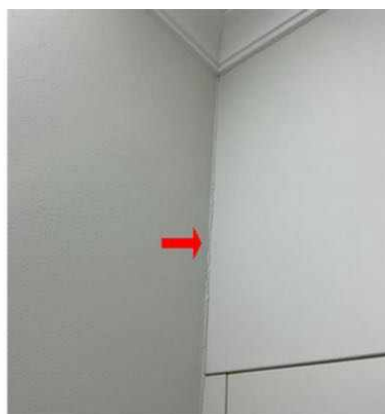
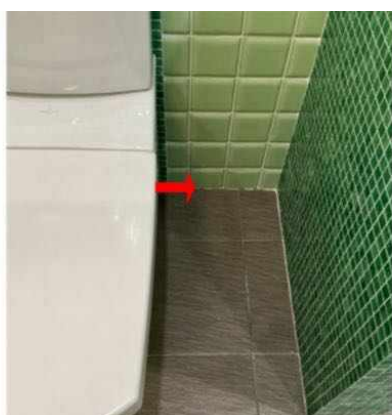
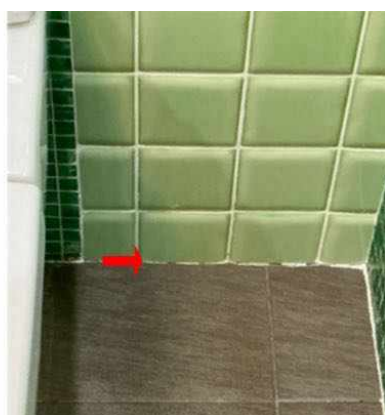
Finding 3.22

Building:	Main Building
Location:	All Internal Areas
Finding:	Sealant and grouting - Missing or degraded to some areas
Information:	It was noted on inspection that sealant or grout is degraded.

Different materials and floor areas move at different rates, generally causing cracking to grout or sealant at this point. A flexible sealant is required to allow for expected expansion and contraction, while keeping the joint water tight and protective of all associated building materials.

Excessive mould to the sealant and grout may require scraping out and replacement.

Flexible and mould resistant materials should be applied to affected areas to prevent any subsequent water damage that is likely to occur. Regular maintenance and replacement of damage or missing or damaged sealant and grout is highly recommended to the wet areas, as this is a regular wear and tear defect. Sealant and grouting in areas that come into regular contact with water should be maintained for the long term care of your property.

A sealant specialist or tiling contractor should be appointed to complete these works as soon as possible

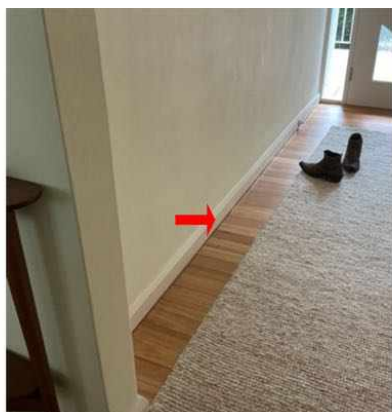
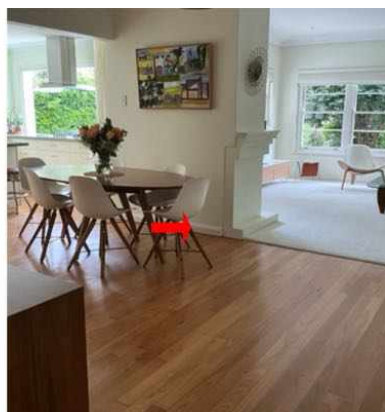
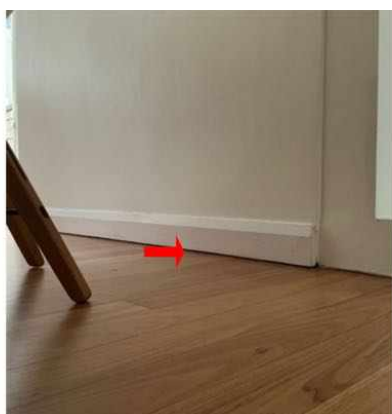
**Finding 3.23**

Building:	Main Building
Location:	All Internal Areas
Finding:	Gap between skirting and Floor
Information:	A localised gap is visible between the skirting board and the laminate/timber floor finish, indicating minor floor level variation or movement of the floating floor system. This condition is most consistent with minor slab/floor unevenness, floor finish movement or shrinkage. While primarily cosmetic/serviceability in nature, monitoring is recommended and further assessment may be warranted by a licensed builder if additional signs of structural movement become apparent.

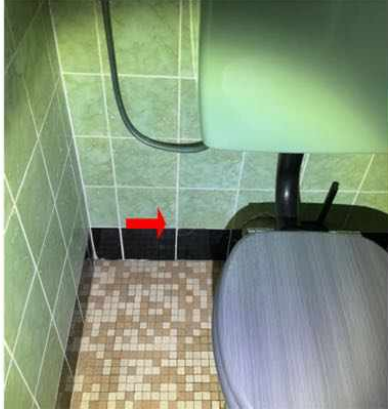
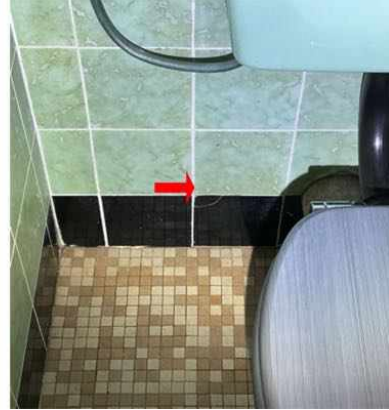
### Finding 3.24

Building:	Main Building
Location:	Bathroom
Finding:	Tiles - Cracked or damaged
Information:	Cracking was evident to the tiling in this area at the time of inspection. While the cracking appears to be minor, this area is frequently exposed to water, allowing potential for water penetration into adjoining sections of walls or flooring.

If left unmanaged, water penetration to these areas may lead to subsequent water damage, which is likely necessitate repair work to affected building elements.

A tiling contractor should be appointed to ensure that no further water damage

occurs. The re-application of silicone and grouting throughout remaining tile work is also advised, to further protect the area against water penetration.

Where water penetration has led to water damage, appointment of a relevant tradesperson may be required to repair damaged building elements.

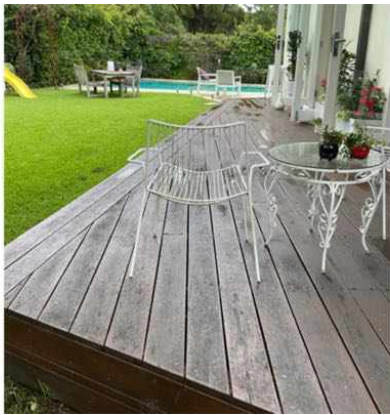
External timber structures are also constantly exposed to weather elements and can deteriorate in an accelerated manner, ongoing assessments are required.

It is highly recommended that a Structural Engineer further assess the external timber balcony or deck to inform the client of its load capacity. Regular maintenance inspections by competent practitioners is needed.

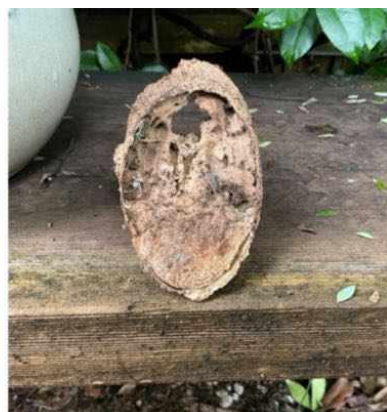
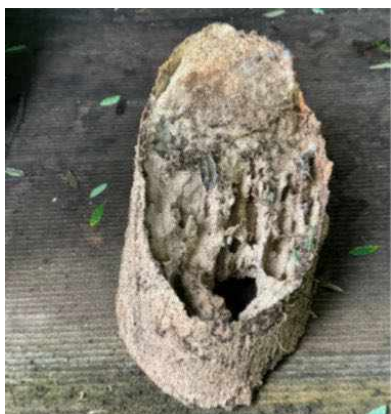
Building: Main Building  
Location: All External Areas - Left side near fence  
Finding: Timber pest Damage  
Information: A section of timber found near the left fence under a bench exhibited significant internal deterioration, with hollowing, loss of structural fibres.

This pattern of damage is highly consistent with termite activity, particularly where the external surface remains intact while internal timber is eaten away.

A further invasive inspection by a licensed timber pest technician is recommended to check for any concealed activity.

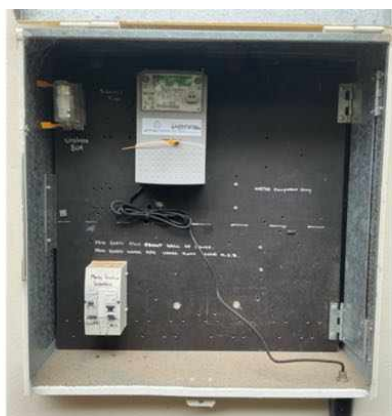
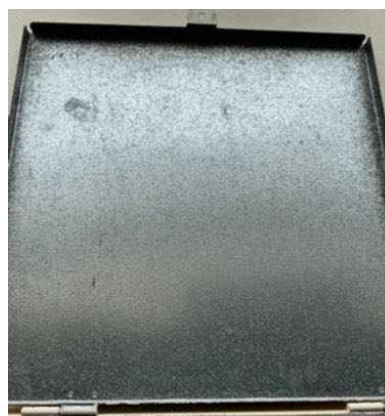
### Finding 6.01

Building:	Main Building
Location:	All External Areas
Finding:	Termite Management System - no evidence of a chemical installation
Information:	The application of a post-construction chemical termite barrier is highly recommended for all properties, particularly if live termite activity has been found on the site previously. Such barriers are highly effective in preventing termite attack on any timber building elements throughout the property.

A durable notice should be placed in the switchboard unit to indicate current termite barriers. At the time of inspection, it appeared as though no termite management system has been installed, with no evidence to suggest preventative works taking place.

The client may consider gaining further advice from a pest controller as to the costs and procedures involved with this application. It is recommended that obtaining such advice be a short-term priority.

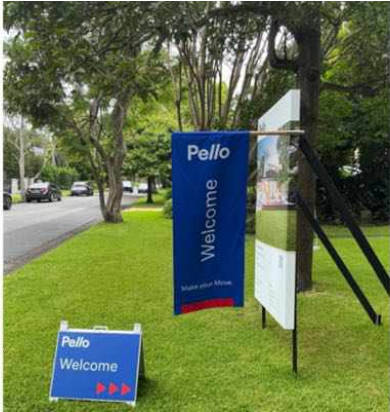
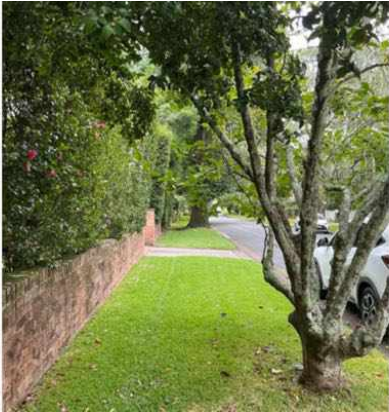
### Finding 6.02

Building: Main Building  
 Location: All External Areas  
 Finding: Trees within 50m  
 Information: Trees within 50m of the property can be conducive to termite activity. It is recommended an invasive inspection of all trees with 50m to the property be carried out by a qualified pest control expert.

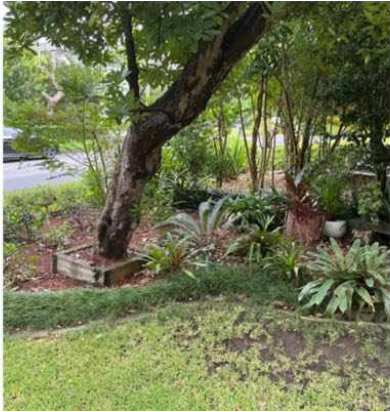
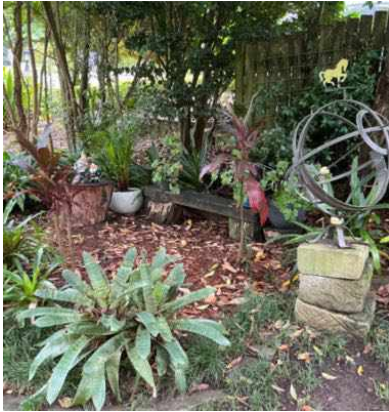
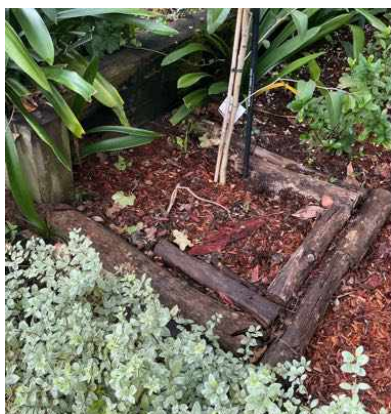
**Finding 6.03**

Building: Main Building  
 Location: All External Areas  
 Finding: In ground contact - Timber - to some areas  
 Information: Any timbers in direct ground contact provide opportunity for concealed termite entry and are likely to be subject to premature rot and decay as the soil retains moisture or damp conditions against the timbers.

Remove untreated timber that is in direct contact with external grounds. Consider replacement with more durable materials i.e. treated timber or non timber elements. Frequent pest inspections are advised to readily identify any termite activity in these areas.

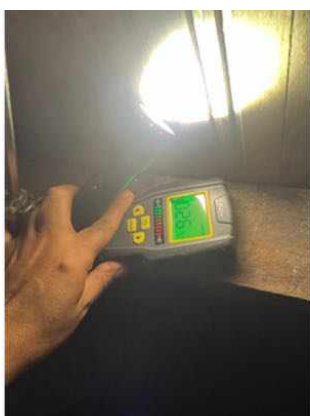
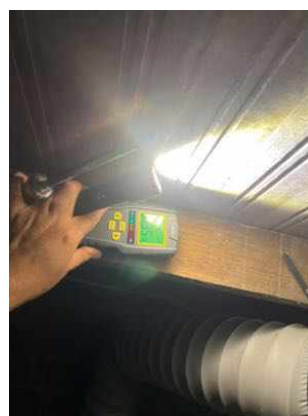
Building:	Main Building
Location:	All Internal Areas
Finding:	Elevated moisture - identified
Information:	Elevated moisture can attract termites and produce conditions that promote fungal growth and wood decay.

Elevated moisture is generally caused by deteriorated, inadequate or missing roof drainage, leaking plumbing pipes or fixtures, poorly plumbed HWS overflows or condenser units and poor site drainage.

If mould growth has been found there may be environmental biological or health issues involved. In these cases an appropriately qualified inspector should also be contacted.

Prior to any remedial works being performed a qualified plumber should be appointed to further inspect the property and to identify the cause of the excessive moisture. Works to remove affected building elements may then be necessary and should be performed by an appropriate tradesperson.

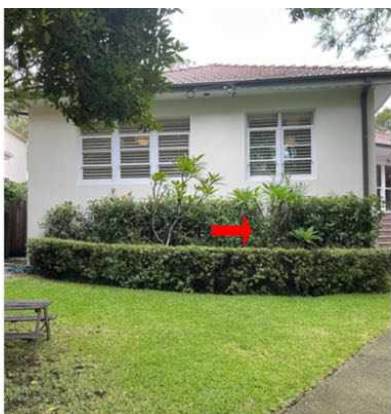
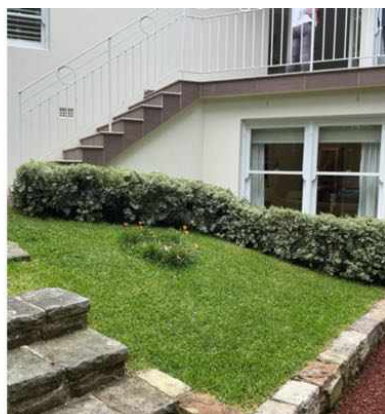
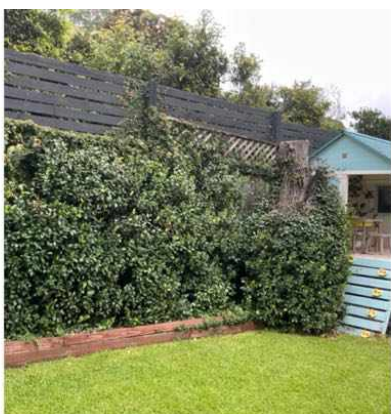
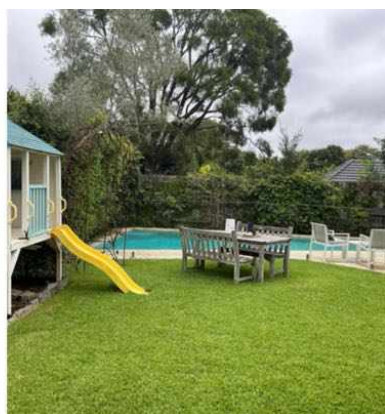
### Finding 6.06

Building:	Main Building
Location:	All External Areas
Finding:	Bridging - Vegetation to some areas
Information:	Where vegetation obstructs inspection of building elements, also known as bridging as it provides a bridging point for the access of termites, full inspection can not be achieved. Consequently moisture or dampness may be present and the areas becomes conducive to termite activity. Plants against or very close to buildings provide cover, shade and can provide an environment that is attractive to termite infestation.

The removal and replanting of species that do not provide "cover" or cutting back of existing vegetation will assist greatly in preventing Bridging from occurring.

The removal of any such materials that may be conducive to termite activity should be carried out as soon as possible and arrange re inspection to minimize the risk of termite attack.

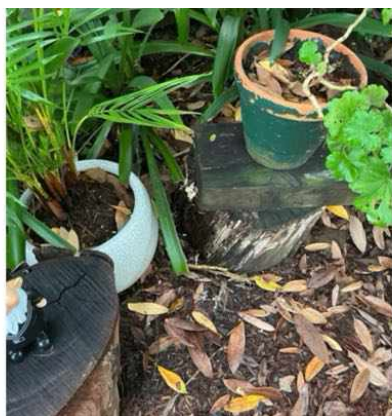
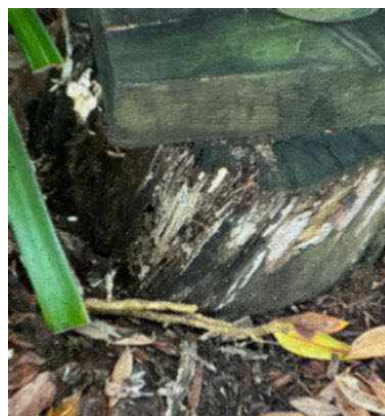
Building:	Main Building
Location:	All External Areas
Finding:	Fungal decay - present to some areas
Information:	Fungal decay also known as wood decay or wood rot generally refers to the deterioration of timber elements when in contact with excessive levels of moisture for a prolonged period of time.

The development of fungal decay is accelerated by temperatures in the range of 5degreeC to 40degreeC as well as the presence of oxygen. Generally fungal decay develops on timber elements that are in use in an external environment which are exposed to rain penetration.

In this case although the affected timber element is in a decaying state the extent of any visible damage appears to be localised to a specific area and is yet to spread to other parts of the building element or affect adjoining structures. The fungal decay is therefore likely to be of a relatively superficial nature with minimal impact on the structural integrity or tensile strength of the timber element.

A further invasive inspection by a licensed timber pest technician is highly recommended to check for concealed activity.

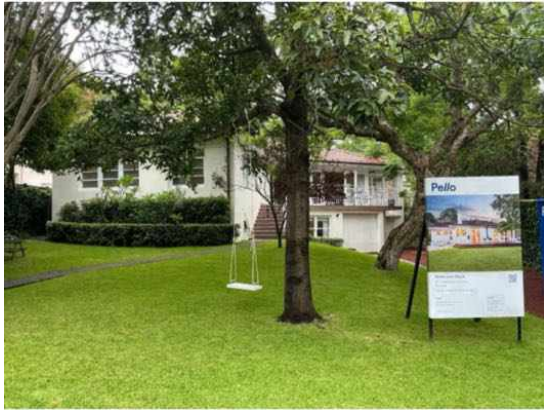
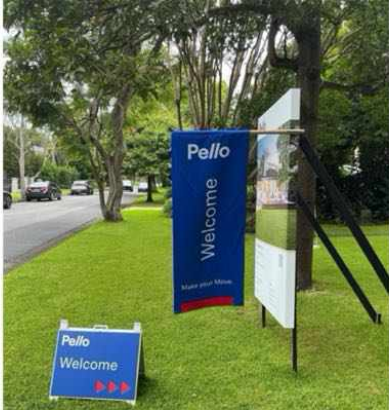
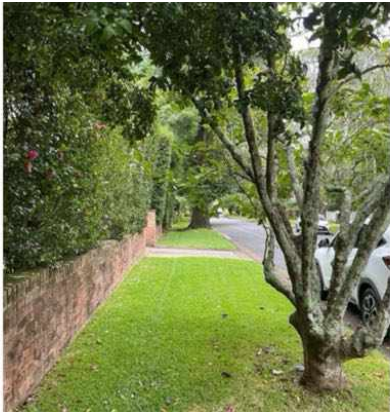
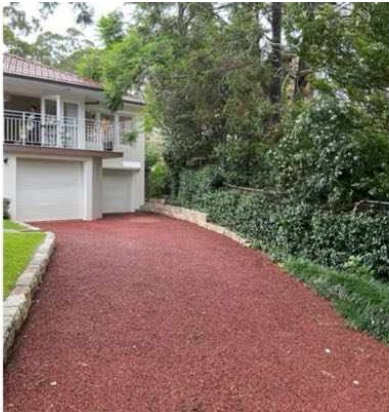
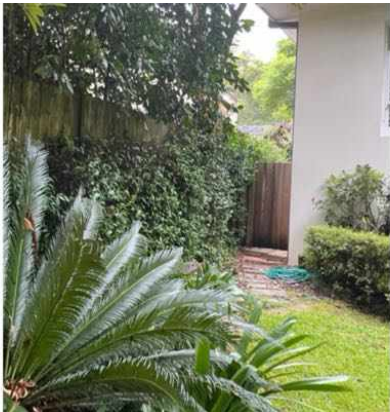
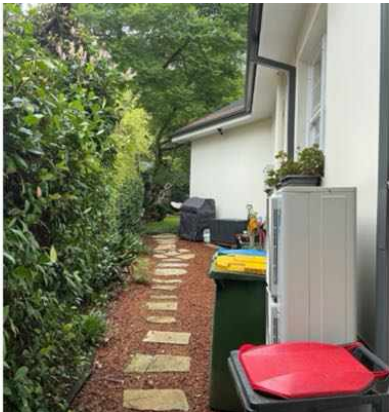
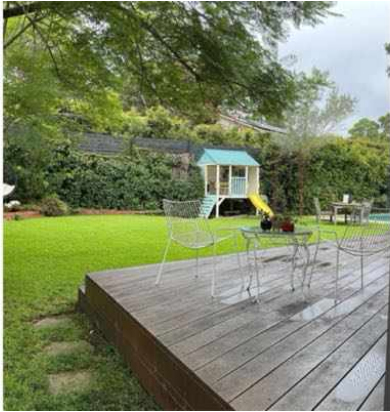
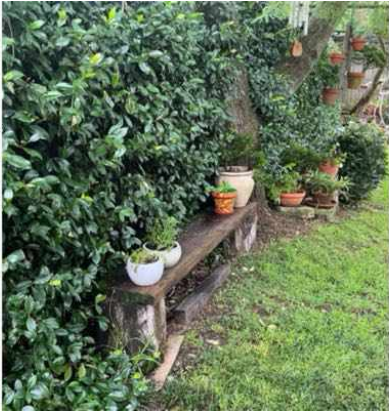
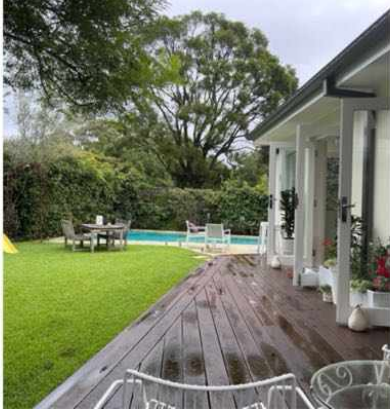
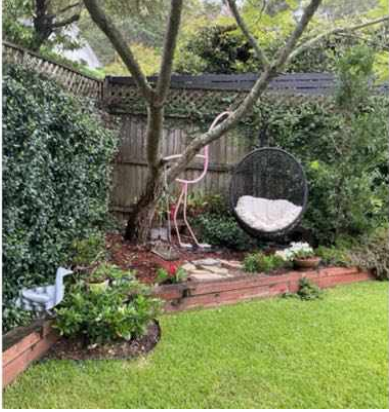
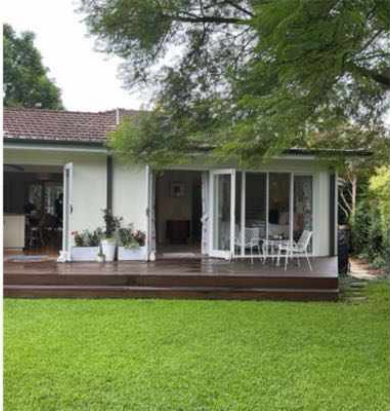
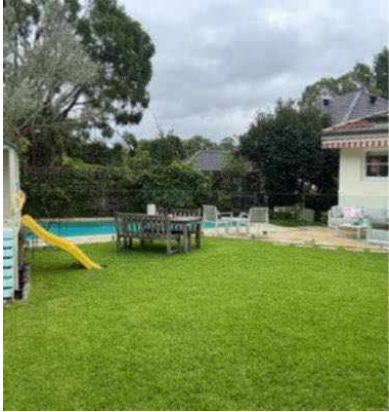
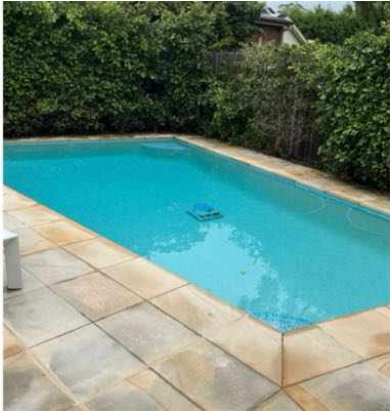
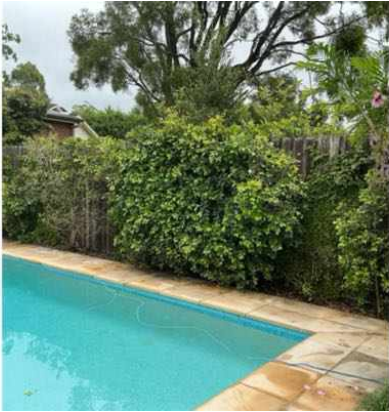
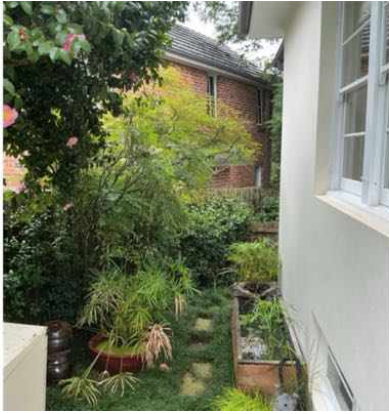
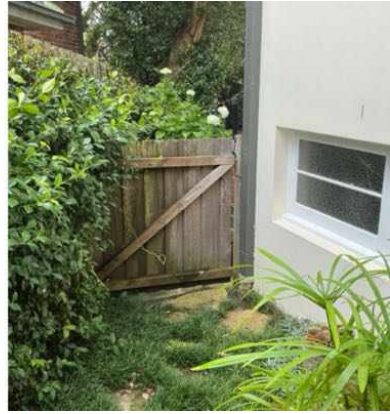
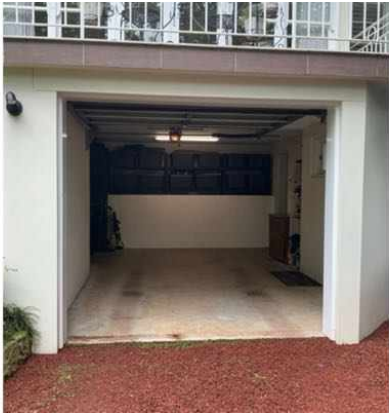
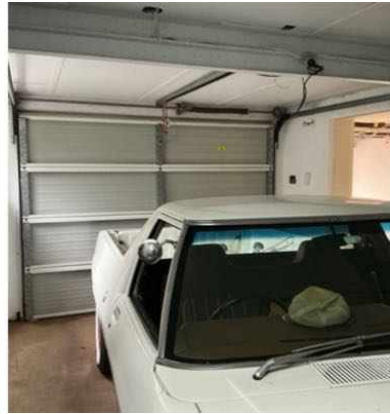
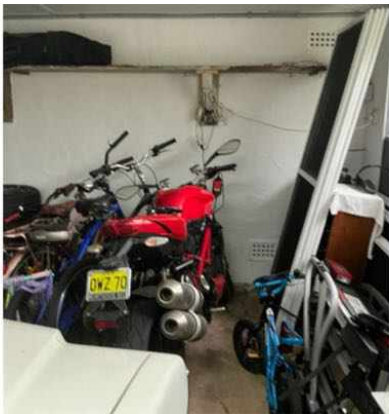
#### Noted Item

Building: Main Building  
Location: All External Areas  
Finding: Additional Photos - Obstructions and Limitations  
Information: These photographs are an indication of the obstructions and limitations which impeded full inspection of the property at the time of inspection. These obstructions can hide an array of defects and should be removed to allow full inspection to be carried out. A re-inspection is recommended once the areas are made accessible.

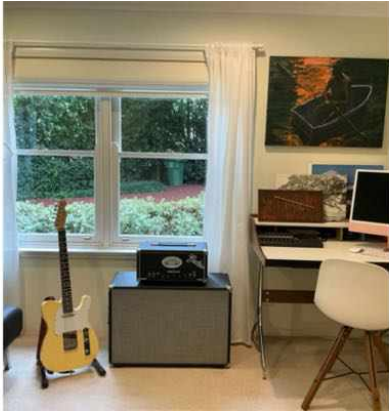
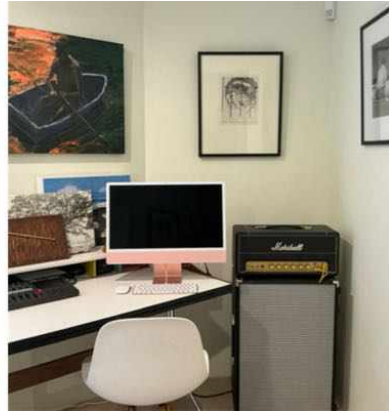
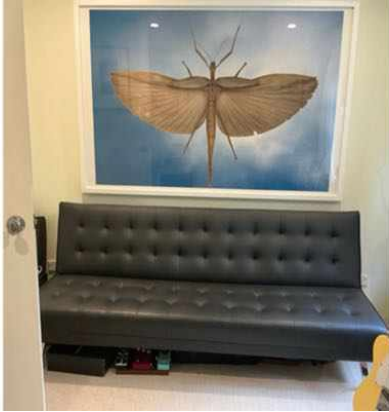
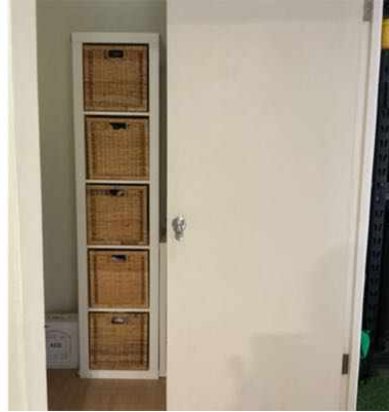
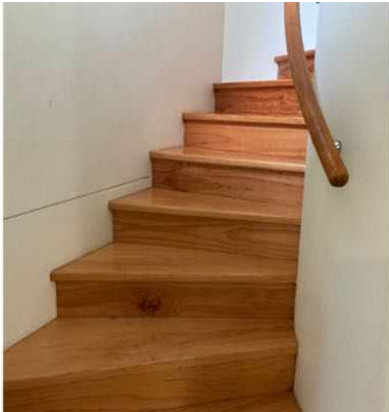
### Noted Item

Building:	Main Building
Location:	All Internal Areas
Finding:	Additional Photos - Obstructions and Limitations
Information:	These photographs are an indication of the obstructions and limitations which impeded full inspection of the property at the time of inspection. These obstructions can hide an array of defects and should be removed to allow full inspection to be carried out. A re-inspection is recommended once the areas are made accessible.

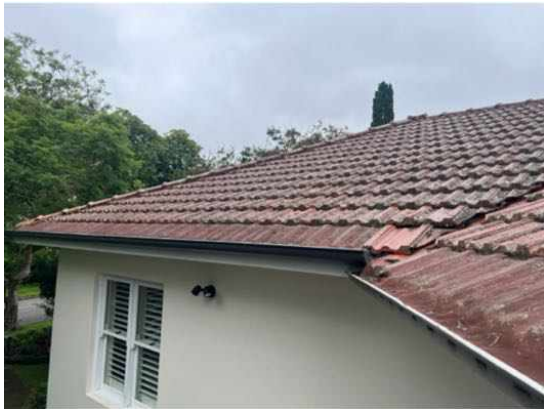
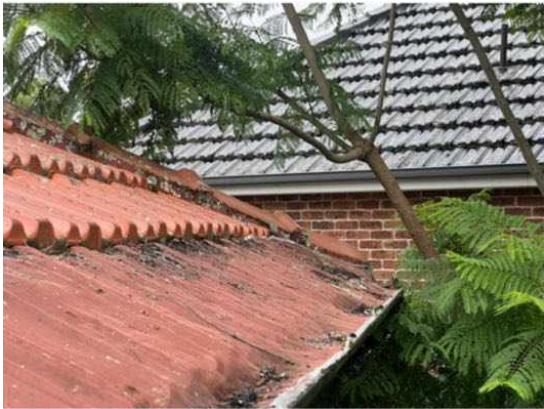
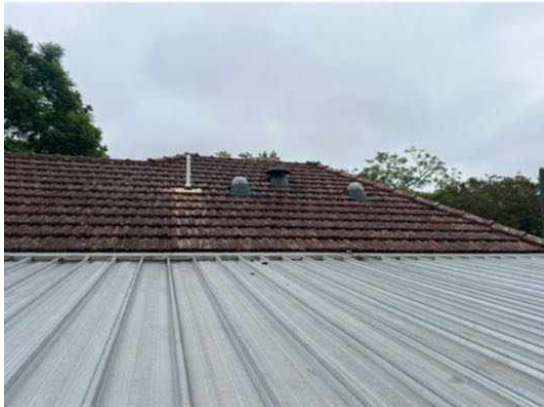
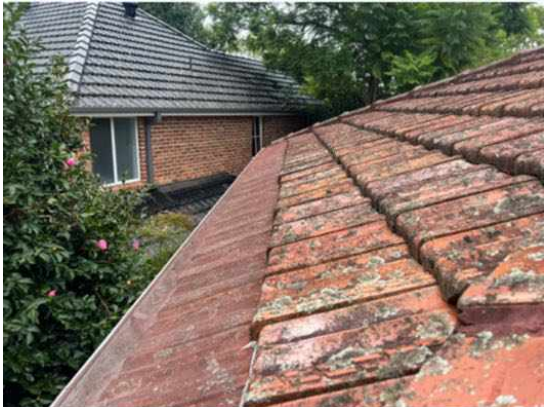
Building: Main Building  
 Location: Roof Exterior  
 Finding: Additional Photos - Obstructions and Limitations  
 Information: These photographs are an indication of the obstructions and limitations which impeded full inspection of the property at the time of inspection. These obstructions can hide an array of defects and should be removed to allow full inspection to be carried out. A re-inspection is recommended once the areas are made accessible.

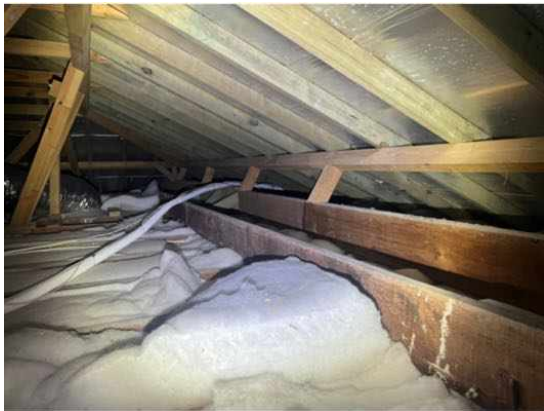
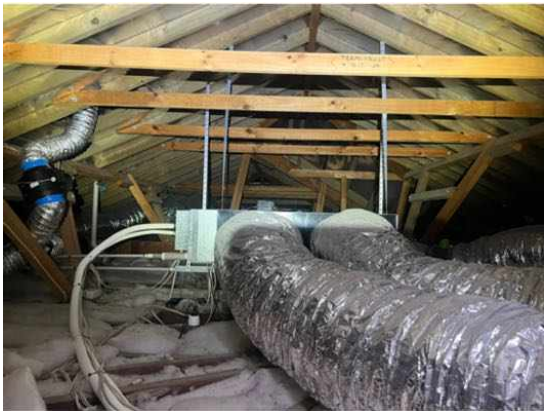
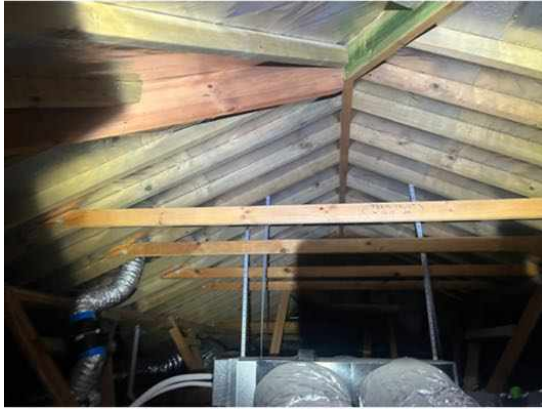
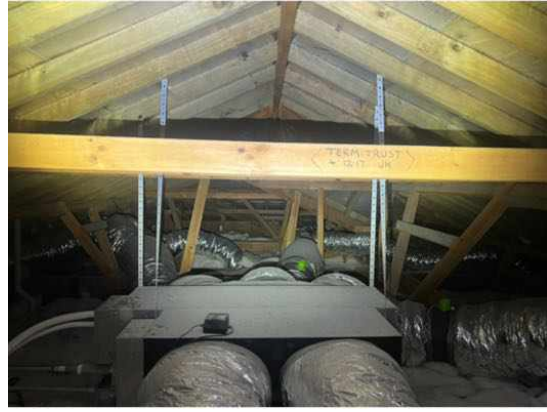
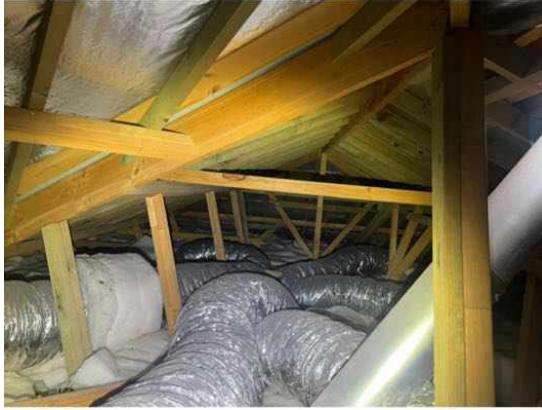
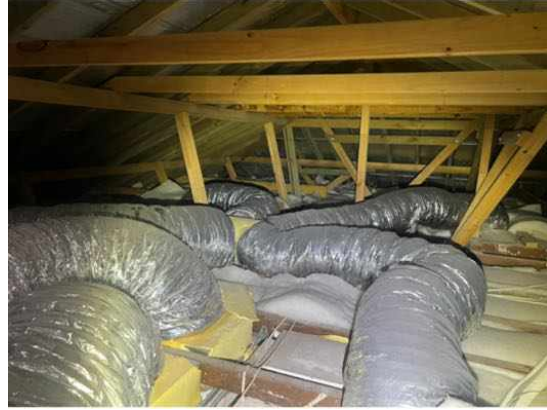
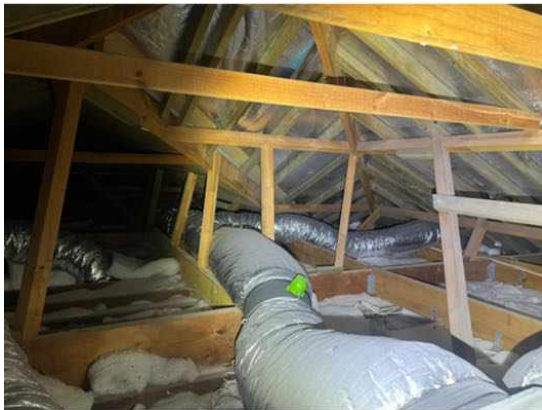
Building: Main Building  
Location: Roof Void  
Finding: Additional Photos - Obstructions and Limitations  
Information: These photographs are an indication of the obstructions and limitations which impeded full inspection of the property at the time of inspection. These obstructions can hide an array of defects and should be removed to allow full inspection to be carried out. A re-inspection is recommended once the areas are made accessible.

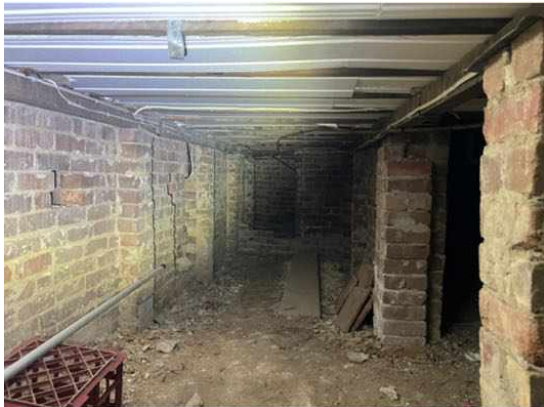
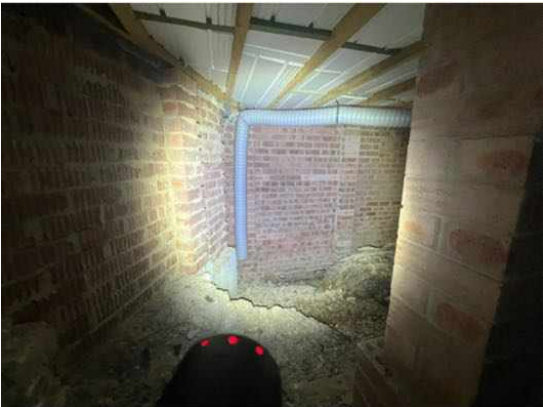
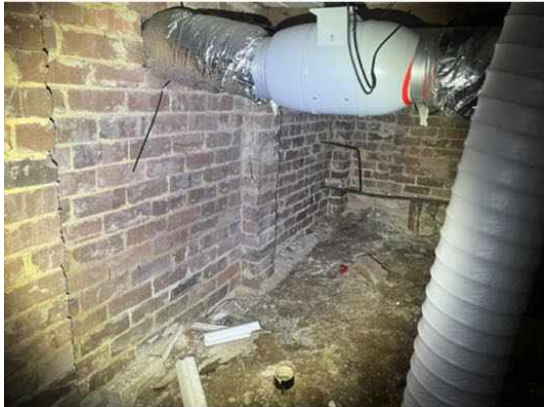
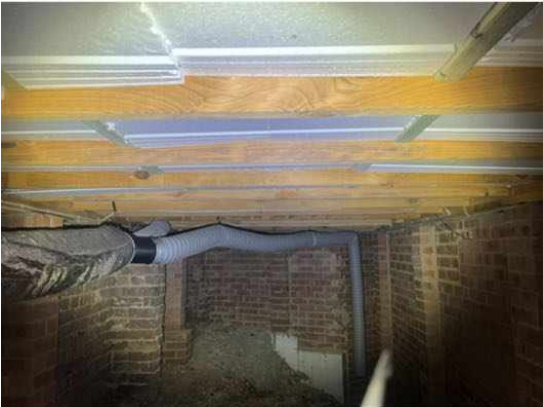
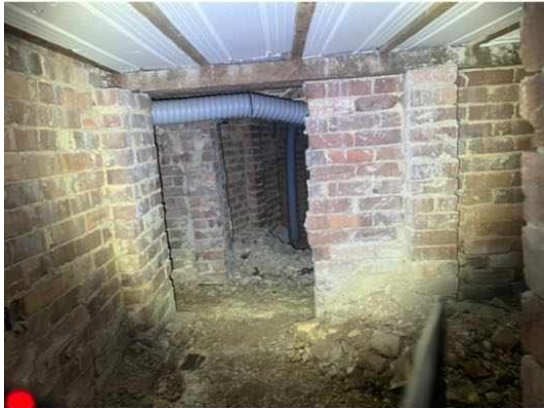
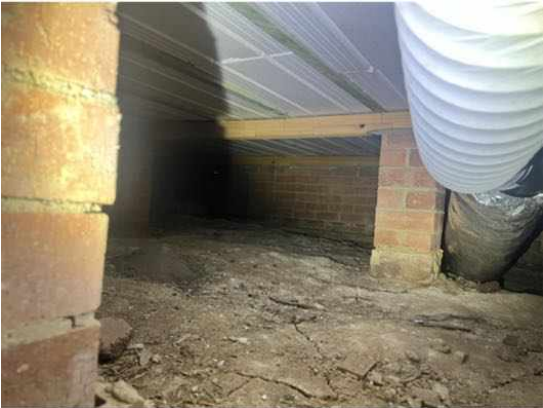
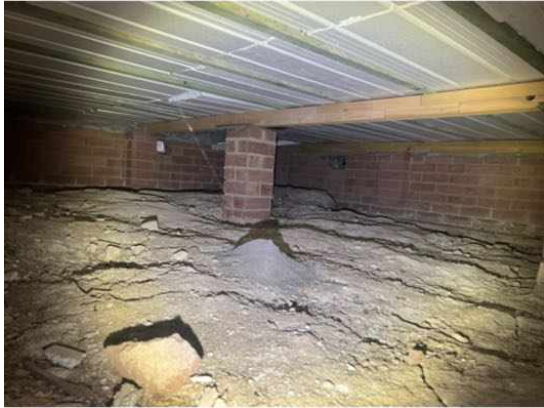
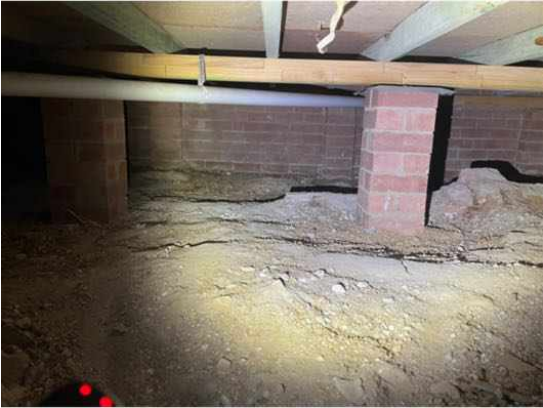
Building:	Main Building
Location:	Subfloor
Finding:	Additional Photos - Obstructions and Limitations
Information:	These photographs are an indication of the obstructions and limitations which impeded full inspection of the property at the time of inspection. These obstructions can hide an array of defects and should be removed to allow full inspection to be carried out. A re-inspection is recommended once the areas are made accessible.
