Building and Timber Pest Inspection Report

Inspection Date: Thu, 26 Mar 2026

Property Address: 7 Erin Ave, Berkeley Vale NSW 2261,
Australia

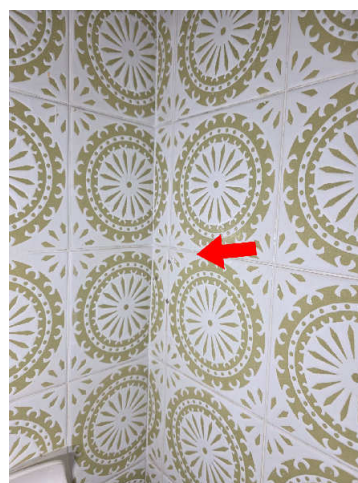
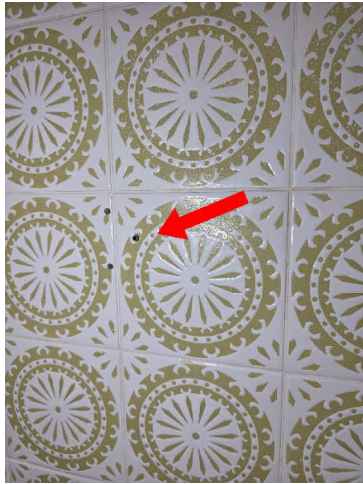
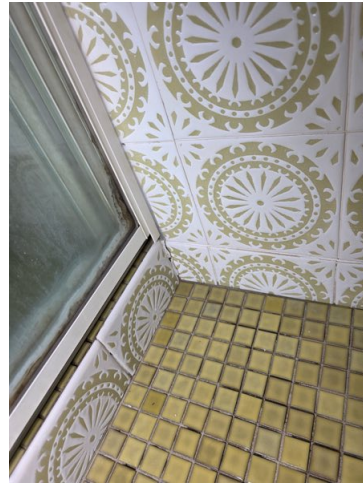
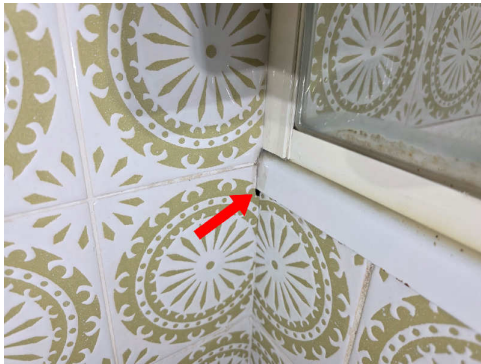
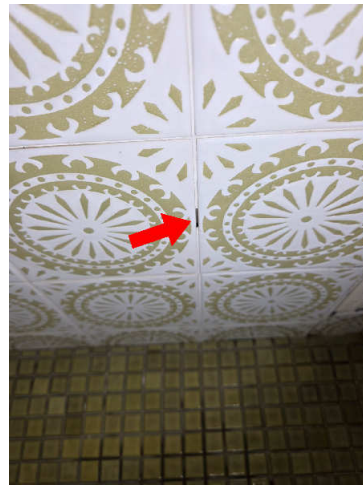
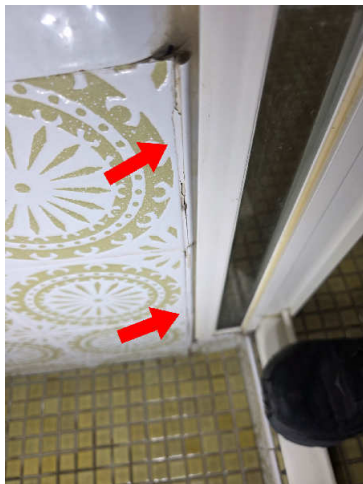
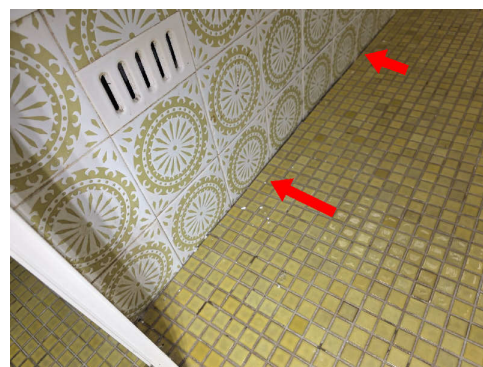
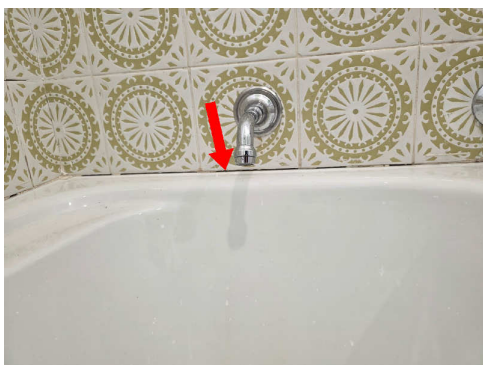
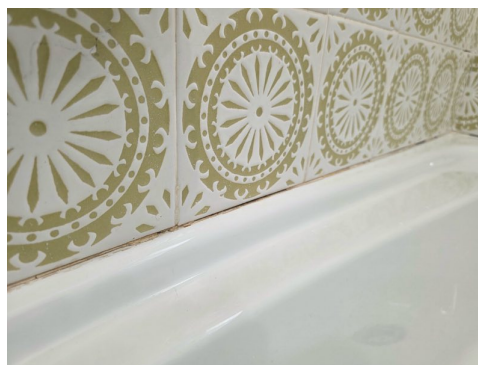
Finding: Deteriorated sealing and minor grout loss – Bathroom

Information: Sealant is deteriorated or missing in the shower and bath areas, and there are small sections of missing grout. The bathroom appears otherwise serviceable. Failed sealing can allow water ingress into wall and floor substrates, potentially leading to concealed damage over time.

A licensed plumber should be engaged to carry out further investigation and rectify as required. This should be addressed without delay and prior to regular use recommencing after occupancy.

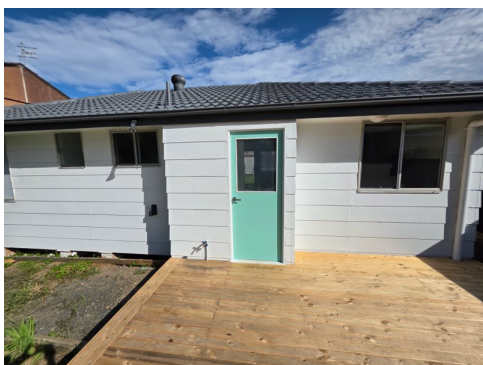
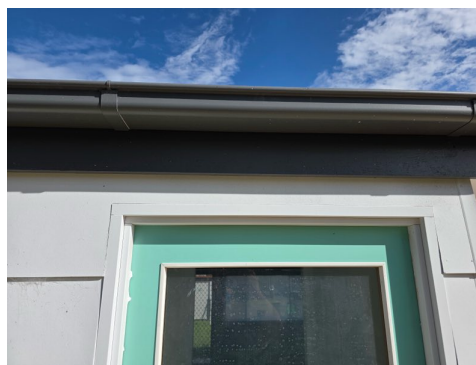
Information: There is no head flashing above the laundry door, and the junction between the door frame and weatherboards is not sealed. This increases the likelihood of water ingress into the wall structure.

A qualified carpenter should be engaged to assess and rectify as required. This should be addressed without delay.

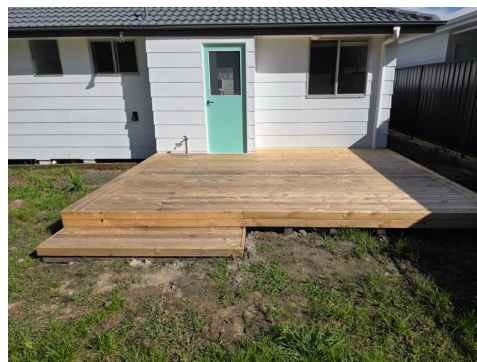
Information: The deck timbers have not been painted or sealed and are exposed to the elements. Unprotected timber is susceptible to weathering, moisture ingress, and premature deterioration.

A licensed builder should be engaged to assess and rectify as required. This should be addressed as soon as practicable.

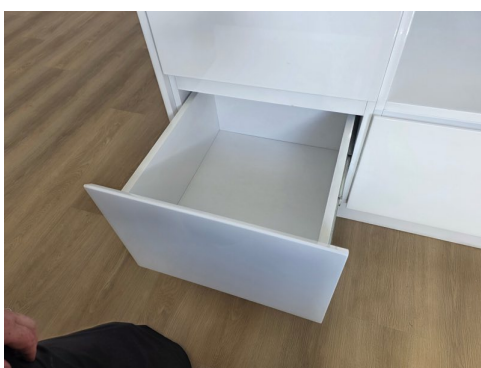
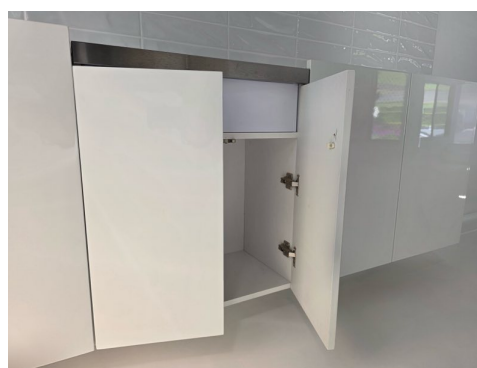
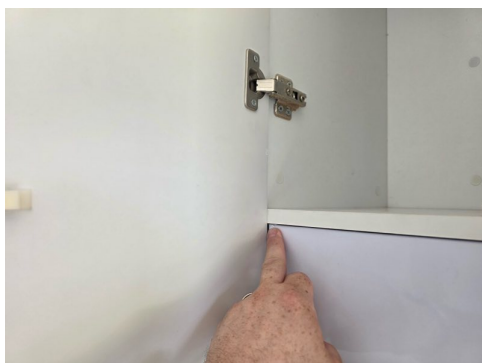
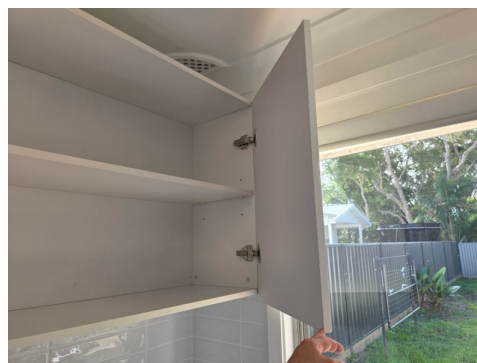
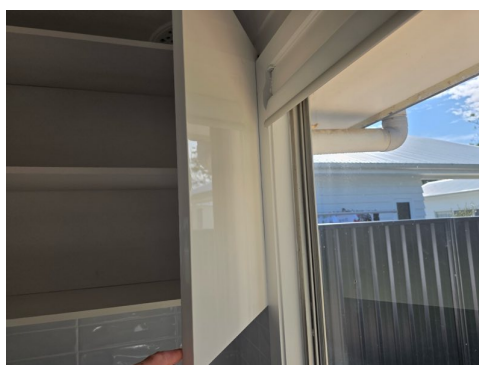
Information: Several cabinet doors are binding and require adjustment, the bottom drawer does not run smoothly, and one overhead cupboard door binds against the window architrave and cannot open fully or stay open.

Misalignment may worsen with use and affect functionality of cabinetry components. A qualified carpenter should be engaged to assess and rectify as required. This should be addressed as soon as practicable.

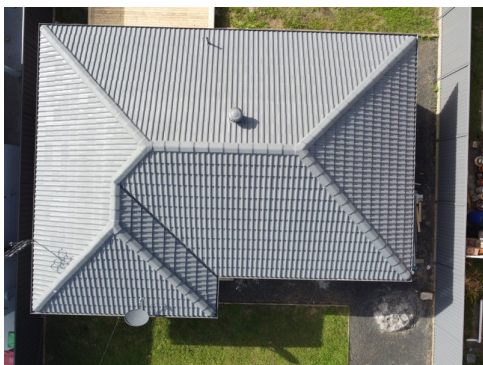
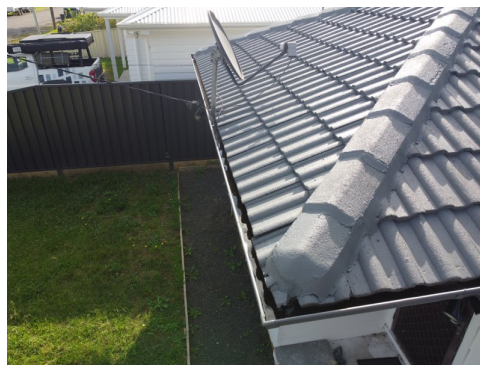
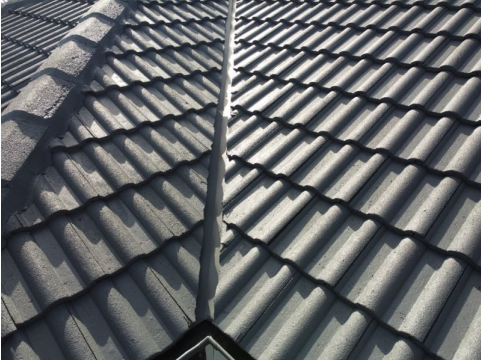
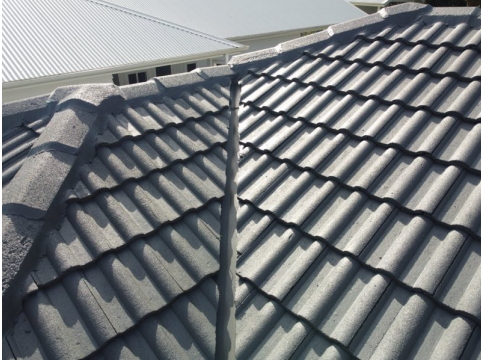
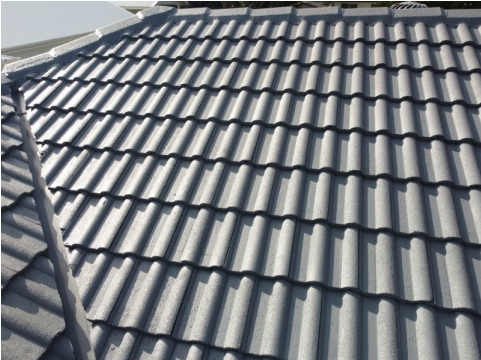
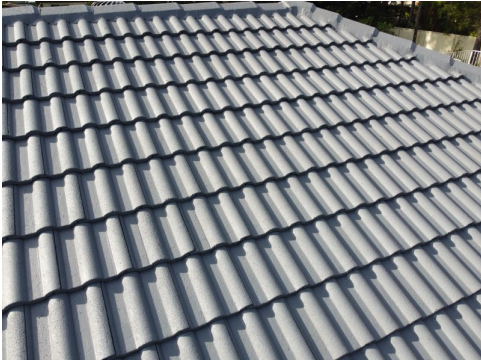
Finding: Additional Photos - Roof Exterior

Information: Additional photos of the roof exterior are provided for your general reference
