Building and Timber Pest Inspection Report

Inspection Date: Tue, 17 Feb 2026

Property Address: 6/6 Stypandra Pl, Springwood NSW 2777,
Australia

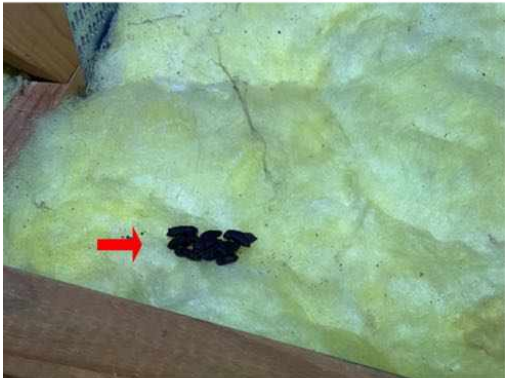
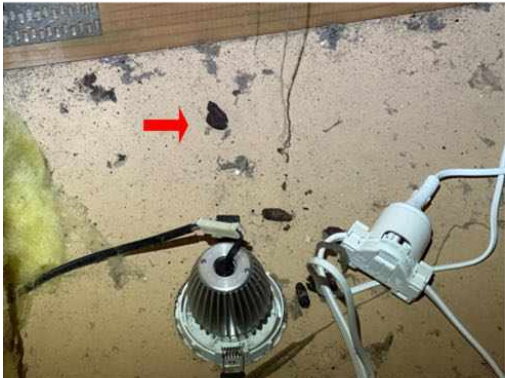
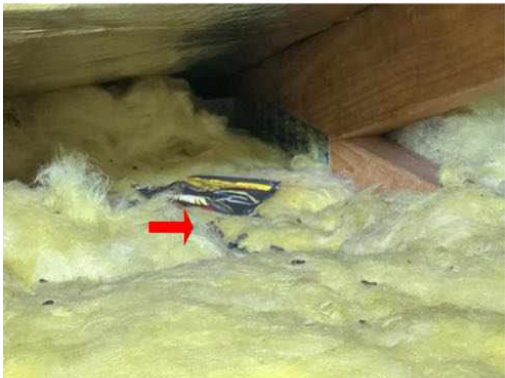
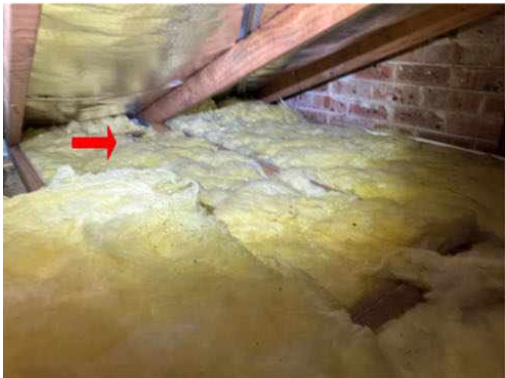
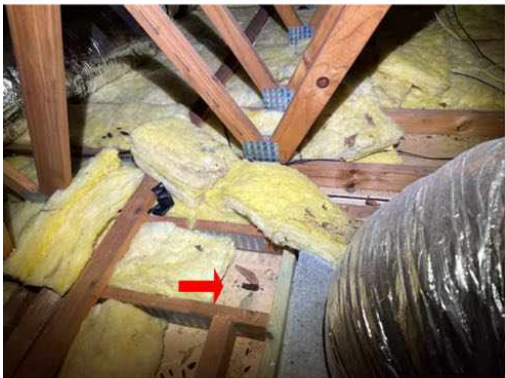
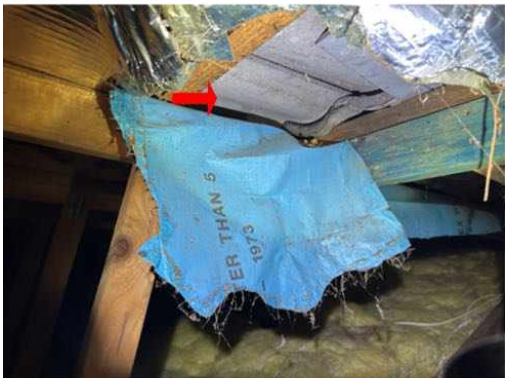
Building:	Main Building
Location:	Roof Void > All Areas
Finding:	Evidence of Vermin
Information:	Evidence of pests or rodents were present in the roof space at time of inspection including animal pings and odor. Rodents can cause issues ranging from smells and stains through to physical damage to wiring and other elements in the roof void. A licensed pest controller should be appointed to free the roof void of any pests and to

install deterrents or seal access points to ensure that rodents can not enter the roof space as easily.

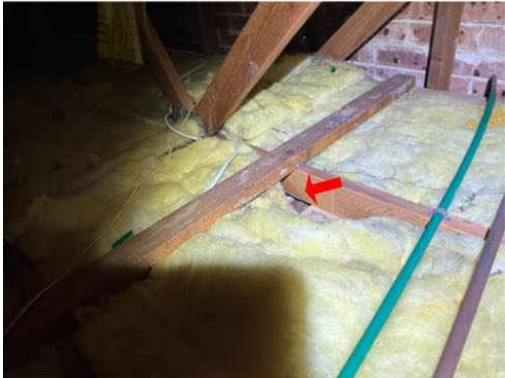
Finding 3.02

Building: Main Building
Location: Roof Void > Rear Right
Finding: Ant Infestation: roof void
Information: At the time of inspection it appeared that a species of black ants had infested the property around roof space of the bedroom 2. It is recommended that a pest control technician be appointed to clear the roof void of ants.

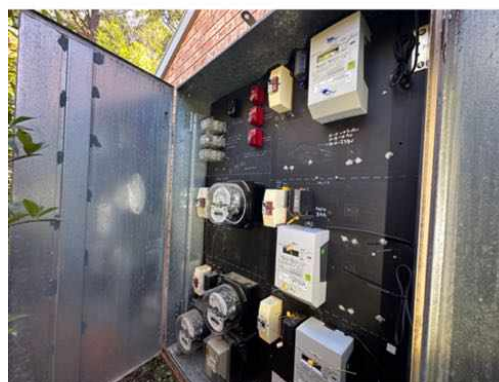
Building: Main Building
 Location: Electrical circuit box > Centre Left
 Finding: Termite Management System - no evidence of a chemical installation
 Information: The application of a post-construction chemical termite barrier is highly recommended for all properties, particularly if live termite activity has been found on the site previously. Such barriers are highly effective in preventing termite attack on any timber building elements throughout the property.

A durable notice should be placed in the switchboard unit to indicate current termite barriers. At the time of inspection, it appeared as though no termite management system has been installed, with no evidence to suggest preventative works taking place.

The client may consider gaining further advice from a pest controller as to the costs and procedures involved with this application. It is recommended that obtaining such advice be a short-term priority.

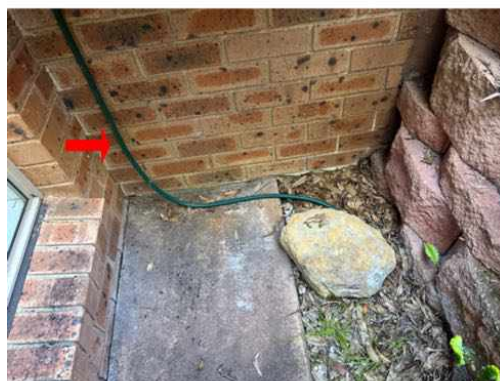
Finding 6.02

Building: Main Building
 Location: Exterior walls - rear > Rear Left
 Finding: HWS Overflow - Not Connected
 Information: The Hot Water System (HWS) overflow was found to be disconnected from storm water drainage and is creating excessive moisture in the surrounding area.

These damp conditions can lead to secondary defects such as rot, rust or corrosion of associated building elements, the formation of fungal decay, or even the creation of potential slip hazards. When coupled with poor site drainage, pooling of water may also attract termite activity to this area.

It is highly recommended that a licensed plumber be appointed to connect the HWS overflow in order to prevent such an environment from being created. These minor works should be carried out as soon as possible.

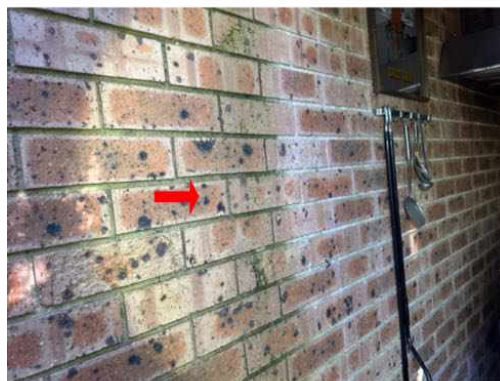
Finding 6.03

Building:	Main Building
Location:	Exterior walls - right side > Centre Right
Finding:	Water staining
Information:	Water staining was evident in this area at the time of inspection. Water staining indicates that surfaces have been exposed to excessive moisture over time. The minerals and other elements in the water lead to staining, which may graduate to corrosion and deterioration if left unmanaged.

While mostly an appearance defect, water staining can be indicative of more serious defects, which may be currently concealed by other building elements.

Where water staining is active, a licensed plumber must be consulted to identify the

cause of the staining and to provide advice on any reparation works that may be required. Replacement of any broken or damaged structures is advised.

Conversely, where water staining is old and inactive, affected building materials may be repaired or replaced at client discretion. A qualified carpenter or registered builder may be appointed to perform these works.

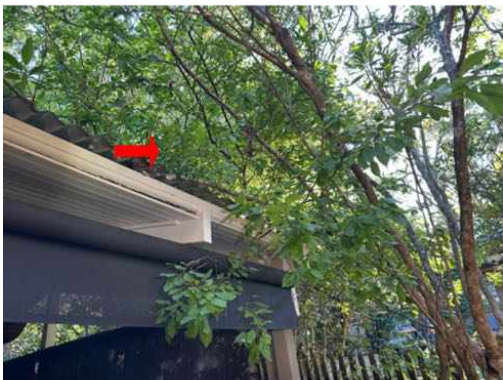
Finding 6.04

Building:	Main Building
Location:	All Areas > All Areas
Finding:	Bridging - Vegetation
Information:	Where vegetation obstructs inspection of building elements, also known as bridging as it provides a bridging point for the access of termites, full inspection can not be achieved. Consequently moisture or dampness may be present and the areas becomes conducive to termite activity. Plants against or very close to buildings provide cover, shade and can provide an environment that is attractive to termite infestation.

The removal of any such materials that may be conducive to termite activity should be carried out as soon as possible and arrange re inspection to minimize the risk of

termite attack.

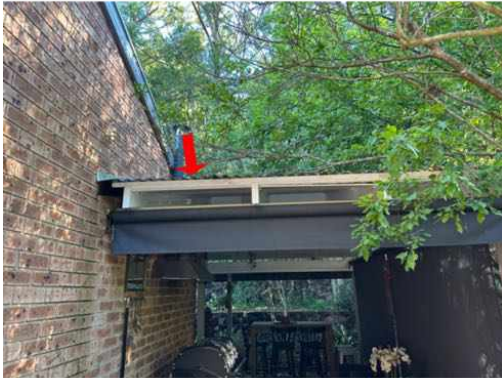
Finding 6.05

Building:	Main Building
Location:	Roof Exterior > Rear Right
Finding:	Roof plumbing - Missing
Information:	Some sections of the roof are not adequately drained via gutters and downpipes. Gutters and downpipes that are not installed adequately are likely to result in excessively damp conditions against the exterior surfaces and around the base perimeter of the building.

Excessive moisture creates an environment which accelerates the deterioration of building elements in the area, as well as being conducive to termite and pest infestation. Such an environment is likely to necessitate repair and/or replacement of building elements, which are prone to sustaining wood rot, rust or corrosion.

A roofing plumber should be appointed as soon as possible to install relevant roof plumbing materials. Depending on the extent of the damage, repair and/or replacement of damaged building elements may be required.

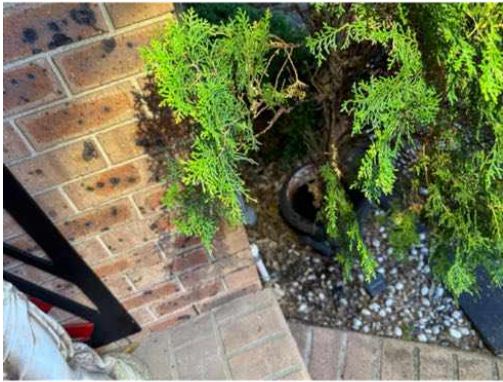
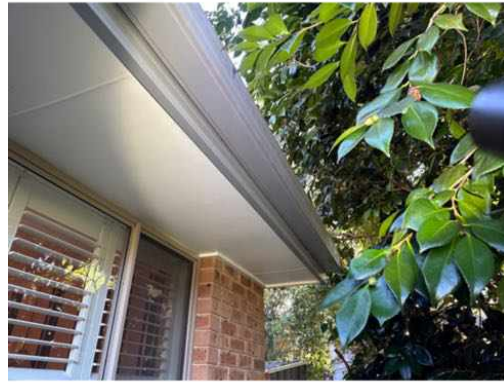
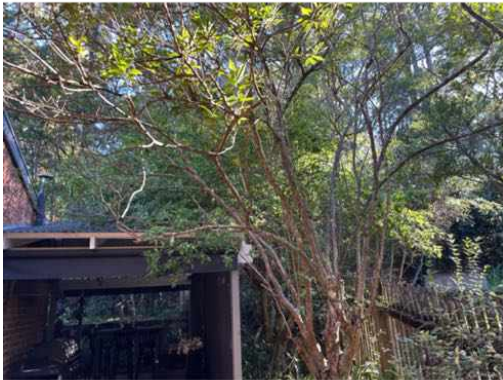
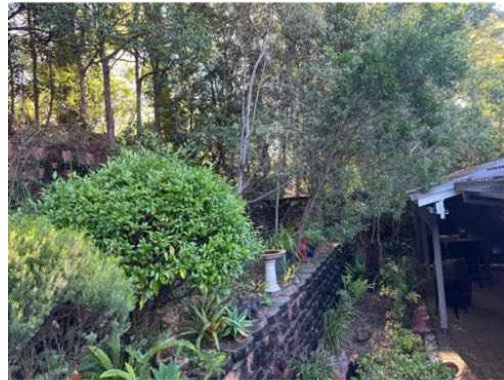
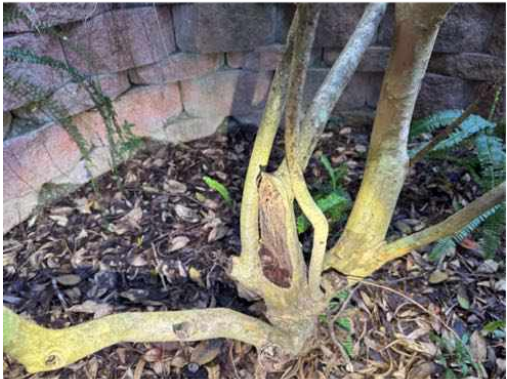
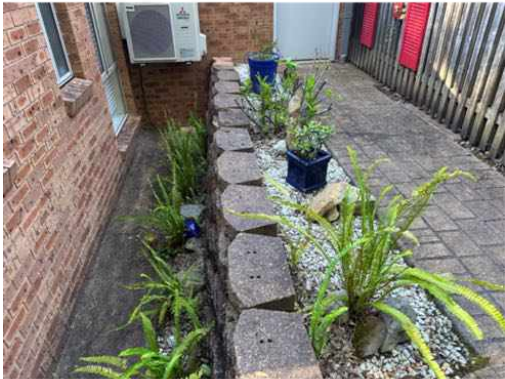
Building: Main Building
Location: All Areas > All Areas
Finding: Additional Photos - Obstructions and Limitations
Information: These photographs are an indication of the obstructions and limitations which impeded full inspection of the property at the time of inspection. These obstructions can hide an array of defects and should be removed to allow full inspection to be carried out. A re-inspection is recommended once the areas are made accessible.

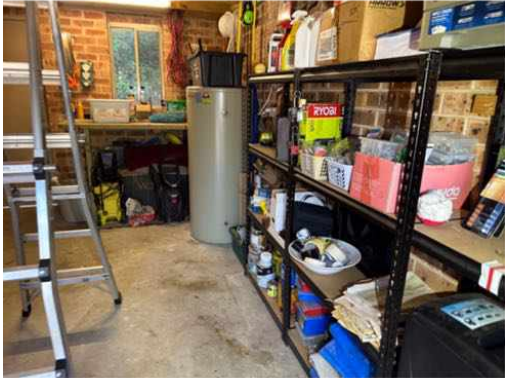
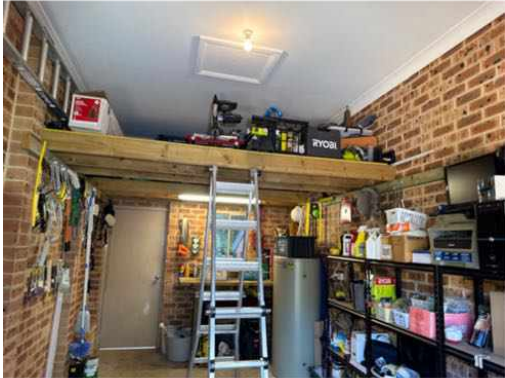
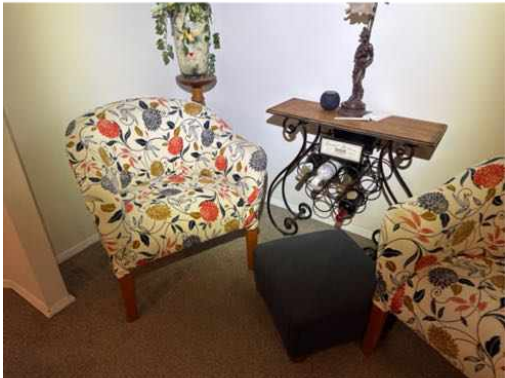
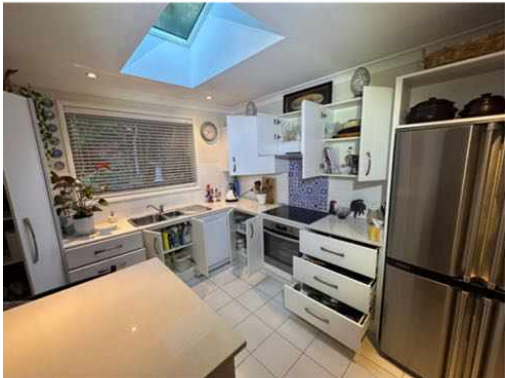
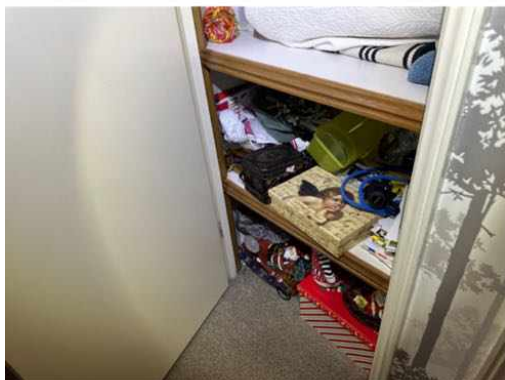
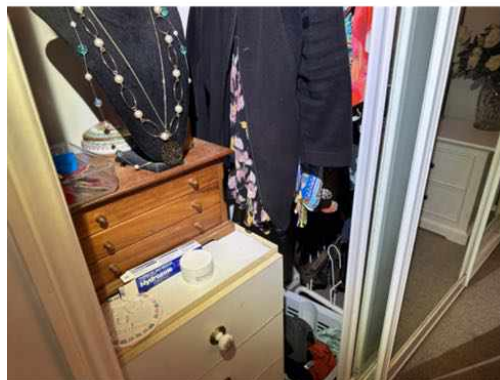
Building: Main Building
Location: All Areas > All Areas
Finding: Additional Photos - Obstructions and Limitations
Information: These photographs are an indication of the obstructions and limitations which impeded full inspection of the property at the time of inspection. These obstructions can hide an array of defects and should be removed to allow full inspection to be carried out. A re-inspection is recommended once the areas are made accessible.

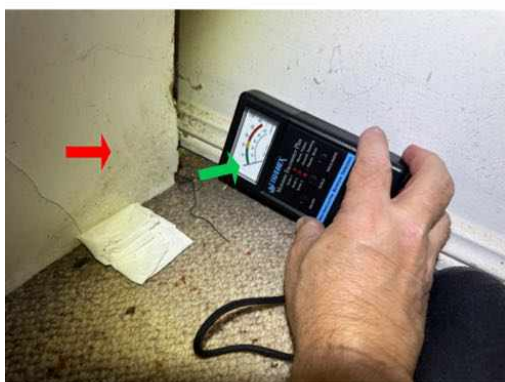
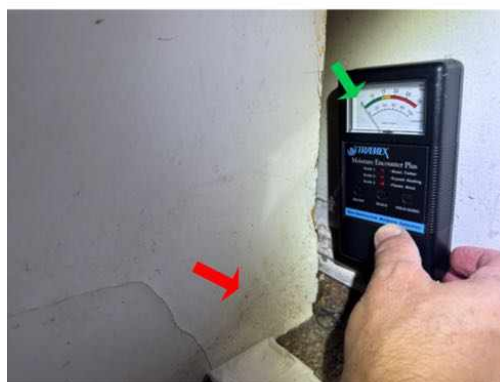
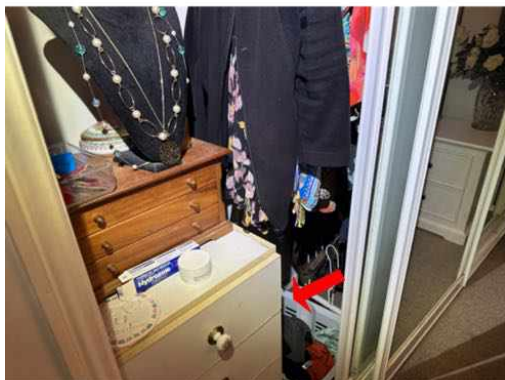
Building: Main Building
 Location: Bedroom - Master > Front Right
 Finding: Moisture Meter used: No Moisture Detected.
 Information: Moisture meter was used during the inspection and no excessive moisture was detected to accessible walls inside the property at the time of inspection.

Monitoring the area is advised and if any visual signs of excessive moisture appear (peeling paint, mould) then consultation with a qualified plumber, builder, or damp proof specialist would be advised to identify the cause of damp and to perform remedial works as required

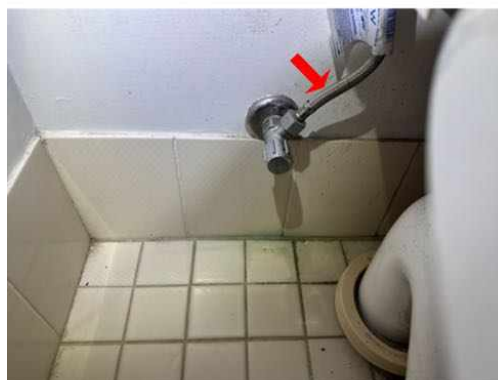
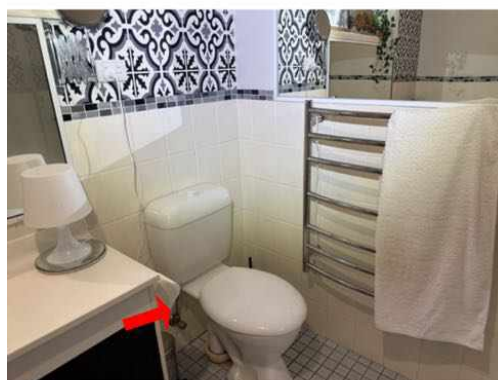
Building: Main Building
 Location: All Areas > All Areas
 Finding: Pipe: Flexible Braided pipes.
 Information: Braided Stainless Steel Flexi connector hose are popular in modern home fit outs because they can be bent into shape. They started to be installed in the early two thousands and their use is now extremely widespread in contemporary construction and renovations.

It is recommended that the Flexi pipes to be replaced at the owners discretion to avoid an "escape water incident" which may lead to water damage to other building elements in the home.

This work can be undertaken by a licensed plumber, general handy person at the owners discretion.

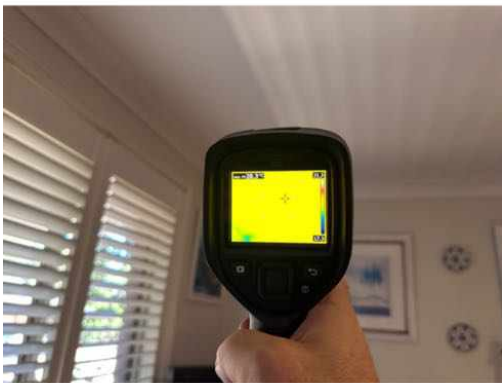
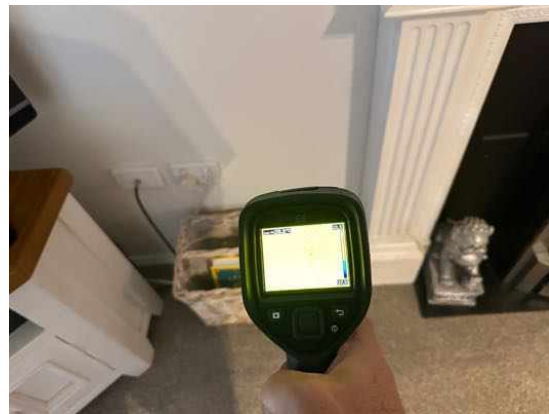
Building: Main Building
 Location: All Areas > All Areas
 Finding: Thermal imaging: No excessive moisture presentation.
 Information: At the time of inspection there appeared to be no excessive moisture presentation in this area.
