Building and Timber Pest Inspection Report

Inspection Date: Thu, 19 Feb 2026

Property Address: 108 Alfred Rd, Chipping Norton NSW 2170,
Australia

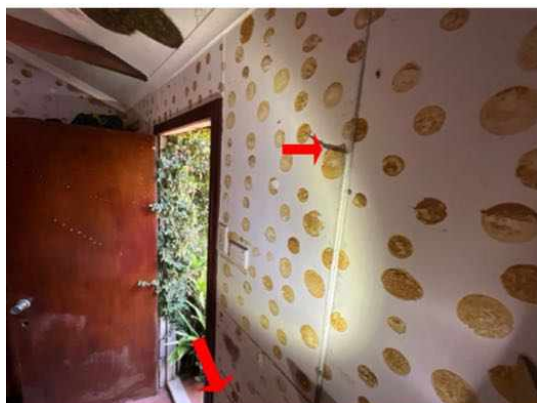
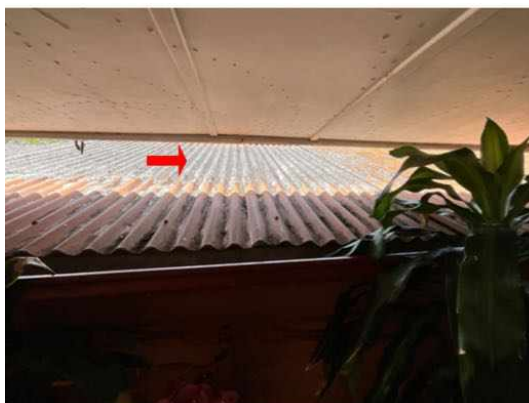
Building:	Main Building
Location:	Multiple areas
Finding:	Asbestos - Suspected ACM Identified on Site
Information:	Reporting on Asbestos is outside the Scope of this Report. This suspected defect is highlighted as a caution only. We suspect, based on our experience in the building industry, that there is a higher risk of the identified building element containing asbestos.

As Asbestos Reporting is outside the scope of this report, we advise that you consider a separate Asbestos Inspection and Condition Audit, which can include the taking of samples for definitive confirmation of the presence of Asbestos.

In the interim, the client is advised to act with caution, especially when considering any damage to building materials general wear and tear renovations extensions demolition and general maintenance activities due to the suspected presence of Asbestos.

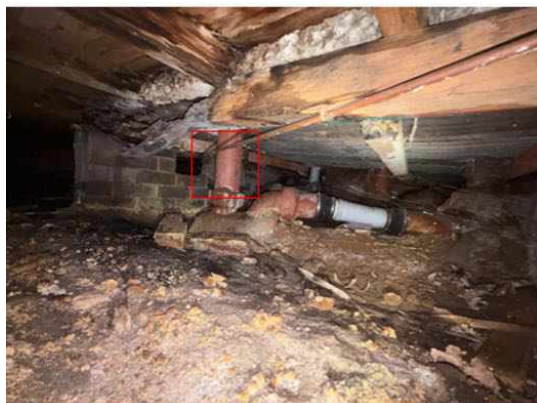
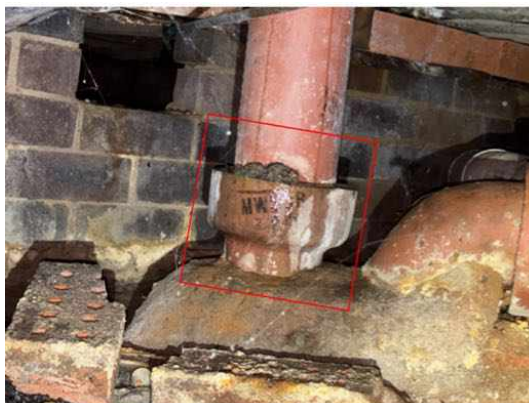
Finding 2.01

Building:	Main Building
Location:	Subfloor
Finding:	Pipework - Leaking into subfloor
Information:	Dampness to localised sections of the subfloor area was identified. It is suspected that this dampness has occurred due to leaking pipes in this area, which may be exacerbated by poor site drainage and inadequate subfloor ventilation.

Dampness in this area is likely to lead to wood rot and general deterioration of structures within the subfloor space. Excessive moisture also creates an environment which is conducive to termite and pest infestation.

A licensed plumber should be appointed immediately to repair any pipes that may be leaking. This will ensure a dry subfloor space as well as improving the water efficiency of the property.

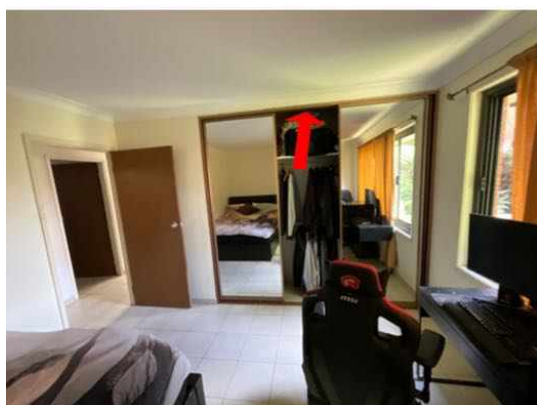
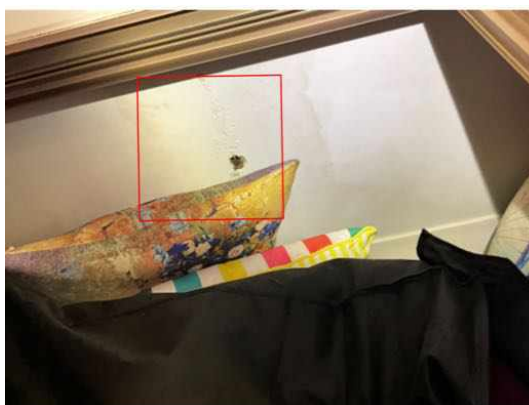
Building:	Main Building
Location:	Bedroom 2
Finding:	Ceiling - Water damaged
Information:	Water damage to the ceiling lining is generally an indication of excessive moisture being present in the roof void, usually via a leak to the roof covering.

Where water damage is evident to the ceiling, the primary requirement is to identify and rectify the source of the leak. A roofing plumber should be appointed as soon as possible to identify the leak and perform rectification works as necessary, ensuring the water damage is restricted.

Once the leak is repaired, consultation with relevant tradespeople, including plasterers and painters, is advised. Rectification works may include replacement of ceiling lining or minor repainting, depending on the extent of the damage.

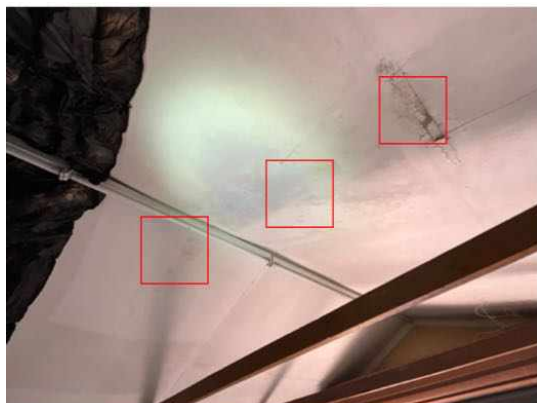
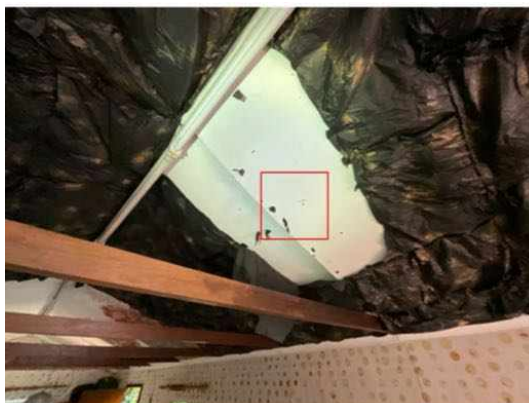
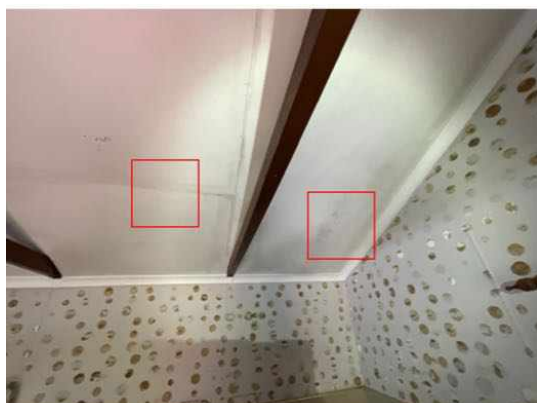
Finding 2.04

Building:	Bungalow
Location:	Garage
Finding:	Ceiling - Water damaged
Information:	Water damage to the ceiling lining is generally an indication of excessive moisture

being present in the roof void, usually via a leak to the roof covering.

Where water damage is evident to the ceiling, the primary requirement is to identify and rectify the source of the leak. A roofing plumber should be appointed as soon as possible to identify the leak and perform rectification works as necessary, ensuring the water damage is restricted.

Once the leak is repaired, consultation with relevant tradespeople, including plasterers and painters, is advised. Rectification works may include replacement of ceiling lining or minor repainting, depending on the extent of the damage.

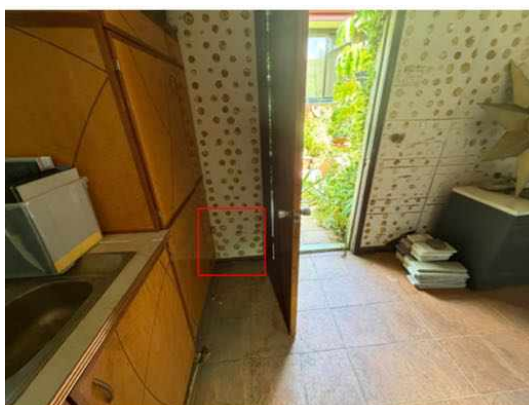
Finding 2.05

Building:	Main Building
Location:	Garage
Finding:	Exterior walls - Lateral damp
Information:	Lateral penetrating damp refers to the sideways movement of moisture, predominantly from the surrounding ground, which tends to affect basement walls and other earth-retaining walls. The implications of unmanaged damp range from mould fungi growth, wood rot and decaying building materials, to finishes including lifting, bubbling, peeling and staining of paint, plaster and wallpaper.

It is important to address damp conditions as the World Health Organisation notes that excess moisture leads - on almost all indoor materials - to the growth of microbes

Structural waterproofing barriers or tanking barriers are often used to protect internal surfaces against the effects of lateral penetrating dampness. These types of work are generally undertaken where the source of the penetrating damp cannot be prevented.

Immediate consultation with a licensed plumber is advised to address the cause of the damp and to perform remedial works as necessary.

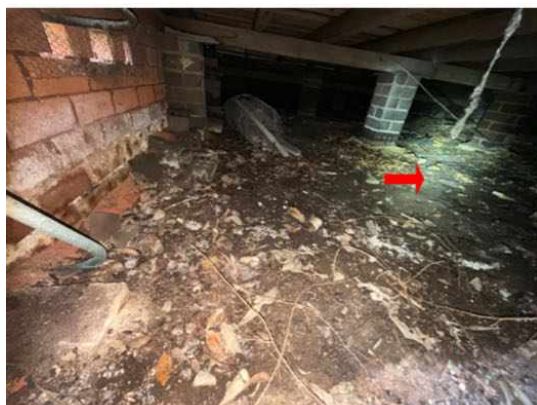
Finding 2.06

Building:	Main Building
Location:	Subfloor
Finding:	Site drainage— Inadequate
Information:	The site drainage in this area was found to be inadequate at the time of inspection, creating potential for subsequent water damage to associated building elements. This is additionally conducive to termite activity.

ground levels should be sloped to drain water away from walls. Downpipes should not disgorge stormwater onto lower walls or plinths. Stormwater should be carried away by large, regularly cleaned drains. Ground levels may need to be lowered to expose a buried DPC.

Where site drainage is inadequate, installation of an Agricultural (Aggie) Drain may be required. A licensed plumber should be appointed to further inspect the property and perform any remedial works as necessary. Water damage and secondary defects are likely to occur if left unmanaged.

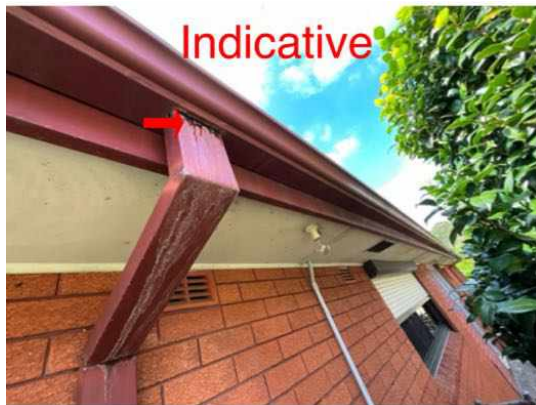
Finding 3.01

Building:	Main Building
Location:	Multiple areas of roof plumbing
Finding:	Water leak - External
Information:	Water leaks were found to be present to exterior plumbing work. Leaks are generally caused by deterioration of the plumbing elements over time, due to exposure to weather conditions, but may have also been caused by minor impact damage.

Such leaking creates damp conditions in the affected area, causing potential for water pooling and subsequent water damage if left unattended. These conditions may also attract termite attack, particularly if the area is subject to minimal levels of sun throughout daylight hours.

It is highly advised that a licensed plumber be appointed to rectify any water leaks that may be present. Areas of repair and replacement of plumbing fittings and fixtures may be required and, as such, a quotation should be sought.

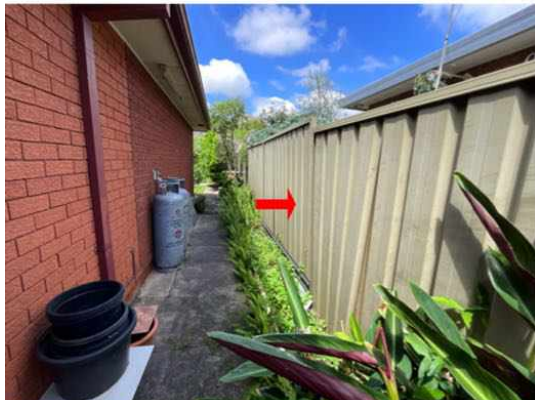
Finding 3.02

Finding: Fencing - Deteriorated

Information: It was noted at the time of inspection that sections of the fencing in this area has deteriorated. Typically fencing deteriorates due to age and or wear, rot and or rust which is generally expected for a structure of this age, due to prolonged exposure to weather conditions. Sometimes inadequate installation or maintenance can be to blame.

If left unattended, it is likely that further damage will occur. It is suspected that repair of several elements of the fencing may be required however replacement may be a consideration of the client also.

A licensed fencing contractor should be appointed to provide further advice and perform rectification works as necessary.

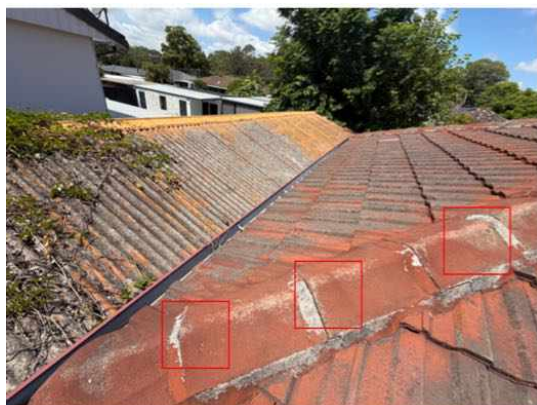
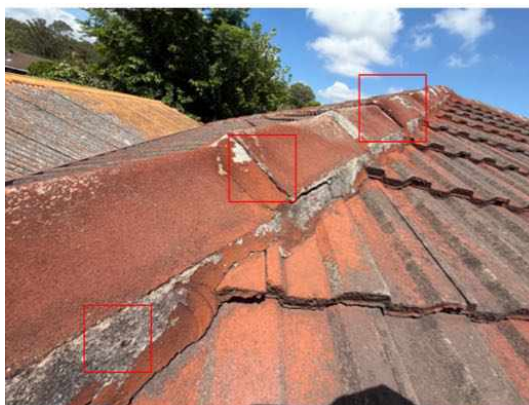
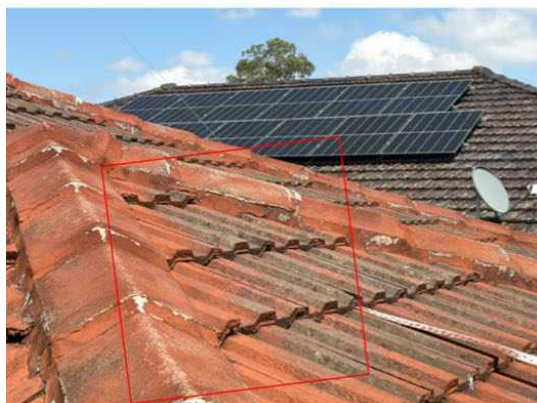
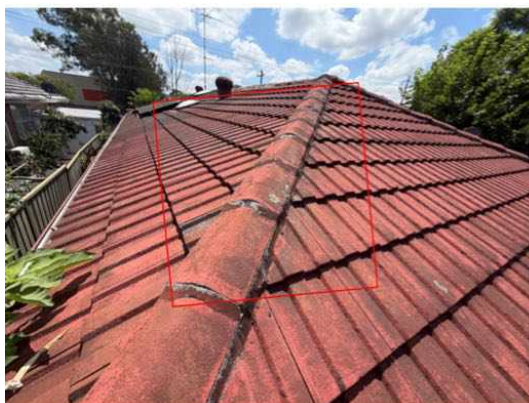
Finding 3.03

Information: Upon inspection of the exterior roofing, the majority of roof tiles were considered to be in a fair condition. While weathering of the tiles is consistent with the age of the property, maintenance works are required.

Isolated areas of mortar have come loose and minor cracking is also present. Re-pointing and re-sealing the may be considered as an interim solution by the client to help preserve and extend the life span of the tiles.

Where left unmanaged, deteriorating roof tiles are likely to lead to a number of secondary defects, including minor water leaks and weather exposure to internal roofing structures.

Consultation with a licensed roofing contractor is highly advised to gain advice on cost of remedial works that may be required in the short to medium term. Remedial works are likely to increase the longevity of the exterior roofing structure.

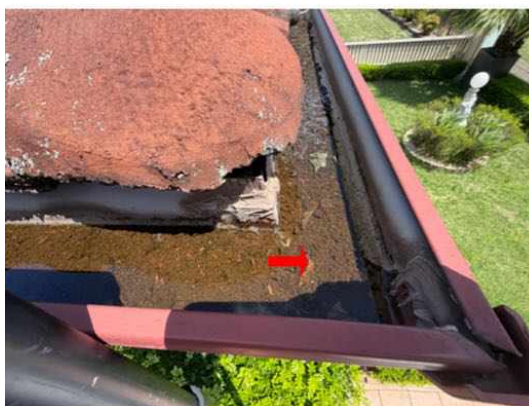
Finding 3.04

Building: Main Building
 Location: Front Elevation
 Finding: Gutters - Water pooling
 Information: Water was found to be pooling in sections of the roof guttering. This is generally a secondary defect caused by blocked or partially blocked gutters. Furthermore

inadequate fall to the adjacent downpipe could also be the underlying cause.

Water pooling is likely to lead to rust and water damage to associated structures if left unattended. This excess dampness is additionally conducive to termite activity.

Any areas of guttering that shows evidence of water pooling should be checked for partial or full blockages or otherwise appropriate fall to the downpipe must be applied accordingly. Any secondary damage that may have occurred as a result must be rectified. Depending on the extent of the damage, building elements may require repair and/or replacement to ensure adequate roof drainage and function of exterior plumbing system.

A roofing plumber must be appointed as soon as possible if inadequate fall to downpipe is deemed to be the cause. It is highly advised that all gutters be maintained on a frequent basis to ensure the condition of roof plumbing.

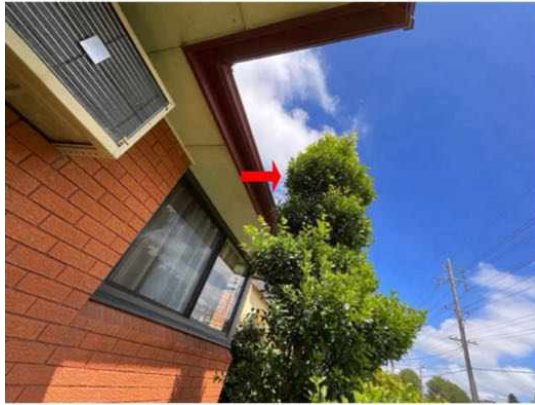
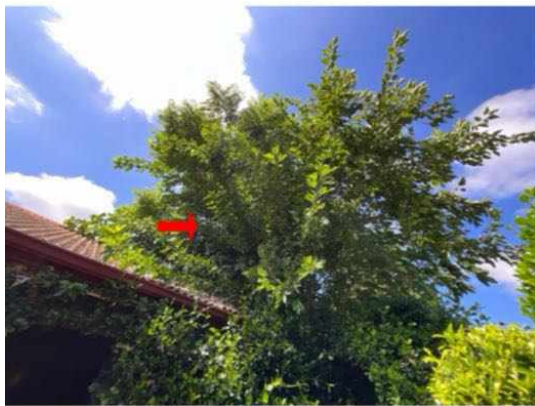
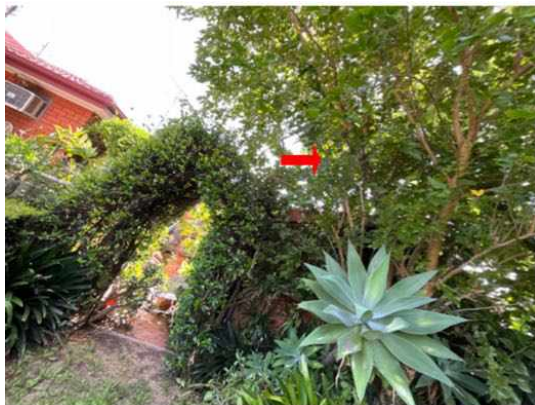
Finding 3.05

Building:	Main Building
Location:	Roof Exterior
Finding:	Trees - Overhanging and filling gutters
Information:	Overhanging trees often result in excessive amounts of leaf debris accumulating in gutters.

Gutters are a critical part of the building's management of storm water and rain. It is therefore important that they be kept clear to prevent secondary damage to associated building elements, including exterior and interior walls, ceiling linings and any adjoining building elements. Where gutters are blocked, pooling of rainwater is likely to occur, fast-tracking rust and corrosion of the roof plumbing elements.

It is highly advised that all overhanging tree branches be removed as soon as possible to prevent any further damage. Repair and/or replacement of sections of damaged guttering may also be required where the extent of the damage necessitates.

Such works should be performed by the homeowner; however, appointment of a

landscape contractor or an arborist may be required. Consultation with a licensed roof plumber is required where guttering has been damaged.

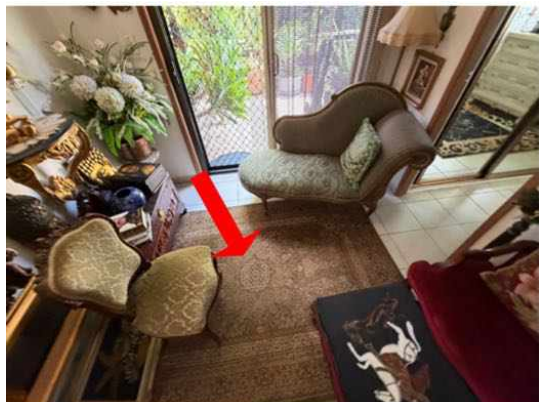
Finding 3.06

Building:	Main Building
Location:	Rear bedroom (extension)
Finding:	Floors — bouncy
Information:	The internal flooring in this area was identified as being bouncy and squeaky at the time of inspection. A bouncy floor surface generally presents as a discernible change in level as they are walked across, in noisy or creaking flooring, or in consequent movement of surrounding furniture and fixtures.

Bouncy floors generally indicate that the floorboards or the subfloor structures are coming loose from the joists that they are installed on. Bouncy flooring may also be the result of gaps between flooring and joist structures, which require packing.

Although not a matter of urgency, the client is advised to seek quotations for required repairs from a licensed Builder.

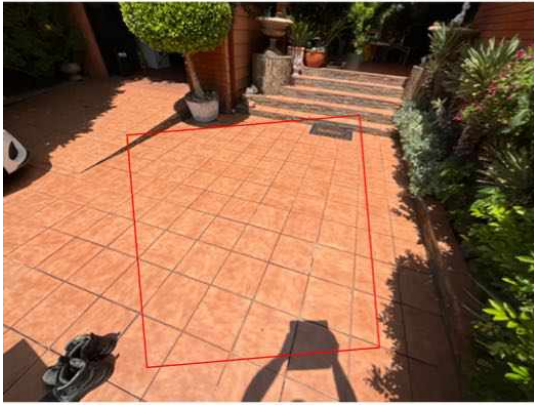
Finding 3.07

Building:	Main Building
Location:	Driveway
Finding:	Tiles - Drummy
Information:	Drummy tiled areas were identified at the time of inspection. The term 'drummy' refers to tiles that have become detached from their fixing, despite otherwise being in relatively good condition. Such defects are generally caused by physical or moisture damage to the area. Drummy tiled areas may also be a direct result of poor workmanship during the construction process.

Tiled areas may swell and shrink with changes in air humidity if the area has sustained moisture damage. Any exposure to moisture is capable of causing tiled areas to become drummy and/or cracked over a prolonged period of time. Drummy tiled areas generally require removal and replacement of affected tiles, with adequate sealant and grouting.

Specialist trades are available for these types of services. A licensed tiling contractor may be appointed to perform works as necessary.

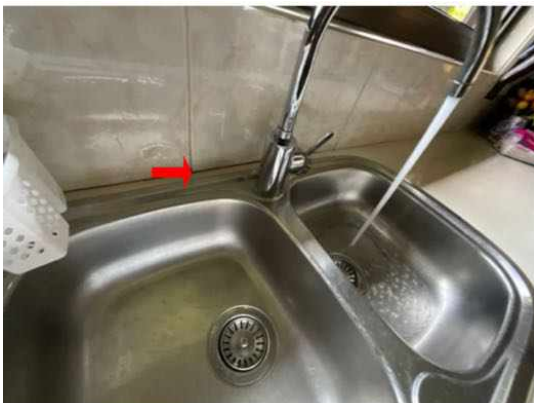
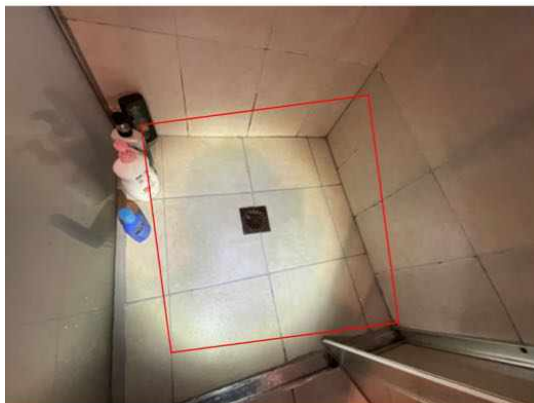
Finding 3.08

Building:	Main Building
Location:	All Wet Areas
Finding:	Sealant and grouting - Missing or damaged
Information:

It was noted on inspection that sealant or grout is degraded to this area.

Different materials and floor areas move at different rates, generally causing cracking to grout or sealant at this point. A flexible sealant is required to allow for expected expansion and contraction, while keeping the joint water tight and protective of all associated building materials.

Flexible and mould resistant materials should be applied to affected areas to prevent any subsequent water damage that is likely to occur. Regular maintenance and replacement of damage or missing or damaged sealant and grout is highly recommended to the wet areas, as this is a regular wear and tear defect. Sealant and grouting in areas that come into regular contact with water should be maintained for the long term care of your property.

A sealant specialist should be appointed to complete these works as soon as possible.

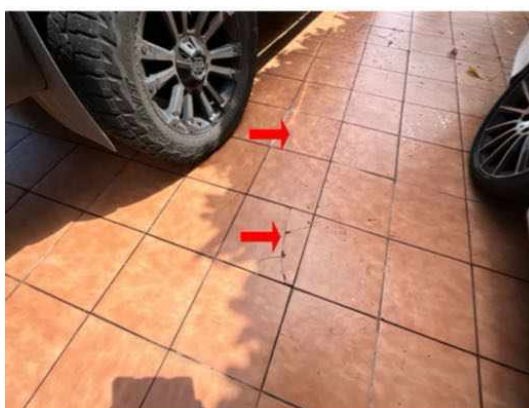
Finding 3.09

Building: Main Building
 Location: Driveway
 Finding: Cracked floor tiles
 Information:

Cracking in the floor tiles was evident in this area at the time of inspection. It is suspected that this cracking has occurred as a result of minor settlement or shrinkage.

Cracked tiles throughout the household detract from the overall appearance of the affected areas however it is unlikely to create or lead to any secondary defects.

While not considered a matter of urgency, replacement of cracked floor tiles is recommended at the clients discretion. A licensed tiling contractor may be appointed to perform these works. Where cracks become more numerous, contact a licensed building inspector for further investigation.

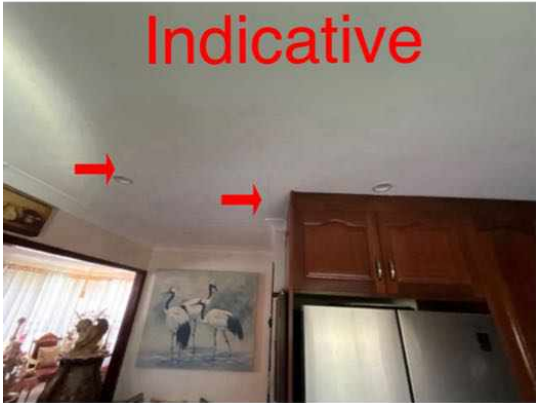
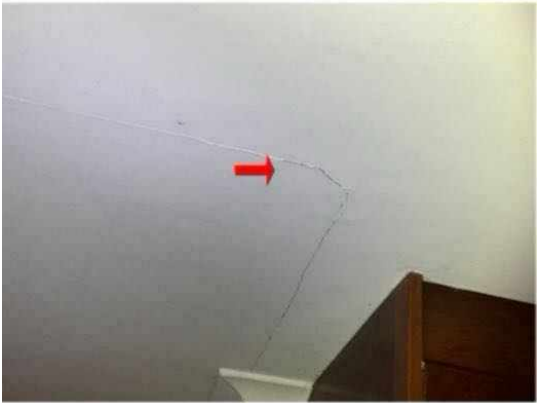
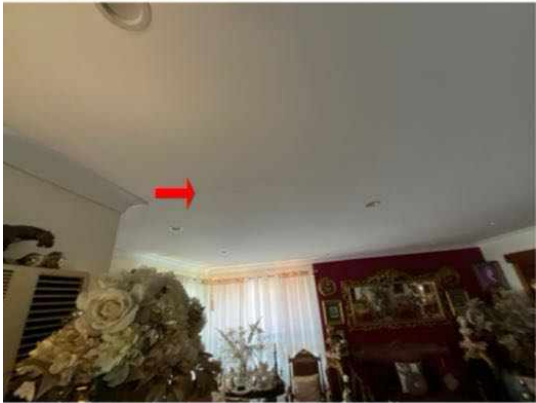
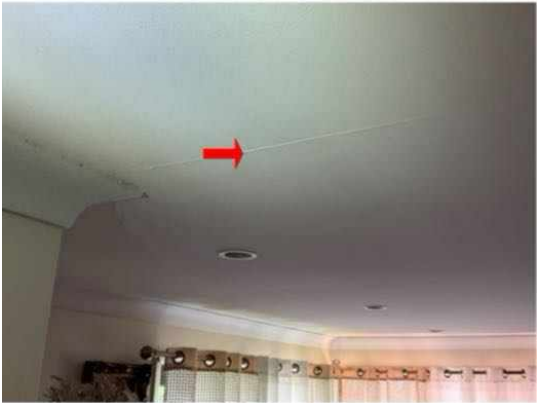
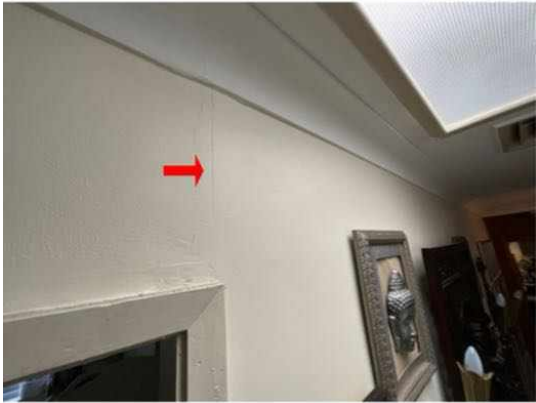
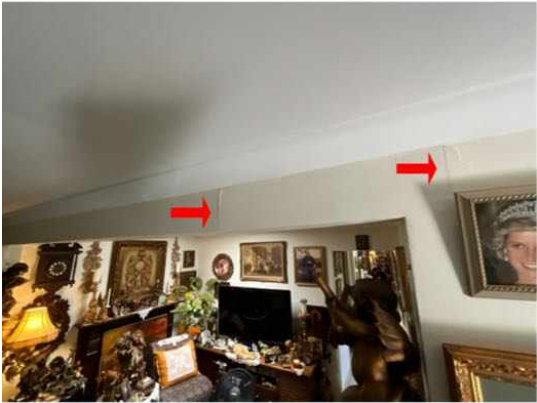
Finding 3.10

Building: Main Building
 Location: Multiple areas
 Finding: Cracking - Damage Category 1 - Fine (up to 1mm)
 Information: Although fine cracks are quite noticeable, they are often only considered to be an appearance defect, and usually do not indicate any structural damage. Generally, the

cause of a fine crack is indicative of a separation between building materials and finishes (e.g. paint, plaster, etc.) along joins.

Cracking of this nature can generally be repaired with minor sanding, filling and/or repainting. Such works should be performed by a qualified painter or a general handyman.

Monitoring of all cracking should be conducted frequently. Always contact a building inspector should cracks widen, lengthen, or become more numerous.

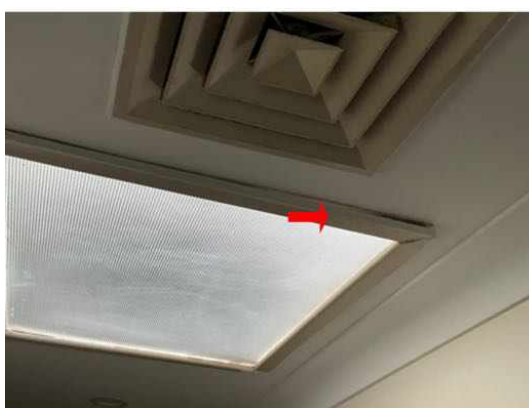
Building:	Main Building
Location:	Hallway
Finding:	Beads - Damaged
Information:	Beading acts (like cornice or skirtings) to cover the intersection or joins of building materials. It was noted at the time of inspection that beading in this area has deteriorated. This deterioration is suspected to have been caused by general ageing and frequent exposure to weather, which is expected in a building of this age and condition.

Beading is important in weatherproofing the surrounding building elements and preventing pest ingress. Furthermore, beading works to protect the joins of building materials, which are more susceptible to deterioration and decay.

Repair or replacement of the beading is advised to ensure the protection and longevity of any associated building elements. Such works may be performed by a general handyperson or qualified carpenter.

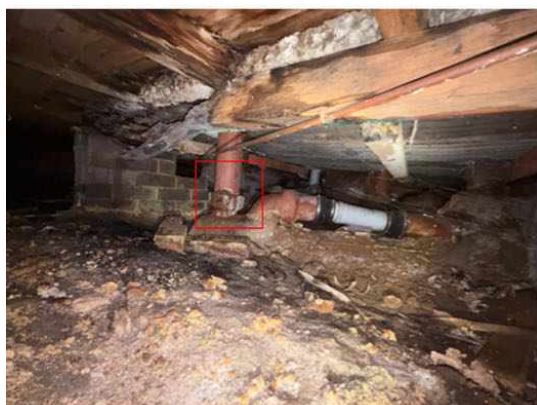
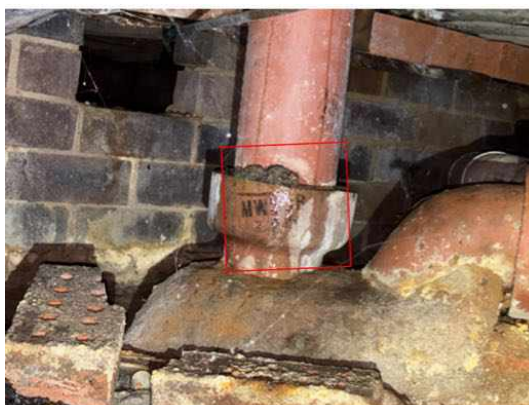
Dampness in this area is likely to lead to wood rot and general deterioration of structures within the subfloor space. Excessive moisture also creates an environment which is conducive to termite and pest infestation.

A licensed plumber should be appointed immediately to repair any pipes that may be leaking. This will ensure a dry subfloor space as well as improving the water efficiency of the property.

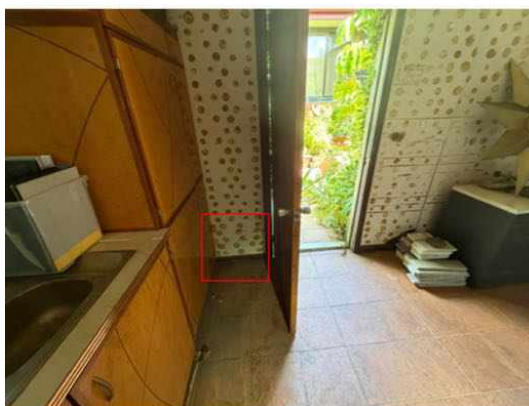
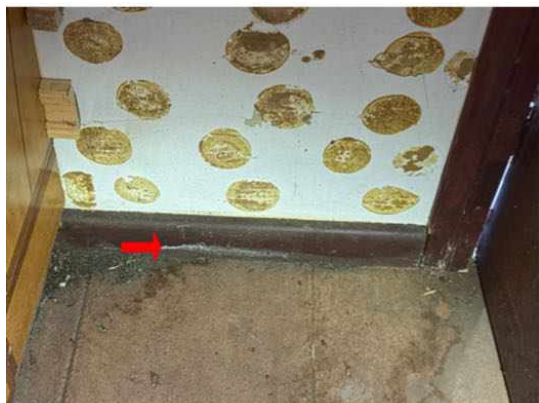
Finding 6.02

Building:	Main Building
Location:	Garage
Finding:	Exterior walls - Lateral damp
Information:	Lateral penetrating damp refers to the sideways movement of moisture, predominantly from the surrounding ground, which tends to affect basement walls and other earth-retaining walls. The implications of unmanaged damp range from mould fungi growth, wood rot and decaying building materials, to finishes including lifting, bubbling, peeling and staining of paint, plaster and wallpaper.

Structural waterproofing barriers or tanking barriers are often used to protect internal surfaces against the effects of lateral penetrating dampness. These types of work are generally undertaken where the source of the penetrating damp cannot be prevented.

Immediate consultation with a licensed plumber is advised to address the cause of the damp and to perform remedial works as necessary.

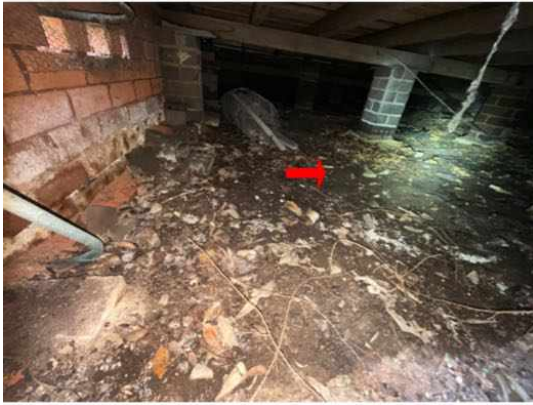
Building:	Main Building
Location:	Subfloor
Finding:	Site drainage— Inadequate
Information:	The site drainage in this area was found to be inadequate at the time of inspection, creating potential for subsequent water damage to associated building elements. This is additionally conducive to termite activity.

It is important that water does not lie against the base of walls; surrounding paths and ground levels should be sloped to drain water away from walls. Downpipes should not discharge stormwater onto lower walls or plinths. Stormwater should be carried away by large, regularly cleaned drains. Ground levels may need to be lowered to expose a buried DPC.

Where site drainage is inadequate, installation of an Agricultural (Aggie) Drain may be required. A licensed plumber should be appointed to further inspect the property and perform any remedial works as necessary. Water damage and secondary defects are likely to occur if left unmanaged.

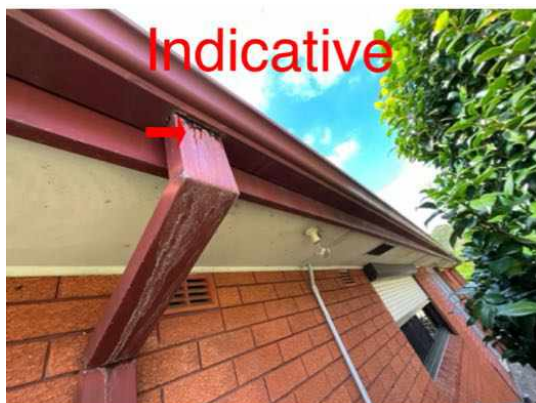
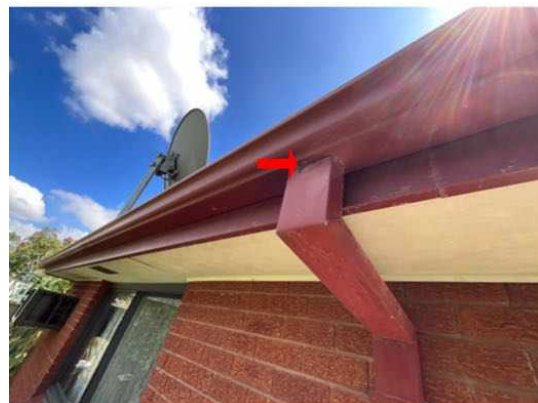
Finding 6.04

Building:	Main Building
Location:	Multiple areas of roof plumbing
Finding:	Water leak - External
Information:	Water leaks were found to be present to exterior plumbing work. Leaks are generally caused by deterioration of the plumbing elements over time, due to exposure to weather conditions, but may have also been caused by minor impact damage.

Such leaking creates damp conditions in the affected area, causing potential for water pooling and subsequent water damage if left unattended. These conditions may also attract termite attack, particularly if the area is subject to minimal levels of sun throughout daylight hours.

It is highly advised that a licensed plumber be appointed to rectify any water leaks that may be present. Areas of repair and replacement of plumbing fittings and fixtures may be required and, as such, a quotation should be sought.

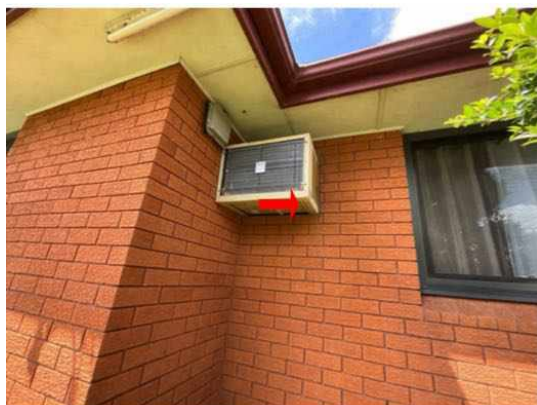
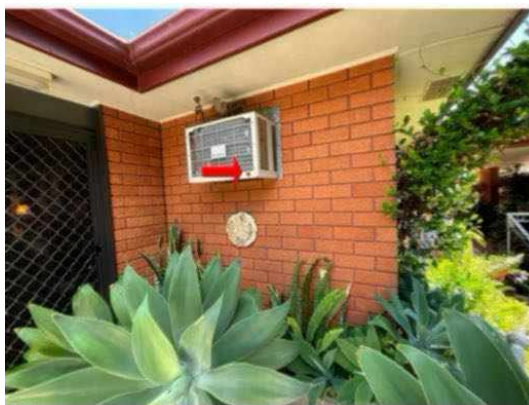
These damp conditions can lead to secondary defects such as rot, rust or corrosion of associated building elements, the formation of fungal decay, or even the creation of potential slip hazards. When coupled with poor site drainage, pooling of water may also attract termite activity to this area.

It is highly recommended that a licensed plumber be appointed to install adequate drainage to the overflow. These works will ensure that the area remains dry and free of any secondary defects.

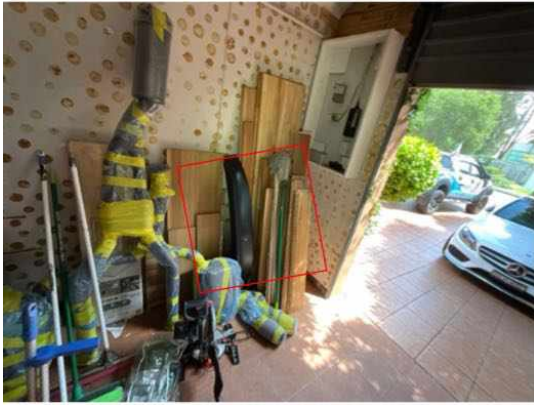
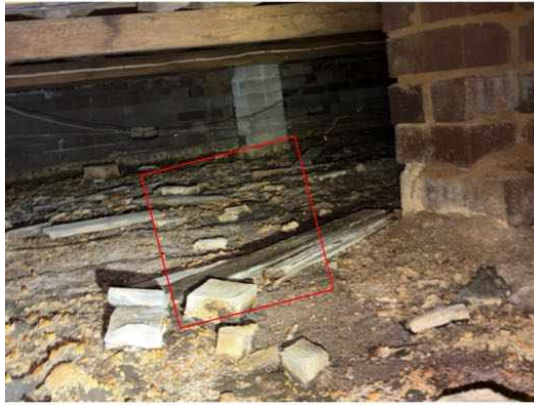
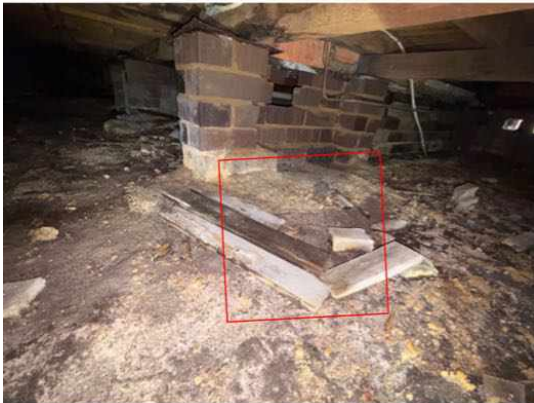
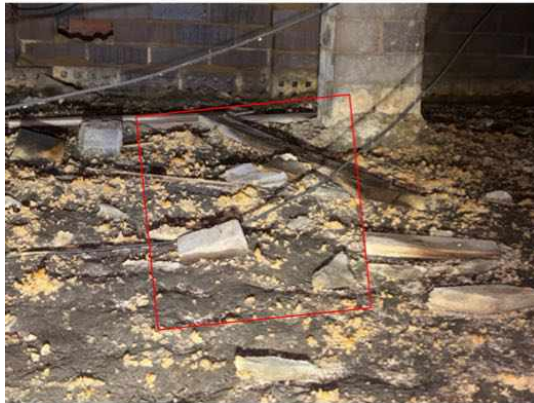
Finding 6.07

Building:	Main Building
Location:	Garage, subfloor
Finding:	Stored timbers - subfloor space or external area
Information:	The storing of timbers in the subfloor space or around the external property increases the risk of termite activity being present. As they are likely to come into contact with weather conditions or excessive moisture wood rot is likely to develop on timbers that are not treated.

It is highly recommended that any stored timbers be immediately removed from areas in which they may attract any termite / timber pest attack. Minimisation of risk / prevention of termite attack is far more adequate than dealing with the presence of termite activity.

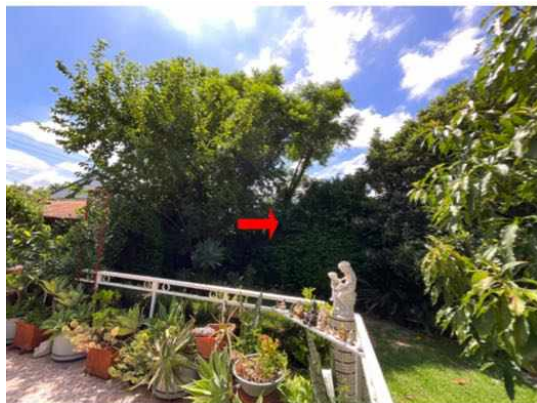
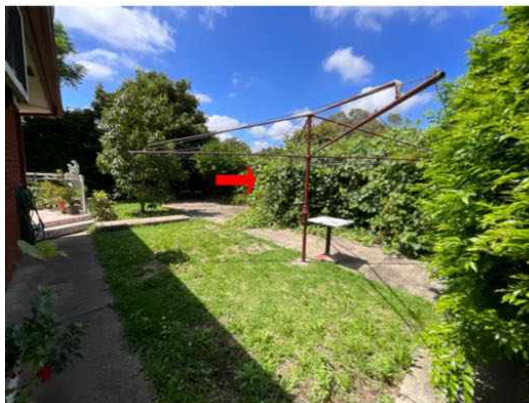
Finding 6.09

Building:	Main Building
Location:	
Finding:	Surrounding bushland - Conductive
Information:	Home and or building is situated in a high risk area for termite activity, due to close proximity to surrounding bushland.

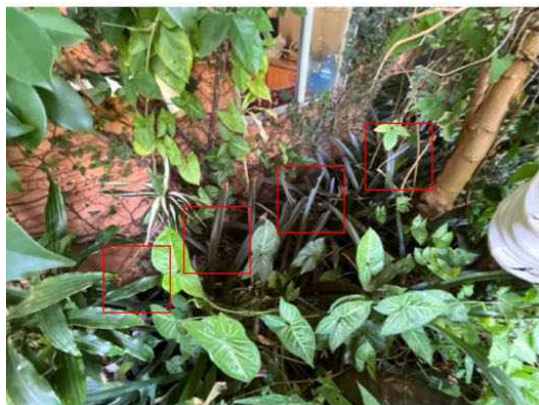
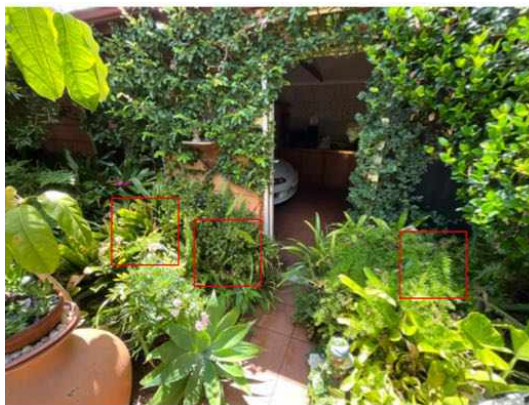
Finding 6.11

Building: Main Building
 Location: Garage
 Finding: Bridging or breaching of termite barriers - adjacent internal flooring
 Information: Bridging is the spanning of a termite barrier or inspection zone so that subterranean termites are provided with passage over or around that barrier.

internal flooding is likely to occur which may attract termite activity to the internal area.

It is highly advised that a landscaper or paver be appointed to lower external grounds that are raised above adjacent internal flooring. Alternatively if external grounds and internal flooring is level installation of a raised door sill may be appropriate in preventing any water pooling in the area.

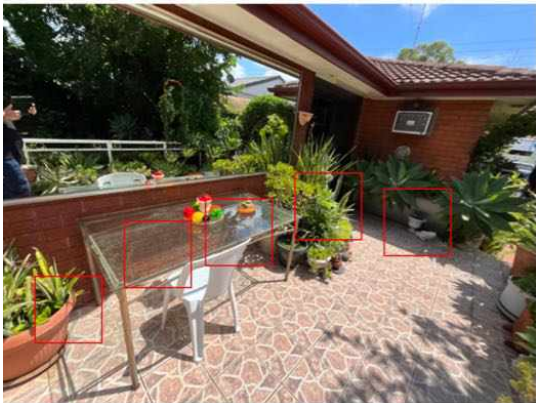
Finding 6.12

Building:	Main Building
Location:	Alfresco
Finding:	Bridging or breaching of termite barriers - damp course level
Information:	Bridging is the spanning of a termite barrier or inspection zone so that subterranean termites are provided with passage over or around that barrier.

Damp proof course (DPC) is a barrier of impervious material built into a wall or pier to prevent moisture from moving to any part of the building. Where external ground levels are built up over this barrier ingress is provided for moisture from the exterior grounds into the base brickwork or other building material and allowed to rise.

Such conditions attract termites into these damp areas which is likely to lead to infestation if left untreated.

While retrospective fitting of DPC is considered to be impractical works are required in order to prevent the extraction of moisture from the external environment into exterior brickwork or wall materials. Landscaping or re-paving of external grounds may be considered by the client. Regular annual inspections are strongly advised.

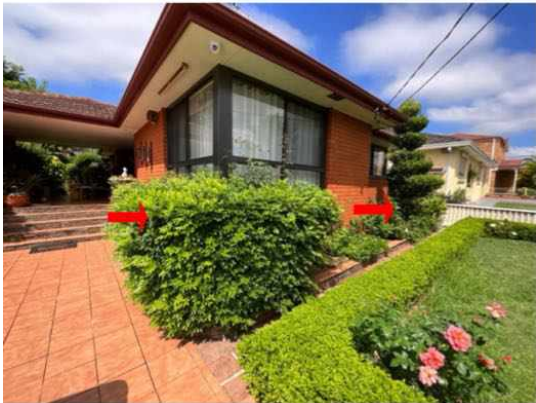
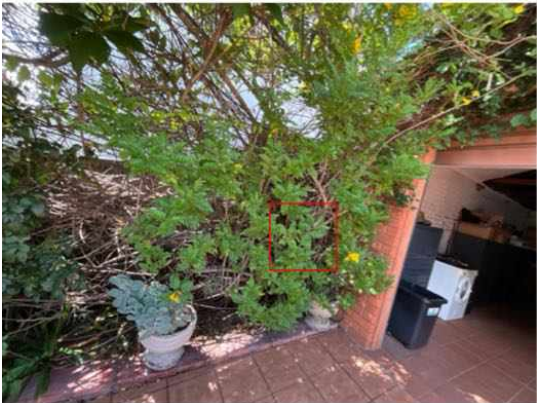
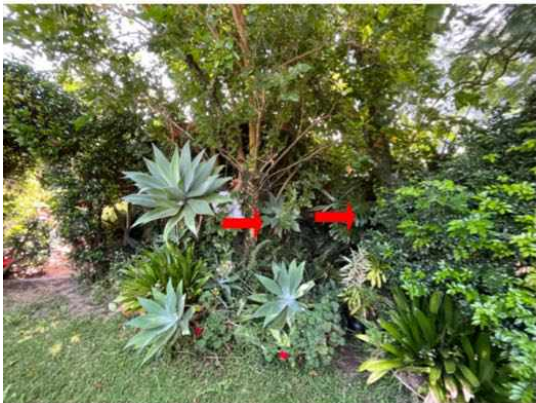
Finding 6.13

Building: Main Building
 Location: Vegetation
 Finding: Vegetation - Abutting property
 Information: Vegetation against external wall may have an invasive root system. If there are weak points in the brick work or concrete slab, it is possible for the roots to gain entry into these areas. Once the roots have gained entry, it is possible for termites to gain concealed entry via these roots. It is recommended to remove the vegetation and root system where possible.

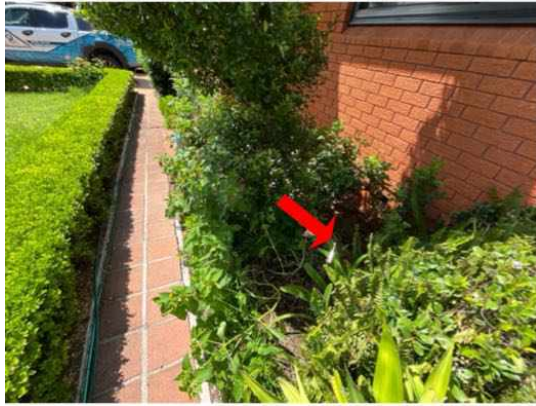
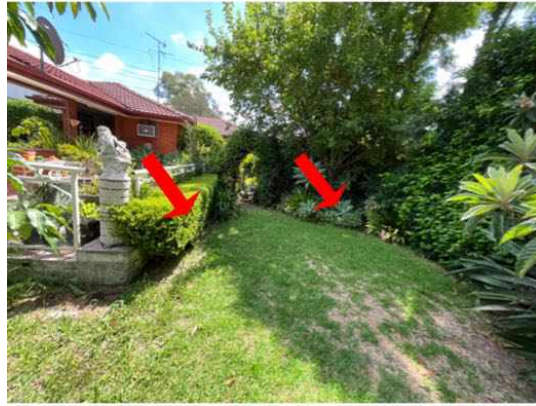
Finding 6.14

Building:	Main Building
Location:	Garden beds
Finding:	Garden Beds
Information:	Garden beds were found to be evident in the garden area. These garden beds can include untreated timber, and with a combination of moisture from watering hosing can make conditions conducive to termite activity and termite ingress.

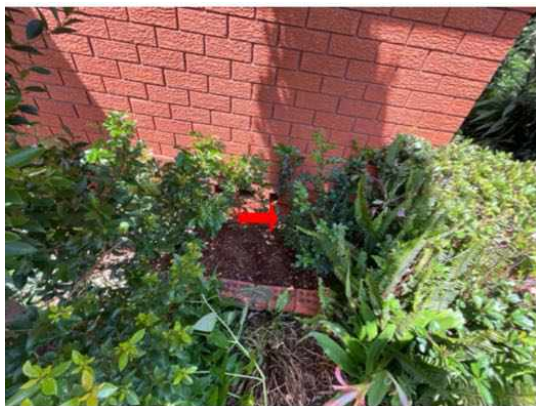
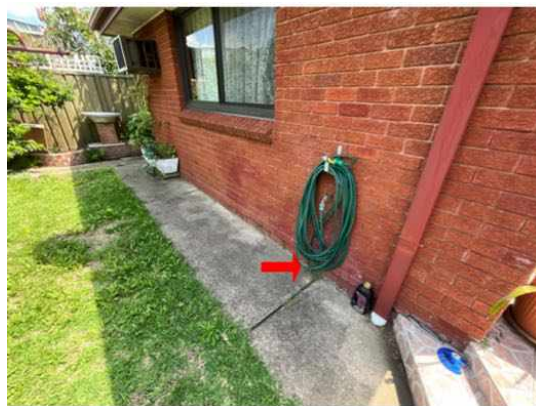
Finding 6.15

Building:	Main Building
Location:	External tap
Finding:	Tap - No drain
Information:	The external tap in this area was noted to have no drain at the time of inspection.

This keeps the surrounding surfaces damp while using the tap, which becomes conducive to termite activity.

A licensed plumber must be appointed to ensure an appropriate drain is installed.

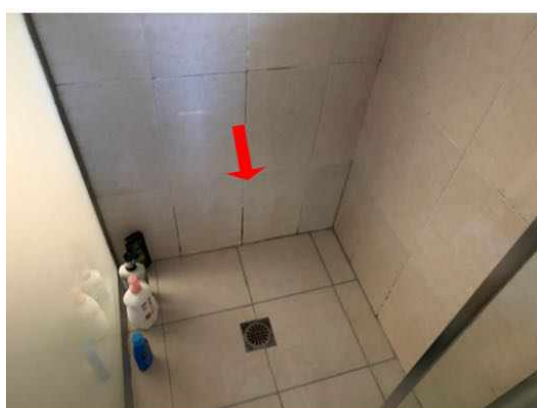
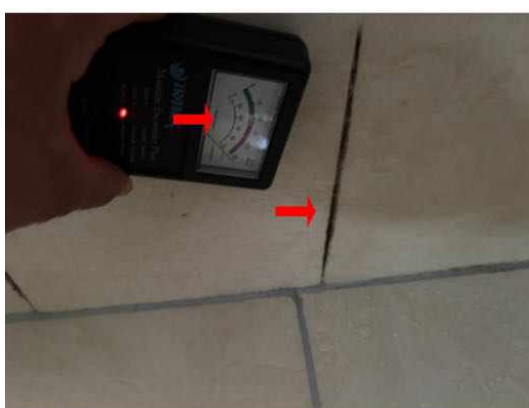
Finding 6.16

Information: Damp is evident to the lower 400mm of wall to the shower alcove. This defect is quite common, and is suspected to have been caused by moisture permeating or leaching through the grouting and sealant in this area, which shows evidence of deterioration. Leaking pipes within the wall is also a possible cause however this seems unlikely in this instance as there is no moisture build up around the taps or transferring to the other side of the wall. There appears to be no sealant around the tap spindles which may be a small contributing factor.

Damp (or structural damp) refers to the presence of unwanted moisture in the structure of a building, either as the result of intrusion from outside, or condensation from within the structure. In the shower area, internal water leaks, degraded materials or other sources of excessive moisture are generally the cause of damp.

Unmanaged damp in the shower recess is likely to facilitate the formation and development of mould and fungi growth, decaying associated building materials and compromising their structural integrity of associated elements. It is important to address damp conditions, as the World Health Organisation notes that excess moisture leads - on almost all indoor materials - to growth of microbes such as moulds, fungi and bacteria, which subsequently emit spores and other matter into the indoor air. Exposure to these contaminants is associated with a wide range of respiratory and other health-related problems. Damp conditions also create a conducive environment for termite infestation.

Consultation with a bathroom sealant specialist is advised immediately to identify the cause of damp and to perform remedial works as required.

Always ensure that sealant and grout is in good condition to prevent any moisture issues occurring in the future.

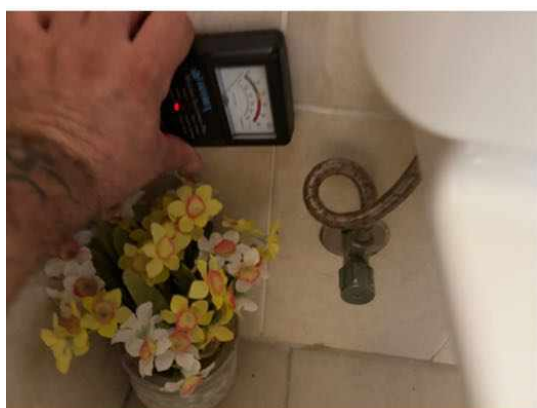
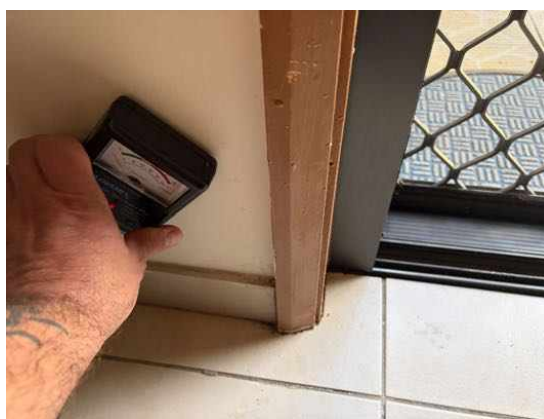
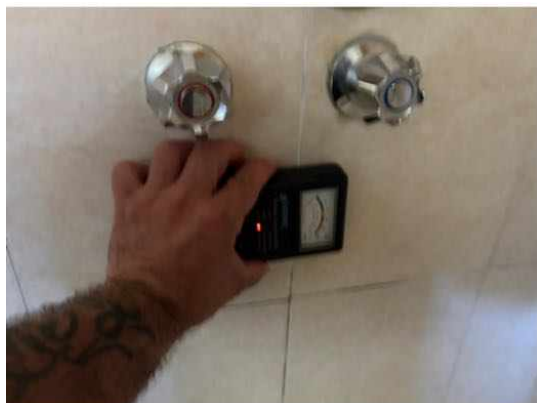
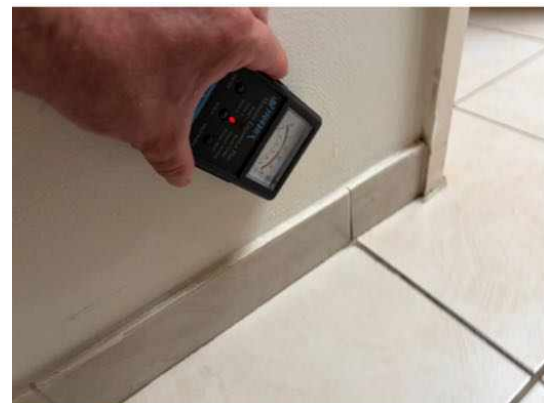
Noted Item

Building: Main Building
Location: All Areas
Finding: Moisture metre
Information: During the inspection the property was checked for moisture using a moisture metre.

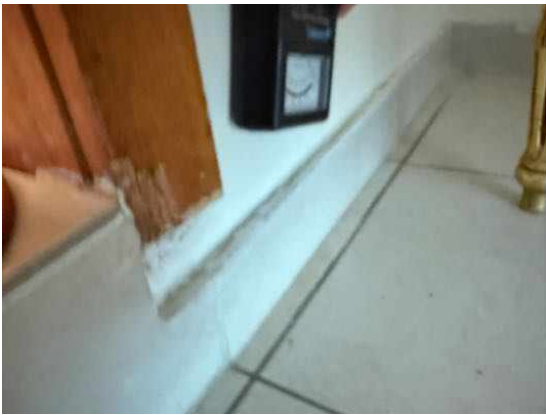
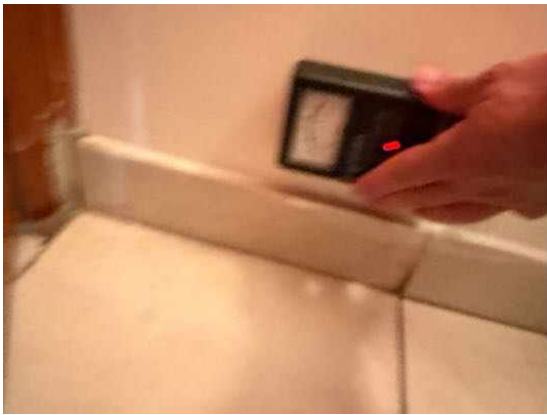
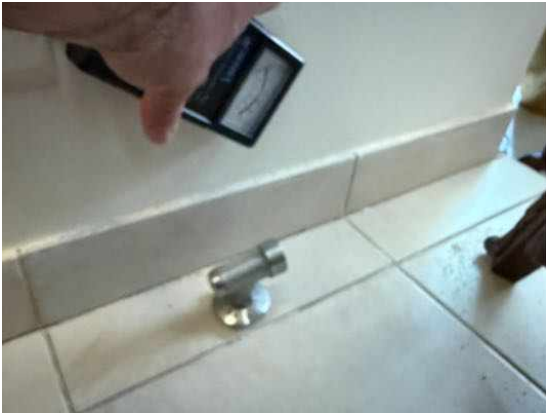
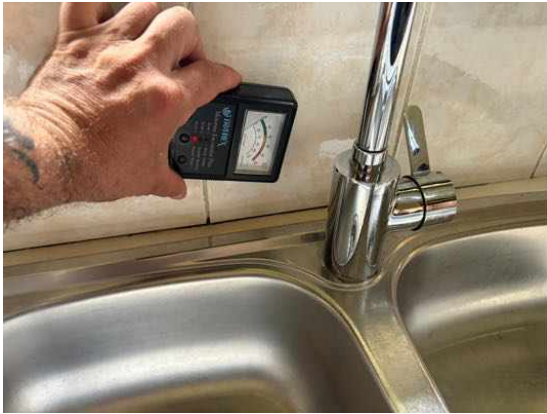
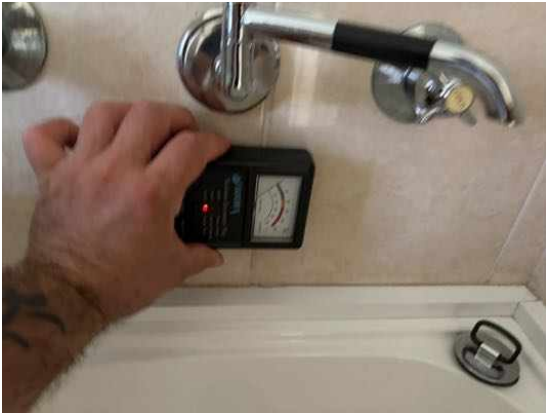
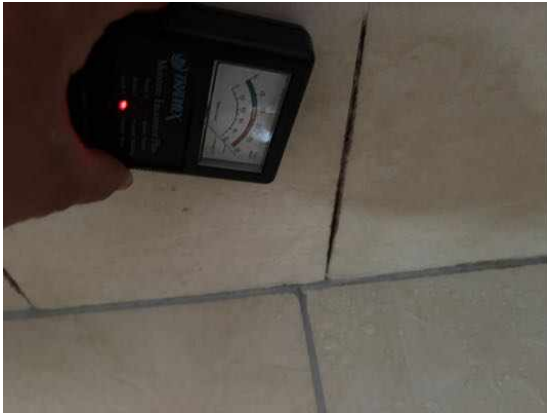
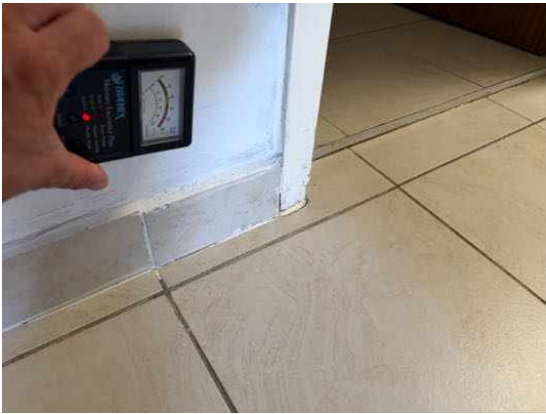
This is for information only.
