Building and Timber Pest Inspection Report

Inspection Date: Thu, 19 Feb 2026

Property Address: 108 Alfred Rd, Chipping Norton NSW 2170,
Australia

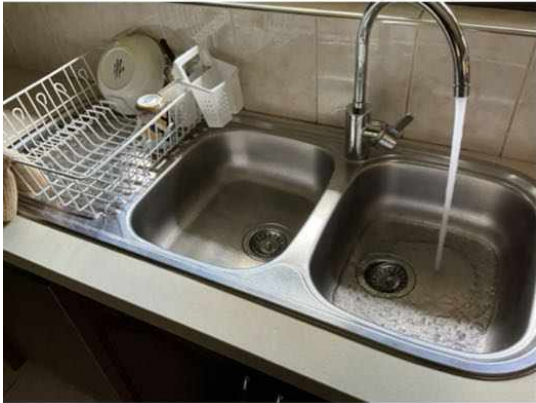
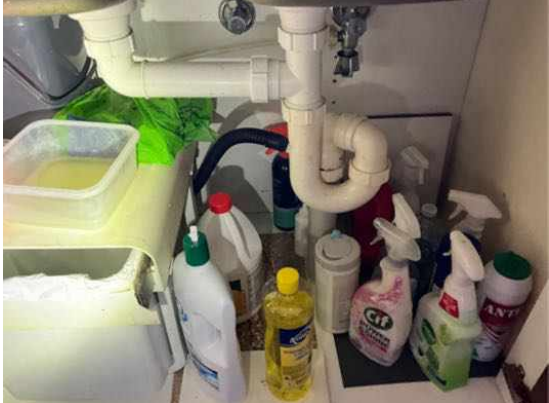
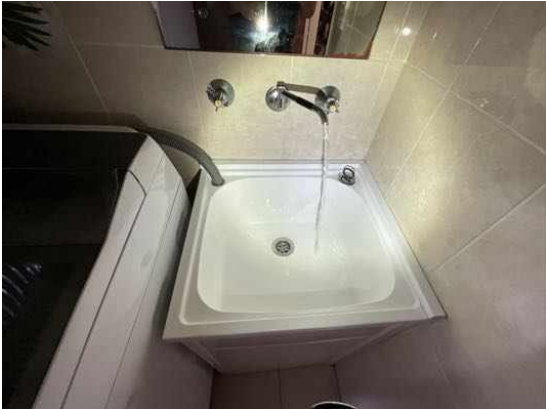
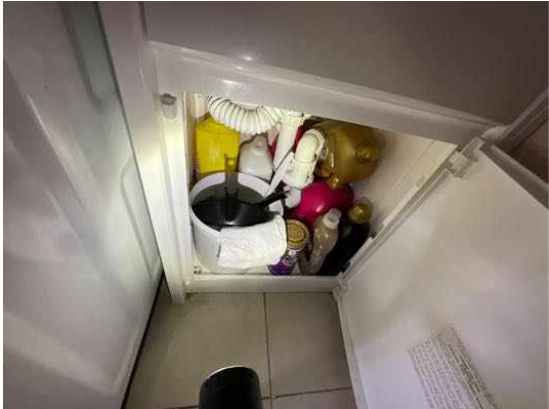
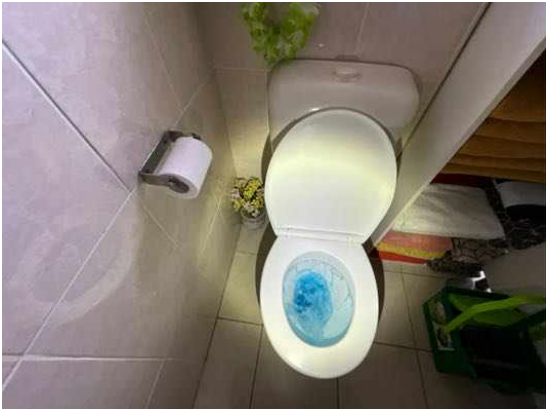
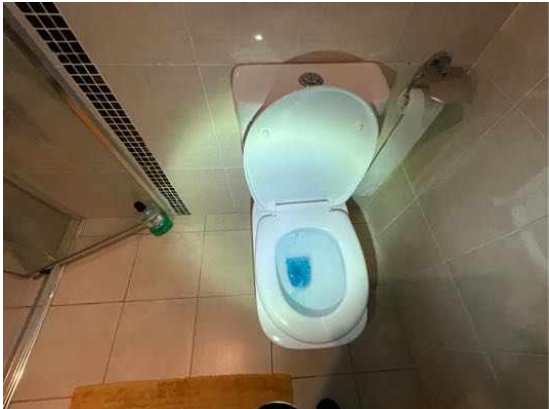
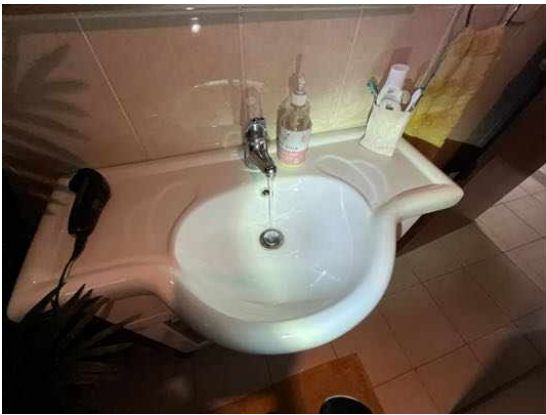
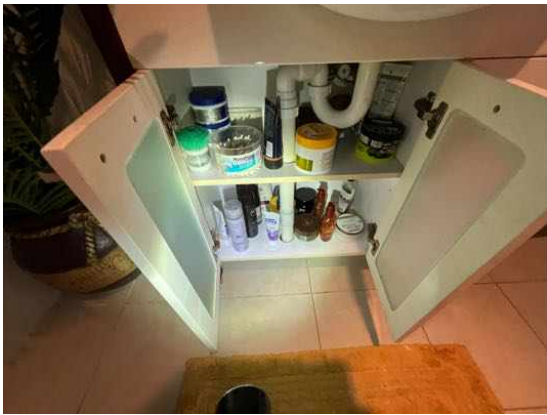
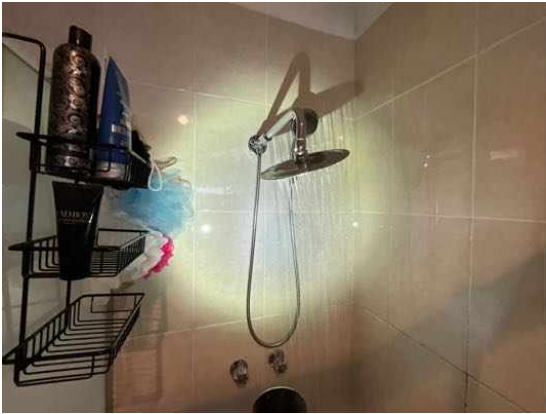
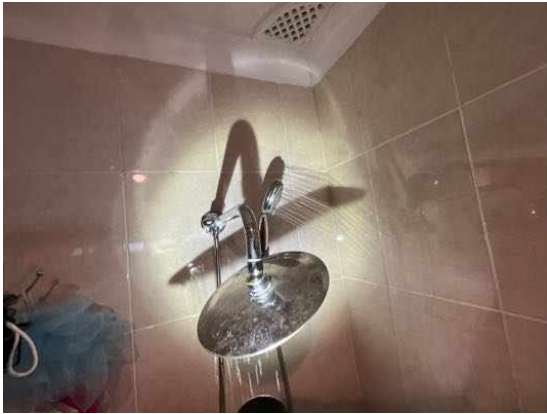
Building: Main Building
Location: All Wet Areas
Finding: Additional Photos
Information:

Additional photos are provided for your general reference.

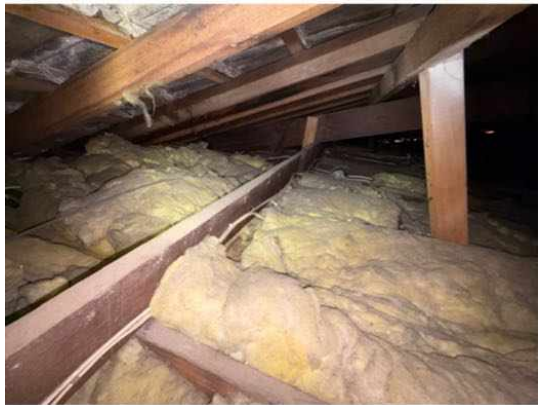
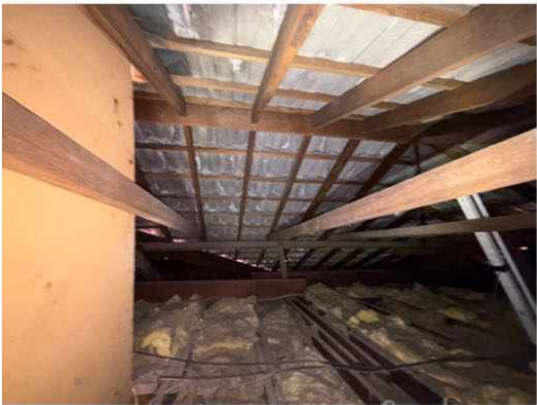
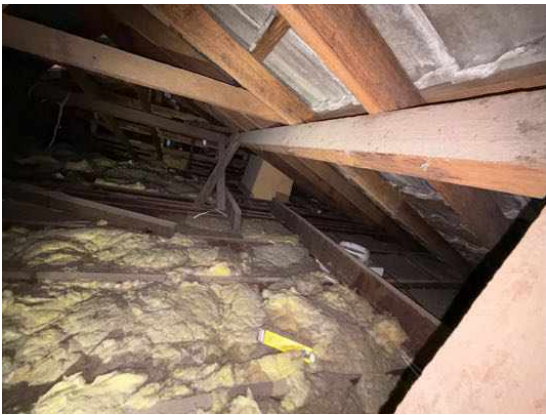
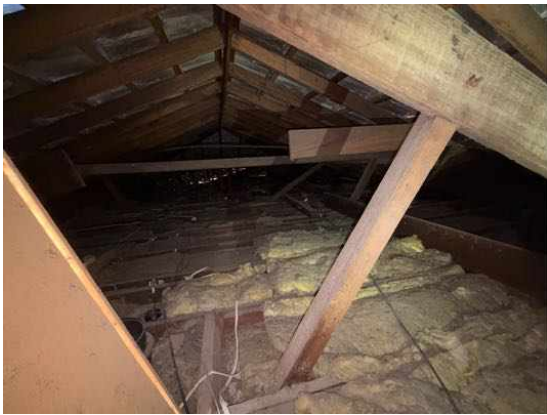
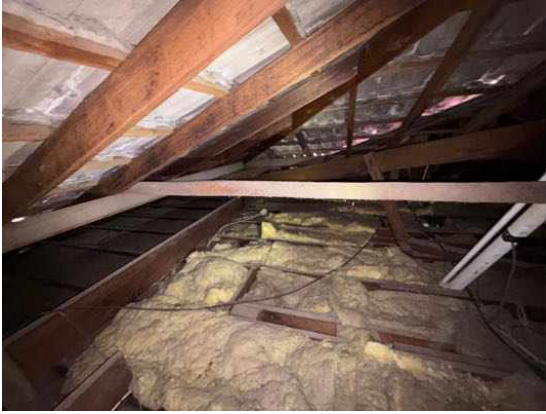
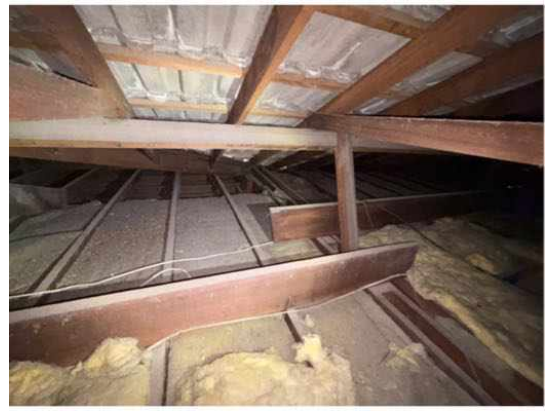
Building: Main Building
Location: Roof Void
Finding: Additional Photos
Information:

Additional photos are provided for your general reference.

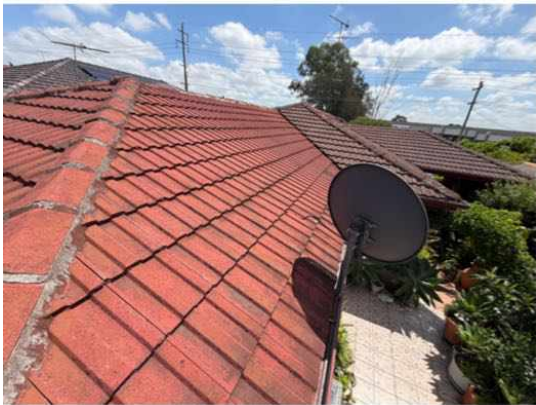
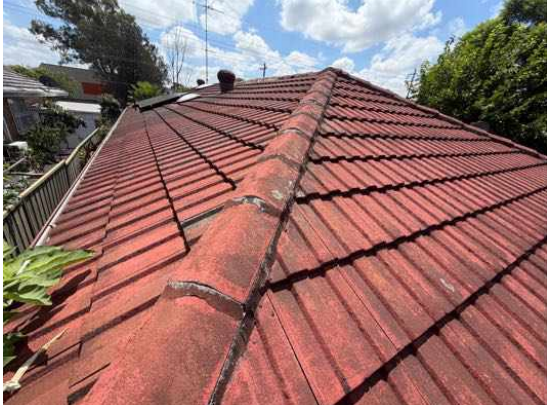
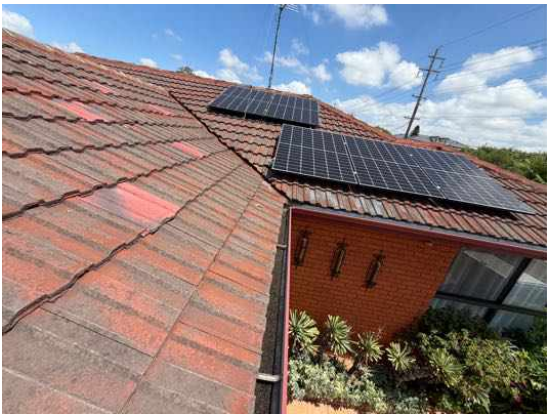
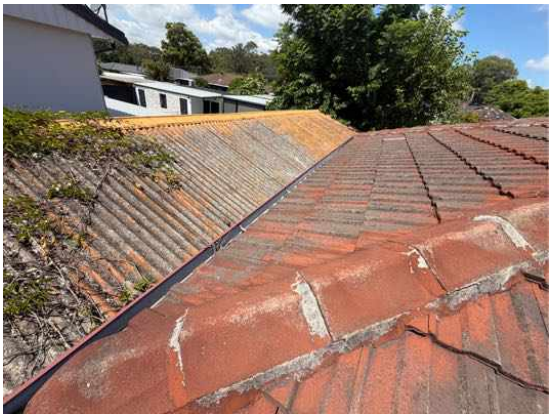
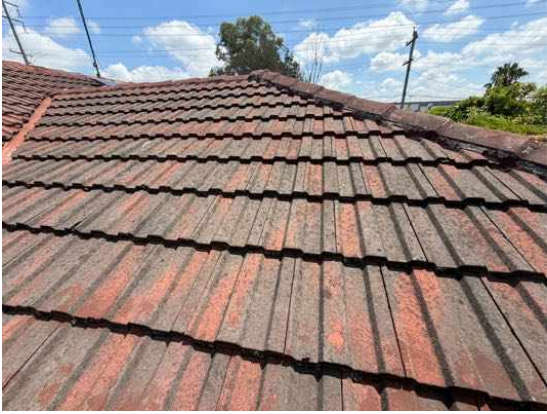
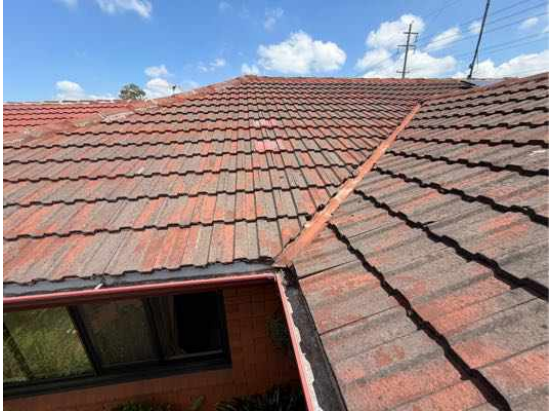
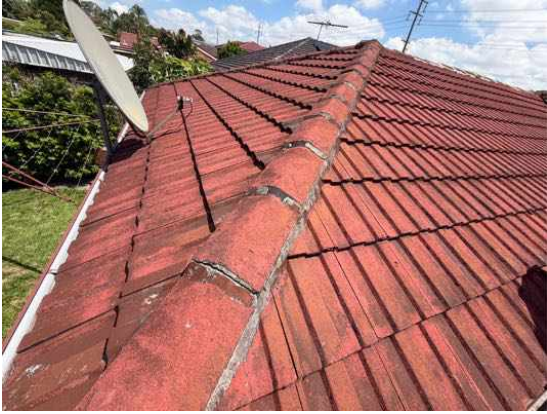
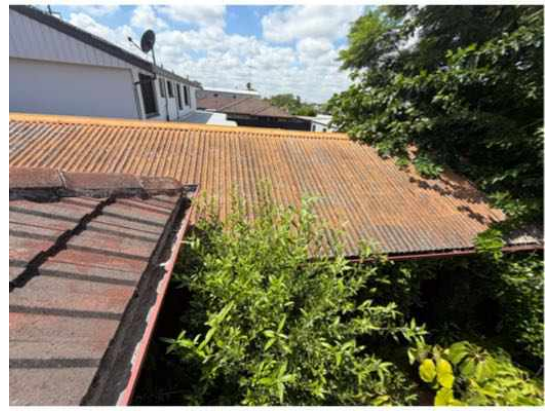
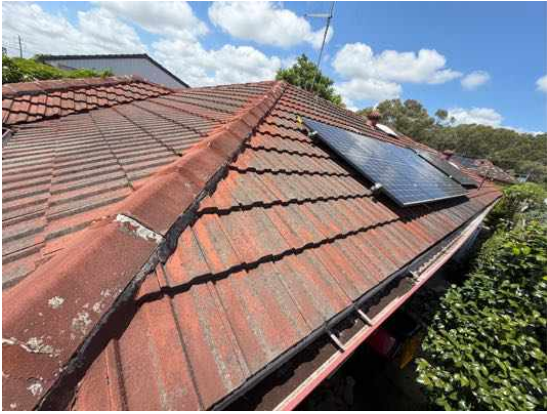
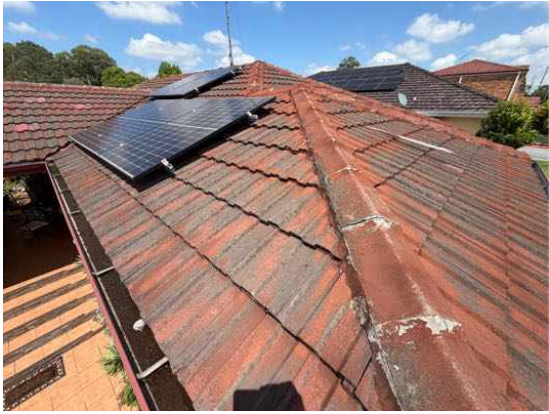
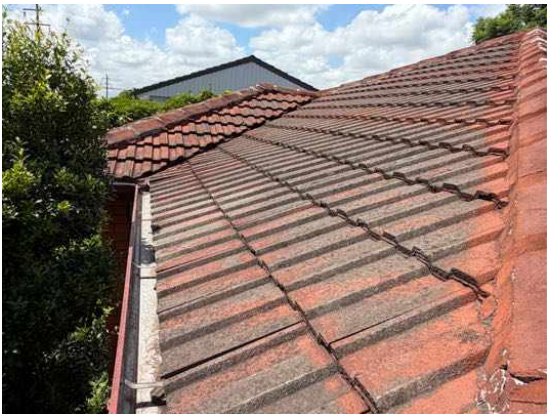
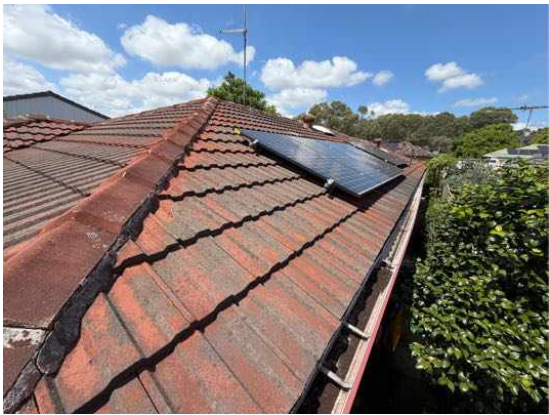
Building: Main Building
Location: Roof Exterior
Finding: Additional Photos
Information:

Additional photos are provided for your general reference.

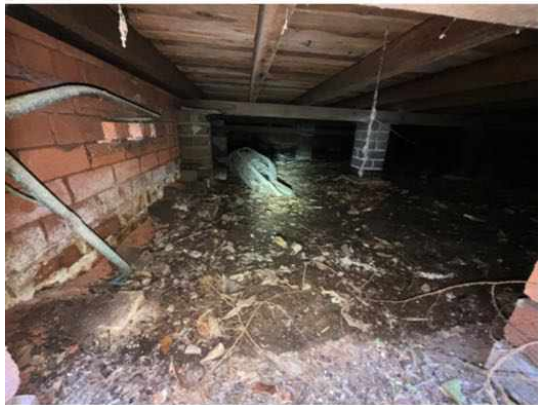
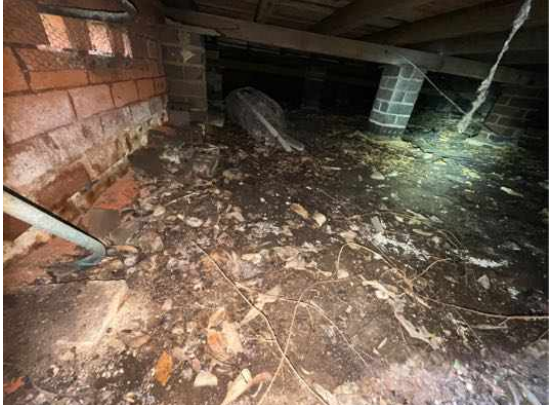
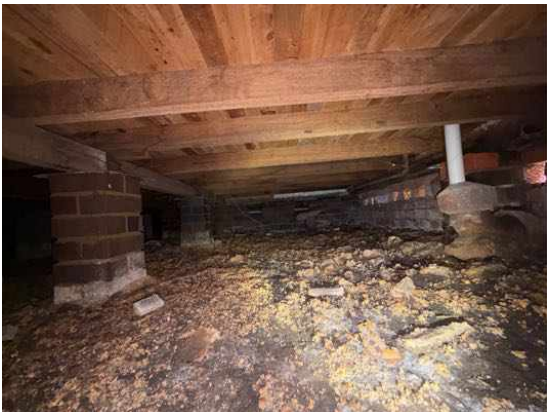
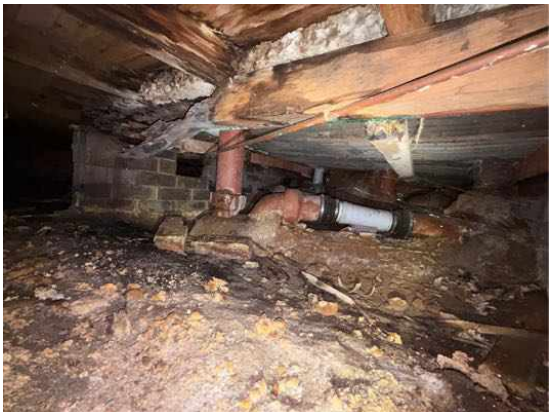
Finding: Additional Photos

Information: Additional photos are provided for your general reference.

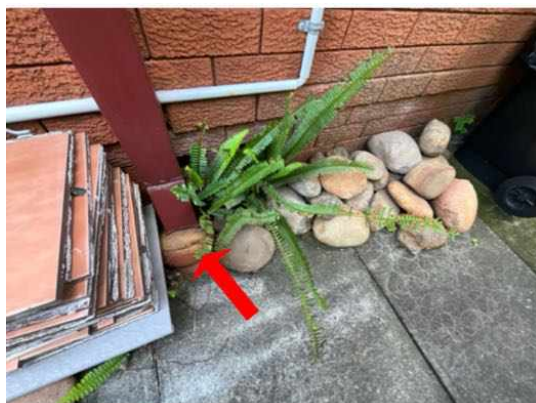
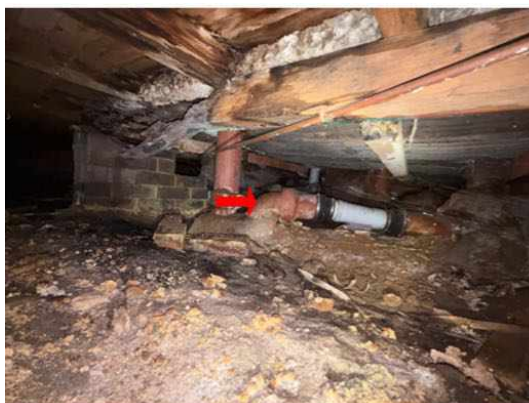
Building: Main Building
 Location:
 Finding: Pipework - Old urban wear pipes
 Information: Old urban wear pipes were identified at the time of inspection.

Consultation with a licensed plumber is advised. CCTV inspection on pipes may be required.

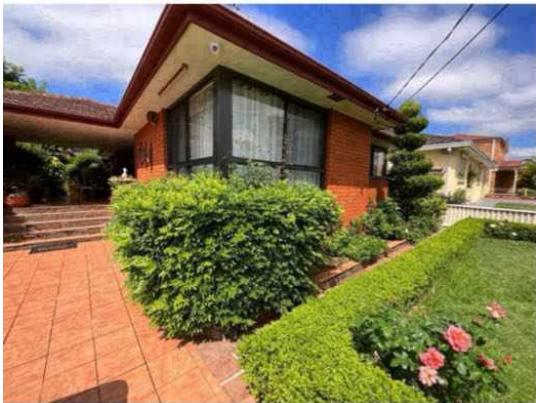
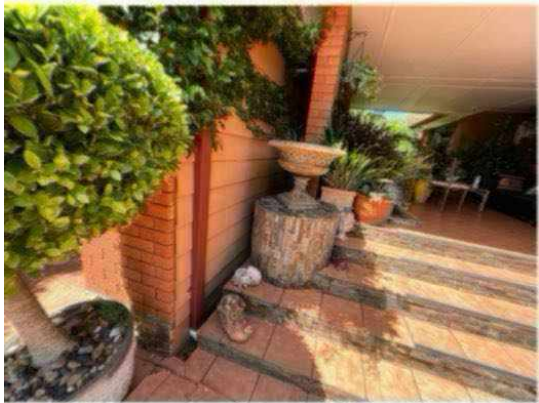
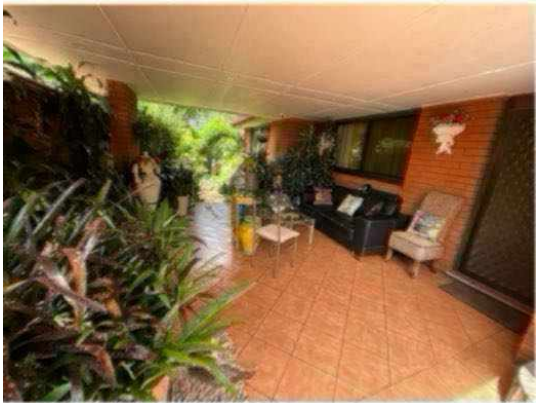
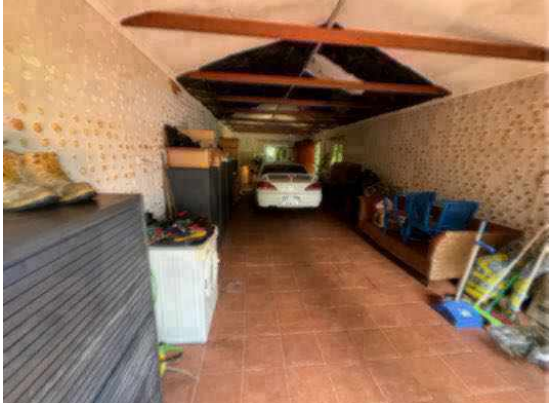
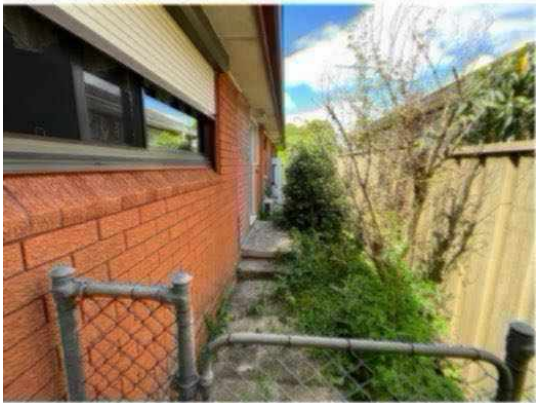
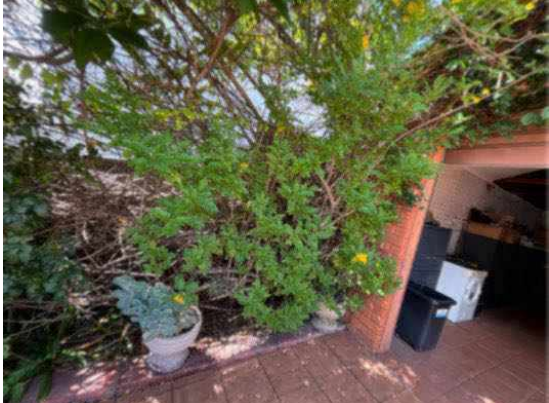
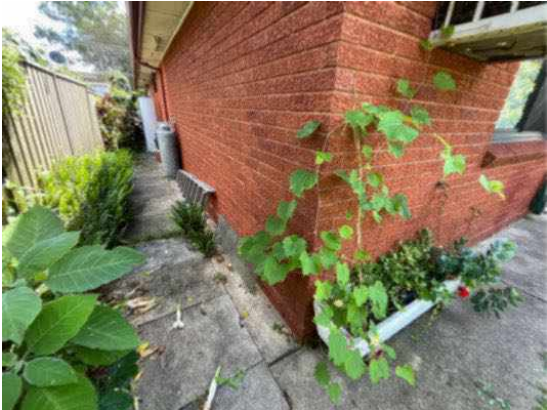
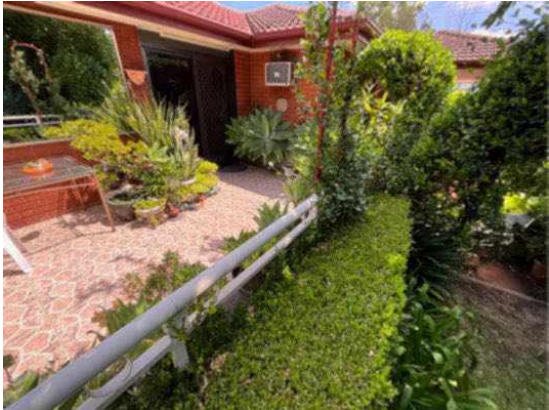
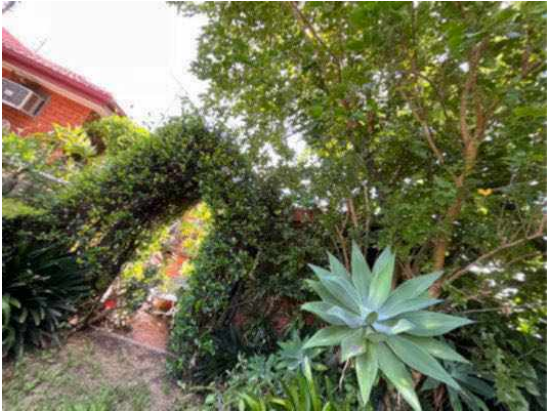
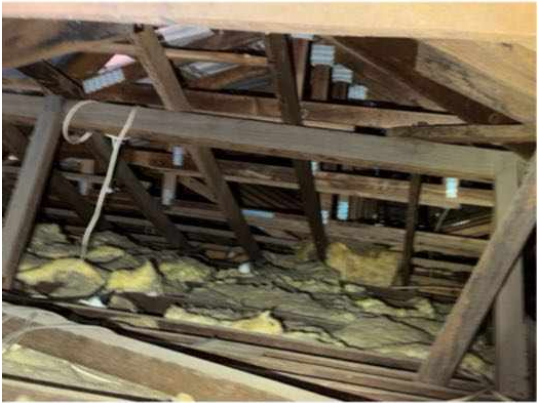
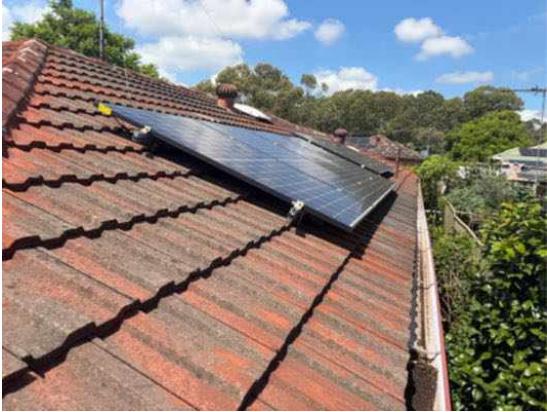
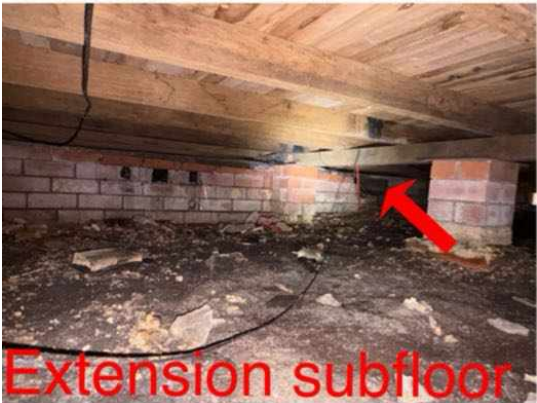
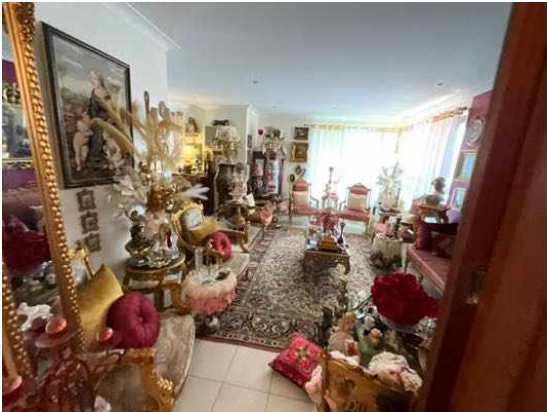
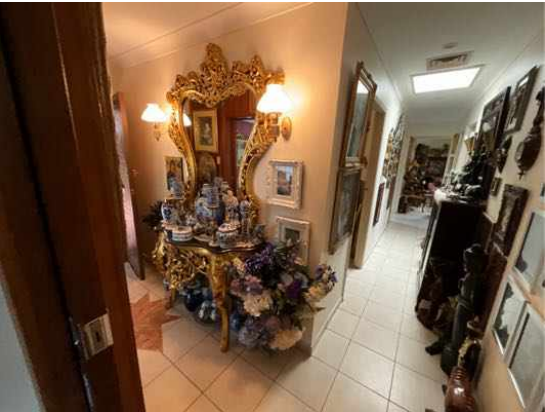
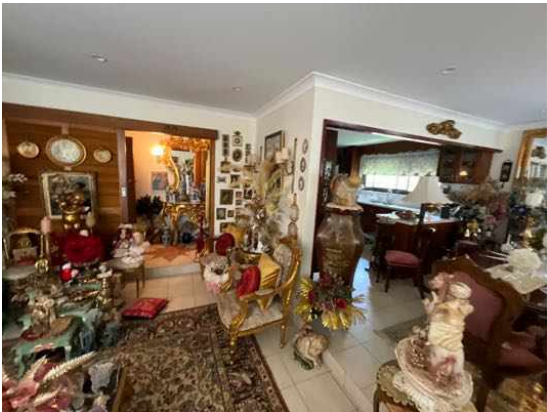
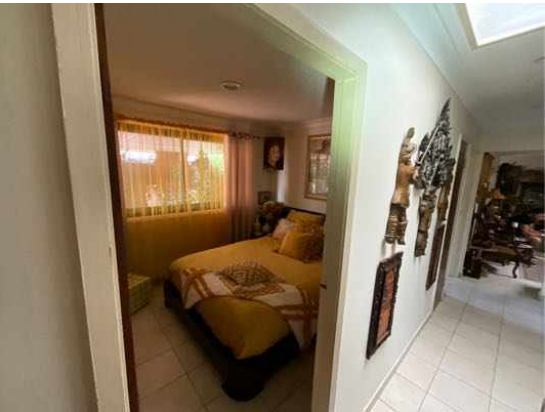
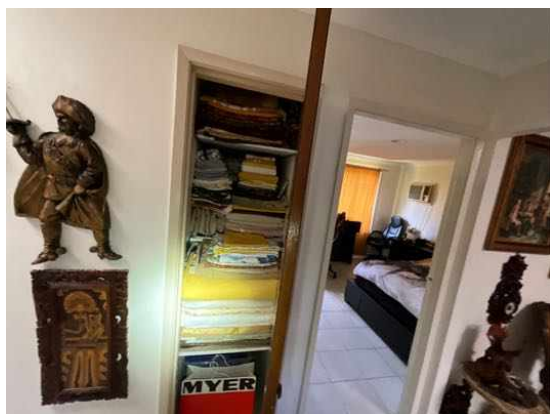
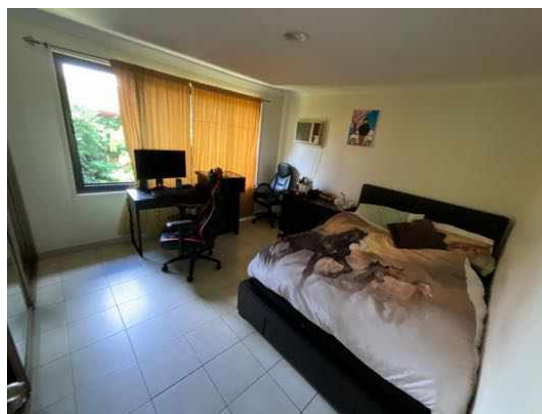
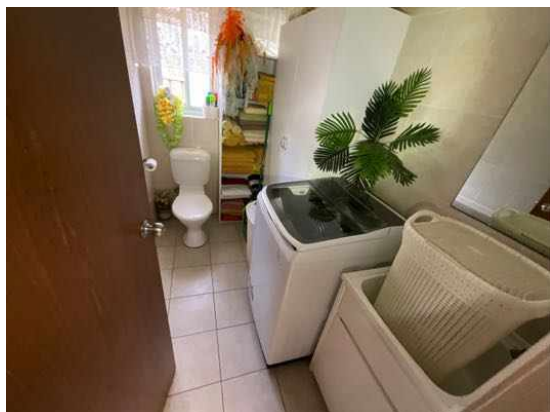
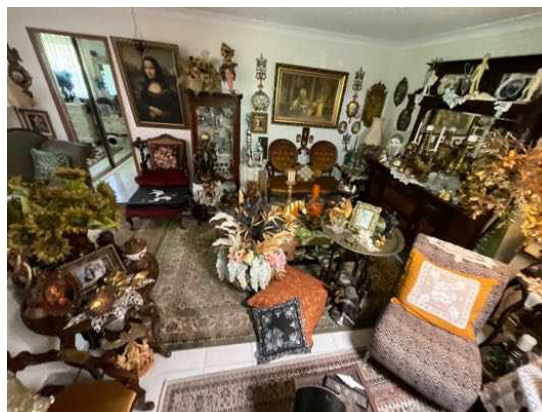
Building: Main Building
 Location: All Areas
 Finding: Additional Photos - Obstructions and Limitations
 Information:

These photographs are an indication of the obstructions and limitations which impeded full inspection of the property at the time of inspection. These obstructions can hide an array of defects and should be removed to allow full inspection to be carried out. A re-inspection is recommended once the areas are made accessible.

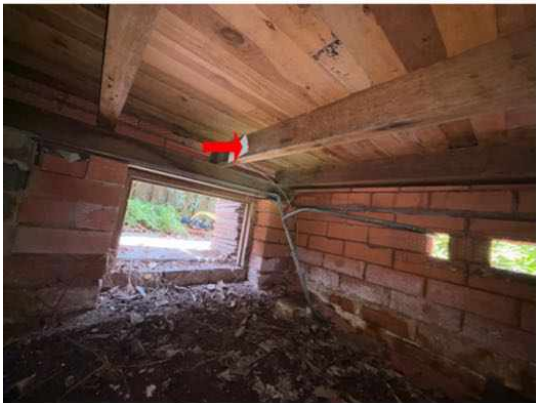
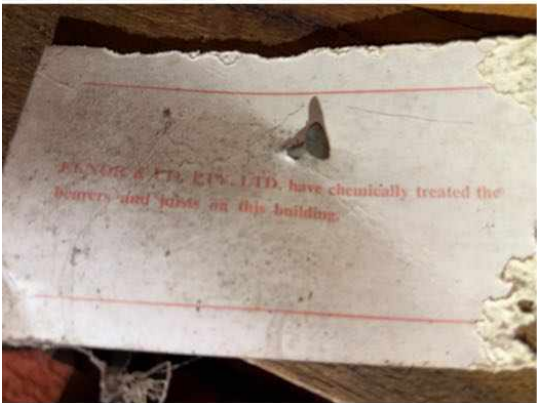
The following items were noted as - Evidence of a previous termite management program

Where a Termite Management System has been identified you should refer to the type of barrier date of installation warranty conditions and any documentation provided by a builder or past owner. Consult the company who installed the barrier to confirm whether the system is still under warranty.

Most chemical termite management systems expire and require replenishment and all physical systems are primarily designed to prevent concealed entry.
