Building and Timber Pest Inspection Report

Inspection Date: Thu, 26 Mar 2026

Property Address: 14 Illawarra St, Mosman NSW 2088,
Australia

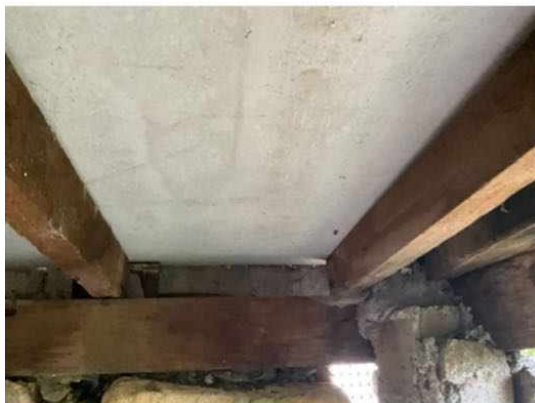
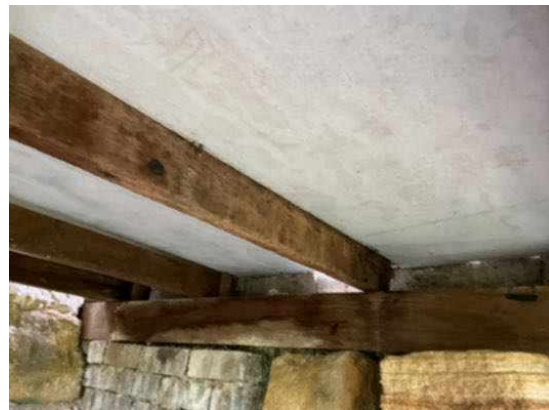
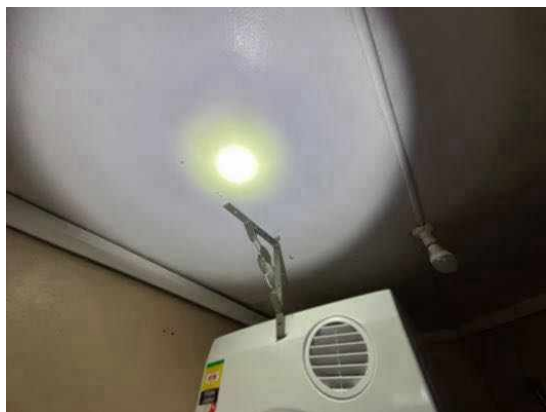
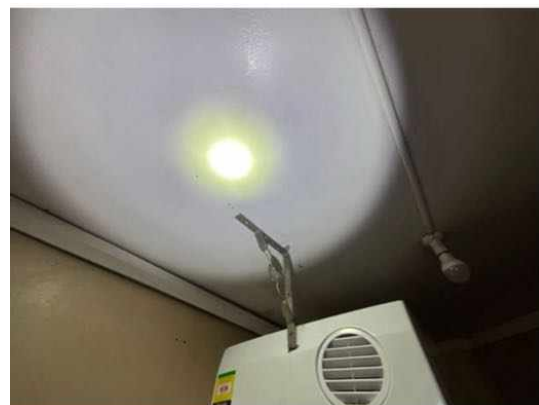
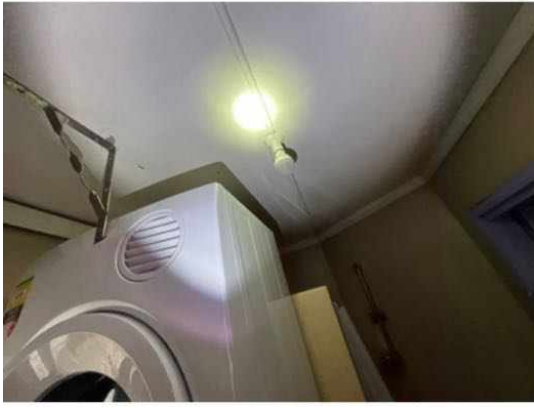
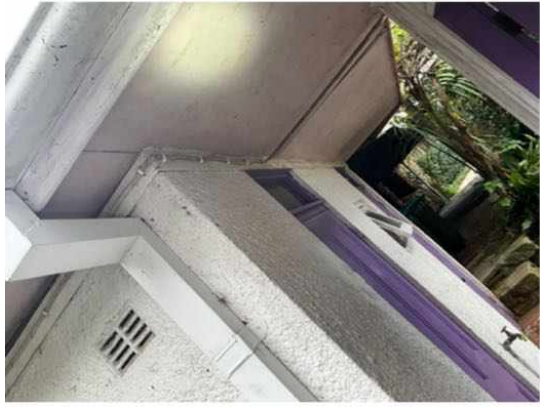
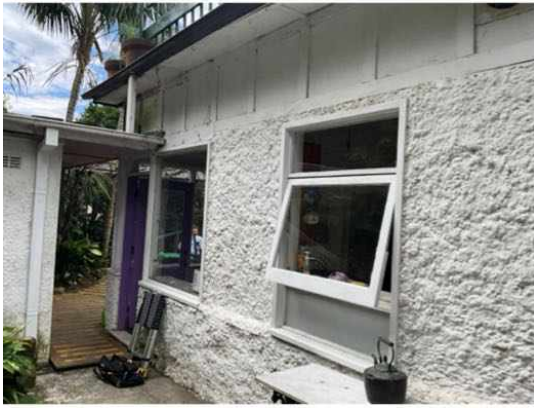
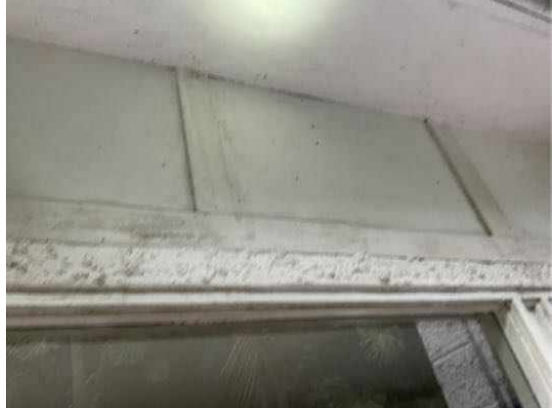
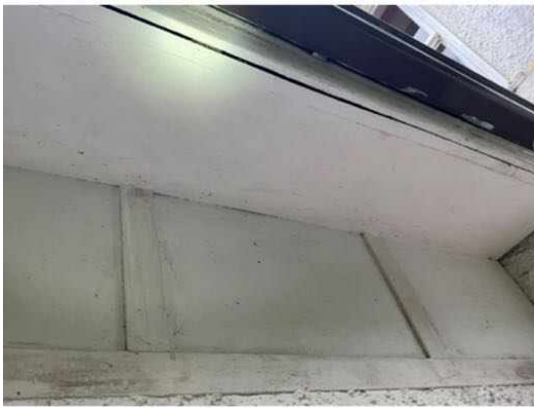
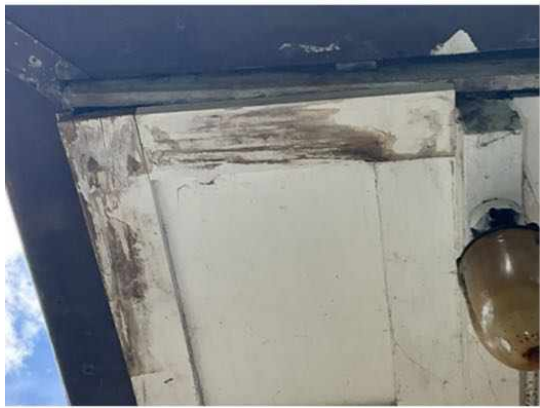
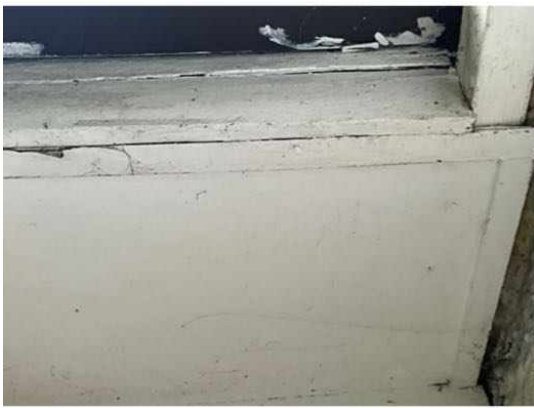
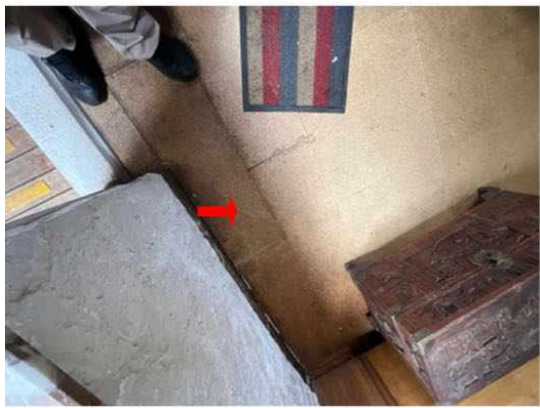
Building:	Main Building
Location:	All Areas
Finding:	Asbestos - Suspected ACM Identified on Site
Information:	Reporting on Asbestos is outside the Scope of this Report. This suspected defect is highlighted as a caution only. We suspect, based on our experience in the building industry, that there is a higher risk of the identified building element containing asbestos.

As Asbestos Reporting is outside the scope of this report, we advise that you consider a separate Asbestos Inspection and Condition Audit, which can include the taking of samples for definitive confirmation of the presence of Asbestos.

In the interim, the client is advised to act with caution, especially when considering any damage to building materials general wear and tear renovations extensions demolition and general maintenance activities due to the suspected presence of Asbestos.

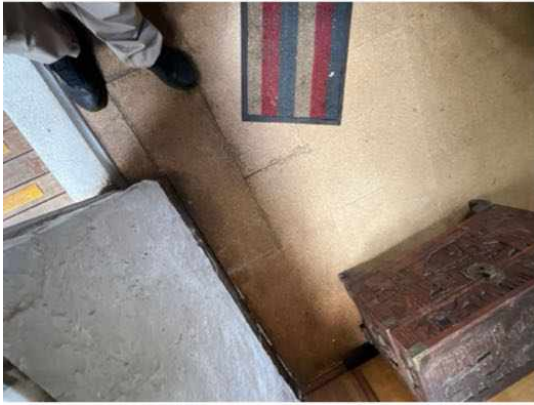
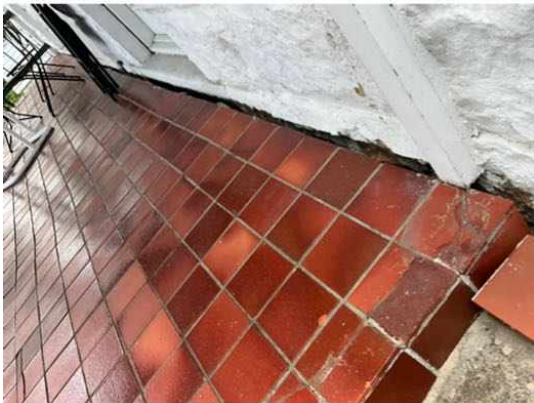
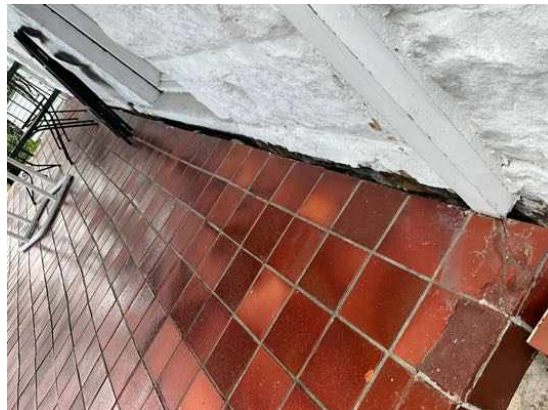
Finding 1.02

Building:	Main Building
Location:	Deck
Finding:	External timber balcony or deck-structural stability
Information:	The load capacity of the external balcony or deck could not be verified during the inspection.

External timber structures are also constantly exposed to weather deteriorates in an exhilarate manner, ongoing assessments are required.

It is highly recommended that a structural engineer further, assess the external timber balcony or a deck to inform the client of its load capacity.

Regular maintenance inspections by competent practitioners is needed.

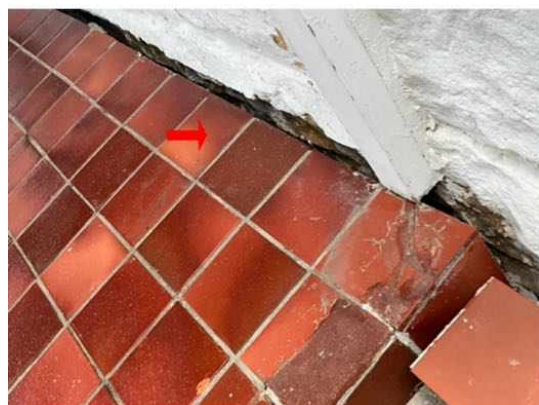
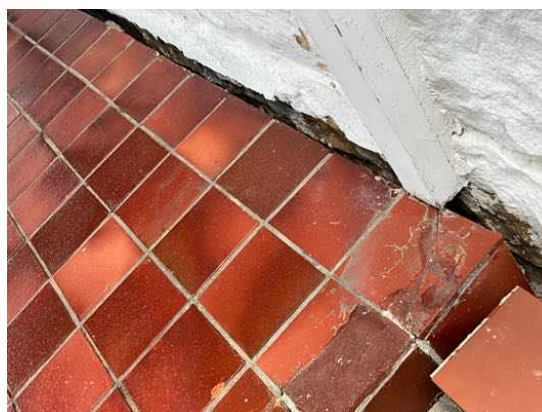
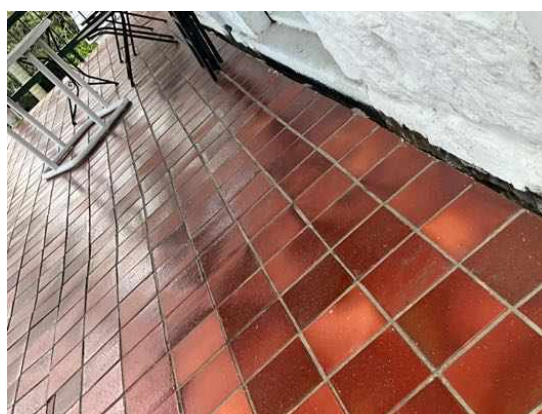
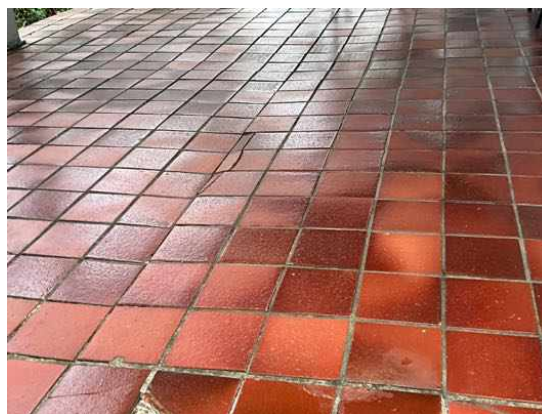
Finding 2.03

Building:	Main Building
Location:	Deck
Finding:	Subsidence - Structure
Information:	It appears that the structure has been affected by movement of the foundations, often referred to as sinking or subsidence. Whilst a degree of movement is expected over time, especially as environmental conditions change and buildings 'settle' after construction, this degree of subfloor movement requires attention.

General subsidence is usually initiated by changes in soil moisture content. The most critical factor is identifying the specific causes, and identifying if this is a recurring or ongoing problem, or one that has been resolved by previous works in the past.

Subsidence can have complex and varying causes, which will influence the required remedial works. It is advised to begin by consulting a structural engineer to determine the required scope of works. This generally includes some form of underpinning, as well as addressing the underlying cause. Consultation with a geotechnical engineer may also be necessary where changes to soil moisture content is apparent.

A Registered Builder specialising in carry out works as advised by an Engineer.

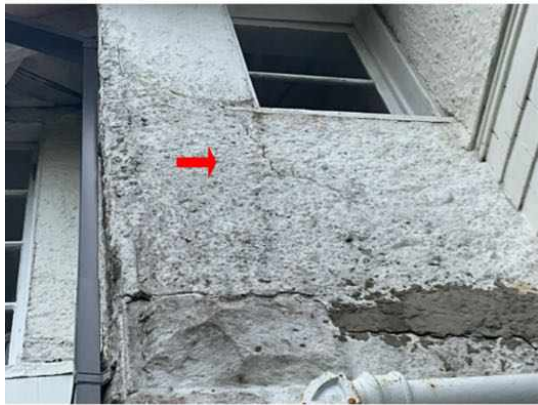
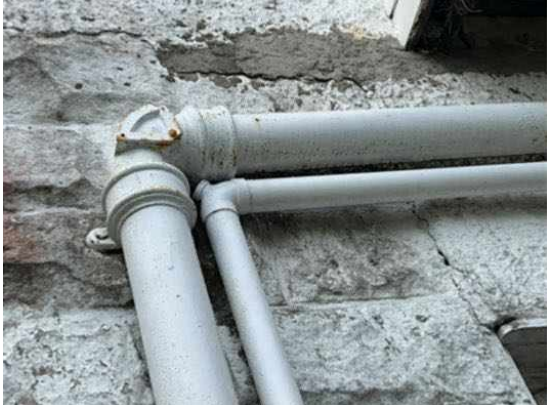
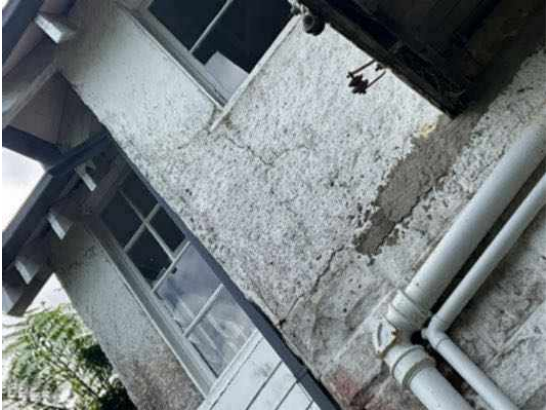
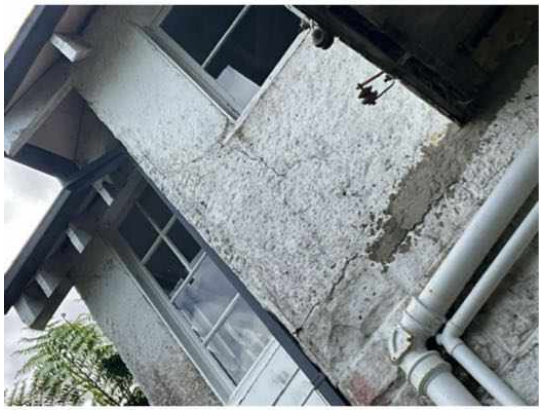
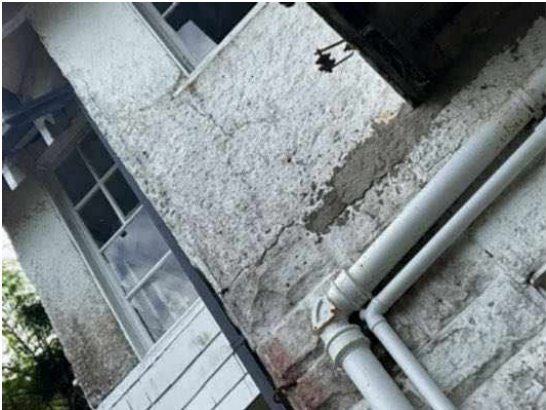
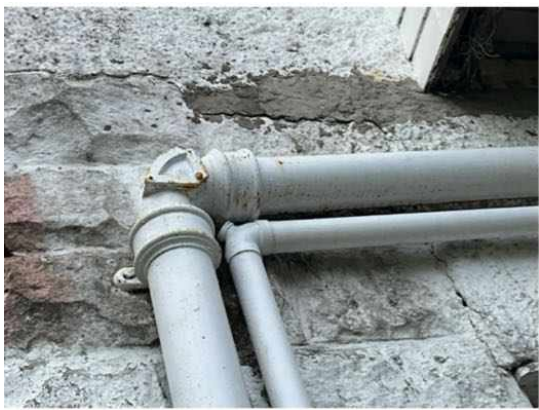
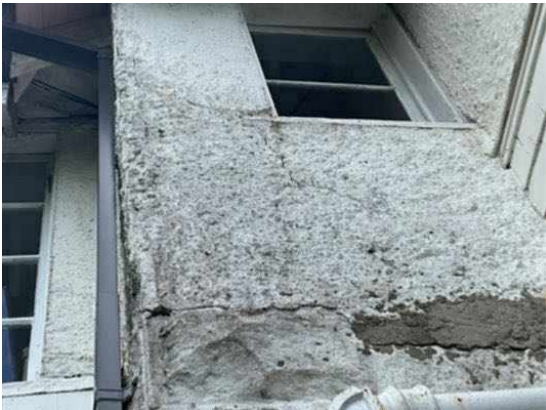
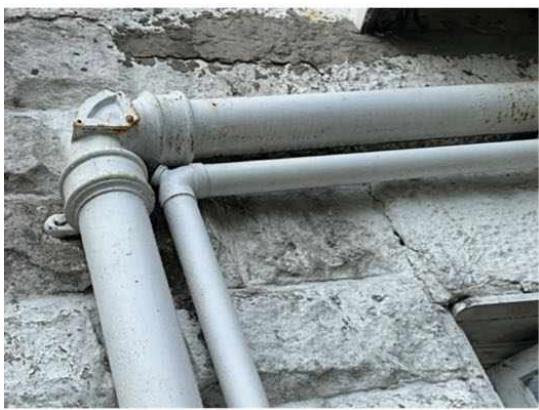
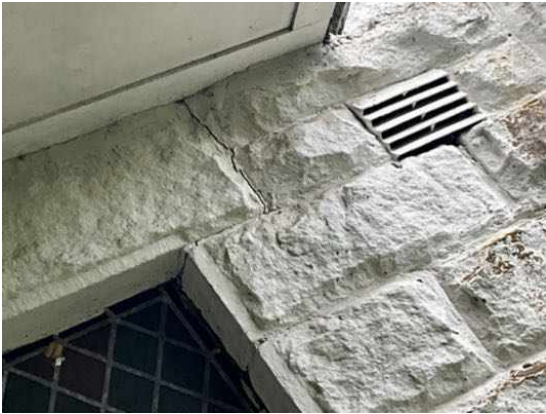
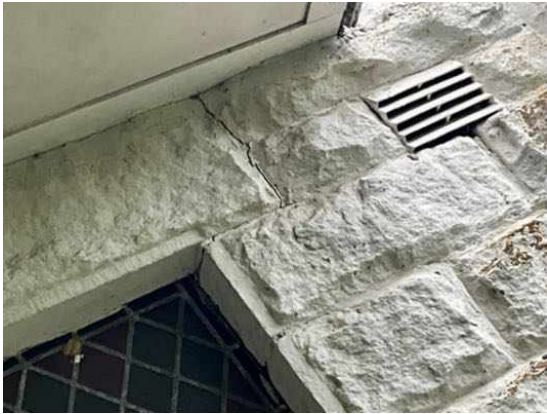
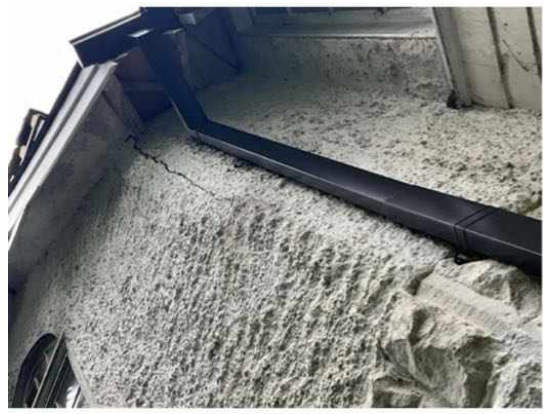
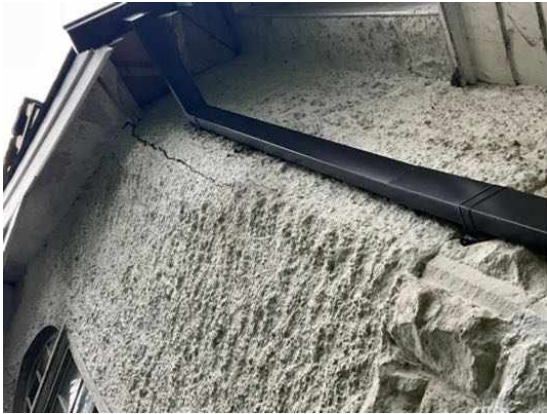
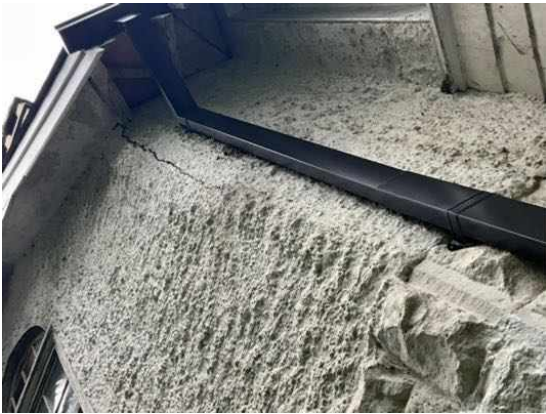
Finding 2.04

Building:	Main Building
Location:	Exterior walls - rear
Finding:	Brickwork - Cracking [Repair required]
Information:	Major cracking was identified to the brickwork in this area. Cracks of this type are likely to have been caused by movement of building elements, but may also have a structural cause that is more significant.

A crack of this size may be repaired by extensive filling. Additionally, further remedial works to associated building elements, such as eave sheeting or external door frames, is likely to be required.

A qualified bricklayer should be contacted immediately to estimate and perform repair and restoration works. Consultation with a structural engineer may be required where structural instability is found to be the underlying cause of the cracking.

Always contact a building inspector should cracks widen, lengthen, or become more numerous.

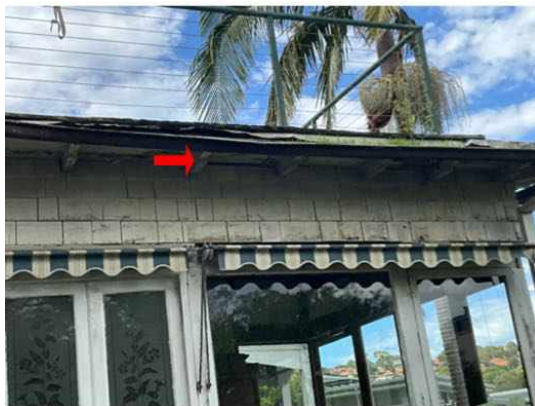
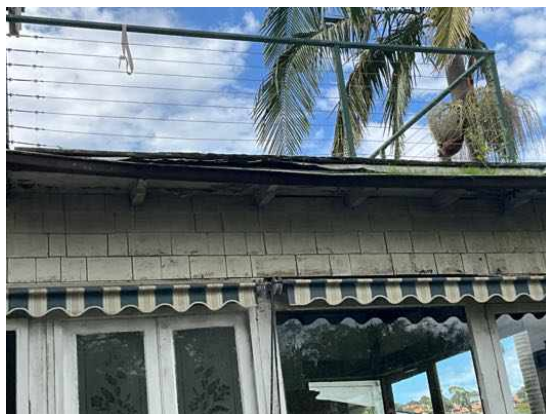
Building:	Main Building
Location:	All Areas
Finding:	Rusty Gutters
Information:	The gutters exhibit signs of rust, including corrosion and discoloration, compromising their functionality and aesthetics.

Risk: Rusty gutters pose several risks, including reduced water drainage efficiency, potential water damage to the building's exterior and foundation, and aesthetic degradation. Corrosion weakens the structural integrity of the gutters, making them prone to leaks, cracks, and eventual failure. Inadequate water drainage can lead to water pooling around the foundation, causing erosion, moisture infiltration, and potential structural damage over time. Additionally, rust stains may detract from the curb appeal of the property, impacting its overall appearance and value.

A qualified gutter repair or maintenance professional should be engaged to address the issue. They can assess the extent of rust damage, recommend appropriate repair or replacement options, and perform necessary repairs to restore the functionality and integrity of the gutters. Depending on the severity of the rust, repairs may involve cleaning, sanding, patching, or replacing corroded sections of the gutters. Additionally, they may apply protective coatings or install gutter guards to prevent future rust formation and prolong the lifespan of the gutters. Regular gutter maintenance, including cleaning and inspection, can also help prevent rust and ensure optimal performance.

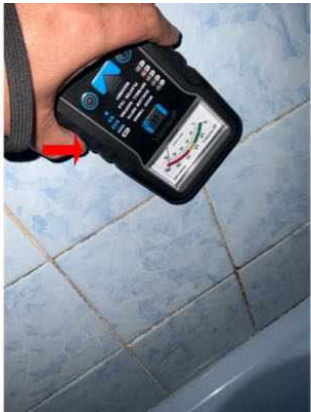
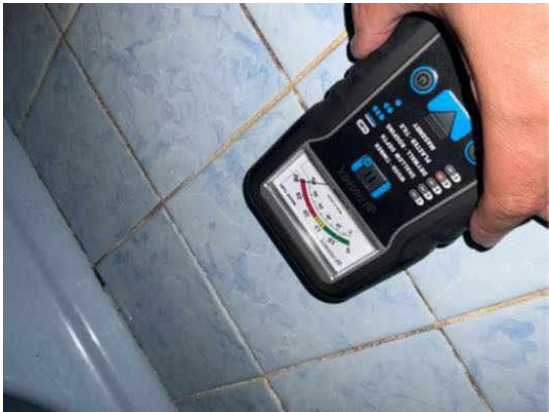
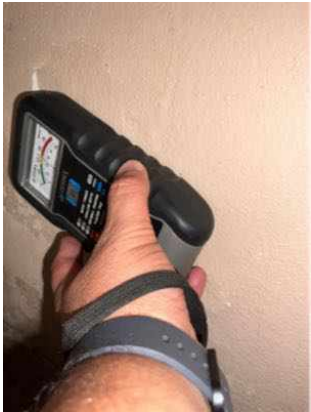
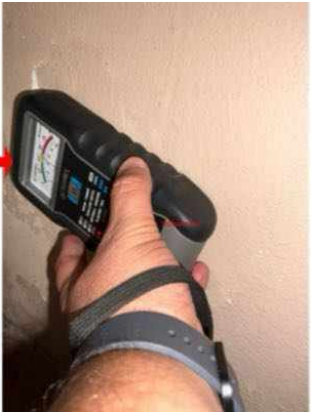
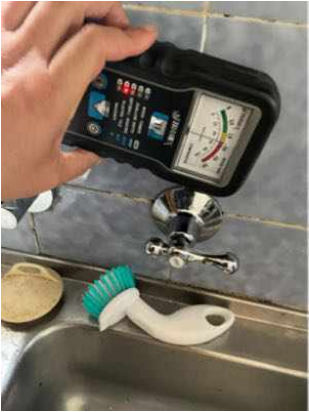
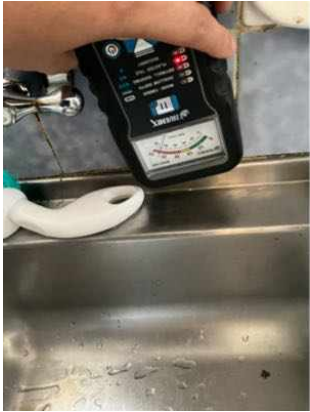
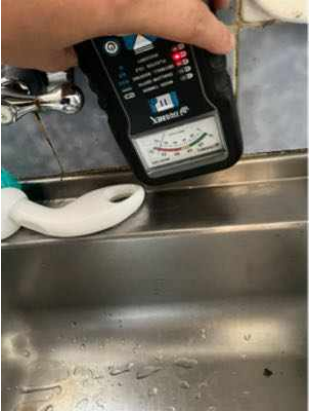
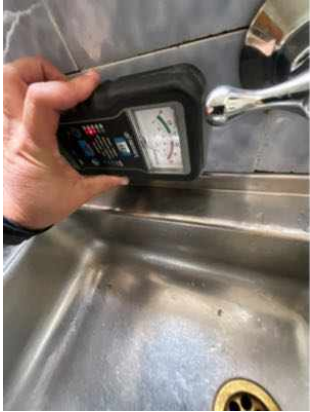
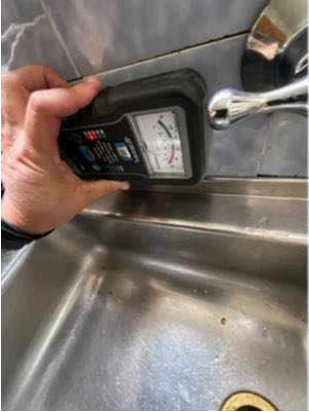
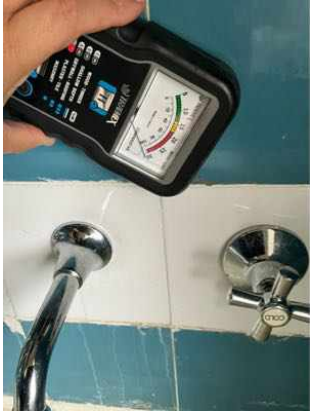
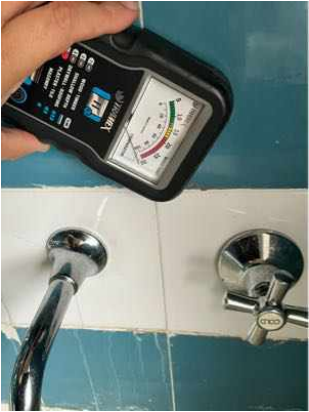
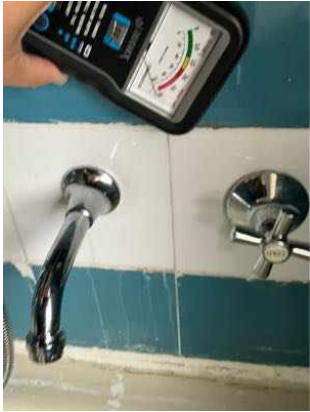
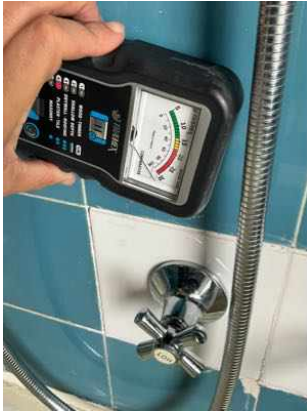
Finding 2.06

Building: Main Building
Location: All Areas
Finding: Evidence of excessive moisture was present at the time of inspection
Information: Excessive moisture is present behind the bathroom tiles, indicating a potential water leakage issue within the wall.

The prolonged presence of moisture can lead to mold growth, deteriorate the structure, and create an environment conducive to health hazards. Additionally, it may compromise the adhesive holding the tiles, leading to their detachment.

A licensed plumber or a qualified contractor specializing in water damage remediation should investigate the source of the moisture, fix any leaks, and address the damage. Additionally, replacing affected tiles and ensuring proper waterproofing are crucial to preventing future issues.

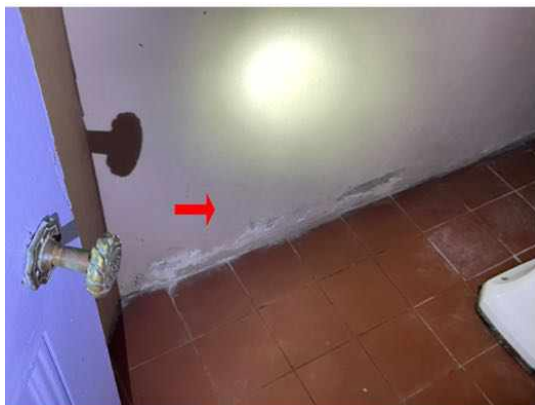
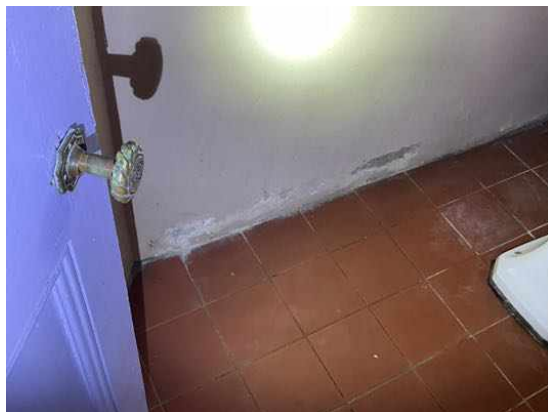
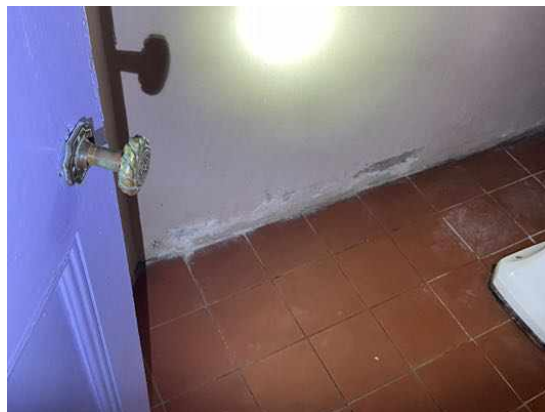
Finding 2.07

Building:	Main Building
Location:	Laundry / bathroom
Finding:	Water damage
Information:	The area has sustained water damage resulting in potential structural issues. This damage compromises both the aesthetic and functional aspects.

1 ****Plumber:**** If the water damage is due to plumbing issues, a plumber can fix leaks and ensure there are no further water-related problems.

2 ****General Contractor:**** If the damage is extensive and affects the surrounding area, a general contractor can coordinate the repair work, including any related structural or cosmetic repairs.

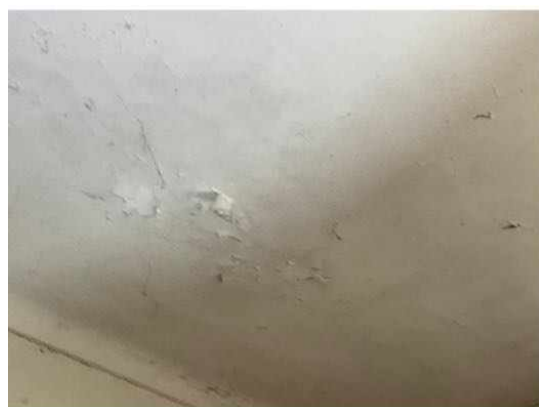
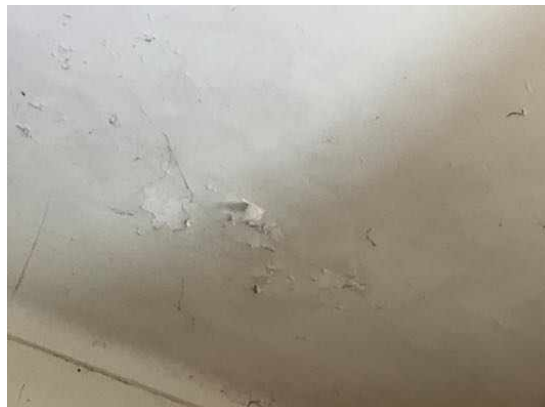
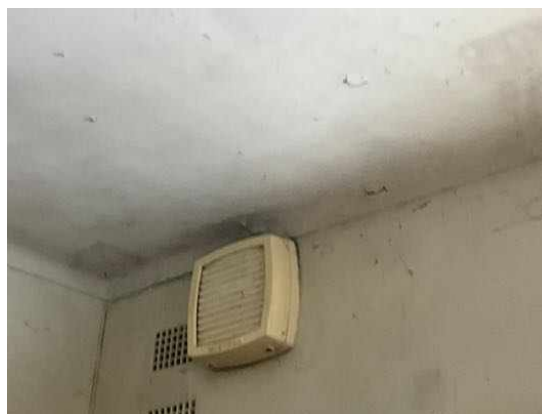
Finding 2.08

Information: Sections of the paint in this area was found to have deteriorated. Paint deteriorating is generally an indication of excessive moisture in the area that is currently hidden by the painted surface.

The presence of excessive moisture can have major implications on associated building elements if left unattended. the damage cannot be determined due to the paint, obstructing any further inspection of the damage.

It is highly advised that the affected paint to be cleaned to allow a further, more invasive inspection by a licensed builder/painter. Failure to act on this defect may necessitate major works in the future.

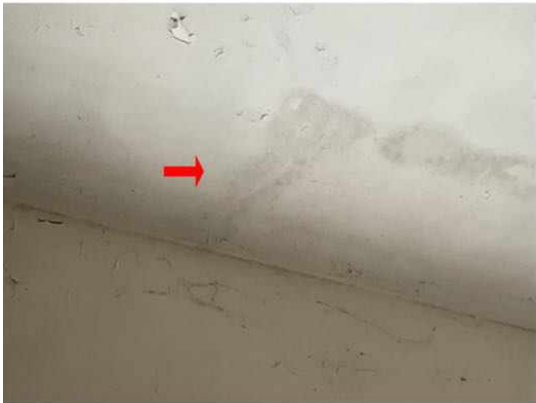
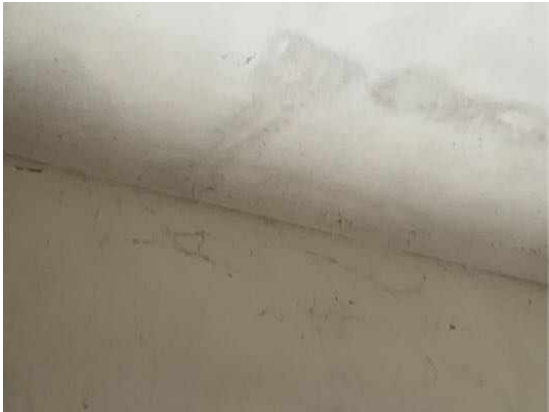
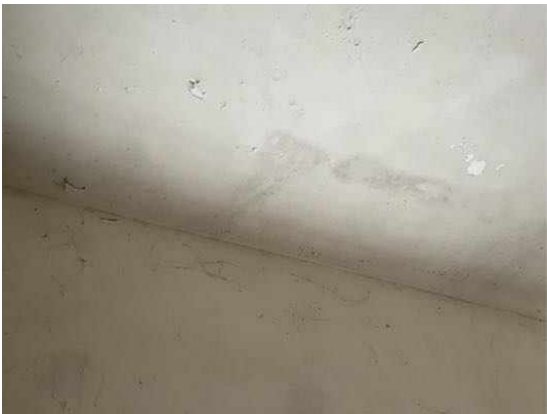
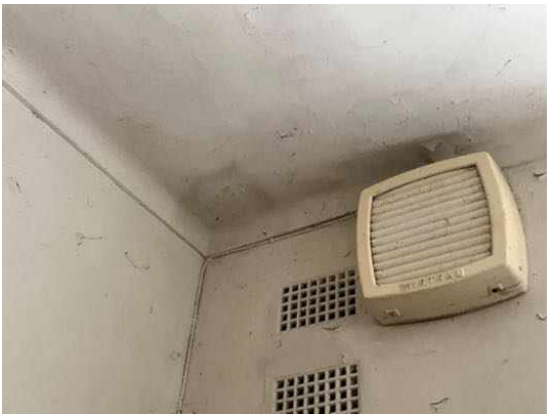
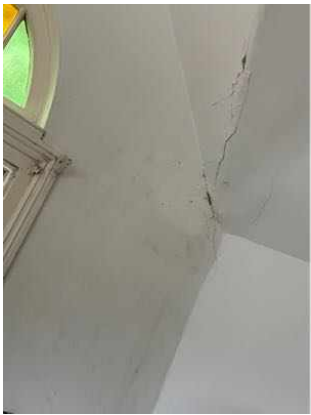
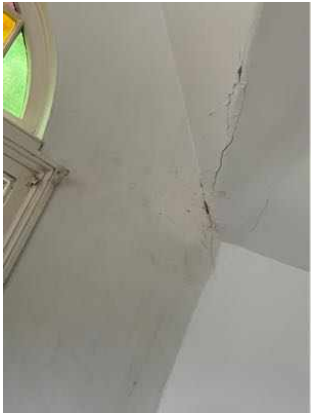
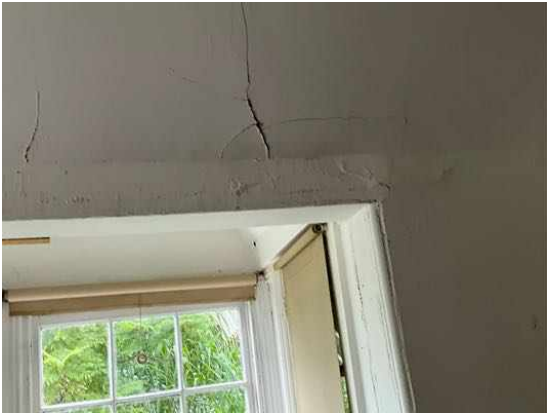
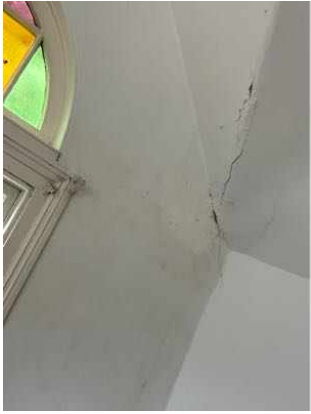
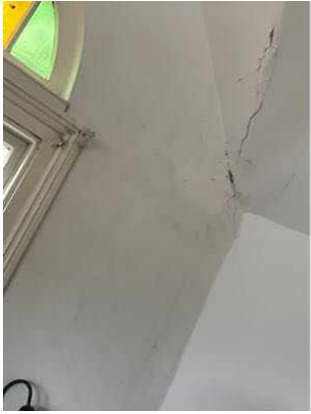
Finding 2.09

Finding: Roof Leaks

Information: The roof has developed leaks, allowing water to penetrate the building envelope. These leaks may be due to damaged or missing shingles/tiles, deteriorated flashing, clogged gutters, or other roof system failures.

A licensed roofing contractor or qualified roofer should be contacted to inspect and repair the roof leaks. They will:

- Identify the source of the leaks and assess the extent of the damage.

- Repair or replace damaged shingles, tiles, flashing, or other roofing materials.
- Ensure proper sealing around roof penetrations, such as vents, chimneys, and skylights.
- Clean and maintain gutters and downspouts to ensure proper drainage.
- Provide recommendations for any additional necessary repairs or preventive measures to avoid future leaks.

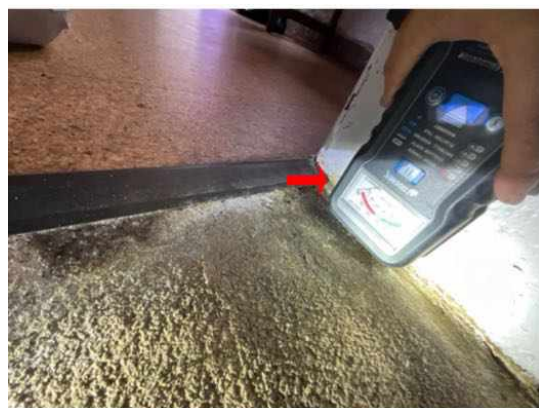
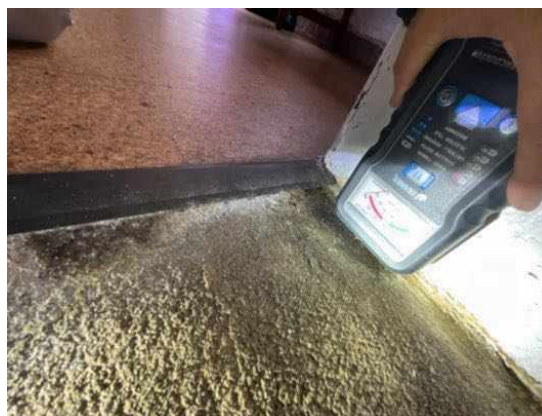
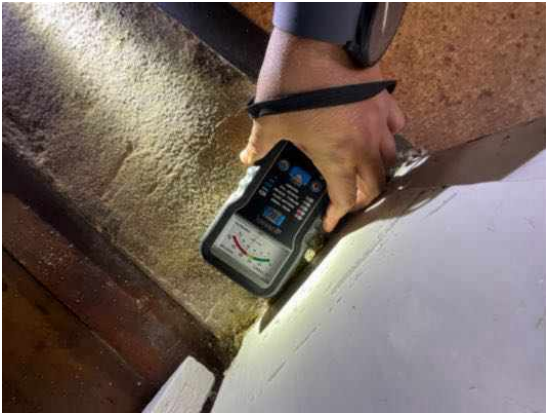
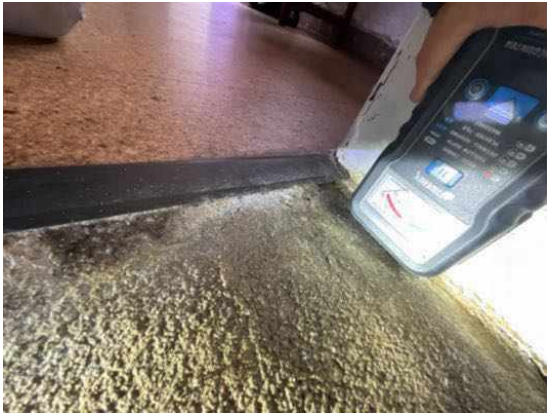
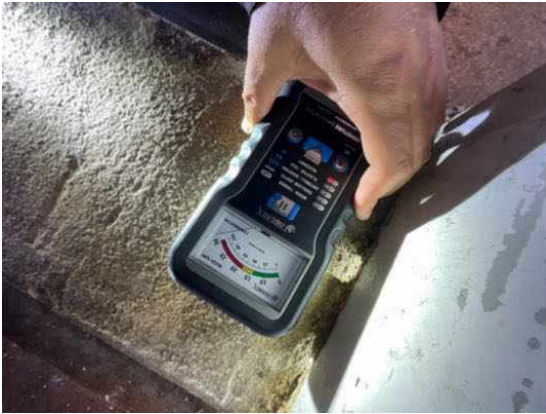
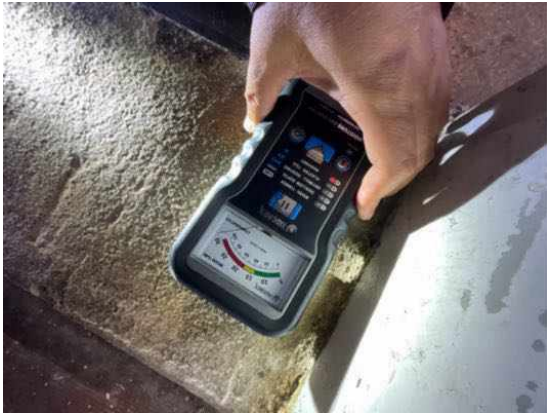
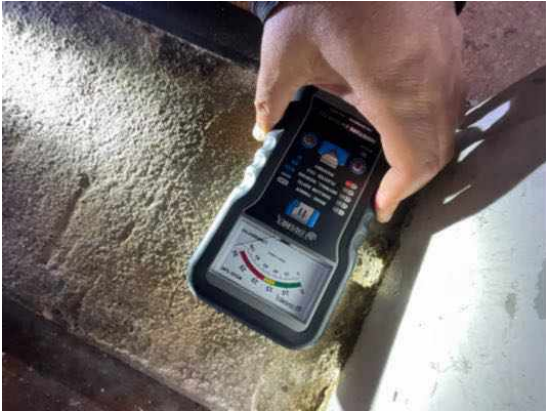
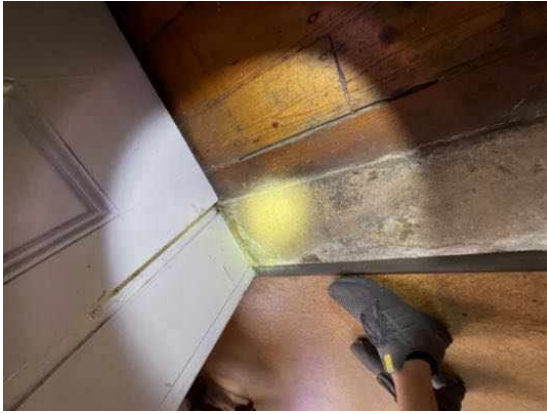
Finding 2.10

Building:	Main Building
Location:	All Areas
Finding:	Damp - Rising
Information:	Rising damp describes the upward movement of water in low sections of building elements (e.g. walls) by capillary action - the movement of water through porous materials such as bricks, sandstone or mortar.

Rising damp is generally managed by the installation of a damp proof course during construction. A Damp Proof Course (DPC) is an impermeable barrier at the base of the wall above ground level. However, many 19th Century buildings have no damp course installed, or the materials have failed. The DPC may have been omitted as a consequence of poor workmanship, or it may have been bridged where materials built up against the side of the house allow moisture ingress above the DPC level.

The first step in addressing rising damp is to diagnose the cause. The identified cause should be addressed first before addressing the appearance and other defects which have resulted from the rising damp. If the original cause is not resolved, further cases of damp are likely to ensue, resulting in secondary defects.

Consultation with a qualified plumber is advised immediately to identify the cause of the damp and perform remedial works as required.

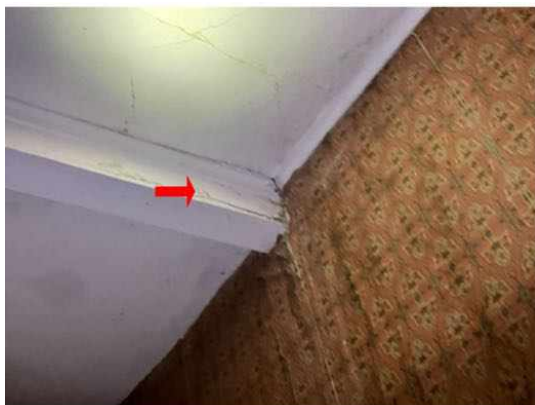
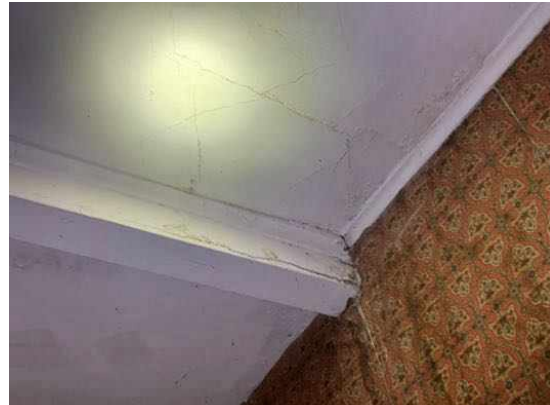
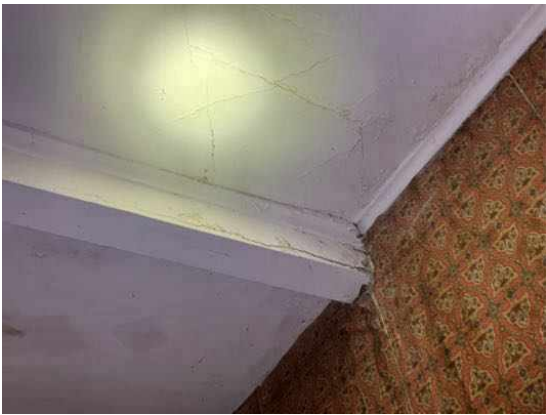
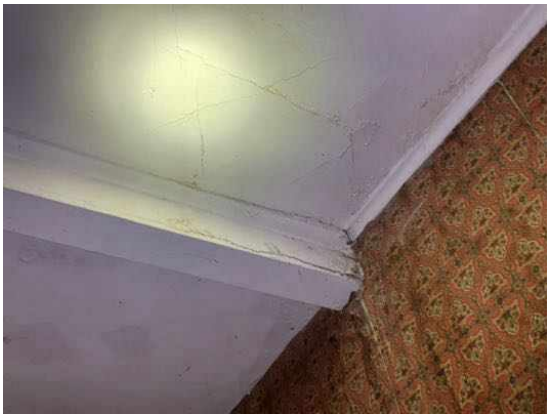
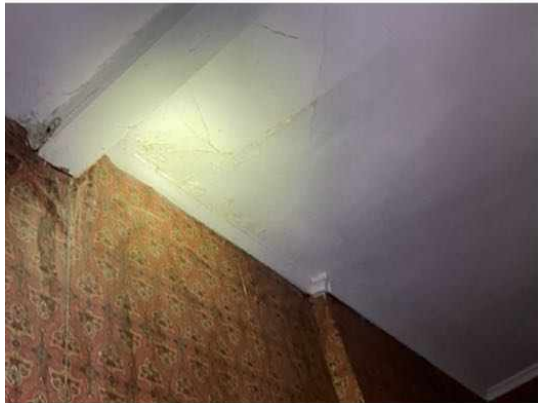
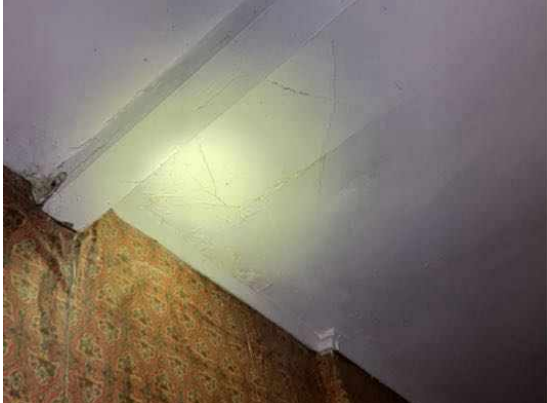
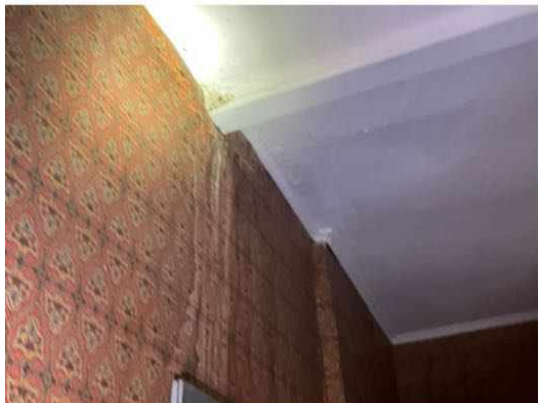
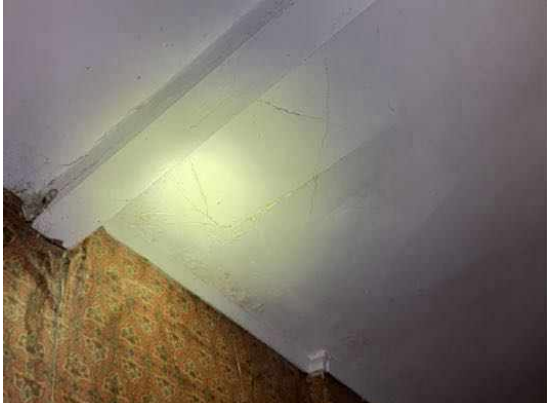
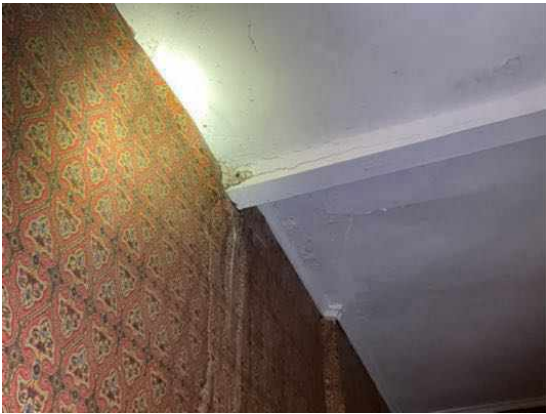
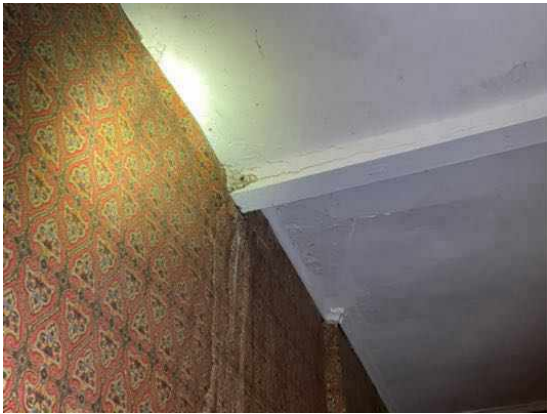
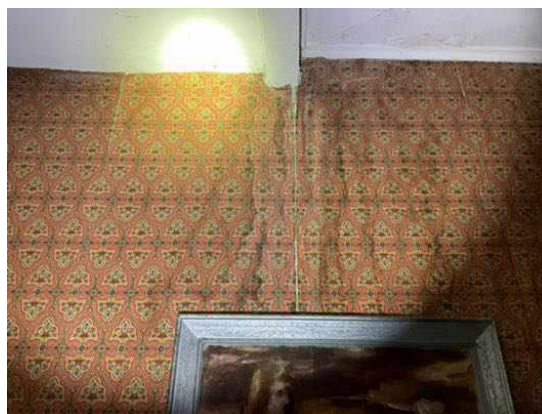
Finding 2.11

Finding: Water damage

Information: The area has sustained water damage resulting in potential structural issues. This damage compromises both the aesthetic and functional aspects.

1 **Plumber:** If the water damage is due to plumbing issues, a plumber can fix leaks and ensure there are no further water-related problems.

2 **General Contractor:** If the damage is extensive and affects the surrounding area, a general contractor can coordinate the repair work, including any related structural or cosmetic repairs.
