Building and Timber Pest Inspection Report

Inspection Date: Thu, 26 Mar 2026

Property Address: 14 Illawarra St, Mosman NSW 2088,
Australia

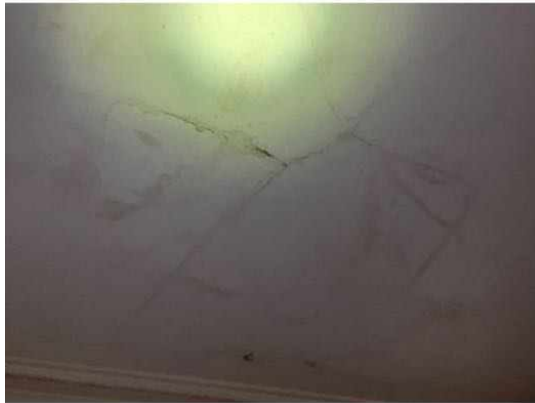
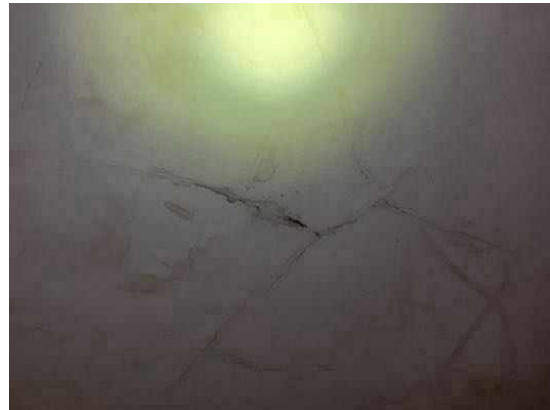
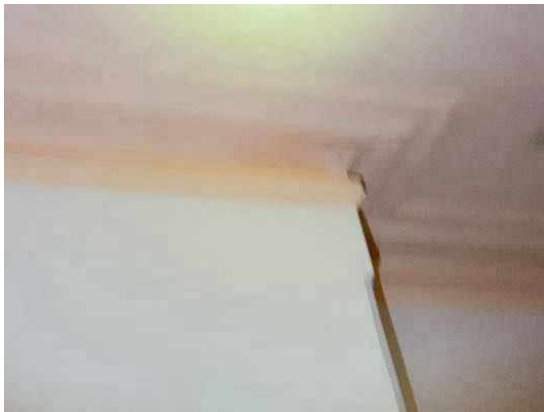
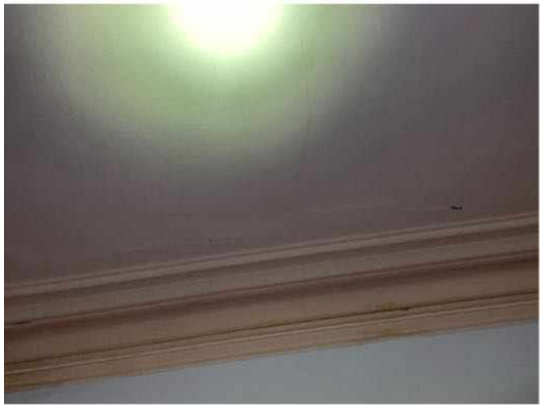
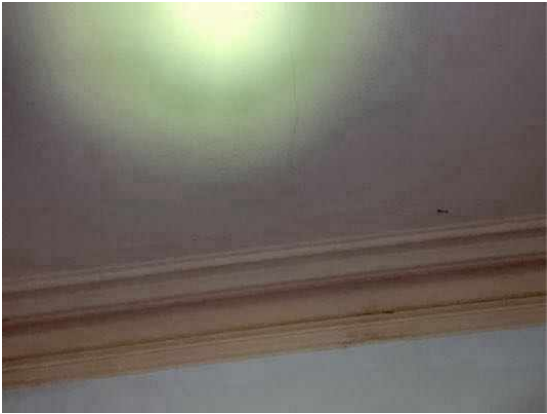
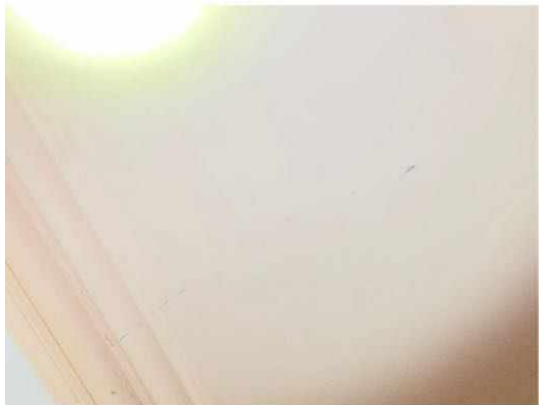
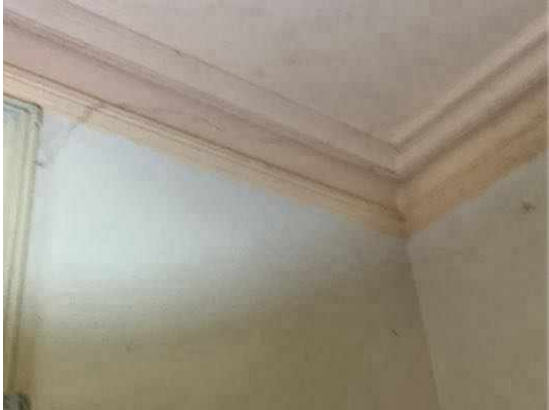
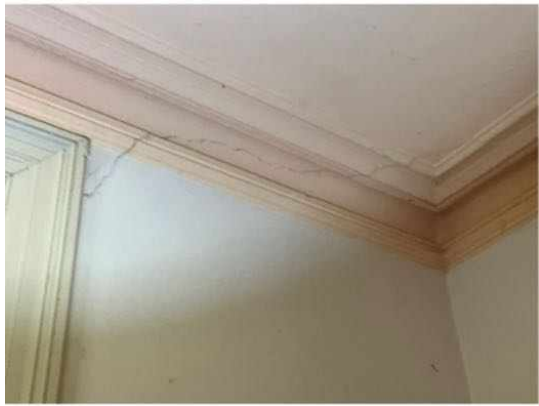
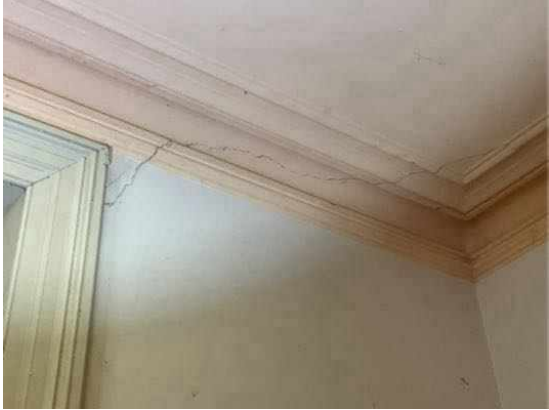
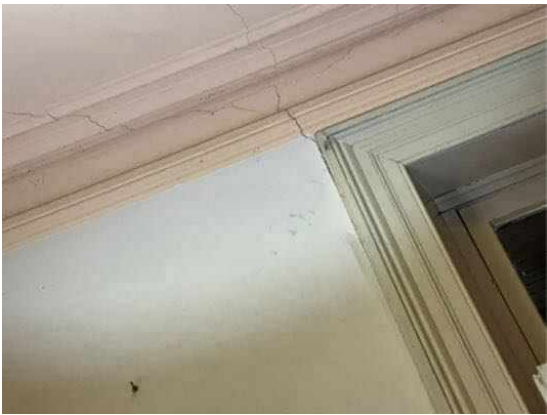
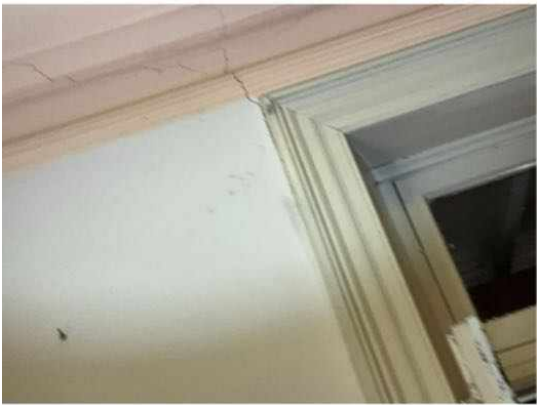
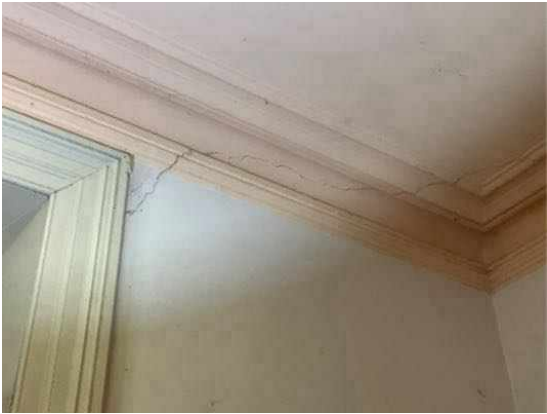
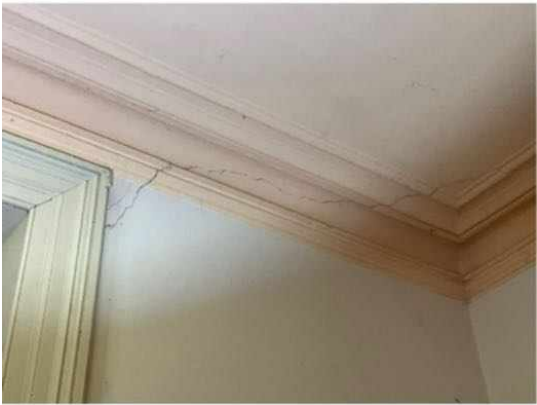
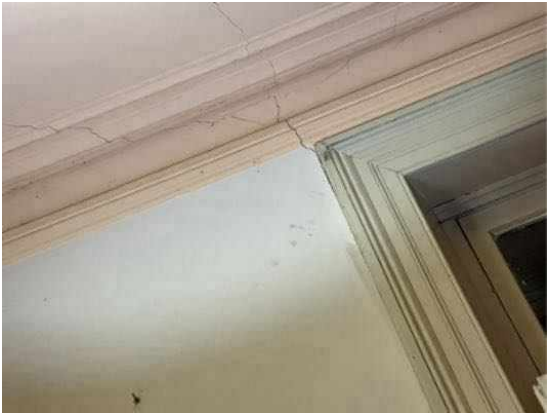
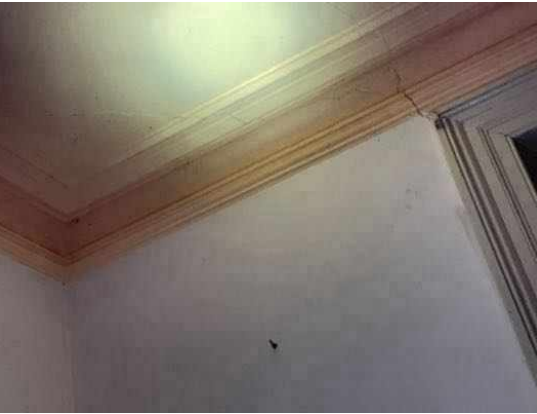
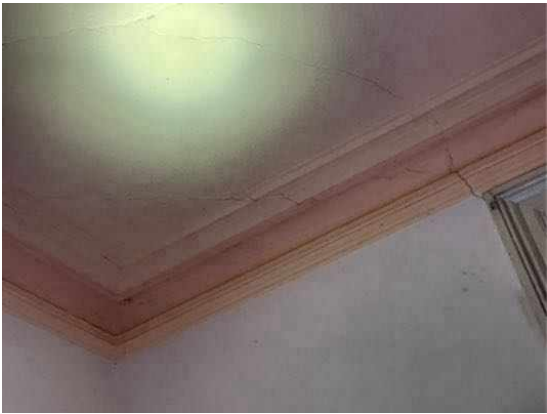
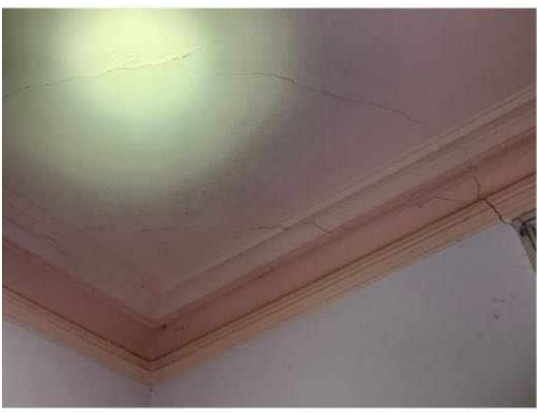
Finding 2.12

Building:	Main Building
Location:	All Areas
Finding:	Structural Cracking - Various locations within the property
Information:	Significant cracks have been observed in Various locations within the property including internal walls, particularly around structural joints and corners. These cracks are consistent with those that may arise from differential settlement, particularly in a house sitting on piers. The cracking pattern and the width of the cracks suggest potential movement of the structural elements, which could indicate subsidence or failure in the foundation support.

****Consequences:**** The observed cracks could compromise the structural integrity of the building if left unattended. This could lead to further deterioration, water ingress, pest intrusion, and potential safety hazards. If the cause is due to foundation movement or subsidence, it could result in significant structural failures, which could be costly to repair.

- **Immediate Inspection by a Structural Engineer:**** A licensed structural engineer should be engaged immediately to assess the extent and cause of the cracking. The engineer will provide a detailed report and recommend appropriate remediation measures.
- **Foundation Specialist Inspection:**** If foundation issues are confirmed, a specialist in underpinning and foundation repair should be consulted. They may recommend solutions such as underpinning, pier replacement, or other foundation stabilization methods.
- **Monitoring:**** If the engineer determines that the movement is ongoing, monitoring equipment may need to be installed to assess further movement over time.

4. **Repair:** Once the underlying cause is identified and stabilized, the cracks can be repaired. This might involve re-plastering, crack stitching, or other appropriate methods as advised by the engineer.

- **Structural Engineer:** To assess the damage and provide a remediation plan.
- **Foundation Specialist:** If foundation repair is necessary.
- **Licensed Builder or Repair Specialist:** For crack repairs and any other structural repairs as per the engineer's recommendations.

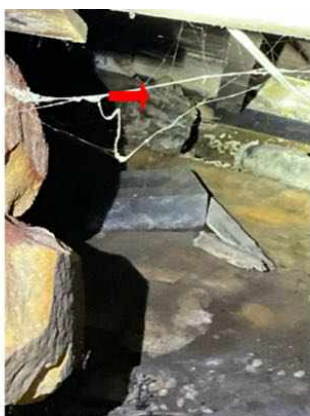
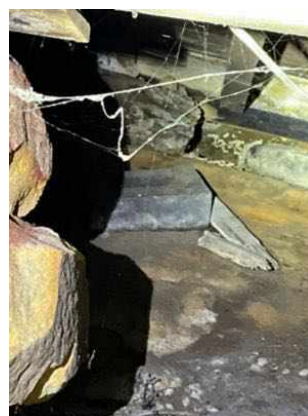
Finding 2.13

Finding: Subfloor- Wood Rot in Bearer and Joist

Information: The bearer and joist in the subfloor show significant wood rot, which has compromised the structural integrity of the timber. Wood rot typically occurs due to prolonged exposure to moisture, and in this case, it has led to severe decay, weakening the timber and reducing its load-bearing capacity. This deterioration poses a critical risk to the overall stability of the floor structure.

- **Structural Risk:** High risk of structural failure in the affected area due to compromised load-bearing capacity. If left unaddressed, this could lead to sagging, uneven floors, or even collapse in extreme cases.
- **Safety Risk:** Elevated safety risk for occupants, as a weakened subfloor could fail under load, posing a potential hazard.
- **Moisture and Decay Propagation Risk:** The presence of rot in the timber can spread if the source of moisture is not addressed, potentially affecting adjacent timbers and leading to widespread damage.

This defect should be classified as a major defect due to the severe impact on structural integrity and safety. Immediate action is required to rectify the issue and maintain the building's stability.

- **Engage a Licensed Carpenter or Structural Engineer:** A qualified carpenter or structural engineer should assess the extent of the damage and replace the affected bearer and joist. They will ensure the replacement timbers are adequately treated and installed to meet structural standards.
- **Address Moisture Source:** It is critical to identify and eliminate the moisture source contributing to the wood rot. Improving subfloor ventilation, repairing leaks, or installing a moisture barrier may be necessary to prevent future decay.

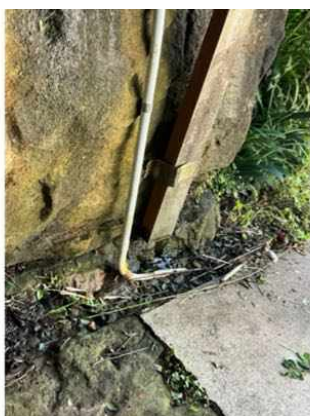
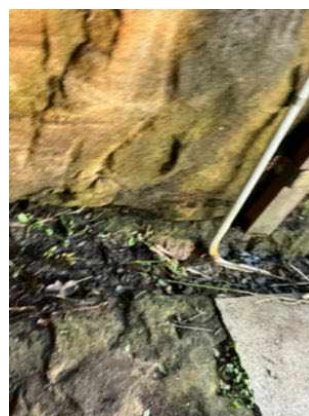
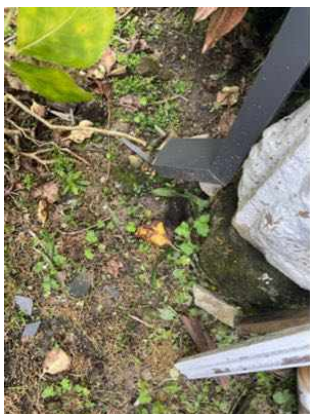
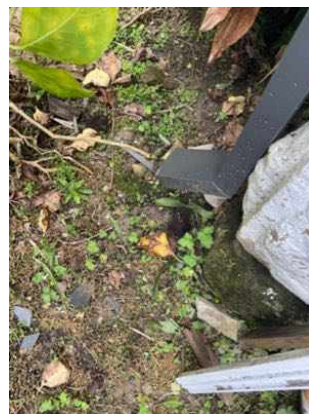
Finding 3.01

Building:	Main Building
Location:	All Areas
Finding:	Disconnected downpipe
Information:	A notable defect with a disconnected downpipe, compromising the efficient drainage

of rainwater from the roof. This disconnectivity poses an increased risk of water accumulation, potentially leading to foundation erosion, water damage to the property, and a conducive environment for mold growth.”

1. Foundation Erosion: Accumulated water around the foundation due to the disconnected downpipe can lead to soil erosion, jeopardizing the stability of the property’s foundation.
2. Water Damage: Uncontrolled water runoff can result in water penetrating the building envelope, causing interior water damage to walls, ceilings, and other structural components.
3. Mold Growth: The presence of excess moisture provides an ideal environment for mold growth, posing health risks and necessitating costly remediation.

Engage a qualified and licensed roofing or gutter specialist to address the disconnected downpipe. This professional will reconnect the downpipe to ensure proper water drainage, mitigating the associated risks and preserving the integrity of the property.

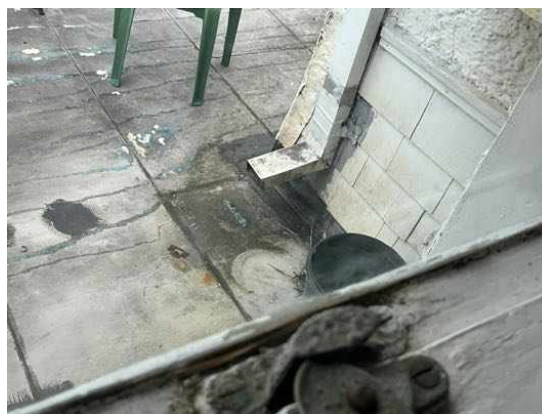
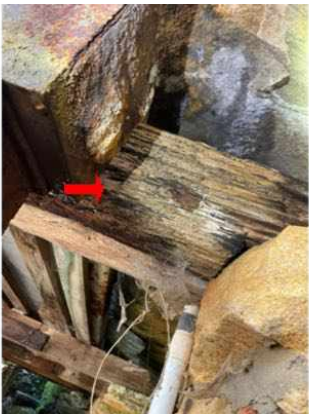
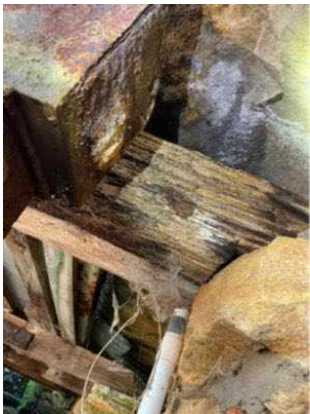
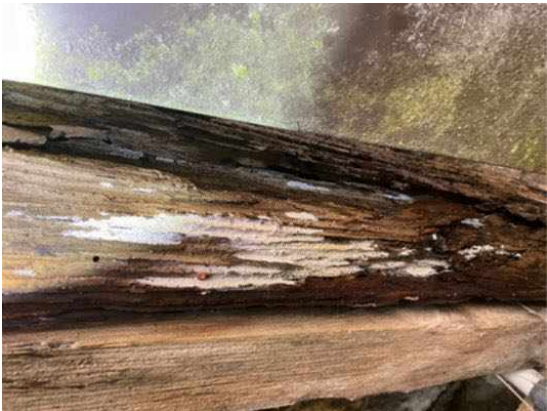
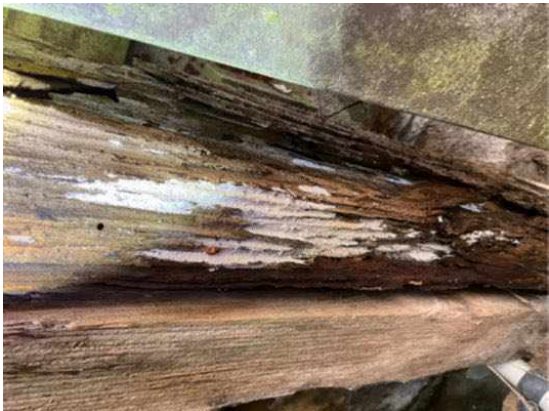
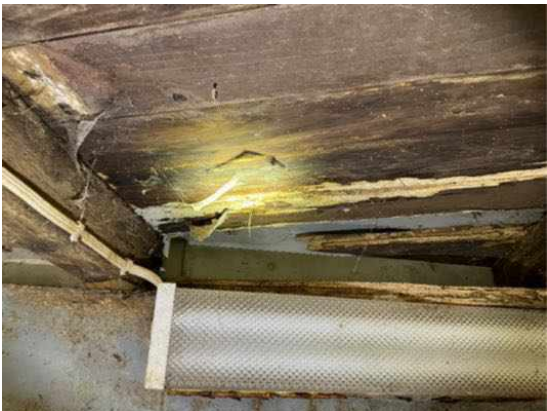
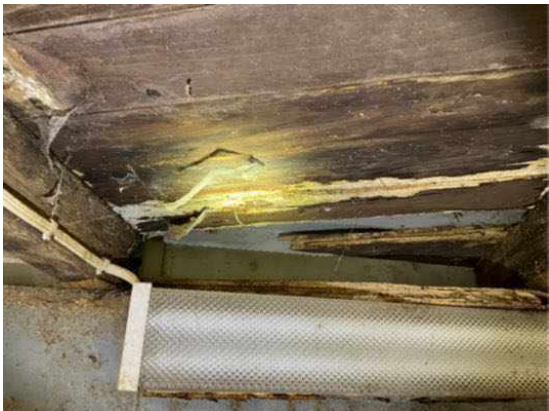
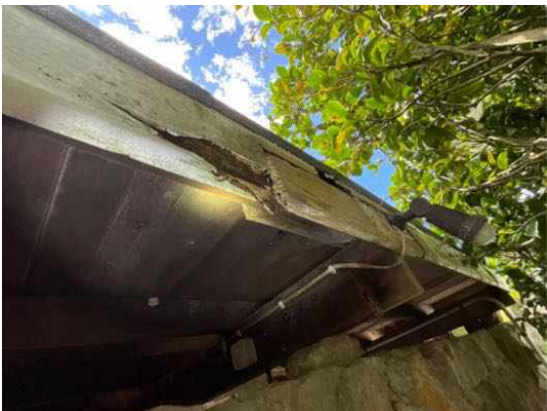
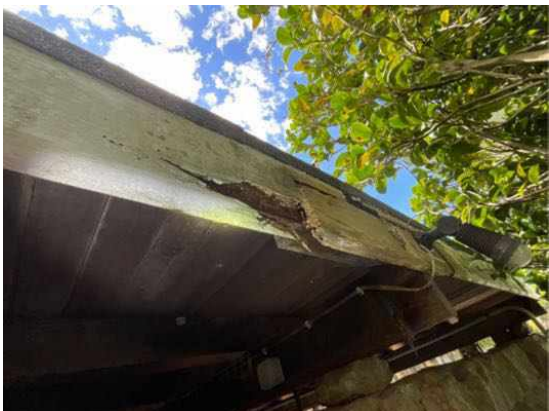
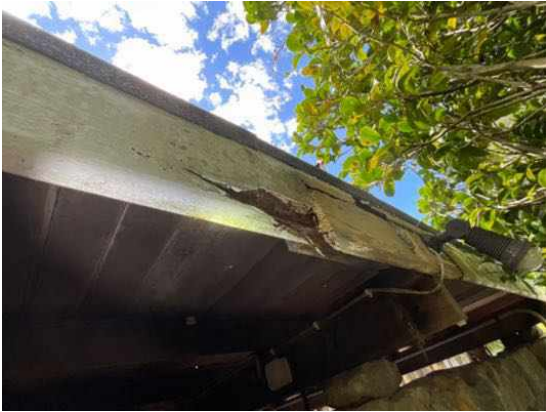
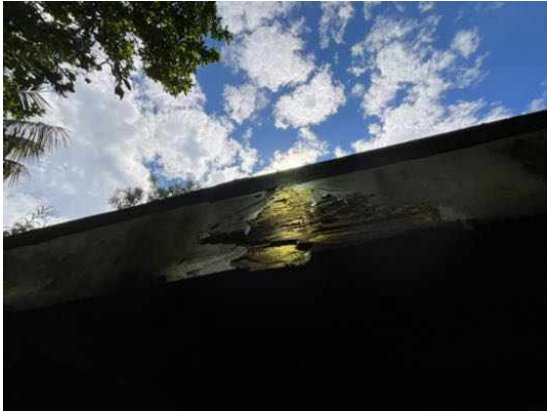
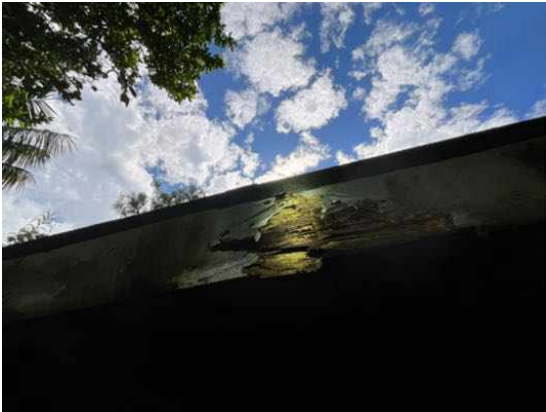
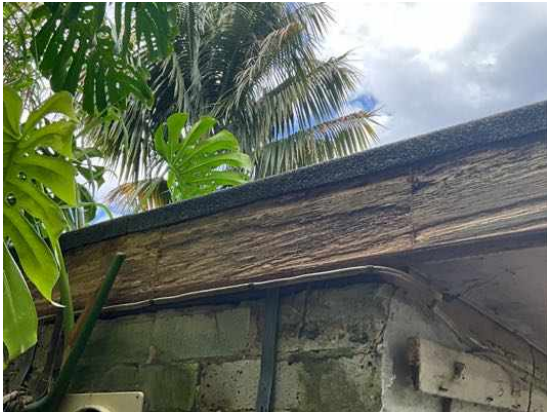
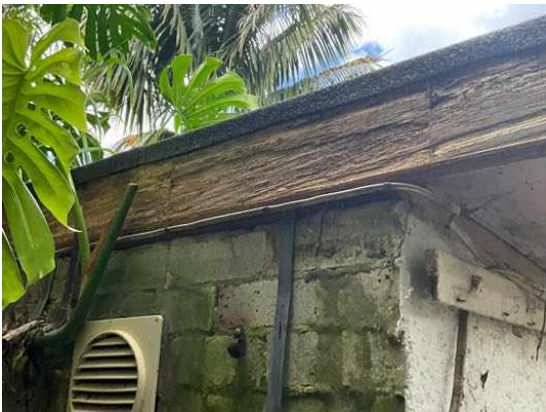
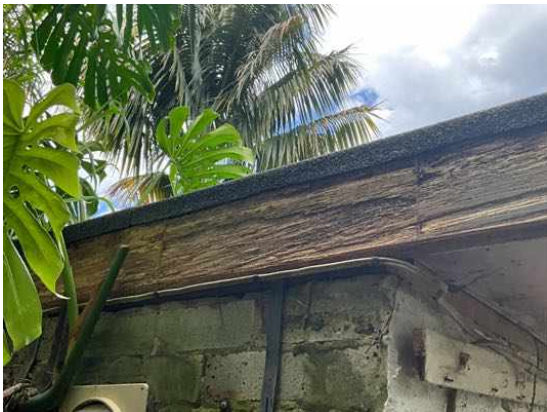
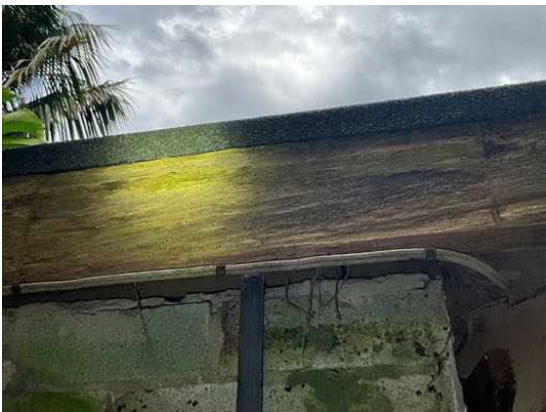
Building: Main Building
 Location: All Areas
 Finding: Timber Pest Damage
 Information: Termite damage and timber decay were observed. The affected timbers show hollowing, delamination, and mud-like residue consistent with termite activity, where in contact with soil, and vegetation is overgrown, providing potential termite access points.

The damage has compromised the structural integrity and may indicate active or previous termite infestation. If left untreated, termite activity could spread to nearby structures, leading to significant hidden timber damage and costly repairs.

Replace all affected timber members using H3/H4 treated pine or non-timber alternatives,

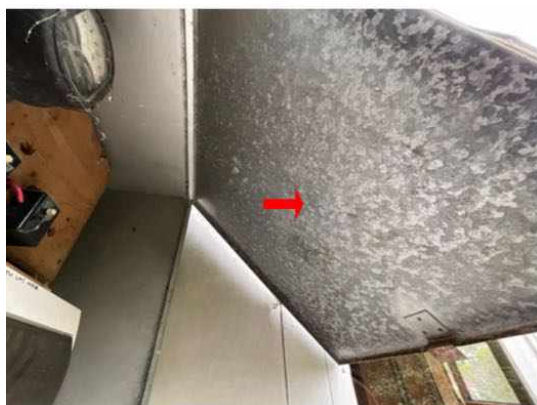
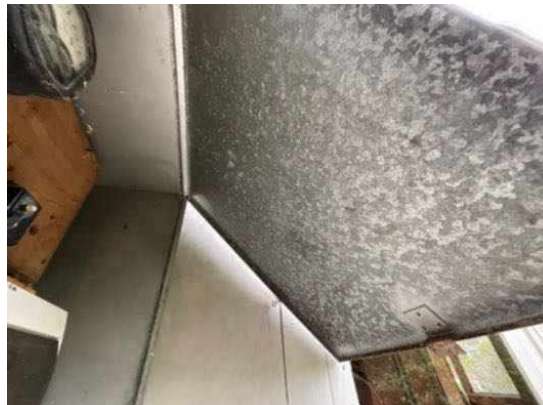
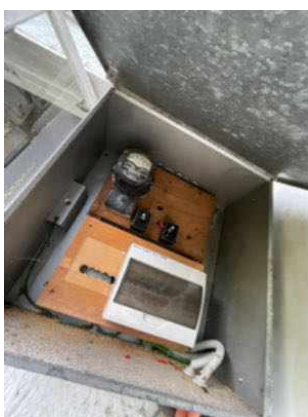
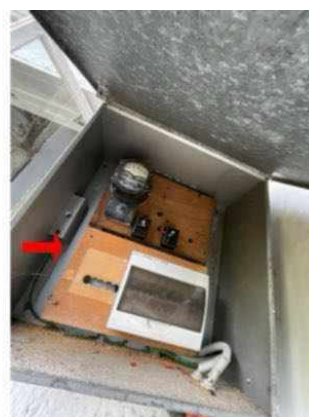
Finding 6.01

Building: Main Building
Location: Exterior walls - rear
Finding: No Evidence of Termite Management System - Durable notice / Legible Sticker
Information: The application of a pre & post-construction chemical termite barrier is highly recommended for all properties. Such barriers are highly effective in preventing termite attack on any timber building elements throughout the property.

A durable notice was not placed in the switchboard unit to indicate current termite barriers is legible at the time of inspection.

Client must seek further information from the vendor or real estate agent if the conditions of termite management systems were maintained.

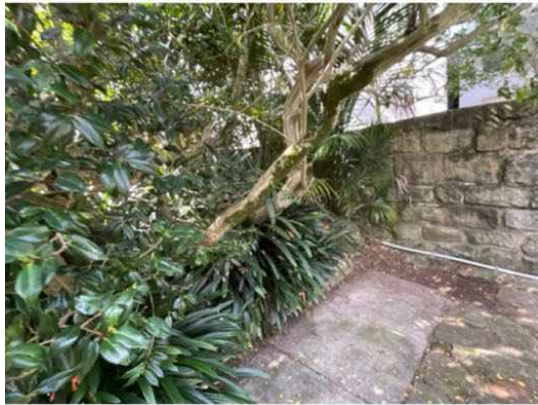
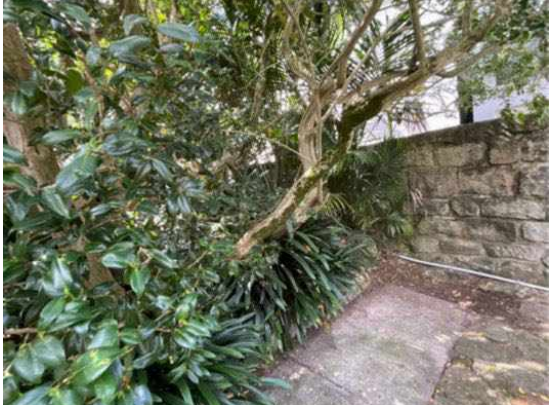
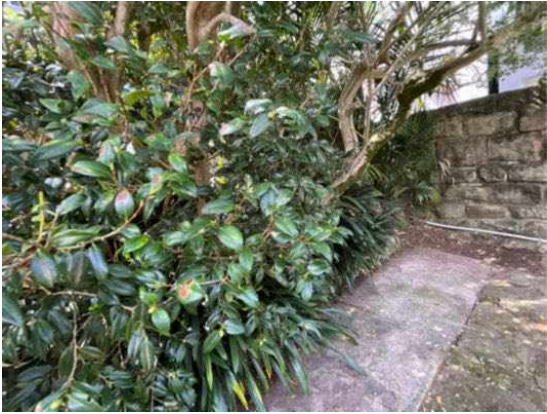
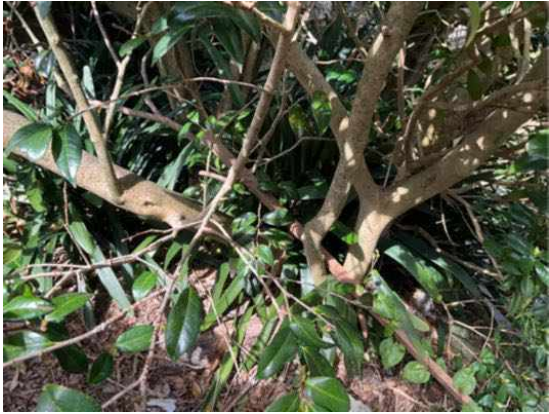
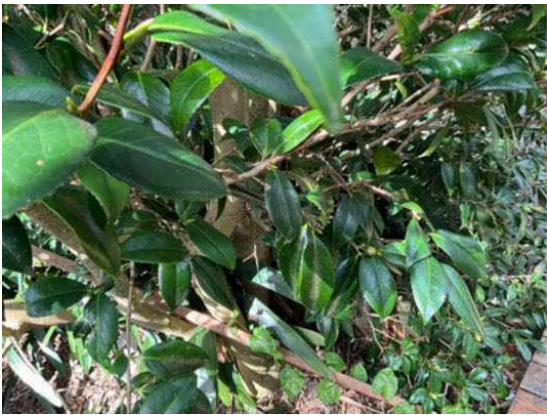
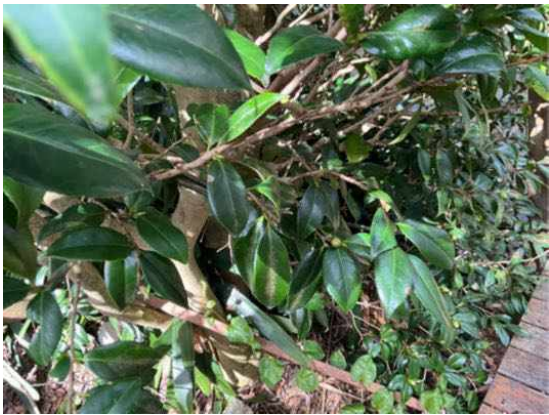
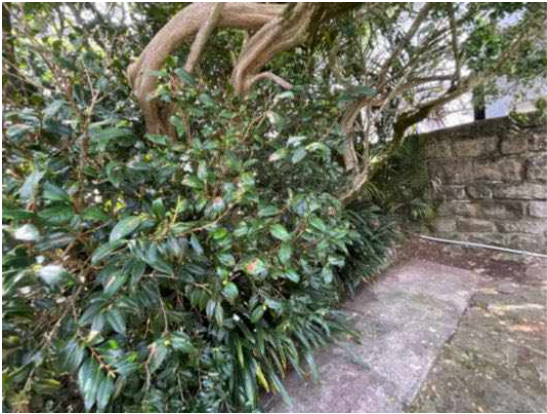
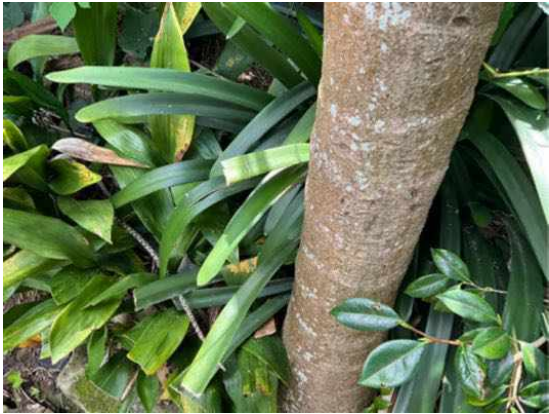
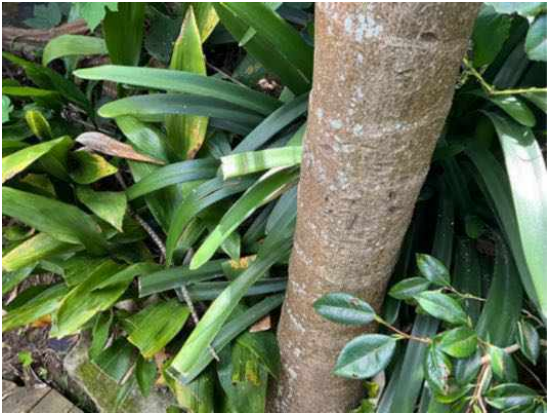
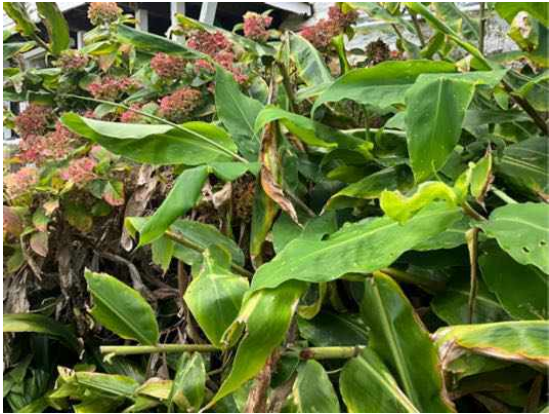
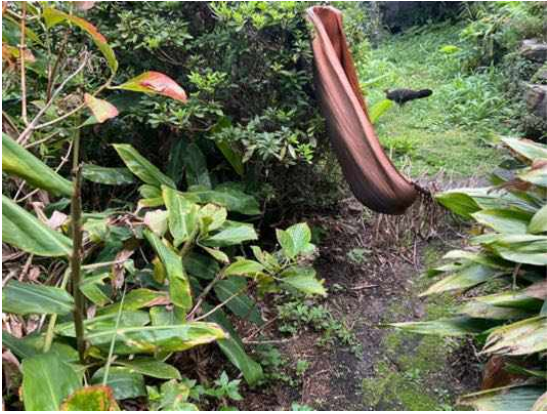
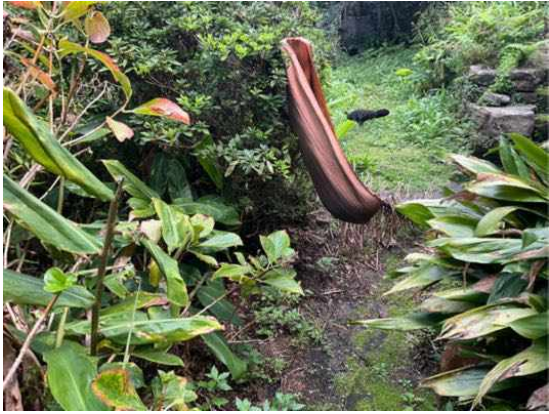
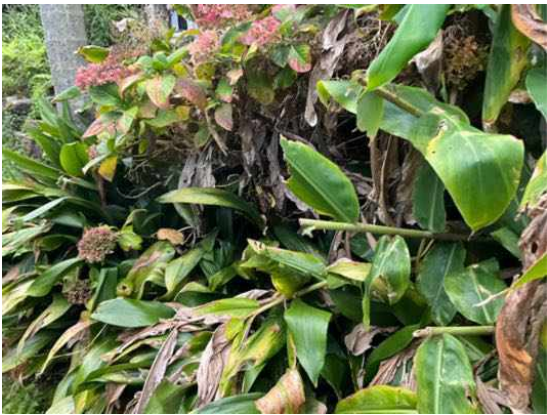
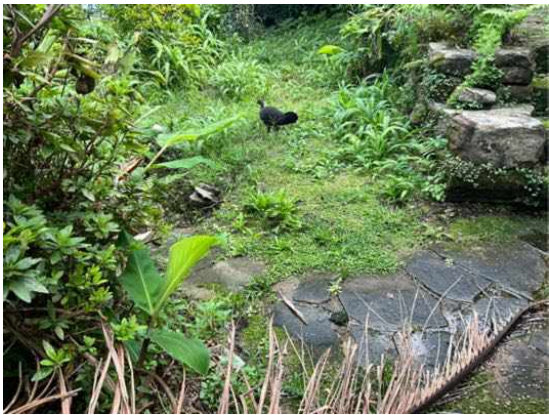
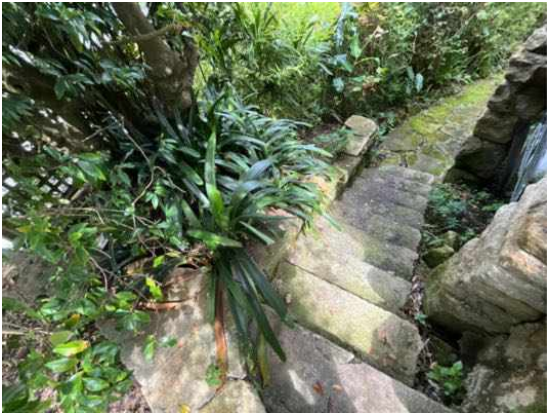
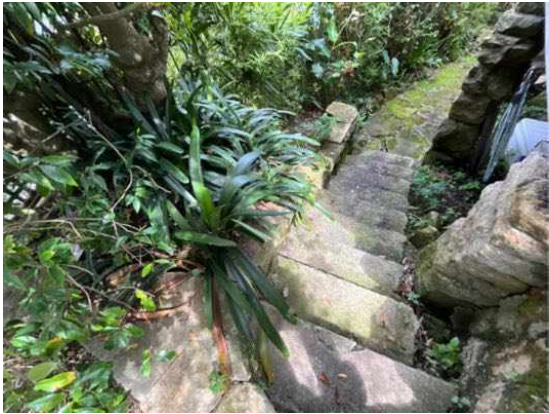
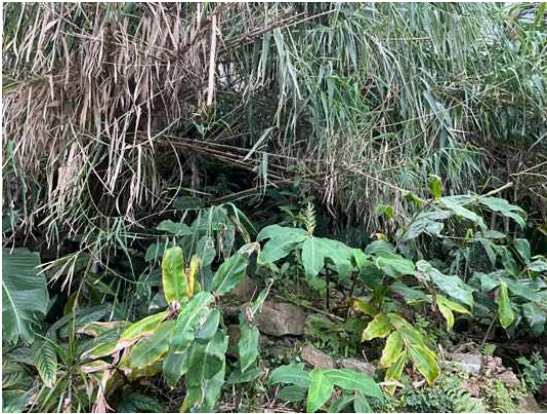
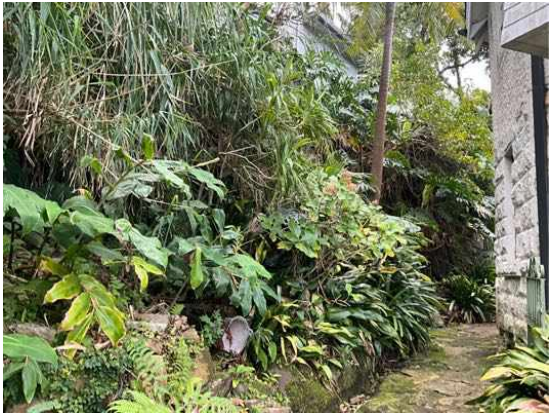
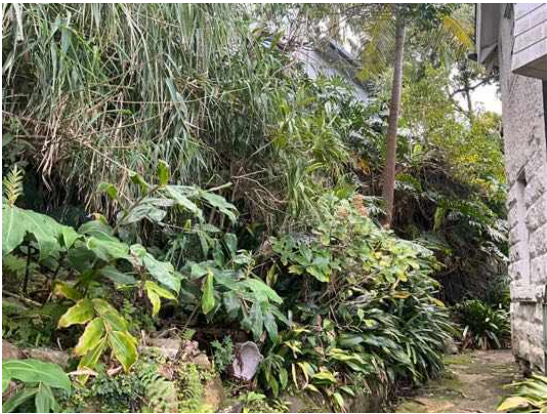
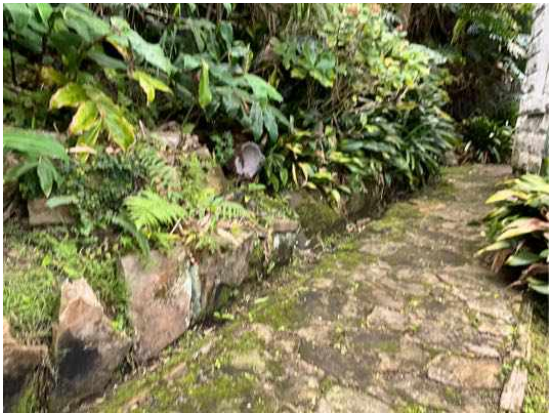
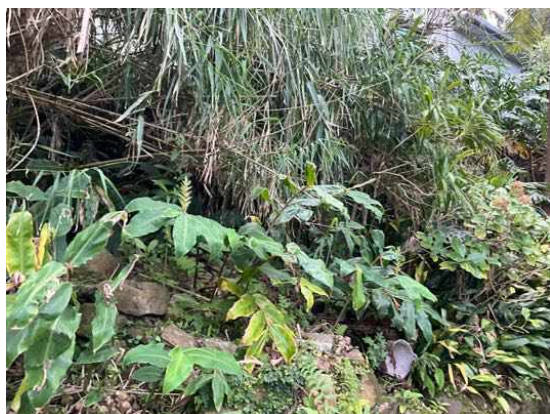
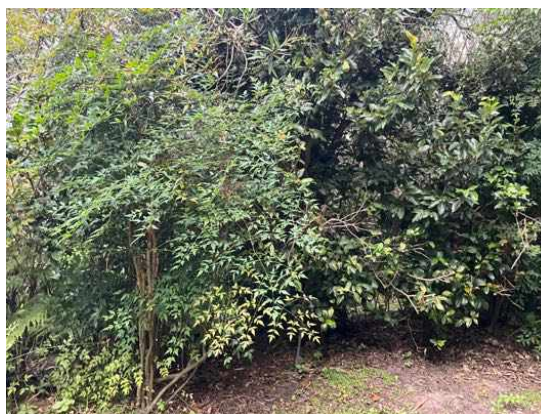
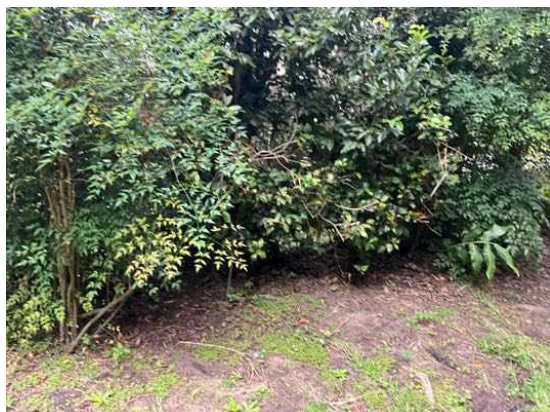
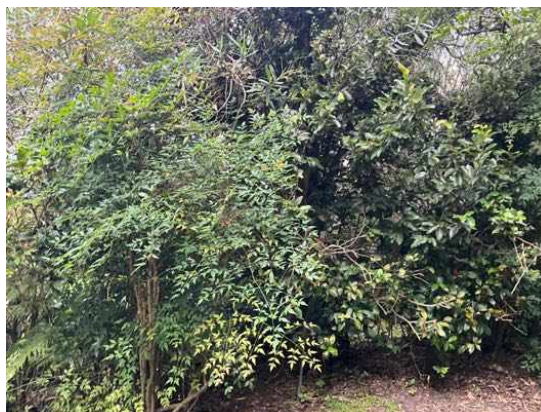
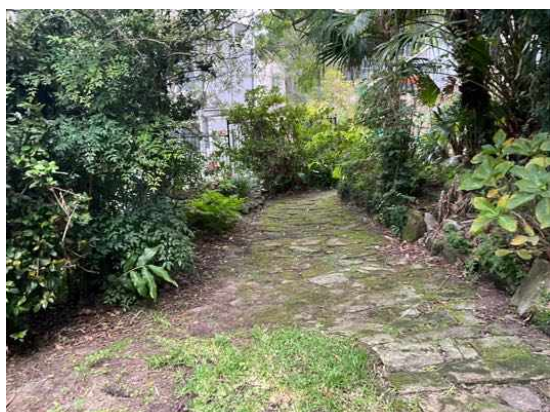
Finding 6.02

Finding: Dense vegetation around a property can increase the risk of termite infestation

Information: The presence of dense vegetation around a property can increase the risk of termite infestation, as it provides a conducive environment for them. To address this, consider maintaining a clear space between the vegetation and your home. If you suspect a termite issue, it's advisable to consult with a licensed pest control professional for inspection and treatment.

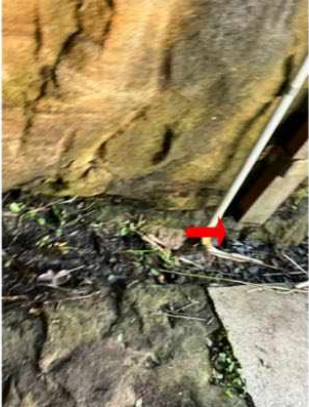
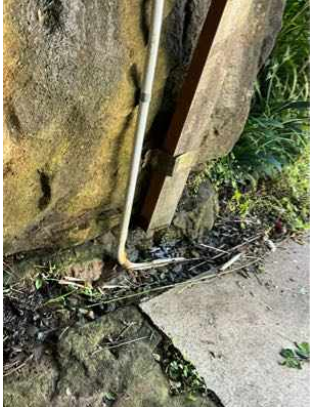
Finding 6.03

Building:	Main Building
Location:	All Areas
Finding:	Downpipes not connected- Conducive conditions for timber pest
Information:	<p>Unconnected downpipes can indeed pose a risk for attracting termites, as they provide a source of moisture near a building's foundation. Termites are attracted to moisture and wood, so it's important to address this issue to prevent potential infestations. Connecting downpipes to the stormwater system or ensuring proper drainage away from the building can help mitigate this a licensed plumber is the most qualified professional to handle plumbing-related tasks, including connecting downpipes to the stormwater system. They have the necessary expertise and tools to</p>

ensure proper installation.

Please remember that proper installation is essential to ensure effective drainage and prevent future issues, so it's often best to hire a qualified professional, especially for complex or extensive downpipe installations.

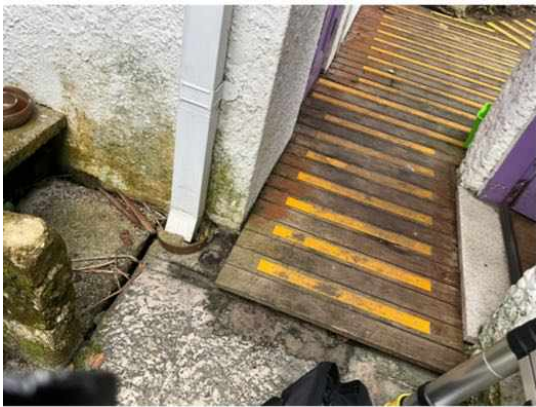
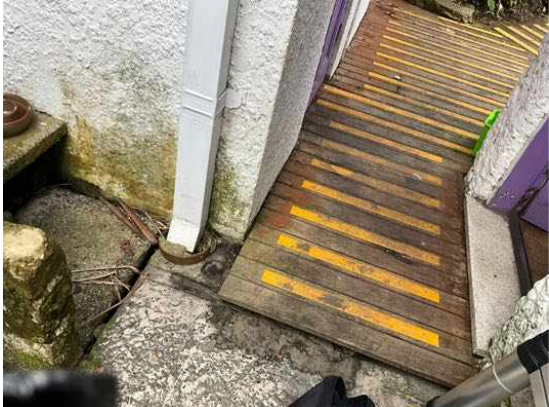
Finding 6.04

Building: Main Building
Location: All Areas
Finding: Timber on ground / conducive conditions to termite damage
Information: Timber on the ground is indeed conducive to termite damage. Termites are known to thrive in moist environments, and wood in contact with soil or moisture is more susceptible to infestation.

To prevent this, it's important to keep timber elevated and away from direct ground contact. Regular inspections and proper termite control measures are also essential to protect your wooden structures from termite damage.

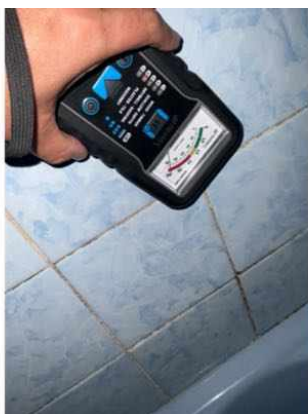
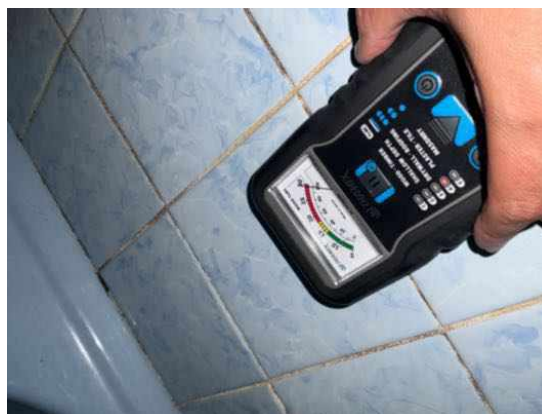
Finding 6.05

Building:	Main Building
Location:	Laundry / bathroom
Finding:	Excessive moisture - Conducive to Timber pest
Information:	Excessive moisture can attract termites and produce conditions that promote fungal growth and wood decay.

Excessive moisture is generally caused by deteriorated inadequate or missing roof drainage leaking plumbing pipes or fixtures poorly plumbed HWS overflows or condenser units and poor site drainage.

If mould growth has been found there may be environmental biological or health issues involved. In these cases an appropriately qualified inspector should also be contacted.

Prior to any remedial works being performed a qualified plumber should be appointed to further inspect the property and to identify the cause of the excessive moisture. Works to remove affected building elements may then be necessary and should be performed by an appropriate tradesperson.

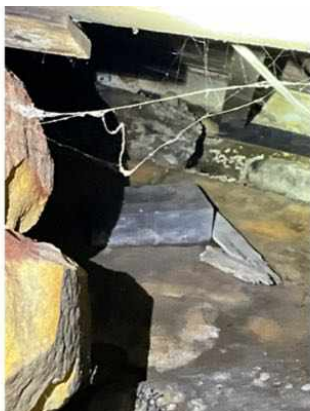
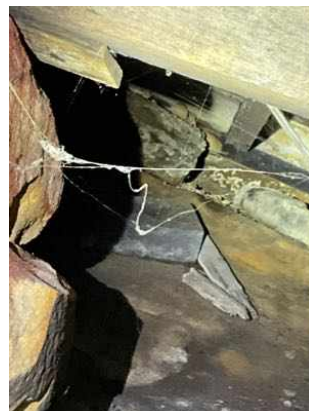
Finding 6.06

Building:	Main Building
Location:	Subfloor
Finding:	Subfloor - poor ventilation, inadequate site drainage, water stains, and no ant caps
Information:	The subfloor lacks adequate ventilation, suffers from inadequate site drainage, exhibits water stains, and lacks ant caps, creating conducive conditions for timber pests such as termites.

Risk: The combination of poor ventilation, inadequate drainage, water stains, and absence of ant caps significantly increases the risk of timber pest infestations. Termites are attracted to moist environments and can thrive in subfloors with high humidity levels and water damage. The lack of proper ventilation and drainage exacerbates moisture retention, providing an ideal habitat for timber pests to establish colonies and cause extensive damage to the subfloor structure. Additionally, water stains indicate previous or ongoing moisture issues, which further attract timber pests and contribute to the deterioration of timber materials.

A licensed pest control professional specializing in timber pest management should be consulted to assess the extent of the infestation and develop a comprehensive treatment plan. They can implement strategies to eliminate existing timber pests, such as termites and prevent future infestations by addressing underlying moisture issues. Additionally, a qualified contractor or builder may be needed to improve subfloor ventilation, enhance site drainage, repair water-damaged areas, and install ant caps to prevent pest entry points. Regular inspections and maintenance are essential to ensure ongoing protection against timber pests and maintain the structural integrity of the subfloor.

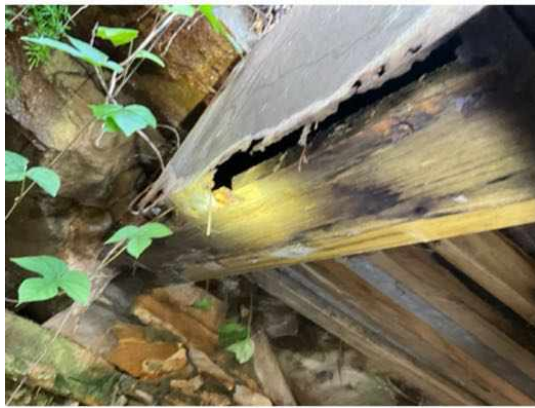
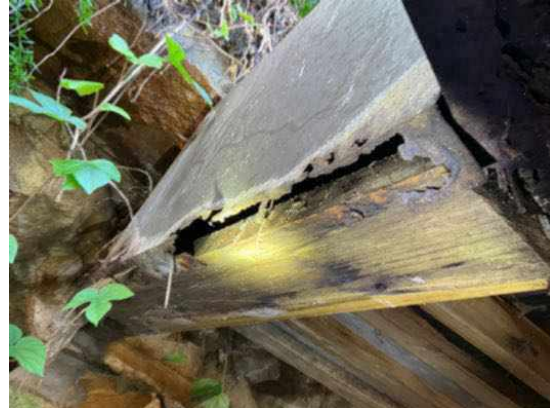
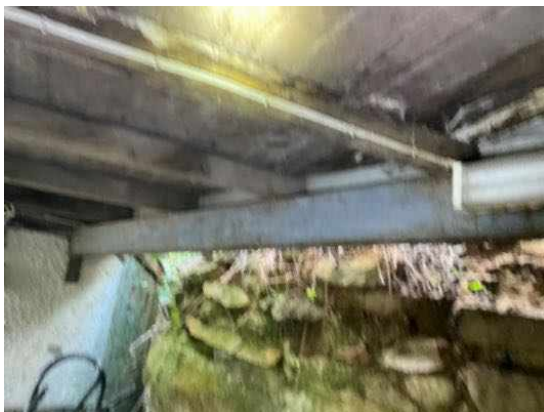
Finding 7.01

Finding: Wood rot

Information: This building element shows evidence of wood rot. Wood rot, also known as Fungal Decay, occurs when timbers and other cellulose building materials are exposed to damp conditions on an ongoing basis. This could be the result of exposure to weathering over a prolonged period of time, or the attraction of excessive moisture

Wood rot is often associated with general damp problems and is evidenced by a 'musty' smell or mould and mildew occurring on surfaces. If left unmanaged, damp conditions can lead to further health problems and the decay of timbers will continue.

Early intervention and regular maintenance, particularly of exterior timbers, will prolong the useful life of these building elements. Prior to any works being performed, the cause of the moisture that has created the visible wood rot should be identified and addressed in a suitable manner. Replacement of affected timbers may then be a necessary step in protecting surrounding building elements from such deterioration.

A qualified plumber may be appointed to assess the cause of excessive moisture and to provide advice on any remedial works as required. A qualified carpenter or registered builder may also be required to replace affected building materials.
