Building and Timber Pest Inspection Report

Inspection Date: Thu, 26 Mar 2026

Property Address: 14 Illawarra St, Mosman NSW 2088,
Australia

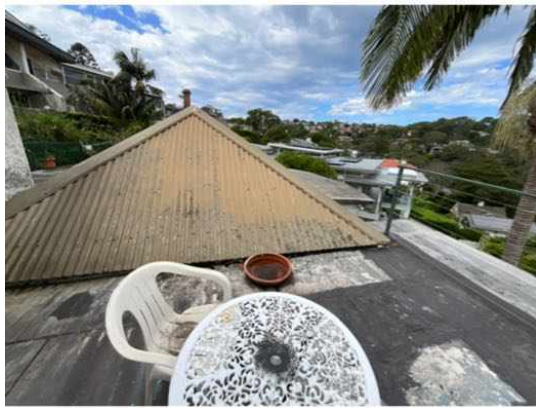
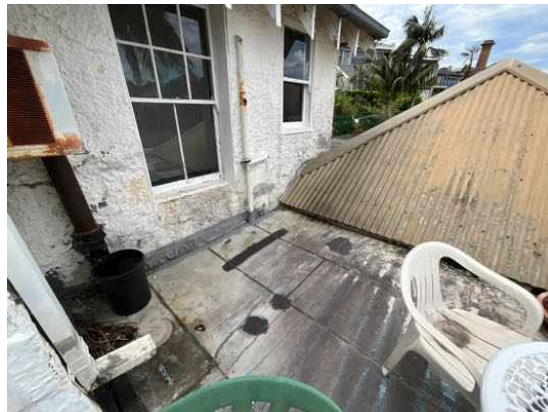
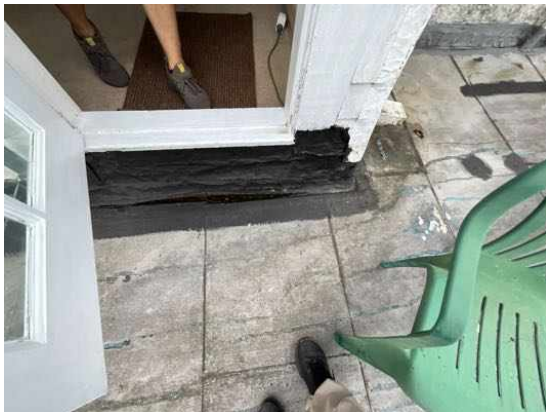
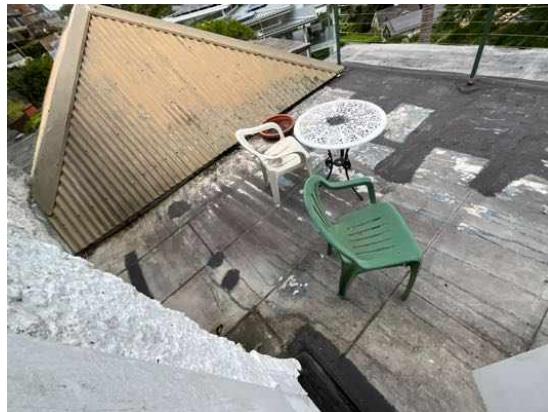
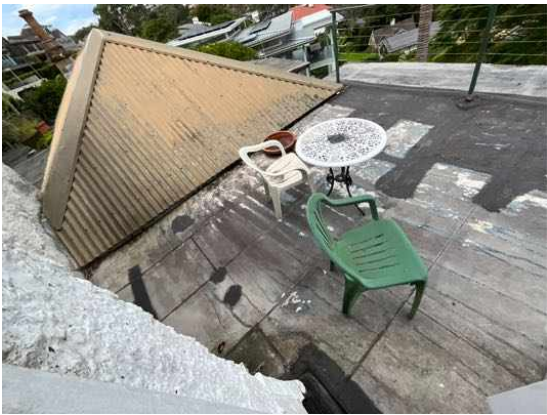
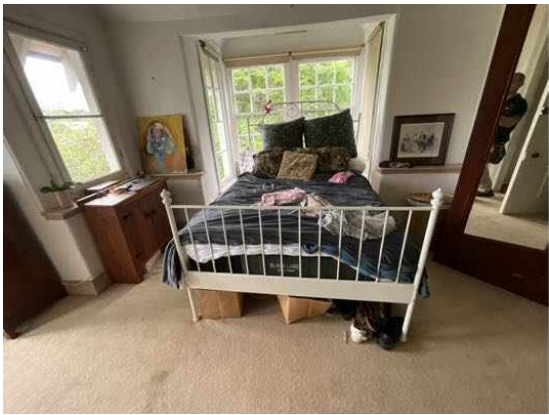
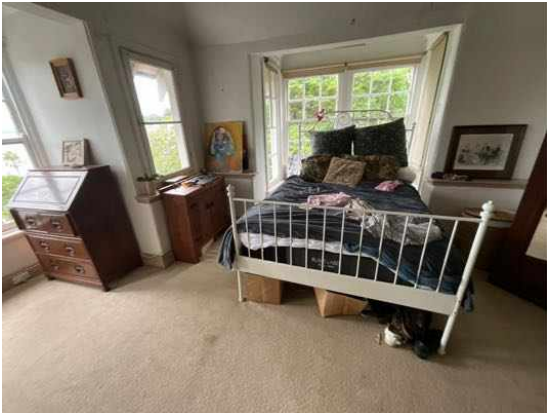
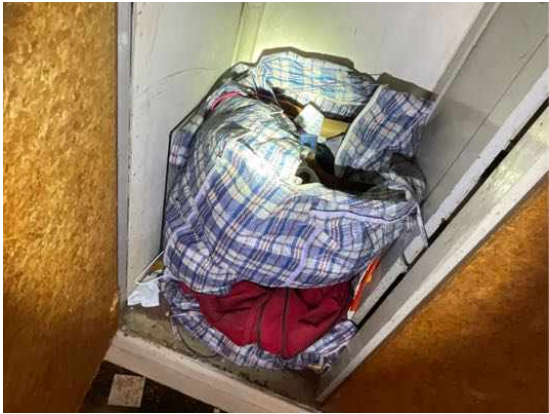
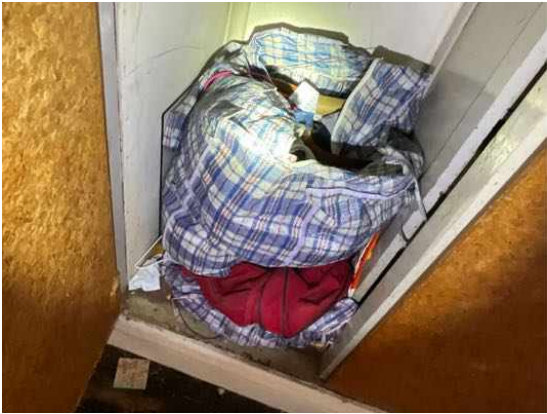
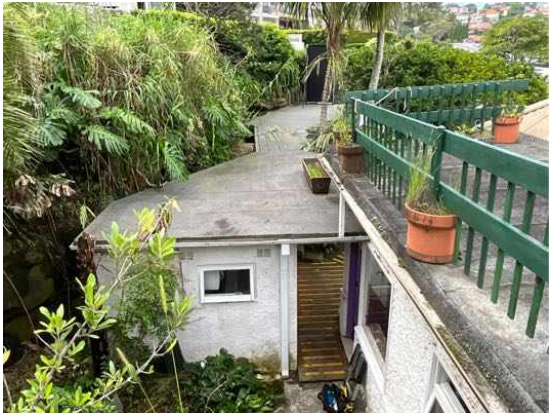
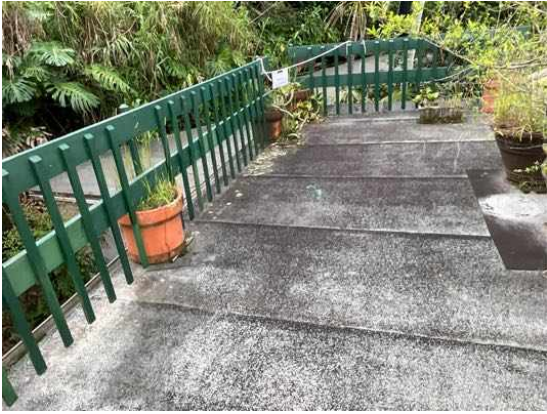
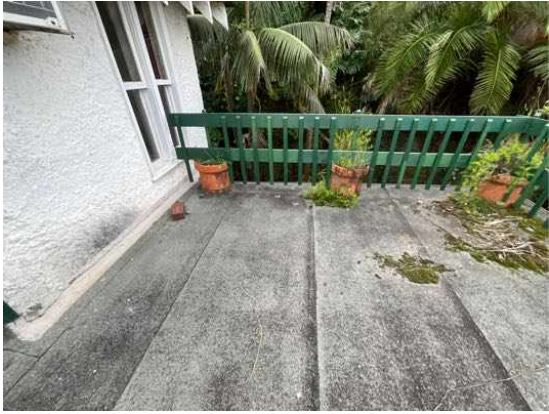
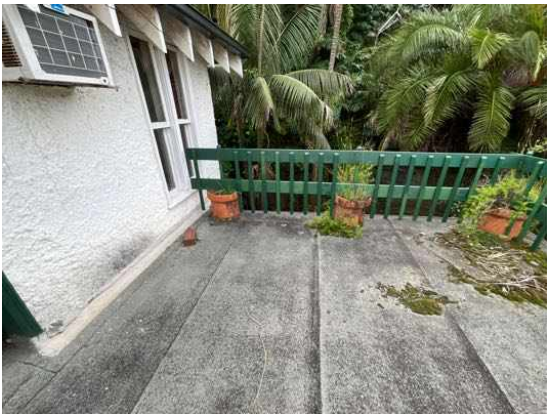
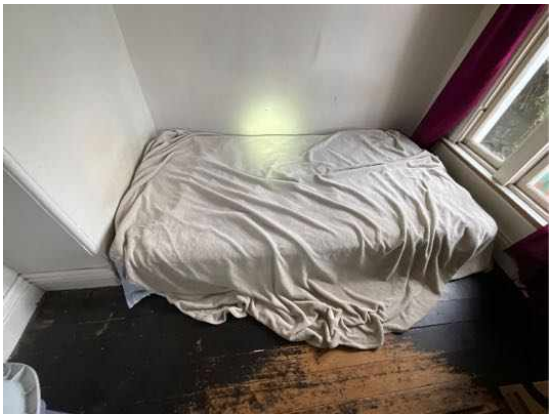
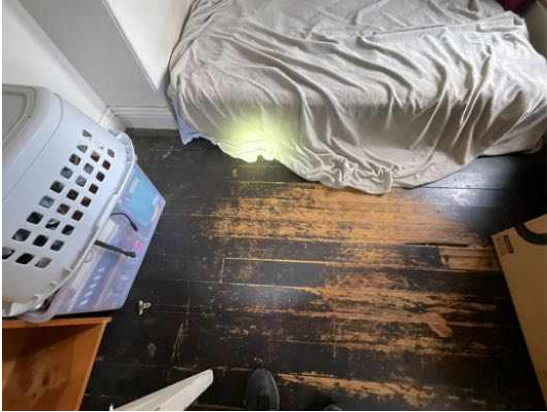
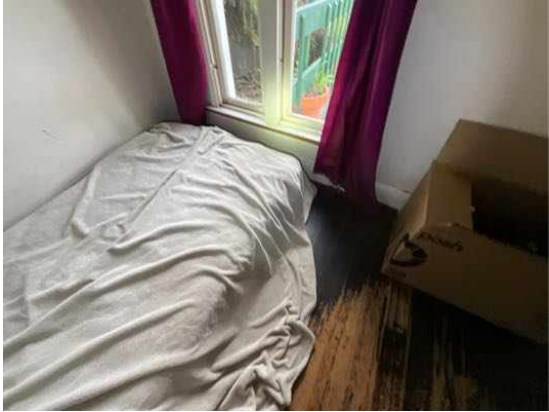
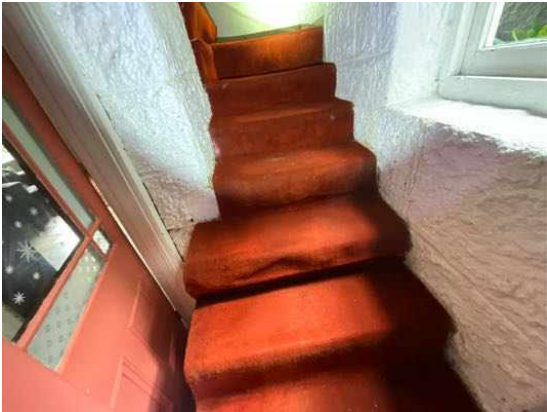
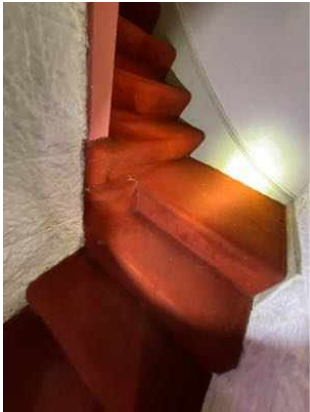
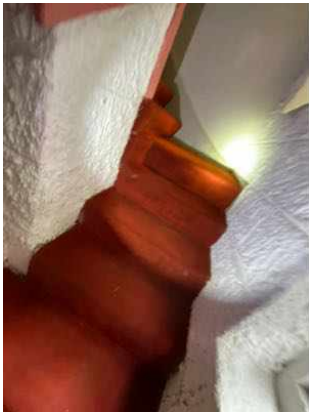
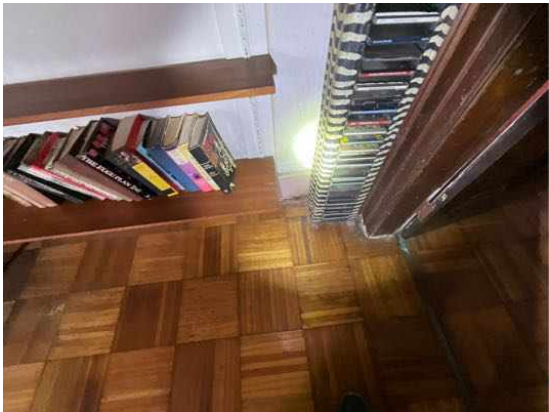
Finding: Additional Photos - Obstructions and Limitations

Information: These photographs are an indication of the obstructions and limitations which impeded full inspection of the property at the time of inspection. These obstructions can hide an array of defects and should be removed to allow full inspection to be carried out. A re-inspection is recommended once the areas are made accessible.
