Building and Timber Pest Inspection Report

Inspection Date: Wed, 11 Mar 2026

Property Address: 11 Myee Rd, Macquarie Fields NSW 2564,
Australia

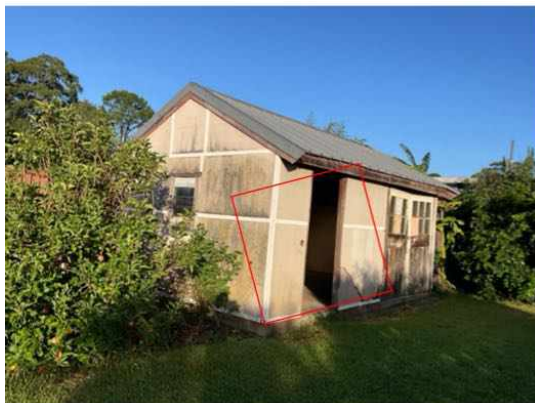
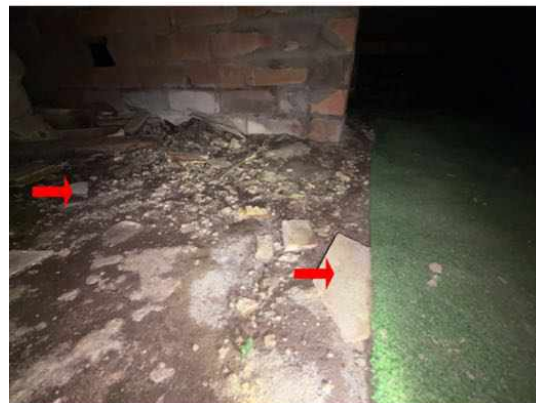
Building:	Main Building
Location:	Shed, subfloor
Finding:	Asbestos - Suspected ACM Identified on Site
Information:	Reporting on Asbestos is outside the Scope of this Report. This suspected defect is highlighted as a caution only. We suspect, based on our experience in the building industry, that there is a higher risk of the identified building element containing asbestos.

As Asbestos Reporting is outside the scope of this report, we advise that you consider a separate Asbestos Inspection and Condition Audit, which can include the taking of samples for definitive confirmation of the presence of Asbestos.

In the interim, the client is advised to act with caution, especially when considering any damage to building materials general wear and tear renovations extensions demolition and general maintenance activities due to the suspected presence of Asbestos.

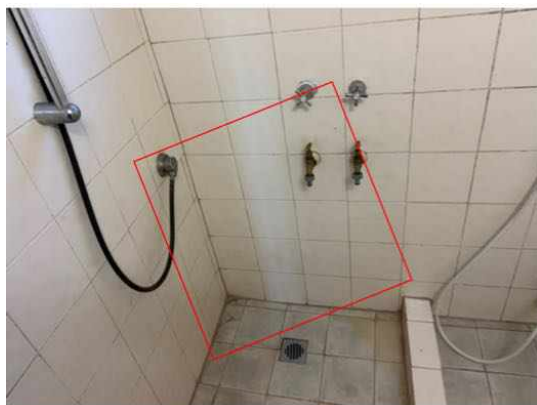
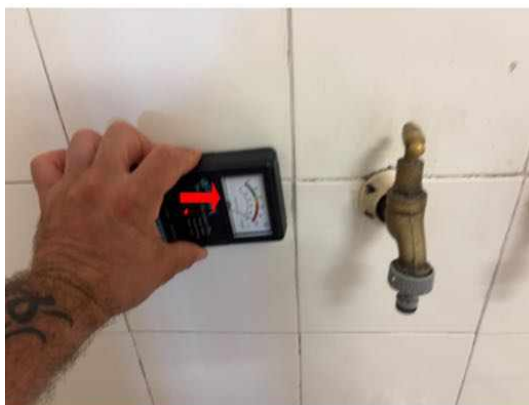
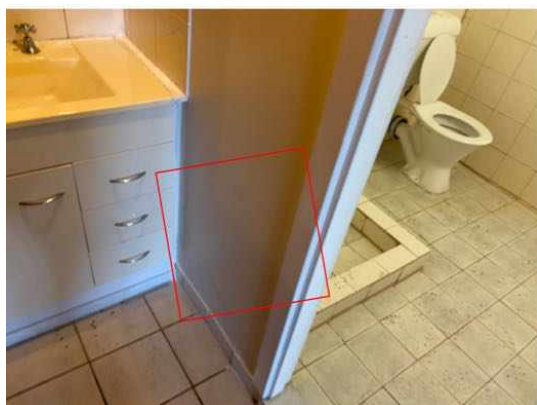
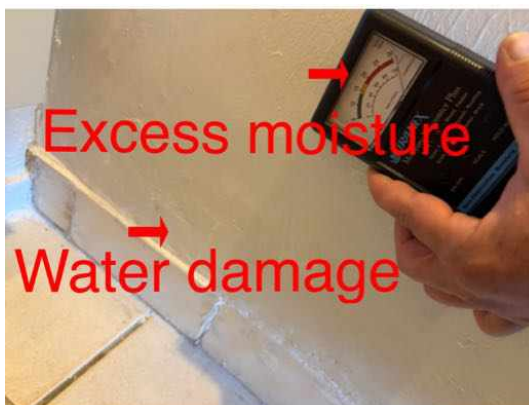
Finding 2.01

Building:	Main Building
Location:	External shower
Finding:	Water leak suspected - Internal
Information:	A water leak is suspected in this area at the time of inspection. Internal water leaks can be detrimental to surrounding building elements; their potential causes include damage to plumbing fittings and fixtures, through to water damage and deterioration of associated building elements.

Rust, corrosion, decay and water damage are potential outcomes where a minor water leak is left unattended. More serious defects may also result, such as electrical hazards, or water damage to structural building elements.

In extreme cases, structural damage may develop due to a prolonged water leak. A bathroom specialist must be appointed immediately for rectifications.

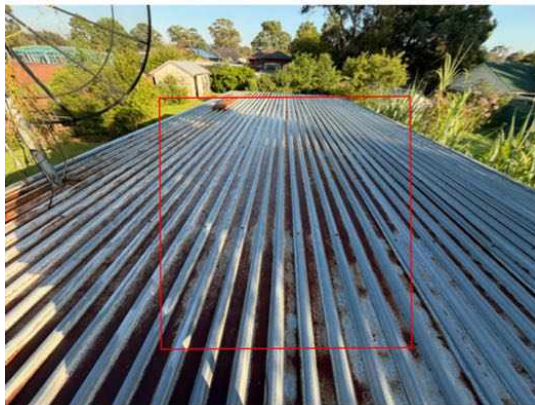
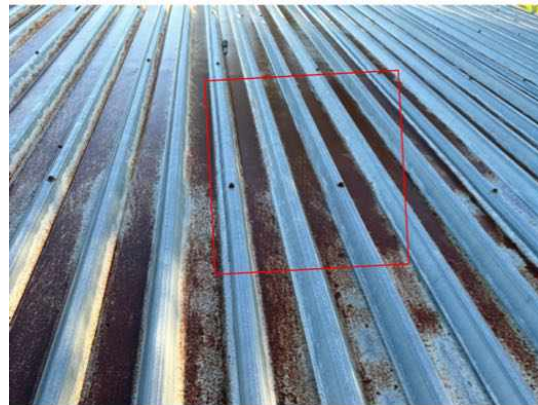
Finding 2.02

Building:	Main Building
Location:	Garage
Finding:	Roof sheets - Rusted
Information:	Metal roofs generally comprise numerous individual sheets, which join and overlap. These intersections are particularly prone to lift at the edge and consequently rust at these points.

Upon inspection of the exterior roofing structure, evidence of rust to these sections was identified. If left unmanaged, these degrading joints can allow water ingress to the internal roofing structures, potentially leading to secondary damage of building elements. Accelerated deterioration of the roofing sheets and any associated building elements is also likely to occur.

A roofing contractor should be appointed immediately to assess the damage to the

roofing sheets and to perform remedial works as necessary. Works may include replacement of severely affected roofing sheets or minor works such as the application of rust-retardant surface protectors.

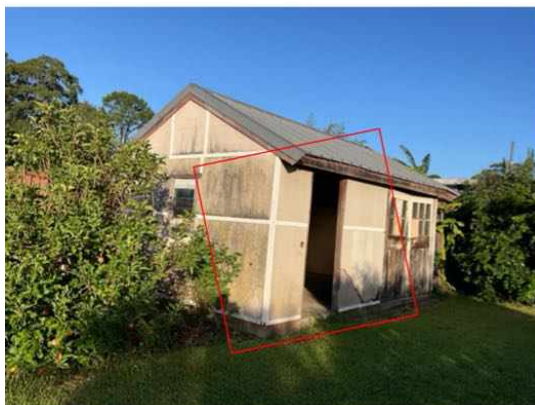
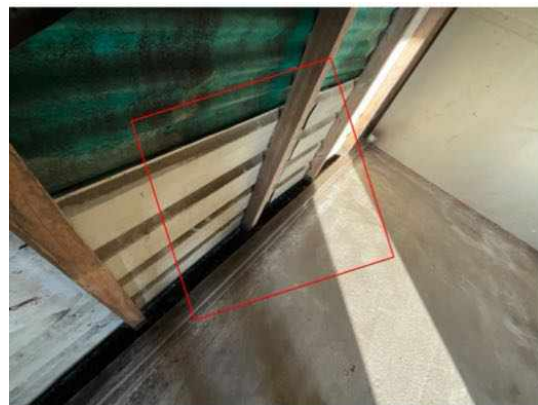
Finding 2.03

Information: Movement was evident in the structure, indicating that it may not be structurally sound or compliant with current building regulations. The shed was noted to have severely deteriorated.

If left unmanaged, the structure is likely to deteriorate further, potentially collapsing.

A licensed builder should be appointed for consultations and replacement as a matter of urgency.

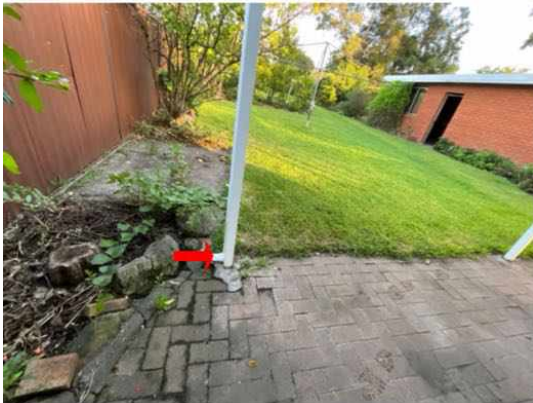
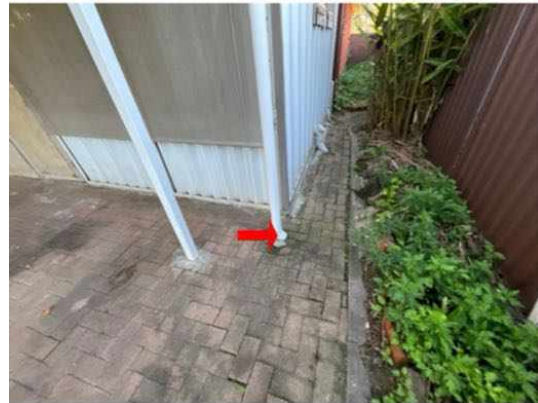
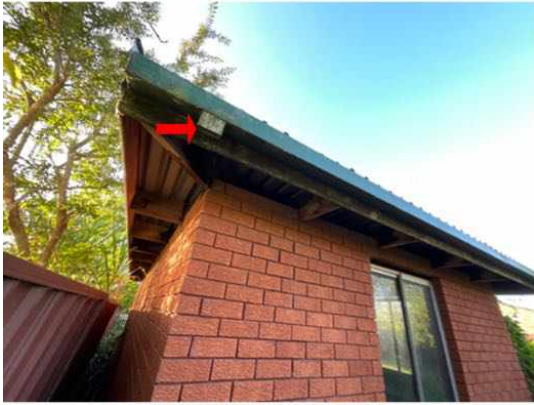
Finding 3.06

Building:	Main Building
Location:	Multiple areas of roof plumbing
Finding:	Water leak - External
Information:	Water leaks were found to be present to exterior plumbing work. Leaks are generally caused by deterioration of the plumbing elements over time, due to exposure to weather conditions, but may have also been caused by minor impact damage.

Such leaking creates damp conditions in the affected area, causing potential for water pooling and subsequent water damage if left unattended. These conditions may also attract termite attack, particularly if the area is subject to minimal levels of sun throughout daylight hours.

It is highly advised that a licensed plumber be appointed to rectify any water leaks that may be present. Areas of repair and replacement of plumbing fittings and fixtures may be required and, as such, a quotation should be sought.

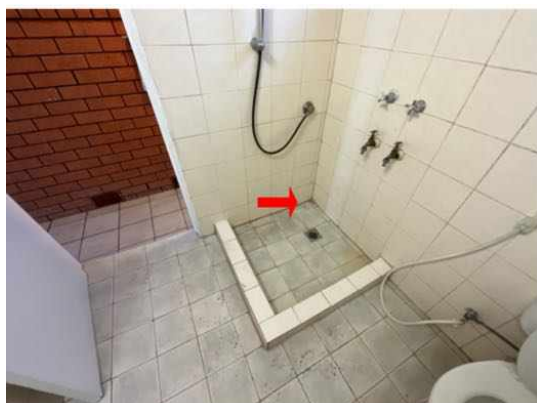
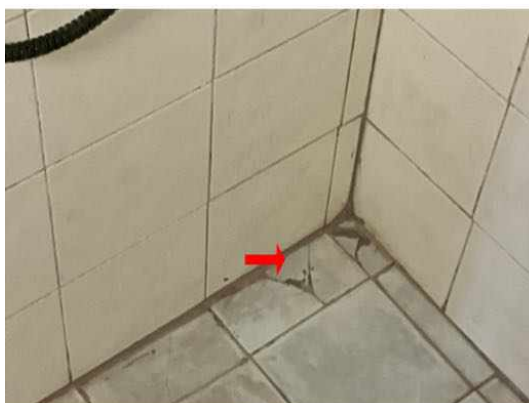
Finding 3.15

Building:	Main Building
Location:	All Wet Areas
Finding:	Sealant and grouting - Missing or damaged

Information: It was noted on inspection that sealant or grout is degraded to this area.

Different materials and floor areas move at different rates, generally causing cracking to grout or sealant at this point. A flexible sealant is required to allow for expected expansion and contraction, while keeping the joint water tight and protective of all associated building materials.

Flexible and mould resistant materials should be applied to affected areas to prevent any subsequent water damage that is likely to occur. Regular maintenance and replacement of damage or missing or damaged sealant and grout is highly recommended to the wet areas, as this is a regular wear and tear defect. Sealant and grouting in areas that come into regular contact with water should be maintained for the long term care of your property.

A sealant specialist should be appointed to complete these works as soon as possible.

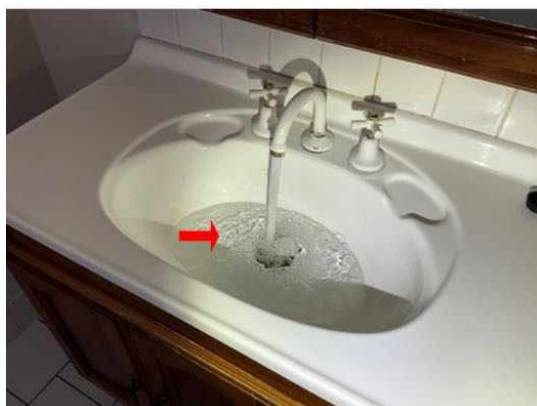
The sink/basin drain appeared to be partially blocked at the time of inspection. Blockages here are usually caused by hair and other debris. If left unmanaged, a lack of general maintenance may lead to the development of more significant defects, such as water damage to surrounding building materials.

A licensed plumber should be appointed to remove the blockage at the client discretion.

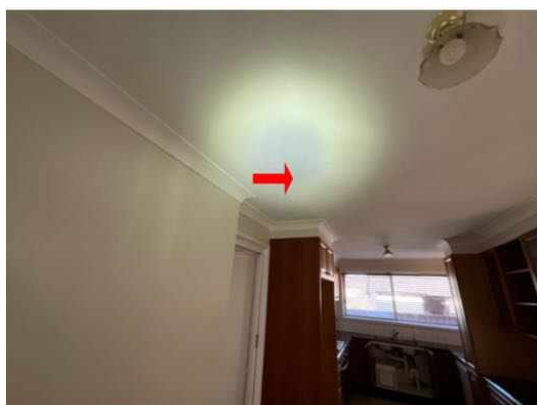
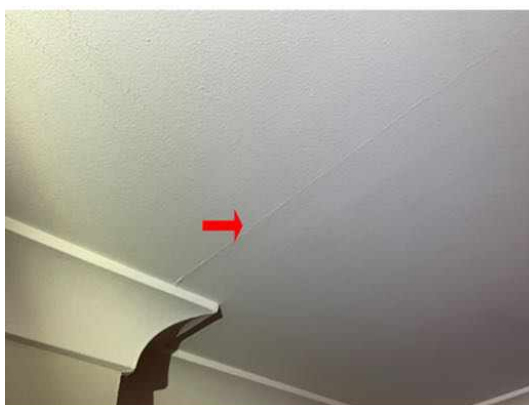
Finding 3.18

Building:	Main Building
Location:	Multiple areas
Finding:	Cracking - Damage Category 1 - Fine (up to 1mm)
Information:	Although fine cracks are quite noticeable, they are often only considered to be an appearance defect, and usually do not indicate any structural damage. Generally, the cause of a fine crack is indicative of a separation between building materials and finishes (e.g. paint, plaster, etc.) along joins.

Cracking of this nature can generally be repaired with minor sanding, filling and/or repainting. Such works should be performed by a qualified painter or a general handyman.

Monitoring of all cracking should be conducted frequently. Always contact a building inspector should cracks widen, lengthen, or become more numerous.

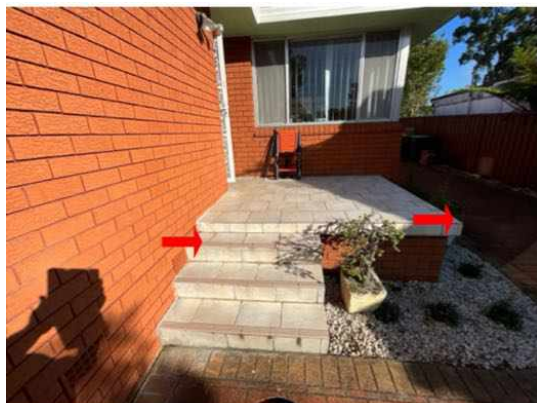
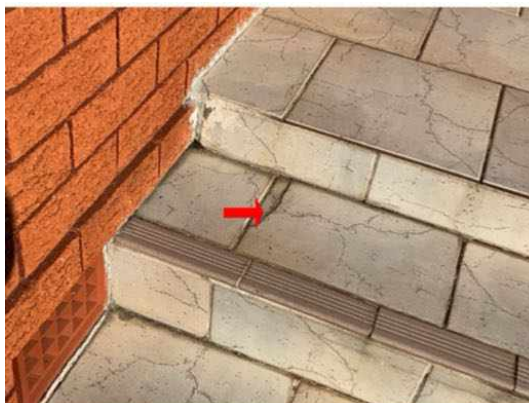
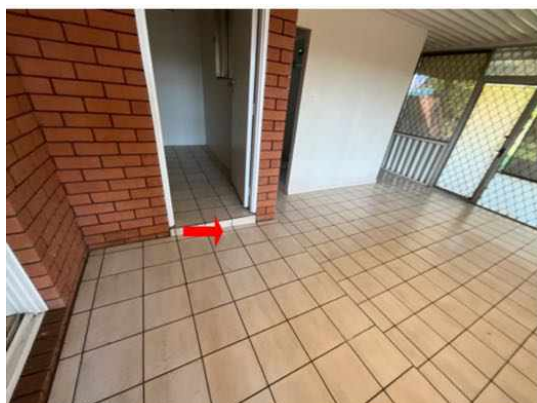
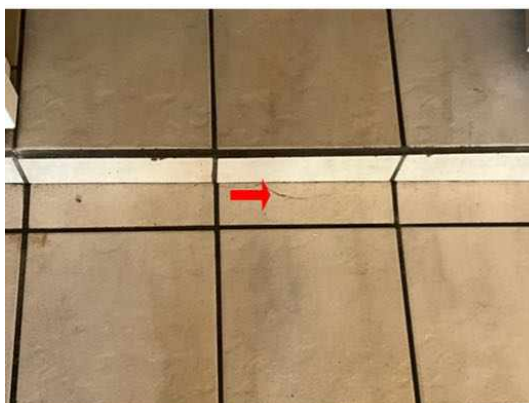
Finding 3.19

Building:	Main Building
Location:	Porch, alfresco
Finding:	Cracked floor tiles
Information:	Cracking in the floor tiles was evident in this area at the time of inspection. It is

suspected that this cracking has occurred as a result of minor settlement or shrinkage.

Cracked tiles throughout the household detract from the overall appearance of the affected areas however it is unlikely to create or lead to any secondary defects.

While not considered a matter of urgency, replacement of cracked floor tiles is recommended at the clients discretion. A licensed tiling contractor may be appointed to perform these works. Where cracks become more numerous, contact a licensed building inspector for further investigation.

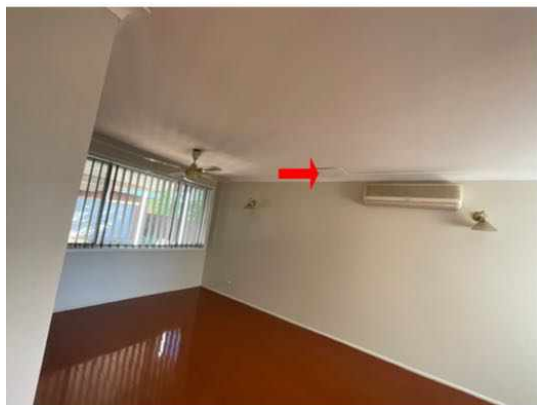
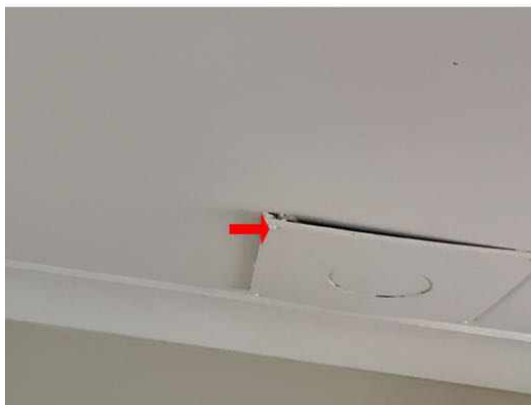
Finding 3.20

Building:	Main Building
Location:	Lounge
Finding:	Fitting or fixture - Loose
Information:	The fitting in this area is loose and requires adjustment to tighten.

If left unmanaged, the fitting may further deteriorate, causing potential for the development of other minor secondary defects.

A relevant tradesperson should be appointed to perform these rectification works at discretion of the client.

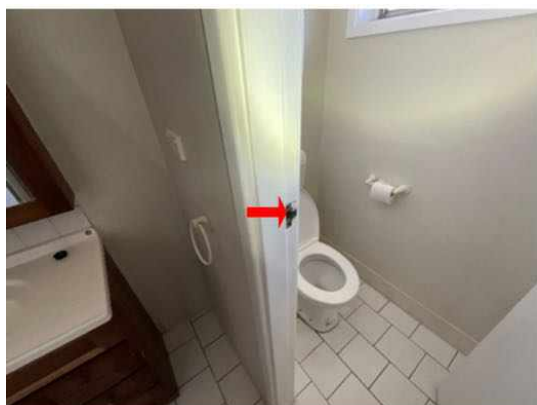
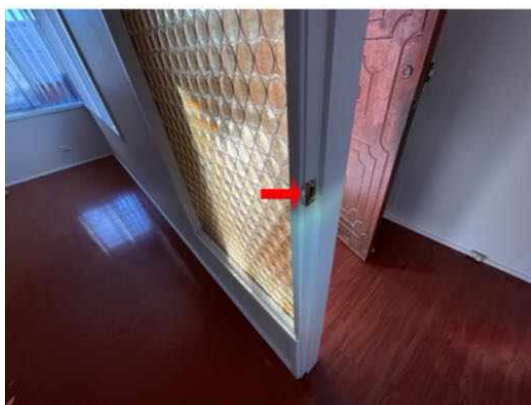
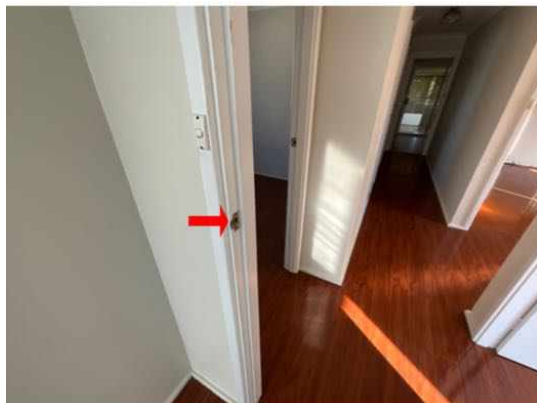
Finding 3.21

This is a common defect and is expected in a property of this age, whether being due to substandard installation or general deterioration of the door hardware.

Readjustment of the striker plate is recommended at client discretion. Works such as these can be completed by a general handyman or qualified carpenter.

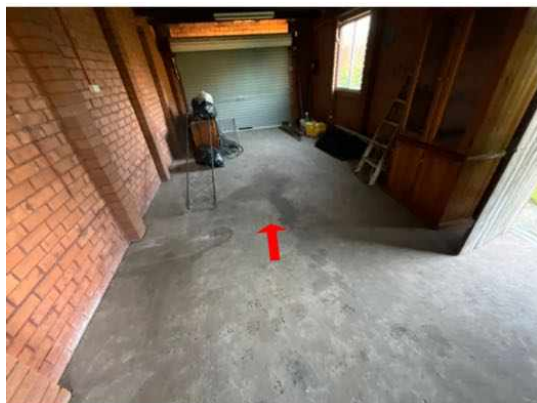
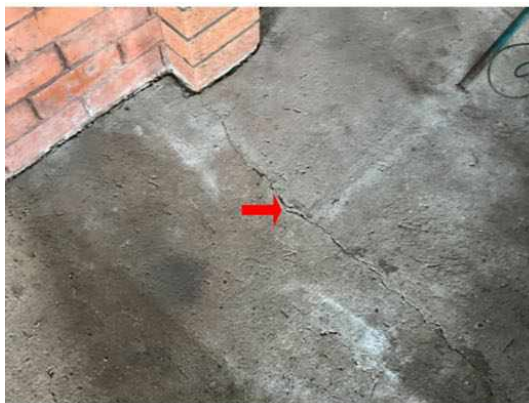
Building:	Main Building
Location:	Garage
Finding:	Crack in concrete slab - Category 1
Information:	A crack coded as Category 1 was identified in the slab. A Category 1 crack is described as a fine but noticeable crack, with the slab at an otherwise reasonable level.

To be considered Category 1, the approximate width of the crack is less than 1.0mm, or a less than 10mm change in offset when a 3m straight edge is placed over the defect.

Category 1 cracks should be monitored for a period of 12 months. At the end of the monitoring period, identified cracks that are rated greater than Category 2 are considered defects, and require rectification.

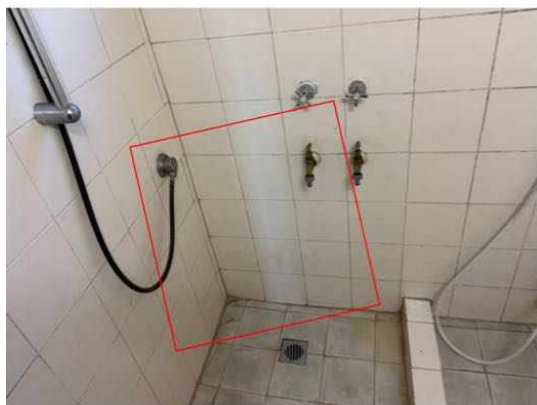
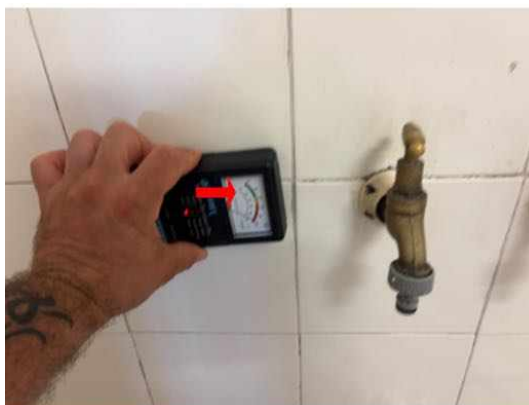
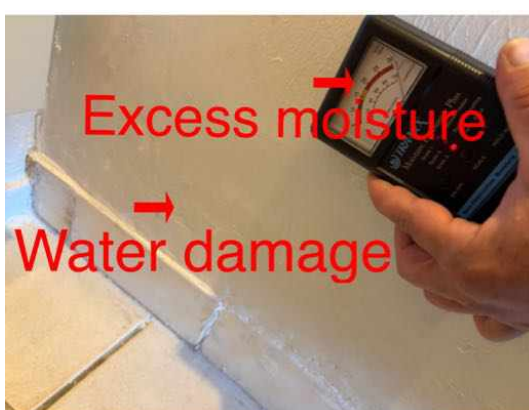
Building:	Main Building
Location:	External shower
Finding:	Water leak suspected - Internal
Information:	A water leak is suspected in this area at the time of inspection. Internal water leaks can be detrimental to surrounding building elements; their potential causes include damage to plumbing fittings and fixtures, through to water damage and deterioration of associated building elements.

Rust, corrosion, decay and water damage are potential outcomes where a minor water leak is left unattended. More serious defects may also result, such as electrical hazards, or water damage to structural building elements.

In extreme cases, structural damage may develop due to a prolonged water leak. A

An internal leak is suspected to the external shower, due to excess moisture to the surfaces as well as water damages behind the shower. A bathroom specialist must be appointed immediately for rectifications.

bathroom specialist must be appointed immediately for rectifications.

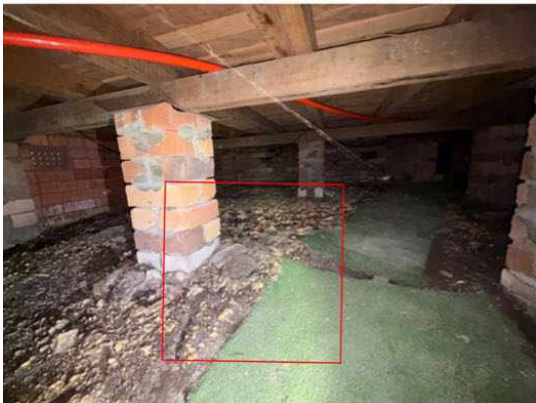
Finding 6.02

Building:	Main Building
Location:	Subfloor
Finding:	Subfloor - Dampness
Information:	Dampness to several sections of the subfloor area was identified. It is suspected that this dampness may be exacerbated by inadequate subfloor ventilation although there maybe other reasons attributing. Dampness is likely to lead to wood decay and general deterioration of structures within the subfloor space. Excessive moisture also creates an environment which is conducive to termite and pest infestation. A licensed electrician should be engaged immediately to install manual ventilation. A licensed plumber should also be appointed to determine whether any active leaks or otherwise poor drainage may also be the underlying cause.

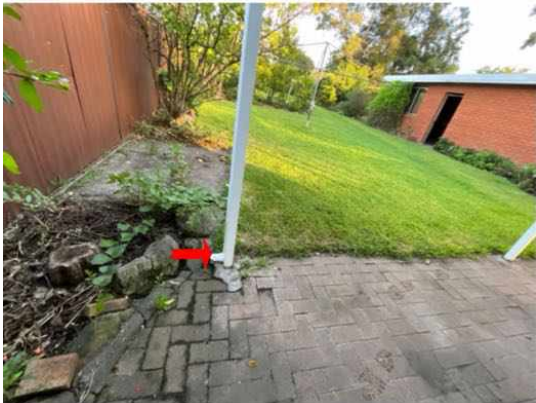
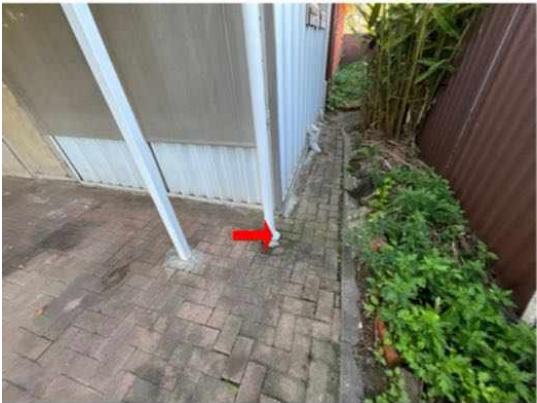
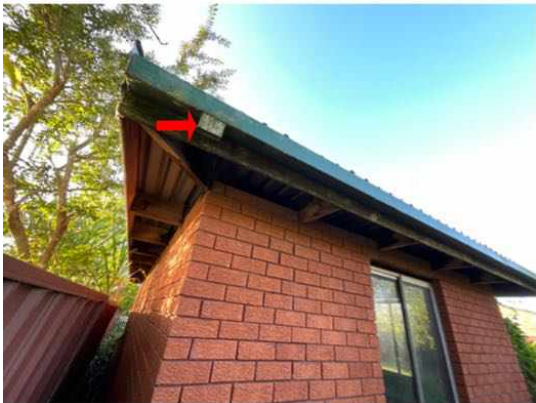
Finding 6.03

Building: Main Building
Location: Alfresco, garage
Finding: Stormwater drain - Not connected
Information: The roof plumbing is not adequately connected to stormwater drainage on the site. This disconnection negatively impacts the functional capacity of the roof plumbing.

Where roof plumbing doesn't drain adequately, the area at the base perimeter can become excessively damp, potentially creating an environment that is susceptible to rust and corrosion of surrounding building elements, as well as attracting termites and other pests.

It is highly recommended that a plumber be appointed to further inspect the area and to install adequate drainage equipment where necessary.

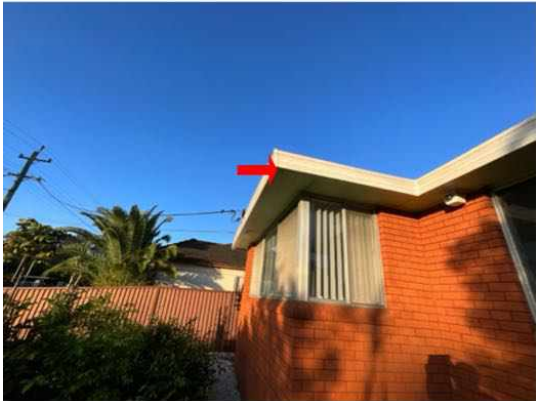
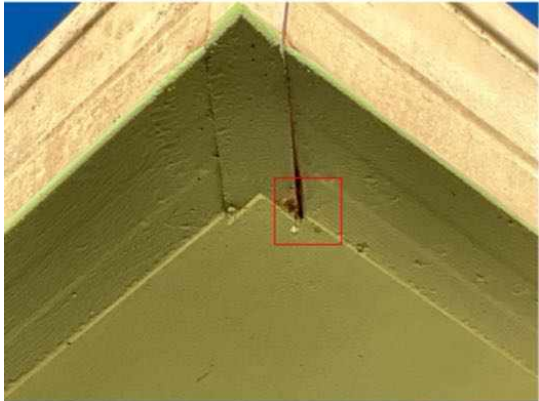
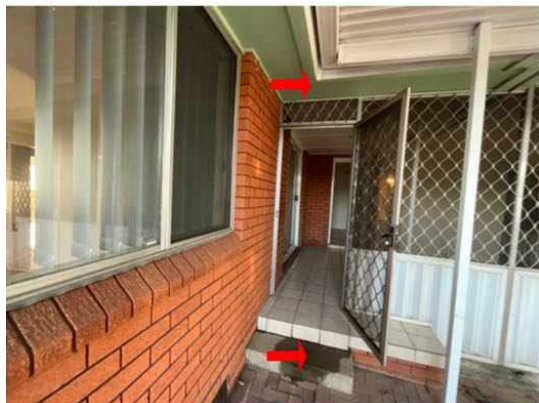
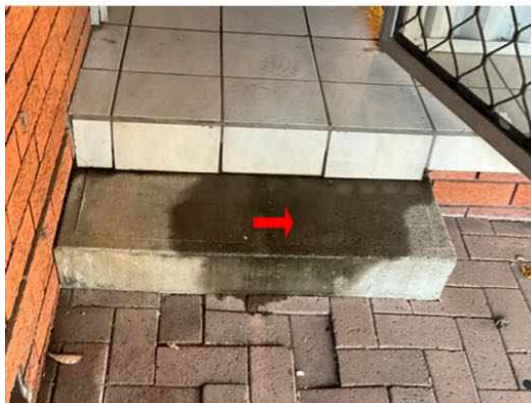
Finding 6.04

Building: Main Building
Location: Multiple areas of roof plumbing
Finding: Water leak - External
Information: Water leaks were found to be present to exterior plumbing work. Leaks are generally caused by deterioration of the plumbing elements over time, due to exposure to weather conditions, but may have also been caused by minor impact damage.

Such leaking creates damp conditions in the affected area, causing potential for water pooling and subsequent water damage if left unattended. These conditions may also attract termite attack, particularly if the area is subject to minimal levels of sun throughout daylight hours.

It is highly advised that a licensed plumber be appointed to rectify any water leaks that may be present. Areas of repair and replacement of plumbing fittings and fixtures may be required and, as such, a quotation should be sought.

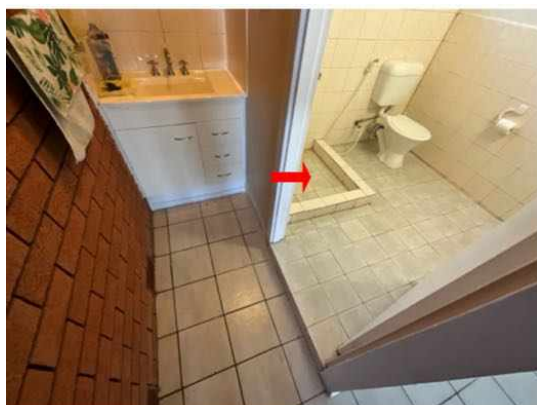
Building: Main Building
 Location: Extension

Finding: Service penetrations
 Information: Services into home can allow for concealed termite entry without additional or adequate termite protection.

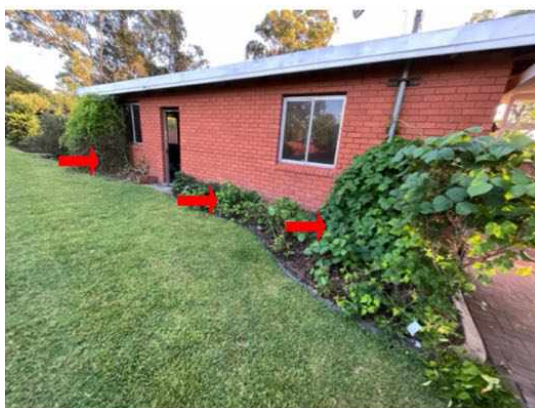
Finding 6.07

Building: Main Building
 Location: Garage
 Finding: Slab Edge - Exposure
 Information: Slab Edge Exposure: Where external concrete slab edges are not exposed there is a high risk of concealed termite entry. In some buildings built since July 1995 the edge of the slab forms part of the termite shield system. In these buildings an inspection zone of at least 75mm should be maintained to permit detection of termite entry. The concrete edge should not be concealed by render, tiles, cladding, flashings, adjoining structures, paving, soil, turf or landscaping etc. Where this is the case you should arrange to have the slab edge exposed for inspection. Concealed termite entry may already be taking place but could not be detected at the time of the inspection. This may have resulted in concealed timber damage. Does the slab edge inspection zone fully comply?

Not able to comment. A very high proportion of termite attacks are over the edge of both Infill and other concrete slabs types. Covering the edge of a concrete slab makes concealed termite entry easy. Infill slab type construction has an even higher risk of concealed termite ingress as the slab edge is concealed due to the construction design and cannot be exposed. The type of slab may only be determined by assessment of the construction plans by a qualified person e.g. Builder, Architect. Construction Plans may be obtainable by your local Council or Builder. Termite activity and or damage may be present in concealed timbers of the building. We strongly recommend frequent regular inspections in accordance with AS 3660.2. Where the slab edge is not fully exposed or the slab is an infill slab or the slab type cannot be determined then we strongly recommend inspections every 3 to 6 months in accordance with AS 3660.2 or AS 4349.3.

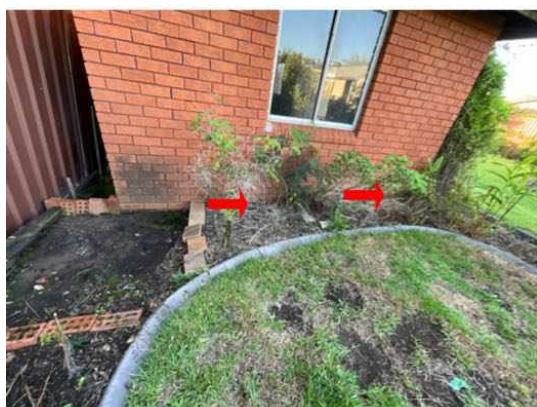
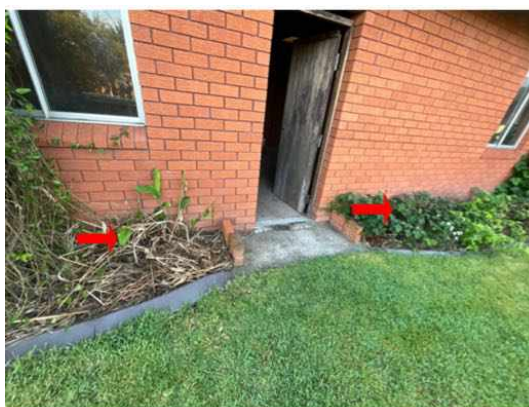
Finding 6.09

It is important for internal flooring to be raised above adjacent external ground levels. Where external ground levels are above internal flooring water pooling and subsequent internal flooding is likely to occur which may attract termite activity to the internal area.

It is highly advised that a landscaper or paver be appointed to lower external grounds that are raised above adjacent internal flooring. Alternatively if external grounds and internal flooring is level installation of a raised door sill may be appropriate in preventing any water pooling in the area.

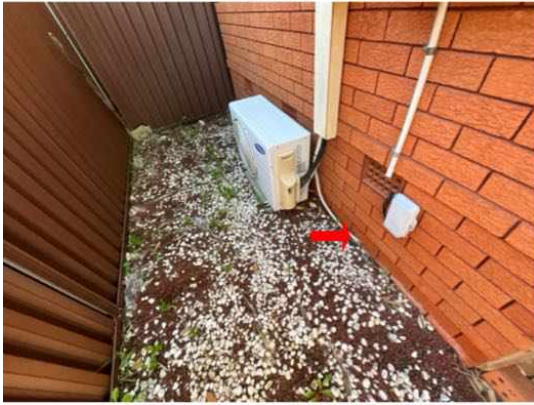
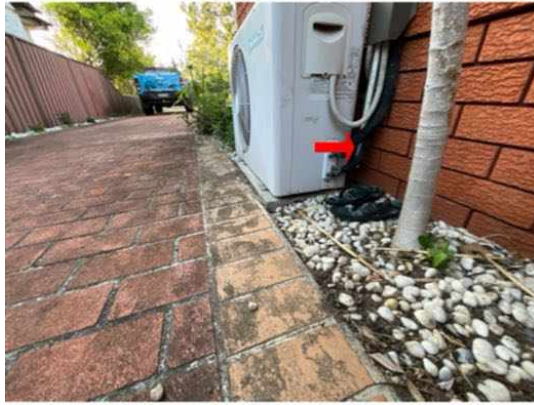
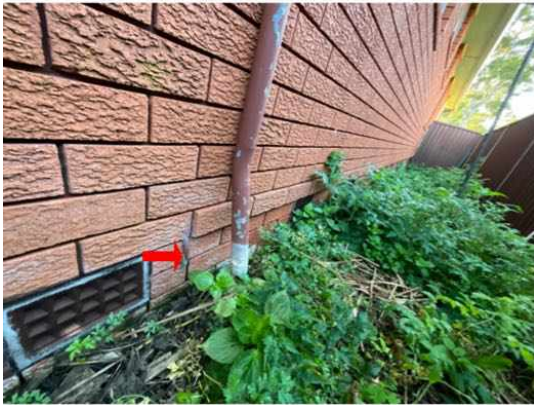
Finding 6.10

Building: Main Building
 Location: Yard - Side
 Finding: Overflow - Not plumbed for drainage
 Information: The overflow is not plumbed or connected to suitable drainage, which can result in the surrounding area becoming excessively damp.

These damp conditions can lead to secondary defects such as rot, rust or corrosion of associated building elements, the formation of fungal decay, or even the creation of potential slip hazards. When coupled with poor site drainage, pooling of water may also attract termite activity to this area.

It is highly recommended that a licensed plumber be appointed to install adequate drainage to the overflow. These works will ensure that the area remains dry and free of any secondary defects.

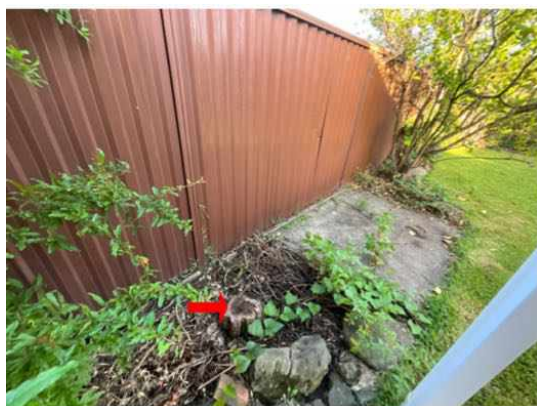
Finding 6.11

Building:	Main Building
Location:	Yard
Finding:	Tree stump - Remove
Information:	Old tree stumps were found around the property. Attached photos are examples of these.

Any tree stumps in ground contact provide opportunity for concealed termite infestation and are likely to be subject to decay as the soil retains moisture or damp conditions against the tree stump.

All tree stumps should be removed where possible. Frequent pest inspections are advised to readily identify any termite activity in these areas.

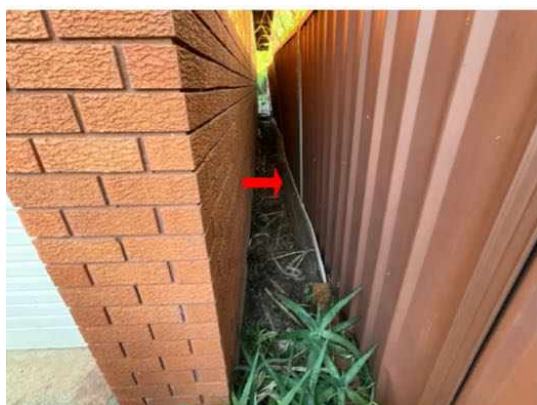
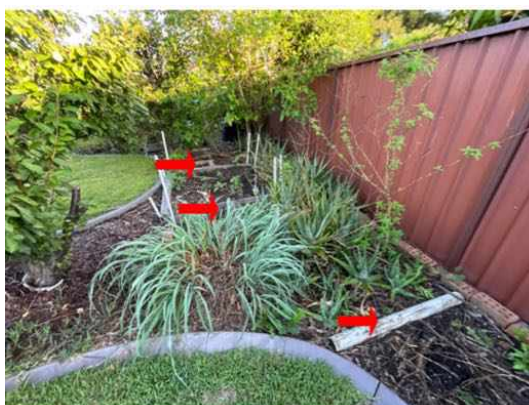
Finding 6.12

Building:	Main Building
Location:	Fencing & Landscaping
Finding:	Building materials in direct ground contact - conducive to termites
Information:	Where timber elements are in direct contact with the ground and consequently moisture or dampness they become conducive to termite activity. Whether timber is used as a building element part of a fencing structure or stored as an unused item they can provide an environment that is attractive to termite infestation.

When met with excessive moisture timber begins to decay and develop wood rot. Any timbers that are in direct contact with external grounds especially if left untreated or non-durable also provide ingress for subterranean termites into that particular element.

The removal of any such materials that may be conducive to termite activity should be removed as soon as possible to minimise the risk of termite attack.

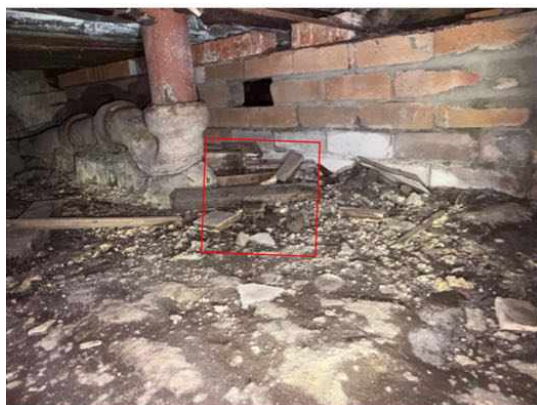
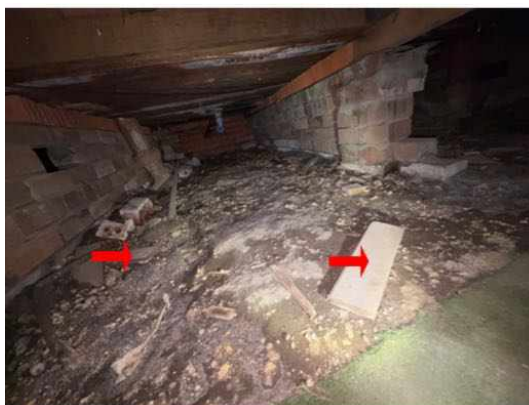
Finding 6.13

Building:	Main Building
Location:	Subfloor
Finding:	Stored timbers - subfloor space or external area
Information:	The storing of timbers in the subfloor space or around the external property increases

the risk of termite activity being present. As they are likely to come into contact with weather conditions or excessive moisture wood rot is likely to develop on timbers that are not treated.

It is highly recommended that any stored timbers be immediately removed from areas in which they may attract any termite / timber pest attack. Minimisation of risk / prevention of termite attack is far more adequate than dealing with the presence of termite activity.

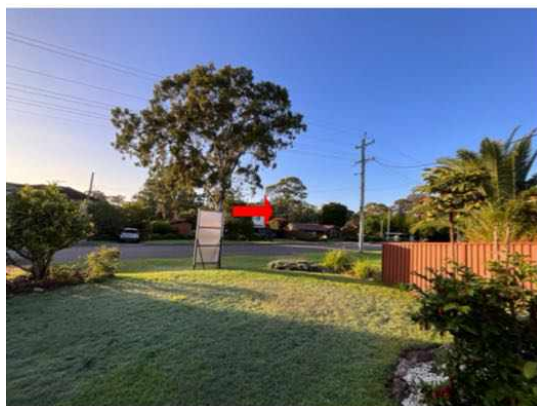
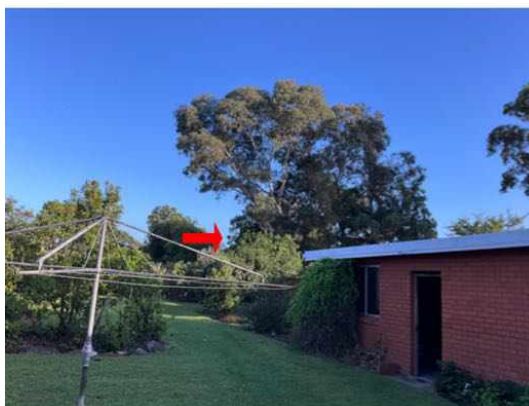
Finding 6.14

Building:	Main Building
Location:	
Finding:	Surrounding bushland - Conductive
Information:	Home and or building is situated in a high risk area for termite activity, due to close proximity to surrounding bushland.

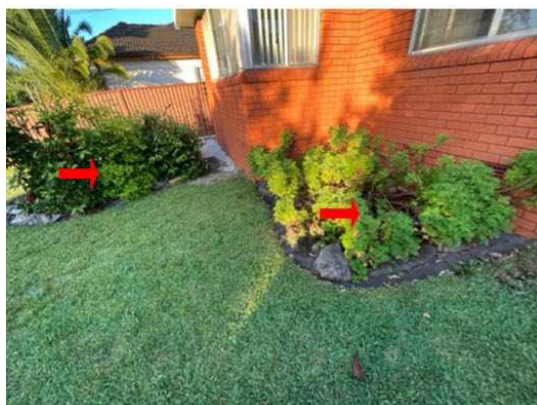
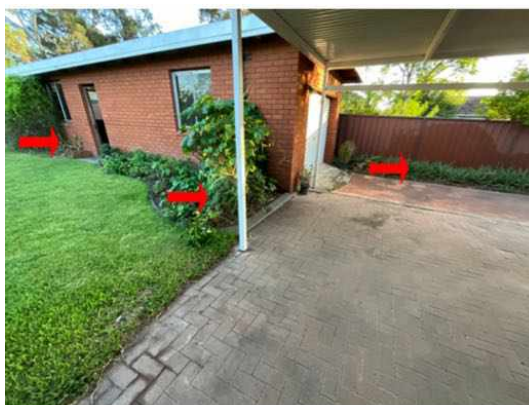
Building:	Main Building
Location:	Garden beds
Finding:	Garden Beds
Information:	Garden beds were found to be evident in the garden area. These garden beds can

include untreated timber, and with a combination of moisture from watering hosing can make conditions conducive to termite activity and termite ingress.

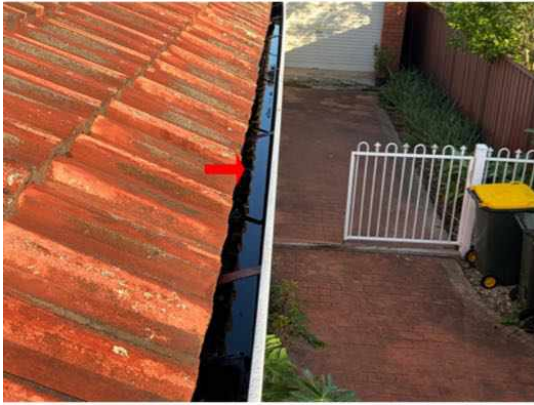
Finding 6.16

Building:	Main Building
Location:	Gutters
Finding:	Gutters - Water pooling
Information:	Water was found to be pooling in sections of the roof guttering. This is generally a secondary defect caused by blocked or partially blocked gutters. Furthermore inadequate fall to the adjacent downpipe could also be the underlying cause.

Water pooling is likely to lead to rust and water damage to associated structures if left unattended. This excess dampness is additionally conducive to termite activity.

Any areas of guttering that shows evidence of water pooling should be checked for partial or full blockages or otherwise appropriate fall to the downpipe must be applied accordingly. Any secondary damage that may have occurred as a result must be rectified. Depending on the extent of the damage, building elements may require repair and/or replacement to ensure adequate roof drainage and function of exterior plumbing system.

A roofing plumber must be appointed as soon as possible if inadequate fall to downpipe is deemed to be the cause. It is highly advised that all gutters be maintained on a frequent basis to ensure the condition of roof plumbing.

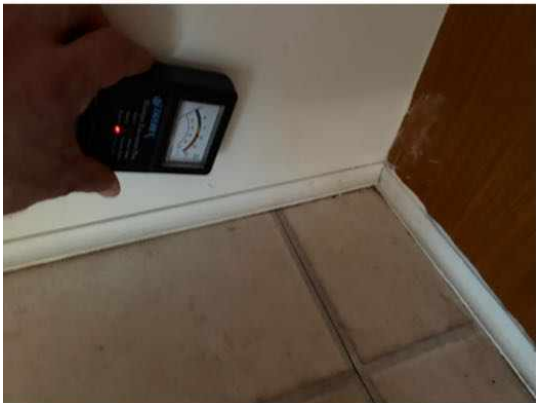
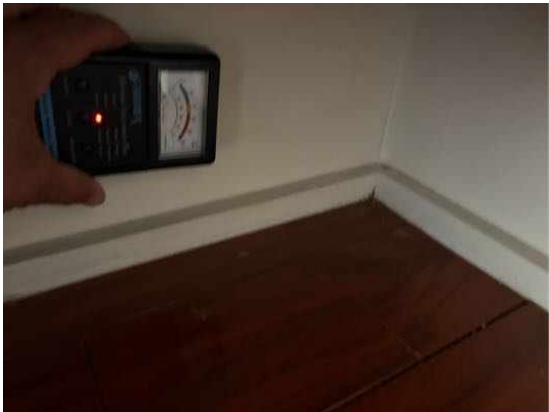
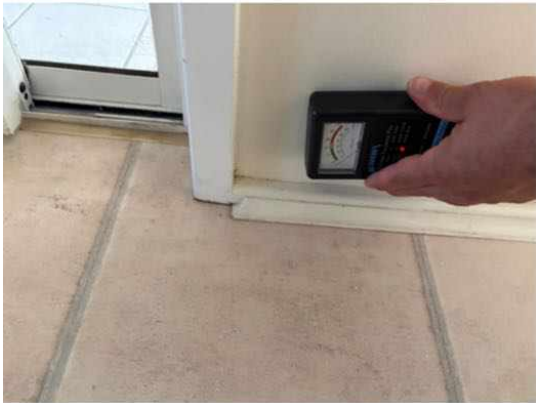
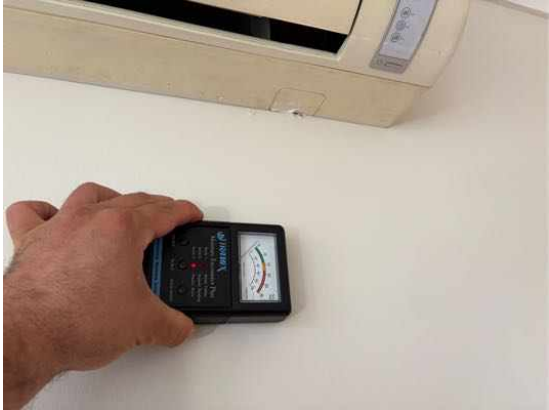
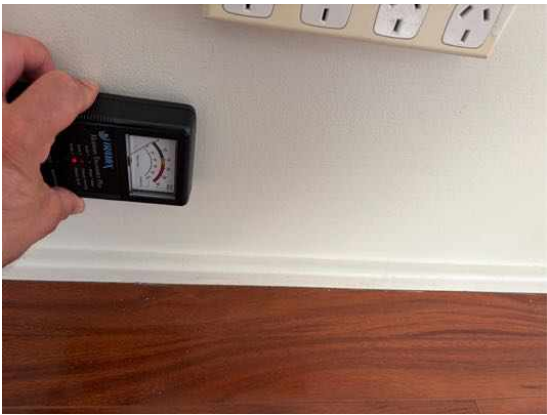
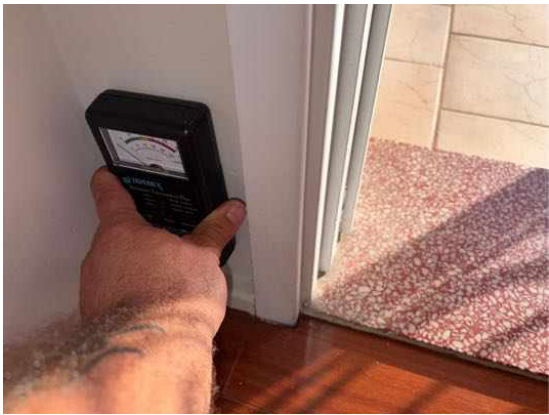
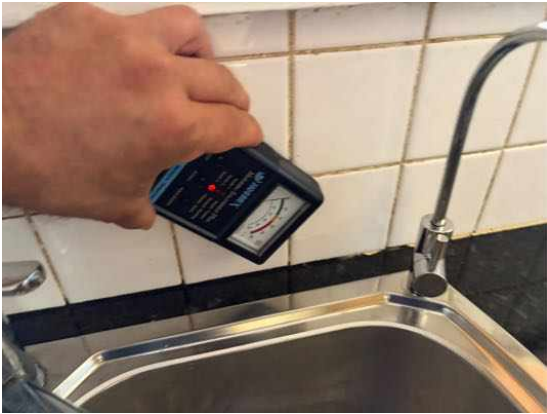
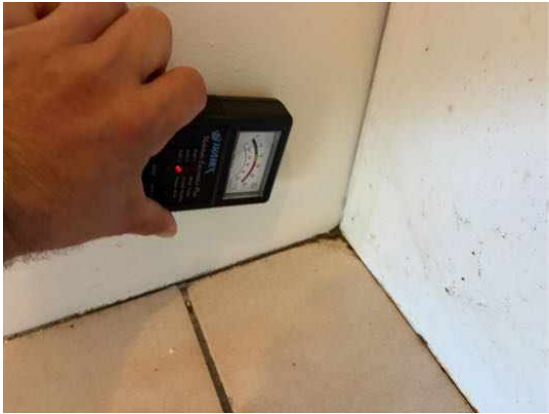
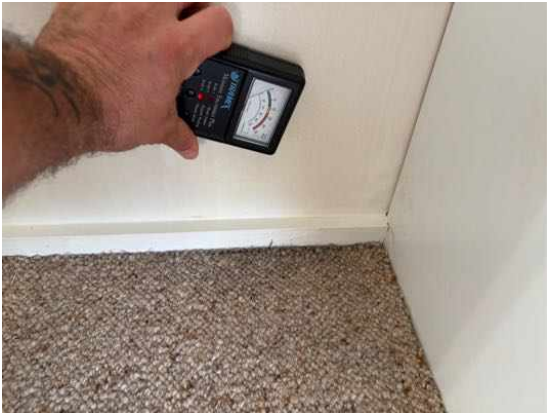
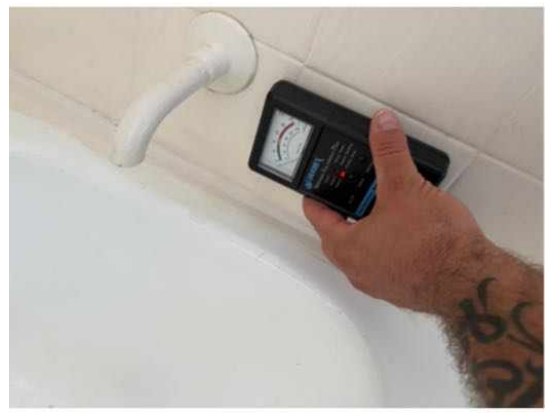
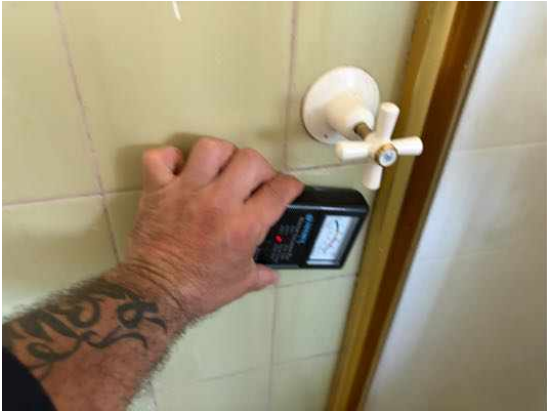
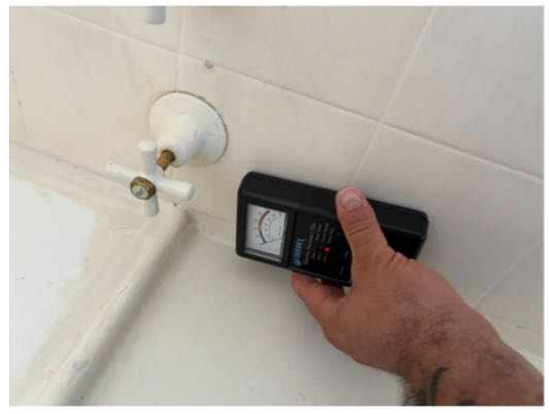
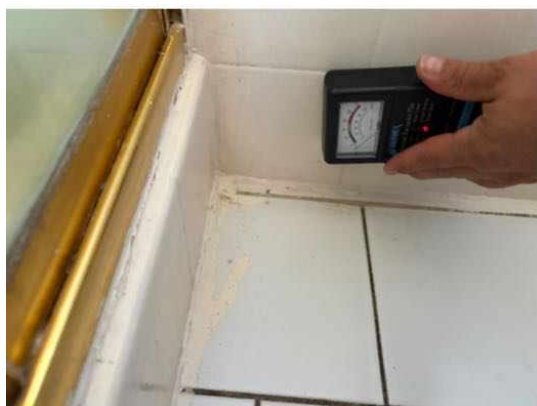
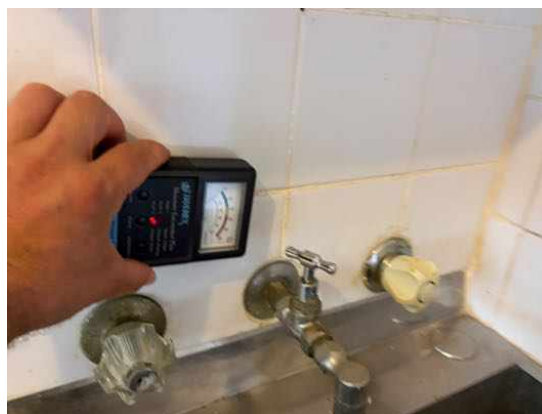
Noted Item

Building: Main Building
Location: All Areas
Finding: Moisture metre
Information: During the inspection the property was checked for moisture using a moisture metre.

This is for information only.
