Building and Timber Pest Inspection Report

Inspection Date: Wed, 11 Mar 2026

Property Address: 11 Myee Rd, Macquarie Fields NSW 2564,
Australia

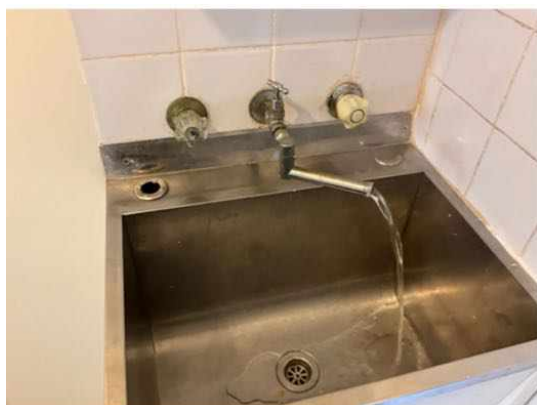
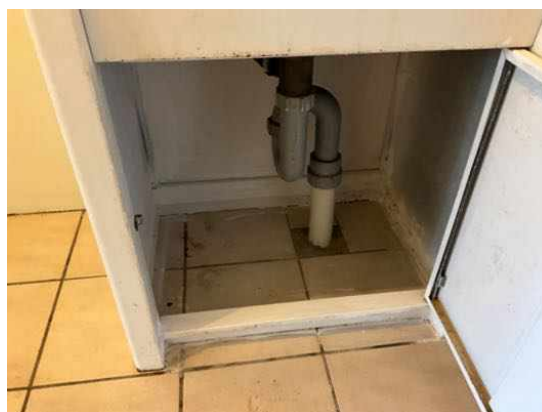
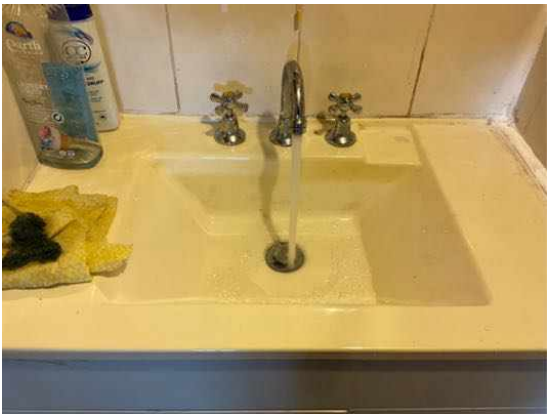
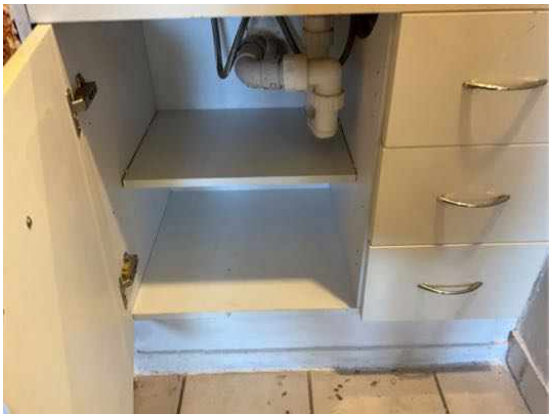
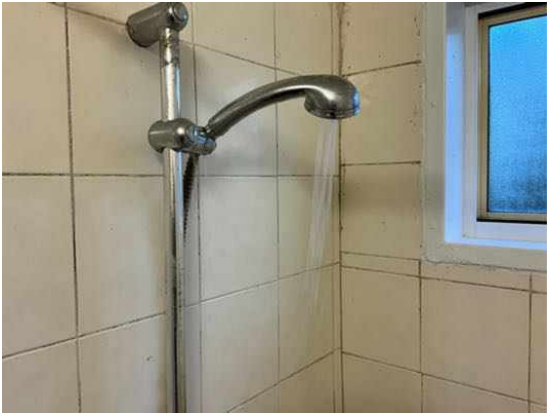
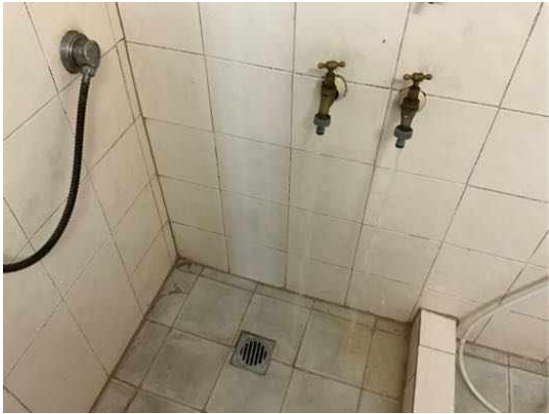
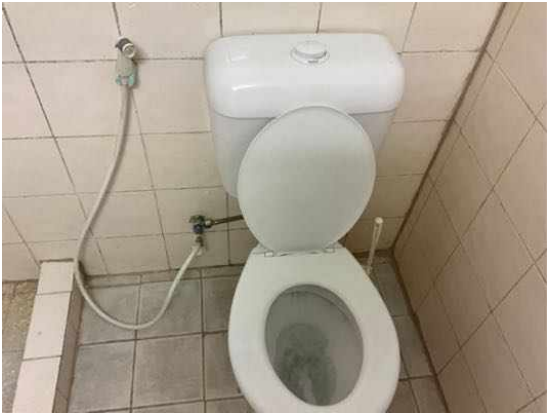
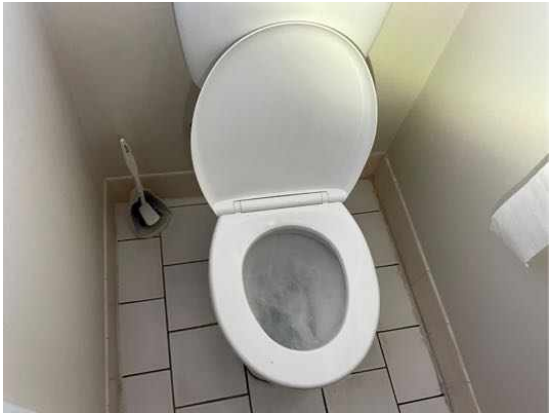
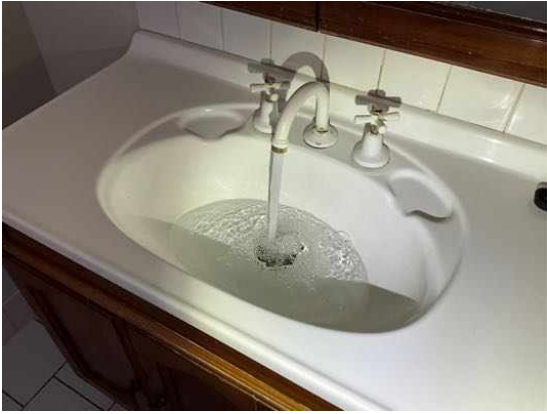
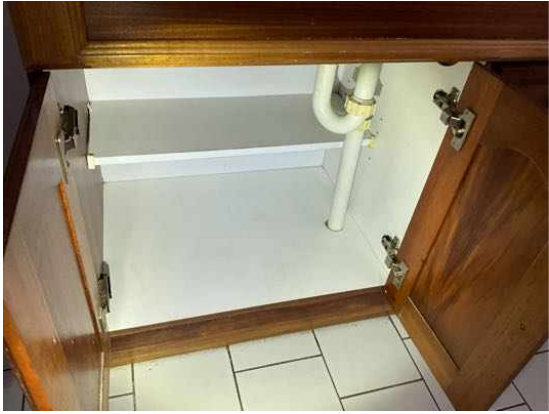
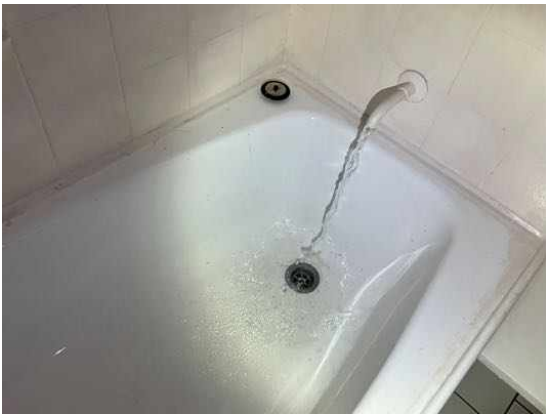
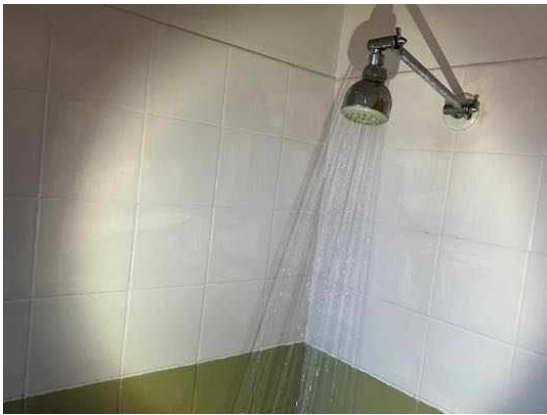
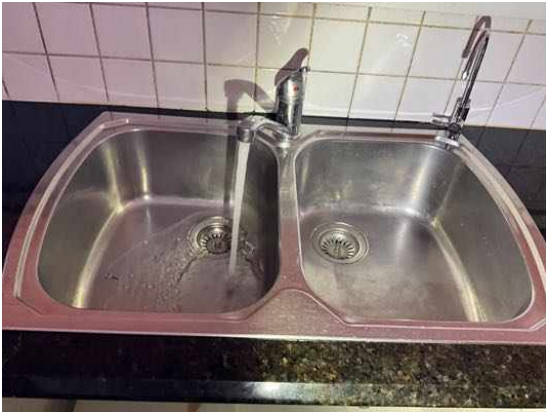
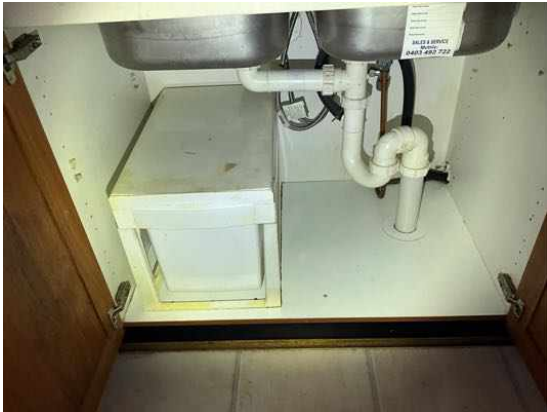
Noted Item

All taps, mixers and toilets were tested for operation, except for those obstructed. The waterproofing to the shower recess was assessed by checking the walls in and around the shower recess for varying moisture content. There were no significant variations across the tested areas. No sign of recent water damage was evident upon a visual inspection of the surrounding walls, where the visual nature of the inspection was possible.

Consequently, there is no conclusive evidence of any current shower recess leakage other than those which may have already been mentioned earlier in this report. It is reasonable to assume the shower waterproofing is sound. Note that if the shower is not used, or has not been used for some time, moisture readings would not vary significantly and this can lead to erroneous results. It is not possible under the visual inspection criteria (under which a prepurchase inspection is carried out) to categorically determine if there are leaks. If a more accurate assessment is required, a special purpose inspection should be requested. Alternatively, the assumption should be made that the shower may leak.

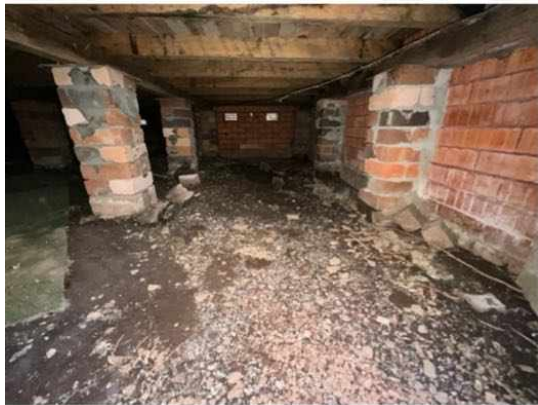
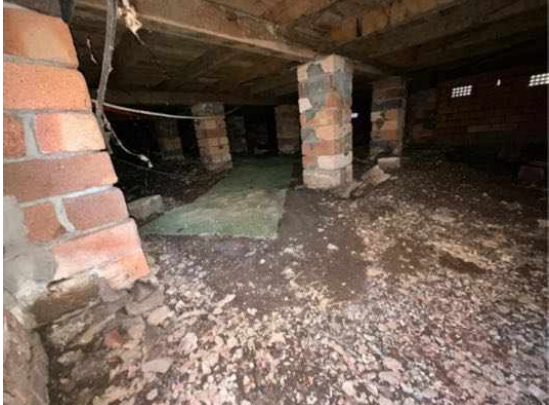
Building: Main Building
Location: Subfloor
Finding: Additional Photos
Information:

Additional photos are provided for your general reference.

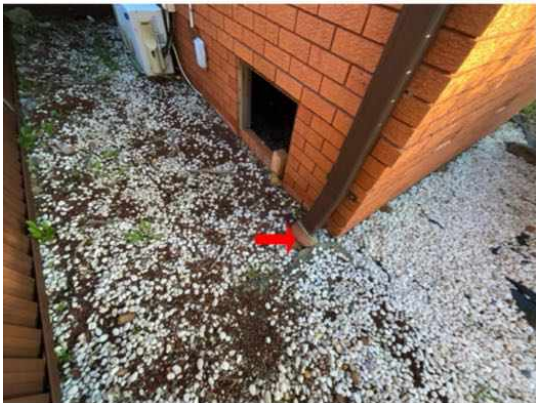
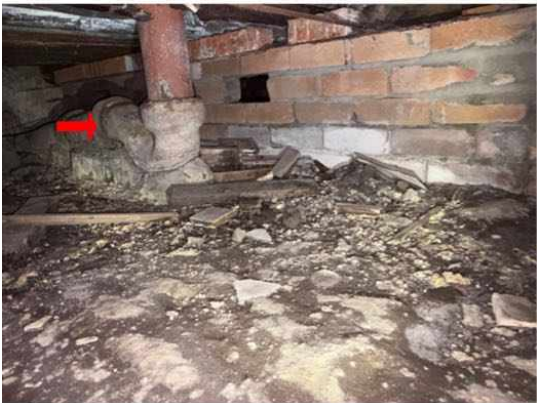
Building:	Main Building
Location:	
Finding:	Pipework - Old urban wear pipes
Information:	Old urban wear pipes were identified at the time of inspection. Consultation with a licensed plumber is advised. CCTV inspection on pipes may be required.

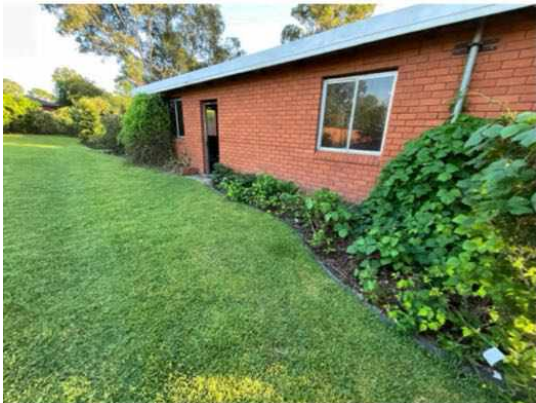
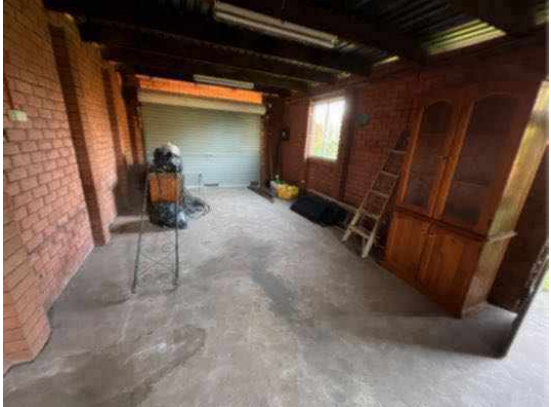
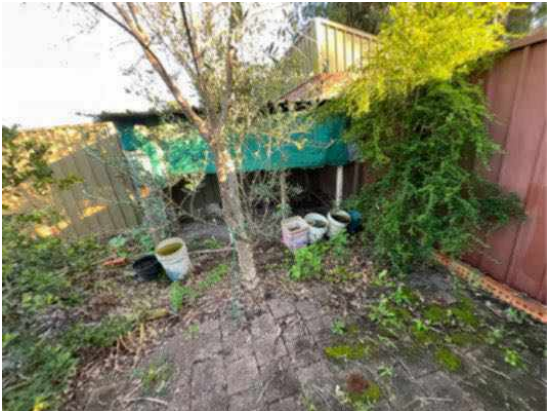
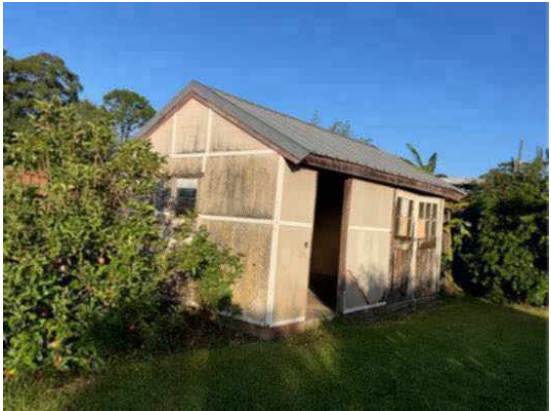
Building: Main Building
Location: All Areas
Finding: Additional Photos - Obstructions and Limitations
Information:

These photographs are an indication of the obstructions and limitations which impeded full inspection of the property at the time of inspection. These obstructions can hide an array of defects and should be removed to allow full inspection to be carried out. A re-inspection is recommended once the areas are made accessible.
