## Building Inspection Report

Inspection Date: Fri, 20 Feb 2026

Property Address: 11 Paxton Link, Pakenham VIC 3810,  
Australia

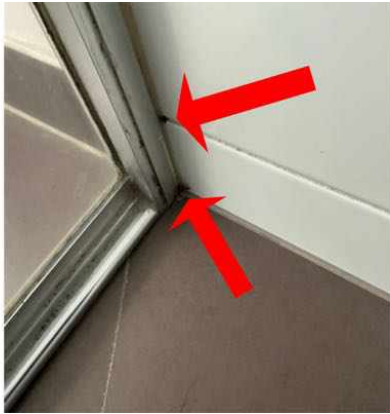
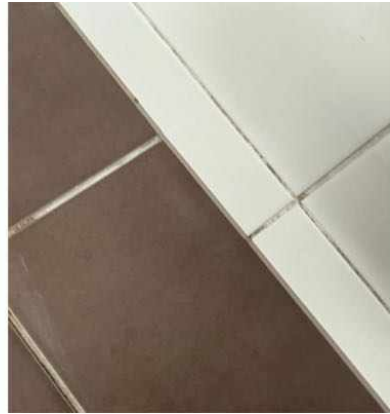
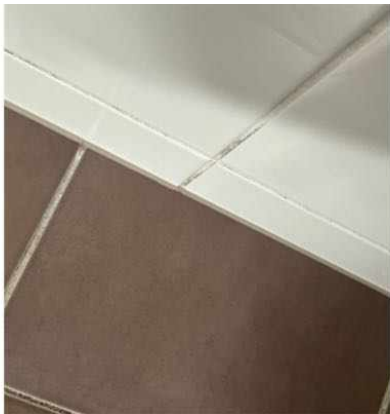
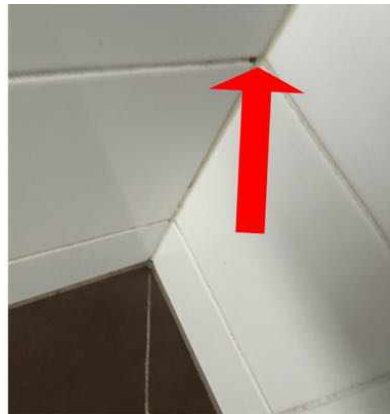
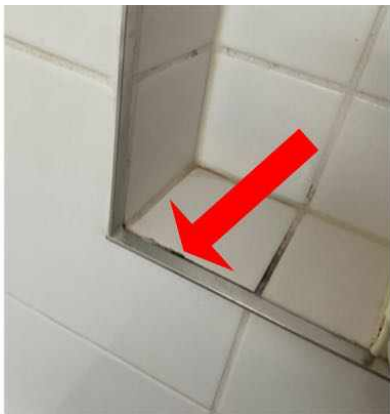
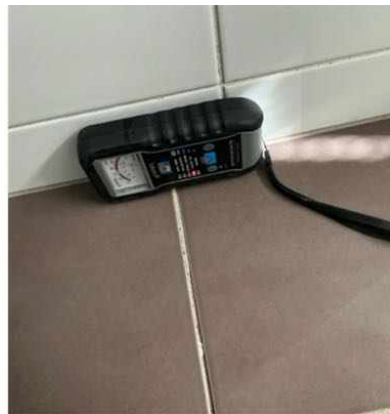
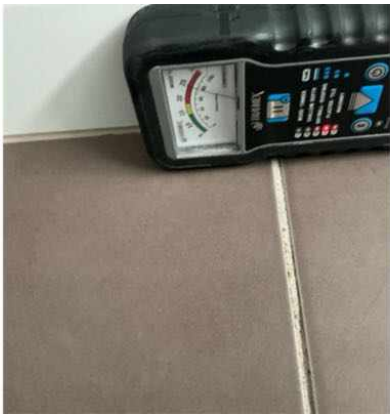
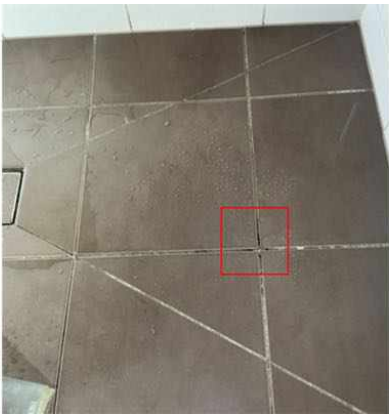
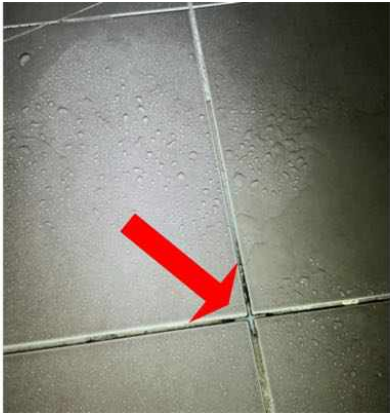
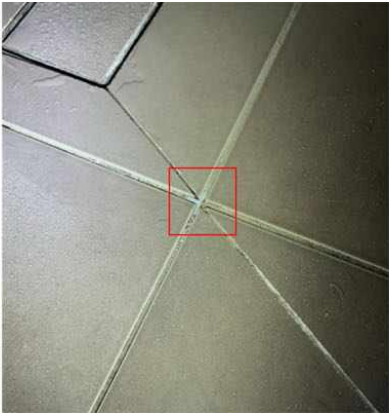
#### Defects 3.01

Building: Main Building  
 Location: Ensuite - Master  
 Finding: Shower damp and Deteriorated Grout/Sealant – Shower Alcove  
 Information:

Dampness was observed to the lower approximately 300 mm of the wall within the shower alcove. The affected area corresponds with sections of deteriorated grout and degraded sealant to the tiled surfaces and junctions. The condition is commonly associated with moisture permeating through failed grout lines or compromised sealant; however, concealed plumbing leakage within the adjoining wall cavity cannot be ruled out without further investigation. Localised mould growth was also noted to sections of grout and sealant.

Excess moisture within shower recesses can lead to the development of mould, fungi, and bacterial growth, as well as deterioration of associated building materials including wall linings, framing, and finishes. Movement between adjoining materials (e.g., wall and floor junctions) often results in cracking of rigid grout, and flexible sealant is required at junctions to accommodate expansion and contraction while maintaining watertightness. If left unmanaged, ongoing damp conditions may compromise structural elements and pose potential health concerns due to microbial growth.

Immediate assessment by a licensed plumber or bathroom specialist is recommended to determine the source of moisture and undertake necessary remedial works. This may include moisture testing, plumbing checks, removal and replacement of deteriorated grout and sealant, and application of flexible, mould-resistant sanitary-grade silicone at junctions. Where mould growth is extensive, further evaluation by a suitably qualified environmental health or mould specialist should be considered. Ongoing maintenance of grout and sealant to wet areas is essential to preserve watertight integrity and prevent recurrence.

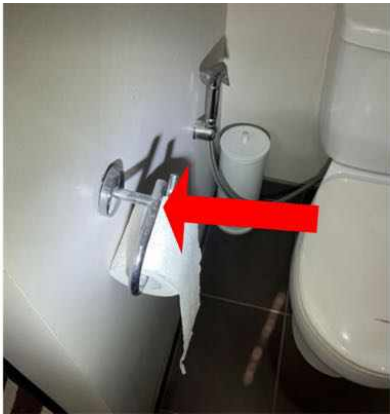
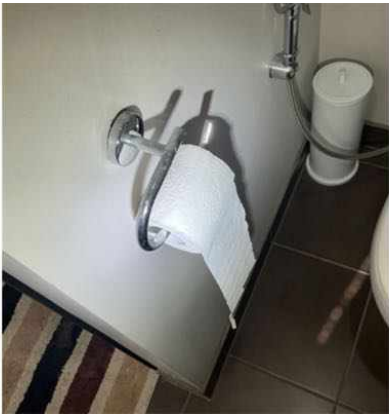
**Defects 3.02**

Building: Main Building  
Location: Ensuite - Master  
Finding: Toilet roll holder - Loose  
Information: The toilet roll holder was found to be loose at the time of inspection. While not a major operational defect, function can deteriorate if the problem is left unmanaged.

It is advised that the homeowner performs remedial works to re-attach the toilet roll holder to its original fixing. A general handyperson may be required to perform these works.

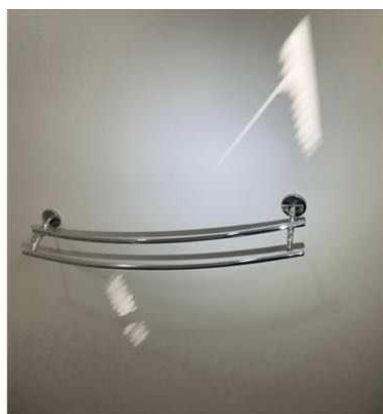
### Defects 3.03

Building:	Main Building
Location:	Ensuite - Master
Finding:	Towel rail - loose
Information:	The towel rail was found to be loose at the time of inspection. While not a major operational defect, function can deteriorate if the problem is left unmanaged.

It is advised that the homeowner performs remedial works to re-attach the towel rail to its original fixing. A general handyperson may be required to perform these works.

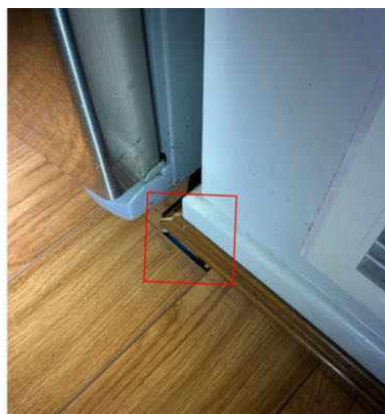
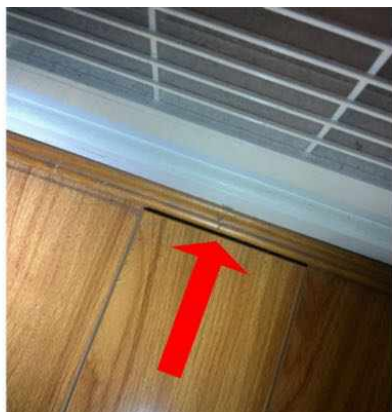
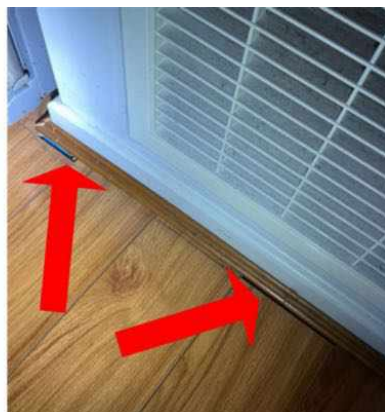
### Defects 3.04

Building:	Main Building
Location:	Kitchen
Finding:	Minor Gap – Internal Finish
Information:

A minor gap was observed to the affected internal junction. The separation appears small and consistent with normal building movement, material shrinkage, or minor installation tolerances.

Such gaps are generally cosmetic in nature and do not indicate structural concern at the time of inspection. However, they may detract from the overall finish quality and allow minor dust accumulation.

If considered unsightly, a qualified handyman or relevant trade specialist can apply a suitable flexible sealant or undertake minor adjustment works to achieve a neat and uniform finish.

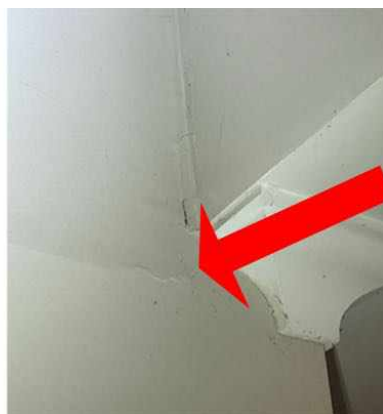
### Defects 3.05

Building:	Main Building
Location:	Gallery
Finding:	Minor Settlement Cracking – Plaster Wall (Kitchen Area)
Information:	Minor cracking was observed to the plaster wall facing the kitchen at the time of inspection. The cracks appear narrow and consistent with typical settlement and movement-related cracking that commonly develops in residential dwellings over time.

Such cracking is generally cosmetic in nature and is often attributable to normal building movement, material shrinkage, and seasonal expansion and contraction. No evidence was observed at the time of inspection to suggest structural failure associated with these cracks.

If improved presentation is desired, a qualified plasterer or painter can undertake cosmetic rectification works including filling, sanding, and repainting to achieve a smooth and uniform finish. Ongoing monitoring is recommended to ensure the cracks do not progressively widen.

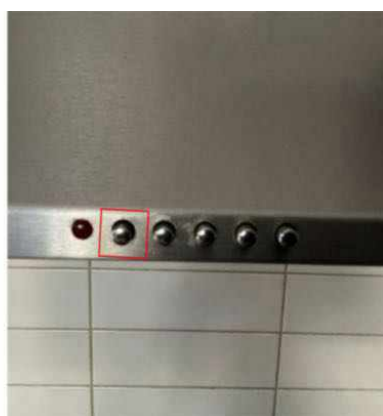
### Defects 3.06

Building: Main Building  
 Location: Kitchen  
 Finding: Defective Rangehood Light Switch – Kitchen  
 Information:

At the time of inspection, the rangehood light switch was found to be defective. When manually pressed, the light would illuminate; however, it did not remain engaged once released and would immediately switch off.

This condition indicates a likely fault within the switch mechanism or associated internal electrical components. A malfunctioning switch may result in unreliable operation and could indicate wear or internal failure of the unit.

It is recommended that a licensed electrician inspect the rangehood assembly and repair or replace the faulty switch as required to restore proper and safe operation.

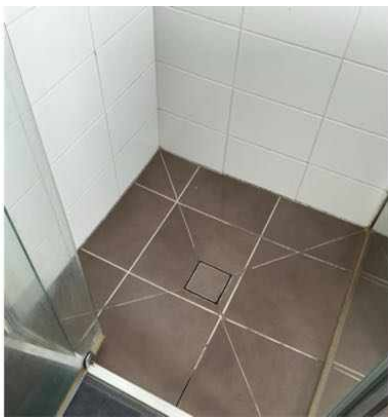
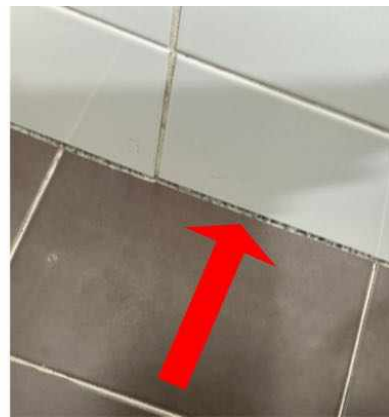
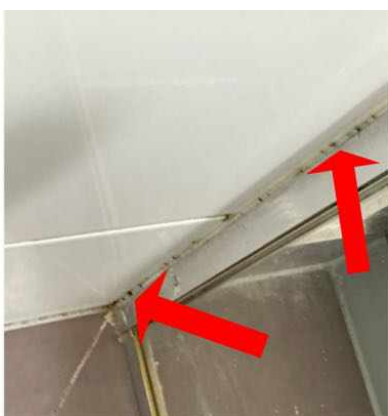
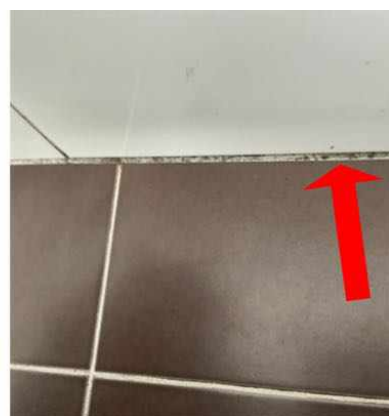
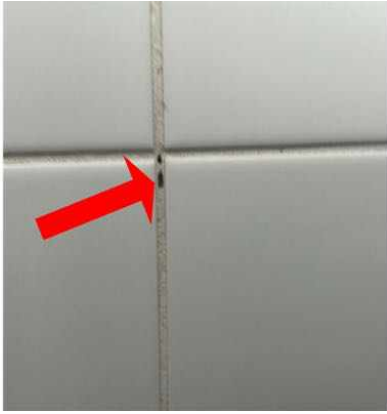
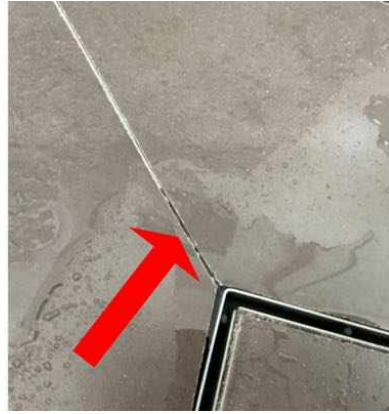
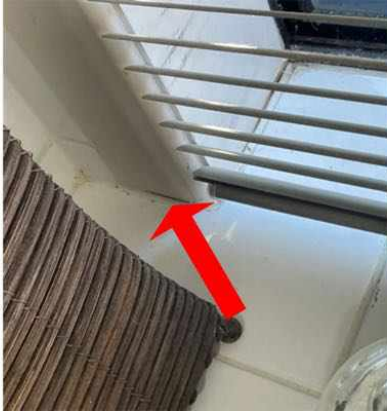
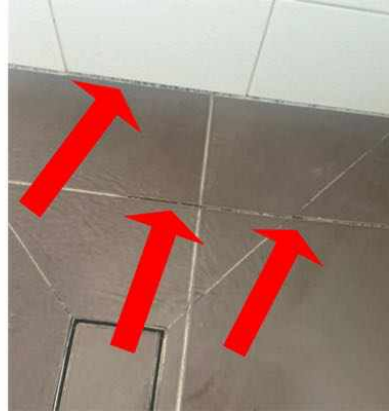
### Defects 3.07

Building: Main Building  
 Location: Bathroom 2  
 Finding: Sealant and grouting - Deteriorated  
 Information: It was noted on inspection that sealant or grout is degraded to the tiled shower alcove and or other areas of the bathroom.

Different materials and floor areas move at different rates, generally causing cracking to grout or sealant at this point. A flexible sealant is required to allow for expected expansion and contraction, while keeping the joint water tight and protective of all associated building materials.

There appears to be some mould to the sealant and grout which will likely require scraping out and replacement.

Flexible and mould resistant materials should be applied to affected areas to prevent any subsequent water damage that is likely to occur. Regular maintenance and replacement of damage or missing or damaged sealant and grout is highly recommended to the wet areas, as this is a regular wear and tear defect. Sealant and grouting in areas that come into regular contact with water should be maintained for the long term care of your property.

A sealant specialist or tiling contractor should be appointed to complete these works as soon as possible

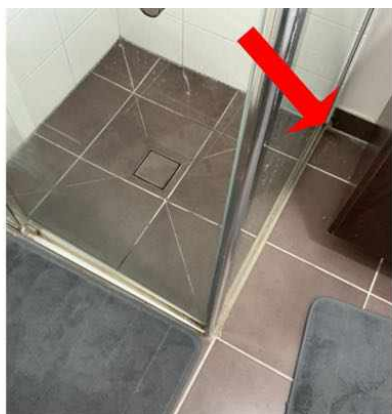
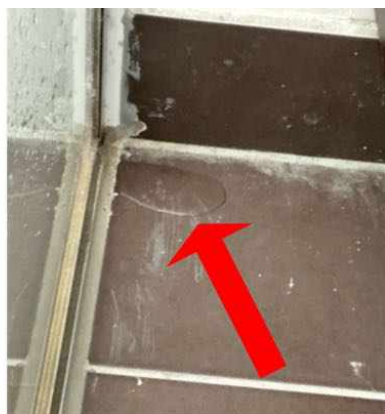
### Defects 3.08

Building:	Main Building
Location:	Bathroom 2
Finding:	Shower screen - Leaking
Information:	Leaking was evident to the 2nd bathroom's shower screen at the time of inspection. It is suspected that the leaking has occurred as a result of deteriorated or missing caulking to the shower or general ageing of the building elements.

Leaking from the shower where left unattended, is likely to lead to water damage to adjoining flooring and walls. Such damage can lead to water damage and necessitate extensive remedial works being required. Active water leaks may also create an environment that is susceptible to the formation and development of mould.

Appointment of a caulking contractor is required to repair or replace the caulking to the shower area. Such works should be performed as soon as possible to ensure that no further damage occurs.

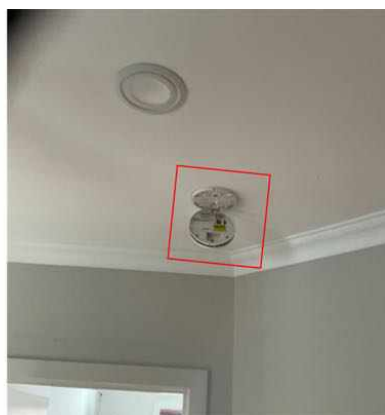
### Defects 3.09

Building:	Main Building
Location:	Hallway 2
Finding:	Smoke Alarm Non-Operational
Information:	During inspection, the smoke alarm appeared to have been opened and did not appear to be operational at the time of inspection. Smoke alarms are essential safety devices and must be fully functional in accordance with current building regulations and Australian Standards.

It is recommended that a licensed electrician inspect and test the smoke alarm, and carry out any necessary repairs or replacement to ensure it is fully operational.

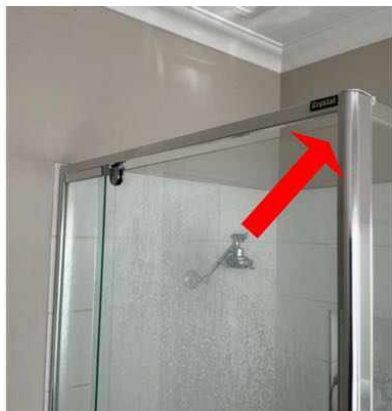
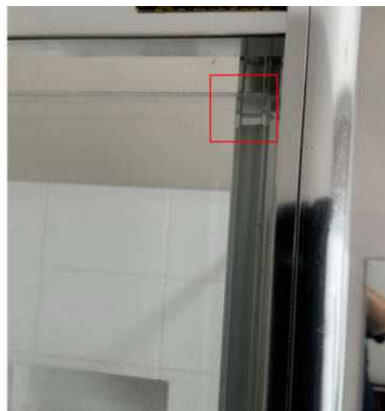
### Defects 3.10

Building:	Main Building
Location:	Bathroom 2
Finding:	Shower door fails to latch properly
Information:	The shower door in the ensuite does not latch securely when closed. The magnetic strip or latch mechanism that typically keeps the door in place is missing, leaving the door loose and unable to remain closed properly.

allowing water to escape and potentially cause damage to the surrounding floor area. Over time, this could lead to water damage, increased wear on the door hinges, and a reduction in the overall functionality of the shower enclosure.

It is recommended to hire a handy-person at client discretion to install the necessary magnetic strip or latch to ensure the door closes securely and functions as intended.
