Building and Timber Pest Inspection Report

Inspection Date: Mon, 30 Mar 2026

Property Address: 69 Southern View Dr, West Albury NSW
2640, Australia

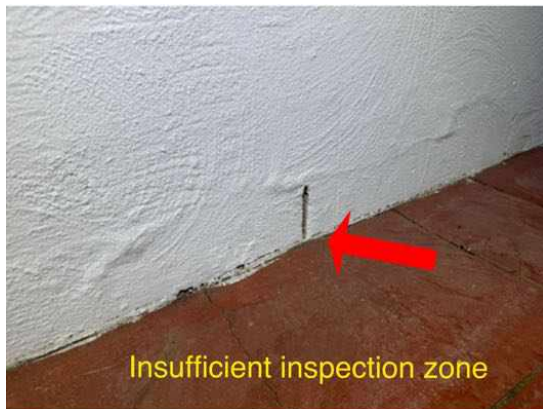
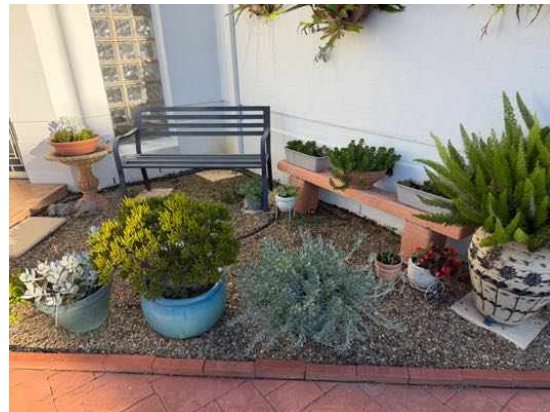
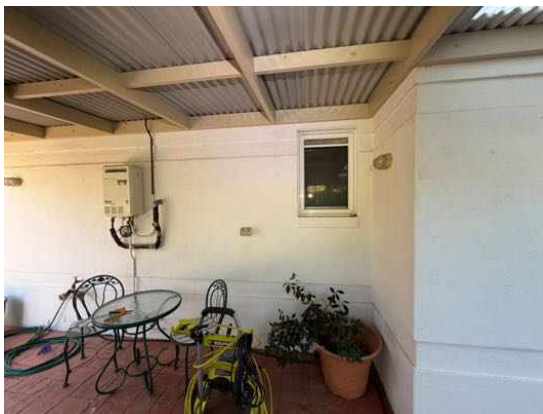
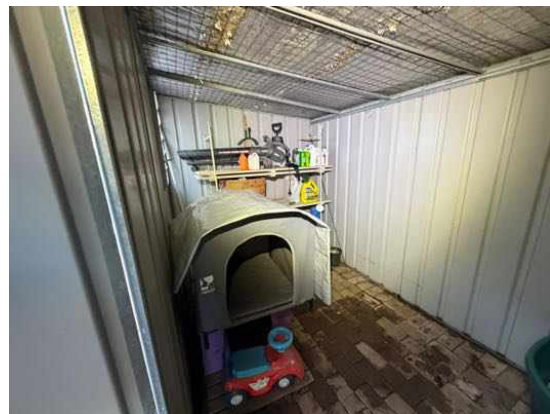
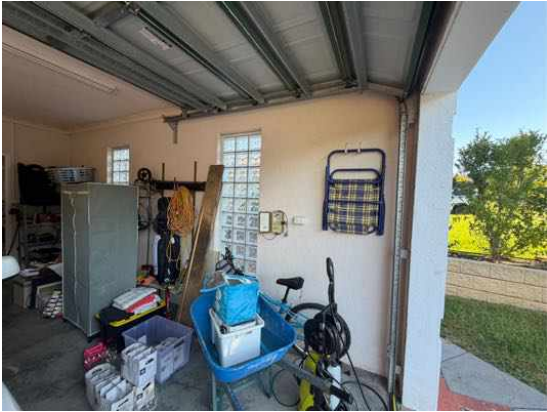
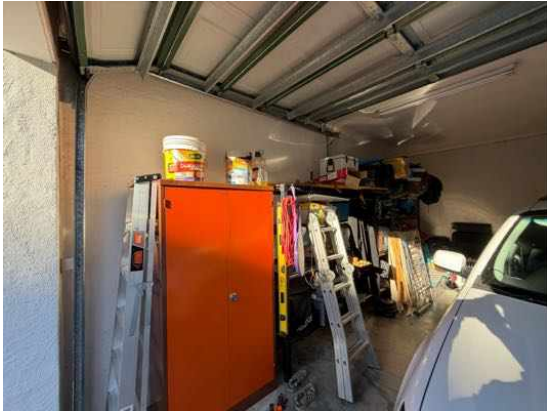
Building: Main Building
Location: All Areas
Finding: Additional Photos - Obstructions and Limitations
Information: These photographs are an indication of the obstructions and limitations which impeded full inspection of the property at the time of inspection. These obstructions can hide an array of defects and should be removed to allow full inspection to be carried out. A re-inspection is recommended once the areas are made accessible.
