Building and Timber Pest Inspection Report

Inspection Date: Tue, 24 Feb 2026

Property Address: 7 Moreton Dr, Jacobs Well QLD 4208,
Australia

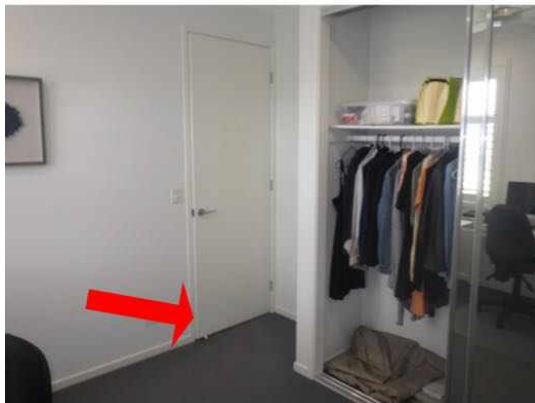
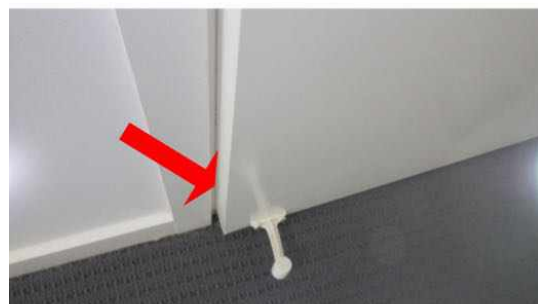
Building: Main Building
 Location: Bedroom 4 > Front
 Finding: Door - Binding/Jamming
 Information: Binding and/or jamming of the bedroom 4 door on the door frame was evident during standard operation. This defect inhibits the functionality of affected door as well as creating potential for secondary defects to associated building elements, such as damage to the door framing.

A door that binds to the associated door frame or sill may have several causes, such as poor installation of the door or deteriorated hinges.

A qualified carpenter or general handyperson could be appointed to perform minor rectification works at client discretion.

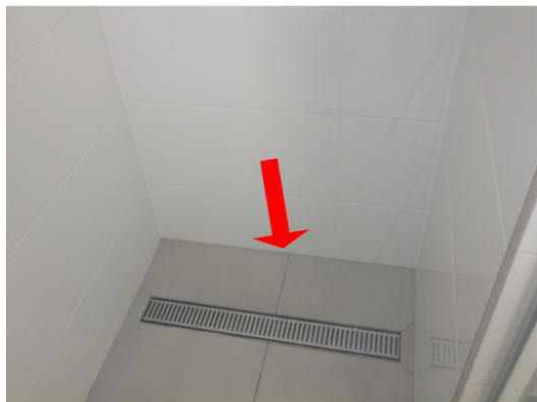
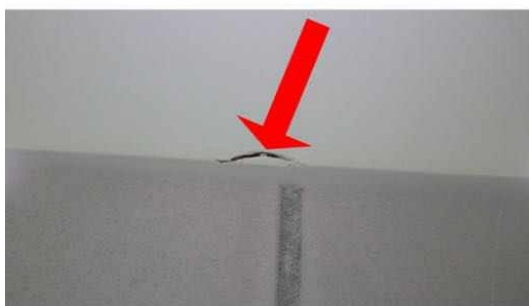
Finding 3.02

Building: Main Building
 Location: Ensuite > Rear Right
 Finding: Shower - Cracked tile
 Information: Cracking was evident to a wall tile in the bathroom shower cubicle at the time of

inspection. The cracking is more than likely due to impact damage, but may have also been caused by general movement of associated building elements. While the cracking appears to be minor, any additional impact may lead to further cracking.

As this area is frequently exposed to water, any cracking is likely to allow water penetration if left unmanaged.

Appointment of a tiling contractor is required to repair the cracked shower wall tile, so as to ensure no water damage occurs.

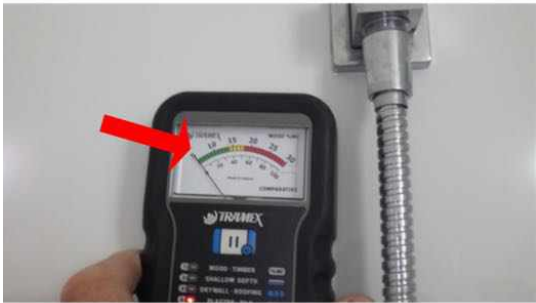
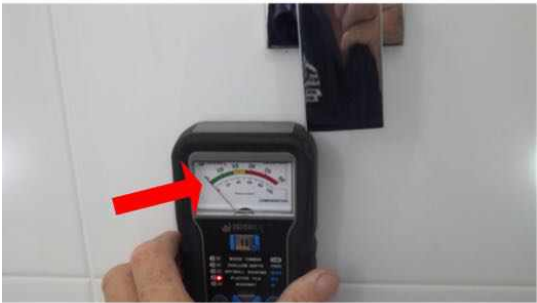
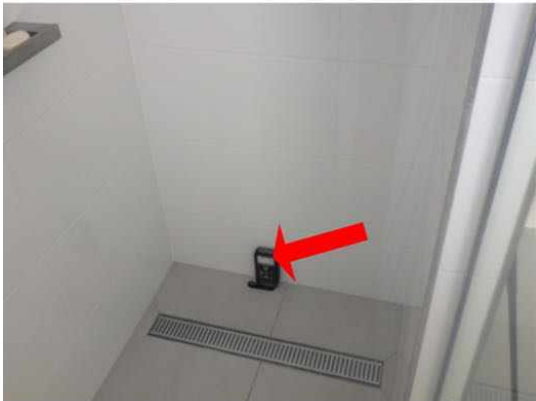
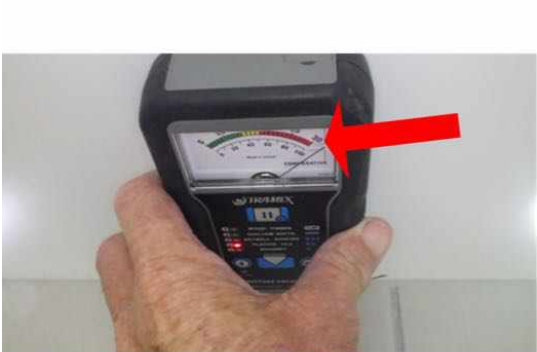
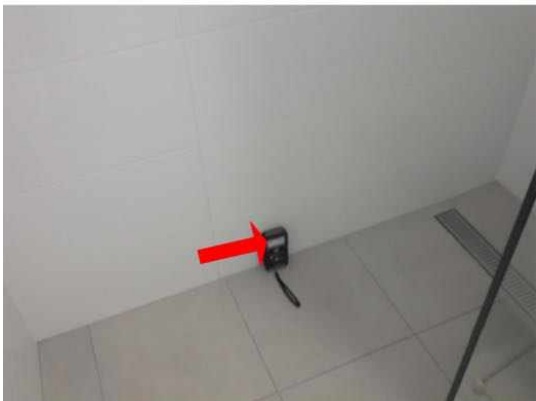
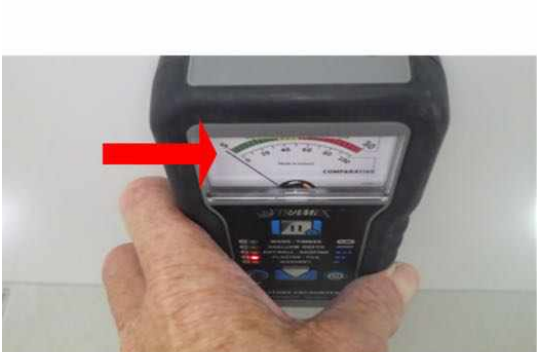
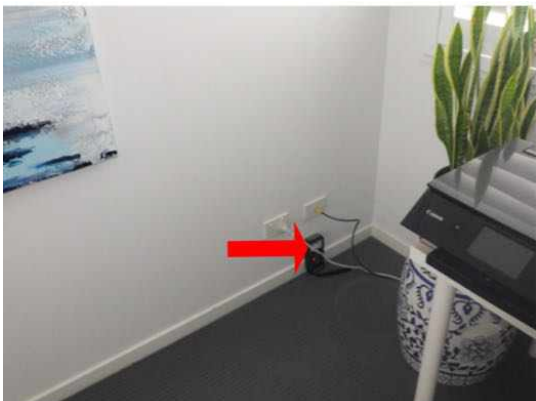
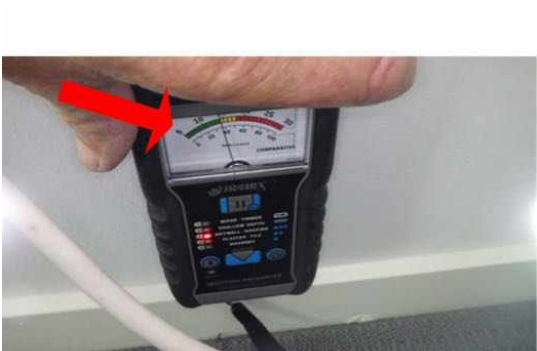
Finding 3.03

| Information: | Elevated moisture level readings were recorded to the right side lower 200mm of wall to the ensuite shower alcove at the time of inspection. There was no elevated moisture level readings around the tap area, and no elevated readings transferring to the other side of the wall in the areas where moisture readings were able to be obtained. Both sealant and grout appear in good condition at present. |

This defect is quite common, and is suspected to have been caused by moisture permeating or leaching through the grouting and perhaps gaps in the sealant or a cracked wall tile.

Monitoring the area is advised and if any visual signs of excessive moisture appear (peeling paint, mould) then consultation with a bathroom specialist would be advised to identify the cause of damp and to perform remedial works as required.

Always ensure that sealant and grout is in good condition to prevent any moisture issues occurring in the future.

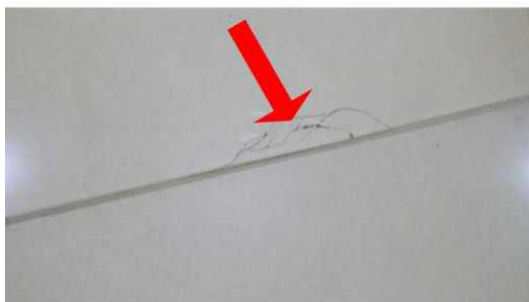
Finding 3.04

Building: Main Building
 Location: Living Room > Front
 Finding: Tile - Cracked
 Information: A cracked tile to the living room walkway area was identified at the time of inspection. Such defects are generally caused by impact. Cracked or broken tiled areas may also be a direct result of poor workmanship during the construction process.

A tiling contractor could be appointed to perform repair works at the clients discretion.

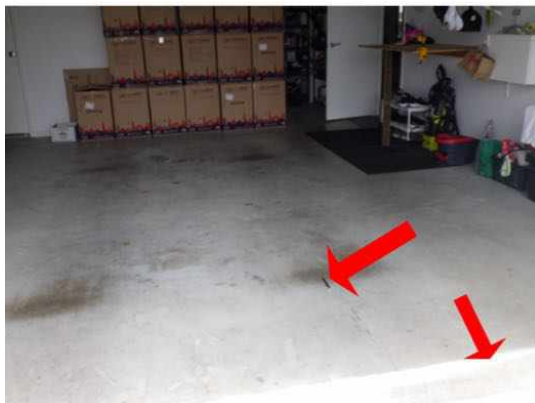
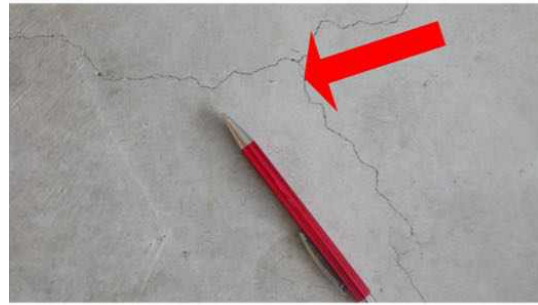
Building: Main Building
 Location: Garage > Existing
 Finding: Cracking in concrete slab - Category 1
 Information: Cracking coded as Category 1 was identified in the garage floor concrete slab (as per example photos). A Category 1 crack is described as a fine but noticeable crack, with the slab at an otherwise reasonable level.

To be considered Category 1, the approximate width of the crack is less than 1.0mm, or a less than 10mm change in offset when a 3m straight edge is placed over the defect.

Category 1 cracks should be monitored for a period of 12 months. At the end of the monitoring period, identified cracks that are rated greater than Category 2 are considered defects, and require rectification.

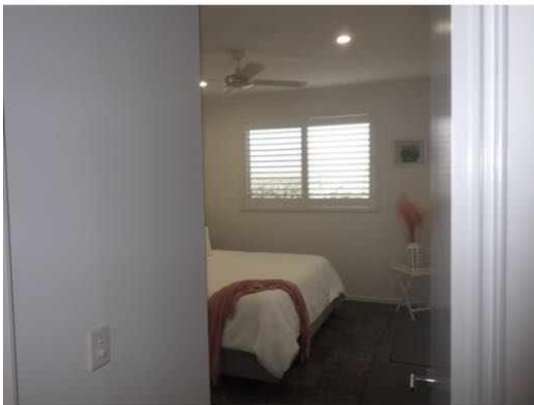
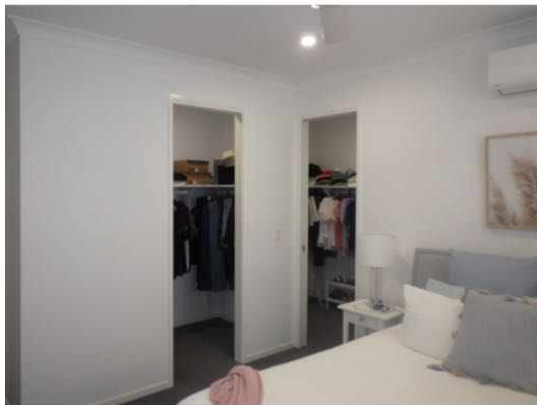
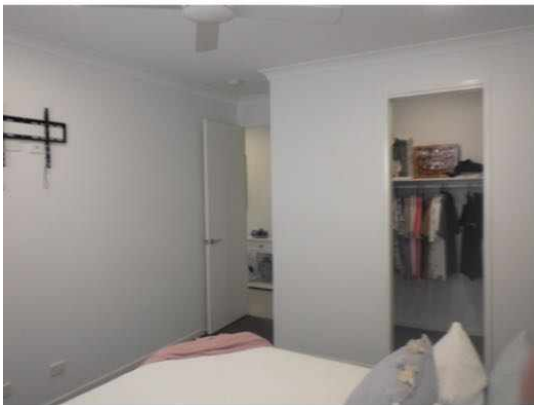
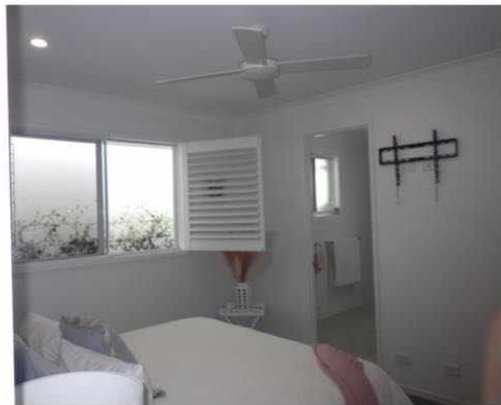
Building: Main Building
Location: Bedroom - Master > Existing
Finding: No obvious defect
Information: No obvious defects found at the time of inspection.

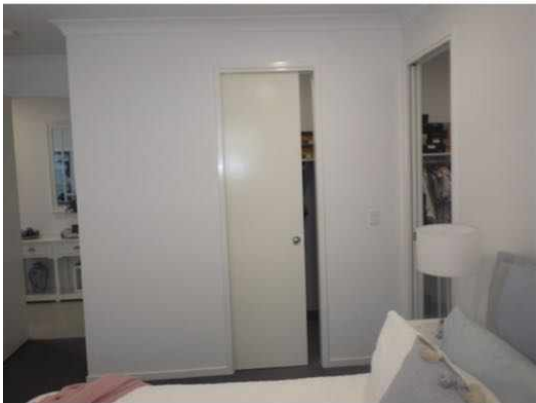
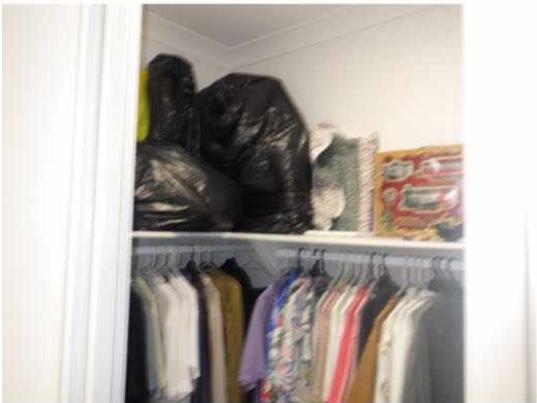
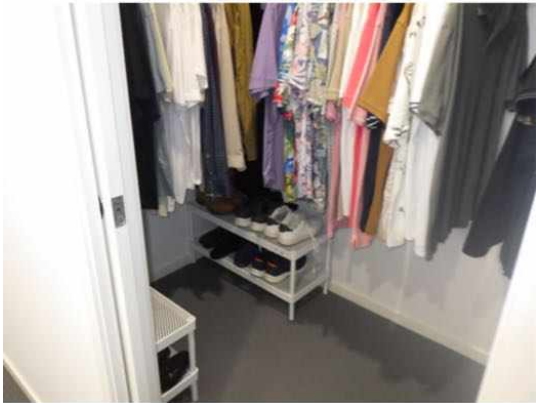
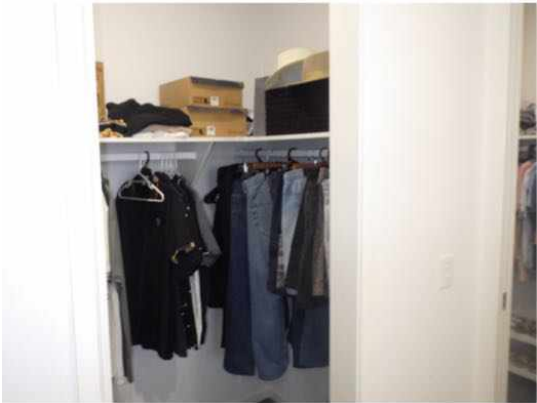
Building: Main Building
Location: Walk In Robe 1 > Existing
Finding: No obvious defect

Information: No obvious defects found at the time of inspection.

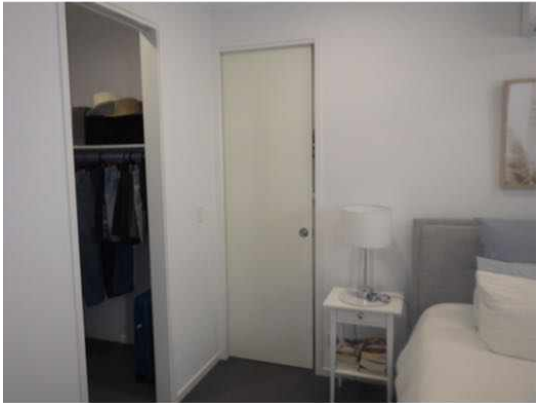
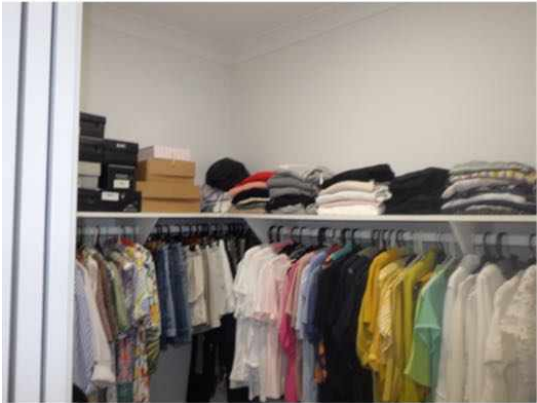
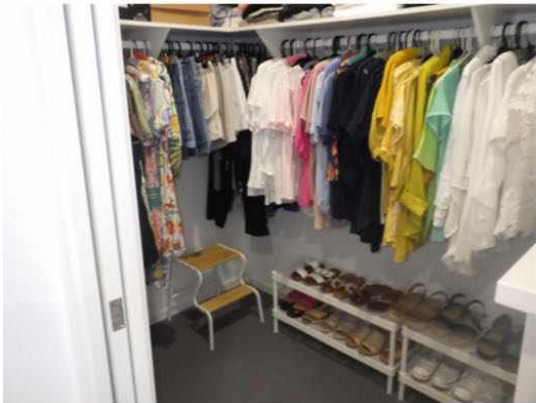
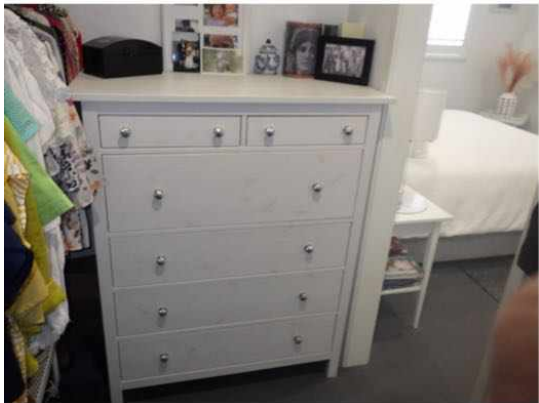
Building: Main Building
Location: Walk In Robe 2 > Existing
Finding: No obvious defect
Information: No obvious defects found at the time of inspection.

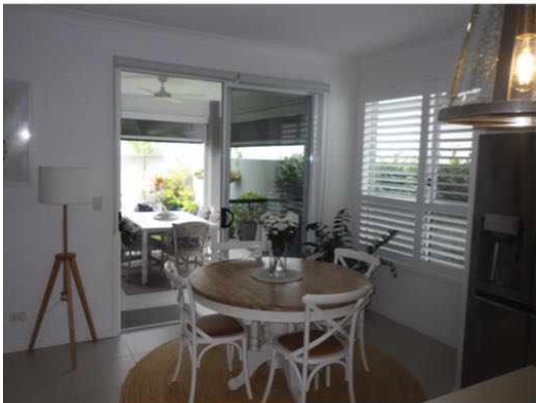
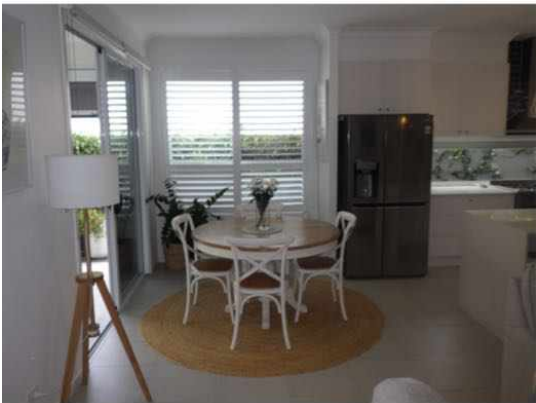
Building: Main Building
Location: Dining Room > Existing
Finding: No obvious defect

Information: No obvious defects found at the time of inspection.

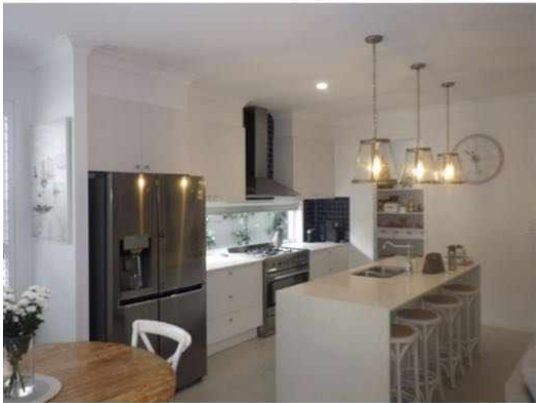
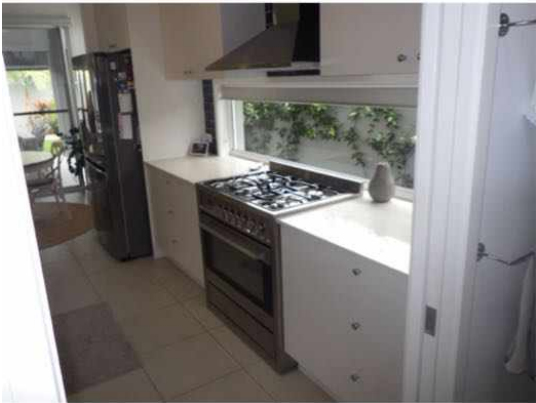
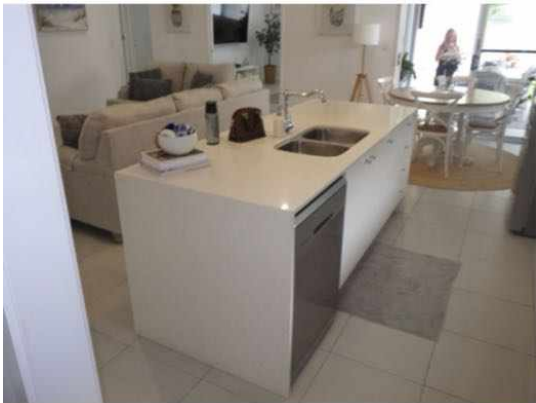
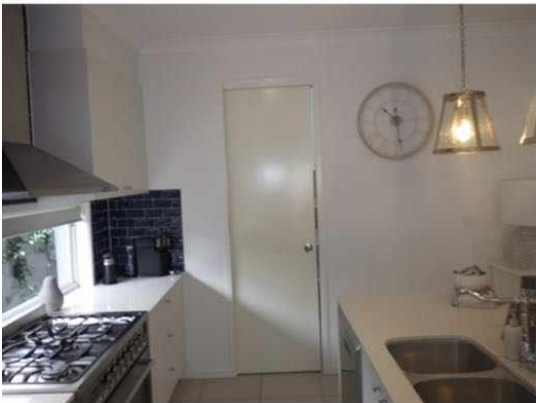
Building: Main Building
Location: Kitchen > Existing
Finding: No obvious defect
Information: No obvious defects found at the time of inspection.

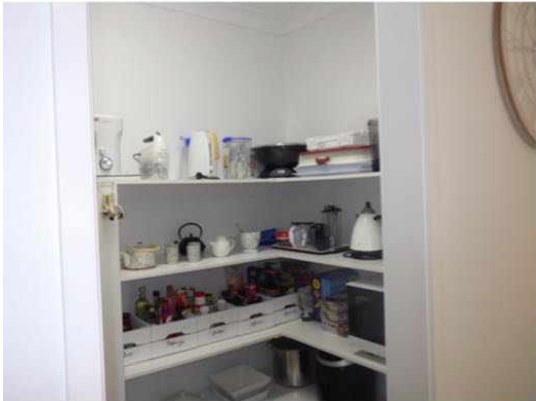
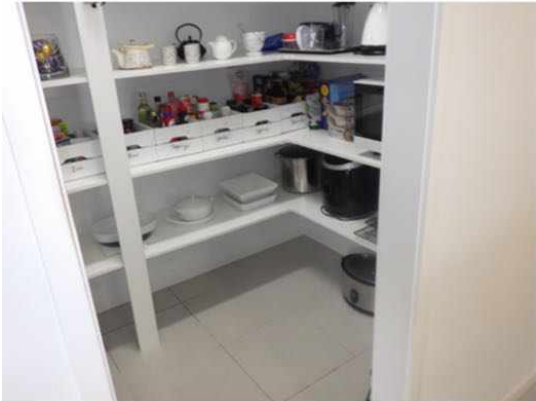
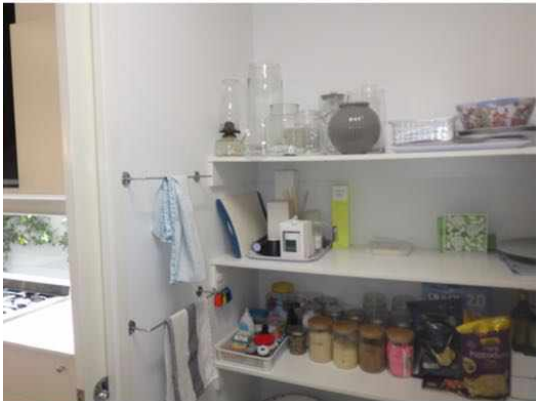
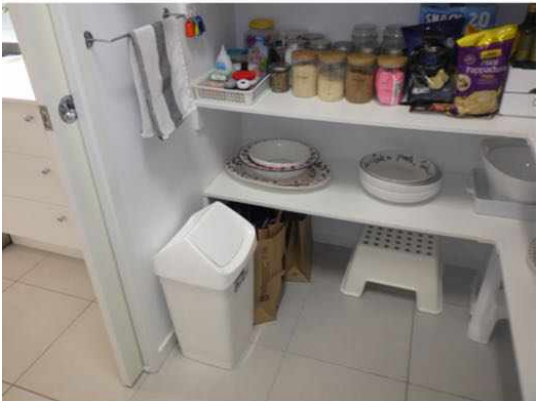
Location: Pantry - Walk In > Existing
Finding: No obvious defect
Information: No obvious defects found at the time of inspection.

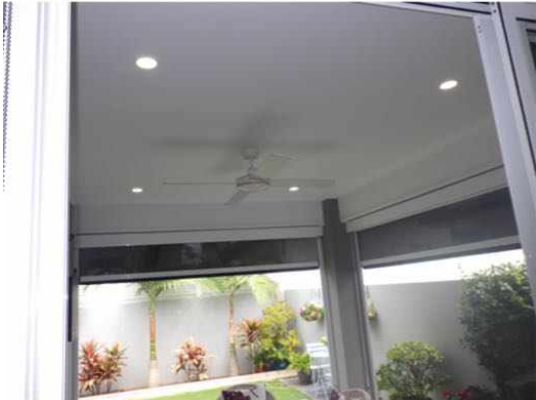
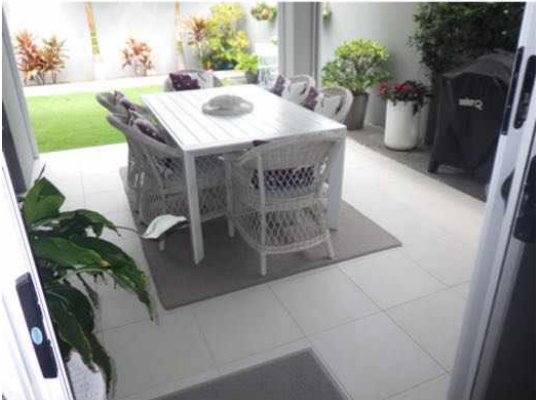
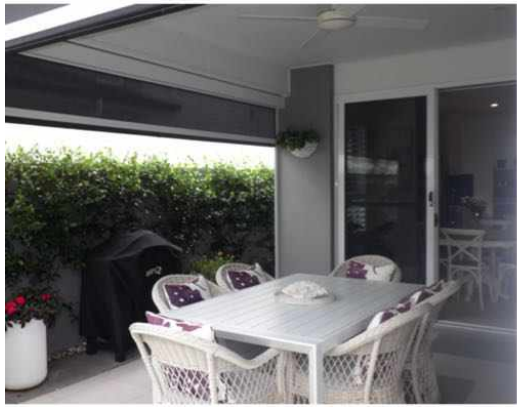
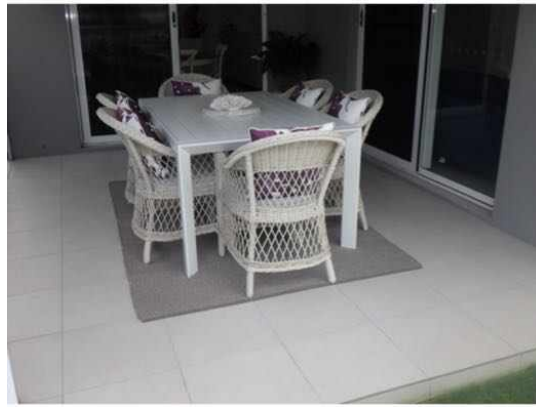
Building: Main Building
Location: Alfresco > Existing
Finding: No obvious defect
Information: No obvious defects found at the time of inspection.

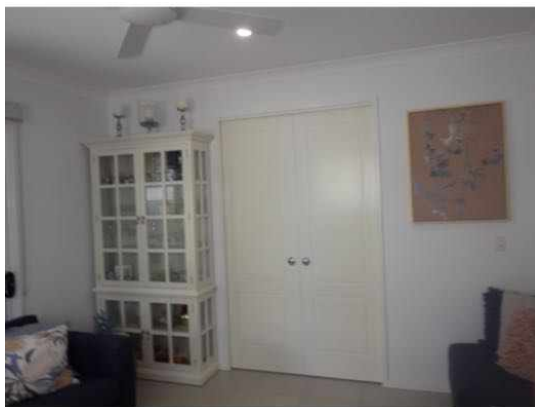
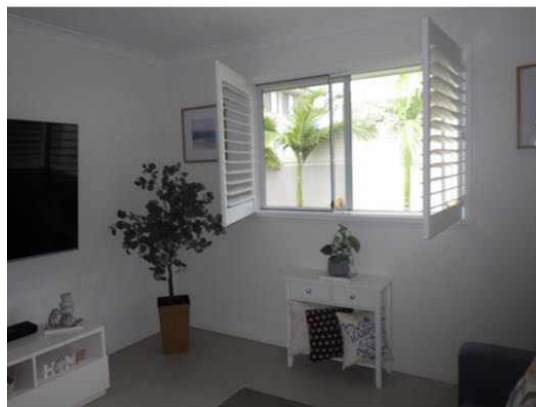
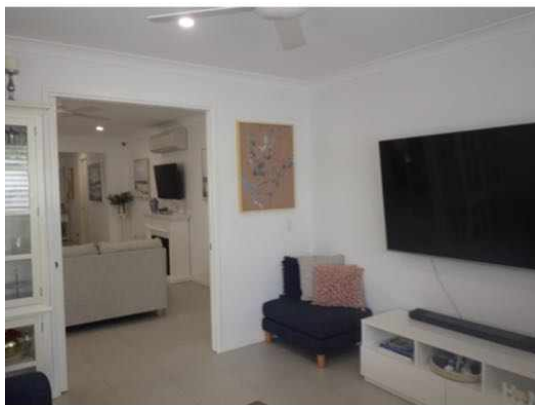
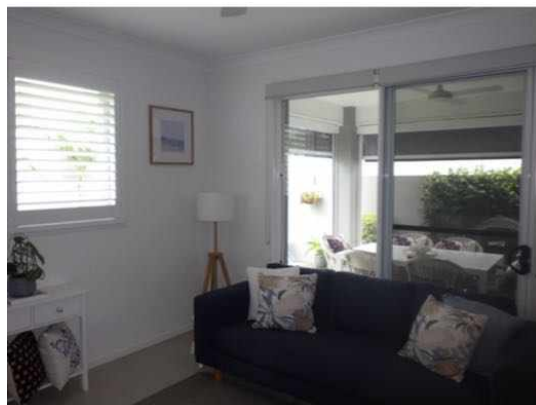
Building: Main Building
Location: Lounge Room > Existing
Finding: No obvious defect
Information: No obvious defects found at the time of inspection.

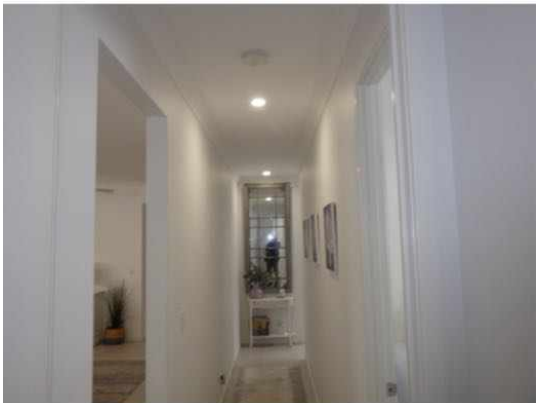
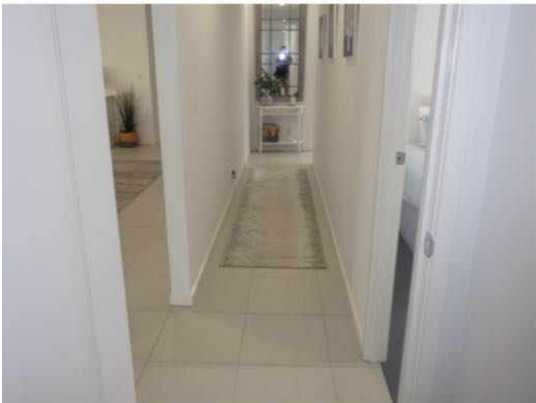
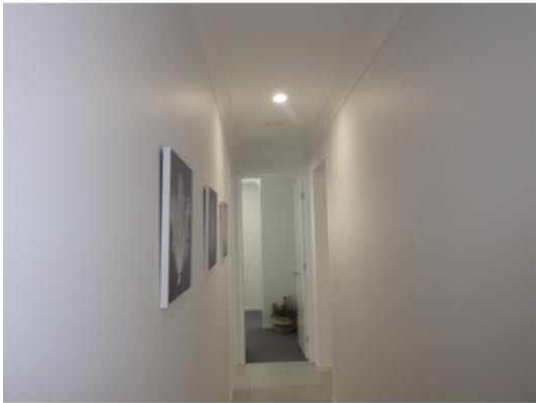
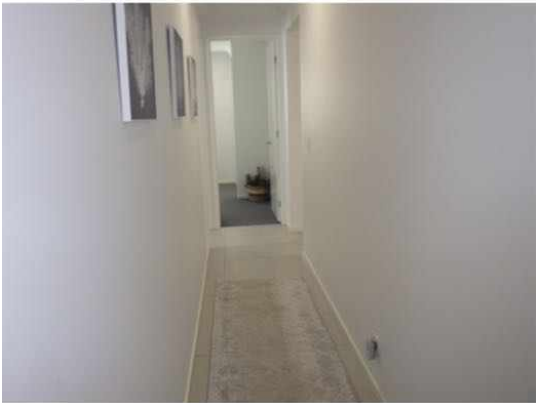
Building: Main Building
Location: Hallway 2 > Existing
Finding: No obvious defect

Information: No obvious defects found at the time of inspection.

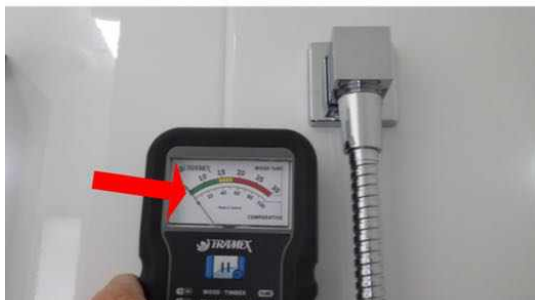
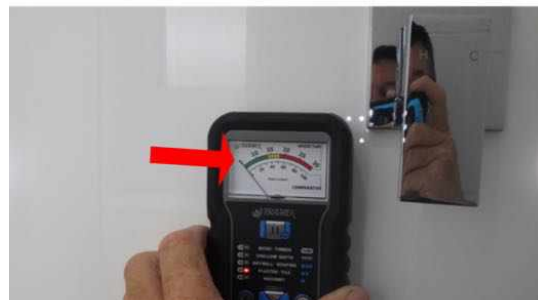
Building: Main Building
Location: Bathroom > Rear Left
Finding: Moisture Level Readings
Information: At the time of inspection the bathroom shower cubicle areas checked with the TrameX Moisture Meter returned low - normal moisture level readings.

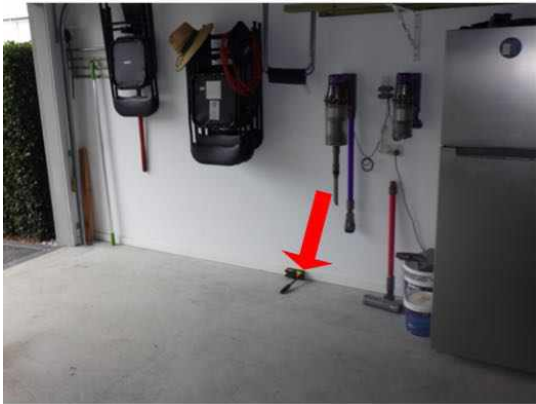
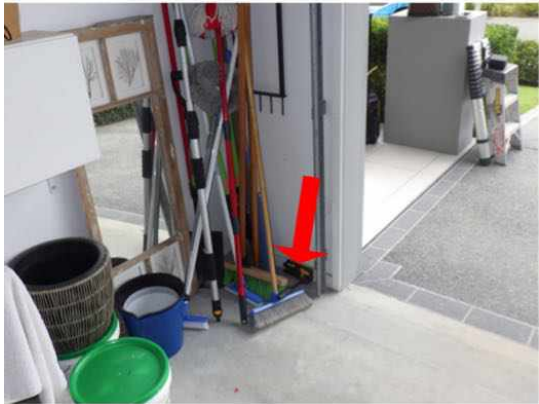
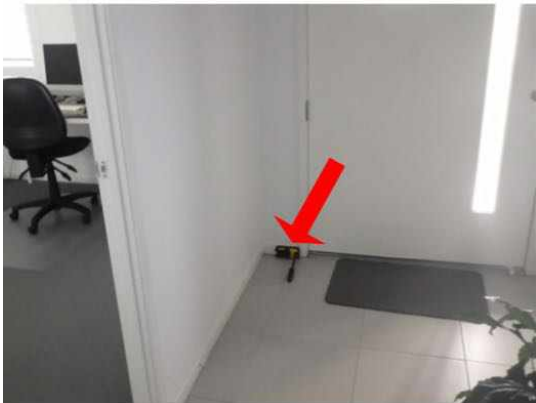
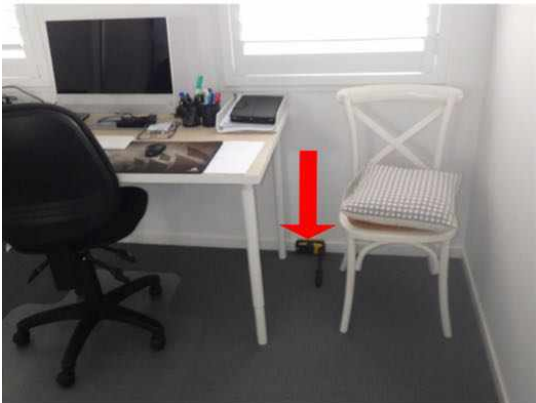
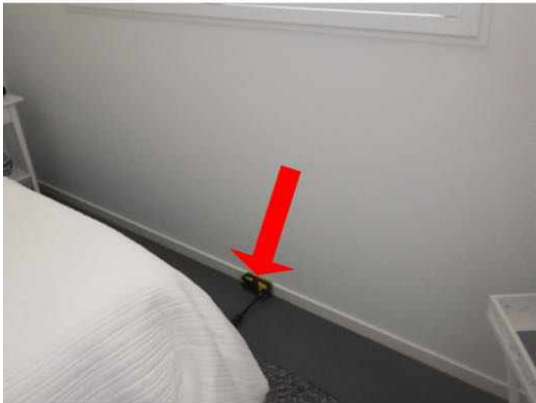
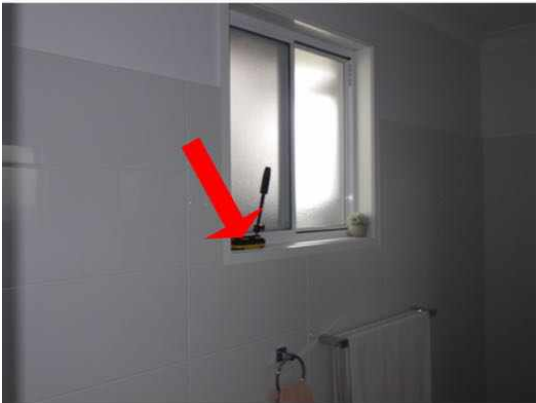
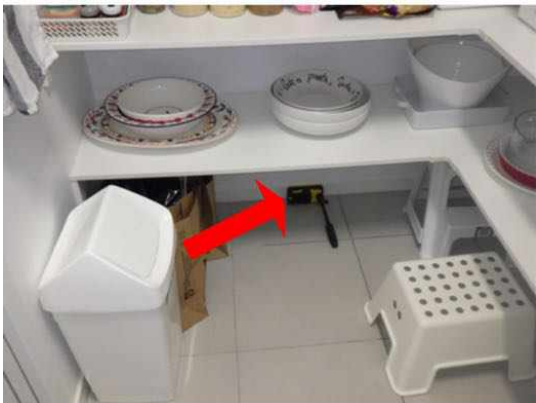
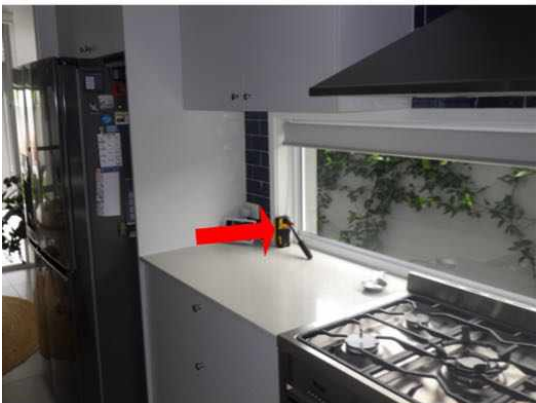
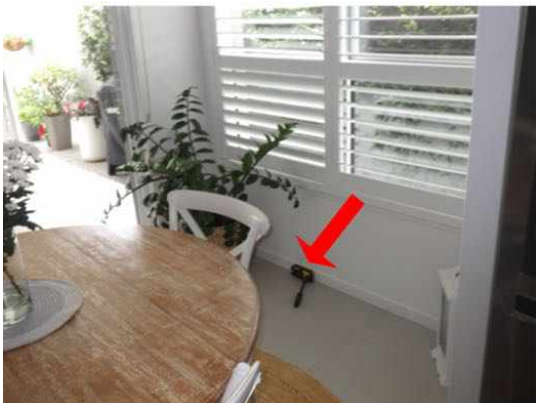
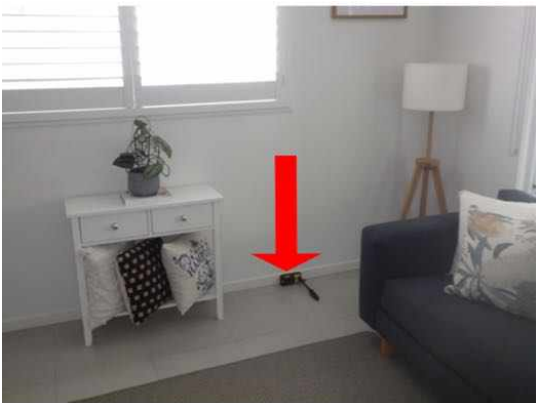
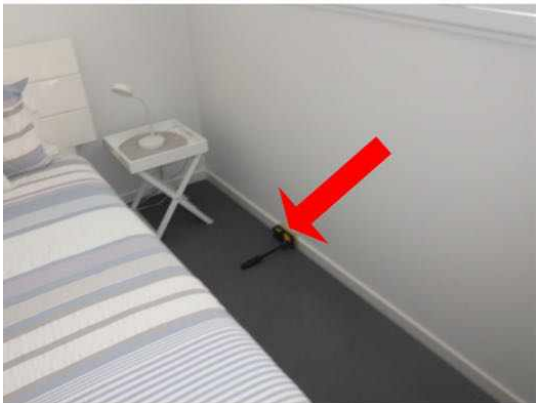
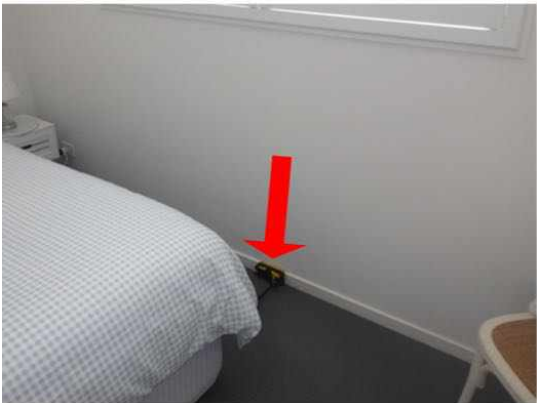
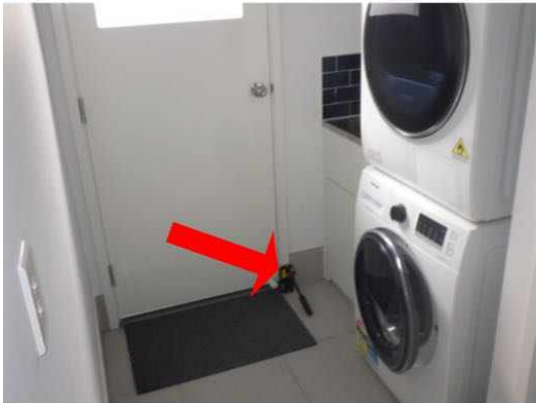
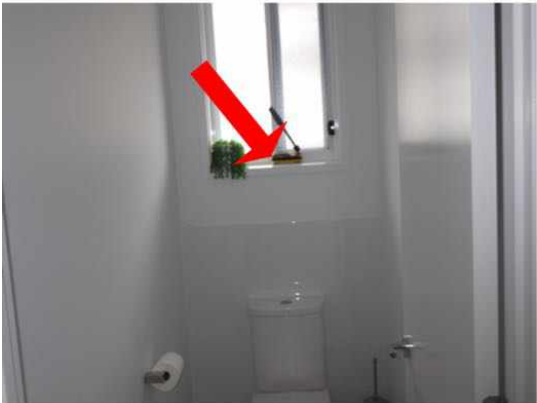
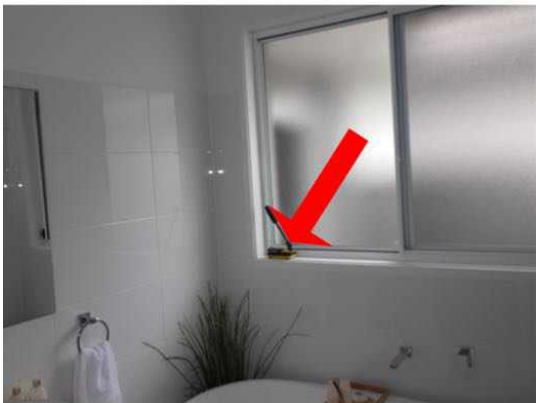
Building: Main Building
Location: Internal Areas > Existing
Finding: Termitracker
Information: The termitracker itracker was positioned randomly to internal wall, timber skirting and window frame areas checking for signs of termite activity.

No activity was recorded at the time of inspection.

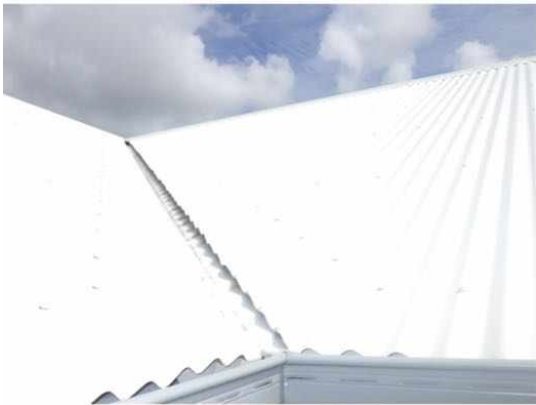
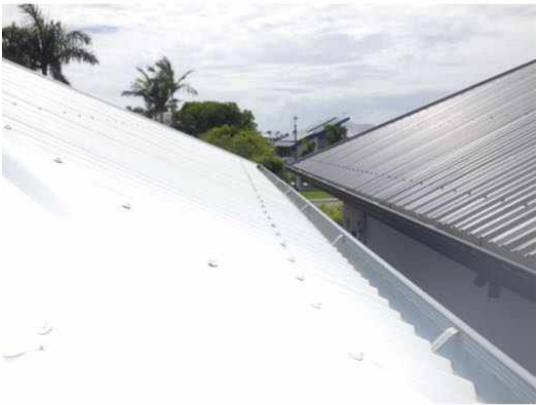
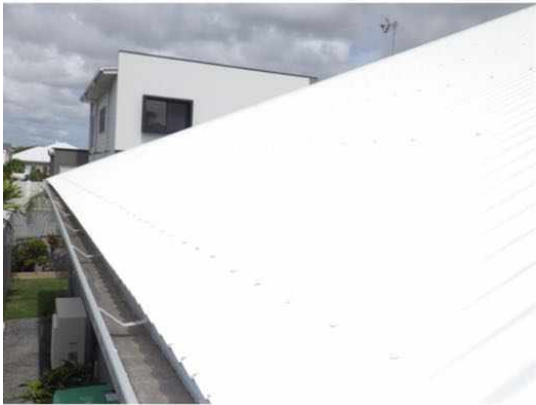
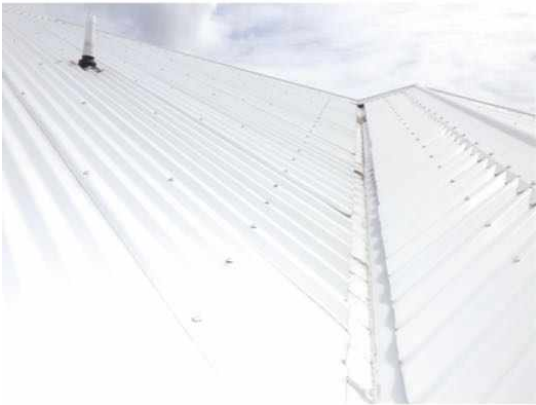
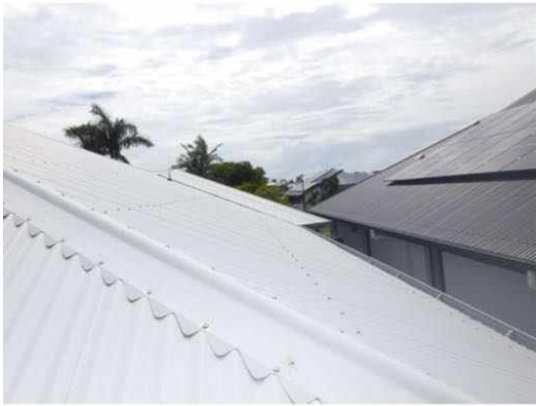
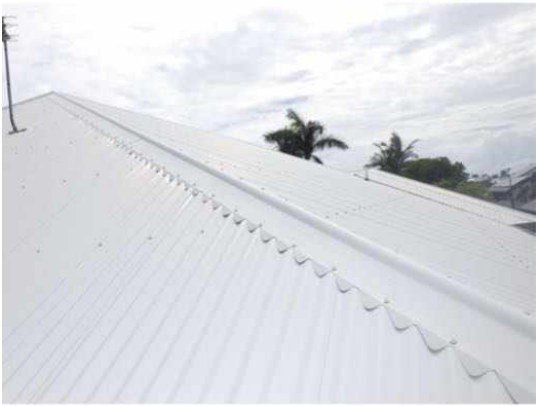
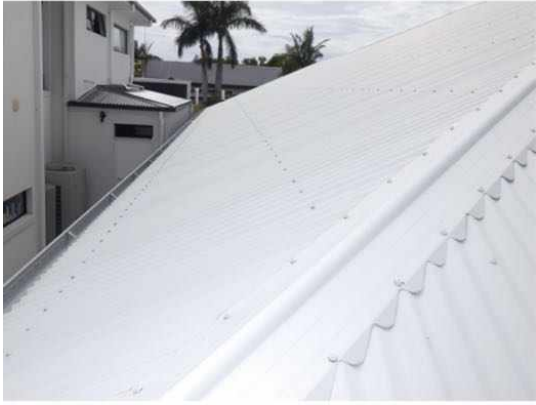
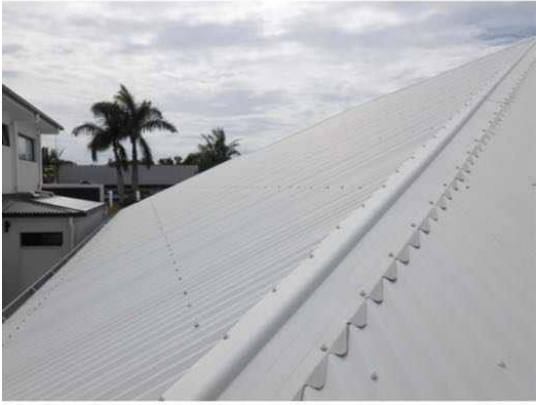
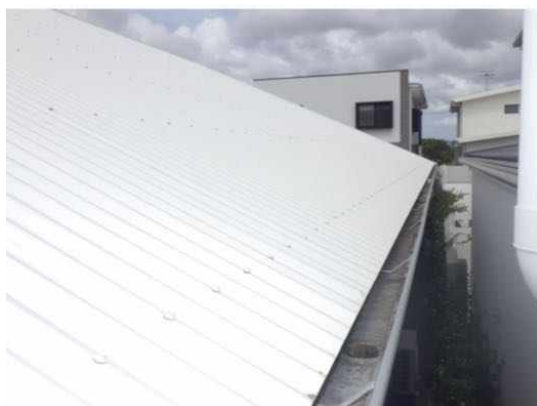
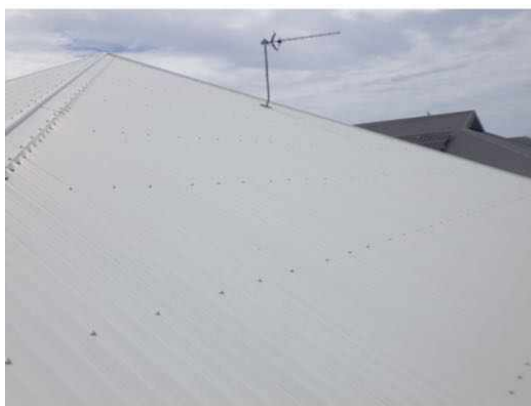
Building: Main Building
Location: Roof Exterior > Existing
Finding: Additional Photos
Information: Additional photos are provided for your general reference

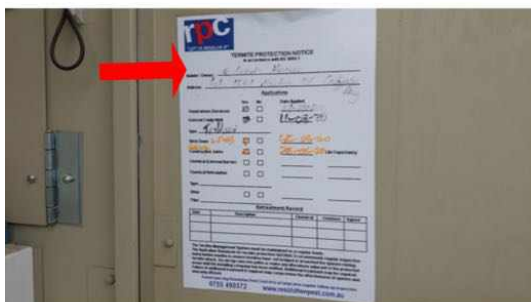
In this instance evidence of a previously installed physical barrier was observed, along with a durable notice inside the electrical meter box (dated 28/8/2020). This system requires regular annual inspections.

No evidence of regular or annual inspections was found.

Where a Termite Management System has been identified you should refer to the type of barrier date of installation warranty conditions and any documentation provided by the barrier installation company or past owner.
