## Building Inspection Report

Inspection Date: Mon, 16 Feb 2026

Property Address: 12 Verna Pl, Quakers Hill NSW 2763,  
Australia

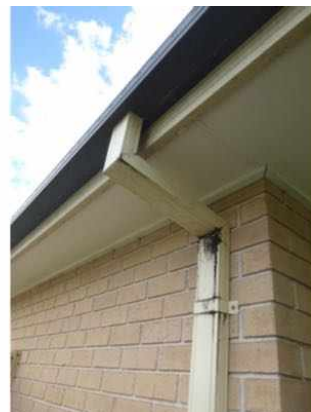
#### Defects 3.01

Building:	Main Building
Location:	Down pipe - Front
Finding:	Roof plumbing - Rusted or corroded
Information:	The roof plumbing has areas of evidence of water leak (rust and corrosion).

Rusted roof plumbing will generally develop holes and leaks that can affect other building elements with poor drainage of storm water. Poorly drained roof areas will also lead to damp conditions surrounding the base perimeter of the building which, if left unmanaged, can lead to a range of secondary building defects.

Repair and/or replacement of rusted roof plumbing is highly required in order to reinstate the roof drainage system to a fully operational level. To further maintain these areas, gutters should be cleaned frequently, allowing the avoidance of any partial blockages.

A licensed plumber or specialist roof restoration company should be appointed to undertake these works. It is advised that such works be completed as soon as possible to prevent any further damage and deterioration.

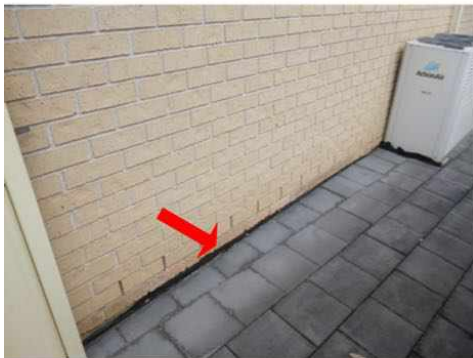
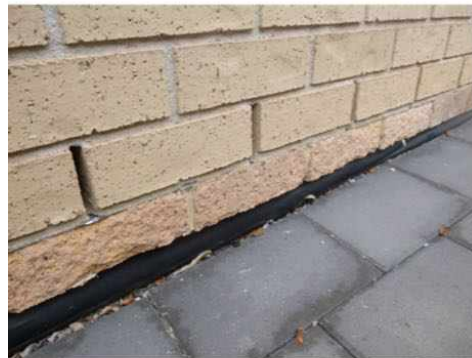
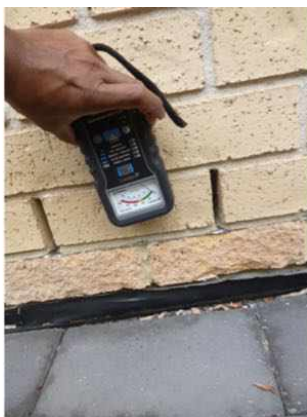
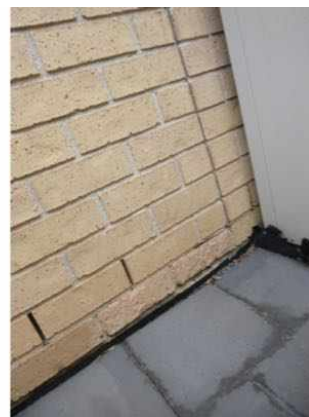
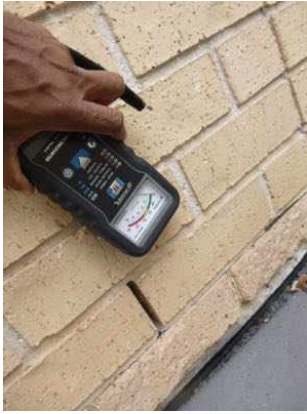
#### Defects 3.02

Building: Main Building  
Location: Exterior walls - right side  
Finding: Brickwork - Minor deterioration  
Information: Minor deterioration was evident to sections of the brickwork in this area at the time of inspection. Commonly referred to as brick corrosion or erosion, the bricks are aged and likely to have been affected by a variety of factors, including weather exposure, damage, salt-based deterioration, and more.

Overtime, these factors can affect the bricks, causing them to become brittle and appear corroded or eroded. The mortar in the brickwork may also become powdery, further detracting from the structural integrity of the brickwork. If left unmanaged, potential implications include further deterioration of the building materials, the development of secondary defects, and potential development of structural instability of the wall.

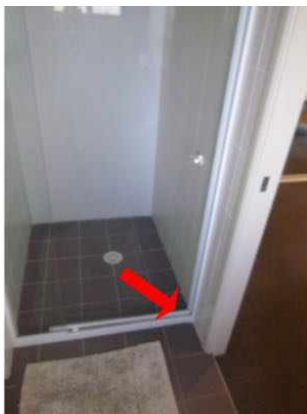
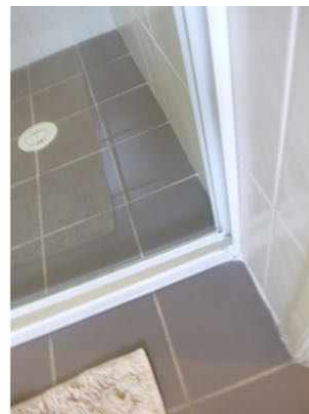
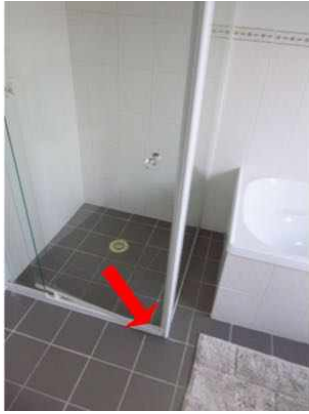
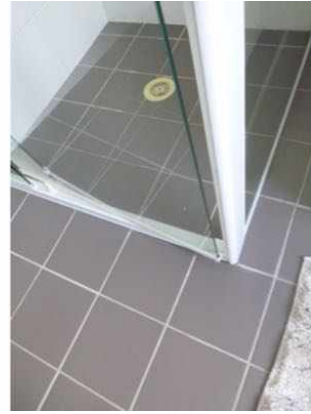
### Defects 3.03

Building:	Main Building
Location:	Bathroom
Finding:	Shower door - Binding/jamming
Information:	Binding and/or jamming of this shower door is evident during standard operation. This defect inhibits the functionality of the affected door as well as creating potential for secondary defects to associated building elements, such as damage to the frames covering.

A door that binds to the associated door frame may have several causes, ranging from minor defects, such as poor installation of the door or deteriorated hinges.

For minor causes, a qualified glazer or general handyperson should be appointed to perform minor rectification works at client discretion.

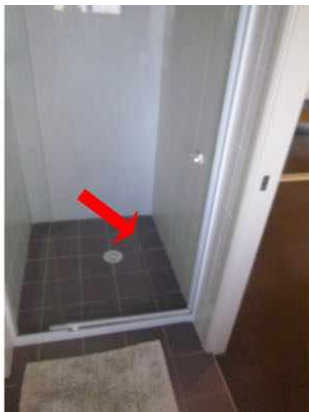
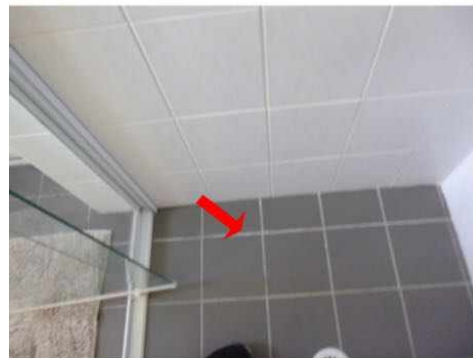
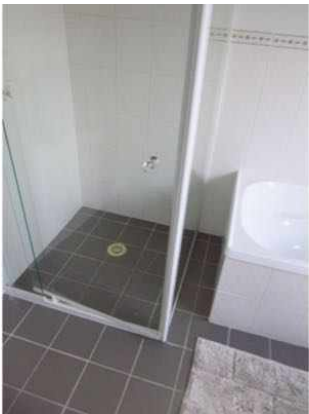
### Defects 3.04

Building: Main Building  
 Location: Shower area  
 Finding: Grout - Missing  
 Information: Grout is missing in this area. Grout is used to protect gaps and crevices in building materials to ensure that they are water-tight and prevent water penetration to the associated structures. While damage grout appears to be minor, this area is frequently exposed to water, allowing potential for water penetration into adjoining sections of walls or flooring.

Failure to do so is likely to lead to water damage to the surrounding area.

A tiling contractor should be appointed to ensure that no further water damage occurs. The re-application of silicone and grouting throughout remaining tile work is also advised, to further protect the area against water penetration.

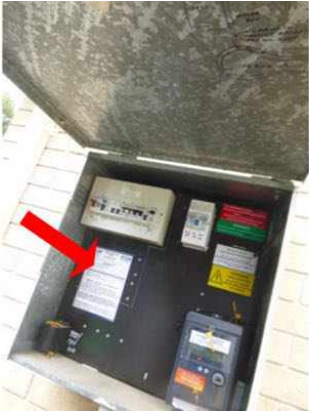
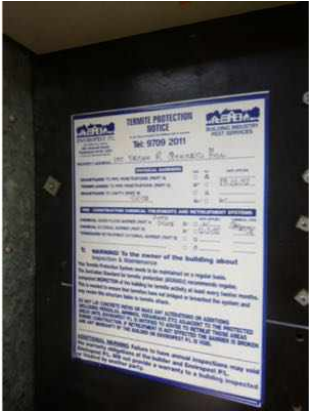
Building:	Main Building
Location:	Meter Box
Finding:	Termite Management System - Evidence of installation
Information:	<p>There are a number of factors which indicate the presence of a previously installed or applied termite barrier. The most common are a durable notice (to the inside of your meter box) observable physical barriers installed to building perimeter and in ground reticulation systems. Where a Termite Management System has been identified you should refer to the type of barrier date of installation warranty conditions and any documentation provided by a builder or past owner. Consult the company who installed the barrier to confirm whether the system is still under warranty.</p> <p>Most chemical termite management systems expire and require replenishment and all physical systems are primarily designed to prevent concealed entry. The client may consider gaining further advice from a pest controller as to the costs and procedures involved with this application. It is recommended that obtaining such advice be a short-term priority.</p>

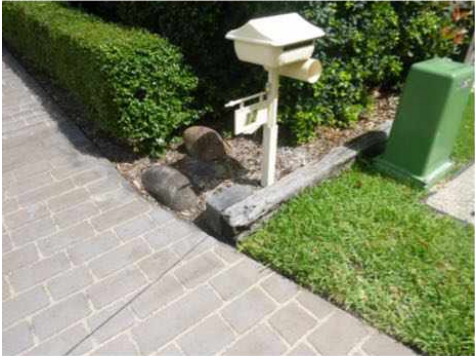
Building: Main Building  
 Location: All External Areas  
 Finding: Landscaping Timber  
 Information: Any timbers in direct ground contact provide opportunity for concealed termite entry and are likely to be subject to premature rot and decay as the soil retains moisture or damp conditions against the timbers. Remove untreated timber that is in direct contact with external grounds. If there is old tree stumps present frequent pest inspections are advised to readily identify any termite activity in these areas. Monitor treated landscape timbers within the garden area, as treated pine breaks down and rots over a period of time causing conducive conditions for termite activity.

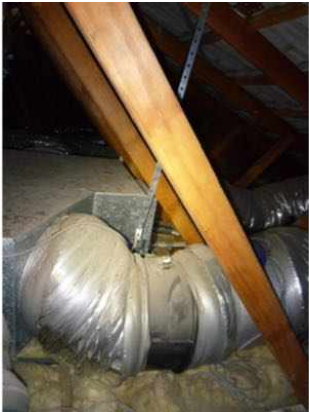
Building: Main Building  
 Location: Roof void  
 Finding: Air condition Unit- Good condition NO drain leaks  
 Information: There is NO drain leaks in air condition during the inspection. Leaking from an air-conditioning unit in roof space may be a result of several causes, including poor installation, blockages in internal drains, or a blockage to the drain hole. Heavy leaking from the air-conditioning unit is likely to produce damp conditions in the surrounding area conditions which are conducive to termite attack. If left unattended, such leaking can develop into water pooling below the unit, creating potential for subsequent water damage to associated building elements.

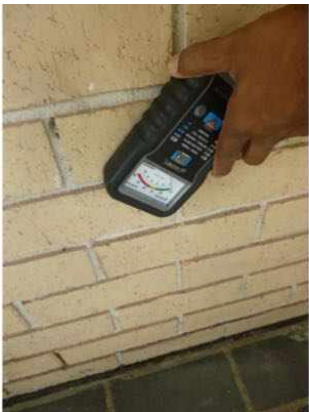
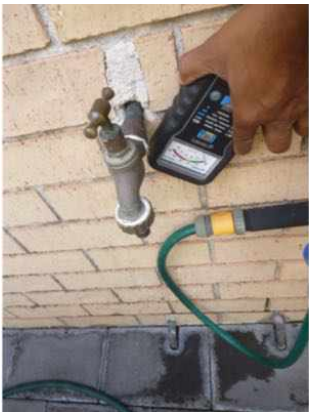
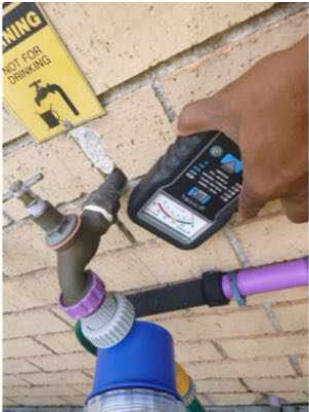
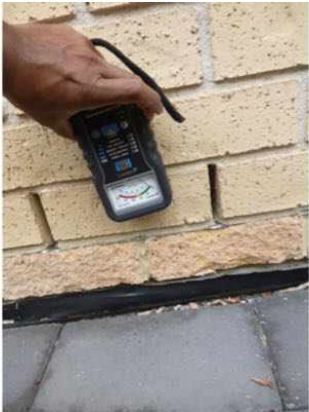
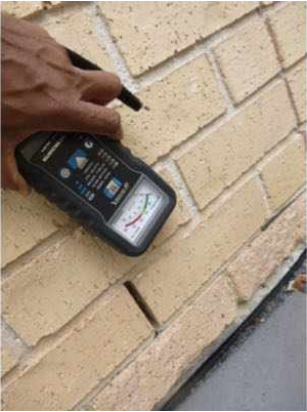
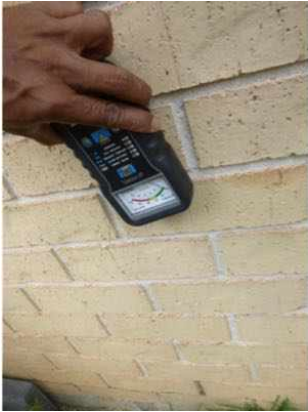
Building: Main Building  
Location: All Areas  
Finding: No Excessive Moisture  
Information: All areas of the dwelling are checked with particular attention paid to wet areas which were closely assessed to check for excessive levels of moisture and temperature anomalies. No evidence of excessive moisture was found inside the house at the time of the inspection.

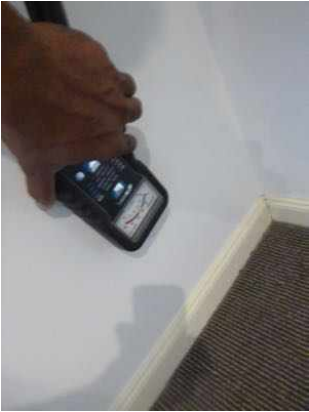
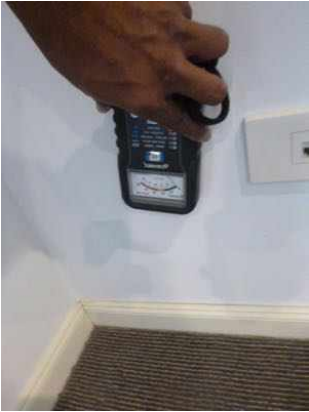
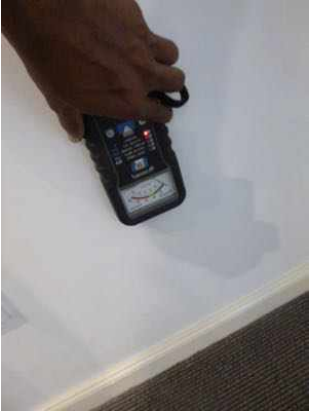
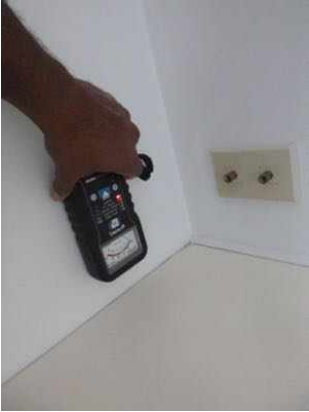
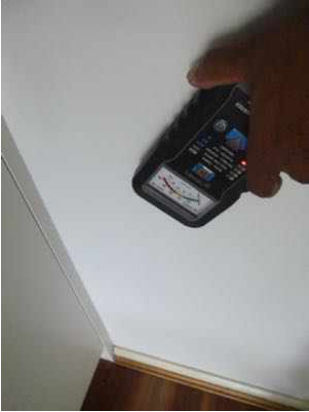
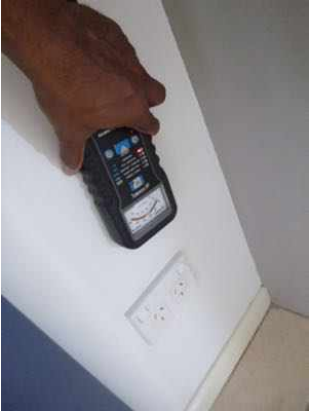
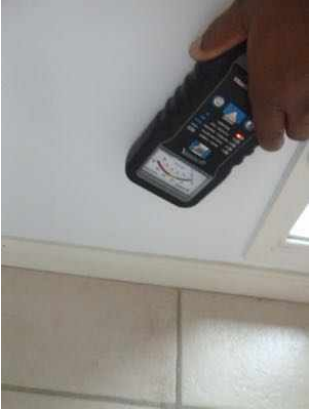
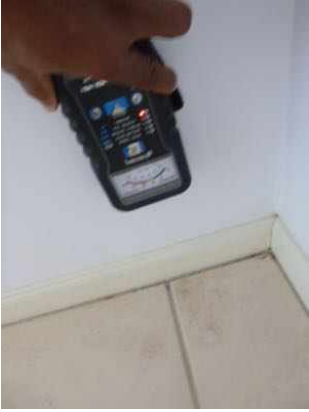
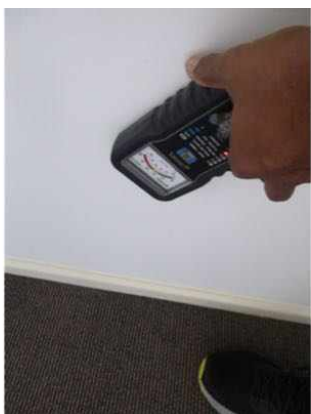
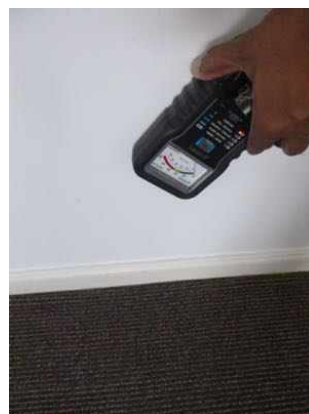
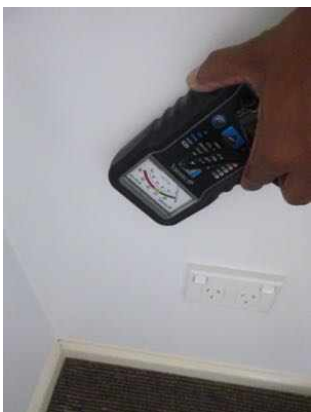
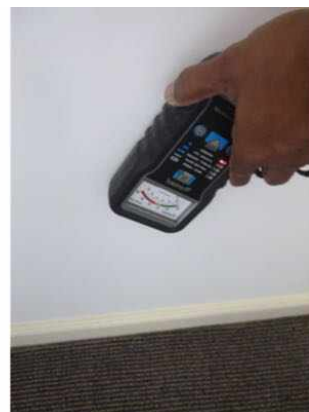
Building: Main Building  
Location: All Internal Areas  
Finding: Cracking - Damage Category 0 - Hairline (less than 1mm)  
Information: Hairline cracks are very minor in nature and generally are only ever an appearance defect. While such cracking may be noticeable in some cases, it is quite common and does not indicate any structural damage.

Cracking of this nature can generally be repaired with minor sanding, filling and/or repainting. Such works should be performed by a qualified painter or a general handyman.

Monitoring of all cracking should be conducted frequently. Always contact a building inspector should cracks widen, lengthen, or become more numerous.

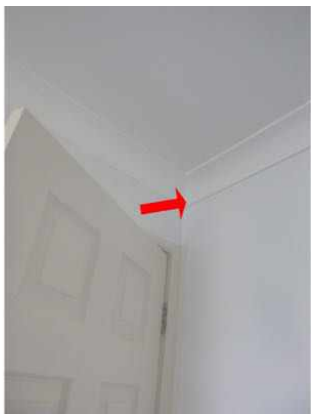
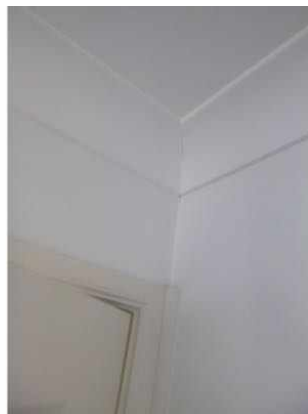
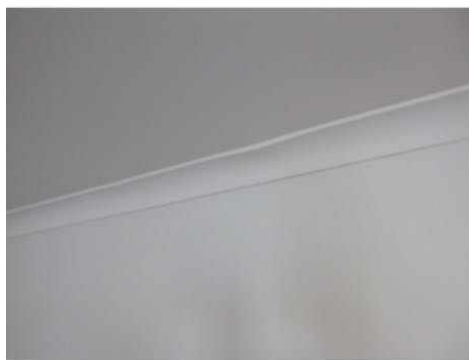
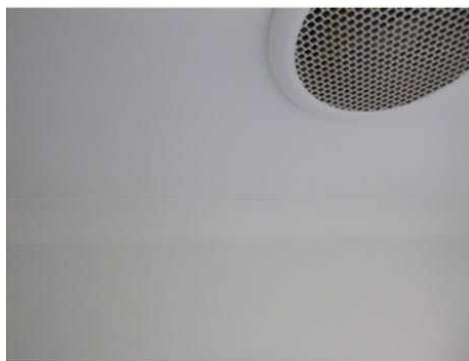
Building: Main Building  
 Location: Bathroom And other wet area  
 Finding: No evidence of excessive moisture- Bathroom  
 Information: All areas of the dwelling are checked with particular attention paid to wet areas which were closely assessed to check for excessive levels of moisture and temperature anomalies. There was NO evidence of excessive moisture present at the time of inspection in bathrooms.

Regular maintenance and replacement of damage or missing or damaged sealant and grout is highly recommended to the wet areas, as this is a regular wear and tear defect. Sealant and grouting in areas that come into regular contact with water should

be maintained for the long term care of your property. Excessive moisture can attract termites and produce conditions that promote termite attack fungal growth and wood decay. It is highly recommended that all plumbing and drainage fixtures and fittings be maintained regularly in order to prevent excessive moisture being present in the external / internal property.

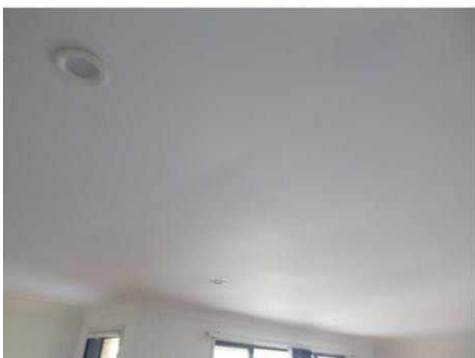
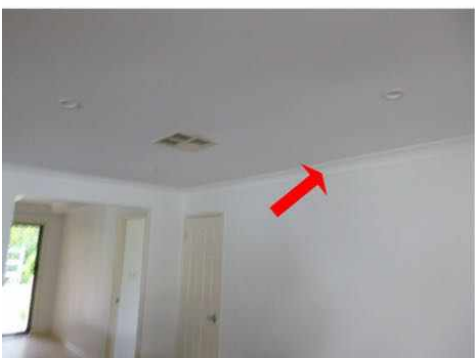
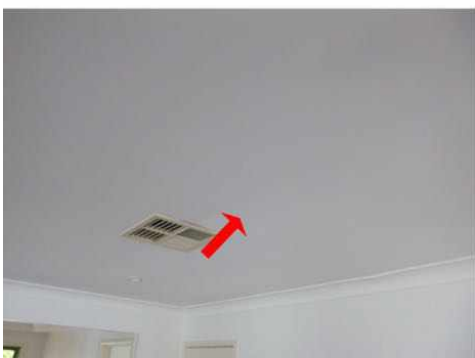
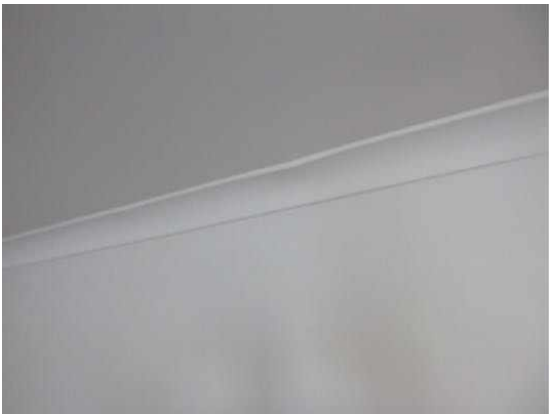
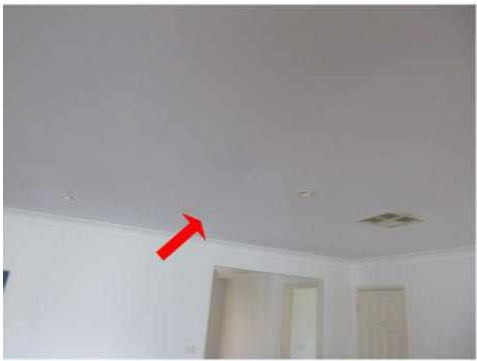
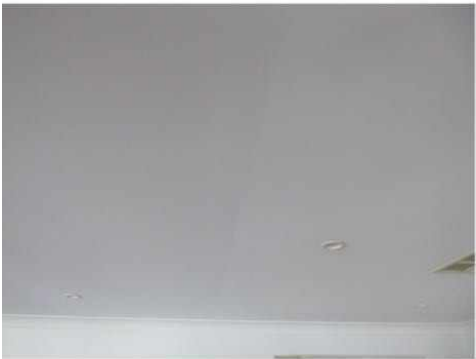
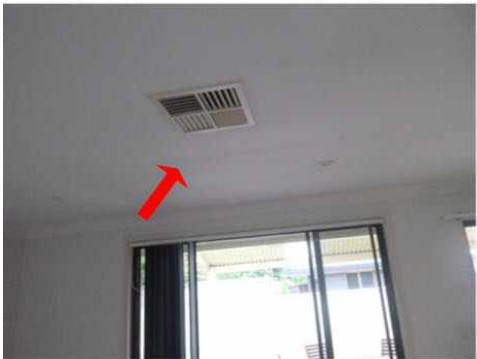
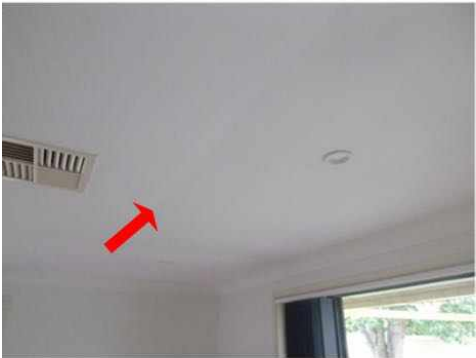
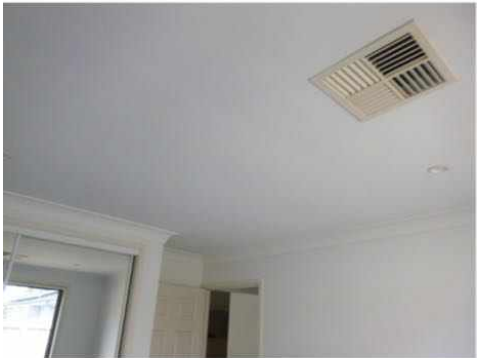
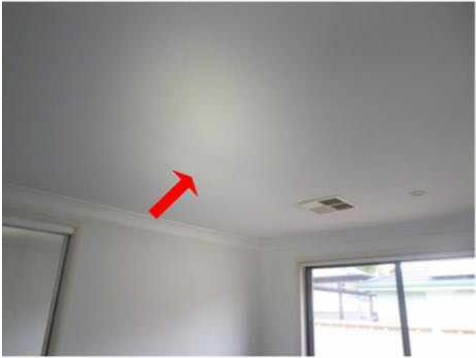
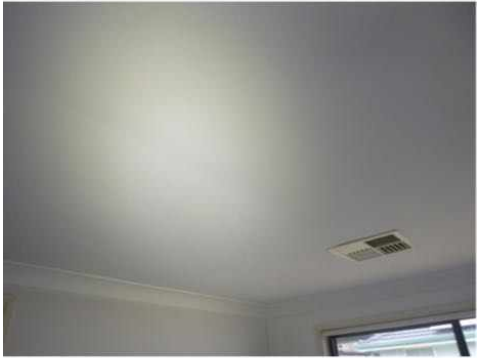
Building:	Main Building
Location:	Garage And other areas
Finding:	Ceiling - Sagging
Information:	Sections of the ceiling were found to be sagging at the time of inspection. Sagging to the fixed ceiling structure generally indicates that the building materials have swollen, due to contact with water, or that fixings (e.g. nails or glue) have become loose and require reattachment.

Where minor sagging is evident, comparatively minor works, such as re-gluing of ceiling sheets, may be required. Such works may be performed by relevant tradespeople, such as plasterers and painters. Where excessive moisture has caused the roofing structure to swell and sag, the source of the water leak should primarily be identified prior to any remedial works being performed.

The appropriate action should be taken by the client as soon as possible to ensure that any potential further damage is limited.

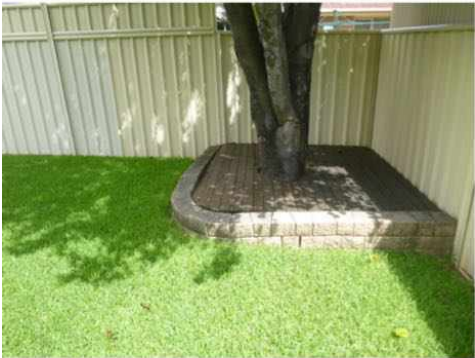
Building: Main Building  
Location: All Areas  
Finding: Additional Photos - Obstructions and Limitations  
Information: These photographs are an indication of the obstructions and limitations which impeded full inspection of the property at the time of inspection. These obstructions can hide an array of defects and should be removed to allow full inspection to be carried out.

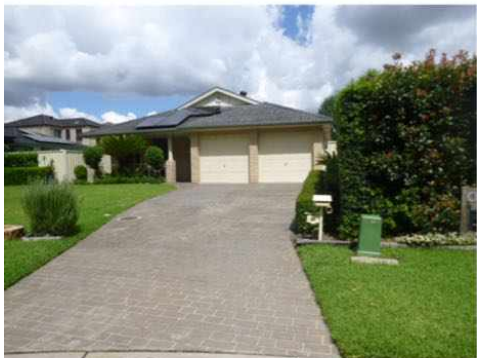
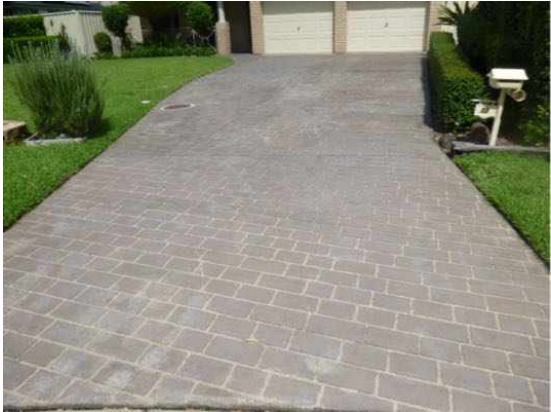
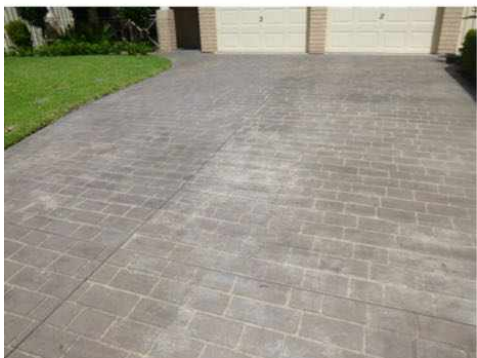
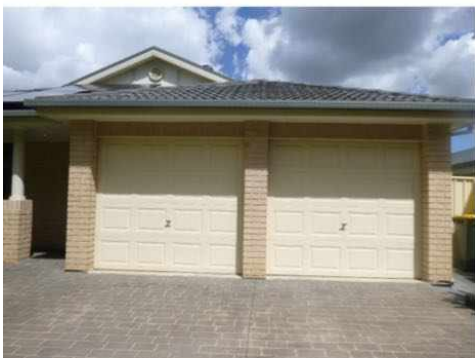
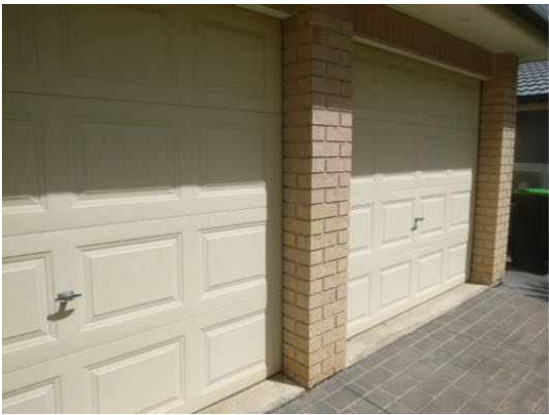
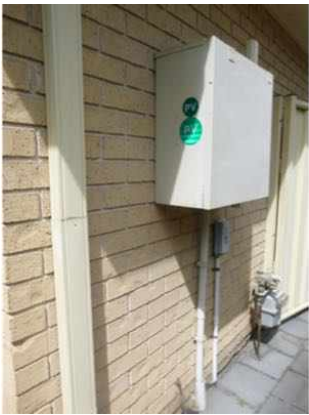
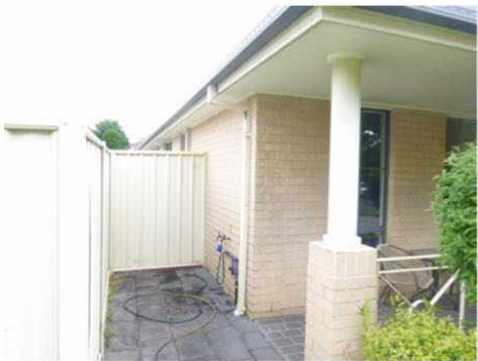
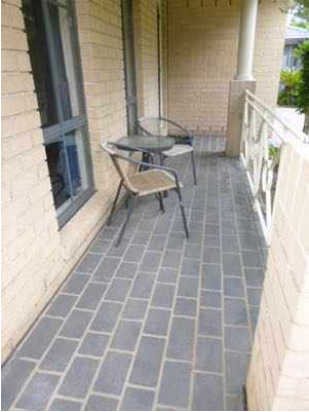
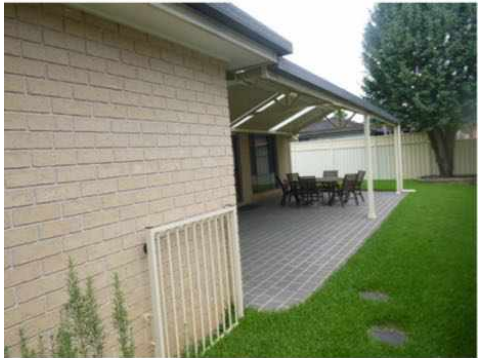
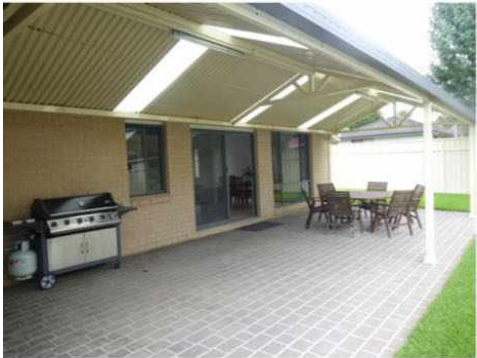
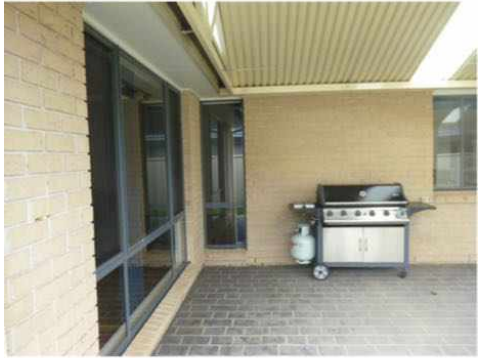
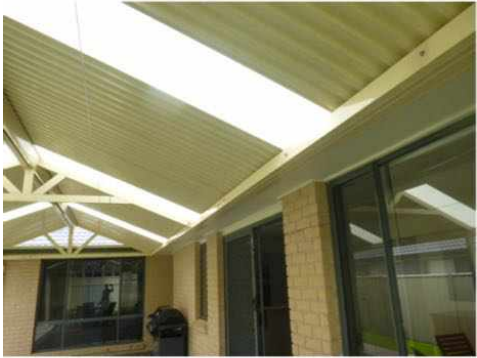
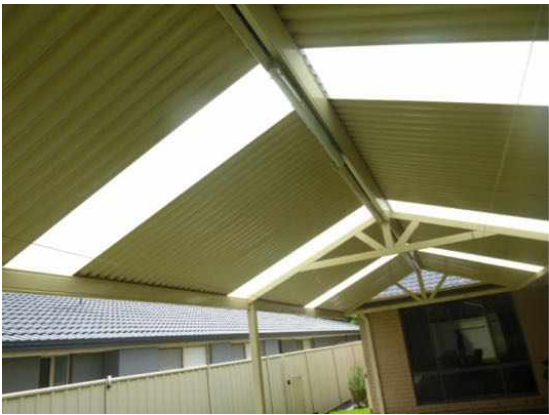
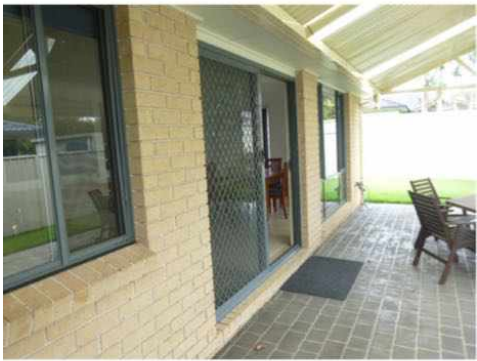
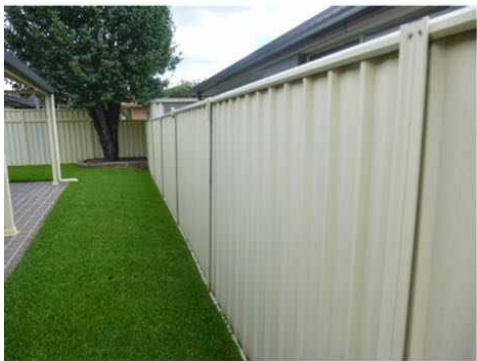
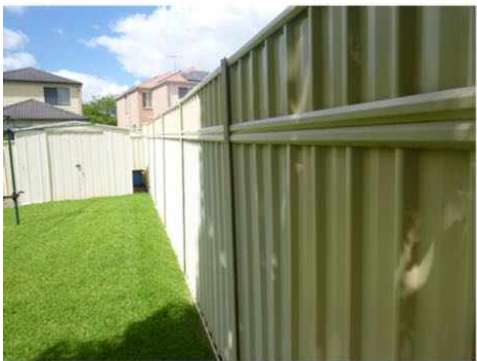
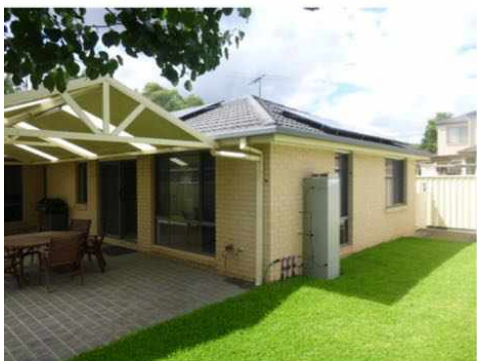
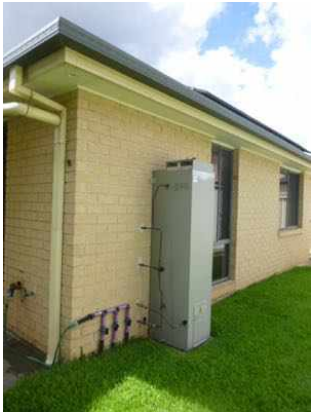
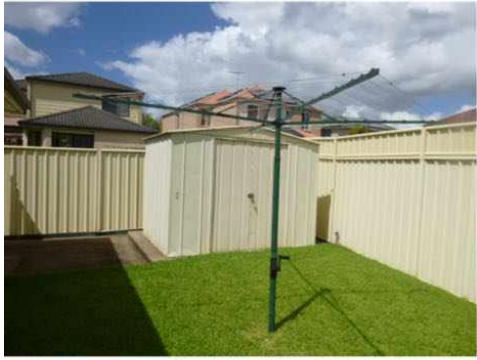
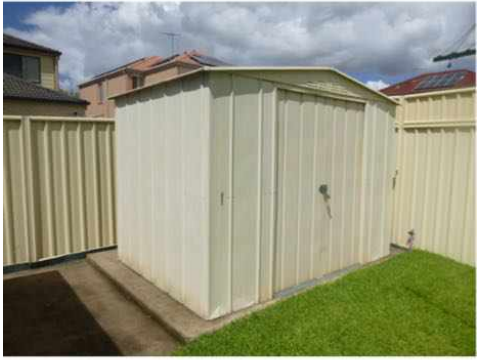
Building: Main Building  
Location: All Areas  
Finding: Additional Photos  
Information: Additional photos are provided for your general reference. Arrows have been included to highlight areas of importance. Please discuss these photos with your building consultant for clarification.

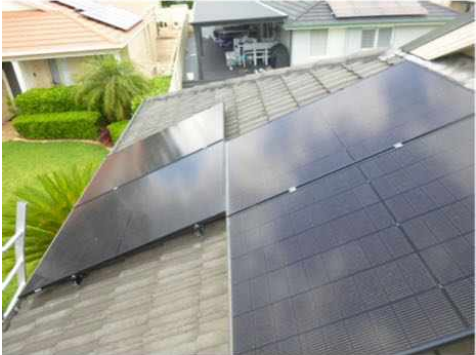
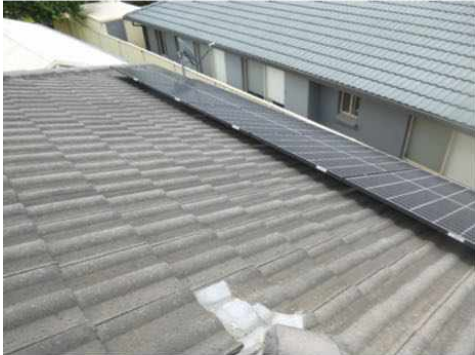
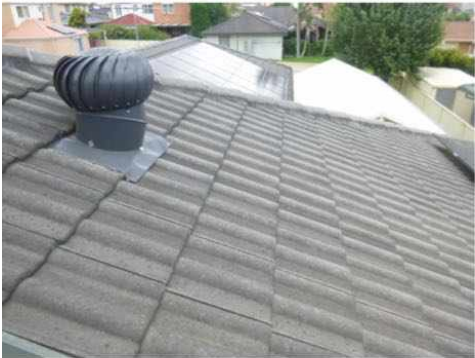
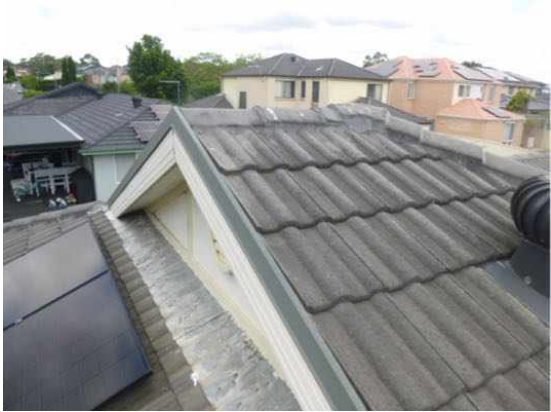
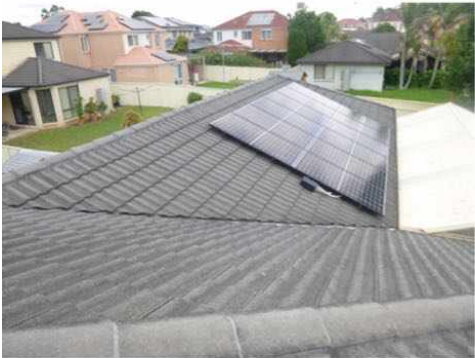
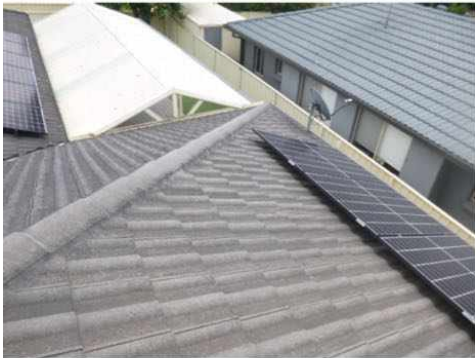
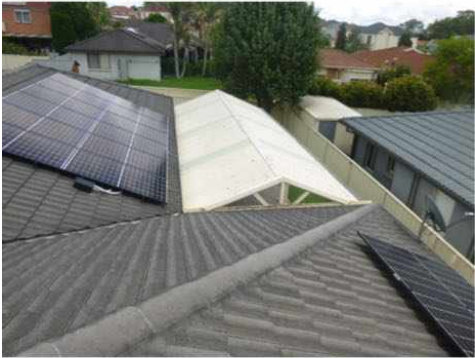
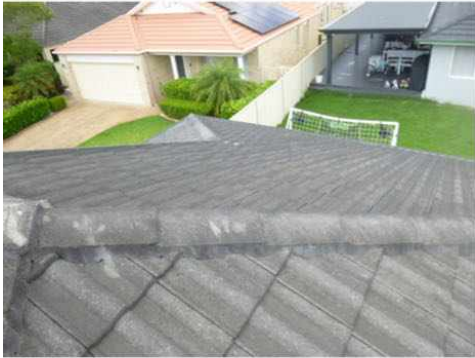
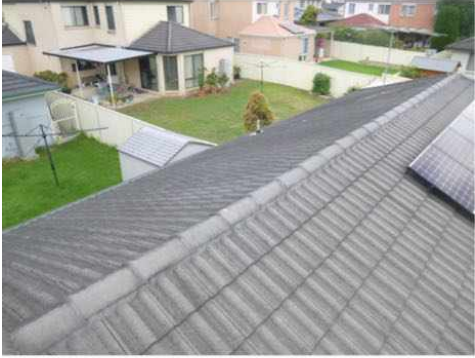
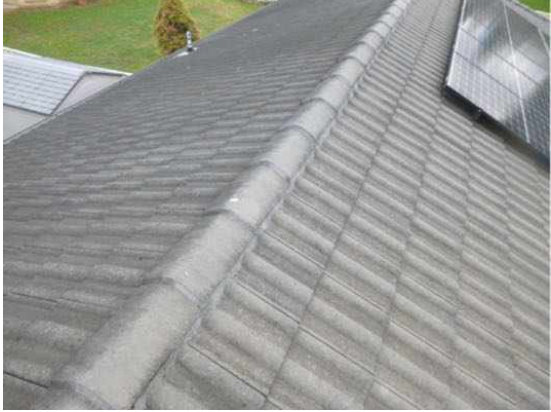
Building: Main Building  
Location: Roof Exterior  
Finding: Roof Tile - Good condition  
Information: Upon inspection of the exterior and interior roofing, the majority of rood tiles were considered to be in a good condition. Few crack tiles were noted during the inspection. It should be replace asap soon as possible to avoid further damage and leakages.
