Building and Timber Pest Inspection Report

Inspection Date: Tue, 10 Feb 2026

Property Address: 7 Downshire Parade, CHESTER HILL, NSW, 2162, Australia

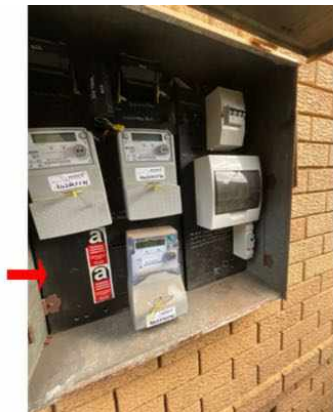
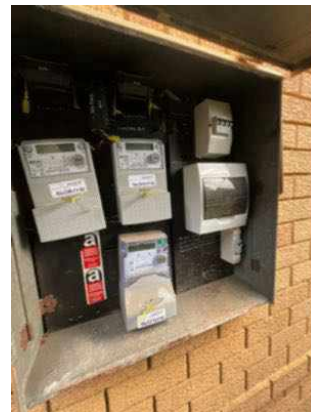
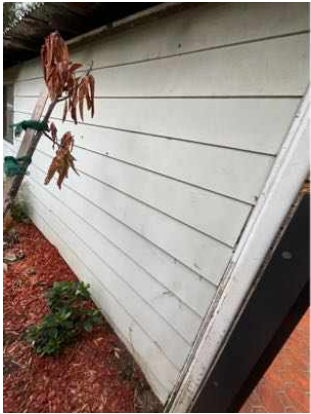
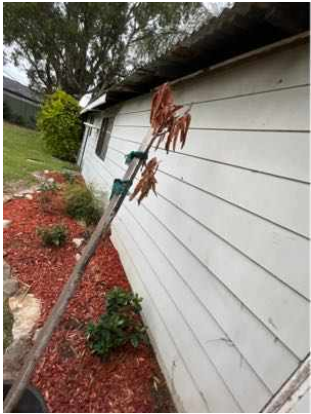
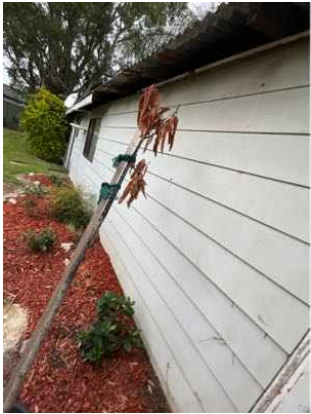
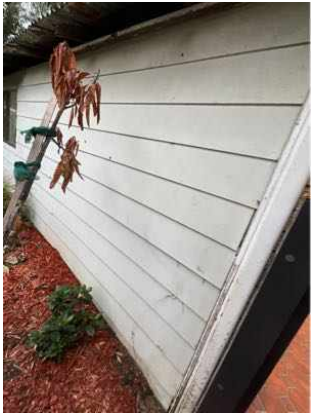
Building:	Main Building
Location:	All Areas
Finding:	Asbestos - Suspected ACM Identified on Site
Information:	Reporting on Asbestos is outside the Scope of this Report. This suspected defect is highlighted as a caution only. We suspect, based on our experience in the building industry, that there is a higher risk of the identified building element containing asbestos.

As Asbestos Reporting is outside the scope of this report, we advise that you consider a separate Asbestos Inspection and Condition Audit, which can include the taking of samples for definitive confirmation of the presence of Asbestos.

In the interim, the client is advised to act with caution, especially when considering any damage to building materials general wear and tear renovations extensions demolition and general maintenance activities due to the suspected presence of Asbestos.

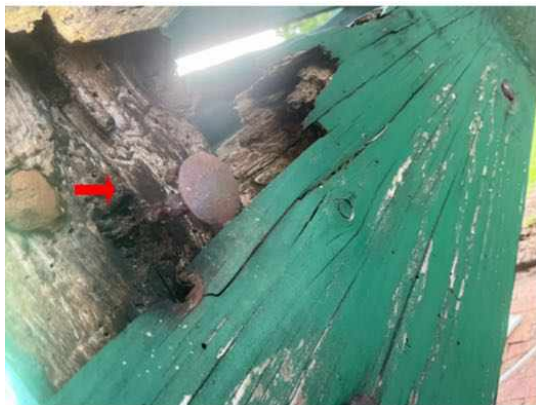
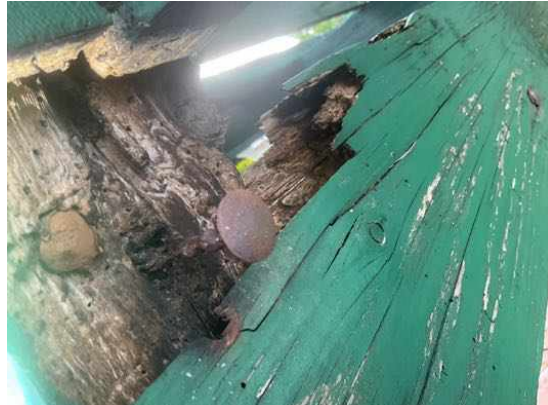
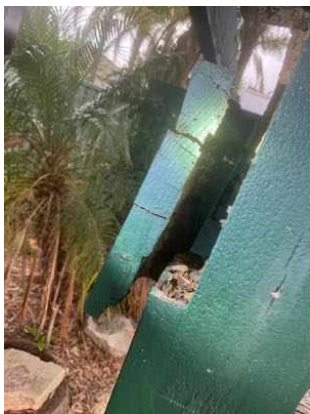
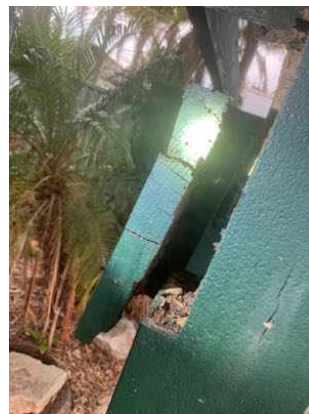
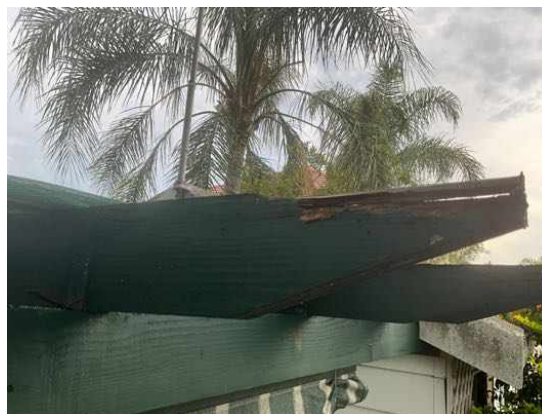
Finding 2.01

Building: Main Building
Location: Pergola
Finding: Rot weakening the timber structure
Information: Cracks and signs of wood rot have been observed, weakening the timber structure. The deterioration could be due to moisture exposure, aging, or insect infestation, compromising the structural integrity of the timber.

- ****Structural Instability:**** The cracks and wood rot can compromise the load-bearing capacity of the timber, potentially leading to structural failure or collapse, especially in load-bearing walls, beams, or frames.
- ****Safety Hazard:**** Weakening of the timber structure increases the risk of accidents, such as falling debris or collapse, posing a danger to occupants.
- ****Progressive Damage:**** If left unaddressed, wood rot can spread, further degrading the timber and accelerating the risk of structural failure.
- ****Pest Infestation:**** Wood rot can attract pests such as termites, which may cause additional damage.

A structural engineer or professional carpenter should be contacted to assess the extent of the damage. Depending on the severity, repairs may involve replacing the affected timber sections, treating the wood with preservatives, or reinforcing the structure. If there is extensive rot, a specialist in wood restoration or pest control may also be required to prevent further decay or infestation.

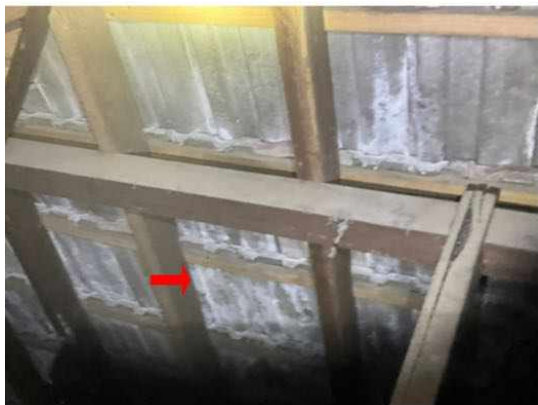
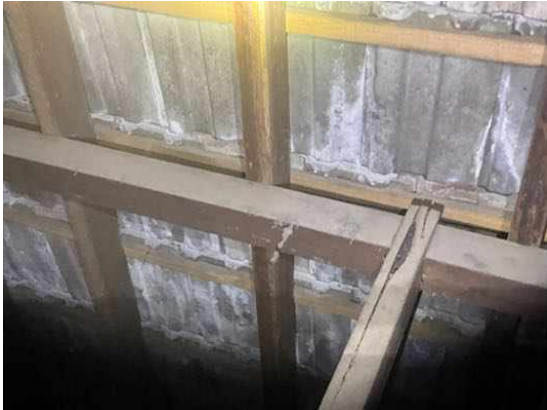
Finding 2.02

Building:	Main Building
Location:	Roof Void
Finding:	Roof void - Suspected water leak
Information:	Suspected water leak in the roof void, as evidenced by the presence of water stains, indicating potential gaps or holes.

- **Structural Damage:** Continuous water leakage can weaken the structural integrity of the roof and ceiling, leading to potential collapse.
- **Mold and Mildew:** Persistent moisture can promote the growth of mold and mildew, posing health risks such as respiratory problems and allergic reactions.
- **Electrical Hazard:** Water intrusion near electrical wiring can create a risk of short circuits, fires, or electrical shocks.
- **Insulation Damage:** Prolonged exposure to moisture can damage insulation, reducing its effectiveness and increasing energy costs.

A licensed roofing contractor should be contacted immediately to inspect, diagnose,

and repair the source of the leak to prevent further damage.

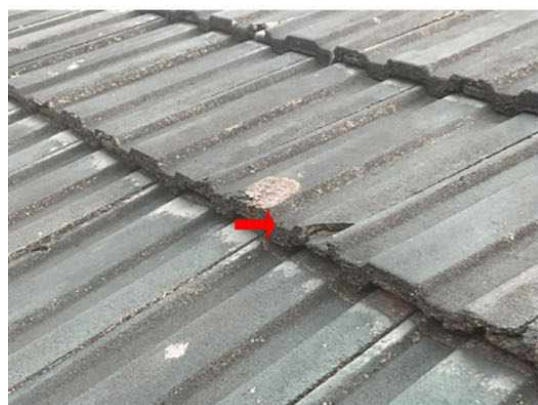
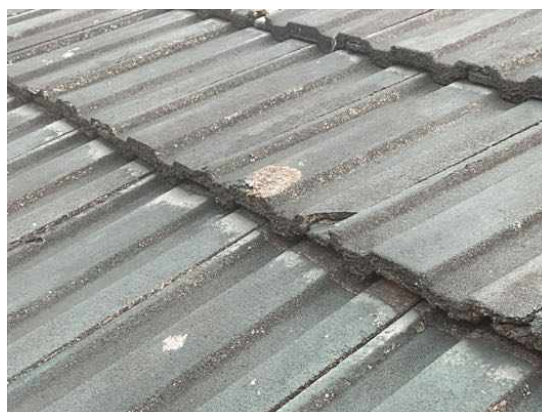
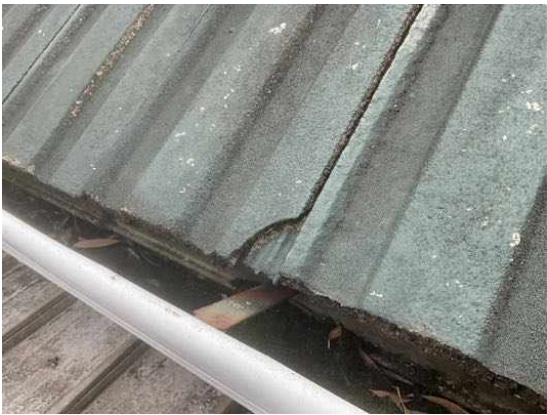
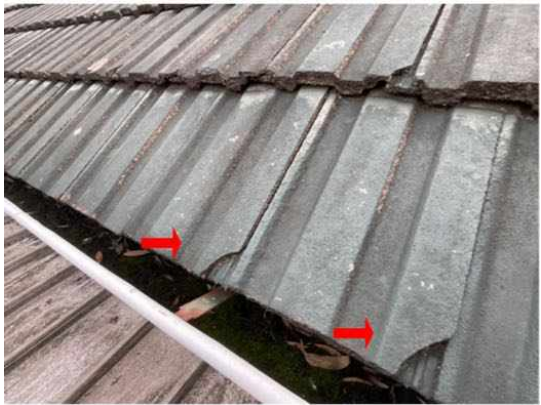
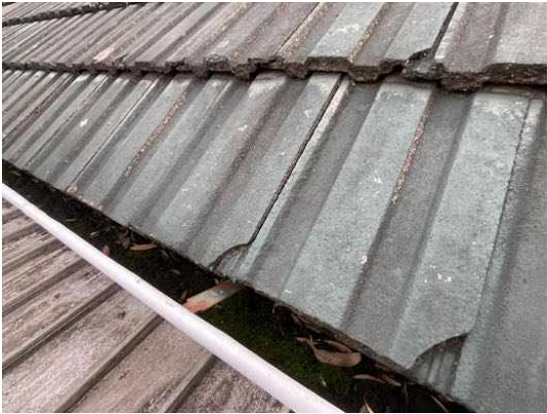
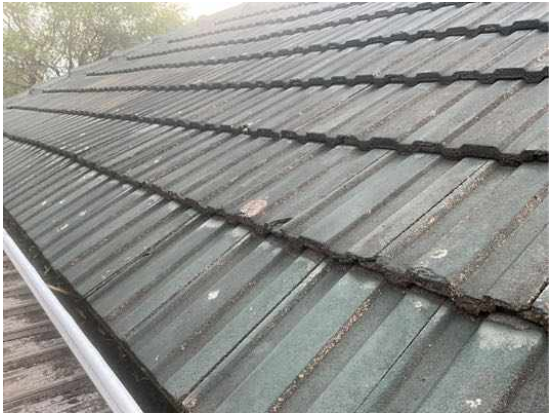
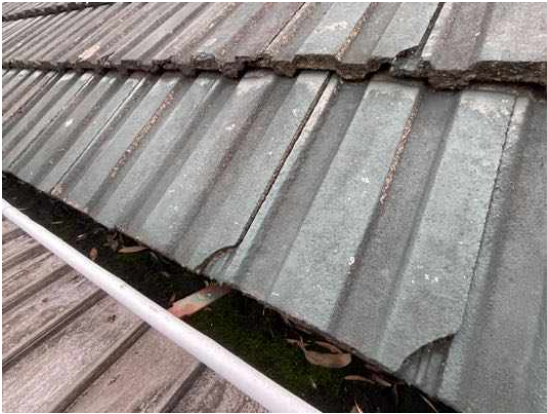
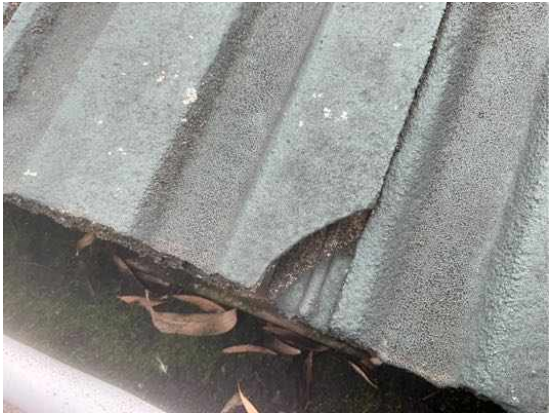
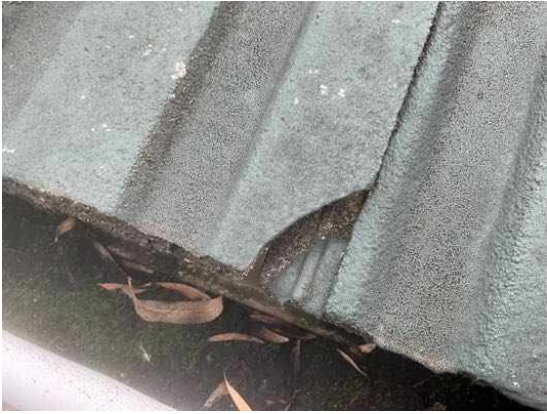
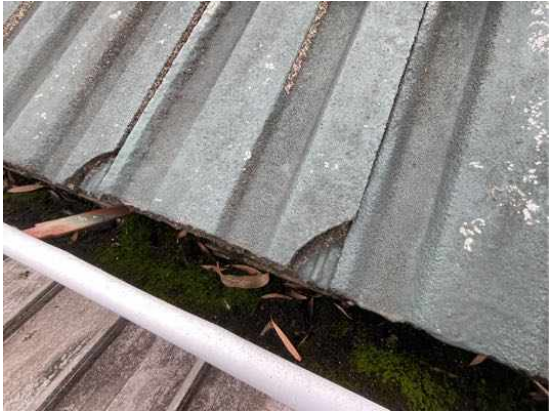
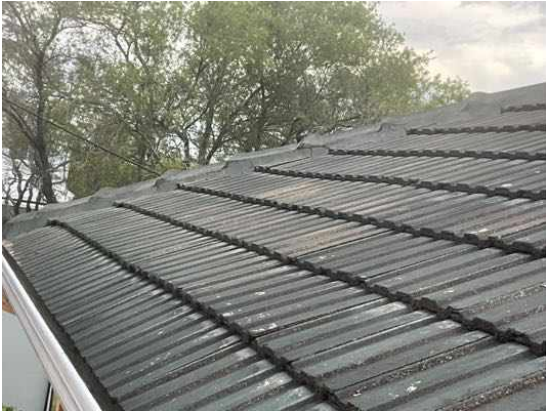
Finding 3.01

Building:	Main Building
Location:	All Areas
Finding:	Roof Weathered
Information:	Upon inspection of the exterior roofing, the majority of roof was not in a fair condition. While weathering of the roof is consistent with the age of the property, maintenance works are required.

Isolated areas of mortar have come loose in the valleys and minor cracking is also present. Re-pointing and re-sealing the may be considered as an interim solution by the client to help preserve and extend the life span of the tiles.

Where left unmanaged, deteriorating roof are likely to lead to a number of secondary defects, including minor water leaks and weather exposure to internal roofing structures.

Consultation with a roofing contractor is highly advised to gain advice on cost of remedial works that may be required in the short to medium term. Remedial works are likely to increase the longevity of the exterior roofing structure.

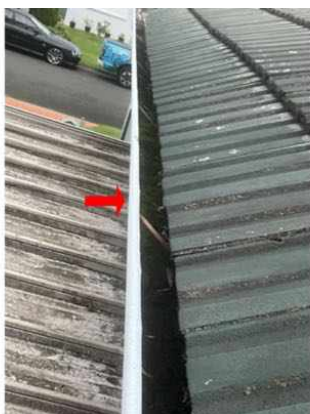
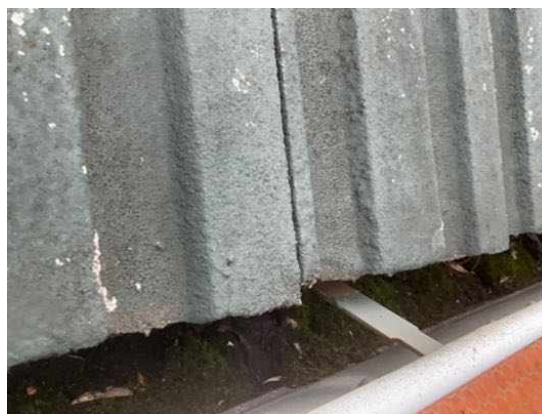
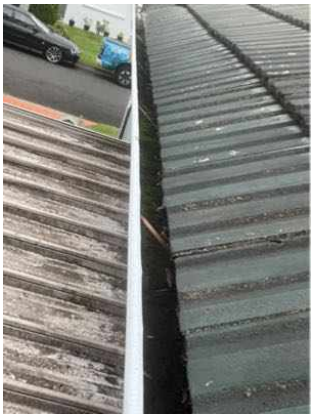
Finding 3.02

Building: Main Building
Location: All Areas
Finding: Blocked gutters - organic debris
Information: The roof gutter system was observed to be blocked with organic debris and moss growth, as evident in the provided images.

- Water ingress into the eaves or walls,
- Timber rot or deterioration of fascia and soffits,
- Accelerated moss and algae growth, promoting further blockages,
- Potential foundation issues if water pools near the base of the structure.

A licensed roofing contractor or qualified gutter cleaning service should be engaged to remove the debris and inspect the system for any further issues.

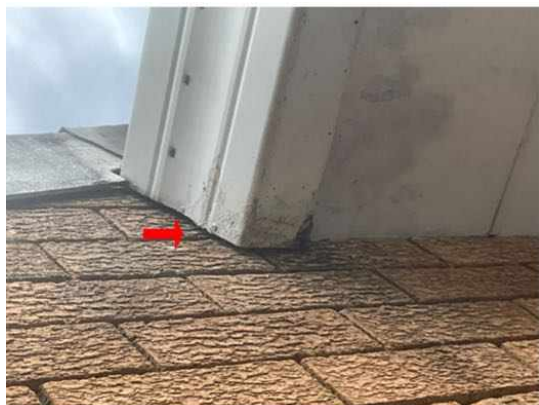
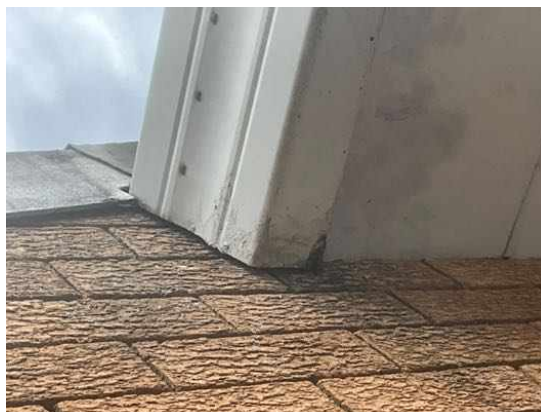
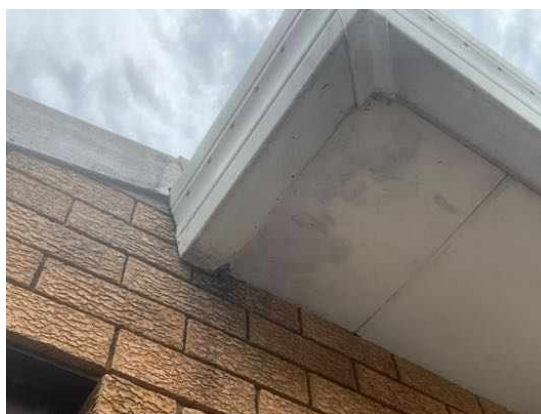
Finding 3.03

Building: Main Building
 Location: Exterior walls - left side
 Finding: Roofing Gutters - leak
 Information: Roofing gutters are experiencing leaks, compromising their ability to channel water effectively, posing a risk of water damage to the building structure and surroundings.

Risk: "The gutter leaks may result in water seepage into the foundation, potential interior damage, and deterioration of the building's exterior surfaces."

Resolution: "To address the issue, it is recommended to hire a licensed roofing plumber or gutter specialist to inspect, identify, and repair the leaks promptly."

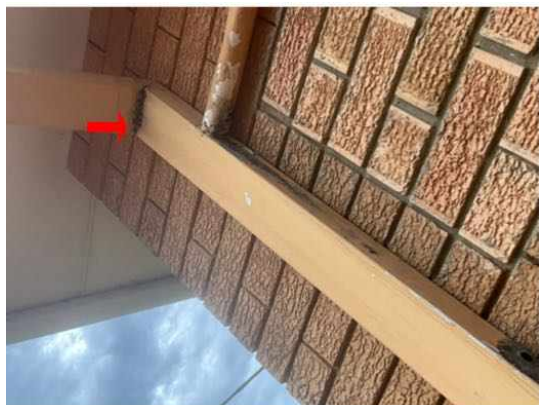
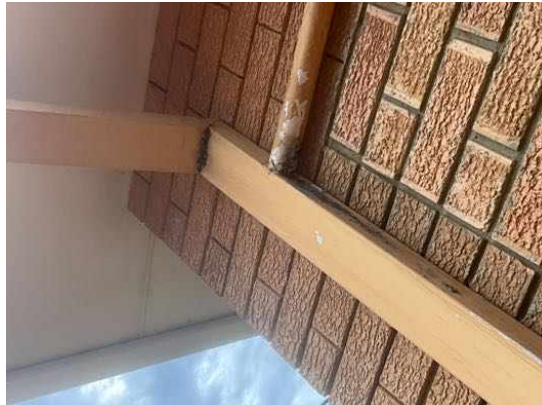
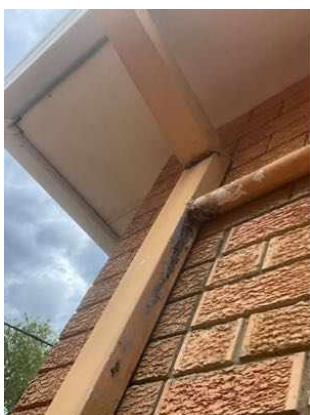
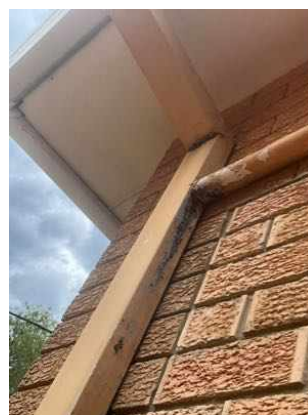
Finding 3.04

Building:	Main Building
Location:	Exterior walls - right side
Finding:	Downpipes Rusty / leaking
Information:	The downpipes on the property show significant signs of rust and leakage. The rust has weakened the structural integrity of the pipes, and the leaks are causing water to escape, potentially leading to further damage to the building's exterior and foundation.

- ****Water Damage****: Leaking downpipes can cause water to accumulate around the foundation of the building, leading to erosion, foundation damage, and potential structural instability. Additionally, water seeping into walls can cause mold growth, wood rot, and other moisture-related issues.

- ****Structural Deterioration****: The rusting of the downpipes compromises their ability to effectively channel water away from the building, increasing the risk of corrosion spreading to other parts of the drainage system and potentially causing more extensive damage.

A licensed plumber or roofing contractor should be hired to inspect and replace the rusty and leaking downpipes. The new downpipes should be made from rust-resistant materials and properly sealed to prevent future leaks. Regular maintenance checks should also be performed to ensure the drainage system remains in good working order, preventing water damage to the property.

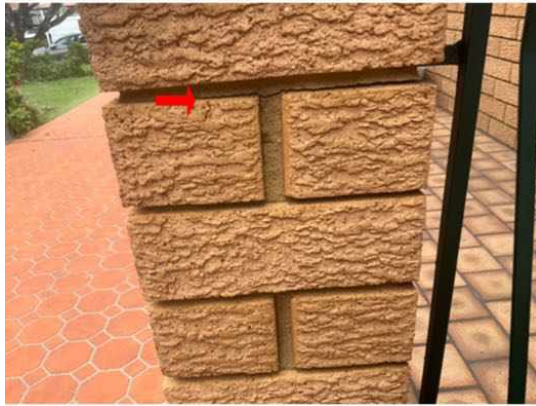
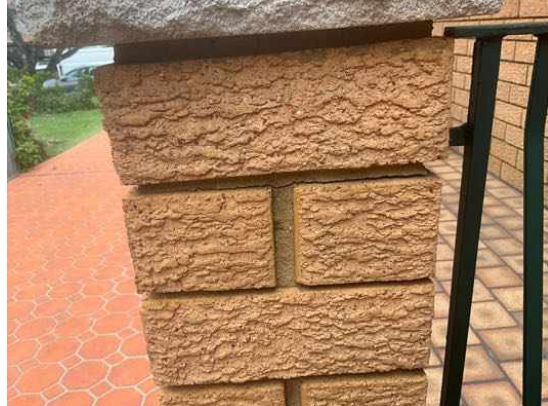
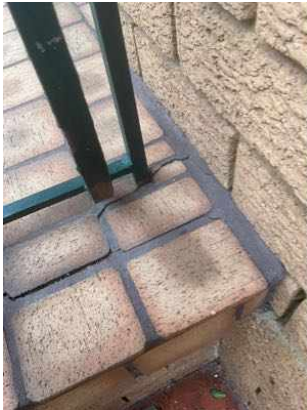
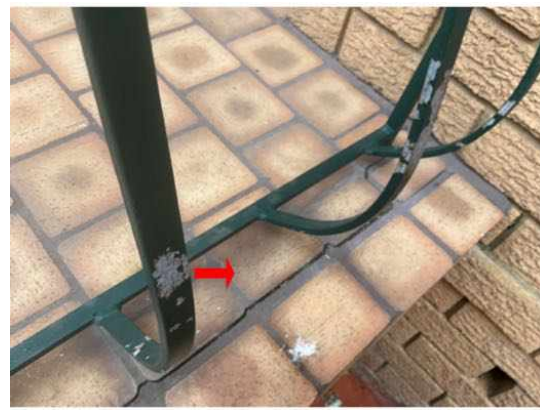
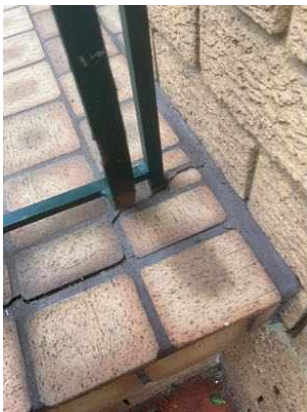
Building: Main Building
 Location: Front porch
 Finding: Mortar - damage and deterioration
 Information: The mortar joints in the brickwork and concrete structures, exhibit signs of damage and deterioration. The mortar has visibly cracked, crumbled, and eroded in sections, leading to weakened structural integrity of the affected areas.

If left unaddressed, the deterioration of mortar can allow moisture ingress, leading to potential water damage, mold growth, or further weakening of the wall's structure. Over time, this could lead to more significant structural issues such as cracking in the masonry or even partial collapse, presenting safety hazards.

A qualified bricklayer or masonry specialist should be engaged to perform repointing of the damaged mortar joints. The process involves removing the deteriorated mortar and replacing it with fresh mortar to restore the integrity of the structure. The affected concrete areas should also be repaired, possibly with a concrete repair specialist to ensure proper sealing and protection against further weathering and water infiltration.

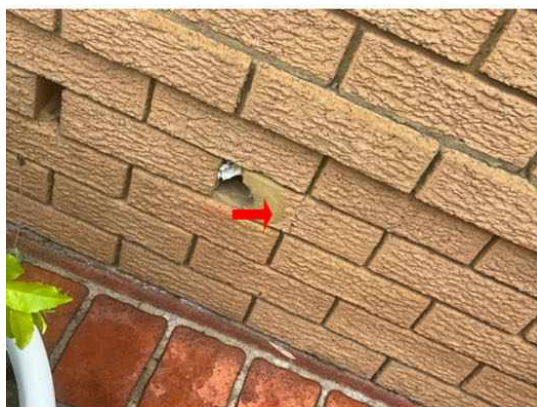
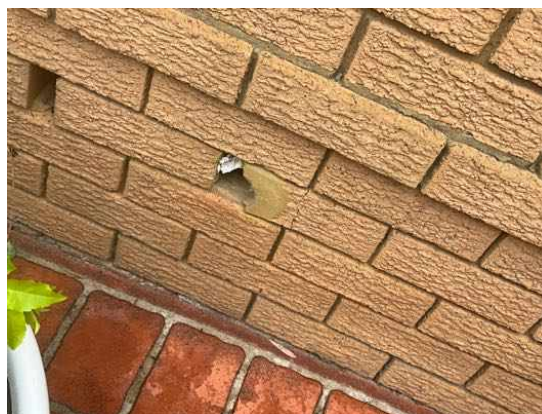
Finding 3.06

Building:	Main Building
Location:	Exterior walls - right side
Finding:	Brickwork - Cracking [Fine]
Information:	Although fine cracks are quite noticeable, they are often only considered to be an

appearance defect and usually do not indicate any structural damage. Generally, the cause of a fine crack is indicative of a separation between brickwork and mortar throughout the structure, but single bricks may also show cracks of this nature.

Cracking of this nature can generally be repaired with minor filling and should be conducted by a qualified bricklayer.

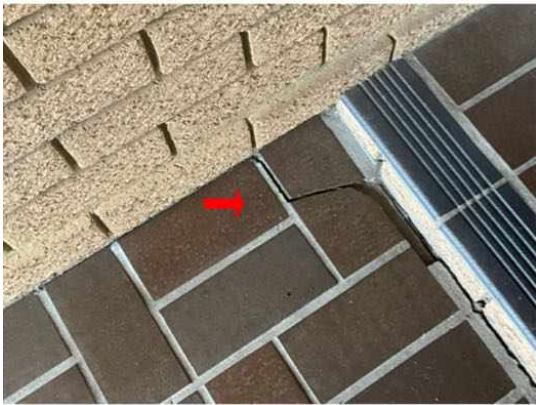
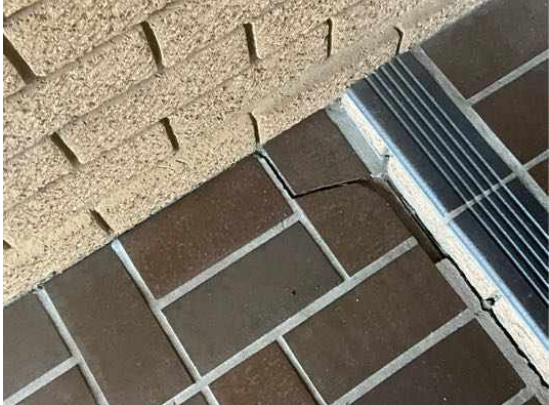
Finding 3.07

Building: Main Building
Location: Alfresco
Finding: Floor Tile crack
Information: A floor tile has a visible crack on the surface.

The damaged tile presents a trip hazard, may lead to cuts if stepped on barefoot, and can allow moisture ingress into the substrate, which may cause further deterioration or loosening of adjacent tiles. It also affects the overall appearance of the floor.

A licensed tiler should be engaged to remove the damaged tile and install a matching replacement. If spare tiles are unavailable, additional remedial work may be required to blend the repair with surrounding finishes.

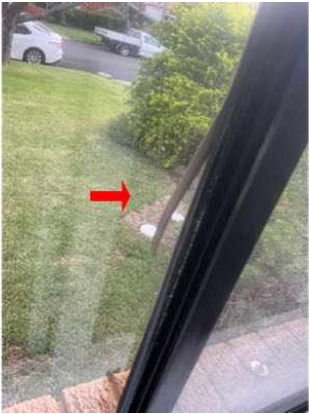
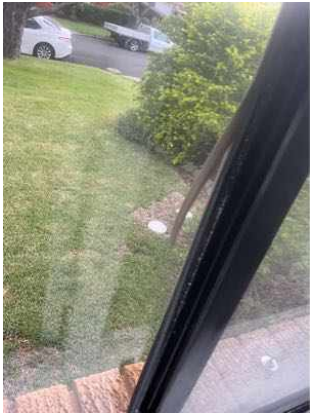
Finding 3.08

Building: Main Building
Location: Front Elevation
Finding: Beadings - damaged or deteriorated.
Information: Damaged or deteriorated beadings pose several risks. They compromise the integrity , allowing drafts, moisture, and even pests to enter the building. This can lead to energy loss, water damage, and decreased indoor air quality.

A qualified repair technician should be contacted to assess and repair the damaged or deteriorated beadings. They can replace worn-out beadings, and ensure it is properly installed and function to maintain energy efficiency and structural integrity.

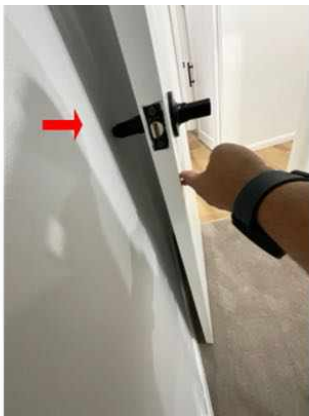
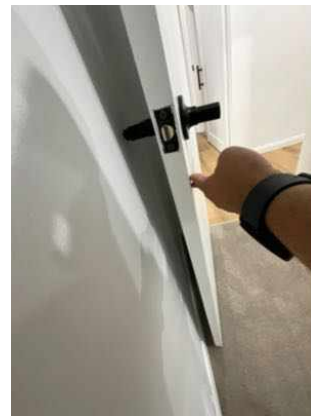
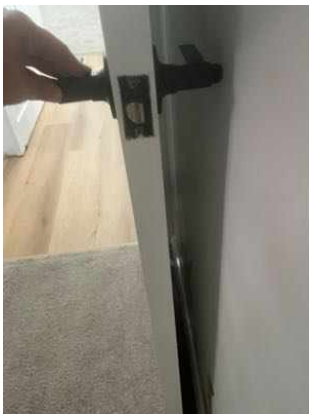
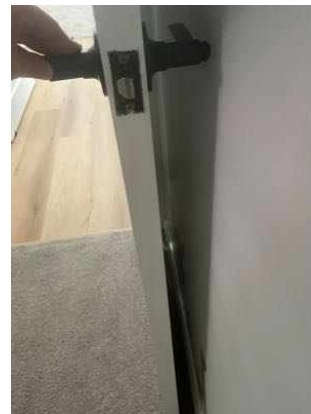
Finding 3.09

Building: Main Building
Location: All Areas
Finding: Missing Door Stopper
Information: The door lacks a stopper, which is essential to prevent the door from swinging too far and potentially damaging the wall or the door handle. The absence of a door stopper increases the likelihood of impact damage to both the door and surrounding surfaces

- **Damage Risk:** Moderate risk of damage to the door handle, wall, or door itself from repeated impacts when the door is opened forcefully or by a gust of wind.
- **Wear and Tear Risk:** Increased wear on door hardware and hinges due to the potential for abrupt stops without a dedicated stopper.

- **Engage a Handyperson or Carpenter:** A handyperson or carpenter should install a suitable door stopper to prevent excessive door movement. This could be a floor-mounted or wall-mounted stopper depending on the space and door design.

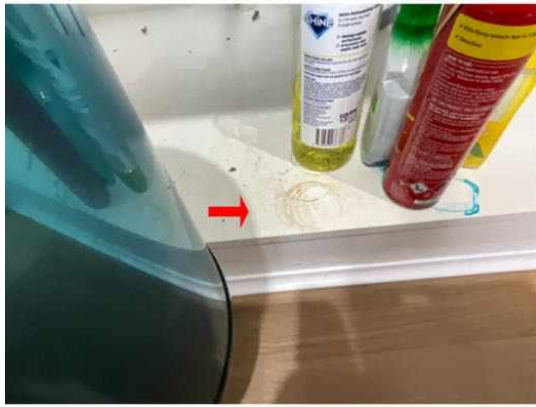
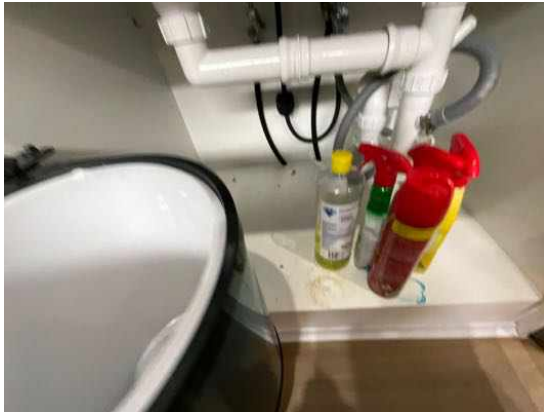
Finding 3.10

Building: Main Building
 Location: Kitchen
 Finding: Stains in Vanity

Description: The vanity surface exhibits general stains that may be due to water exposure, soap scum, cosmetics, or other substances. These stains are unsightly and may indicate ongoing maintenance issues.

- Clean the vanity using appropriate cleaning agents to remove stains.
- Inspect for any underlying issues, such as leaks or surface damage, and address them accordingly.
- Consider refinishing or replacing the vanity if stains are persistent and cannot be removed.

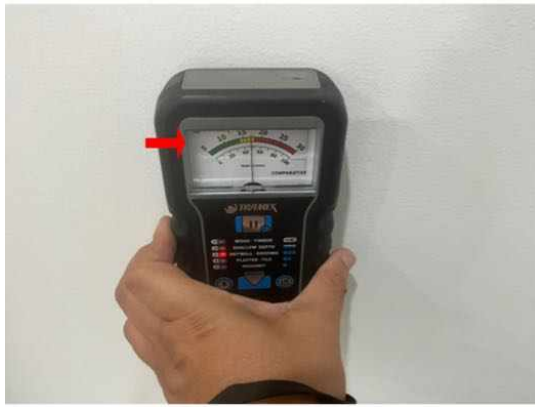
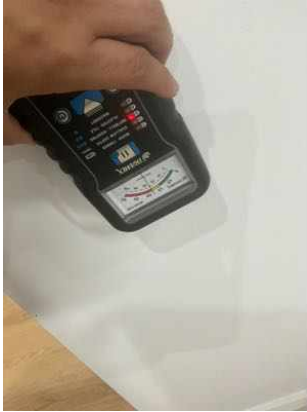
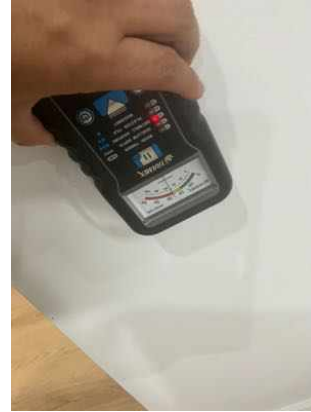
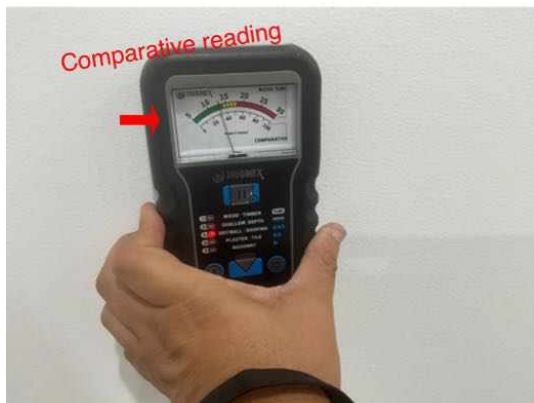
Finding 3.11

Building:	Main Building
Location:	Living Room
Finding:	Evidence of excessive moisture - Drywall
Information:	Excessive moisture is present at the time of , indicating a potential water leakage issue within the wall.

The prolonged presence of moisture can lead to mold growth, deteriorate the structure, and create an environment conducive to health hazards. Additionally, it may compromise the adhesive holding the tiles, leading to their detachment.

A licensed plumber or a qualified contractor specializing in water damage remediation should investigate the source of the moisture, fix any leaks, and address the damage. Additionally, replacing affected tiles and ensuring proper waterproofing are crucial to preventing future issues.

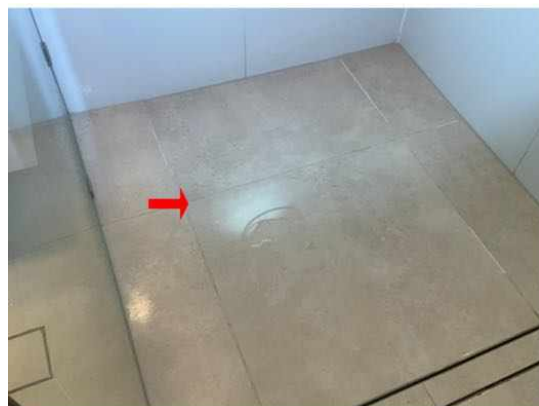
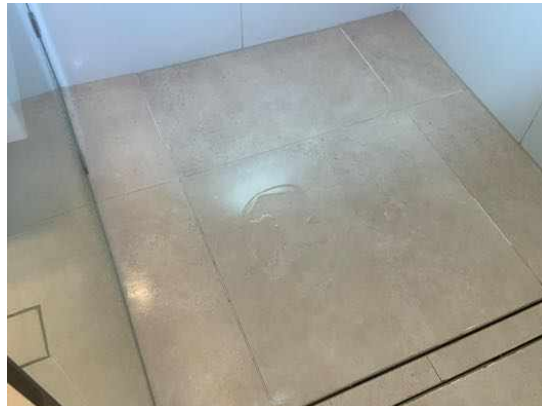
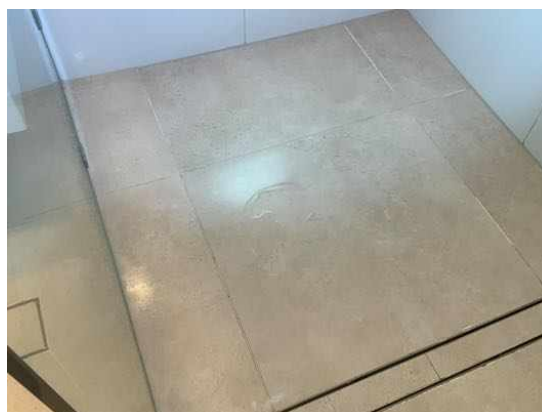
Finding 3.12

Building: Main Building
 Location: Bathroom
 Finding: Shower base - Water pooling
 Information: Evidence of water pooling around the floor waste in the shower recess was noticed at the time of inspection. It is suspected that this excessive moisture is attributed to insufficient fall in the shower floor tiles.

This pooling is minor overall but is still considered unsatisfactory, as standard tiling practices would not permit this situation to occur. Pooling water around floor wastes can create a slip hazard in extreme cases and create conditions that are conducive to mould growth over time. Where left unmanaged, the degradation of sealant and

grouting is also likely to occur, possibly necessitating further repair works.

Remedial works may involve some sections of tiling and flooring repair and replacement. A tiling contractor or bathroom specialist should be appointed to provide further advice on reparation options and to perform works as necessary.

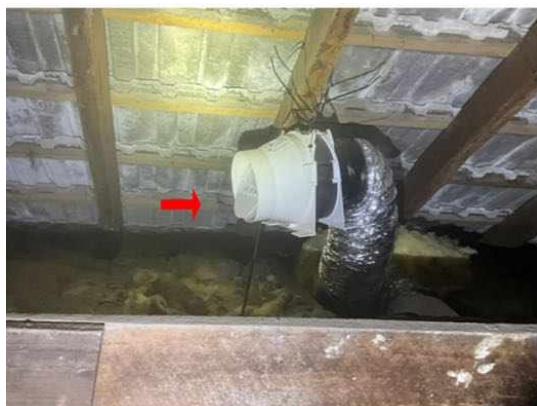
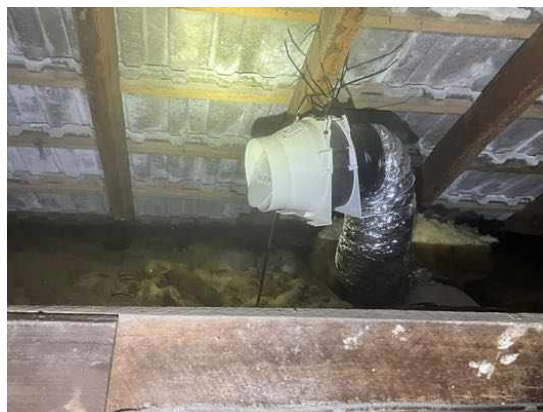
Finding 3.13

Building:	Main Building
Location:	Roof Void
Finding:	Exhaust fan not vented out
Information:	The exhaust fan located within the roof void is not appropriately ducted to the external atmosphere and is currently discharging moist air directly into the roof space. This is considered a defect under AS 4349.1, as it does not meet the minimum standard of residential building performance expected under normal residential building practices.

This condition may lead to excessive condensation within the roof void, increasing the risk of mould growth, deterioration of insulation, timber decay, and overall reduced durability of building elements. It may also result in poor indoor air quality, potentially affecting occupant health.

It is recommended that the exhaust fan be modified by a licensed HVAC contractor or qualified builder, ensuring it is properly ducted to discharge externally in accordance with manufacturer specifications, the National Construction Code (NCC), and applicable Australian Standards.

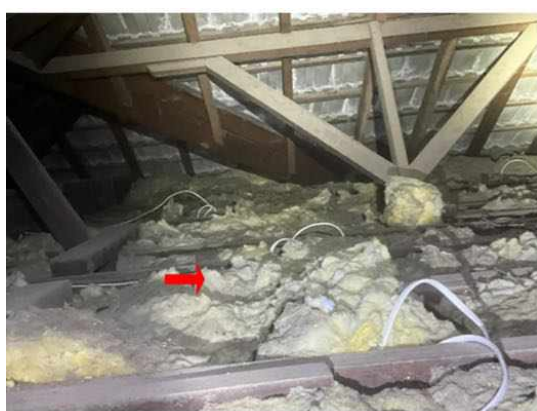
Finding 3.14

Building: Main Building
 Location: Roof Void
 Finding: Insulation - Covering downlights
 Information: Sections of insulation in the roof void have been poorly installed or moved from their original position and are covering down light fittings. While the down lights have been fitted with appropriate protective covers, the presence of this insulation creates a potential fire hazard.

Any insulation within the vicinity of down light fixtures should be moved and re-applied to more appropriate sections of the roof void, thus ensuring the area is fire-safe. An insulation contractor should be appointed as soon as possible to perform any necessary works as required.

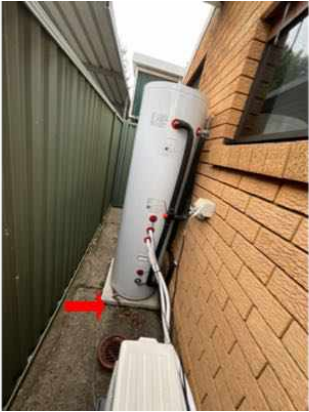
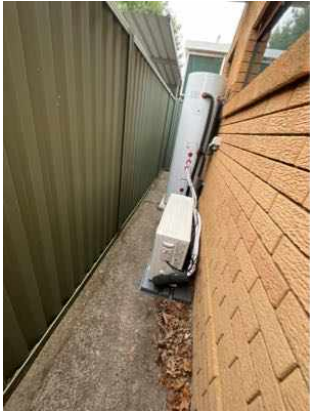
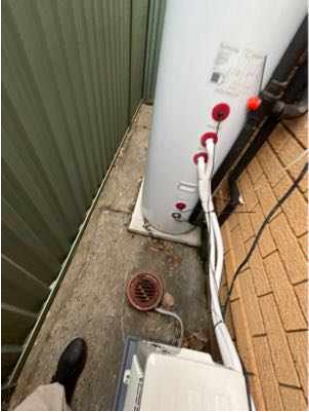
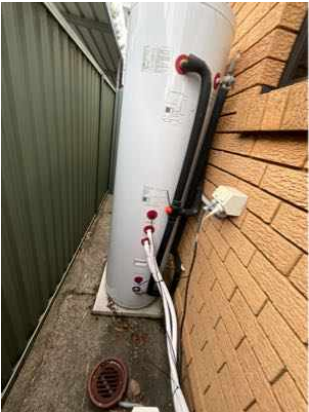
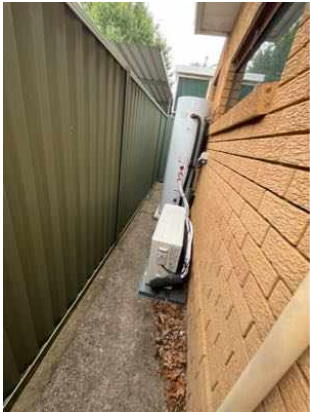
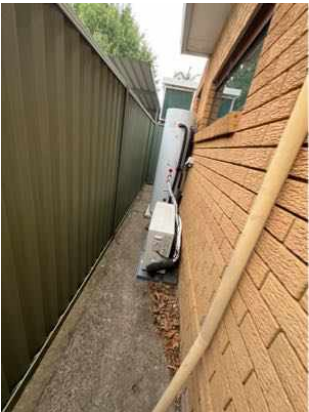
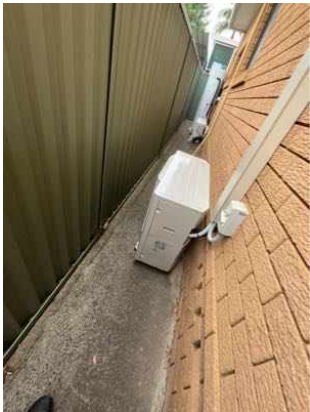
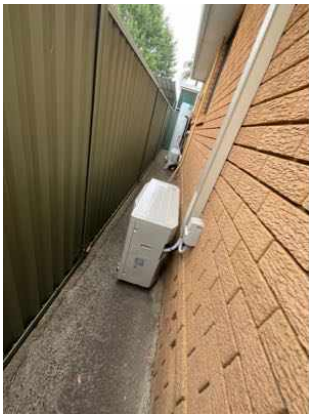
Finding 6.03

Building:	Main Building
Location:	All Areas
Finding:	Bridging or Obstruction Conducive environment for Termites
Information:	Bridging of termite barriers occurs when termites bridge (usually by building a mud tunnel) a termite barrier or inspection inspection zone or where termites have a passage, allowing them to bridge the barrier.

Where bridging has occurred full inspection is prevented and termites may enter a property in a concealed or undetected manner.

Recommended moving obstructions away from the external walls for further and future inspections.

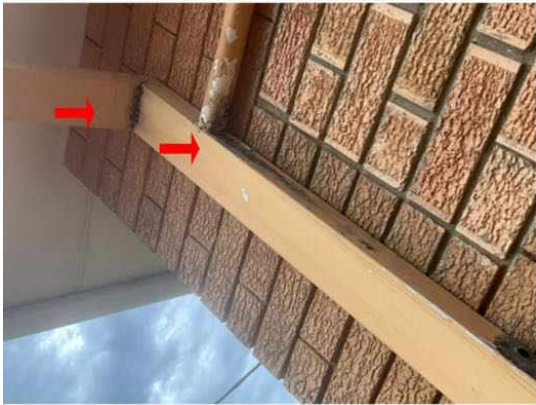
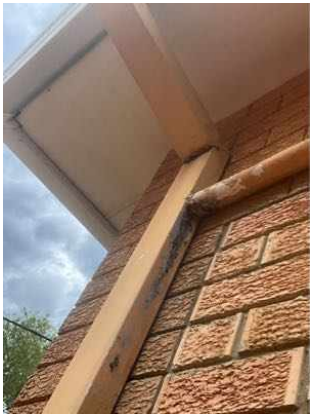
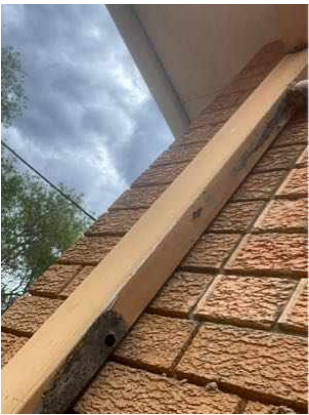
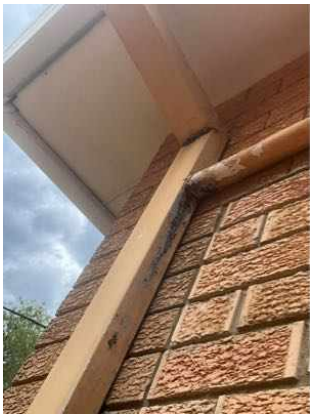
Finding 6.04

Building: Main Building
Location: Exterior walls - right side
Finding: Downpipes Rusty / leaking - Conductive conditions for Timber pest
Information: Rusty / leaking downpipes can indeed pose a risk for attracting termites, as they provide a source of moisture near a building's foundation. Termites are attracted to moisture and wood, so it's important to address this issue to prevent potential infestations. Connecting downpipes to the stormwater system or ensuring proper drainage away from the building can help mitigate this a licensed plumber is the most qualified professional to handle plumbing-related tasks, including connecting downpipes to the stormwater system. They have the necessary expertise and tools to ensure proper installation.

Please remember that proper installation is essential to ensure effective drainage and prevent future issues, so it's often best to hire a qualified professional, especially for complex or extensive downpipe installations.

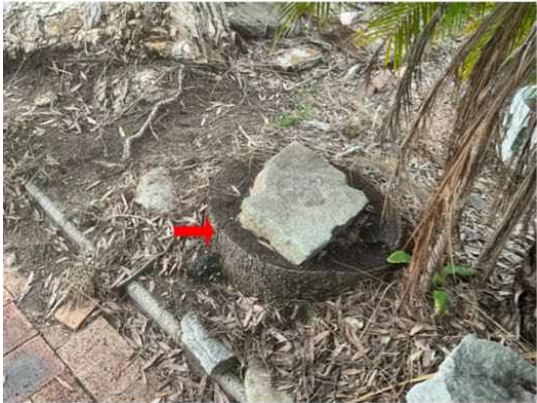
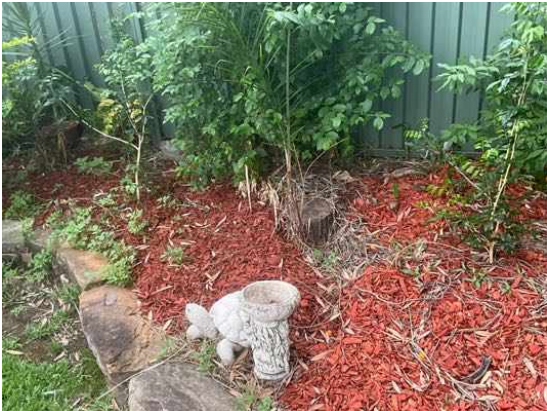
Finding 6.05

Building: Main Building
 Location: All Areas
 Finding: Cut and Exposed tree Stumps
 Information: The tree stump, which has been cut and exposed, poses a potential risk of termite infestation due to its increased vulnerability to termite attacks.

Please contact Licenced pest controller for further advice. Pictures attached for your reference.

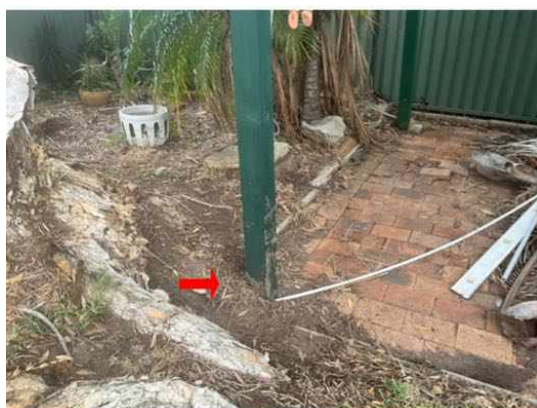
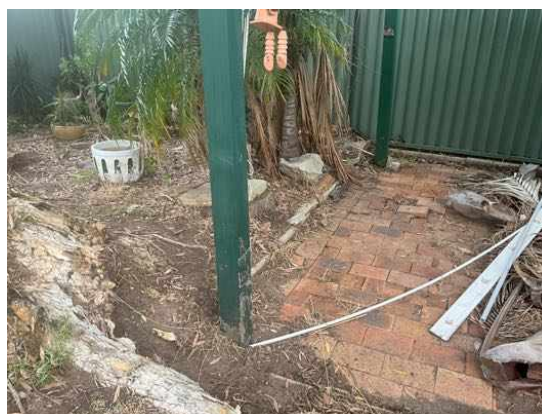
Finding 6.06

Building:	Main Building
Location:	All Areas
Finding:	Timber on ground / conducive conditions to termite damage
Information:	Timber on the ground is indeed conducive to termite damage. Termites are known to thrive in moist environments, and wood in contact with soil or moisture is more susceptible to infestation.

To prevent this, it's important to keep timber elevated and away from direct ground contact. Regular inspections and proper termite control measures are also essential to protect your wooden structures from termite damage.

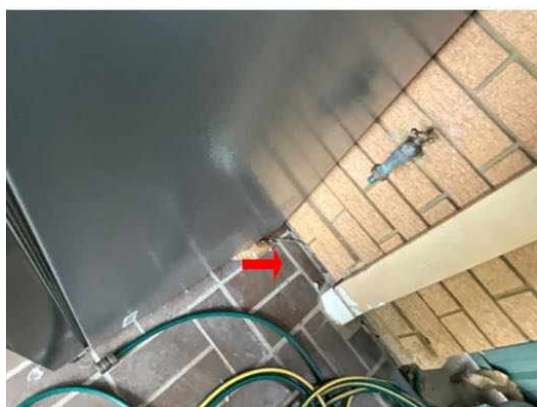
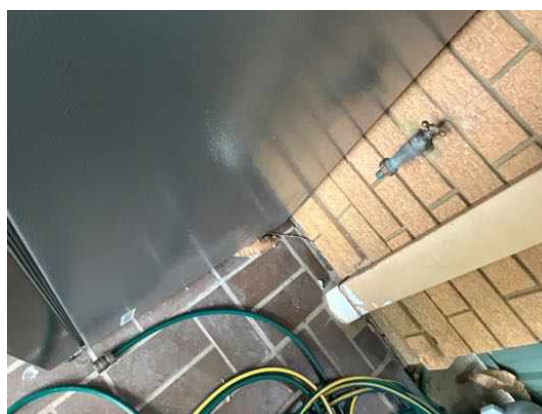
Finding 6.07

Building:	Main Building
Location:	Exterior walls - rear
Finding:	No Drain under tap
Information:	There is no drain installed under the tap, leading to water accumulation and creating conducive conditions for timber pests. This defect needs immediate attention to prevent potential damage and pest infestation.

1. Water Accumulation: Without proper drainage, water can accumulate around the base of the tap, leading to persistent dampness in the surrounding area.
2. Timber Pest Infestation: The damp environment created by standing water is highly conducive to timber pests, such as termites and wood borers, which thrive in moist conditions and can cause significant damage to wooden structures.
3. Structural Damage: Prolonged exposure to moisture can lead to wood rot and deterioration of structural timber, compromising the integrity of the building.
4. Health Hazards: Persistent dampness can also promote mold and mildew growth, posing health risks to occupants.

5. Aesthetic Damage: Water stains and damage to finishes and materials around the tap area can detract from the appearance of the building and lead to costly repairs.

A licensed plumber or a qualified building contractor can address this defect by:

1. Assessment: Evaluating the area to determine the best approach for installing a proper drainage system under the tap.
2. Installation: Installing a drain that effectively channels water away from the base of the tap, preventing water accumulation and dampness.
3. Repair and Prevention: Inspecting and repairing any existing water damage and implementing measures to prevent future water accumulation and pest infestations.

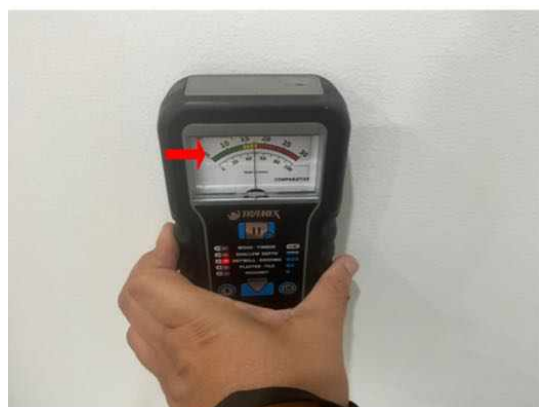
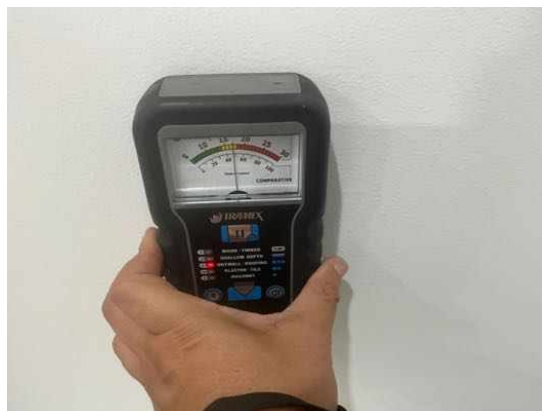
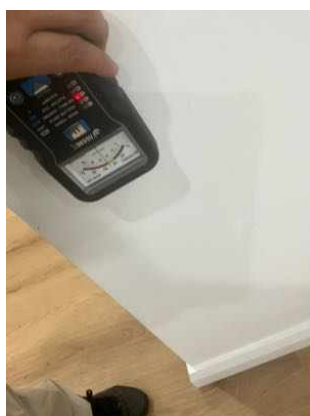
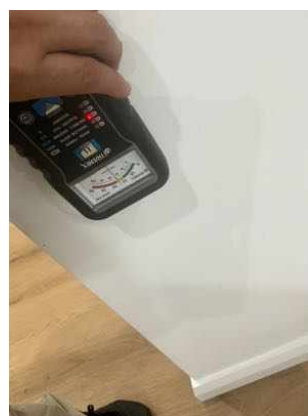
Finding 6.08

Building:	Main Building
Location:	Living Room
Finding:	Excessive moisture - Conducive to Timber pest
Information:	Excessive moisture can attract termites and produce conditions that promote fungal growth and wood decay.

Excessive moisture is generally caused by deteriorated inadequate or missing roof drainage leaking plumbing pipes or fixtures poorly plumbed HWS overflows or condenser units and poor site drainage.

If mould growth has been found there may be environmental biological or health issues involved. In these cases an appropriately qualified inspector should also be contacted.

Prior to any remedial works being performed a qualified plumber should be appointed to further inspect the property and to identify the cause of the excessive moisture. Works to remove affected building elements may then be necessary and should be performed by an appropriate tradesperson.

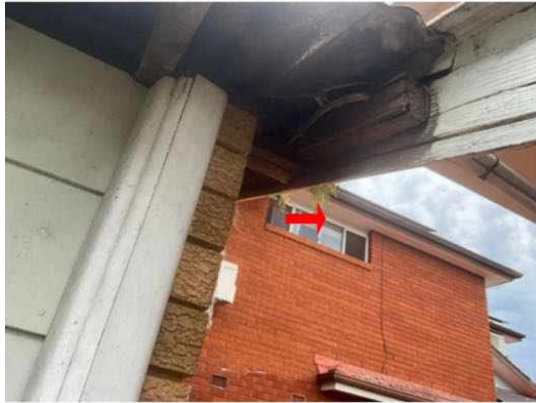
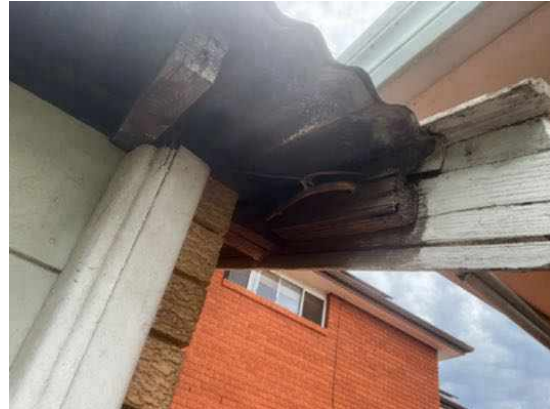
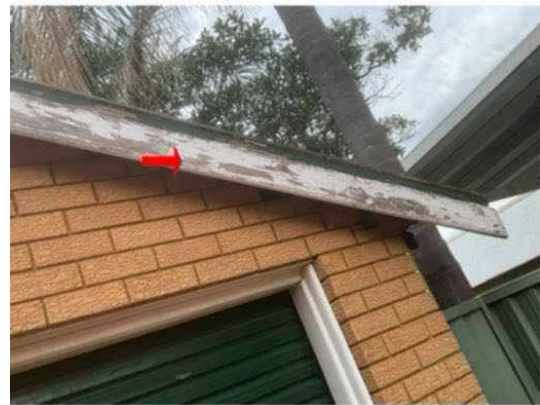
Finding 7.01

Building:	Main Building
Location:	All Areas
Finding:	Wood rot
Information:	This building element shows evidence of wood rot. Wood rot, also known as Fungal Decay, occurs when timbers and other cellulose building materials are exposed to damp conditions on an ongoing basis. This could be the result of exposure to weathering over a prolonged period of time, or the attraction of excessive moisture from other abutting building materials. Contributing factors also include poor air ventilation in the area.

Wood rot is often associated with general damp problems and is evidenced by a 'musty' smell or mould and mildew occurring on surfaces. If left unmanaged, damp conditions can lead to further health problems and the decay of timbers will continue.

Early intervention and regular maintenance, particularly of exterior timbers, will prolong the useful life of these building elements. Prior to any works being performed, the cause of the moisture that has created the visible wood rot should be identified and addressed in a suitable manner. Replacement of affected timbers may then be a necessary step in protecting surrounding building elements from such deterioration.

A qualified plumber may be appointed to assess the cause of excessive moisture and to provide advice on any remedial works as required. A qualified carpenter or registered builder may also be required to replace affected building materials.
