Building and Timber Pest Inspection Report

Inspection Date: Tue, 10 Feb 2026

Property Address: 7 Downshire Parade, CHESTER HILL, NSW, 2162, Australia

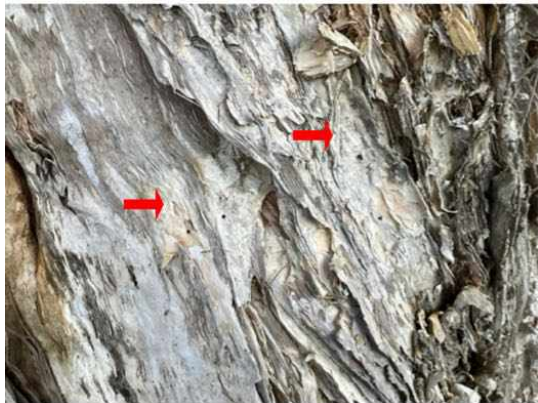
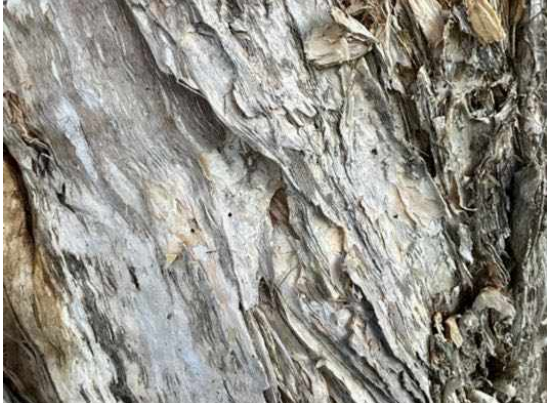
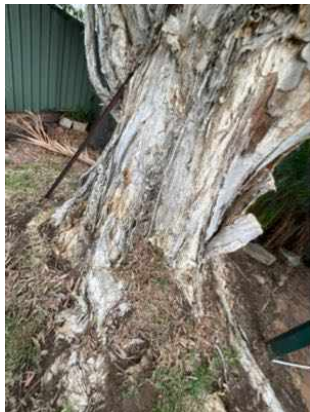
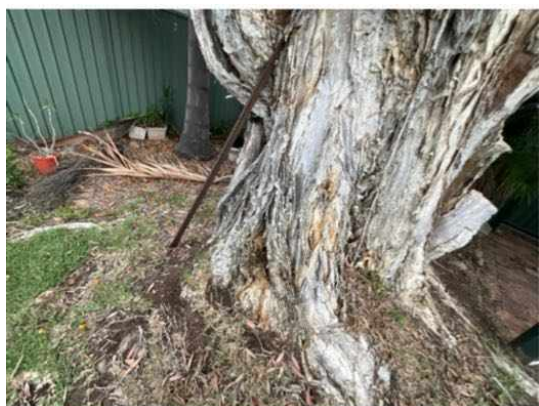
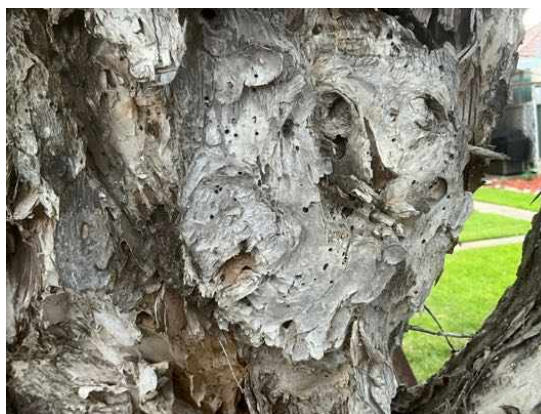
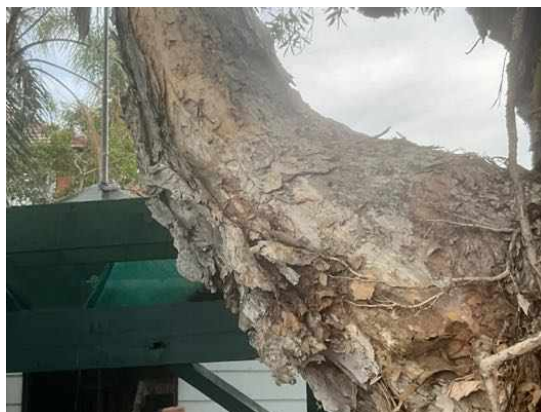
Finding 7.02

Building:	Main Building
Location:	Yard - Back
Finding:	Wood Borer Activity - Trees
Information:	Numerous small to medium-sized exit holes and surface tunnelling marks were noted along the trunk and branches of a dead standing tree. The pattern and shape of the damage are consistent with wood borer infestation. No live activity was observed at the time of inspection, though damage is clearly evident.

- The tree maybe structurally compromised and may pose a fall or safety hazard, especially during wind events.
- Proximity to structures or power lines may increase the risk of damage or injury.
- Although native borers are not typically a threat to treated structural timbers, their presence indicates decay and weakened wood that could attract secondary pests.

Recommendation:

- Engage a qualified arborist to assess the structural integrity of the tree and arrange for safe removal if required.

- If the tree is within falling distance of a building, fence, or utility infrastructure, urgent removal is recommended.
- Regular site monitoring is advised for surrounding trees to detect any early signs of similar pest activity.

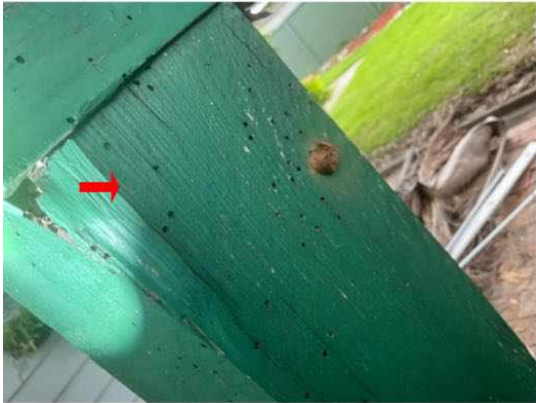
Finding 8.01

Building:	Main Building
Location:	Pergola
Finding:	Evidence of wood borer activity identified
Information:	Wood borers small beetles that colonise in exposed timber elements are a common timber pest that are regularly mistaken for termites. Although wood borer activity is generally not detrimental to the affected timber they may lead to serious damage and necessitate replacement of certain building elements if left unattended.

As no live wood borer activity was identified treatment is not required at this time. Replacement of affected timbers may be considered by the client for superficial reasons.

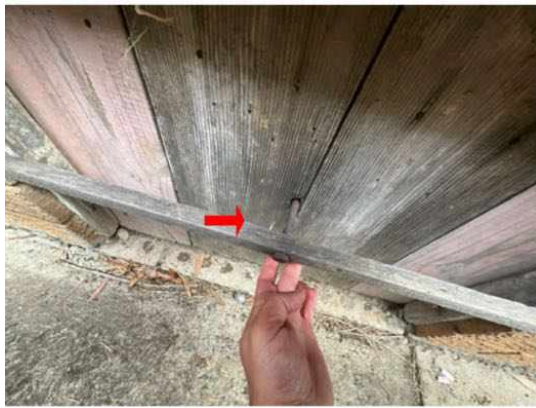
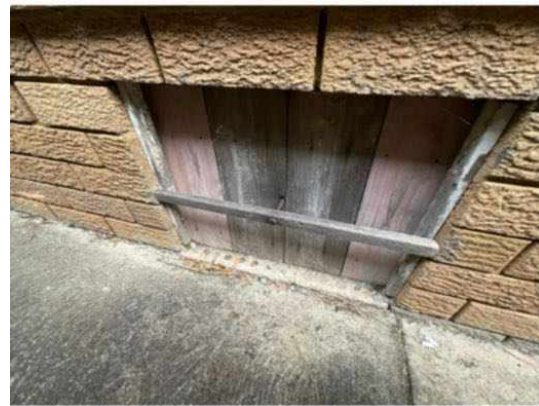
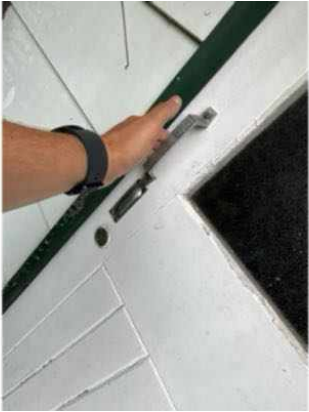
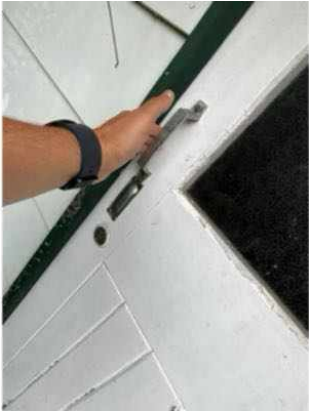
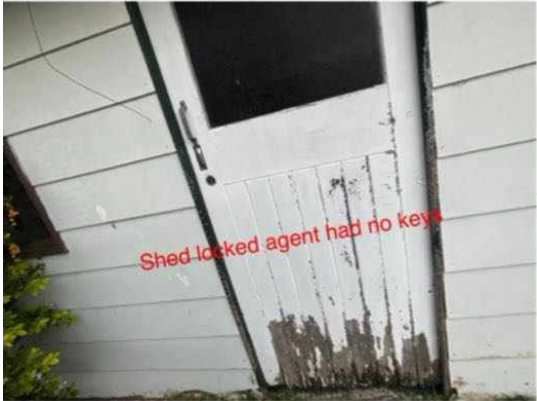
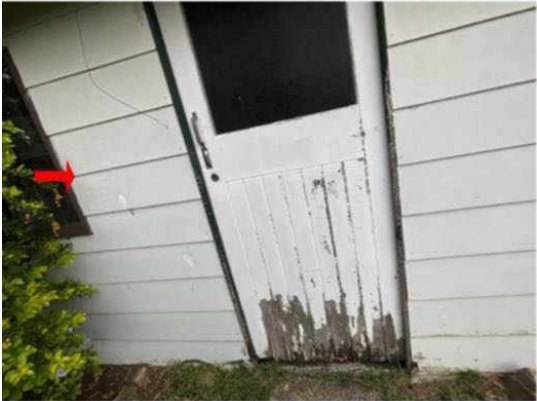
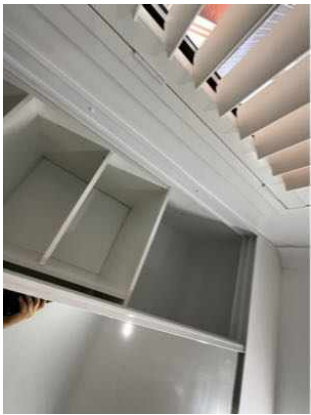
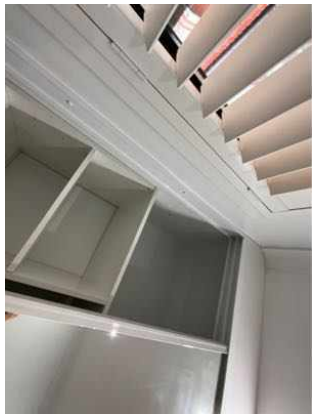
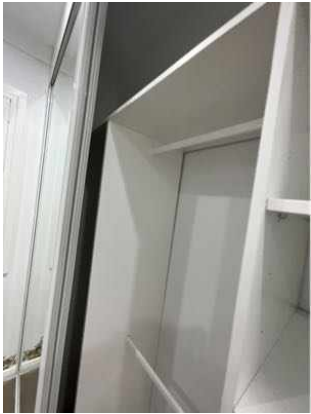
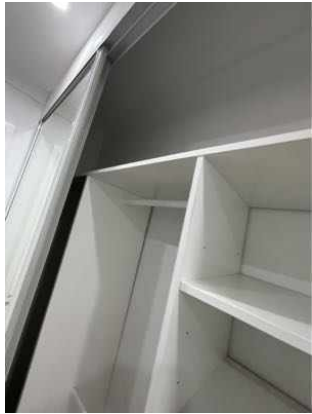
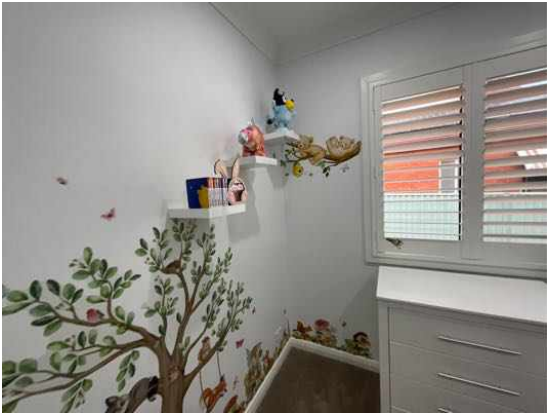
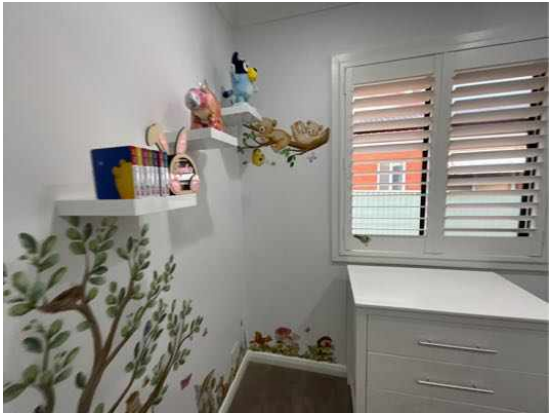
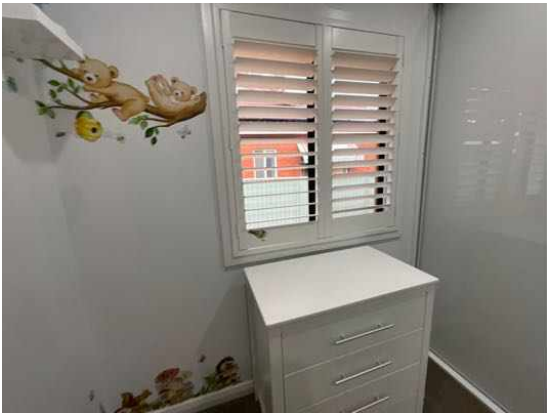
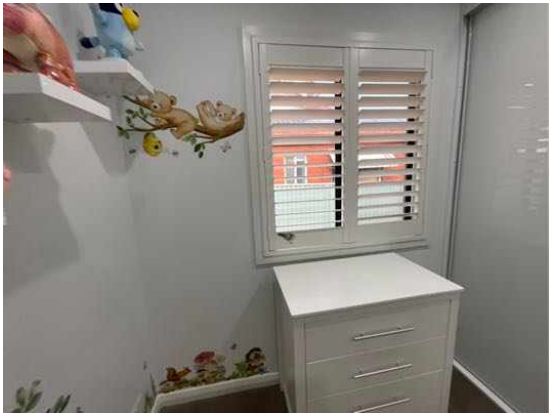
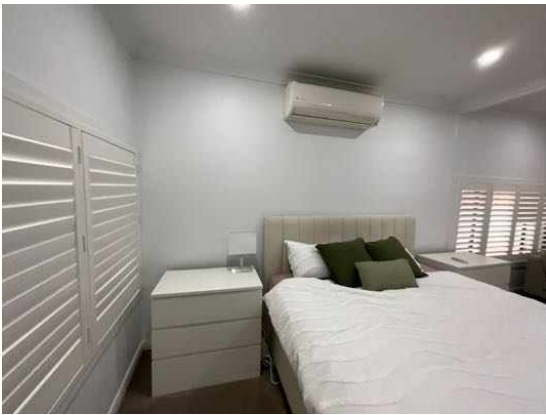
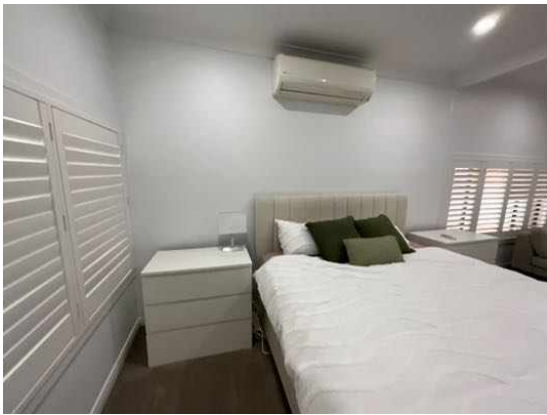
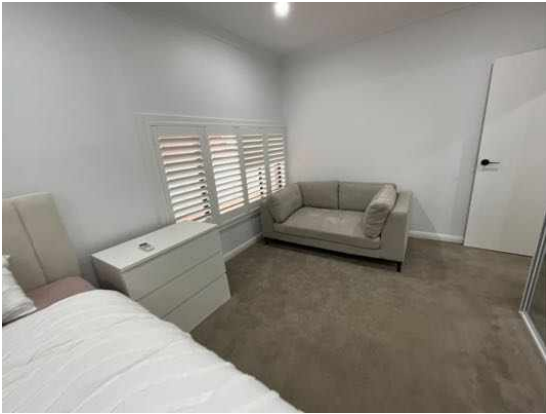
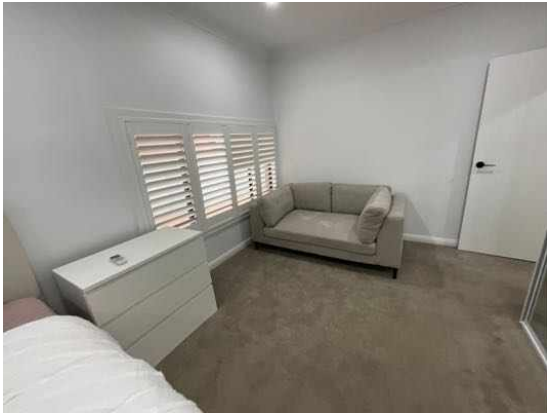
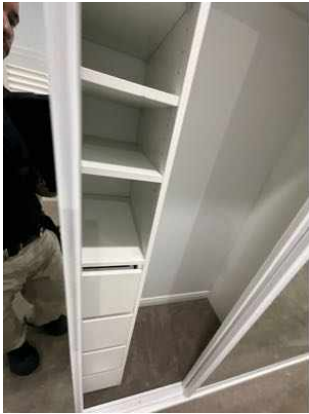
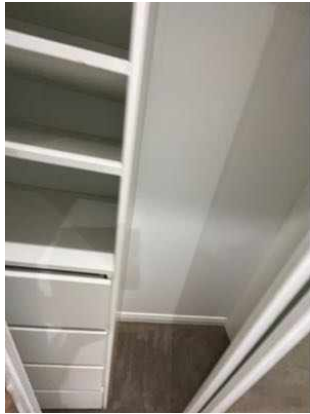
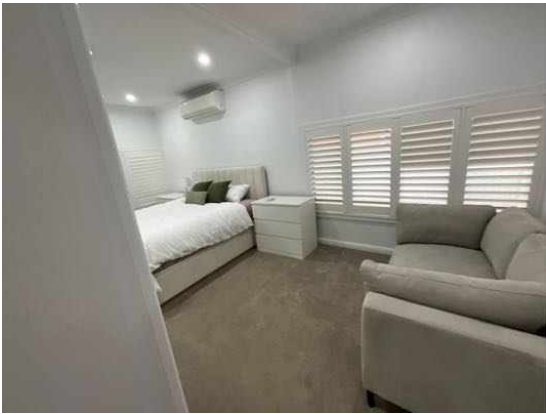
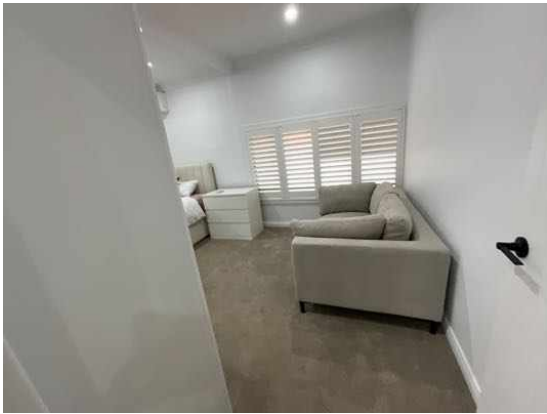
Building: Main Building
Location: All Areas
Finding: Additional Photos - Obstructions and Limitations
Information: These photographs are an indication of the obstructions and limitations which impeded full inspection of the property at the time of inspection. These obstructions can hide an array of defects and should be removed to allow full inspection to be carried out. A re-inspection is recommended once the areas are made accessible.
