# Building and Timber Pest Inspection Report VR

Inspection Date: Thu, 12 Mar 2026

Property Address: 63 Breimba St, Grafton NSW 2460,  
Australia

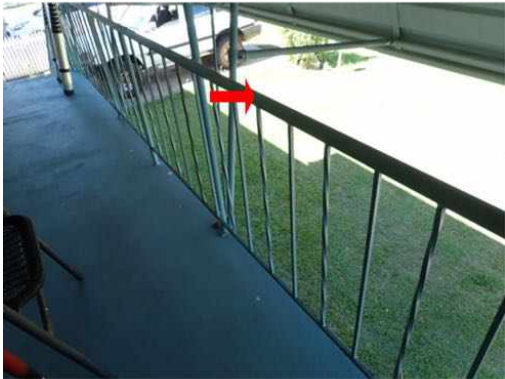
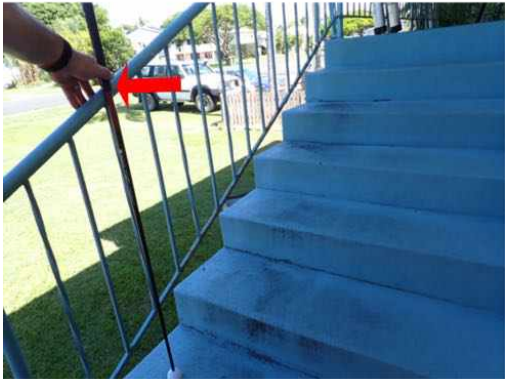
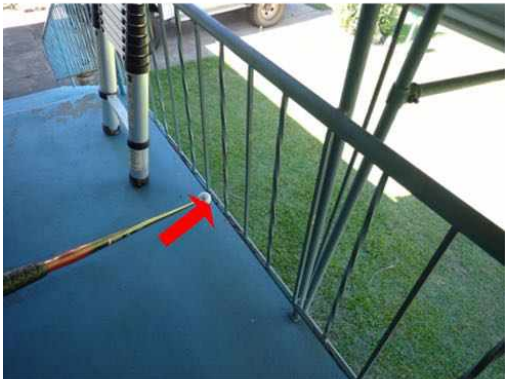
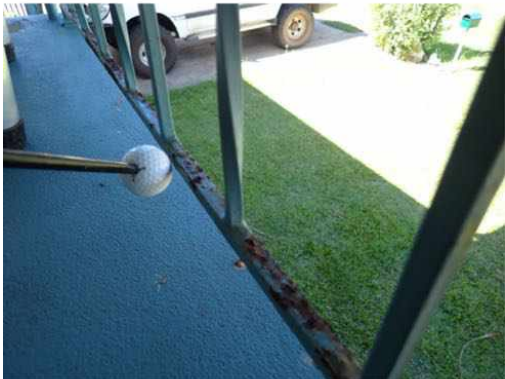
Building:	Main Building
Location:	Front balcony
Finding:	Front Balcony – Balustrade Height
Information:	The steel balustrade to the front balcony appears lower than current safety standards. In plain English, the height of the balcony railing may not meet today's building requirements, which commonly occurs with older properties constructed to earlier standards. A suitably qualified builder or metal fabricator should assess the balustrade and carry out any upgrades if considered necessary to improve safety.

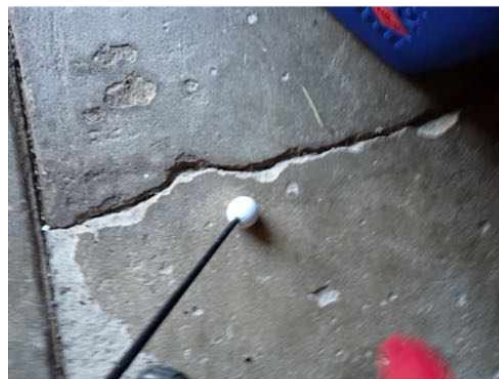
Building:	Main Building
Location:	Garage
Finding:	Garage Concrete Slab – Large Cracks

Information: Large cracks were identified in the garage concrete slab at the time of inspection. In plain English, significant cracking was noted in the concrete floor which may be caused by ground movement or structural stress. This is a common defect with properties of this age and location. A suitably qualified concreter or builder should assess the slab and carry out rectification works as required. A structural engineer may also need to be consulted.

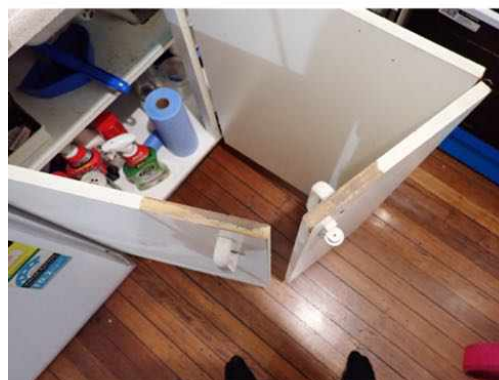
Information: The kitchen was found to be in fair condition at the time of inspection with age-related defects noted, including damaged edge tape to cabinetry and deteriorated silicone to junctions. In plain English, the kitchen appears functional but shows general wear and deterioration consistent with a property of this age. Maintenance or minor repairs may be carried out at the owner’s discretion. A cabinet maker or suitably experienced handyman would be the appropriate trade to carry out any repairs if required.

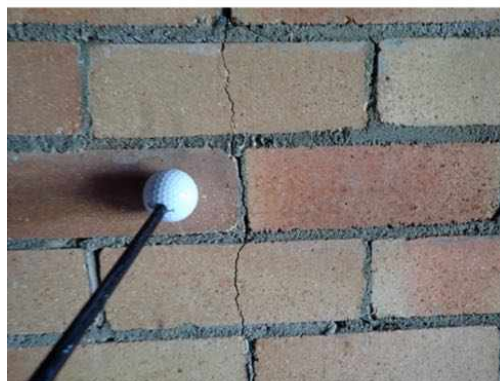
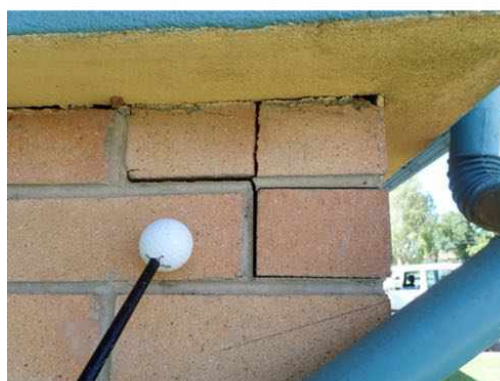
Building:	Main Building
Location:	Below front concrete porch area.
Finding:	Brickwork Below Front Porch – Minor Cracks
Information:	Minor cracks were identified in the brickwork below the front concrete porch area at the time of inspection. In plain English, small cracks were noted in the brickwork which can occur due to normal movement and age of the structure. This is a common defect with properties of this age. The area should be monitored for any signs of further movement. If the cracks increase in size, a suitably qualified builder or bricklayer

should be contacted to assess and carry out repairs as required.

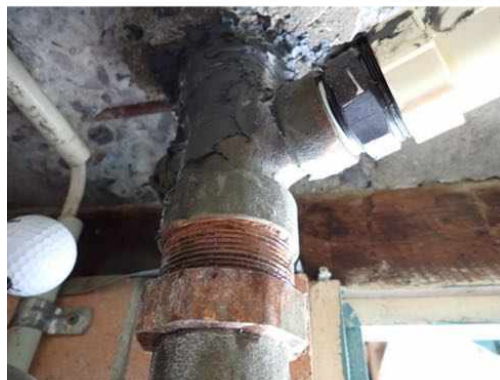
Building:	Main Building
Location:	Laundry
Finding:	Bathroom Plumbing – Minor Leak
Information:	A minor leak was identified to the plumbing below the bathroom within the laundry area at the time of inspection. In plain English, a small amount of water was observed leaking from plumbing pipes servicing the bathroom. This is a common defect with plumbing of this age. A licensed plumber should assess the plumbing and carry out repairs to prevent further damage or deterioration.

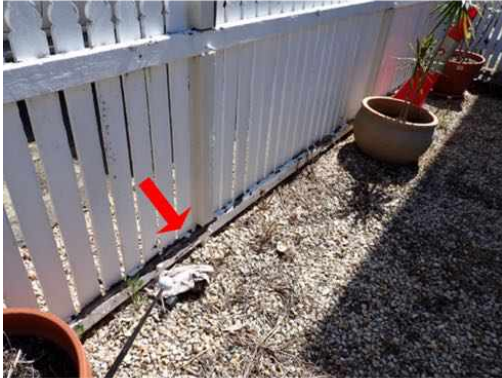
### Finding 7.02

Building:	Main Building
Location:	Right hand side fence
Finding:	Right Hand Side Fence – Wood Rot
Information:	Wood rot was identified to sections of the timber fence on the right-hand side of the property at the time of inspection. In plain English, parts of the fence timber have started to decay due to age and weather exposure. Wood rot is also conducive to termite attack. Repairs or replacement of the affected sections may be required. A fencing contractor, carpenter, or suitably experienced handyman would be the appropriate trade to carry out the works.
