Building and Timber Pest Inspection Report

Inspection Date: Thu, 12 Mar 2026

Property Address: 66 Minnamurra St, Kiama NSW 2533, Australia

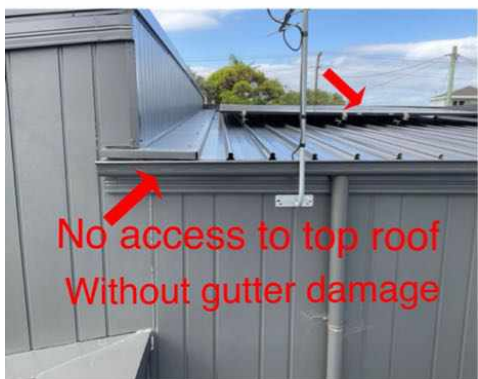
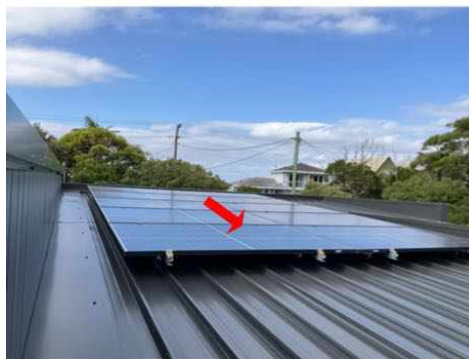
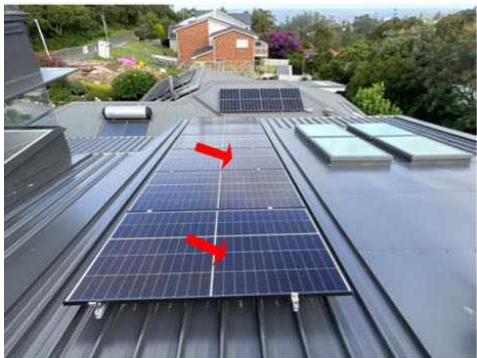
Building: Building 1
Location: All External Areas
Finding: Additional Photos - Obstructions and Limitations of EXTERNAL AREAS
Information: These photographs are an indication of the obstructions and limitations which impeded full inspection of external areas at the time of inspection. These obstructions can hide an array of defects and should be removed to allow full inspection to be carried out. A re-inspection is recommended once the areas are made accessible.

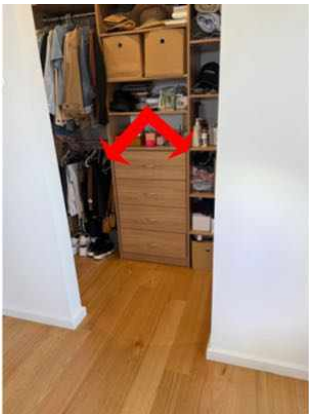
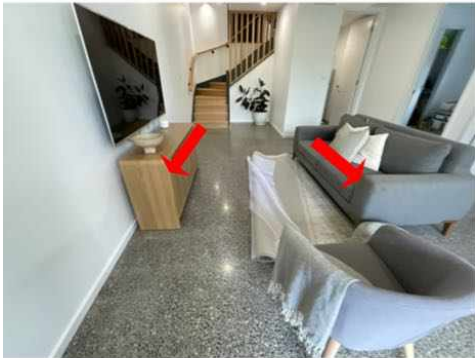
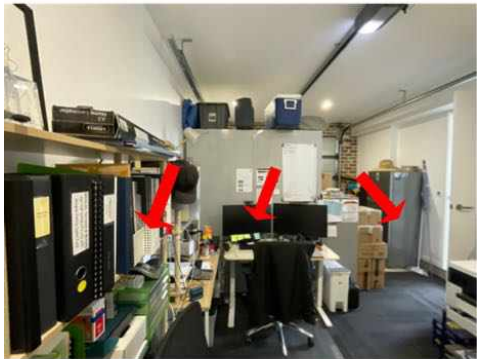
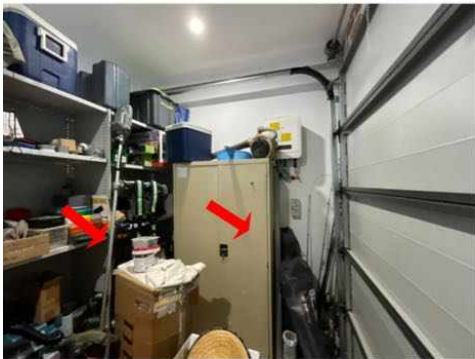
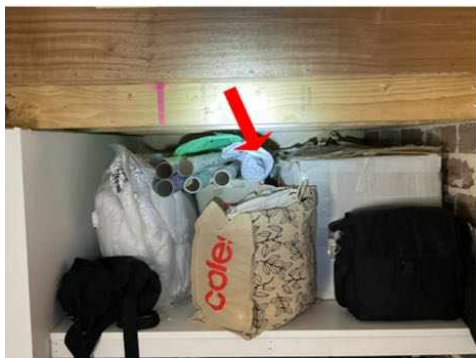
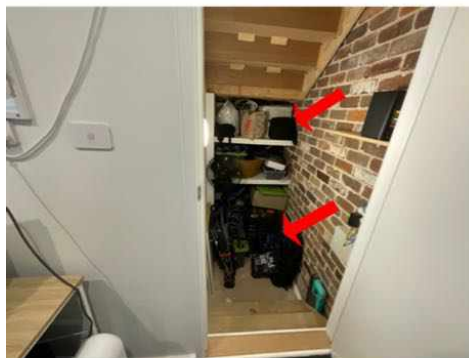
Building: Building 1
Location: All Internal Areas
Finding: Additional Photos - Obstructions and Limitations of INTERNAL AREAS
Information: These photographs are an indication of the obstructions and limitations which impeded full inspection of Internal areas at the time of inspection. These obstructions can hide an array of defects and should be removed to allow full inspection to be carried out. A re-inspection is recommended once the areas are made accessible.

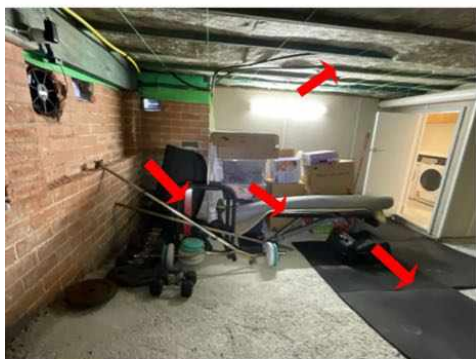
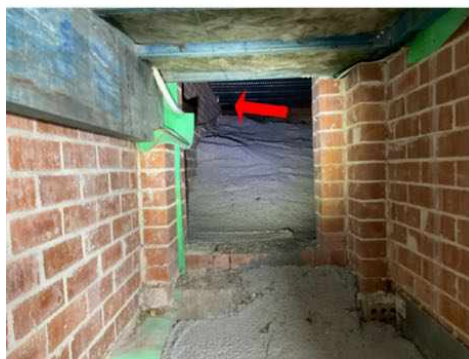
Building: Building 1
 Location: All Subfloor Areas
 Finding: Additional Photos - Obstructions and Limitations of SUBFLOOR AREAS
 Information: These photographs are an indication of the obstructions and limitations which impeded full inspection of subfloor areas at the time of inspection. These obstructions can hide an array of defects and should be removed to allow full inspection to be carried out. A re-inspection is recommended once the areas are made accessible.

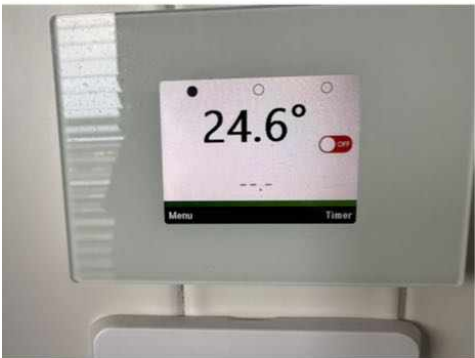
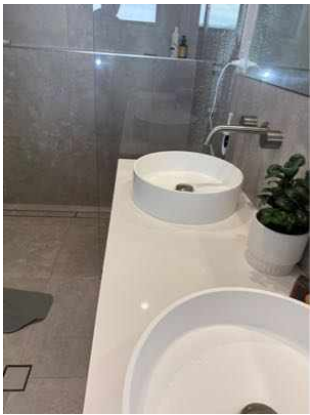
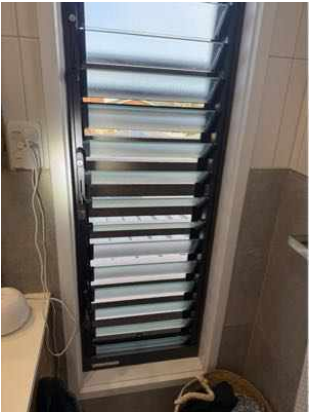
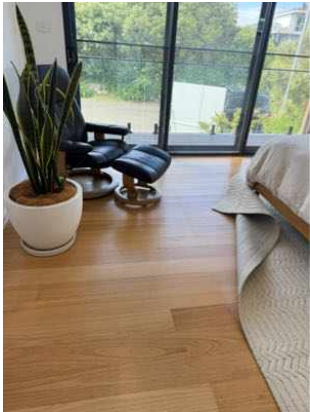
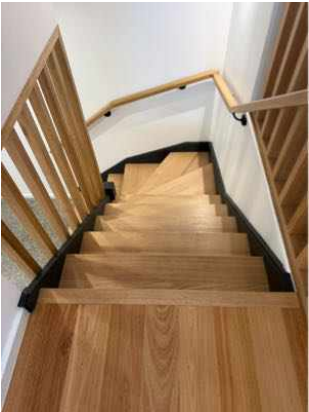
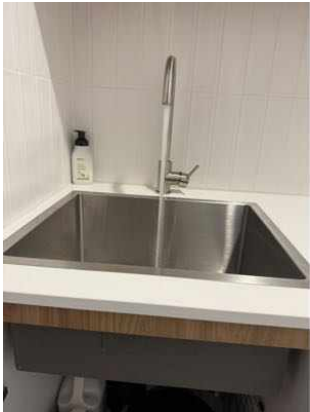
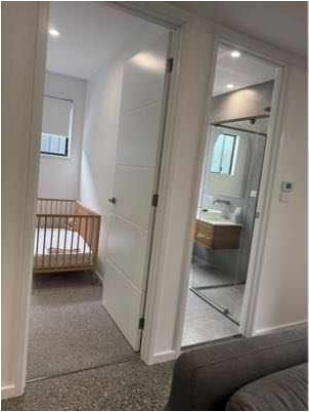
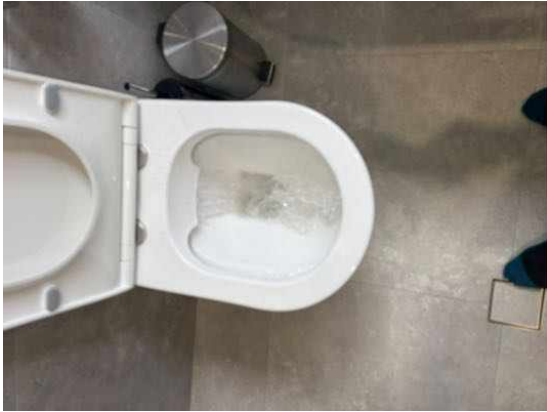
Building: Building 1
Location: All Internal Areas
Finding: Additional Photos
Information: Additional photos are provided for your general reference

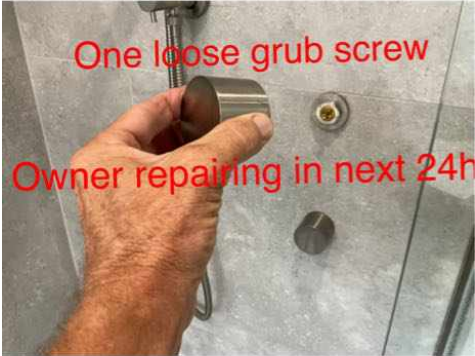
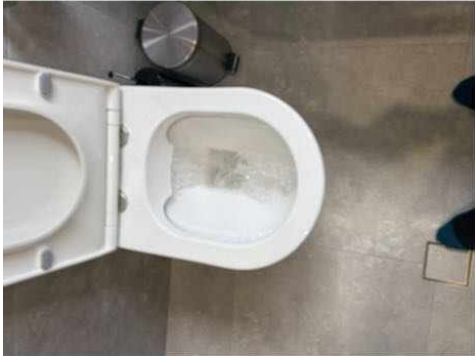
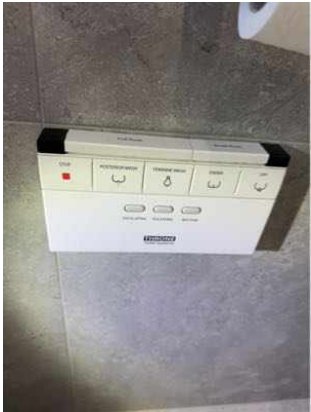
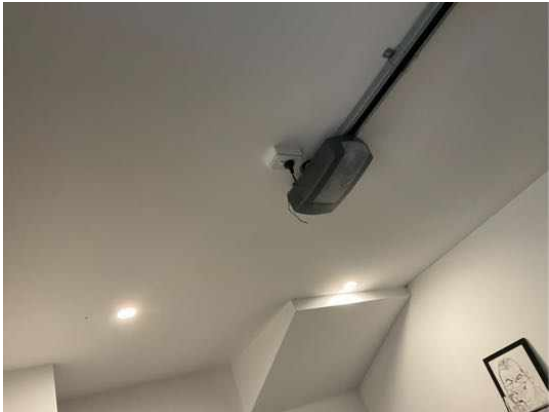
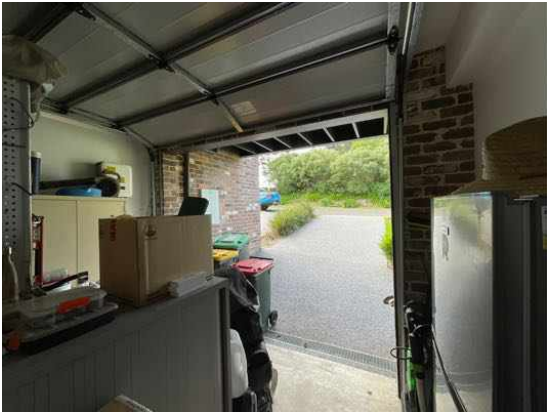
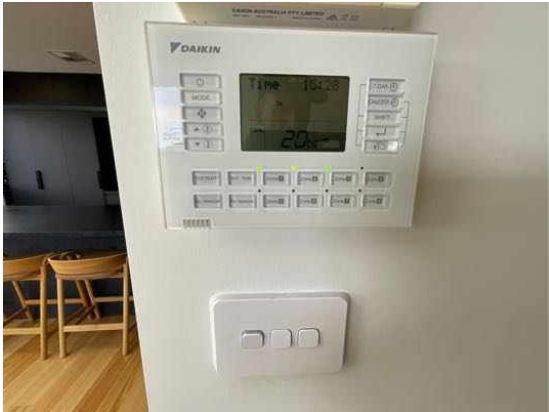
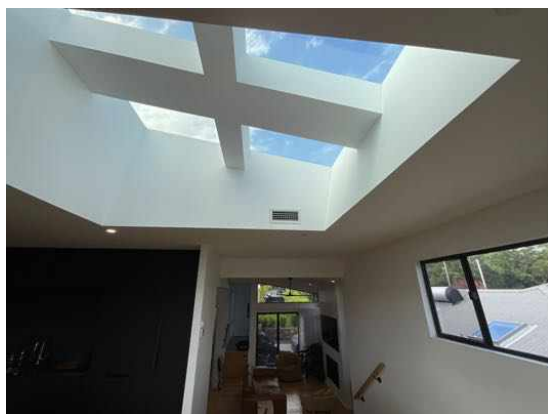
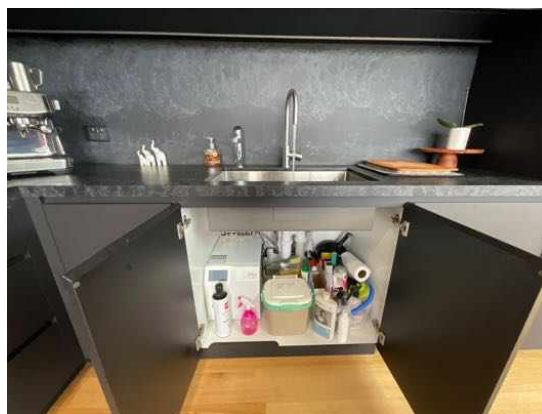
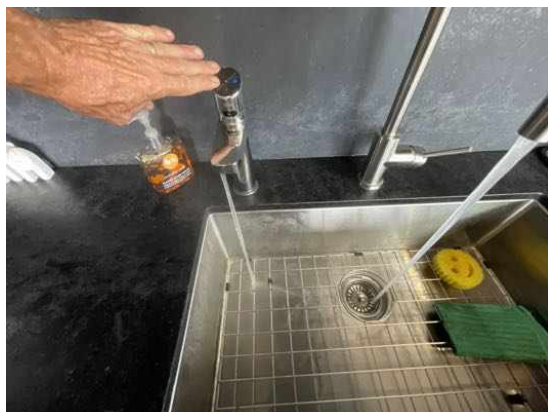
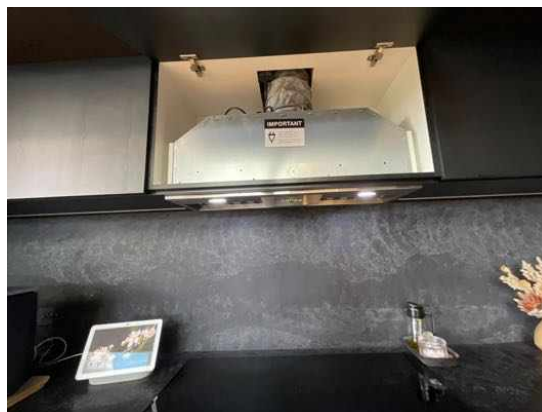
Building: Building 1
Location: All Internal Areas
Finding: Additional Photos
Information: Additional photos are provided for your general reference

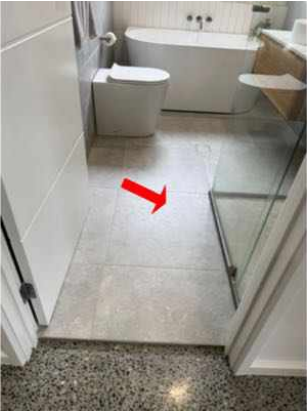
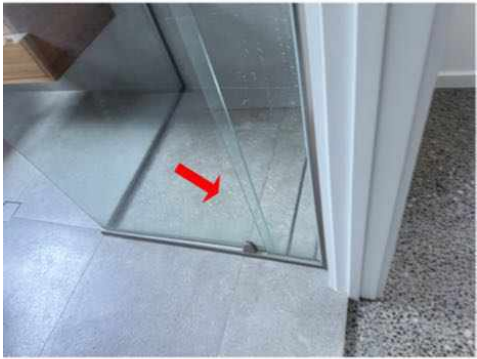
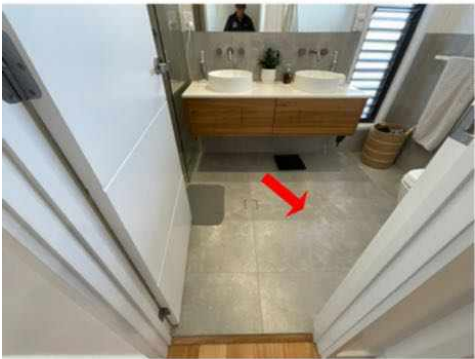
Building: Building 1
 Location: Bathrooms and laundry
 Finding: Waterproofing membranes - Information Only
 Information: Internal Water Proofing Membranes, are crucial in preventing water ingress into the property is important to know that the Membrane System used is to Australian Standards and has been installed correctly.

With older property's where this information is unavailable all wet areas should be monitored. If any leaks, water staining, peeling or bubbling of the paint become evident to any adjacent walls or ceilings below a licensed builder or waterproofing specialist is recommended to investigate further.
