Building and Timber Pest Inspection Report

Inspection Date: Wed, 8 Apr 2026

Property Address: 6 Harrower Place, Glenmore Park NSW
2745

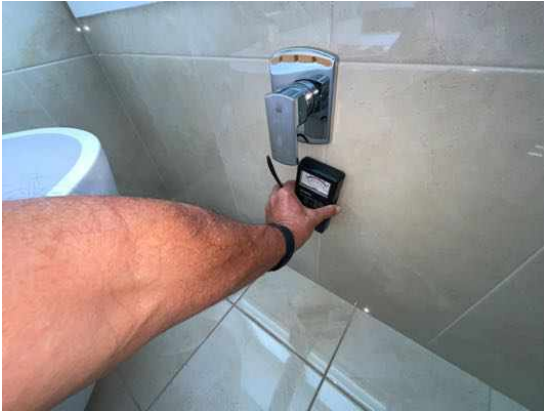
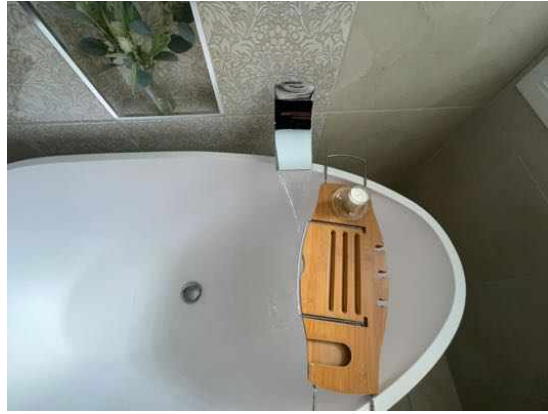
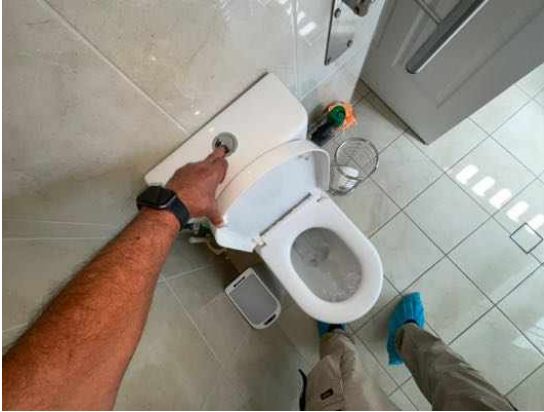
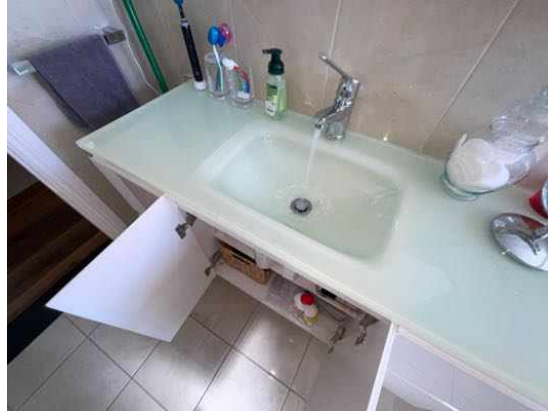
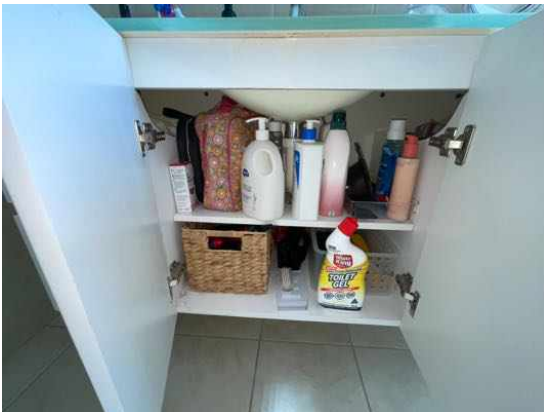
Building: Main Building
Location: Ensuite
Finding: Wet Areas - Bathroom(s) - Overall Condition & Recommendations.
Information: Overall Condition & Recommendations

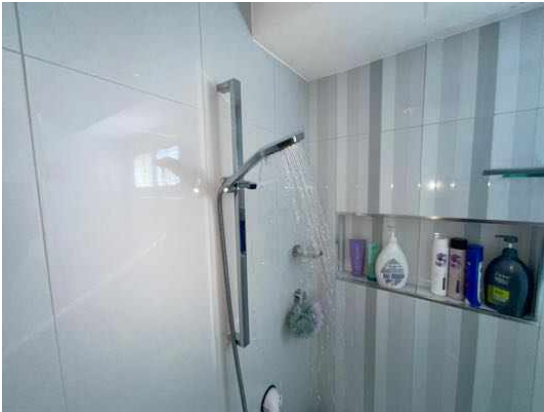
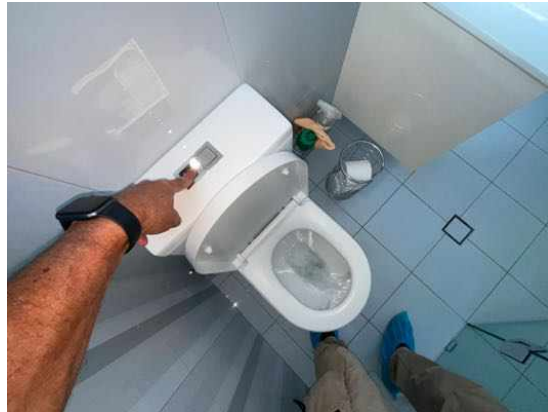
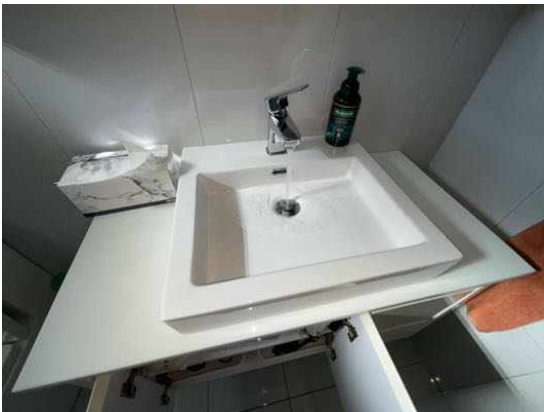
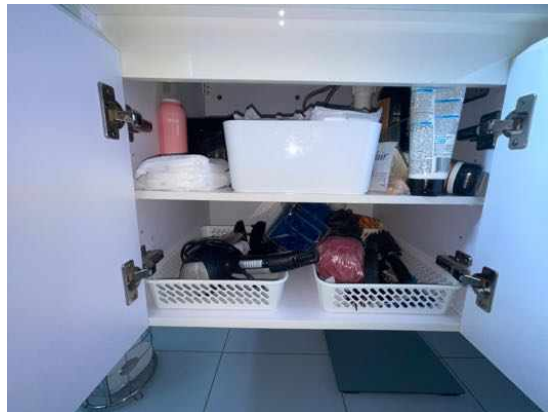
Building: Main Building
 Location: All Areas
 Finding: Water Pressure – Observation Only.
 Information: During the inspection, water pressure appeared to be within a normal operating range based on a basic functional check. However, this observation was made without the use of pressure testing equipment and does not constitute an assessment by a licensed plumber.
