Building and Timber Pest Inspection Report

Inspection Date: Wed, 8 Apr 2026

Property Address: 24 Hornseywood Ave, Penrith NSW 2750,
Australia

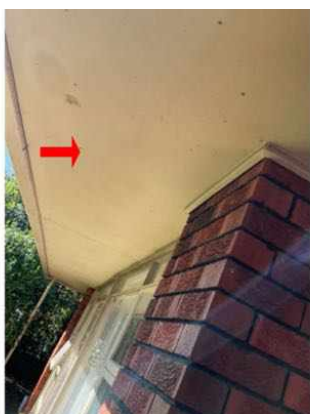
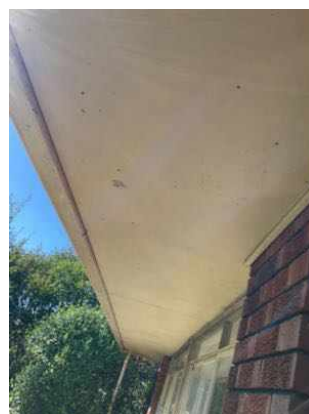
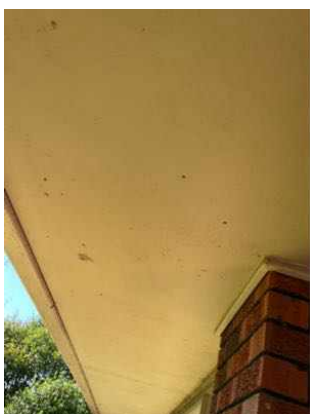
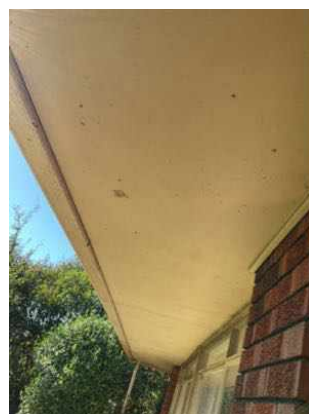
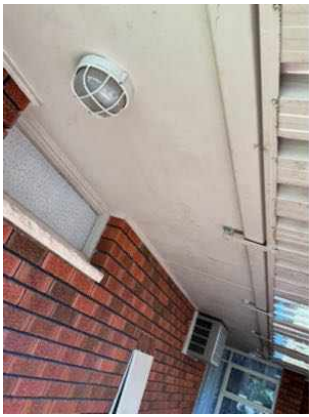
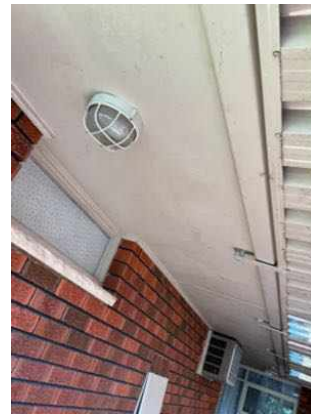
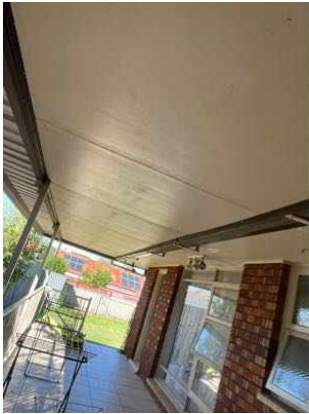
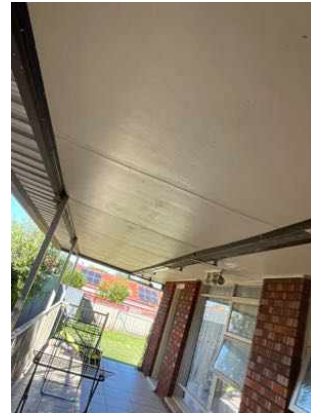
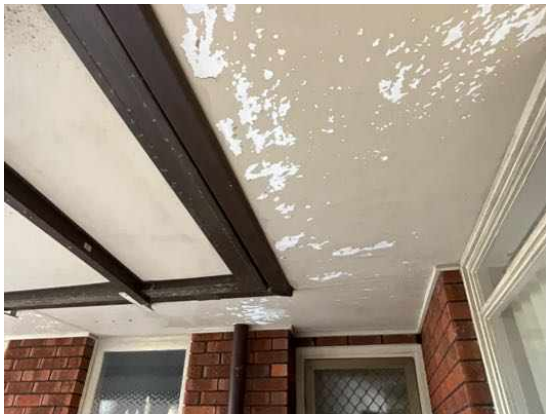
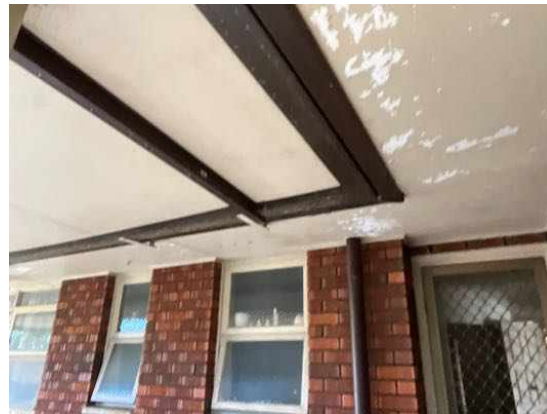
Building:	Main Building
Location:	All Areas
Finding:	Asbestos - Suspected ACM Identified on Site
Information:	Reporting on Asbestos is outside the Scope of this Report. This suspected defect is highlighted as a caution only. We suspect, based on our experience in the building industry, that there is a higher risk of the identified building element containing asbestos.

As Asbestos Reporting is outside the scope of this report, we advise that you consider a separate Asbestos Inspection and Condition Audit, which can include the taking of samples for definitive confirmation of the presence of Asbestos.

In the interim, the client is advised to act with caution, especially when considering any damage to building materials general wear and tear renovations extensions demolition and general maintenance activities due to the suspected presence of Asbestos.

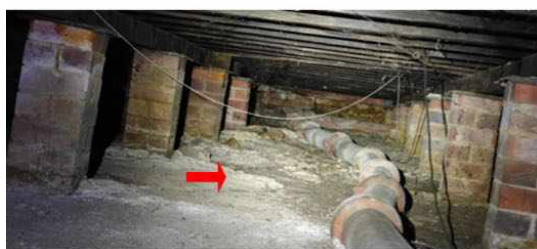
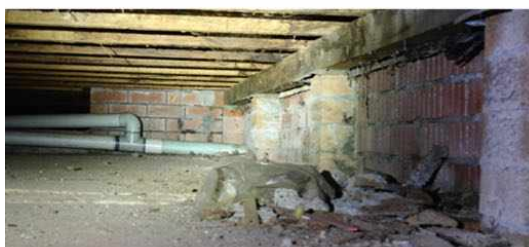
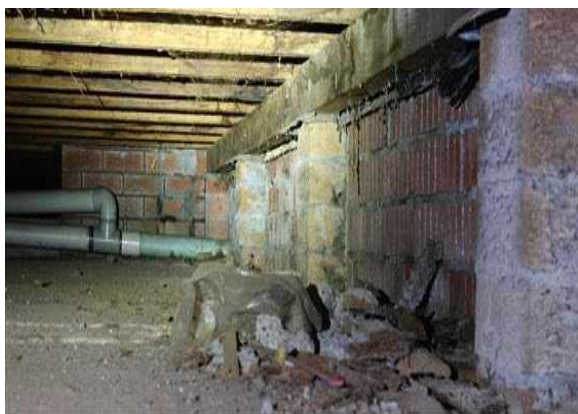
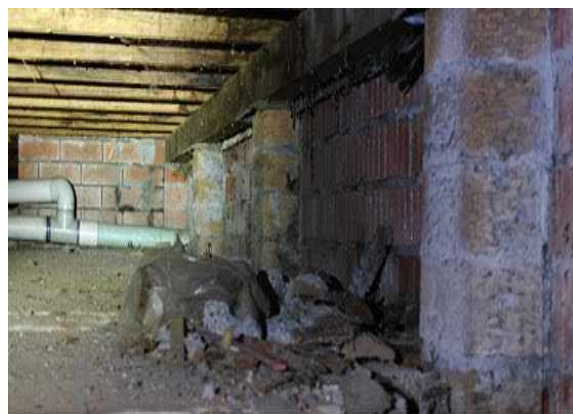
Finding 1.02

Building: Main Building
 Location: Subfloor
 Finding: Mould - Present
 Information: Mold growth is present throughout the property, primarily due to inadequate ventilation. Poor airflow and moisture accumulation within the house have created ideal conditions for mold to thrive.

A licensed mold remediation specialist should be engaged to remove the mold and treat affected areas. In addition, a ventilation expert or builder should assess and improve the house's ventilation system, possibly installing exhaust fans, vents, or mechanical ventilation systems to ensure adequate airflow and prevent future mold growth.

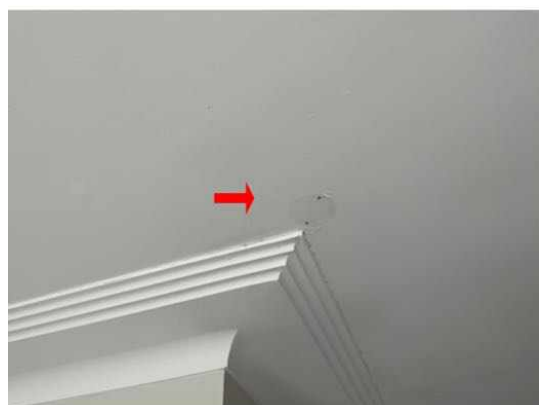
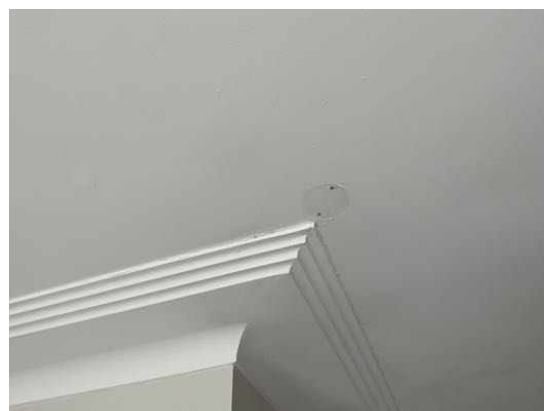
Finding 1.03

Building:	Main Building
Location:	Bedroom
Finding:	Smoke Detectors and Alarms
Information:	Reporting on Smoke Detectors or Alarms, including hard wired smoke detection systems and their legislative requirements, is outside the Scope of this Report.

Please note that this defect is highlighted as a caution only. We suspect, based on our experience in the building industry, that the absence of smoke detectors, or their poor condition, should be addressed as a matter of urgency to improve occupant safety.

Always ensure sufficient working and suitable smoke detectors are installed prior to occupying any building. Additionally, it is advised that all smoke detectors be tested by the homeowner on a monthly basis.

Please refer to AS3786 and state based legislation, which may also apply.

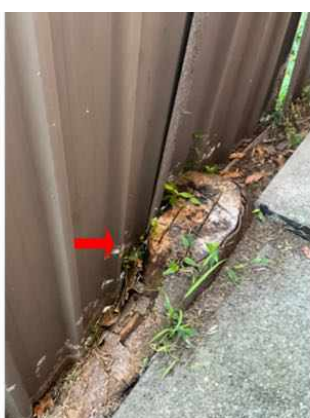
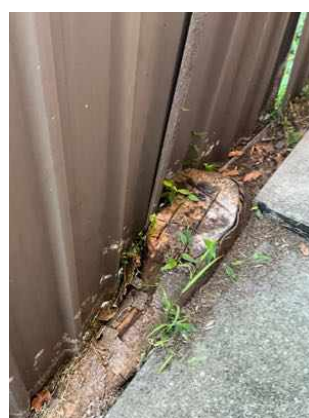
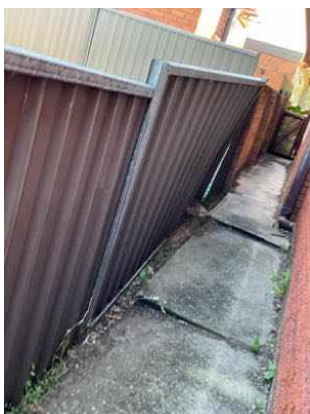
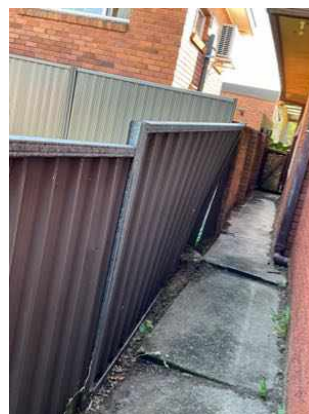
Finding 2.01

Building:	Main Building
Location:	Yard - Side
Finding:	Tree roots have uplifted & damaged fence & paving
Information:	Tree roots and trunk growth have displaced the pavers and caused visible deformation and damage to the boundary fence. This presents a trip hazard, creates movement to adjacent structures, and indicates ongoing root activity. Visual inspection only in accordance with AS 4349.1. Recommend further evaluation by a qualified arborist and rectification of fencing and paving by appropriate contractors.

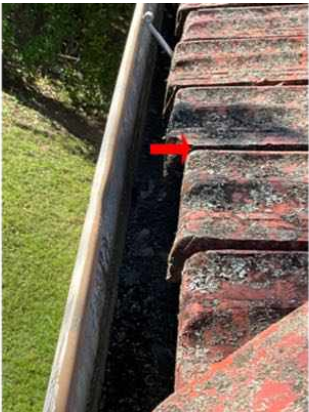
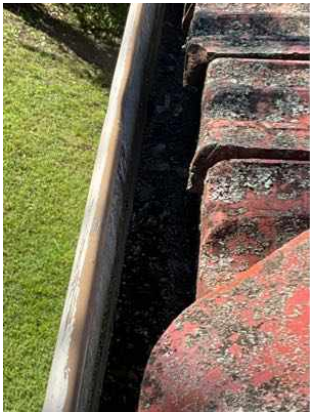
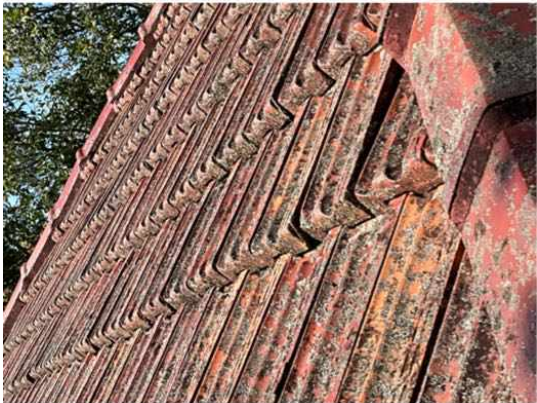
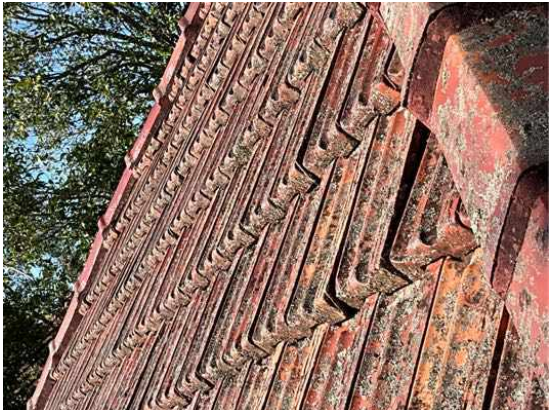
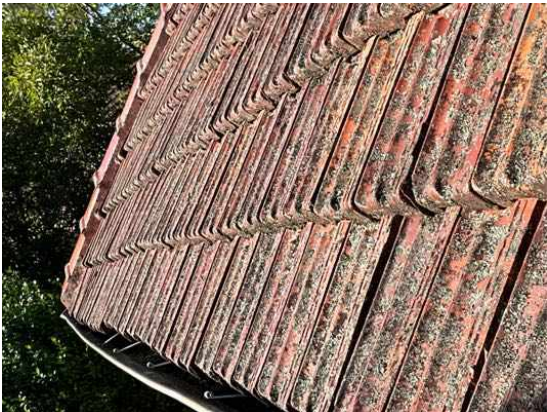
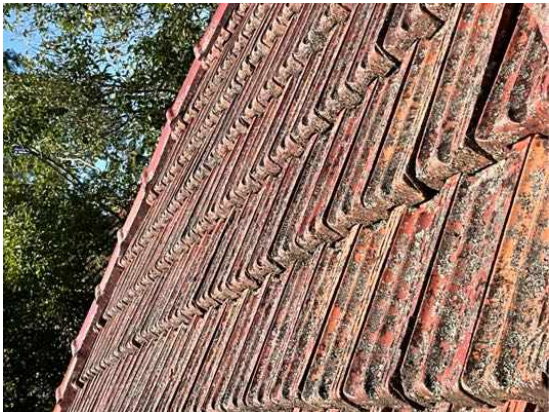
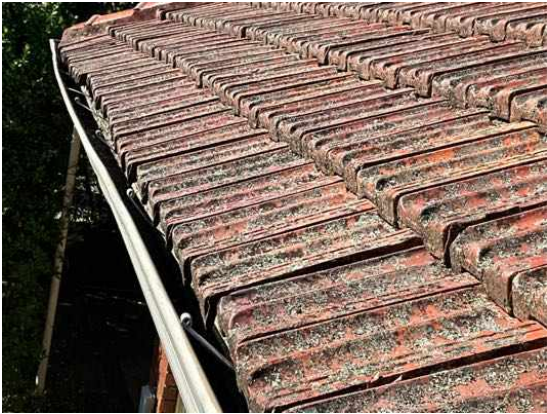
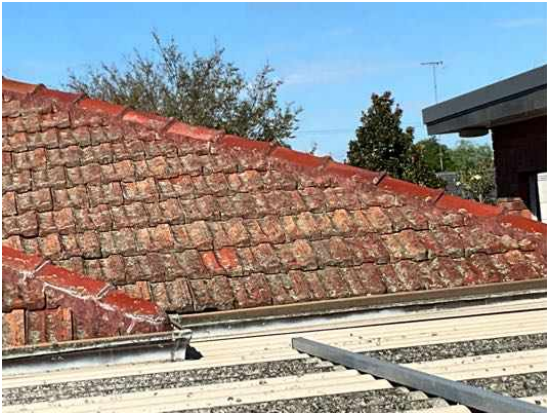
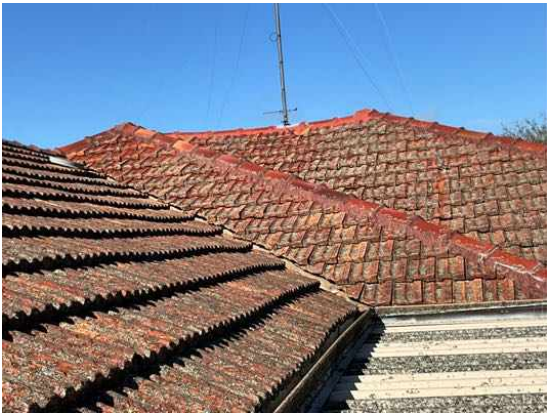
Finding 2.02

Building:	Main Building
Location:	All Areas
Finding:	Roof Weathered
Information:	Upon inspection of the exterior roofing, the majority of roof was not in a fair condition. While weathering of the roof is consistent with the age of the property, maintenance works are required.

Isolated areas of mortar have come loose in the valleys and minor cracking is also

Where left unmanaged, deteriorating roof are likely to lead to a number of secondary defects, including minor water leaks and weather exposure to internal roofing structures.

Consultation with a roofing contractor is highly advised to gain advice on cost of remedial works that may be required in the short to medium term. Remedial works are likely to increase the longevity of the exterior roofing structure.

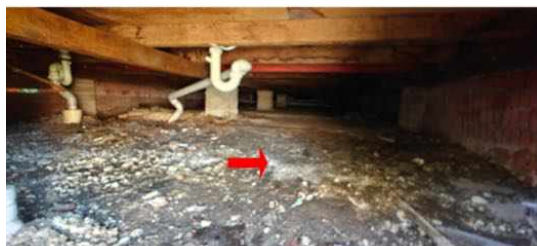
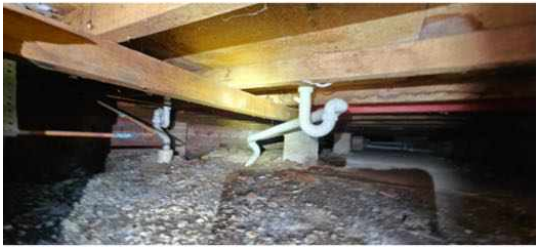
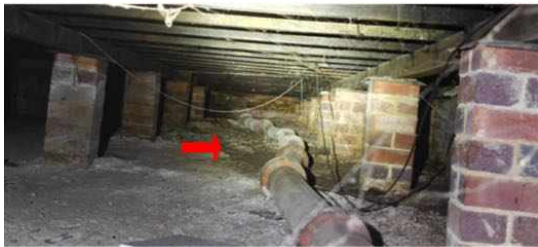
Finding 2.03

Building: Main Building
Location: Subfloor
Finding: Subfloor - Site drainage - Inadequate
Information: The site exhibits poor drainage under the subfloor, leading to several critical issues. Water accumulates and does not properly drain away from the subfloor area, creating a hazardous condition.

1. Frequent water pooling and stagnation under the subfloor.
2. Risk of subfloor structural damage due to prolonged moisture exposure.
3. Potential for mold and mildew growth, compromising indoor air quality and a potential of Termite attack.
4. Safety hazard for occupants due to slippery surfaces and potential electrical hazards.

The poor site drainage under the subfloor poses a significant safety risk to the occupants, as it can lead to structural damage and health hazards.

This issue requires immediate attention and rectification. A licensed and experienced plumber or licensed builder specialising in drainage and foundation work should be engaged to assess the problem and implement necessary drainage solutions, such as improved grading, installation of drainage systems, and moisture barrier enhancements. Regular maintenance and inspections should also be scheduled to prevent future occurrences. Water damage and secondary defects are likely to occur if left unmanaged.

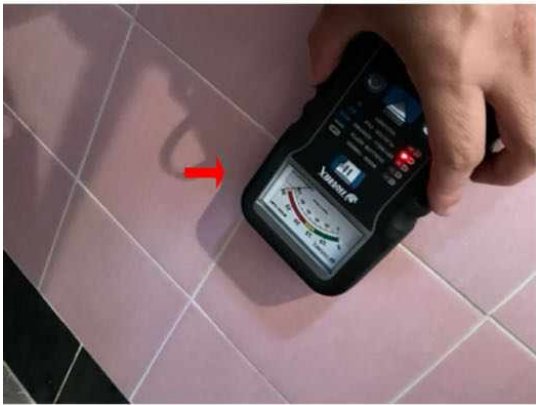
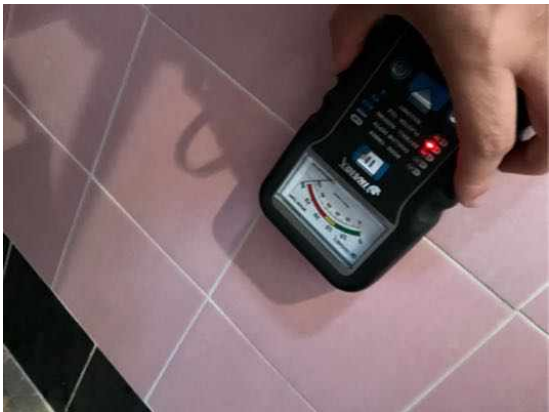
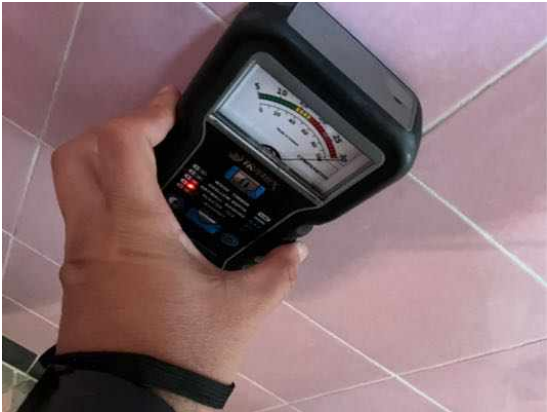
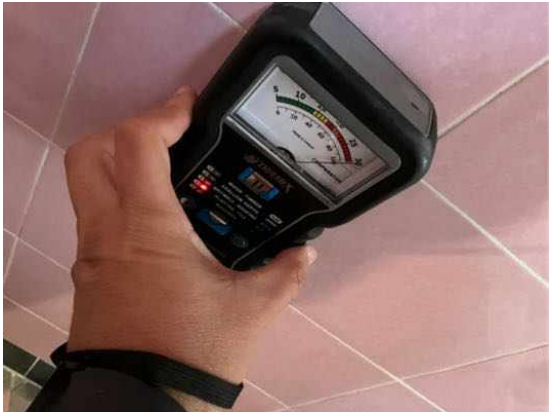
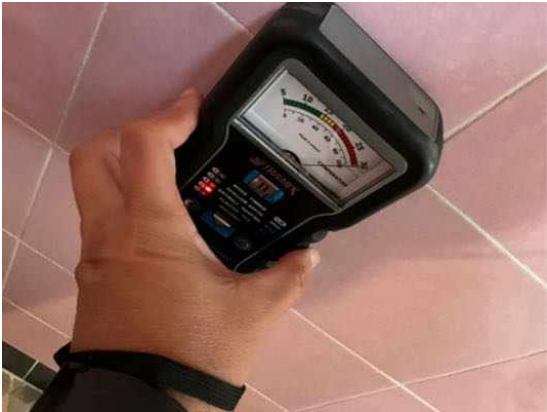
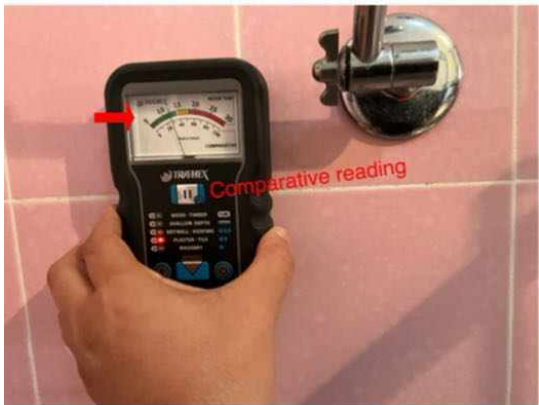
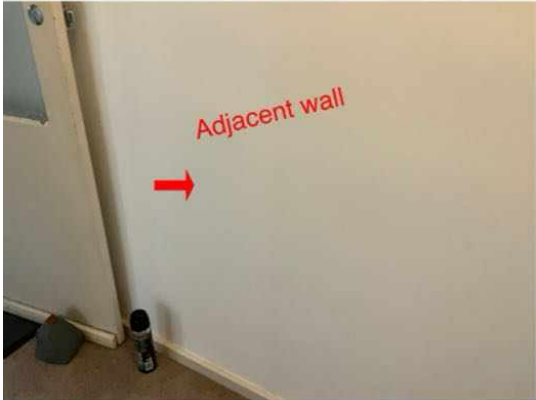
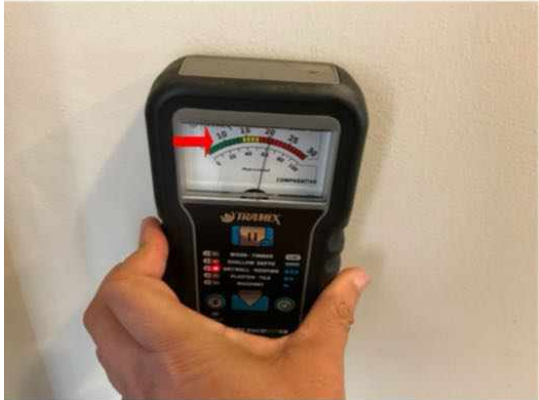
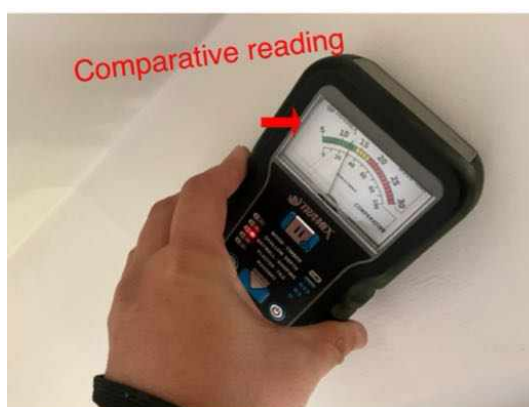
Finding 2.05

Building:	Main Building
Location:	Bathroom
Finding:	Evidence of excessive moisture was present at the time of inspection
Information:	Excessive moisture is present behind the bathroom tiles, indicating a potential water leakage issue within the wall.

The prolonged presence of moisture can lead to mold growth, deteriorate the structure, and create an environment conducive to health hazards. Additionally, it may compromise the adhesive holding the tiles, leading to their detachment.

A licensed plumber or a qualified contractor specializing in water damage remediation should investigate the source of the moisture, fix any leaks, and address the damage. Additionally, replacing affected tiles and ensuring proper waterproofing are crucial to preventing future issues.

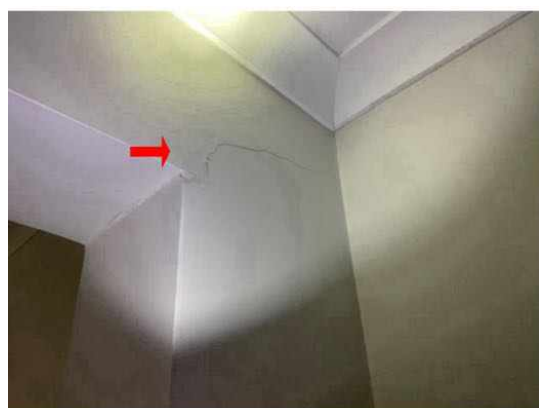
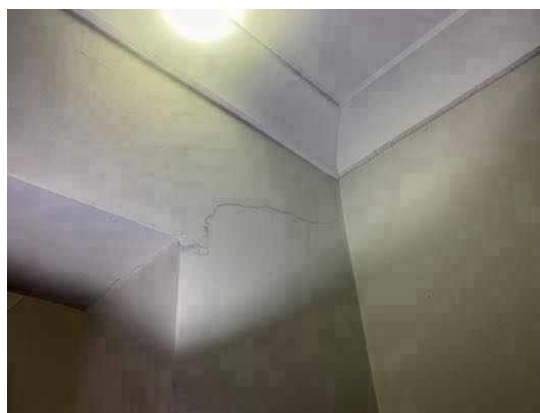
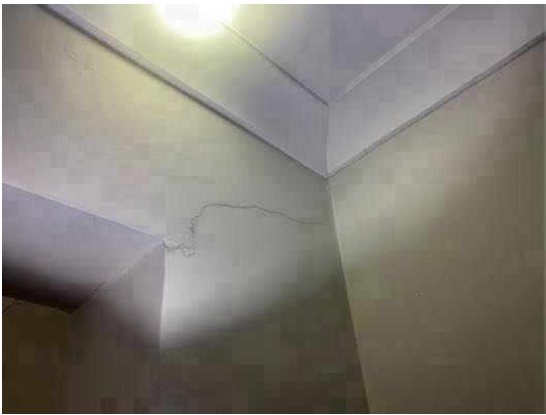
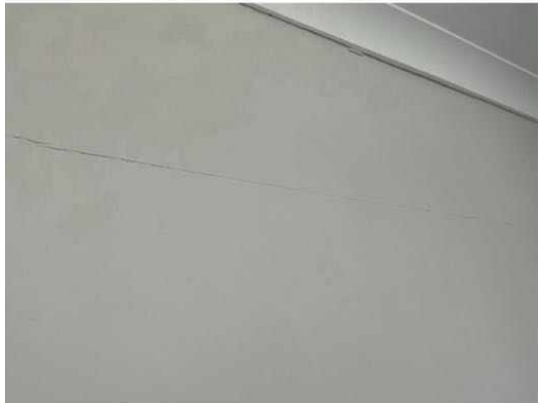
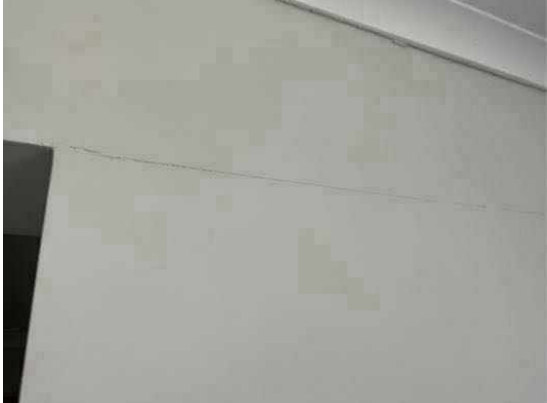
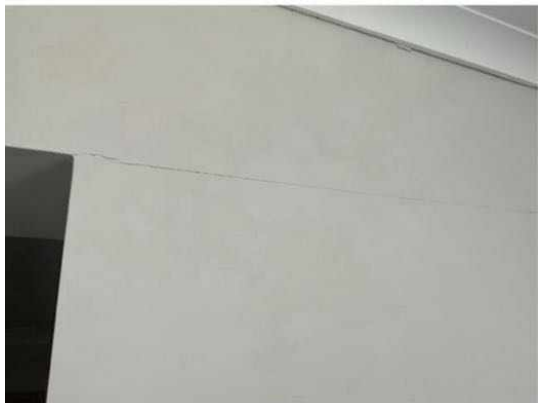
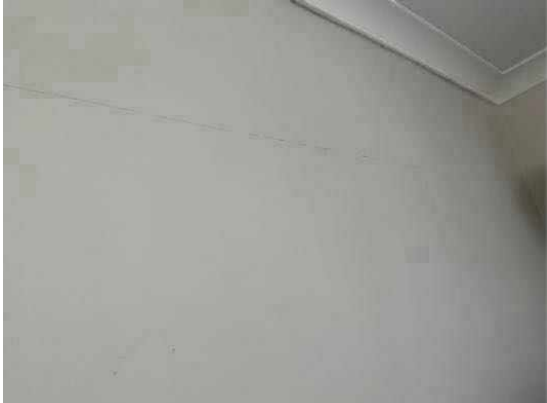
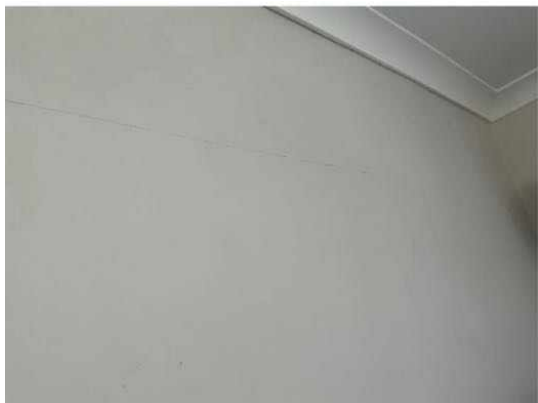
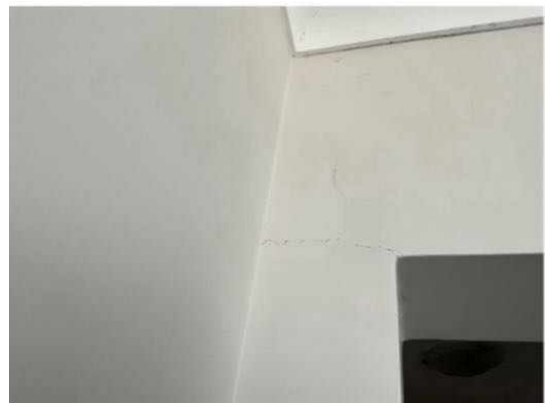
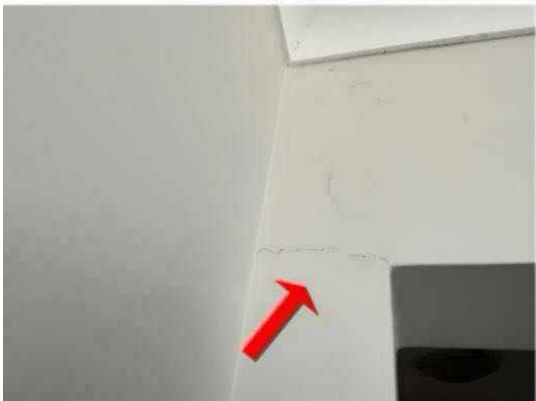
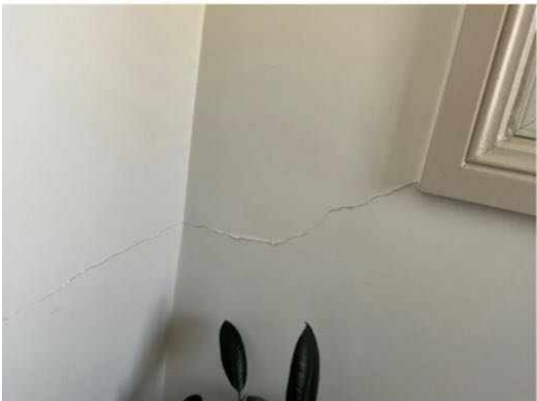
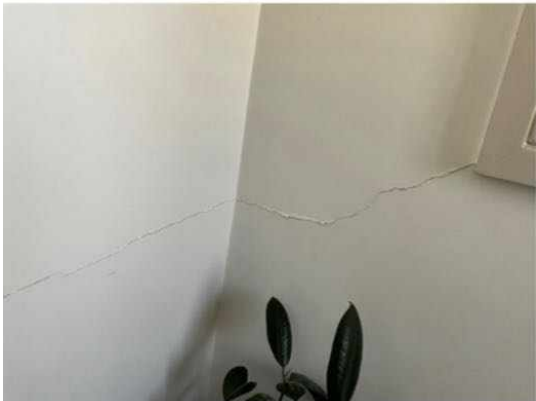
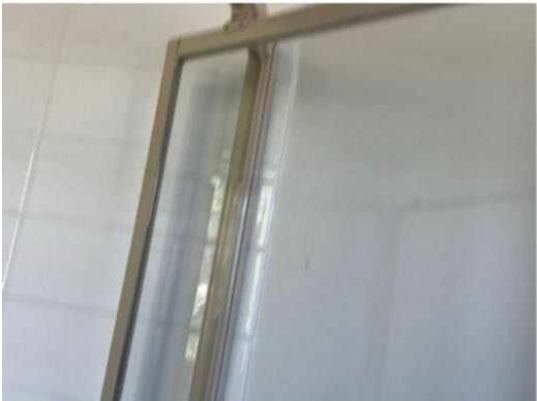
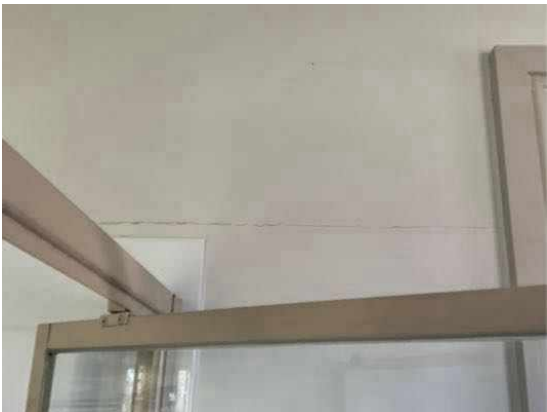
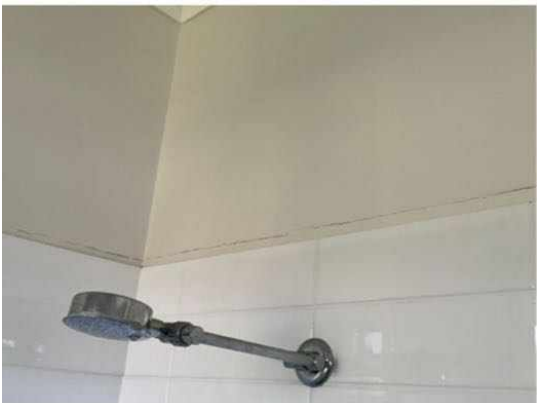
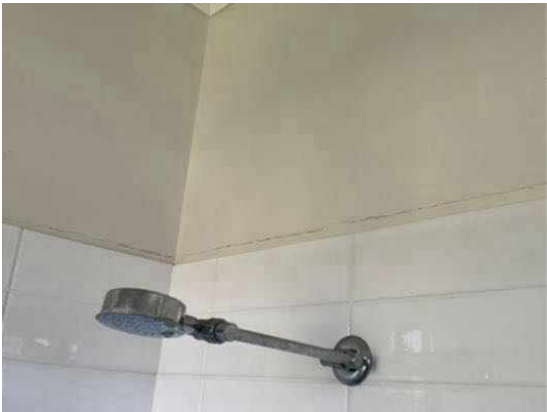
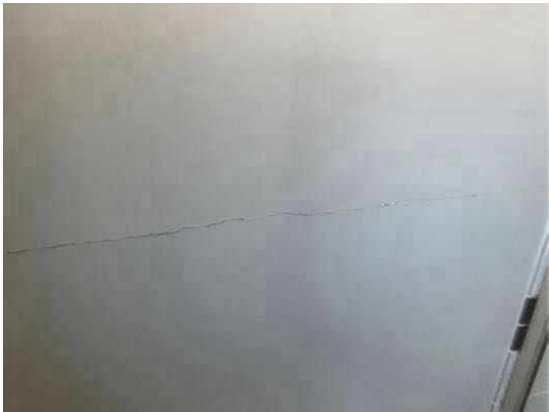
Finding 2.06

Building: Main Building
 Location: Bedroom 3 & en-suite
 Finding: Cracking - internal walls
 Information: Cracking was observed on the internal walls. These cracks may be indicative of differential movement within the structure, such as foundation settlement or structural stress at junctions.

If left unaddressed, the cracking may worsen, potentially affecting structural integrity, leading to misalignment of doors/windows or water ingress.

- Engage a structural engineer to investigate the extent and cause of the cracking across the building.
- If deemed non-structural, repairs can be carried out by a licensed plasterer or builder.

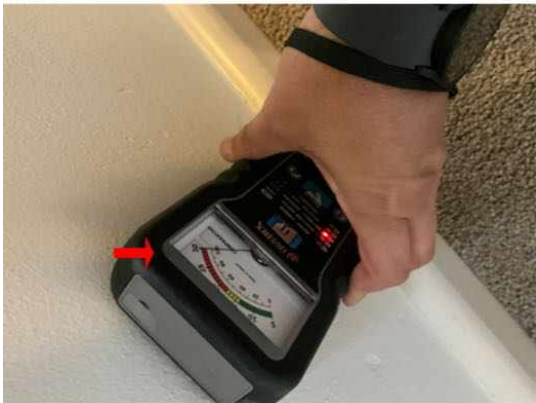
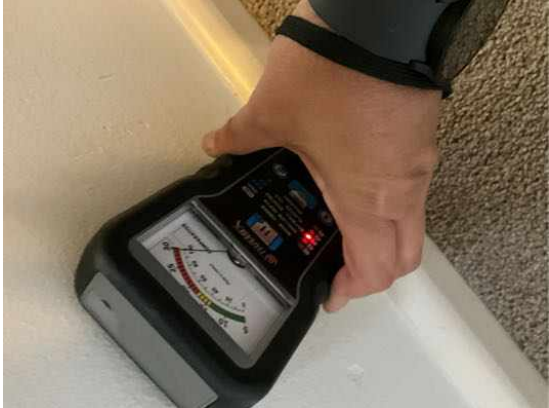
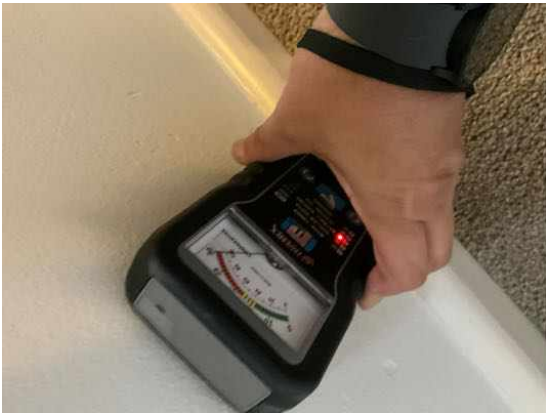
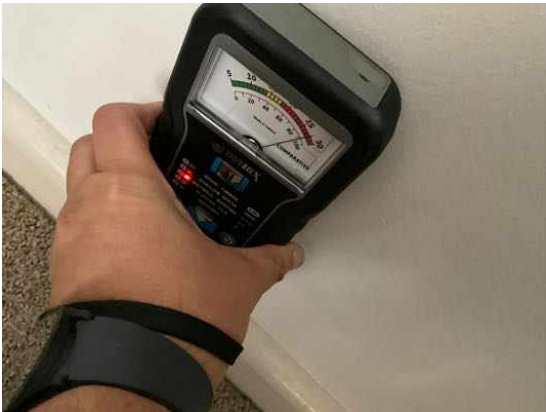
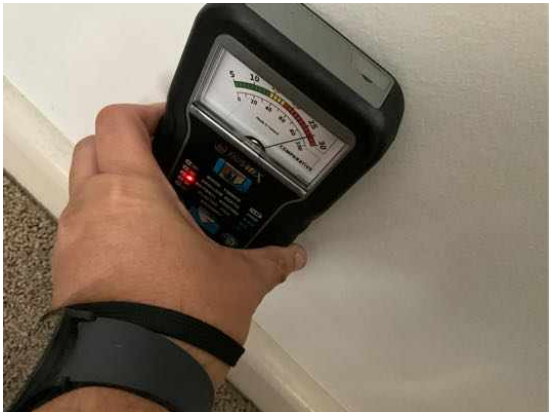
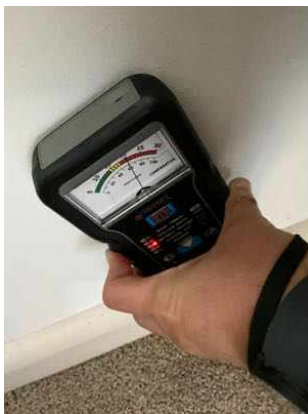
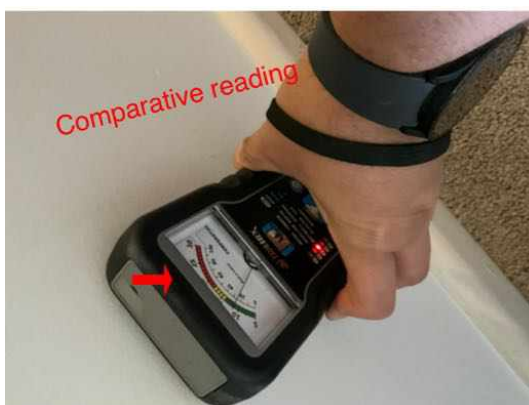
Finding 2.07

Building:	Main Building
Location:	All Areas
Finding:	Damp - Rising
Information:	Rising damp describes the upward movement of water in low sections of building elements (e.g. walls) by capillary action - the movement of water through porous materials such as bricks, sandstone or mortar.

Rising damp is generally managed by the installation of a damp proof course during construction. A Damp Proof Course (DPC) is an impermeable barrier at the base of the wall above ground level. However, many 19th Century buildings have no damp course installed, or the materials have failed. The DPC may have been omitted as a consequence of poor workmanship, or it may have been bridged where materials built up against the side of the house allow moisture ingress above the DPC level.

The first step in addressing rising damp is to diagnose the cause. The identified cause should be addressed first before addressing the appearance and other defects which have resulted from the rising damp. If the original cause is not resolved, further cases of damp are likely to ensue, resulting in secondary defects.

Consultation with a qualified plumber is advised immediately to identify the cause of the damp and perform remedial works as required.

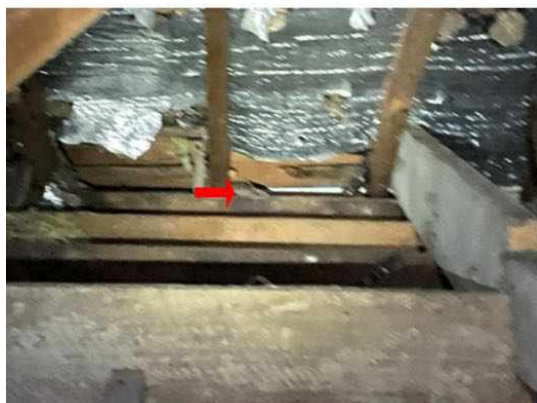
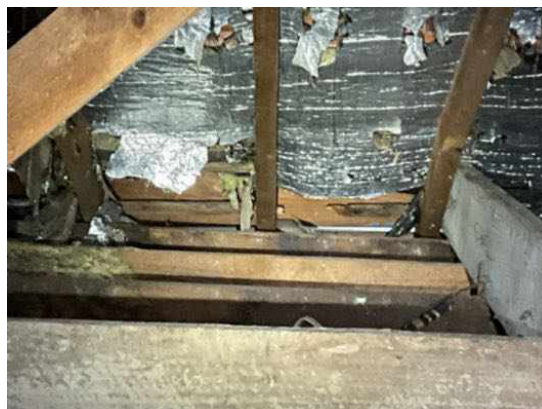
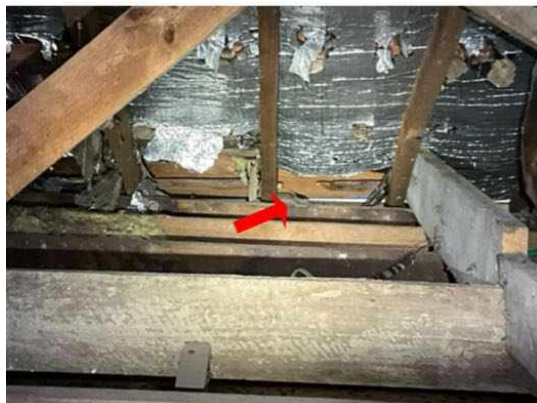
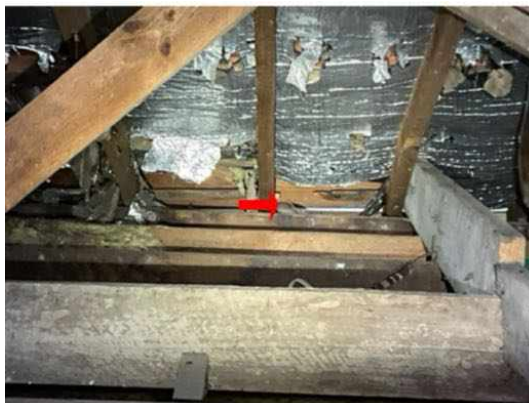
Finding 2.08

Building: Main Building
 Location: Roof Void
 Finding: Roof void - Cracked Roof Truss Member
 Information: A timber member of the roof truss within the roof cavity has sustained a significant crack and splitting, compromising its ability to adequately support roof loads.

The damage impacts the structural integrity of the roof framing system. According to AS 4349.1, such a defect is considered a major structural defect, as it may result in loss of structural strength or stability. Failure to rectify could lead to roof sagging, deformation, or collapse under load conditions, posing a safety hazard to occupants and risking further property damage.

It is strongly recommended that a licensed structural engineer assess the extent of the defect to determine whether the affected member can be repaired or must be replaced. Rectification should be carried out by a qualified builder or roof truss specialist following the engineer's direction.

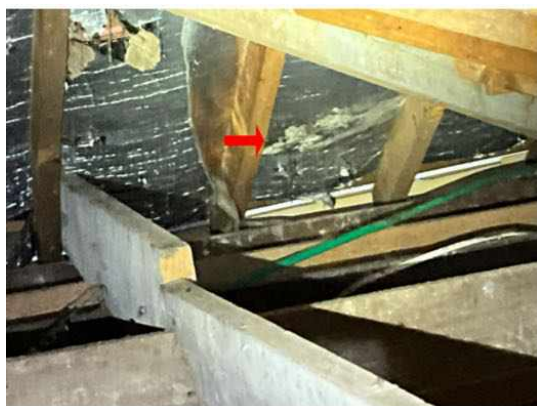
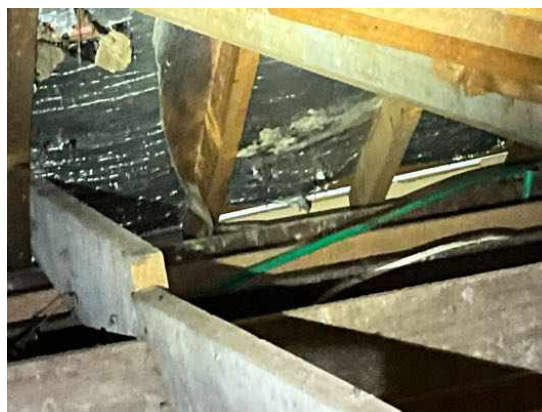
Finding 2.09

Building: Main Building
Location: Roof Void
Finding: Roof void - Suspected water leak
Information: Suspected water leak in the roof void, as evidenced by the presence of water stains, indicating potential gaps or holes.

- **Structural Damage:** Continuous water leakage can weaken the structural integrity of the roof and ceiling, leading to potential collapse.
- **Mold and Mildew:** Persistent moisture can promote the growth of mold and mildew, posing health risks such as respiratory problems and allergic reactions.
- **Electrical Hazard:** Water intrusion near electrical wiring can create a risk of short circuits, fires, or electrical shocks.
- **Insulation Damage:** Prolonged exposure to moisture can damage insulation, reducing its effectiveness and increasing energy costs.

A licensed roofing contractor should be contacted immediately to inspect, diagnose, and repair the source of the leak to prevent further damage.

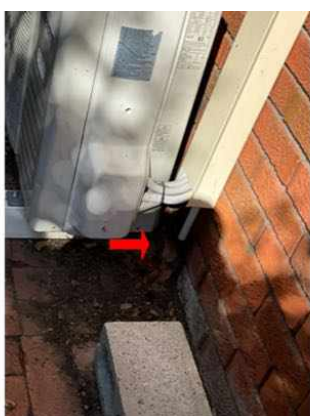
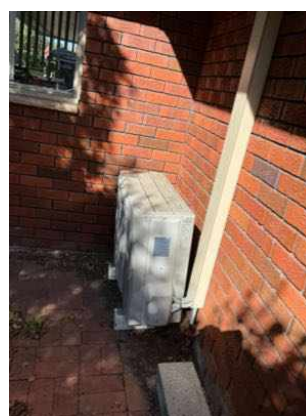
Finding 3.01

Building:	Main Building
Location:	Exterior walls - left side
Finding:	Air conditioner - Disconnected overflow
Information:	The Air Conditioner (A/C) overflow was found to be disconnected from storm water drainage and is creating excessive moisture in the surrounding area.

Such leaking creates an environment which is conducive to an array of defects, including water damage to associated building elements and the attraction of termite or timber pest infestation.

It is highly recommended that a licensed plumber be appointed to connect the A/C overflow in order to prevent such an environment from being created. These minor works should be carried out as soon as possible.

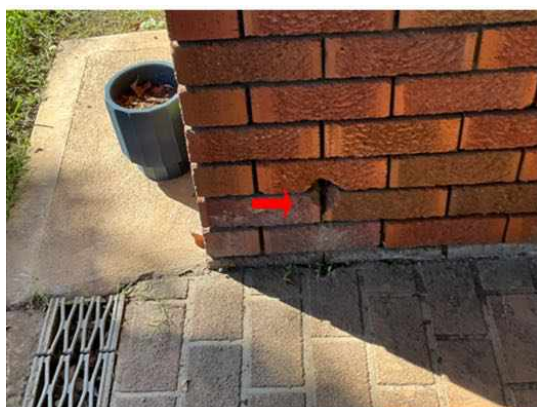
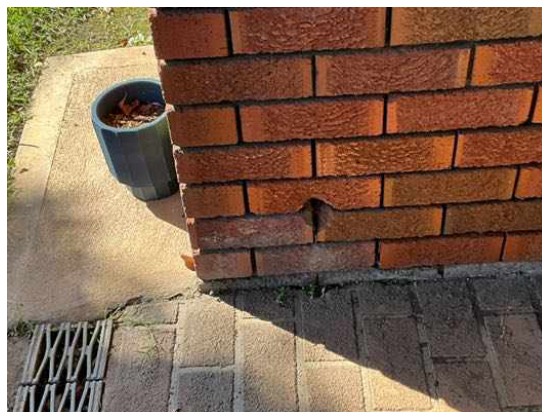
Finding 3.02

Finding: Brickwork - suspected impact damage
 Information: The brickwork on the property shows signs of suspected impact damage.

****Risk:**** Impact damage can weaken the structural integrity of the wall, leading to potential collapse, water infiltration, and increased vulnerability to further damage.

****Recommended Action:**** A qualified mason or bricklayer should carry out the necessary repairs to ensure the structural safety of the property.

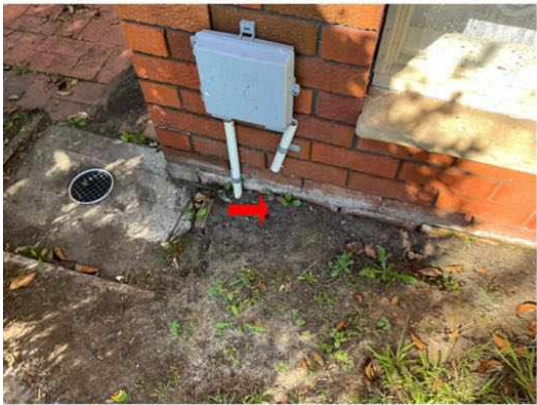
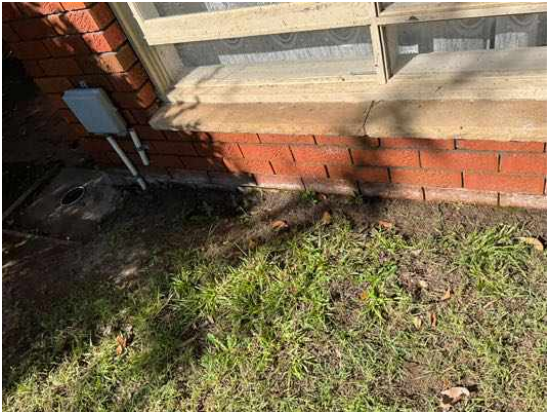
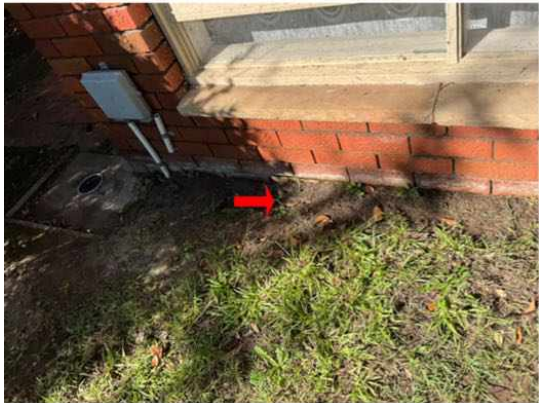
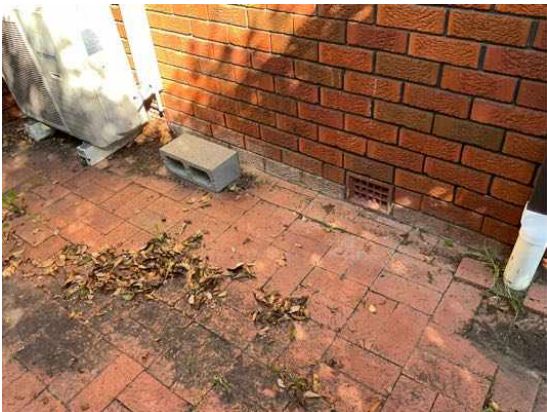
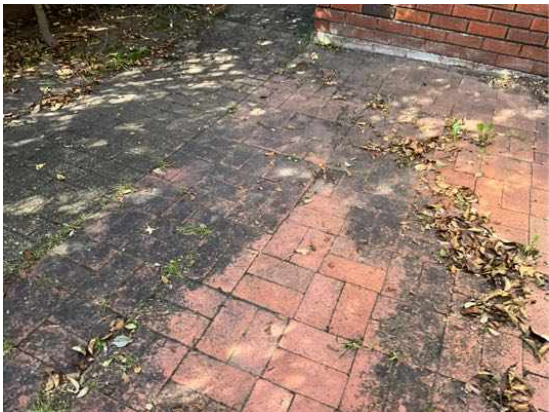
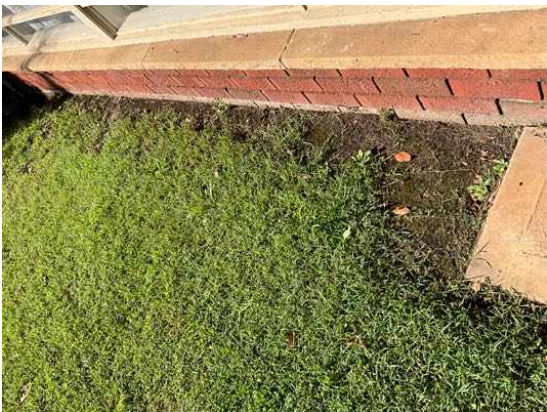
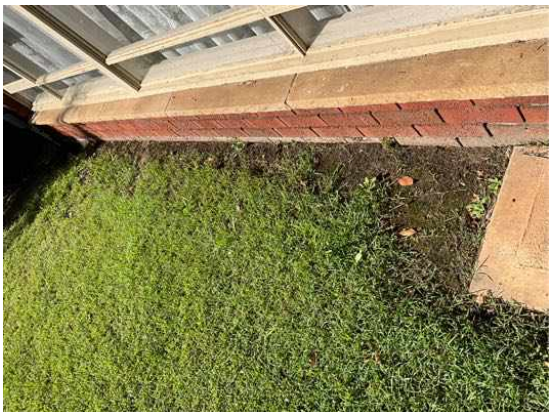
Finding 3.03

Building: Main Building
 Location: All Areas
 Finding: Perimeter - Insufficient Fall
 Information: The perimeter ground levels were found to have an inadequate slope away from the adjoining building structure, creating potential for water pooling in this area.

Perimeter is required to fall from the building by a minimum of 25mm in the first metre and bare ground should fall away from the house by 50mm in the first meter. This standard ensures that excessive moisture does not pool around the base of building structures, which creates potential for water and structural damage, as well as making the area susceptible to termite and timber pest activity.

Where ground levels do not have adequate fall, a licensed paving contractor should be appointed to install or remove and re-level pavement.

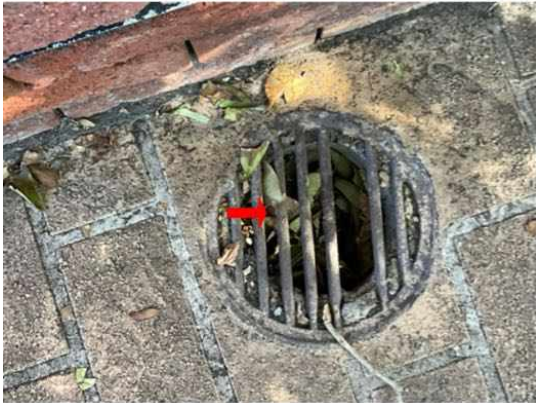
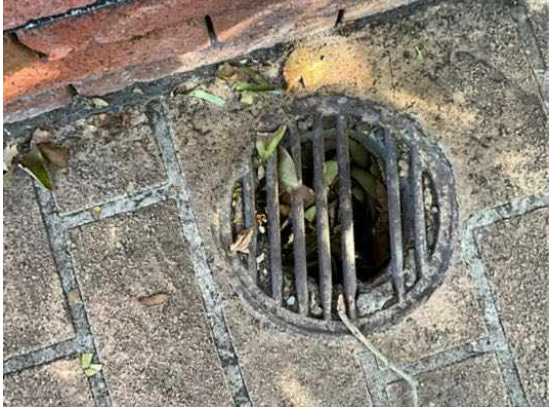
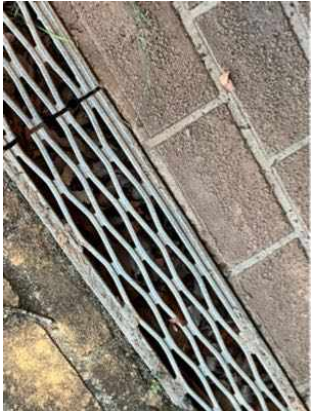
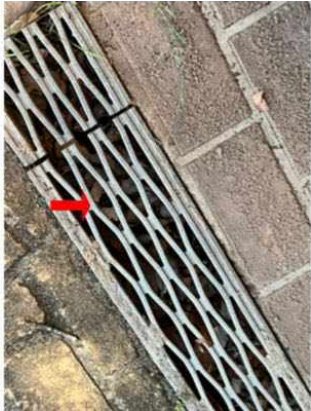
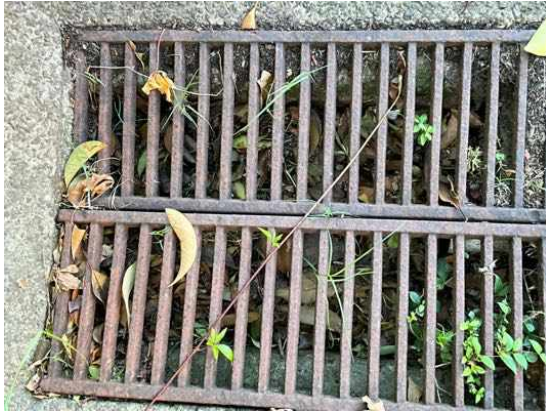
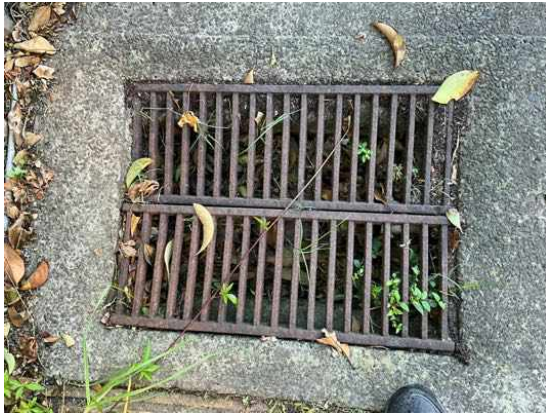
Finding 3.04

Building: Main Building
Location: All Areas
Finding: Vegetation inside Drain
Information: Vegetation, such as roots or foliage, is obstructing the drainage system, impeding water flow and potentially leading to blockages and water damage.

Risk:
The presence of vegetation in the drain poses a risk of water backup, flooding, and structural damage to the property, including foundation issues and mold growth.

Who Can Fix It:
A qualified plumber or drainage specialist should clear the vegetation from the drain, ensuring proper water flow and preventing potential drainage problems and associated damages. Regular maintenance may also be required to prevent future vegetation intrusion.

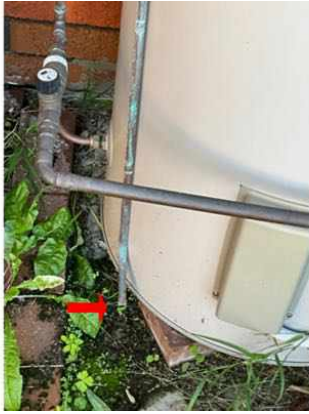
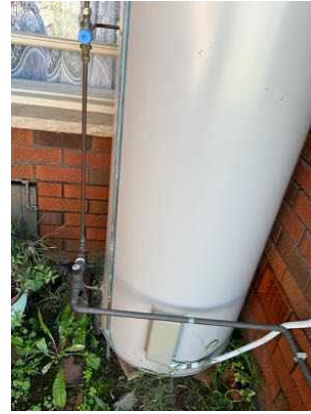
Finding 3.05

Building:	Main Building
Location:	Exterior walls - rear
Finding:	HWS Overflow - Not Connected
Information:	The Hot Water System (HWS) overflow was found to be disconnected from storm water drainage and is creating excessive moisture in the surrounding area.

These damp conditions can lead to secondary defects such as rot, rust or corrosion of associated building elements, the formation of fungal decay, or even the creation of potential slip hazards. When coupled with poor site drainage, pooling of water may also attract termite activity to this area.

It is highly recommended that a licensed plumber be appointed to connect the HWS overflow in order to prevent such an environment from being created. These minor works should be carried out as soon as possible.

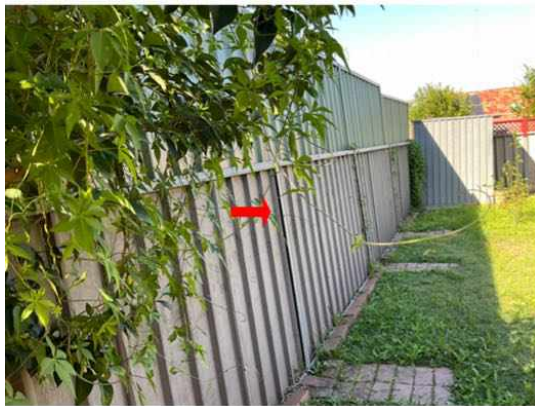
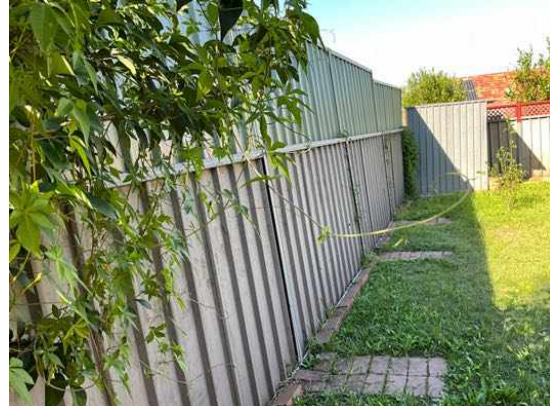
Finding 3.06

Building:	Main Building
Location:	Fencing
Finding:	Leaning fence
Information:	The fence is leaning, deviating from its vertical position, compromising its stability and aesthetic appeal.

The leaning fence poses a risk of collapse, potential property damage, and a security breach, diminishing its effectiveness as a barrier.

A skilled fencing contractor or handyman is needed to assess and rectify the leaning fence. Timely repair is crucial to restore the fence's stability and prevent further damage or safety hazards.

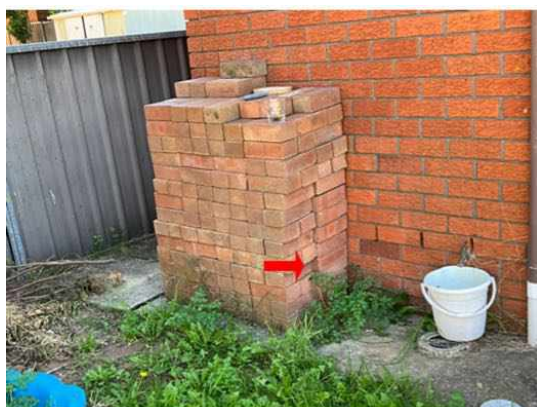
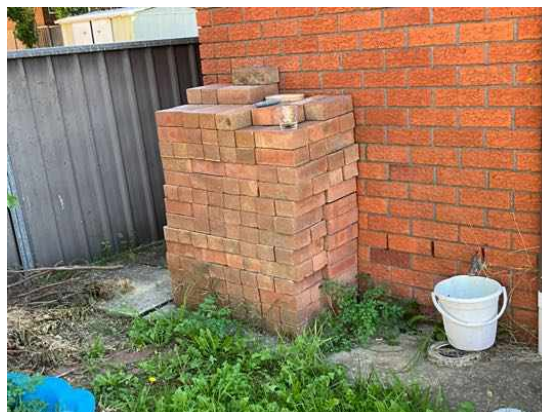
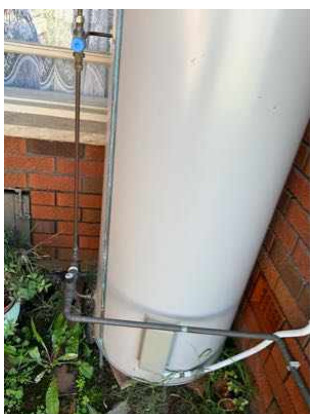
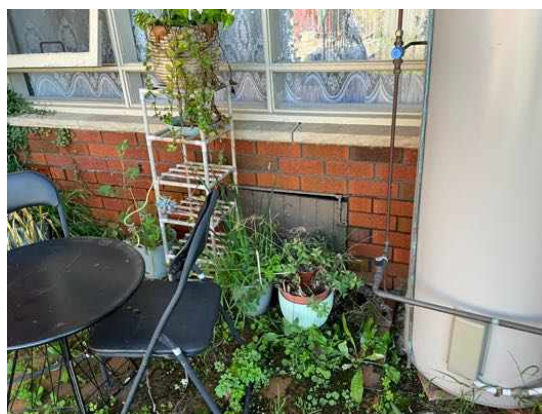
Where bridging has occurred full inspection is prevented and termites may enter a property in a concealed or undetected manner.

Recommended moving obstructions away from the external walls for further and future inspections.
