Building and Timber Pest Inspection Report

Inspection Date: Wed, 8 Apr 2026

Property Address: 24 Hornseywood Ave, Penrith NSW 2750,
Australia

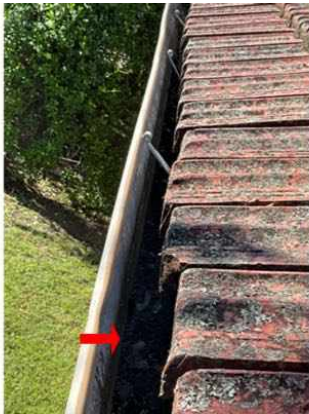
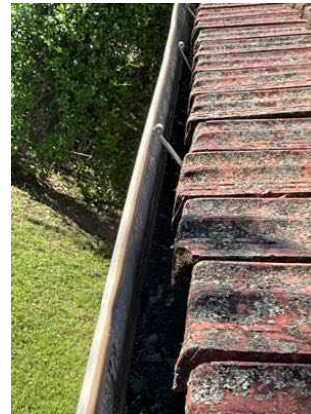
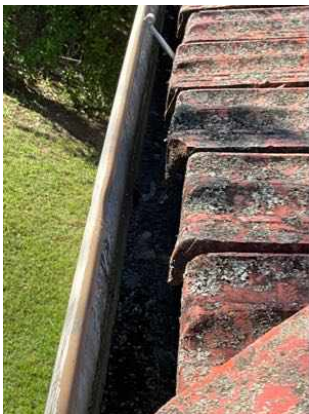
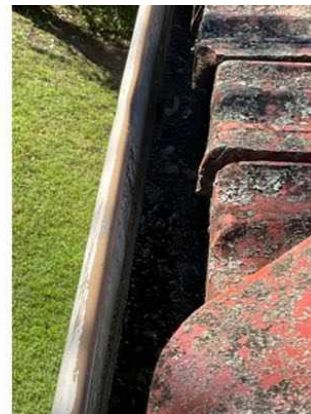
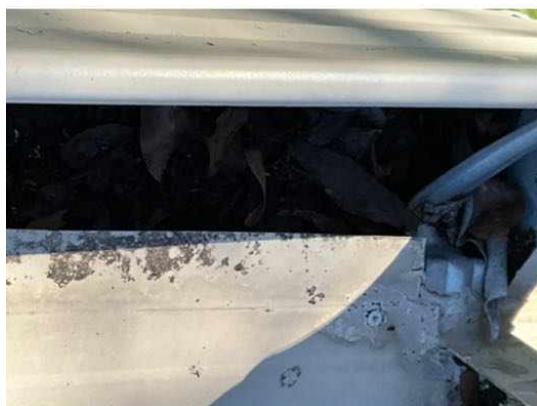
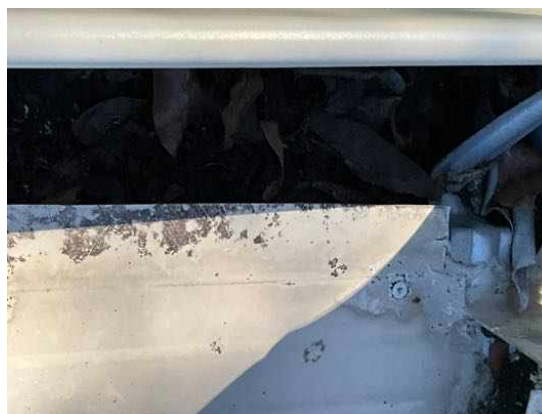
Finding 3.08

Building:	Main Building
Location:	All Areas
Finding:	Blocked gutters - organic debris
Information:	The roof gutter system was observed to be blocked with organic debris and moss growth, as evident in the provided images.

- Timber rot or deterioration of fascia and soffits,
- Accelerated moss and algae growth, promoting further blockages,
- Potential foundation issues if water pools near the base of the structure.

A licensed roofing contractor or qualified gutter cleaning service should be engaged to remove the debris and inspect the system for any further issues.

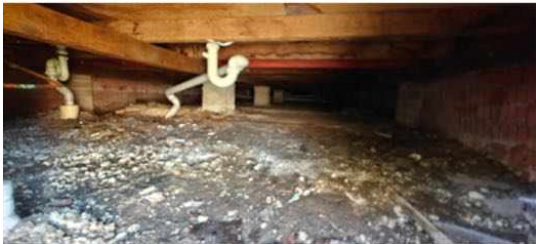
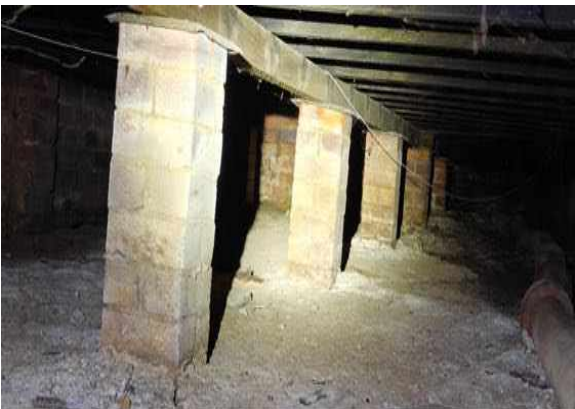
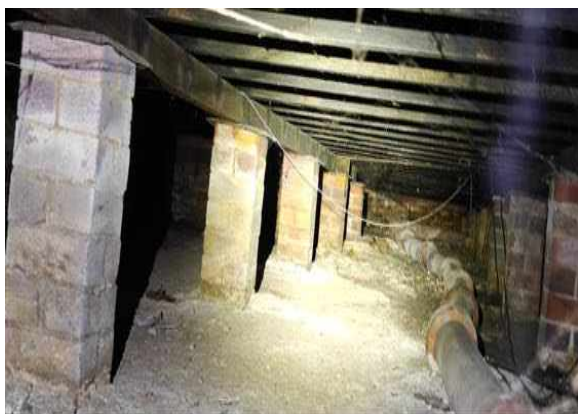
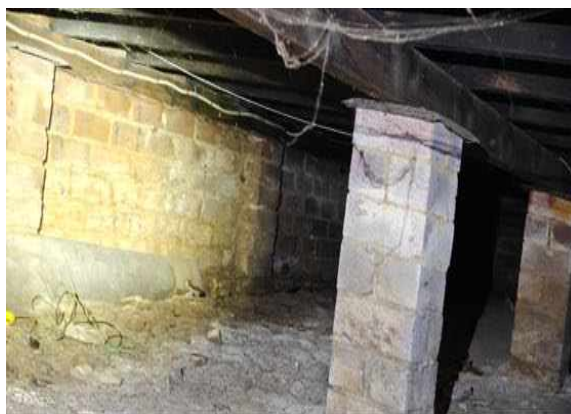
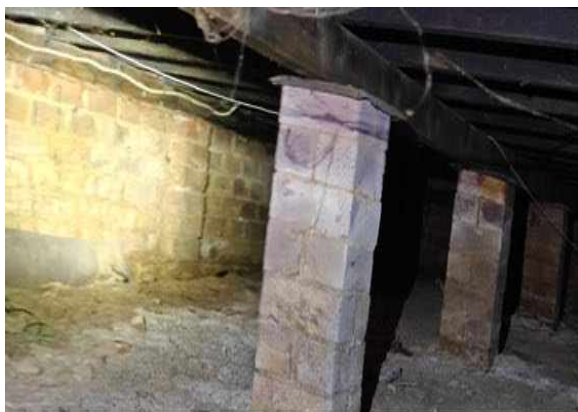
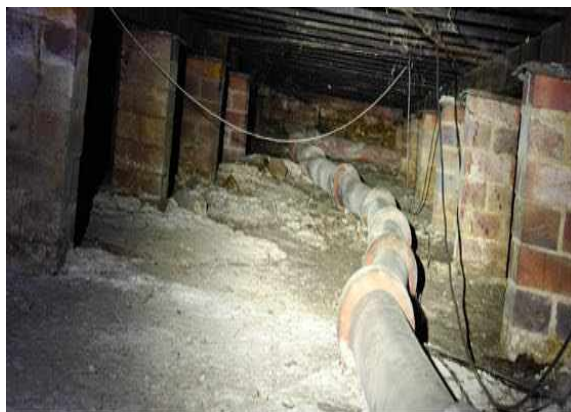
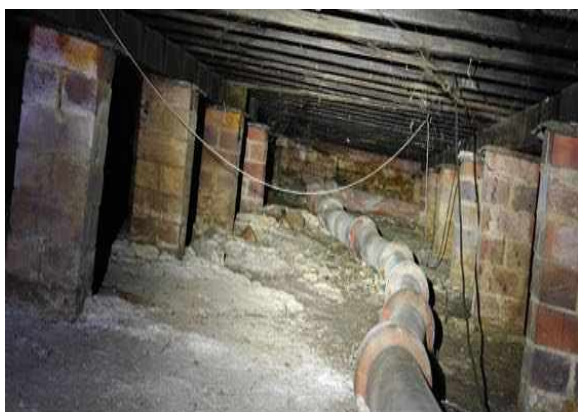
Finding 3.09

Building:	Main Building
Location:	Subfloor
Finding:	Subfloor ventilation - Inadequate - blocked airflow
Information:	The subfloor of the property has inadequate ventilation due to blocked airflow from all sides, preventing proper circulation of air beneath the building.

- ****Moisture Build-Up****: Poor ventilation can lead to excessive moisture accumulation in the subfloor area, promoting mold growth, wood rot, and deterioration of structural elements, such as floor joists and beams.
- ****Pest Infestation****: Stagnant, damp environments create ideal conditions for termites and other pests, which can compromise the integrity of the building's foundation and structure.
- ****Health Hazards****: The accumulation of moisture and mold can pose health risks to occupants, particularly those with respiratory conditions, due to the growth of allergens and mold spores.

A licensed builder or ventilation specialist should be consulted to assess and install adequate subfloor ventilation. This may include installing vents, mechanical fans, or other solutions to improve airflow and prevent moisture buildup. Proper ventilation will ensure the longevity of the building's structural components and reduce health risks associated with dampness.

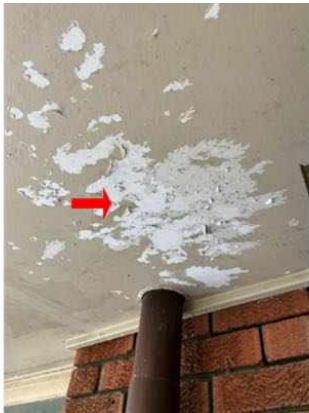
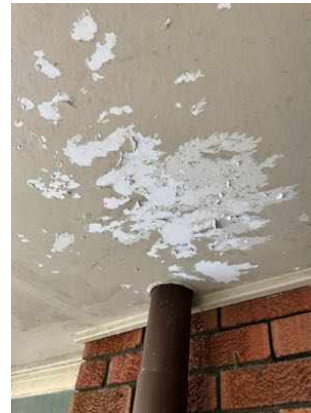
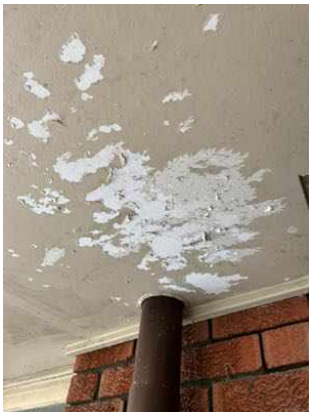
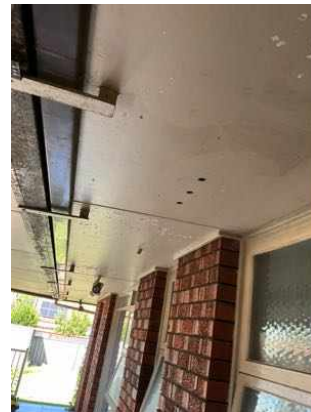
Finding 3.10

Building:	Main Building
Location:	All Areas
Finding:	Flaky Paint
Information:	Sections of the paint in this area was found to have deteriorated. Paint deteriorating is generally an indication of excessive moisture in the area that is currently hidden by the painted surface.

The presence of excessive moisture can have major implications on associated building elements if left unattended. While only seemingly minor at this stage, the damage cannot be determined due to the paint, obstructing any further inspection of the damage.

It is highly advised that the affected paint to be cleaned to allow a further, more invasive inspection by a licensed builder/painter. Failure to act on this defect may necessitate major works in the future.

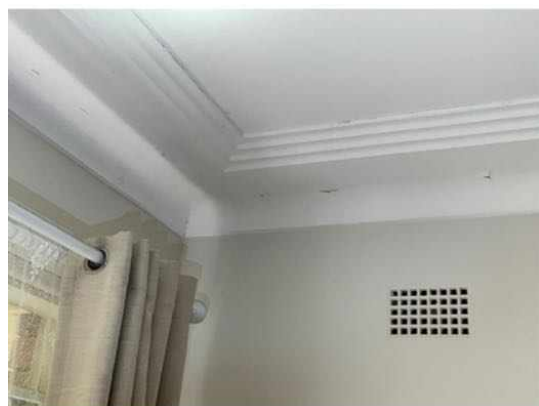
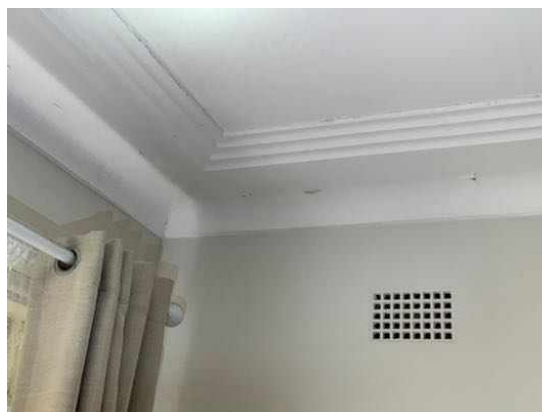
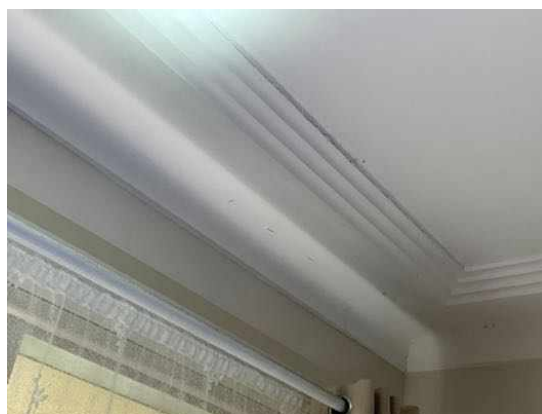
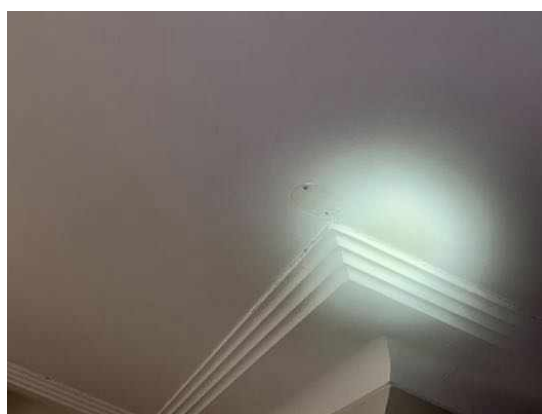
Finding 3.11

Building:	Main Building
Location:	All Areas
Finding:	Flaky Paint
Information:	Sections of the paint in this area was found to have deteriorated. Paint deteriorating is generally an indication of excessive moisture in the area that is currently hidden by the painted surface.

The presence of excessive moisture can have major implications on associated building elements if left unattended. While only seemingly minor at this stage, the damage cannot be determined due to the paint, obstructing any further inspection of the damage.

It is highly advised that the affected paint to be cleaned to allow a further, more invasive inspection by a licensed builder/painter. Failure to act on this defect may necessitate major works in the future.

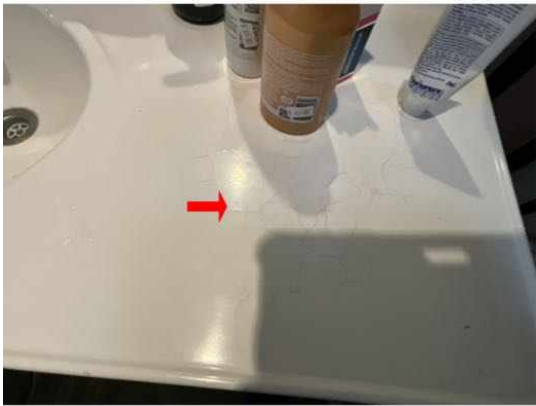
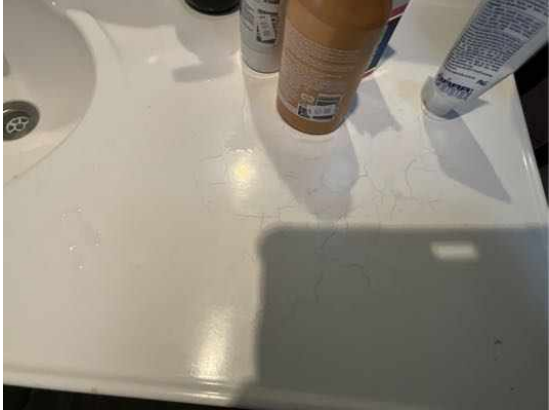
Finding 3.12

Finding: Basin - Cracked

Information: Cracking was evident to the basin at the time of inspection, which is suspected to have been by minor impact damage. While the cracking appears to be minor, any further impact damage sustained by the basin may lead to additional cracking.

As the cracking provides potential ingress for water, secondary water damage may occur to associated cabinetry, walls or flooring, if the cracking is left unmanaged.

Consultation with a plumber regarding basin repair or replacement is required.

Remedial works may be required to protect against any further damage.

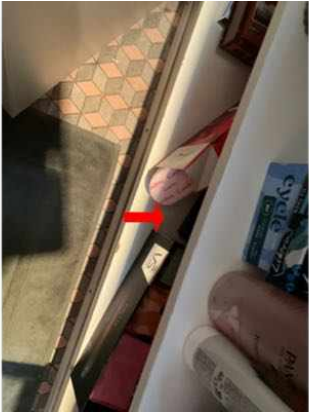
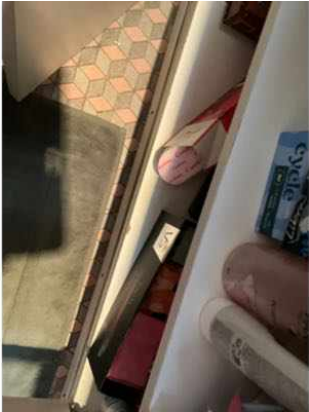
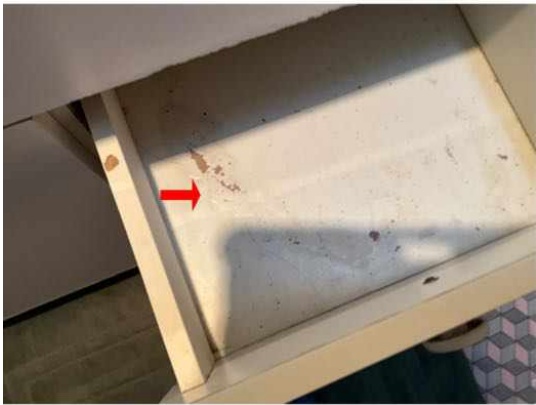
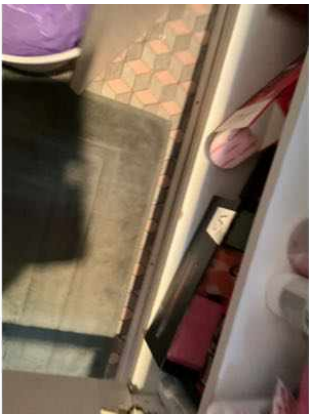
Finding 3.13

Building: Main Building
Location: Bathroom
Finding: Water Stains in Vanity
Information: "Water stains observed in the vanity area, compromising its appearance and potentially causing damage."

Continued water exposure may lead to material damage, mold growth, and diminished aesthetic appeal.

A licensed plumber or maintenance professional should assess and fix any leaks contributing to the water stains, while a cleaning or restoration service may be needed to address the visible stains and prevent further damage.

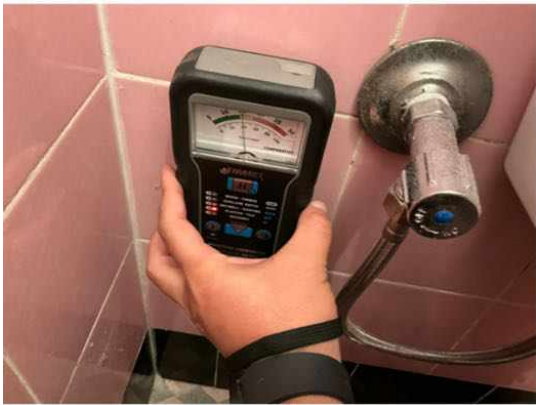
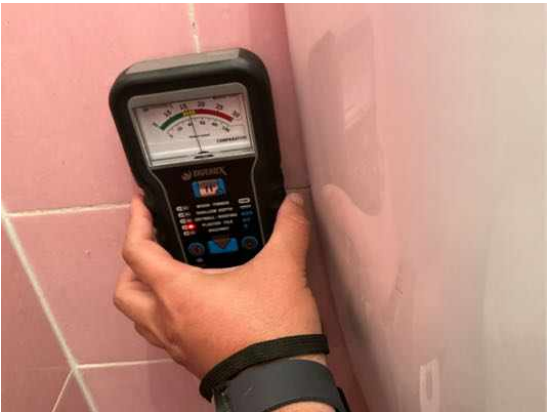
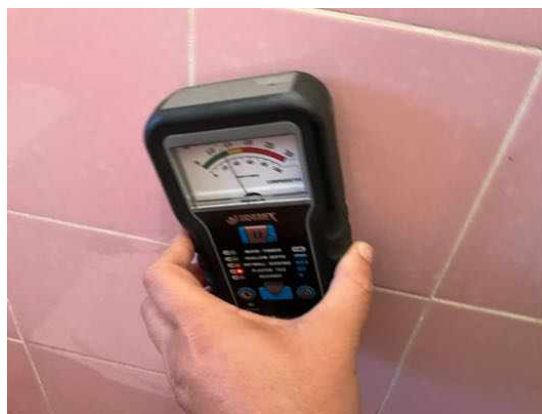
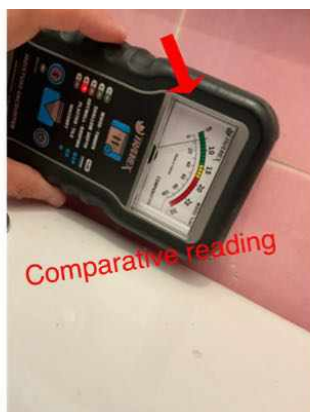
Finding 3.14

Building: Main Building
Location: Toilet (WC)
Finding: Evidence of excessive moisture was present at the time of inspection
Information: Excessive moisture is present behind the bathroom tiles, indicating a potential water leakage issue within the wall.

The prolonged presence of moisture can lead to mold growth, deteriorate the structure, and create an environment conducive to health hazards. Additionally, it may compromise the adhesive holding the tiles, leading to their detachment.

A licensed plumber or a qualified contractor specializing in water damage remediation should investigate the source of the moisture, fix any leaks, and address the damage. Additionally, replacing affected tiles and ensuring proper waterproofing are crucial to preventing future issues.

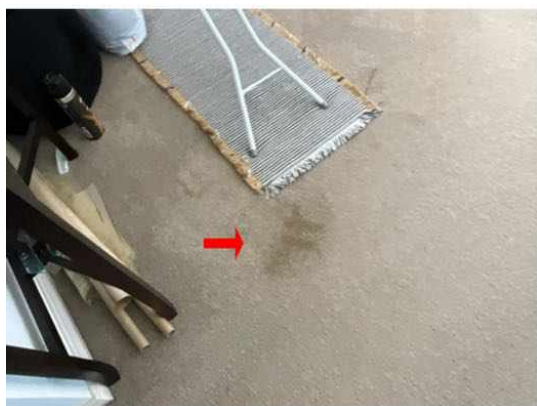
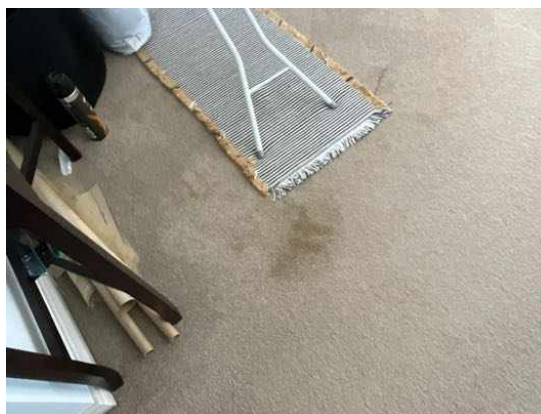
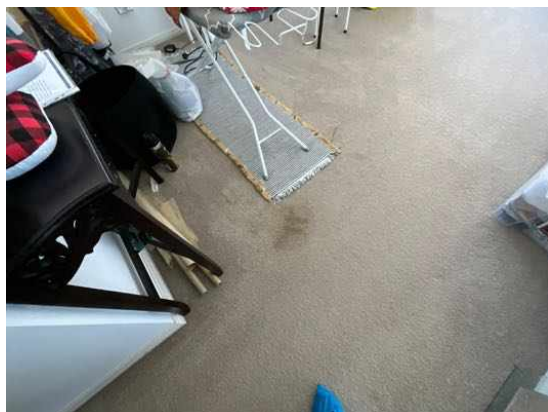
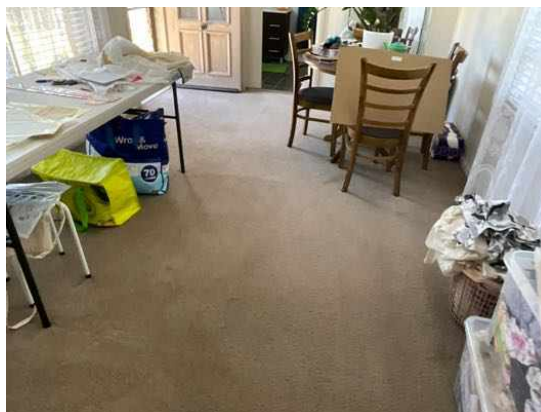
Finding 3.15

Building:	Main Building
Location:	All Areas
Finding:	carpet exhibits visible signs of aging
Information:	Carpets are exhibiting visible signs of aging, including fraying edges, faded colors, and flattened fibers, diminishing their aesthetic appeal and functional quality.
Risk:	<p>The risk associated with aging carpets includes diminished appearance, decreased comfort, potential tripping hazards due to frayed edges, and a negative impact on indoor air quality if fibers begin to degrade and release particles into the air.</p>
Who can fix it:	<p>Professional carpet cleaning and restoration services can address issues such as deep cleaning to rejuvenate colors, repairing frayed edges, and restoring fibers. Additionally, replacing the carpets entirely may be necessary in severe cases of aging or damage beyond repair.</p>

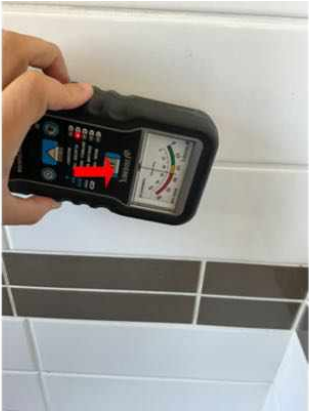
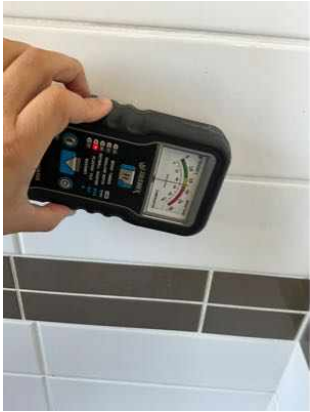
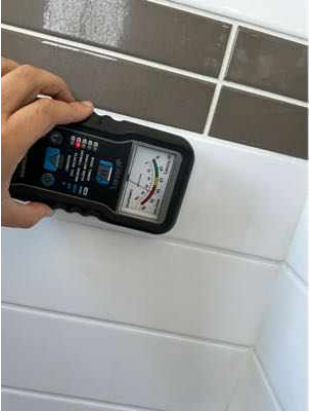
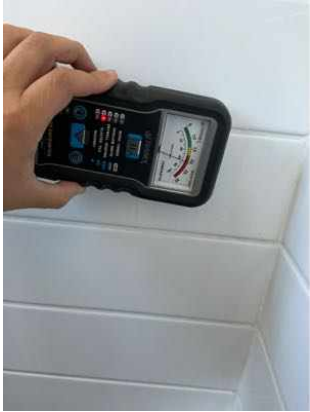
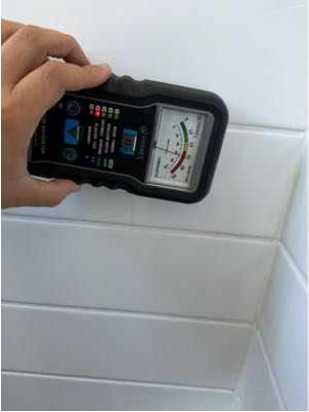
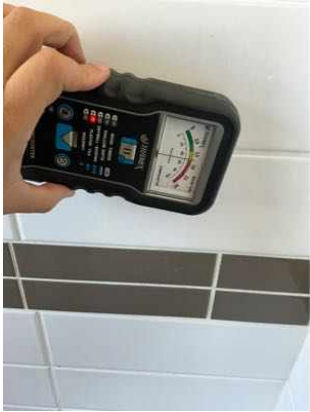
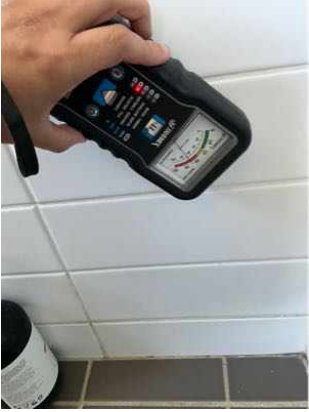
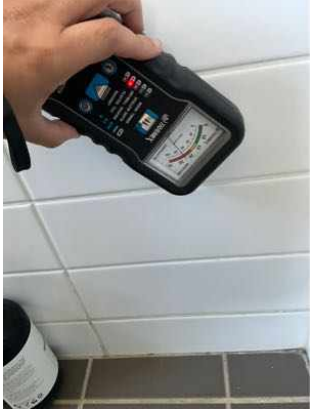
Building:	Main Building
Location:	Ensuite
Finding:	Evidence of excessive moisture was present at the time of inspection
Information:	Excessive moisture is present behind the bathroom tiles, indicating a potential water leakage issue within the wall.

The prolonged presence of moisture can lead to mold growth, deteriorate the structure, and create an environment conducive to health hazards. Additionally, it may compromise the adhesive holding the tiles, leading to their detachment.

A licensed plumber or a qualified contractor specializing in water damage remediation should investigate the source of the moisture, fix any leaks, and address the damage. Additionally, replacing affected tiles and ensuring proper waterproofing are crucial to preventing future issues.

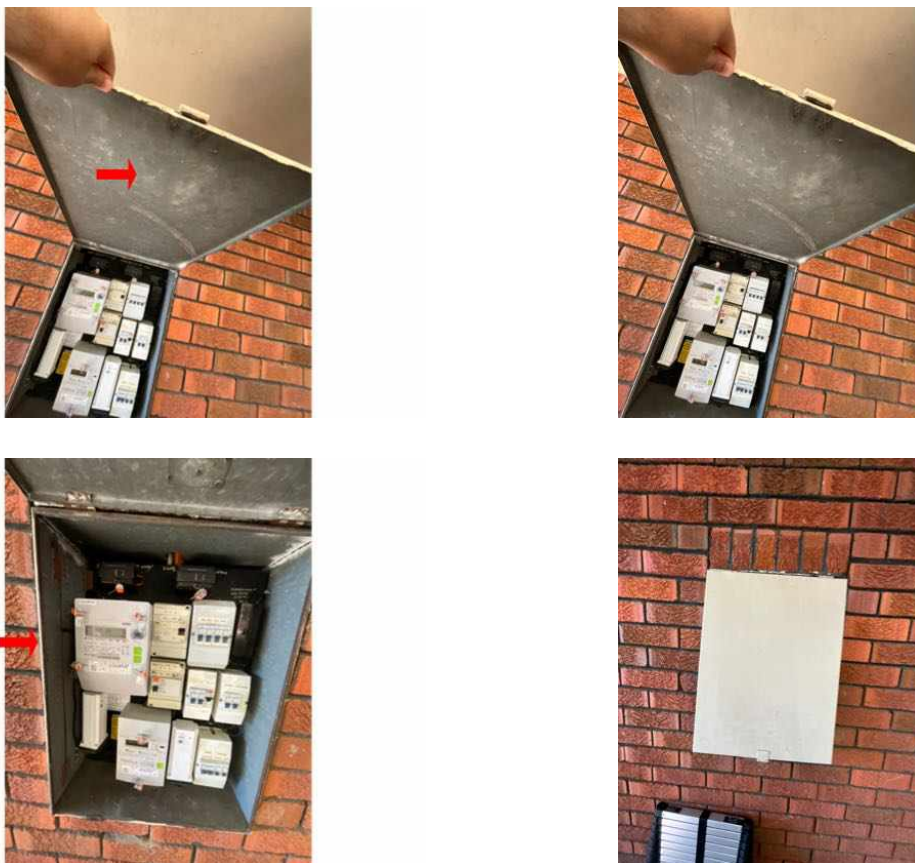
Building: Main Building
Location: Exterior walls - right side
Finding: No Evidence of Termite Management System - Durable notice / Legible Sticker
Information: The application of a pre & post-construction chemical termite barrier is highly recommended for all properties. Such barriers are highly effective in preventing termite attack on any timber building elements throughout the property.

Client must seek further information from the vendor or real estate agent if the

conditions of termite management systems were maintained.

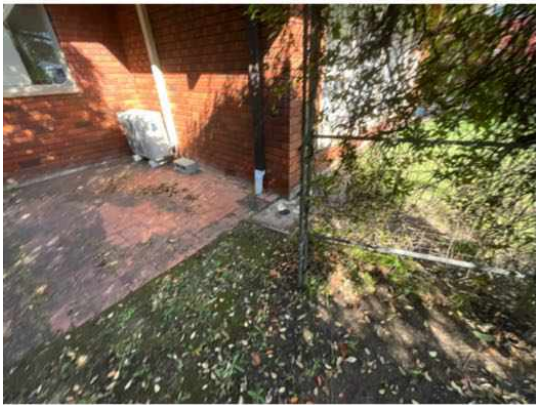
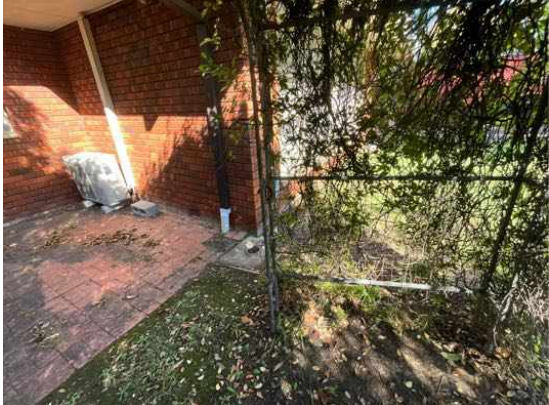
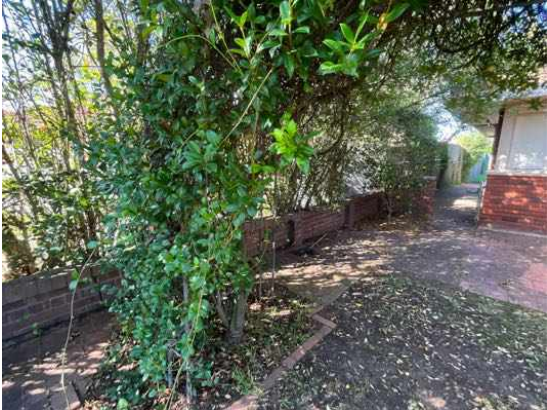
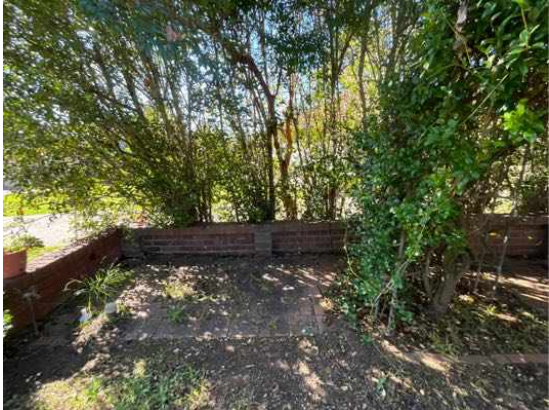
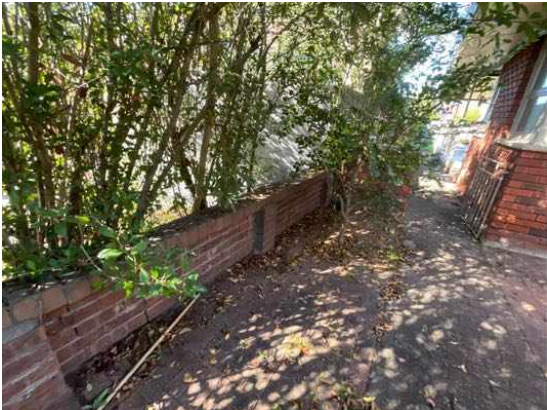
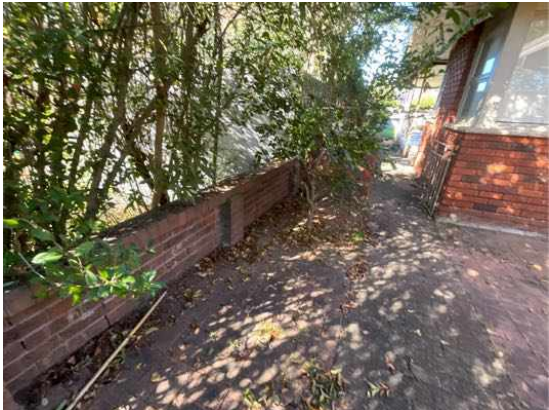
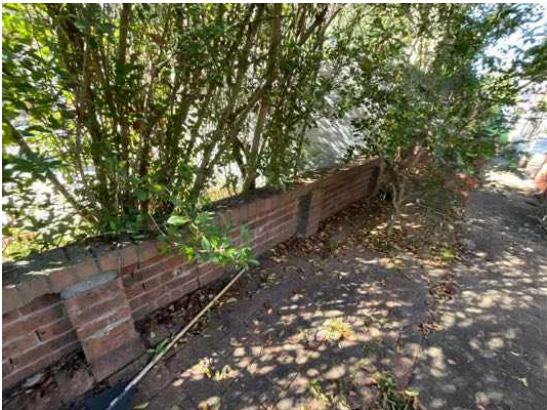
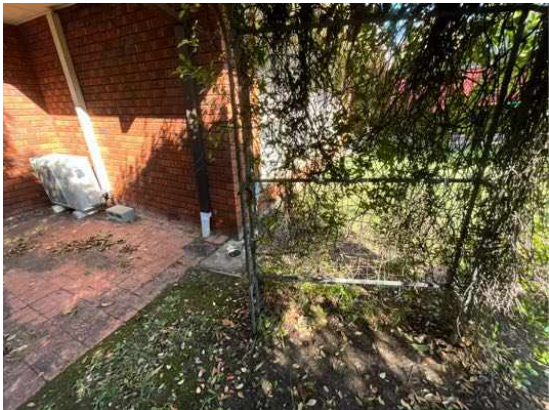
Finding 6.02

Building:	Main Building
Location:	All Areas
Finding:	Dense vegetation around a property can increase the risk of termite infestation
Information:	The presence of dense vegetation around a property can increase the risk of termite infestation, as it provides a conducive environment for them. To address this, consider maintaining a clear space between the vegetation and your home. If you suspect a termite issue, it's advisable to consult with a licensed pest control professional for inspection and treatment.

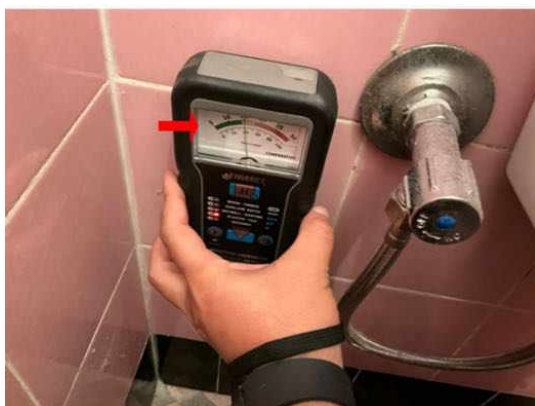
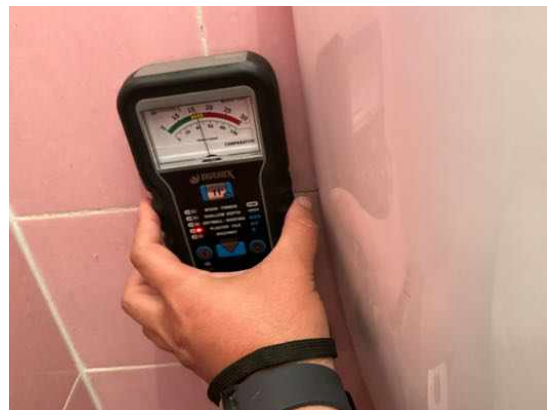
Finding 6.07

Building:	Main Building
Location:	Toilet (WC)
Finding:	Excessive moisture - Conducive to Timber pest
Information:	Excessive moisture can attract termites and produce conditions that promote fungal growth and wood decay.

Excessive moisture is generally caused by deteriorated inadequate or missing roof drainage leaking plumbing pipes or fixtures poorly plumbed HWS overflows or condenser units and poor site drainage.

If mould growth has been found there may be environmental biological or health issues involved. In these cases an appropriately qualified inspector should also be contacted.

Prior to any remedial works being performed a qualified plumber should be appointed to further inspect the property and to identify the cause of the excessive moisture. Works to remove affected building elements may then be necessary and should be performed by an appropriate tradesperson.

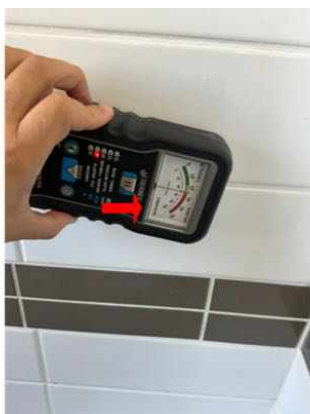
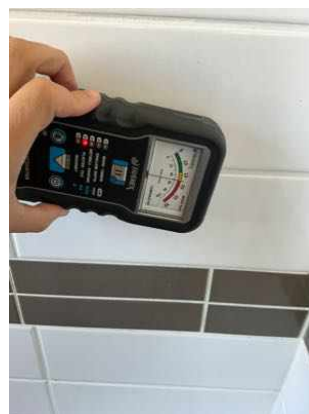
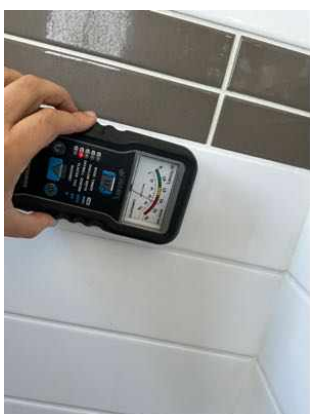
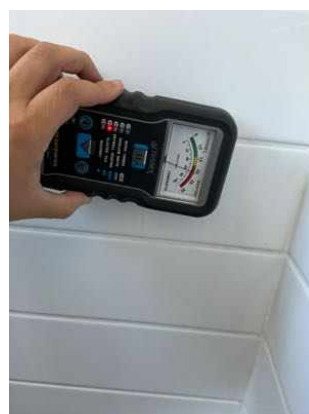
Finding 6.08

Building:	Main Building
-----------	---------------

Location: Ensuite
 Finding: Excessive moisture - Conducive to Timber pest
 Information: Excessive moisture can attract termites and produce conditions that promote fungal growth and wood decay.

Excessive moisture is generally caused by deteriorated inadequate or missing roof drainage leaking plumbing pipes or fixtures poorly plumbed HWS overflows or condenser units and poor site drainage.

If mould growth has been found there may be environmental biological or health issues involved. In these cases an appropriately qualified inspector should also be contacted.

Prior to any remedial works being performed a qualified plumber should be appointed to further inspect the property and to identify the cause of the excessive moisture. Works to remove affected building elements may then be necessary and should be performed by an appropriate tradesperson.

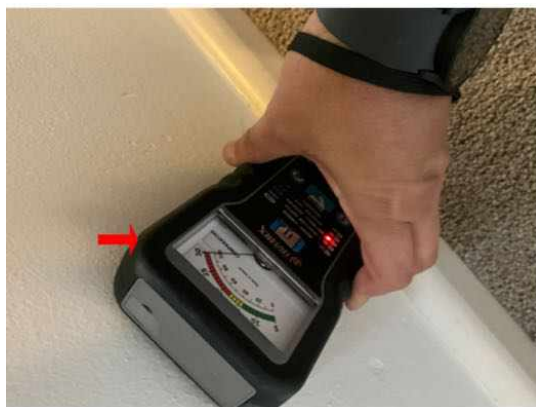
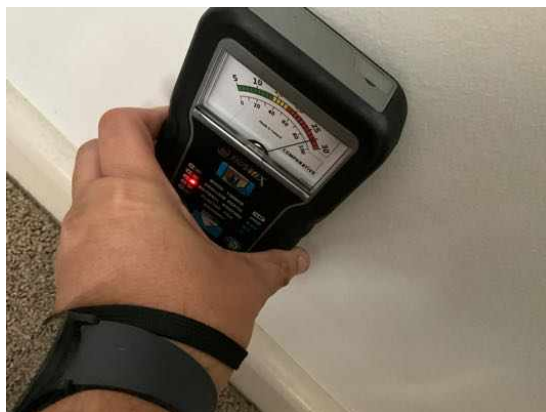
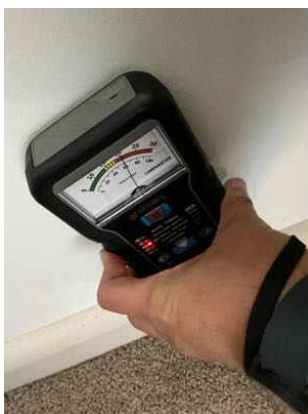
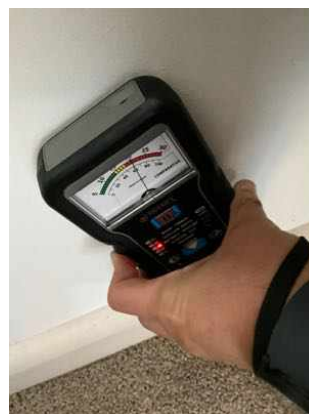
Finding 6.09

Building: Main Building
 Location: All Areas
 Finding: Excessive moisture - Conducive to Timber pest

Information: Excessive moisture can attract termites and produce conditions that promote fungal growth and wood decay.

Excessive moisture is generally caused by deteriorated inadequate or missing roof drainage leaking plumbing pipes or fixtures poorly plumbed HWS overflows or condenser units and poor site drainage.

If mould growth has been found there may be environmental biological or health issues involved. In these cases an appropriately qualified inspector should also be contacted.

Prior to any remedial works being performed a qualified plumber should be appointed to further inspect the property and to identify the cause of the excessive moisture. Works to remove affected building elements may then be necessary and should be performed by an appropriate tradesperson.

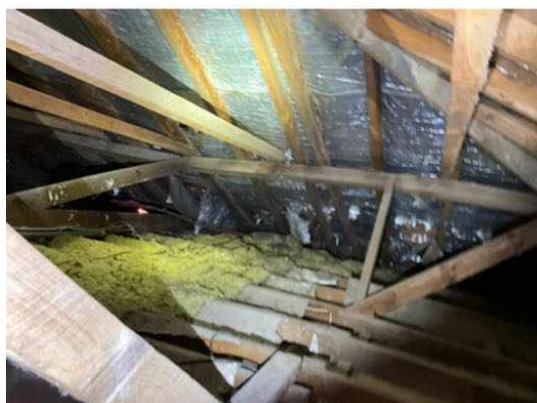
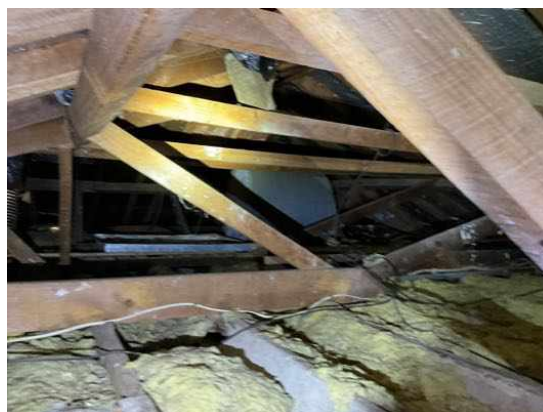
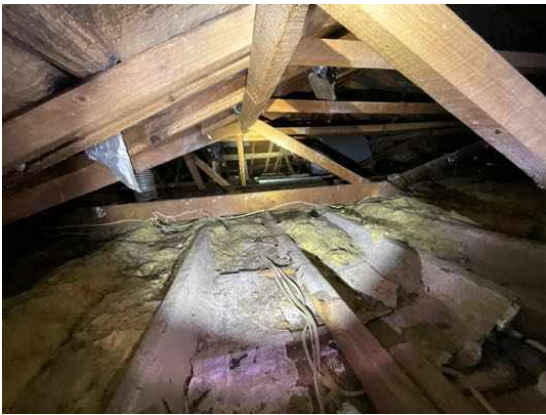
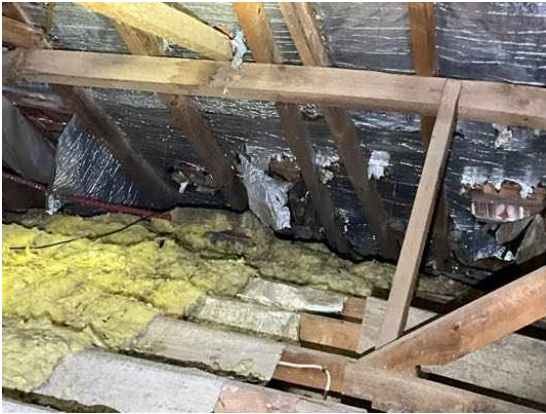
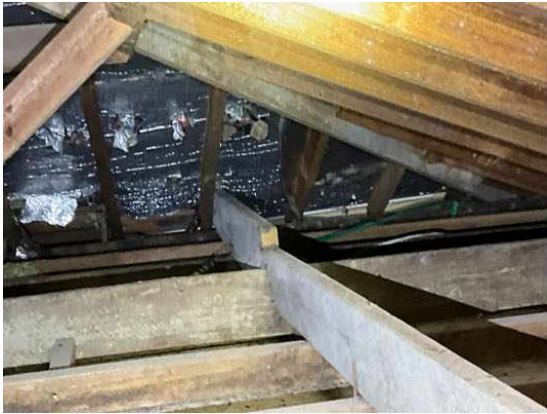
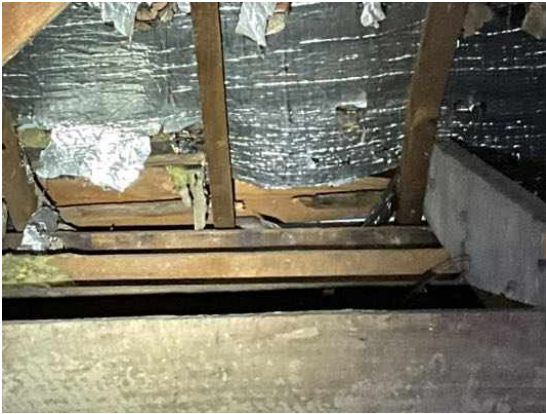
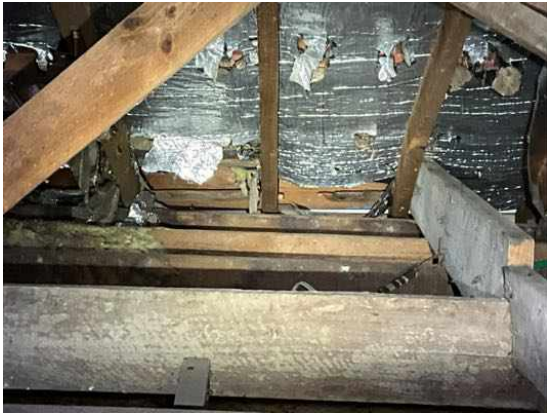
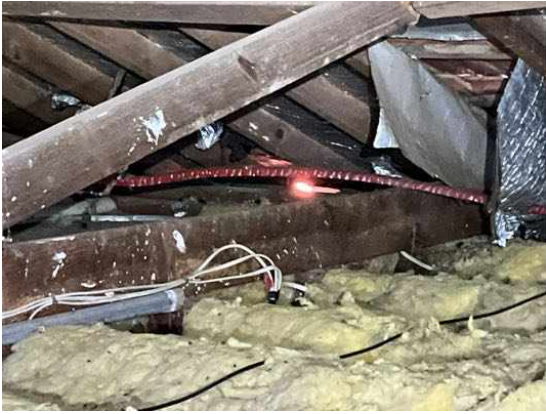
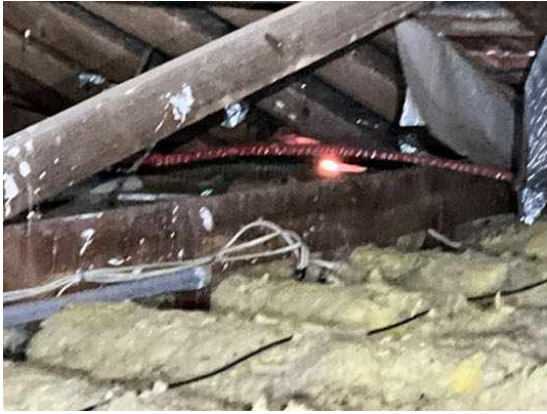
Finding 6.10

Building:	Main Building
Location:	Roof Void
Finding:	Roof void exhibits conspicuous signs of excessive moisture
Information:	The roof void exhibits conspicuous signs of excessive moisture, evident through water staining within the sarking material.

Risk in Terms of Timber Pest: The excessive moisture within the roof void poses a significant risk for timber pests such as termites, as it creates an ideal environment for infestation and proliferation. The damp conditions promote wood decay, making the structure susceptible to damage by these pests.

A qualified roofing contractor and a professional pest control service specialized in timber pest management should be engaged to rectify the issue. They can assess the extent of moisture damage, address any underlying structural issues, and implement effective solutions to mitigate the risk of timber pest infestation.

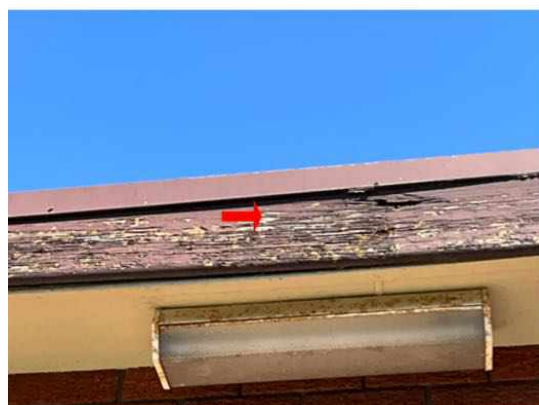
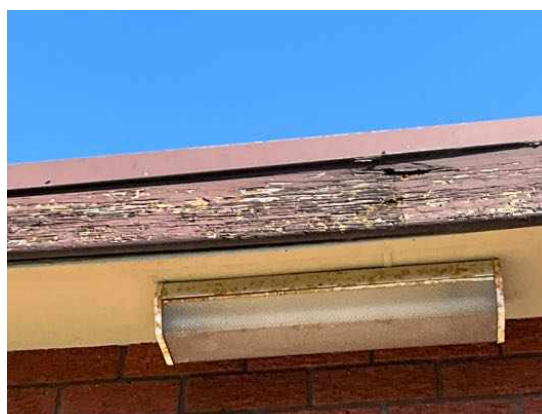
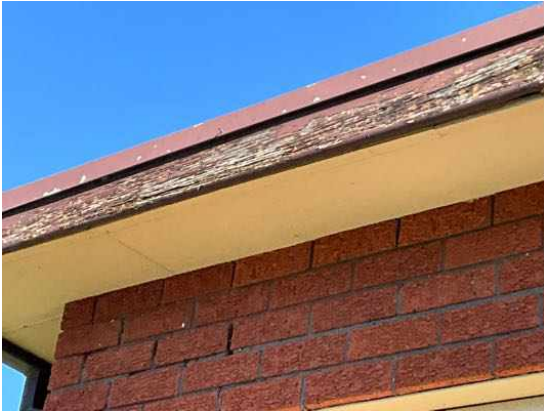
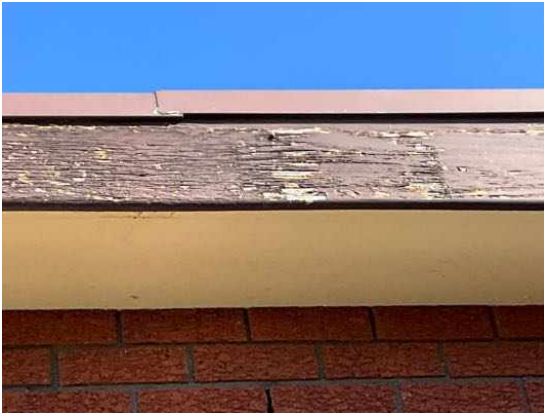
Finding 7.01

Building:	Main Building
Location:	All Areas
Finding:	Fascias - Wood rot
Information:	Wood rot was found to be affecting fascias and barges in this area, evidenced by the presence of mould on the surface in some areas. Wood rot, also known as Fungal Decay, occurs when timbers and other cellulose building materials are exposed to damp conditions on an ongoing basis.

It is likely that this wood rot has developed as a result of faults in the roof plumbing, creating excessive moisture in this areas. Frequent exposure to rain and other weather conditions also make fascias and barges susceptible to accelerated deterioration.

Early intervention and regular maintenance will prolong the useful life of these building elements. Prior to any works being performed, the cause of the moisture that has created the visible wood rot should be identified and addressed in a suitable manner.

It is advised that a roof plumber be appointed to inspect all roof plumbing and subsequently identify the cause of the wood rot. Replacement of affected fascias and barges may then be a necessary step in protecting surrounding building elements from such deterioration.

A qualified plumber may be appointed to assess the cause of excessive moisture and to provide advice on any remedial works as required. A qualified carpenter or registered builder may also be required to replace affected building materials.

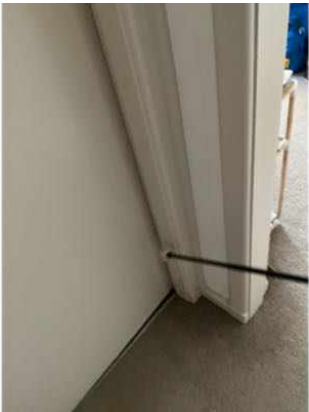
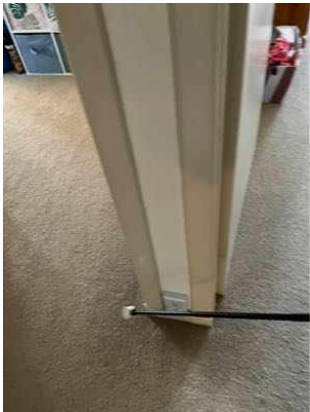
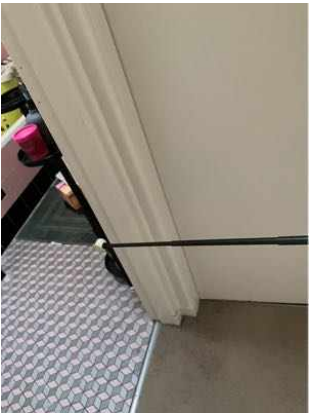
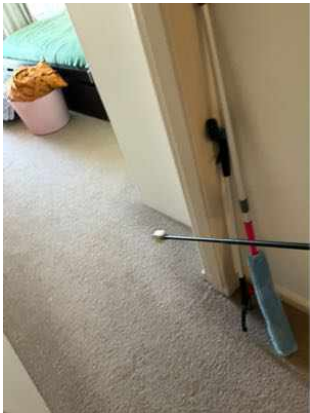
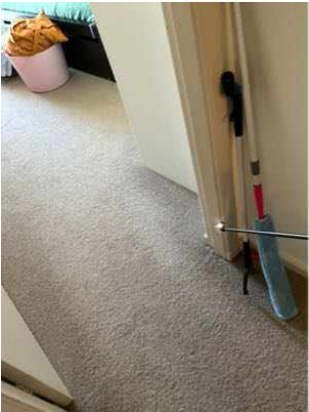
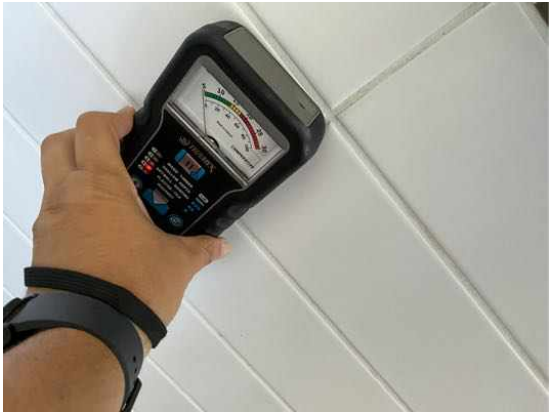
Noted Item

Building: Main Building
Location: All Areas
Finding: Additional Photos
Information: Additional photos are provided for your general reference
