Building and Timber Pest Inspection Report

Inspection Date: Wed, 8 Apr 2026

Property Address: 24 Hornseywood Ave, Penrith NSW 2750,
Australia

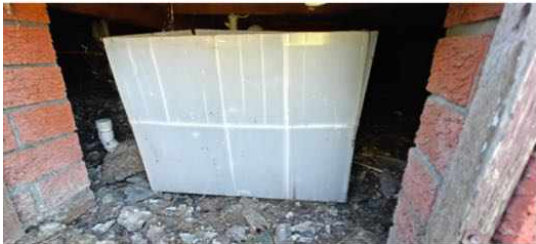
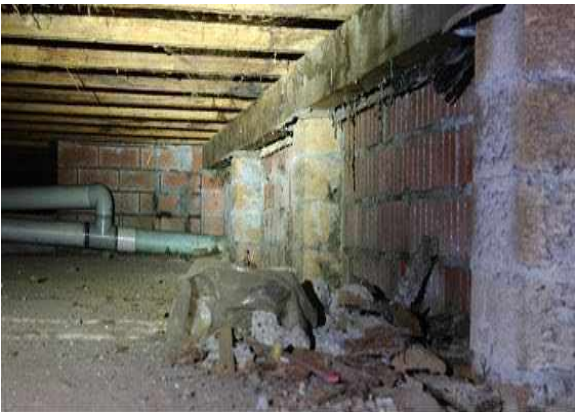
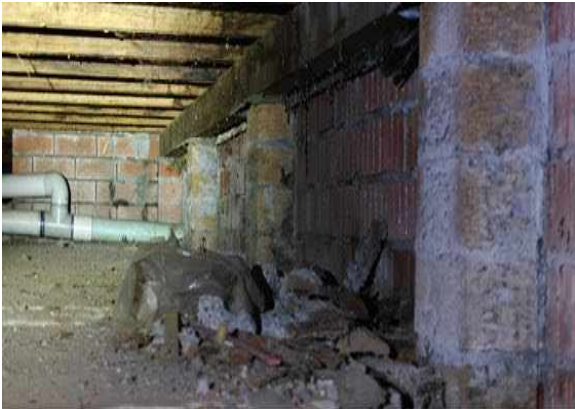
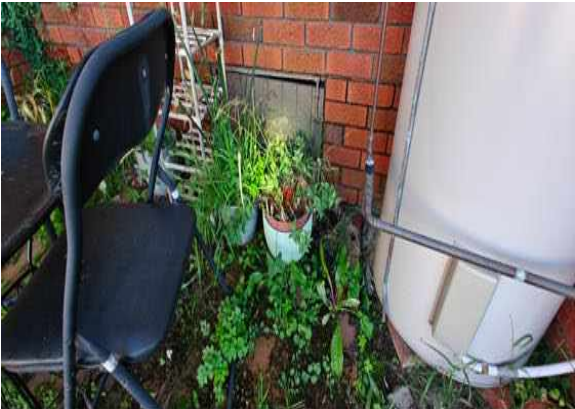
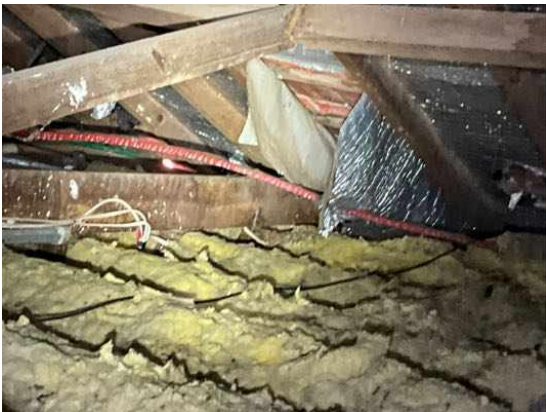
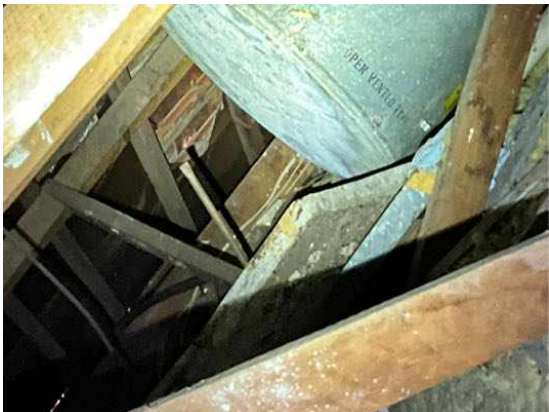
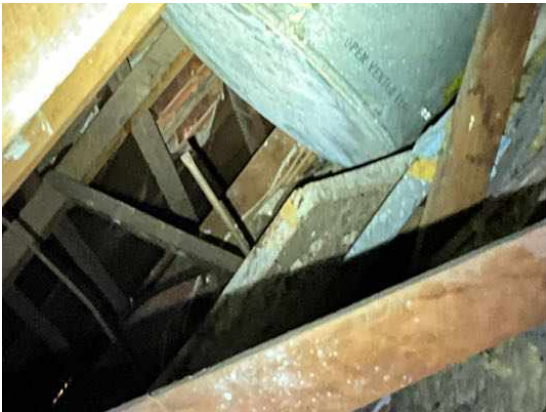
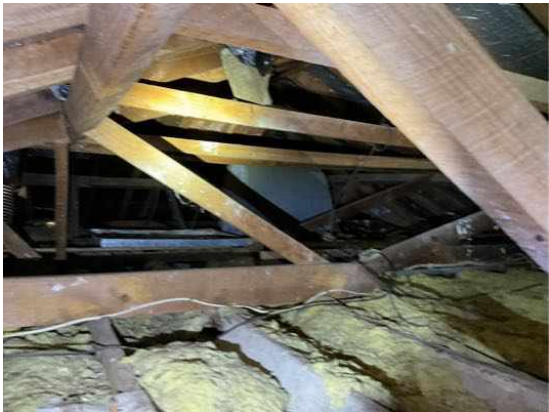
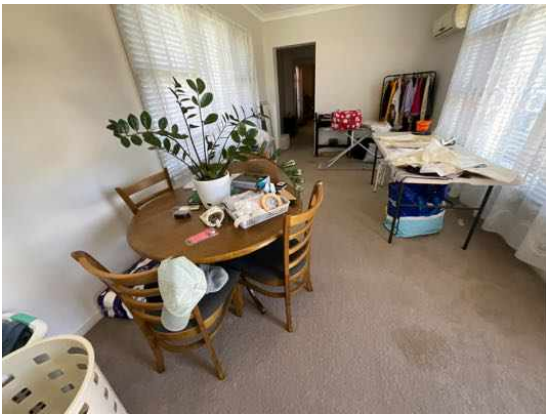
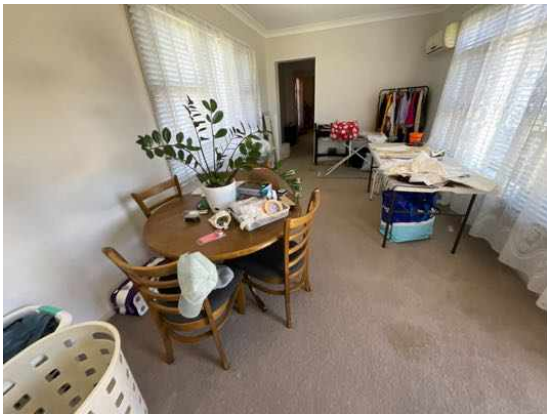
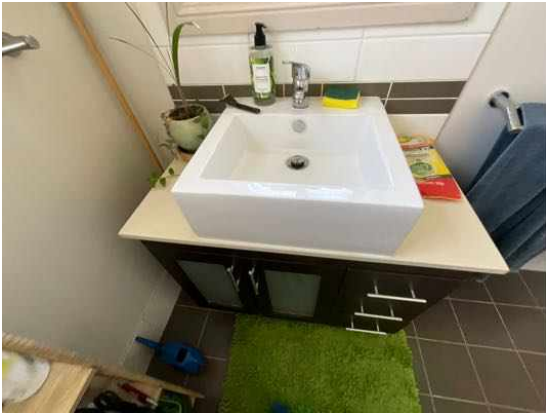
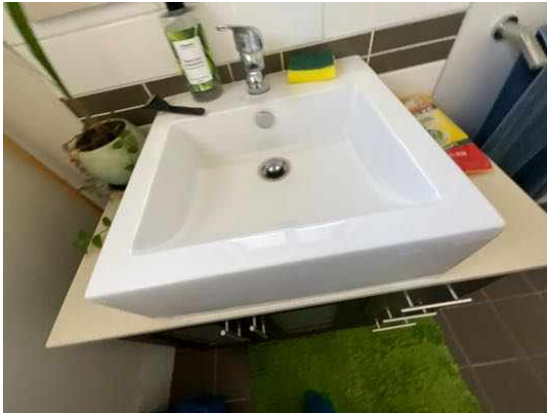
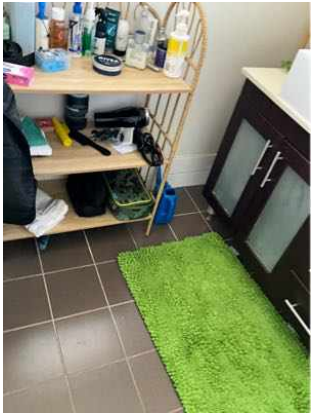
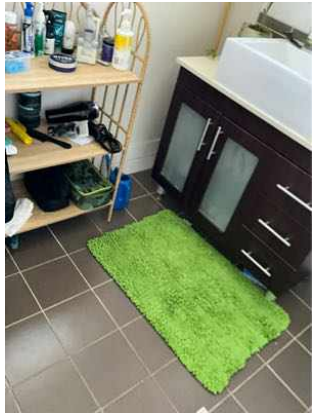
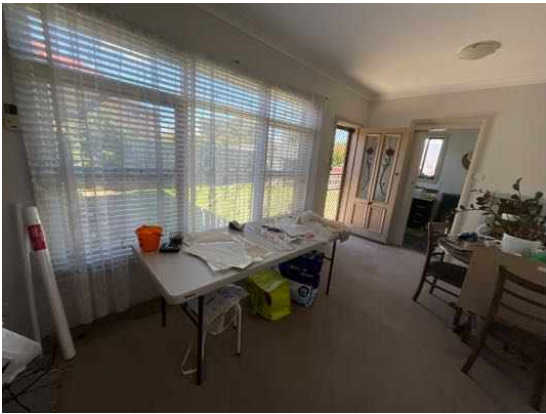
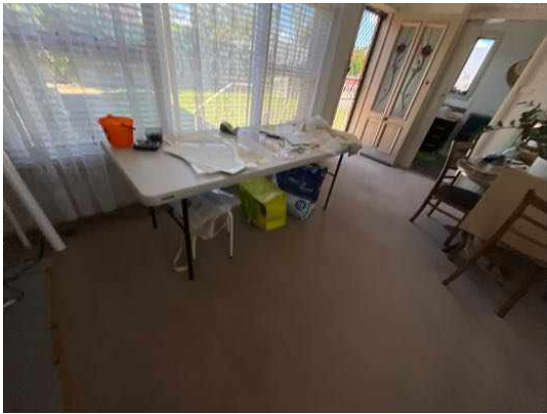
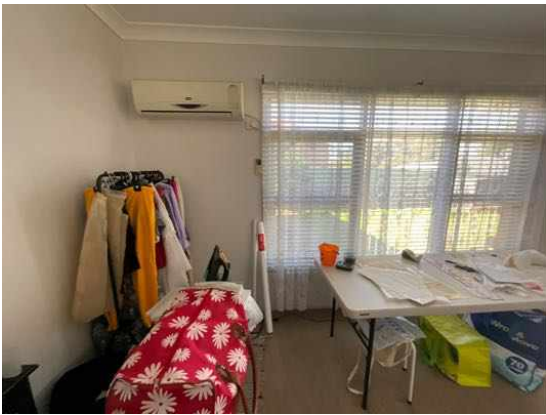
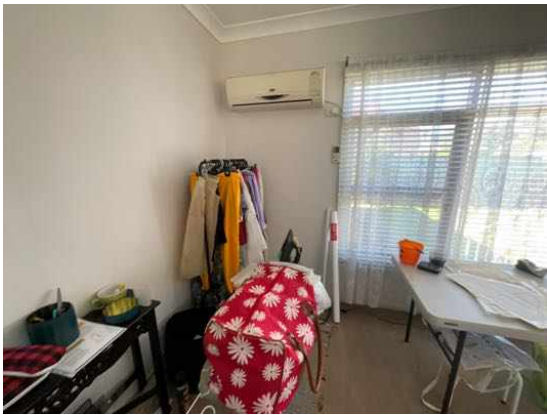
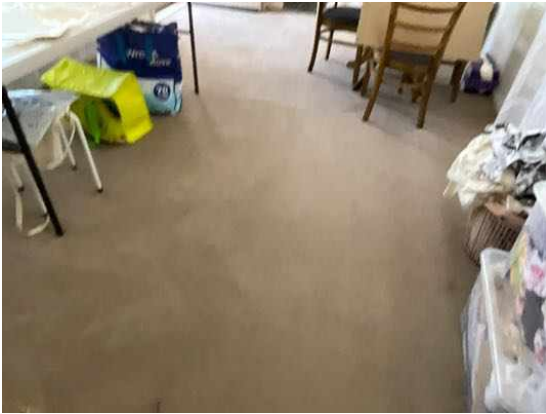
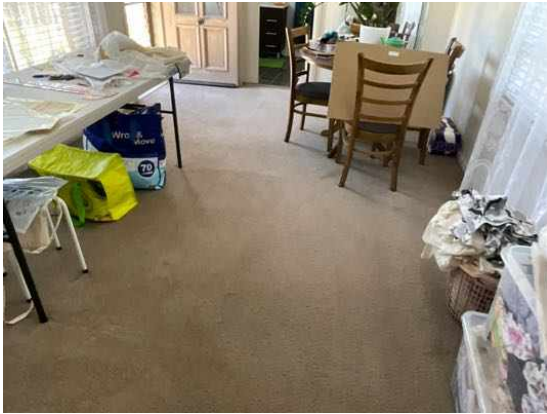
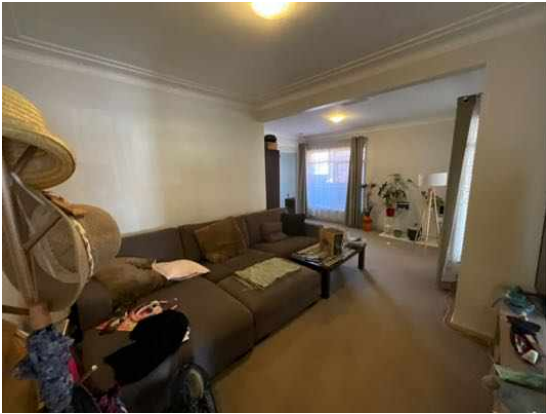
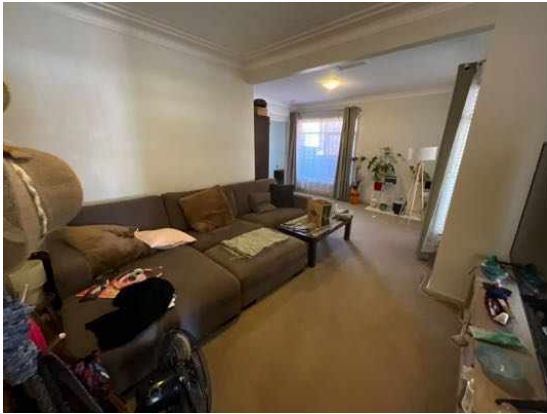
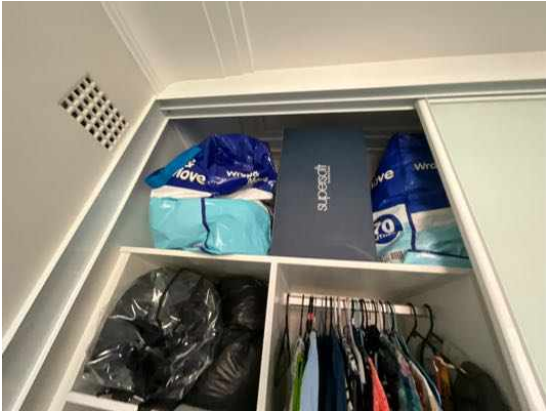
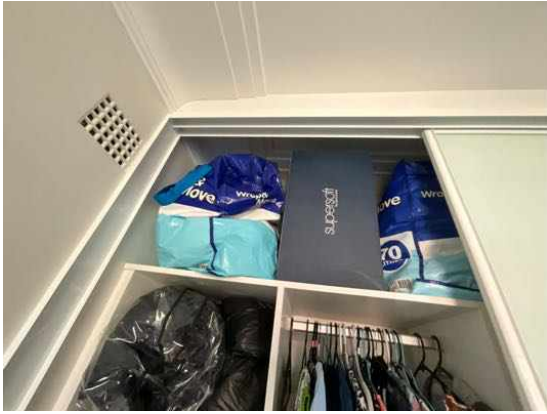
Building:	Main Building
Location:	All Areas
Finding:	Additional Photos - Obstructions and Limitations
Information:	These photographs are an indication of the obstructions and limitations which impeded full inspection of the property at the time of inspection. These obstructions can hide an array of defects and should be removed to allow full inspection to be carried out. A re-inspection is recommended once the areas are made accessible.
