Building and Timber Pest Inspection Report

Inspection Date: Tue, 24 Mar 2026

Property Address: 9/3 Hampstead Rd, Homebush West NSW
2140, Australia

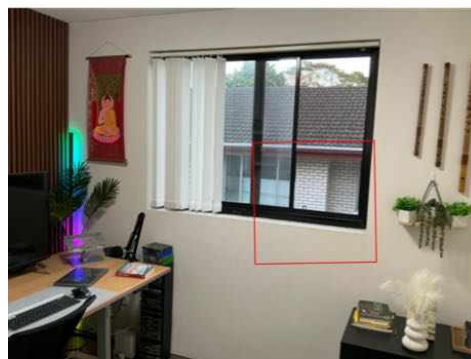
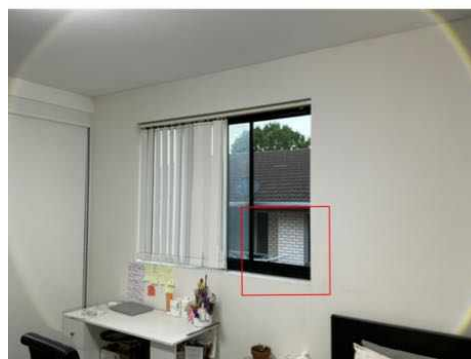
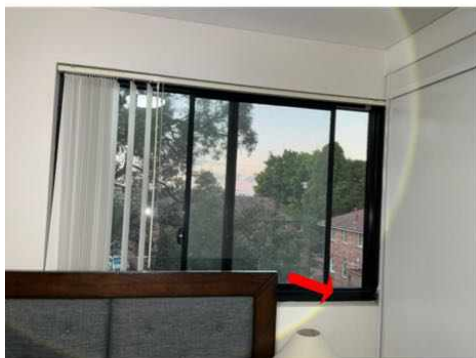
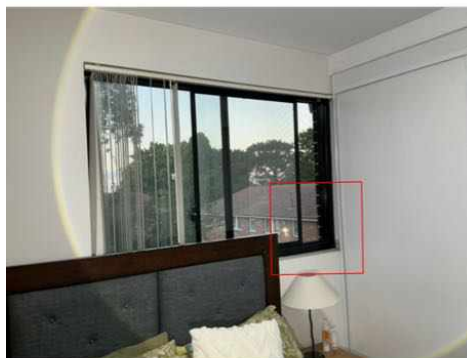
Building: Main Building
 Location: All Areas
 Finding: Window Restrictors - Recommended
 Information: Upstairs windows did not have window restrictors installed. Although not a requirement at the time of construction, it is advisable to install window opening restrictors on all second storey windows with sill heights below 1.7 meter and potential fall of 2 meters or more.

If you live in a strata scheme, window safety devices must be installed on all applicable windows by 13 March 2018. Residents with safety devices installed can still fully open their windows but it's recommended that devices be engaged whenever children are present, to prevent falls.

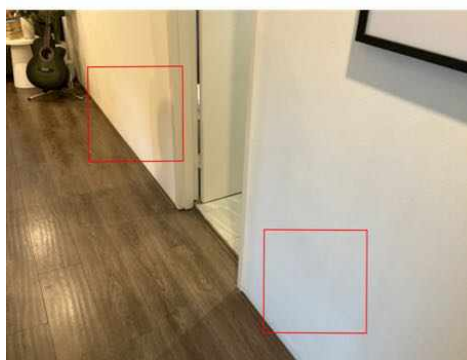
Building:	Main Building
Location:	Hallway opposite both bathrooms
Finding:	Shower Damp - Adjacent Bathroom (Monitoring)
Information:	At the time of inspection, elevated moisture levels were detected on the wall adjacent to the shower area. While no visible water damage or deterioration was noted, the presence of moisture suggests possible seepage or condensation associated with regular shower use.

At this stage, no immediate action is required. However, the area should be monitored over the next 12 months for any signs of deterioration such as staining, bubbling paint, or mould growth. It should be noted that moisture ingress of this nature does not generally resolve without intervention, and at some point remedial works are likely to be required. Should conditions worsen, the client is advised to engage services of a licensed plumber or waterproofing specialist to rectify the issue of moisture before this minor defect turns into major defect.

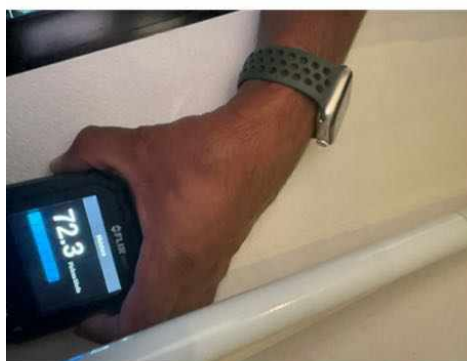
Finding 3.02

Building:	Main Building
Location:	Living Room
Finding:	Rising Damp / Moisture Ingress
Information:	At the time of inspection, signs consistent with rising damp and moisture ingress were noted to the wall in the living room. The condition appears to be associated with the adjoining balcony area, where deteriorated sealant and loose/delaminating tiles were observed compromising the waterproofing allowing moisture to penetrate through to the internal wall.

This condition is indicative of water ingress from the external balcony area rather than an internal plumbing issue, and if left unaddressed, may lead to further deterioration of

internal finishes, paint damage, and potential mould growth over time.

The client is advised to engage the services of a qualified tiler to repair and resurface the affected balcony tiling. The internal affected area should be monitored over a 12-month period, and if signs of progression such as bubbling paint, staining, or surface deterioration are observed, further assessment by a suitably qualified waterproofing tradesperson is recommended.

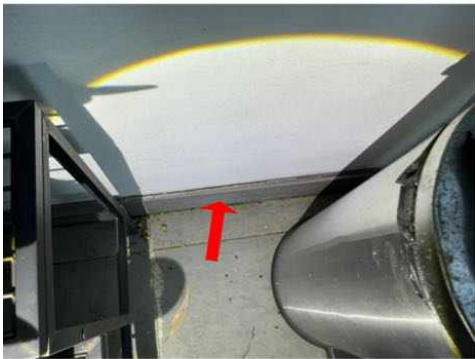
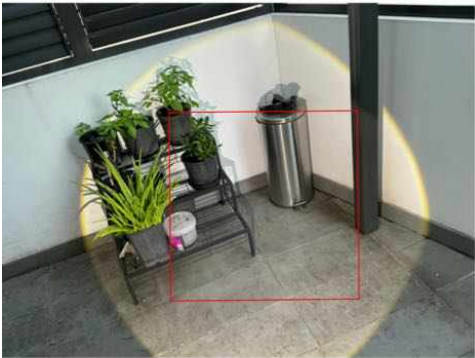
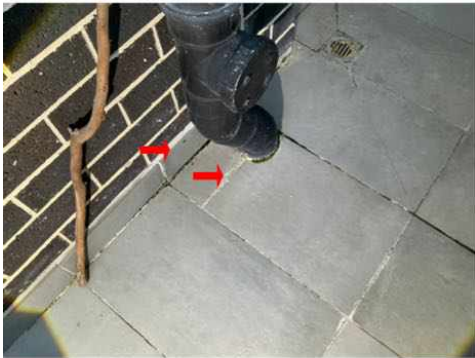
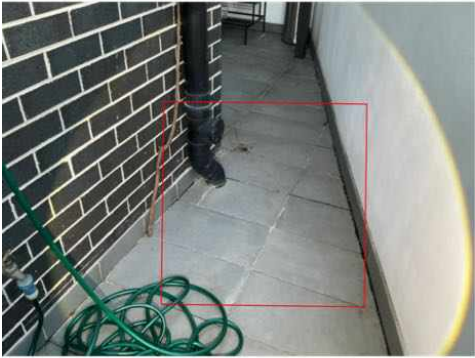
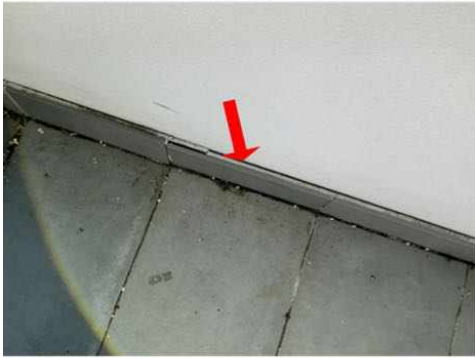
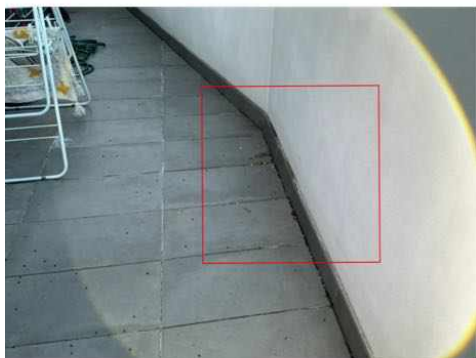
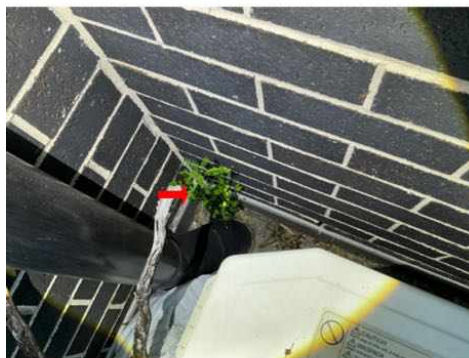
Finding 3.03

Building:	Main Building
Location:	Balcony
Finding:	Deteriorated Sealant and Waterproofing to Balcony Tiling
Information:	At the time of inspection, deterioration of sealant and grout joints was noted across the balcony tiled areas. There is visible white powdery residue (efflorescence) present, which is typically caused by moisture movement through the substrate bringing dissolved salts to the surface. In addition, plant/vegetation growth was observed within tile joints and edges, indicating prolonged moisture retention and lack of adequate sealing.

These conditions suggest that the waterproofing system beneath the tiles is deteriorating, allowing moisture ingress over time. If left unaddressed, this can lead to further deterioration of the substrate, internal moisture penetration, and damage to

This is considered a maintenance-related defect with potential to develop into a major defect if not rectified.

The client is advised to engage the services of a qualified tiling and waterproofing specialist to remove affected tiles where required, reinstate proper waterproofing, reseal joints, and ensure adequate falls and drainage. Addressing these exposed areas promptly will help prevent long-term damage and ongoing moisture-related issues.

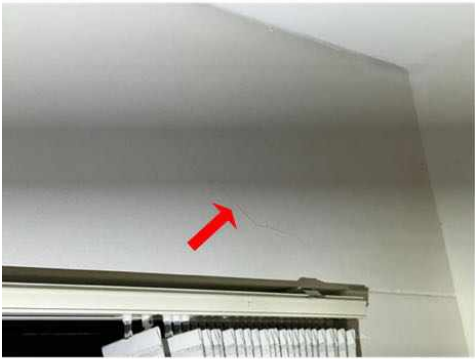
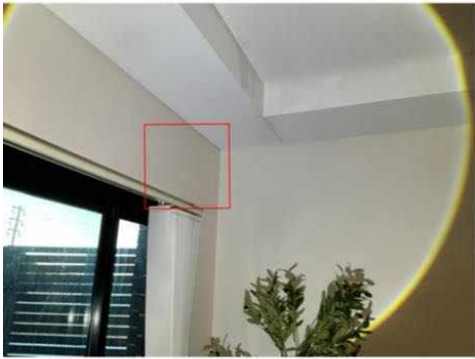
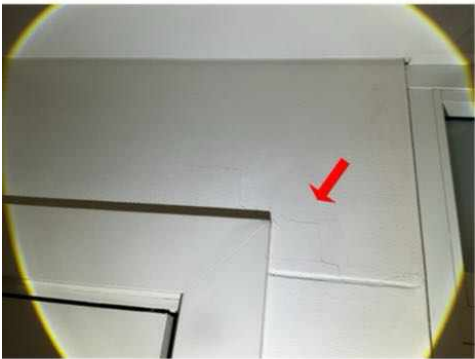
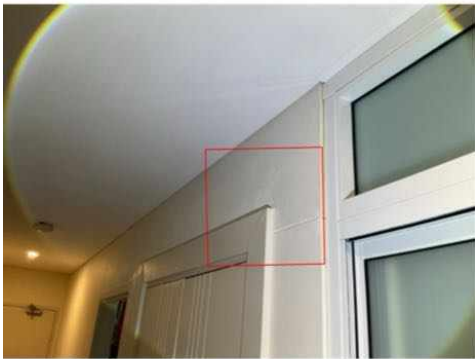
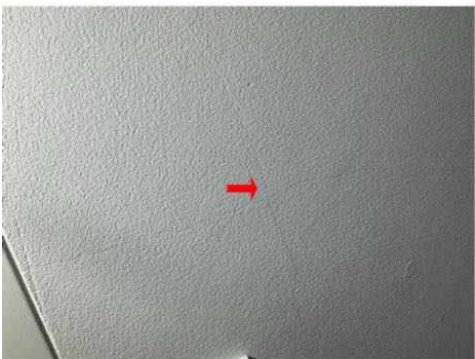
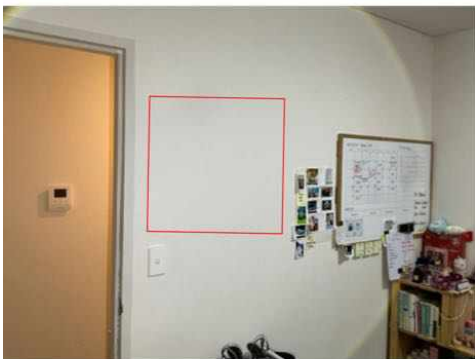
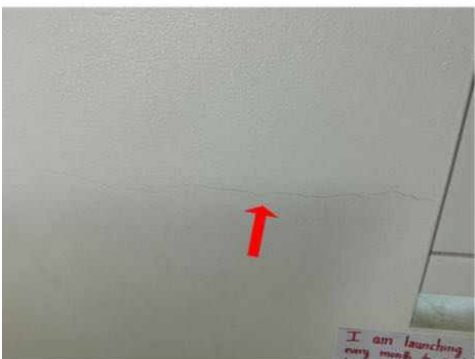
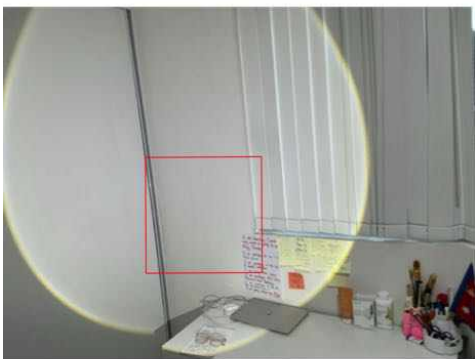
Finding 3.04

Building:	Main Building
Location:	Living, Hallway, Bedroom 2
Finding:	Cracking - Damage Category 1 - Fine (up to 1mm)
Information:	Although fine cracks are quite noticeable, they are often only considered to be an appearance defect, and usually do not indicate any structural damage. Generally, the cause of a fine crack is indicative of a separation between building materials and finishes (e.g. paint, plaster, etc.) along joins.

Cracking of this nature can generally be repaired with minor sanding, filling and/or repainting. Such works should be performed by a qualified painter or a general handyman.

Monitoring of all cracking should be conducted frequently. Always contact a building inspector should cracks widen, lengthen, or become more numerous.

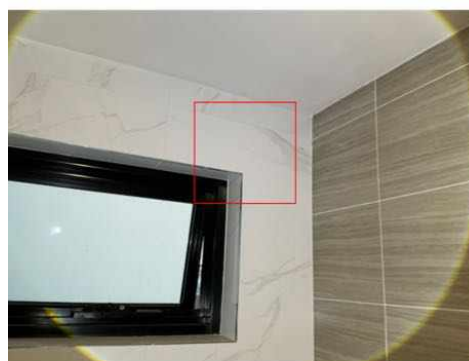
Finding 3.05

Building:	Main Building
Location:	Bathroom
Finding:	Tiles - Cracked and/or Damaged
Information:	At the time of inspection, cracking in the tiles was evident in this area. It is suspected that this cracking has occurred as a result of minor settlement or material shrinkage.

While the cracking appears to be minor, this area may be exposed to water, allowing potential for water penetration into adjoining sections of walls or flooring. In wet areas particularly, cracked or compromised tiles can allow moisture to bypass the surface finish and place additional stress on the underlying waterproofing membrane. Over time, this may contribute to deterioration of the waterproofing system and shorten its effective service life.

While not considered a matter of urgency, replacement of cracked floor tiles is recommended at the client's discretion, particularly in wet areas to preserve the integrity and longevity of the waterproofing system. A licensed tiling contractor may be appointed to perform these works.

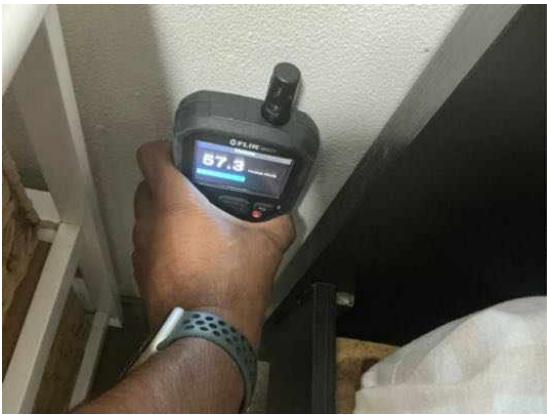
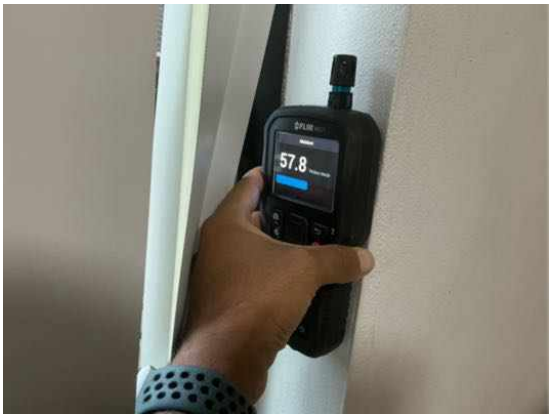
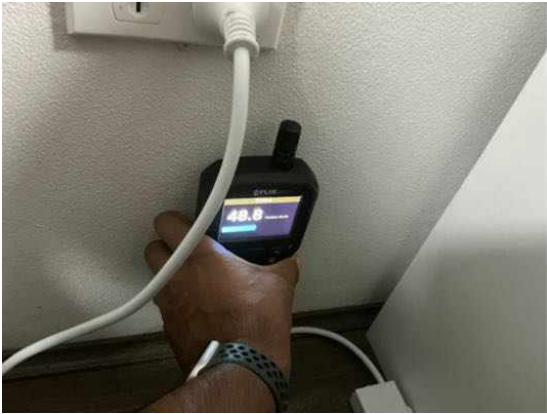
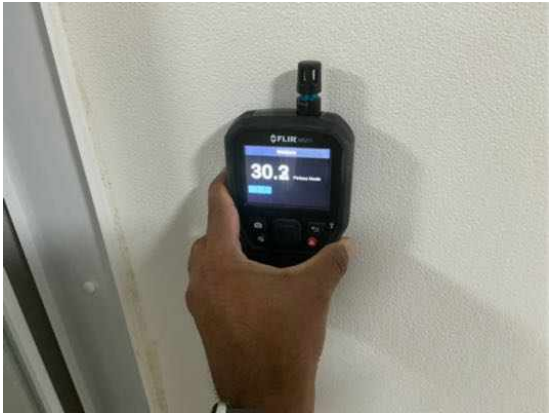
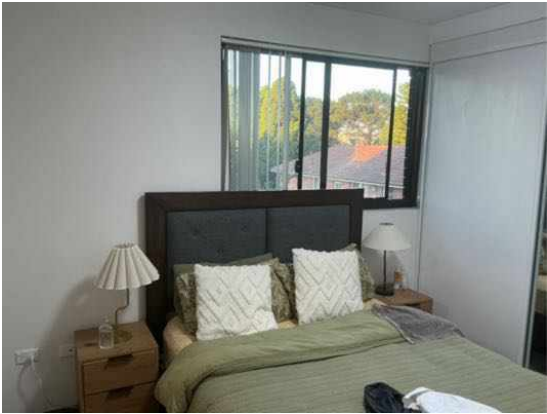
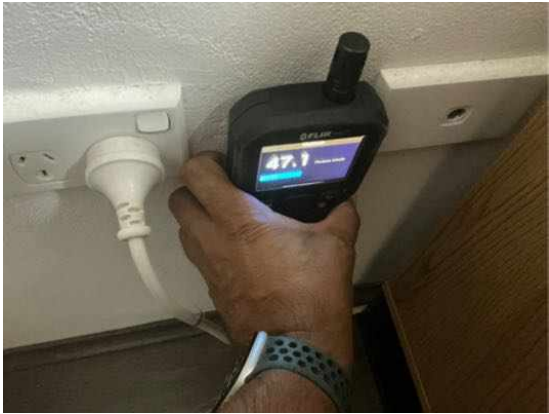
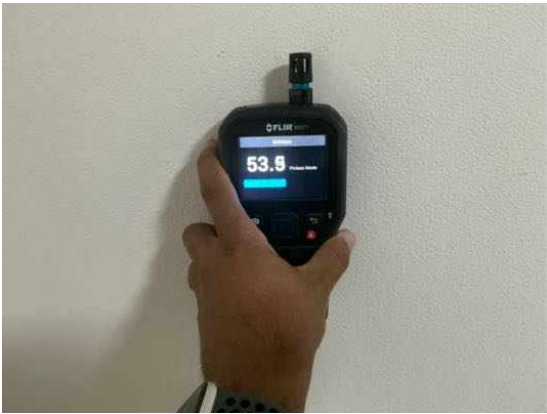
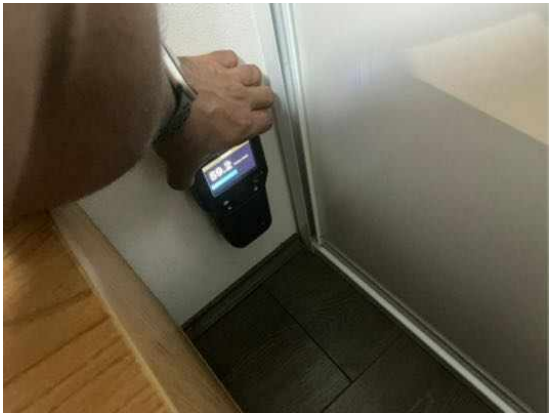
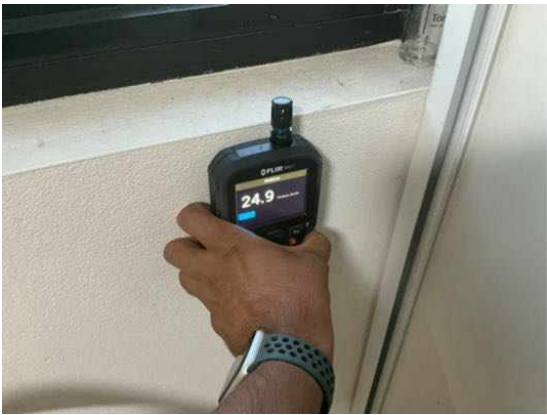
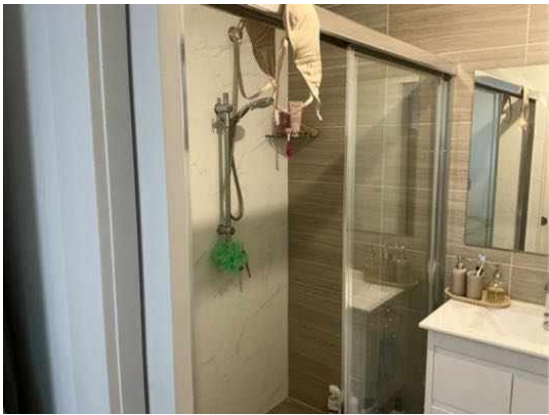
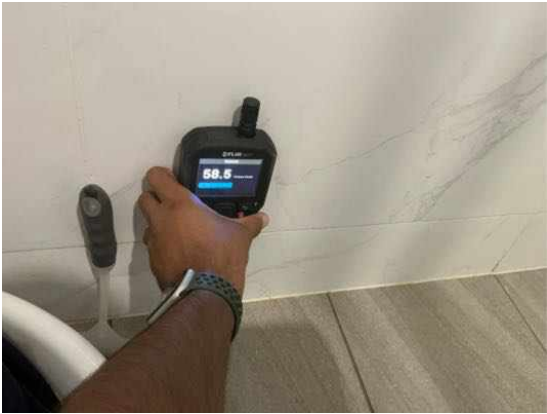
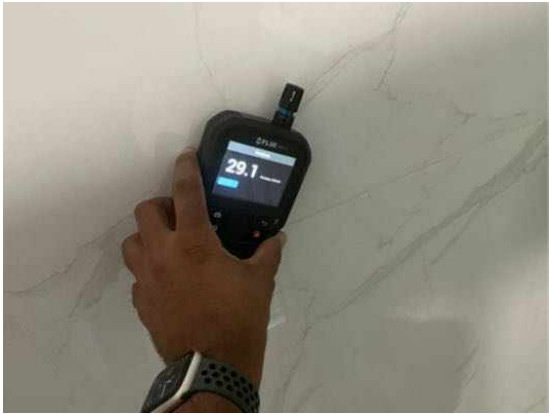
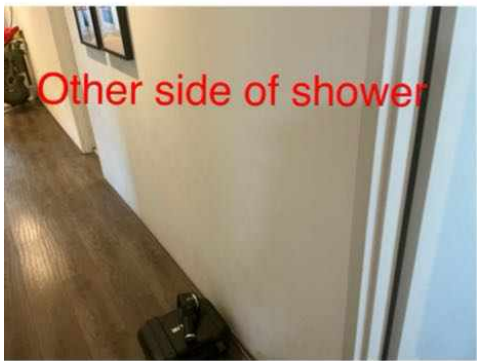
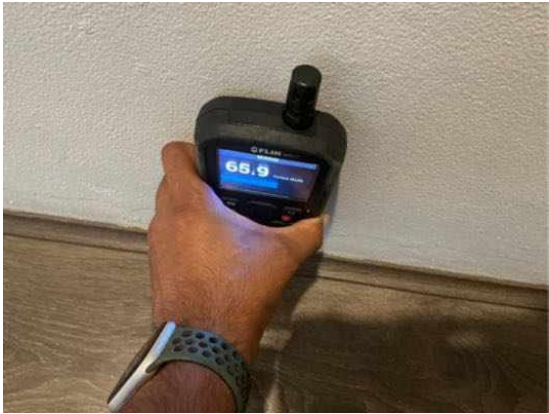
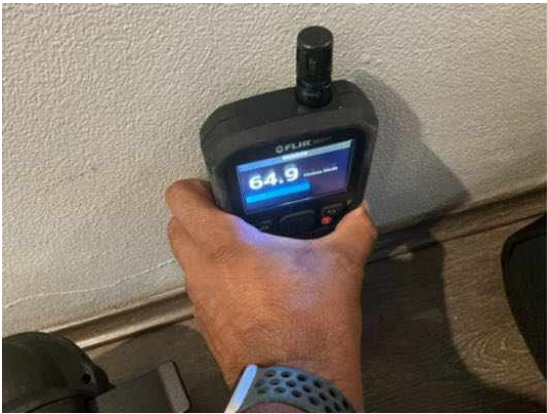
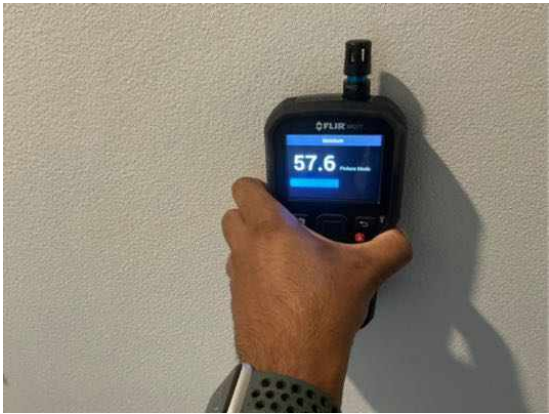
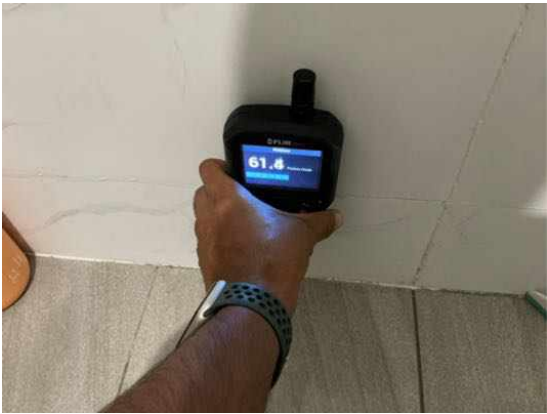
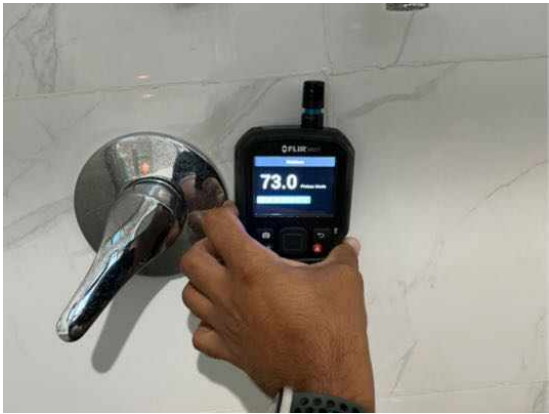
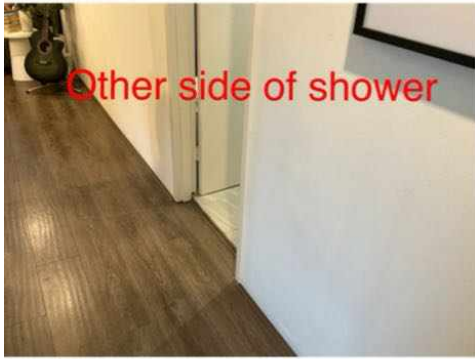
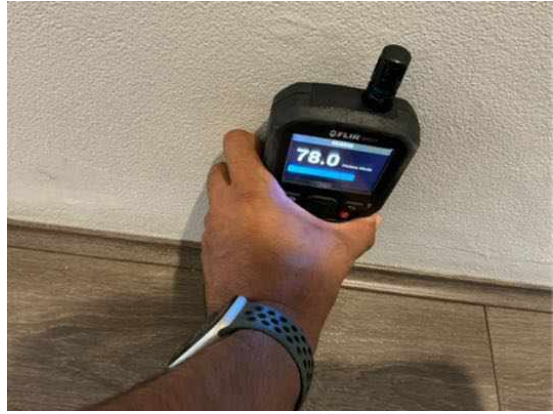
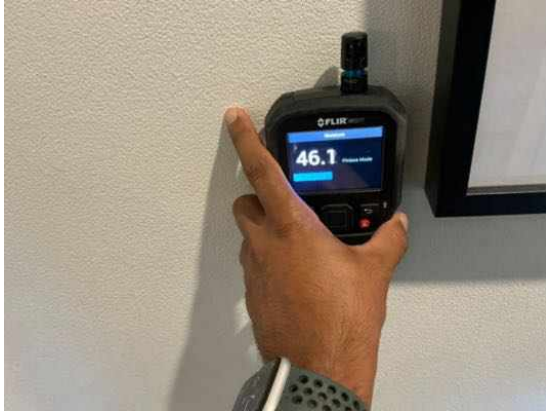
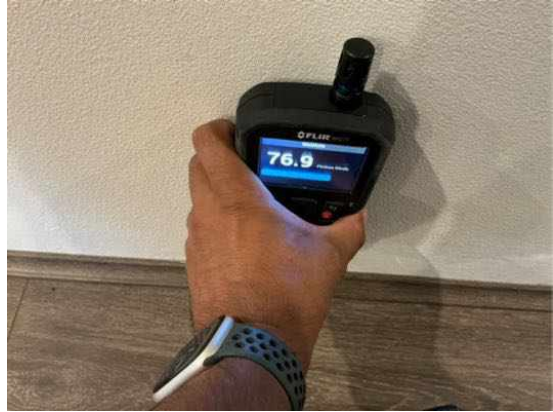
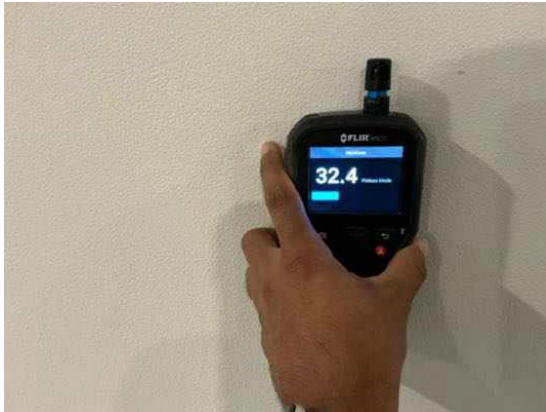
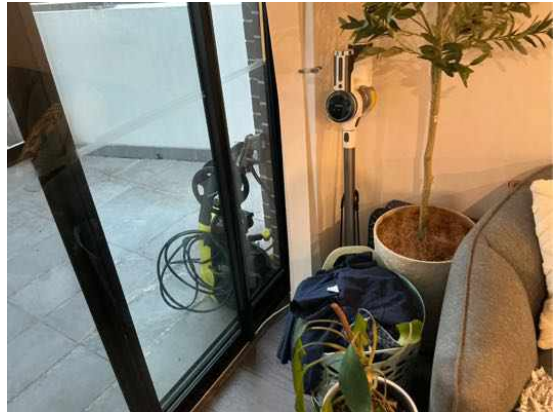
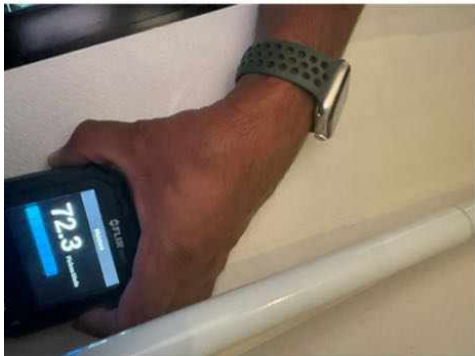
Building: Main Building
Location: All Areas
Finding: Additional Photos - Moisture Meter Readings
Information: Additional moisture meter reading photos have been provided for the property to offer further clarity on areas tested during the inspection. These photos are intended to give a visual reference for the specific locations where moisture levels were measured. These readings were taken at the time of the inspection to assess any potential moisture-related issues within the property. Any defects related to moisture that were identified during the inspection have been separately mentioned in the defect statements within the report.

It is important for the client to understand that moisture levels can fluctuate over time due to various factors, including changes in weather, humidity, and environmental conditions. While the readings reflect the property's moisture levels during the inspection, they may not represent future conditions, and increased moisture could lead to issues such as dampness, mould growth, or deterioration of building materials if left unmonitored.

For further clarification or additional information regarding the moisture readings, the client is encouraged to contact the building inspector directly. Regular monitoring of moisture-prone areas is recommended to ensure any emerging concerns are addressed promptly, particularly during wetter seasons or in high-humidity conditions.

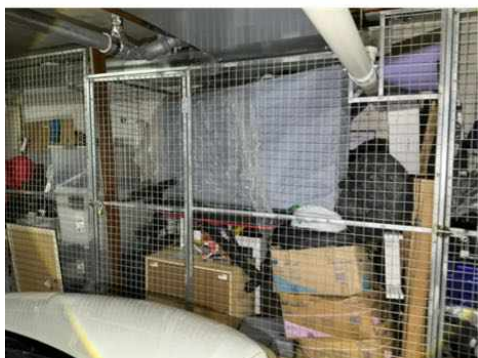
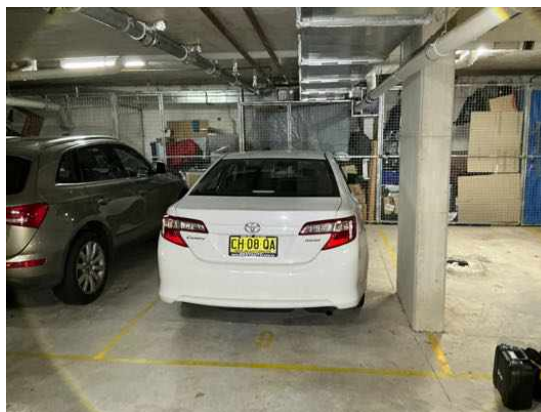
Building: Main Building
 Location: Basement
 Finding: Allocated Car Spaces & Storage Room
 Information: The accompanying photos are provided for your general reference, showcasing the current condition of the car parking spots and storage rooms as observed at the time

of inspection. It is important to note that these images are meant to serve as a visual snapshot of the property’s features at the time of the assessment. However, the client is strongly advised to confirm all allocations, such as car parking spots, storage rooms, and any associated rights or access, within the terms of the contract. Verifying these allocations through the contract ensures clarity and avoids potential disputes regarding ownership or usage. The photos included are intended to give an overview of the designated areas, but the final details should always be cross-referenced with the contractual agreements for accuracy and completeness.

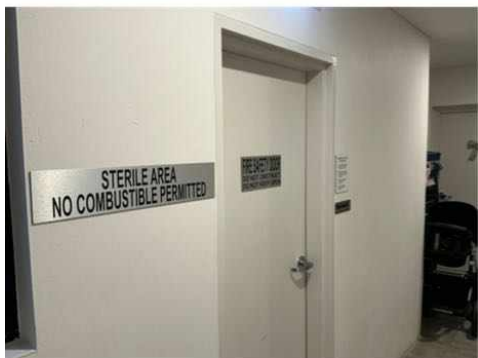
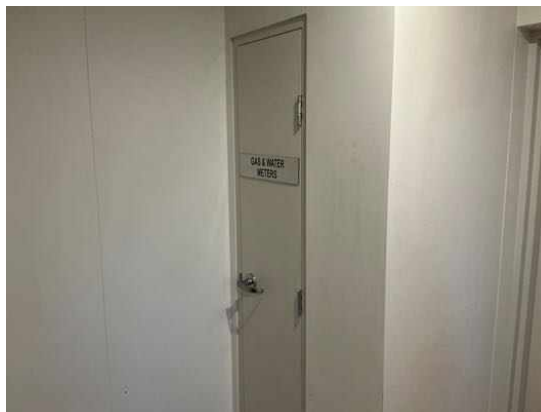
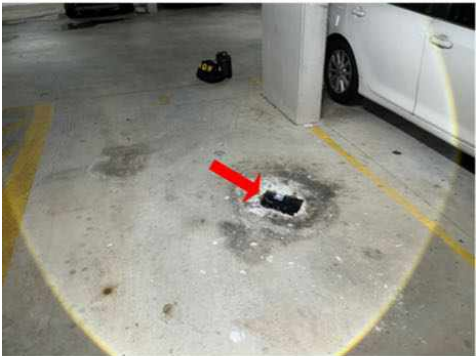
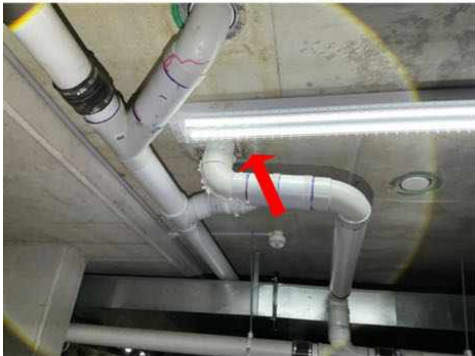
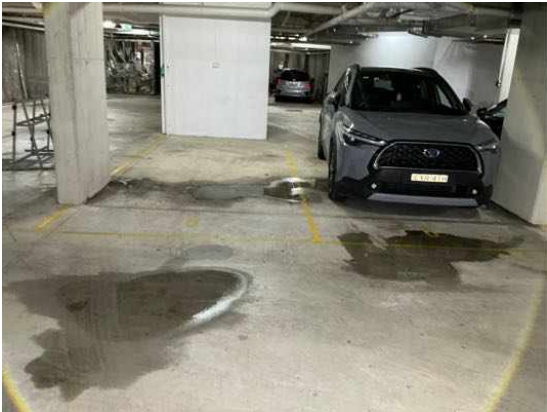
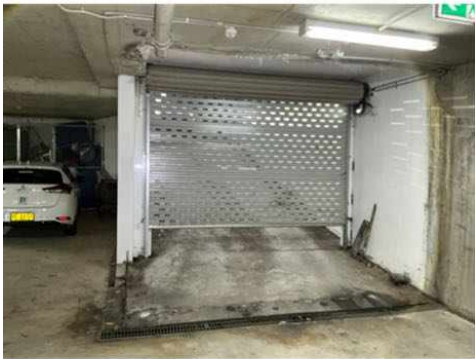
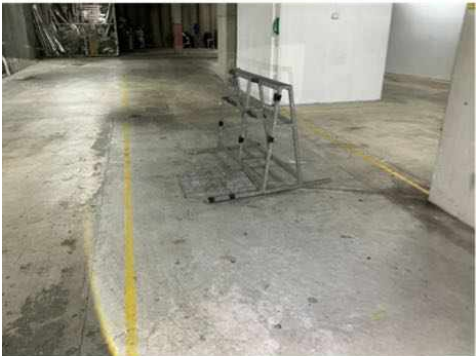
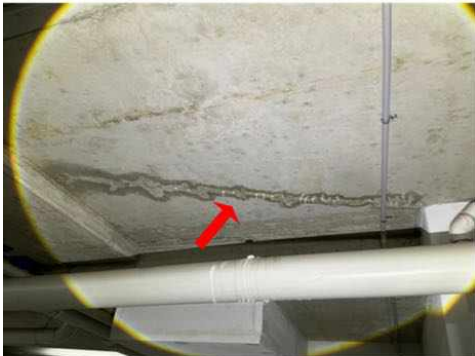
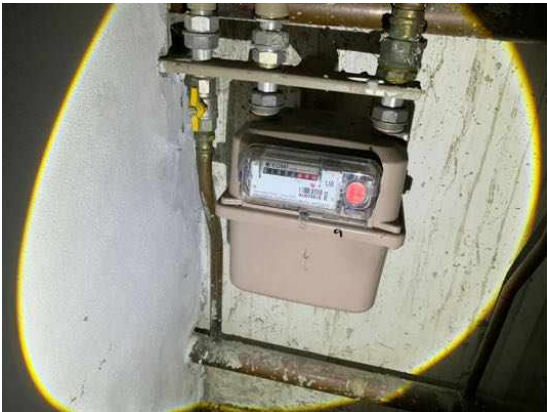
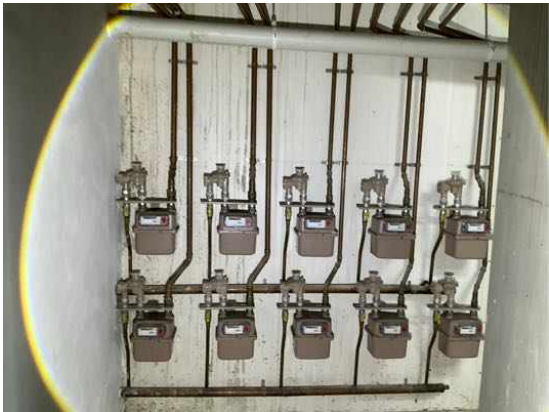
Building: Main Building
 Location: All Areas
 Finding: Additional Photos of Common Areas
 Information: Additional photos have been provided for your general reference. These images serve as visual documentation of the current condition of the common areas within the building complex at the time of inspection. It is recommended that the client consult with strata management regarding any necessary repairs or maintenance required throughout the complex. These photographs are intended to illustrate the present state of the common areas and should be used as a basis for discussing and prioritizing any needed remedial works with the relevant parties.
