# Building and Timber Pest Inspection Report

Inspection Date: Fri, 27 Feb 2026

Property Address: 5 Summit Mews, Hillside VIC 3037, Australia

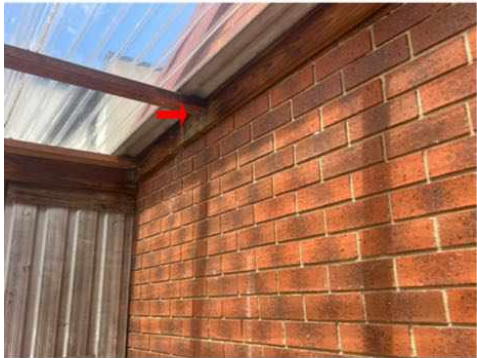
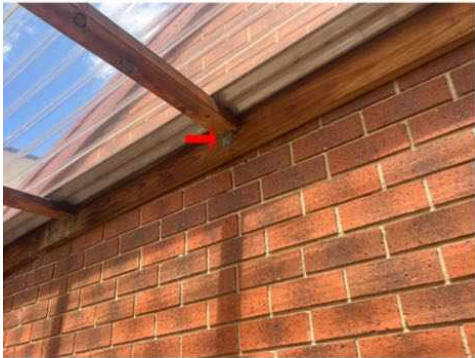
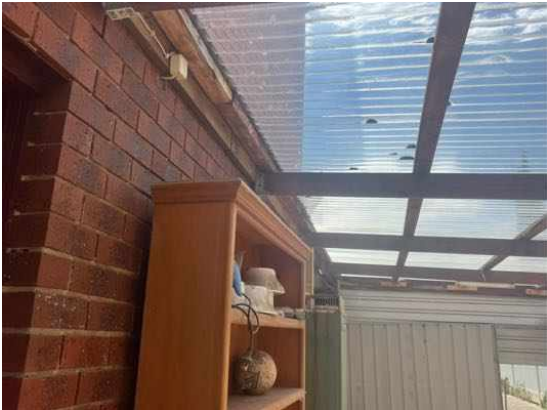
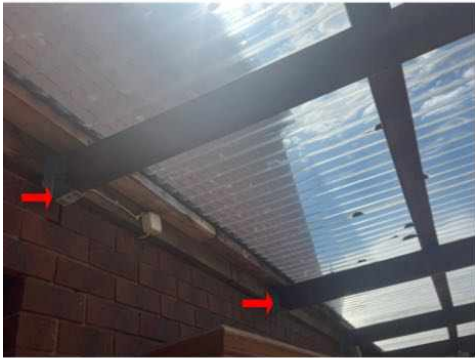
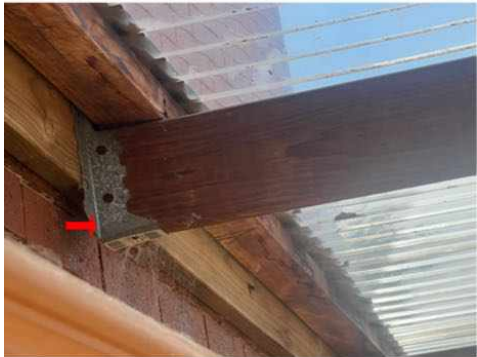
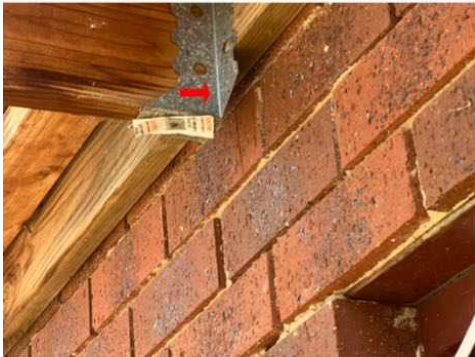
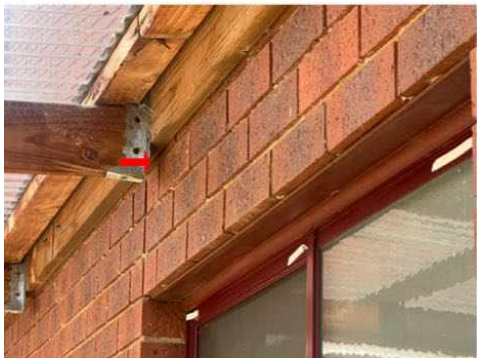
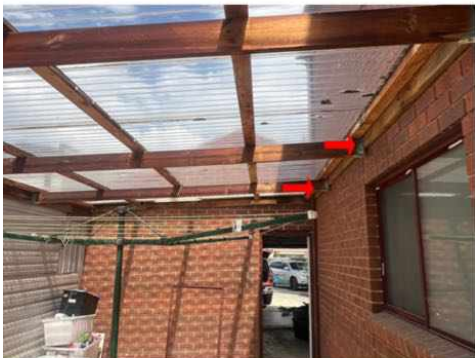
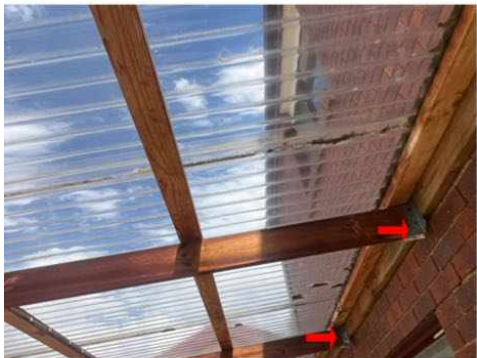
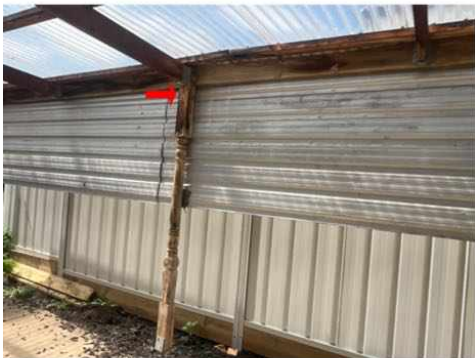
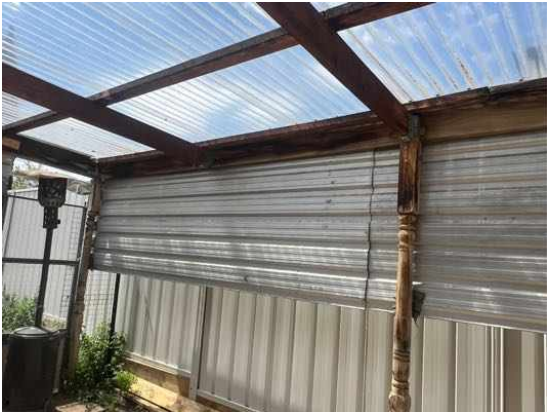
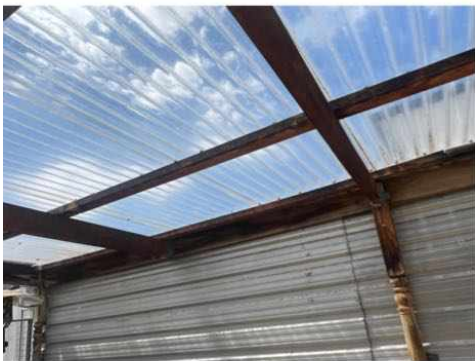
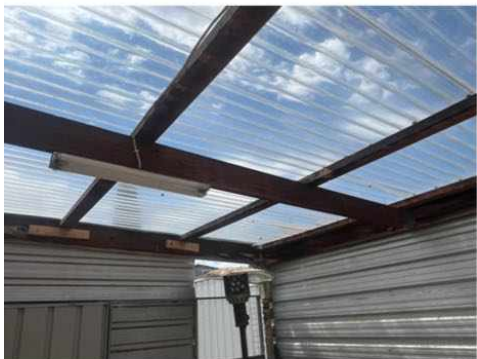
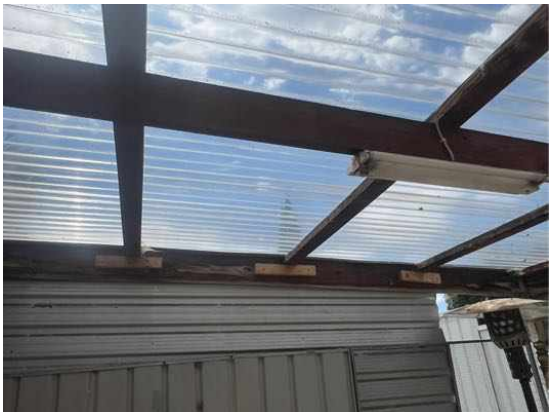
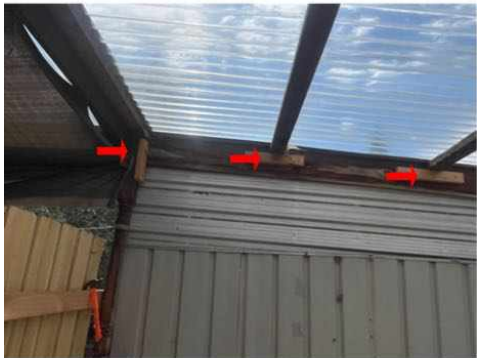
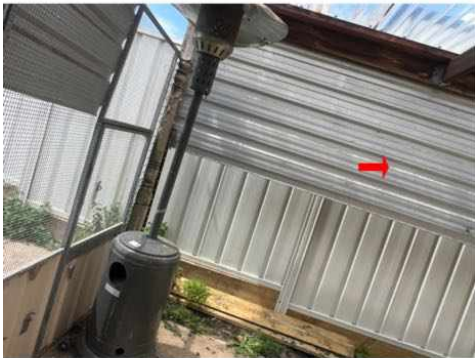
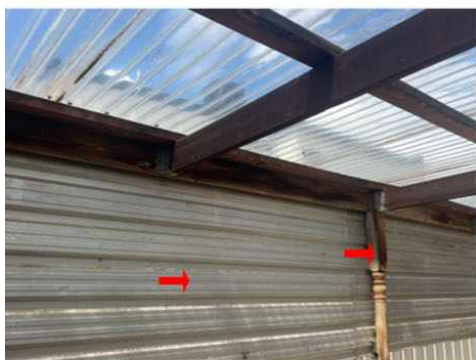
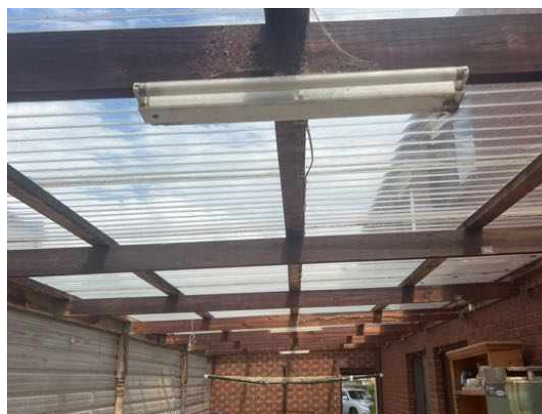
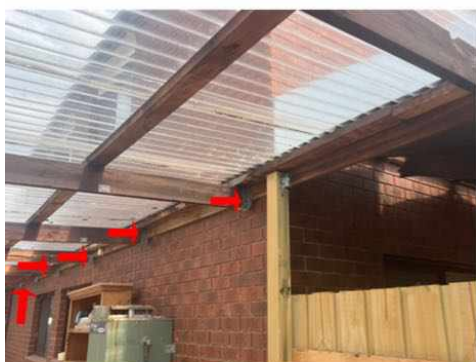
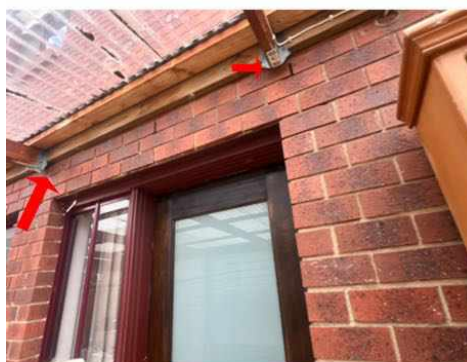
### Finding 3.01

Works that have not been completed to a satisfactory level create potential for the development of building defects and may impede on the safety and integrity of the overall structure.

It is highly recommended that the relevant trades be appointed to complete these works and ensure the safety of the area and the longevity of all associated building elements.

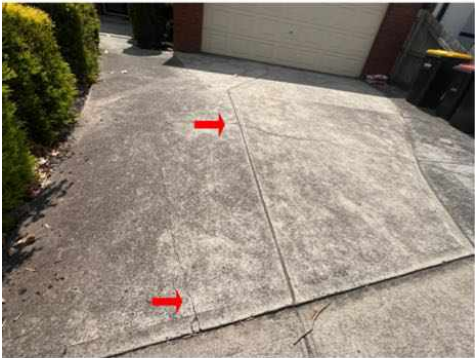
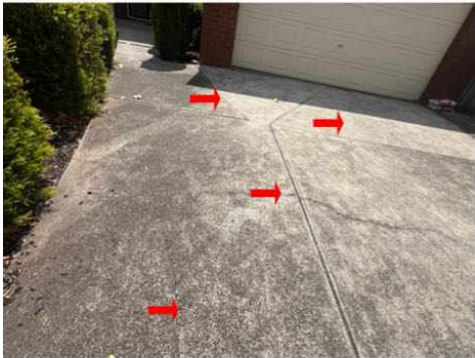
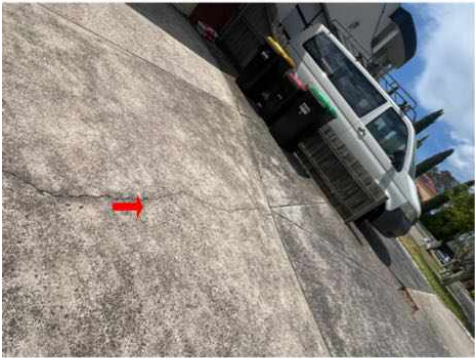
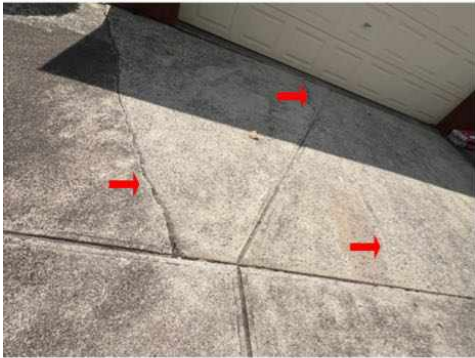
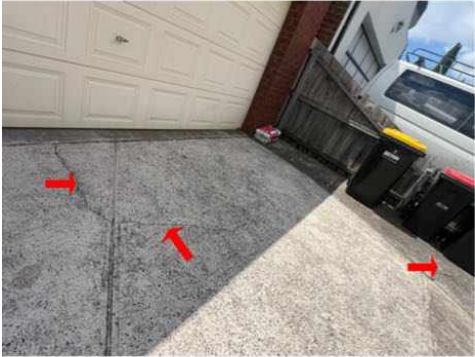
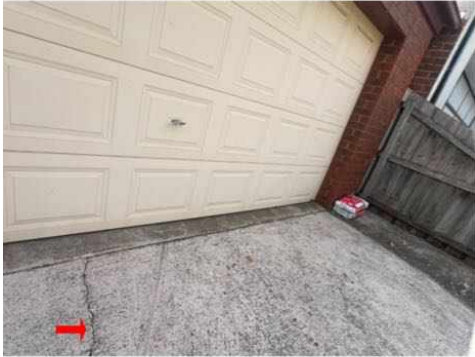
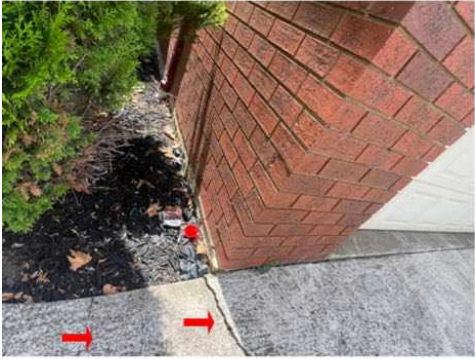
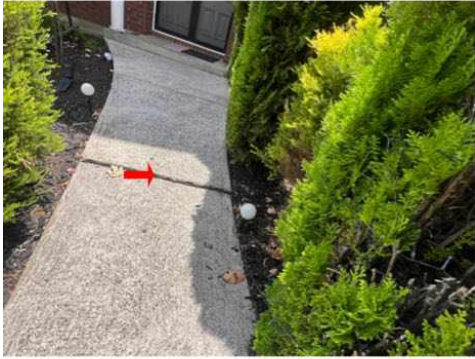
### Finding 3.02

Building:	Yard
Location:	Driveway > All Areas
Finding:	Cracking - External Concrete Paving Damage Category 2 - Distinct (less than 3mm)
Information:	Distinct cracks were identified in external concrete paving. Distinct cracks are generally found in older concrete paving, and may also present as a trip hazard as consequence of an uneven or curved surface.

Cracking to this degree may also be due to poor original installation of the concrete. Factors such as poor compaction of the sub surface and/or inadequate reinforcing of the slab may create cracking and other secondary defects.

Repairs are likely to be required to prevent further cracking and to reduce hazards associated with cracking, such as tripping. Monitoring of all cracking should be conducted frequently. Always contact a building inspector should cracks widen, lengthen, or become more numerous.

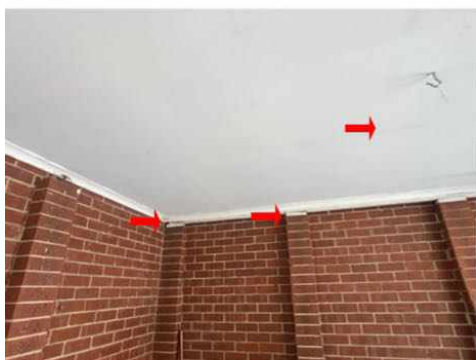
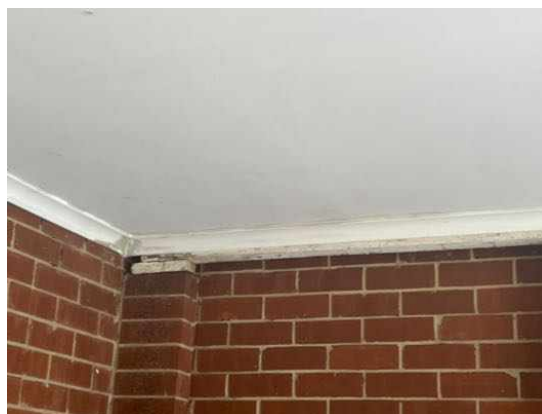
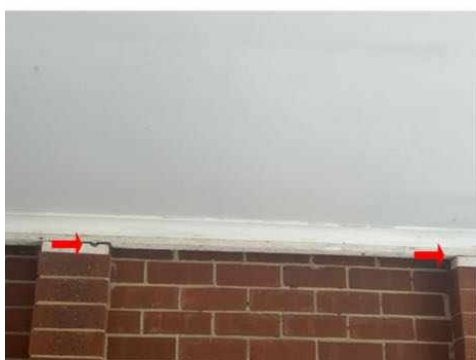
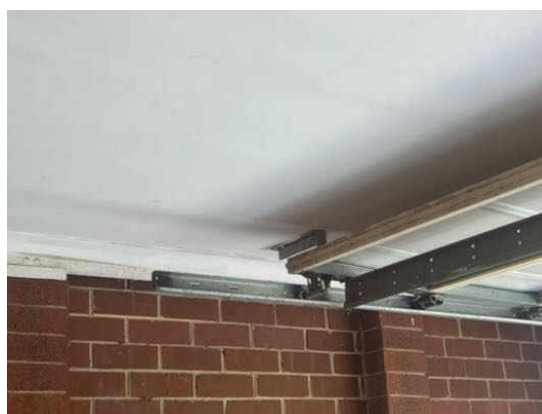
### Finding 3.03

Building:	Garage
Location:	All Areas > All Areas
Finding:	Ceiling - Sagging-evidence of poor remediation works
Information:	Sections of the ceiling were found to be sagging at the time of inspection. Sagging to the fixed ceiling structure generally indicates that the building materials have swollen, due to contact with water, or that fixings (e.g. nails or glue) have become loose and require reattachment.

In some cases, sagging ceiling linings may also indicate that there are structural issues, causing surfaces to warp, twist or sag. Where sagging appears to be major, appointment of a structural engineer is advised to further inspect the property and identify the source and rectification works required.

The appropriate action should be taken by the client as soon as possible to ensure that any potential further damage is limited.

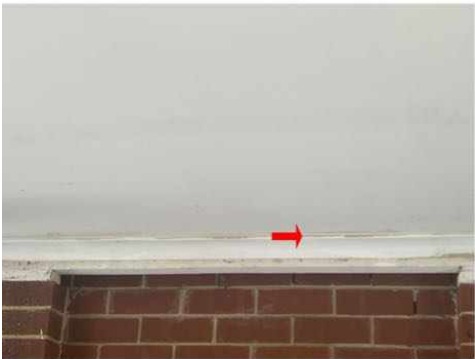
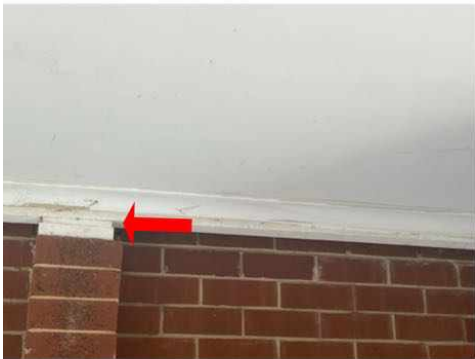
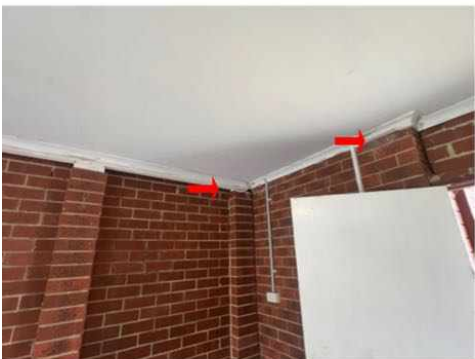
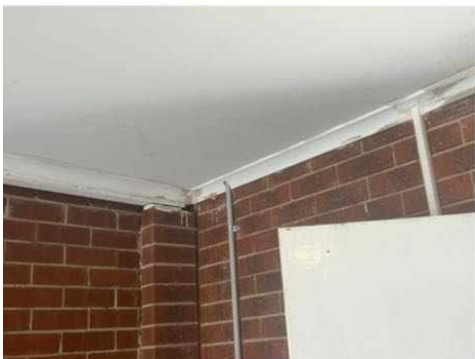
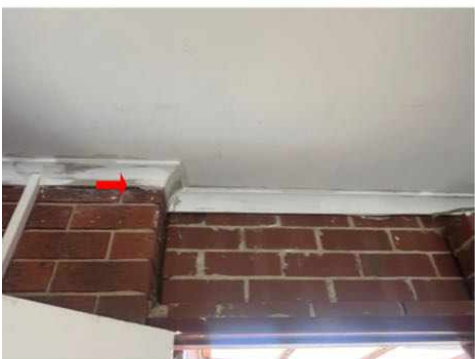
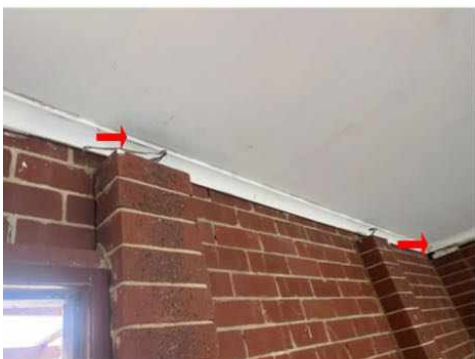
**Finding 3.04**

Building: Main Building  
Location: Rear Elevation > Centre  
Finding: External walls - Holes  
Information: Significant holes were identified around pipe penetrations in this wall section. It is suspected that the installation of this pipework was completed to a substandard level of workmanship or is incomplete.

Gaps and holes around pipework makes the area susceptible to insect and vermin ingress, as well as allowing water penetration to the cavity wall. As such, associated building elements are likely to deteriorate at an accelerated rate, and major

implications are expected if holes around the pipework are left unmanaged.

All excessive holes, gaps or cracks should be adequately filled by a suitable sealant or trimmings as soon as possible to prevent any further damage. Such works may be conducted by a general handyperson or licensed plumber.

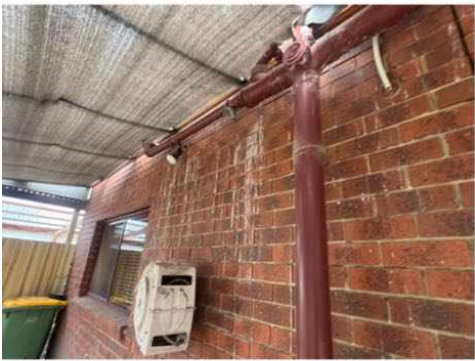
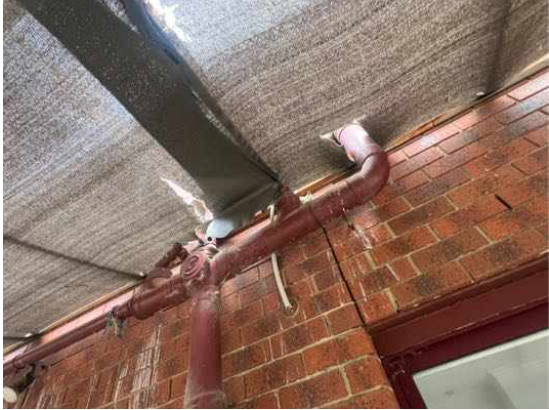
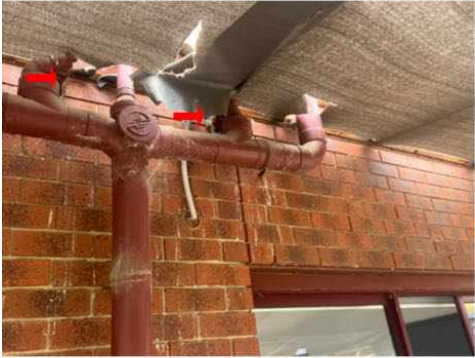
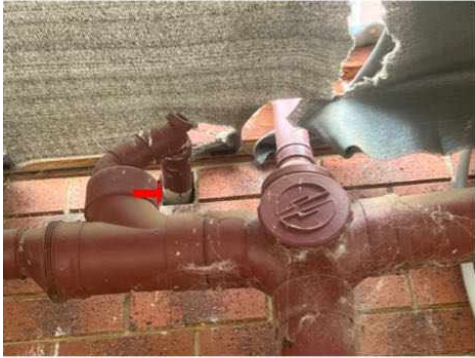
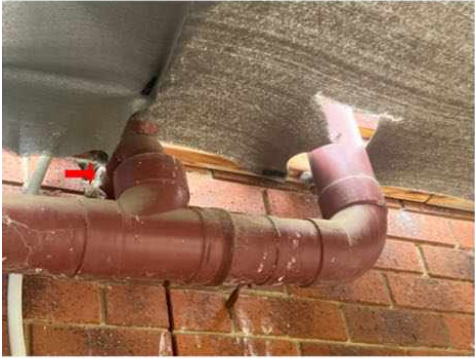
**Finding 3.05**

Building: Main Building  
Location: Rear Elevation > Centre  
Finding: Air conditioner - Disconnected overflow  
Information: The Air Conditioner (A/C) overflow was found to be disconnected from storm water

drainage and is creating excessive moisture in the surrounding area.

Such leaking creates an environment which is conducive to an array of defects, including water damage to associated building elements and the attraction of termite or timber pest infestation.

It is highly recommended that a licensed plumber be appointed to connect the A/C overflow in order to prevent such an environment from being created. These minor works should be carried out as soon as possible.

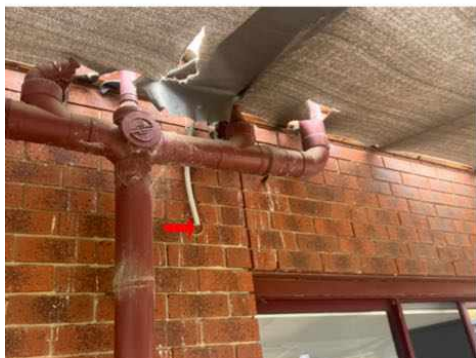
### Finding 3.06

Building:	Main Building
Location:	Exterior walls - right side > Centre
Finding:	HWS Overflow not plumbed-connected
Information:	The Hot Water System (HWS) overflow was found to be disconnected from storm water drainage and is creating excessive moisture in the surrounding area.

These damp conditions can lead to secondary defects such as rot, rust or corrosion of associated building elements, the formation of fungal decay, or even the creation of potential slip hazards. When coupled with poor site drainage, pooling of water may also attract termite activity to this area.

It is highly recommended that a licensed plumber be appointed to connect the HWS overflow in order to prevent such an environment from being created. These minor works should be carried out as soon as possible.

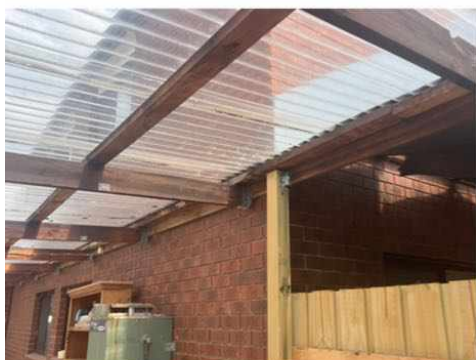
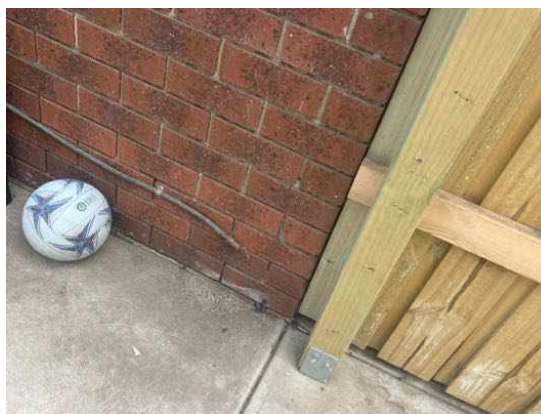
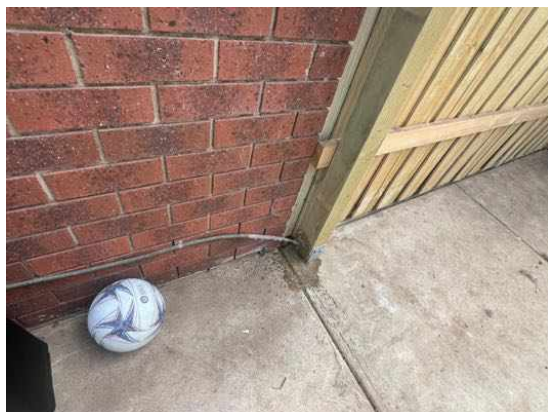
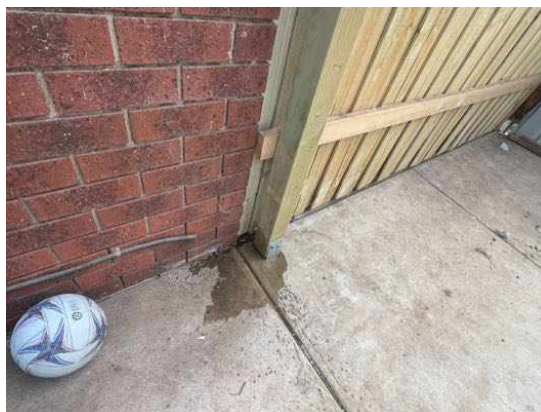
### Finding 3.07

Building:	Main Building
Location:	Pergola > All Areas
Finding:	Installation - substandard or incomplete
Information:	The installation of this building element appears to have been completed to a substandard level of workmanship or is incomplete. Generally substandard repairs or installation are related to poor workmanship, the use of inappropriate materials, or a failure to complete installation to a suitable standard.

Where installation is substandard and/or incomplete, the client should contact the responsible trade to undertake rectification. Unfinished and substandard building works are likely to degrade more quickly and may create potential for secondary defects to associated building elements.

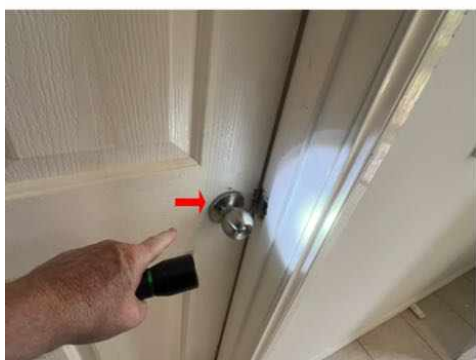
### Finding 3.09

Building:	Main Building
Location:	Bedroom > Front
Finding:	Door not latching
Information:	At the time of inspection it was noted that the door does not latch when closed.

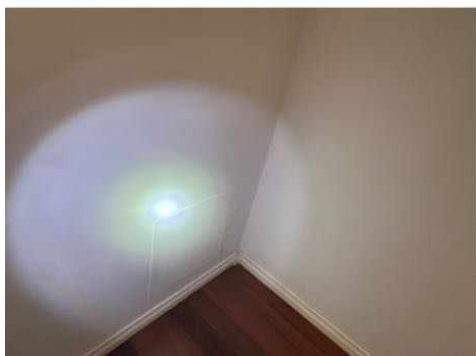
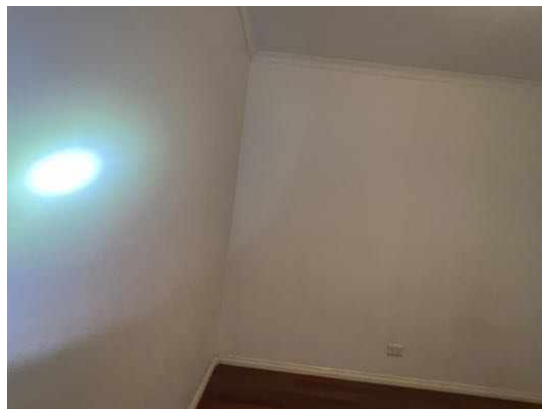
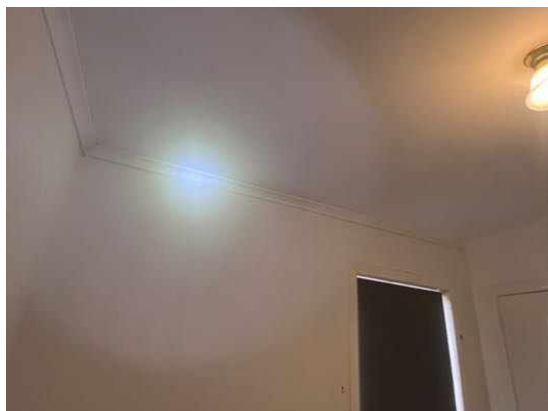
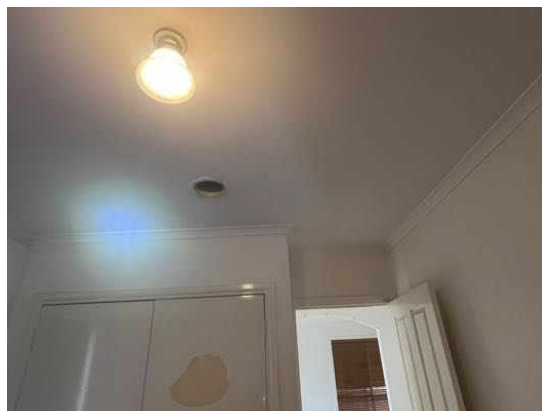
### Finding 3.10

Building:	Main Building
Location:	Bedroom > All Areas
Finding:	Paint finish - Incomplete
Information:	The paint finish in this area was identified as being incomplete at the time of inspection.

Whilst incomplete or missing paint finish is generally an appearance defect, it can also lead to the development of secondary building defects over time. Incomplete areas of paint finish expose the area to moisture, potentially accelerating the deterioration of underlying building materials.

Incomplete paint finishes should be sanded back, filled, leveled and painted, as applicable. Where inadequate or missing paint protection has led to the deterioration of the associated building element, repair and/or replacement of this building element

may be required.

A painting contractor should be appointed as soon as possible to perform necessary works to aid the appearance of the affected area and to ensure the area is protected against further deterioration. Alternatively, the homeowner following manufacturer instructions may perform these works.

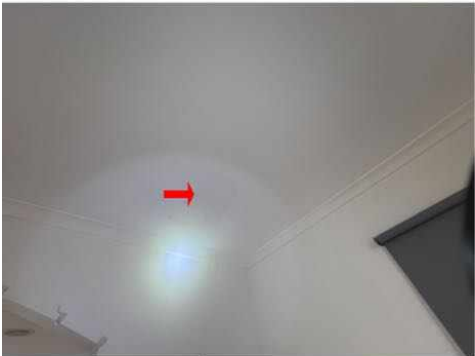
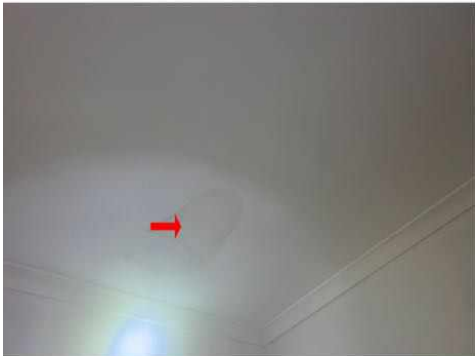
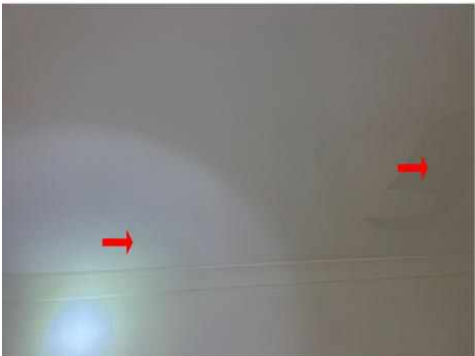
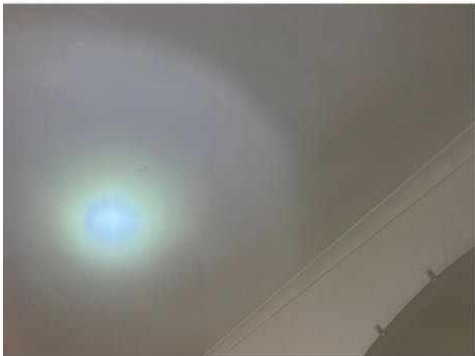
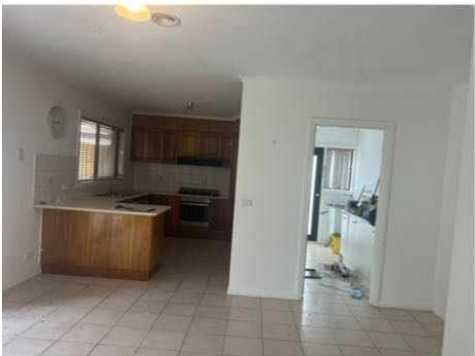
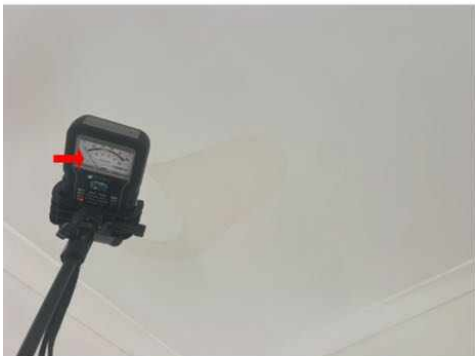
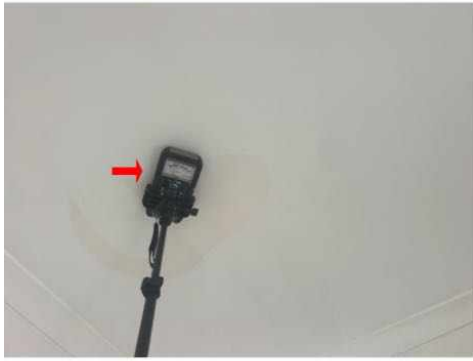
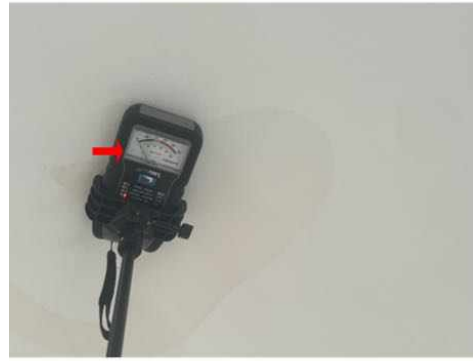
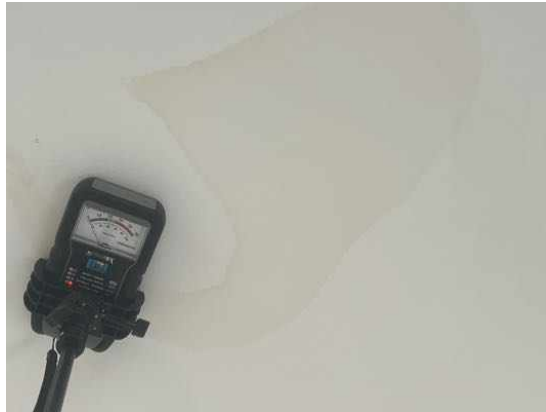
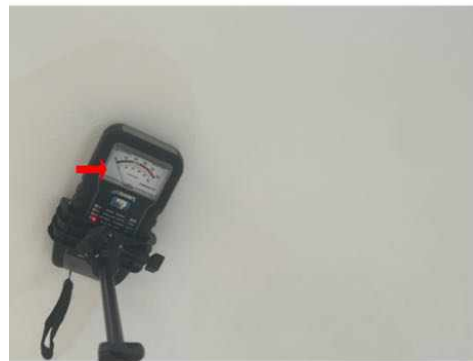
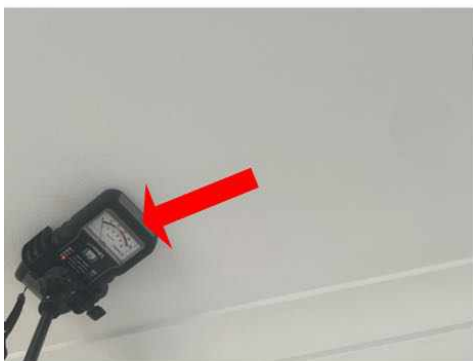
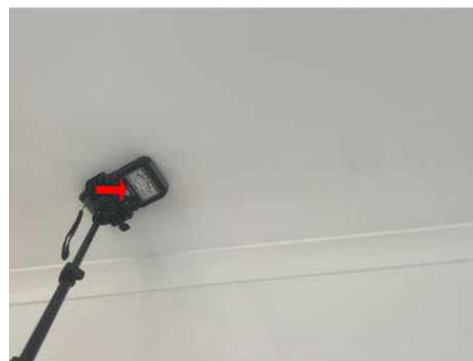
### Finding 3.11

Building:	Main Building
Location:	Dining Room > Front,Front Left
Finding:	Water staining-to ceiling noted-NO moisture detected at time of inspection
Information:	Water staining was evident in this area at the time of inspection. Water staining indicates that surfaces have been exposed to excessive moisture over time. The minerals and other elements in the water lead to staining, which may graduate to corrosion and deterioration if left unmanaged.

While mostly an appearance defect, water staining can be indicative of more serious defects, which may be currently concealed by other building elements.

Where water staining is active, a licensed plumber must be consulted to identify the cause of the staining and to provide advice on any reparation works that may be required. Replacement of any broken or damaged structures is advised.

Conversely, where water staining is old and inactive, affected building materials may be repaired or replaced at client discretion. A qualified carpenter or registered builder may be appointed to perform these works.

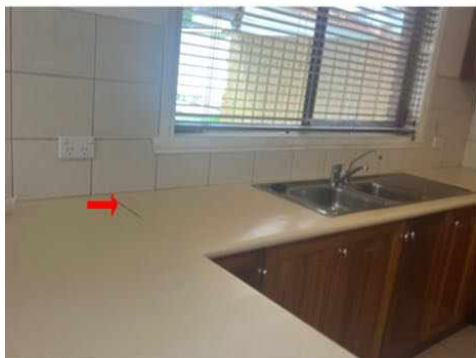
### Finding 3.12

Building:	Main Building
Location:	Kitchen > Centre,Front
Finding:	Delamination of timbers-vinyl bench tops
Information:	Delamination is one means by which composite materials (e.g. layered timber composites) may fail over time. In laminated materials, repeated cyclic stresses may lead to the formation of mini-structures of separate layers, with significant loss of mechanical toughness. Water penetration or the presence of excessive moisture also generally contributes to delamination.

Where building materials have become delaminated, they lose their structural strength, and are likely to have a variety of appearance and serviceability defects as a result.

Delamination of timbers may be repaired where the area affected is minor and/or easily accessible, by gluing and screwing layers back together. However, this is an interim repair, and where delamination has occurred, the client should plan for the replacement of affected timbers sooner than would otherwise be expected.

All timber structures affected by delamination should be replaced as soon as possible to avoid any further damage. Repair and replacement estimates should be sought from a registered builder or qualified carpenter.

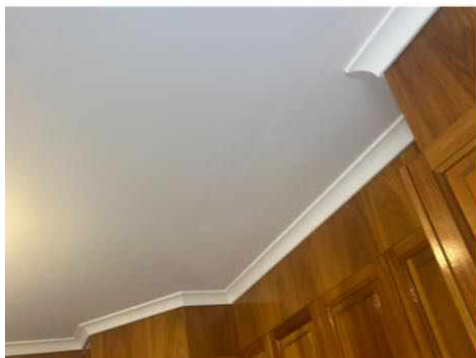
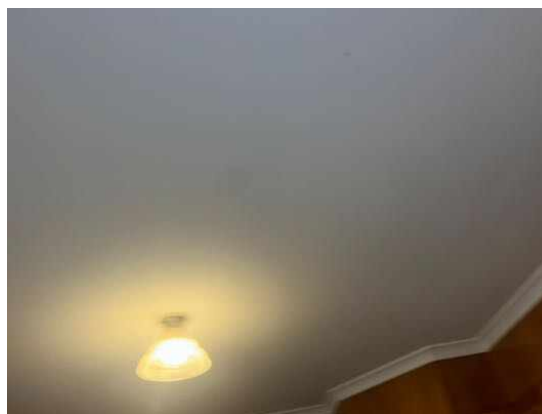
### Finding 3.13

Building:	Main Building
Location:	Kitchen > All Areas
Finding:	Paint finish - Incomplete
Information:	The paint finish in this area was identified as being incomplete at the time of inspection.

Whilst incomplete or missing paint finish is generally an appearance defect, it can also lead to the development of secondary building defects over time. Incomplete areas of paint finish expose the area to moisture, potentially accelerating the deterioration of underlying building materials.

Incomplete paint finishes should be sanded back, filled, leveled and painted, as applicable. Where inadequate or missing paint protection has led to the deterioration of the associated building element, repair and/or replacement of this building element may be required.

A painting contractor should be appointed as soon as possible to perform necessary works to aid the appearance of the affected area and to ensure the area is protected against further deterioration. Alternatively, the homeowner following manufacturer instructions may perform these works.

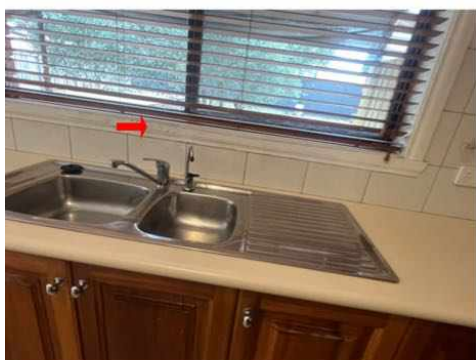
### Finding 3.14

Building:	Main Building
Location:	Kitchen > Front
Finding:	Building element - Swollen
Information:	Swollen building elements generally indicate that the building materials have been affected by excessive moisture over a prolonged period of time, and have swollen as a result. The formation and development of mould/fungi or mildew is also a likely consequence of excessive moisture, which may pose major respiratory issues for occupants, particularly the elderly, the very young and those with existing illnesses and could be potential health safety hazards. In these cases an appropriately qualified inspector/tester should also be contacted for advice and/or technical assistance.

The structural integrity of swollen building elements can not be guaranteed, and further damage is likely to develop if left unmanaged. Excessive moisture is likely to lead to the development of secondary damage to any associated building elements, which may necessitate major repair works if prolonged.

Rectification of the cause of the water leak should be addressed prior to any remedial works to the swollen building elements. A licensed plumber should be appointed immediately to identify the cause of the leak and provide advice on remedial works as necessary, Repair and/or replacement of swollen building elements should be conducted as a matter of urgency by a registered builder or qualified carpenter.

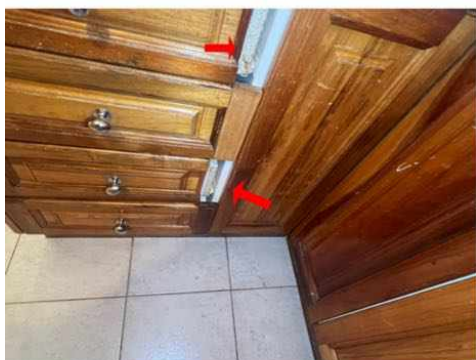
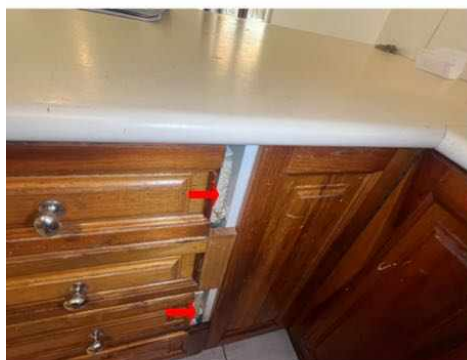
### Finding 3.15

Building:	Main Building
Location:	Kitchen > Centre
Finding:	Building element - Damaged-cabinetry
Information:	Breakage occurs generally when the building materials have either aged and decayed, or as a result of damage (accidental or deliberate).

Repair and/or replacement of broken elements is advised to ensure that additional secondary defects do not arise as a consequence. Such works are necessary, as all building elements play a key role in the operation and function of the overall structure and its performance.

A relevant tradesperson should be appointed to repair or replace the affected building element prior to any subsequent damage being caused.

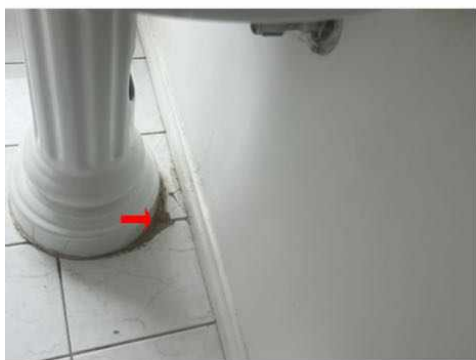
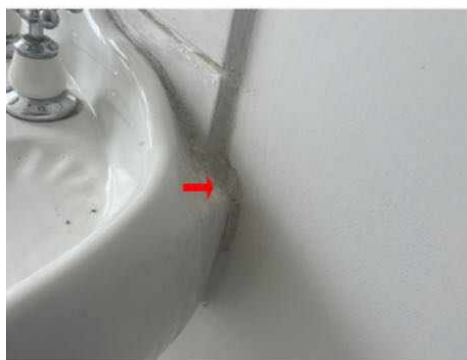
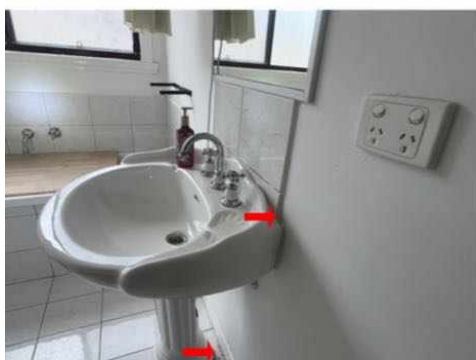
### Finding 3.16

Building:	Main Building
Location:	Bathroom > Centre Right
Finding:	Building element - Damaged-tiles & vanity -as mounted
Information:	Breakage occurs generally when the building materials have either aged and decayed, or as a result of damage (accidental or deliberate).

Repair and/or replacement of broken elements is advised to ensure that additional secondary defects do not arise as a consequence. Such works are necessary, as all building elements play a key role in the operation and function of the overall structure and its performance.

A relevant tradesperson should be appointed to repair or replace the affected building element prior to any subsequent damage being caused.

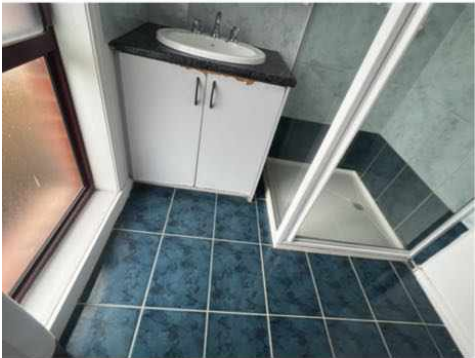
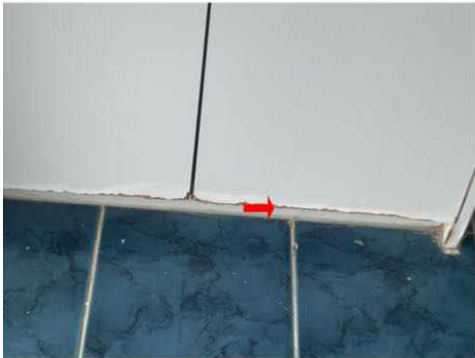
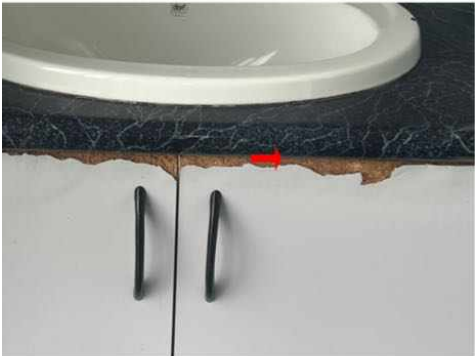
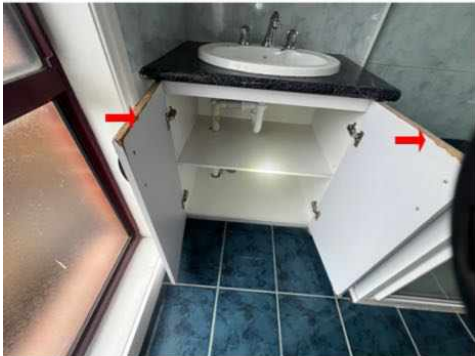
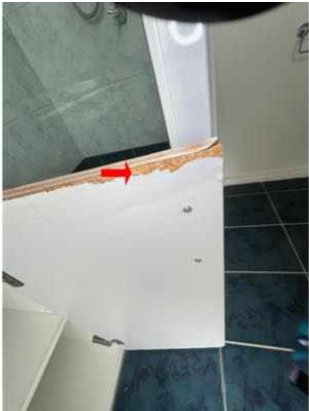
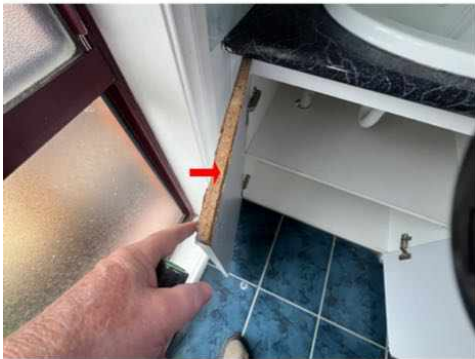
Building:	Main Building
Location:	Ensuite - Master > Front Left
Finding:	Building element - Swollen-cabinetry
Information:	Swollen building elements generally indicate that the building materials have been affected by excessive moisture over a prolonged period of time, and have swollen as a result. The formation and development of mould/fungi or mildew is also a likely consequence of excessive moisture, which may pose major respiratory issues for occupants, particularly the elderly, the very young and those with existing illnesses and could be potential health safety hazards. In these cases an appropriately qualified inspector/tester should also be contacted for advice and/or technical assistance.

The structural integrity of swollen building elements can not be guaranteed, and further damage is likely to develop if left unmanaged. Excessive moisture is likely to lead to the development of secondary damage to any associated building elements, which may necessitate major repair works if prolonged.

Rectification of the cause of the water leak should be addressed prior to any remedial works to the swollen building elements. A licensed plumber should be appointed immediately to identify the cause of the leak and provide advice on remedial works as necessary. Repair and/or replacement of swollen building elements should be conducted as a matter of urgency by a registered builder or qualified carpenter.

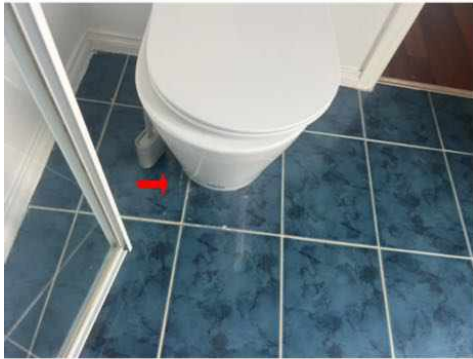
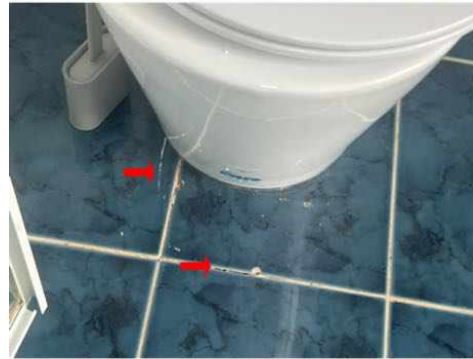
**Finding 3.18**

Building: Main Building  
Location: Ensuite - Master > Front Right  
Finding: Cracked floor tiles  
Information: Cracking in the floor tiles was evident in this area at the time of inspection. It is suspected that this cracking has occurred as a result of minor settlement or shrinkage of the slab.

Cracked tiles throughout the household detract from the overall appearance of the affected areas however it is unlikely to create or lead to any secondary defects.

While not considered a matter of urgency, replacement of cracked floor tiles is recommended at the clients discretion. A tiling contractor may be appointed to perform these works. Where cracks become more numerous, contact a licensed building inspector for further investigation.

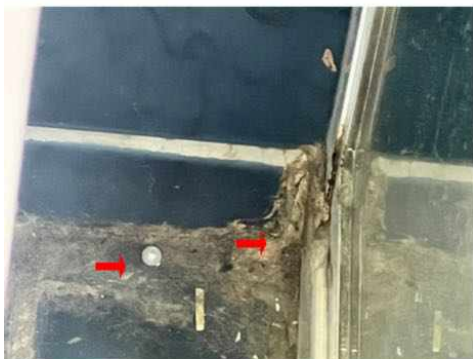
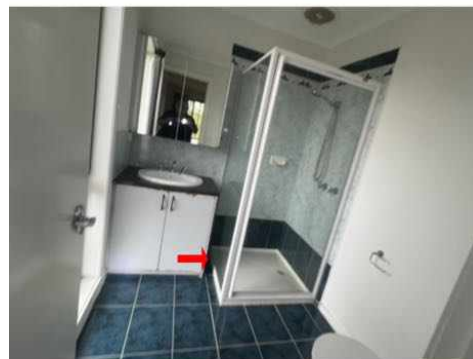
### Finding 3.19

Building:	Main Building
Location:	Ensuite - Master > Front, Centre
Finding:	Building element - Damaged-to corner of shower recess-poor repairs noted-requires further investigation
Information:	Breakage occurs generally when the building materials have either aged and decayed, or as a result of damage (accidental or deliberate).

Repair and/or replacement of broken elements is advised to ensure that additional secondary defects do not arise as a consequence. Such works are necessary, as all building elements play a key role in the operation and function of the overall structure and its performance.

A relevant tradesperson should be appointed to repair or replace the affected building element prior to any subsequent damage being caused.

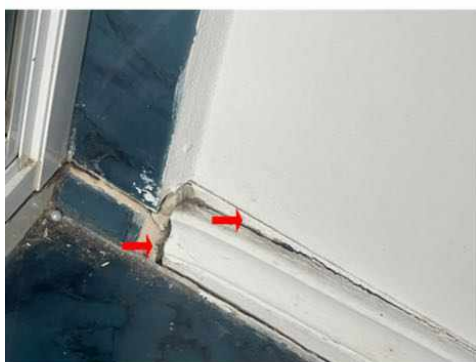
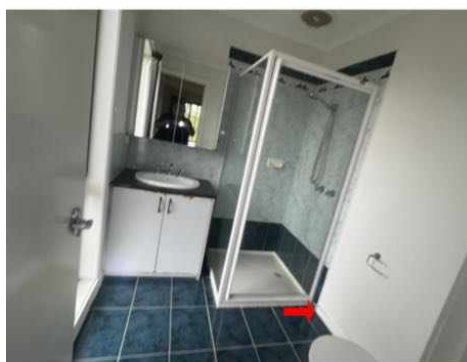
### Finding 3.20

Building: Main Building  
 Location: Ensuite - Master > Centre Right  
 Finding: Building element - Damaged-cracking & swelling noted-however no moisture detected  
 Information: Breakage occurs generally when the building materials have either aged and decayed, or as a result of damage (accidental or deliberate).

Repair and/or replacement of broken elements is advised to ensure that additional secondary defects do not arise as a consequence. Such works are necessary, as all building elements play a key role in the operation and function of the overall structure and its performance.

A relevant tradesperson should be appointed to repair or replace the affected building element prior to any subsequent damage being caused.

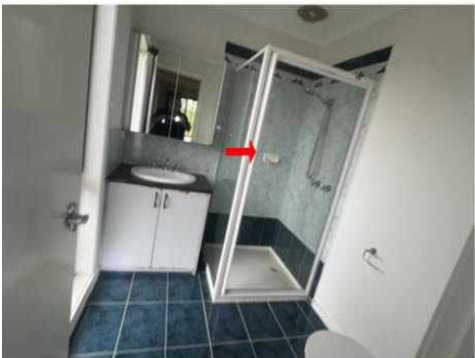
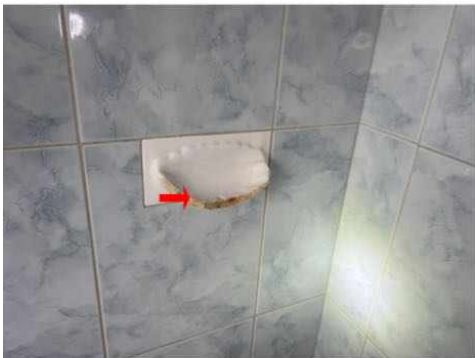
### Finding 3.21

Building: Main Building  
 Location: Ensuite - Master > Rear Right  
 Finding: Building element - Damaged-soap hobb damaged  
 Information: Breakage occurs generally when the building materials have either aged and decayed, or as a result of damage (accidental or deliberate).

Repair and/or replacement of broken elements is advised to ensure that additional secondary defects do not arise as a consequence. Such works are necessary, as all building elements play a key role in the operation and function of the overall structure and its performance.

A relevant tradesperson should be appointed to repair or replace the affected building element prior to any subsequent damage being caused.

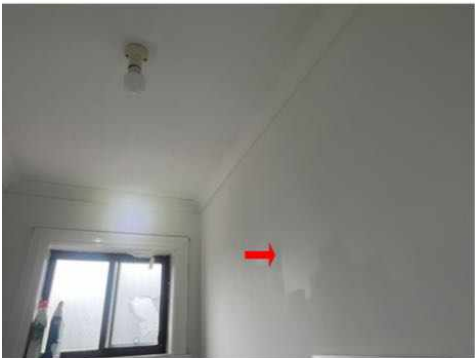
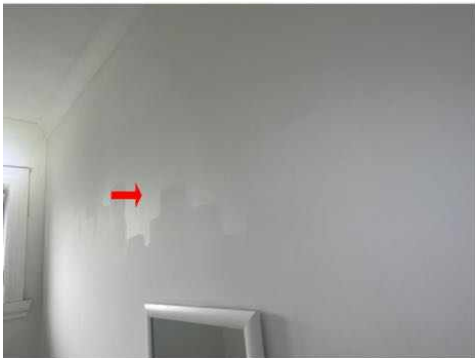
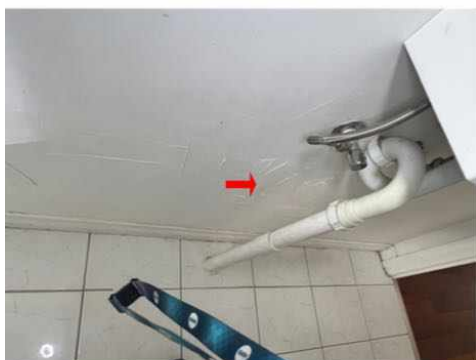
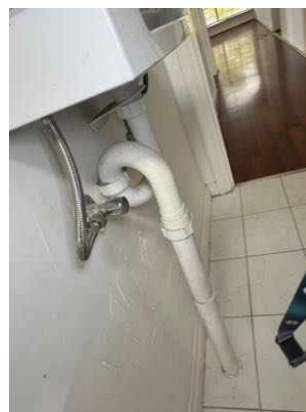
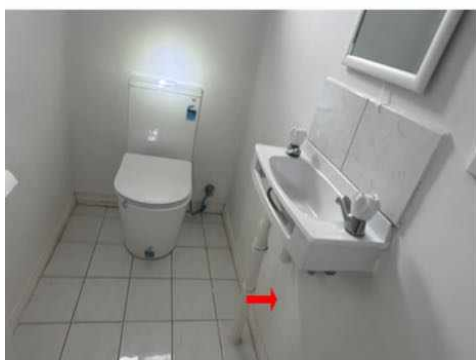
**Finding 3.22**

Building: Main Building  
Location: Toilet (WC) > All Areas  
Finding: Incomplete or substandard works-to plaster & paint  
Information: The works to this area appear to be incomplete or have been completed to a substandard level.

Works that have not been completed to a satisfactory level create potential for the development of building defects and may impede on the safety and integrity of the overall structure.

It is highly recommended that the relevant trades be appointed to complete these works and ensure the safety of the area and the longevity of all associated building elements.

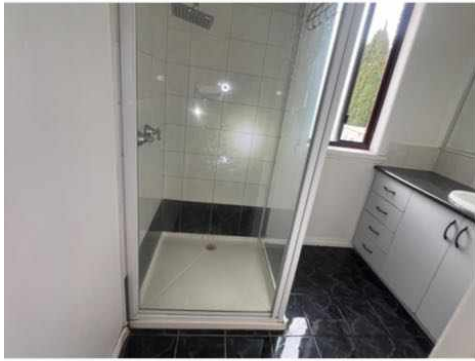
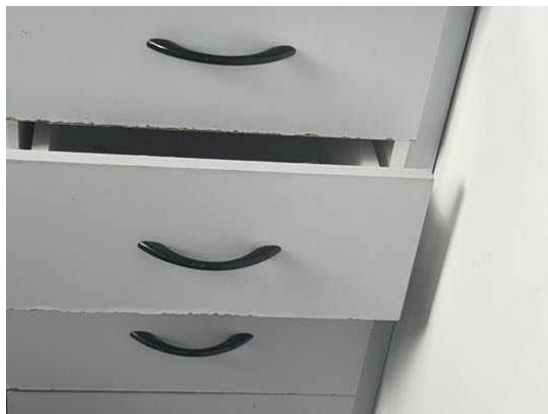
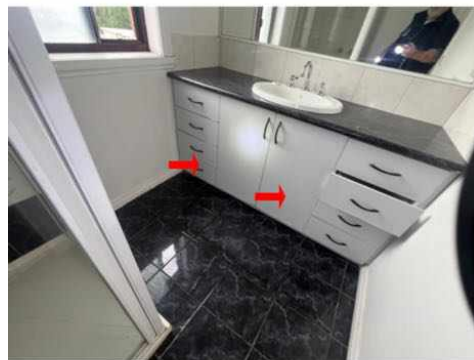
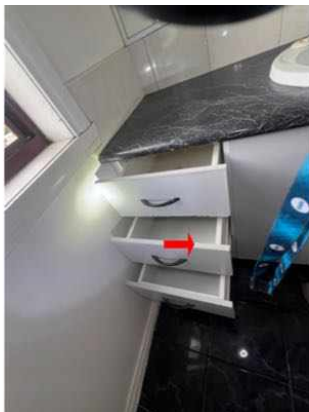
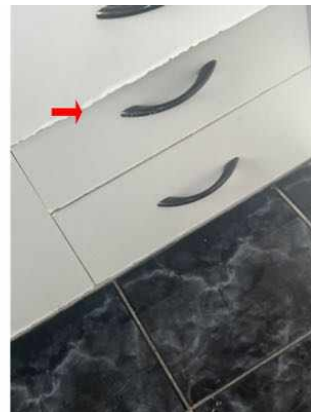
### Finding 3.23

Building:	Main Building
Location:	Ensuite - Other > All Areas
Finding:	Building element - Swollen-all cabinetry
Information:	Swollen building elements generally indicate that the building materials have been affected by excessive moisture over a prolonged period of time, and have swollen as a result. The formation and development of mould/fungi or mildew is also a likely consequence of excessive moisture, which may pose major respiratory issues for occupants, particularly the elderly, the very young and those with existing illnesses and could be potential health safety hazards. In these cases an appropriately qualified inspector/tester should also be contacted for advice and/or technical assistance.

The structural integrity of swollen building elements can not be guaranteed, and further damage is likely to develop if left unmanaged. Excessive moisture is likely to lead to the development of secondary damage to any associated building elements, which may necessitate major reparation works if prolonged.

Rectification of the cause of the water leak should be addressed prior to any remedial works to the swollen building elements. A licensed plumber should be appointed immediately to identify the cause of the leak and provide advice on remedial works as necessary. Repair and/or replacement of swollen building elements should be conducted as a matter of urgency by a registered builder or qualified carpenter.
