# Building and Timber Pest Inspection Report

Inspection Date: Fri, 27 Feb 2026

Property Address: 5 Summit Mews, Hillside VIC 3037, Australia

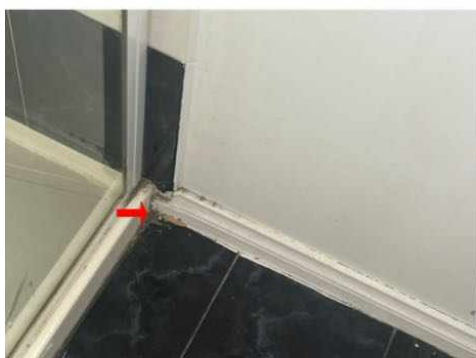
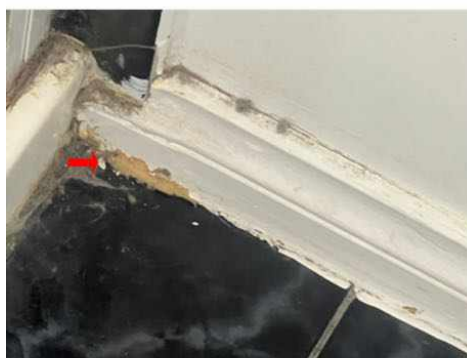
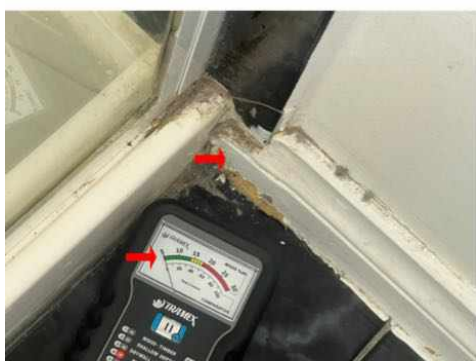
### Finding 3.24

Building:	Main Building
Location:	Ensuite - Other > Front Right
Finding:	Building element - Swollen-no moisture detected
Information:	Swollen building elements generally indicate that the building materials have been affected by excessive moisture over a prolonged period of time, and have swollen as a result. The formation and development of mould/fungi or mildew is also a likely consequence of excessive moisture, which may pose major respiratory issues for occupants, particularly the elderly, the very young and those with existing illnesses and could be potential health safety hazards. In these cases an appropriately qualified inspector/tester should also be contacted for advice and/or technical assistance.

The structural integrity of swollen building elements can not be guaranteed, and further damage is likely to develop if left unmanaged. Excessive moisture is likely to lead to the development of secondary damage to any associated building elements, which may necessitate major repair works if prolonged.

Rectification of the cause of the water leak should be addressed prior to any remedial works to the swollen building elements. A licensed plumber should be appointed immediately to identify the cause of the leak and provide advice on remedial works as necessary. Repair and/or replacement of swollen building elements should be conducted as a matter of urgency by a registered builder or qualified carpenter.

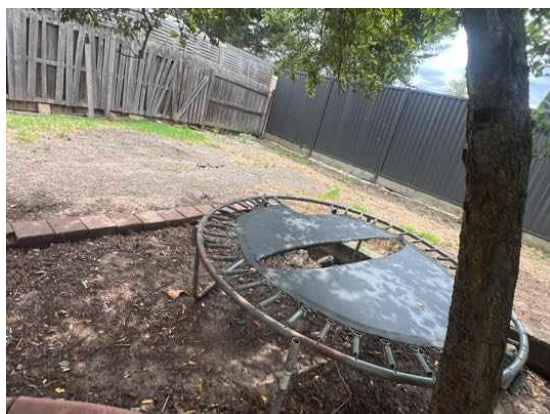
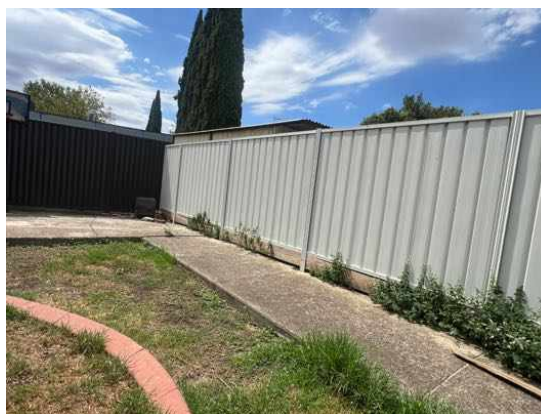
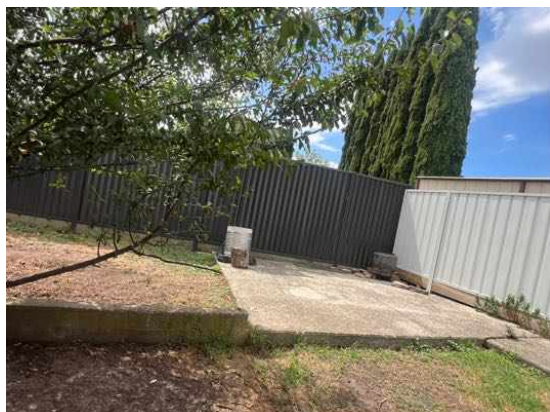
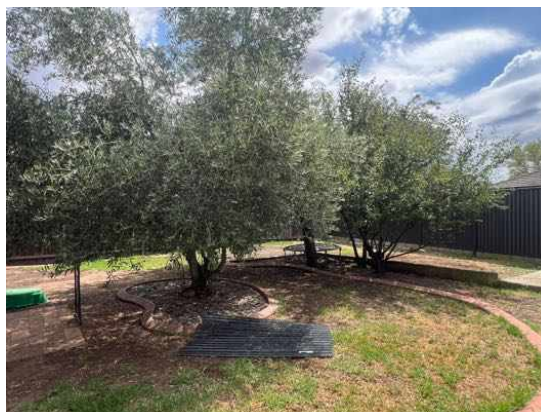
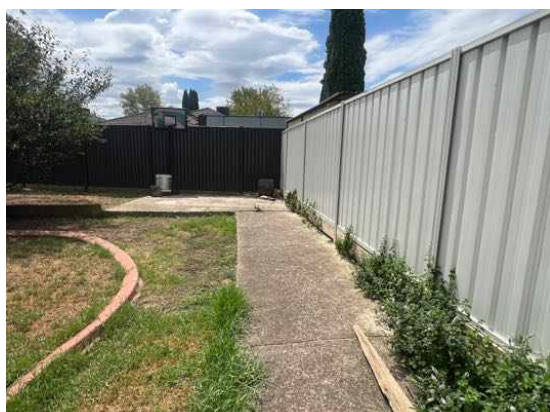
Finding: Soil cracking-shrinkage-  
Information: Soil cracking-degradation

During inspection of the yard area, it was noted that there has been insufficient or no watering provided to the soil. The yard is underlain by clay soils, which are highly sensitive to moisture fluctuations. The lack of regular watering has resulted in observable soil shrinkage, cracking, and a reduction in the overall stability of the ground.

Clay soils, which have a tendency to expand and contract significantly with changes in moisture content, can lead to detrimental effects when not adequately hydrated. In the absence of regular watering, the clay has dried out, causing it to shrink and form cracks in the surface. This can result in uneven ground levels, increased soil erosion, and potential long-term damage to any structures, pathways, or landscaping features in the area.

While there is no specific Australian Standard that directly addresses the lack of watering to yard areas, the effects of soil moisture on the stability of clay soils are well-documented in Australian geotechnical practice. AS 2870:2011 - Residential Slabs and Footings provides guidance on the behavior of different soil types, including clay, and the need to manage moisture levels to prevent excessive shrinkage or swelling. It highlights that uncontrolled moisture variation in clay soils can result in ground movement, which may negatively impact the performance of foundations and other structural elements.

It is recommended to implement a consistent and adequate watering schedule for the yard area to maintain the moisture content of the clay soil. This will help prevent further shrinkage and cracking and stabilize the ground. A drip irrigation system or soaker hoses may be useful to provide slow, deep watering to the soil.

**Monitor Moisture Levels:** Regular monitoring of the soil moisture content is important to ensure that it stays within a range that avoids excessive drying or waterlogging. It may be beneficial to consult with a landscape or soil specialist to establish the optimal watering requirements based on local climate and soil conditions.

Soil Improvement: Consider improving the clay soil by mixing in organic matter or other soil conditioners that improve water retention and stability. This can help reduce the clay's sensitivity to moisture fluctuations and improve overall soil structure.

Repair Surface Cracks: Address the existing cracks by rehydrating the soil and then filling the cracks with appropriate materials to restore the aesthetic and functional appearance of the yard. Over time, continued watering and moisture management will help prevent the recurrence of such issues.

A reputable gardener should be able to assist in setting up a system for future maintenance

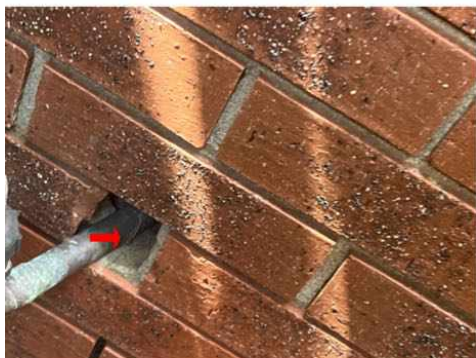
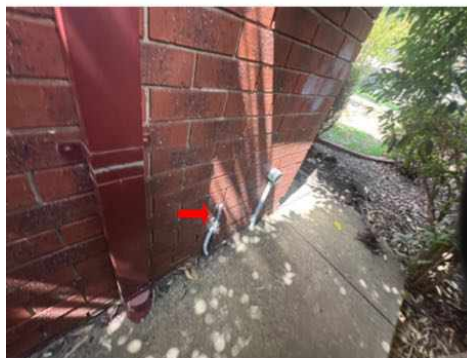
### Finding 3.27

Building:	Main Building
Location:	Exterior walls - left side > Front
Finding:	External walls - Holes
Information:	Significant holes were identified around pipe penetrations in this wall section. It is suspected that the installation of this pipework was completed to a substandard level of workmanship or is incomplete.

Gaps and holes around pipework makes the area susceptible to insect and vermin ingress, as well as allowing water penetration to the cavity wall. As such, associated building elements are likely to deteriorate at an accelerated rate, and major implications are expected if holes around the pipework are left unmanaged.

All excessive holes, gaps or cracks should be adequately filled by a suitable sealant or trimmings as soon as possible to prevent any further damage. Such works may be conducted by a general handyperson or licensed plumber.

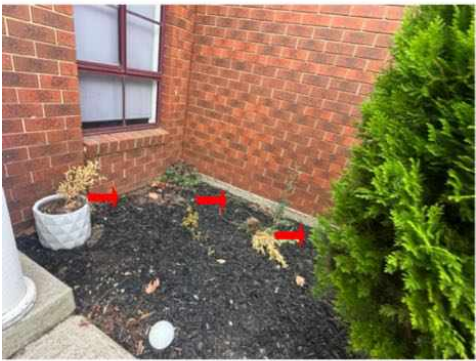
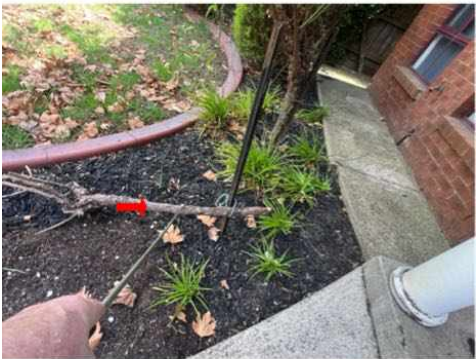
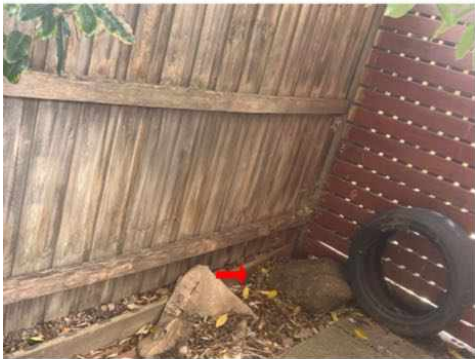
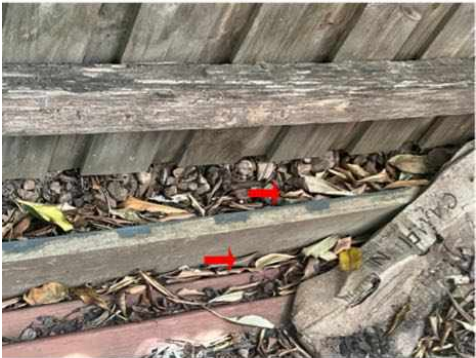
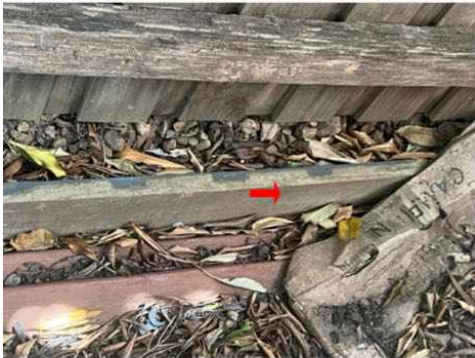
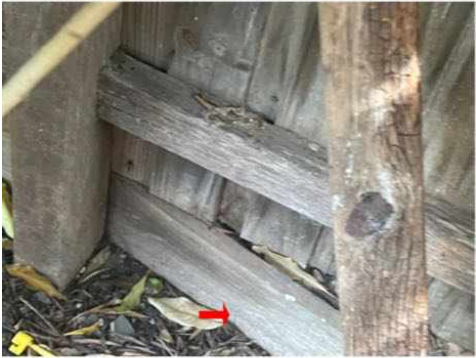
Building:	Yard
Location:	Front Elevation > All Areas
Finding:	Building materials in direct ground contact - conducive to termites
Information:	Where timber elements are in direct contact with the ground and consequently moisture or dampness they become conducive to termite activity. Whether timber is used as a building element part of a fencing structure or stored as an unused item they can provide an environment that is attractive to termite infestation.

When met with excessive moisture timber begins to decay and develop wood rot. Any timbers that are in direct contact with external grounds especially if left untreated or non-durable also provide ingress for subterranean termites into that particular element.

The removal of any such materials that may be conducive to termite activity should be removed as soon as possible to minimise the risk of termite attack.

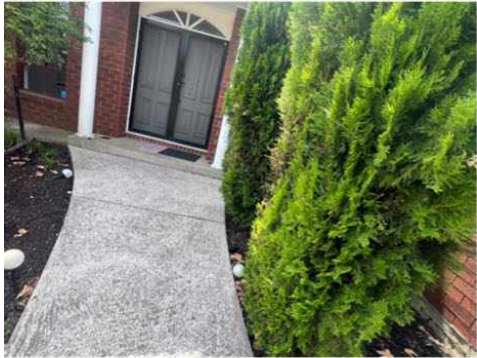
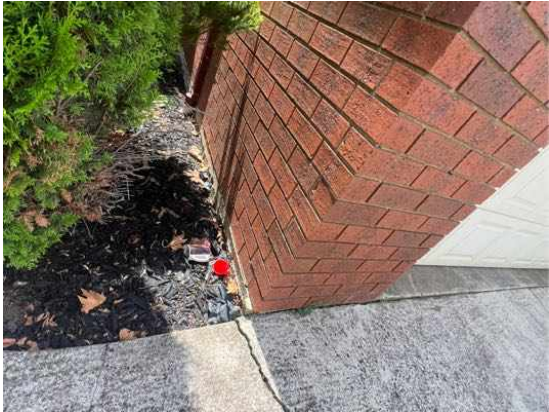
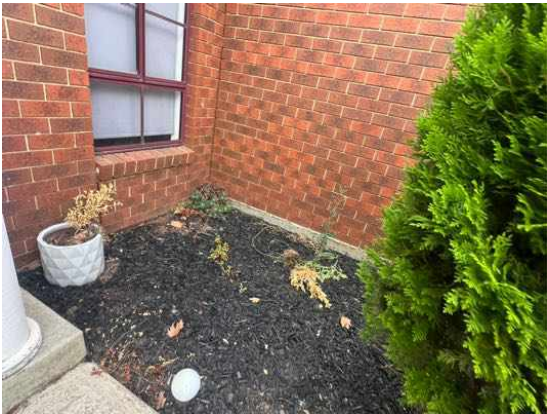
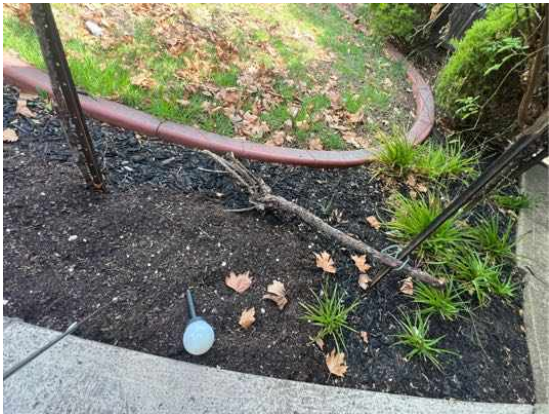
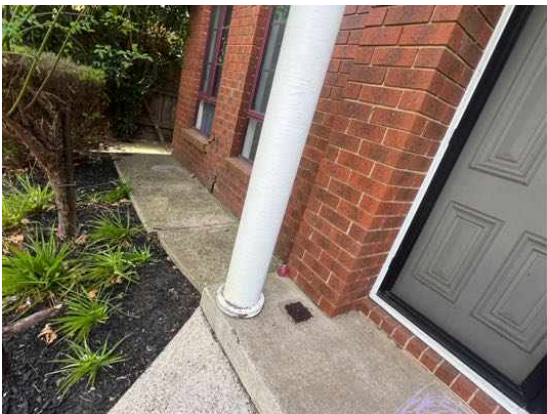
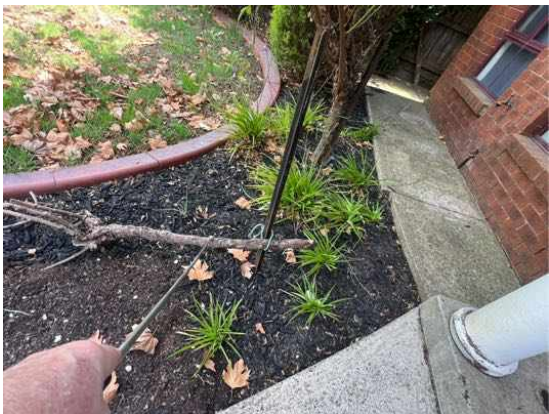
Finding 6.02

Building: Main Building  
Location: Front Elevation > Front Left  
Finding: Garden Beds - Conditions Conducive to Termites  
Information: Garden beds were found to be evident in the garden area. These garden beds can include untreated timber, and with a combination of moisture from watering hosing can make conditions conducive to termite activity and termite ingress.

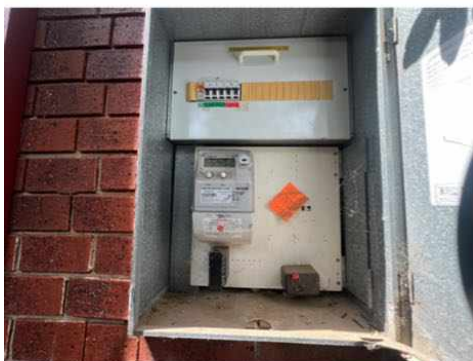
### Finding 6.03

Building: Main Building  
 Location: Exterior walls - left side > Front  
 Finding: Timber Pest-meterbox NO durable notice-found  
 Information: Meter Box

A durable notice should be placed in the meter box to indicate current termite barriers. At the time of inspection, it appeared as though no termite management system has been installed, with no evidence to suggest preventative works taking place.

The application of a post-construction chemical termite barrier is highly recommended for all properties, particularly if live termite activity has been found on the site previously. Such barriers are highly effective in preventing termite attack on any timber building elements

The client may consider gaining further advice from a pest controller as to the costs and procedures involved with this application. It is recommended that obtaining such advice be a short-term priority.

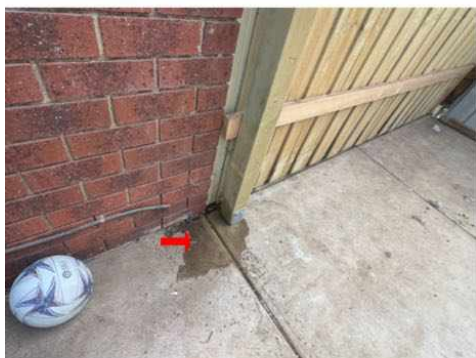
## Finding 6.04

Building:	Main Building
Location:	Exterior walls - right side > Centre
Finding:	HWS Overflow not plumbed-connected
Information:	The Hot Water System (HWS) overflow was found to be disconnected from storm water drainage and is creating excessive moisture in the surrounding area.

These damp conditions can lead to secondary defects such as rot, rust or corrosion of associated building elements, the formation of fungal decay, or even the creation of potential slip hazards. When coupled with poor site drainage, pooling of water may also attract termite activity to this area.

It is highly recommended that a licensed plumber be appointed to connect the HWS overflow in order to prevent such an environment from being created. These minor works should be carried out as soon as possible.

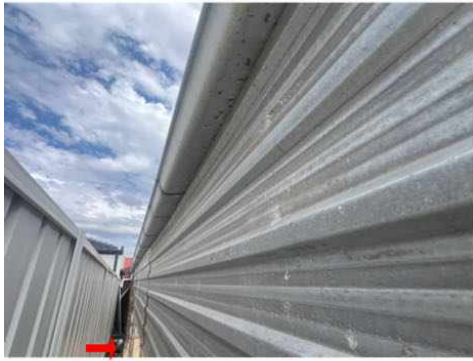
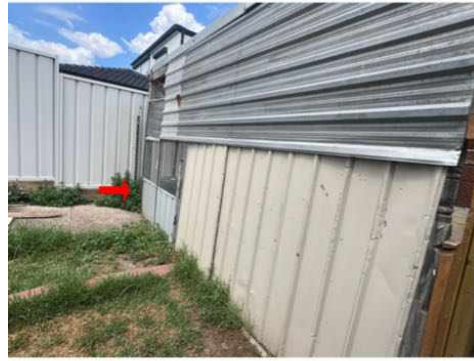
## Finding 6.05

Building:	Main Building
Location:	Exterior walls - right side > Centre
Finding:	Building materials in direct ground contact - conducive to termites
Information:	Where timber elements are in direct contact with the ground and consequently moisture or dampness they become conducive to termite activity. Whether timber is used as a building element part of a fencing structure or stored as an unused item they can provide an environment that is attractive to termite infestation.

When met with excessive moisture timber begins to decay and develop wood rot. Any timbers that are in direct contact with external grounds especially if left untreated or non-durable also provide ingress for subterranean termites into that particular element.

The removal of any such materials that may be conducive to termite activity should be removed as soon as possible to minimise the risk of termite attack.

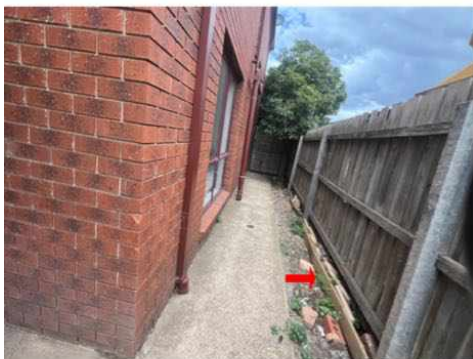
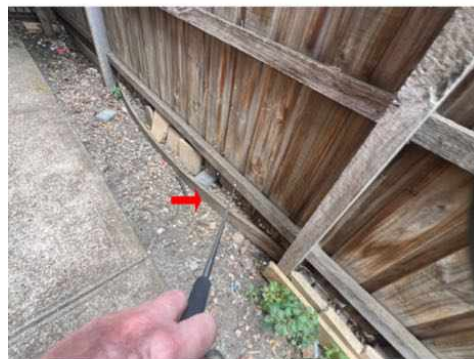
### Finding 6.06

Building:	Main Building
Location:	Exterior walls - left side > All Areas
Finding:	Building materials in direct ground contact - conducive to termites
Information:	Where timber elements are in direct contact with the ground and consequently moisture or dampness they become conducive to termite activity. Whether timber is used as a building element part of a fencing structure or stored as an unused item they can provide an environment that is attractive to termite infestation.

When met with excessive moisture timber begins to decay and develop wood rot. Any timbers that are in direct contact with external grounds especially if left untreated or non-durable also provide ingress for subterranean termites into that particular element.

The removal of any such materials that may be conducive to termite activity should be removed as soon as possible to minimise the risk of termite attack.

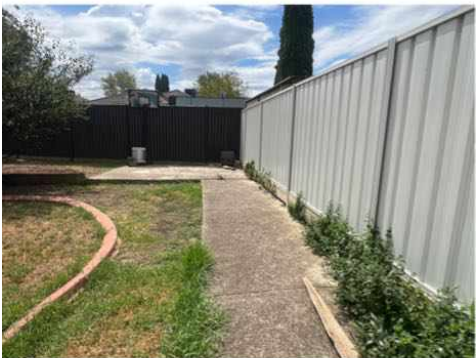
### Finding 6.07

Building:	Yard
Location:	Yard - Back > All Areas
Finding:	Building materials in direct ground contact - conducive to termites
Information:	Where timber elements are in direct contact with the ground and consequently moisture or dampness they become conducive to termite activity. Whether timber is used as a building element part of a fencing structure or stored as an unused item they can provide an environment that is attractive to termite infestation.

When met with excessive moisture timber begins to decay and develop wood rot. Any timbers that are in direct contact with external grounds especially if left untreated or non-durable also provide ingress for subterranean termites into that particular element.

The removal of any such materials that may be conducive to termite activity should be removed as soon as possible to minimise the risk of termite attack.

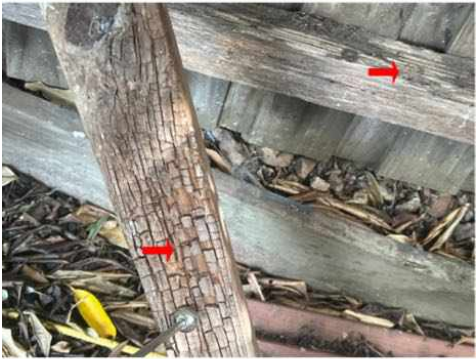
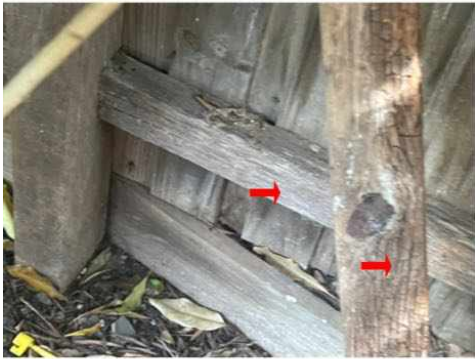
### Finding 7.01

Building:	Yard
Location:	Yard - Side > Centre
Finding:	Fungal decay - present (localised)
Information:	Fungal decay also known as wood decay or wood rot generally refers to the deterioration of timber elements when in contact with excessive levels of moisture for a prolonged period of time.

The development of fungal decay is accelerated by temperatures in the range of 5degreeC to 40degreeC as well as the presence of oxygen. Generally fungal decay develops on timber elements that are in use in an external environment which are exposed to rain penetration.

In this case although the affected timber element is in a decaying state the extent of any visible damage appears to be localised to a specific area and is yet to spread to other parts of the building element or affect adjoining structures. The fungal decay is therefore likely to be of a relatively superficial nature with minimal impact on the structural integrity or tensile strength of the timber element.

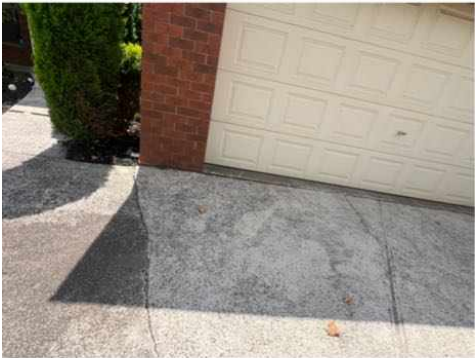
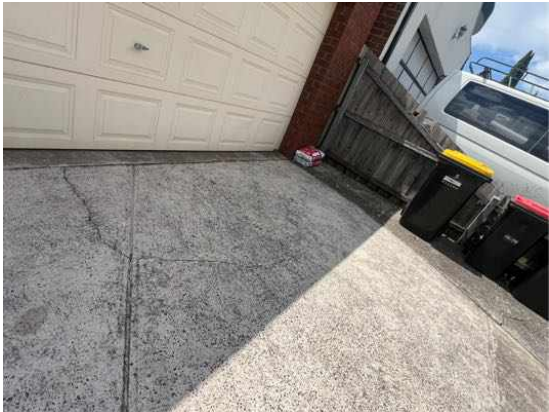
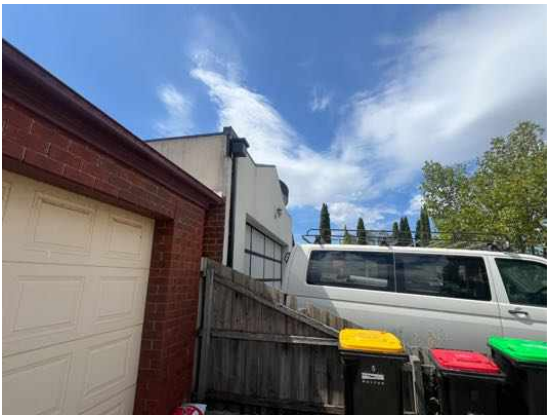
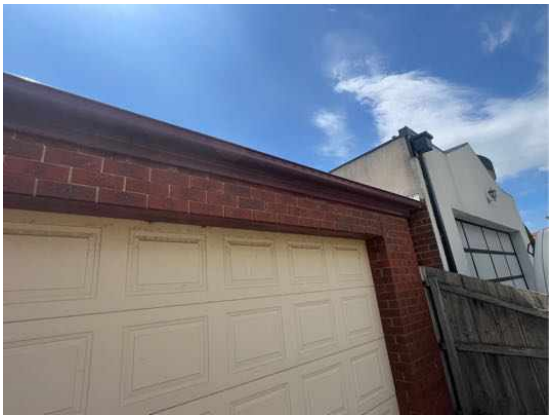
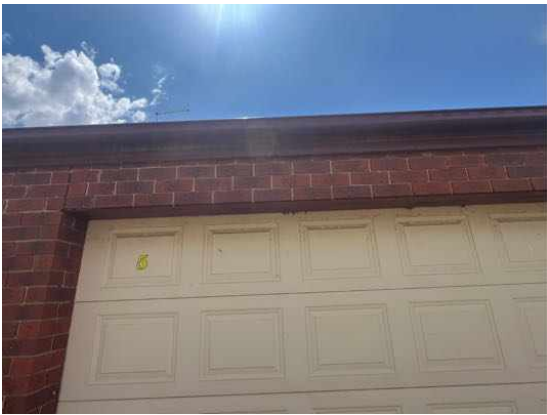
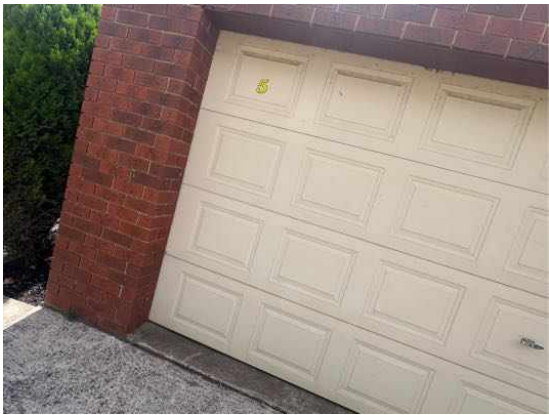
**Noted Item**

Building: Main Building  
Location: Front Elevation > All Areas  
Finding: Additional Photos - Obstructions and Limitations  
Information: These photographs are an indication of the obstructions and limitations which impeded full inspection of the property at the time of inspection. These obstructions can hide an array of defects and should be removed to allow full inspection to be carried out. A re-inspection is recommended once the areas are made accessible.

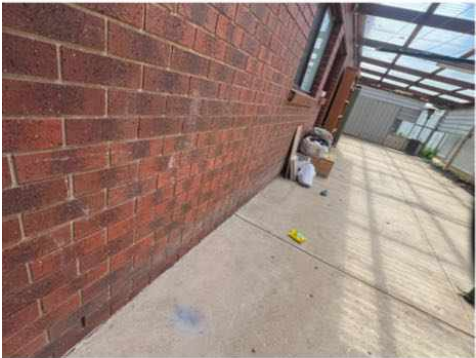
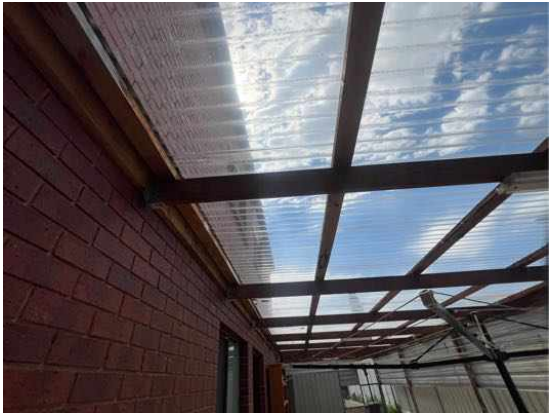
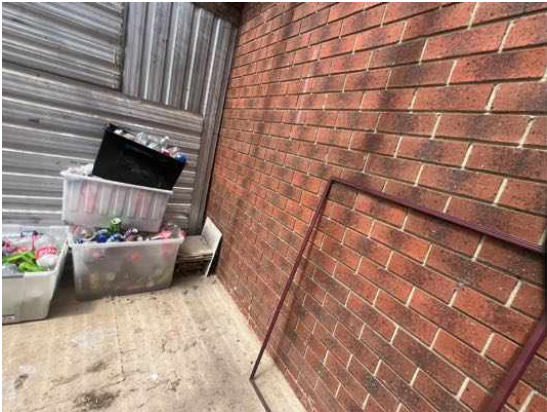
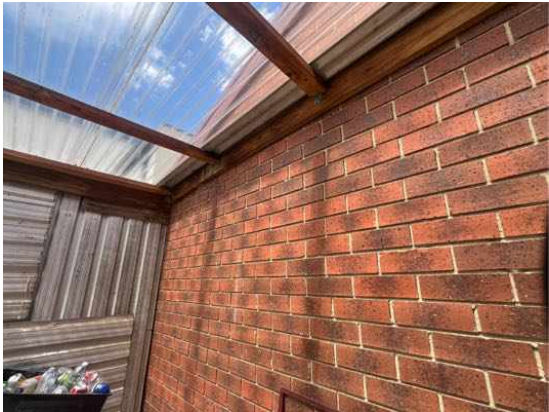
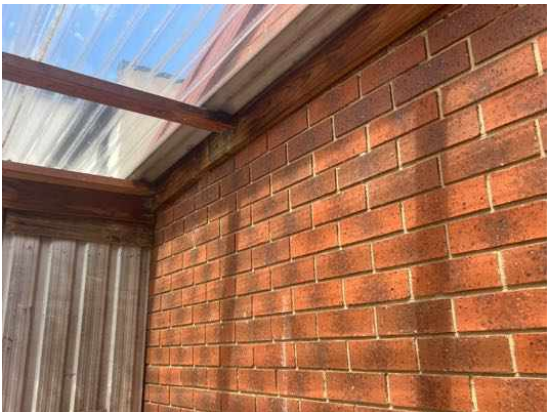
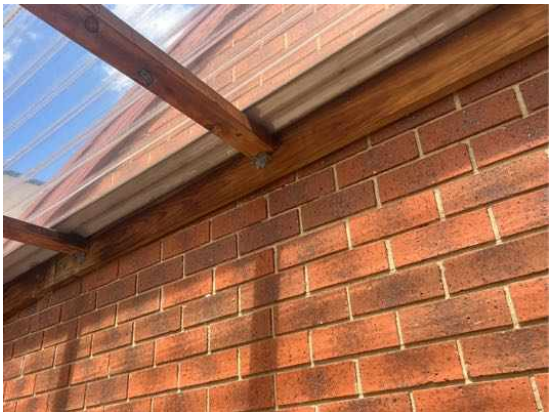
Noted Item

Building: Main Building  
Location: Exterior walls - right side > All Areas  
Finding: Additional Photos - Obstructions and Limitations  
Information: These photographs are an indication of the obstructions and limitations which impeded full inspection of the property at the time of inspection. These obstructions can hide an array of defects and should be removed to allow full inspection to be carried out. A re-inspection is recommended once the areas are made accessible.

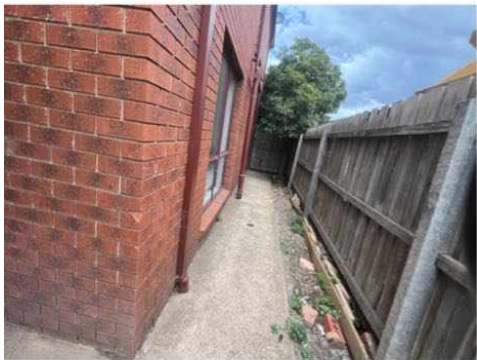
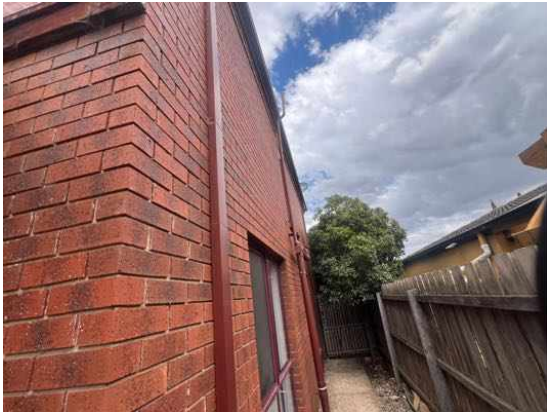
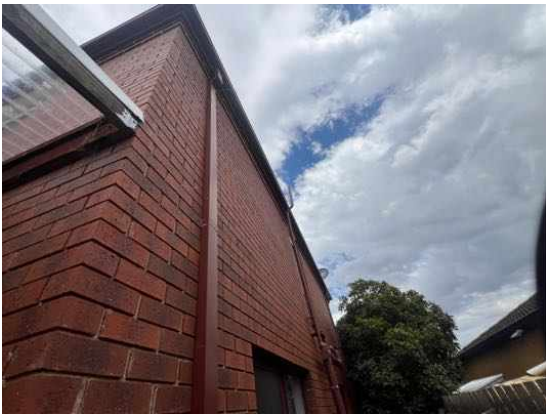
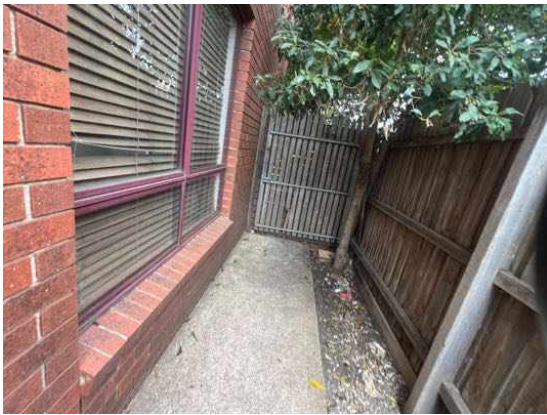
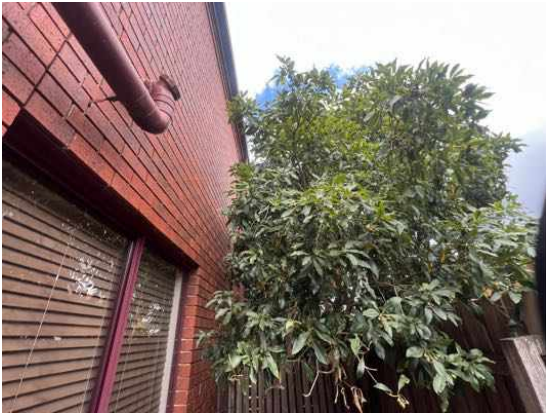
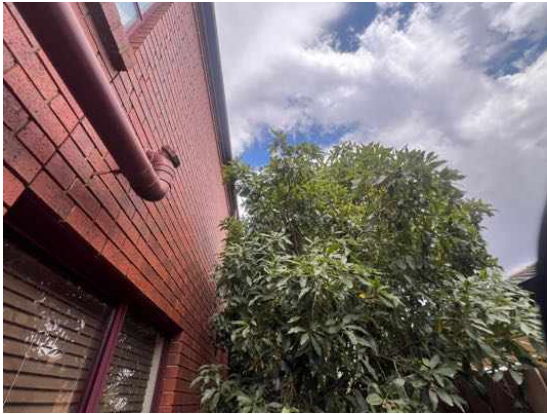
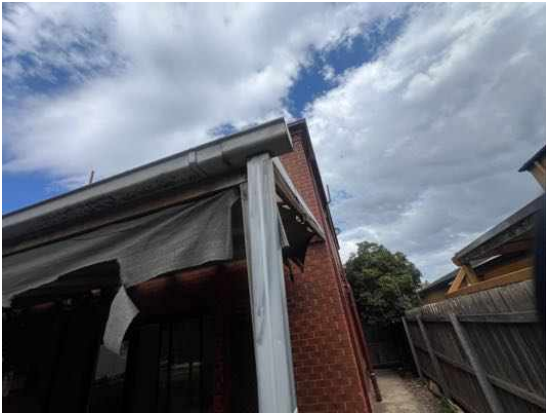
Building: Main Building  
Location: Exterior walls - left side > All Areas  
Finding: Additional Photos  
Information: Additional photos are provided for your general reference

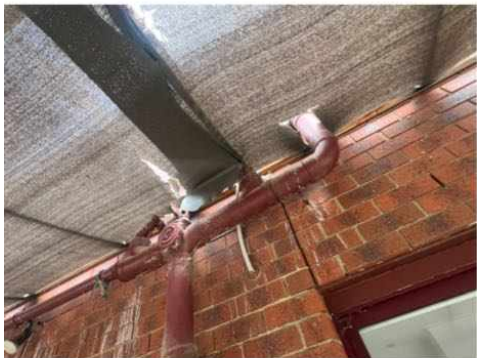
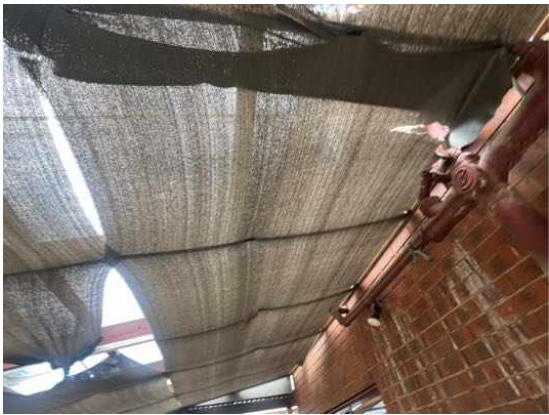
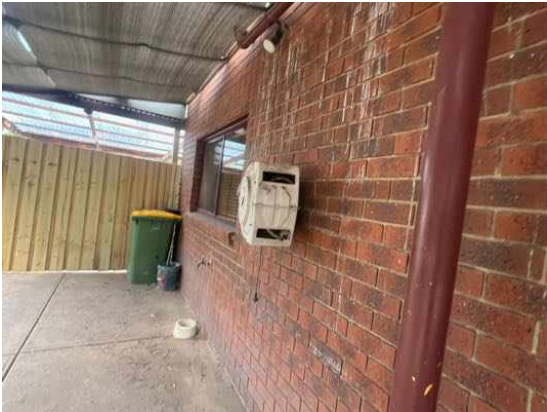
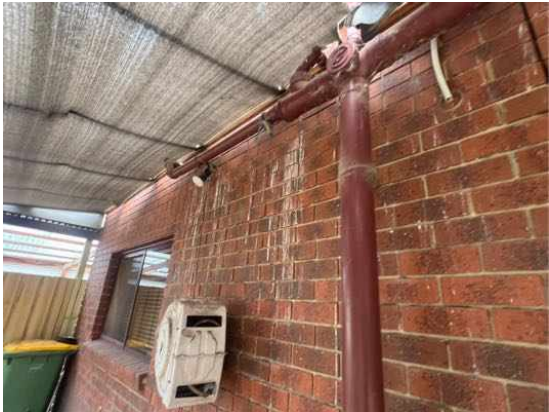
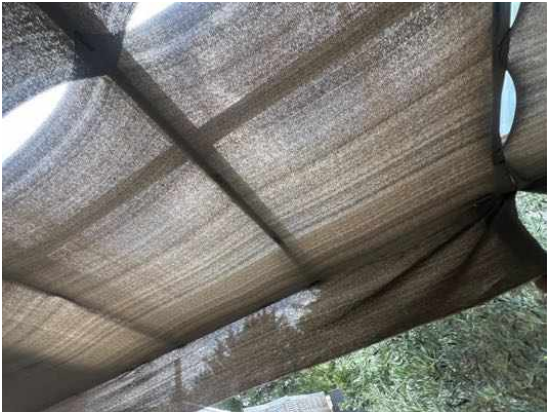
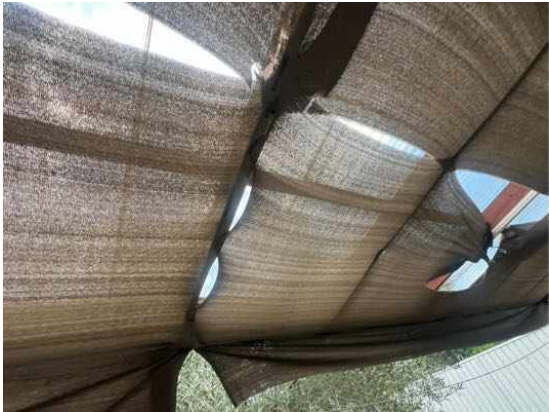
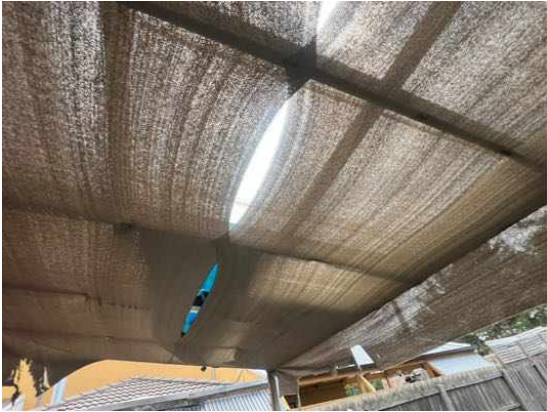
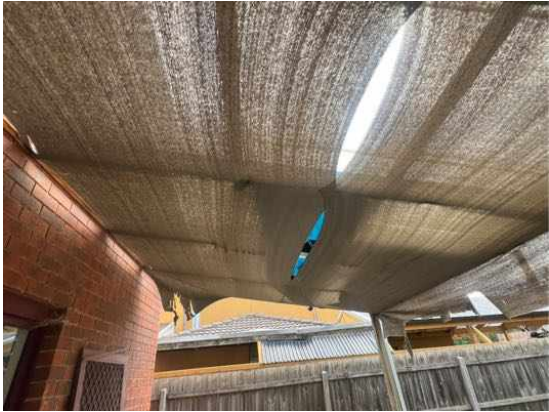
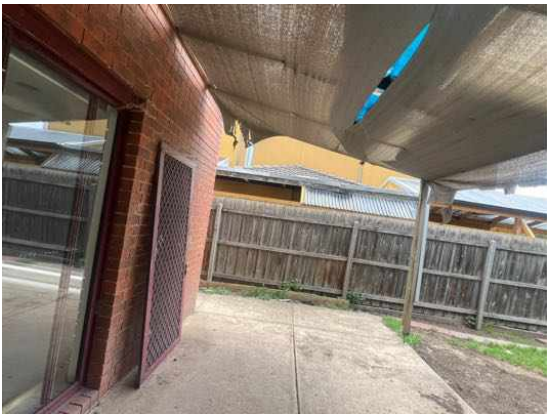
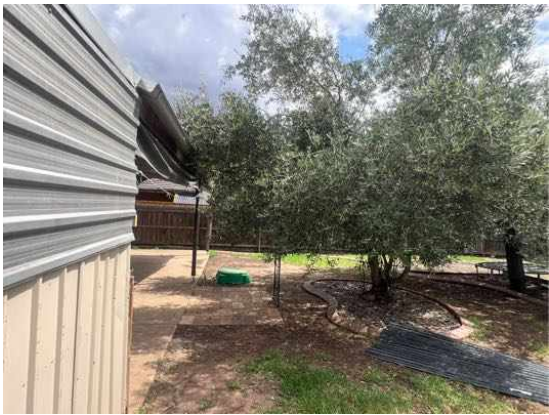
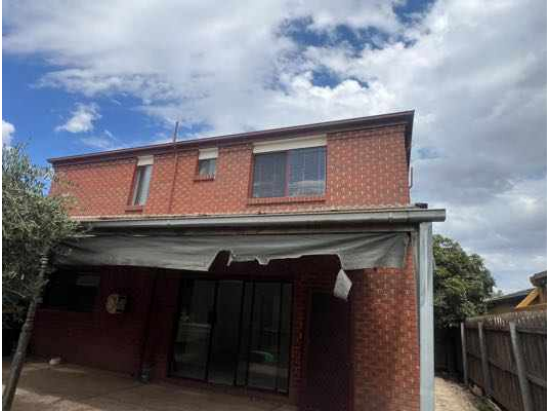
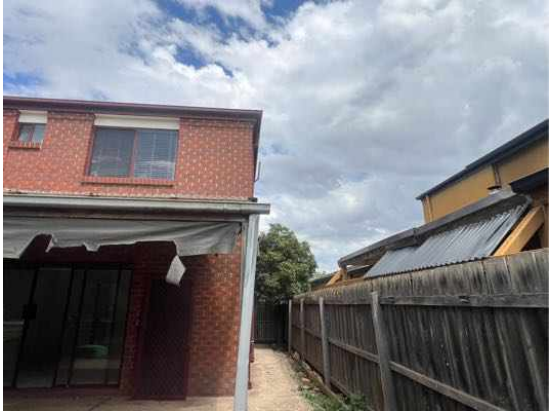
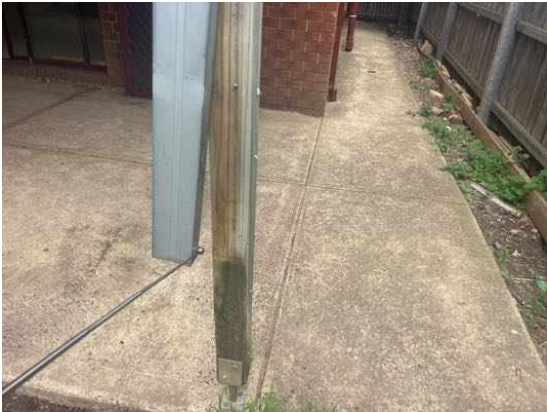
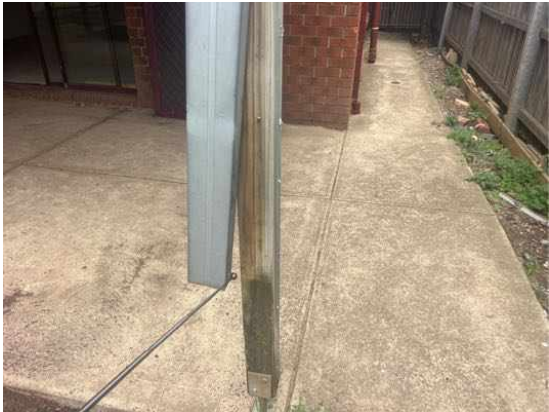
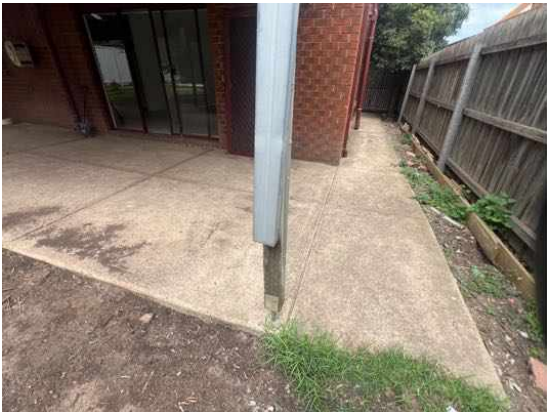
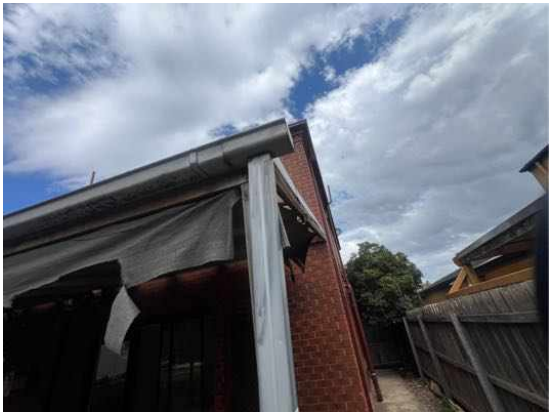
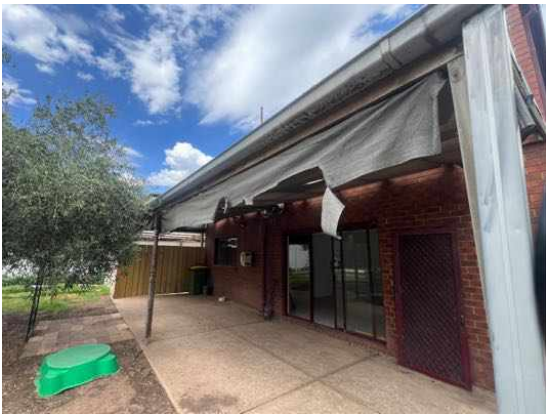
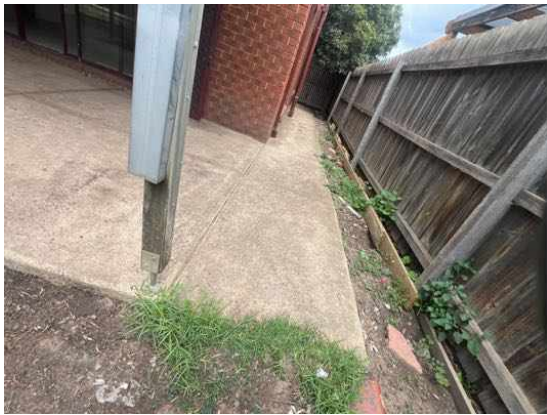
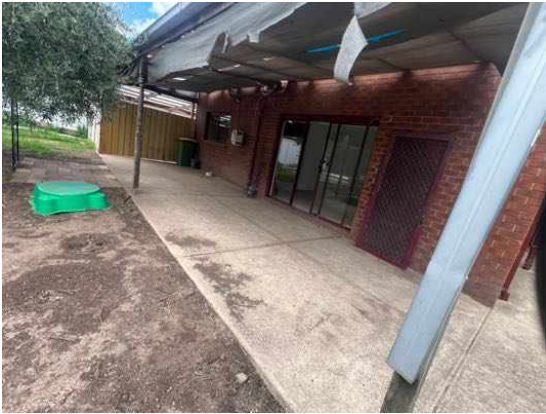
Building: Main Building  
 Location: Pergola > All Areas  
 Finding: Rear -Additional structure built without a permit (Suspected)-pergola enclosed-  
 Information: The pergola structure on the left side of the house is suspected to have been constructed without a building permit. A building permit would be required for the structure.

It is highly advised to request that the current owner provide a Defect report (Owner Builder/Section 137b) for this structure. This would involve a structural engineer or a licenced building surveyor conducting an inspection of the structure and advising of any defects and/or areas of non-compliance in accordance with the current building codes. The current owner should then attend to any issues on this report prior to settlement.

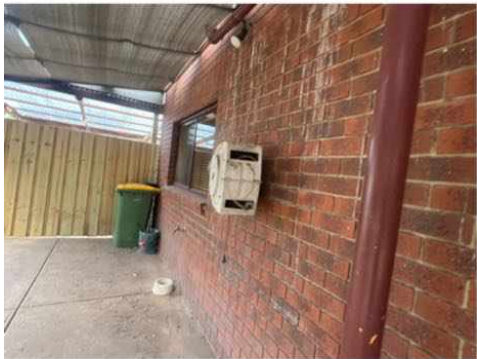
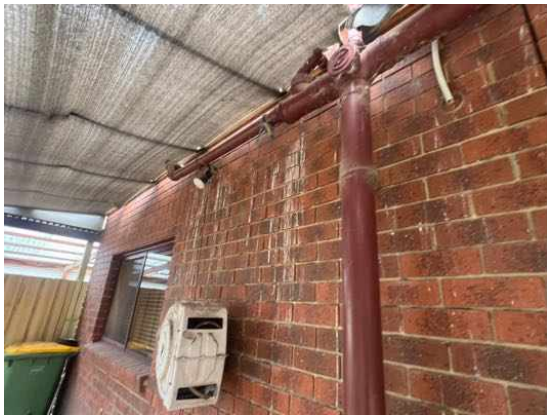
Building: Main Building  
Location: Rear Elevation > All Areas  
Finding: Additional Photos - Obstructions and Limitations  
Information: These photographs are an indication of the obstructions and limitations which impeded full inspection of the property at the time of inspection. These obstructions can hide an array of defects and should be removed to allow full inspection to be carried out. A re-inspection is recommended once the areas are made accessible.
